## Sä Dena Hes Mine, Yukon Territory 2019 Dam Safety Inspection

SRK Consulting (Canada) Inc.  
May 2020

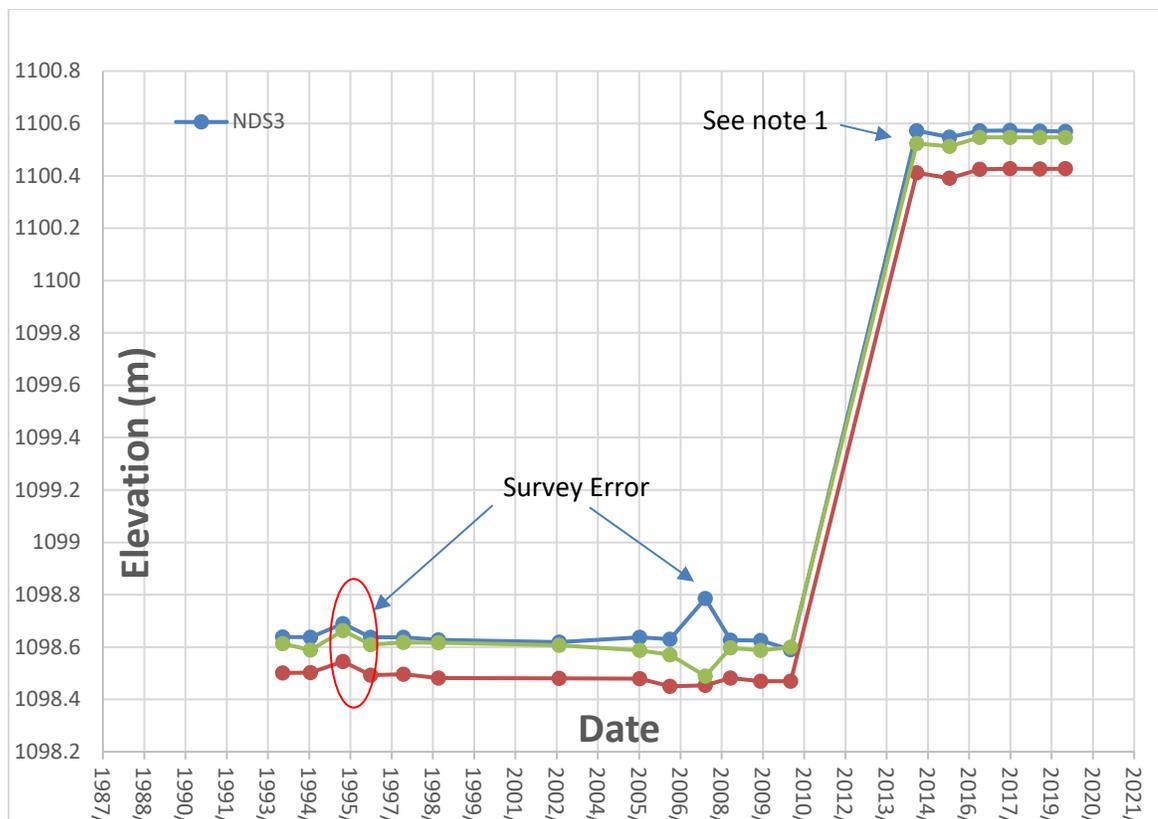
**Figure 13: North Dam Settlements**

Teck has been surveying the settlement gauges on the North Dam since 1993. Results are shown on Table 4-1. The results are elevations taken from the top of the steel pins that were set within the crest of the dam during construction. The last set of readings taken using the 1990 datum was completed in 2010. A recent set of readings was completed in 2017 based on the 2012 datum. The readings are consistent with those observed in previous years, with settlement readings varying to a maximum of 51 mm (or less than 1% of the total height of the dam) from the initial readings taken in 1993. The recorded settlements are considered normal deformation for a small earthen dam and would not compromise the structural integrity of the dam. In the last 3 years, the settlement changes have been less than 1 mm.

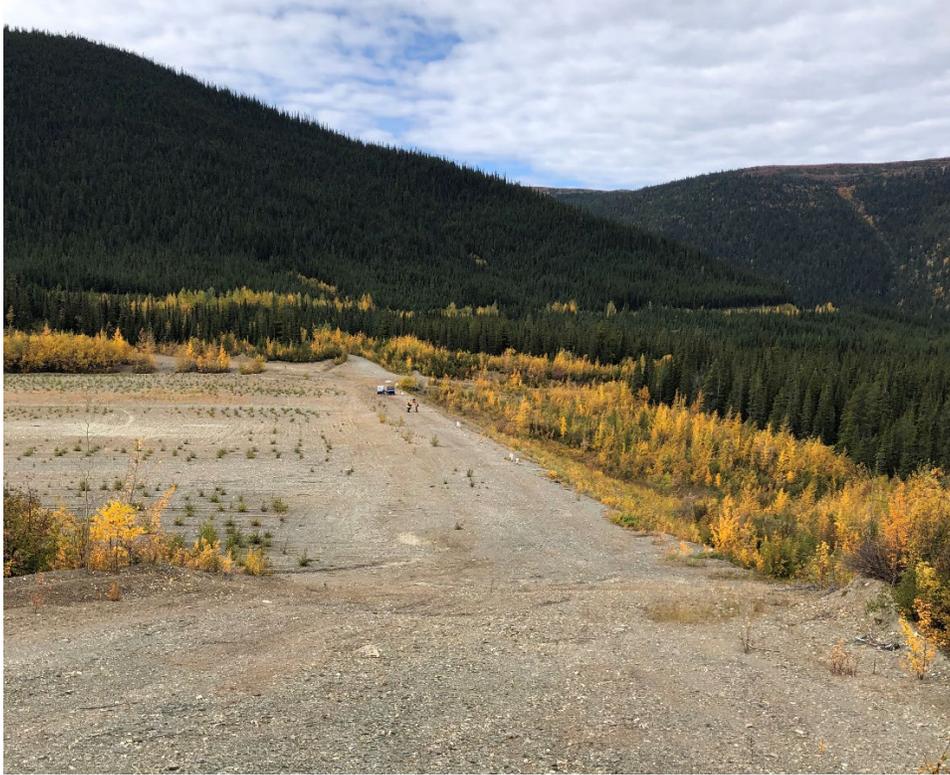
The crest of the North Dam looking west is shown in Photo 1 (Appendix A). The dam is in good condition and shows no signs of deformation or abnormal settling. The downstream slope of the dam (Photo 2) shows no signs of surficial movement or erosion nor is there any sign of bulging at the downstream toe. While there are a few shrubs and small trees on the slope, no excessive vegetation growth beyond the guidelines in OMS was noted.

Photo 1: North Dam Crest looking west

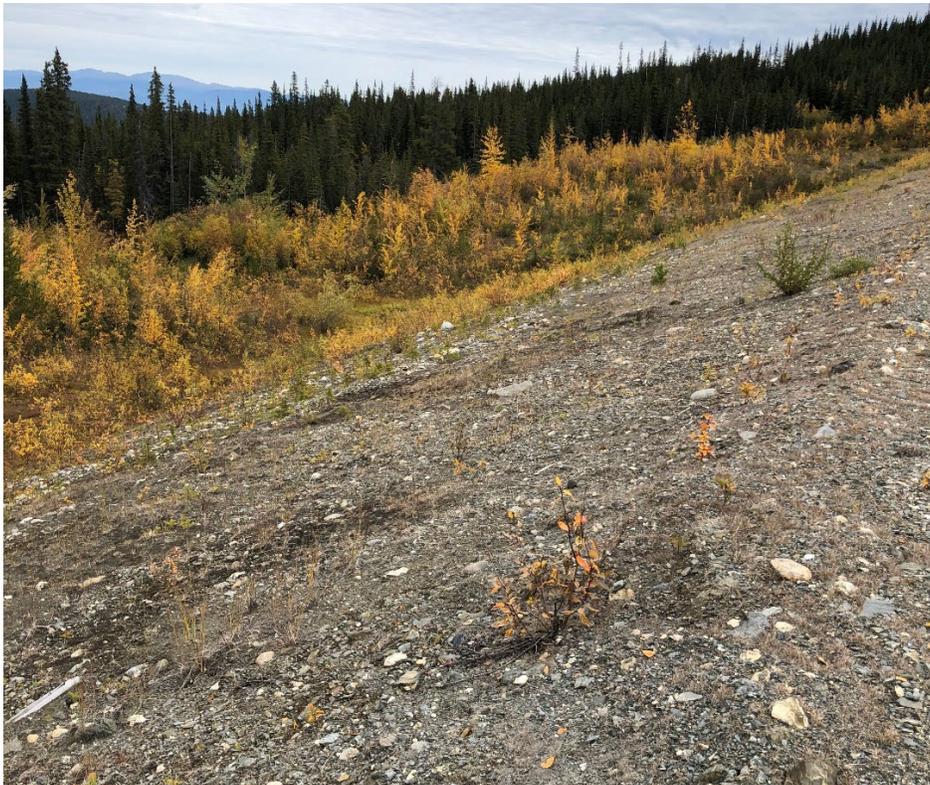
Photo 2: Downstream slope of the North Dam looking east

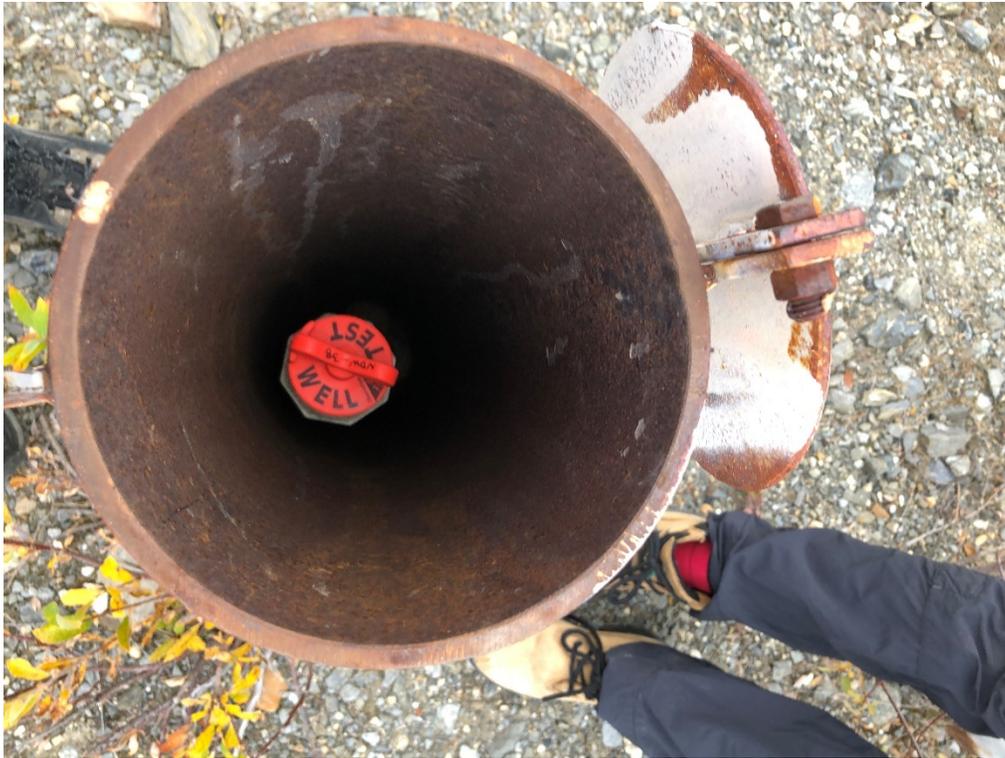
The piezometers and settlement gauges (Photos 3 and 4) on the North Dam are in good condition and continue to function as designed. Orange coloured piezometer caps provide visible identification for the monitoring team.

Photo 3: Typical North Dam Piezometer

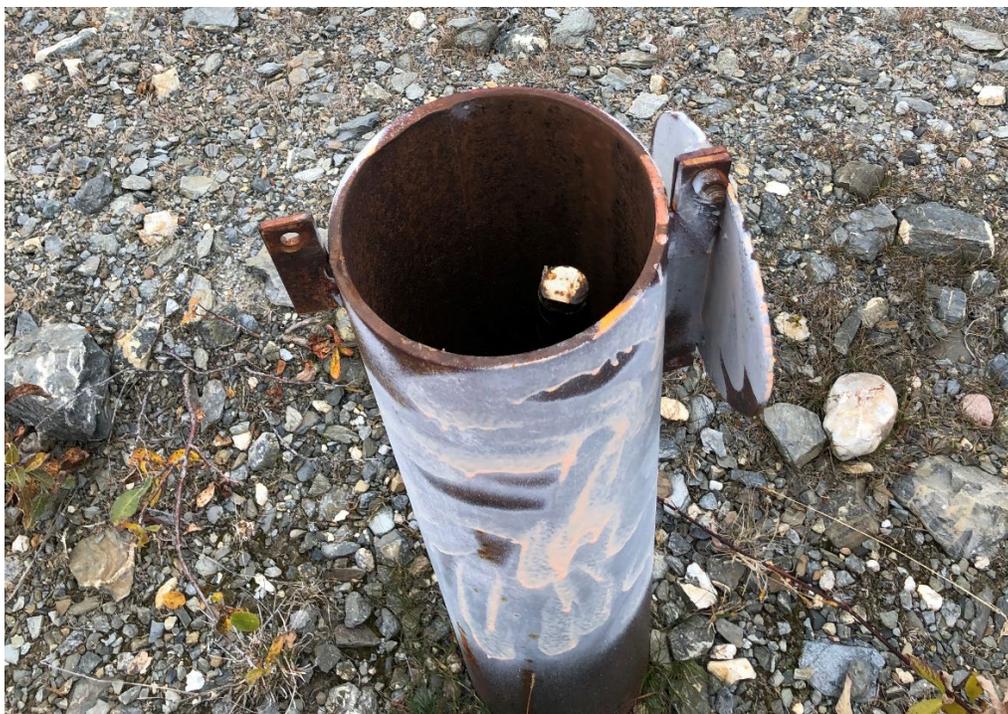
Photo 4: Typical Settlement Gauge.

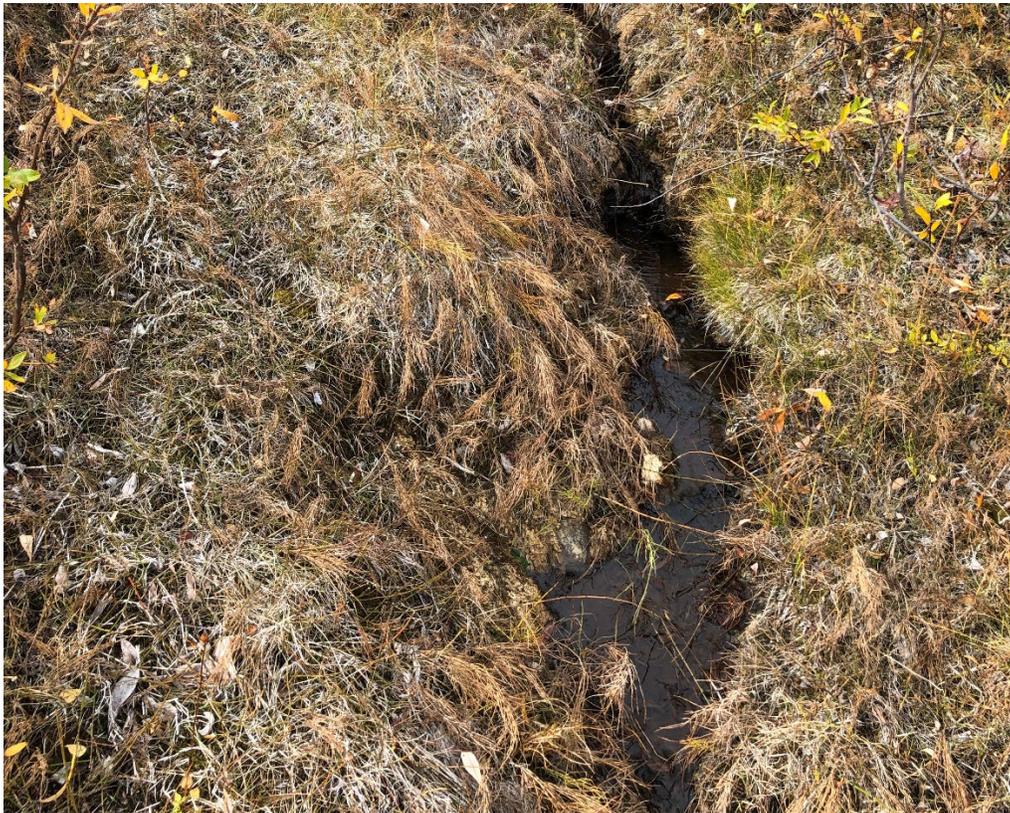
Photo 6: Seepage at toe of North Dam, mainly due to hillside springs

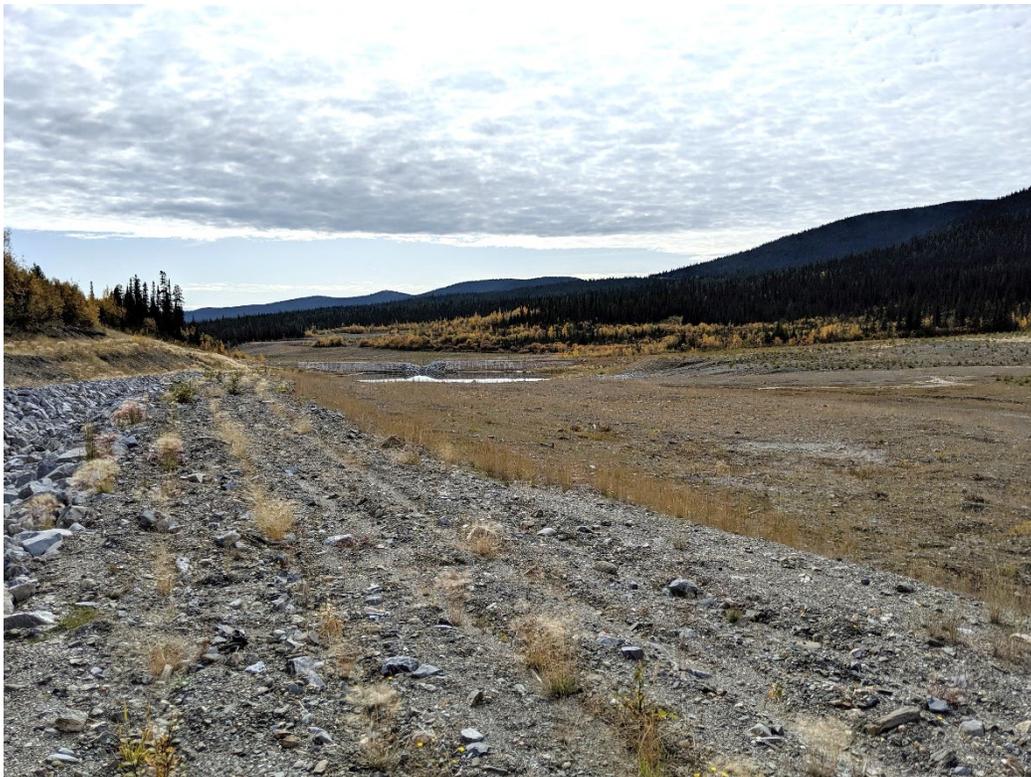
The North drainage channel upstream of the SRS (Photo 12) remains in stable condition with no noticeable subsidence.

Photo 12: View south at the SRS pond in background with North Diversion on the left

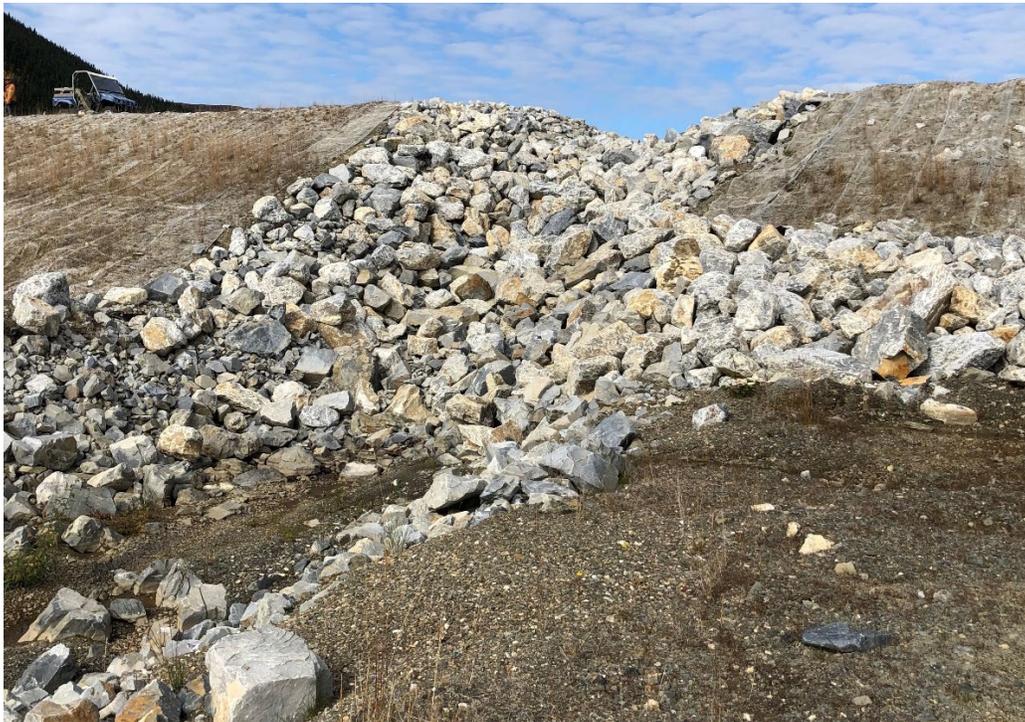
The emergency spillway at the SRS is stable and has no safety concerns (Photo 15). The plunge pool shown in Photo 16 provides adequate capacity to accommodate any high flows over the spillway. Seepage from the hillside area to the east of the structure is still evident along the downstream toe of the SRS (Photo 17). A small active boil (Photo 18) that has been noted in previous inspections was still present. This boil is a remnant of pore pressures that were evident during and after the construction of the South Dam which prompted the construction of a toe buttress. The pore pressures were a result of the hydraulic gradient across the dam due to the stored water in behind the embankment. The pore pressures were accentuated by the sand and gravel zones in the foundation soils below the dam. Since the removal of the South Dam, the pore pressures have significantly reduced, but the small head of water due to the retained pond behind the SRS dike is the likely source of the small boil.

Photo 15: View looking north (upstream) of the SRS emergency spillway

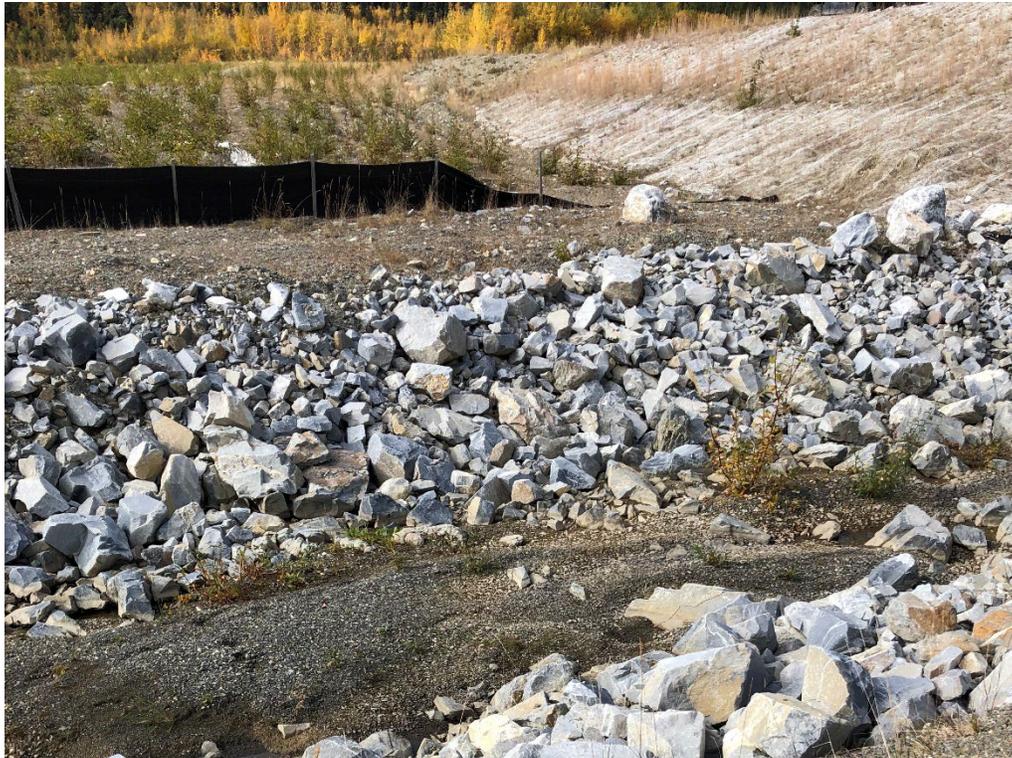
Photo 16: Plunge pool below SRS spillway

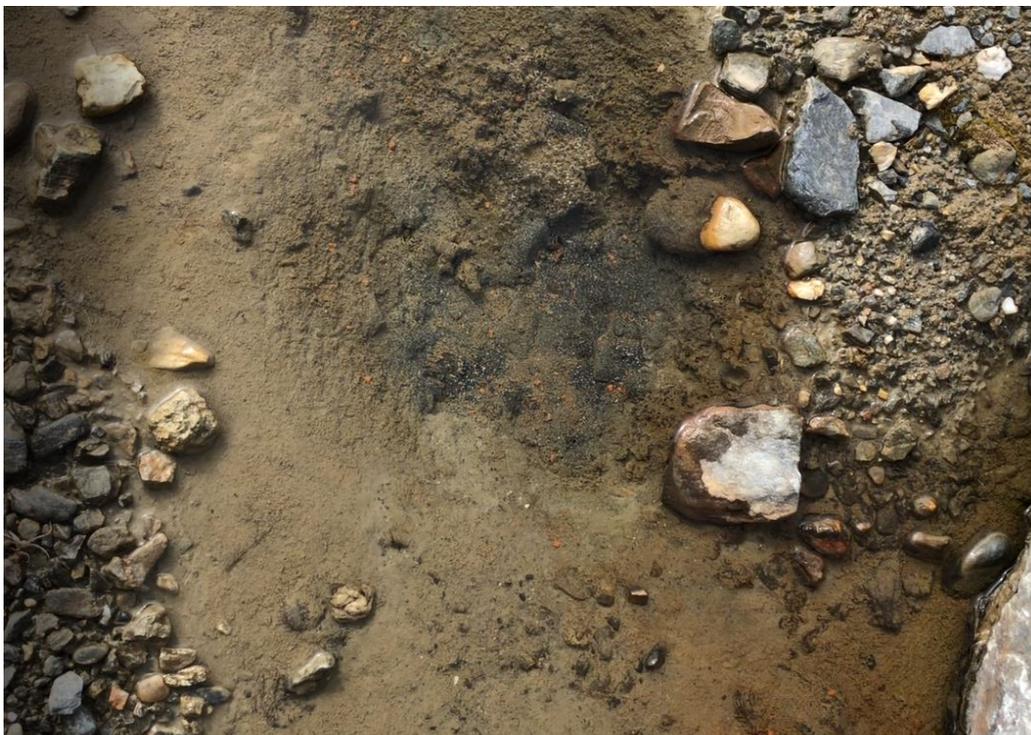
Photo 18: small boils at toe of SRS. Due mainly to local spring activity.

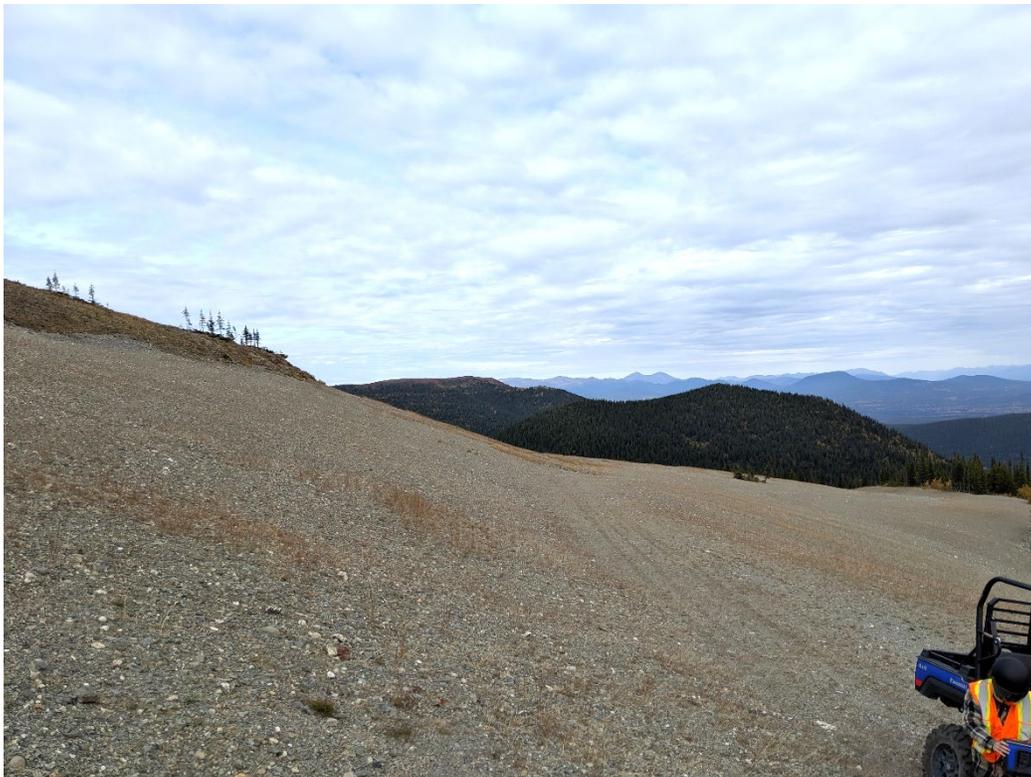
SRK inspected the resloped Main Zone and Jewelbox waste dumps (Photo 24) shown in Figure 12. It was noted that at the northeast end of the JewelBox dump, there was evidence of some erosion (Photo 25). SRK had recommended in the 2018 DSI that additional monitoring pins be installed to monitor any deepening of the gully over time. It was noted during this inspection that the gully had not deepened and there was no impact on the stability of the dump.

Photo 24: Regraded slopes of Jewelbox waste rock dump

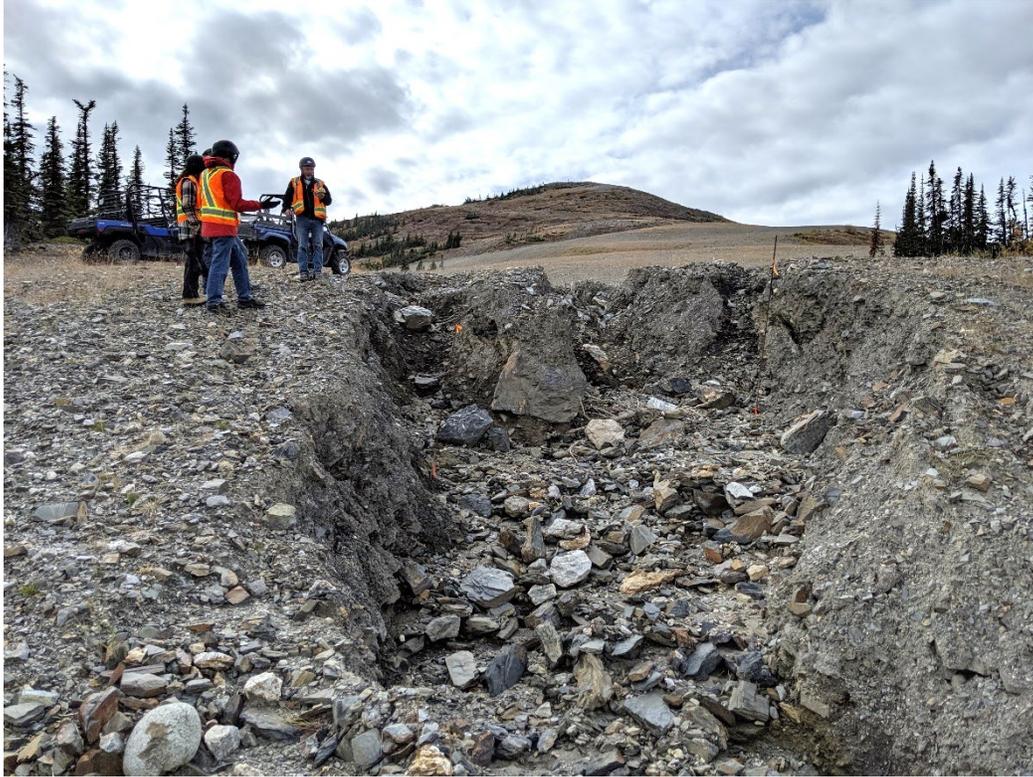
Photo 25: Erosion gully at toe of Jewelbox Waste rock dump

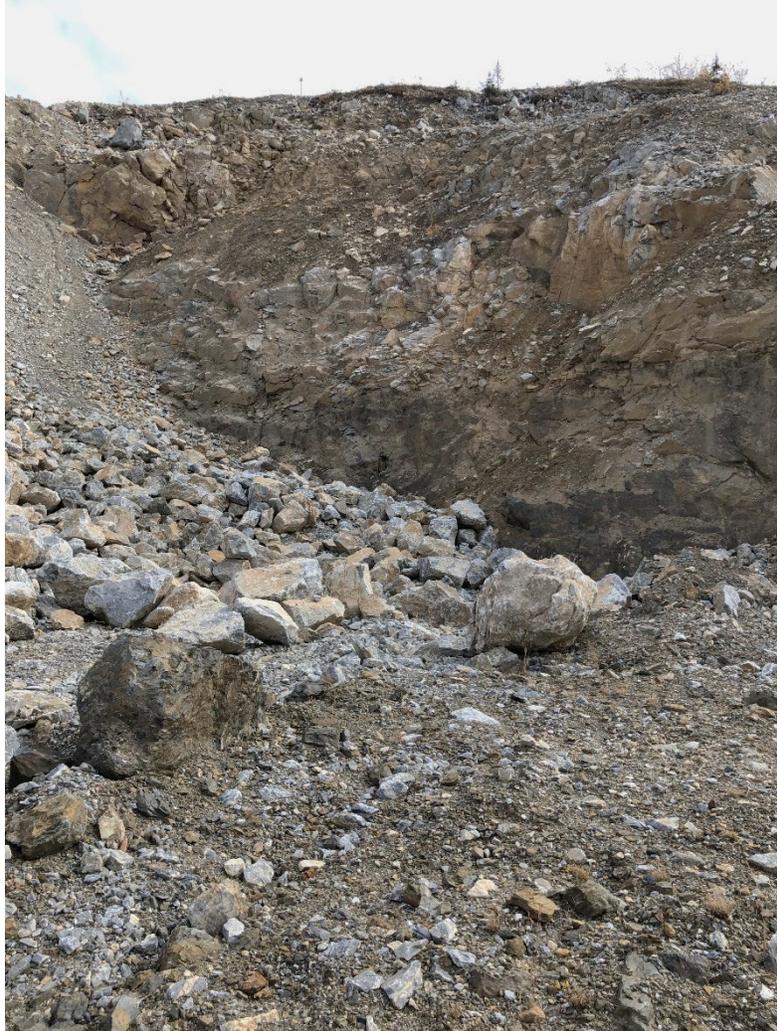
Two to three shallow openings were observed in the pit wall at the Main Zone area. These openings may have been caused by internal subsidence but currently do not pose a safety concern.

Photo 26: Pit wall above the 1380 Portal at the Main Zone

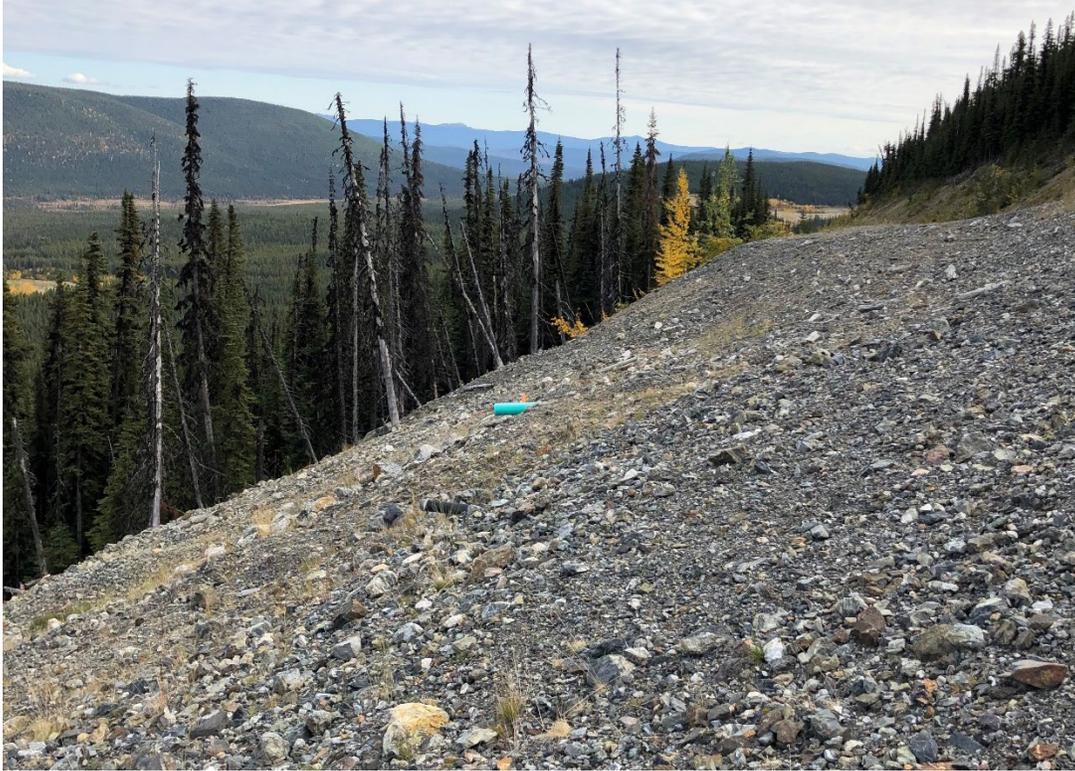
Minor settlement of the fill that was placed over the 1200 portal was noted during the 2017 and 2018 inspection. Minor cracking in the fill caused by the expected settlement of the fill was observed this year. No action is required.

Photo 27 Burnick waste rock dump at 1200 level
