**Teck Metals Ltd.**

**Sullivan Mine Tailings Facilities**

***2019 Dam Safety Inspection***

A05807A19

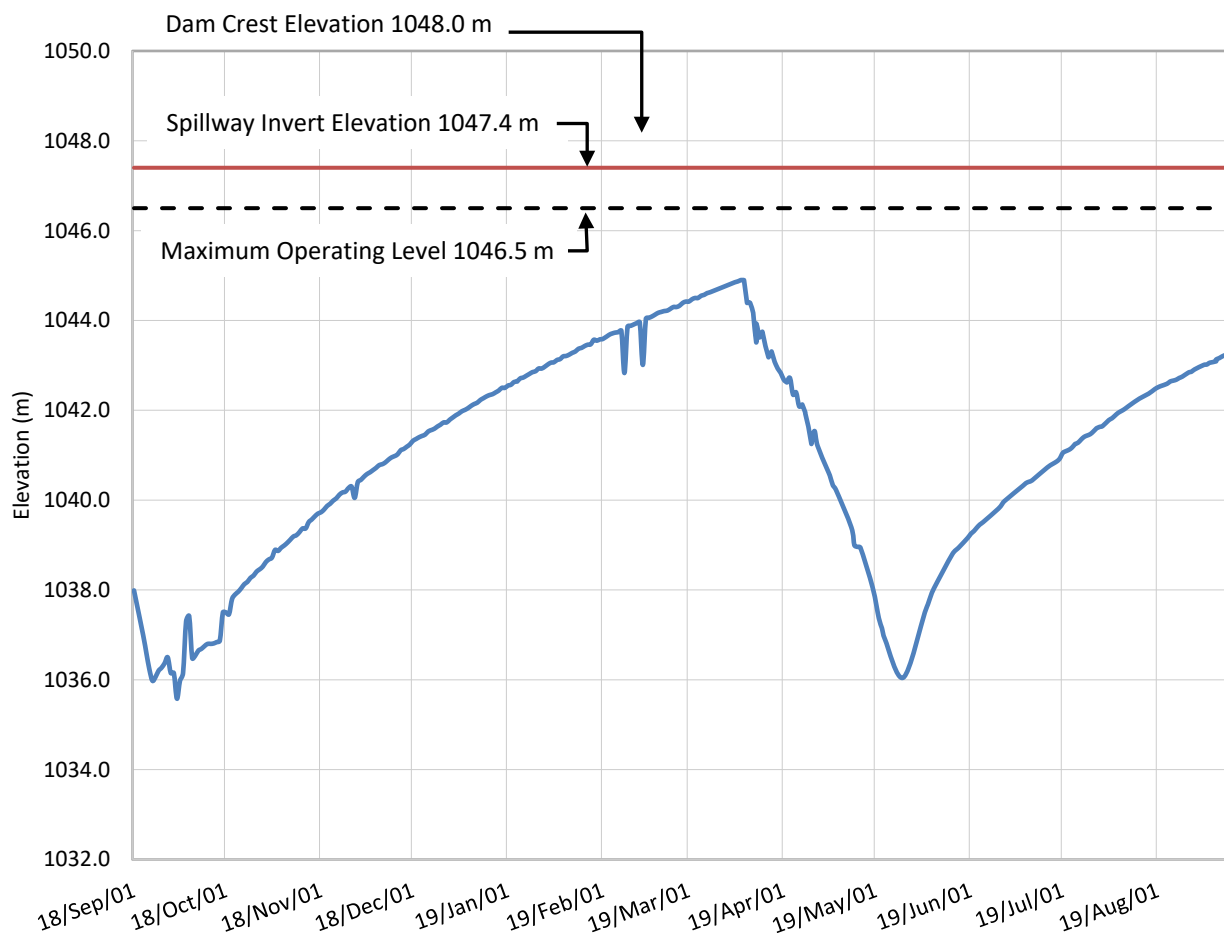
**Figure 3.2 ARD Pond Level 2018 – 2019**

Based on the pond water levels, the maximum level observed during the reporting period was El. 1044.9 m, which occurred on March 18, 2019. This is 1.6 m lower than the maximum operating level (MOL) and is 2.5 m below the spillway crest elevation (spillway flows report to the Iron Pond). There was no water discharged from the ARD Pond spillway to the Iron Pond during the water balance time period.

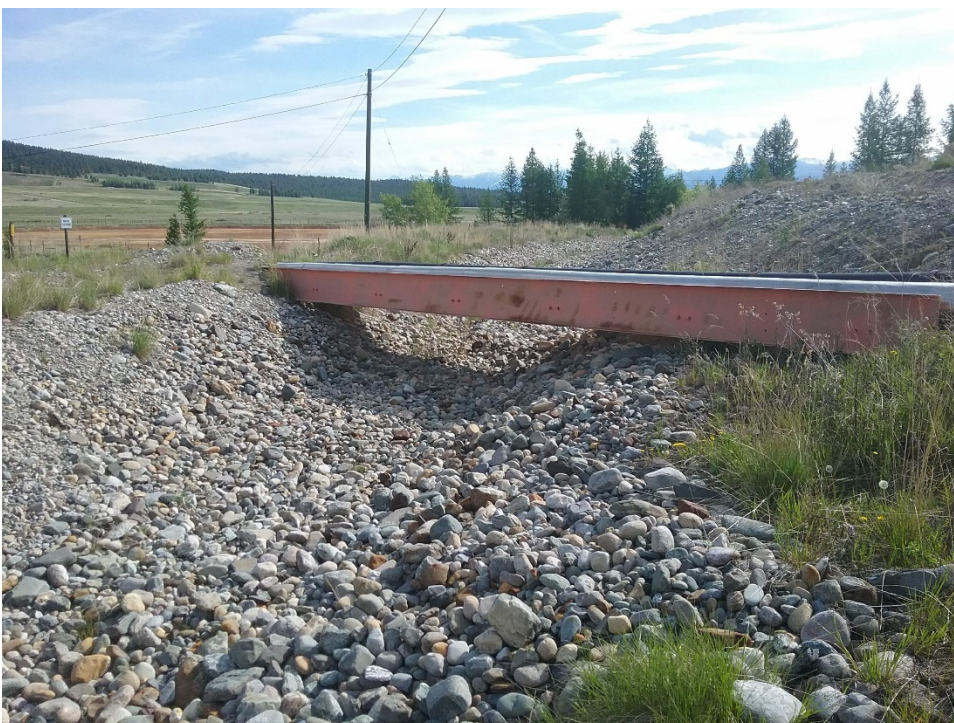
**Photo 1.13 Animal Damage on Slope of ARD Spillway and Pipe with cover removed (246)**

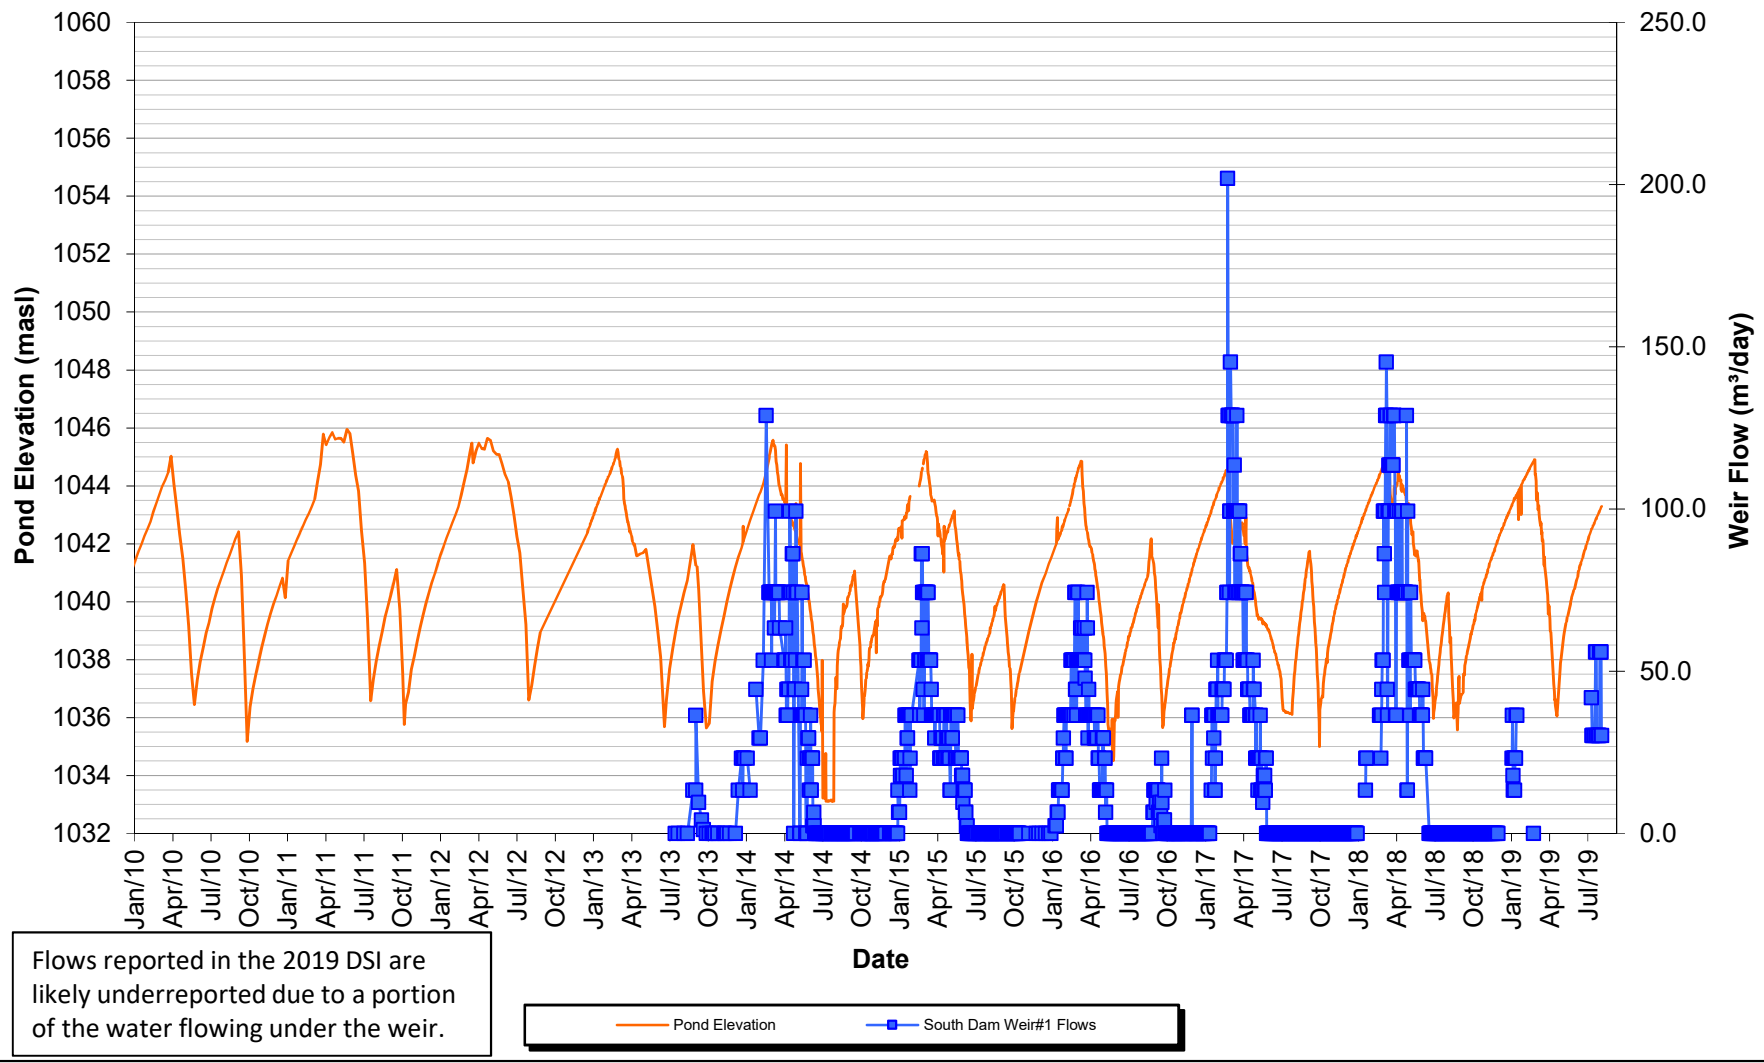
ARD POND

Flows reported in the 2019 DSI are likely underreported due to a portion of the water flowing under the weir.

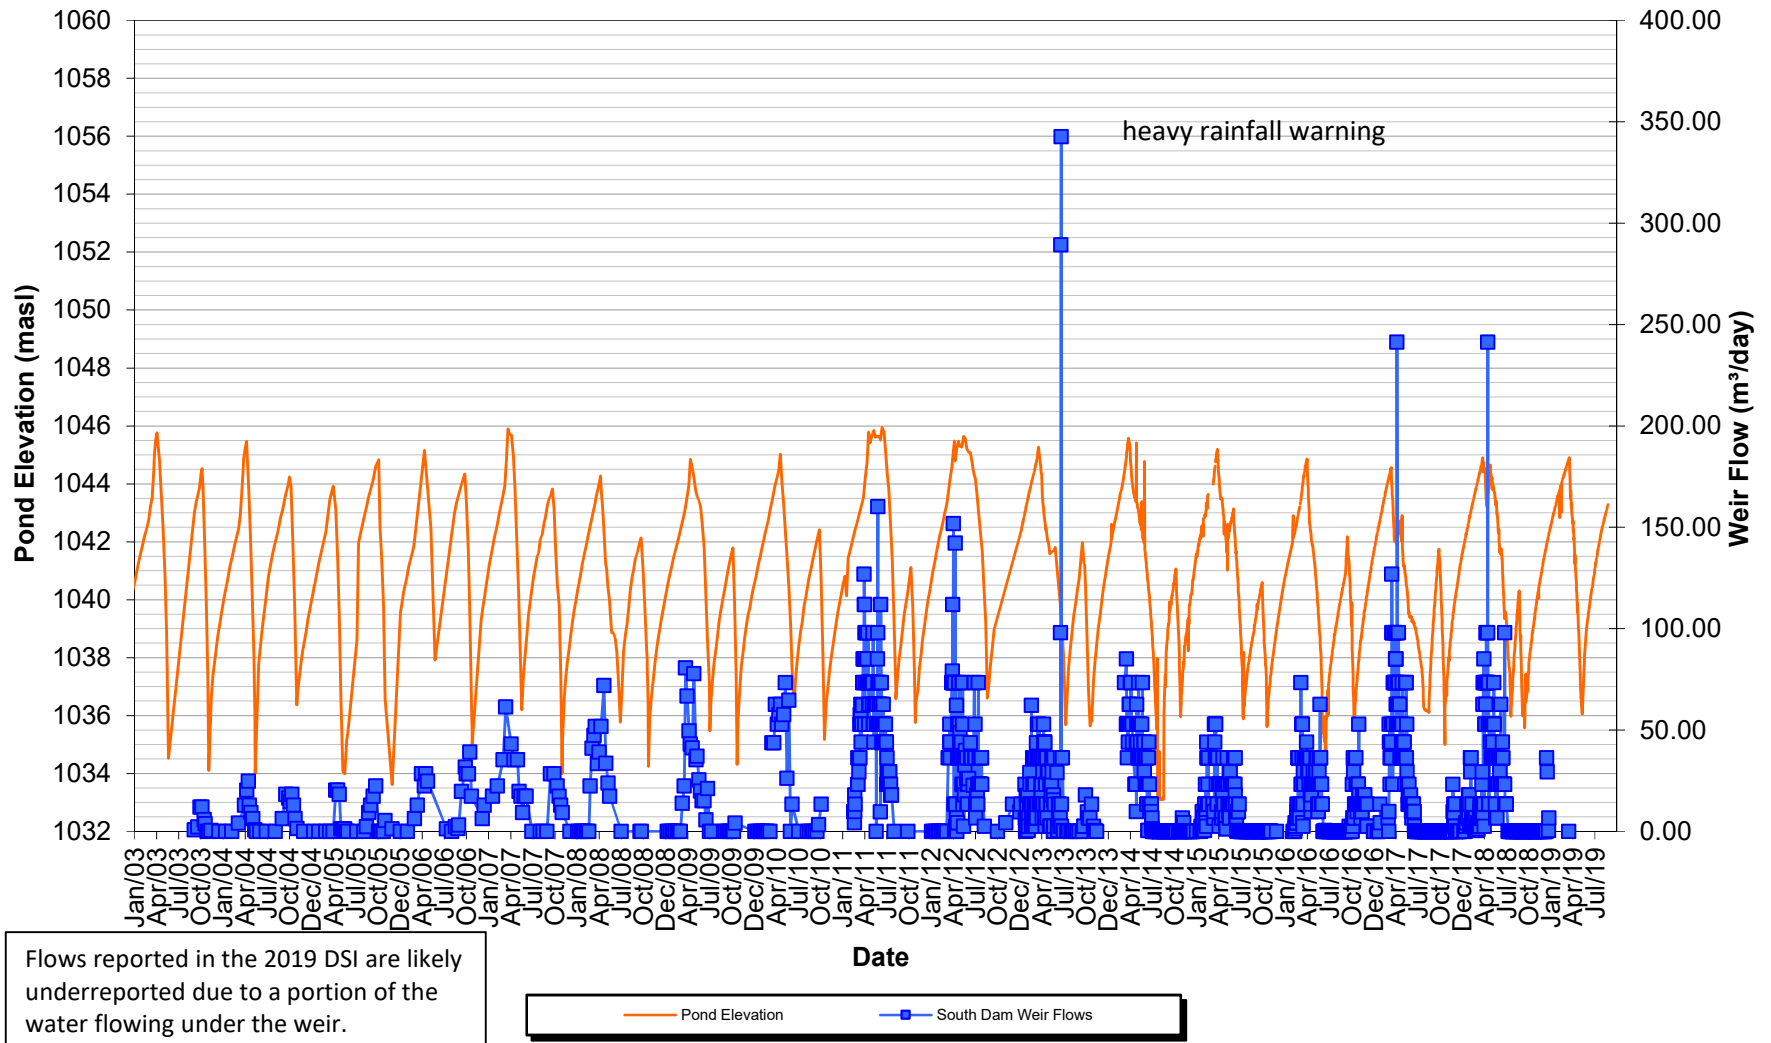
ARD POND

Flows reported in the 2019 DSI are likely underreported due to a portion of the water flowing under the weir.
