Teck Highland Valley Copper Partnership

2019 Dam Safety Inspection Report

Trojan Tailings Storage Facility

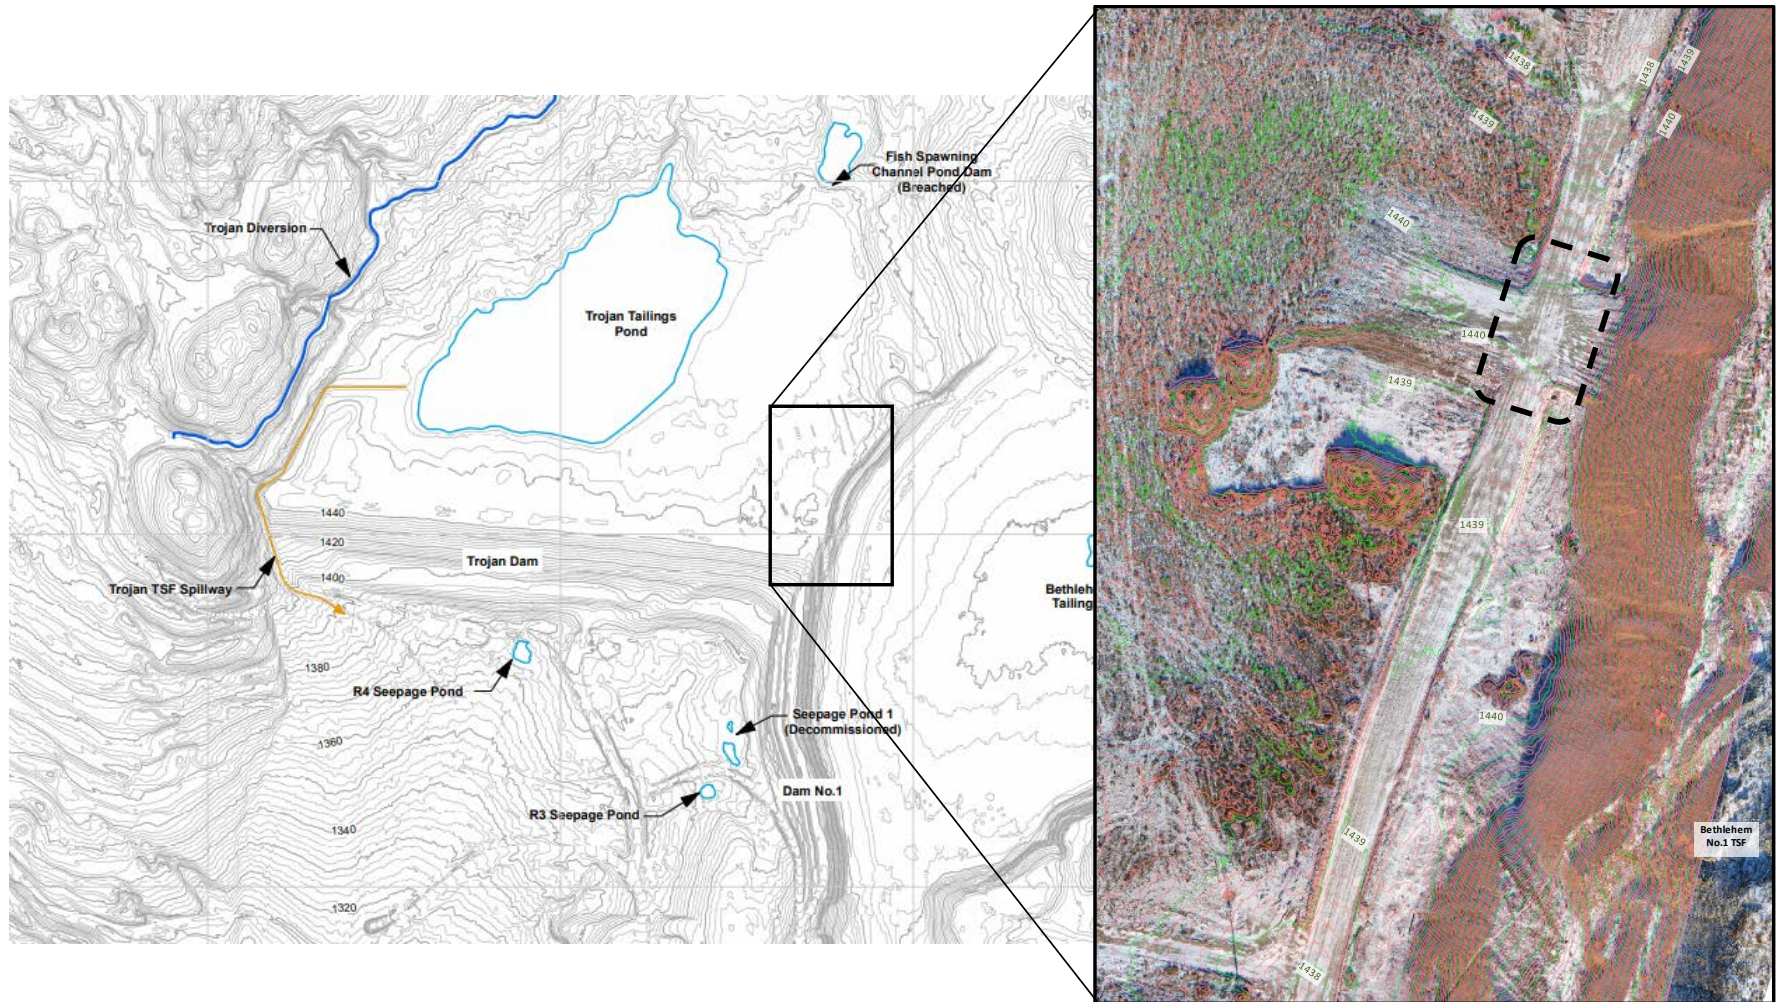
Figure 3.1 Area of Access Road at Left Abutment Raised in 2019 (Dashed Black Line)

- THVCP raised the access road, near the left abutment of Trojan Dam, to El. 1440 m in the area shown on Figure 3.1. This increased the freeboard in this area as discussed in Section 4.5. (Recommendation DSI-2018-01, Table 8.1).
- THVCP repaired the two rill erosions on the left bank of spillway channel (along riprap section) which closes out DSI recommendation (DSI-2018-01, Table 8.1).

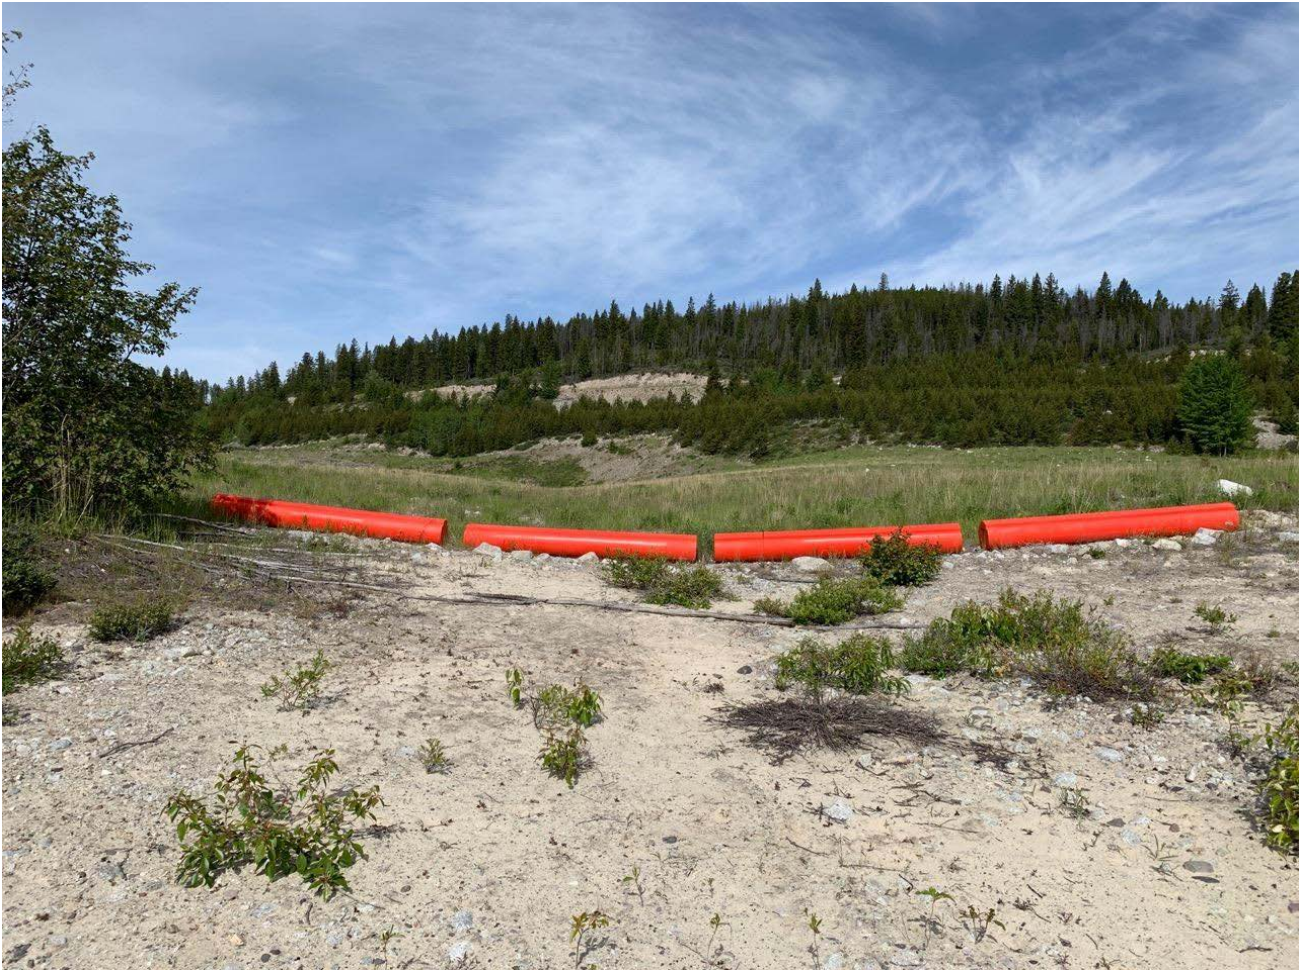
**Photo II-A-10 Trojan spillway inlet. Approach channel is clear and debris boom is secured.
(TRJ-2019-06)**

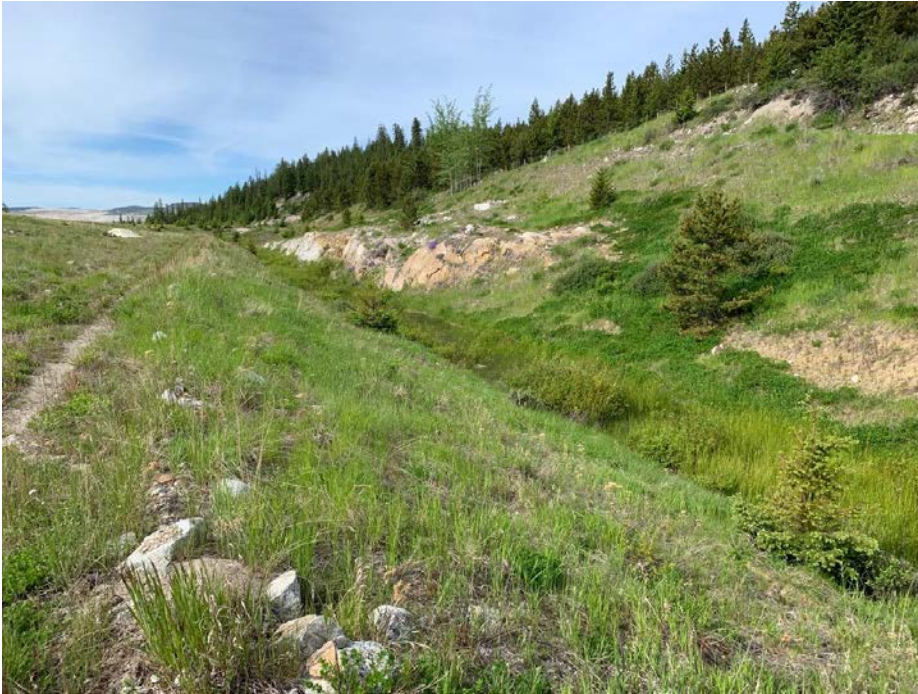
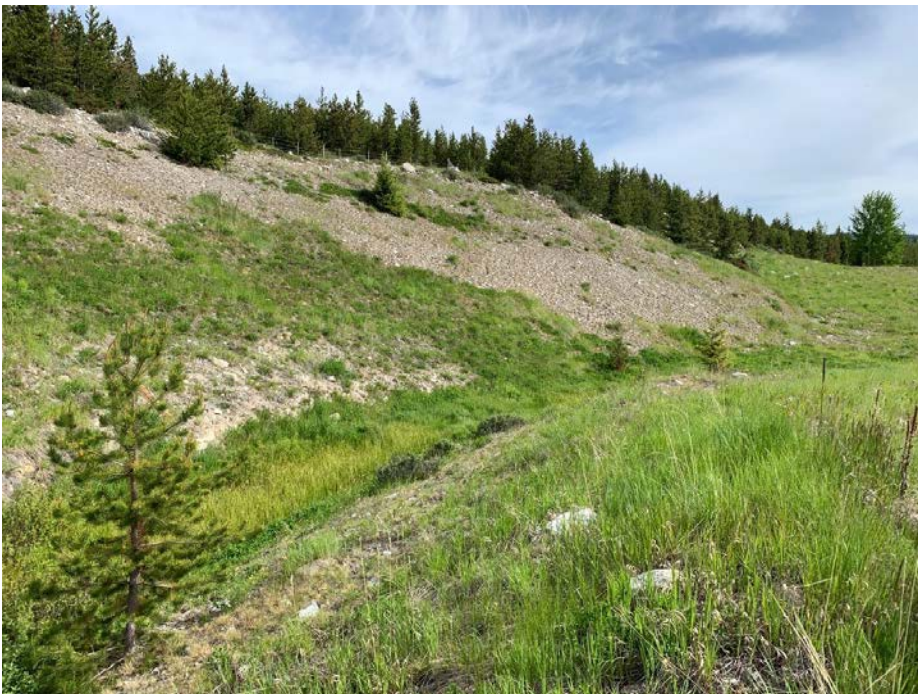
Photo II-A-11 Overview of first length of spillway channel, looking toward southwest (top photo) and looking toward northeast (bottom photo). No sign of recent flow or weathering / disruption of riprap was observed. No evidence of sloughing of cut slopes was observed. Channel is heavily vegetated and should be cleared as part of routine maintenance (TRJ-2019-07)

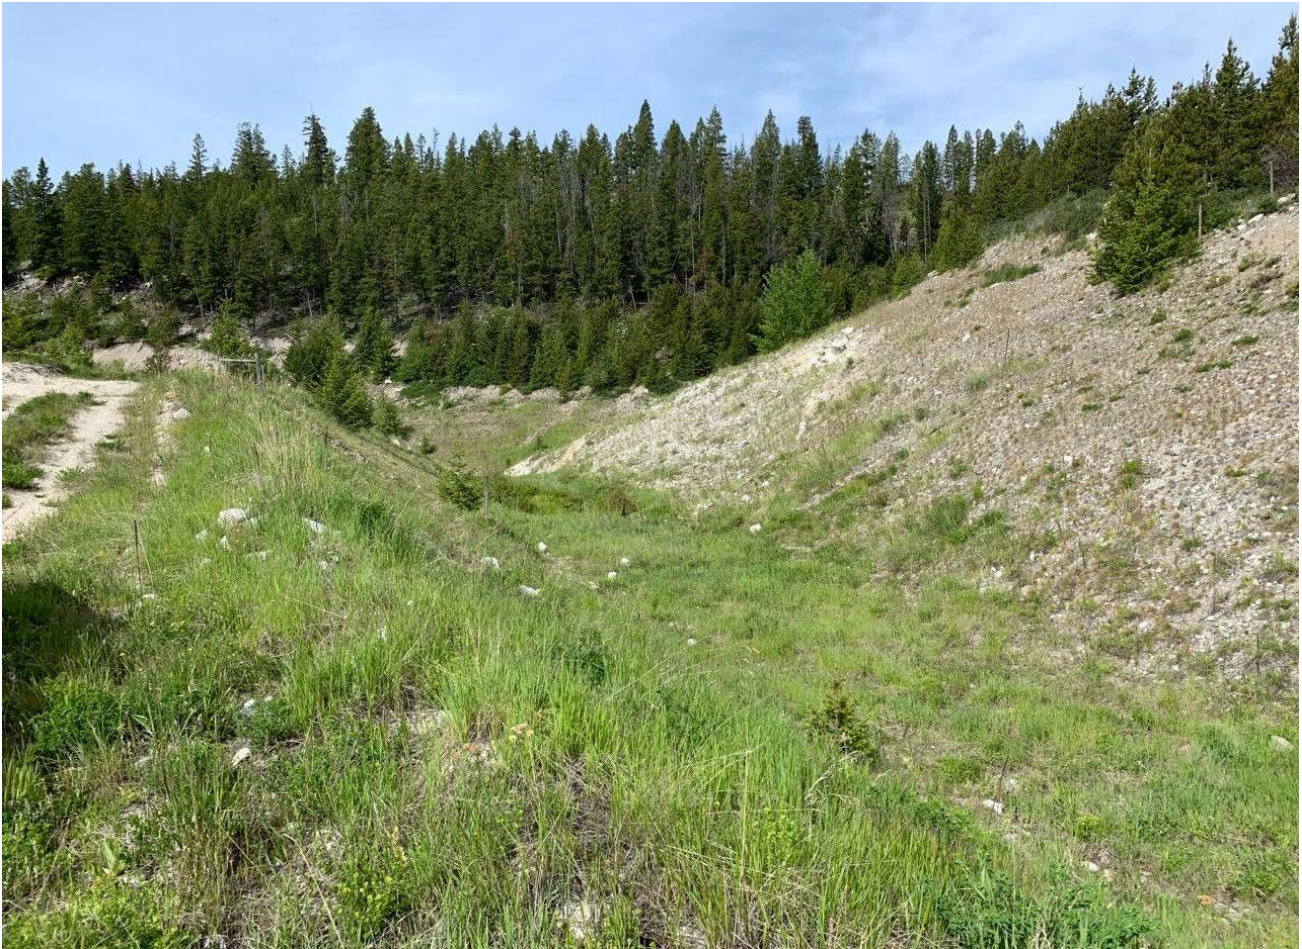
**Photo II-A-12 Overview of spillway channel, downstream of chute. Slopes are in good condition.
(TRJ-2019-08)**

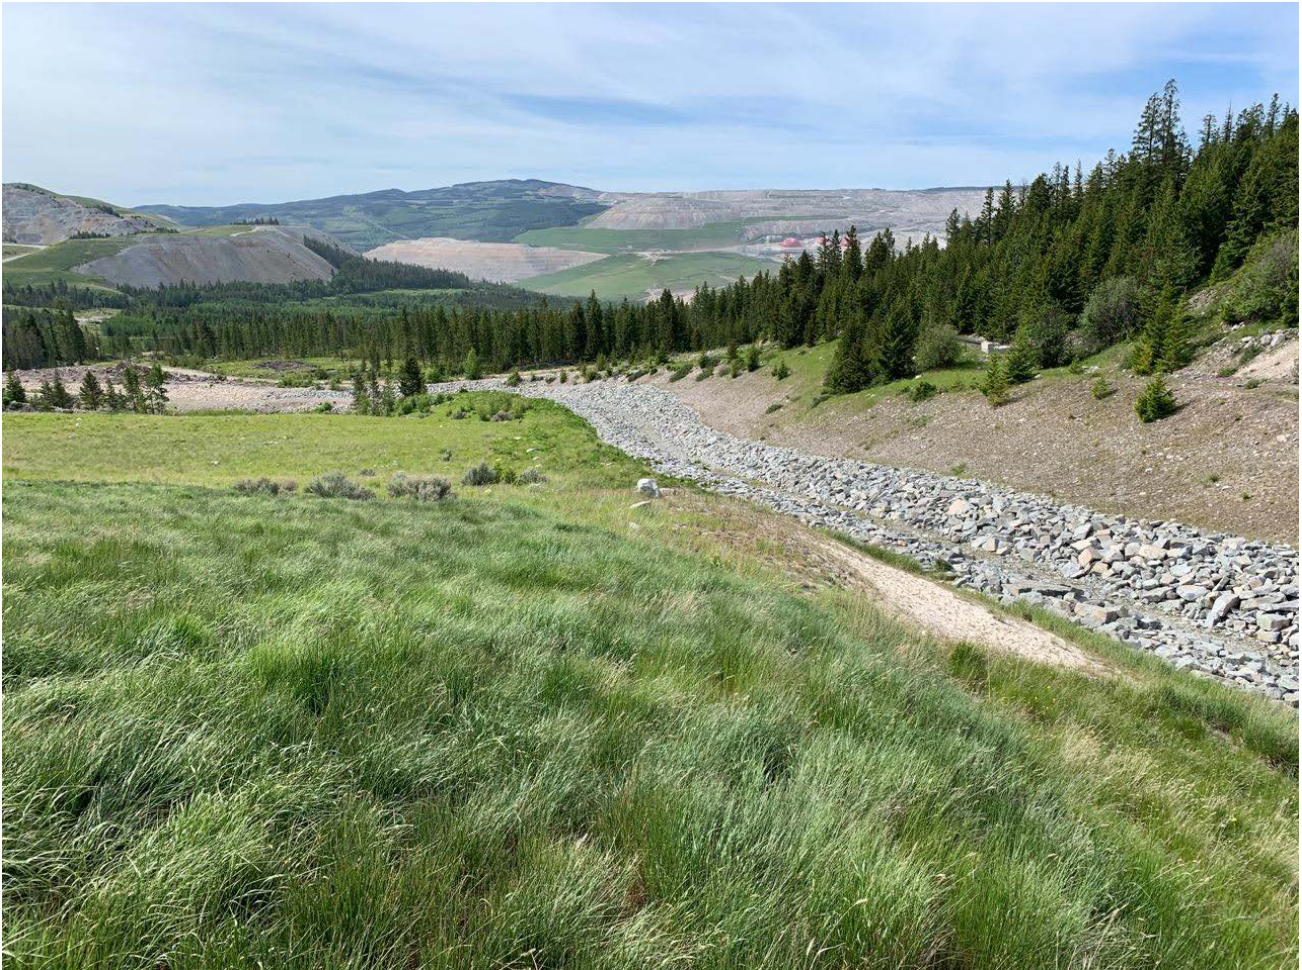
Photo II-A-14 Overview of spillway channel, looking toward south. No sign of recent flow or weathering / disruption of riprap was observed. Exposed sand in slope (as per 2018 DSI) was not covered. Not a dam safety concern as there is no active seepage faces or erosion were observed. (TRJ-2019-09)

Note: THVCP provided photographs showing that this work was completed after the DSI site visit.

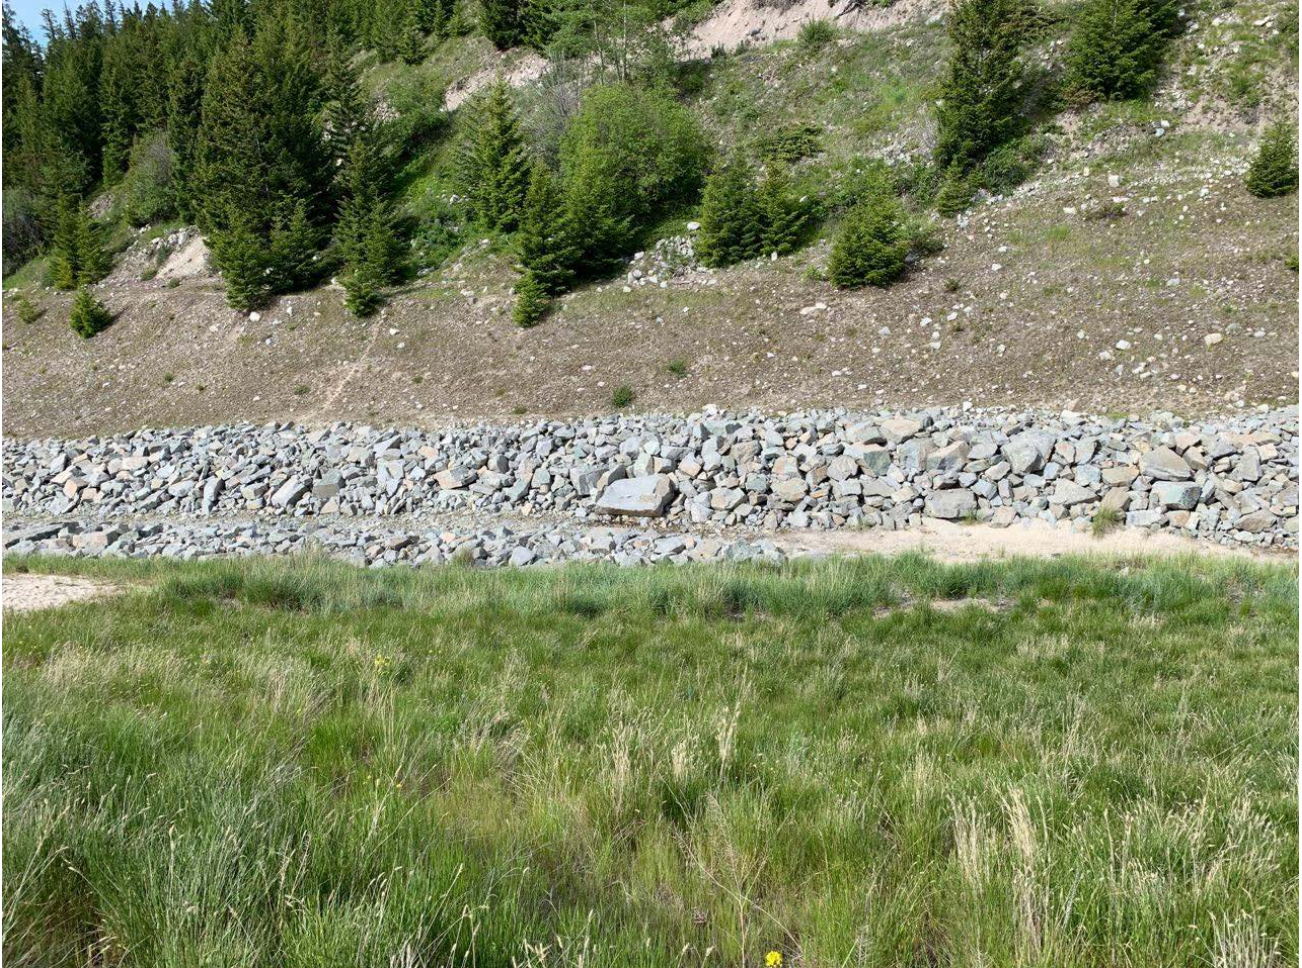
Photo II-A-15 Overview of spillway channel, looking toward west. Some eroded sand from area has accumulated in channel. Not a concern as it would be washed away by flow. (TRJ-2019-09)

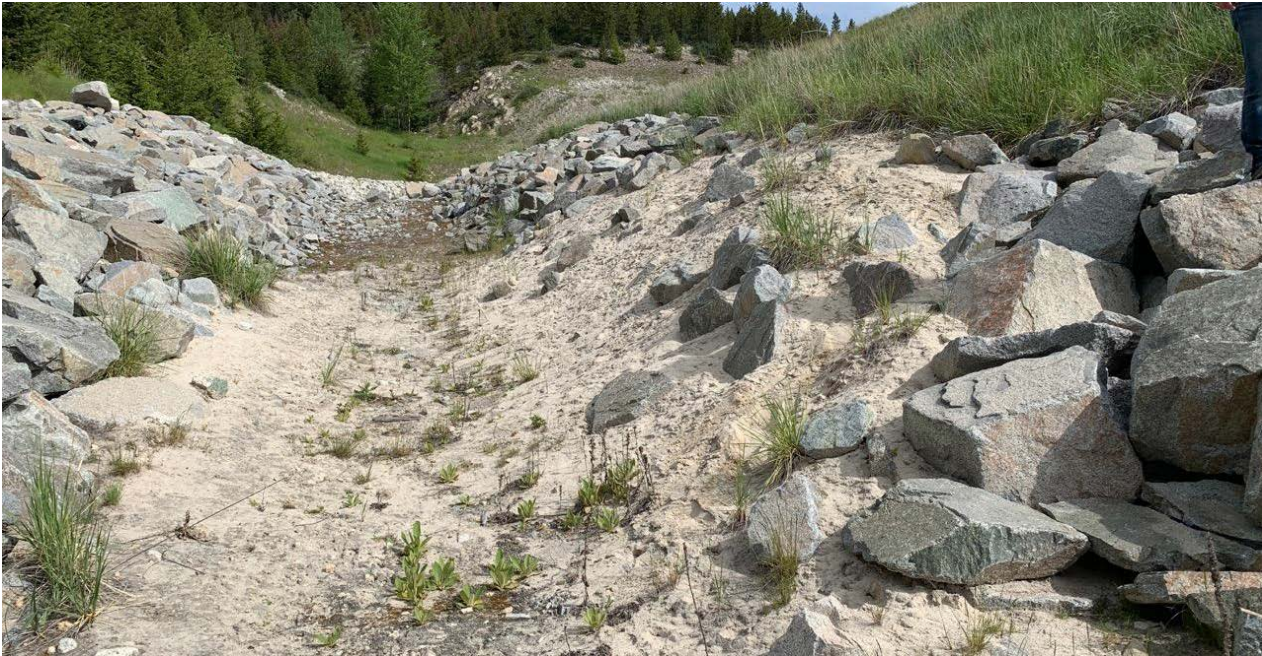
Photo II-A-16 Sand on the base and on right bank of spillway. Sand appears to have been placed/deposited on top of riprap, suggesting this is not related to piping/seepage. No active seepage faces or erosion were observed which indicates these are a dam safety concern. (TRJ-2019-10)

Note: THVCP provided photographs showing that this work was completed after the DSI site visit.

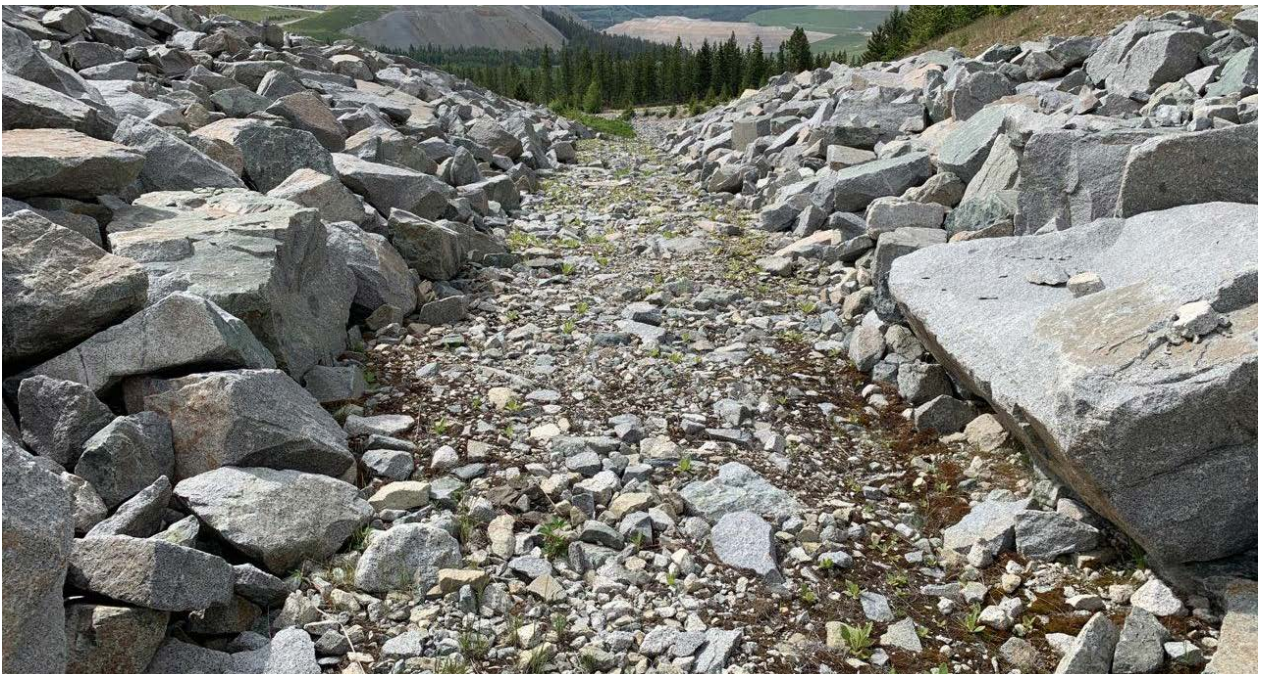
Photo II-A-17 Spillway channel downstream of the sand area observed in Photo II-A-16. No sand was observed downstream (TRJ-2019-10)

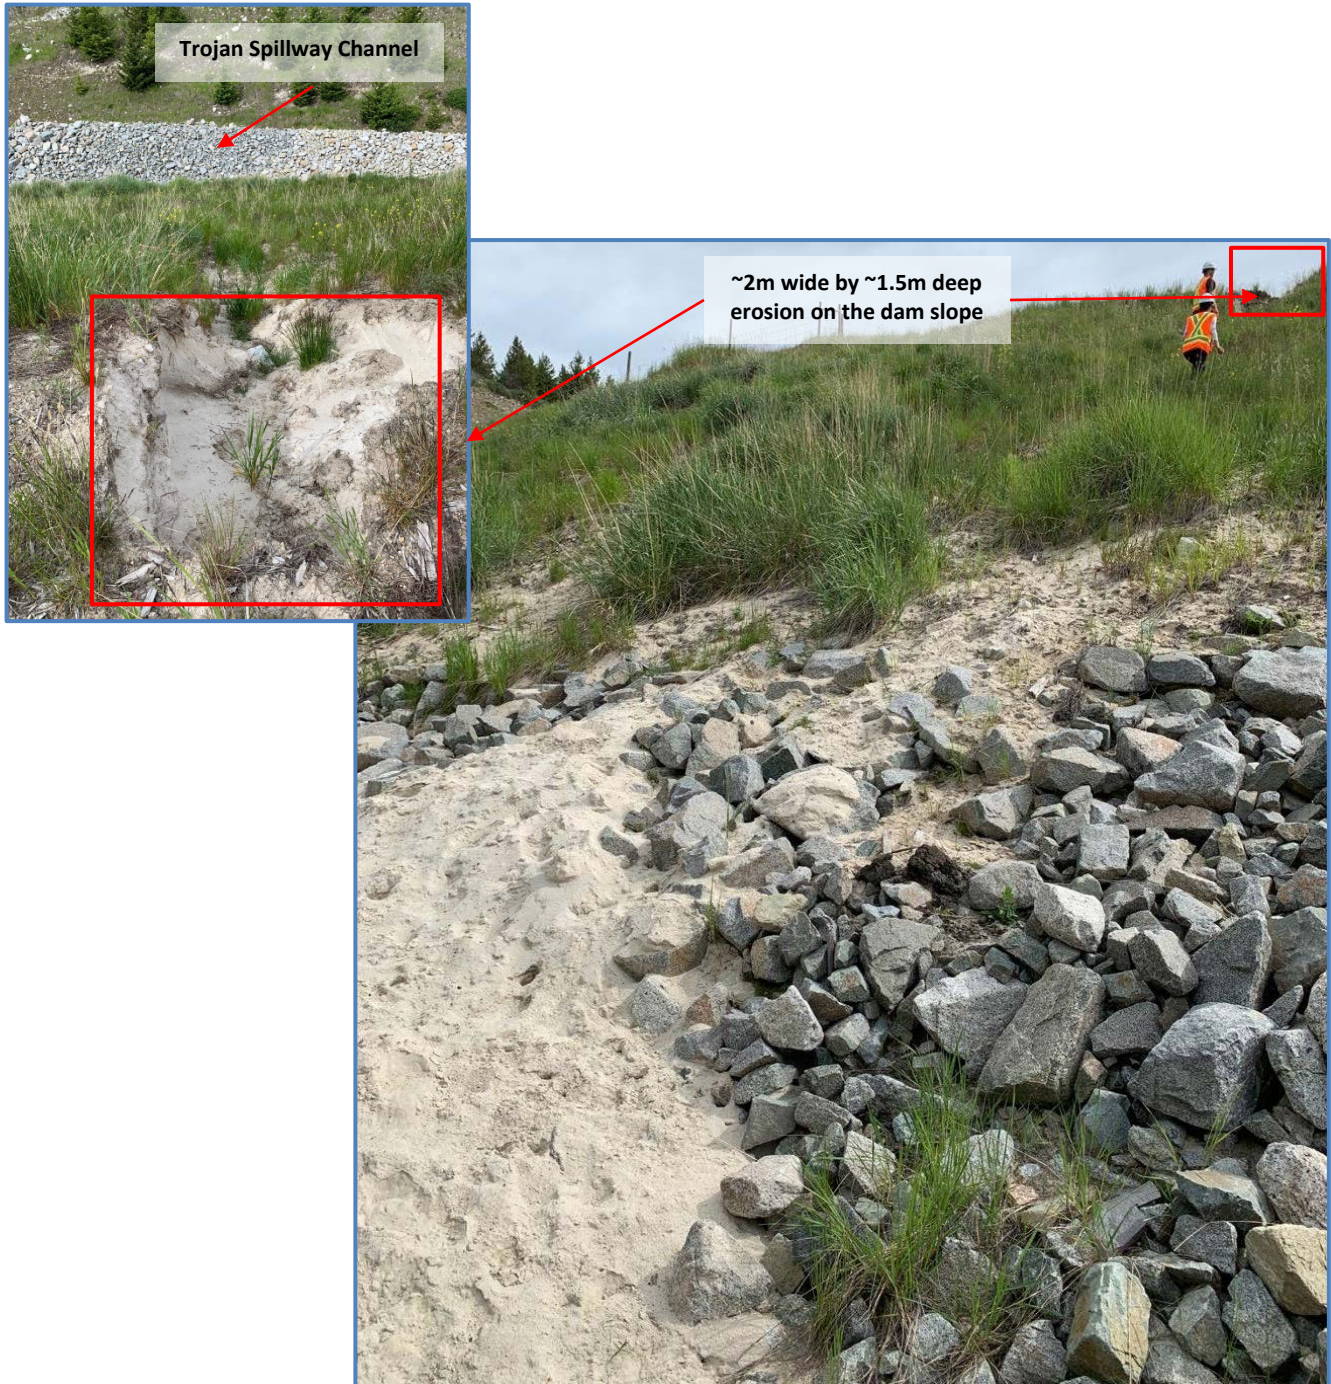
Photo II-A-18 Fan shape sand area observed in spillway channel. Surface erosion / scour evidence was observed upslope on dam slope. Visually looks more fluviially deposited and is not seepage-related. KCB recommends THVCP repair the scour and re-establish the cover. (TRJ-2019-11 and TRJ-2019-12)

Note: THVCP provided photographs showing that this work was completed after the DSI site visit.

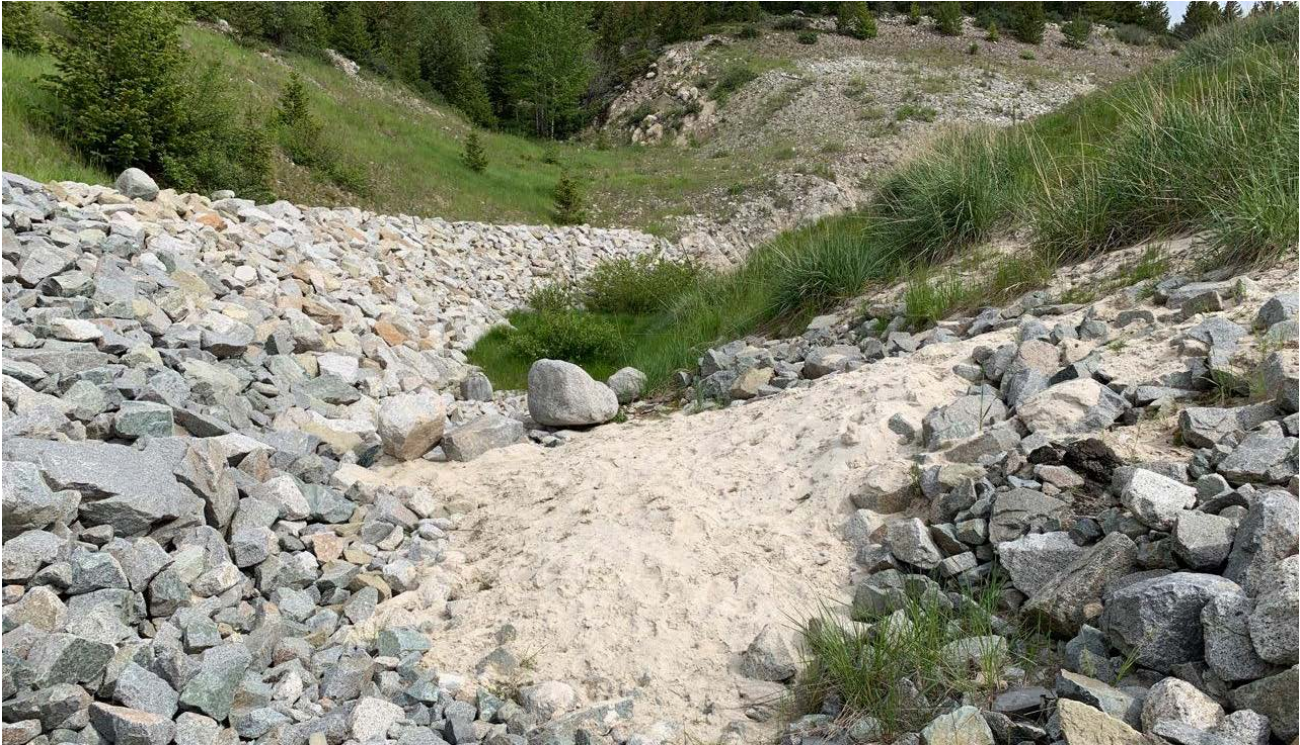
Photo II-A-19 Downstream of fan shape sand area observed in Photo II-A-18 (TRJ-2019-11)

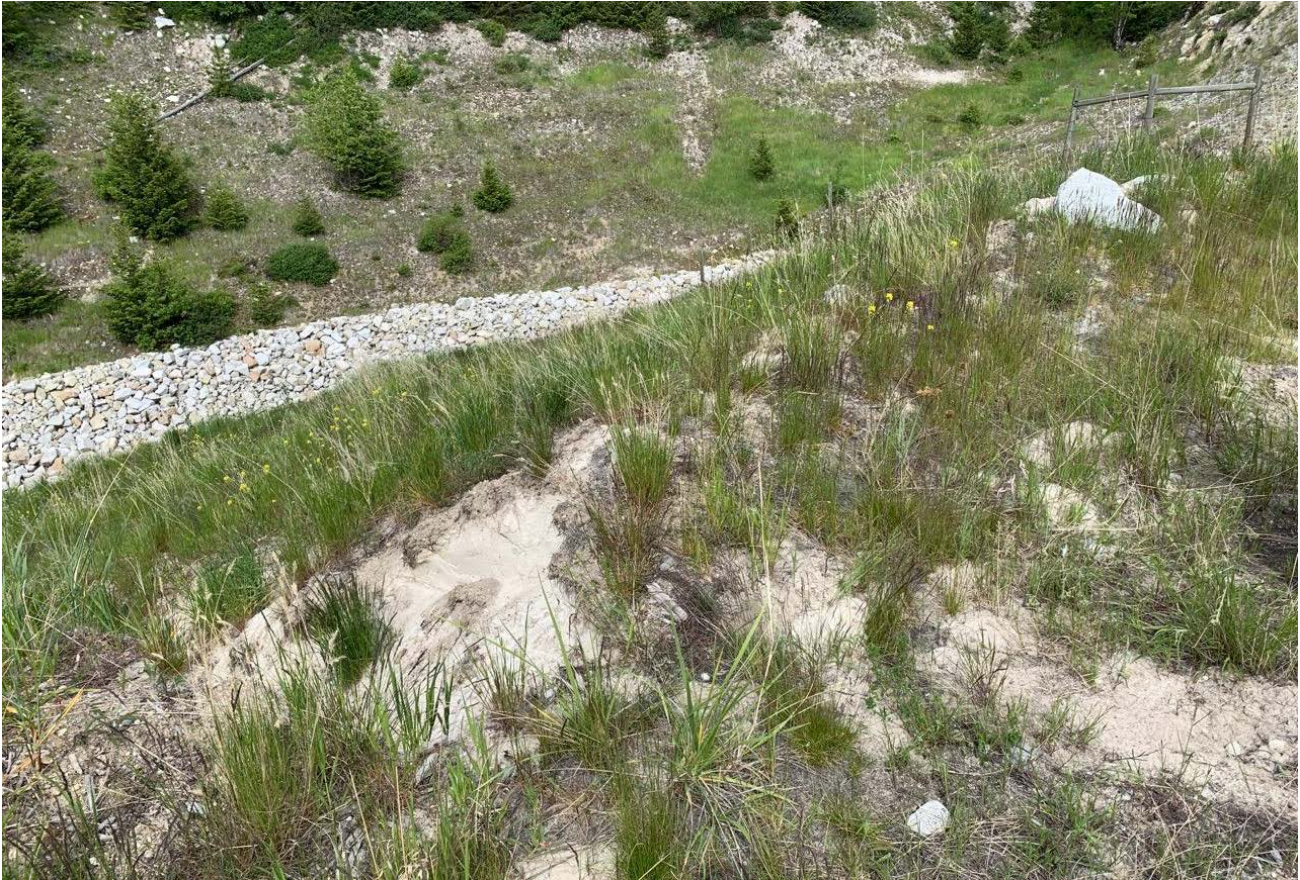
Photo II-A-20 Surface erosion scour upslope of the u/s sand observed in spillway channel (refer to Photo II-A-14). Not seepage flow related. KCB recommends repairing the area. (TRJ-2019-11)

Note: THVCP provided photographs showing that this work was completed after the DSI site visit.

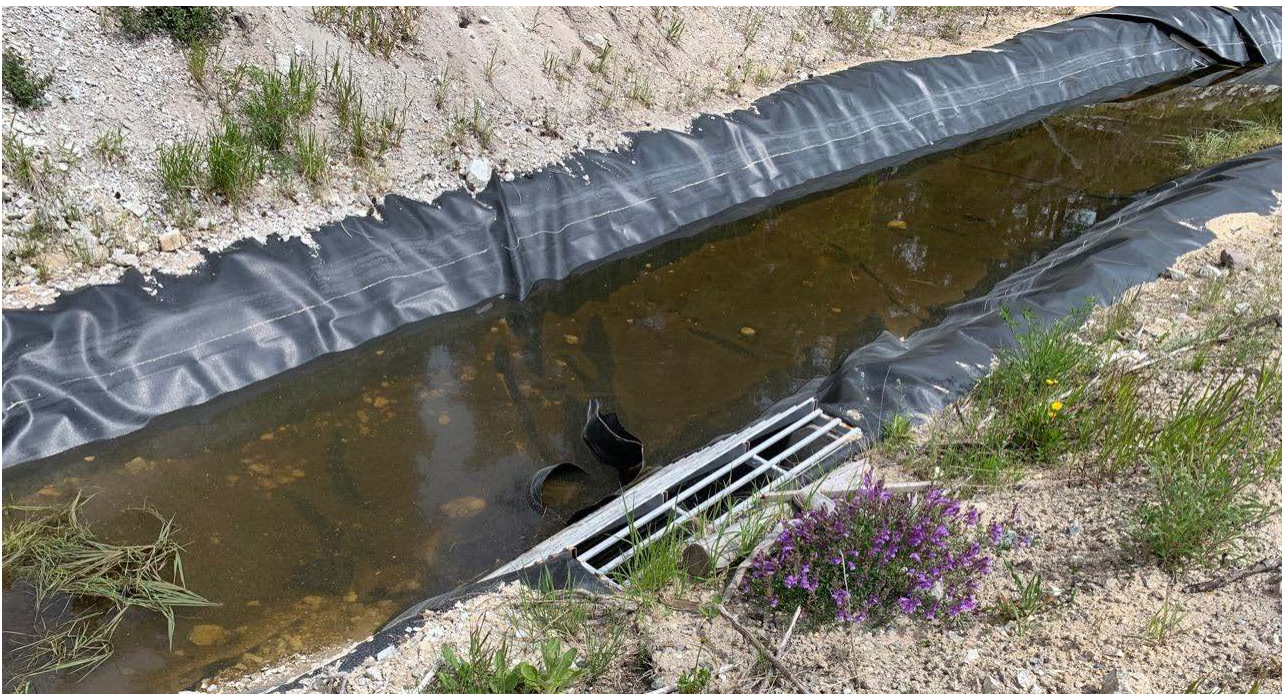
**Photo II-A-23 Water standing at the pipe intake. No outflow was observed, outlet valve is closed.
Diversion channel flow being discharges from outlet further upstream at
Photo II-A-26. (TRJ-2019-14)**

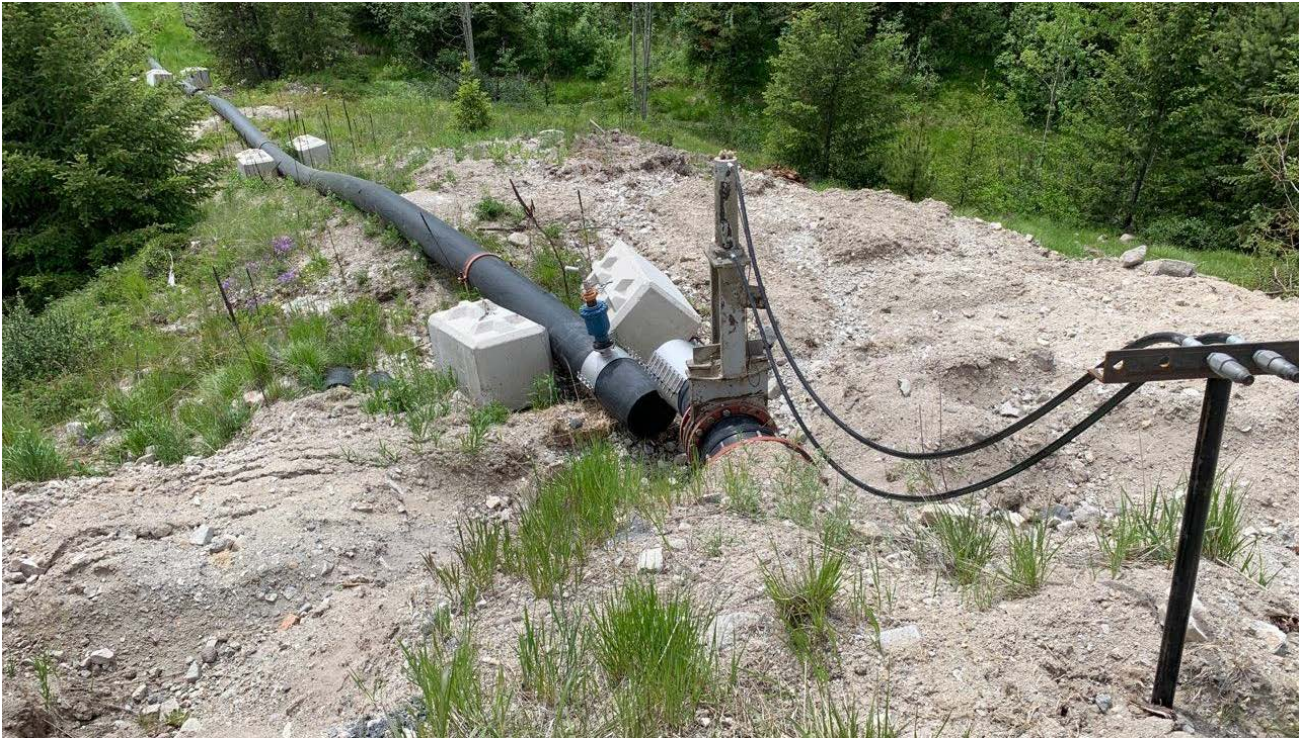
Photo II-A-24 Diversion pipe disconnected. There is some evidence of previous flow from the disconnected pipe. THVCP was aware and attempted unsuccessful repairs prior to the site visit. THVCP informed KCB that the permanent repair was completed after the site visit. (TRJ-2019-15)

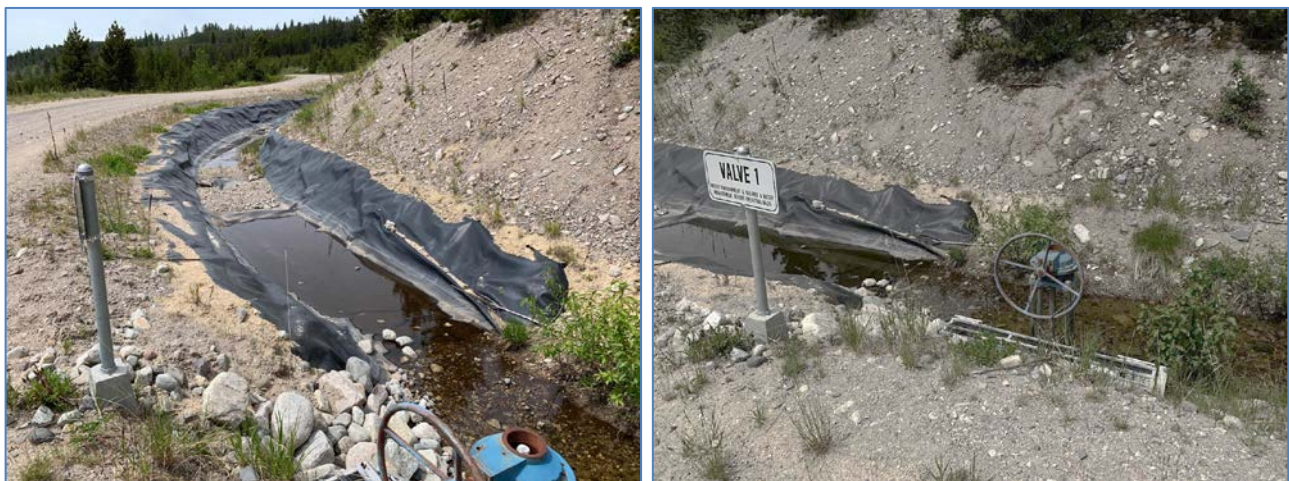
Photo II-A-25 Valve 1 is open and no flowing water bypassing this point was observed. Valve is located at the transition of unlined to lined channel. (TRJ-2019-16)

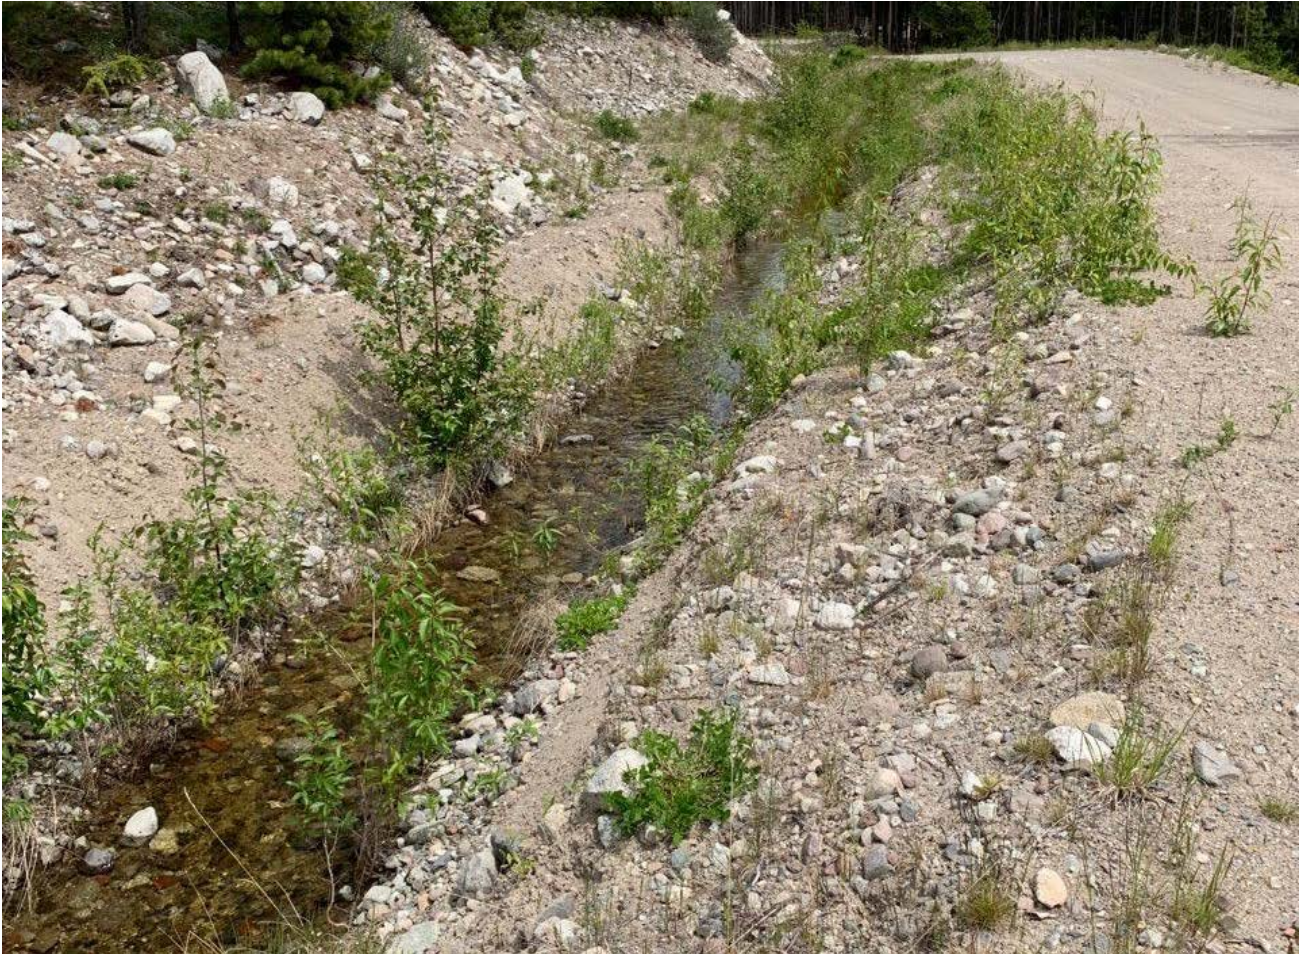
Photo II-A-26 Water flowing in the unlined section of channel upstream of Valve 1 (TRJ-2019-16)

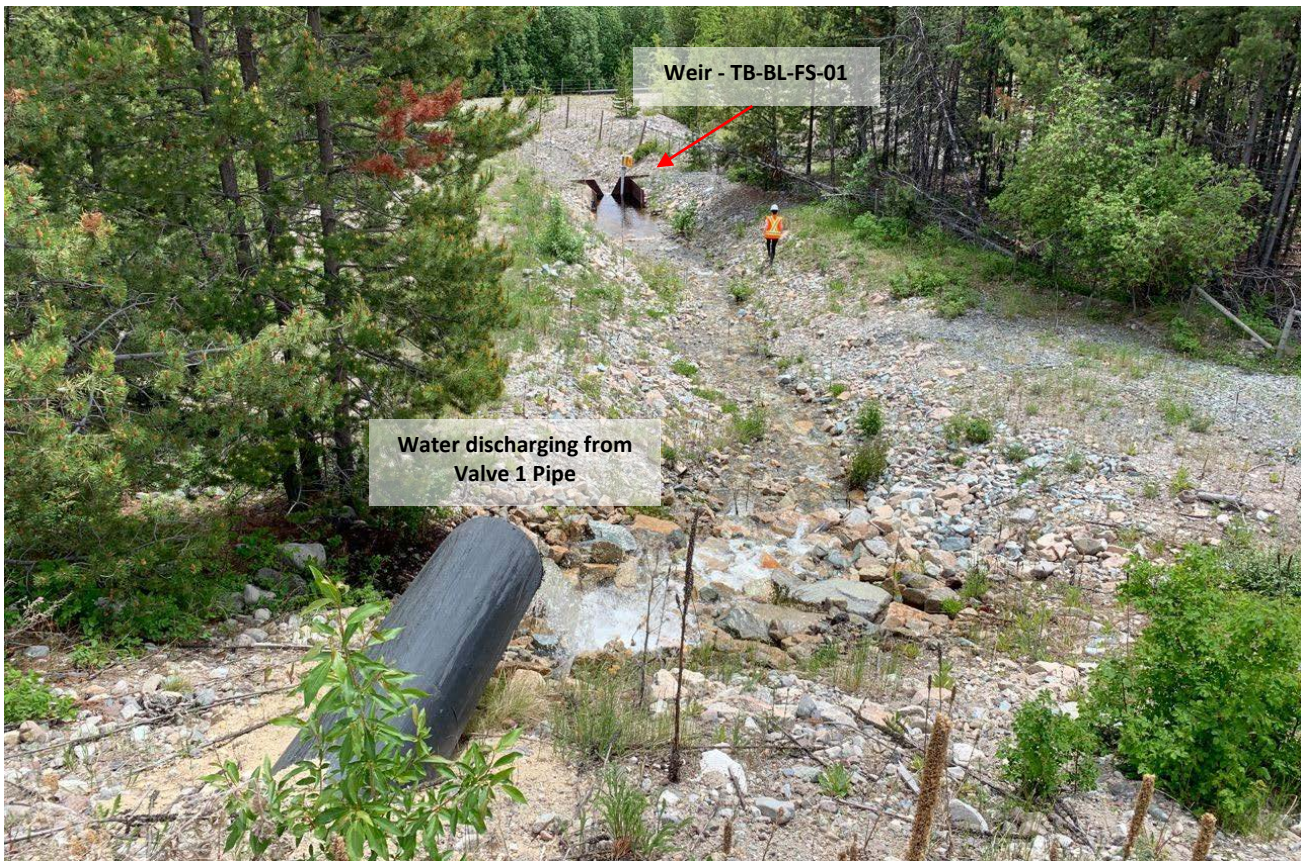
Photo II-A-27 No scour was observed at Valve 1 pipe discharge point. (TRJ-2019-16)
