# **Teck Highland Valley Copper Partnership**

## **2020 Annual Facility Performance Report**

### ***7 Day Pond Tailings Storage Facility***

**2020 Annual Facility Performance Report  
7-Day Pond Tailings Storage Facility**

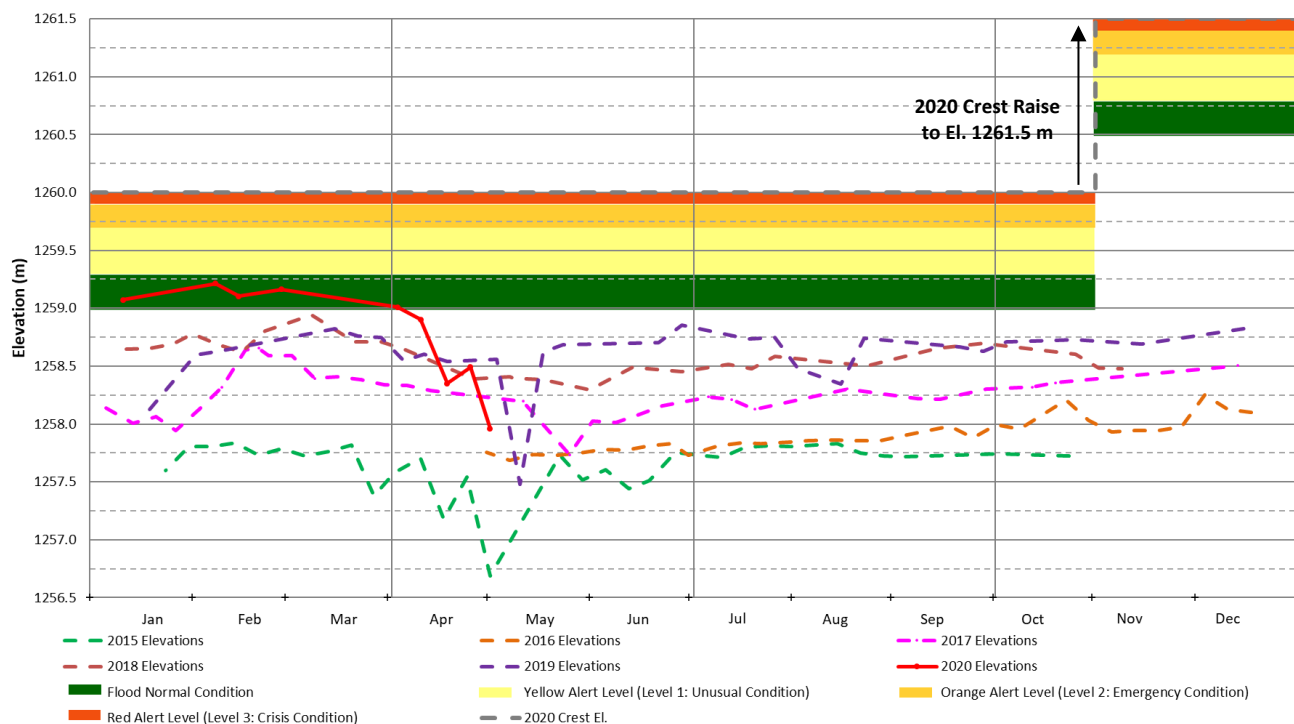
**Figure 5.1 7-Day Pond TSF Pond Levels with Alert Level Ranges**

- The peak pond level rose in late 2019 reaching a peak in February 2020 which was within the “Flood Normal” condition but was below the “unusual condition” level.
- The drop in pond level, starting in April 2020, is related to THVCP pumping down the pond in preparation for tailings excavation (Section 3.1). No further pond levels were recorded after the pond was drained down. The facility was visually inspected quarterly, as per THVCP's monitoring plan, which confirmed that no pond was present at the facility after May.

1. Alert levels used during review period, prior to raise: Flood Normal Condition: El. 1259.3 m (0.7 m freeboard); Level 1 – Unusual Condition: El. 1259.7 m (0.3 m freeboard); Level 2 – Emergency Condition: El. 1259.9 m (0.1 m freeboard); Level 3 – Crisis Condition: El. 1260.0 m (0 m freeboard [near overtopping]).
2. In Figure 5.1, the shift in alert levels based on the 2020 criteria after the crest raise is shown for reference.

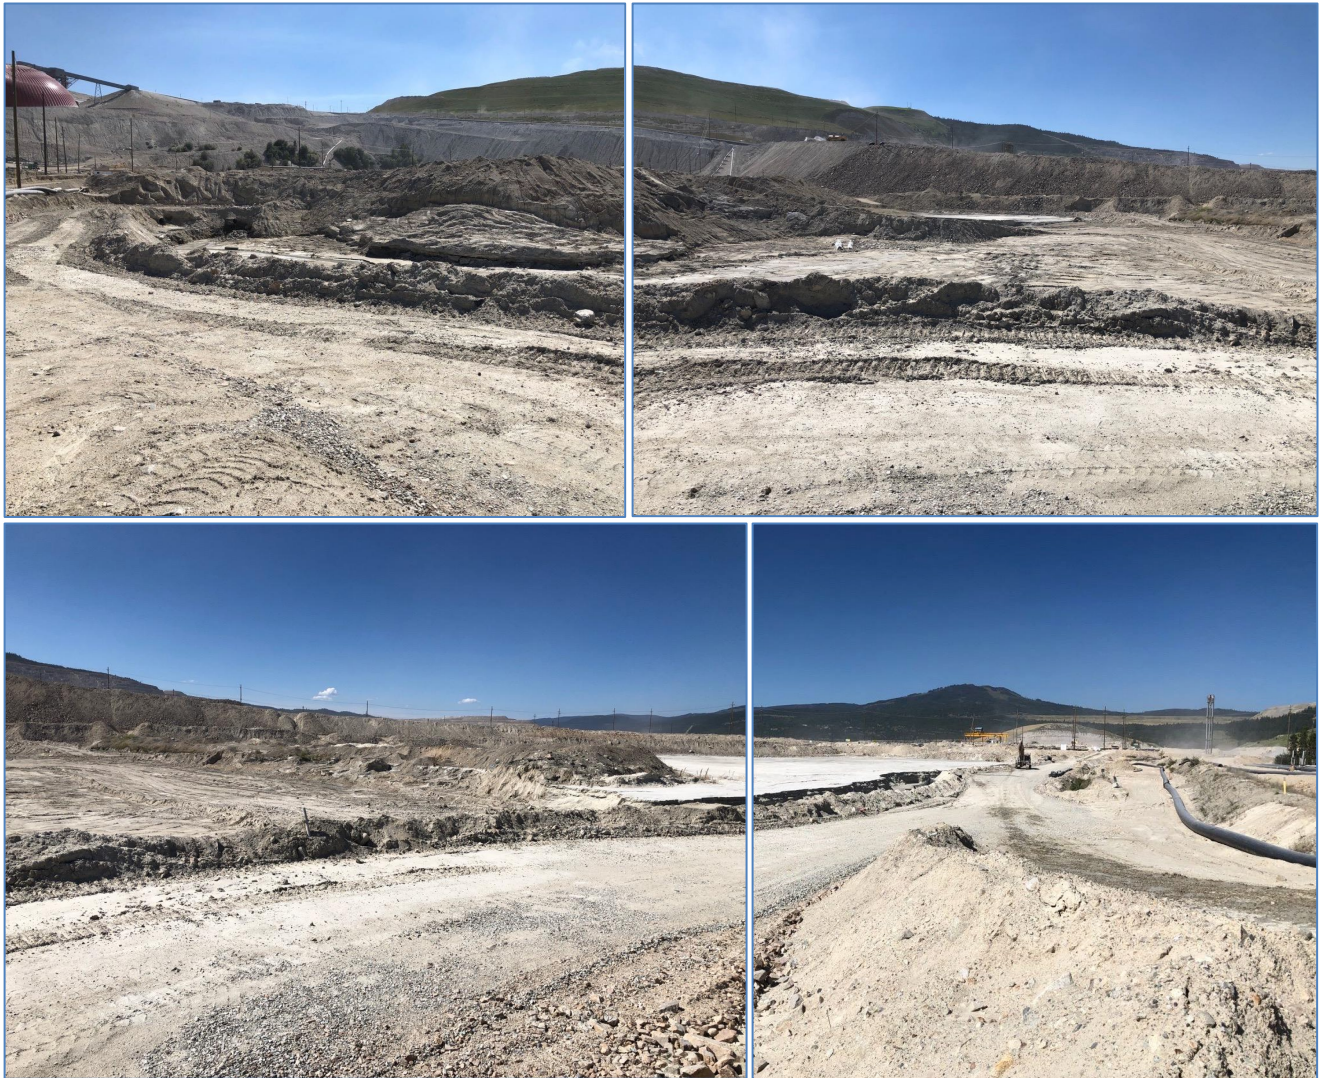
- **Crest:** The haul road which forms the crest of the dam around 7-Day Pond was in good physical condition. No indicators of significant concern were observed (e.g. cracking, slumping) (Photo I-1).

**Photo I-1      7-Day Pond. No discharge to the pond. Tailings were being excavated at the time of inspection (SDP-2020-01)**

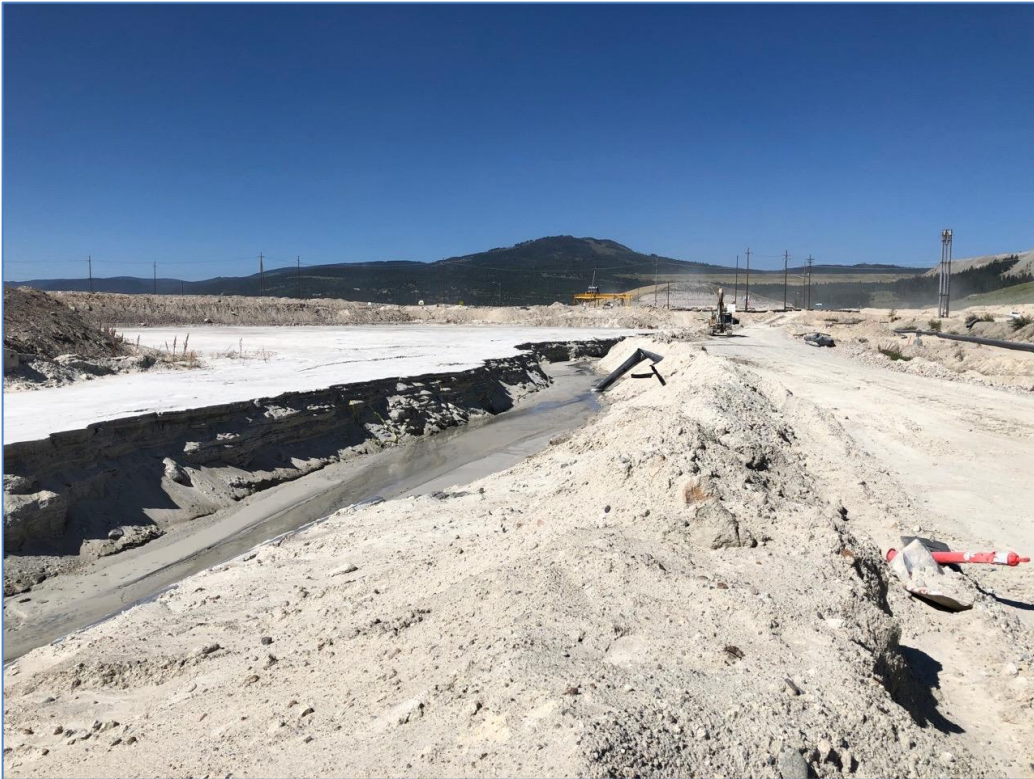
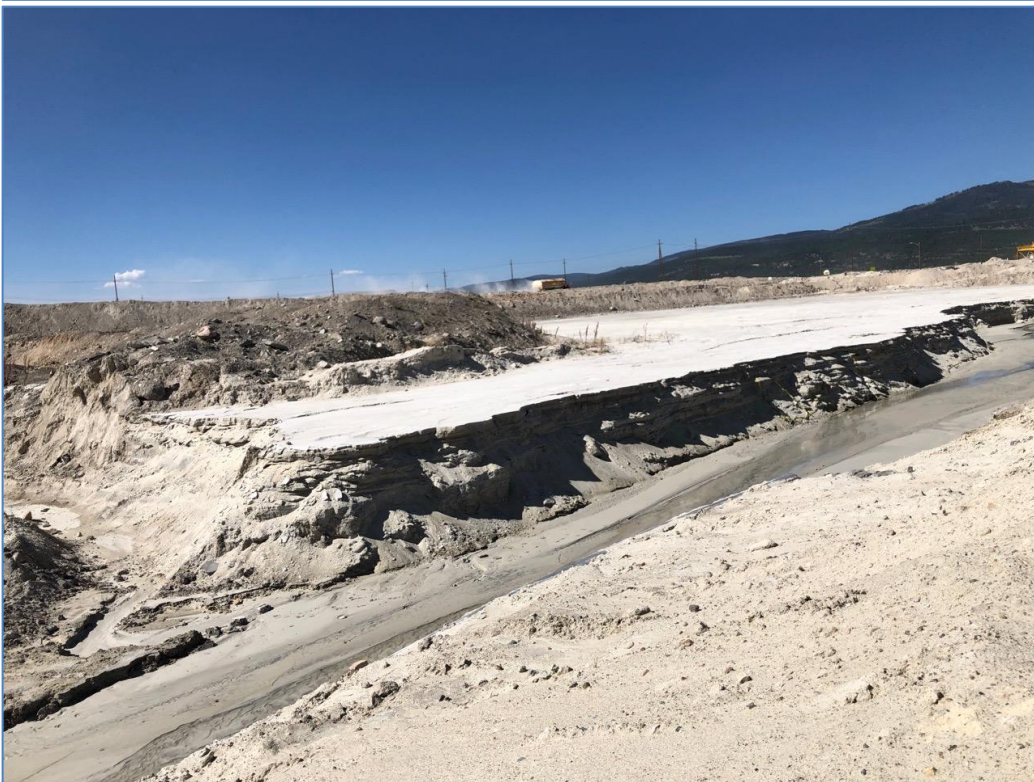
- **Upstream and Downstream Slopes:** Upstream slopes were in good physical condition. The upstream slopes were not vegetated, but no indicators of significant concern were observed (e.g. animal activity, cracking, slumping, surface erosion features). Excavation was ongoing at the time of inspection. The visible parts of the downstream slope of the haul road forming the east containment of the impoundment was in good physical condition (Photo I-2 to Photo I-4).

**Photo I-2      7-Day Pond tailings excavation ongoing (SDP-2020-02)**

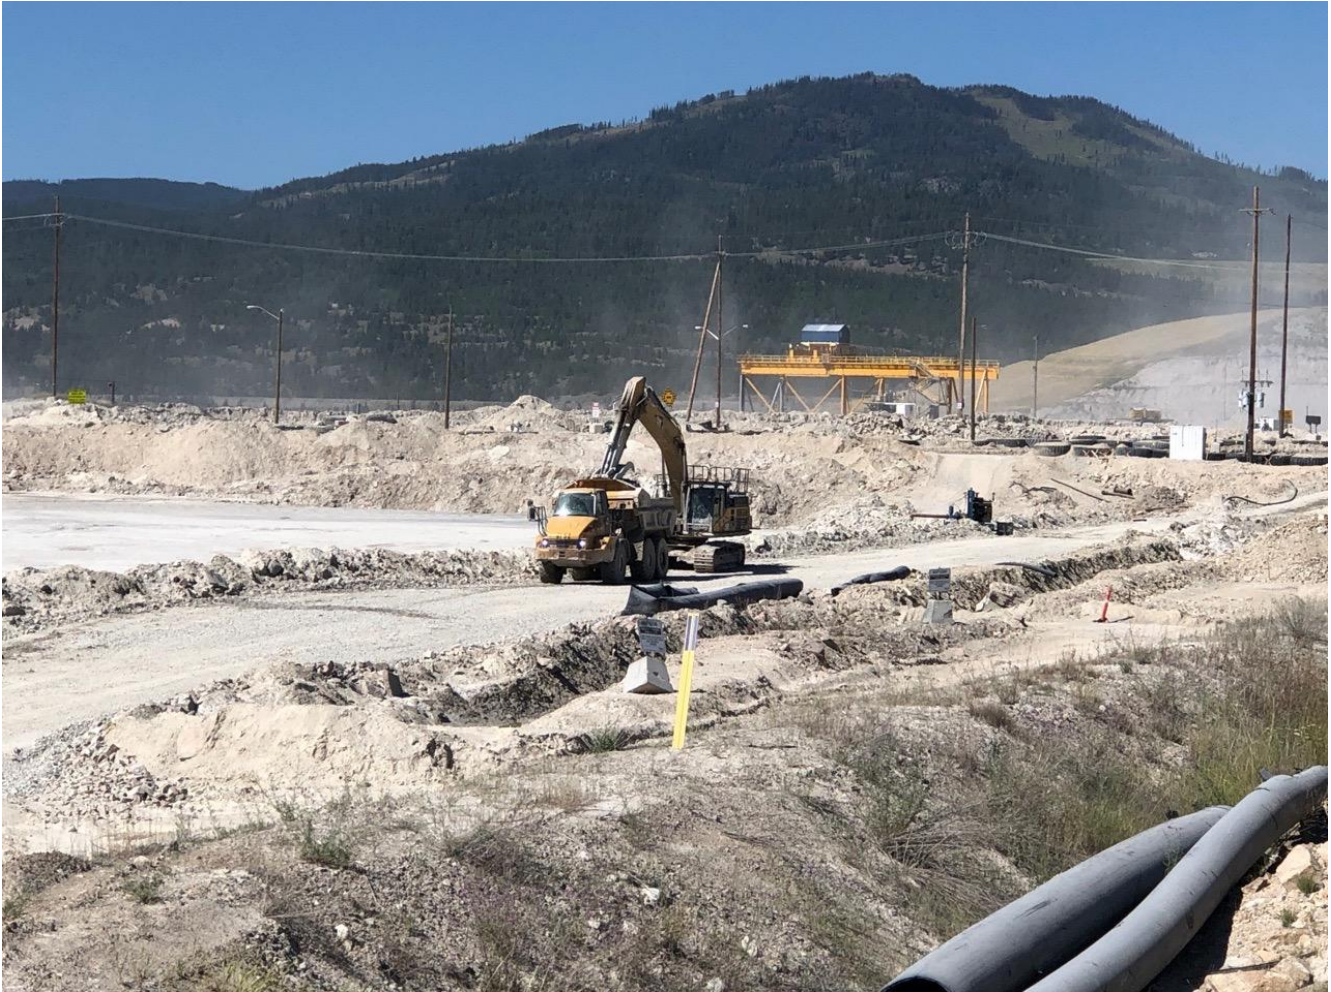
**Photo I-3 View of an excavator loading the haul truck at 7-Day Pond facility (SDP-2020-03)**

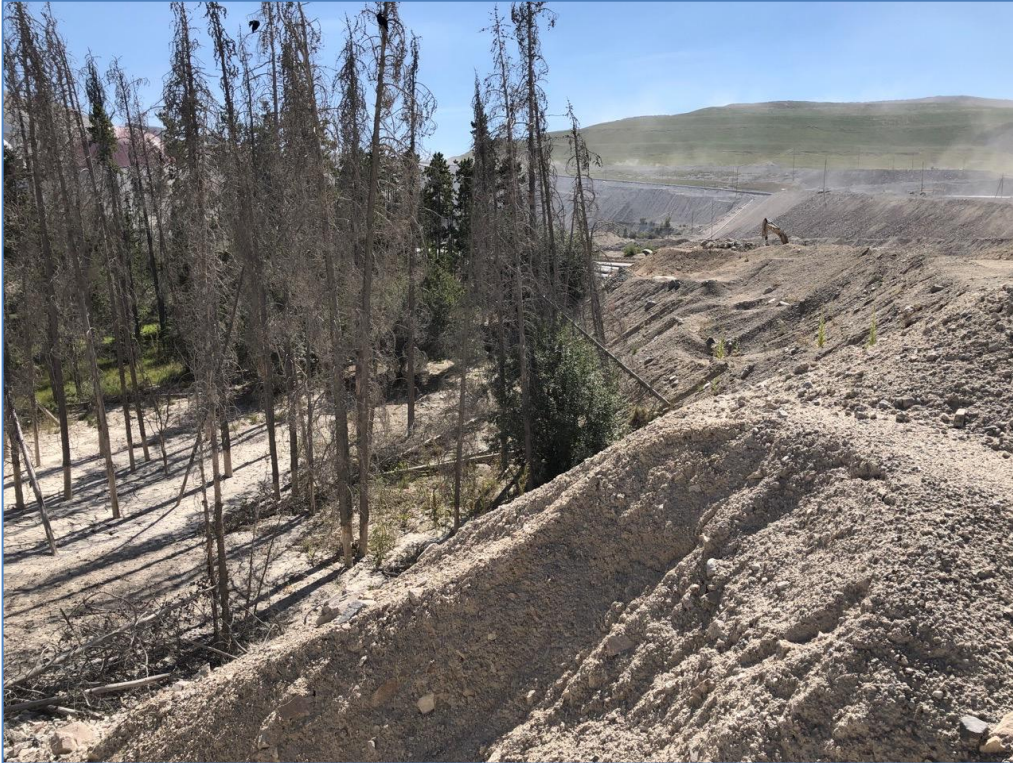
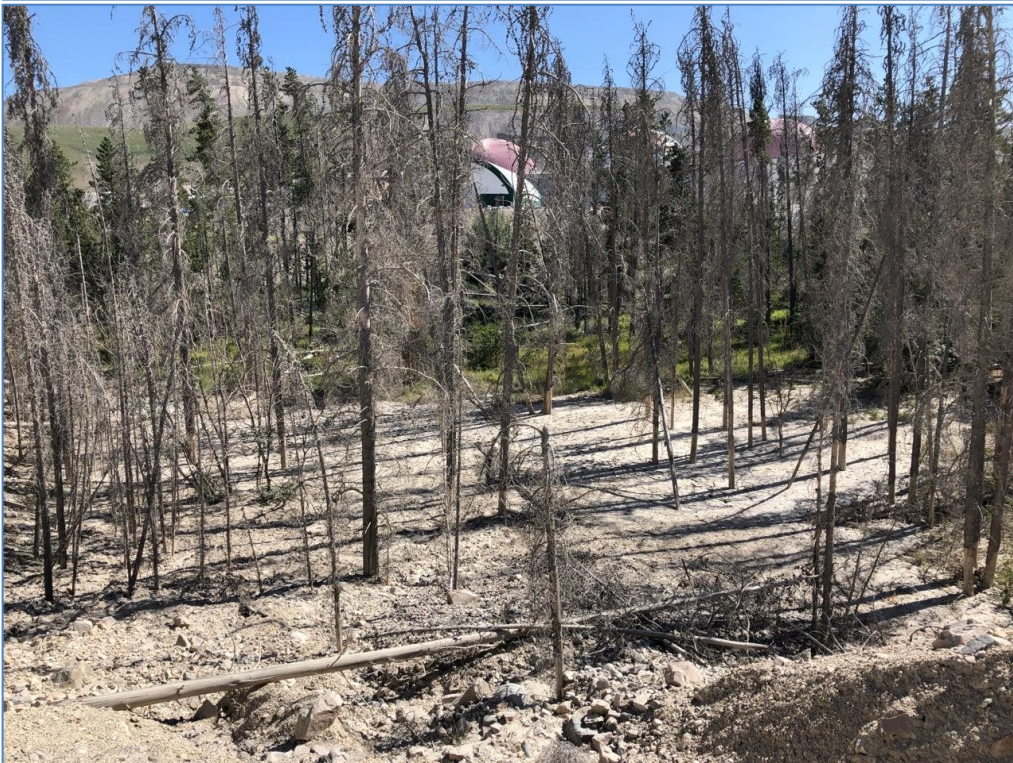
**Photo I-4      Treed area downstream (D/S) of 7-Day Pond retaining berm formed by east perimeter access road (SDP-2020-04)**

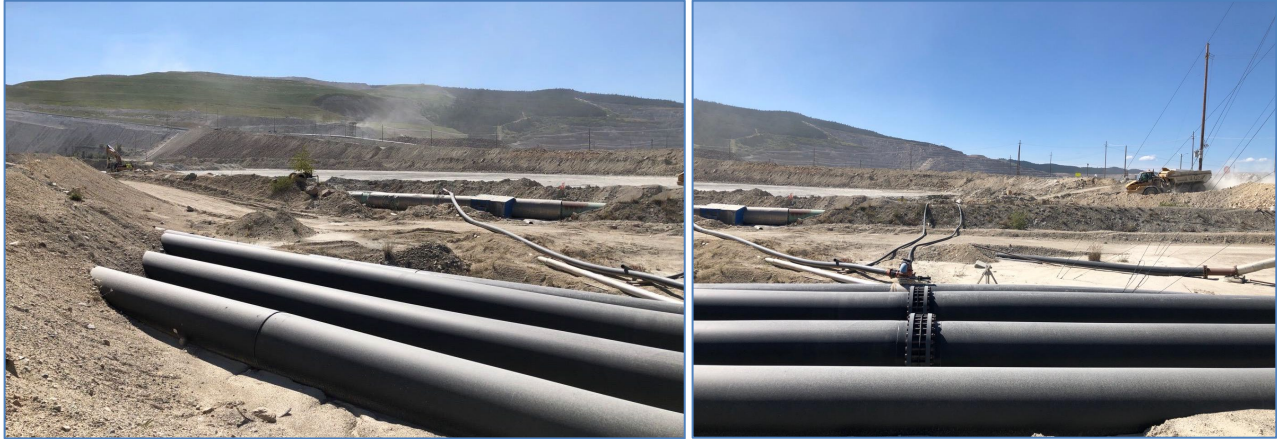
**Photo I-5 Tailings and water pipelines along downstream side of east perimeter access road crest (SDP-2020-05)**

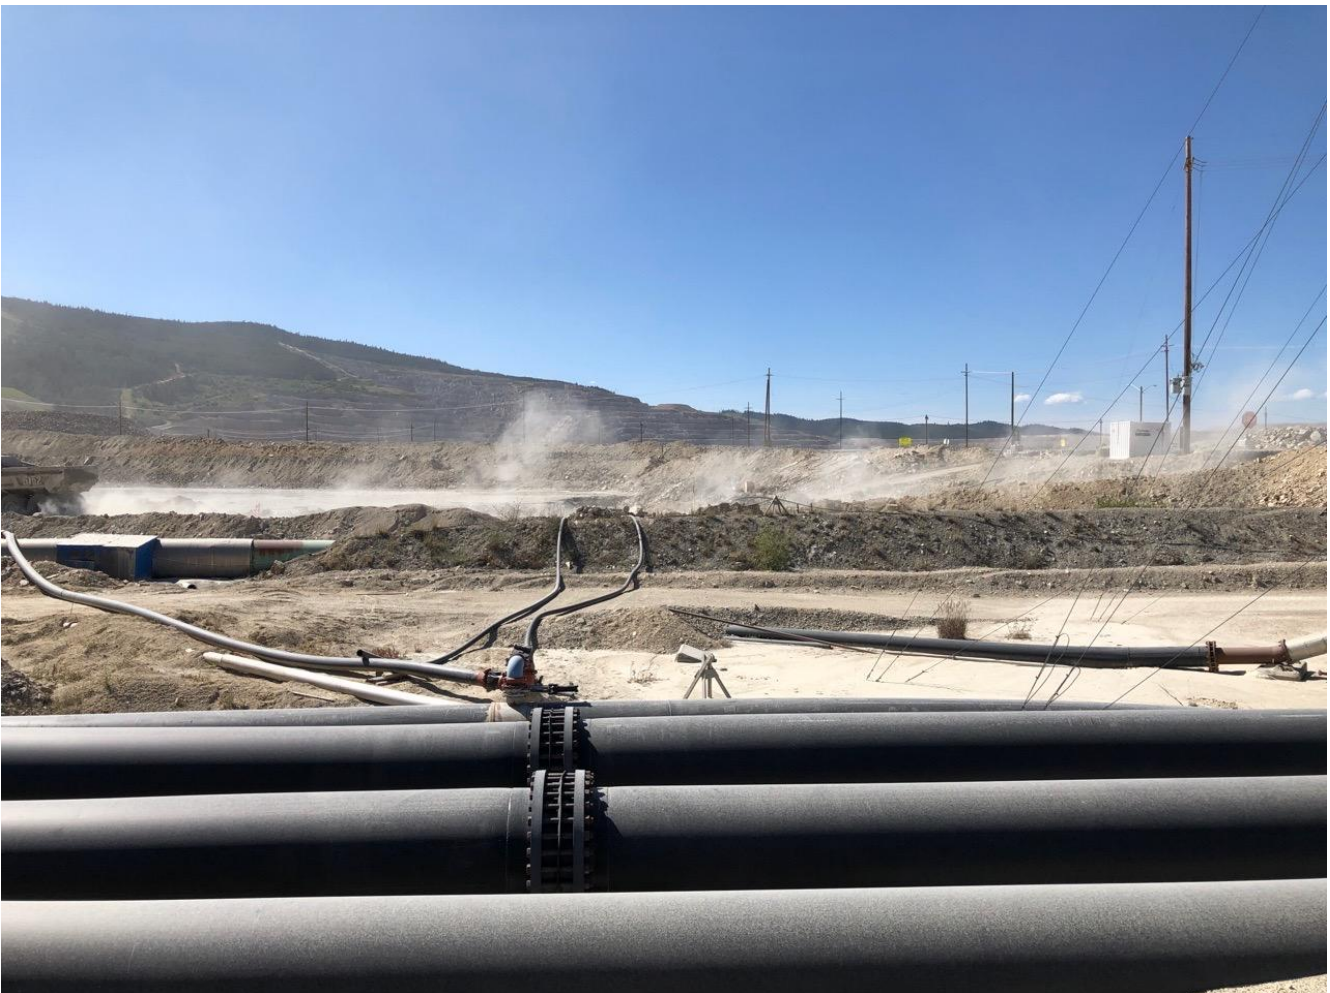
**Photo I-6 Tailings dust due to hauling truck traffic (SDP-2020-05)**

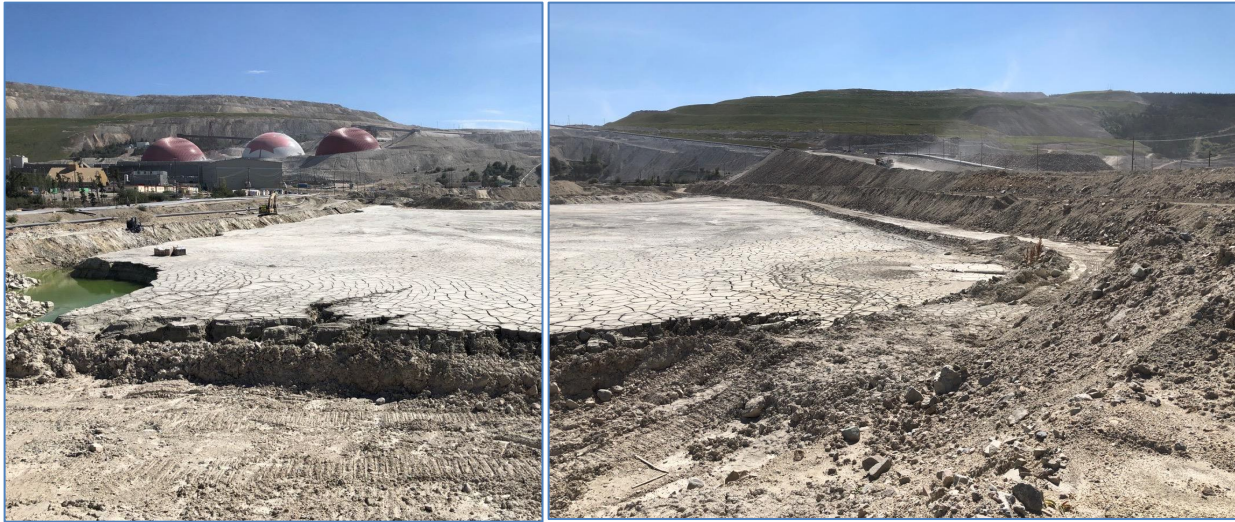
**Photo I-7 View of 7-Day Pond from North perimeter (SDP-2020-06)**
