Beaverdell Tailings Storage Facilities

2020 Annual Facility Inspection Report

Golder Associates Ltd.

Reference No. 20140466-275-R-Rev0-1000

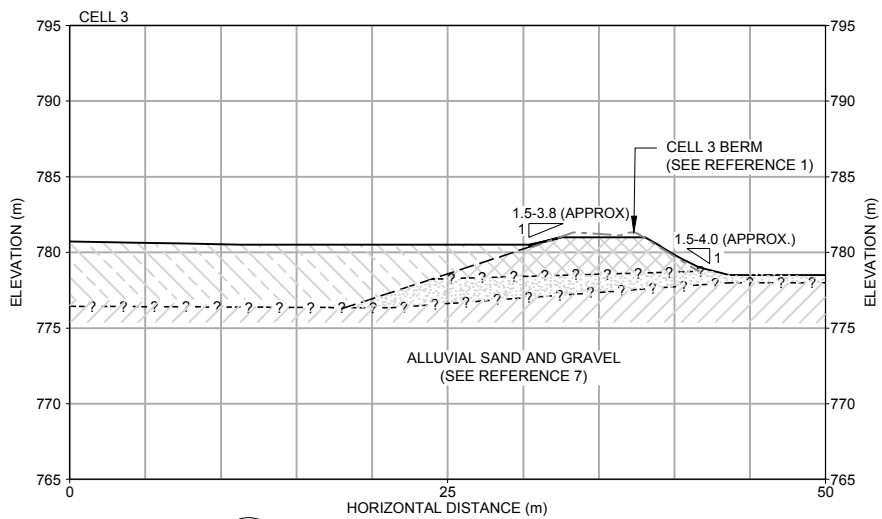
SCALE 1:500 m **D** SECTION THROUGH CELL 3 EMBANKMENT
3

- Test pits completed at the toe of the Cell 3 embankment, as part of the 2020 site investigation, indicated the presence of tailings.
 - The South TSF dam may be founded on tailings in the area of Cell 3. It is recommended that additional investigations be planned to further delineate the extent of tailings downstream of the South TSF. Additional investigations were completed in August 2020 towards addressing this recommendation (reporting in progress by others).

2020-02	Results indicated the presence of tailings at the downstream toe of Cell 3. As such, the South TSF may be founded on tailings in the area of Cell 3.	HSRC §10.1.4	Additional investigation should be planned to further delineate the extent of tailings downstream of the South TSF.	3	New Recommendation End 2021
	2020-03	Results from the Phase 1 geotechnical site investigation indicate that tailings in Cell 4 are finer than the range used in the filter compatibility and internal stability assessment (Golder 2015a).	HSRC §10.1.4	Update filter compatibility and internal stability assessment for dam fill and foundations based on Phase 1 geotechnical investigation laboratory test results.	3	New Recommendation End 2021

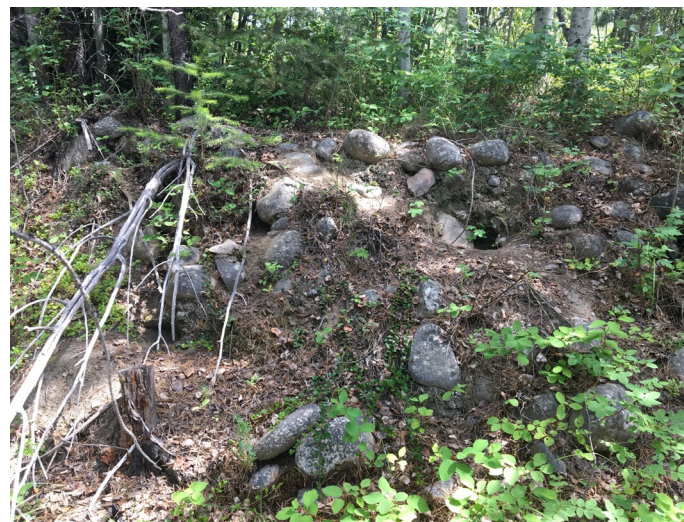
Photograph 2: South TSF, Cell 1, west side downstream toe area with animal burrows, looking east. 21 July 2019.

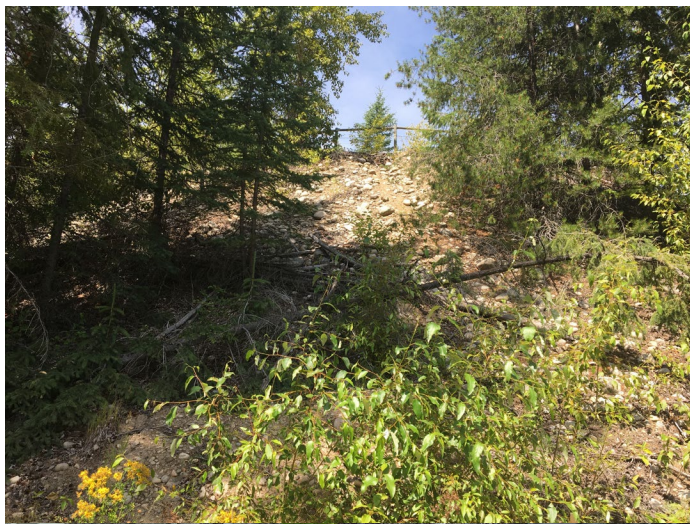
Photograph 7: South TSF, Cell 5, downstream slope, minor erosion, looking northwest. 21 July 2020.

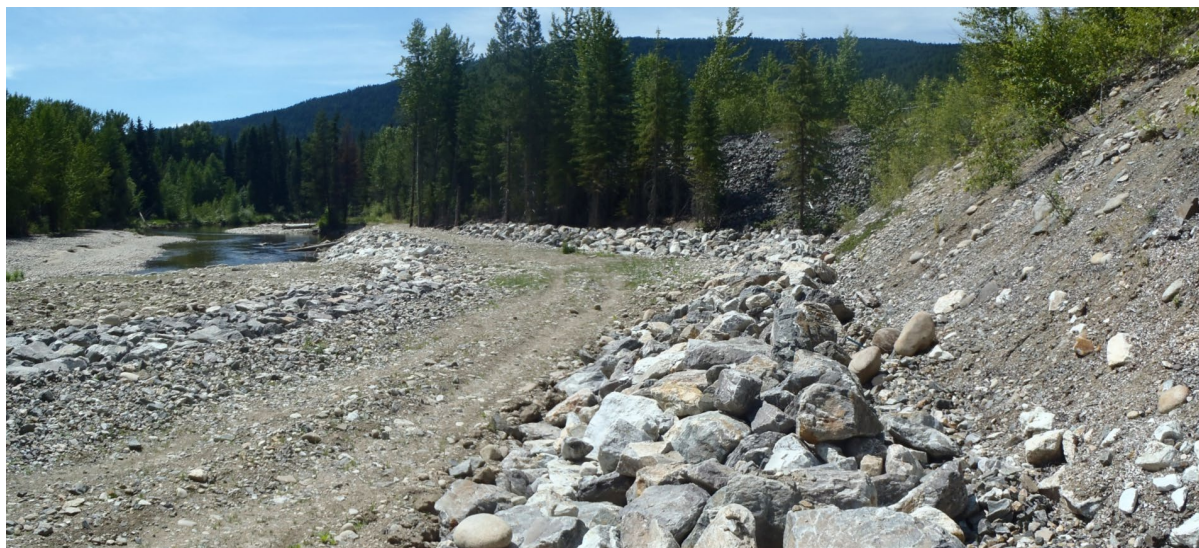
Photograph 9: South TSF, Cell 4/5 downstream toe with recently installed riprap along West Kettle River, looking south. 21 July 2020.

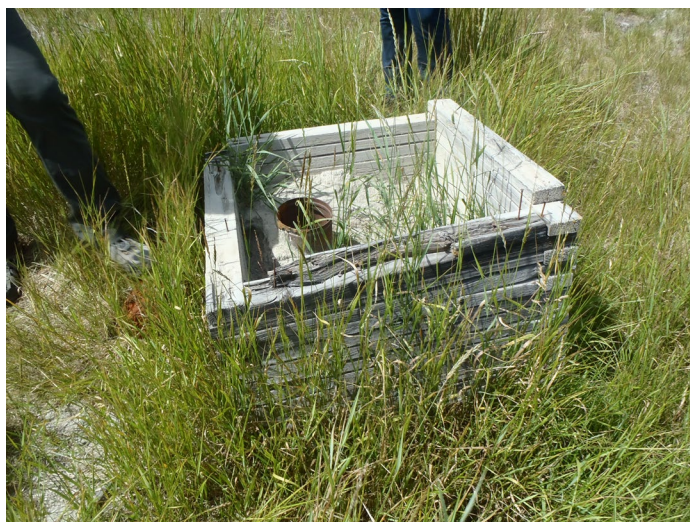
Photograph 10: South TSF, Cell 5, backfilled decant tower, looking northeast
21 July 2020.

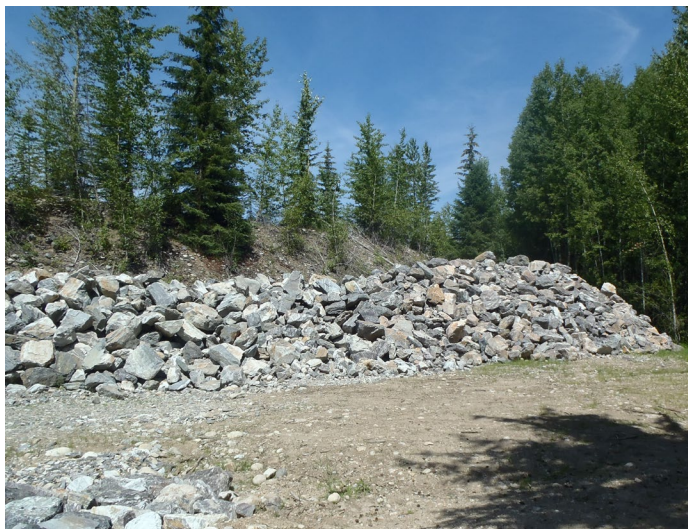
Photograph 12: South TSF, Cell 4, downstream slope and emergency riprap stockpile, looking northwest. 21 July 2020.

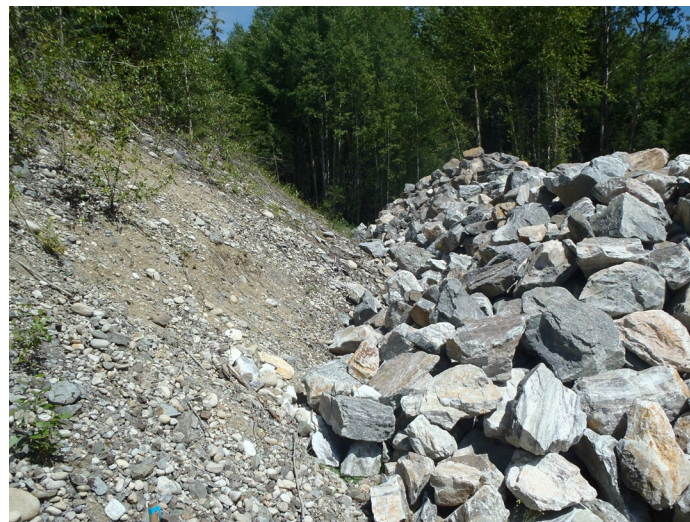
Photograph 13: South TSF, Cell 4, downstream slope and emergency riprap stockpile, looking northeast. 21 July 2020.

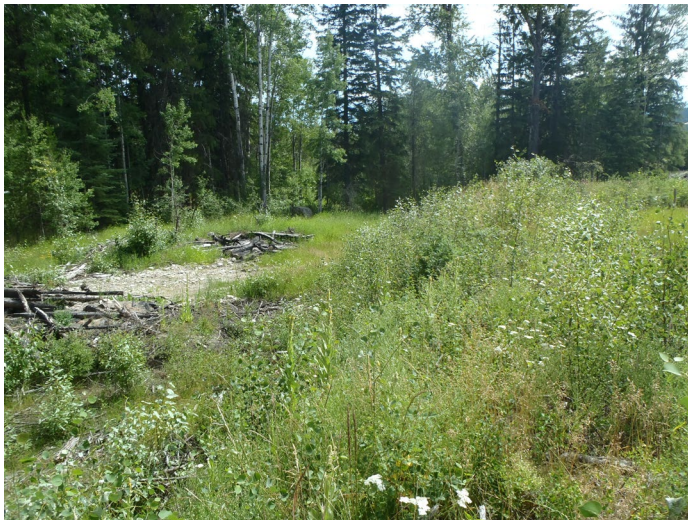
Photograph 20: South TSF, Cell 3, felled trees at toe, looking south. 21 July 2020.

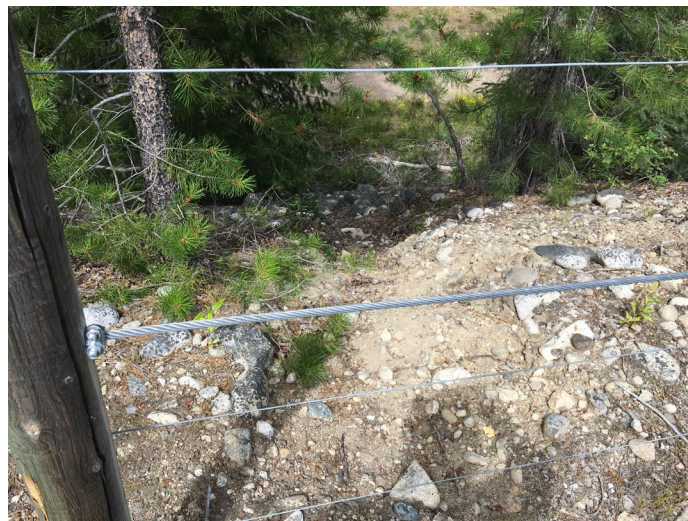
Photograph 23: North TSF, Cell 6, erosion on north downstream slope, looking east. 21 July 2020.

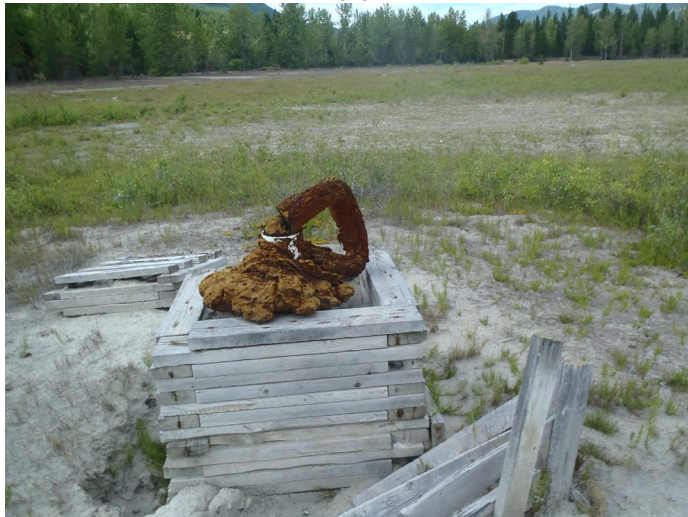
Photograph 27: North TSF, Cell 6, tailings surface and plugged decant tower looking northwest. 21 July 2020.
