Teck Highland Valley Copper Partnership

2020 Annual Facility Performance Report

Bethlehem No.1 Tailings Storage Facility

March 2021

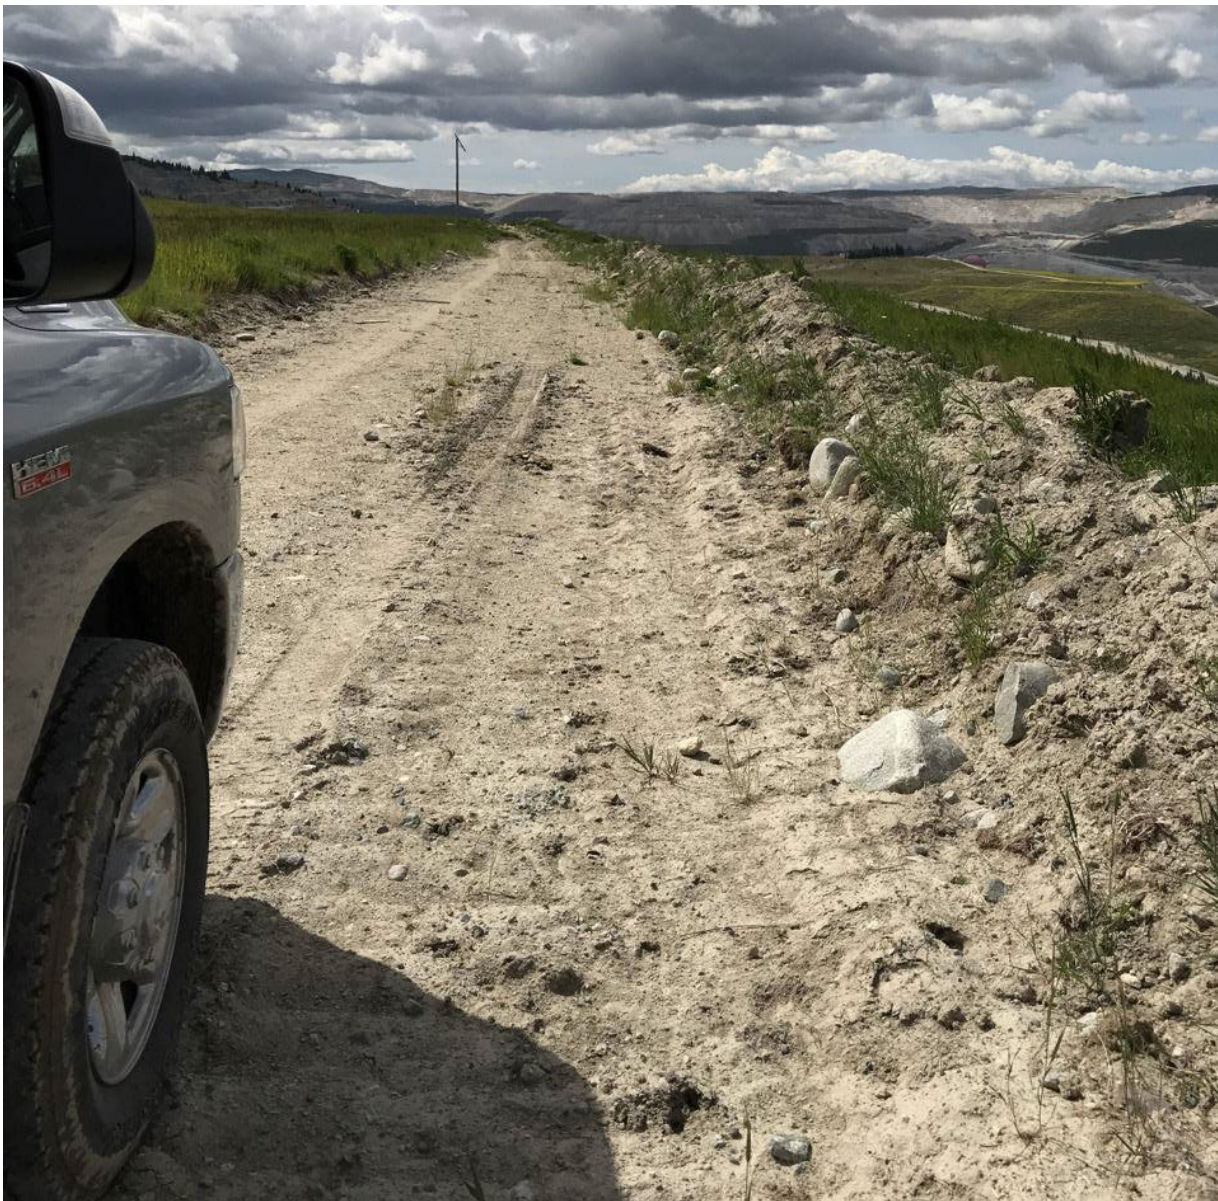
Photo I-A-1 Dam No. 1 crest road. No evidence of erosion or depression was observed (BTH-2020-01)

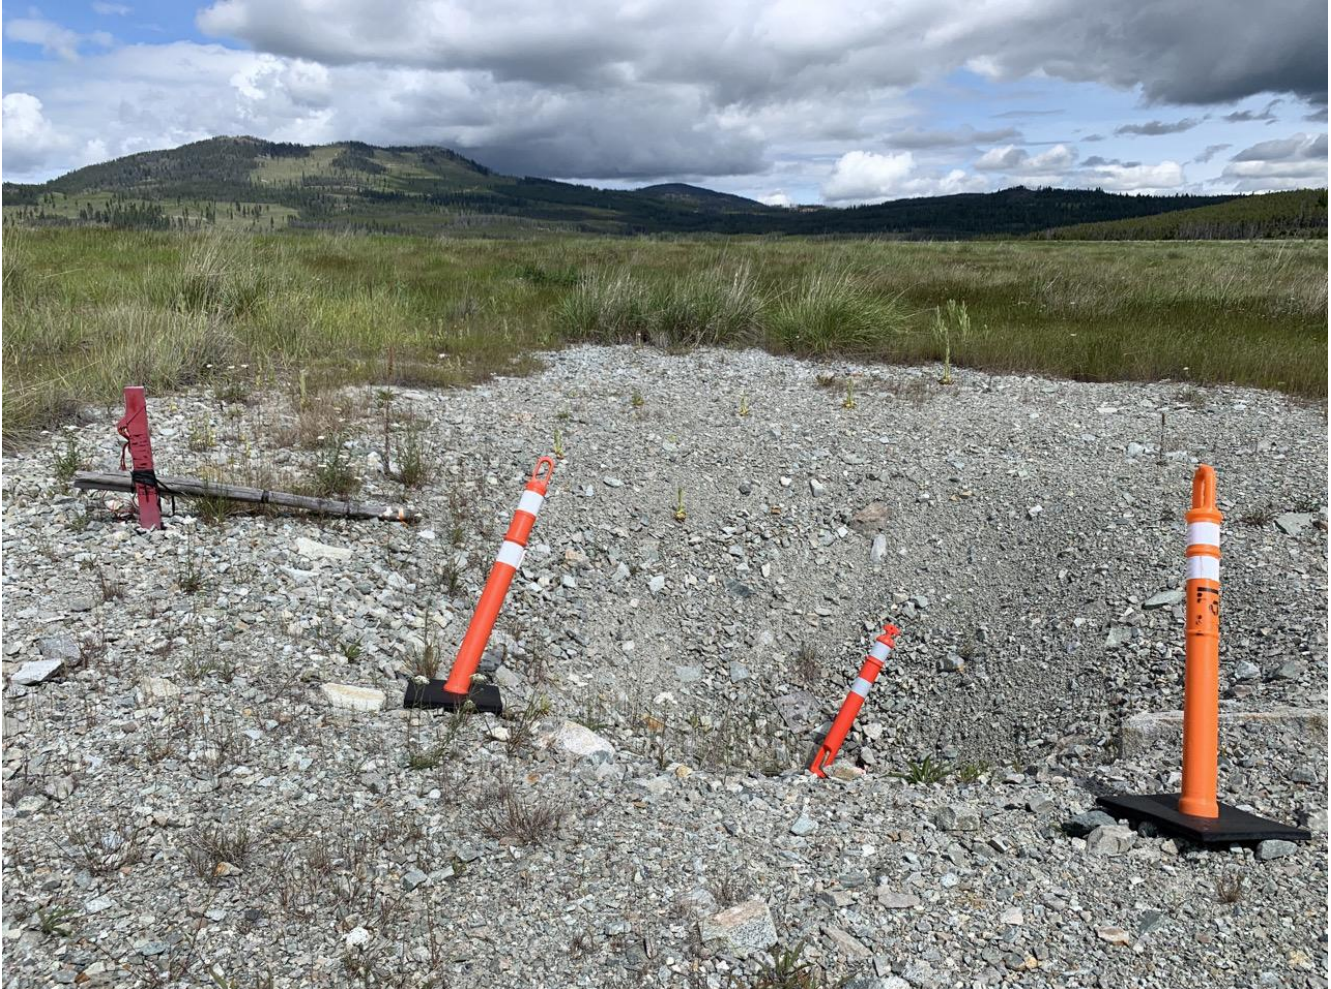
Photo I-A-3 Bethlehem sinkhole on tailings beach, no visual change from 2019 visual observations (BTH-2020-03)

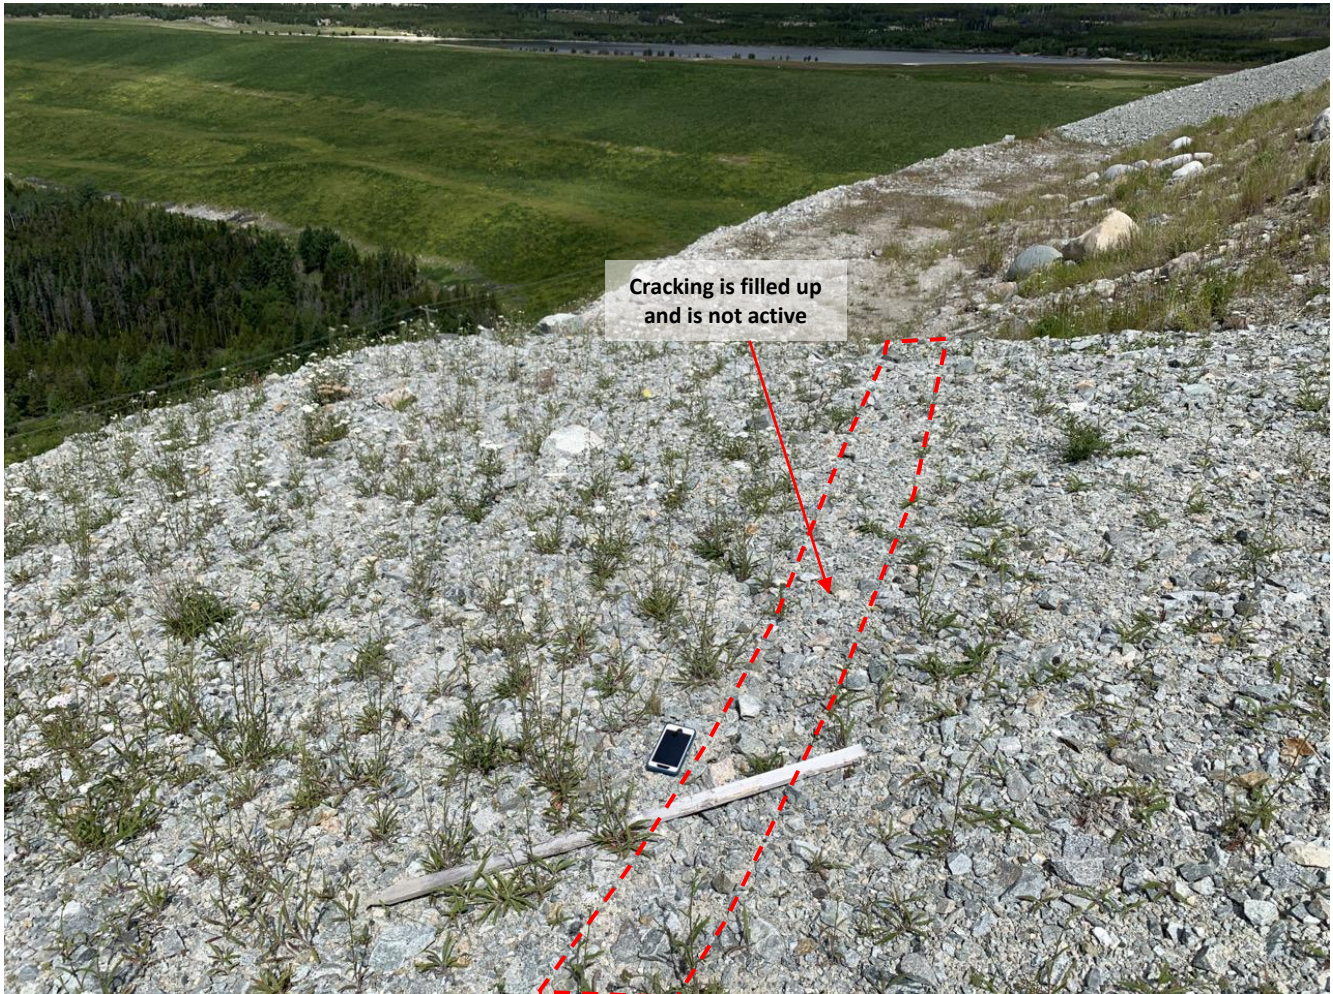
Photo I-A-5 Local cracking of rockfill pushed over downstream slope to fill erosion scour. Previously observed cracking has been filled, indicating area has been inactive (BTH-2020-05)

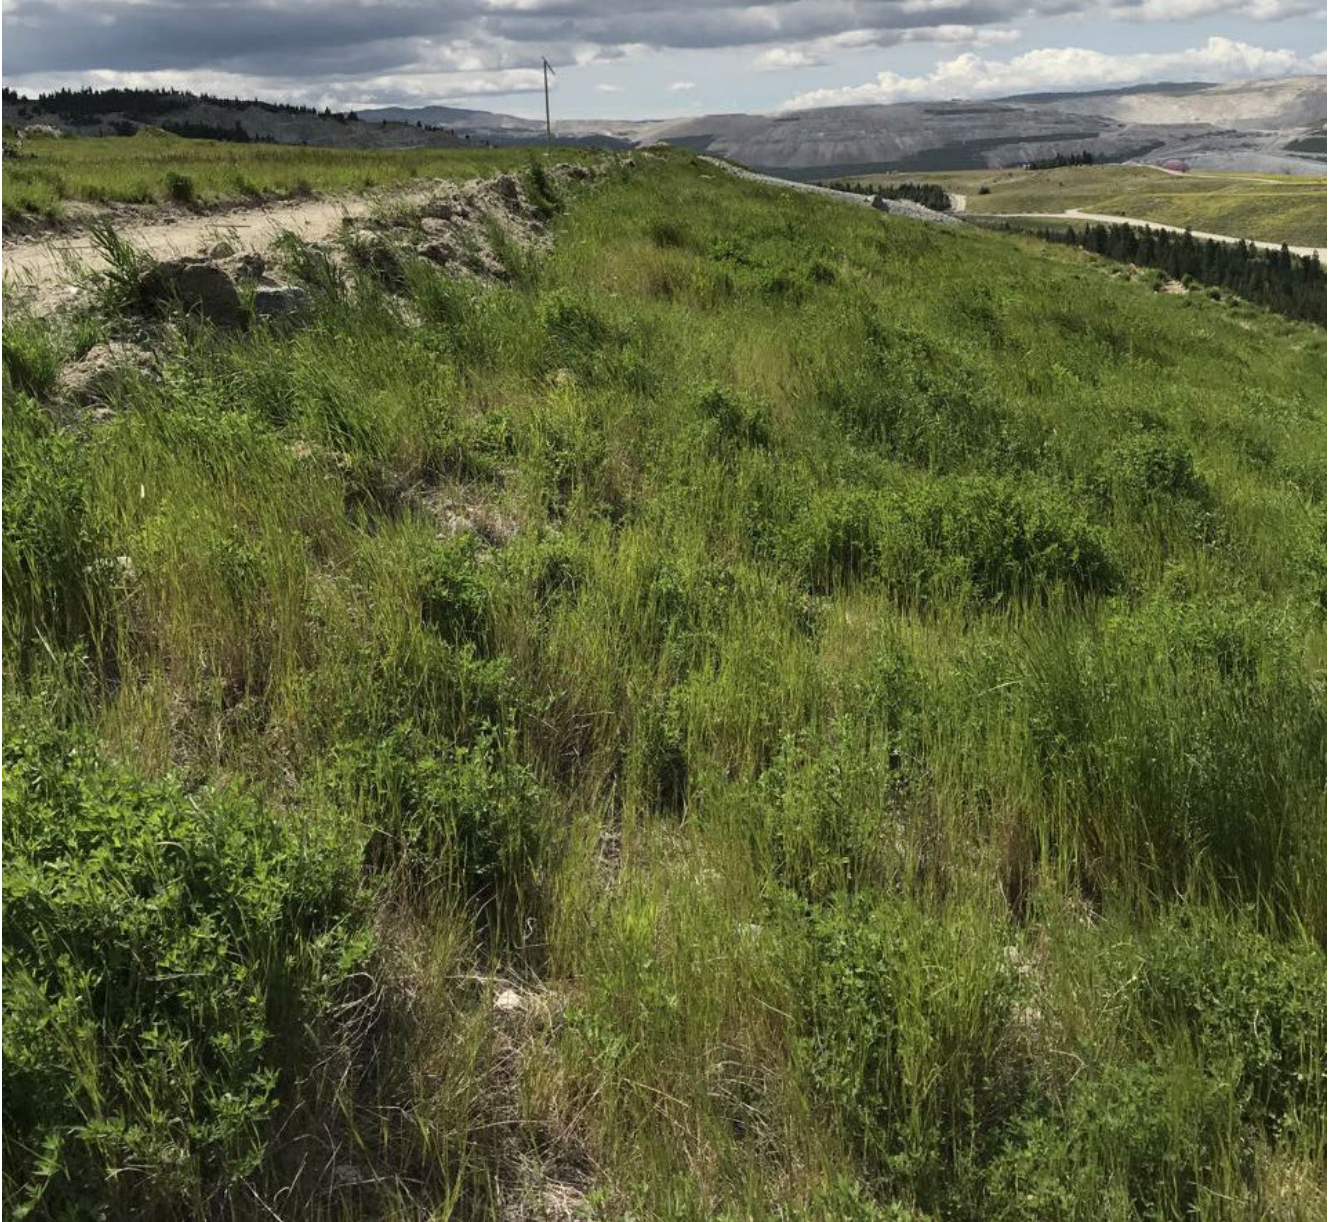
Photo I-A-7 Overview of downstream slope and toe from crest road, looking south. No major erosion areas were observed. (BTH-2020-01)

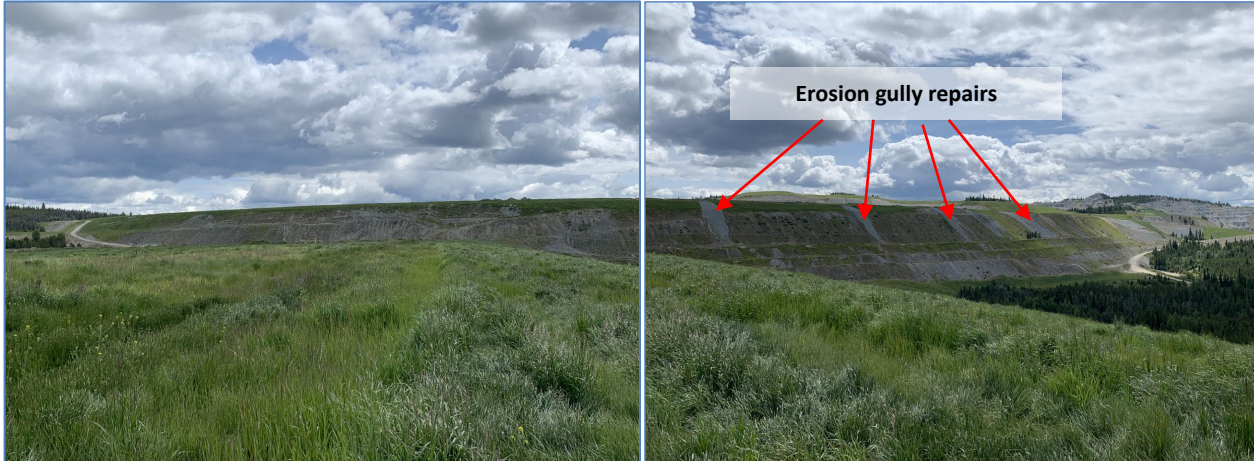
Photo I-A-8 Overview of downstream slope and toe from Trojan Dam. No major erosion areas were observed (BTH-2020-06)

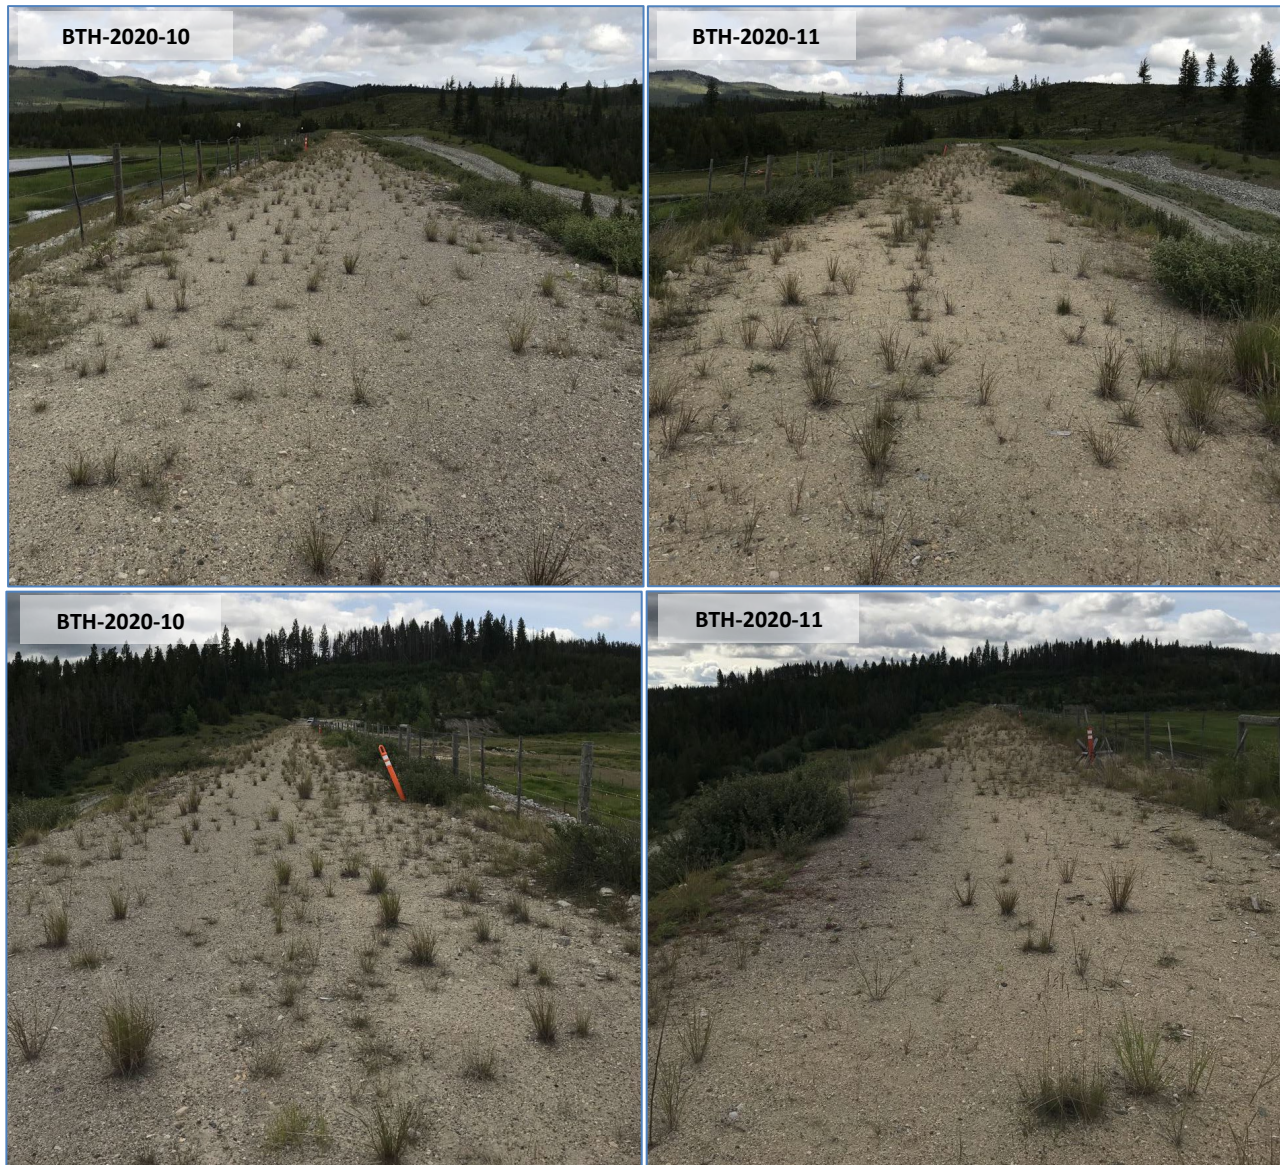
Photo I-B-3 Overview of dam crest, looking towards left abutment (top photos) and right abutment (bottom photos). No sign of erosion or depression was observed (BTH-2020-10 and BTH-2020-11)

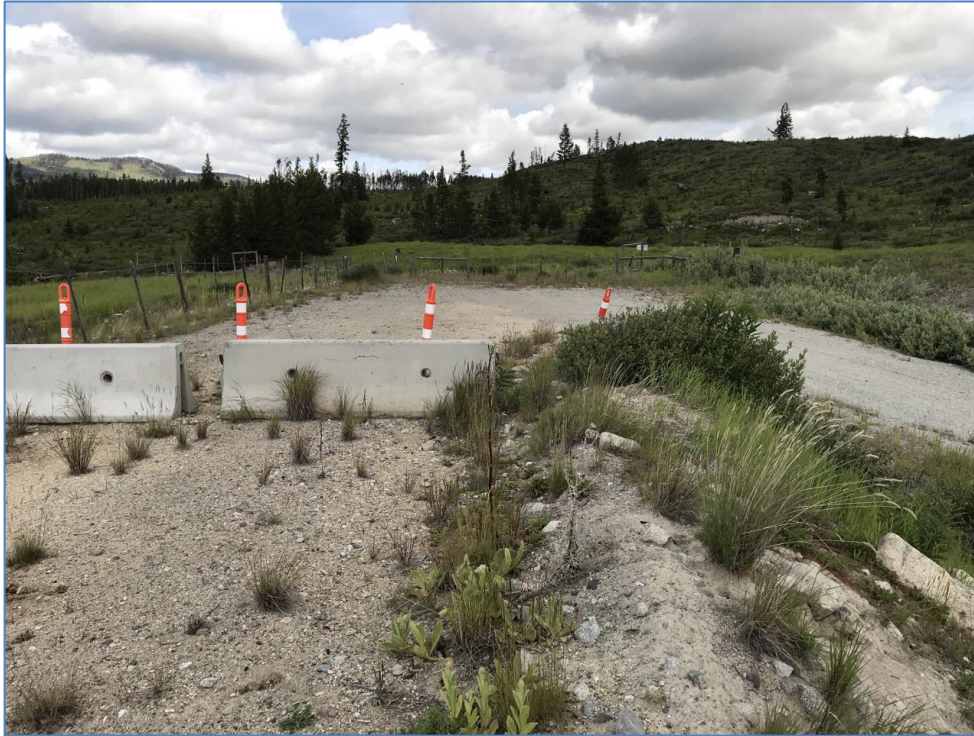
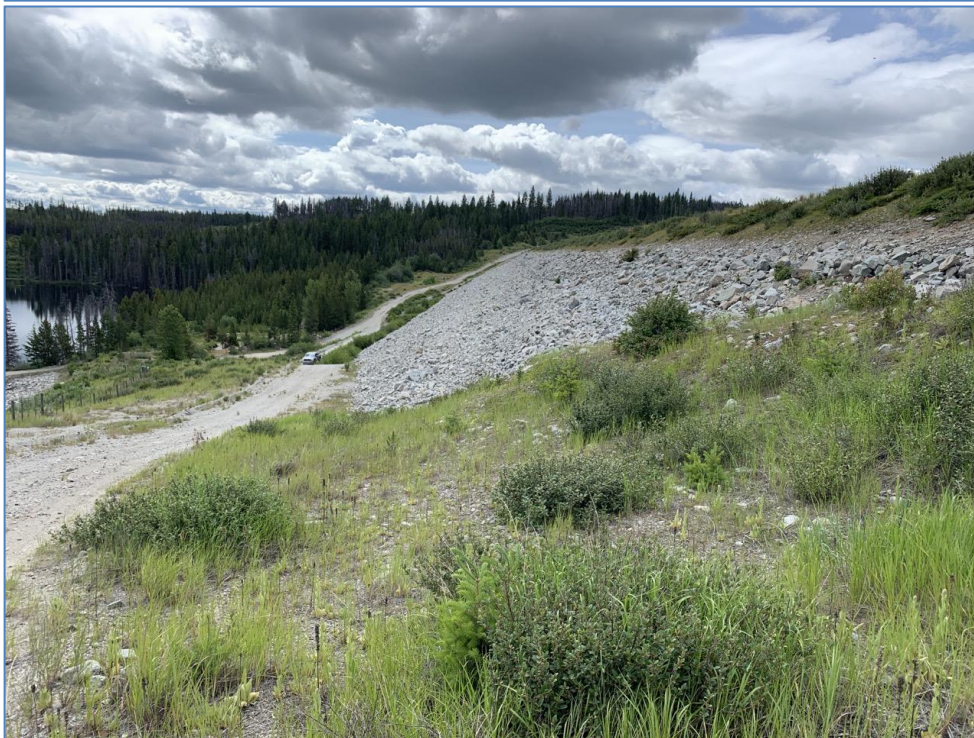
Photo I-B-5 View of left abutment. No sign of erosion or unusual condition (BTH-2020-13 and BTH-2020-14)

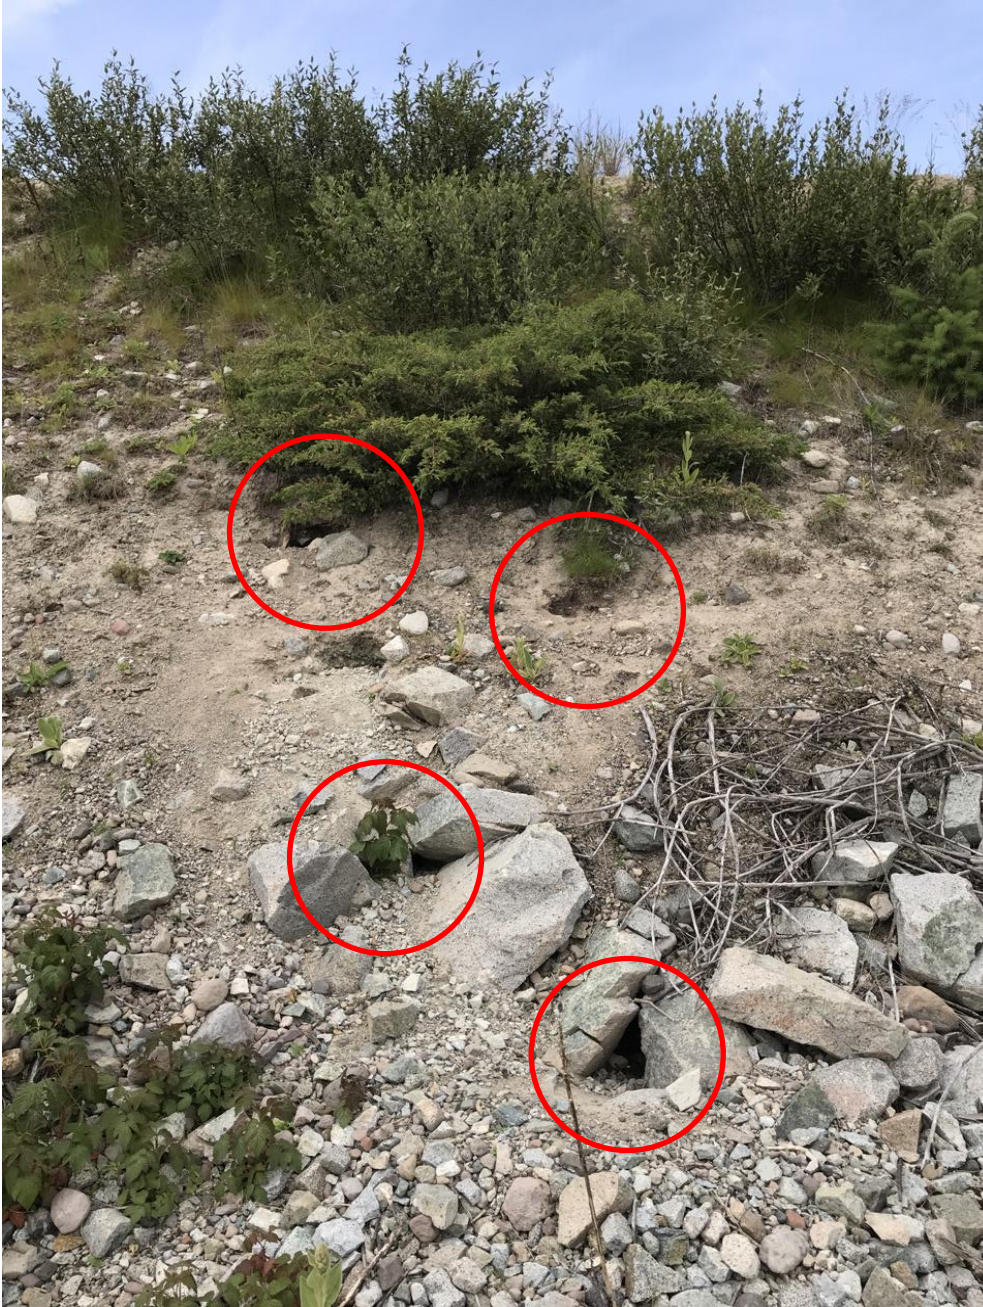
Photo I-B-6 Multiple animal burrows observed at downstream slope near left abutment. Before 2021 freshet, THVCP should conduct an inspection of the upper downstream slope of till, where horizontal width between tailings and downstream slope is narrowest, and fill animal burrows (BTH-2020-15)

ID No.	Performance Area	Recommended Action	Priority ⁽¹⁾	Recommended Deadline (Status)
Bose Lake Dam				
BD-2020-01	Maintenance	Complete inspection of the downstream slope of exposed till fill (above ~El. 1440.1 m) for animal burrows and fill or obstruct them.	3	Q4 2021
Bethlehem No.1 Tailings Storage Facility, Dam No. 1 and R3 Seepage Pond				
No New Recommendations

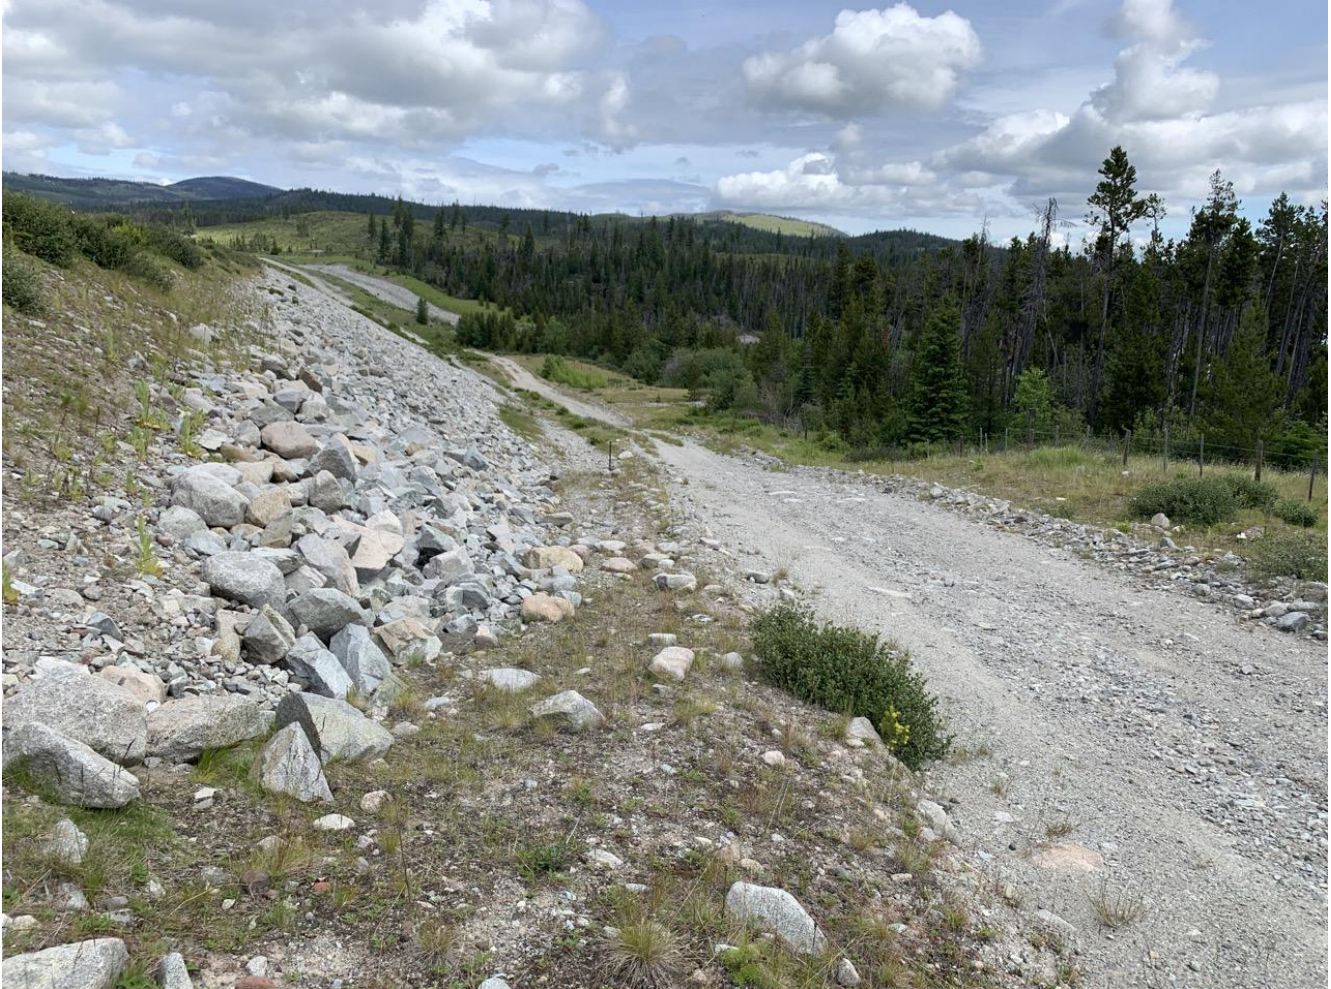
Photo I-B-8 Overview of downstream slope from right abutment. No ongoing erosion, road in good condition, and no seepage or wet sections observed in area (BTH-2020-16)

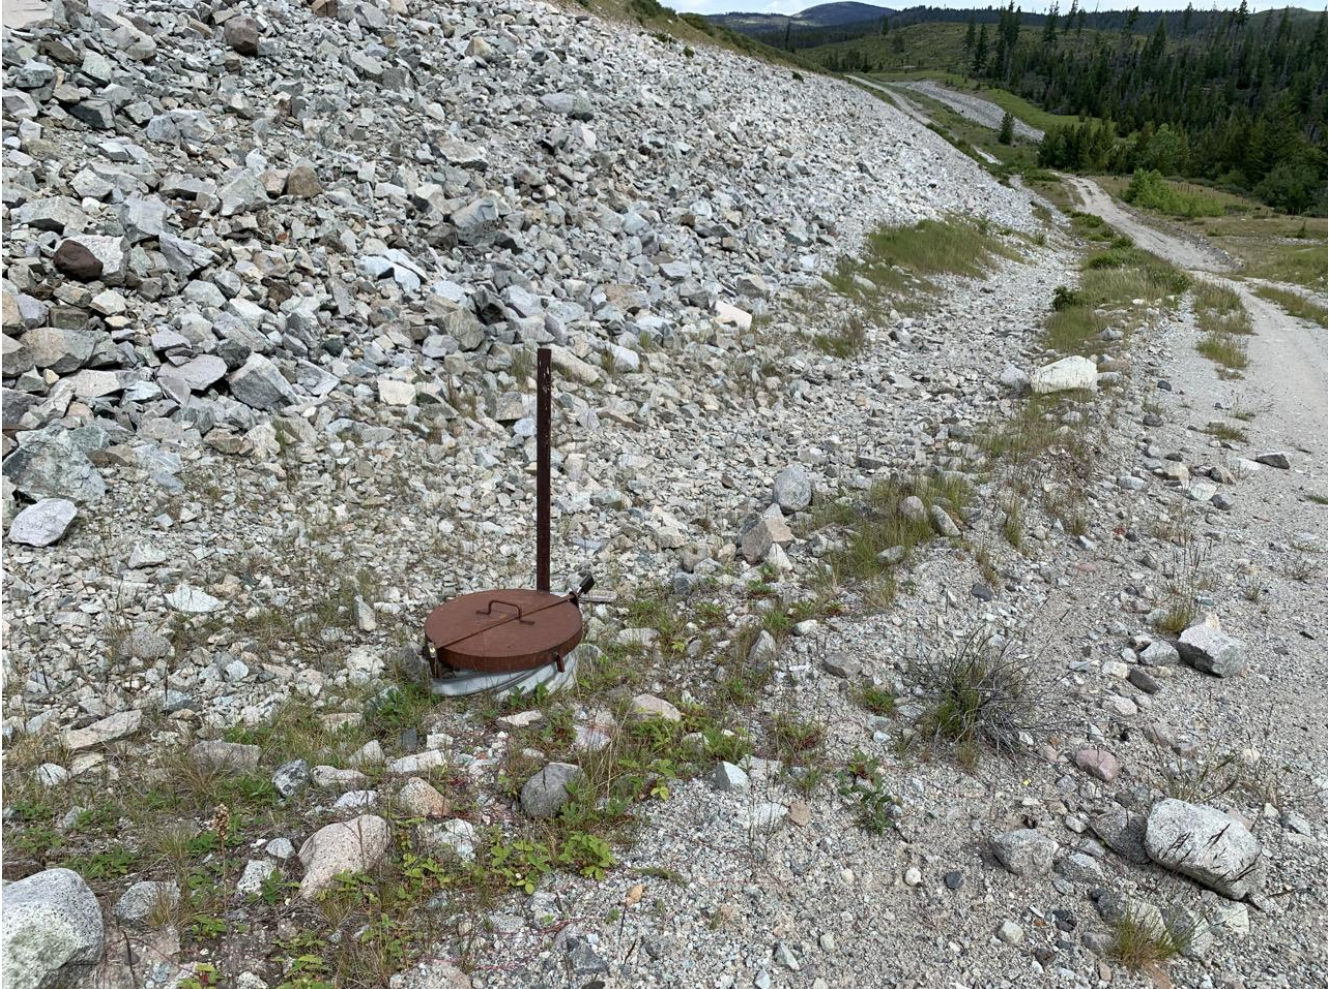
Photo I-B-9 Upslope extent of toe drain along abutment. Toe drain access point is visible. Cap is sealed (BTH-2020-17)

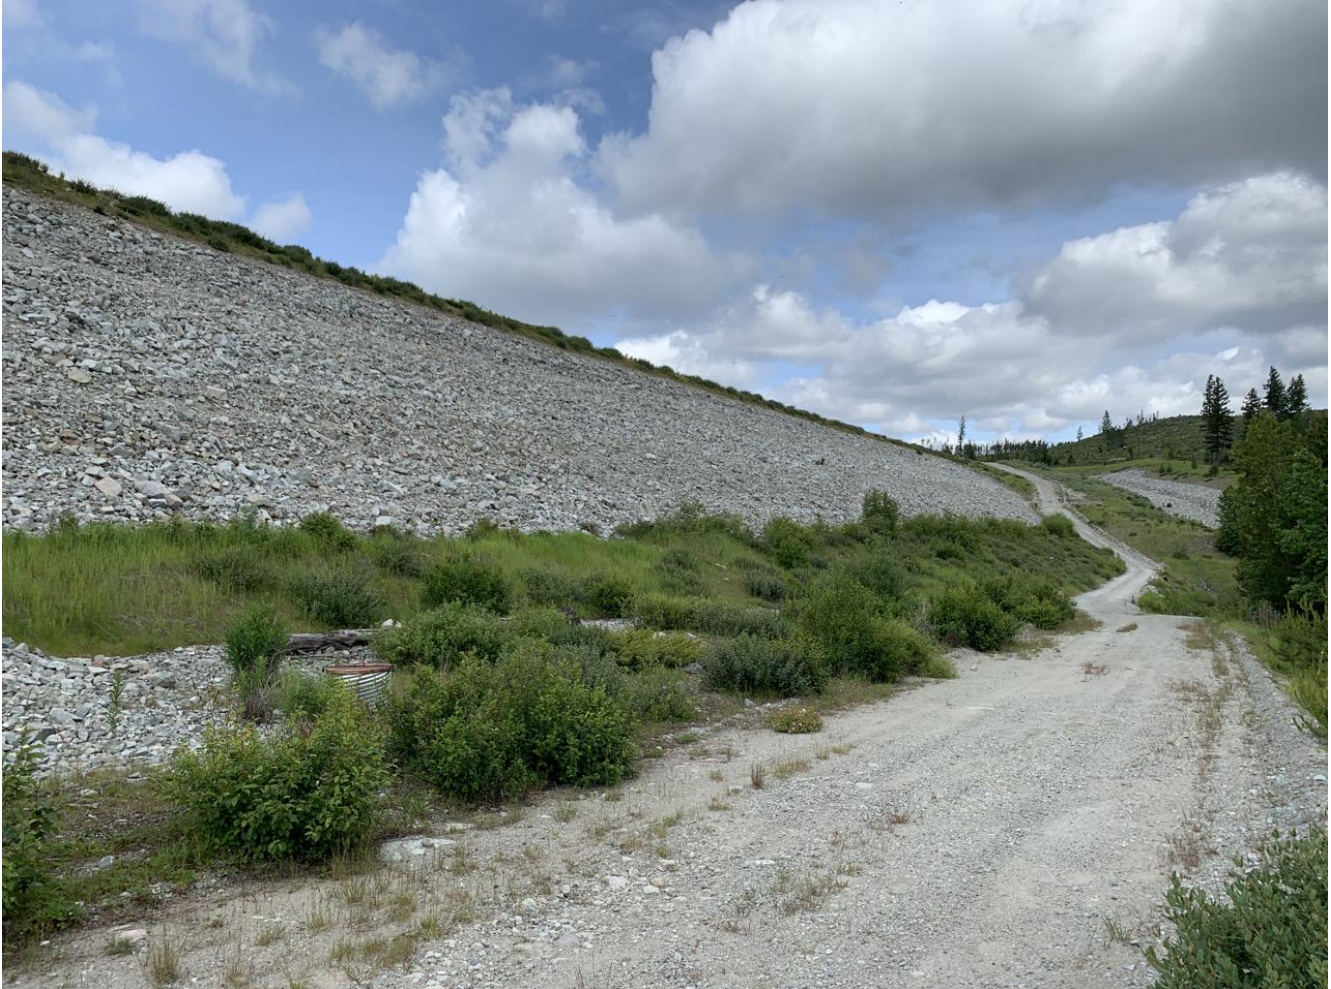
Photo I-B-10 View of downstream slope. Vegetation cover over lower portion of slope, comprised of till fill. No erosion of slope (rock of till) was observed (BTH-2020-18)

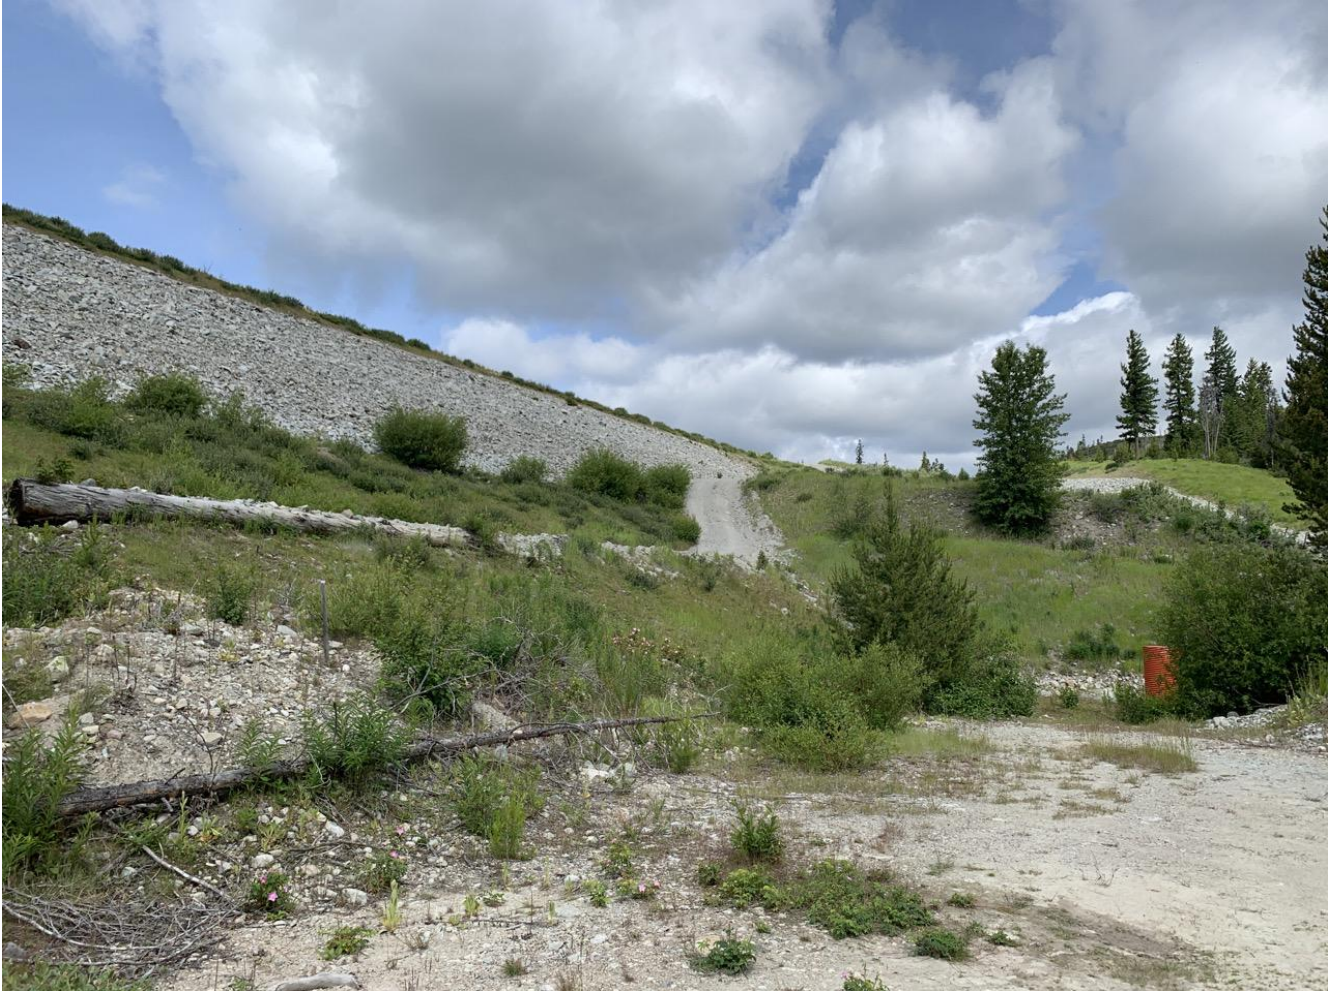
Photo I-B-11 Downstream slope and lower part of left abutment. No sign of unusual condition or erosion (BTH-2020-19)

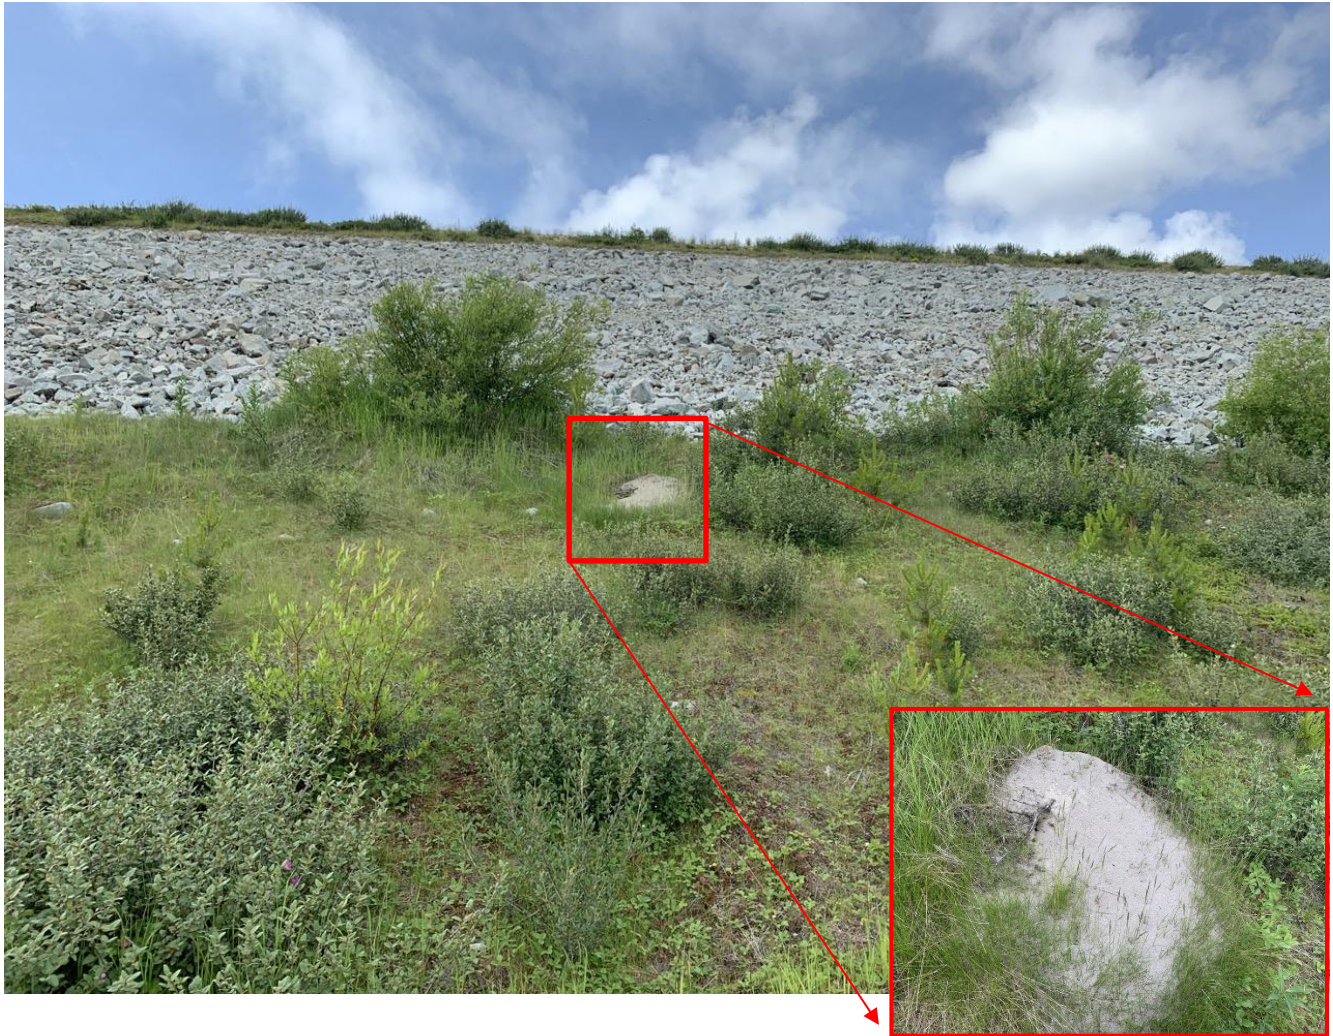
Photo I-B-12 Pile of sand (not tailings) on upper part of starter dam slope. Appears to have been dumped there rather than related to seepage. No change from 2019 visual observations. Well above water level and no sign of flow in the area (BTH-2020-20 and BTH-2020-21)

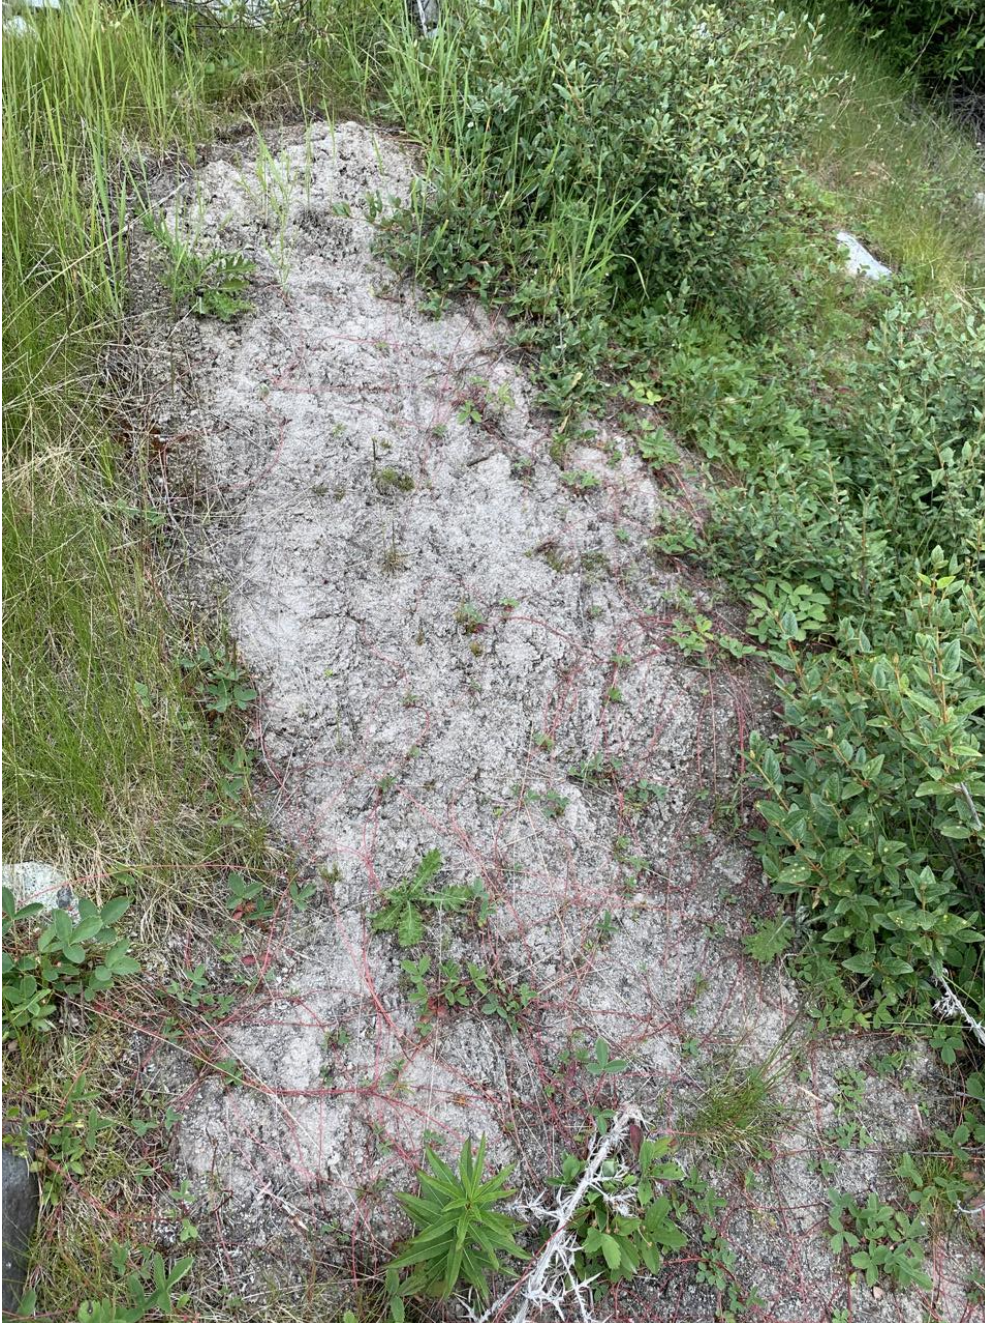
Photo I-B-13 Sand pile similar to the one observed in Photo I-B-12 and at a similar elevation. No change from 2019 visual observations (BTH-2020-22)

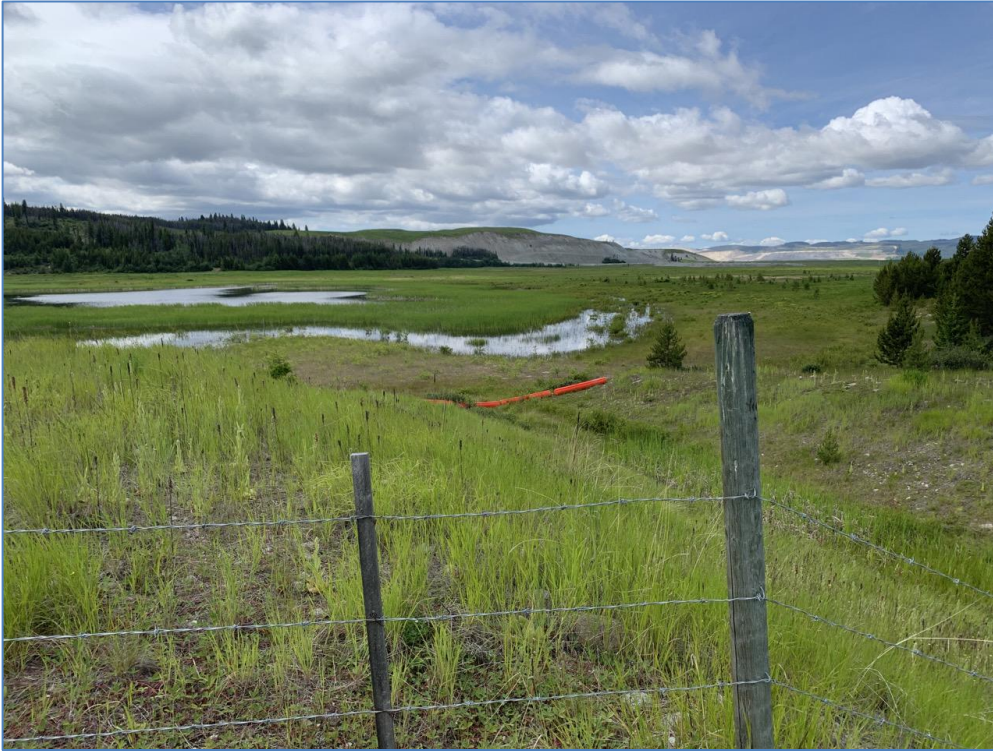
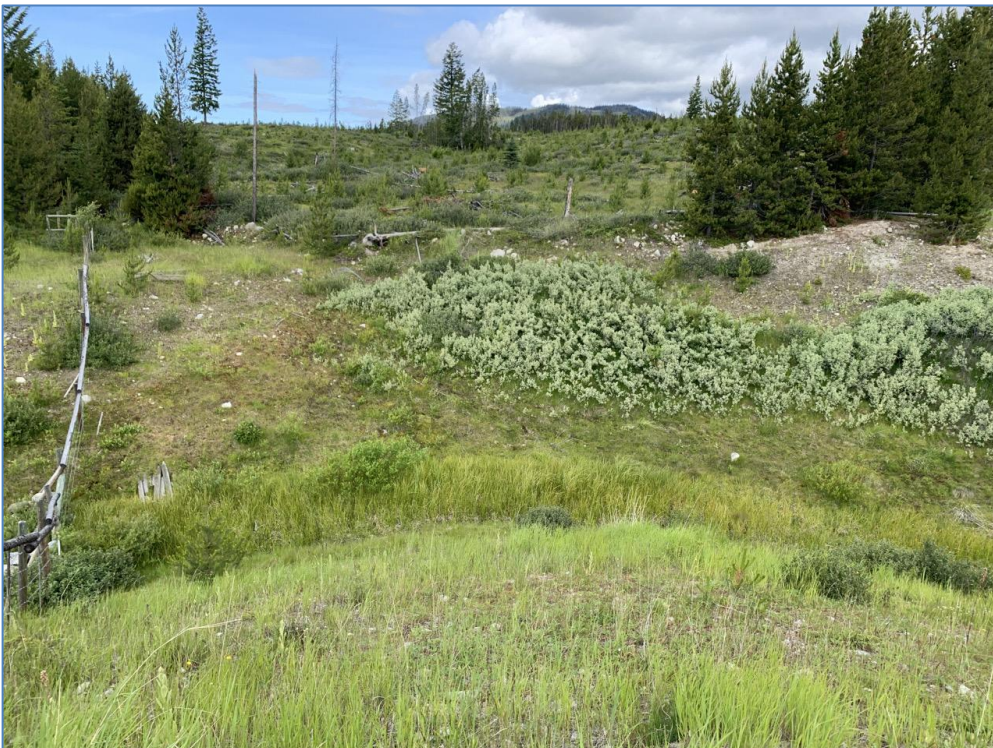
Photo I-B-17 Spillway inlet and approach channel. Vegetation to be cleared from flow channel as part of routine maintenance (BTH-2020-25)

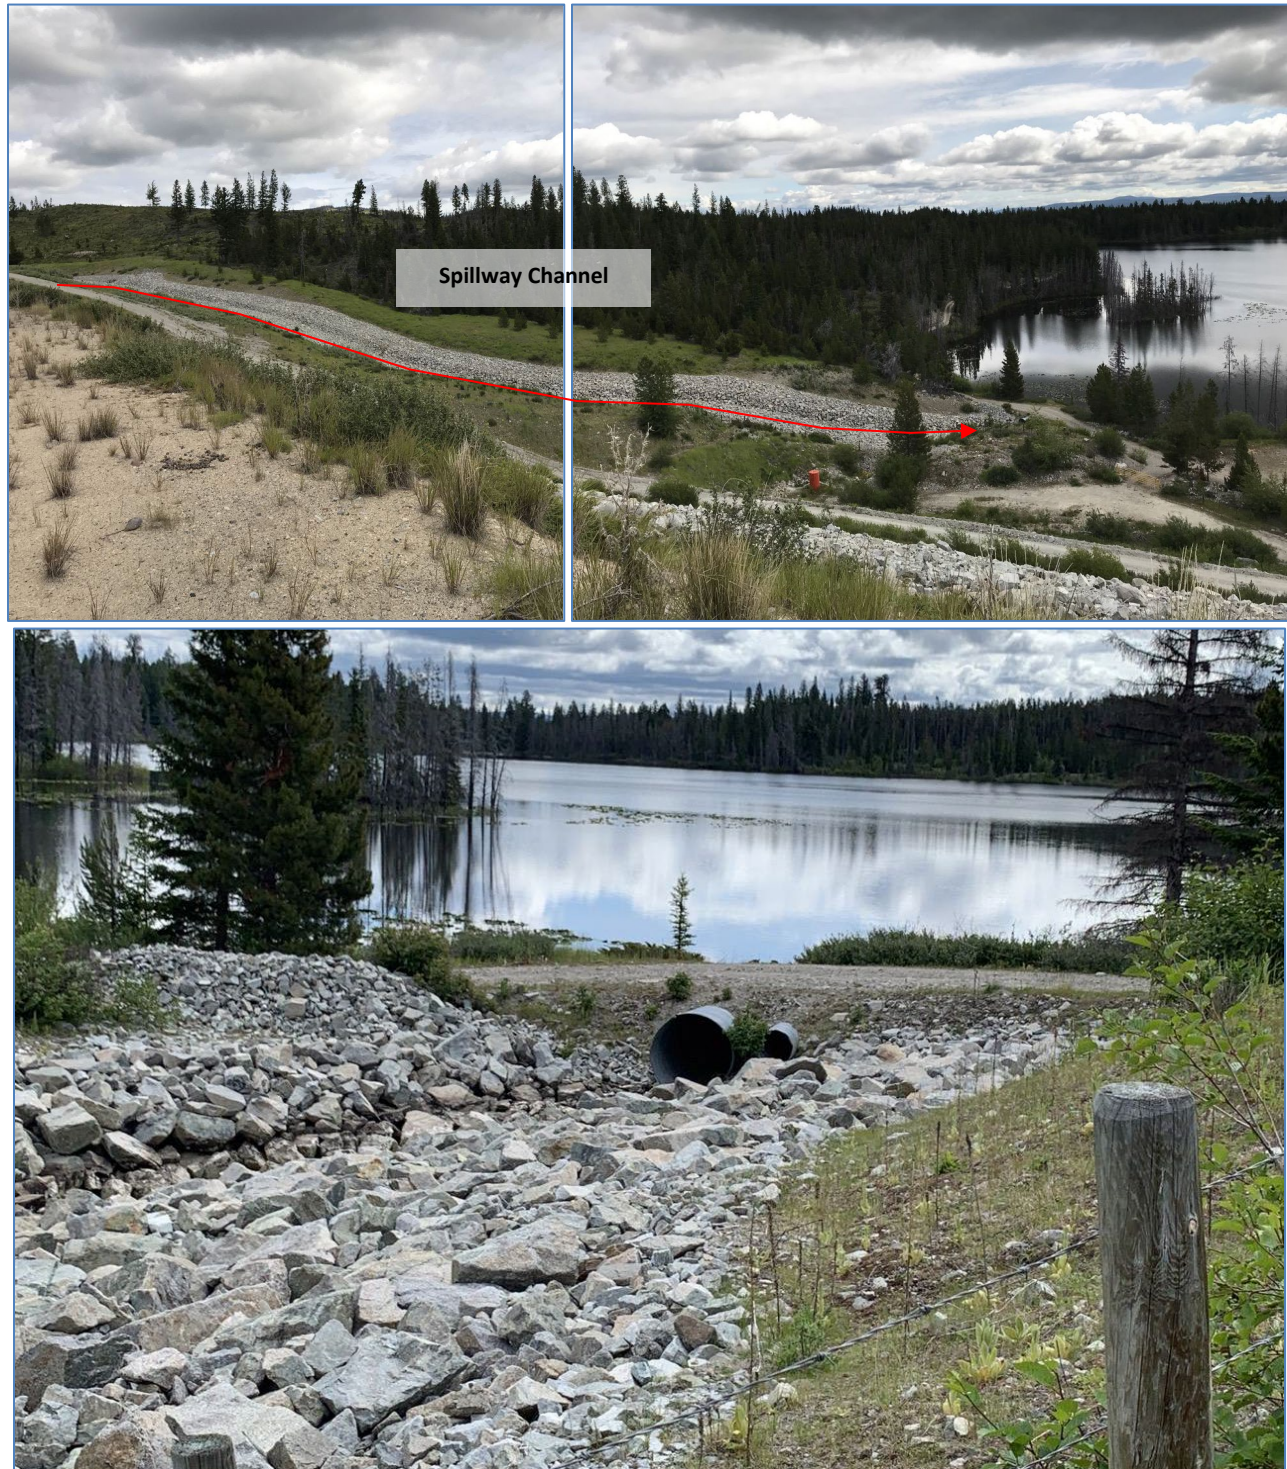
Photo I-B-20 Spillway channel and outlet to Bose Lake. Downstream spillway culverts are unobstructed. Sign of water pooling upstream of culverts in channel but no sign of flow through spillway. Likely pooled runoff (BTH-2020-09 and BTH-2020-27)
