Teck Highland Valley Copper Partnership

2020 Annual Facility Performance Report

Bethlehem No.1 Tailings Storage Facility

March 2021

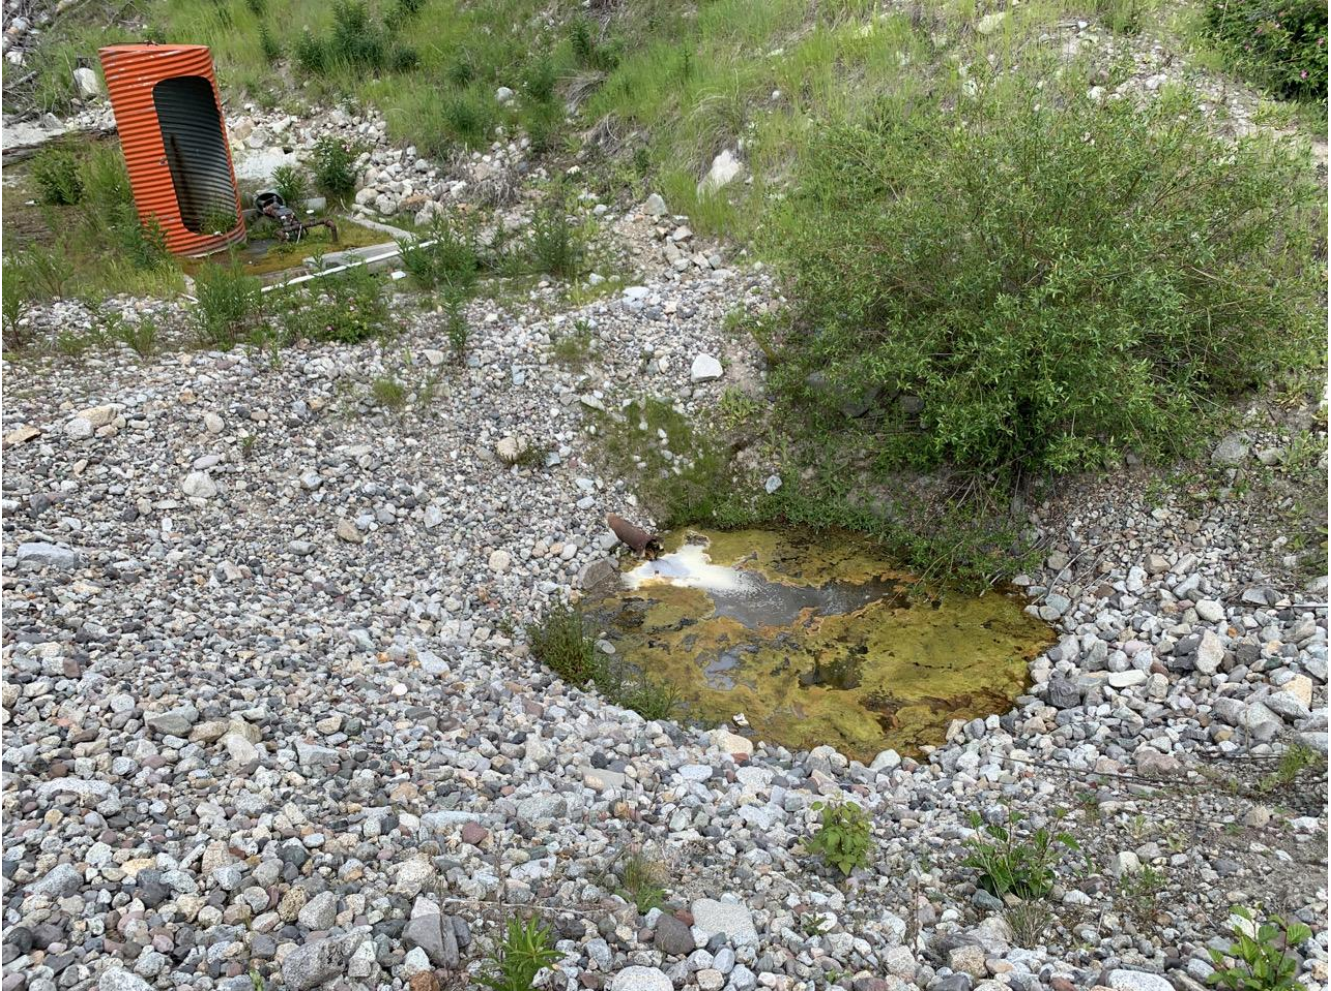
Photo I-B-21 Seepage flow from toe drain is clear. Pond drainage conditions unchanged from 2019 observations (BTH-2020-27)

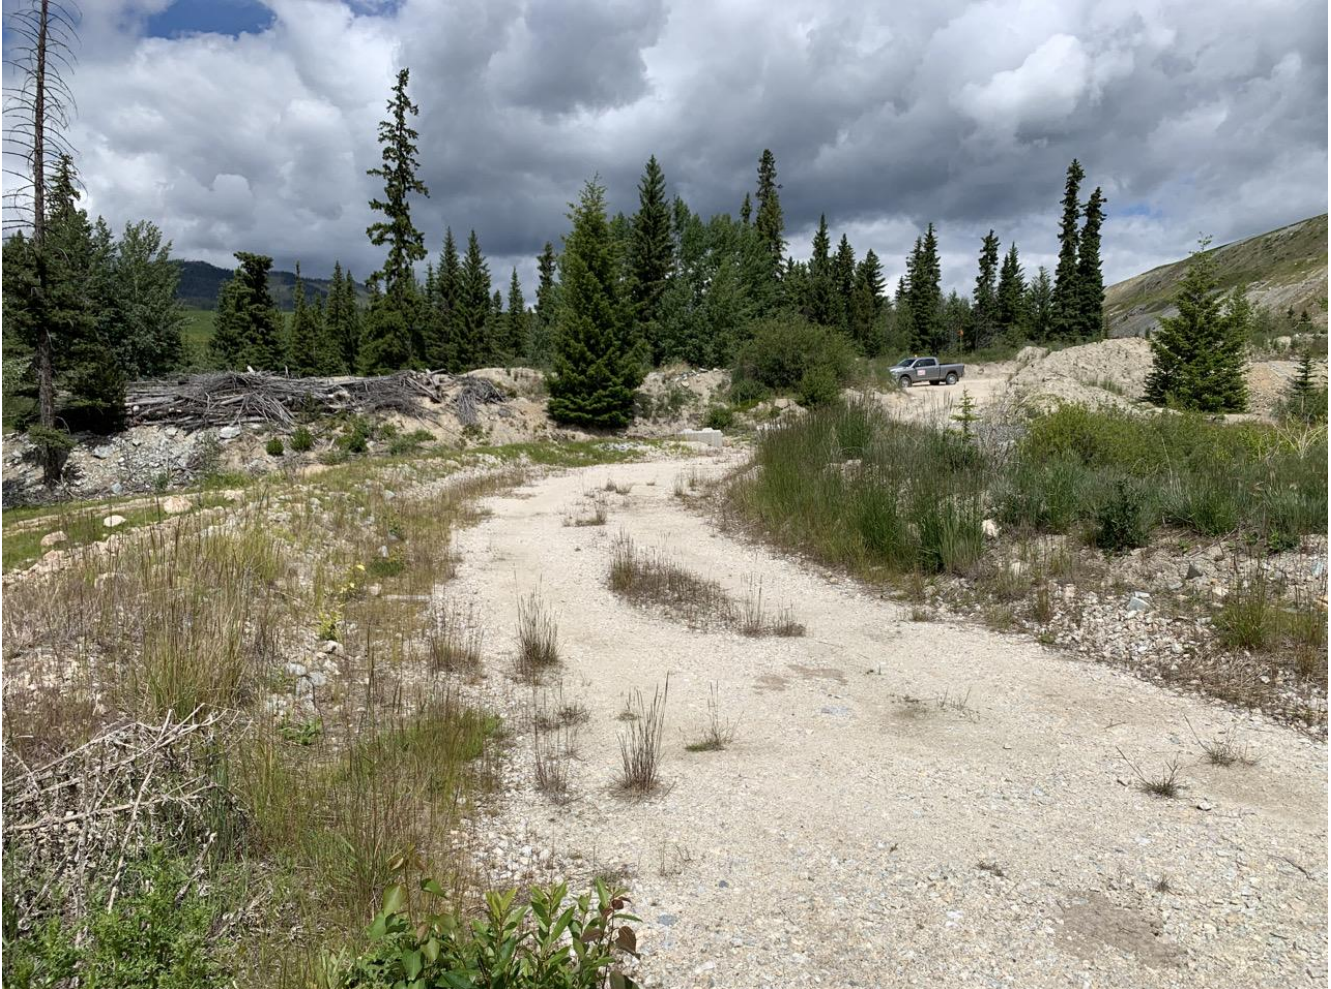
Photo I-C-2 R3 Seepage Pond dam crest. No cracking or no sign of distress was observed (BTH-2020-29)

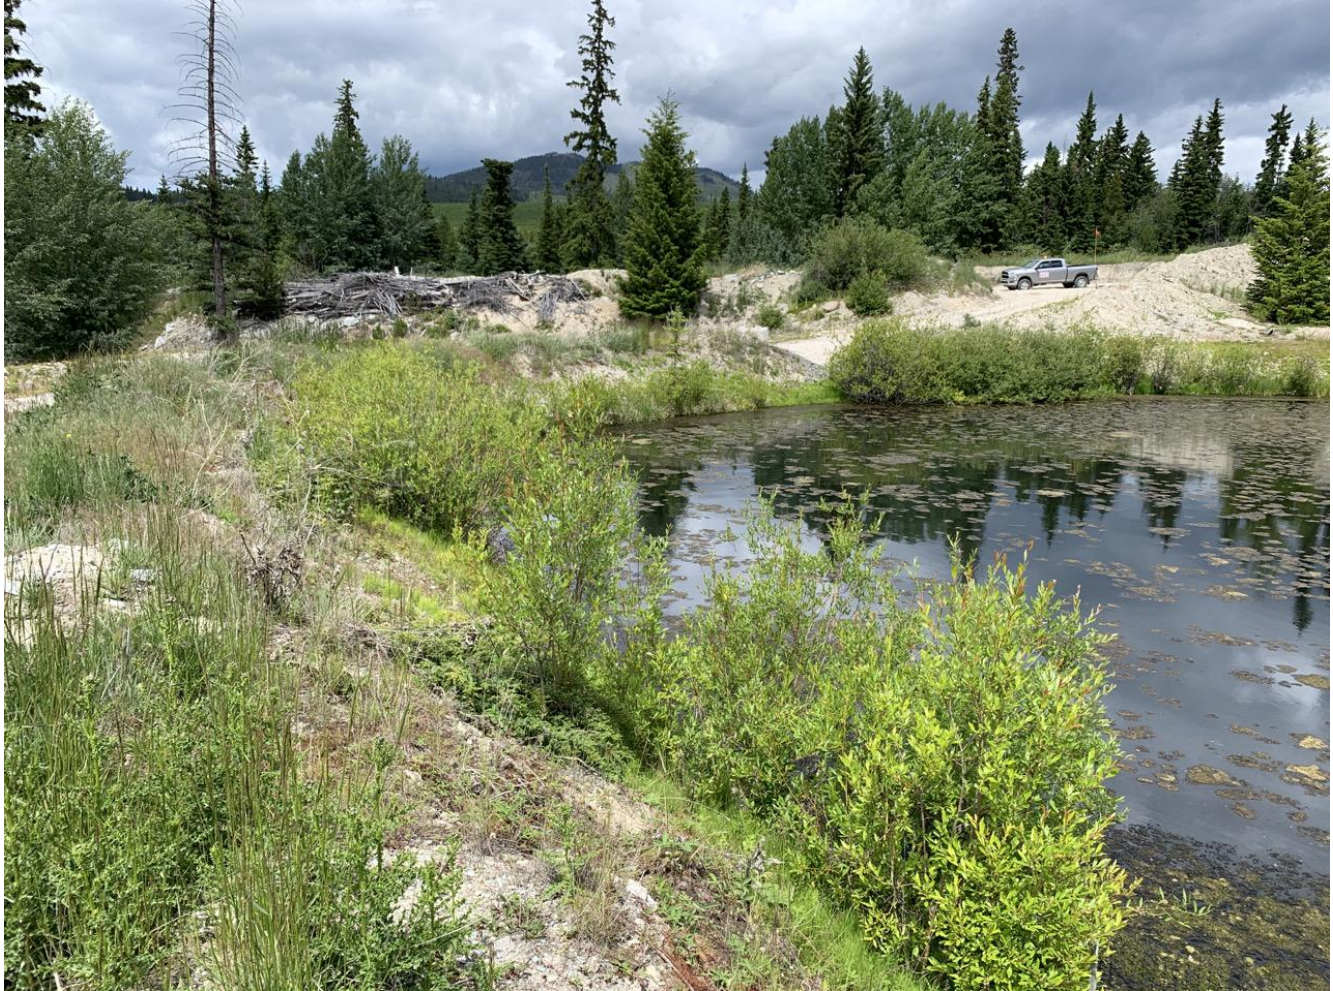
Photo I-C-3 R3 Seepage Pond upstream slope heavily vegetated. Vegetation should be removed as part of routine maintenance (BTH-2020-30)

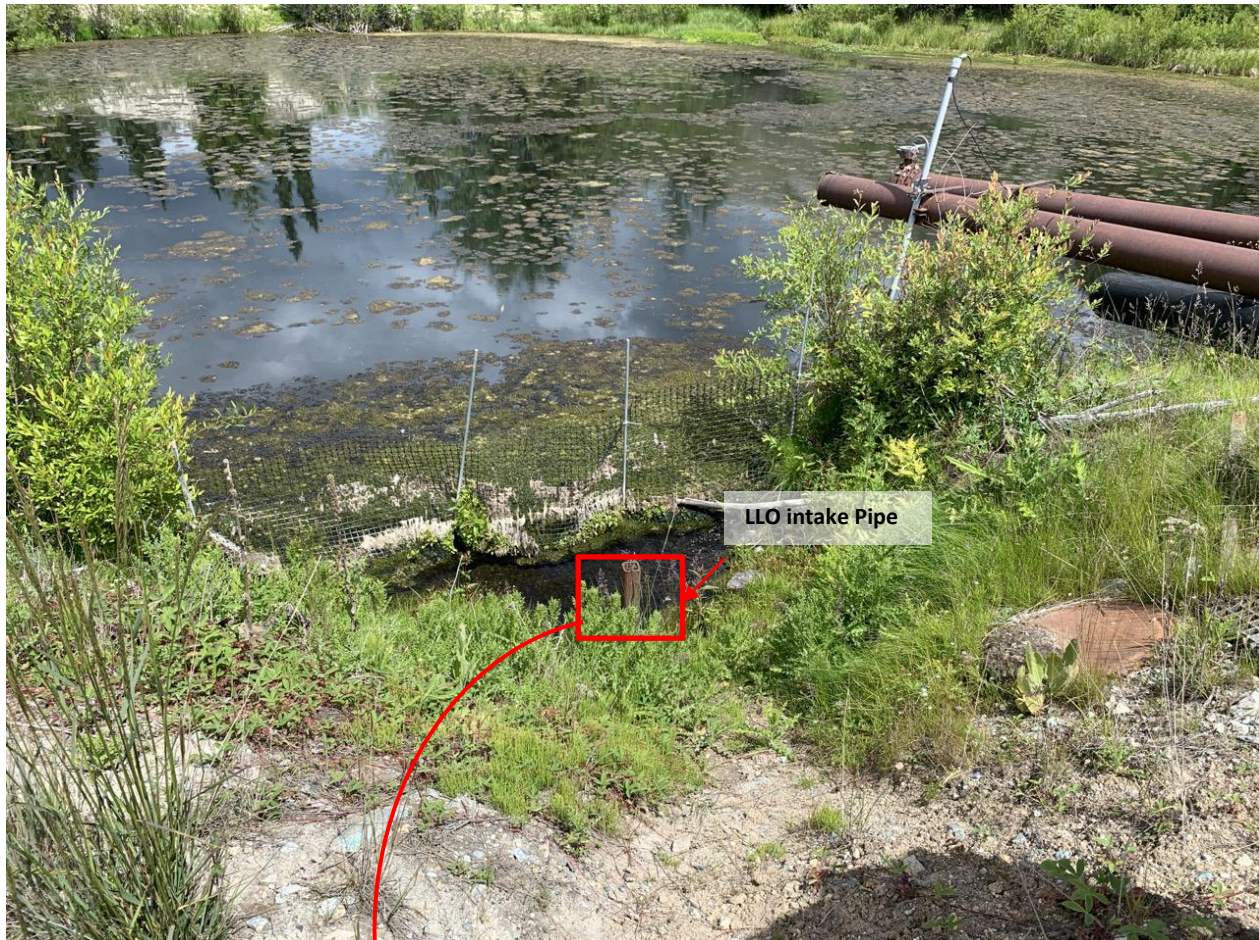
Photo I-C-4 View of R3 Seepage Pond and debris mesh for Low-Level Outlet (LLO). Clear water was flowing at the time of inspection. The debris mesh is clogged below and above water. This does not impact flood routing but could be part of routine maintenance. (BTH-2020-30)

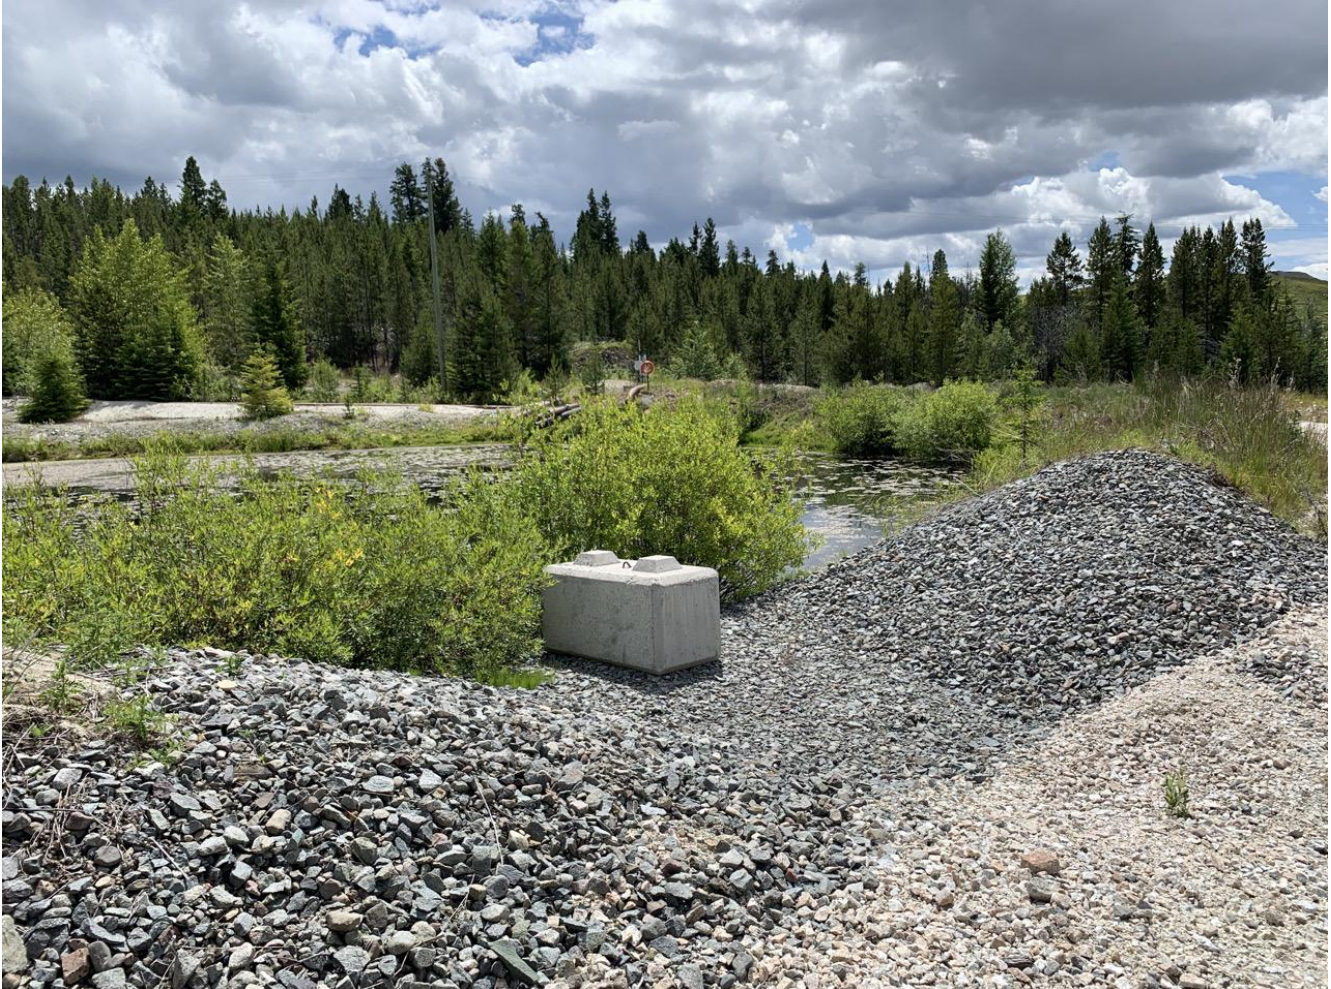
**Photo I-C-5 View of spillway inlet. Lock-block and vegetation to be cleared from inlet
(BTH-2020-31)**

- The lock-block barrier which had partially obstructed the R3 Seepage Pond spillway inlet was in place during the inspection but later removed as recommended by KCB and SRK (2019).
