Teck Coal Limited

Elkview Operations

Coarse Coal Refuse Dump

2020 Annual Summary of Facility Performance Report

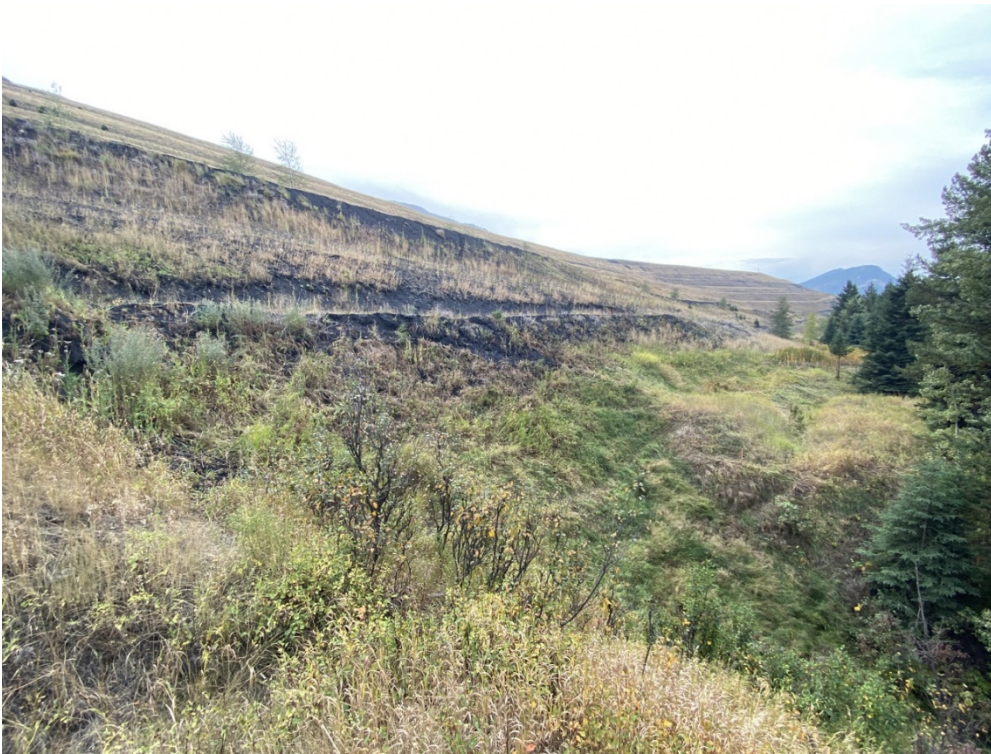
Photo I-5 CCR Dump sparse vegetation at toe benches. (looking southeast)

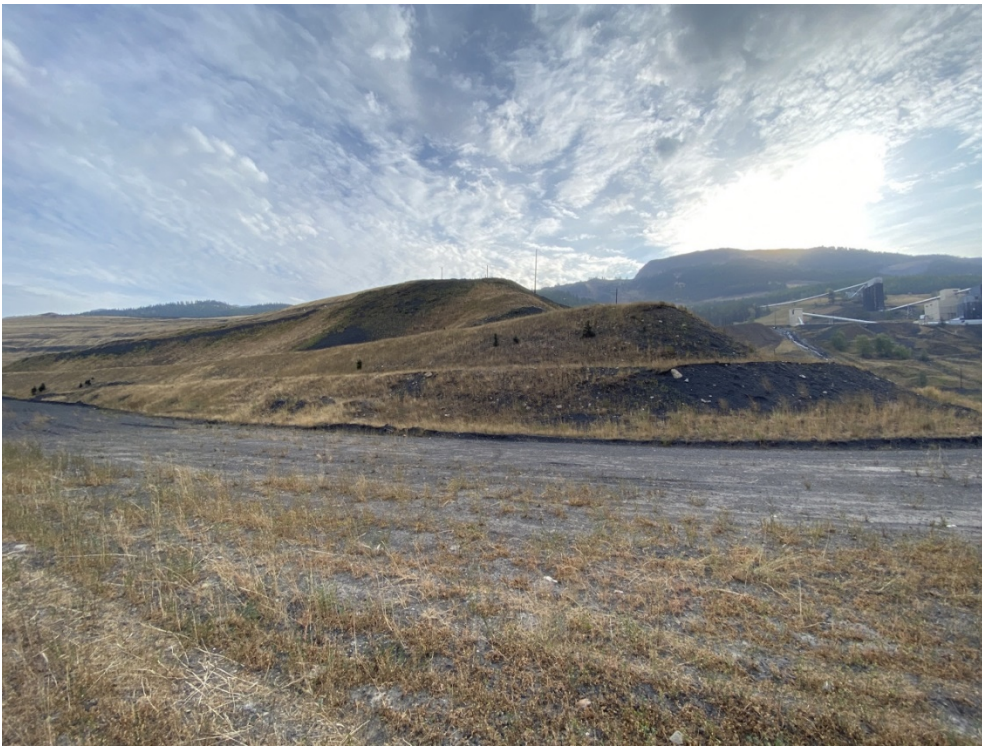
Photo I-7 CCR Dump localised sparse vegetation. (looking east)

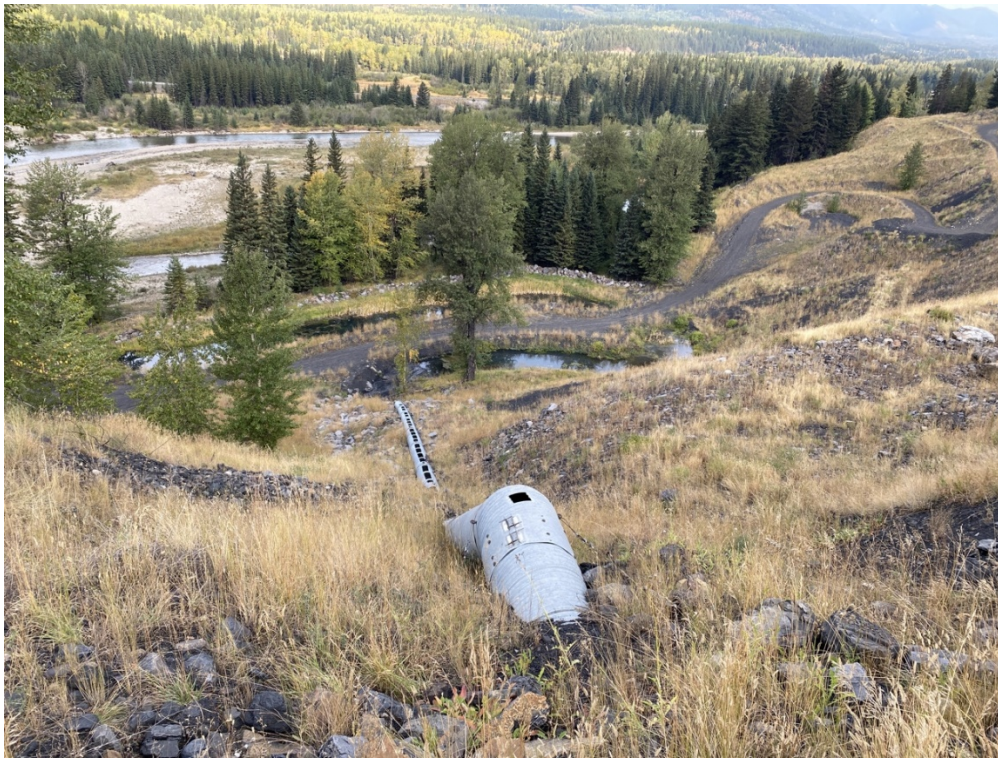
Photo I-9 CCR Dump Lindsay Drain culvert outlet. (looking west)

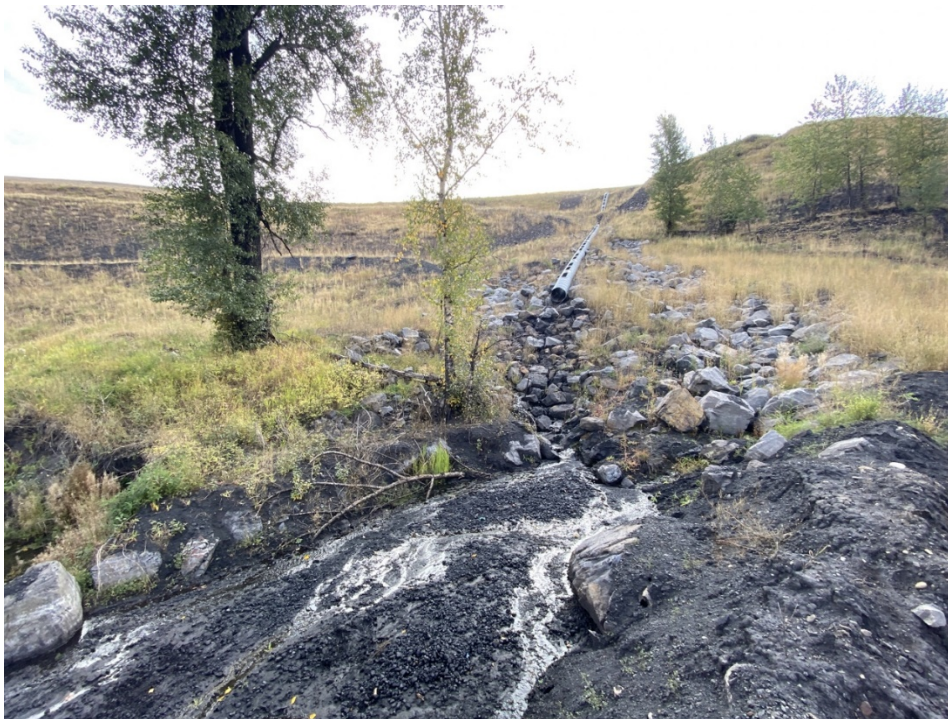
Photo I-10 CCR Dump Lindsay Drain outlet. (looking east)

No.	(Anomalous) Observations	Change from 2019 Inspection?	Facility Safety Concern?	Photo Reference
CCR-1	Minor erosion was observed on some sections of the interbench slopes.	No	No	I-13, I1-14
CCR-2	The top of the Lindsay Drain was observed to be covered by CCR material at the crest of the facility.	No	No	I-4
CCR-3	Orange stained seepage was observed at some CCR Dump interbench ditches.	No	No	I-6
CCR-4	The Lindsay drain outlet was wet, but not flowing at the time of the inspection. The drain outlet appeared to be in good condition.	No	No	I-10

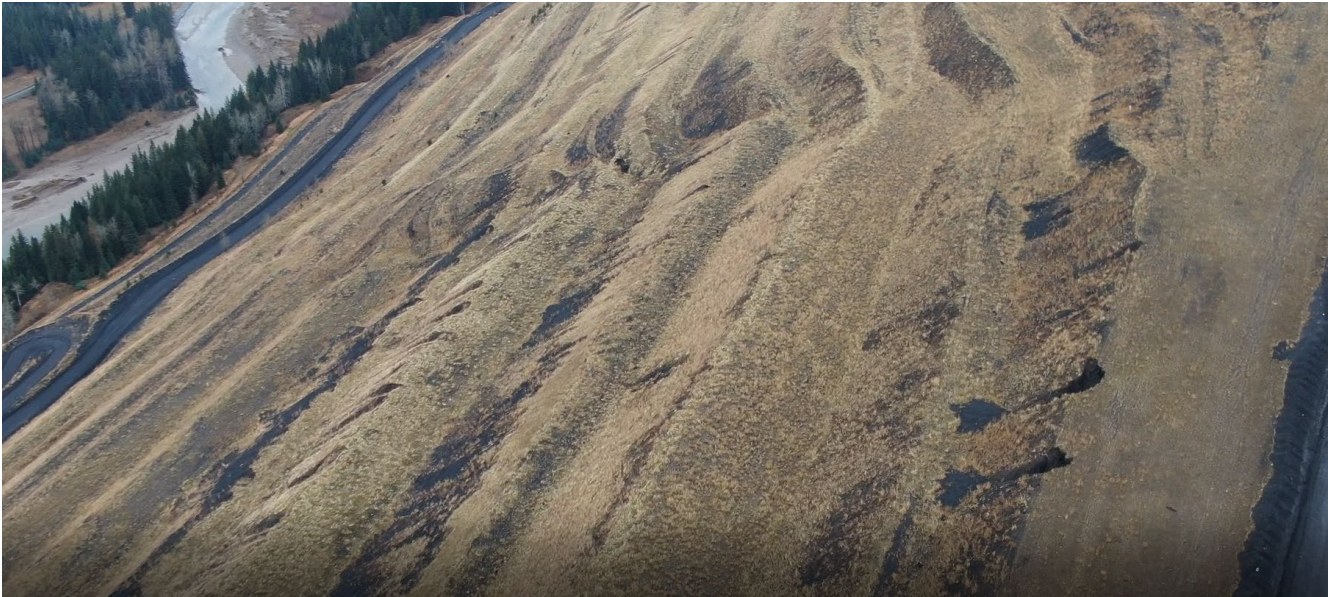
Photo I-13 CCR benches. (looking north, photo taken from drone flight)

During the annual inspection minor bench erosion was observed in several locations, with no significant change since the 2019 inspection. The erosion has been caused by surface water runoff on the external slope where vegetation is sparse. The surface of the CCR Dump is rough, and additional maintenance is required to establish vegetation on the surface. The Lindsay Drain was inspected and the outlet was wet at the time of inspection.

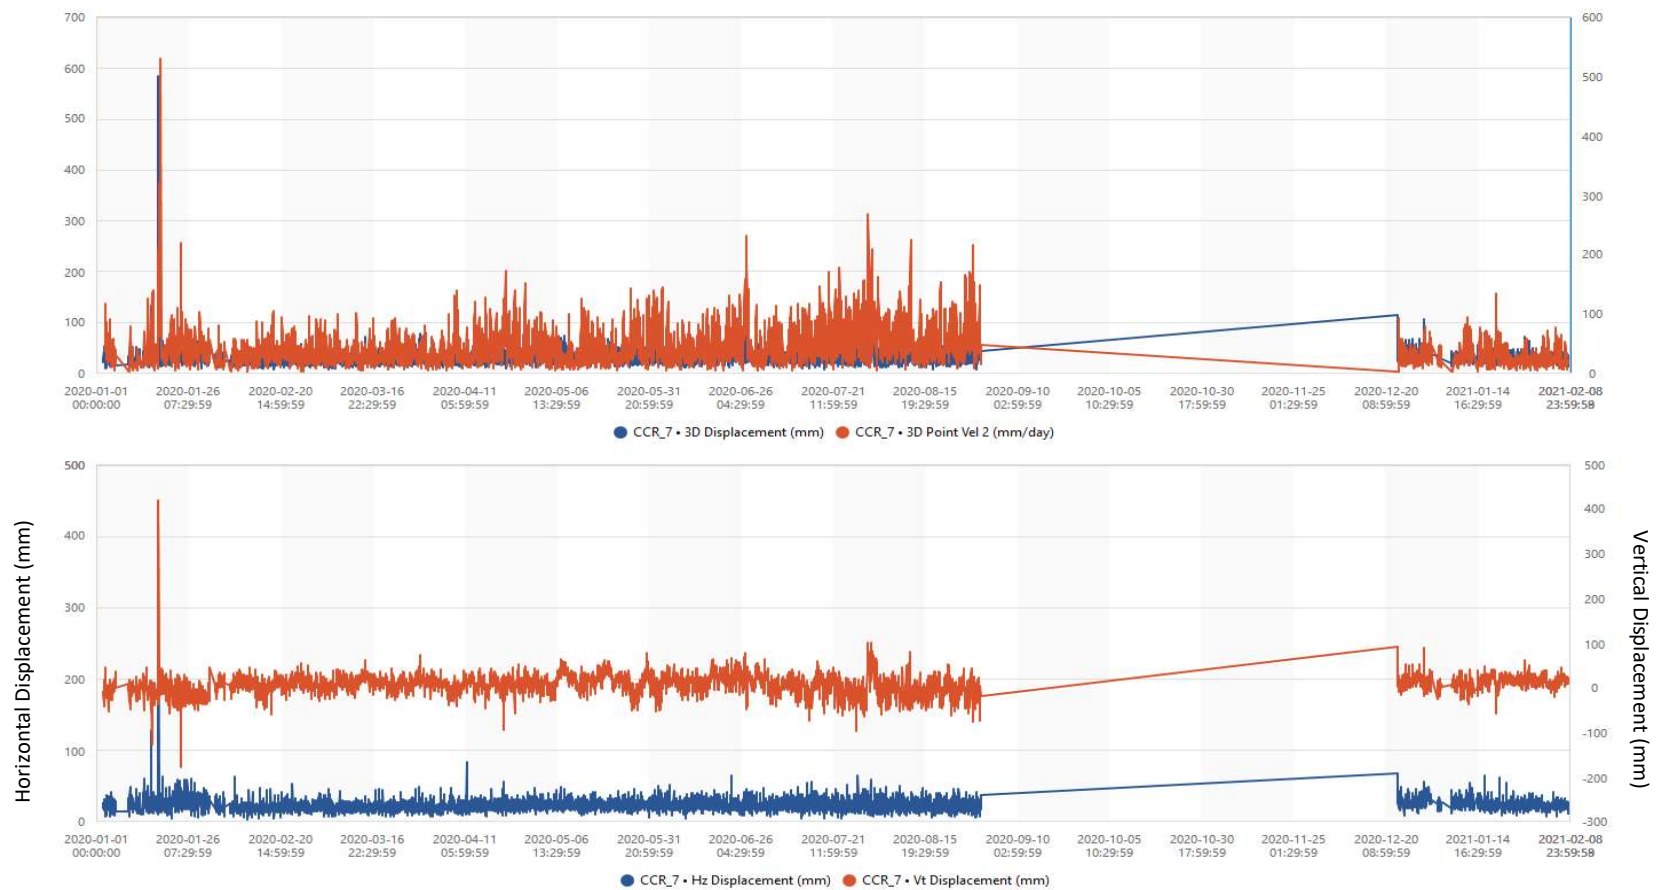
- CCR_7: horizontal differences typically ranging from 0 mm to 50 mm, and vertical differences ranging from -100 mm to +100 mm.
- CCR_8: horizontal differences typically ranging from 0 mm to 50 mm, and vertical differences ranging from -30 mm to +30 mm. Note, some horizontal differences up to 325 mm were recorded, but these discrete instances are considered to be erroneous, because subsequent data falls within the range noted above.

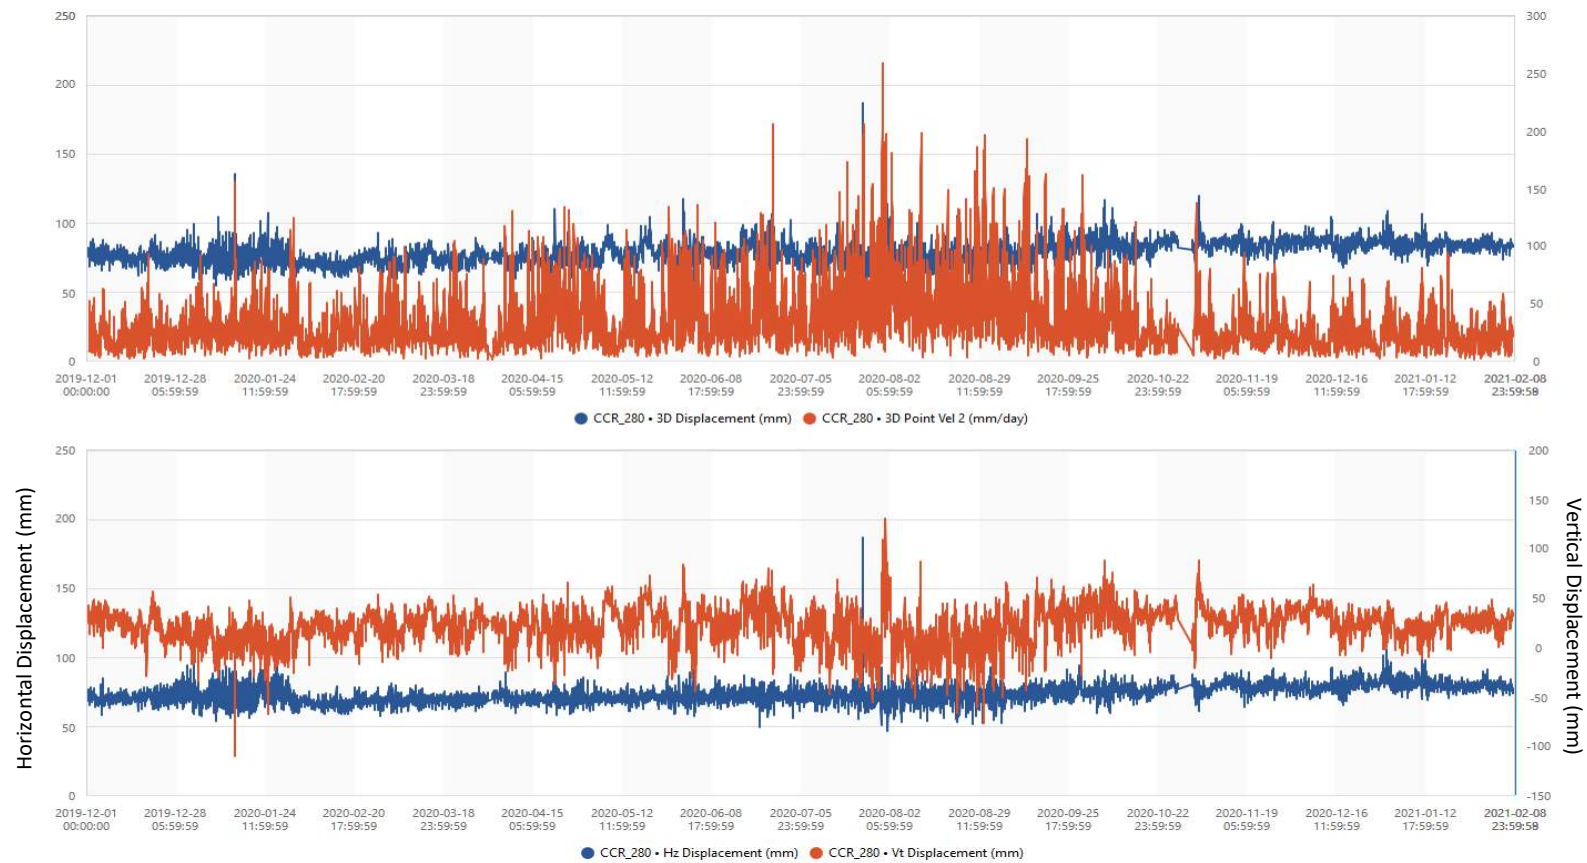
- CCR_280: horizontal differences typically ranging from 50 mm to 100mm, and vertical differences ranging from -50 mm to +50 mm. Note, some larger horizontal and vertical differences were recorded, but these discrete instances are considered to be erroneous, because subsequent data falls within the range noted above.
