2020 ANNUAL DUCK POND OPERATIONS TAILINGS MANAGEMENT FACILITY INSPECTION REPORT

2020 Annual Facility Inspection Report
Duck Pond Operations Tailings Management Facility

20139279 (1000)

April 9, 2021

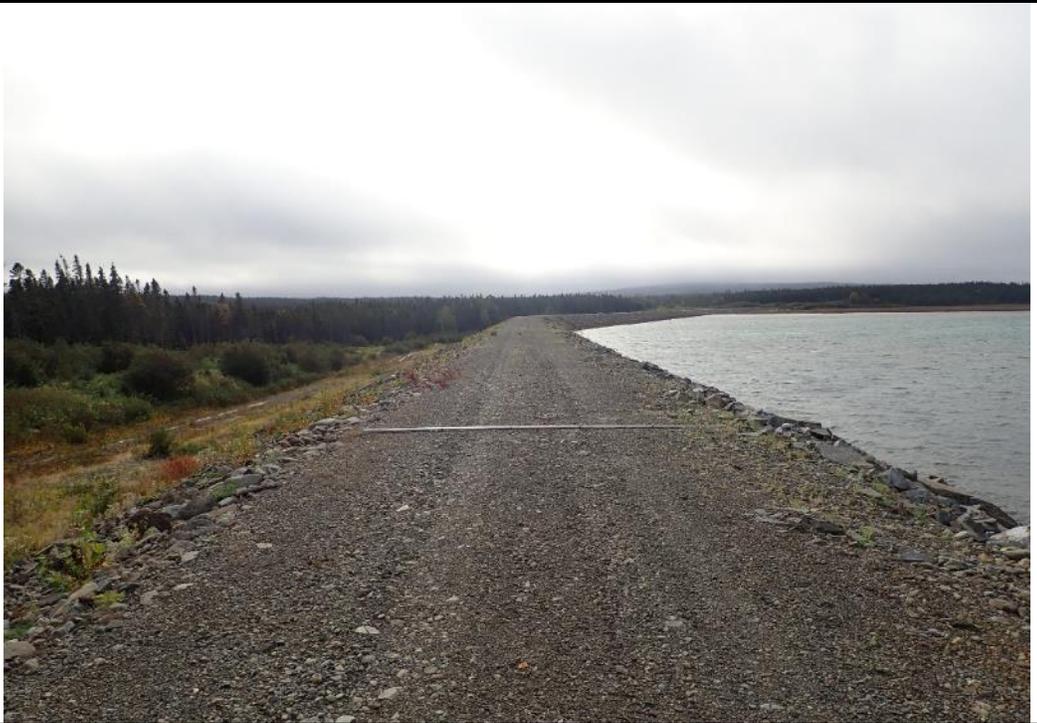
View of crest looking southeast; no crossfall noted (not included as part of design). Tire tracks visible from light vehicles.

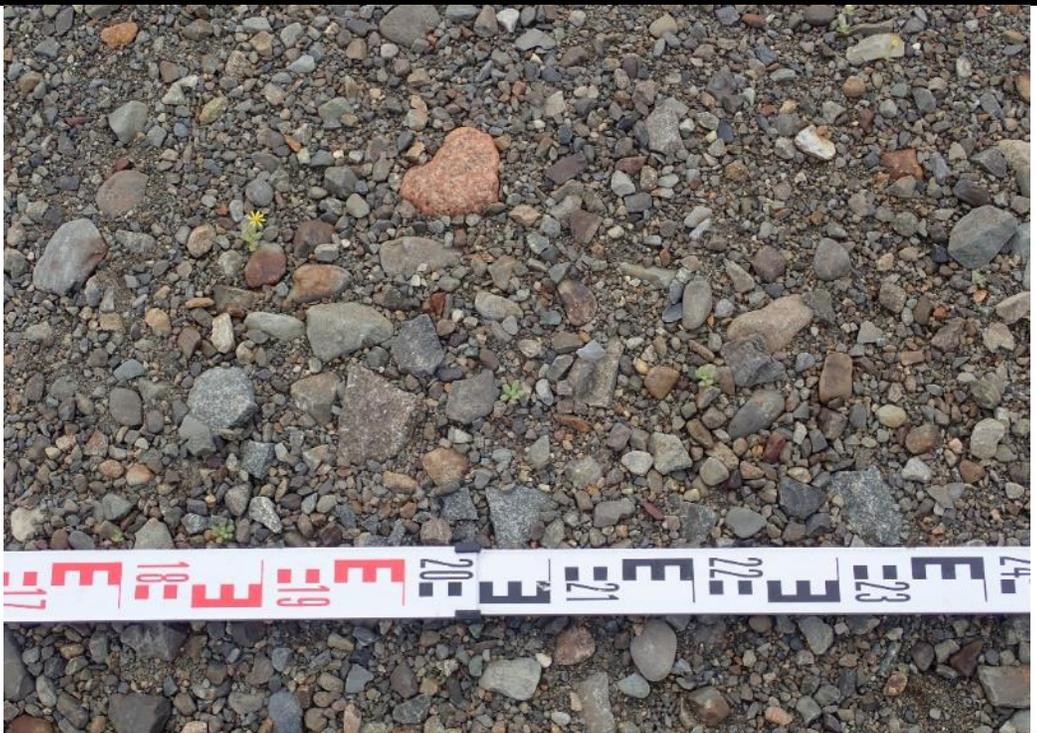
Photograph 2

Closeup view of crest material.

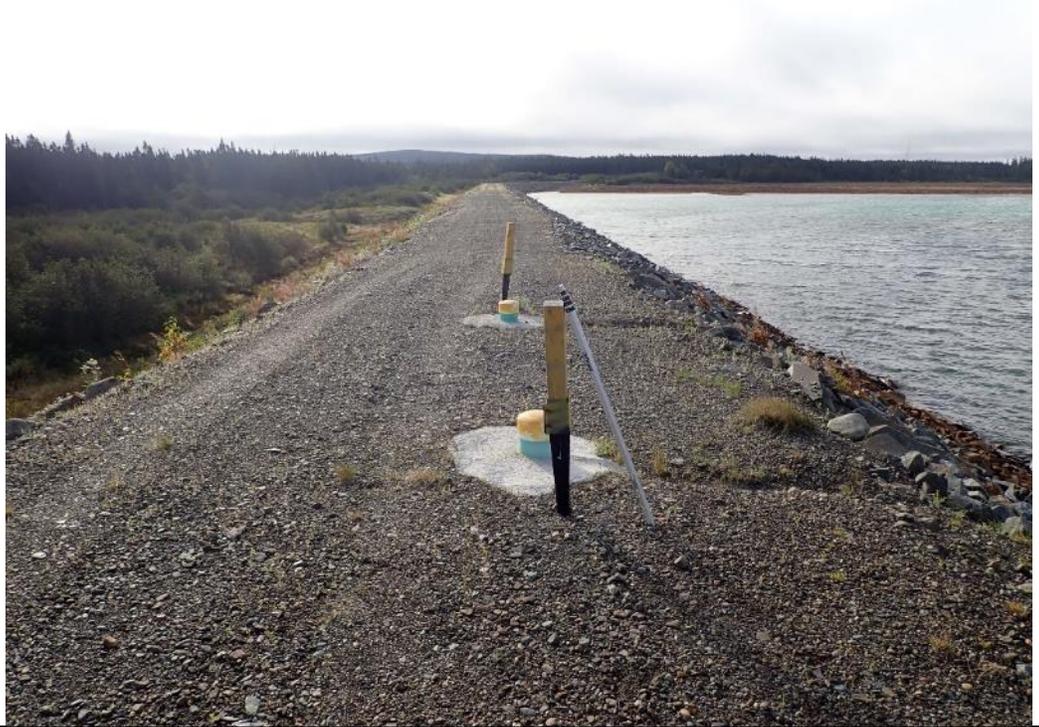
View of piezometer locations, looking southeast; note small ditches to channel surface water away from the wells.

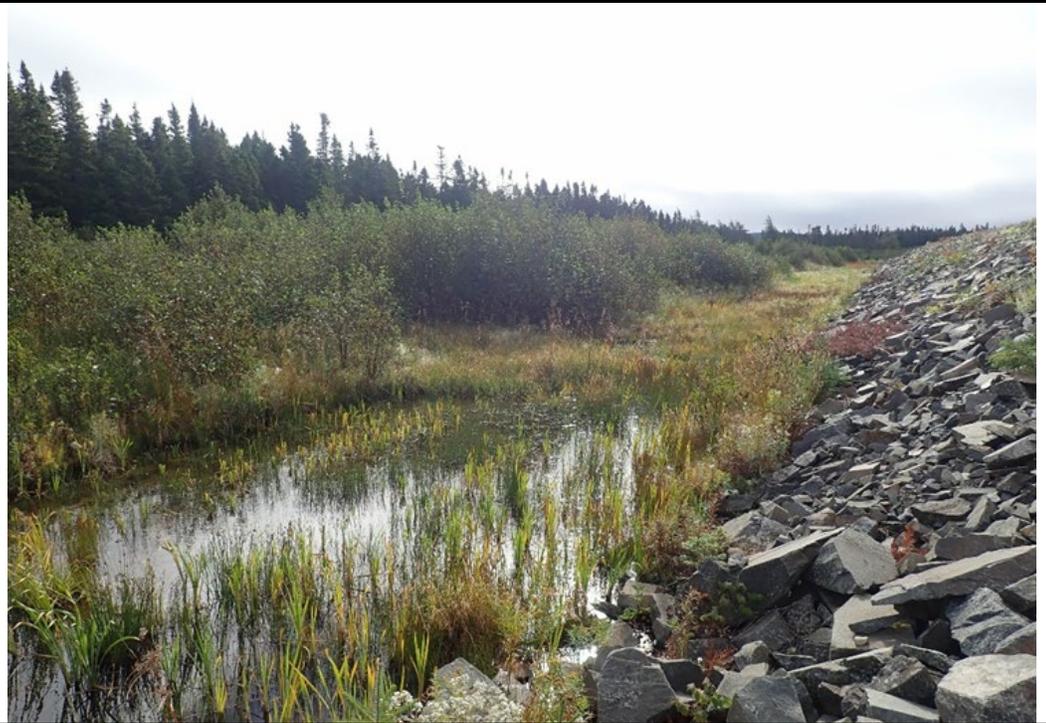
A large amount of ponded water was observed along the toe and visible seepage was noted. There was no water upwelling or flowing directly out of the toe, and the seepage was noted as slightly more than a trickle.

Area of ponded water along downstream toe.

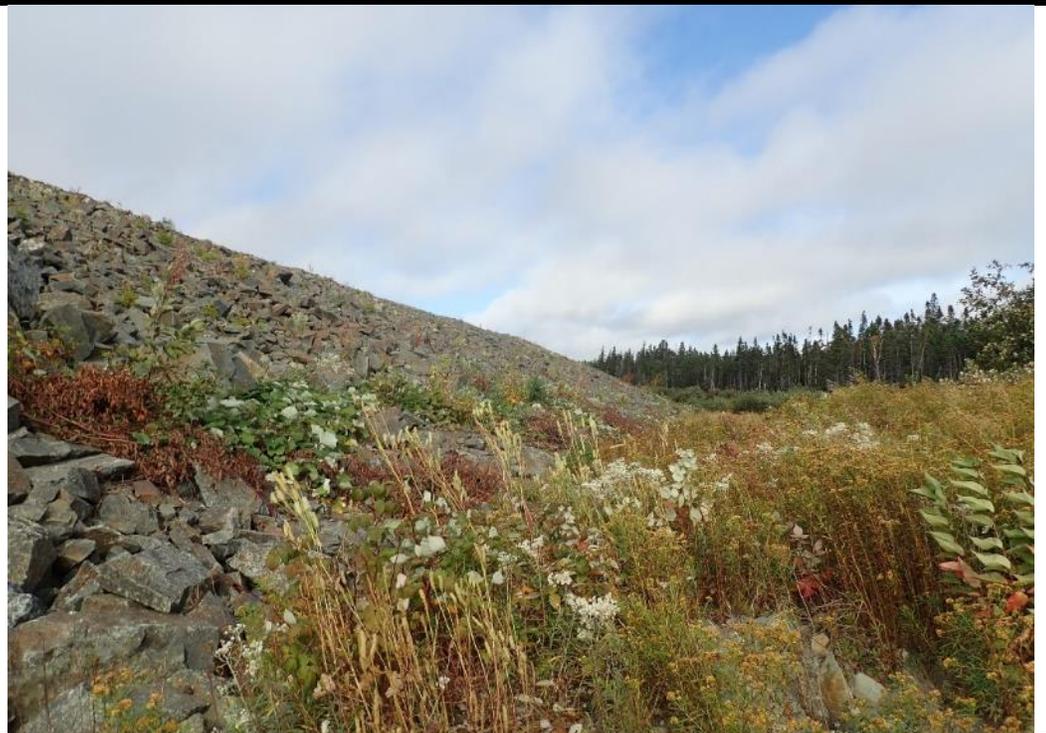
Photograph 8

There was very little vegetation observed along the slopes and the high-water mark on the upstream shell was visible with a large amount of normal freeboard. Some areas along the downstream toe were observed to be covered with thick vegetation (i.e., grasses and shrubs) which limited the inspection of the toe. The upstream slope should be monitored for wave erosion/benching of the rip rap.

View along downstream slope, looking northwest. Thick vegetation (shrubs and grasses) growth obscuring inspection of the toe.

Vegetation is growing on and around the dams and within the hydraulic flow structures. On-going maintenance should include routine clearing of the dams, ditches and spillway channels in order to maintain flow capacities, prevent internal damage to the dams, and permit visual inspection. Another round of vegetation clearing will likely be required in 2021.

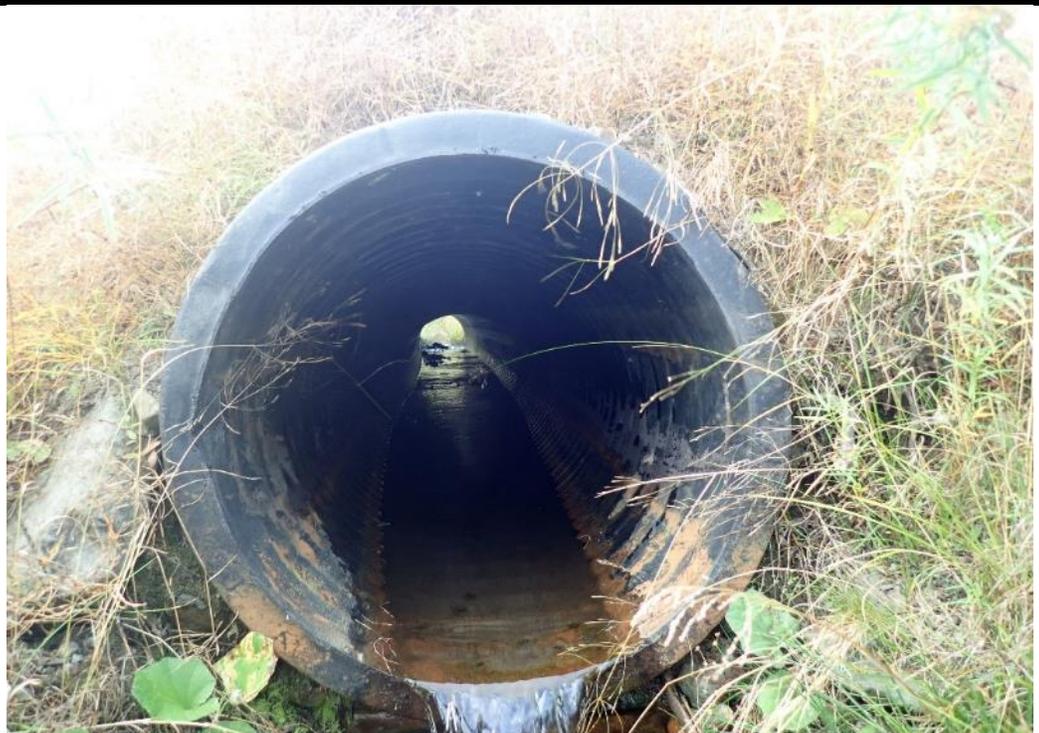
Outlet of HDPE culvert in the access road; culvert associated with the seepage collection sump. Note minor bending visible along the soffit.

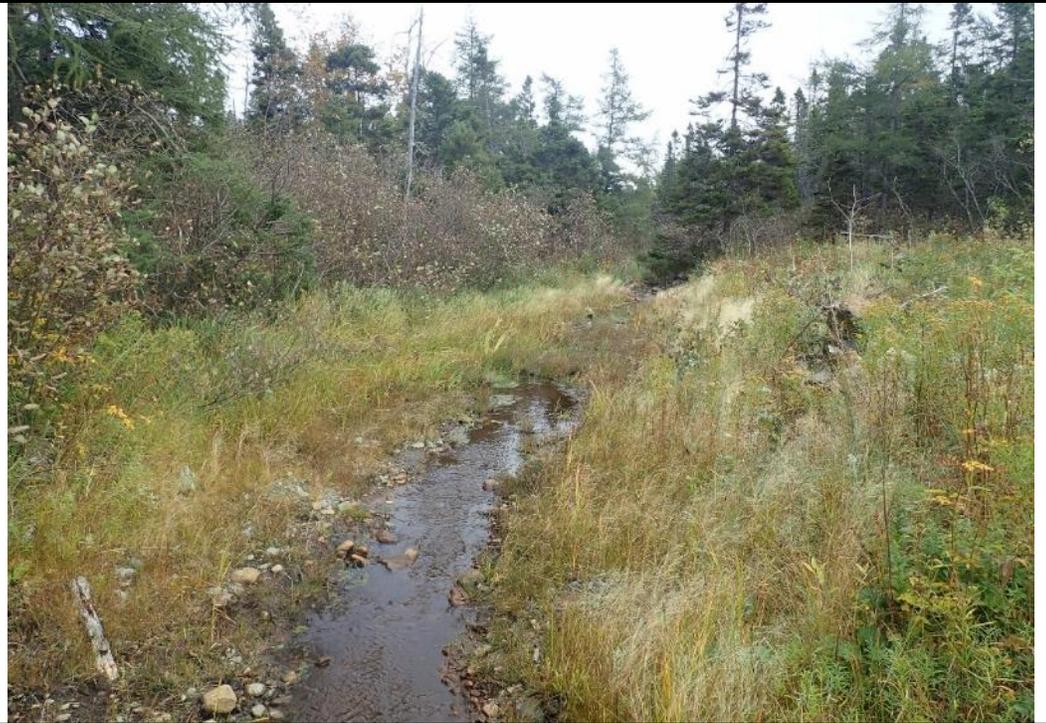
The seepage emanating from the downstream shell and accumulating in the Seepage Collection Sump at Sta 0+550, along with surface runoff from the area, flows through the high-density polyethylene (HDPE) culvert beneath the access road to the environment. The water observed at the toe and discharging through the HDPE culvert was clear (i.e., free of sediment) and showed very little signs of discoloration due to oxidation. Although some portion of this water may be seepage from the TMA, it is understood from site personnel that the water quality at the culvert meets discharge criteria. In 2019, Teck started recording the flowrate at the culvert following recommendations in previous years. The flowrate on September 11th, 2020 was 1.3 L/min. Golder developed a tracking sheet (attached to Form A in Appendix A) that should be used by Teck in the future to identify any trends in seepage flowrates.

View of outflow from HDPE culvert.

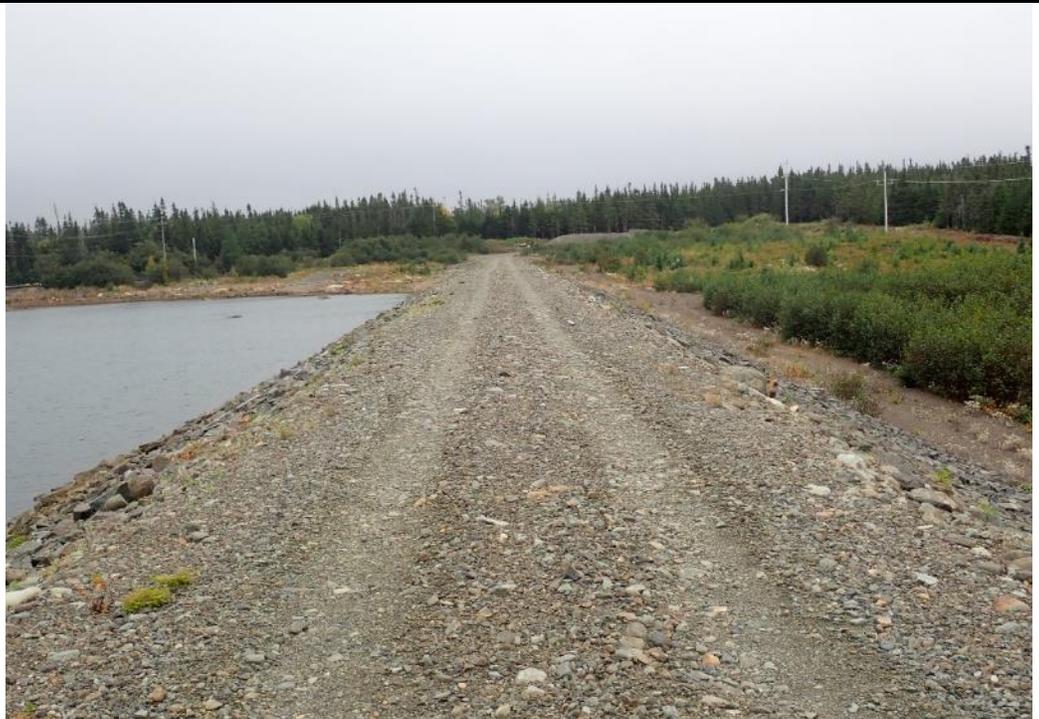
View of crest looking southeast; no crossfall noted (not included as part of design). Ruts starting to form from vehicle/equipment access

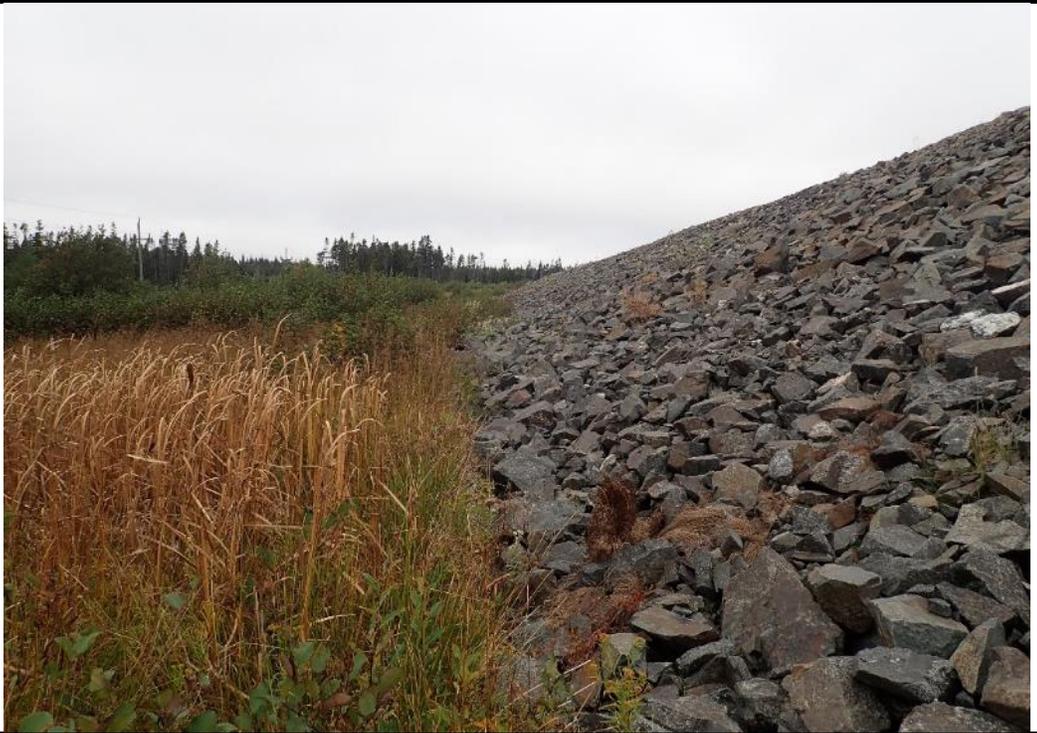
There was very little vegetation observed along the slopes and the high-water mark was visible on the upstream shell with a large amount of normal freeboard. Some areas along the downstream toe were observed to be covered with thick vegetation (i.e., grasses and shrubs) which limited the inspection of the toe.

View along downstream toe, past the end of the access road. Note thick vegetation (grass and shrub) obscuring inspection of the toe.

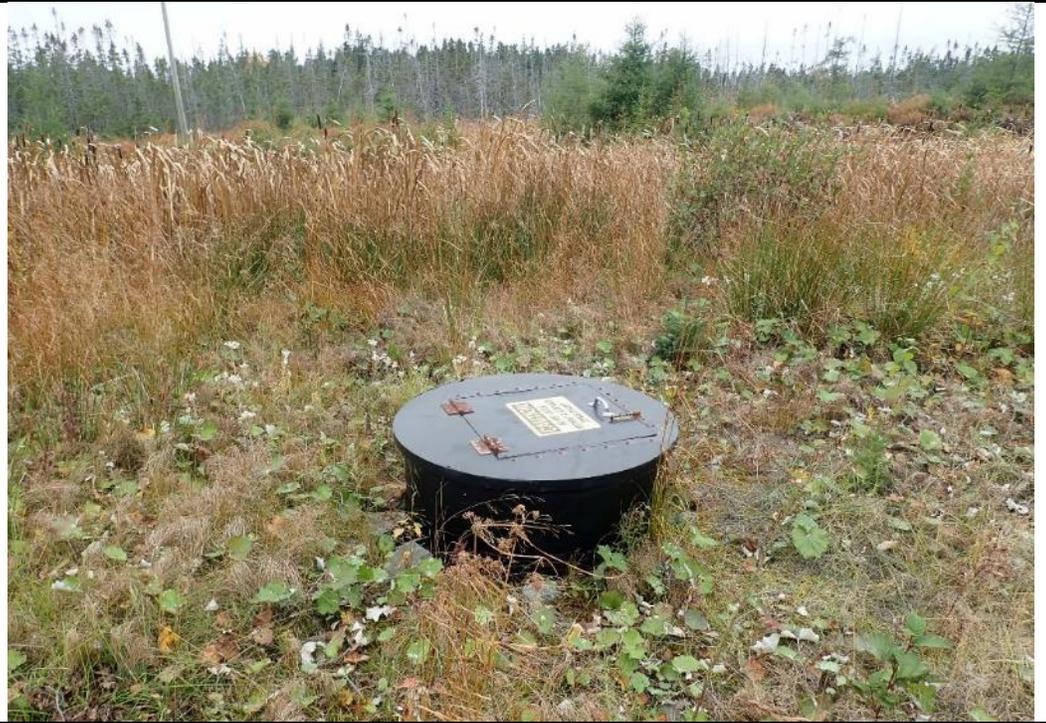
View of seepage collection sump located beyond the toe of the downstream slope.

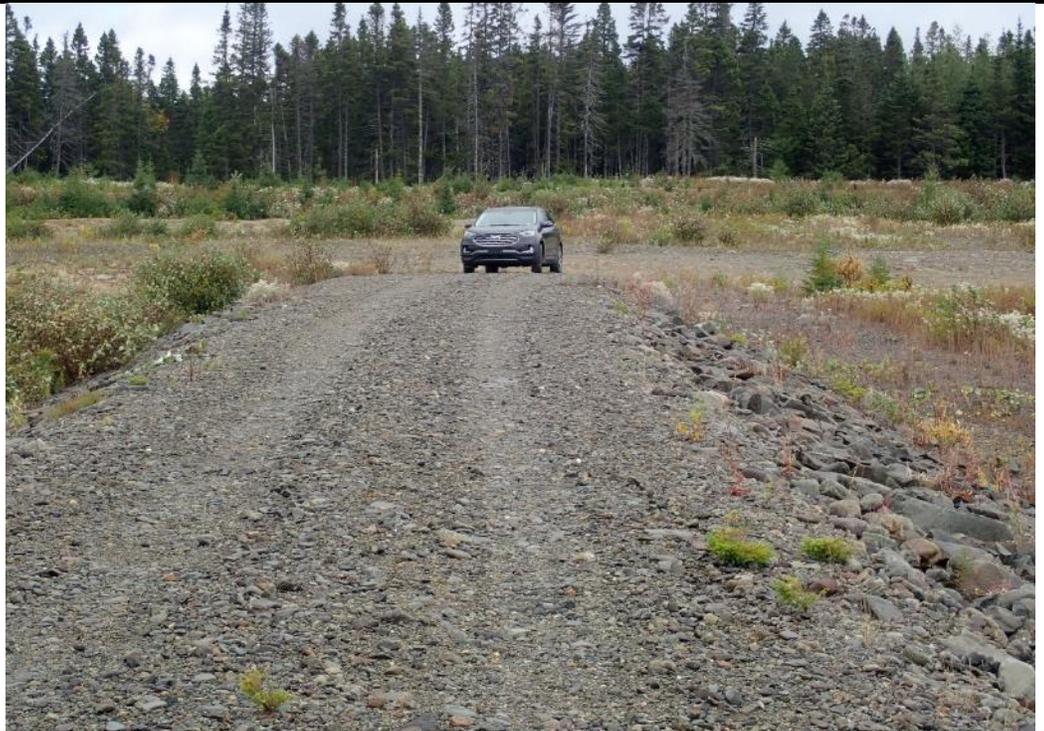
The dam appeared to be in good overall condition. The crest was noted as being topped with mostly sand and gravel with some cobbles and was observed to have no apparent crossfall or camber. An area of low-lying elevation was observed at the north abutment, between the dam and spillway. The area should be surveyed to confirm the crest elevation and required freeboard is maintained through this area.

Looking north towards spillway channel (not visible in background). Note, potential settlement or low point at north abutment between the dam and spillway.

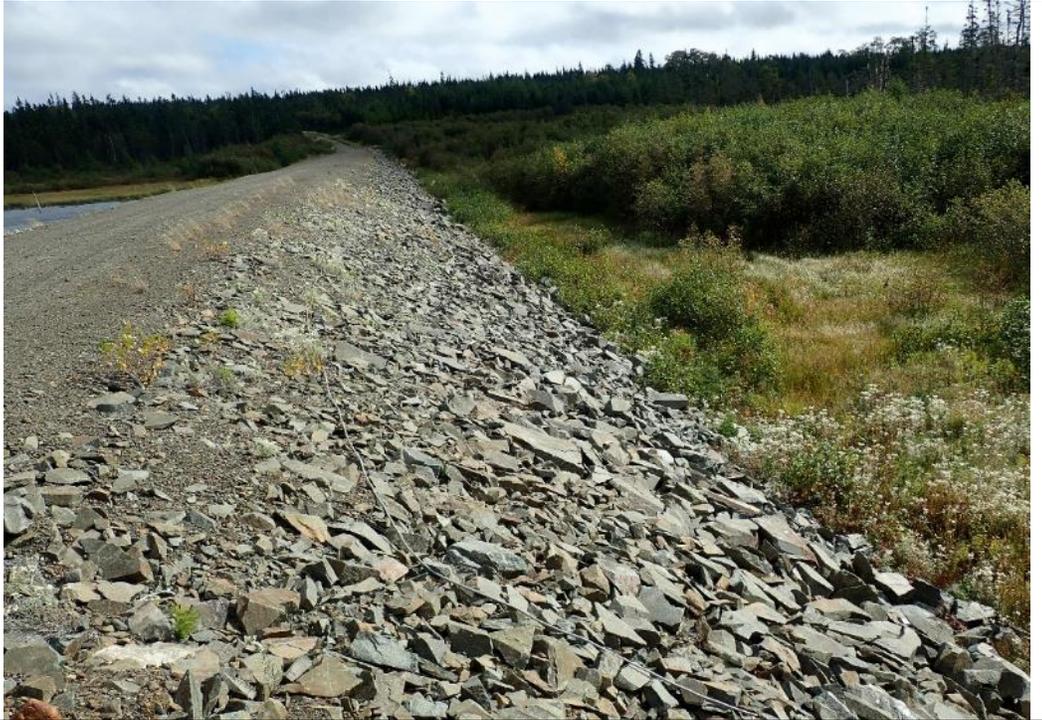
There was very little vegetation observed along the slopes and the high-water mark was visible on the upstream shell with a large amount of normal freeboard. No signs of benching or movement were observed along the upstream slope. Some areas along the downstream toe were observed to be covered with thick vegetation (i.e., grasses and shrubs) which limited the inspection of the toe.

View of downstream slope, looking southeast. Note thick vegetation growth (grass and shrubs) along toe obscuring inspection.

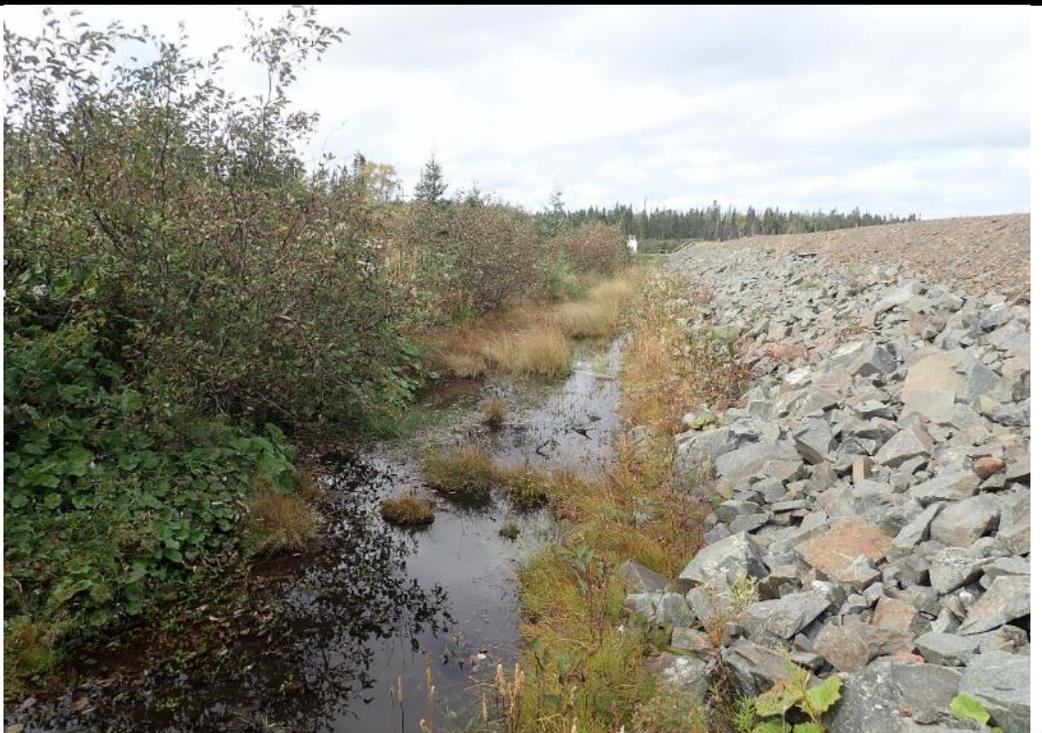
Photograph 6

A large amount of ponded water was observed along the toe; however, there was no visible seepage.

View along downstream slope, showing ponded water, but no visible seepage observed.

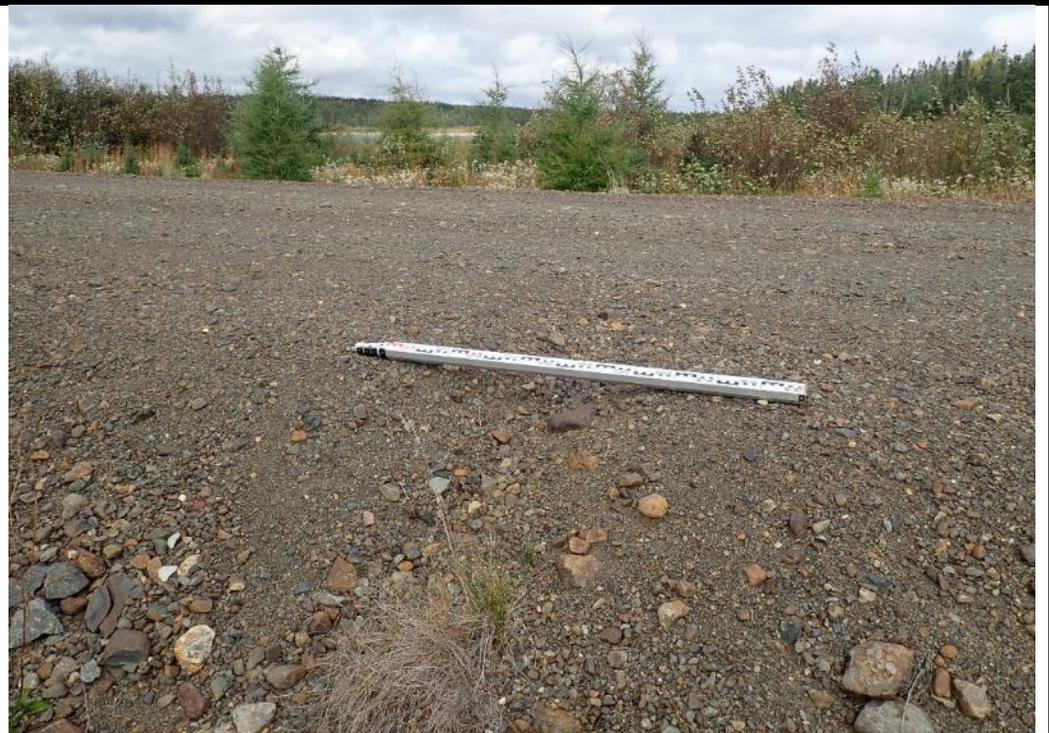
Photograph 8

Minor erosion rill visible along downstream slope, section of slope with concentrated runoff.

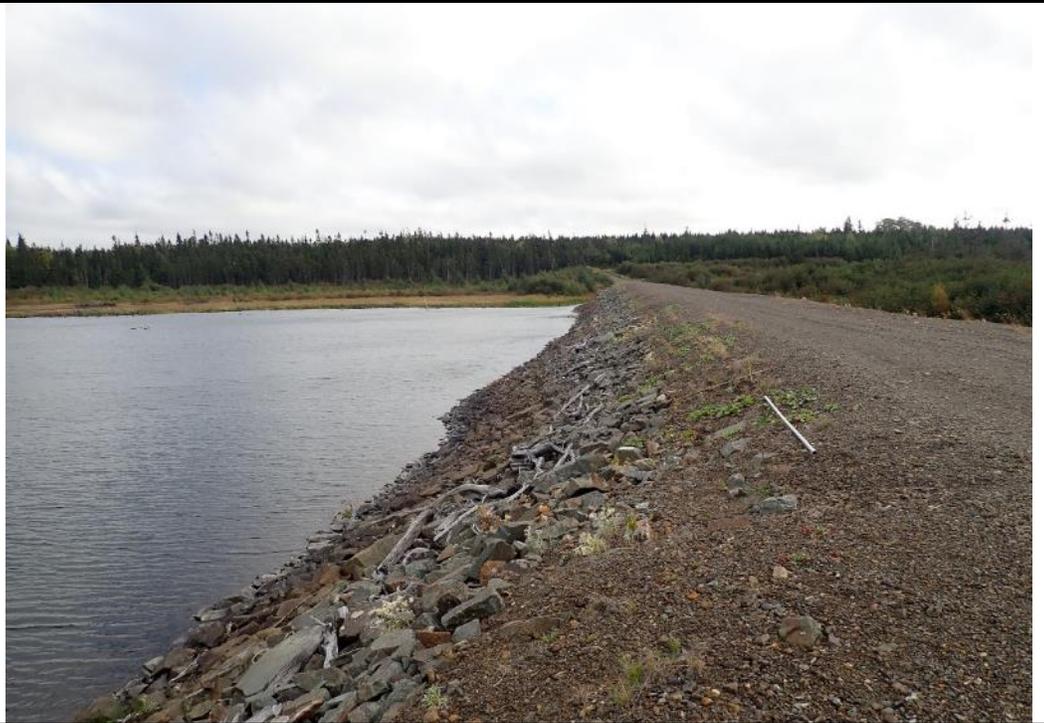
View of upstream slope showing general lack of vegetation. Woody debris is likely due to high water and wind waves or were transported by ice.

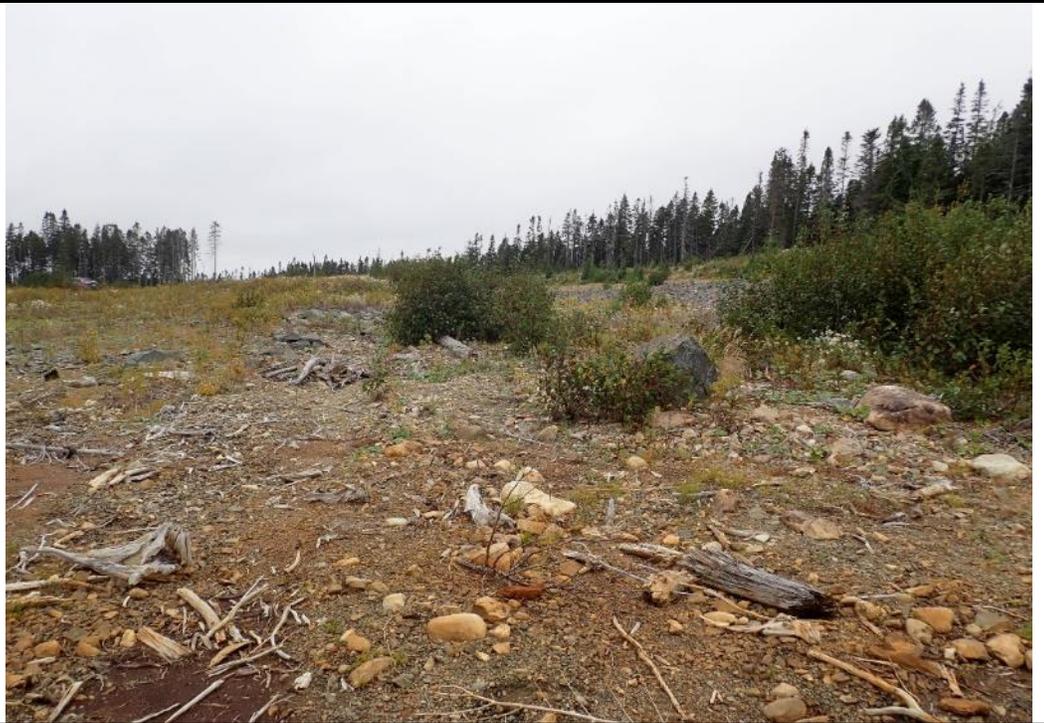
View of Dam B Spillway inlet, note minor vegetation growth.

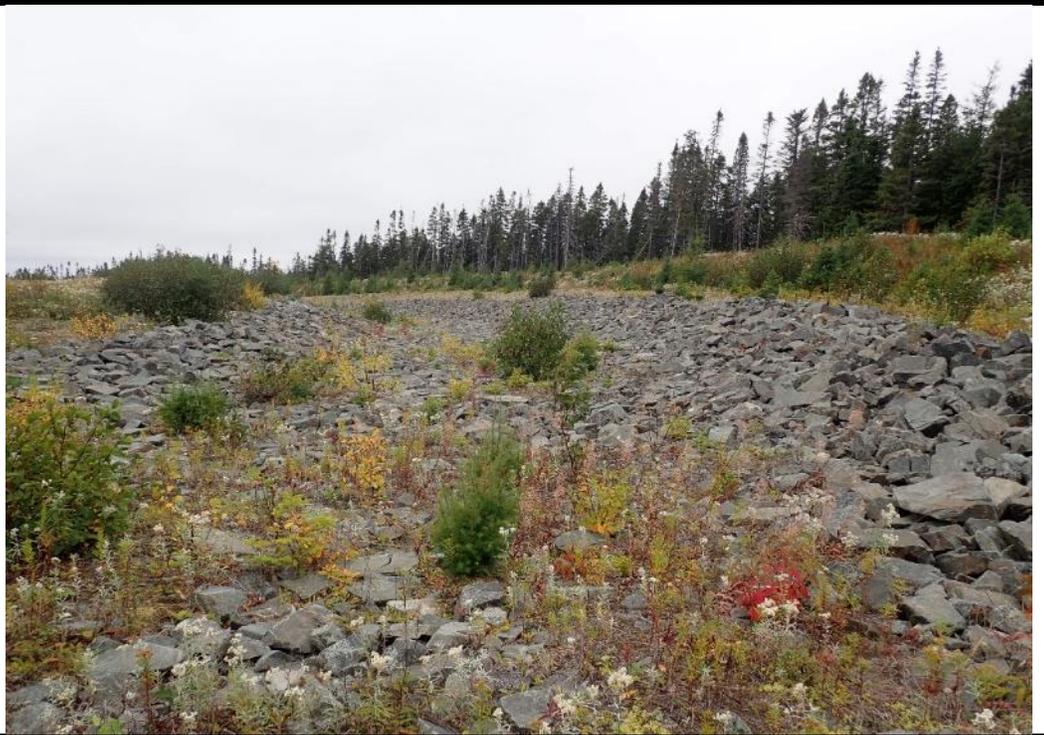
Photograph 2

View of Dam B Spillway approaching the north abutment of the dam. Beginning of clearly defined channel, some minor vegetation growth.

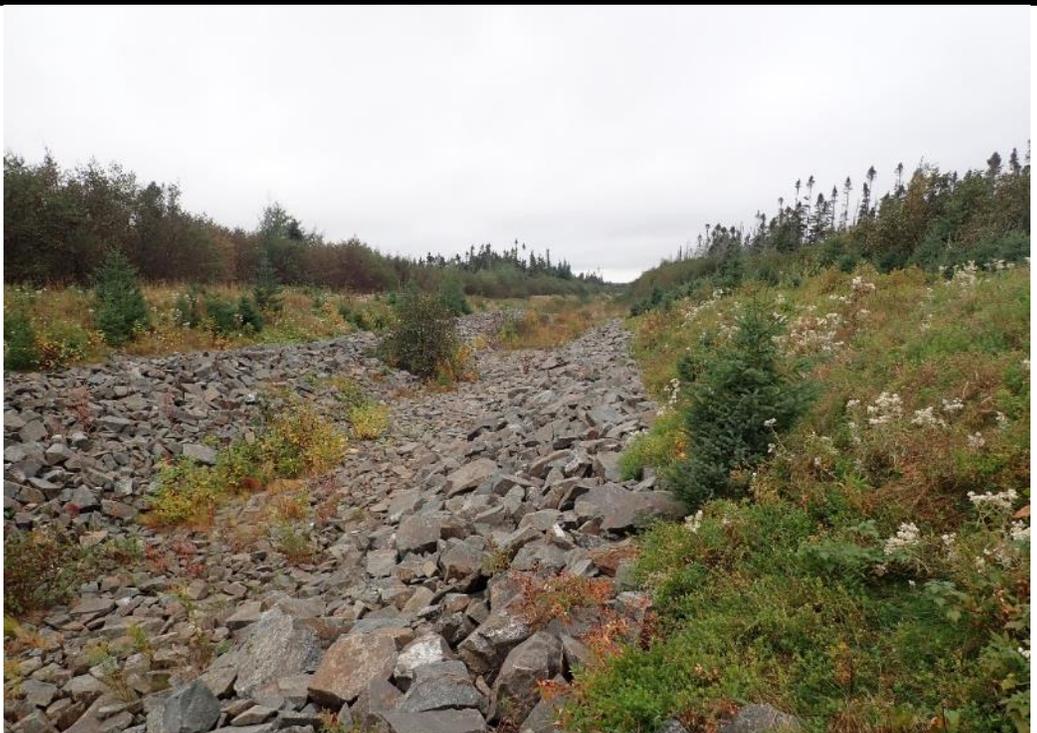
View along Dam B Spillway looking south, note minor vegetation growth in channel.

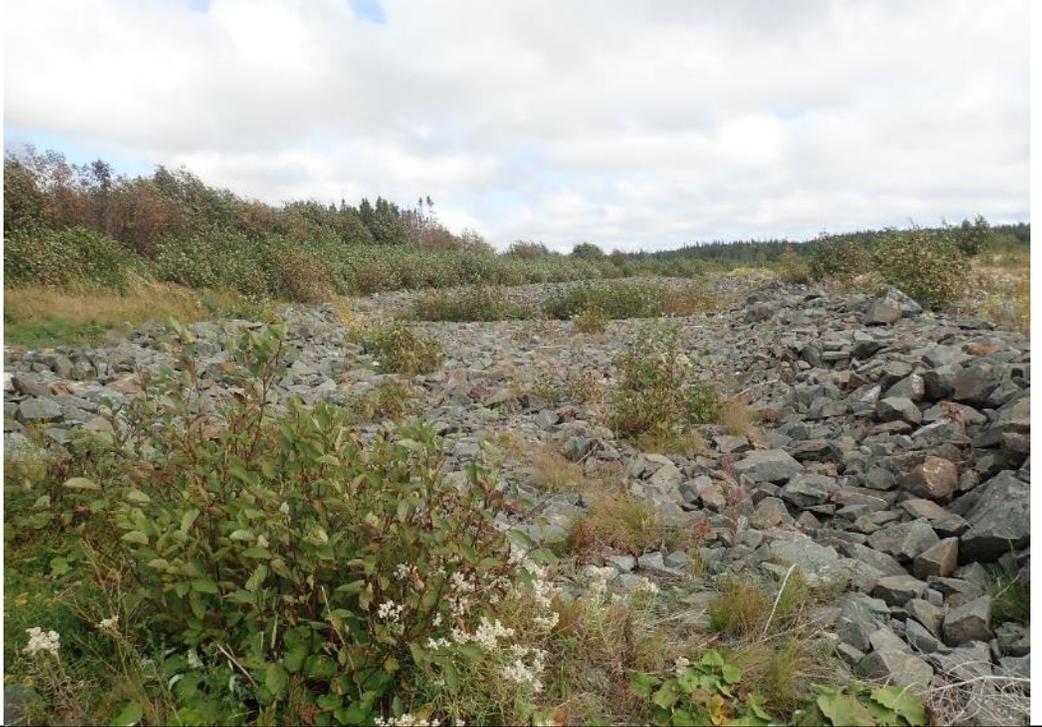
View along Dam C spillway looking towards inlet, concrete sill in background is covered with vegetation.
