Teck Coal Limited Elkview Operations

West Fork Tailings Facility and Lagoons A, B, C, and D

2020 Annual Summary of Facility Performance

March 31, 2021

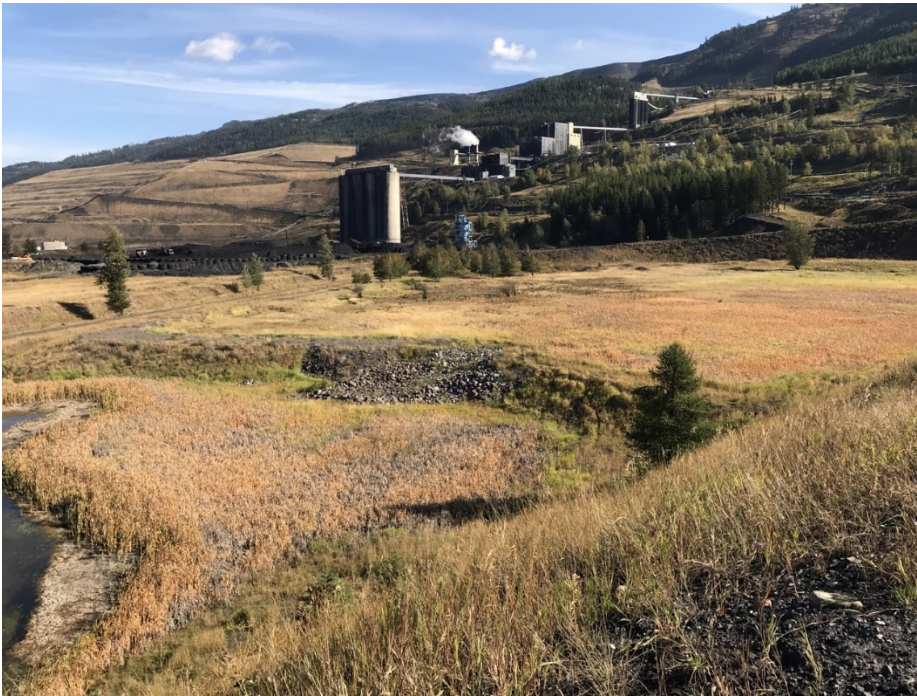
Photo IA-2 Lagoon A surface and Cossarini Creek culvert outlets. (looking west)

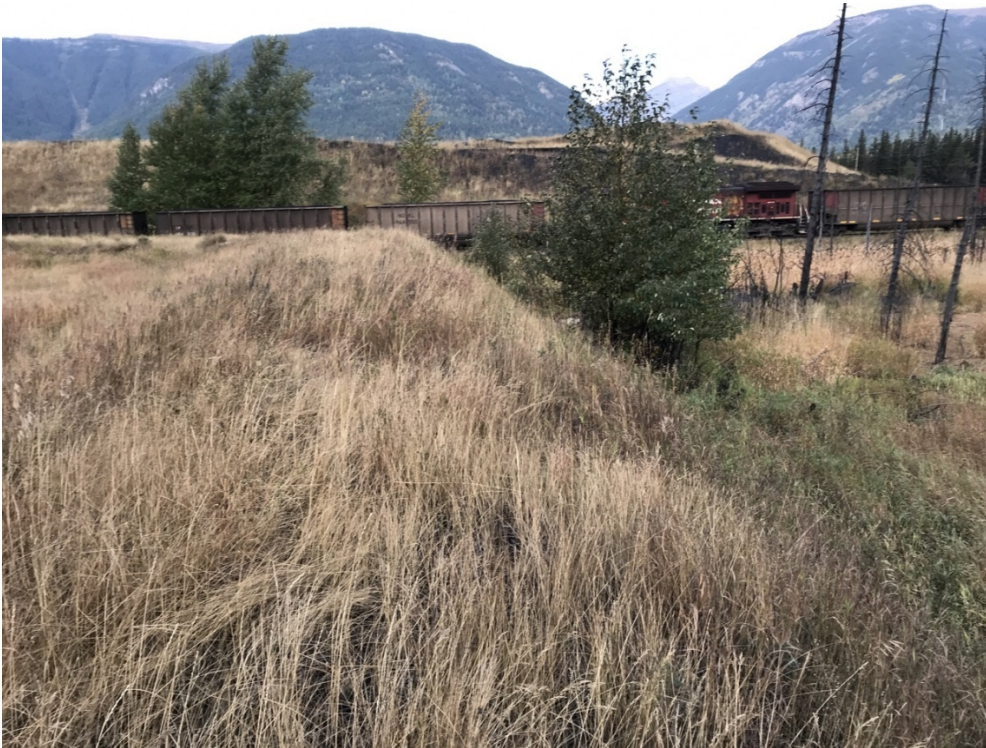
Photo IB-2 Lagoon B crest and typical surface conditions. (looking south)

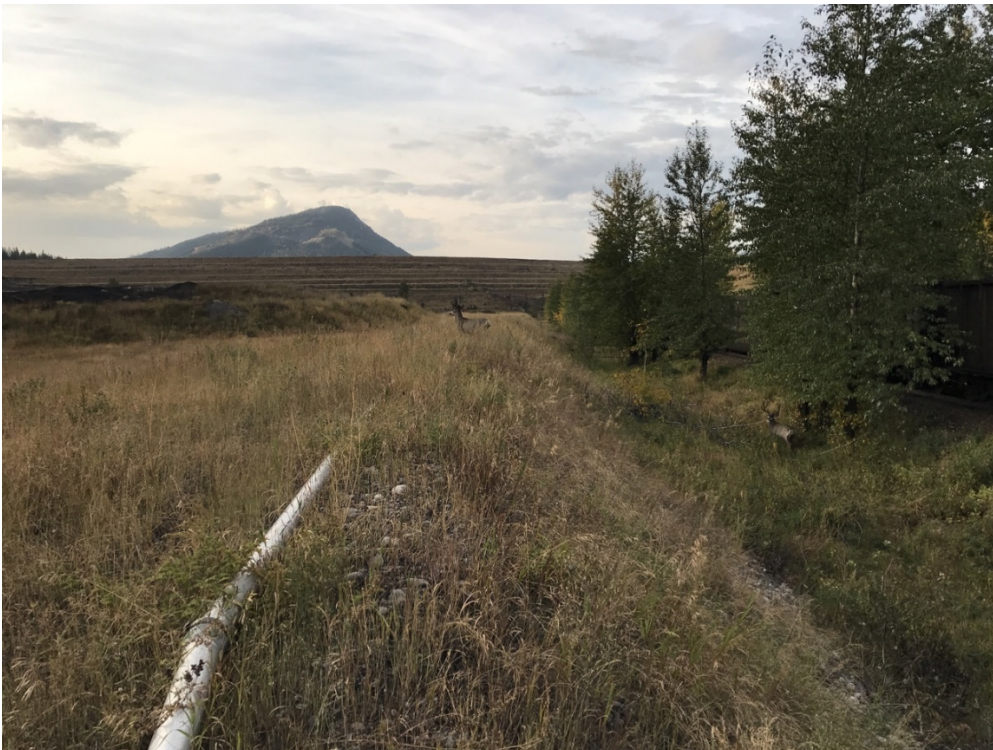
LB-1	A portion of the crest was observed to be narrow, and may possibly be a low spot.	No	No	IB-3
LB-2	A minor erosion gully was observed from the crest of Lagoon B.	No	No	IB-5
Lagoon C				
LC-1	A local low spot on the crest near the trestle was observed.	No	No	IC-9
LC-2	Erosion on the upstream side of the crest was observed at the north section of the Lagoon near the pumphouse. It is not expected that this erosion could propagate though the crest of the dam, causing a significant dam failure.	No	No	IC-3, IC-4

Photo IB-3 Lagoon B potential low spot in crest. (looking west)

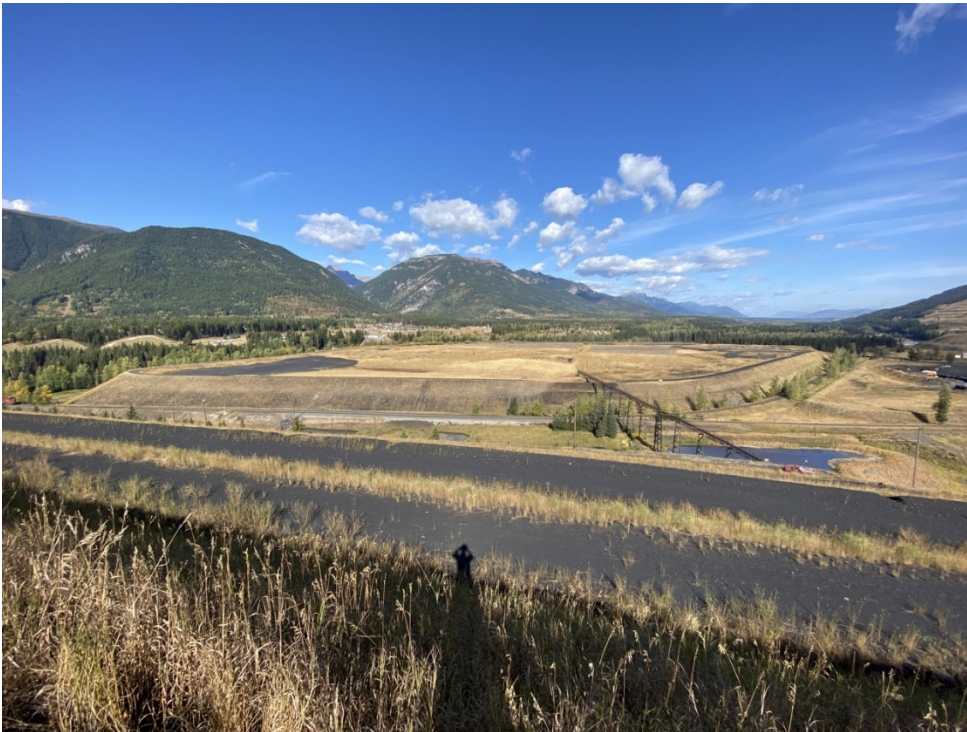
Photo IC-2 Lagoon C Typical crest conditions. (looking northeast)

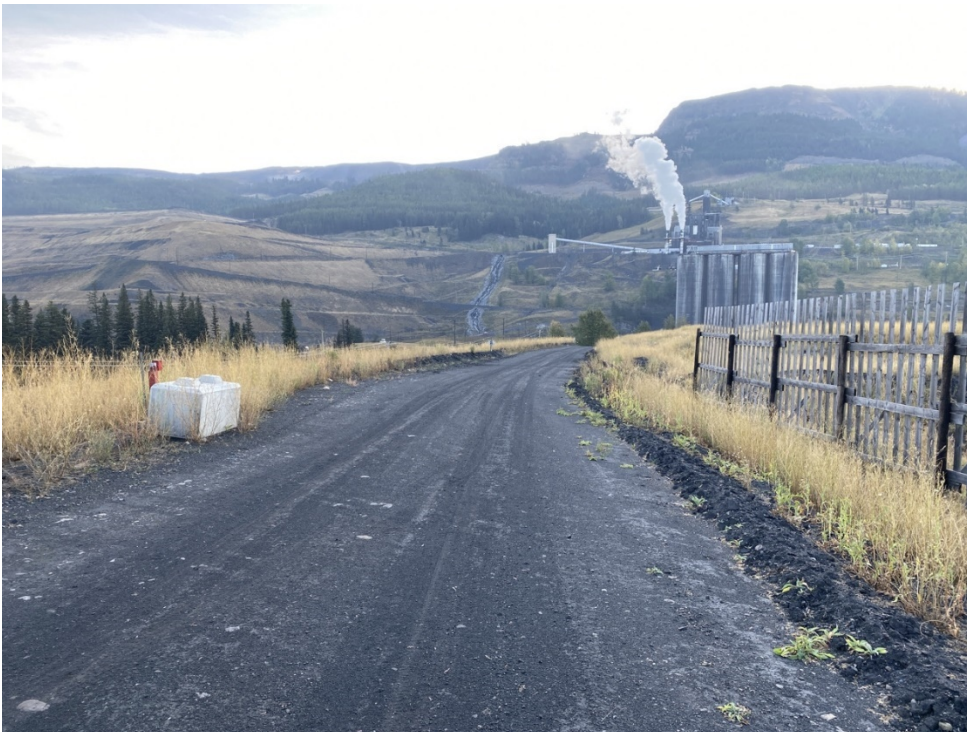
Photo IC-3 Lagoon C minor erosion upstream of crest near pumphouse. (looking southeast)

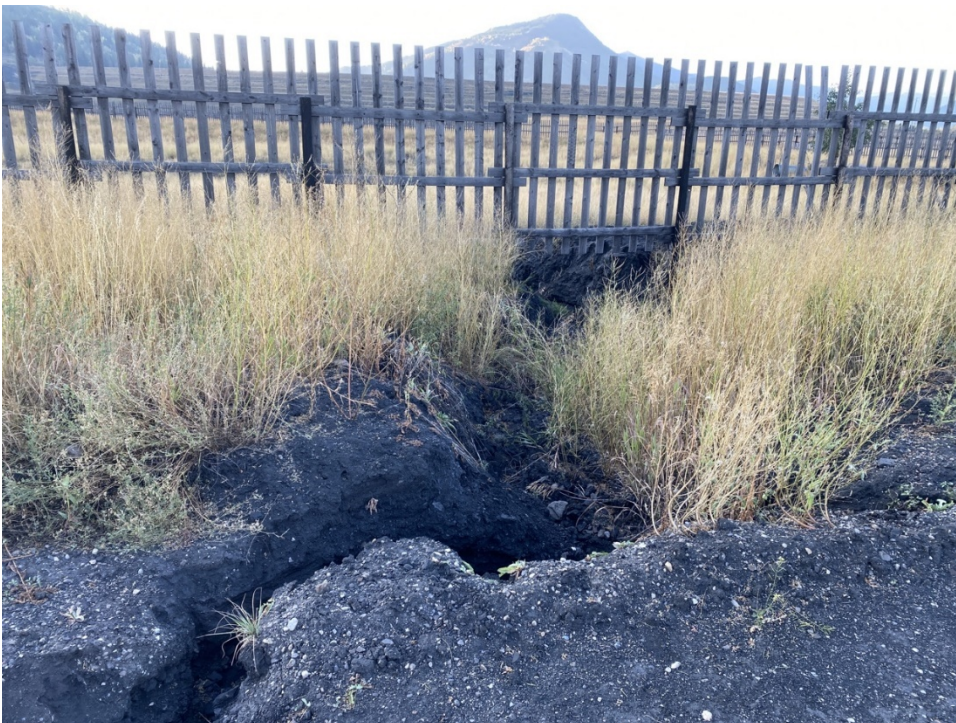
Photo IC-5 Lagoon C typical crest condition. (looking southwest)

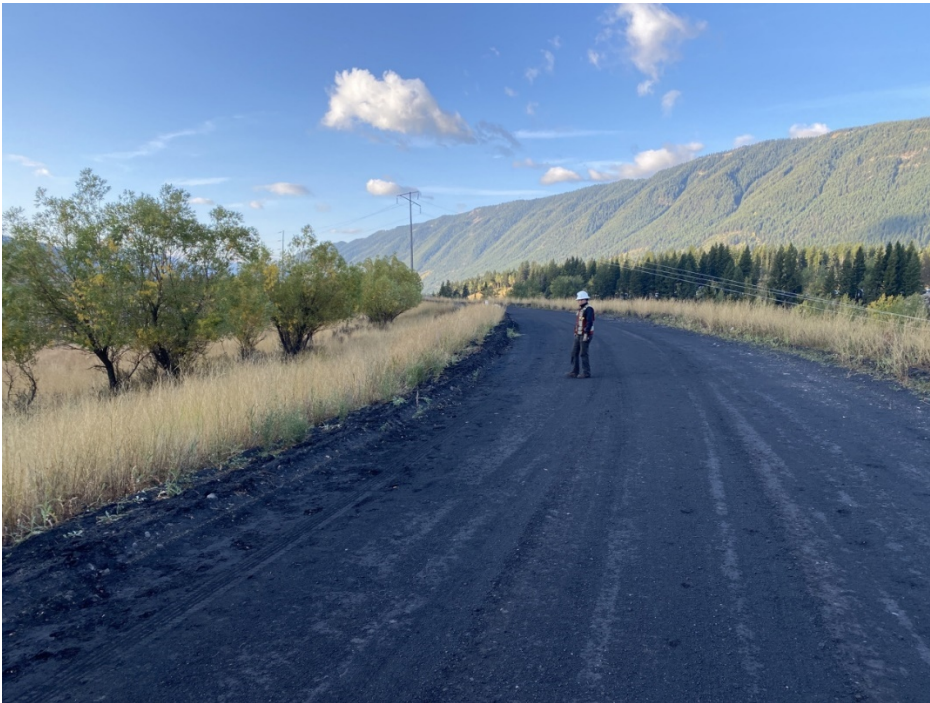
Photo IC-6 Lagoon C crest and powerlines. (looking southeast)

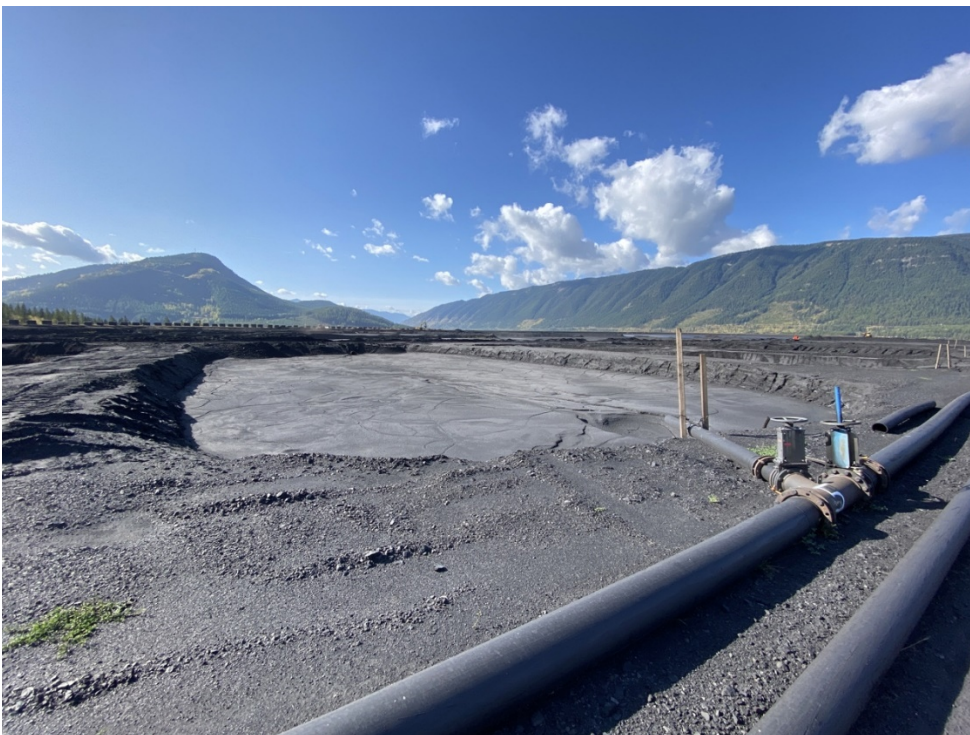
Photo ID-3 Lagoon D crest typical condition. (looking east)

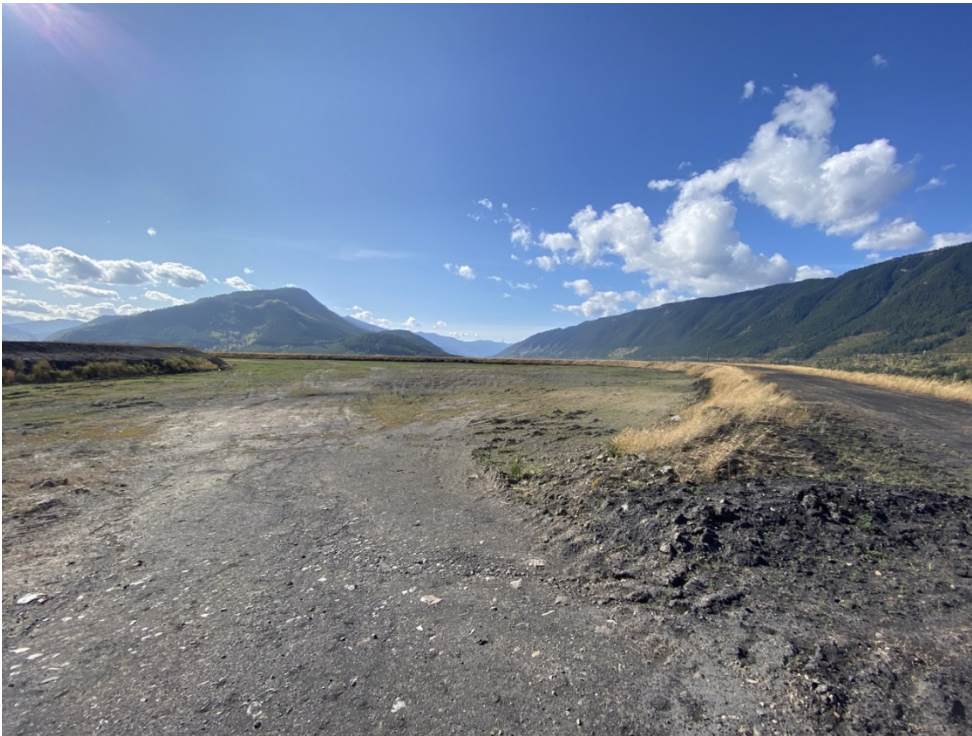
Photo ID-6 Lagoon D crest and bench typical conditions. (looking northeast)

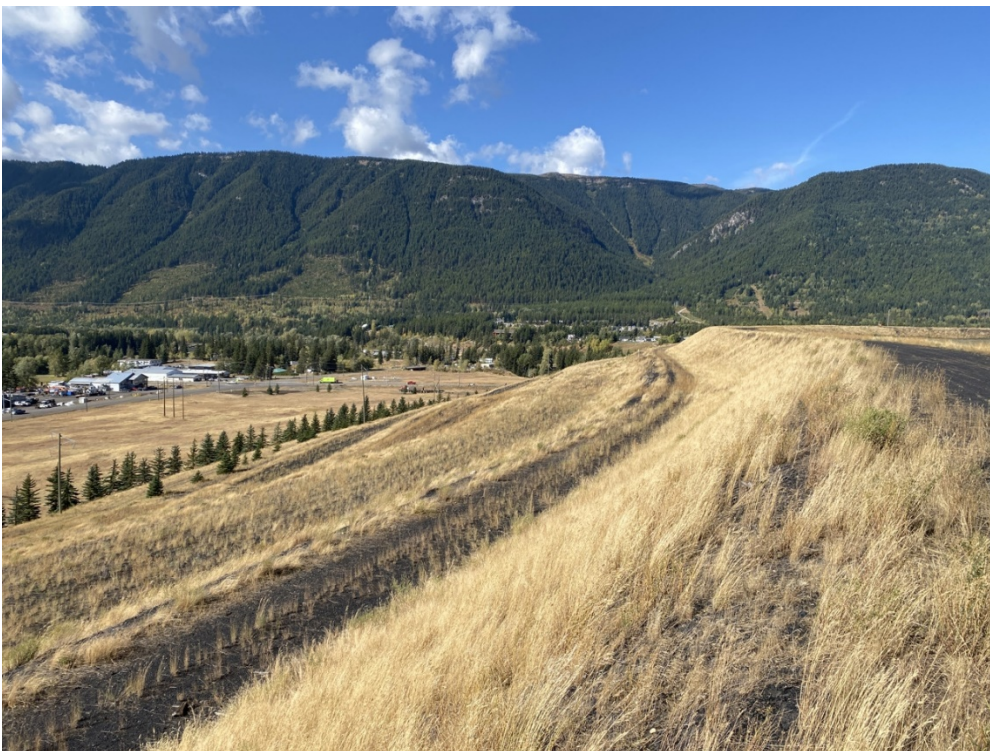
Photo ID-9 Lagoon D crest typical conditions. (looking northeast)

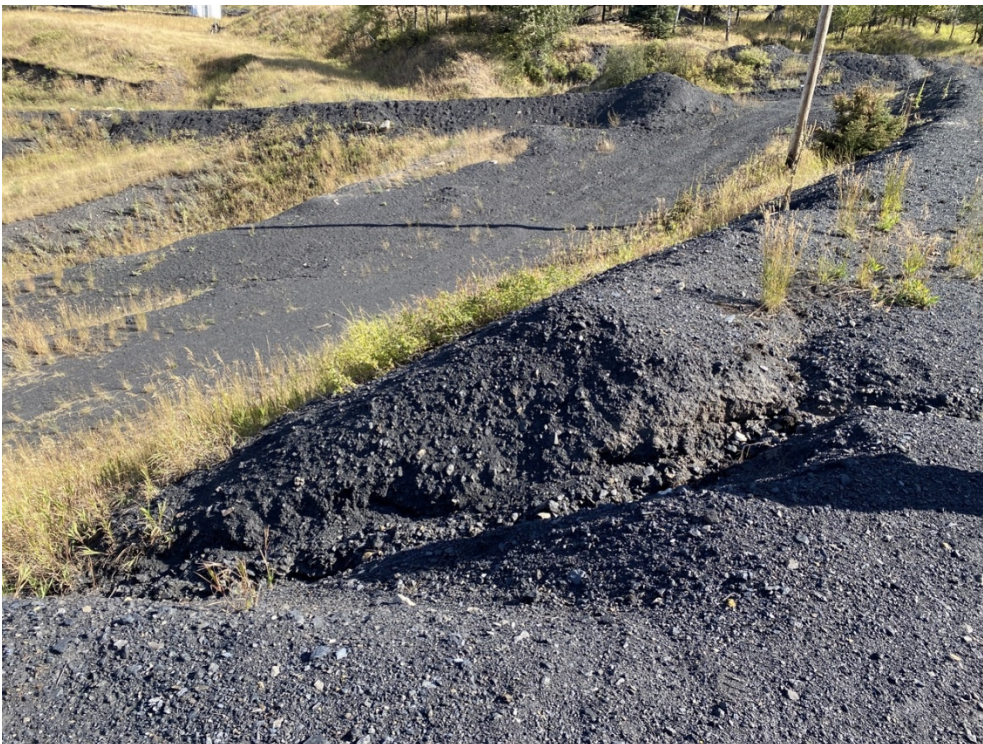
Photo ID-13 Lagoon D bench and instrumentation typical condition. (looking west)

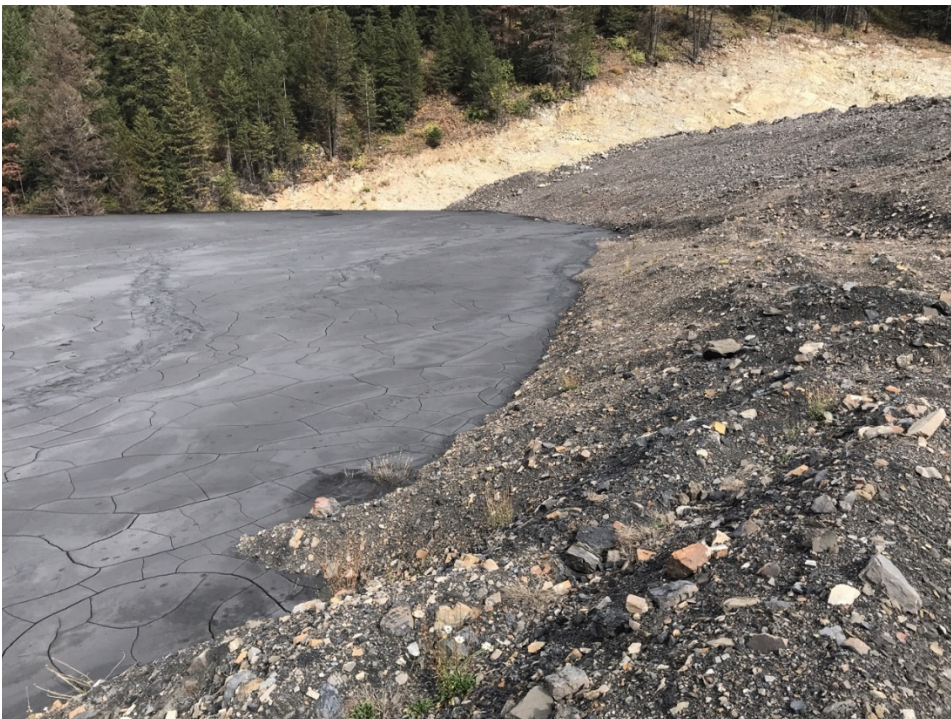
Photo IW-5 WFTF typical crest conditions at the east abutment. (looking east)

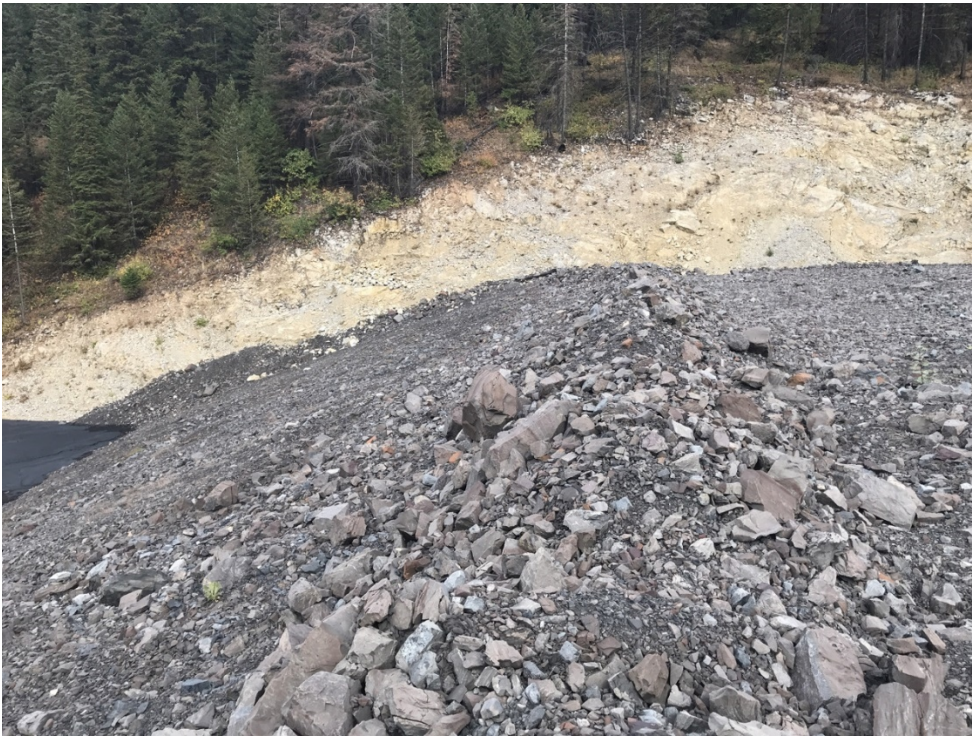
Photo IW-6 WFTF downstream of embankment. (looking south)

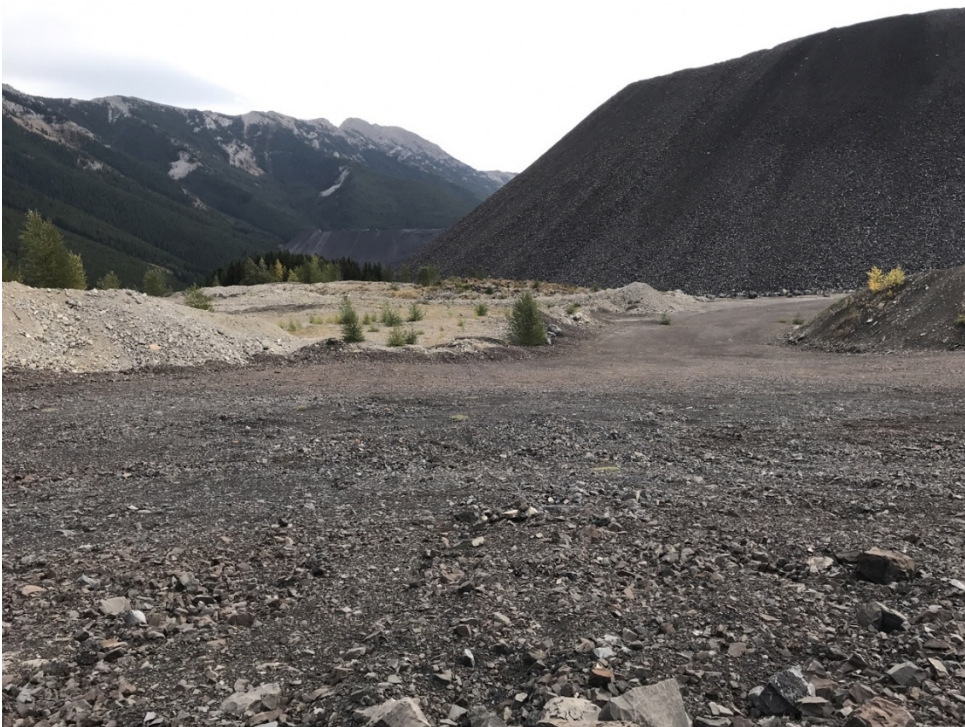
Photo IW-7 WFTF Adit Toe Berm typical conditions. (looking south)

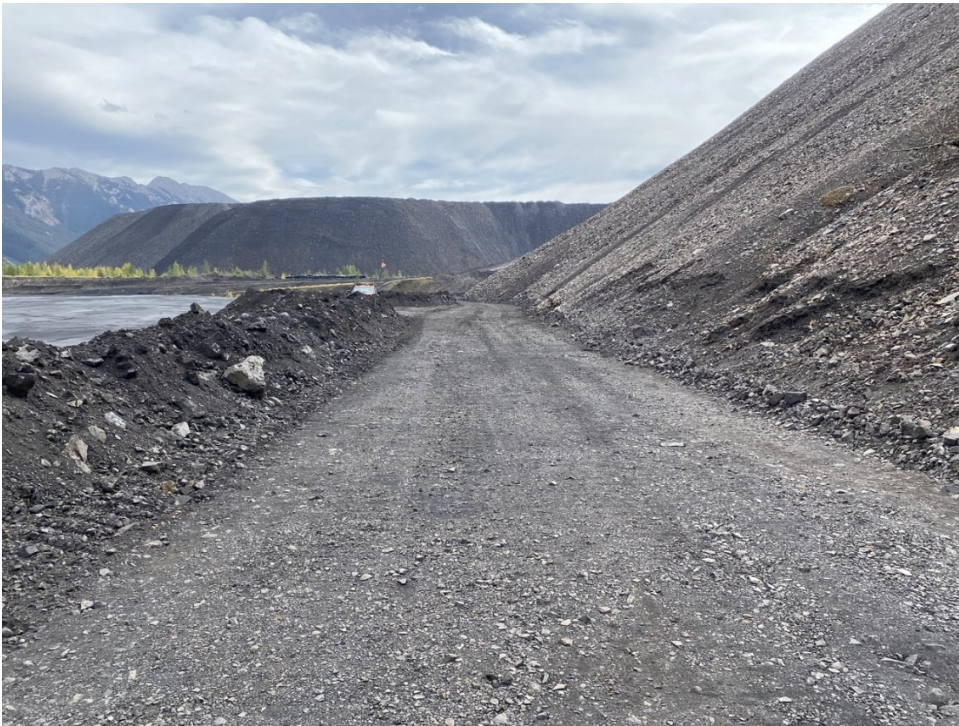
Photo IW-8 WFTF Adit Dump erosion above Adit Toe Berm. (looking west)
