2020 Dam Safety Inspection for South Tailings Pond and North Tailings Pond

Teck Coal Limited, Fording River Operations

Reference No. 20136981-2020-219-R-Rev0-2000

18 March 2021

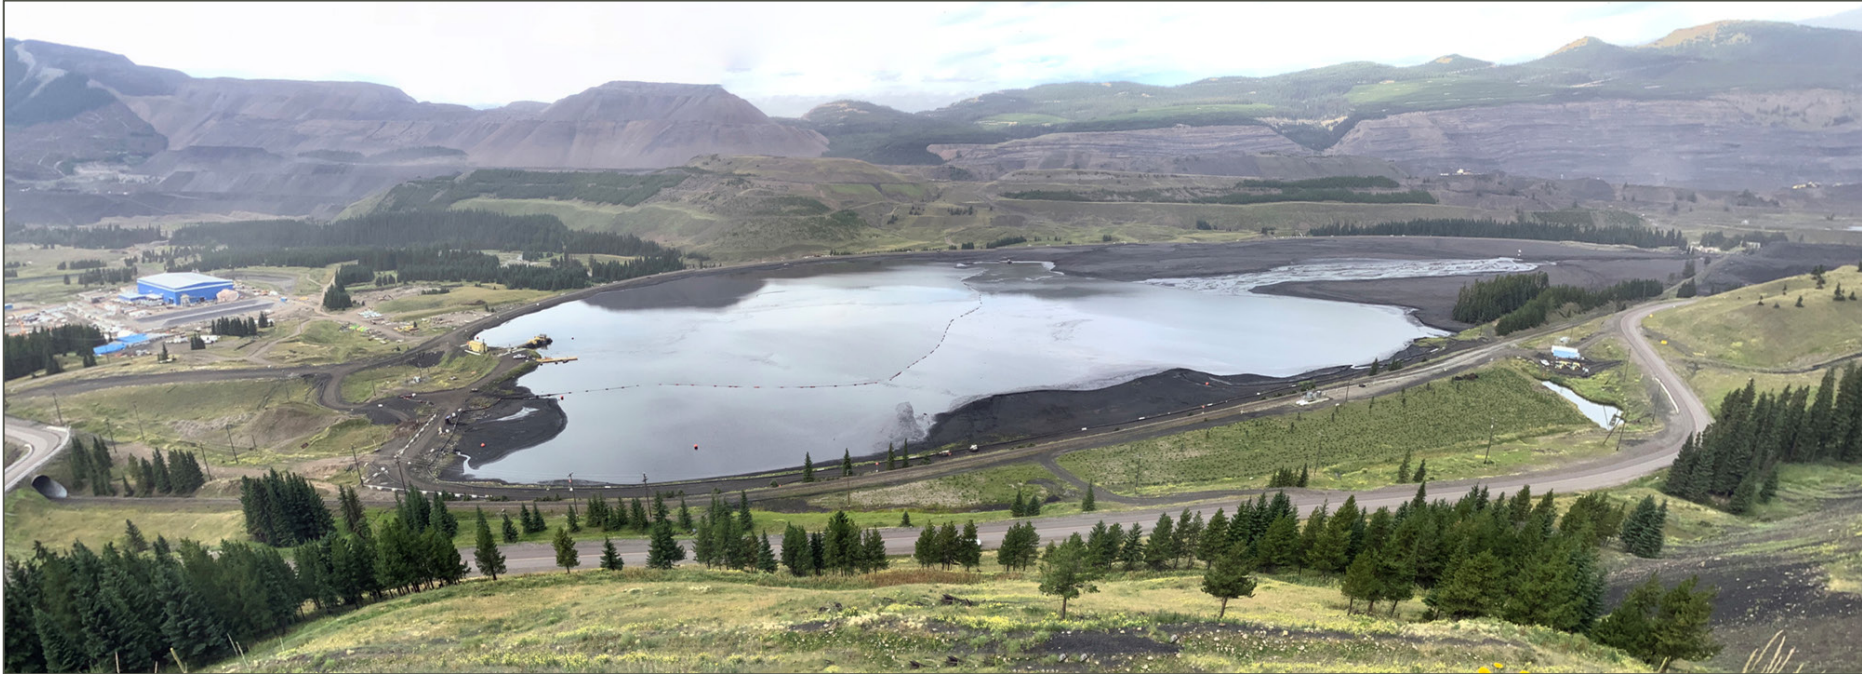
South Tailings Pond (STP) overview, looking southwest

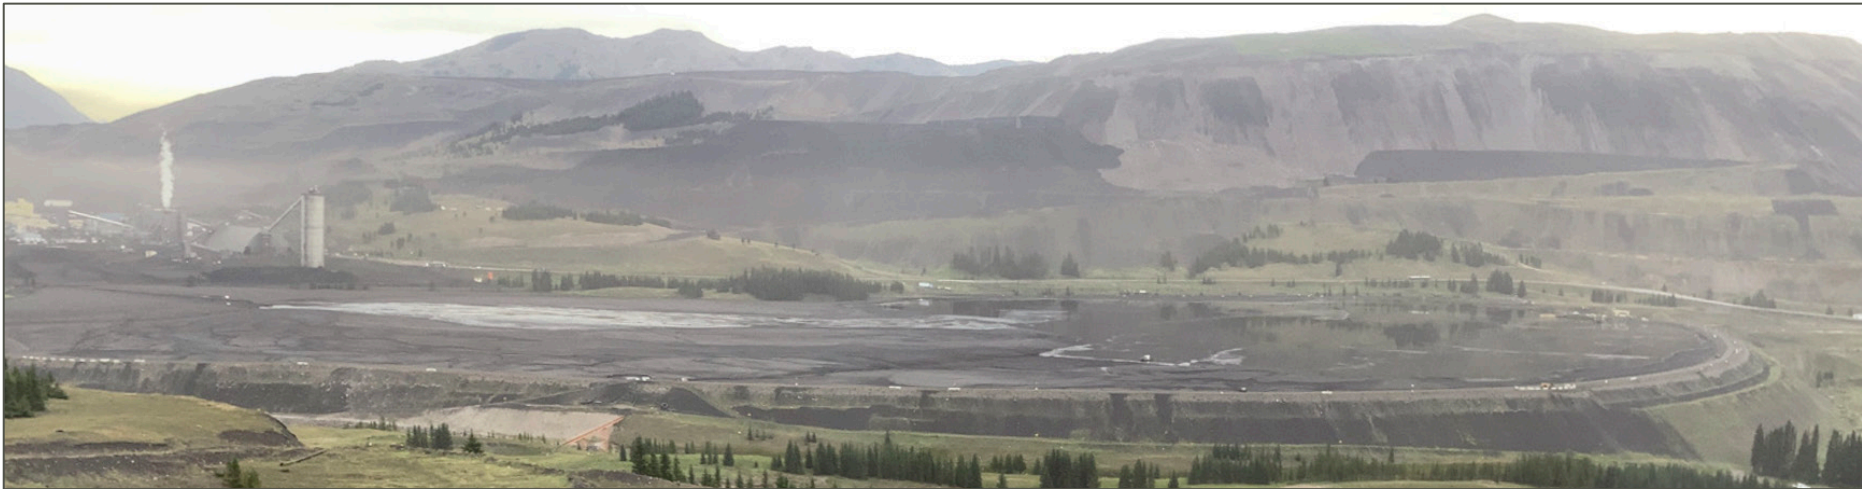
STP overview, looking northeast

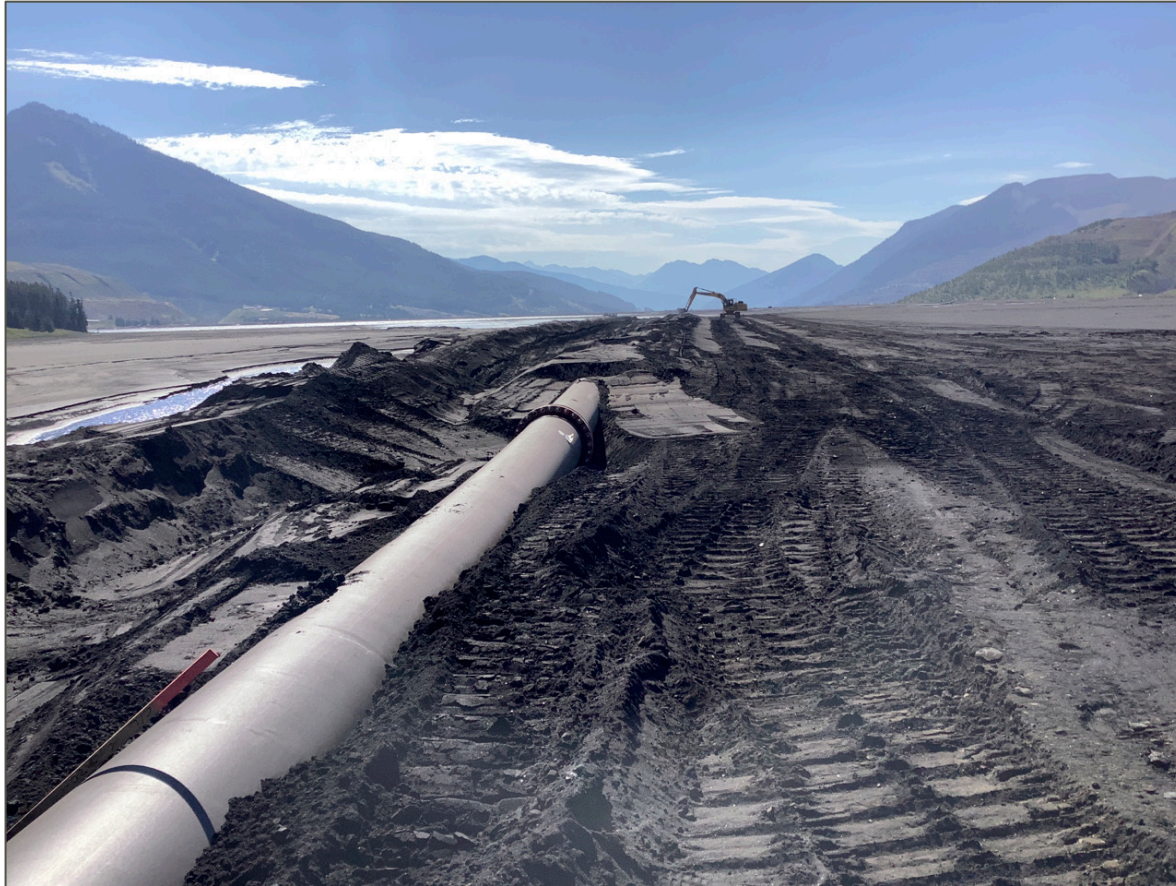
STP north single point discharge pipeline extension and channel to main pond, looking southeast

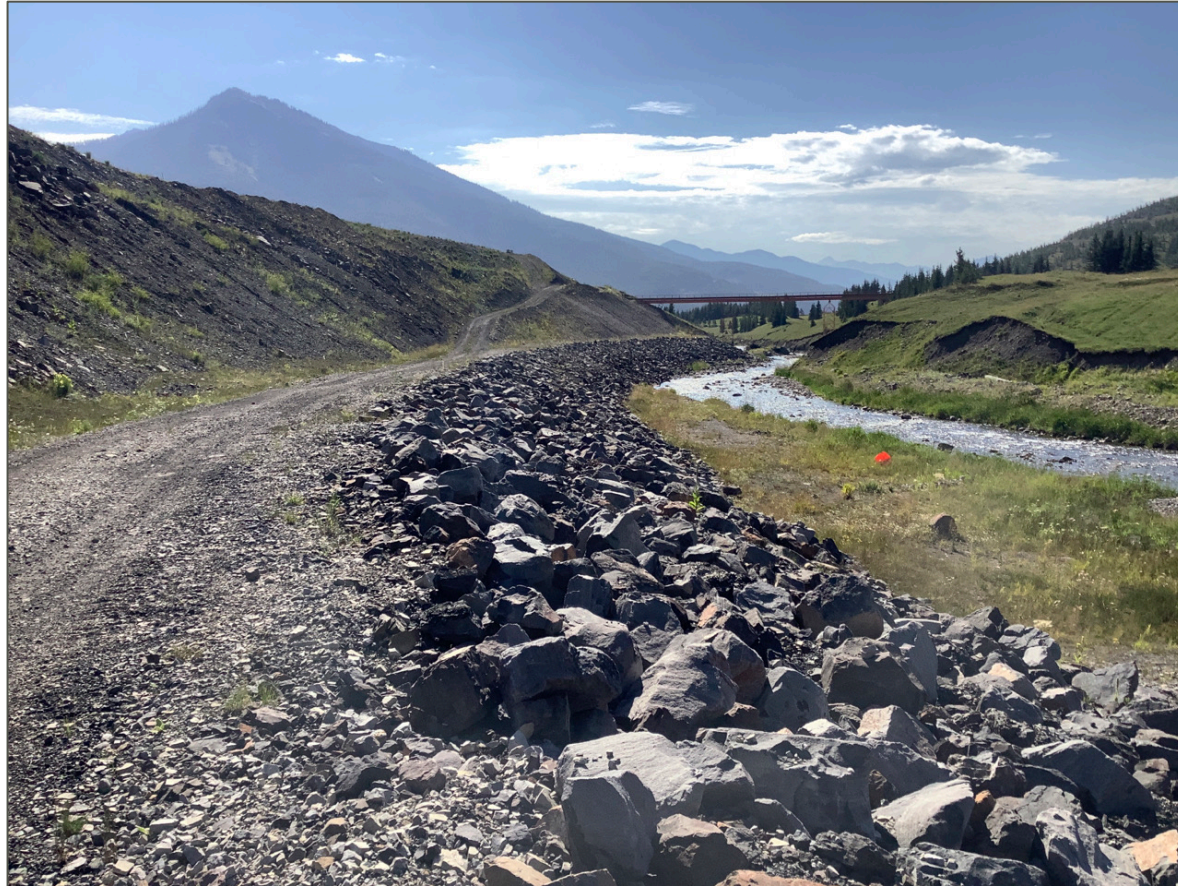
STP West Dam downstream slope and riprap along Fording River, looking southeast from approximately Sta. 0+400

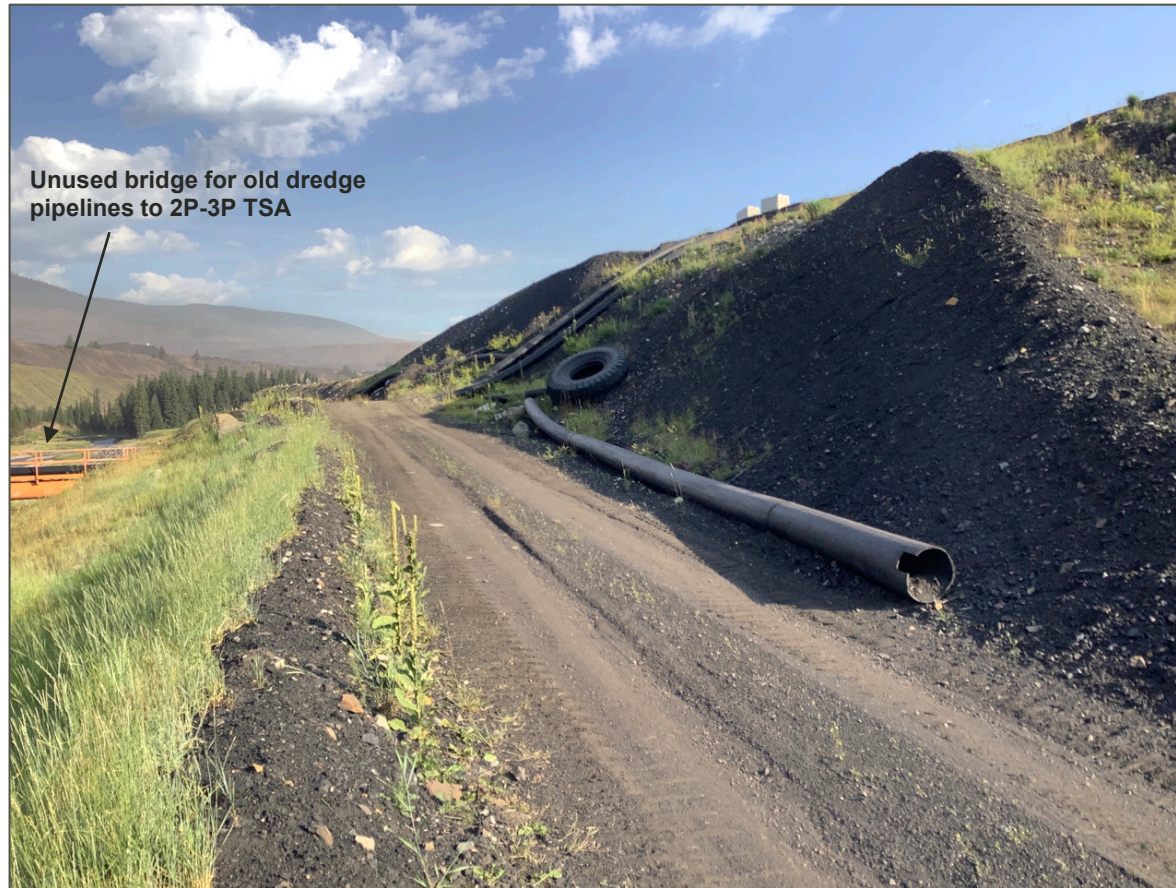
STP West Dam downstream slope and access road, looking northwest from approximately Sta. 0+650

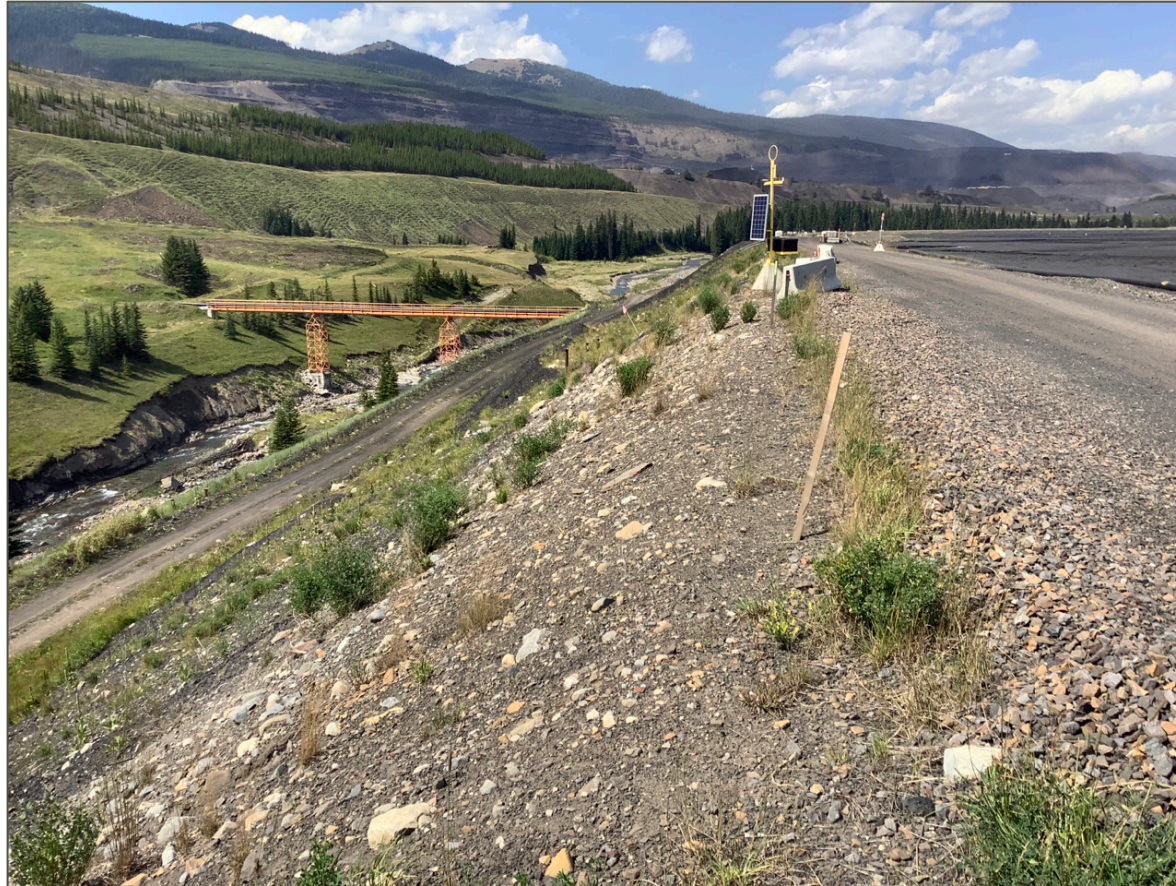
STP West Dam crest and downstream slope, Fording River, and Pipeline Bridge; looking northwest from approximately Sta. 0+800

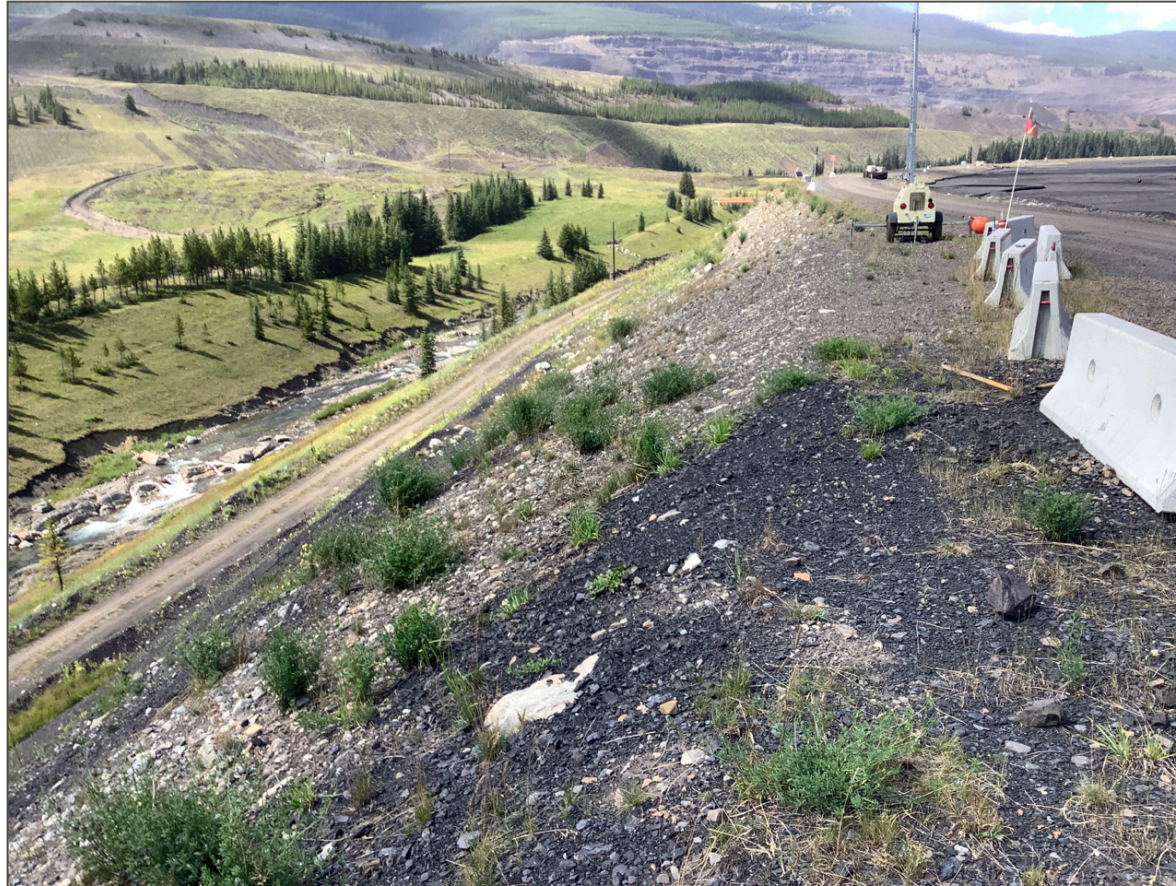
STP West Dam downstream slope and Fording River; looking northwest from approximately Sta. 1+050

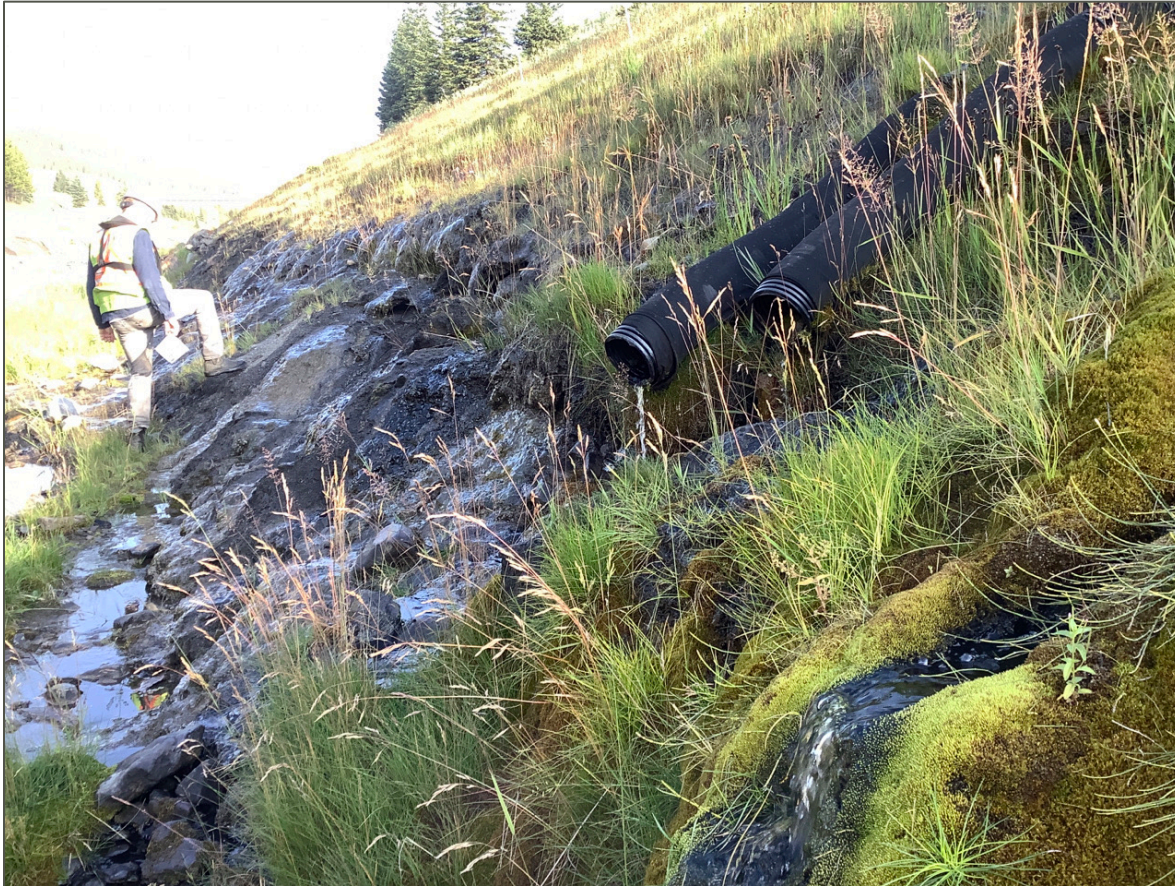
Pipe	Seepage Rate (L/s)
North (left)	0.09
South (right)	0.03
Bypassing pipes (estimated)	0.25

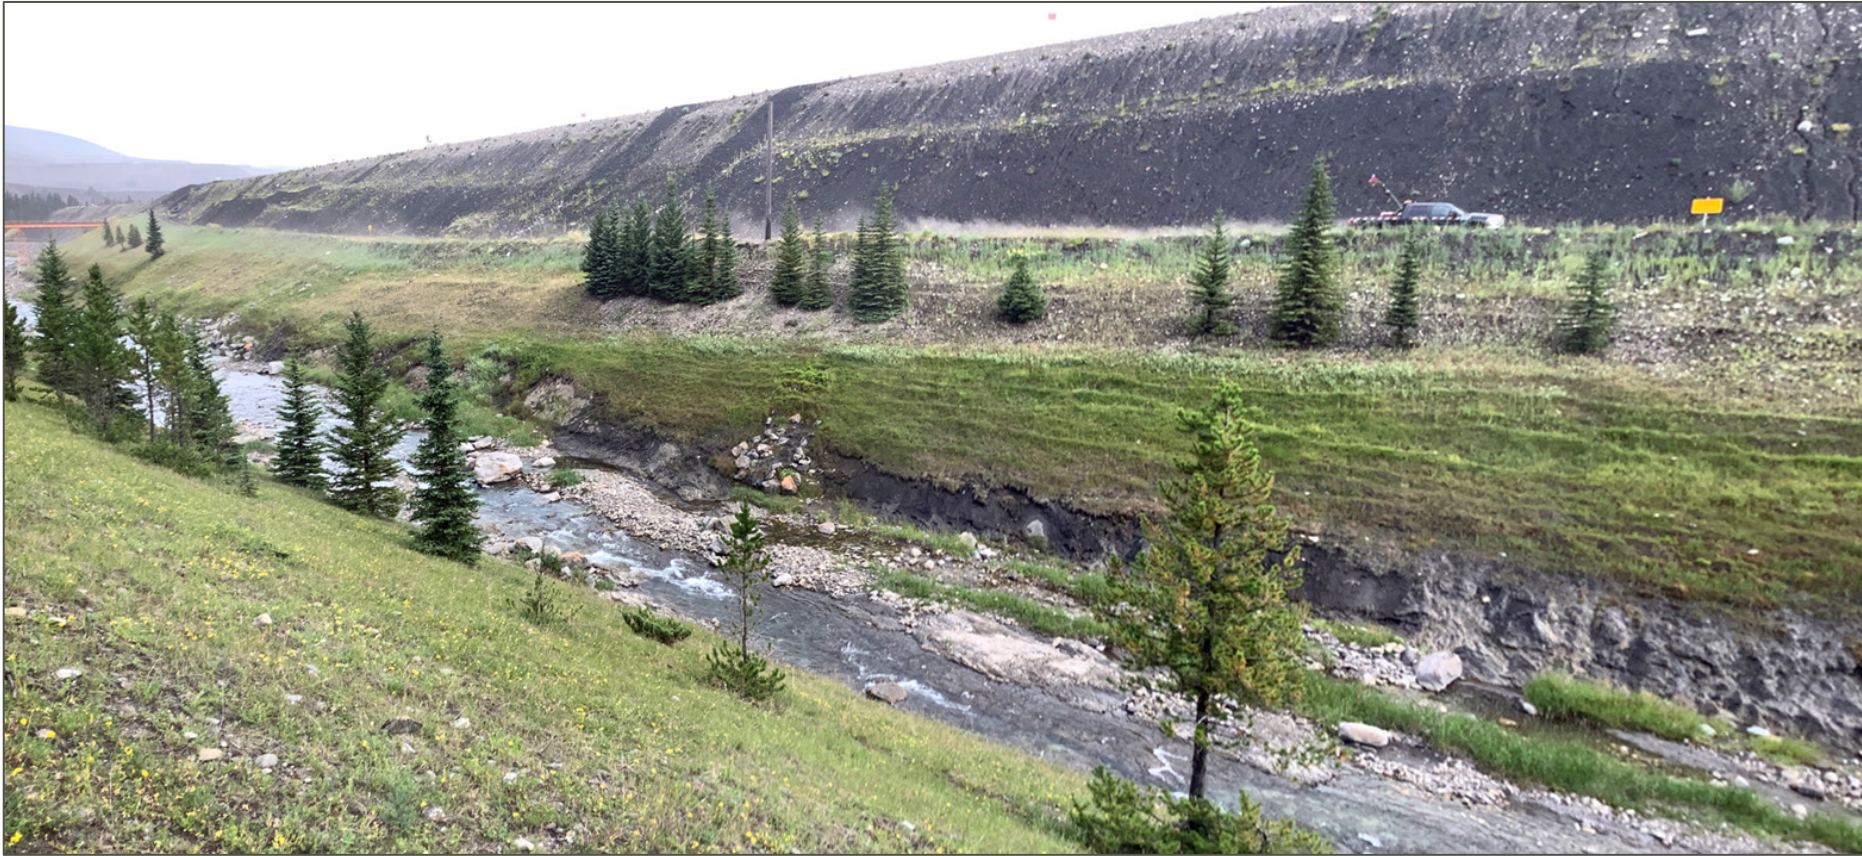
STP West Dam downstream slope, diversion channel till cut, and Fording River; looking north from west side of river at approximately Sta. 1+000

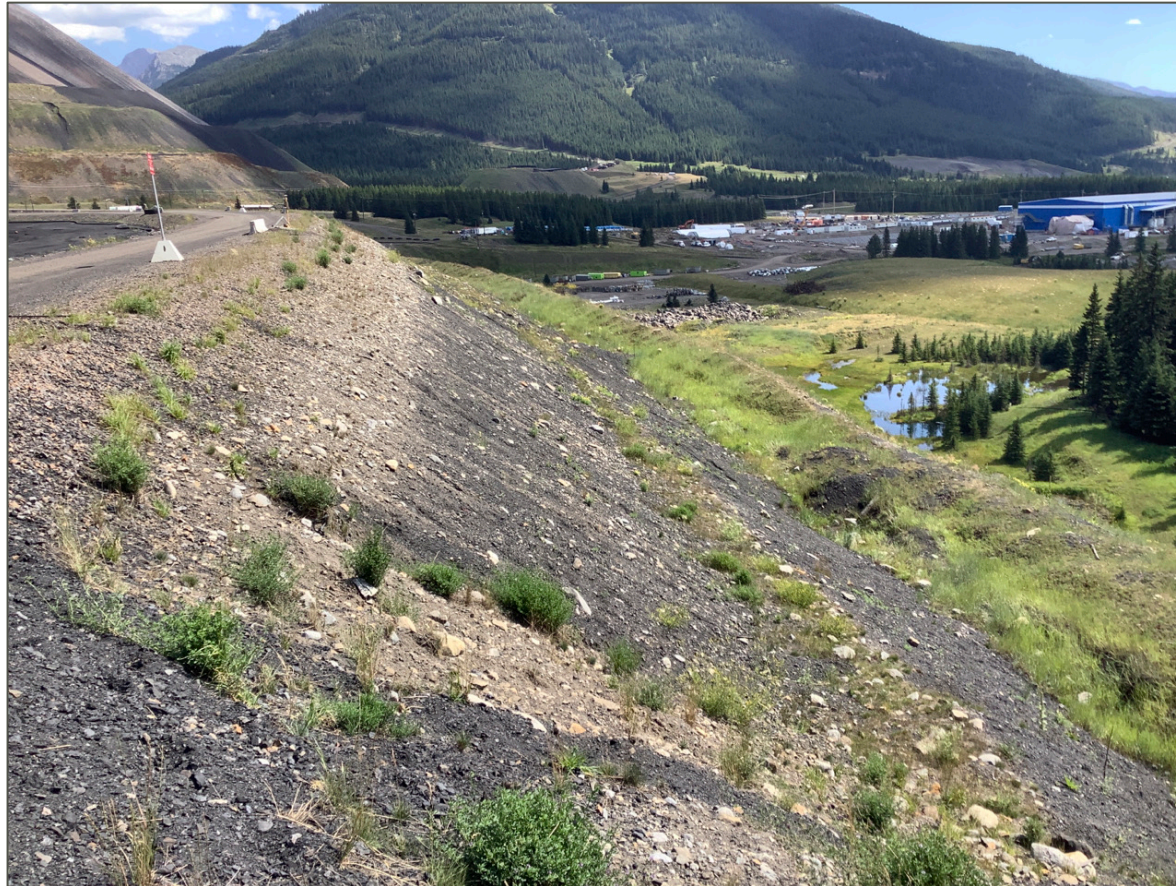
STP West Dam downstream slope, looking southeast from approximately Sta. 1+150

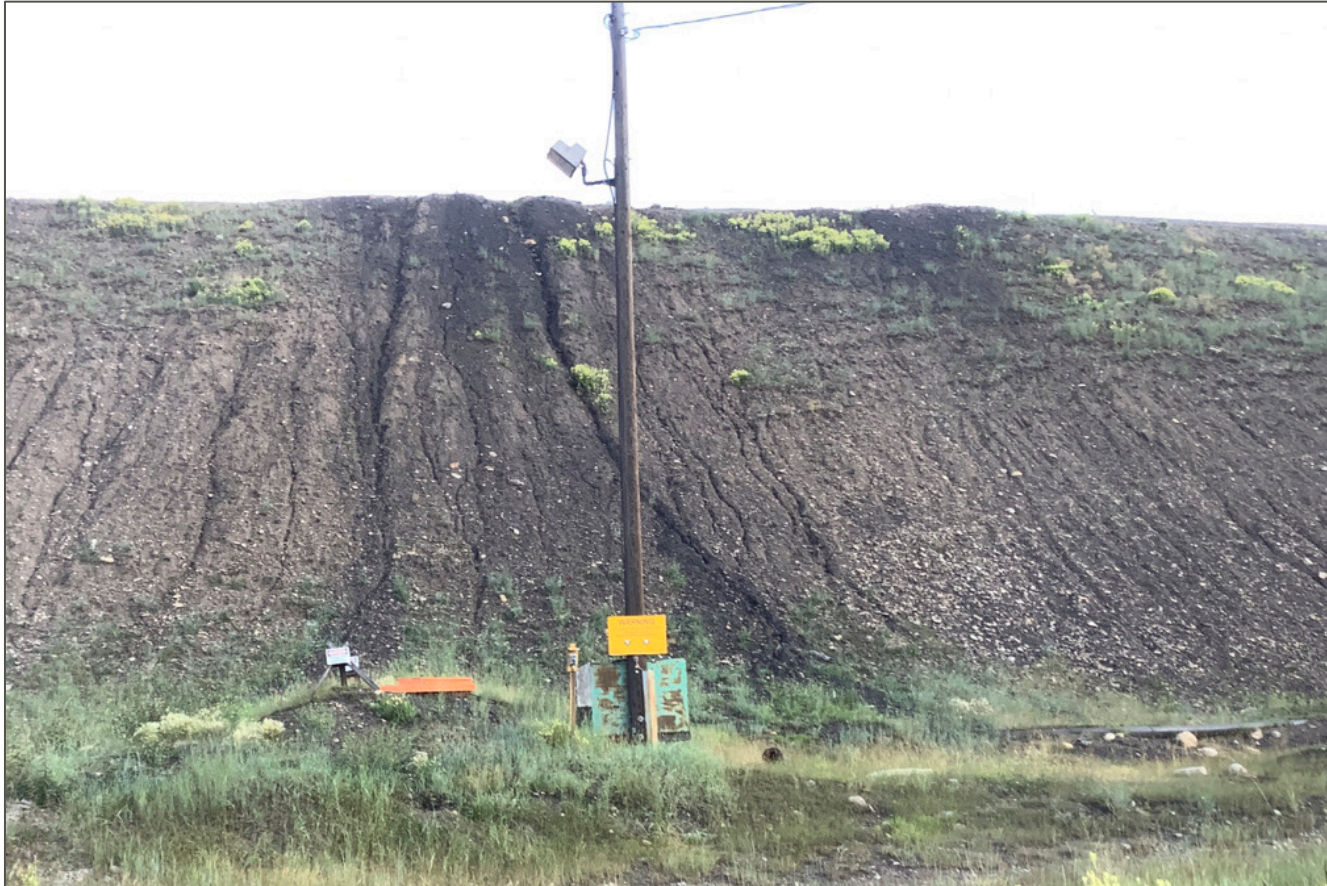
STP Main Dam downstream slope showing erosion above seepage return wells, looking southeast from approximately Sta. 1+450

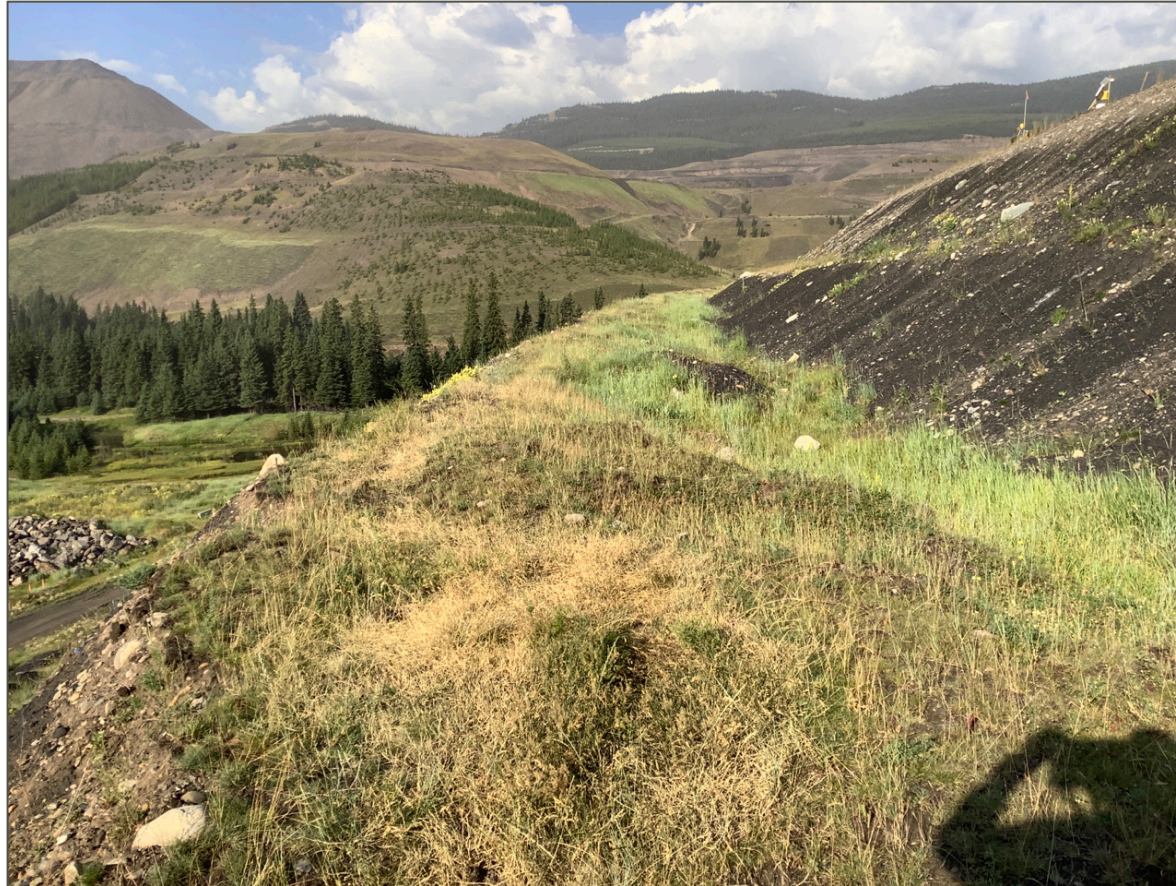
STP Main Dam downstream slope and bench at top of CR section of slope, looking southwest from approximately Sta. 1+450

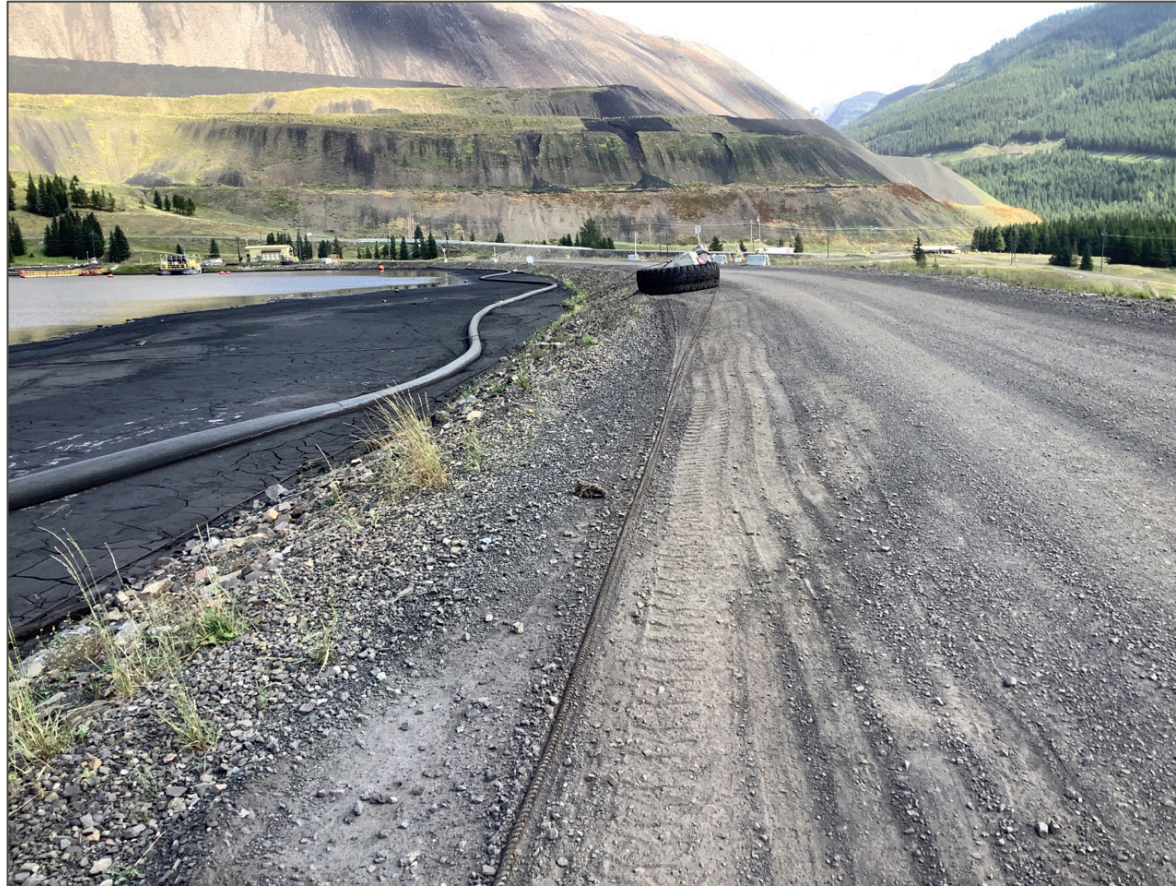
STP Main Dam crest, upstream slope, and tailings beach; looking northeast from approximately Sta. 1+430

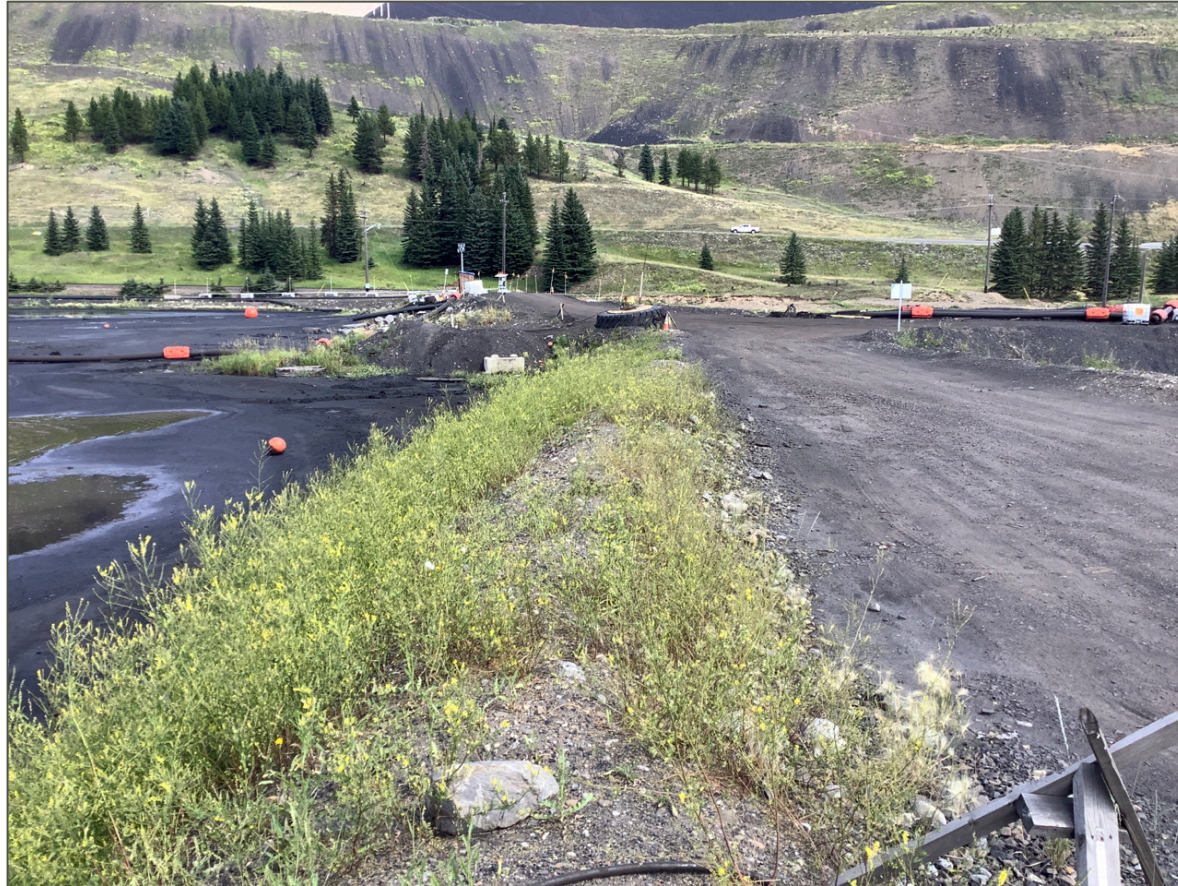
STP Main Dam crest and upstream slope at south abutment, looking northeast from approximately Sta. 1+700

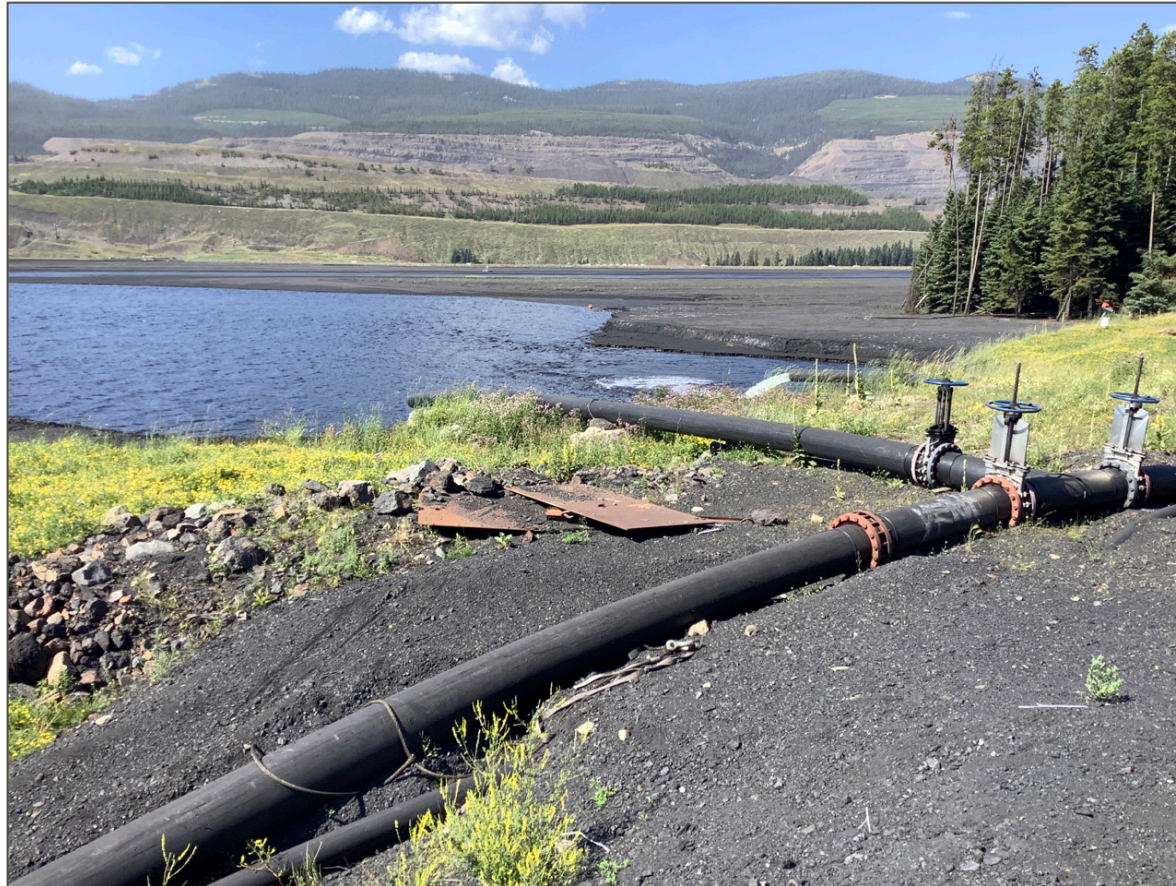
STP water reclaim line from Turnbull TSF, looking southwest

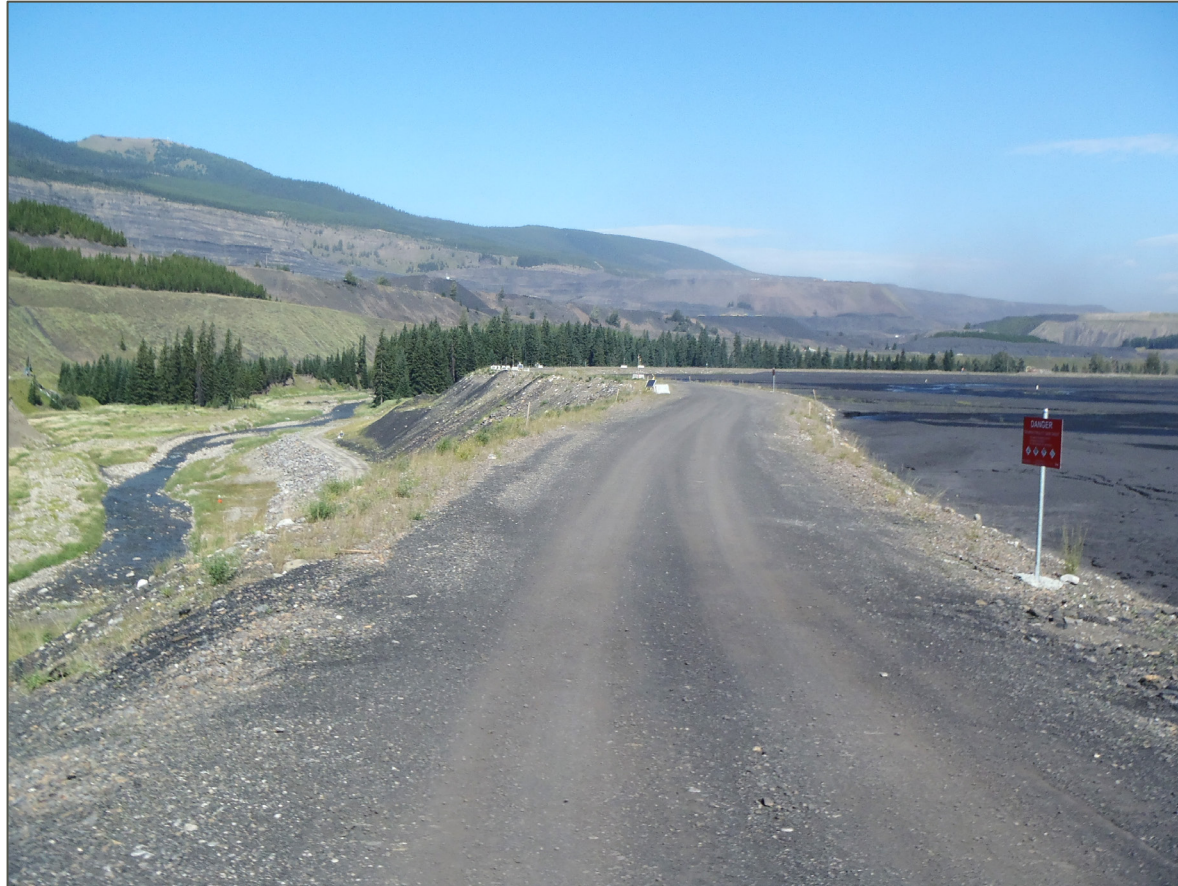
STP West Dam crest and upstream beach, looking northwest from approximately Sta. 0+650

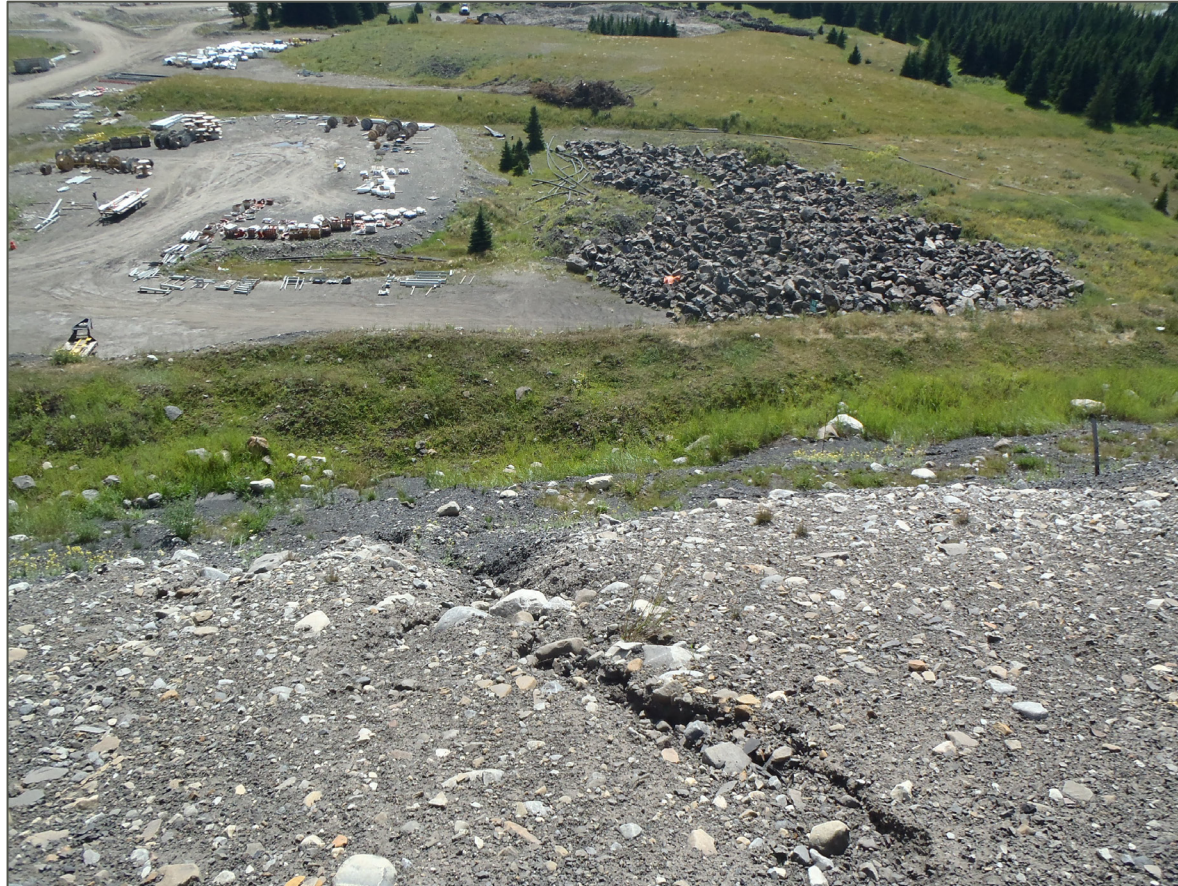
STP Main Dam downstream slope with some erosion on till, and view of riprap stockpile downstream of Main Dam; looking south from approximately Sta. 1+450

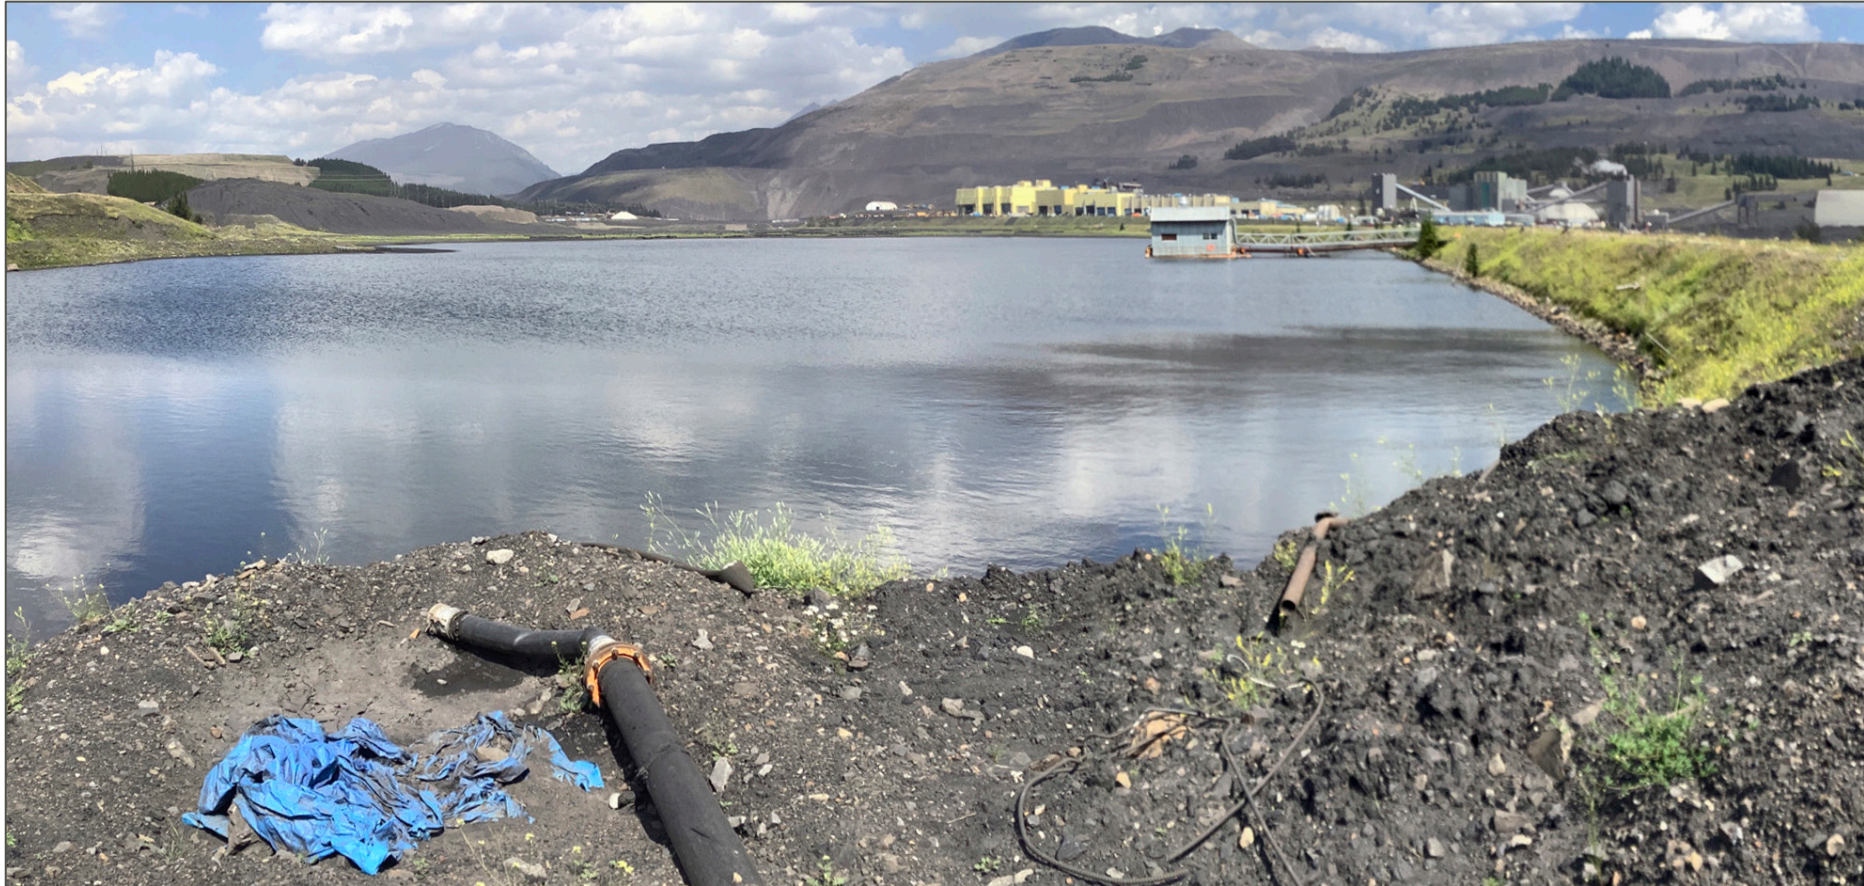
North Tailings Pond (NTP) overview of pond and upstream slope at south end, looking north from approximately Sta. 1+400.

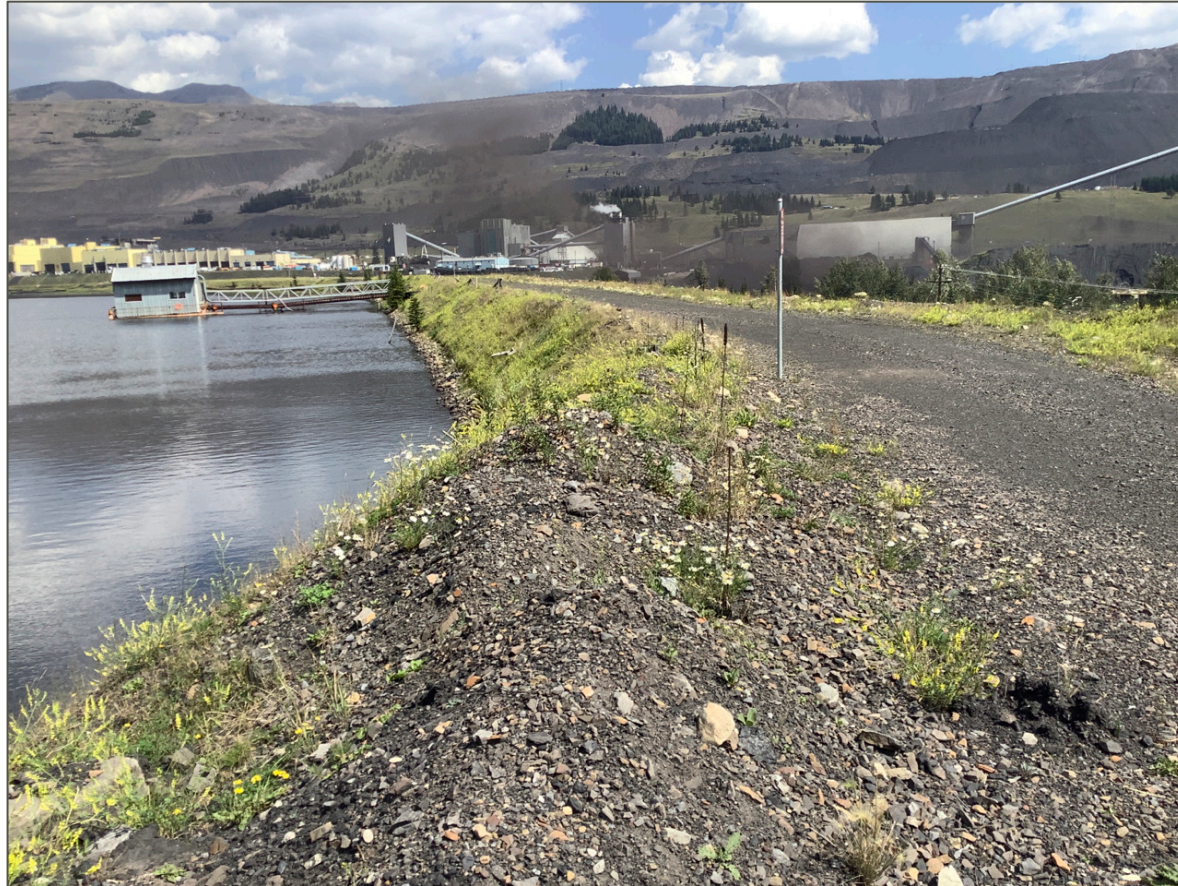
NTP Dam crest and upstream slope, looking northeast from approximately Sta. 1+400

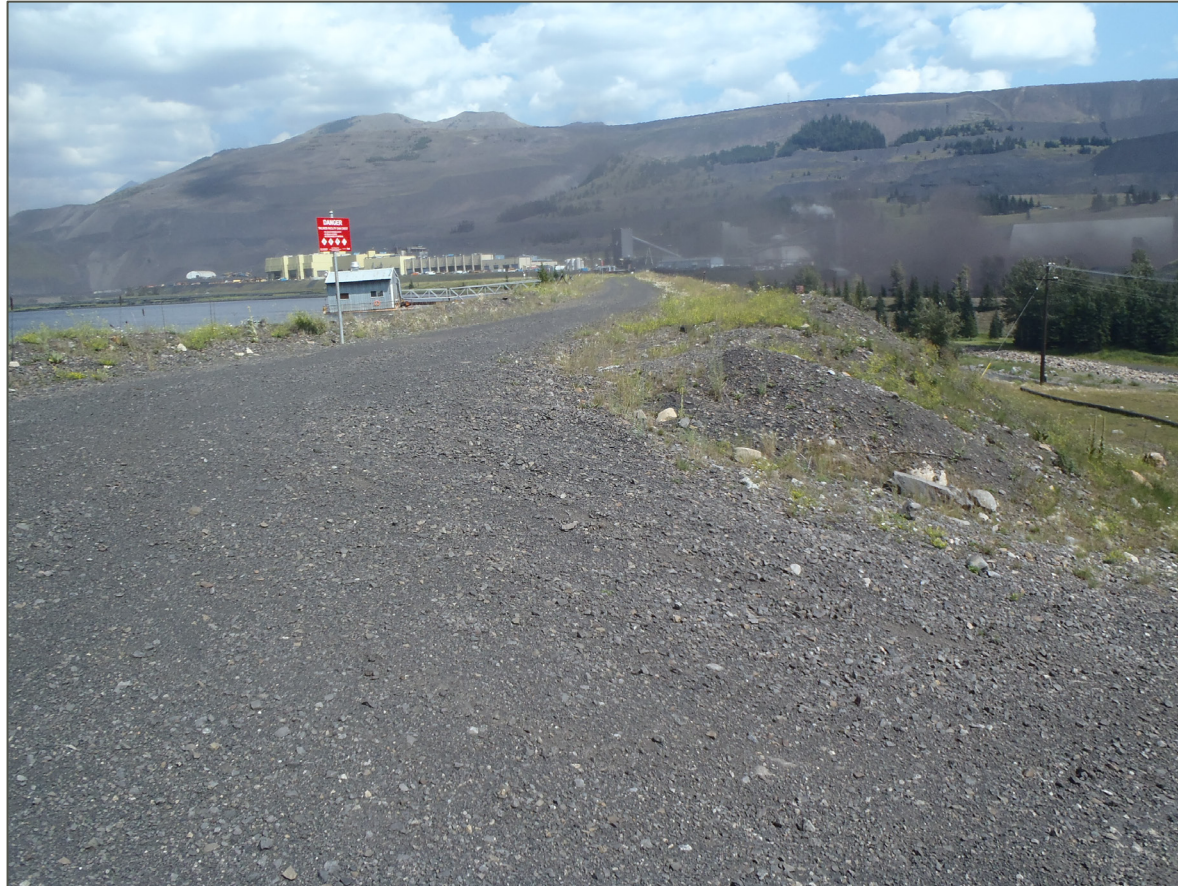
NTP Dam crest and downstream slope; looking northeast from approximately Sta. 1+400
