2020 Dam Safety Inspection for South Tailings Pond and North Tailings Pond

Teck Coal Limited, Fording River Operations

Reference No. 20136981-2020-219-R-Rev0-2000

18 March 2021

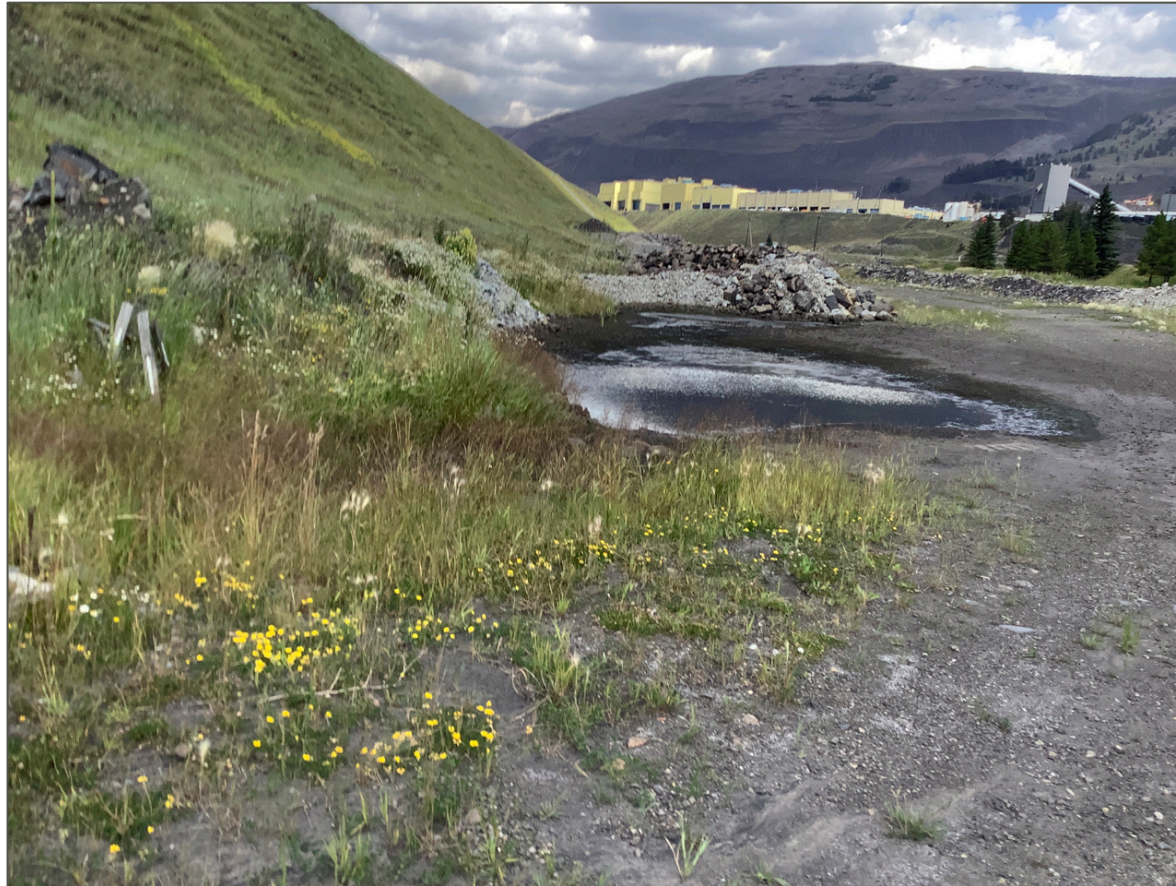
NTP Dam toe and area of ponding water at Sta. 1+200, looking northeast

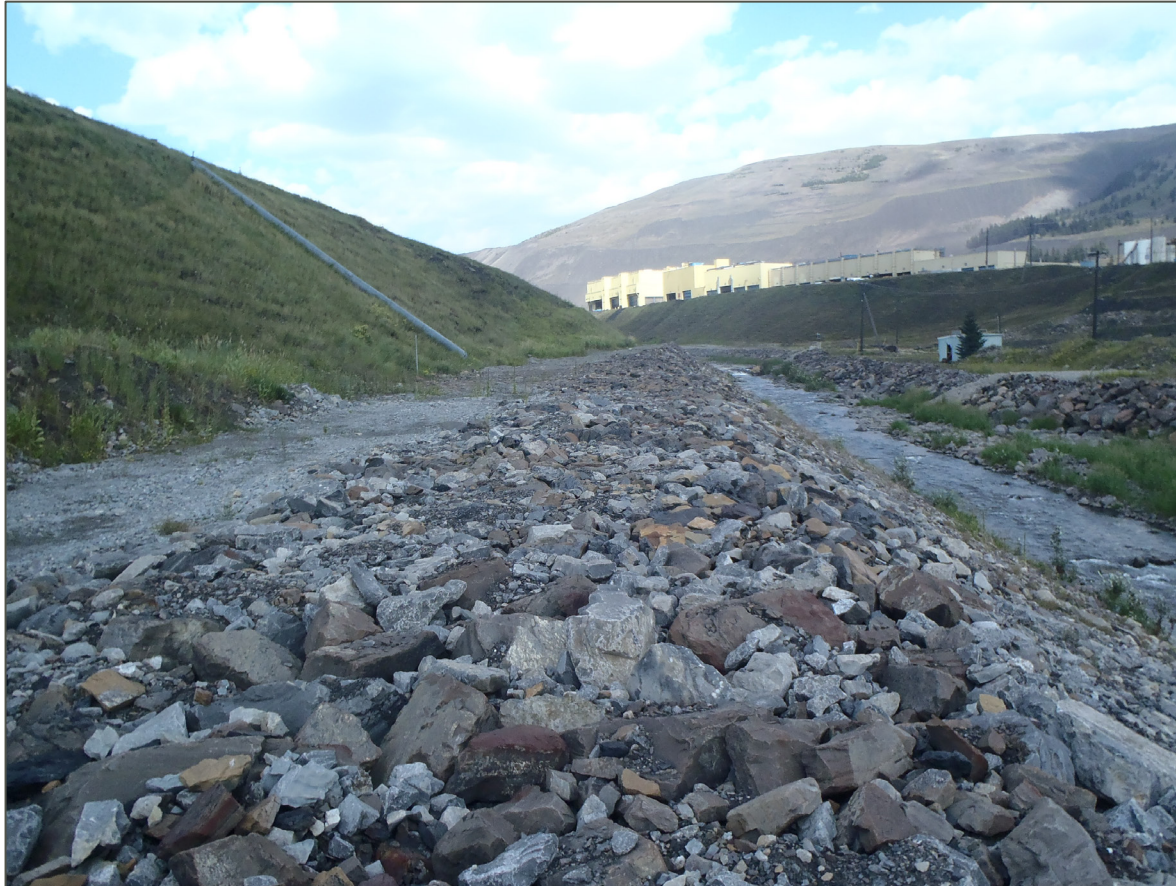
NTP Dam downstream slope and riprap along Fording River; looking northeast from approximately Sta. 0+950

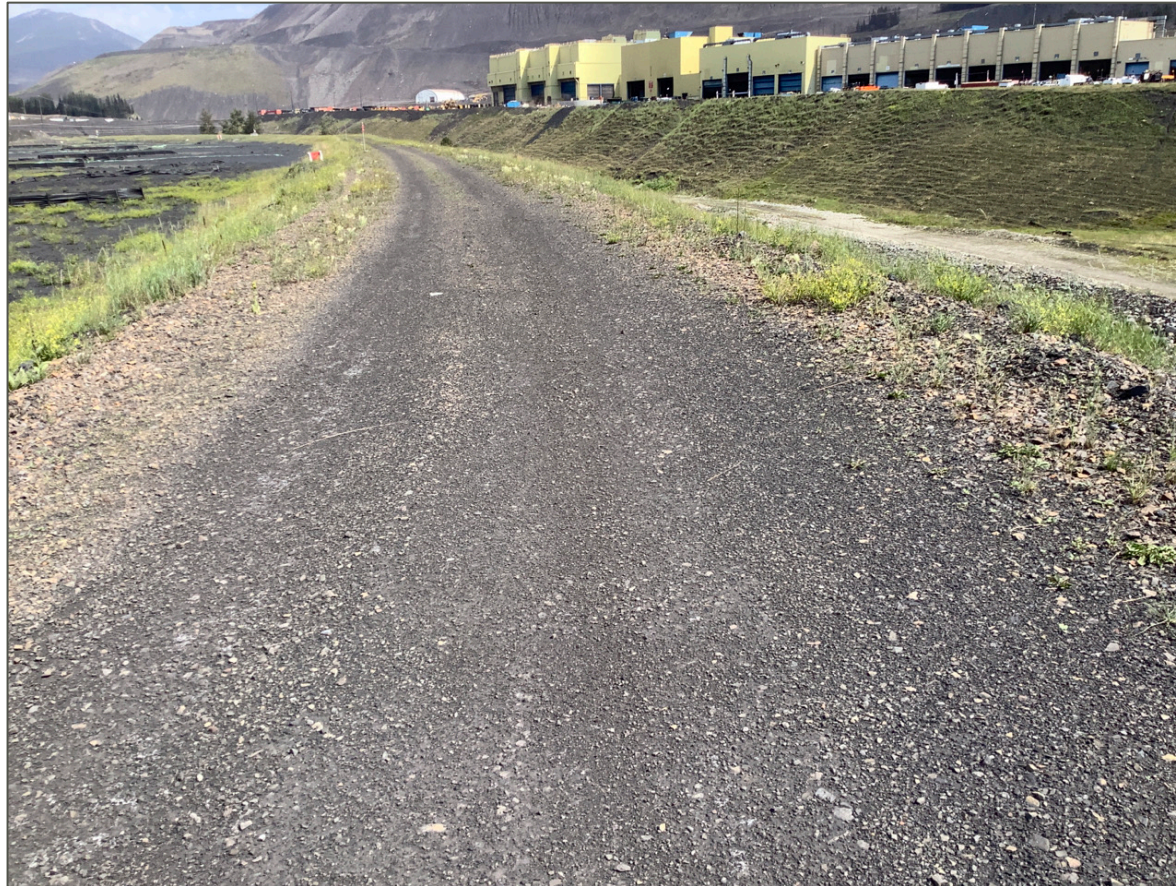
NTP Dam crest, looking northeast from approximately Sta. 0+850

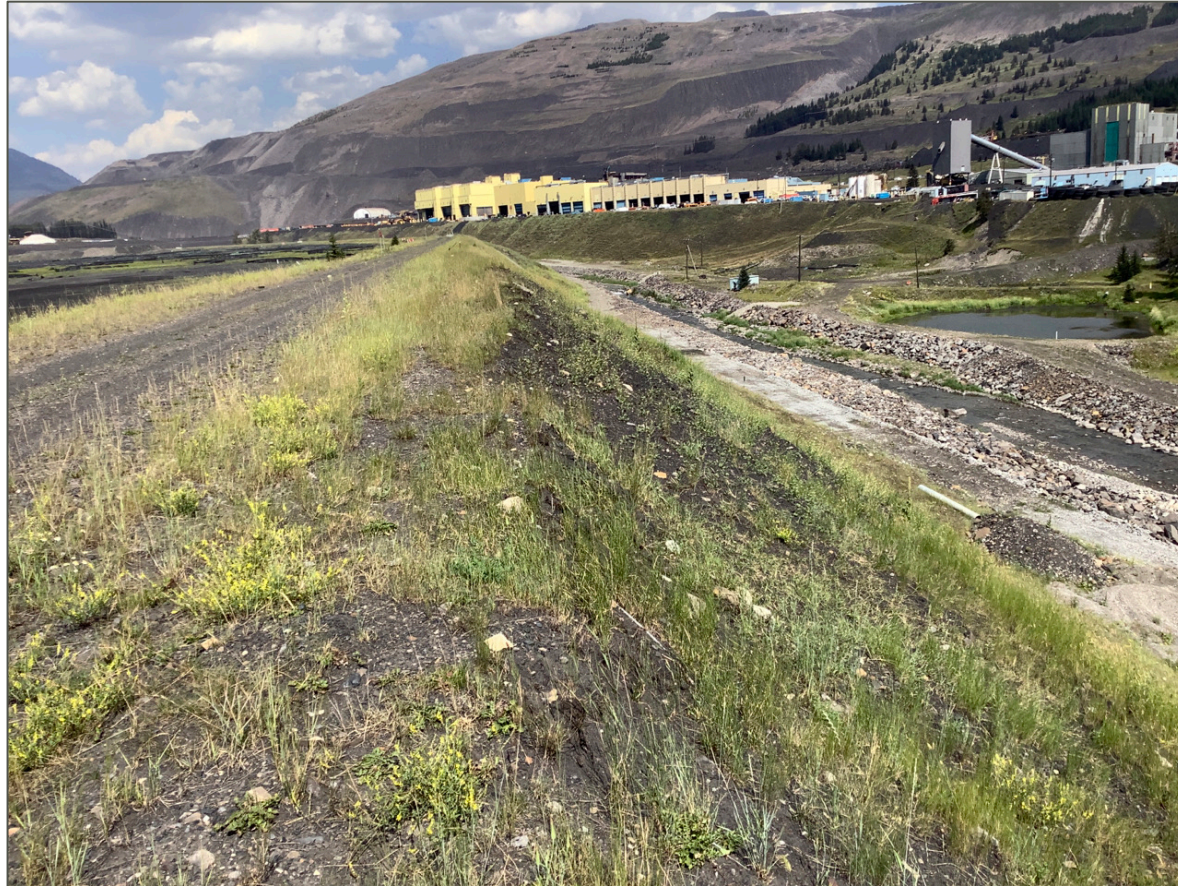
NTP Dam crest and downstream slope, looking northeast from approximately Sta. 1+150

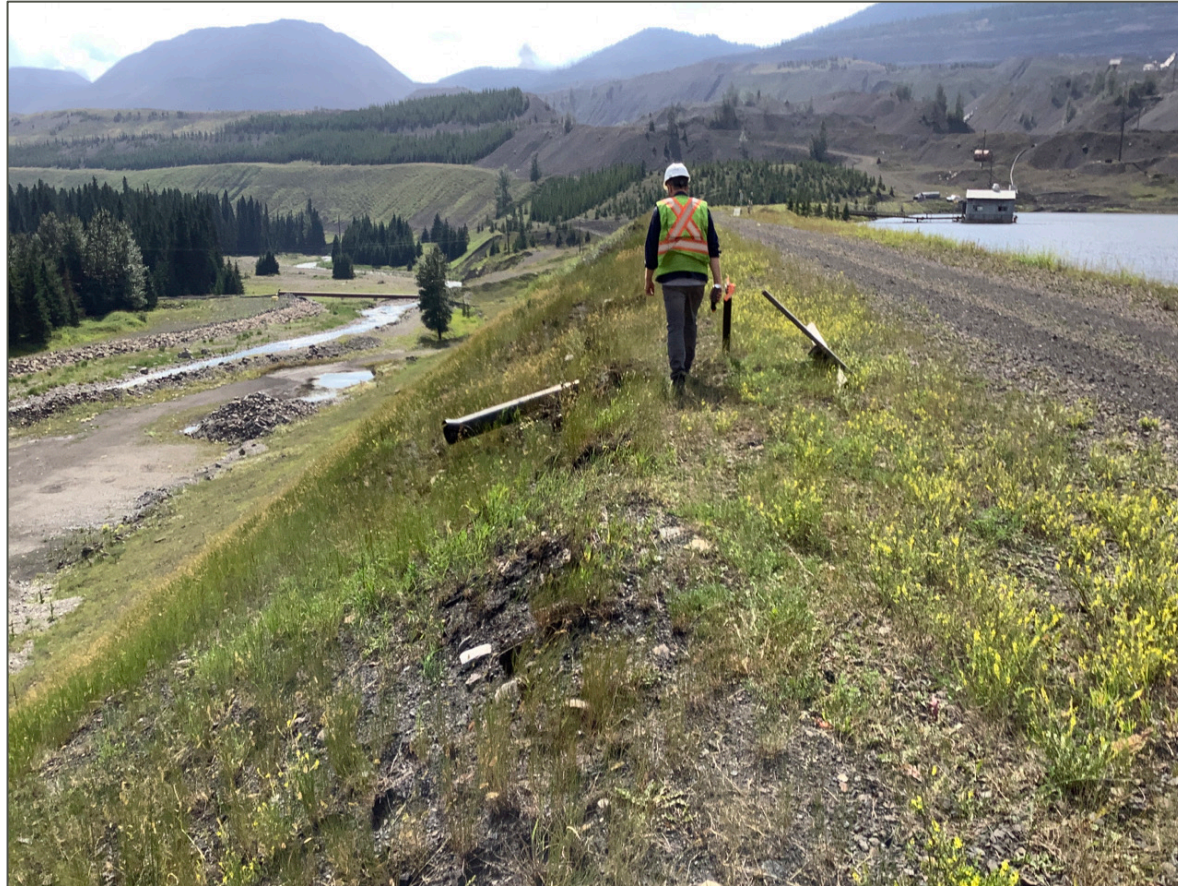
NTP Dam crest, downstream slope, and black PVC pipe on downstream; looking southwest from approximately Sta. 1+050

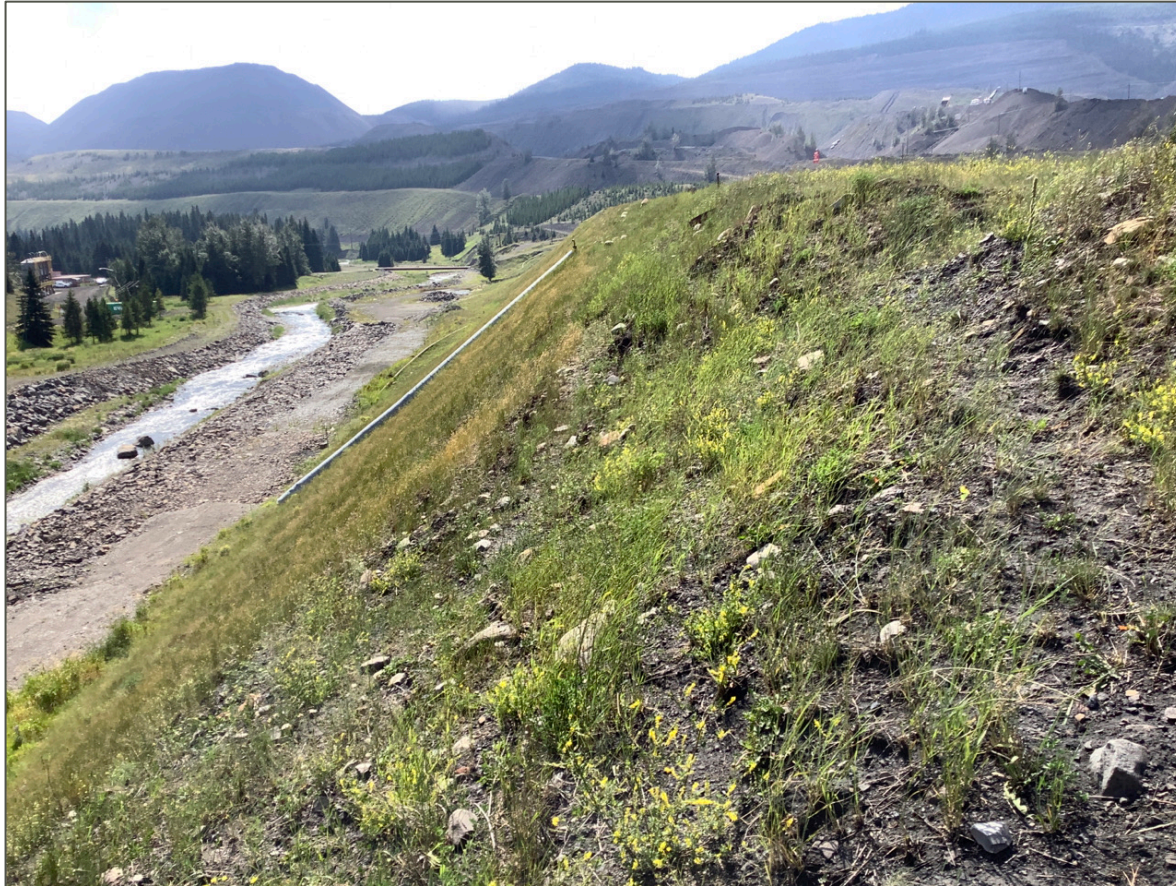
NTP Dam downstream slope, looking southwest from approximately Sta. 0+850

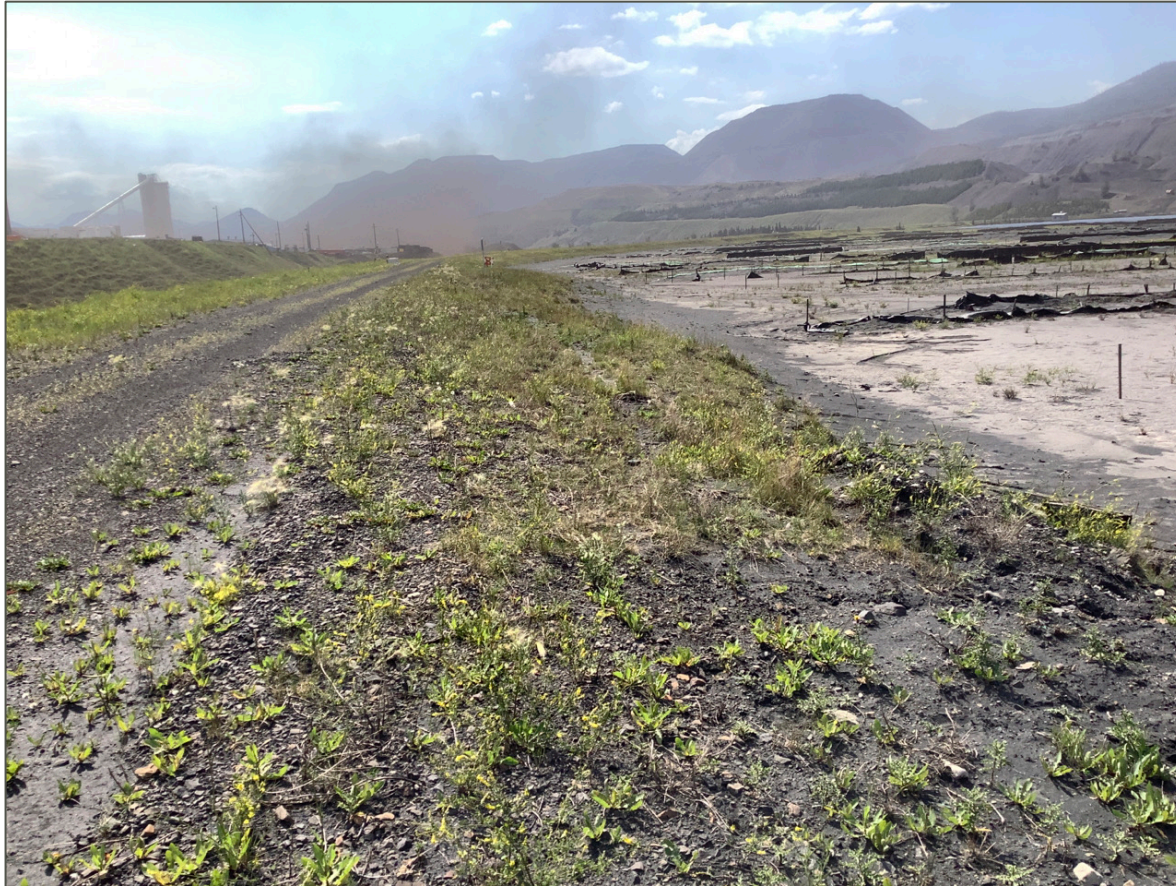
NTP Dam crest, upstream slope, and tailings surface; looking south from approximately Sta. 0+350

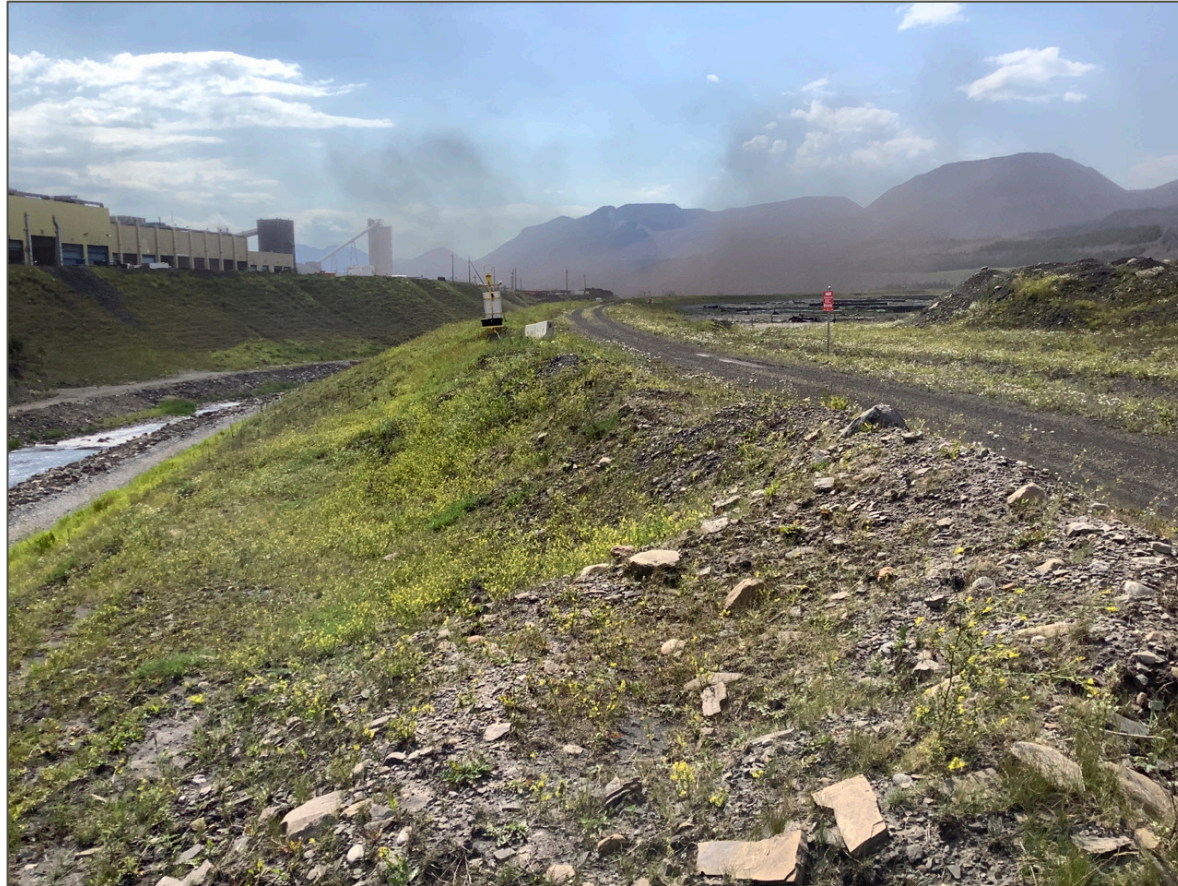
NTP Dam crest and downstream slope, looking south from approximately Sta. 0+250

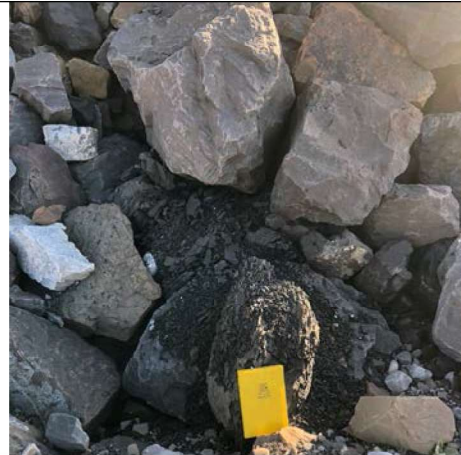
Photo 10: Riprap degradation due to weathering on several pieces of riprap.

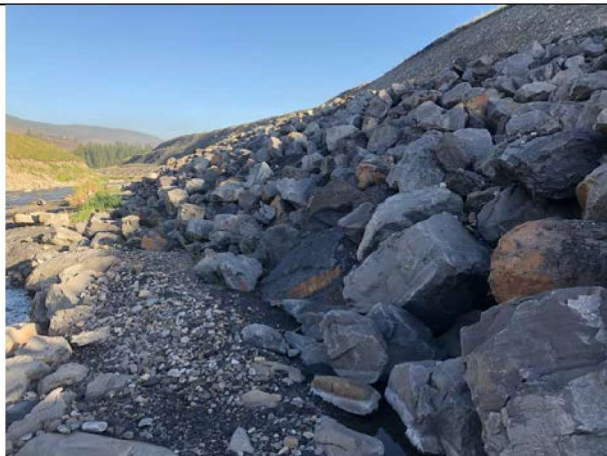
Photo 11: Looking upstream at STP riprap (from approx. Sta. 0+670).

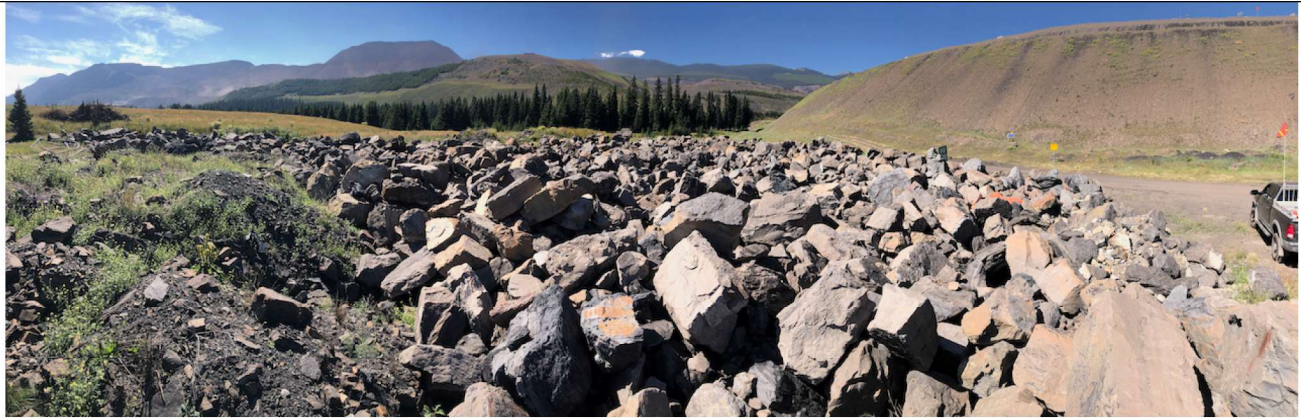
Photo 12: Erosion along the toe of the STP downstream of the pipe bridge. The erosion has exposed bedrock in some areas.
