# 2020 Annual Inspection Report

## *Greenhills Operations Tailings Storage Facility*

**Teck Coal Limited**

**Golder Associates Ltd.**

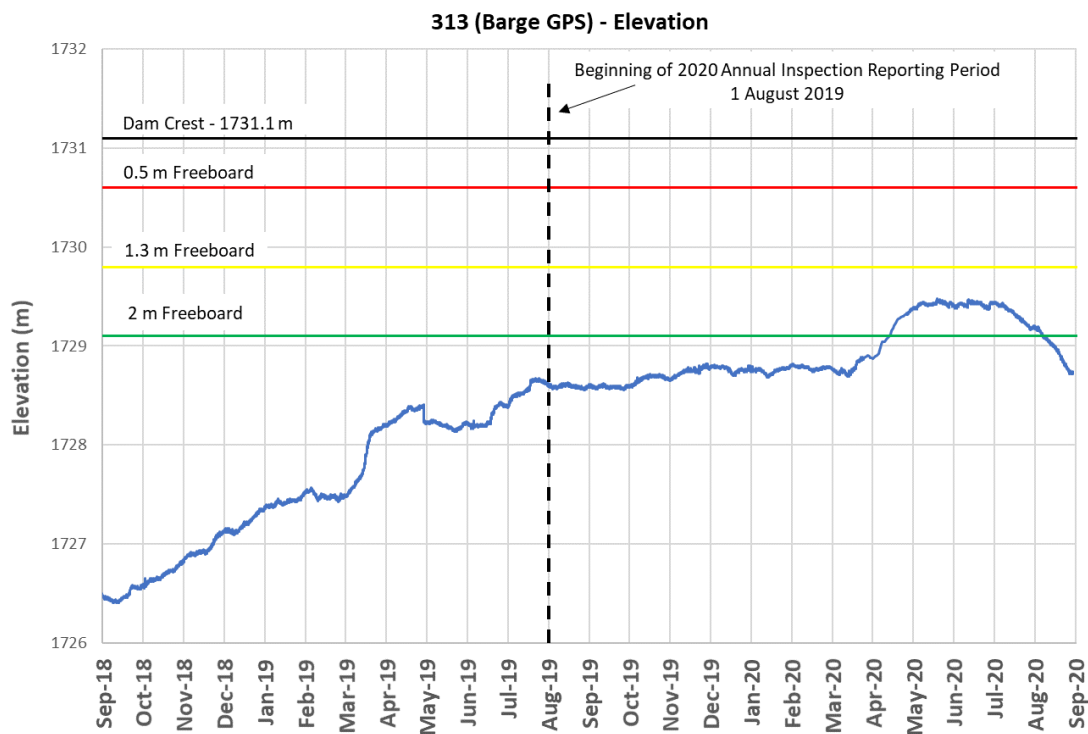
**Illustration 4: Tailings Pond Elevation Relative to Freeboard Levels**

Data indicate that the pond elevation varied between 1,728.6 and 1,729.5 m during the 2019/2020 reporting period. The minimum freeboard during the reporting period was approximately 1.7 m and was therefore compliant with HSRC (Ministry of Energy and Mines 2017) requirements during the reporting period (minimum required freeboard of 1.3 m).

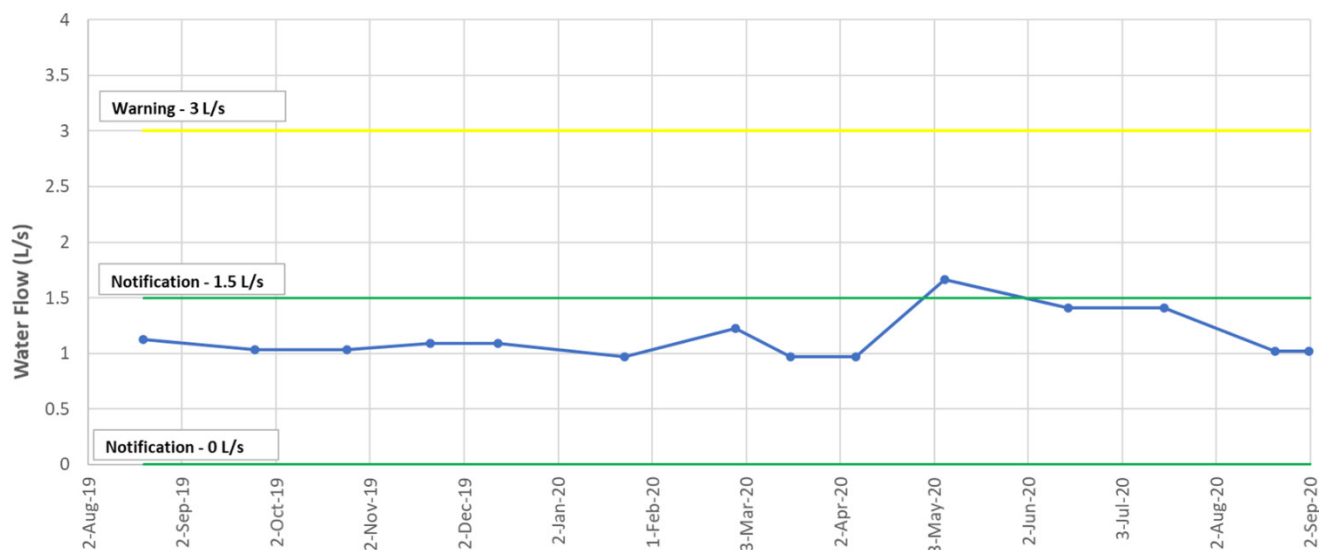
**Illustration 8: West Dam Weir Discharge**

The flows in both weirs were low and within the expected range for normal operation. The West Dam Weir exceeded the green notification level during the May inspection, during the 2020 freshet.

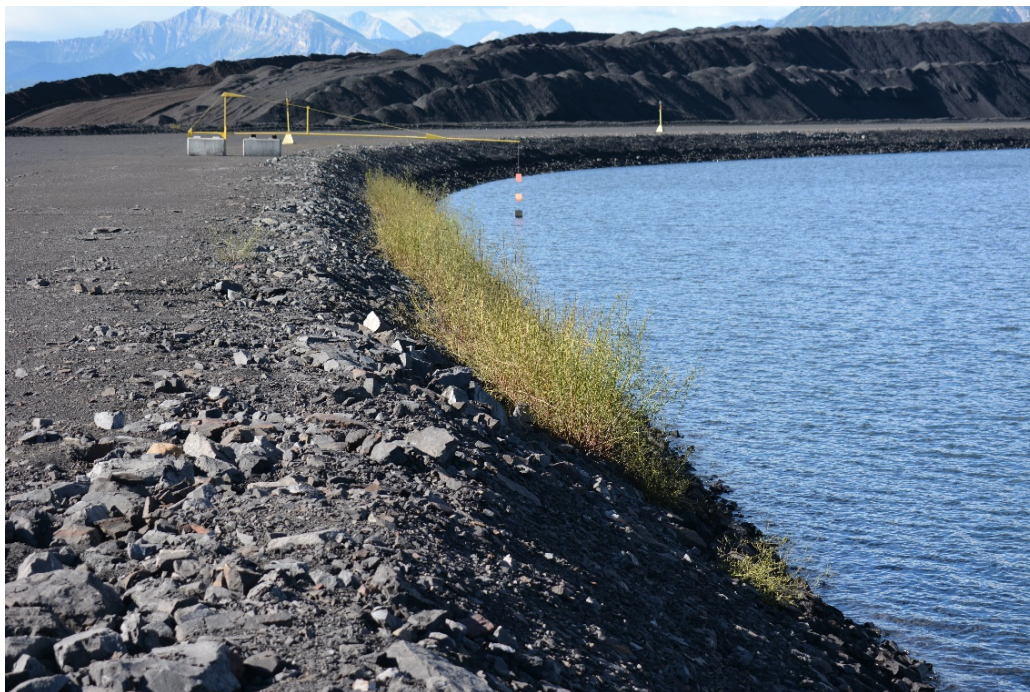
**Photograph 6: Main Tailings Dam – Vegetation on Upstream Crest; Looking Southwest, 1 September 2020**

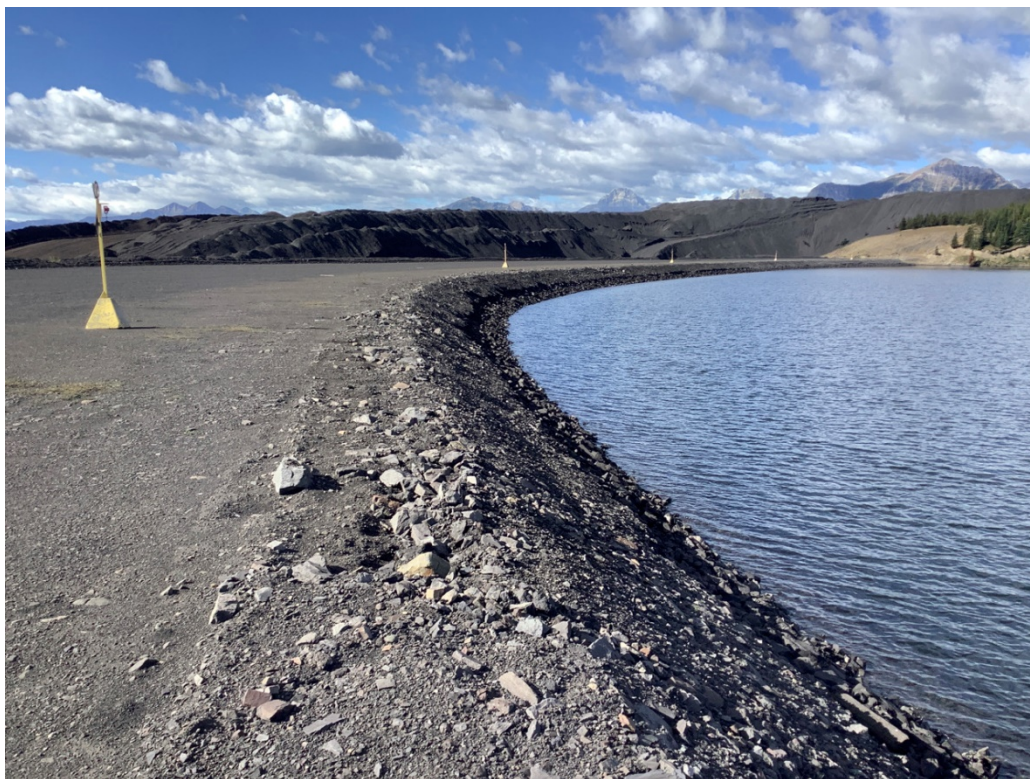
**Figure 11: Main Tailings Dam - Upstream Crest Riprap Erosion; Looking West, 1 September 2020**

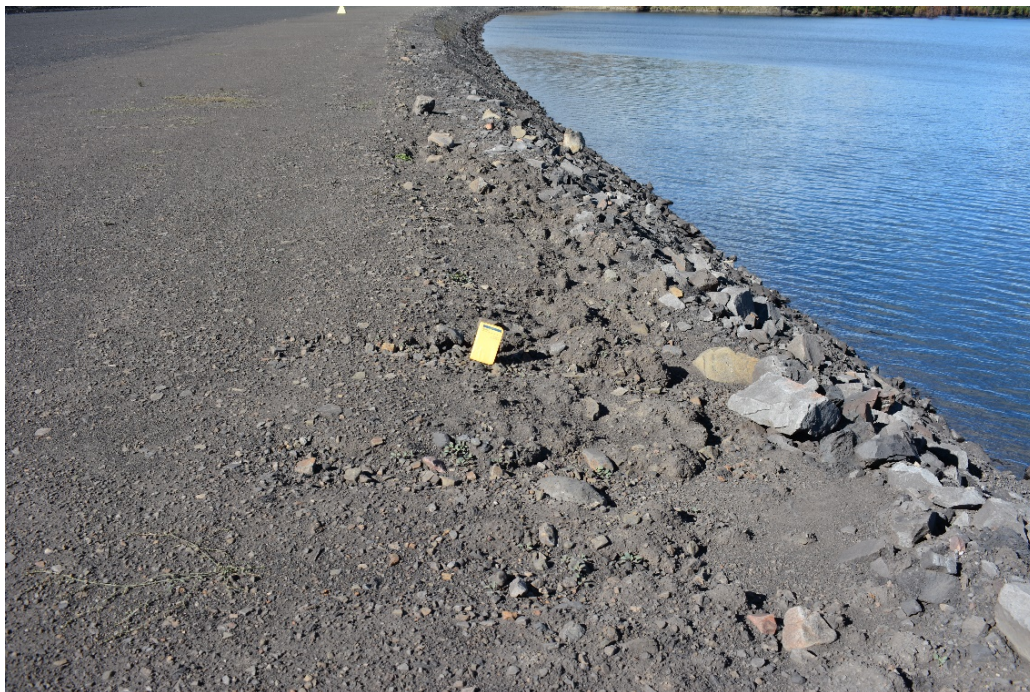
No significant changes were noted during the 2020 site inspection or monthly visual inspections. Some minor erosion of the upstream slope and crest of the Main and West Tailings Dams were observed which require routine maintenance, completed as part of dam raise construction. This minor erosion does not present a dam safety concern.

**Photograph 14: Main Tailings Dam – Minor Erosion Rills on Upstream Crest; Looking West, 1 September 2020**

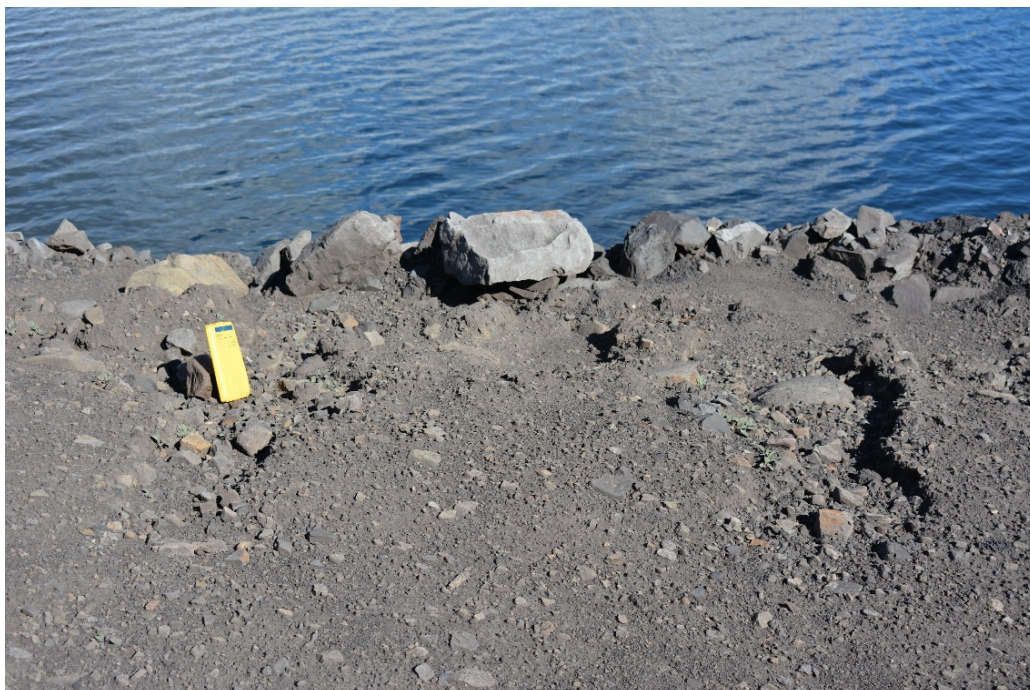
**Photograph 15: Main Tailings Dam – Minor Erosion Rills on Upstream Crest; Looking North, 1 September 2020**

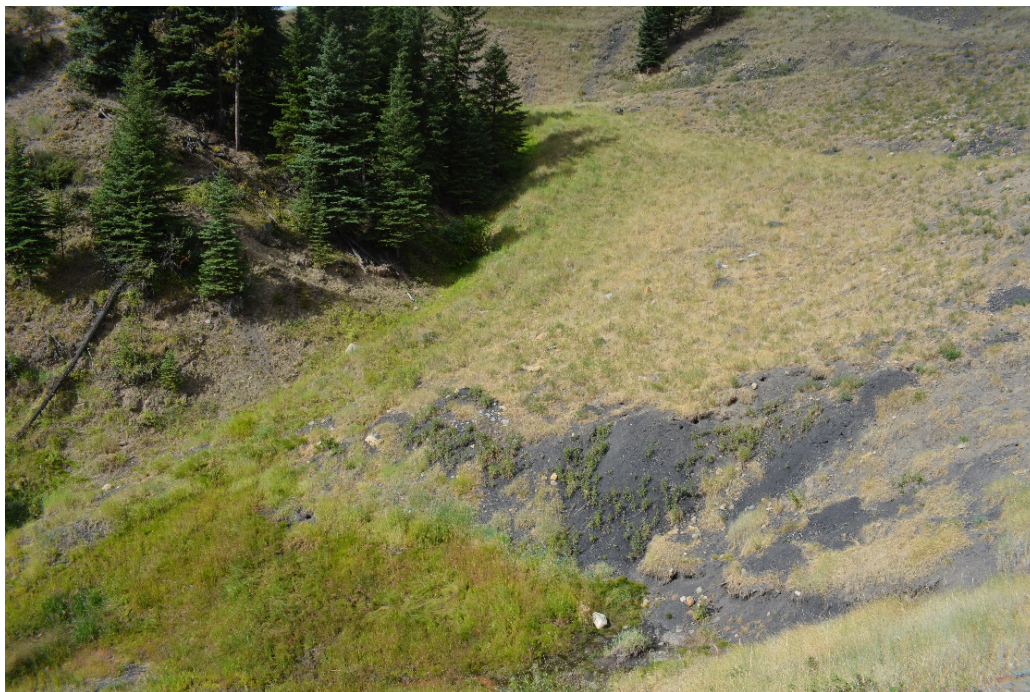
**Photograph 30: Site C/D Coarse Coal Refuse Facility – Toe and Seepage; Looking Northwest, 1 September 2020**

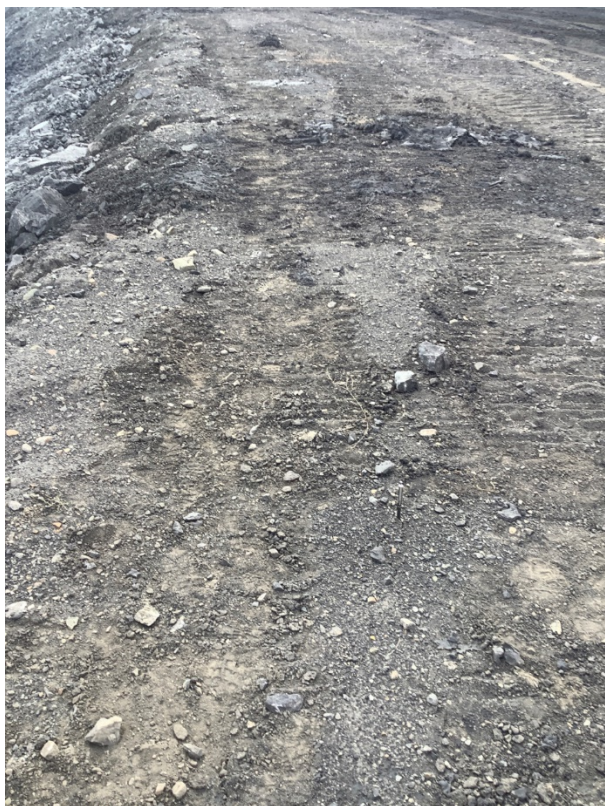
**Photograph 37: West Tailings Dam - Superficial Cracking on Till Blanket; Looking South, 1 September 2020**
