Teck Highland Valley Copper Partnership

2020 Annual Facility Performance Report

Highland Tailings Storage Facility

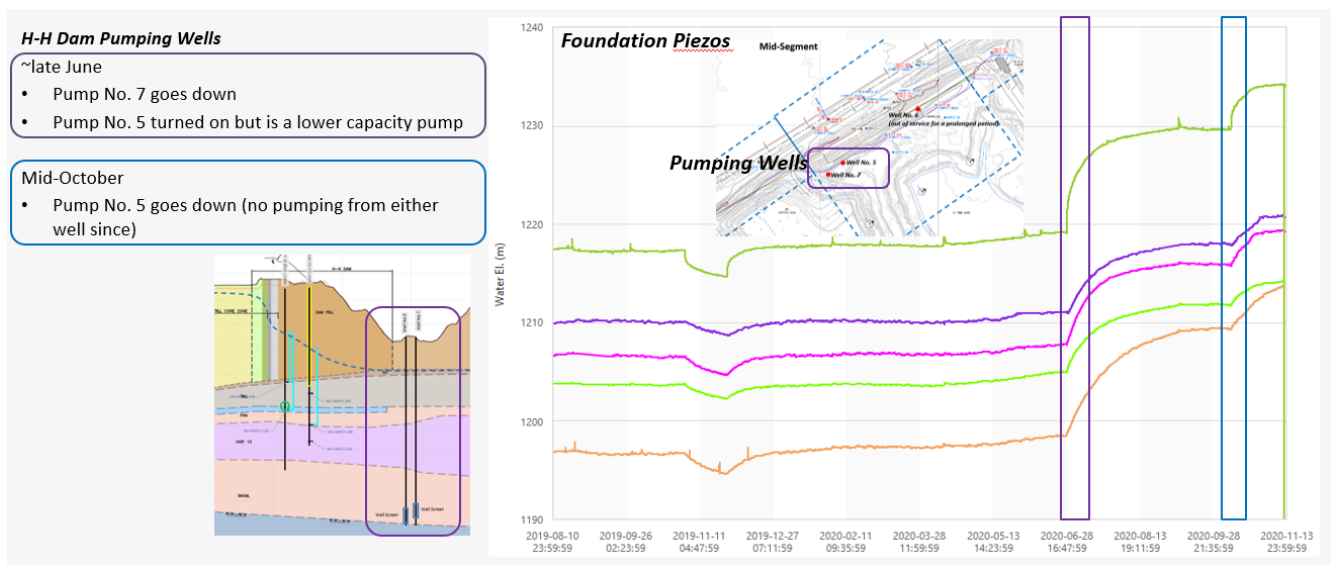
Figure 5.11 Piezometric Response Measured in H-H Dam Foundation

- However, at the H-H Dam, the second level of the TARP was triggered by increasing piezometric levels in the foundation following suspension of groundwater pumping, related to mechanical failure. This situation had not been considered in the forecasted behaviour for 2020. A review by the EoR concluded the dam, under the elevated piezometric levels, remained in compliance with relevant design criteria and therefore performance remained acceptable. Pumping has resumed and potential for a similar response, if pumping is suspended in the future, has been incorporated into 2021 forecast.

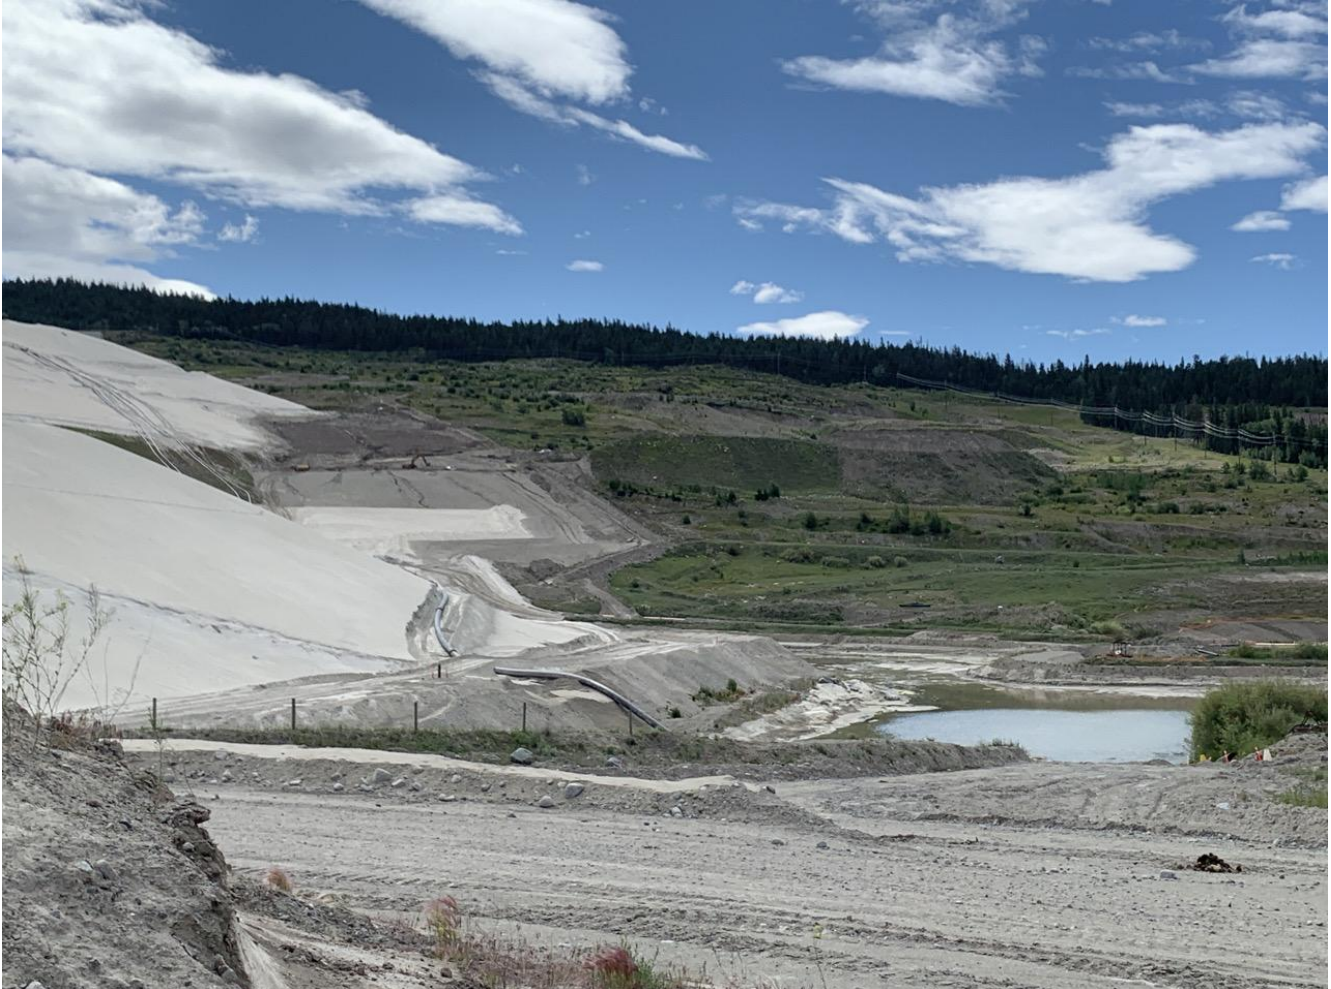
Photo I-A-11 View of Valley Buttress Berm and South Dam downstream slope and toe area. Ponded water is in Sediment Pond 1 (LL-2020-08)

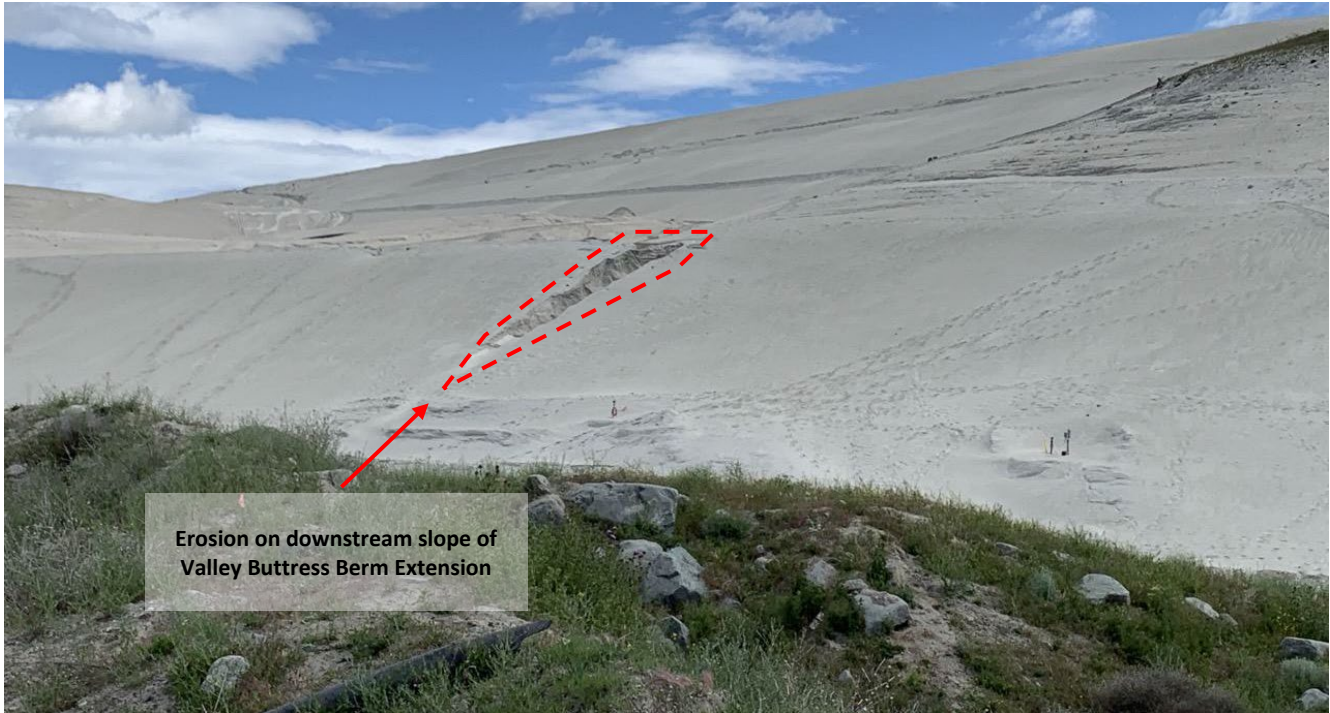
Photo I-A-12 View of Valley Buttress Berm Extension downstream slope. Erosion visible and marked in the photo. Repair was delayed due to habitat concerns from birds which have nested there. Following the site visit, repairs were completed after the birds' migration (LL-2020-08)

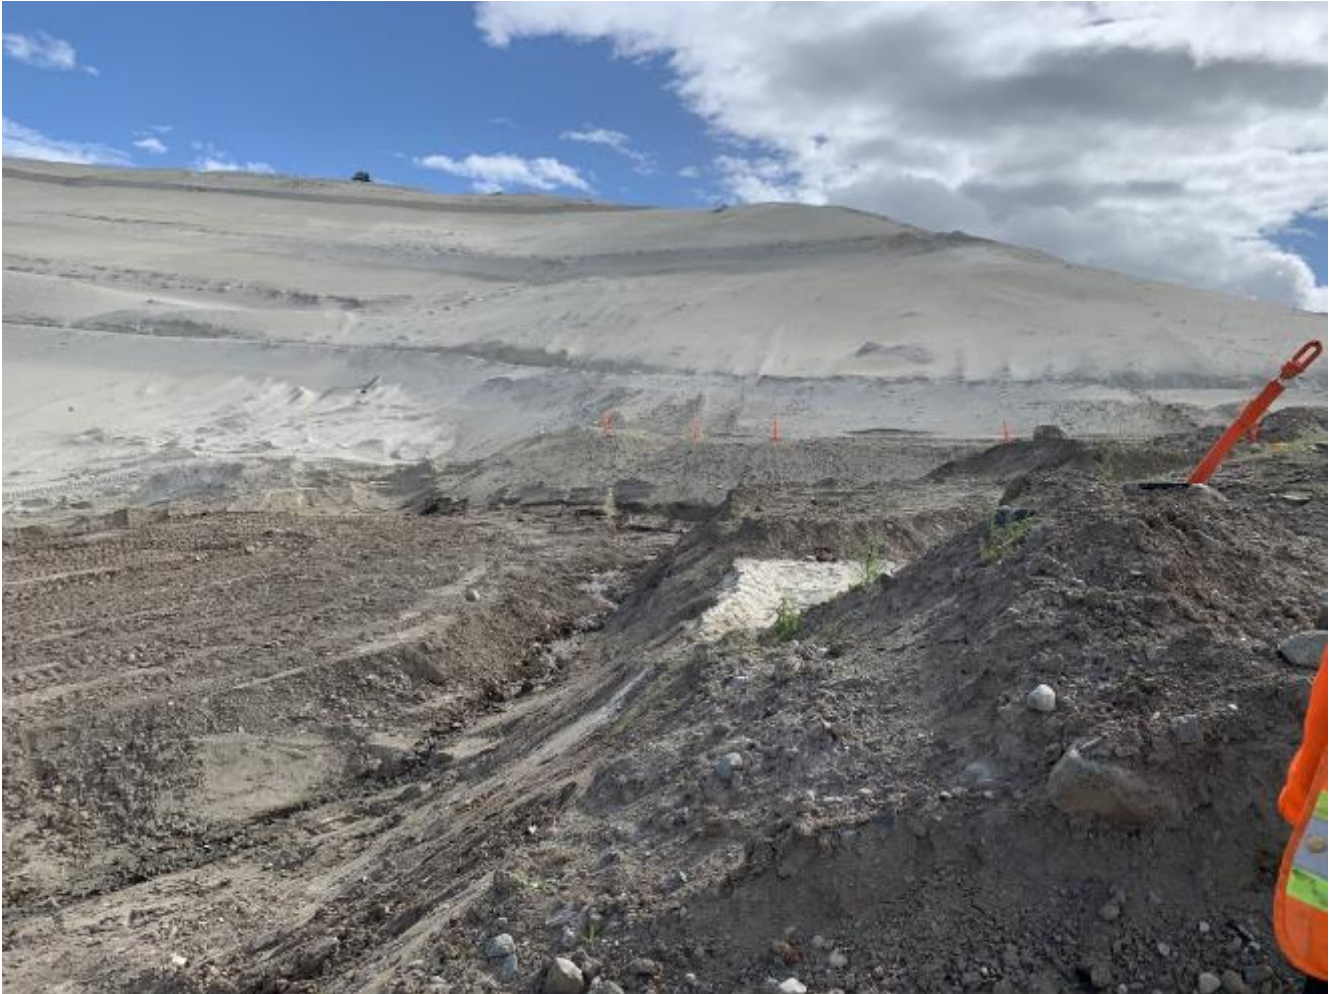
Photo I-A-14 View of South Buttress Berm downstream toe, slope, and foundation area. Seepage was observed at the toe, from area of underdrain, no seepage face observed within cycloned sand. All seepage flows are collected (LL-2020-09)

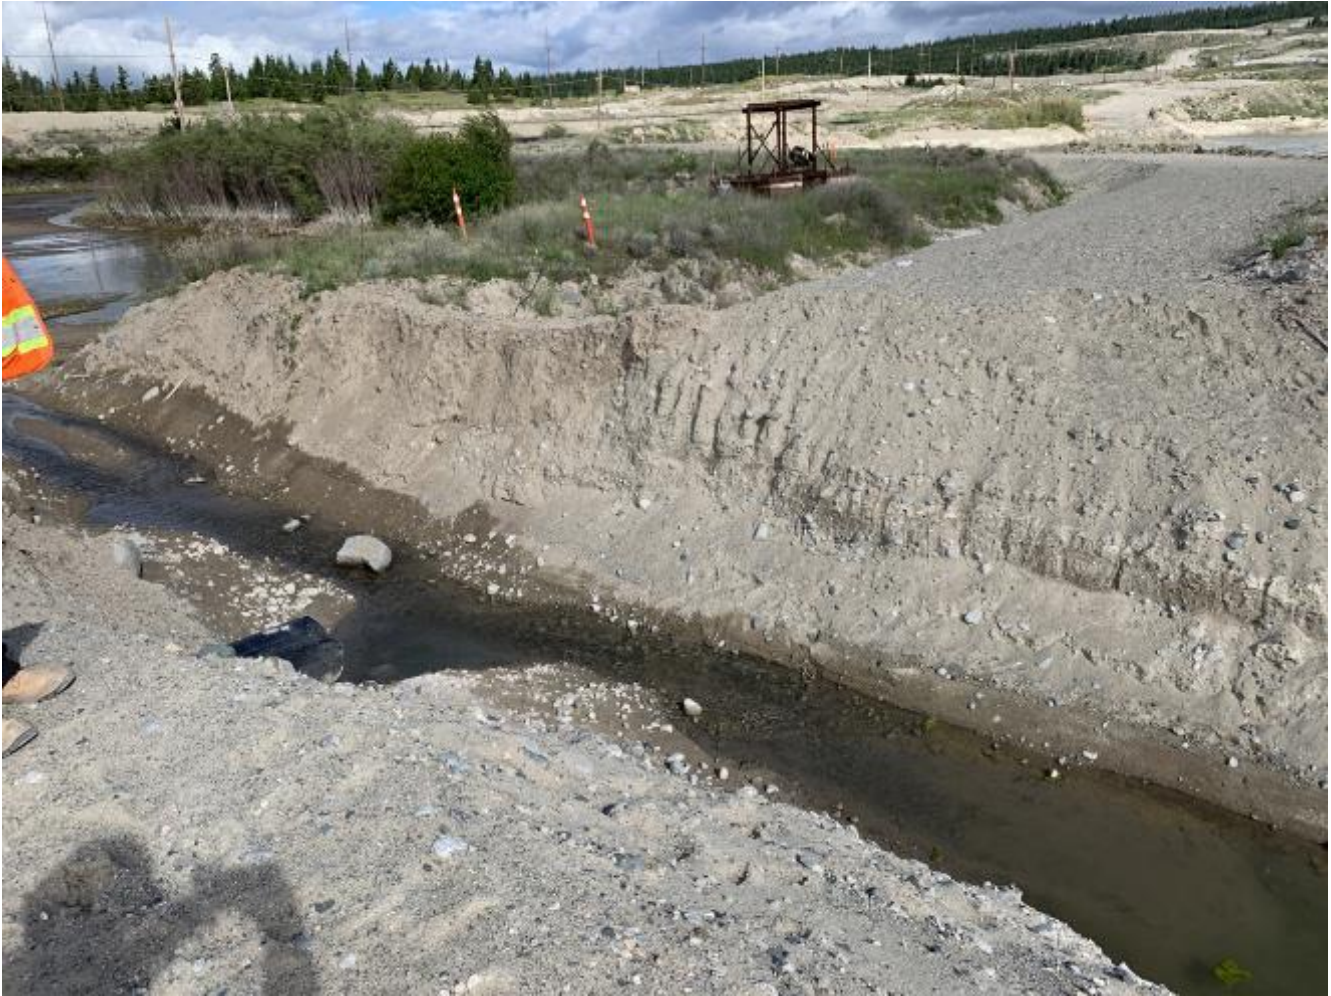
Photo I-A-21 View of Sediment Pond 1 draining to Seepage Water Reclaim Pond (SWRP) via a channel which will be backfilled and replaced with a pipe as part of prep activities to get Sediment Pond 1 to receive hydraulic placement overflow (LL-2020-12)

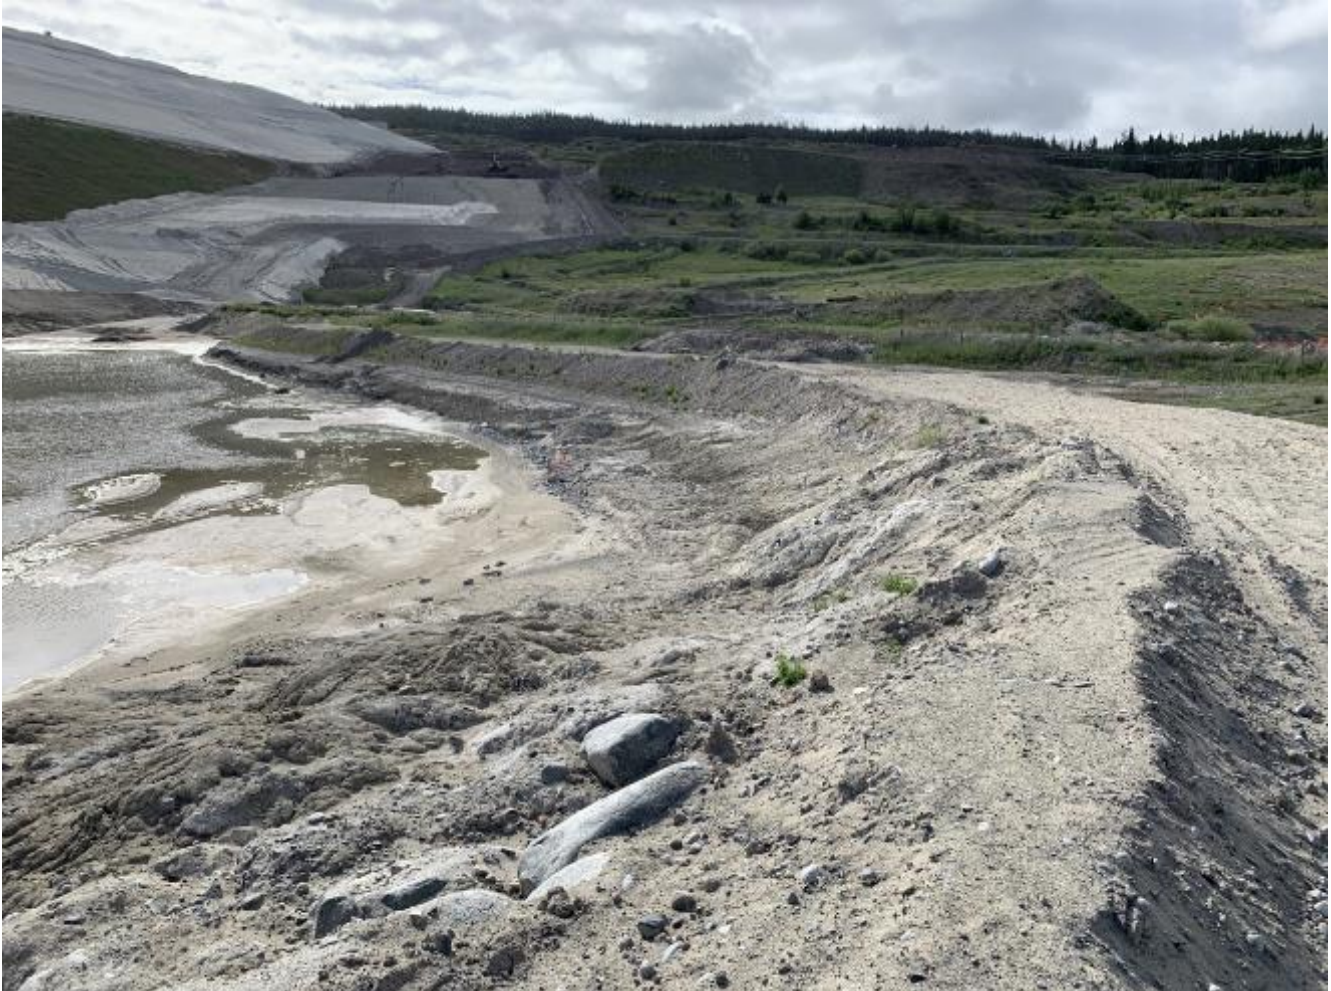
Photo I-A-22 Sediment Pond 1 downstream berm. No ponding water was observed downstream side of berm – looking toward South Abutment (LL-2020-12)

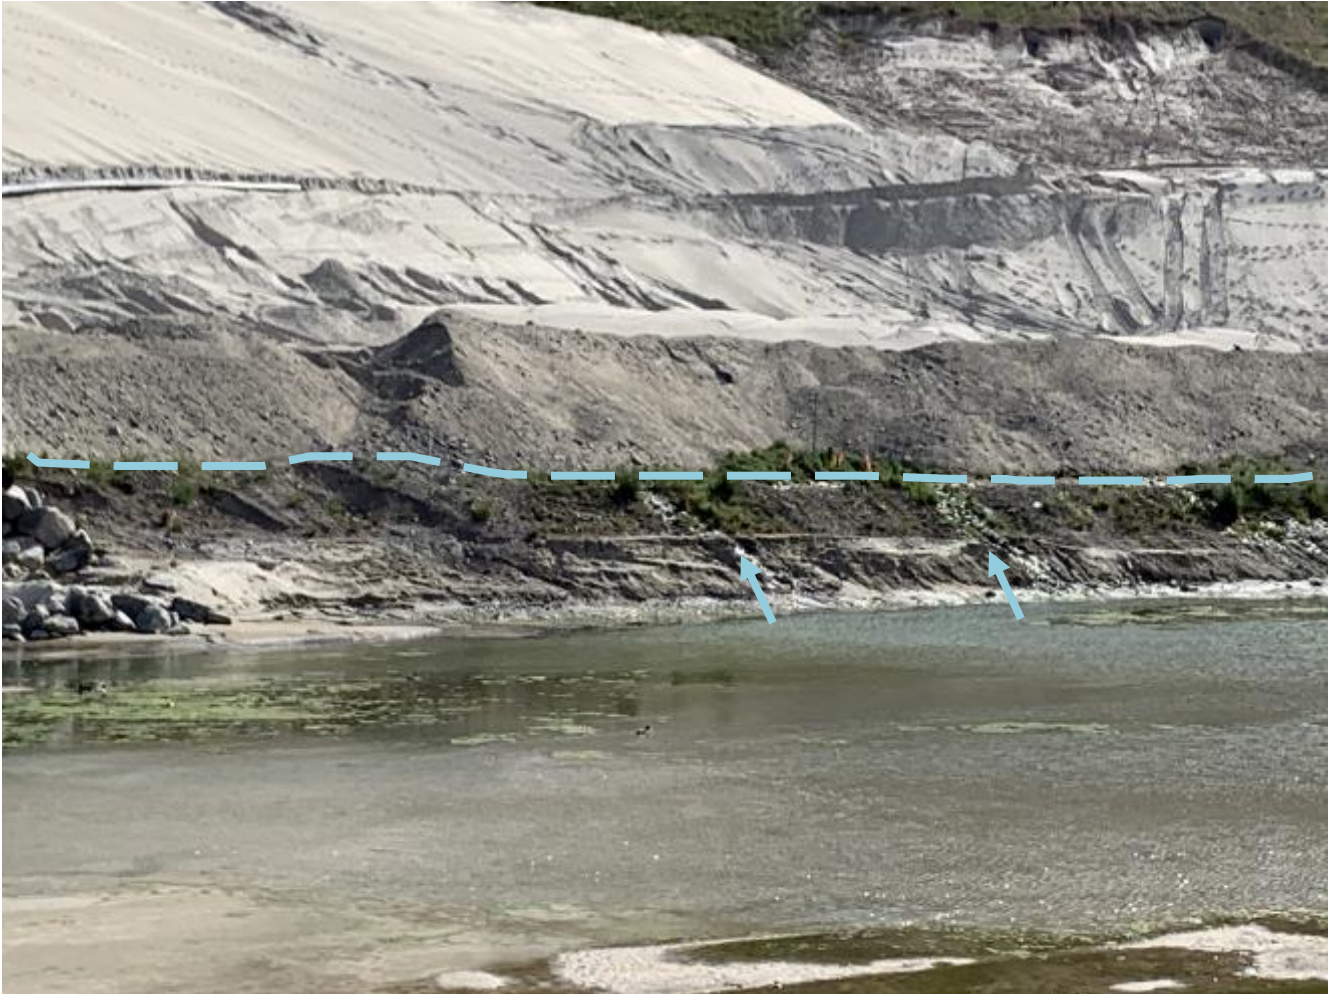
Photo I-A-23 Overview of Sediment Pond 1. Seepage visible on exposed divider dyke slope at the expected location. No seepage or wetted face was observed within the dam fill or drainage blanket (LL-2020-12)

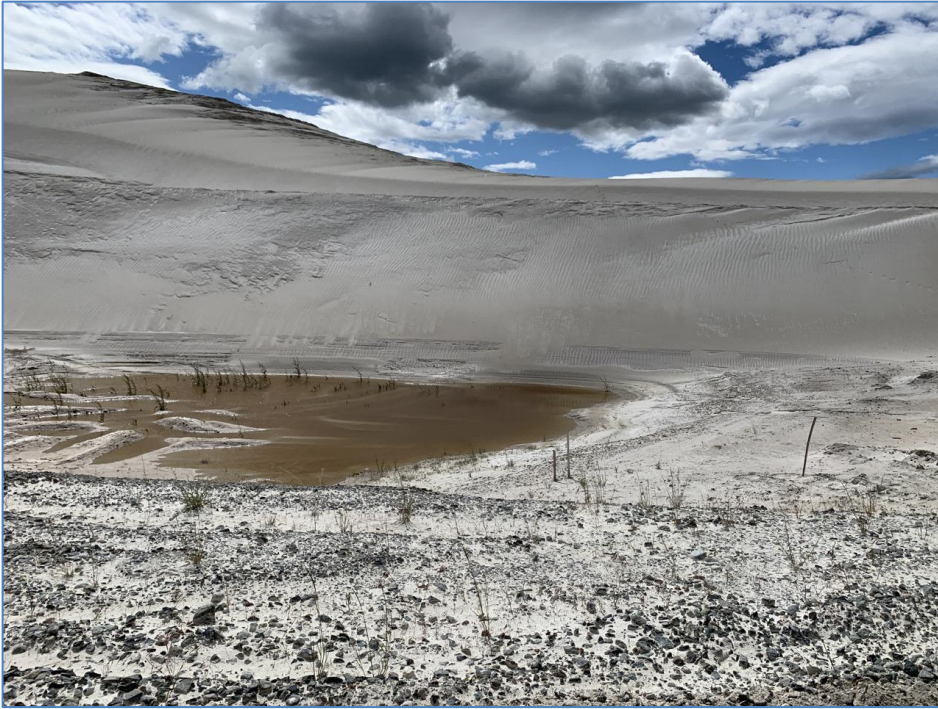
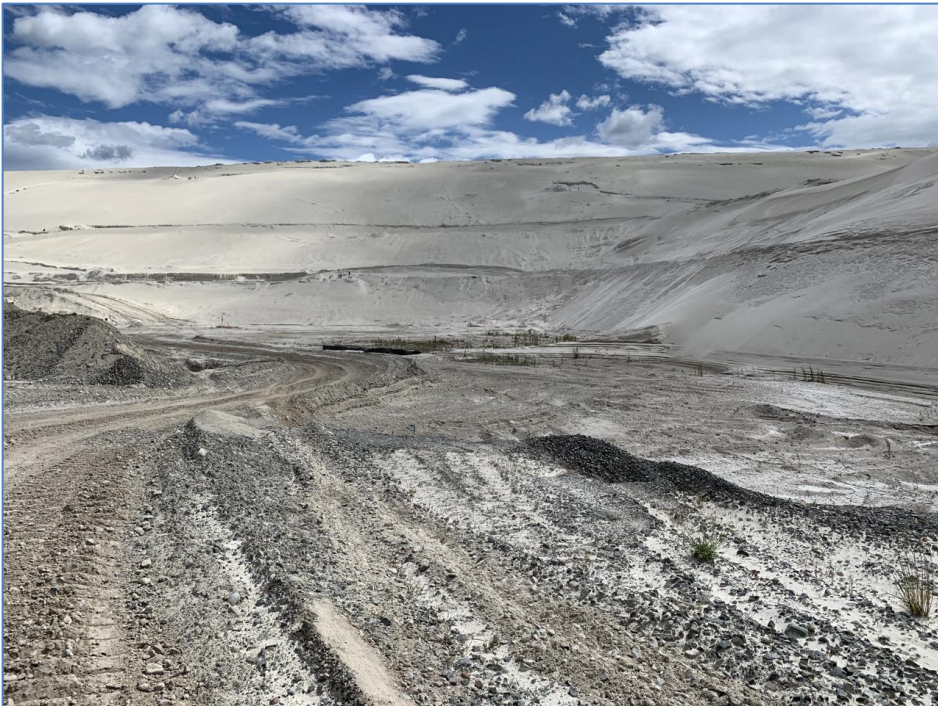
Photo I-A-29 North Buttress Berm low point on north side. Some ponded water was observed which is typical at this location and reoccurs after freshet due to runoff. The ponded water drains draining through the major drain which daylight on north side of NBB. Area is planned to be raised with mechanical placement in 2020 (LL-2020-17)
