Teck Highland Valley Copper Partnership

2020 Annual Facility Performance Report

Highmont Tailings Storage Facility

March 2021

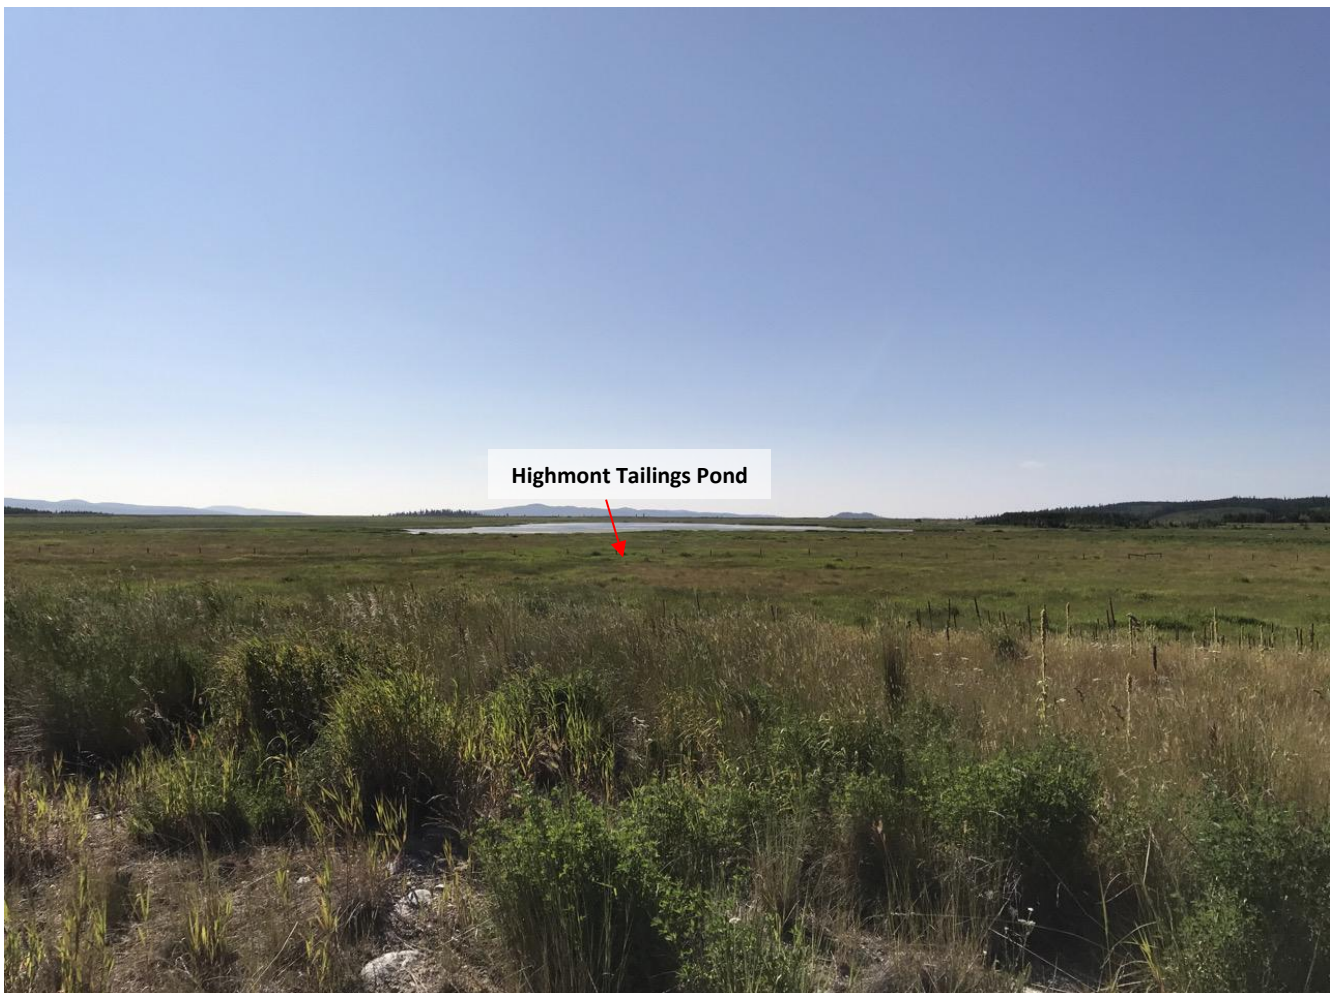
Photo I-A-2 View of tailings impoundment and beach from East Dam (HGH-2020-02)

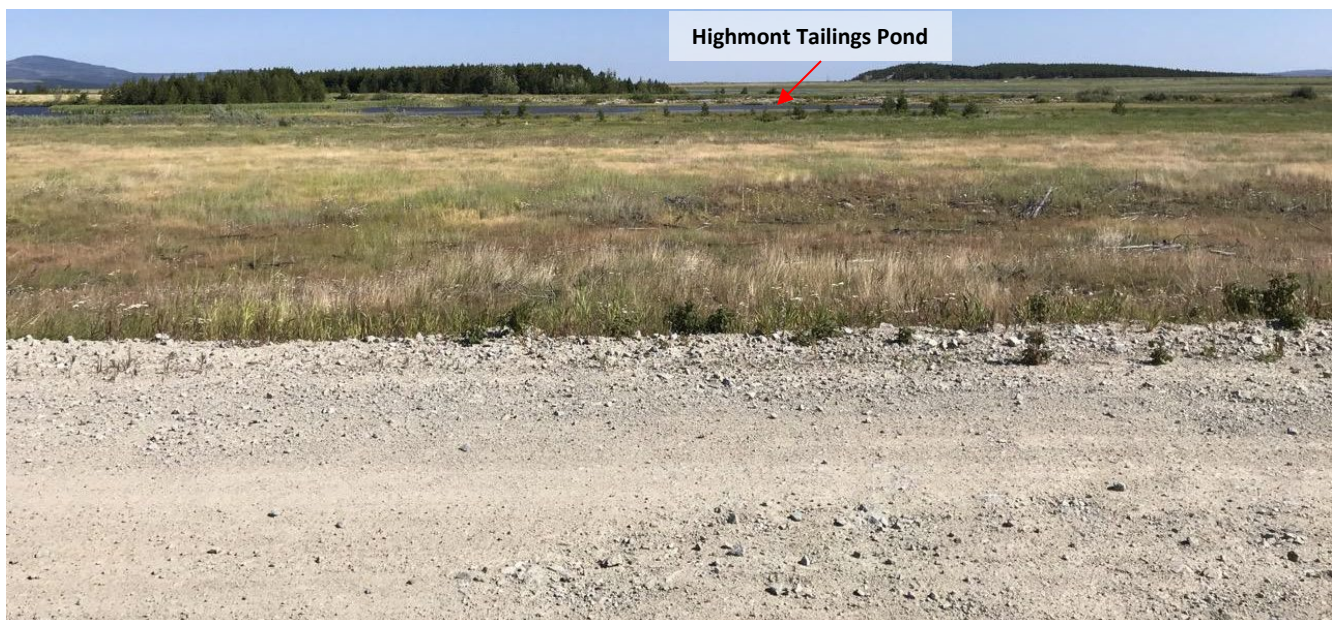
Photo I-A-4 North Dam crest is in good condition. No signs of distress, settlement or depression; minor rutting observed is managed under routine maintenance (HGH-2020-01)

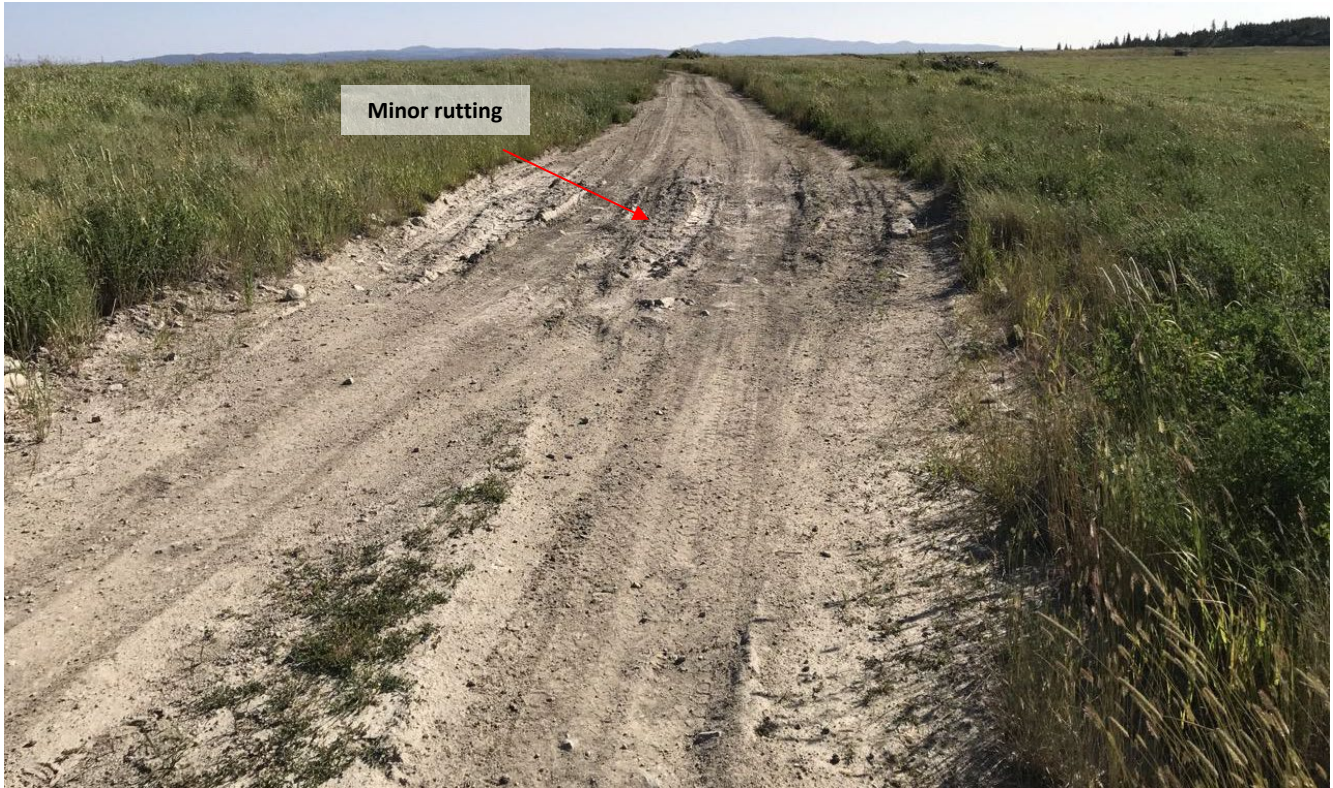
Photo I-A-5 North Dam crest access road to S1 Diversion. Minor rutting observed is managed under routine maintenance (HGH-2020-04)

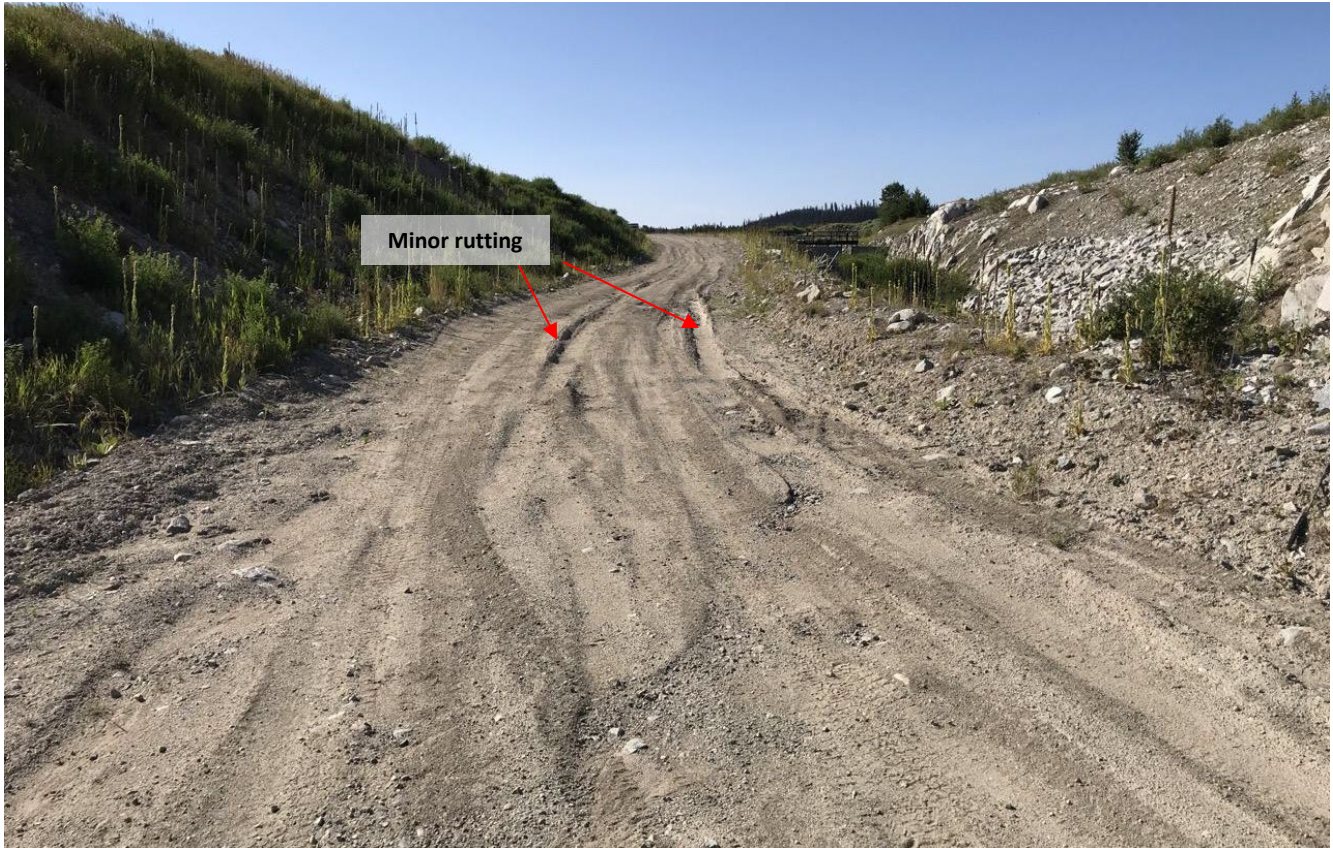
Photo I-A-6 North Dam crest near right abutment. Crest is in good condition. Minor rutting observed in access road is managed under routine maintenance (HGH-2020-05)

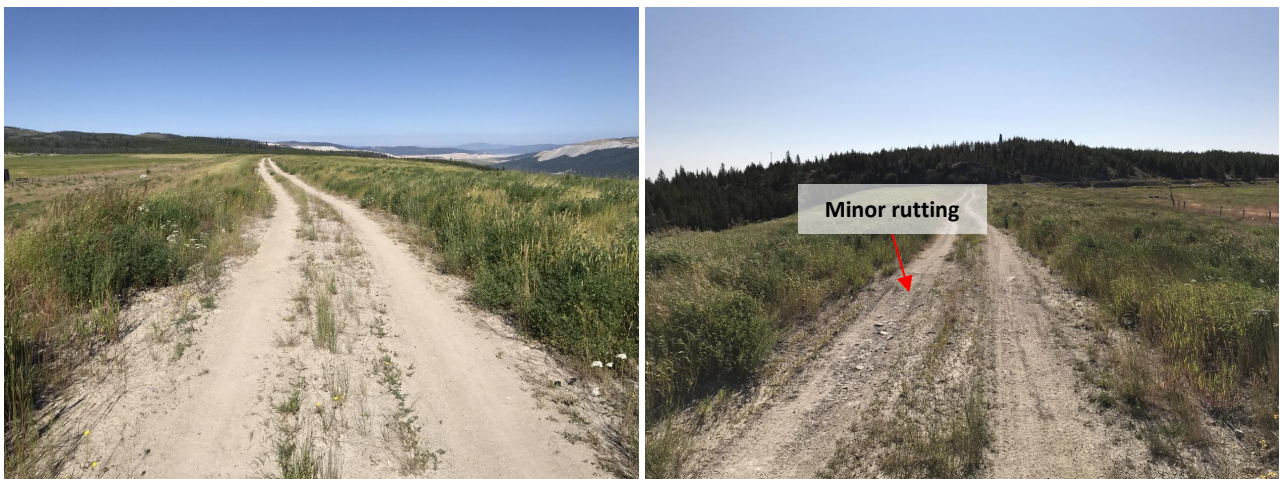
Photo I-A-7 East Dam crest. Crest is in good condition. No signs of deformation or distress were observed (HGH-2020-02)

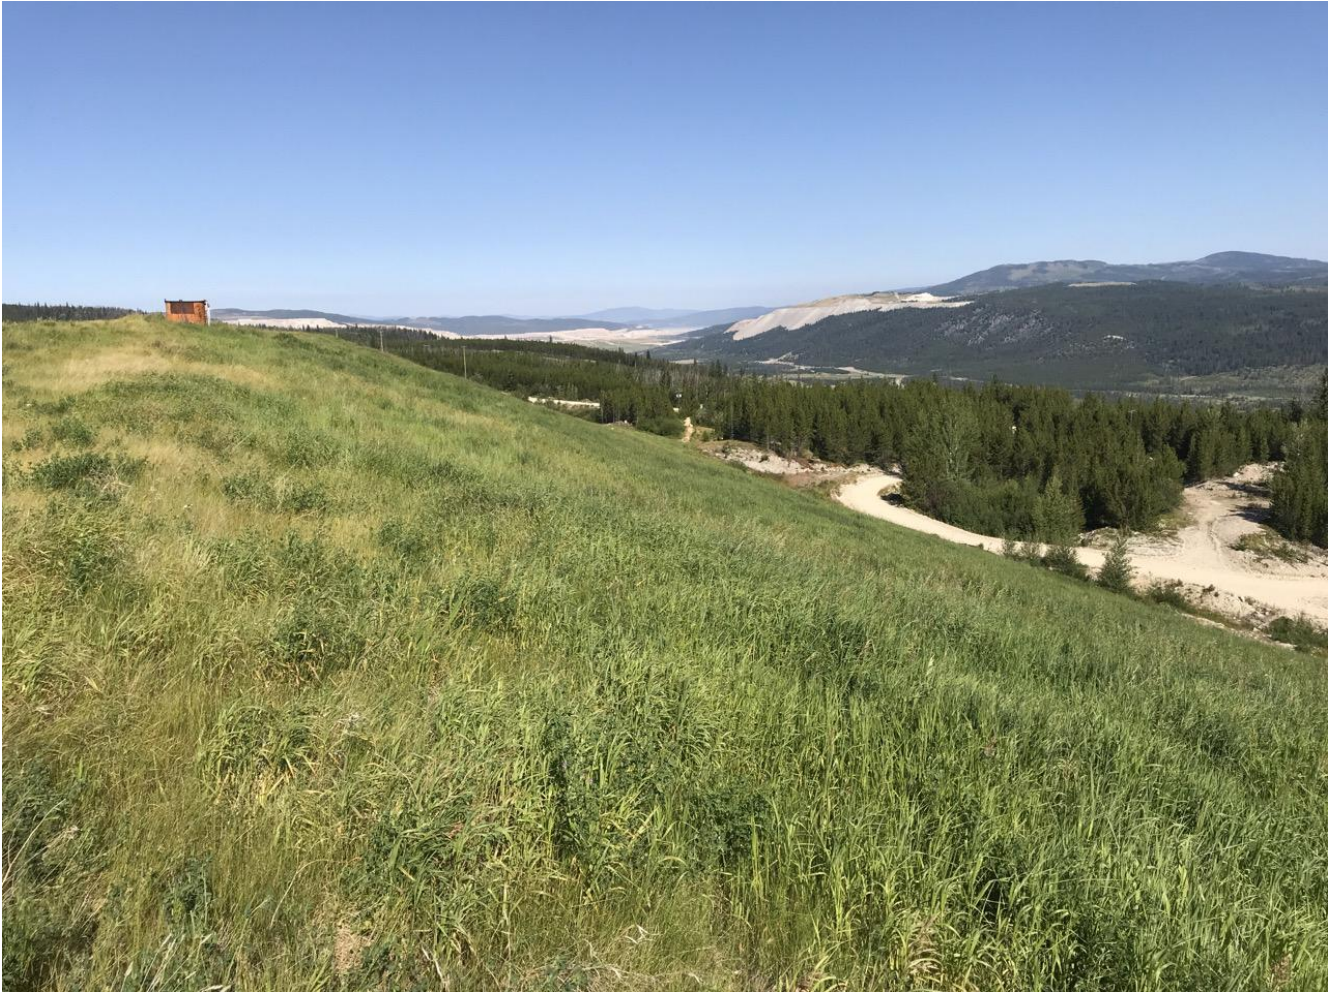
Photo I-A-9 View of North Dam downstream toe and S1 Pond. No signs of distress or deformation were observed (HGH-2020-06)

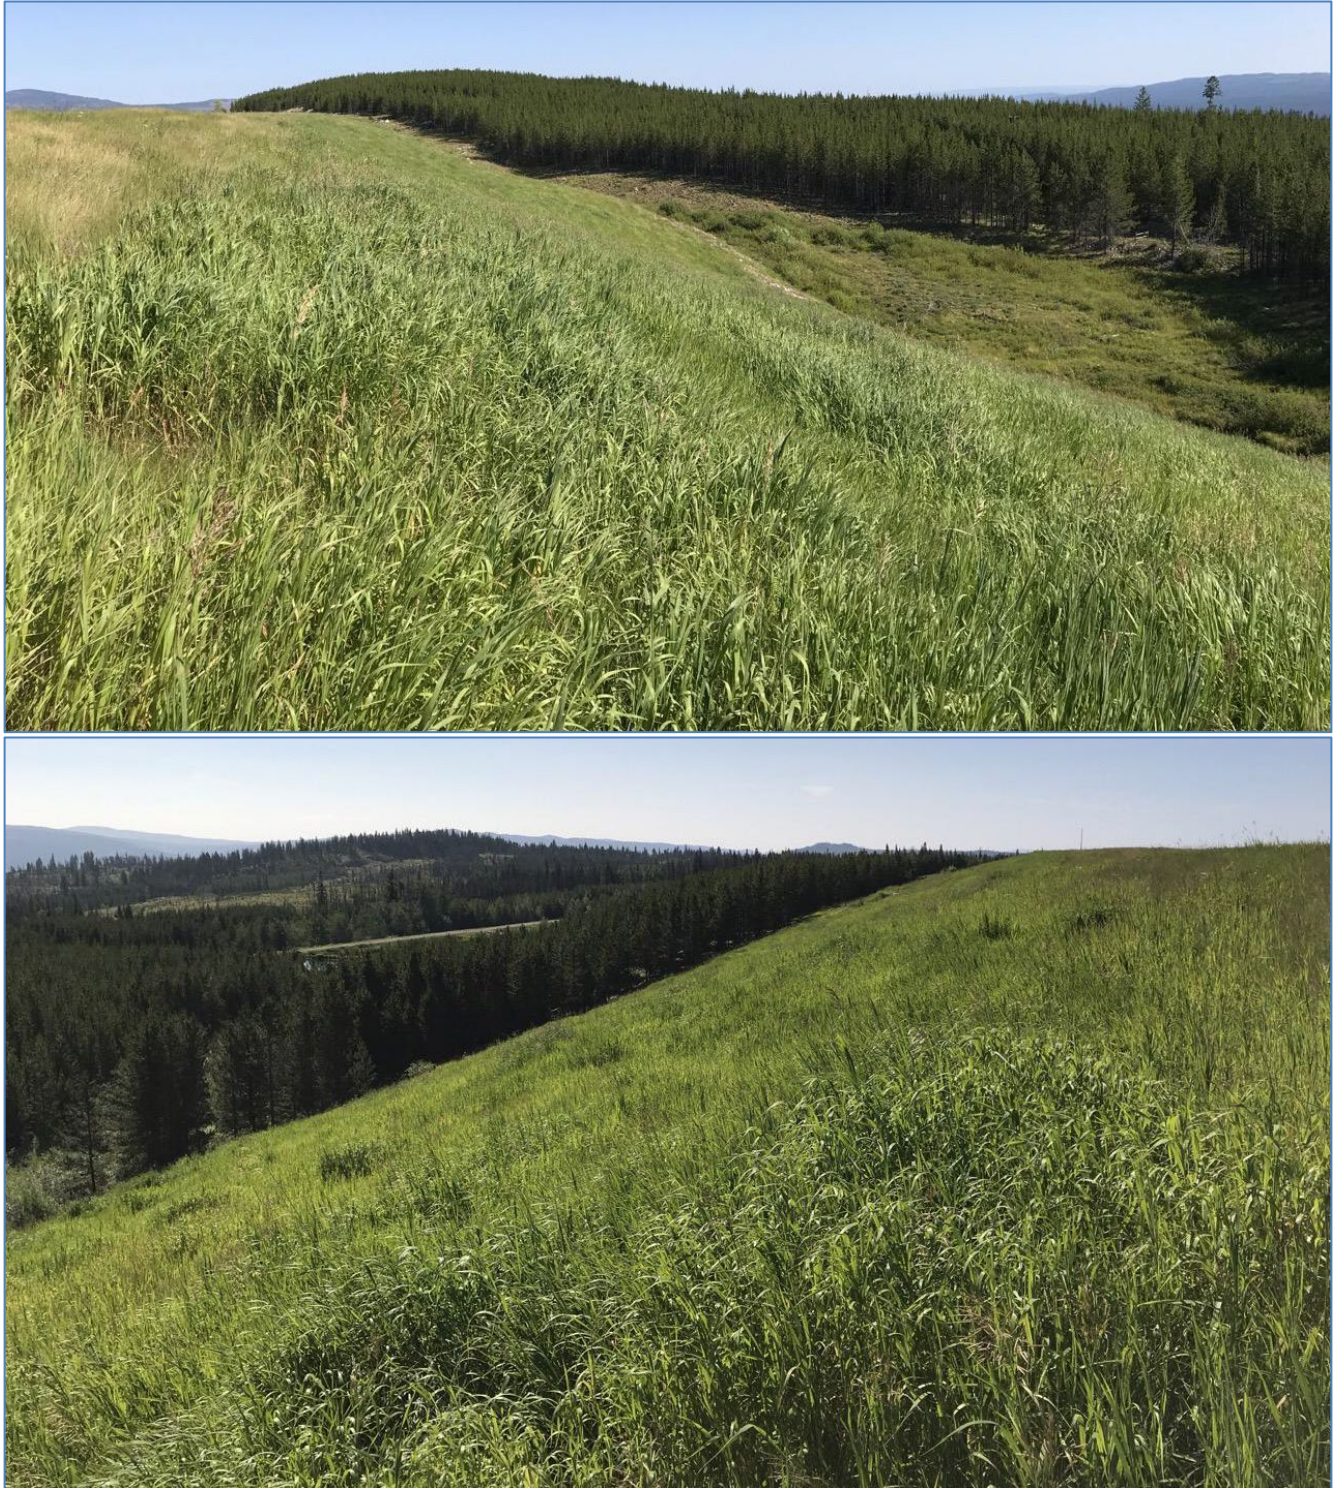
Photo I-A-13 View of South Dam downstream slope looking northeast. Slope is vegetated and in good condition (HGH-2020-09)

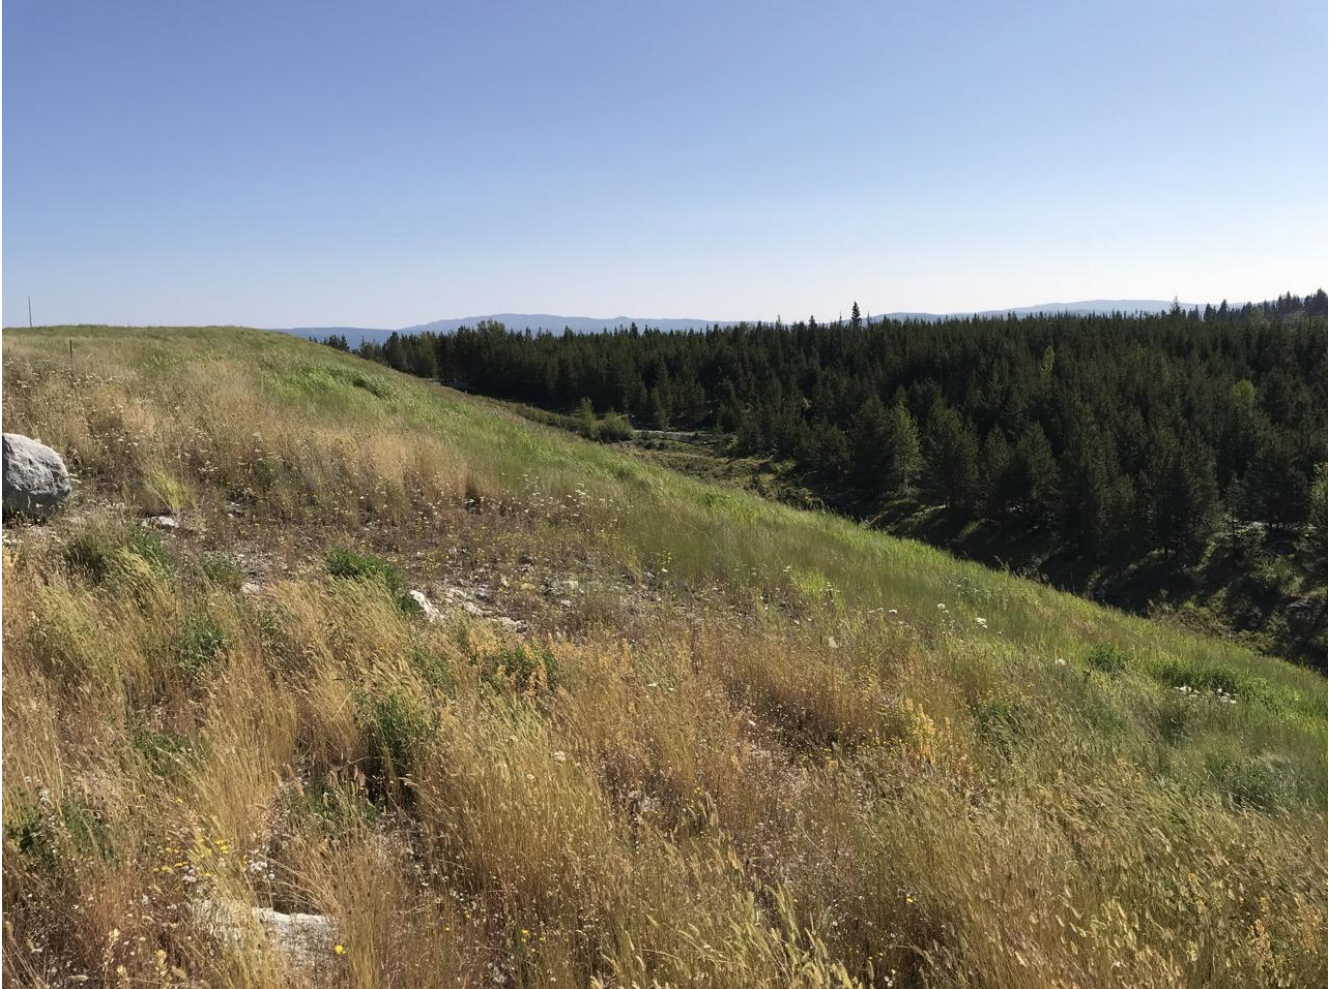
Photo I-A-14 South Dam downstream slope and view of S3 Pond downstream of the dam with two pools of water. South Dam slope is vegetated and in good condition (HGH-2020-09)

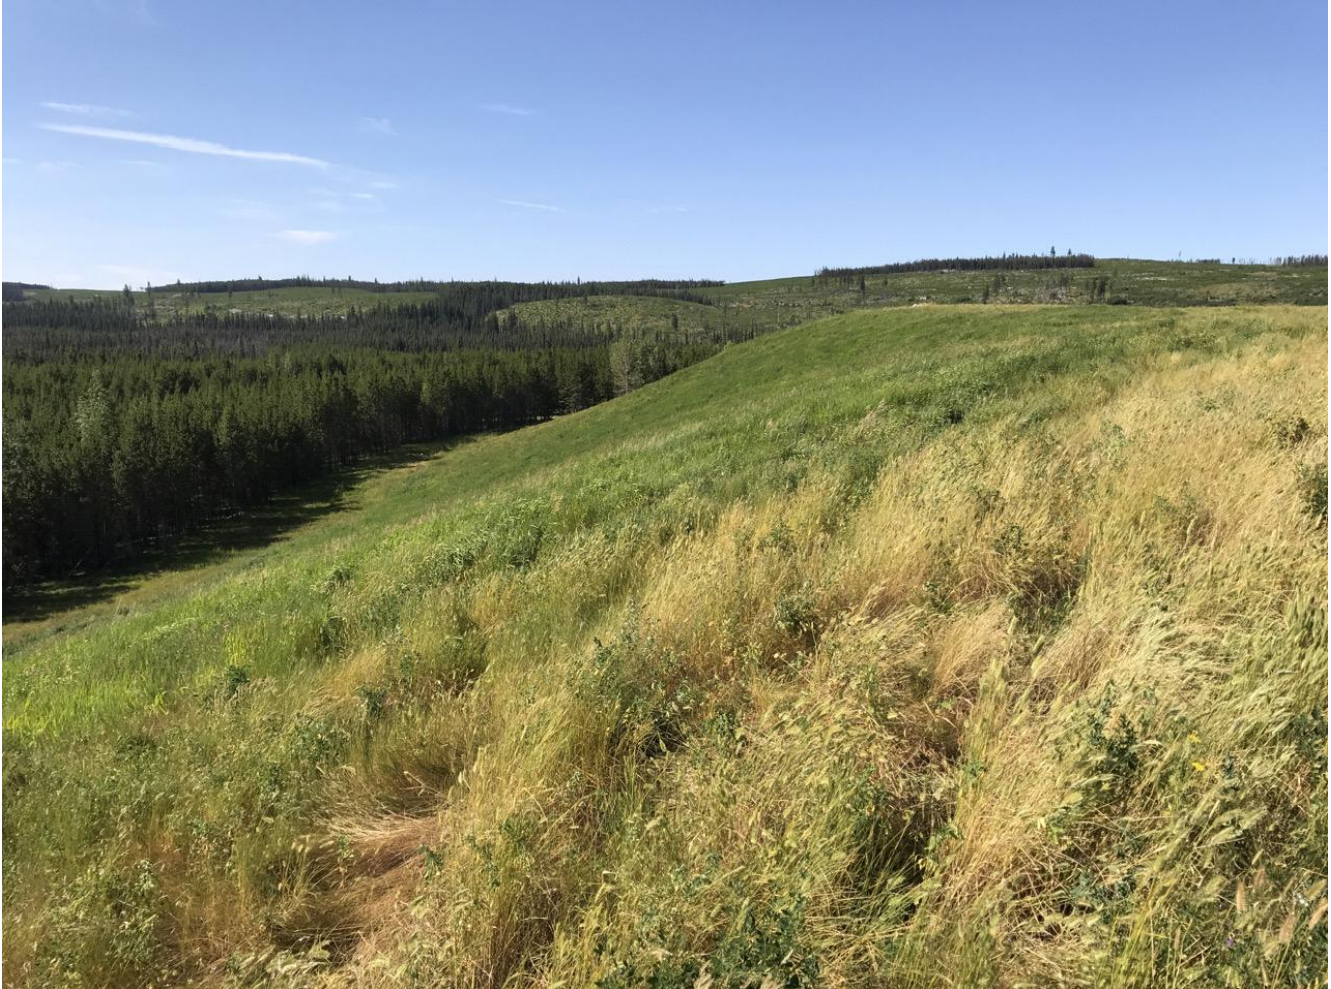
Photo I-A-16 View of South Dam downstream slope at right abutment looking east. Slope is vegetated and in good condition (HGH-2020-03)

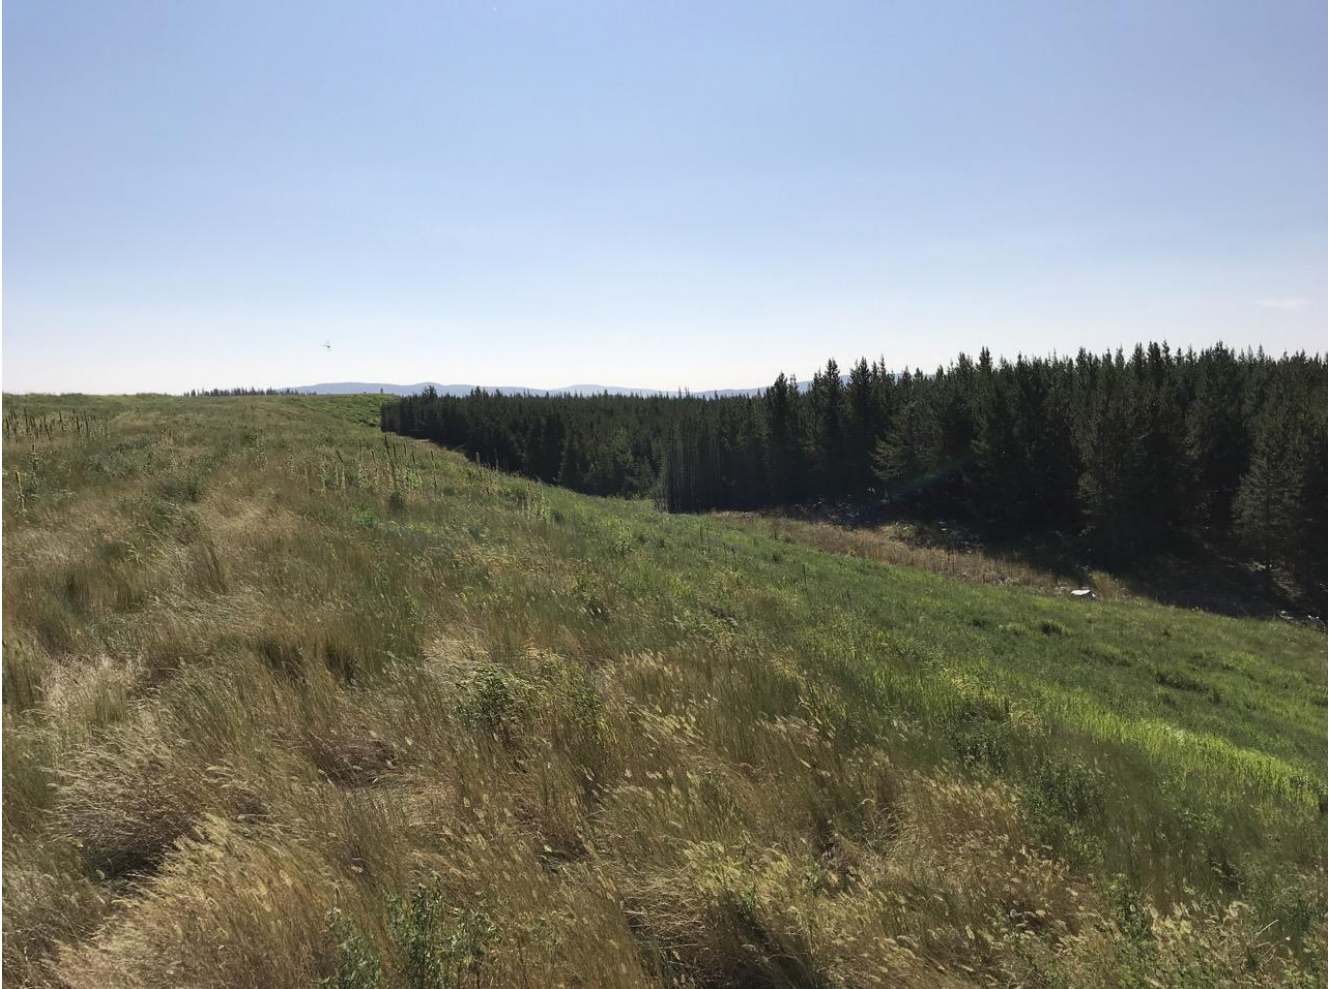
Photo I-A-17 South Dam downstream slope and view of S4 Pond from South Dam. S4 embankment is breached (HGH-2020-03)

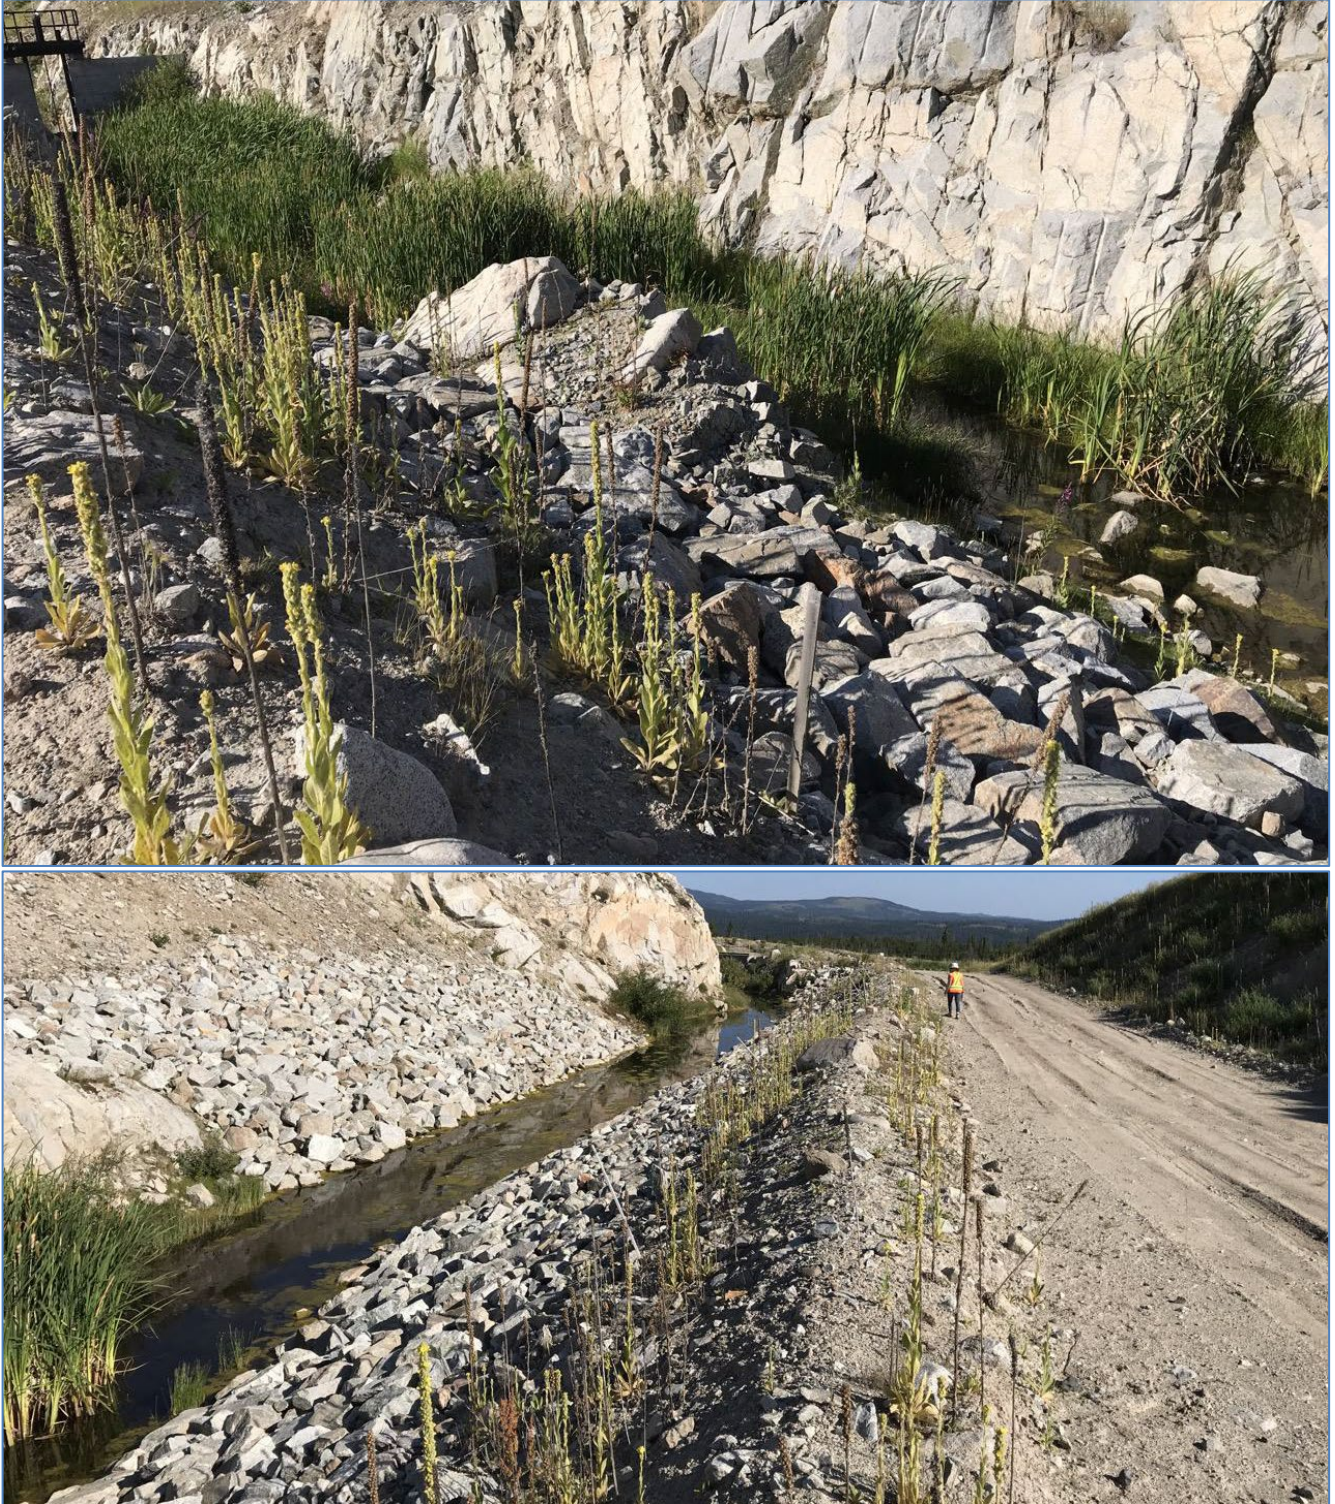
Photo I-A-24 Highmont Spillway channel, S1 Pond diversion trash rack. Minor flow into the diversion. Trash rack is clear of debris. No flow downstream of diversion (HGH-2020-15)

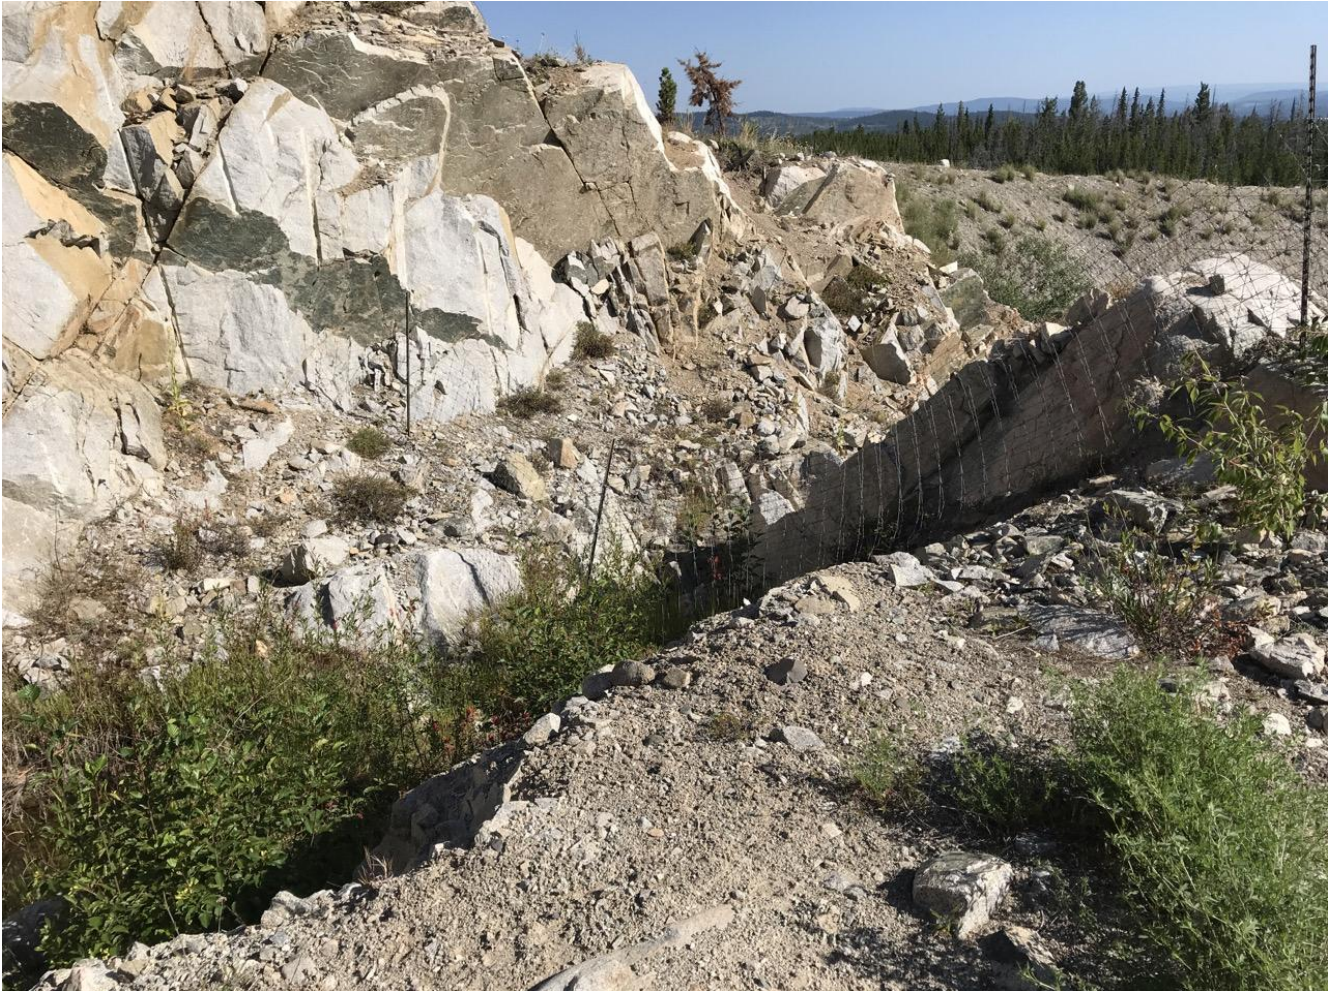
Photo I-A-28 Highmont Spillway channel downstream of spillway drop. Channel is in good condition. North Dam downstream toe is visible. No signs of distress or deformations (HGH-2020-16)

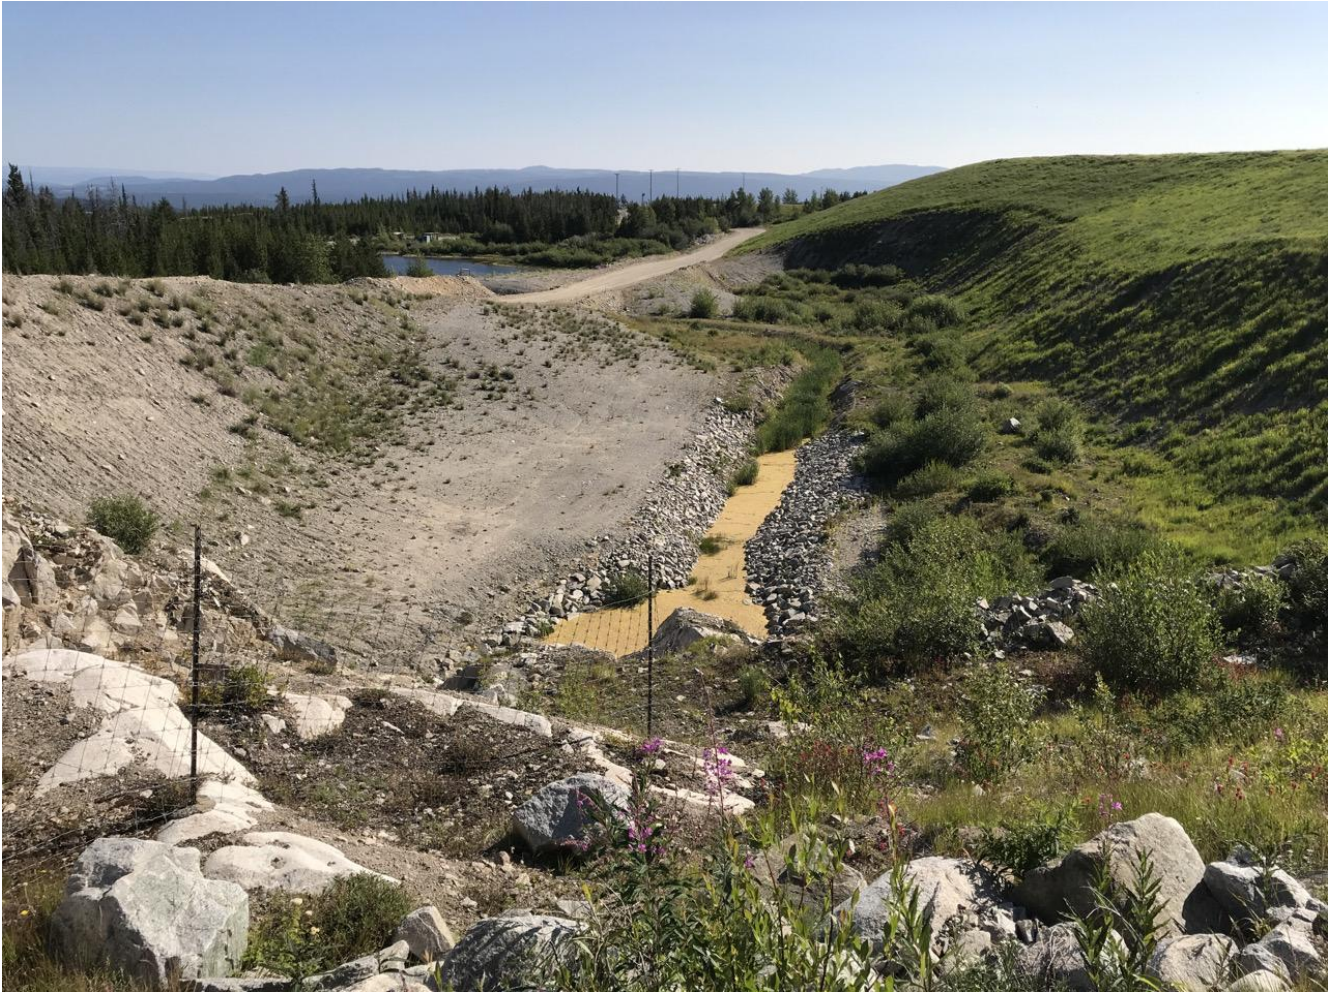
Photo I-A-29 North Dam downstream slope and toe, downstream of Highmont Spillway. North dam toe is in good condition. Spillway stilling basin is heavily vegetated (HGH-2020-17)

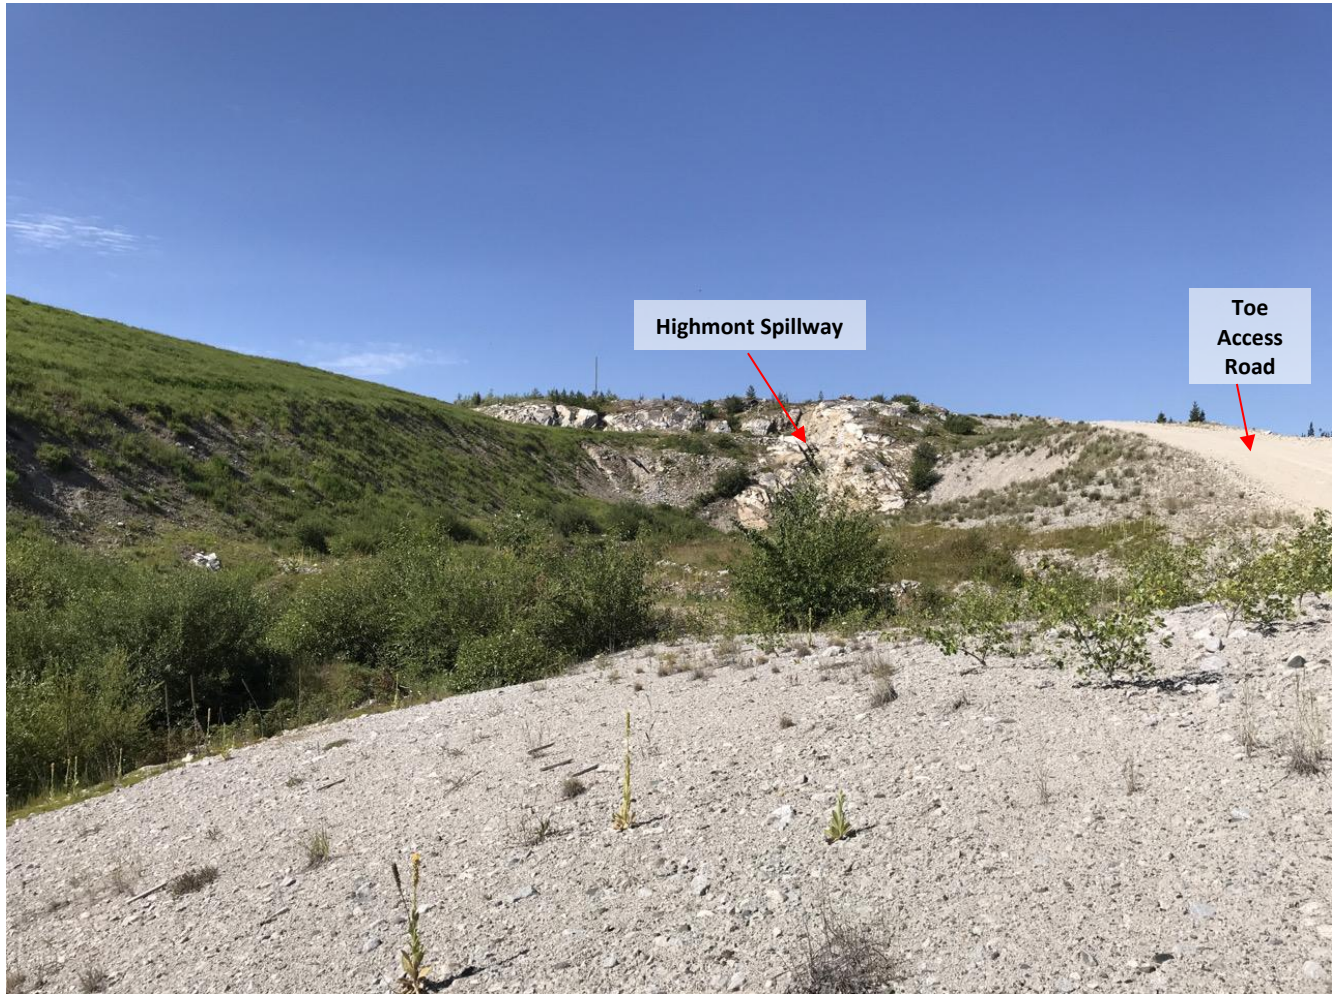
Photo I-A-30 North Dam downstream slope and toe, downstream of Highmont Spillway. Water is ponded upstream of toe access road. Spillway stilling basin is heavily vegetated (HGH-2020-17)

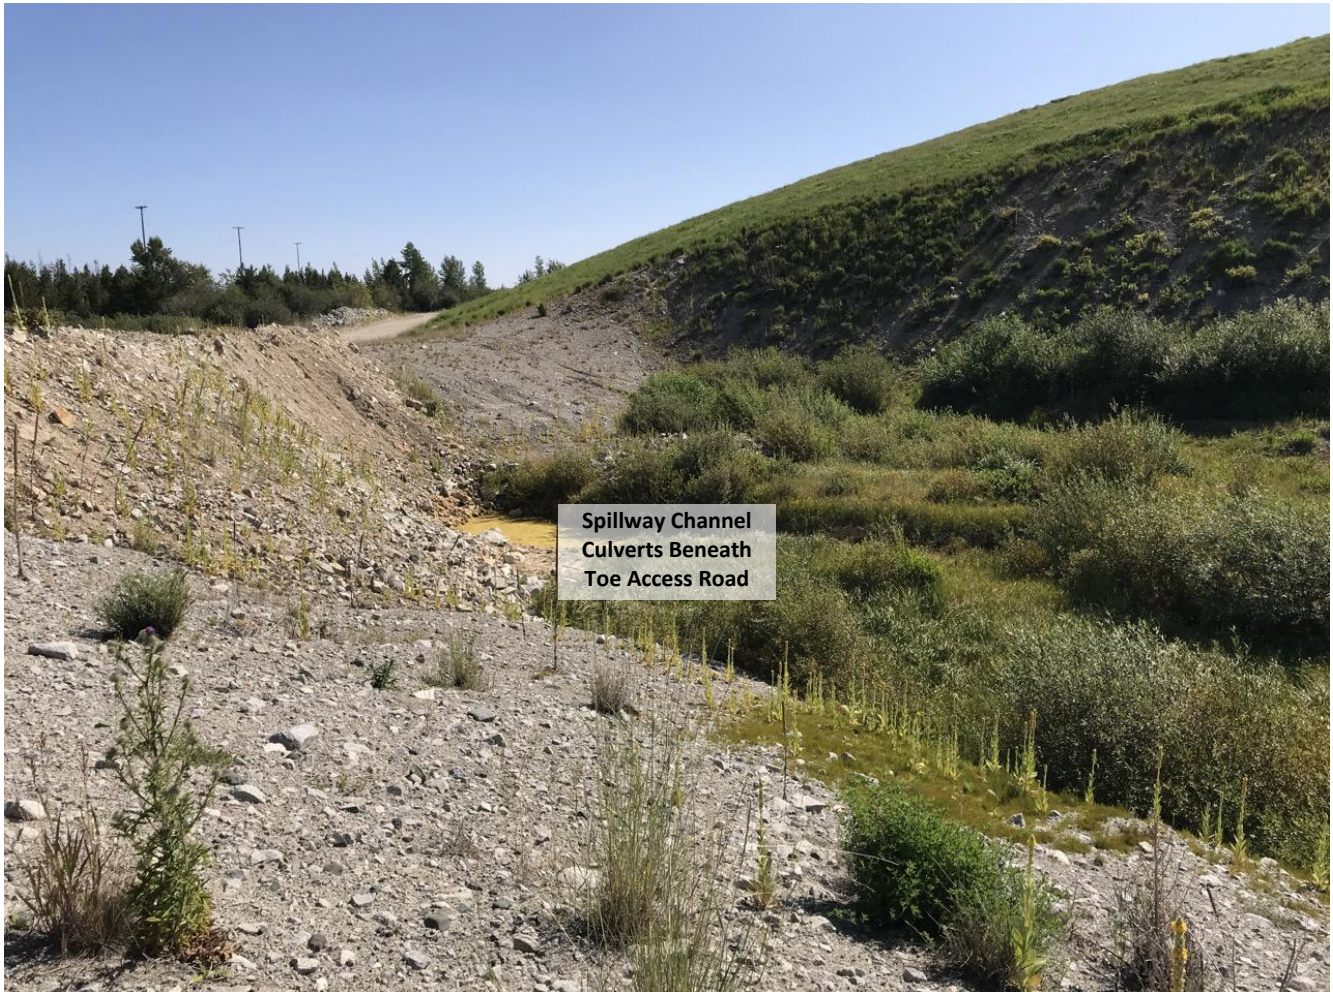
Photo I-A-31 Water is ponded downstream of spillway drop. Vegetation obstructing spillway channel (HGH-2020-18 and HGH-2020-19)

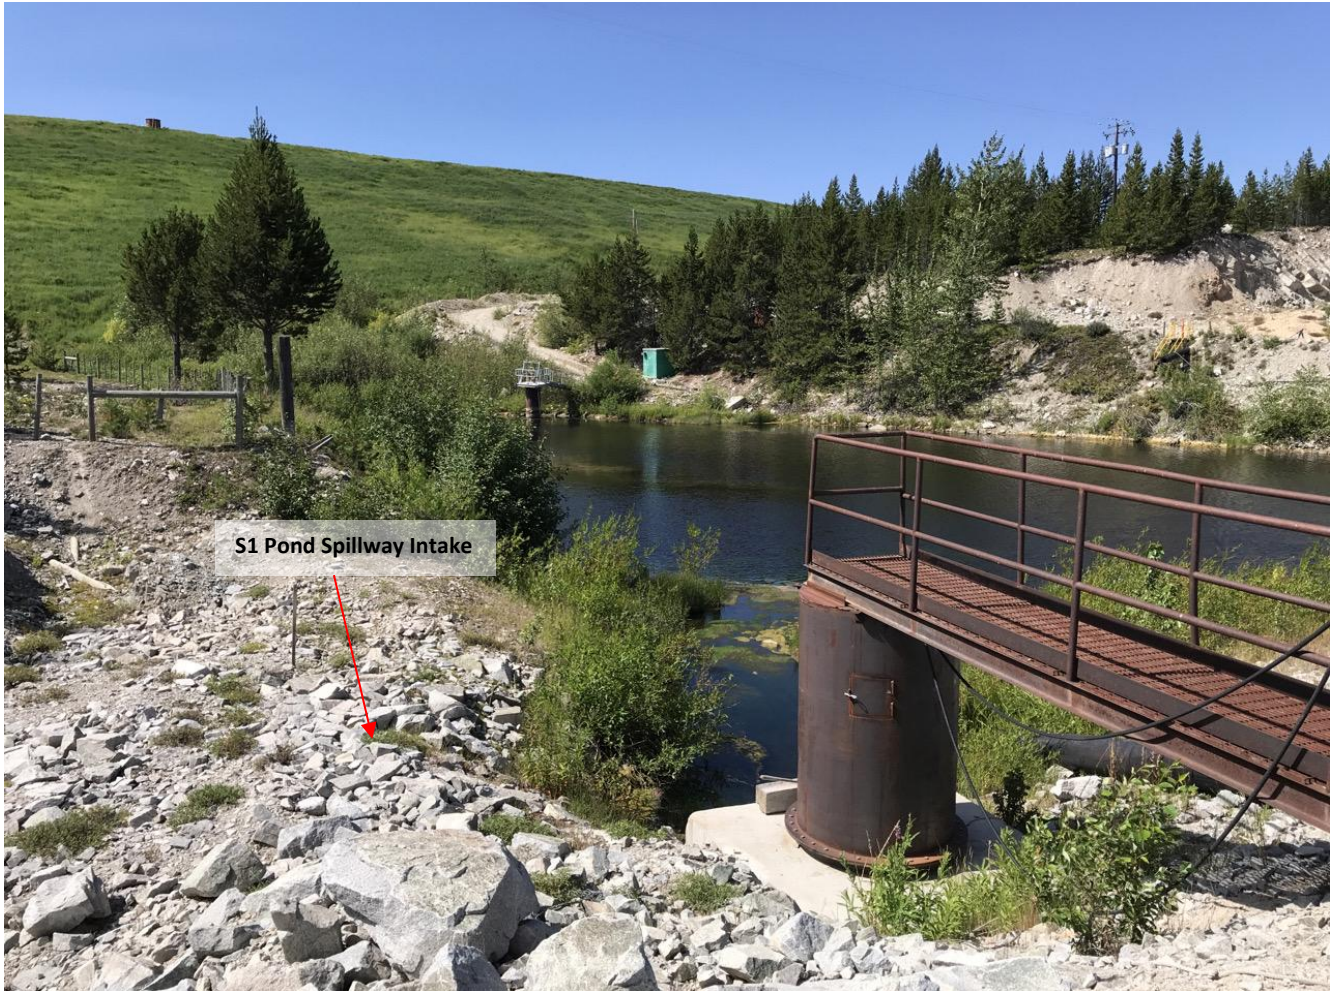
Photo I-B-4 S1 Pond: Low-Level Outlet (LLO) to the left of spillway intake. Pond level was about 1 m below inlet. Vegetation partially obstructing intake; will be cleared during routine maintenance (HGH-2020-20)

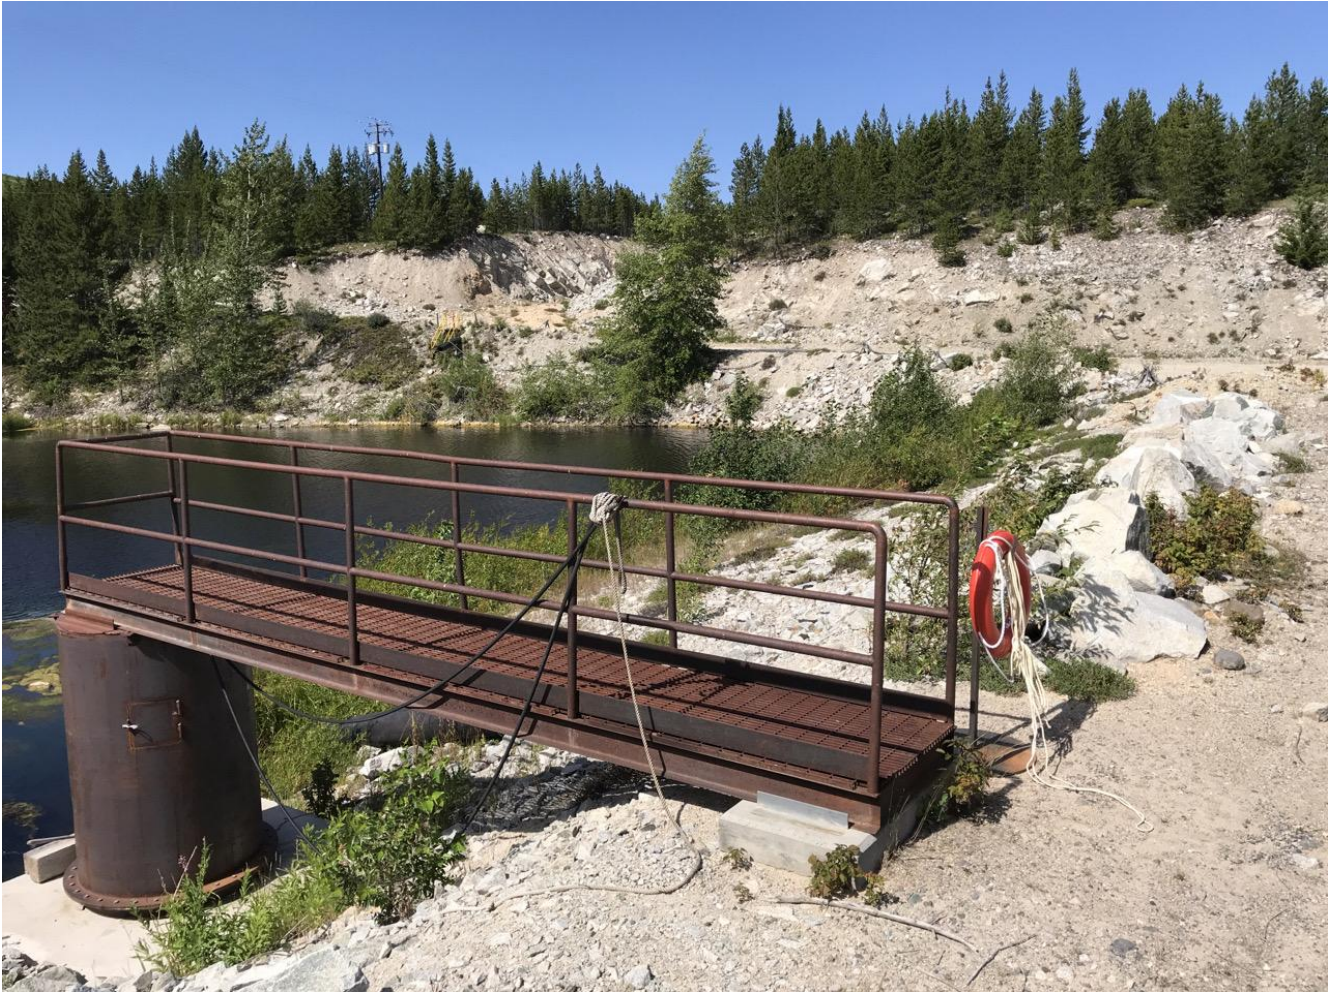
Photo I-B-5 S1 Pond: Spillway channel and pipe intake looking downstream. Channel is clear of vegetation and no sign of obstruction was observed at the pipe intake (HGH-2020-20)
