Teck Highland Valley Copper Partnership

2020 Annual Facility Performance Report

Highmont Tailings Storage Facility

March 2021

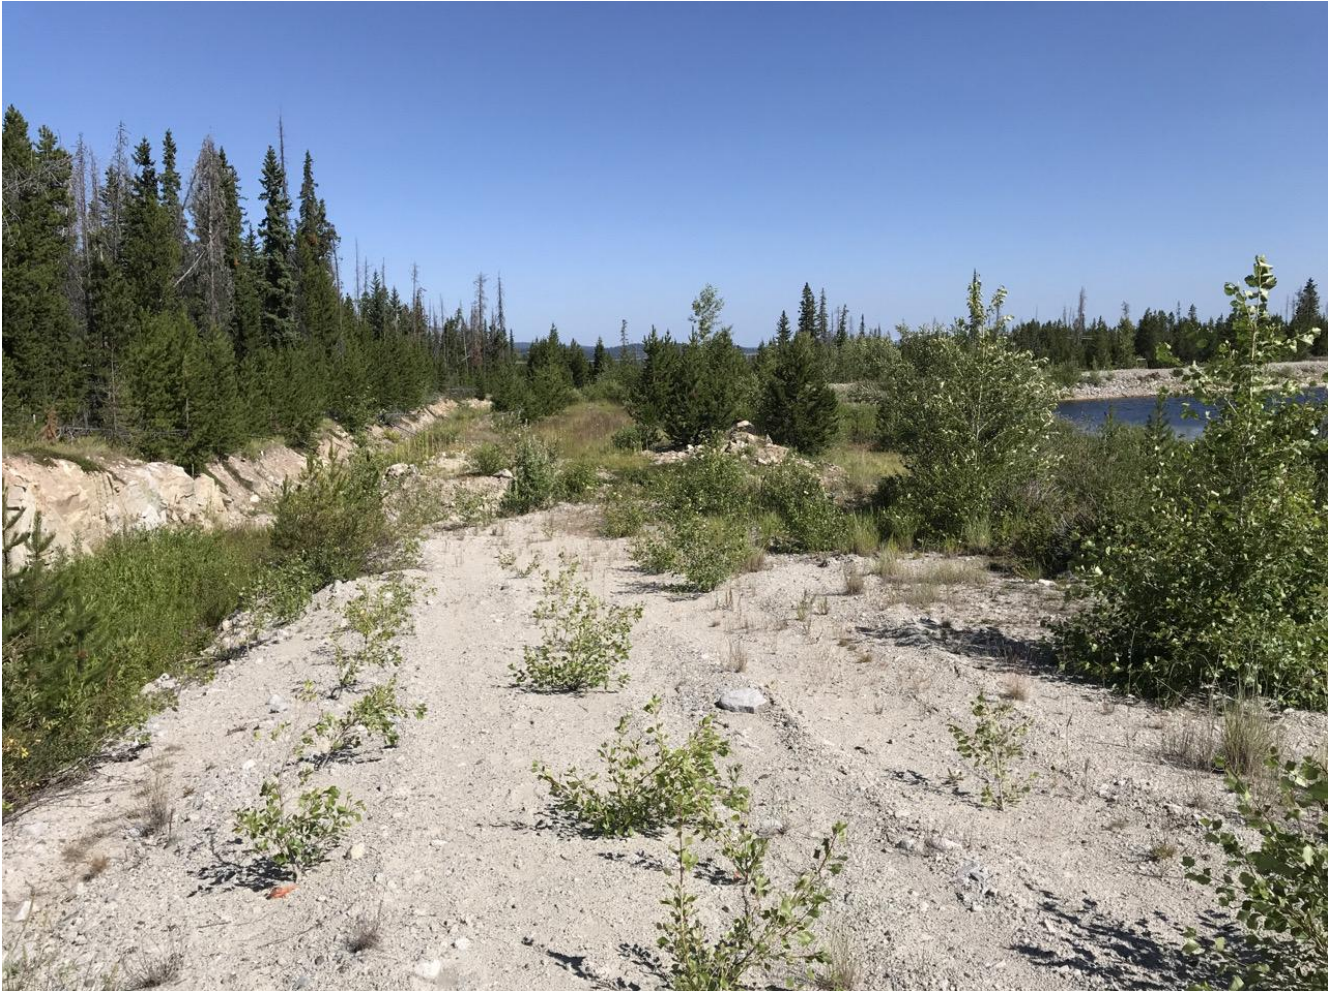
Photo I-B-10 S2 Pond: View of downstream slope. Slope is in good condition (HGH-2020-23)

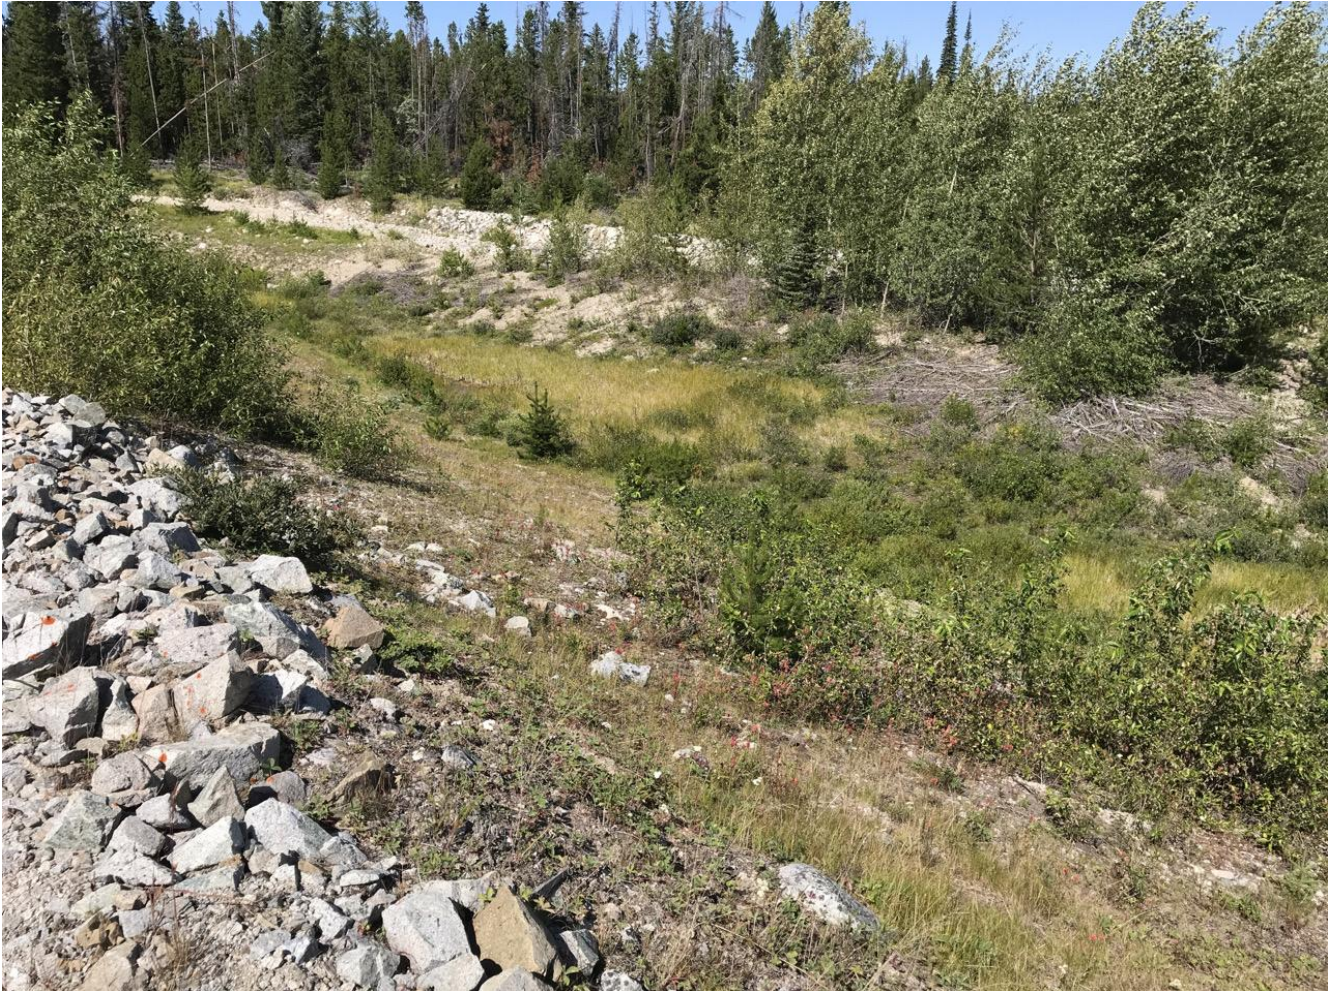
Photo I-B-11 S2 Pond: Overview of upstream slope riprap. Slope is in good condition (HGH-2020-26)

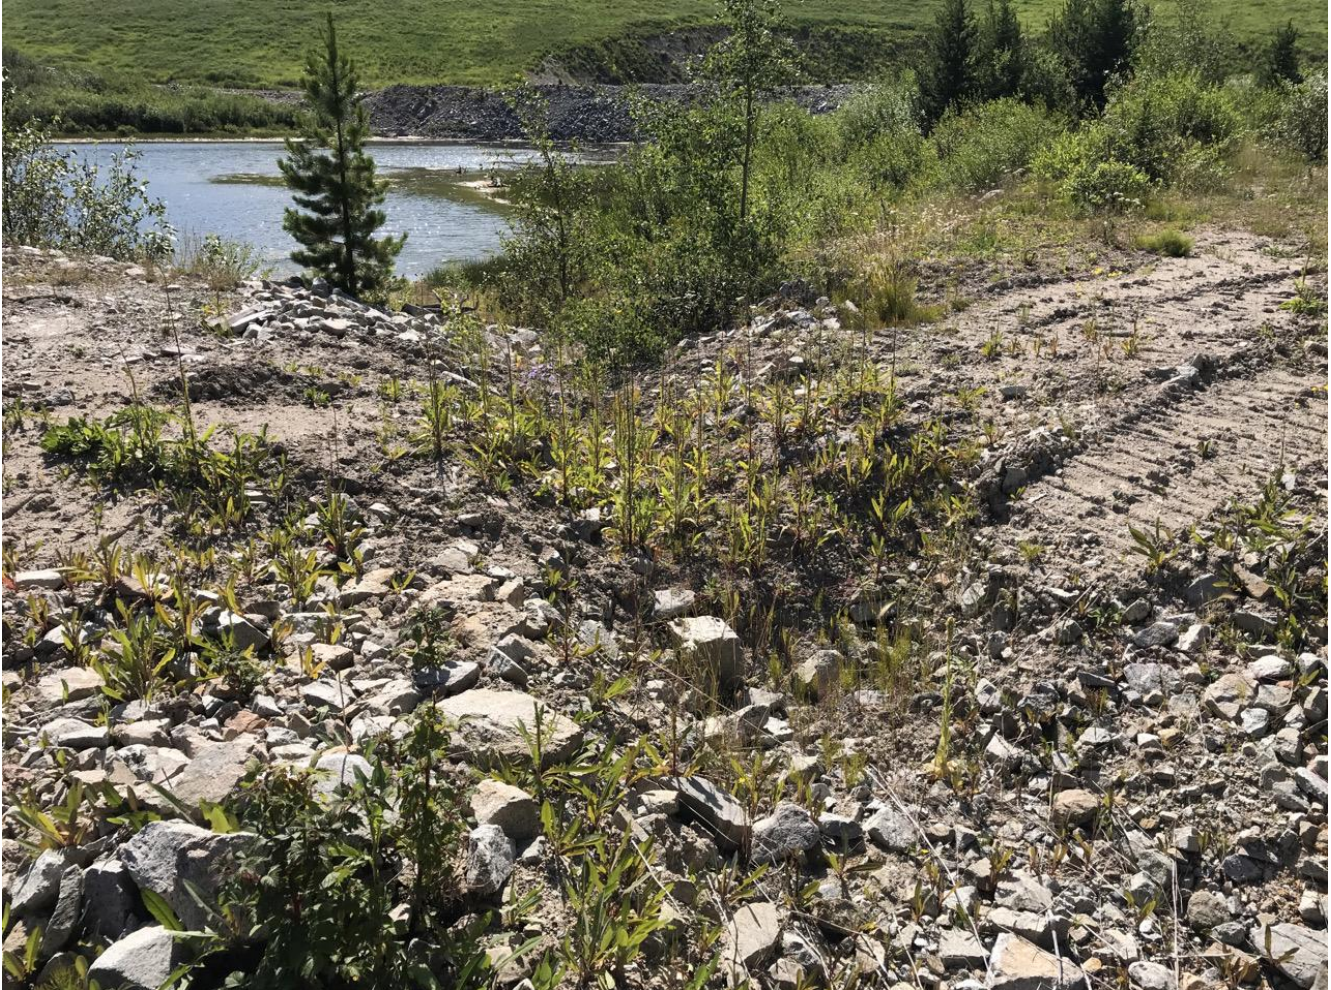
Photo I-B-17 S2 Pond: View of Highmont spillway channel. Channel is in good condition. Excess vegetation was removed after site visit as part of routine maintenance (HGH-2020-30)

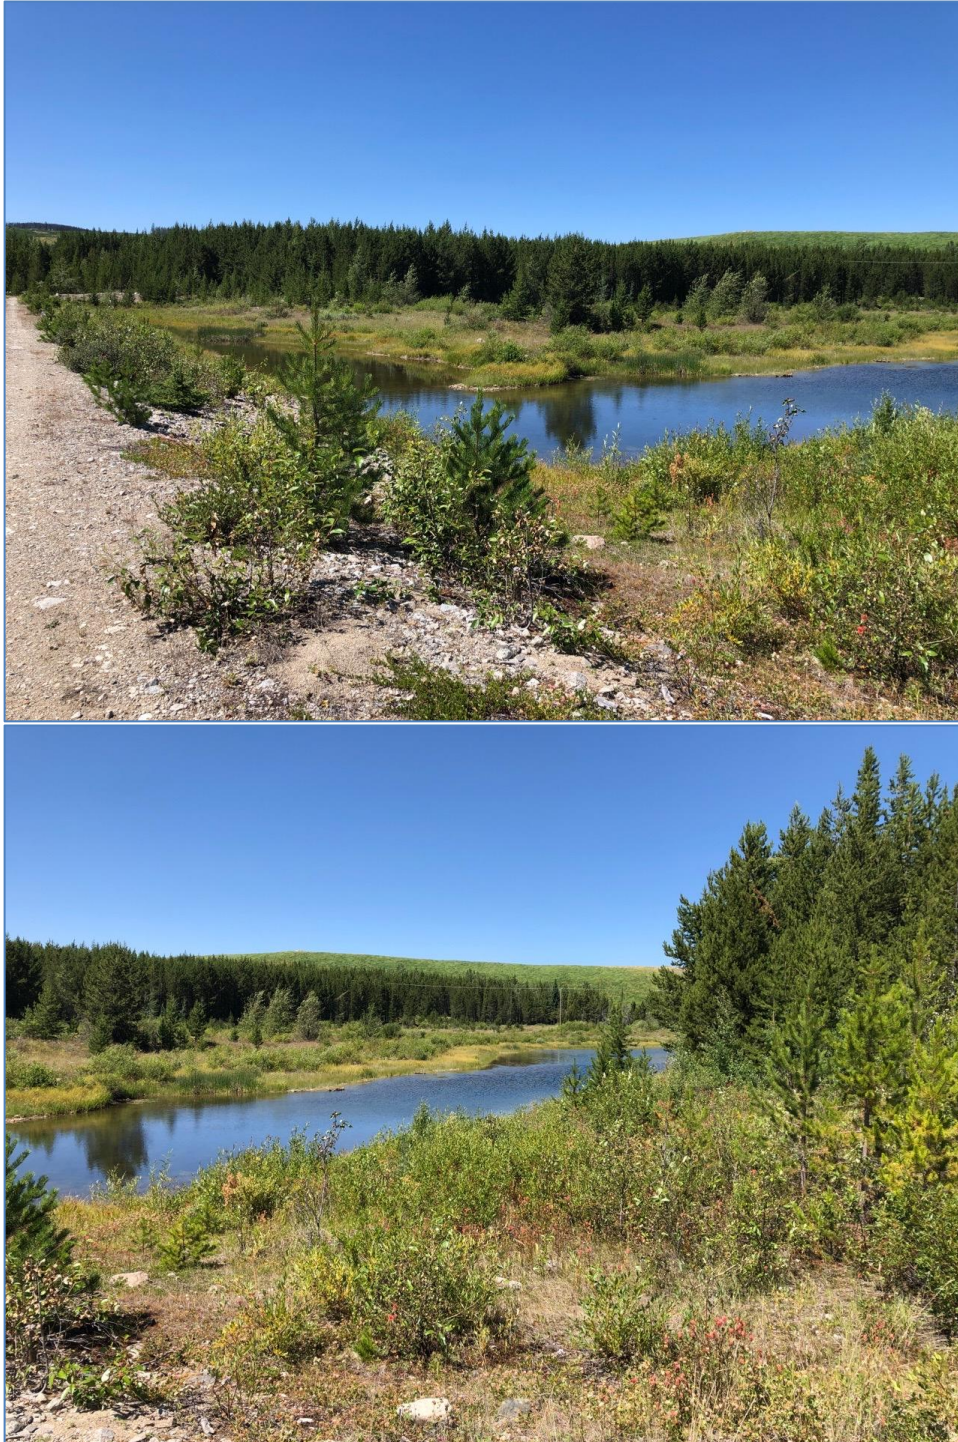
Photo I-B-28 S3 Pond: View of blocked spillway inlet at right abutment (HGH-2020-35)

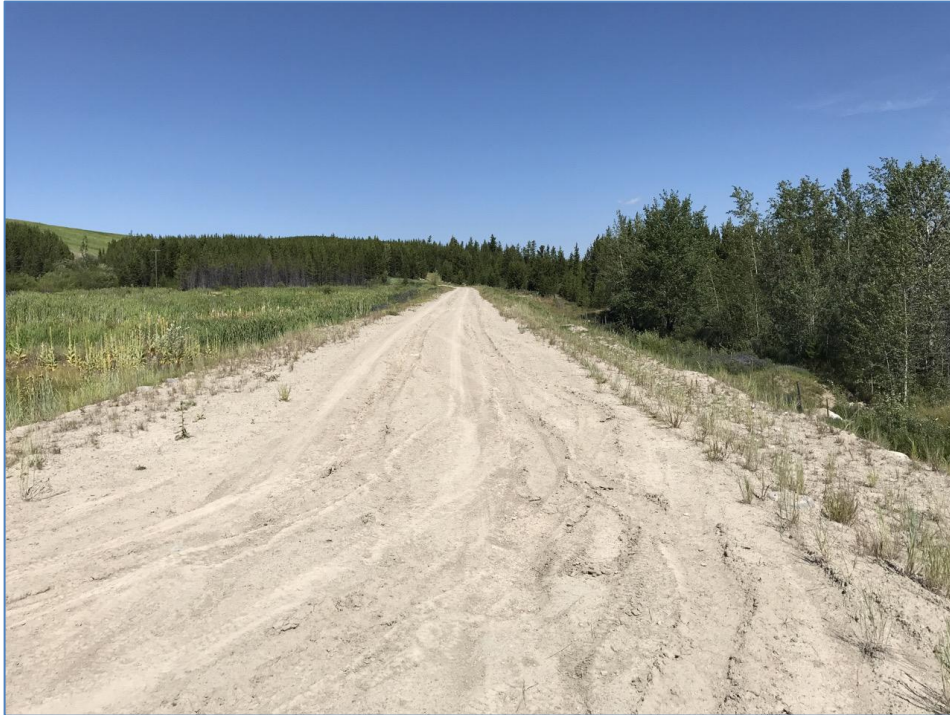
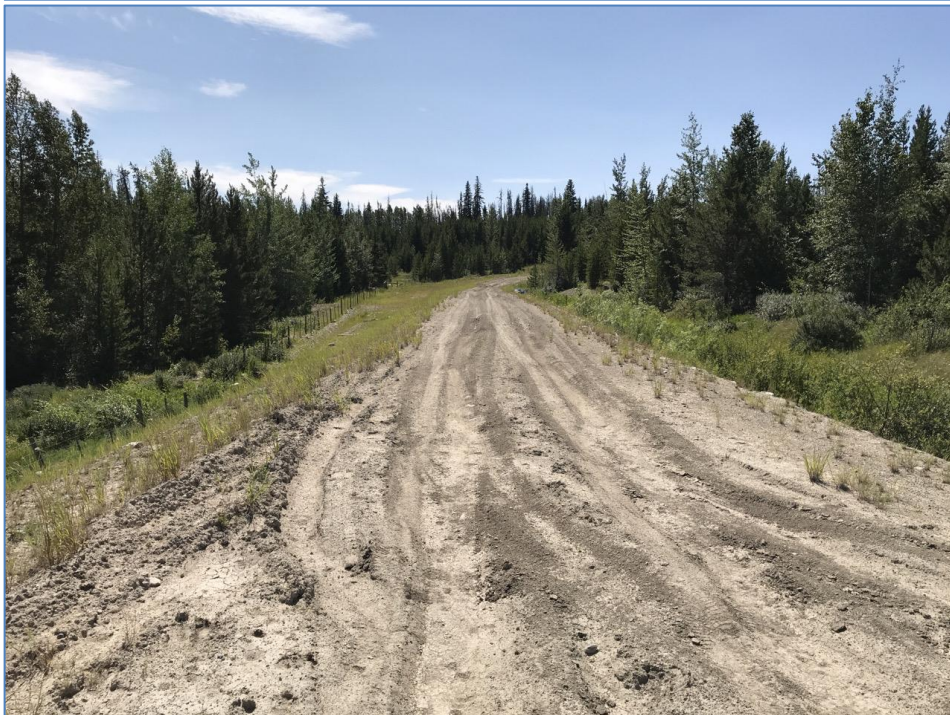
Photo I-B-32 S5 Pond: View of access road on the divider dyke. Minor rutting observed on crest of divider dyke is managed under routine maintenance (HGH-2020-39)

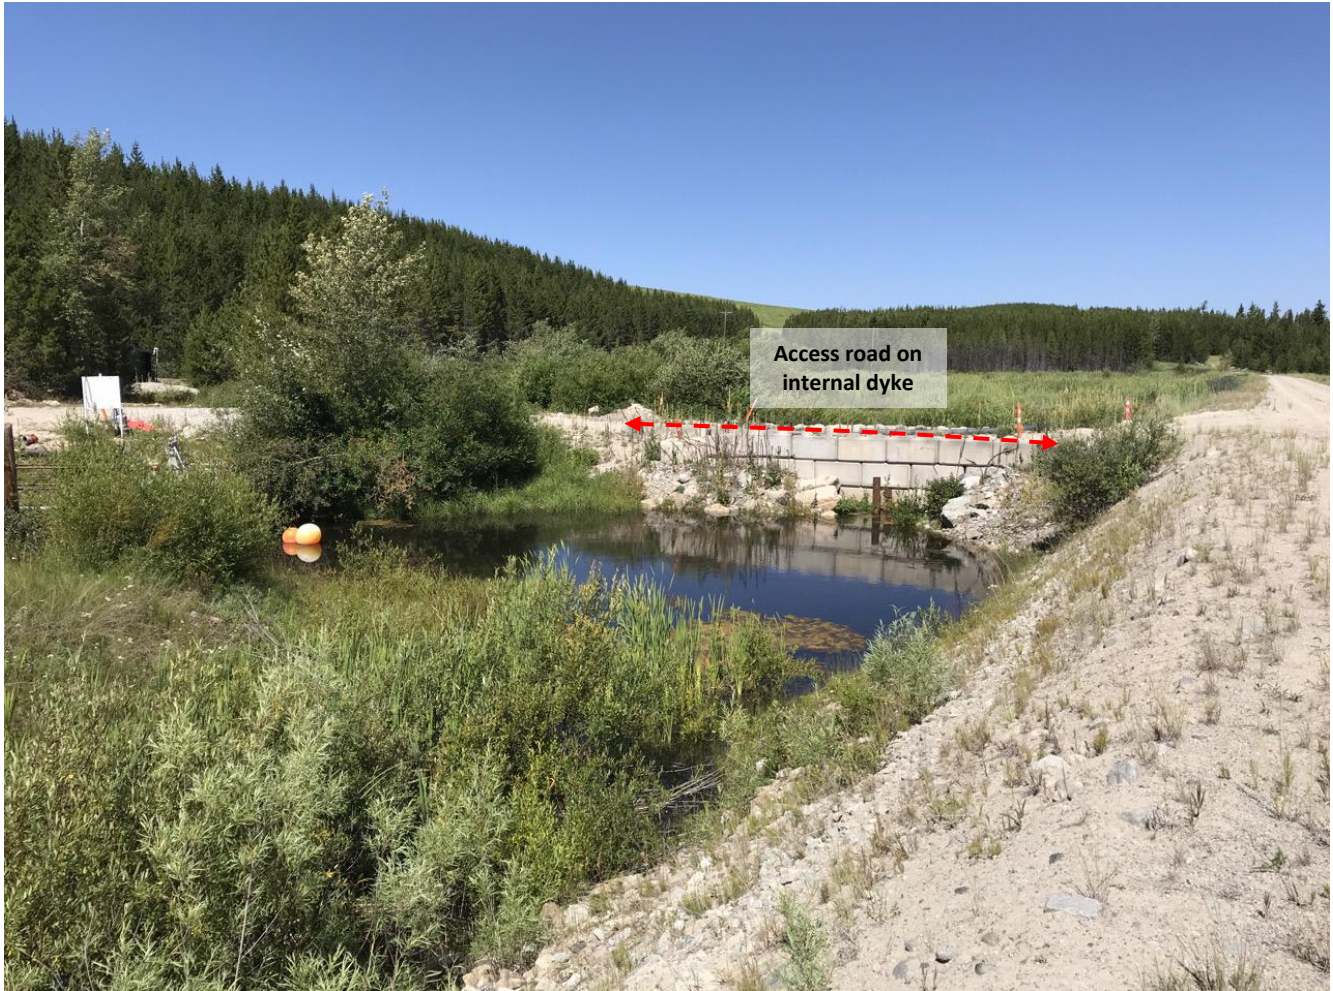
Photo I-B-37 S5 Pond: Pumping Sub-cell spillway channel. Water was ponding in the channel (HGH-2020-42)
