Louvicourt Mine Tailings Storage Facility and Polishing Pond

Tailings Storage Facility Annual Inspection

001-20145710-3000-RA-Rev0

April 2, 2021

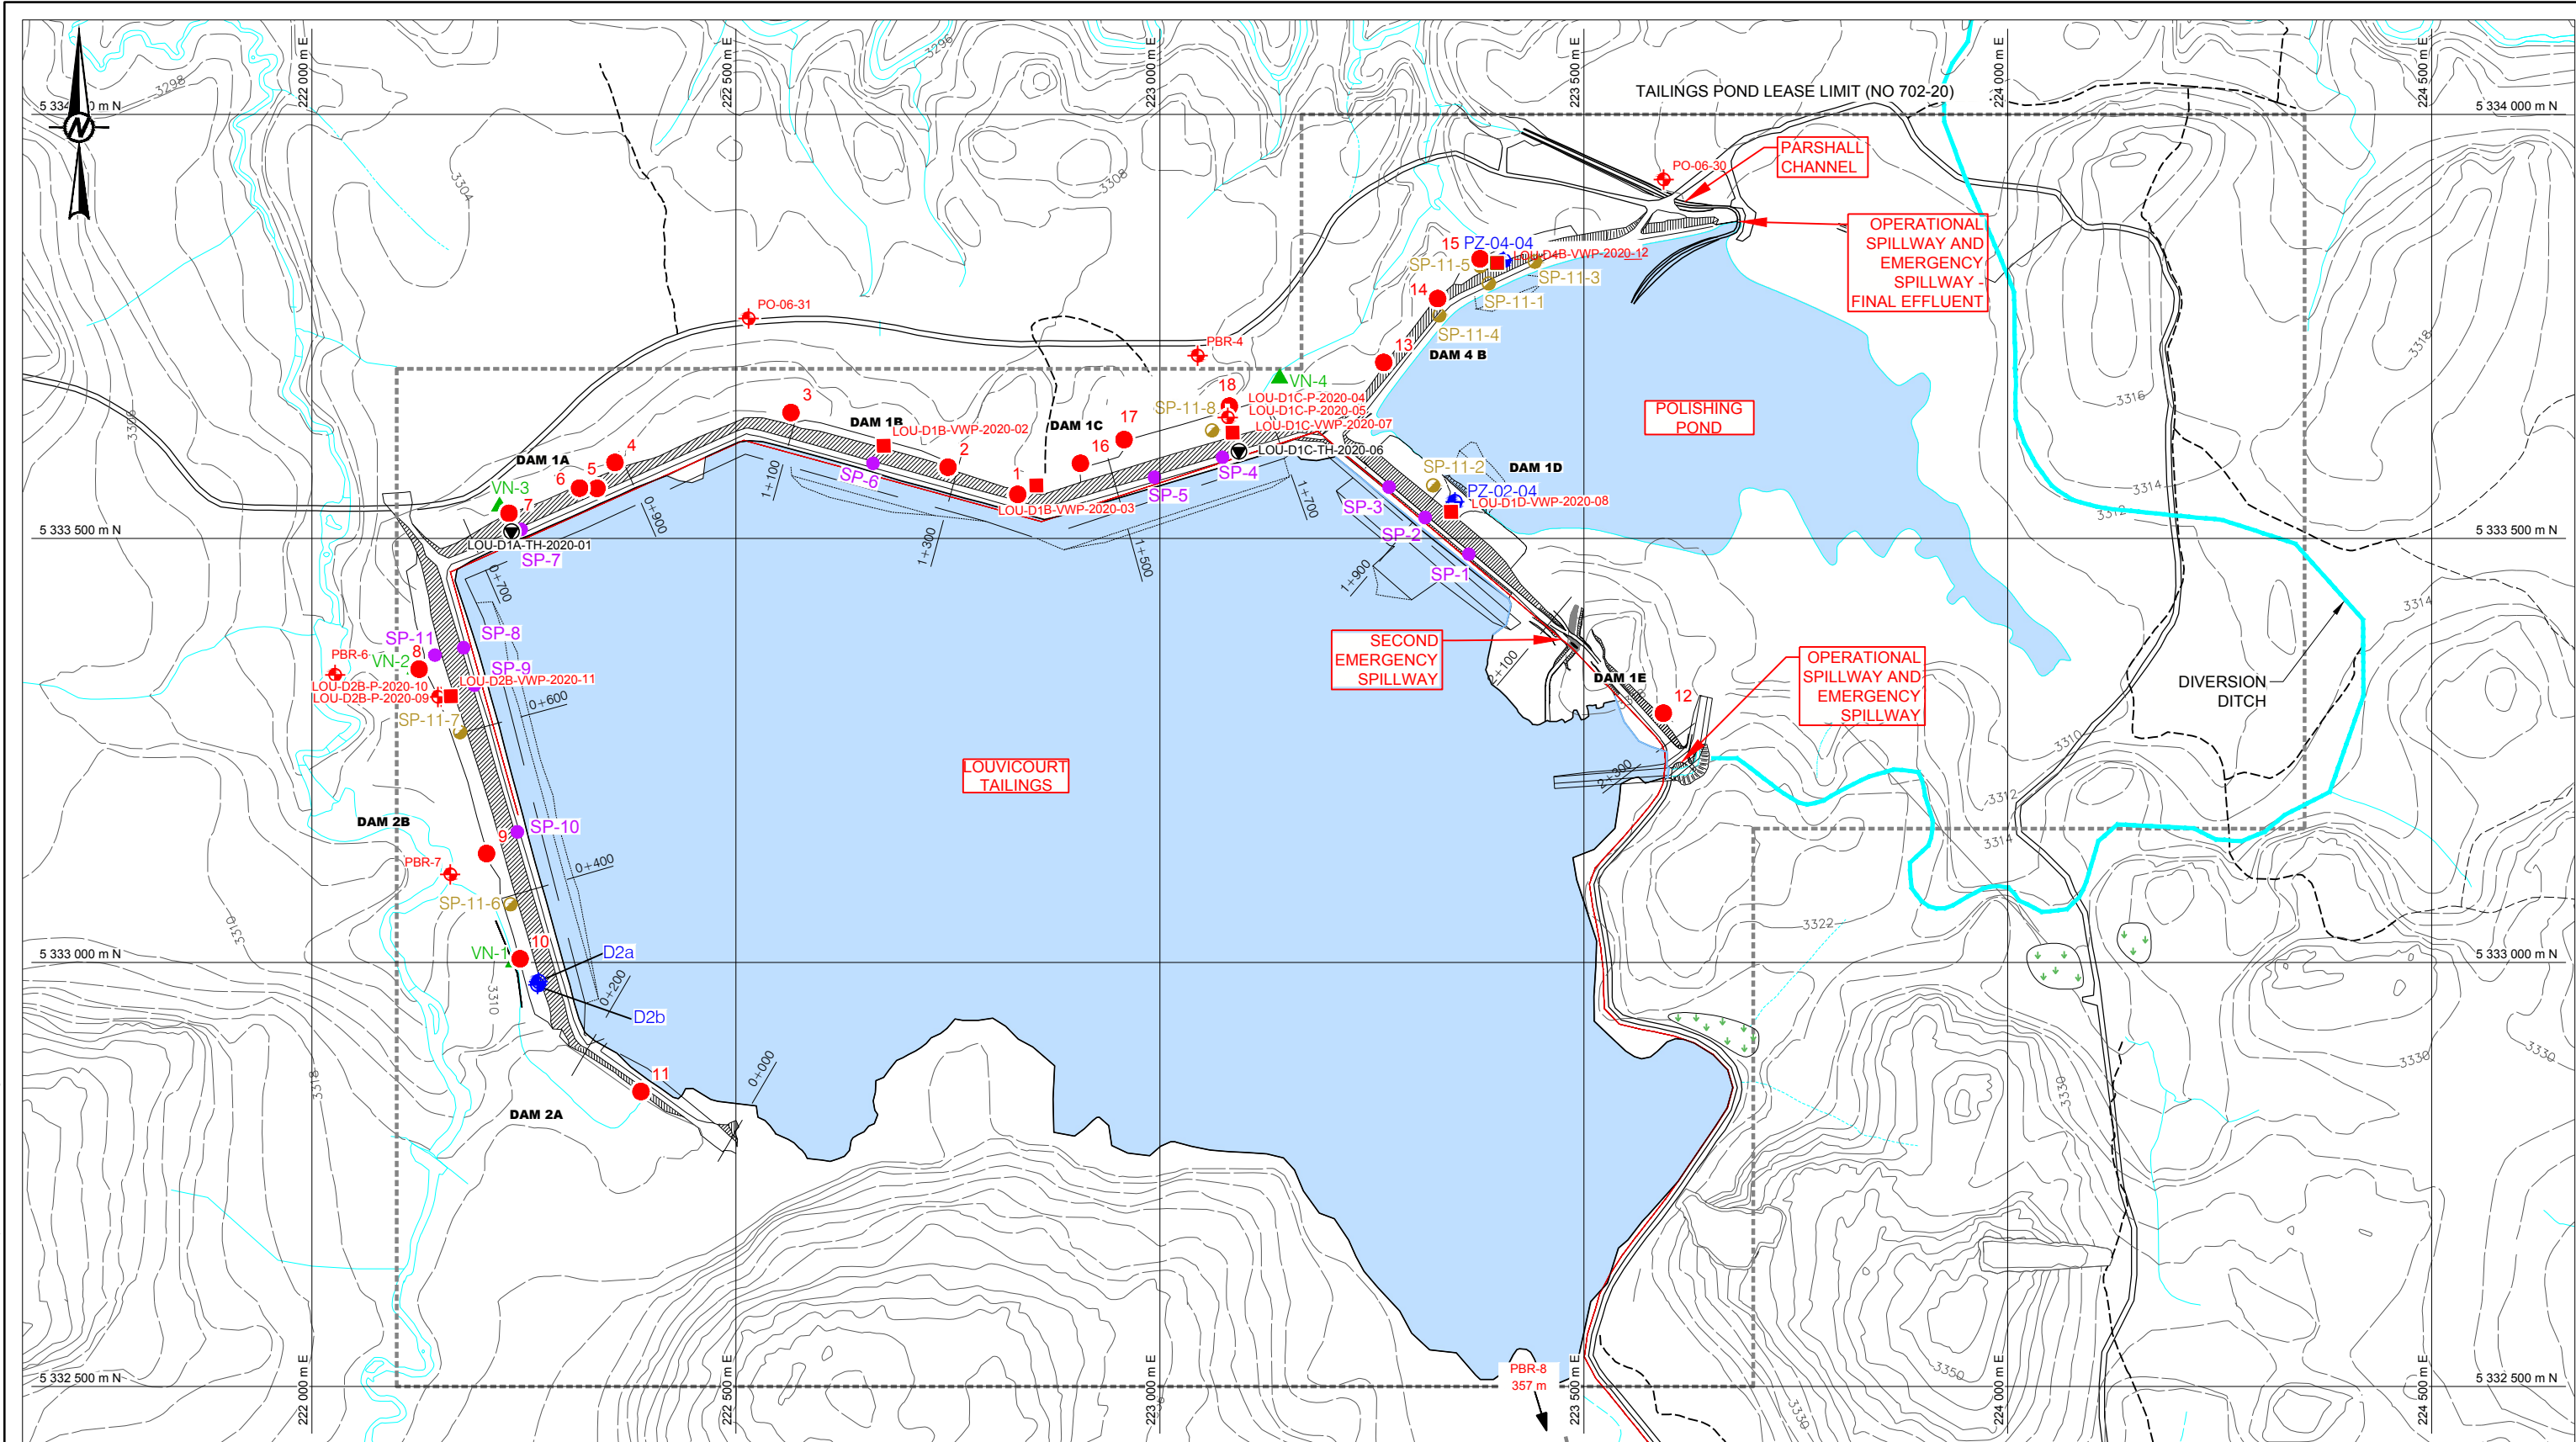
- Very little ponding water was observed at the toe of Dams 1A to 1E at the same locations as last year. The water seems to be stagnant or exhibits very low flow. The location of current and historic seepage points is presented on Figure 1.

- Ponding water was observed at the toe of Dam 4B at almost the same locations as last year (points 13 to 15 on Figure 1). The water appears to be stagnant.

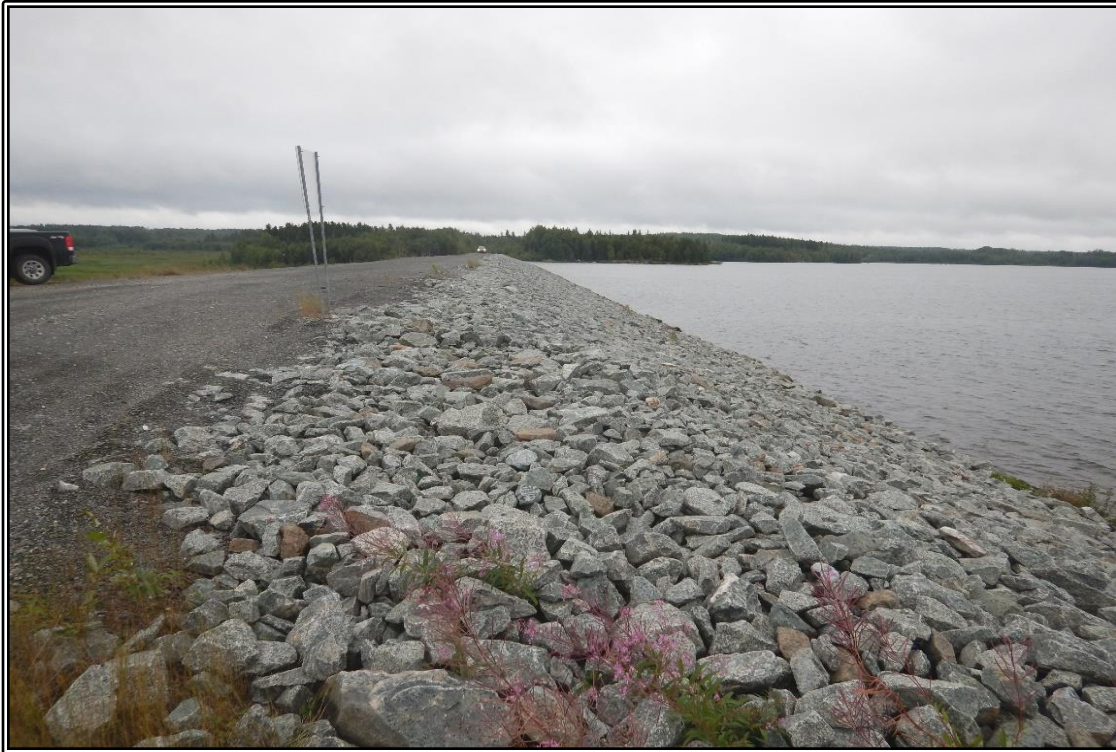
- The riprap on the upstream berms of Dams 1B and 1D, which was repaired with new riprap in 2019 (photograph 1) was unchanged from the previous inspection.

Photo 1 : Dam 1D - New rip rap placed in 2019 on upstream slope.
View looking South-East.

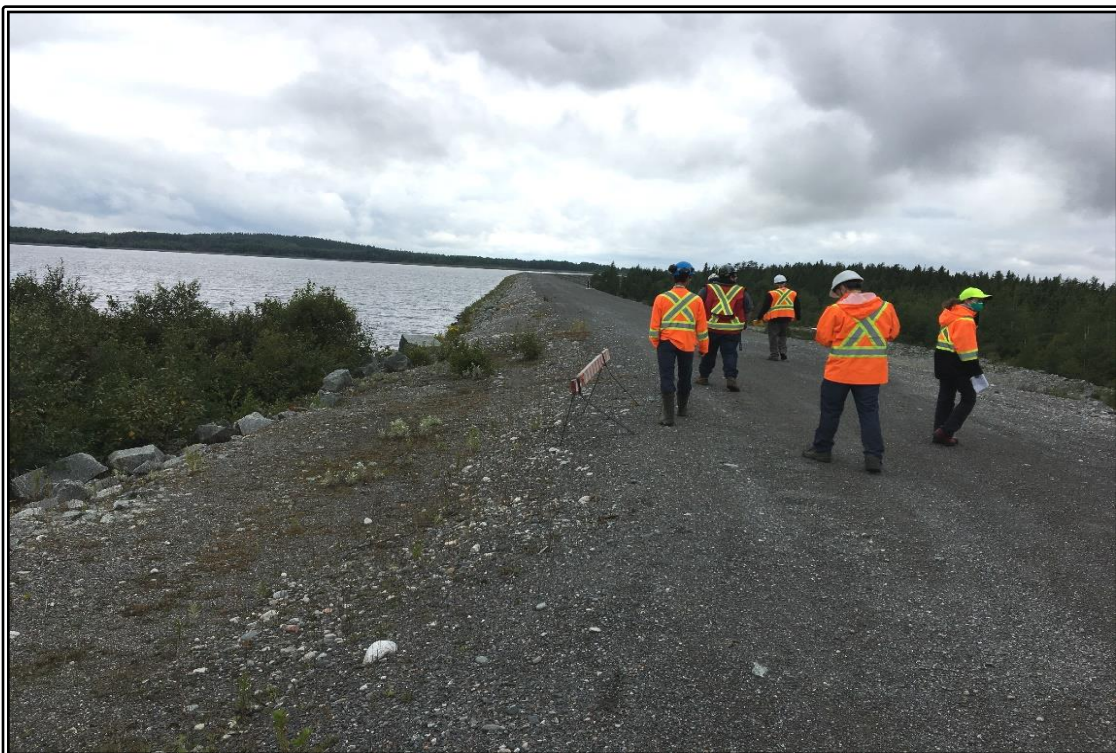
- The riprap on Dams 1A and 1C was unchanged from last year (Photograph 2). Replacement of the riprap will be undertaken within a reasonable timeframe. Operational procedures, including a provision in the OMS for an event-driven inspection after extreme wind events, are used to manage risk in the interim.

Photo 2 : Dam 1C – Degraded rip rap area on the upstream slope.
View looking West.

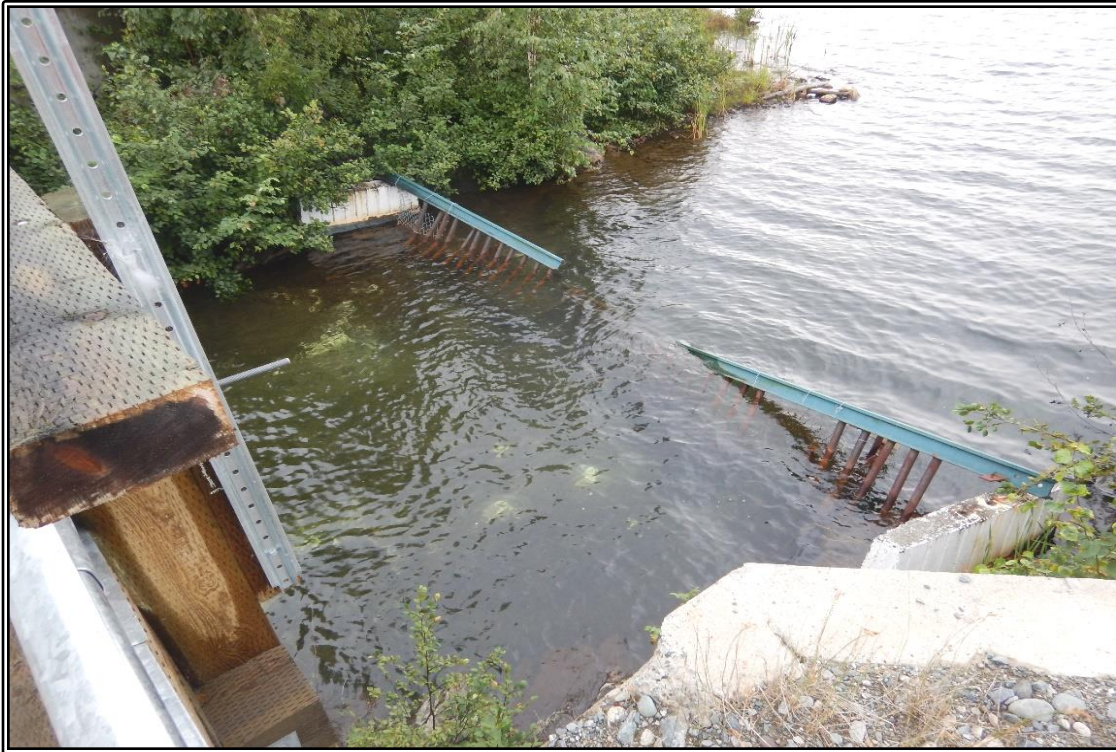
- The trash rack located upstream of the entry to the spillway was damaged (Photograph 3) and should be repaired. It is noted that the trash rack was replaced in November, 2020 (Photograph 4).

Photo 3 : Dam 1E – Damaged trash rack structure upstream from the TSF operational spillway, before a new installation in November 2020.

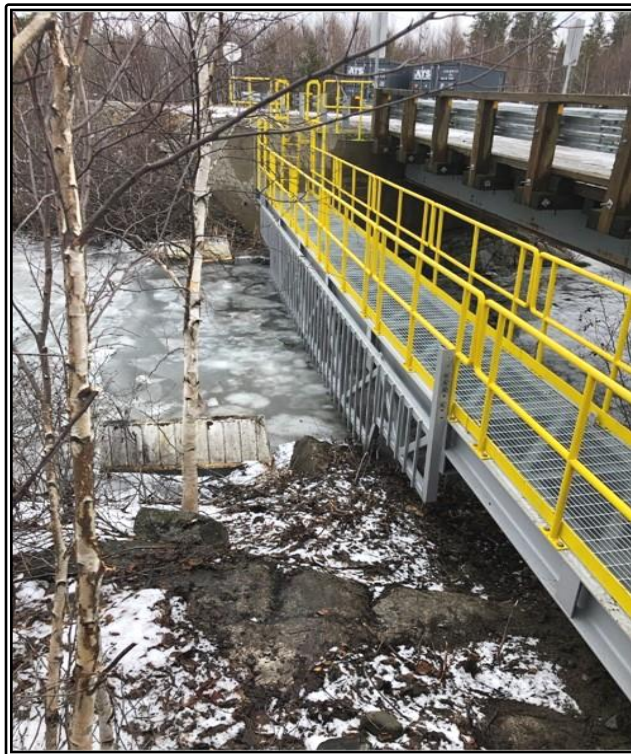
Photo 4 : Dam 1E – New trash rack structure upstream from the TSF operational spillway, installed in November 2020.

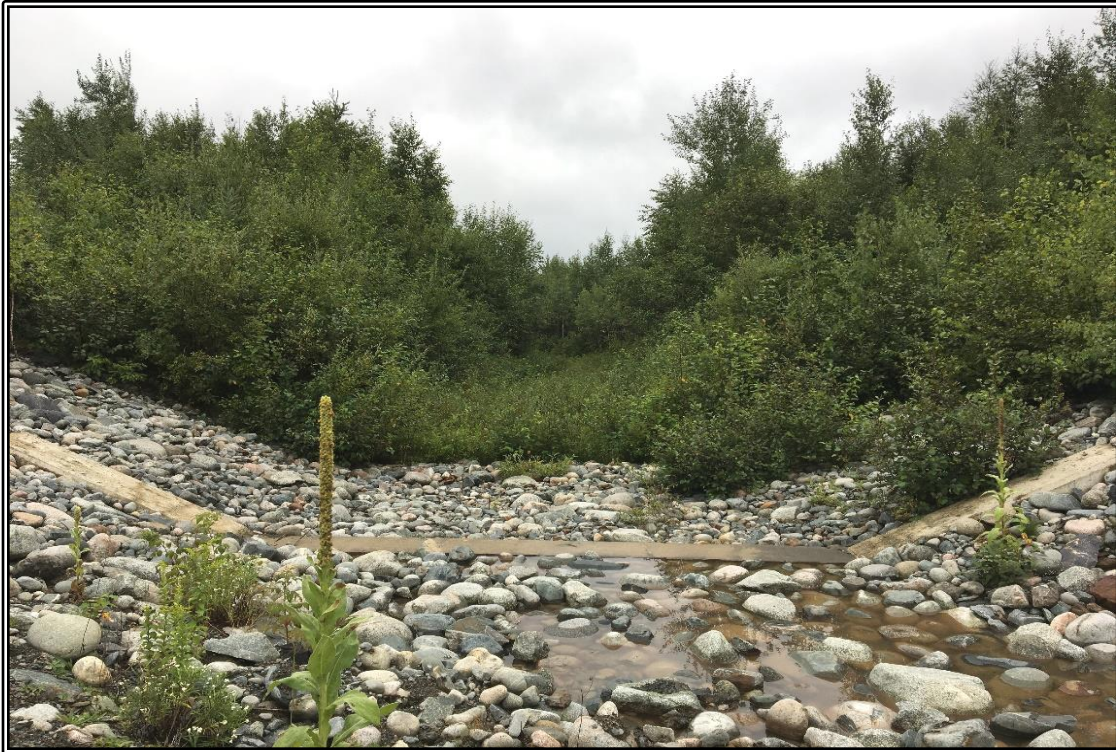
- The emergency spillway located between Dams 1D and 1E (denoted as the second emergency spillway) was in good condition. Vegetation in the downstream channel was cleared in 2020 shortly before the inspection (Photographs 5 and 6). Historically, vegetation is cleared every other year, and clearing in 2022 is considered appropriate.

Photo 5 : Dam 1D – Concrete sill and upstream spillway channel at the TSF emergency spillway. Vegetation was cleared in 2020.

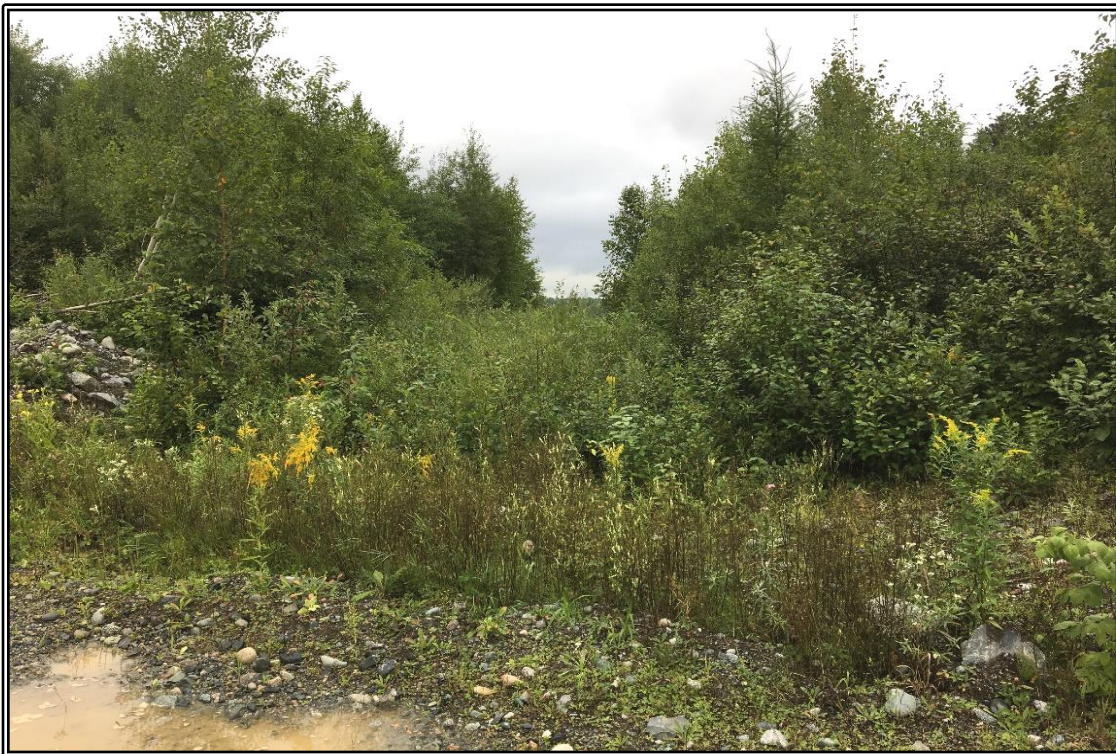
Photo 6 : Dam 1D - Downstream spillway channel at the TSF emergency spillway. Vegetation was cleared in 2020.

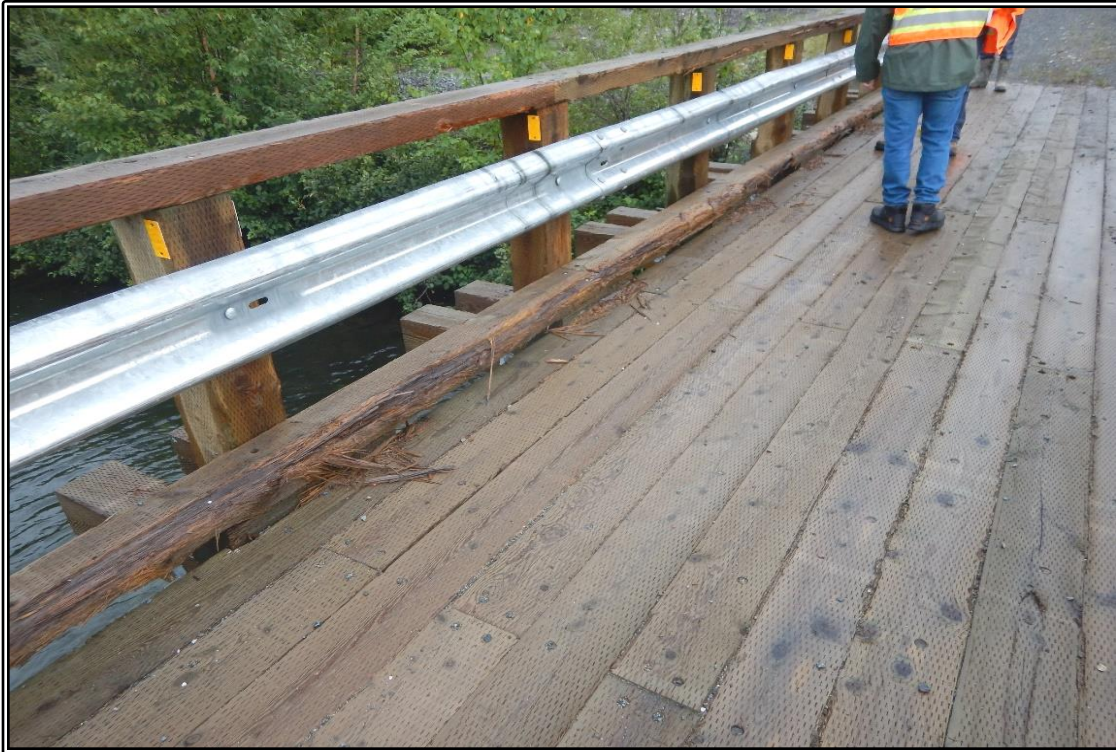
- The access bridge close to the spillway was rehabilitated in 2018 and appears in good condition, although the edge blocks appear to be suffering some scraping, presumably by snow removal equipment (photograph 7). If this issue worsens, it may be advisable to protect the timber blocks with metal covering to improve durability. WSP, 2020 observed these damaged features and indicated that they would require repair or replacement. (WSP, 2020)

Photo 7 : Dam 1E – TSF operational spillway access bridge in good condition.

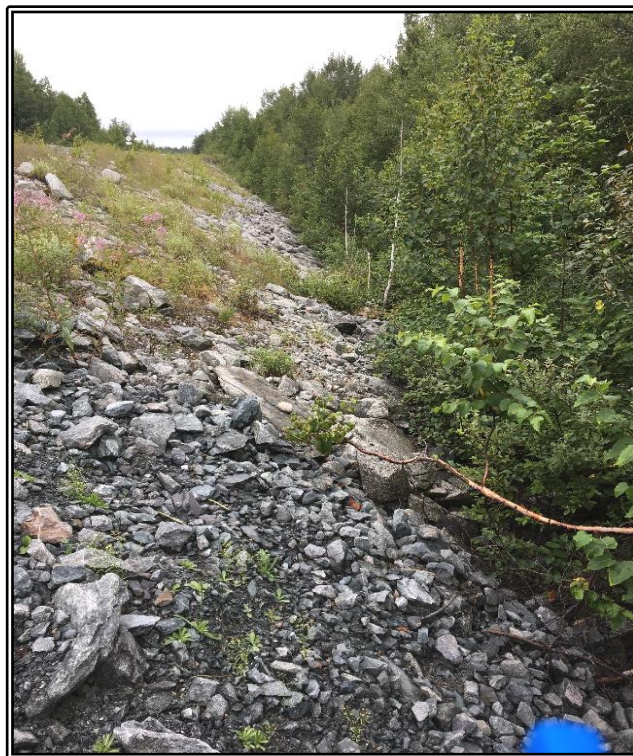
- Several minor erosion points are visible at the crest of Dam 1E. These are not a concern but should continue to be observed.
- Vegetation is present at the downstream toe of Dams 1A, 1B and 1C (Photograph 8). This is not a stability concern.

Photo 8 : Dam 1A – General view of vegetative growth at the toe of the embankment.

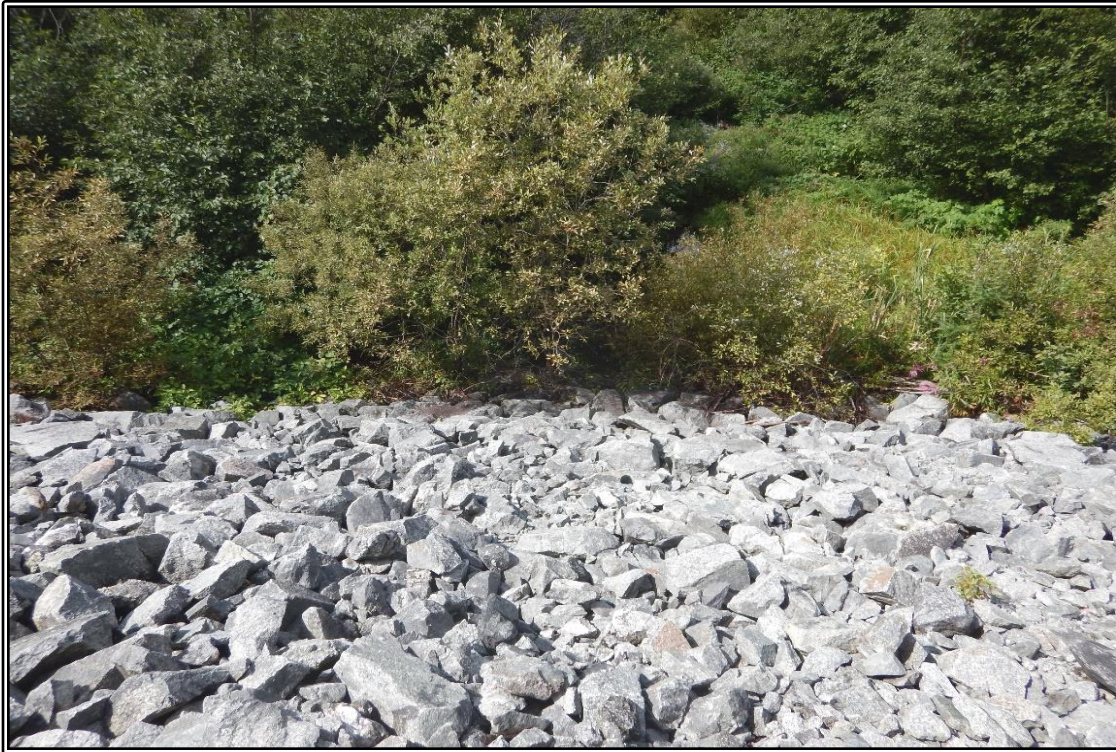
- Some stagnant water and slight seepage were observed at the toe of Dam 2B representing the seepage points labelled 10 thru 13, and reporting to V-notch 1 and V-notch 2, exhibiting very low flow (Photograph 9). The seepage water is clear.
- Stagnant water is observed at the toe of Dam 2A (Photograph 10). The extent of ponding appeared somewhat lower than in 2019; however, it is noted that this area represents a zone where the natural topography drains towards the tailings pond, such that some accumulation at this location is expected.
- The culverts located across the unnamed creek, just north and west of the tailings pond have been cleared since the 2019 inspection (Photograph 11) and drainage of this area was much improved. Limited new beaver activity was observed at this area.

Photo 9 : Dam 2B – Water ponding at the downstream toe of the dam; seepage water is clear.

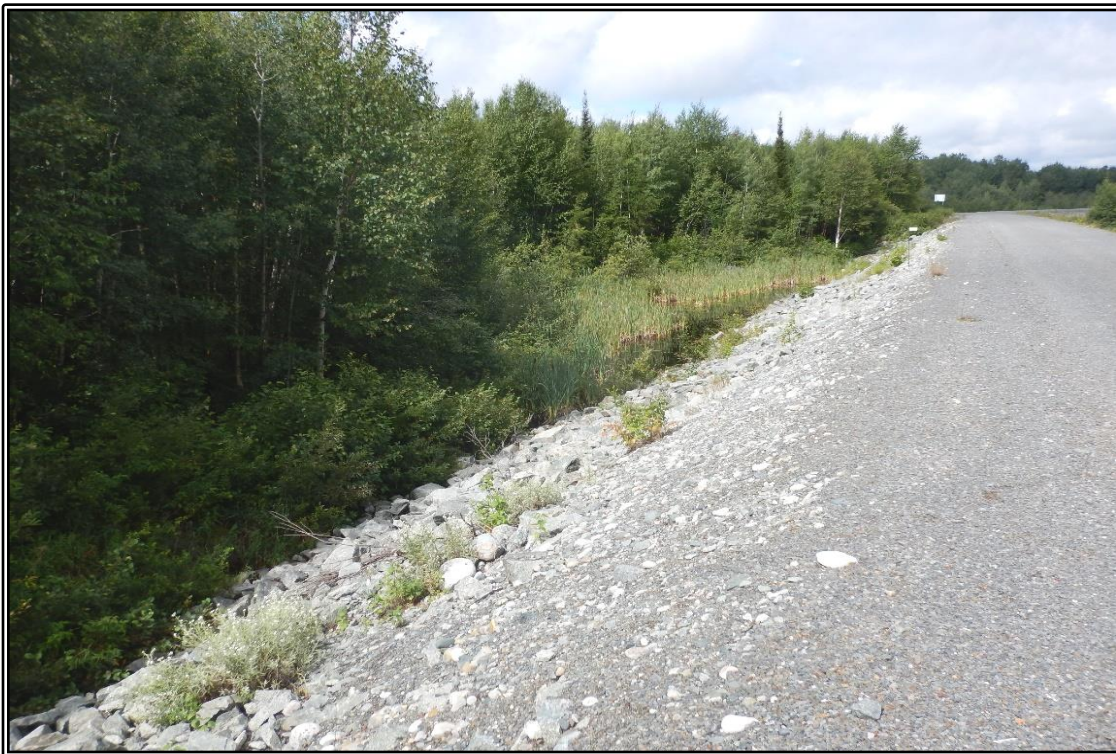
Photo 10 : Dam 2A - Stagnant water at the downstream toe of the dam. This area represents a zone where the natural topography drains towards the tailings pond; some accumulation at this location is expected.

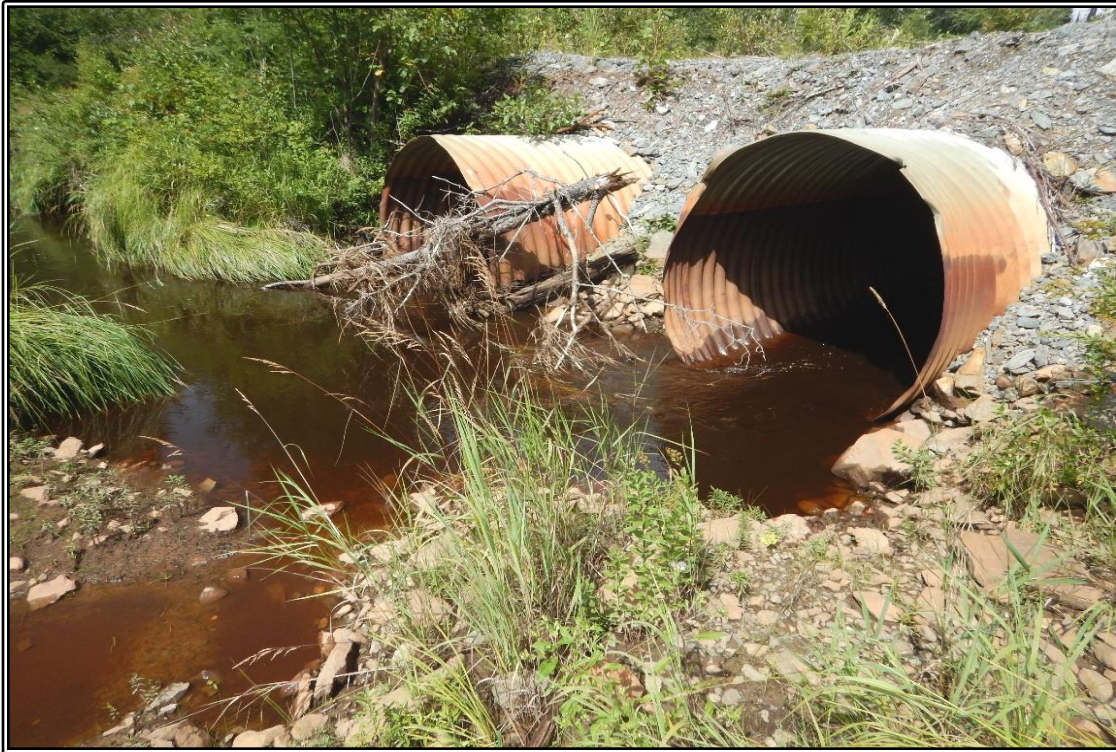
Photo 11 : Dam 2B - Culverts located northwest of the TSF - Drainage improved after clearing during last year.

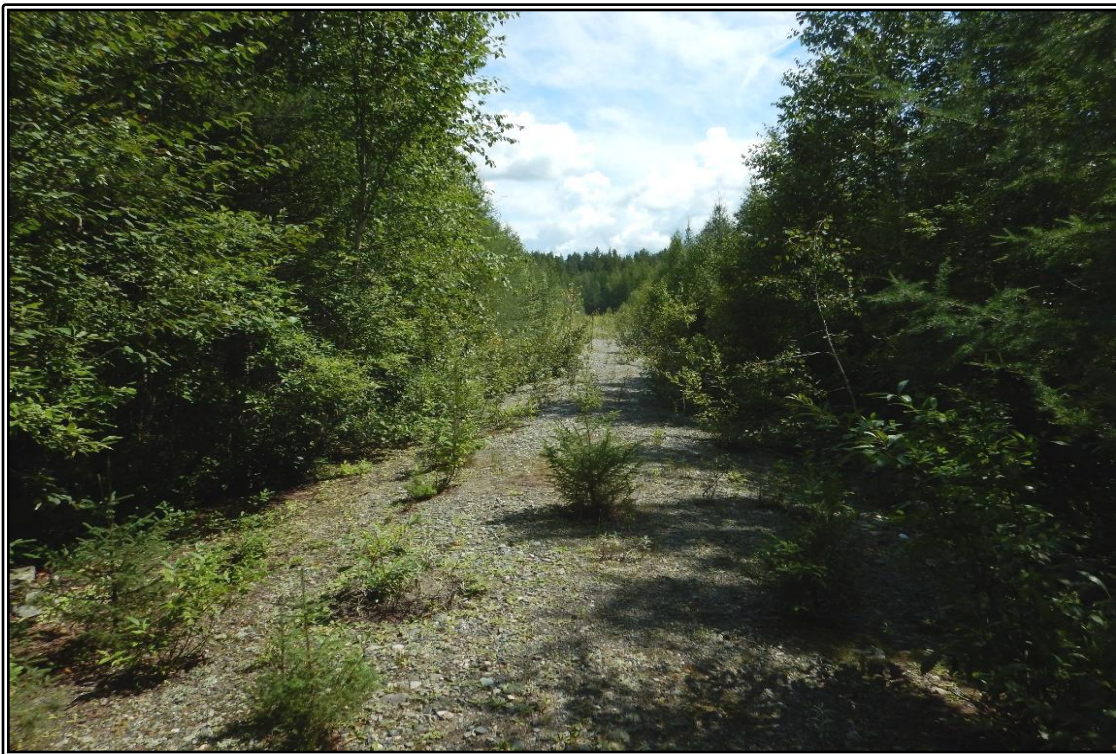
Photo 12 : Dam 4A – Vegetation on the side slopes and crest of the embankment.

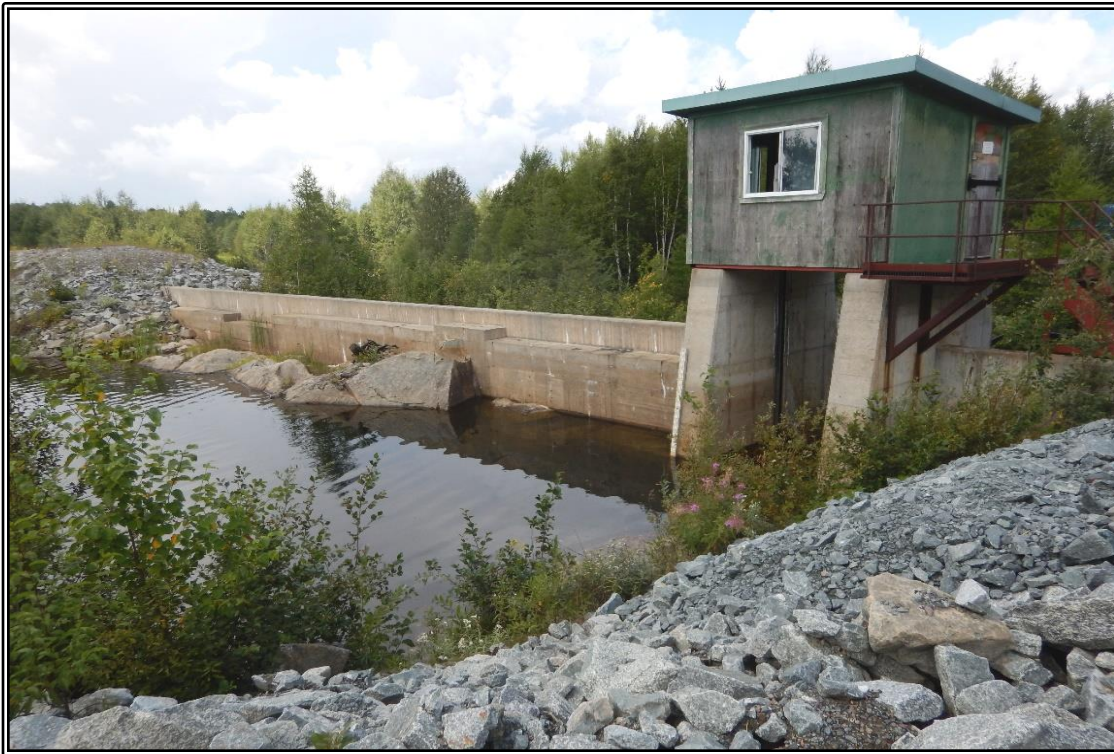
- The main spillway at Dam 4B was in good condition although no flow was passing over the structure (Photograph 13).
- The north shoulder of the Dam 4B service spillway was inspected. Minor seepage and ponding exist at the contact between the rock and concrete structure (Photograph 14). Camera footage suggests that this seepage occurs year-round. The seepage quantity is small and there is no evidence of delamination or piping. No remedial measures are required. However this seepage area should be monitored regularly, similar to other seepage features on the dams.

Photo 13 : Dam 4B – View of main spillway control structure and concrete outflow section adjacent to it. Good condition.

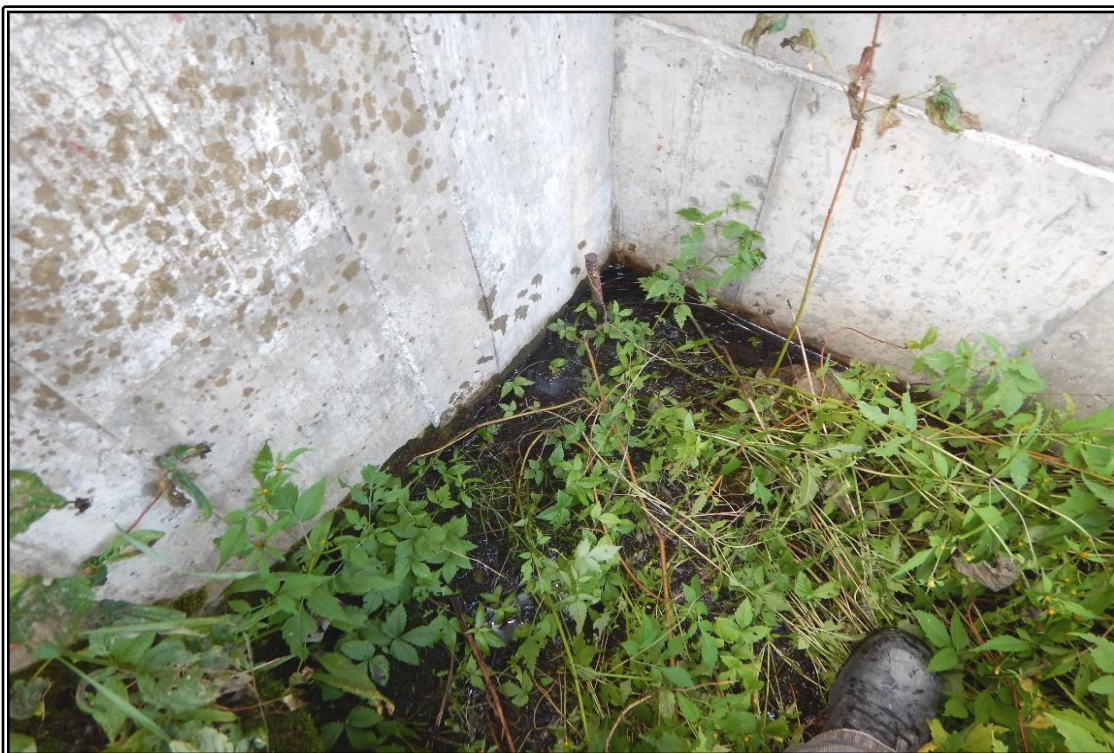
Photo 14 : Dam 4B – North shoulder of the service spillway. Minor seepage and ponding at the contact between the rock and the concrete structure.

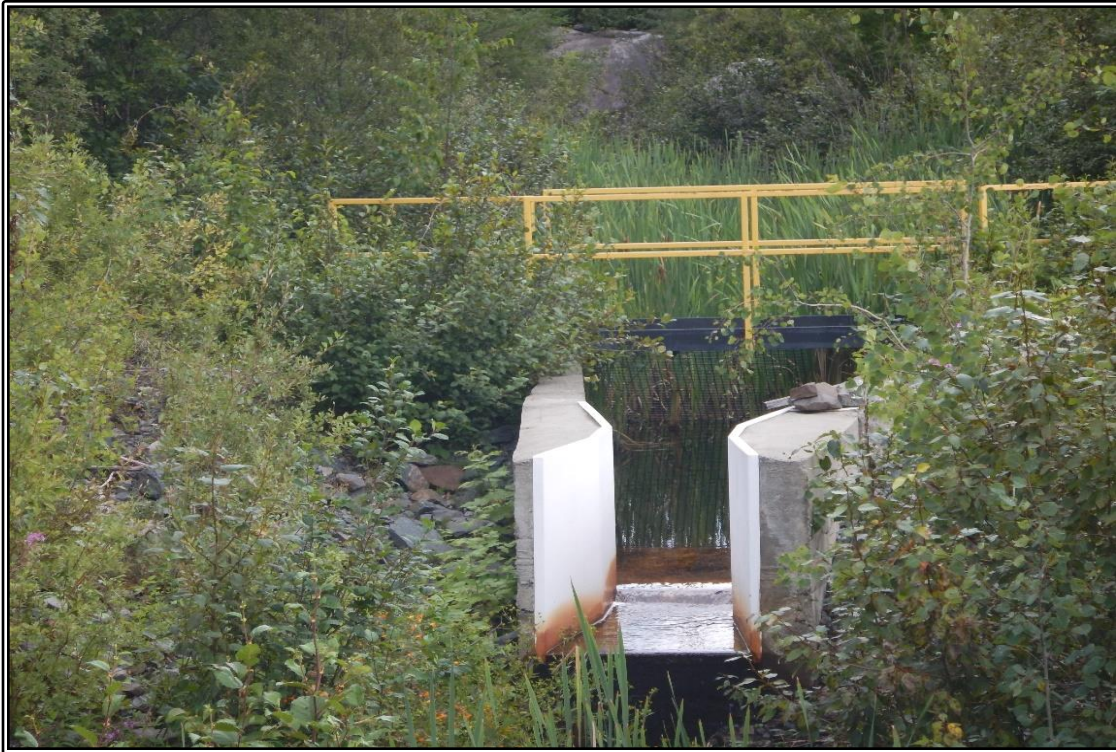
Photo 15 : Dam 4B – Vegetation at the outflow channel from the spillway to the Parshall flume.
