**Teck Metals Ltd.**

**Pinchi Lake Mine Tailings Storage Facility**

***2020 Annual Summary of Tailings Facility Performance***

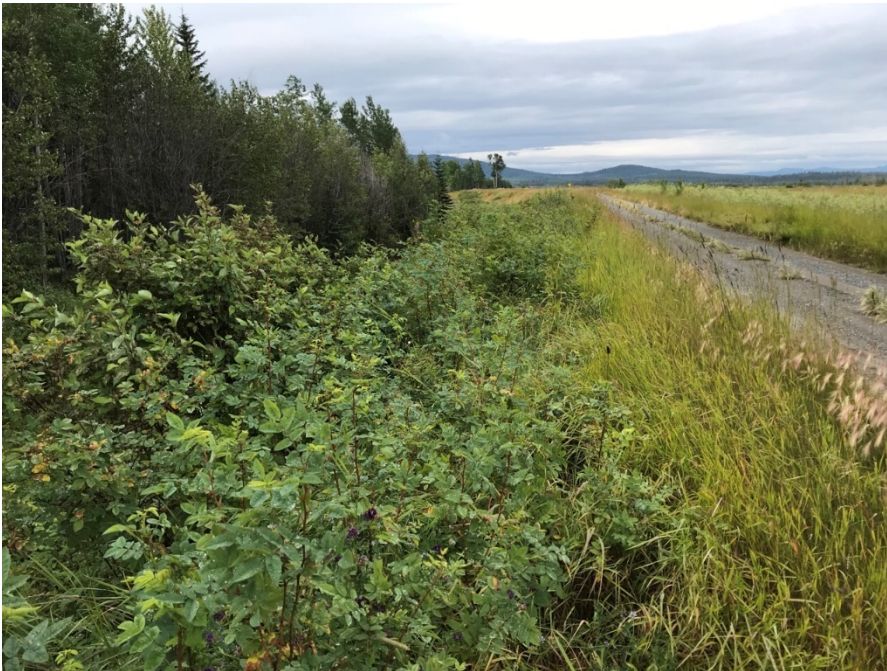
- The dam slopes were covered with grasses and small shrubs. Larger vegetation including some trees were cleared from the east leg of the dam in fall 2019. Some bushes had since regrown in this area (Photo II-1) but were within the 1.5 metre height limit recommended in the vegetation management plan (Spectrum 2017).

**Photo II-1** Tailings Dam – east leg, looking south. Note vegetation.

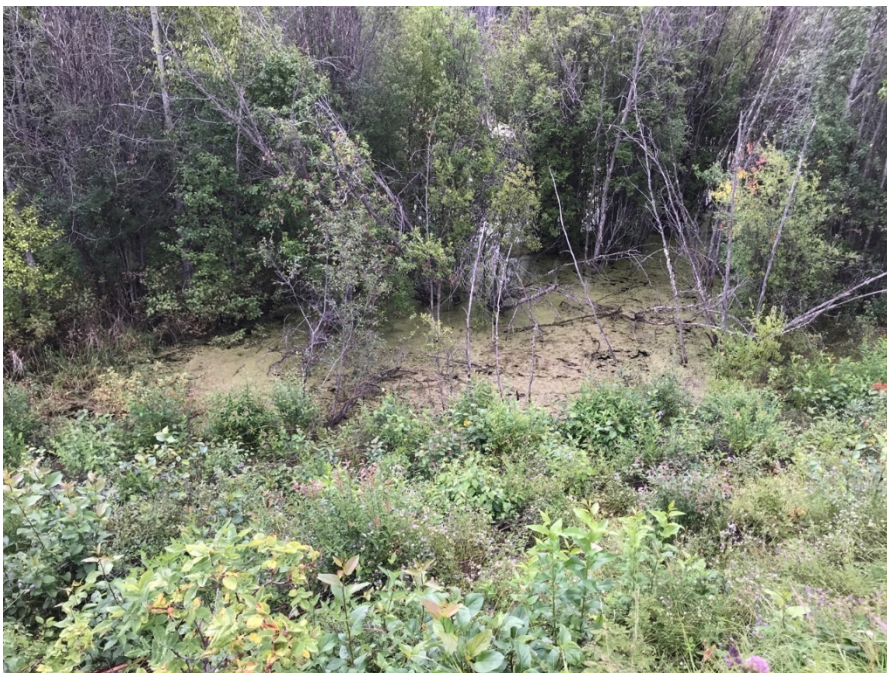
- A pond was observed in the trees near the toe of the east leg of the Tailings Dam (see Figure 1.2 for location; Photo II-2) as in previous inspections. This pond is located near a drainage channel that was shown on historical drawings of the TSF (see Appendix IV) and labelled “runoff channel.” The channel ran parallel to the main Ed Creek channel, and apparently once joined up with Ed Creek just inside the TSF. The pond appears to collect local runoff, and it drains through a channel to the south and through a culvert into Ed Creek Diversion Channel.

**Photo II-2** Tailings Dam – Pond near toe of east leg.

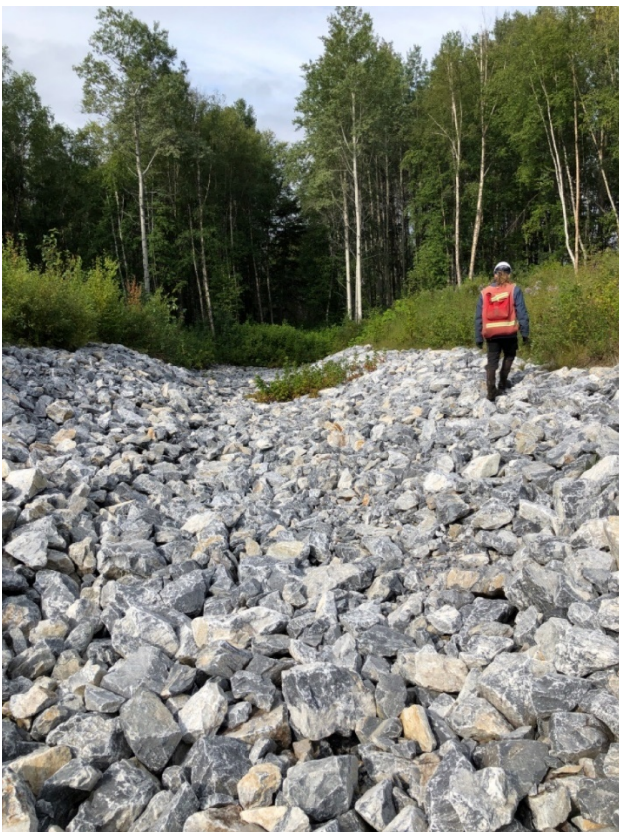
- There was no flow or standing water in the Closure Spillway channel; there was a 30 cm deep pond at the downstream end of the riprap (Photo II-24).
- The riprap along the entire Closure Spillway channel appeared to be in good condition (Photos II-16 to II-22, and II-24). The spillway has likely not experienced any high flood discharges since it was constructed. Vegetation growth in the channel was minimal, only a few small shrubs (Photo II-22).

**Photo II-22 Closure Spillway – looking downstream towards outlet. Note vegetation.**

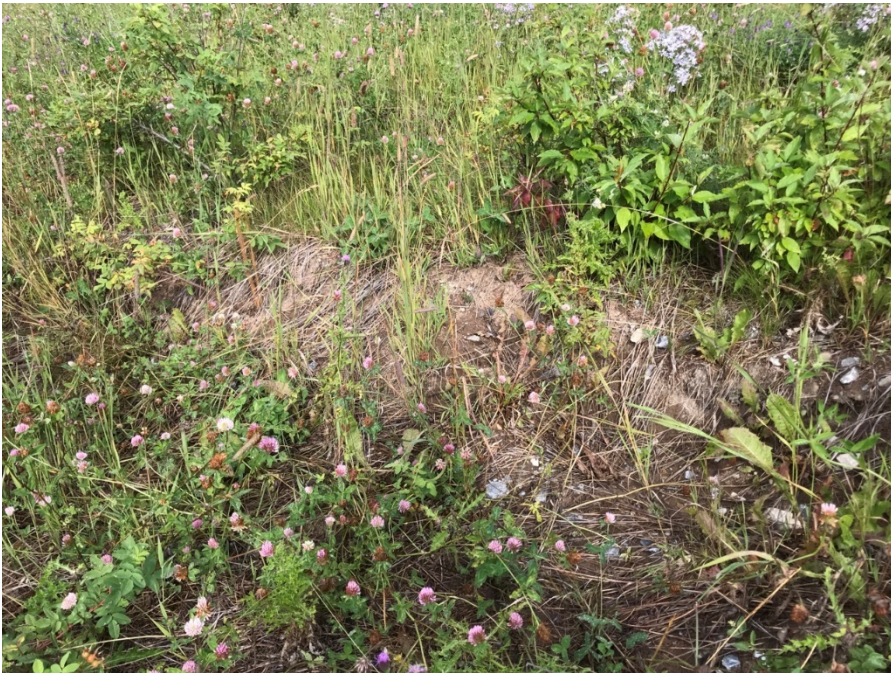
- A small slump in the slope above the riprap on the right (north) side of the spillway channel has been noted in inspections since 2014 (Location 1 in Figure 4.1). The slump area was covered in grass and the head scarp was only visible at close range (Photo II-23). The upstream side of the slump is about 90 m downstream of the dam centreline. The condition of the slump has not noticeably changed in the last six years, and it is not expected to impact the Tailings Dam or the performance of the spillway.

**Photo II-23     Closure Spillway – Head scarp of slump above right bank**

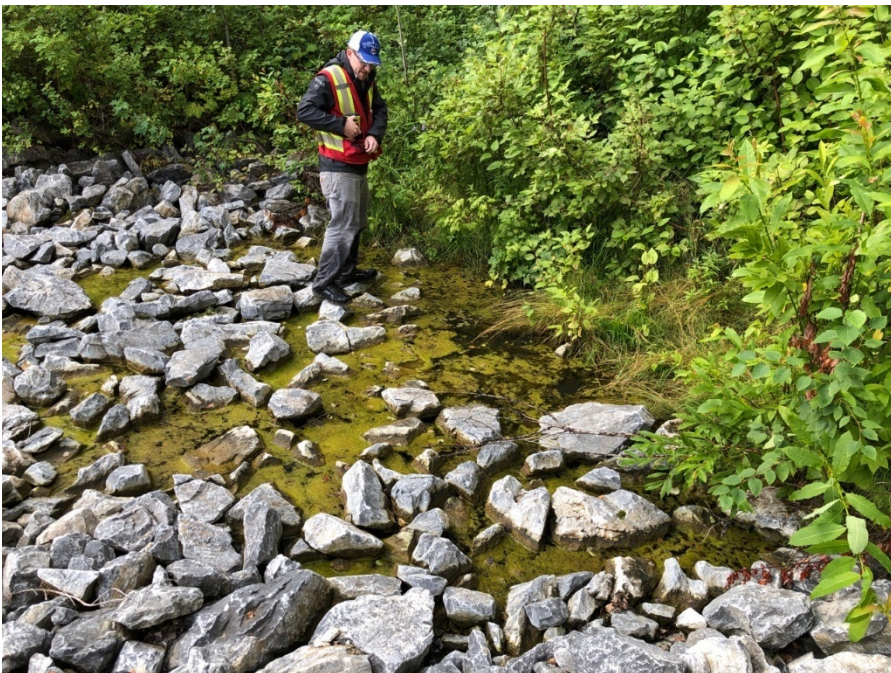
**Photo II-24     Closure spillway – Pond at downstream end of riprap**

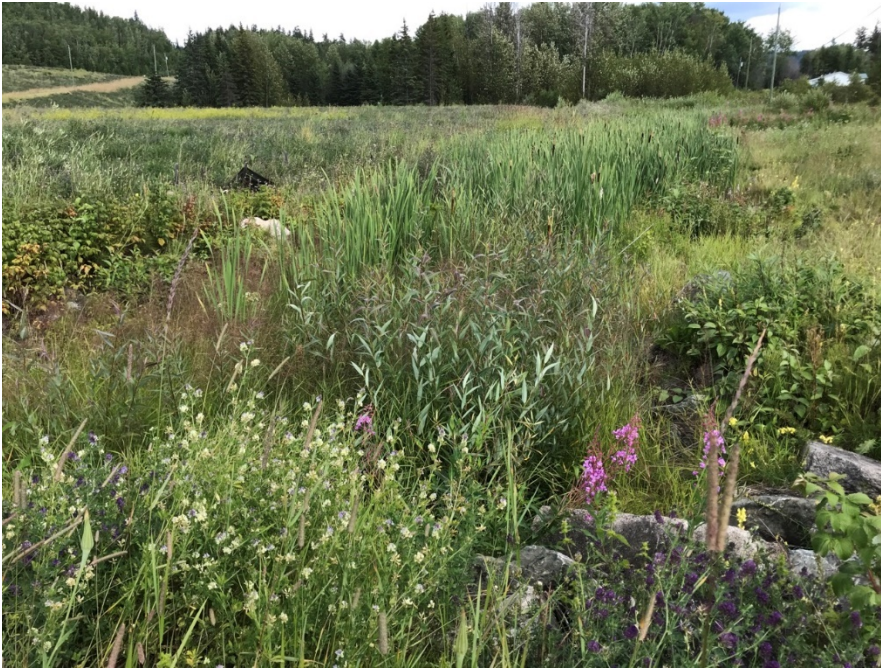
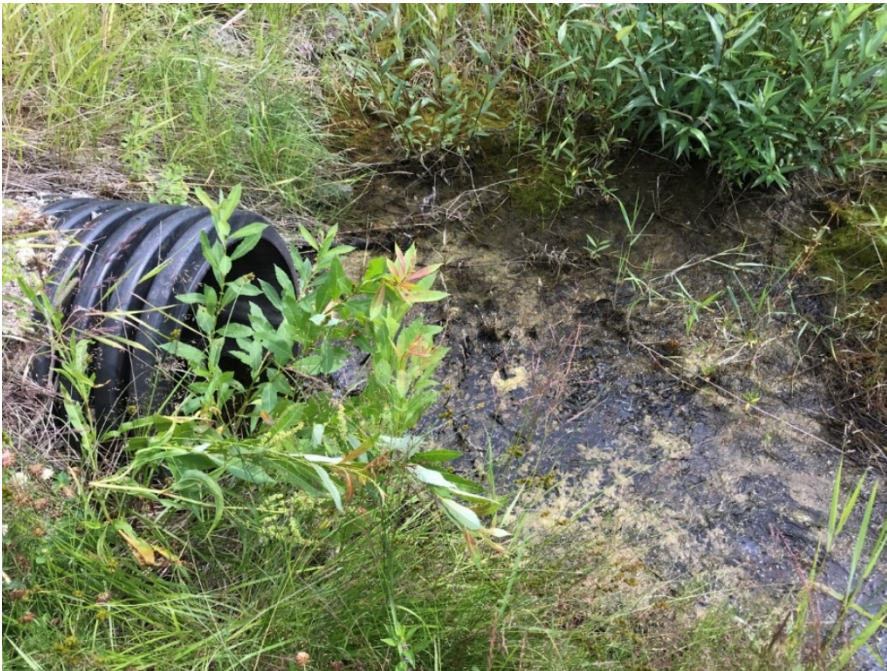
- The spillway downstream channel was observed at the culvert crossing on the road adjacent to the Emergency Spills Lagoon (Photos II-25 to II-27). The middle reach immediately upstream of the culvert appeared to be in good condition. Tall grasses and cattails were growing in the channel but were within the 1.5 metre height limit recommended in the vegetation management plan (Spectrum 2017). There was grass growing in front of the culvert inlet, partially blocking it. There was no flow into the culvert at the time of the inspection. The outlet of the culvert was clear of vegetation, but there was water ponding locally at the outlet to 5 cm above the invert (Photo II-26). The culvert is not related to dam safety but clearing of the inlet may be prudent to restore its normal flow capacity. The lower reach of the spillway

**Photo II-25 Spillway Downstream Channel – Middle Reach, looking upstream from near culvert beneath road to on-site residence.**

**Photo II-26 Spillway Downstream Channel – Outlet of culvert beneath road to on-site residence.**

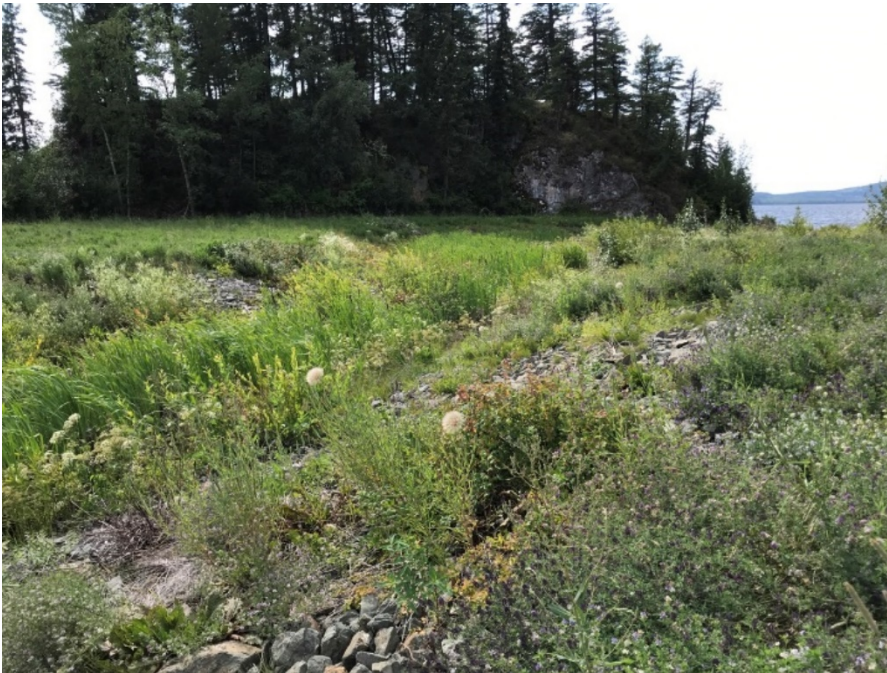
downstream channel appeared to be in good condition, although there were some larger bushes growing that were close to 1.5 m high (Photo II-27).

**Photo II-27     Spillway Downstream Channel – Lower Reach, looking downstream.**

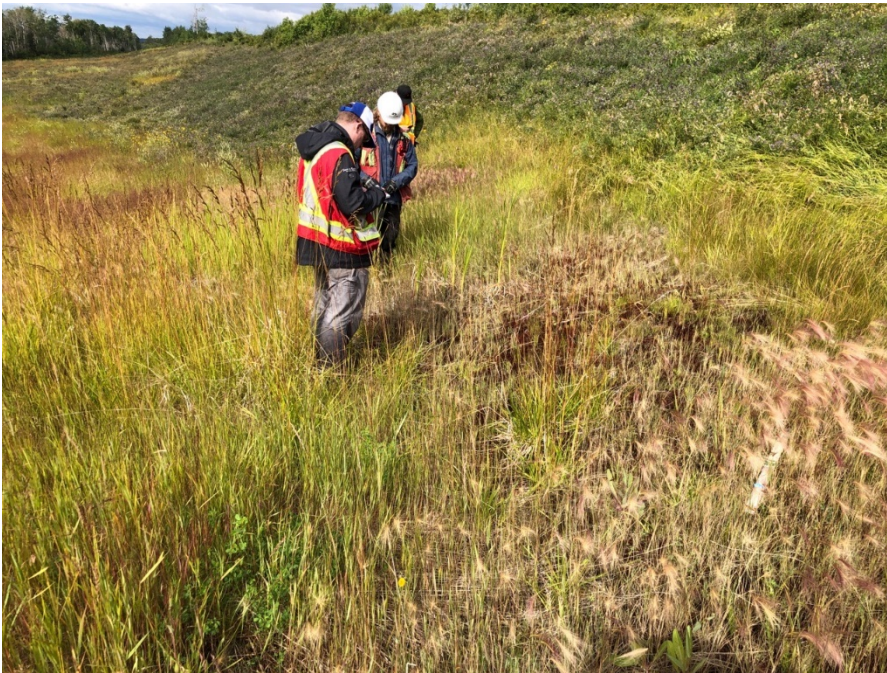
- A few small areas of wet ground were observed starting in the northeast corner of the borrow area and moving slightly downhill to the west along the toe of the slope for 50 m (Location 5 in Figure 4.1; Photo II-31). No ponds larger than a few centimetres diameter were observed, and there was no flowing water. Similar wet areas have been observed since 2011, and they are believed to be associated with groundwater unrelated to the TSF. Outside of these wet areas, the ground on the slope and along the toe was dry.

**Photo II-31 Borrow Area A – Wet ground in northeast corner.**

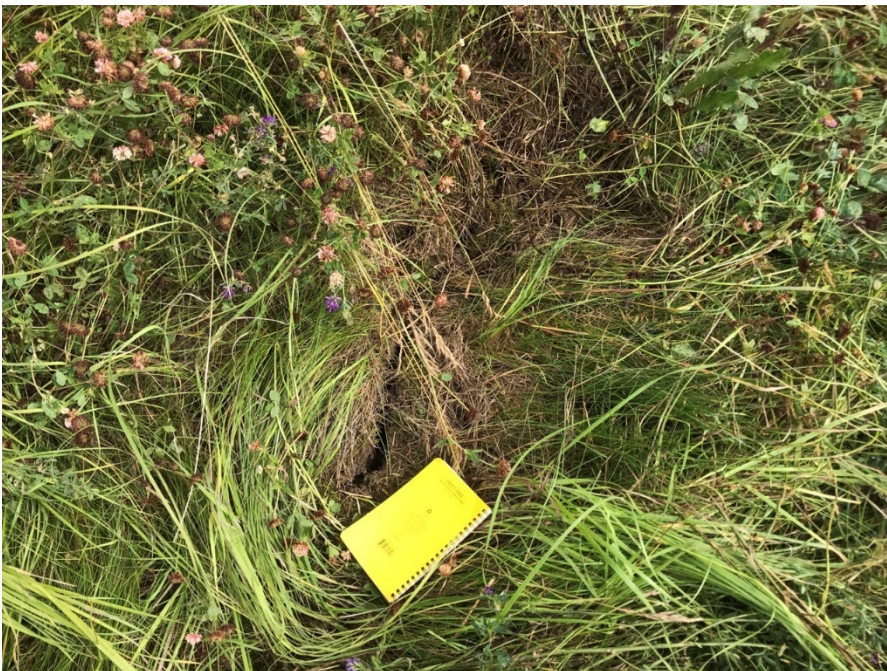
**Photo II-32 Borrow Area A – New crack identified in northeast corner.**

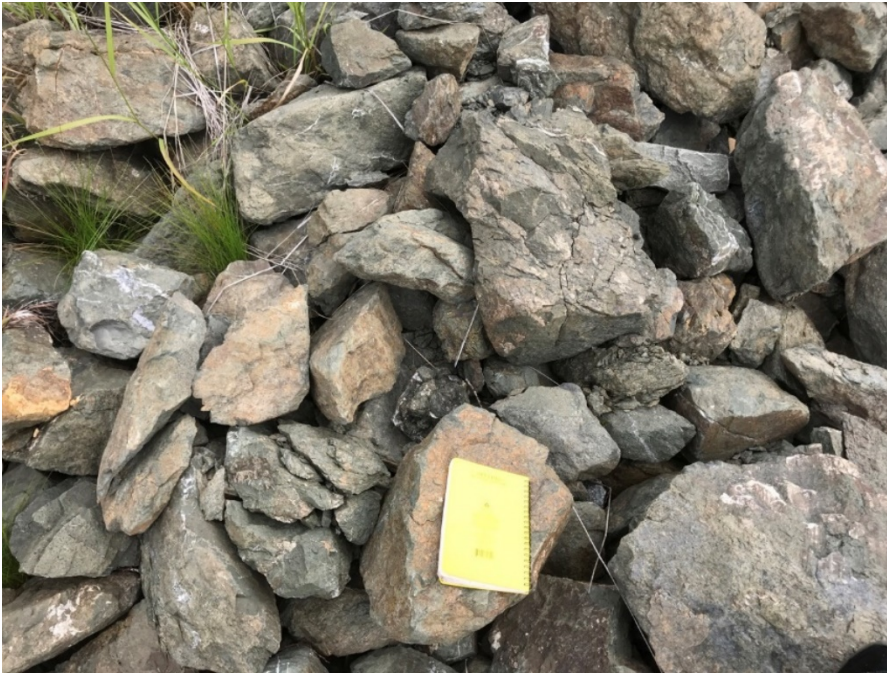
**Surface Erosion:** Ed Creek Diversion Channel was designed to convey the 1000-year flood event without erosion damage, but gradual weathering and breakage of the riprap has reduced its capacity.

A portion of the channel is approximately 10 m from the Tailings Dam, and damage to the riprap during an extreme flood event could initiate gradual erosion of the channel towards the dam. This is addressed through surveillance and maintenance, and erosion would not be allowed to progress to the point where it undermines the dam toe. Options for remediating the channel are also being investigated, including replacing the riprap and possibly realigning the channel away from the dam.

**Photo II-35** Ed Creek Diversion Channel – Riprap on right bank, showing weathering and breakage.

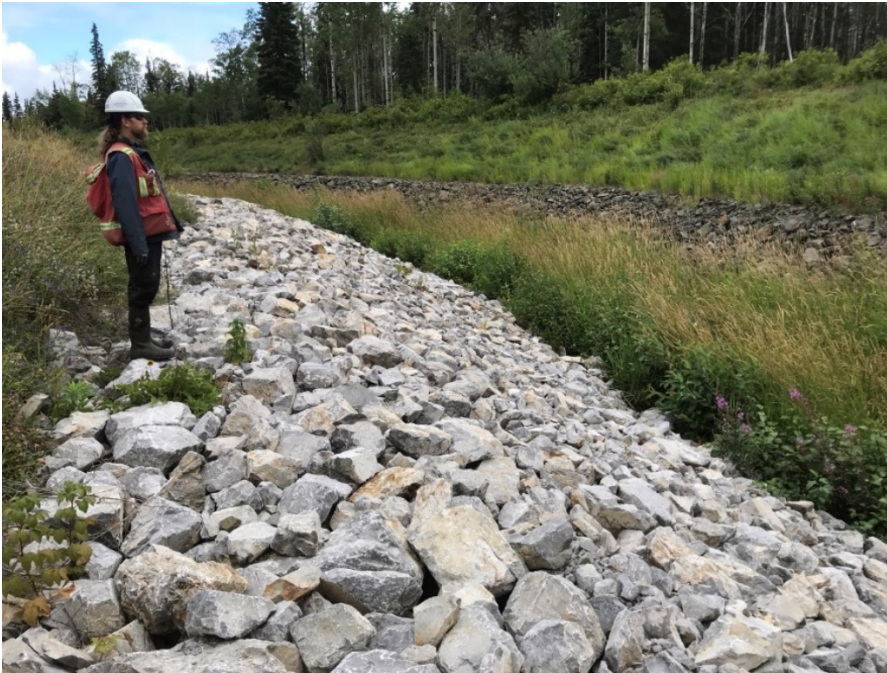
The riprap along a small section of the channel (Location 6 in Figure 4.1; Photo II-39), where a depression had formed in the riprap surface, was replaced in 2014. This riprap appeared to be in good condition.

**Photo II-39** Ed Creek Diversion Channel – looking upstream from near second bend. Light coloured area of riprap was replaced in 2014 and is in good condition.

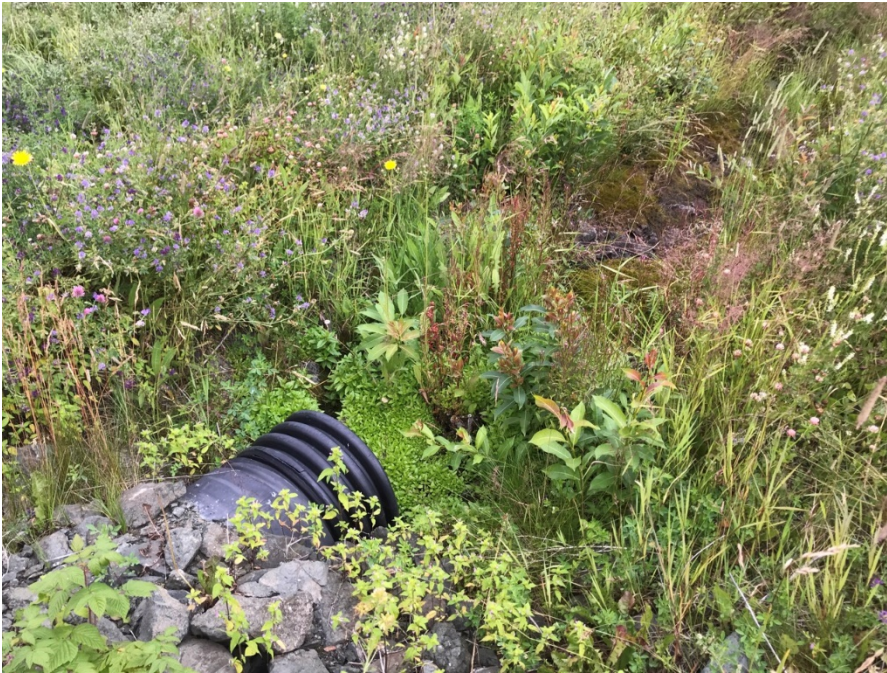
**Photo II-45** Inlet of 460 mm culvert on north bank of Ed Creek Diversion Channel. There is minor vegetation upstream of the inlet.

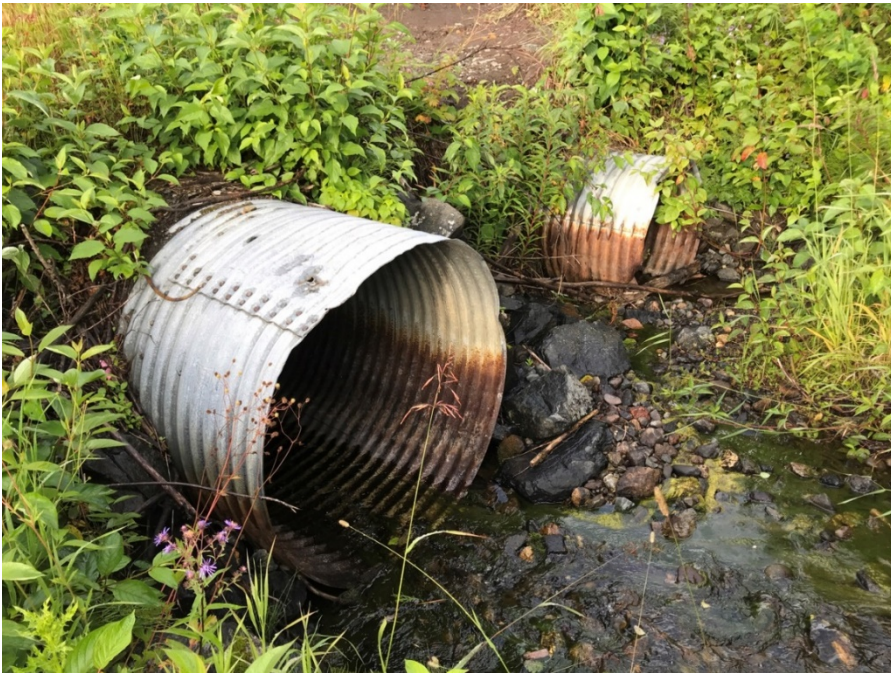
- There are two culverts on Ed Creek under Pinchi Lake Road east of the mine gate (see Figure 1.2 for location). Flow was observed in the east culvert only, with a depth of 70 mm at the inlet.
- There was no vegetation in front of the culvert inlets (Photo II-47).
- A ditch had recently been excavated along Pinchi Lake Road near the culvert inlets (Photo II-49).

**Photo II-47** Inlet of Ed Creek culverts under Pinchi Lake Road. Note only one culvert is flowing.

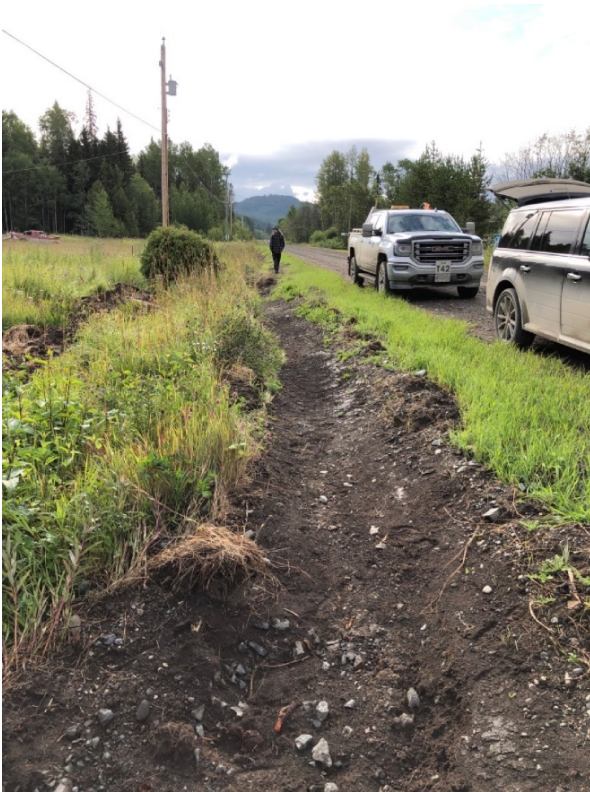
**Photo II-49** Looking east from near upstream end of Ed Creek culverts under Pinchi Lake Rd. Note new ditch excavated along the road.

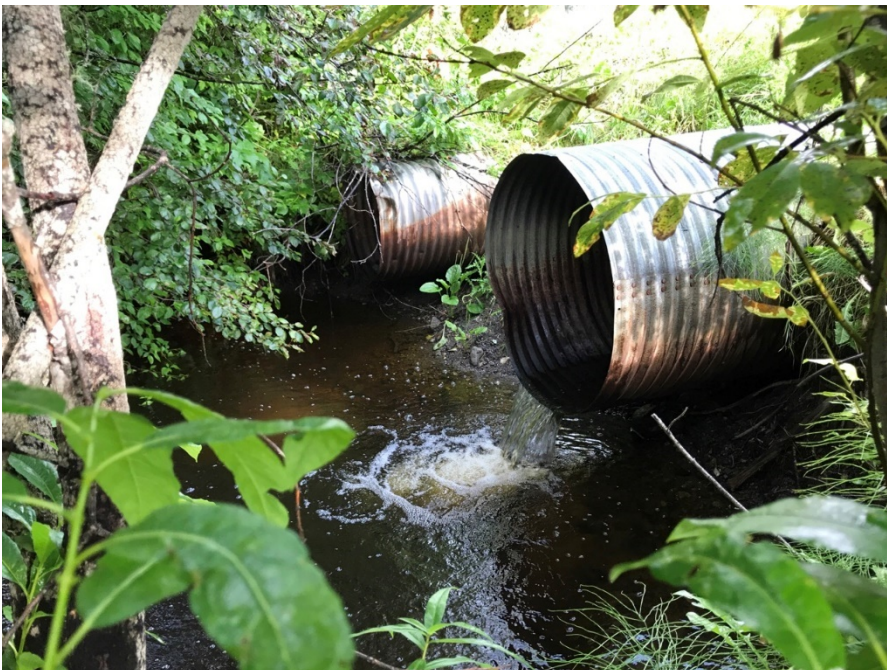
**Photo II-50** Outlet of Ed Creek culverts under Pinchi Lake Road. Note only one culvert is flowing.
