REPORT 2020 Annual Inspection

Pine Point Tailings Impoundment Area, Pine Point, NT

Reference No. 20140895-279-R-Rev0-1000

16 December 2020

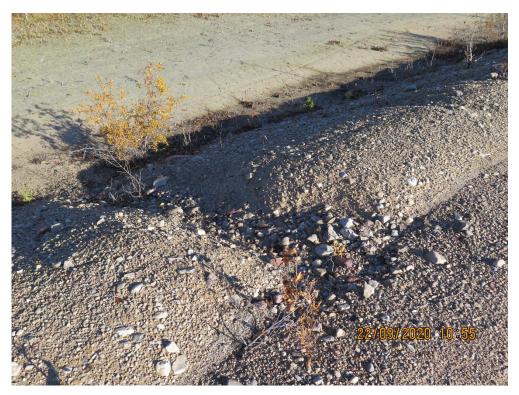
Photograph 2: South Dyke - East End – Erosion Rills on Upstream Slope, Looking Northeast, 22 September 2020

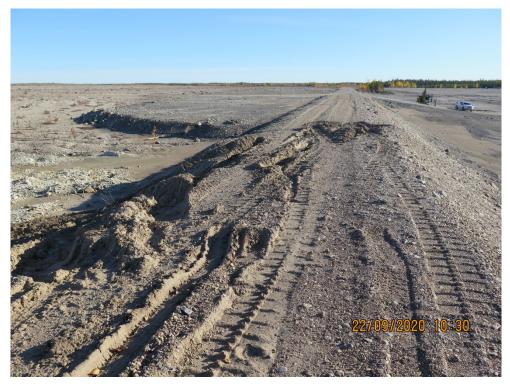
- The east dyke had rills up to 15 cm deep on the upstream and downstream slopes.
- The dam crest had local rutting due to vehicle traffic
 - Ruts on the crest of the south dyke between the two access ramps were repaired on 22 September 2020

Photograph 4: South Dyke – Central Portion - Damage to Crest and Upstream Slope, Looking East, 22 September 2020 (Repaired same day)

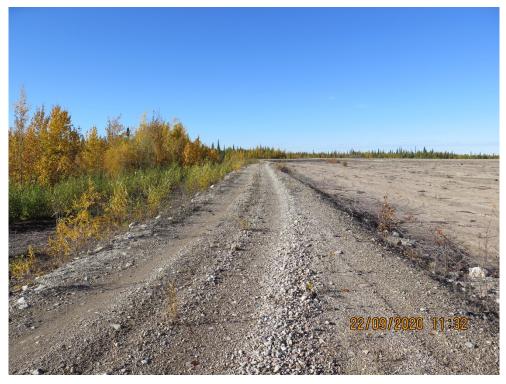
Photograph 5: South Dyke –West End - Crest with Vegetation on Downstream Slope, Looking West, 22 September 2020

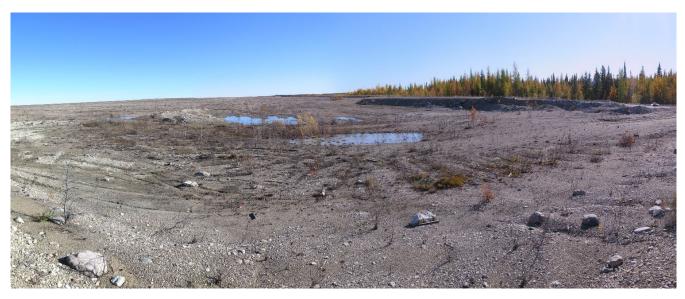
Photograph 8: West Dyke – South End - Ponding in Impoundment, Looking Southeast, 22 September 2020

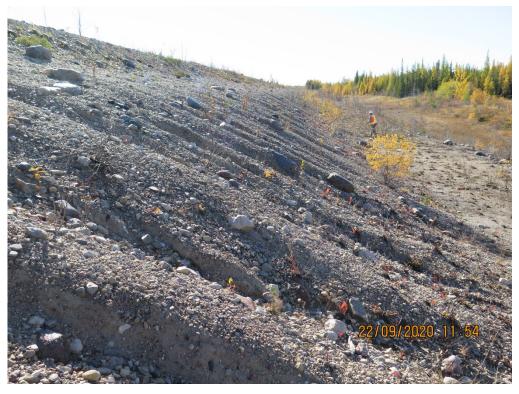
Photograph 9: West Dyke – Central Area - Downstream Slope with Erosion Rills, Looking South 22 September 2020

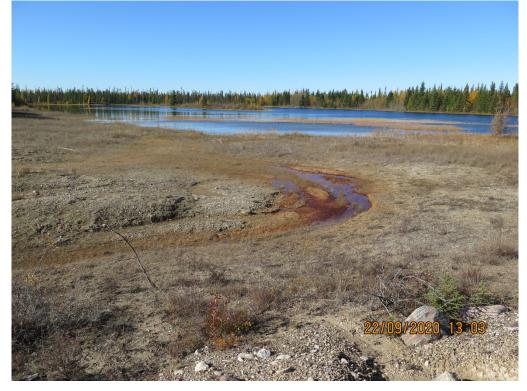
Photograph 10: West Dyke – North End - Downstream Toe Area with Staining Along Drainage, Looking West, 22 September 2020

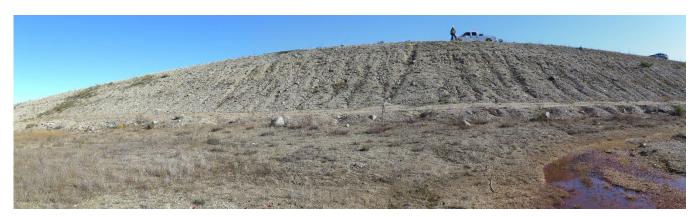
Photograph 11: West Dyke – North End - Downstream Slope with Erosion Rills, Looking East, 22 September 2020

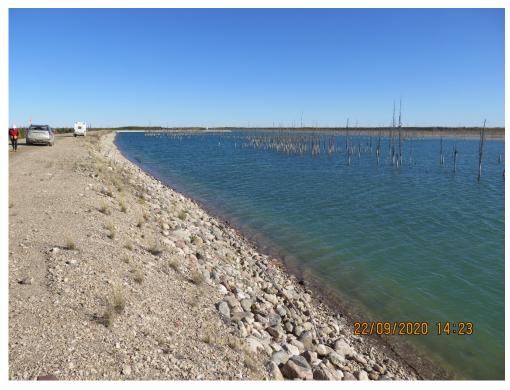
Photograph 17: North Dyke – Upstream Slope, Repaired with Riprap, Looking East, 22 September 2020

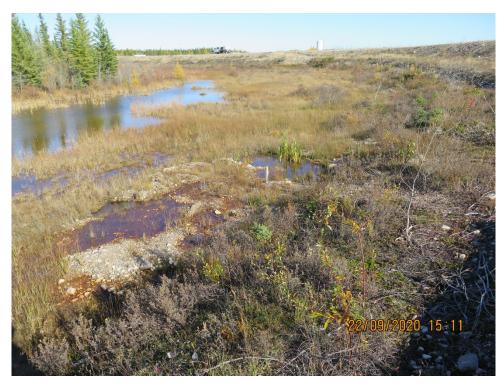
Photograph 20: North Dyke – Downstream Toe Area at Dogleg, Seep and Red Staining, Looking East, 22 September 2020

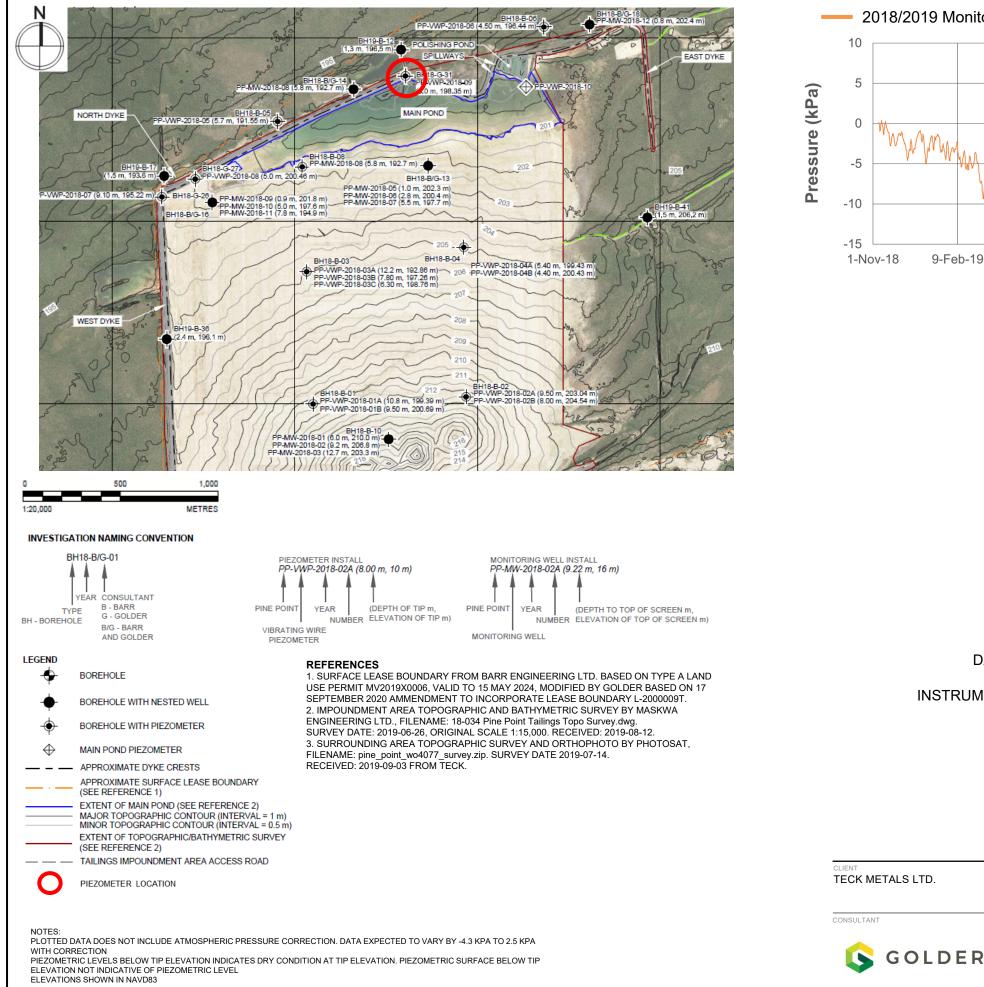
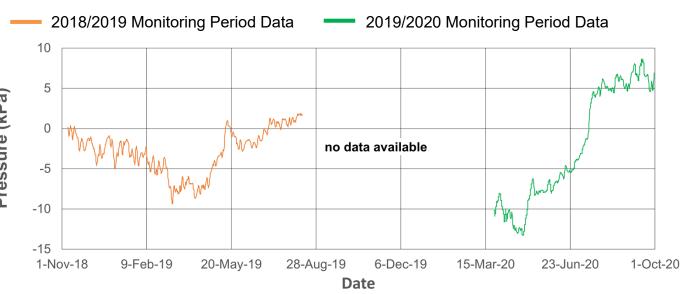
INSTRUMENT REQUIRES CHECK FOR FUNCTIONALITY / CALIBRATION

DATA INDICATES VWP IS DRY AT ELEVATION 198.35 m

Readings from PP-VWP-2018-01B, 02A, 02B, 05, 08 and PP-VWP-2018-09 were considered unreliable due to possible malfunction. The instruments are planned to be reviewed and trigger-action-response-plans (TARPs) developed for the TIA. Any malfunctioning instrument required for a TARP shall be repaired or replaced.
