Quintette Coal Operations

2020 Annual Summary of Tailings Facility Performance

Plantsite Tailings Dam and Plantsite Seepage Collection Pond Dam

March 2021

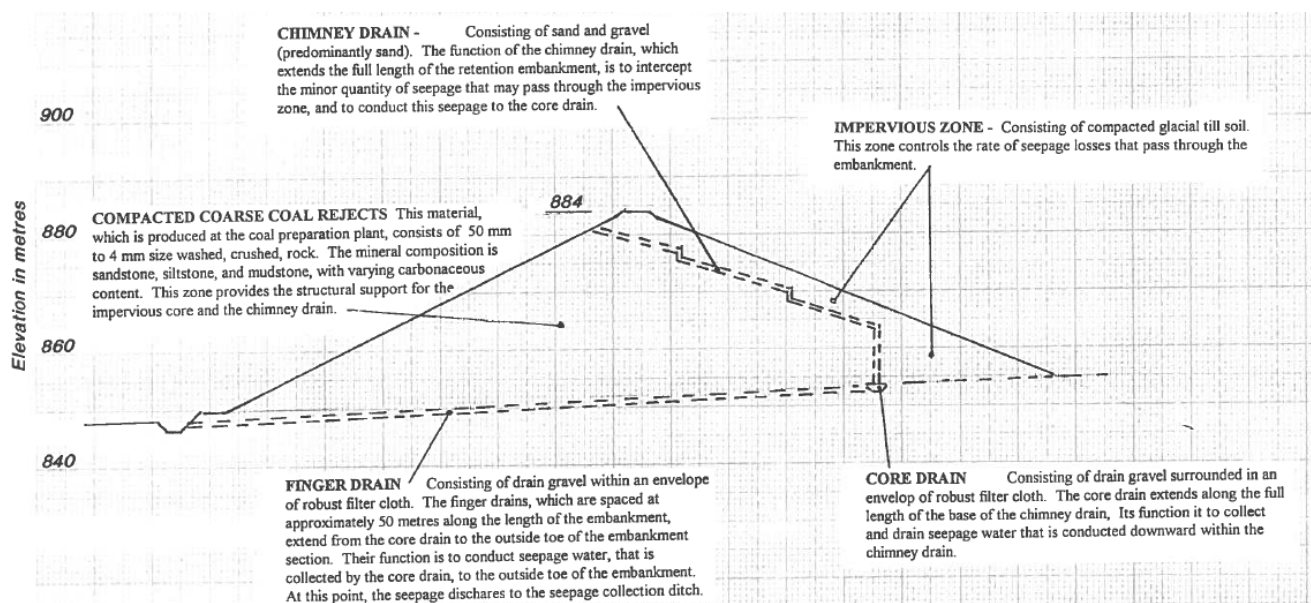
Figure 2.2 Typical Section of PTD Ultimate Embankment (QOC 1997)

The PTD was raised in a downstream configuration with compacted coarse coal rejects (CCR) between 1983 and 1995. The chimney drain and upstream glacial till zone were raised with each crest raise between the glacial till and CCR. The glacial till zone has a minimum thickness of 3.5 m, measured perpendicular to the upstream face (Golder 1988). The overall downstream slope is 2H:1V. The upstream slope was built at 2.5H:1V to El. 878 masl and 2H:1V to the ultimate crest (KCB 2015a). A typical cross-section of the ultimate embankment is shown on Figure 2.2.

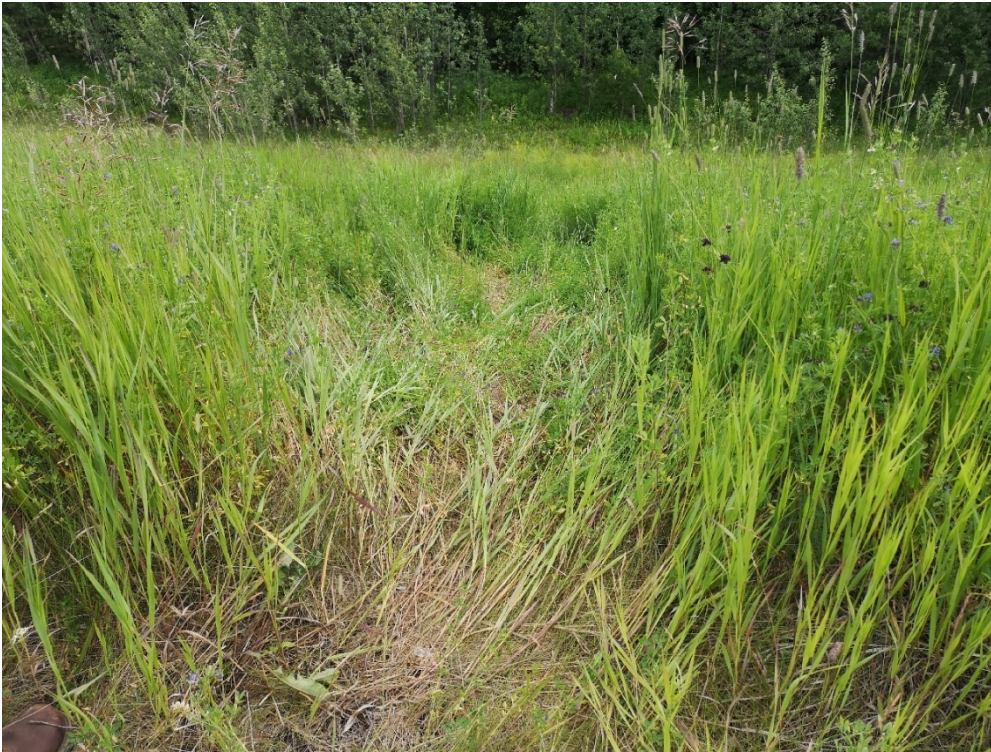
Photo I-26 Small depression, potential animal activity (PTD-2020-11)

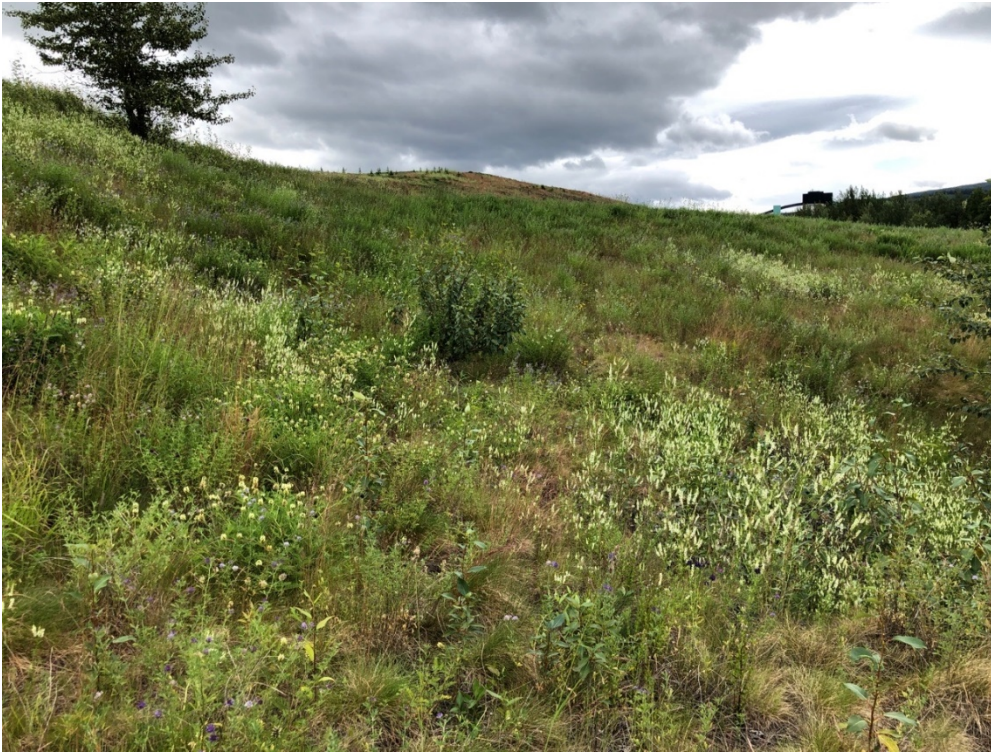
Photo I-33 Ponded water in low spot at toe of dam (PTD-2020-14)

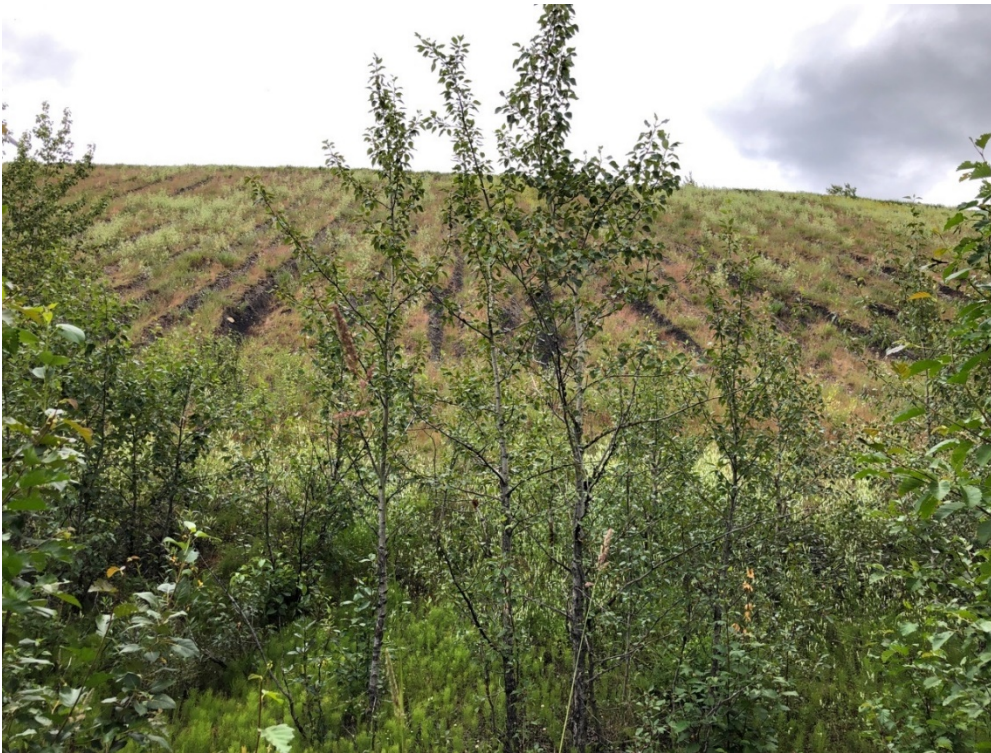
On-going rill erosion has been observed on the slope of the PTD since operations ceased. Monitoring of rill erosion has been done as part of routine monitoring, by comparing photographs from select locations since 2016. Rill monitoring locations and photographs are included in Appendix II. Based on comparison of photographs and previous annual performance reports, changes in the rill erosion of the downstream slope have been negligible since 2011. The rills do not represent a dam safety concern; rather, they represent a maintenance issue that will need to be resolved as part of developing long-term closure plans for the facility.

Photo I-37 Minor rilling along downstream slope. Refer to Appendix II for specific rill monitoring photos (PTD-2020-17)

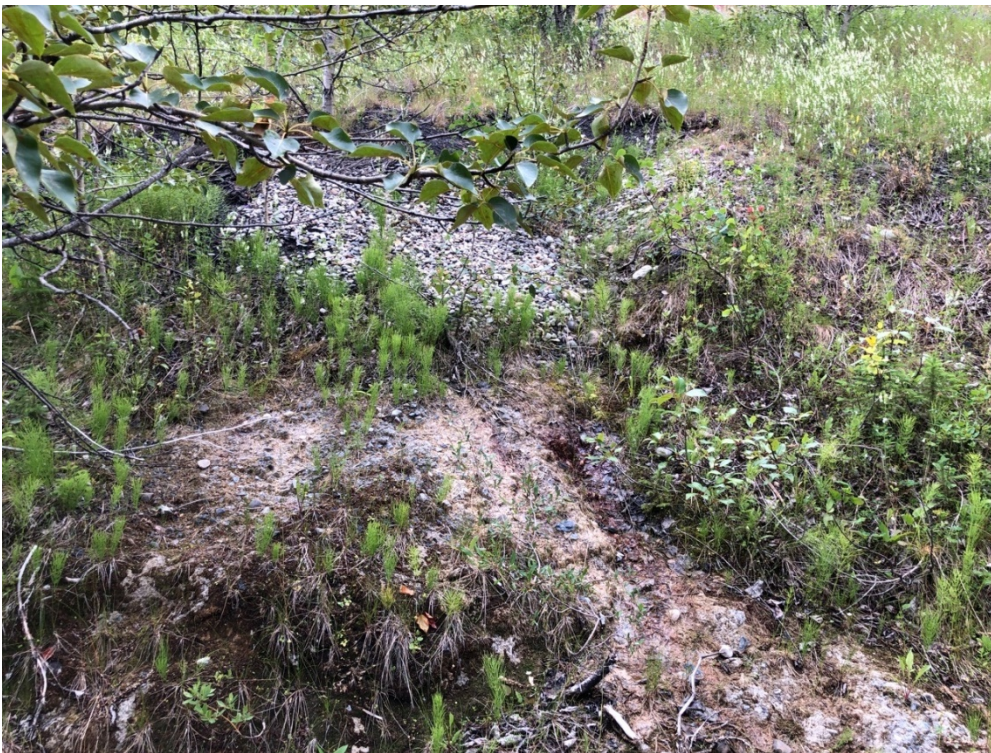
Photo I-39 Finger drain, no flow (PTD-DRAIN-02)

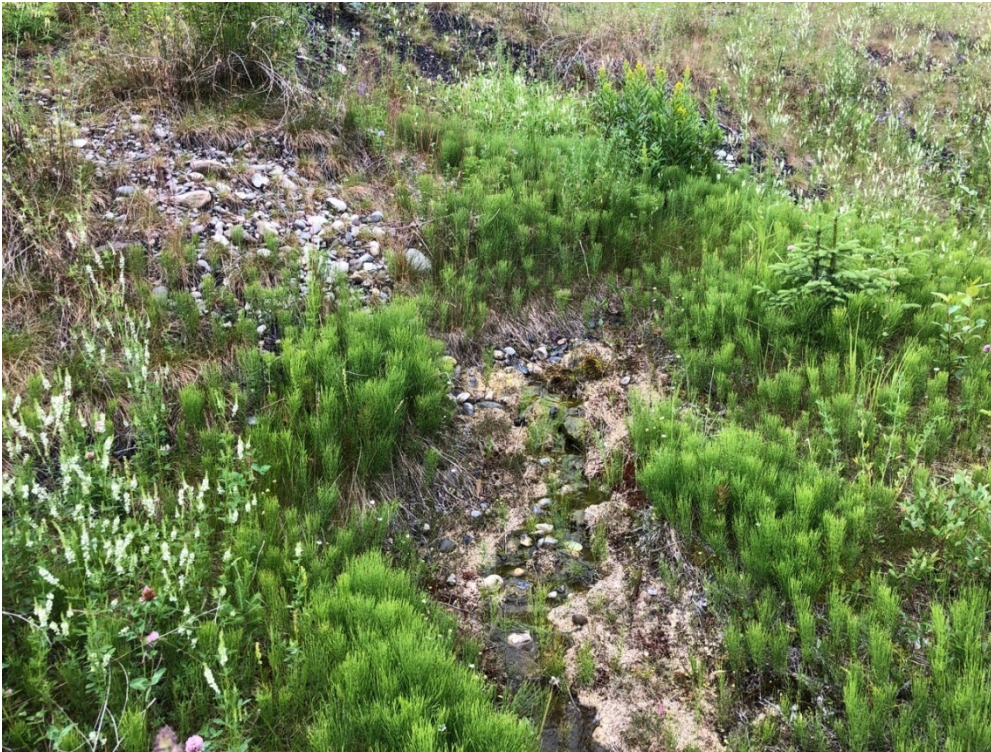
Photo I-40 Finger drain, low flow (<1 L/s) (PTD-DRAIN-03)

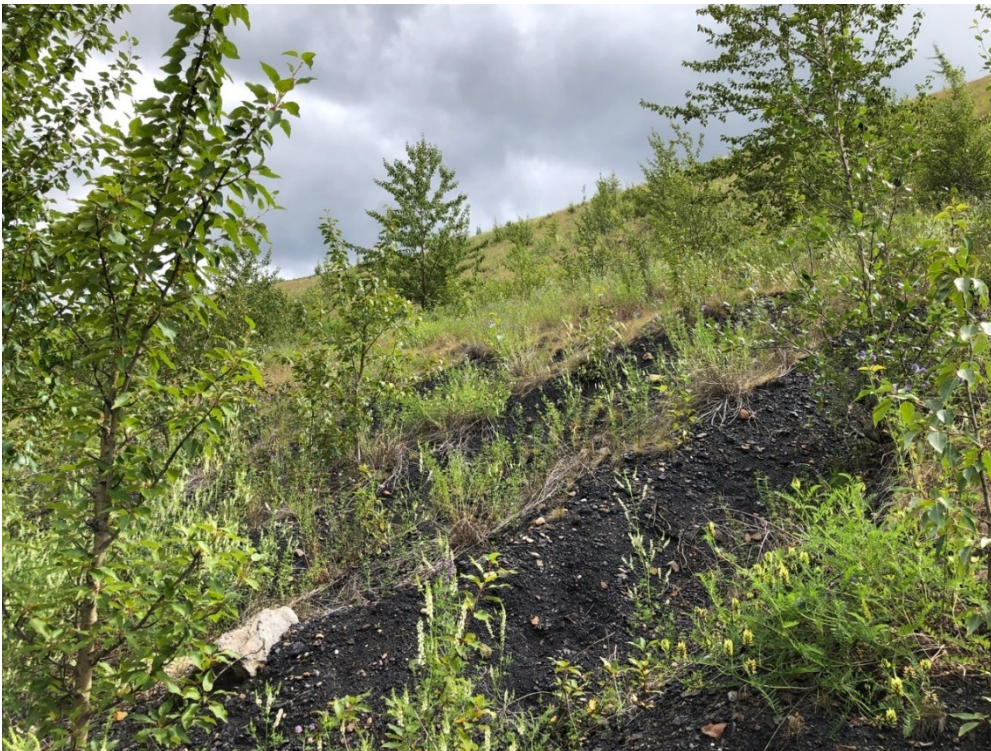
Photo I-46 Finger drain, some seepage observed (PTD-DRAIN-11)

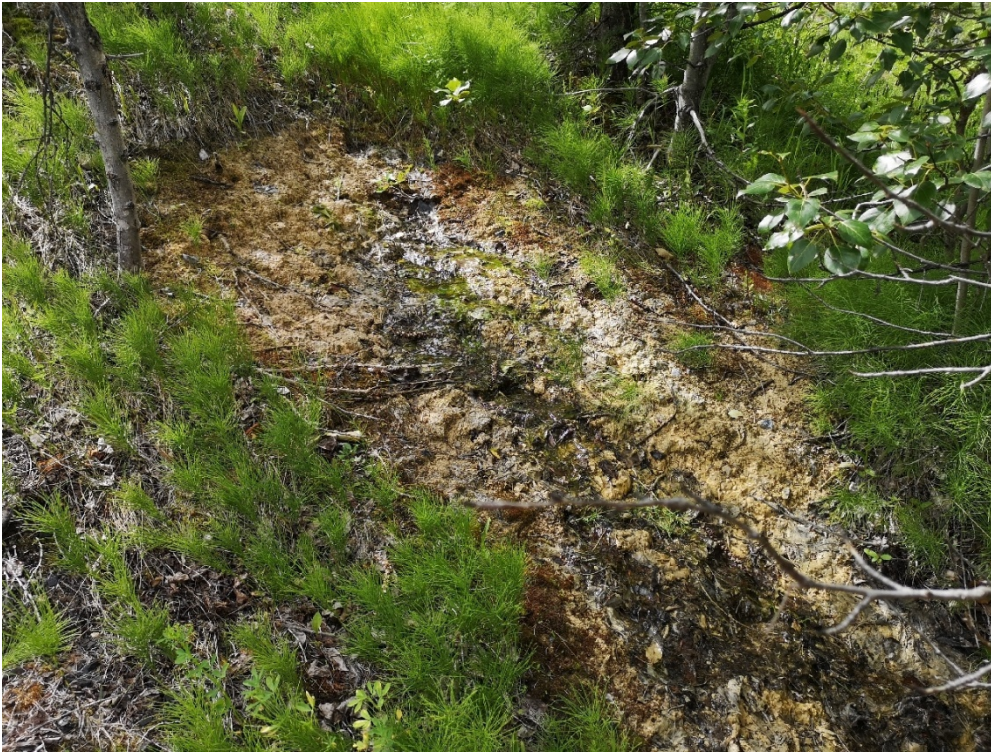
Photo I-47 Finger drain, no seepage (PTD-DRAIN-12)

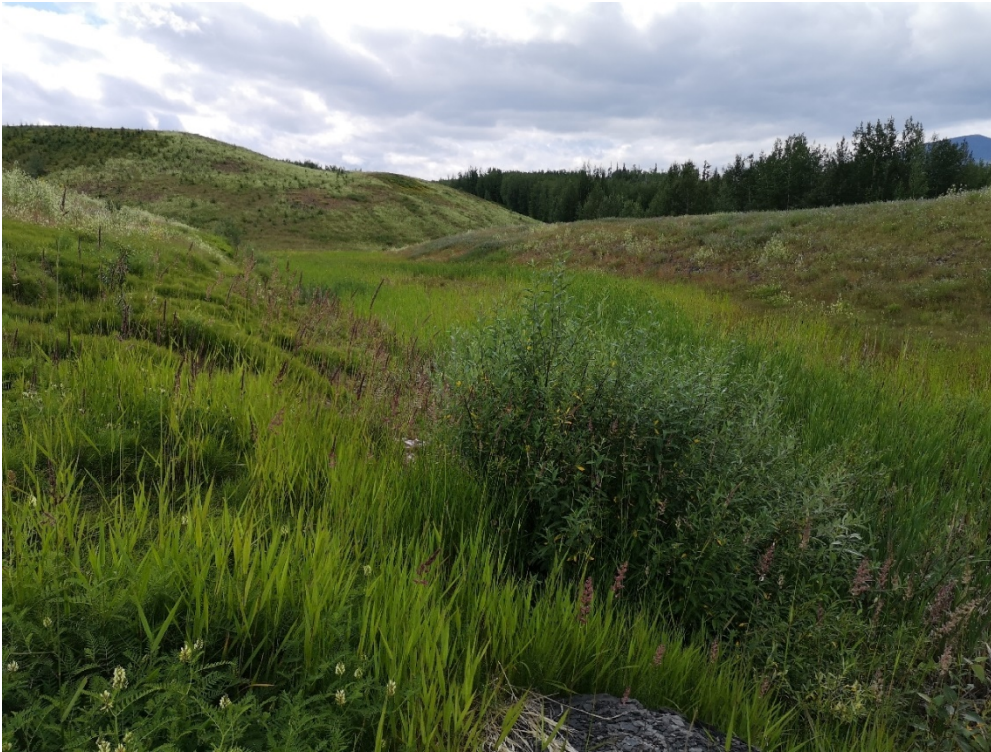
Photo I-81 Closure Spillway channel, some seepage (PTD-2020-28)
