RE: 2020 Periodic Safety Inspection
Tailings Back Dam (NID ID#AK00303)
Red Dog Mine

**2020 Periodic Safety Inspection
Tailings Back Dam (NID ID#AK00303)
Red Dog Mine
Northwest Arctic Borough, Alaska**

NewFields Project No. 475.0433.000
November 2020, Revised February 2021

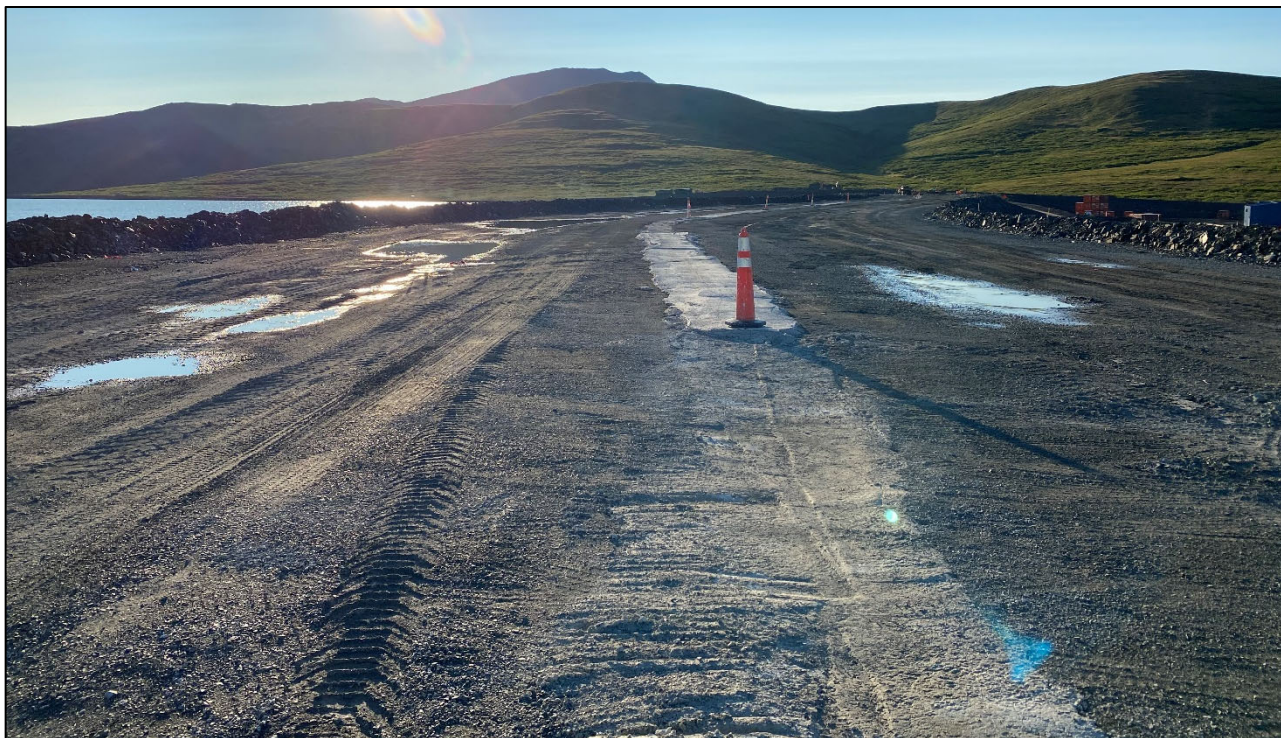
Similar to previous inspections, the embankment is in good condition. The crest and upstream slope were generally smooth and relatively uniform or under construction at the time of the inspection (Photos 01 through 06). Although there were minor amounts of ponded water on the crest of the embankment as a result of recent rainfall, these pools and general grading of the area are not a concern. Wave erosion of the upstream slope was minimal (Photo 07), and no areas of concern were identified. The downstream slope of the embankment was smooth and uniform with no signs of slope deformation or instability (Photos 08 through 10). Ponding of

Photograph 01: TBD crest, near Sta. 25+00 (looking east)

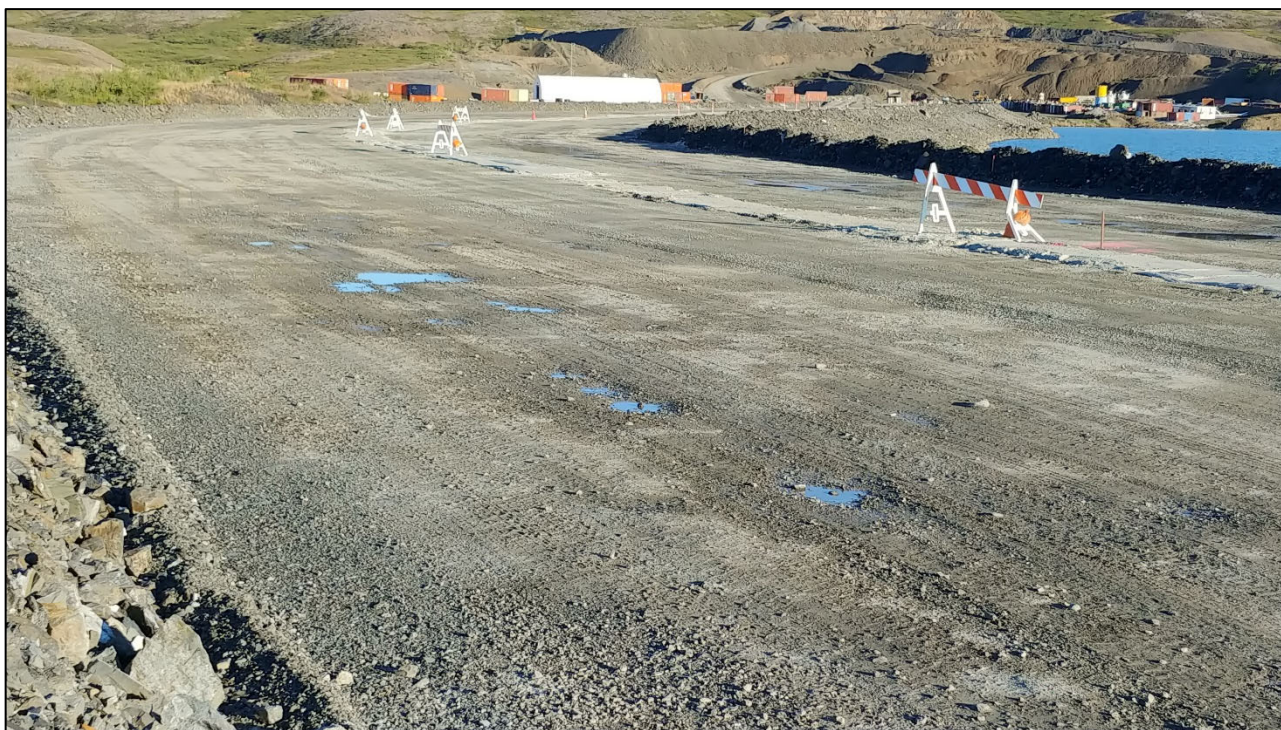
Photograph 02: TBD crest, near Sta. 22+50 (looking northwest)

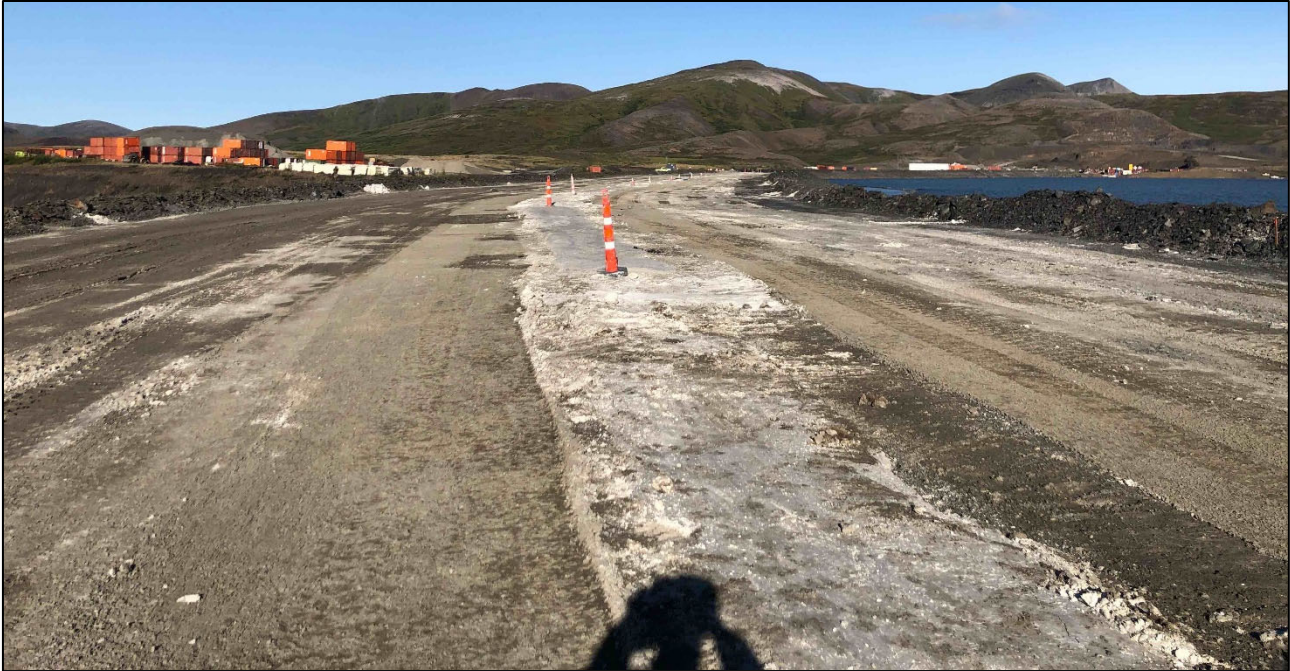
Photograph 03: TBD crest, near Sta. 26+00 (looking west)

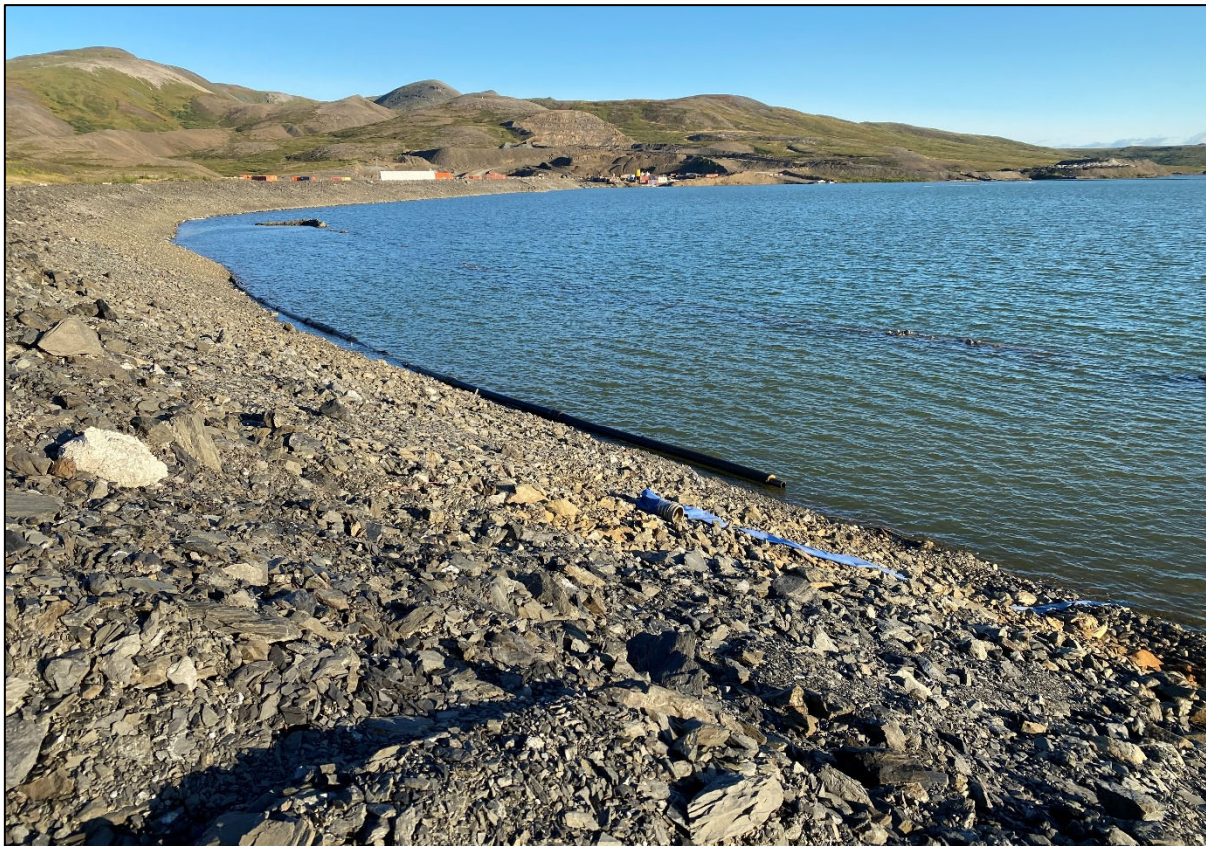
Photograph 04: Upstream slope (looking northwest)

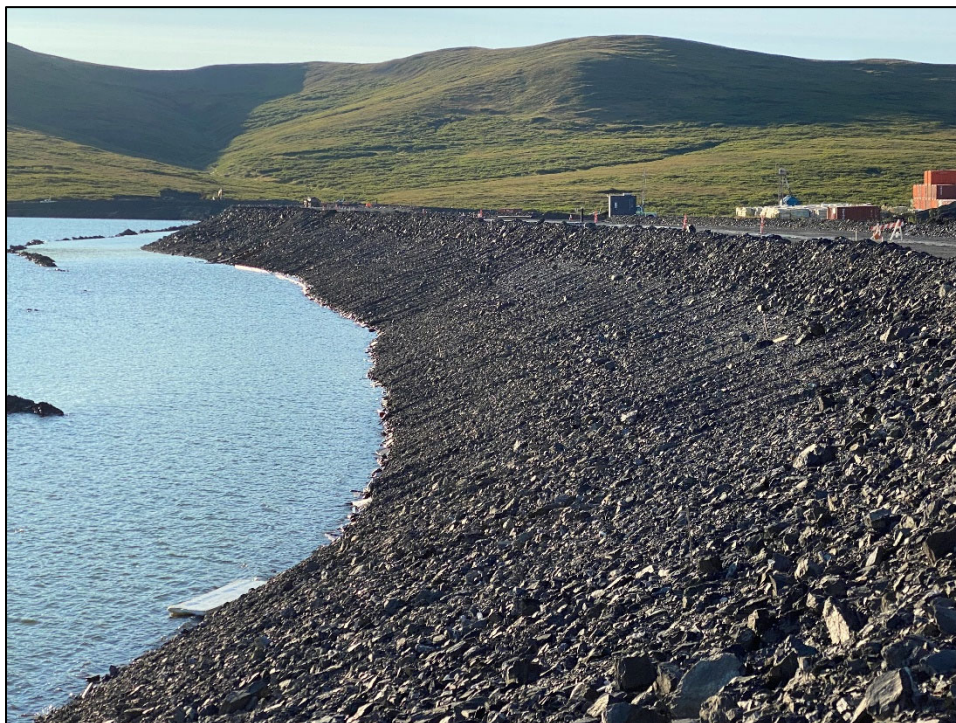
Photograph 05: Upstream slope (looking east)

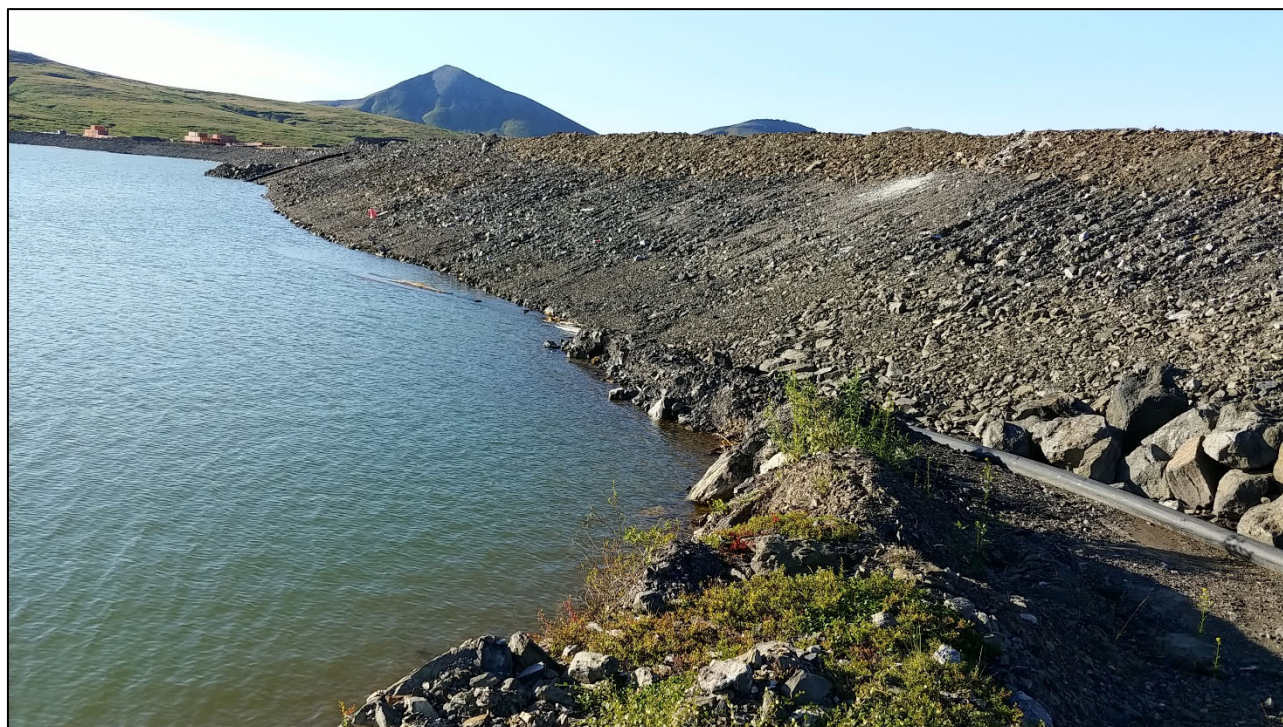
Photograph 06: Upstream slope near Sta. 6+00 (looking southeast)

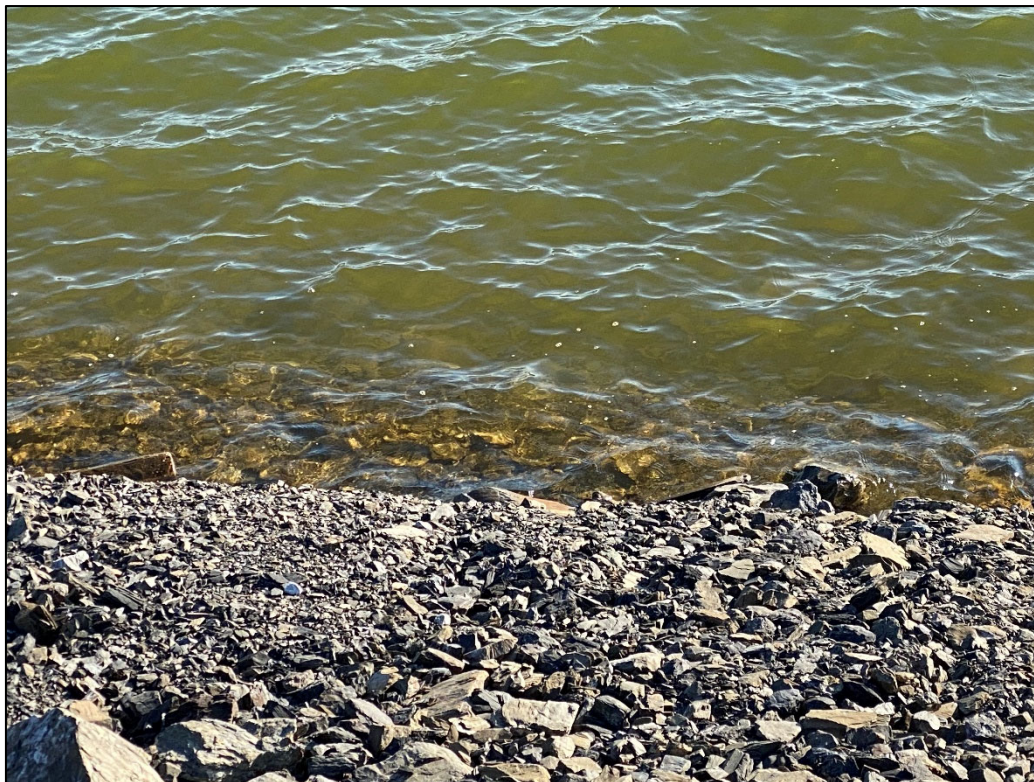
Photograph 07: Wave erosion on upstream slope

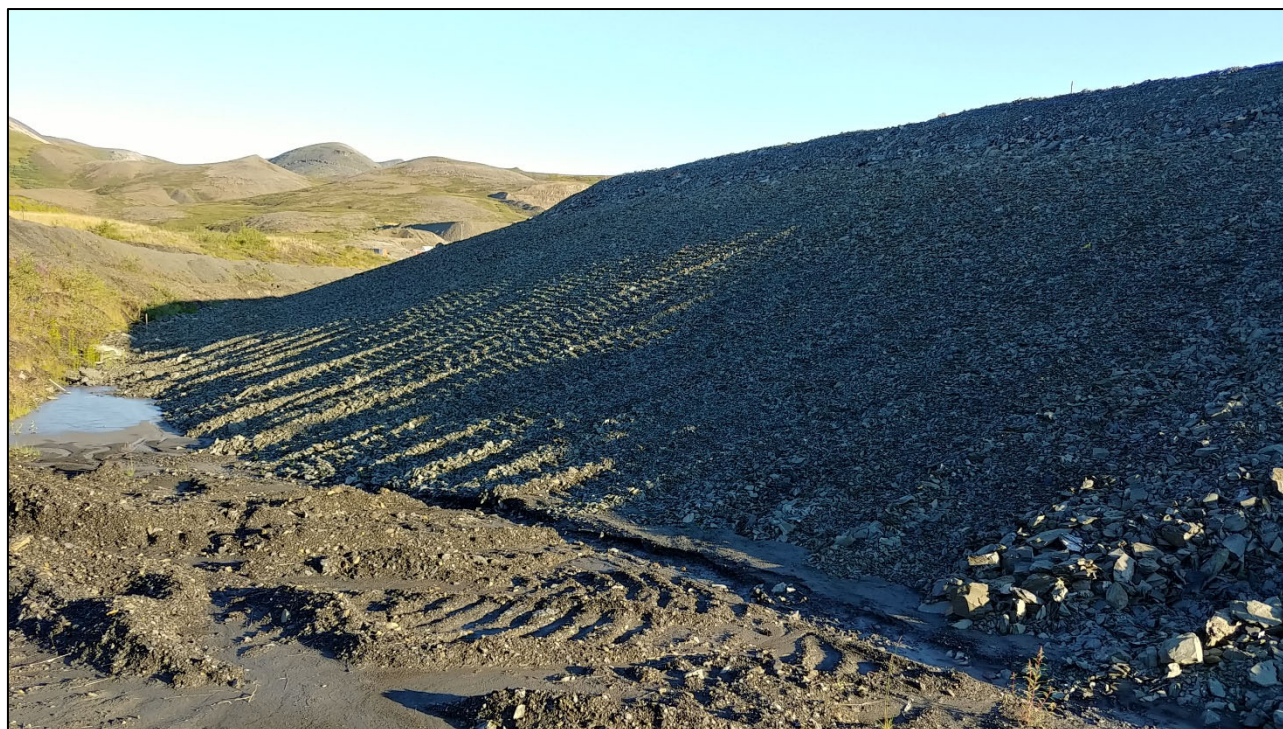
water was noted in several areas along the downstream toe (Photo 08), these areas were inspected and they appear to be the result of stormwater runoff and not seepage.

Photograph 08: Downstream slope near Sta. 22+50 (looking west)

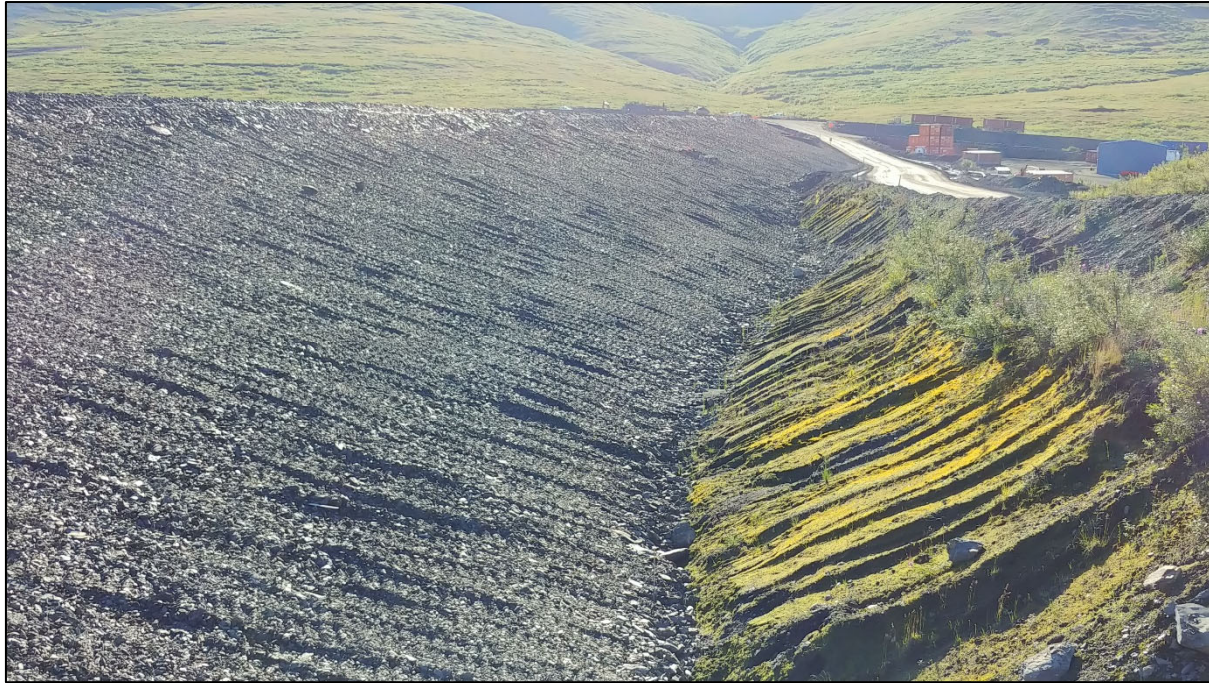
Photograph 09: Downstream slope near Sta. 27+00 (looking east)

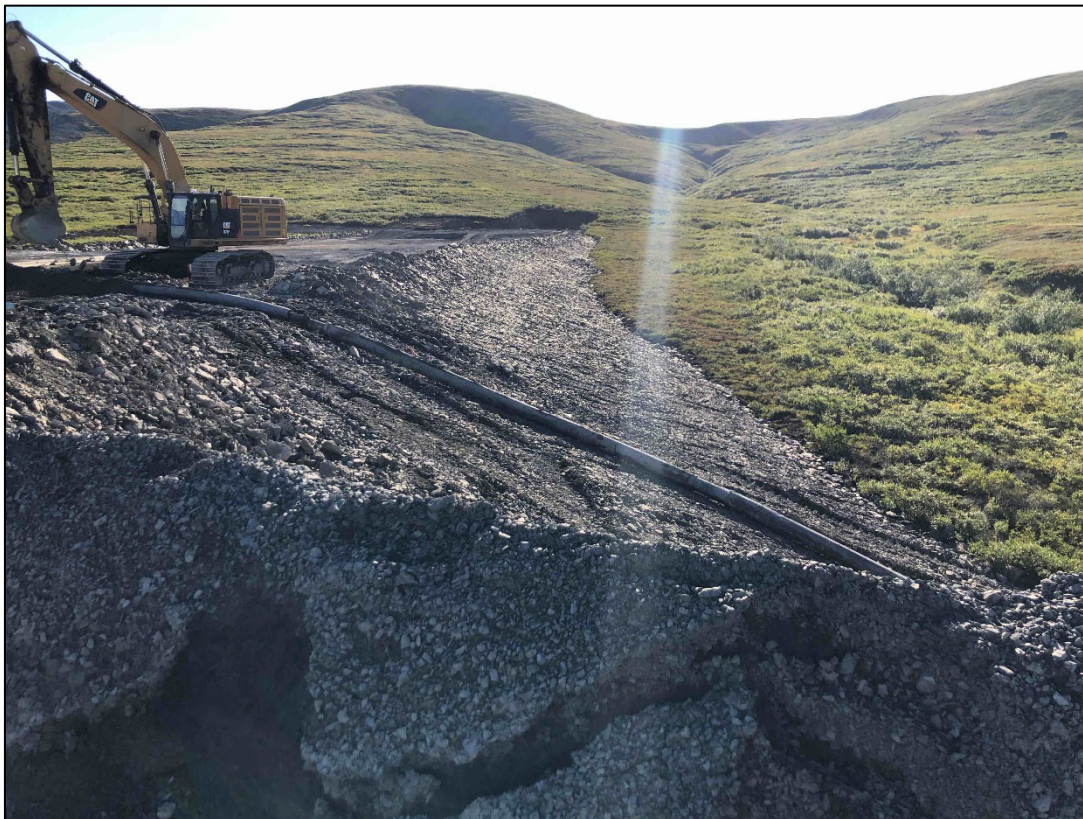
Photograph 10: Downstream slope near Sta. 42+50 (looking east)

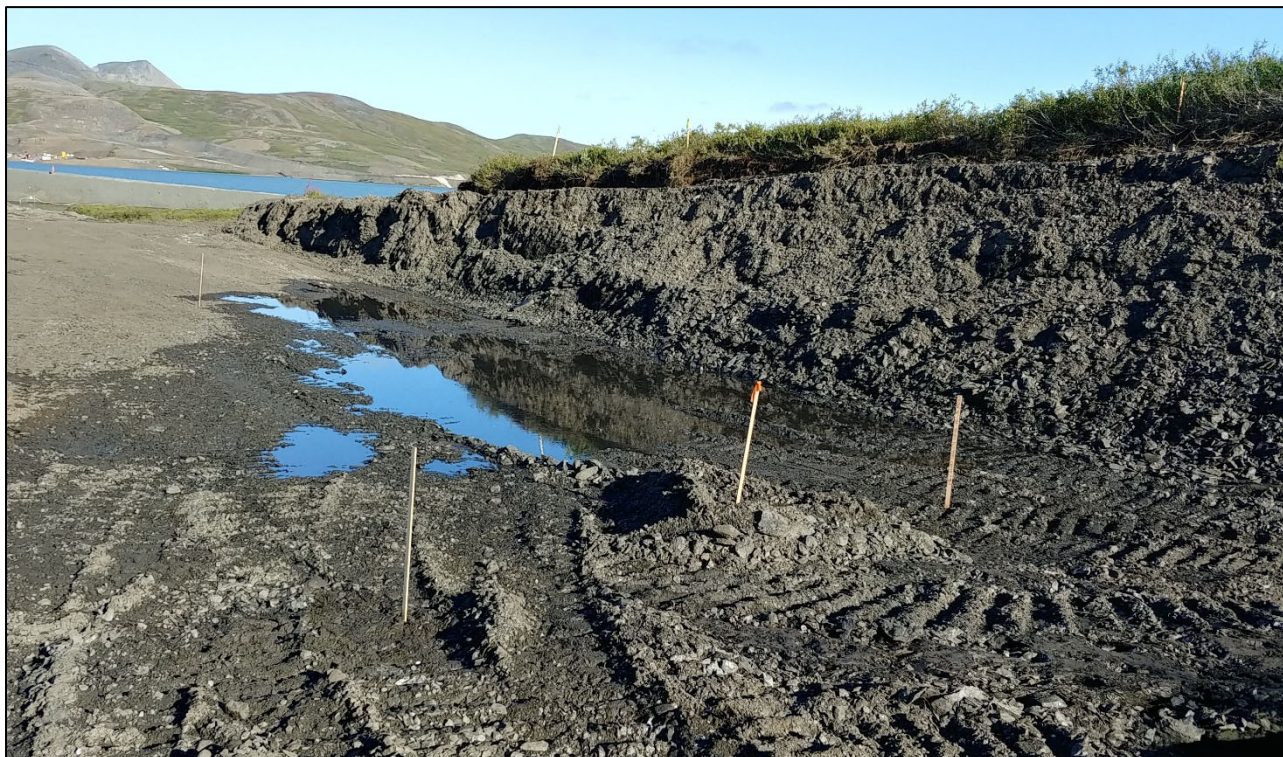
Photograph 11: East abutment excavation

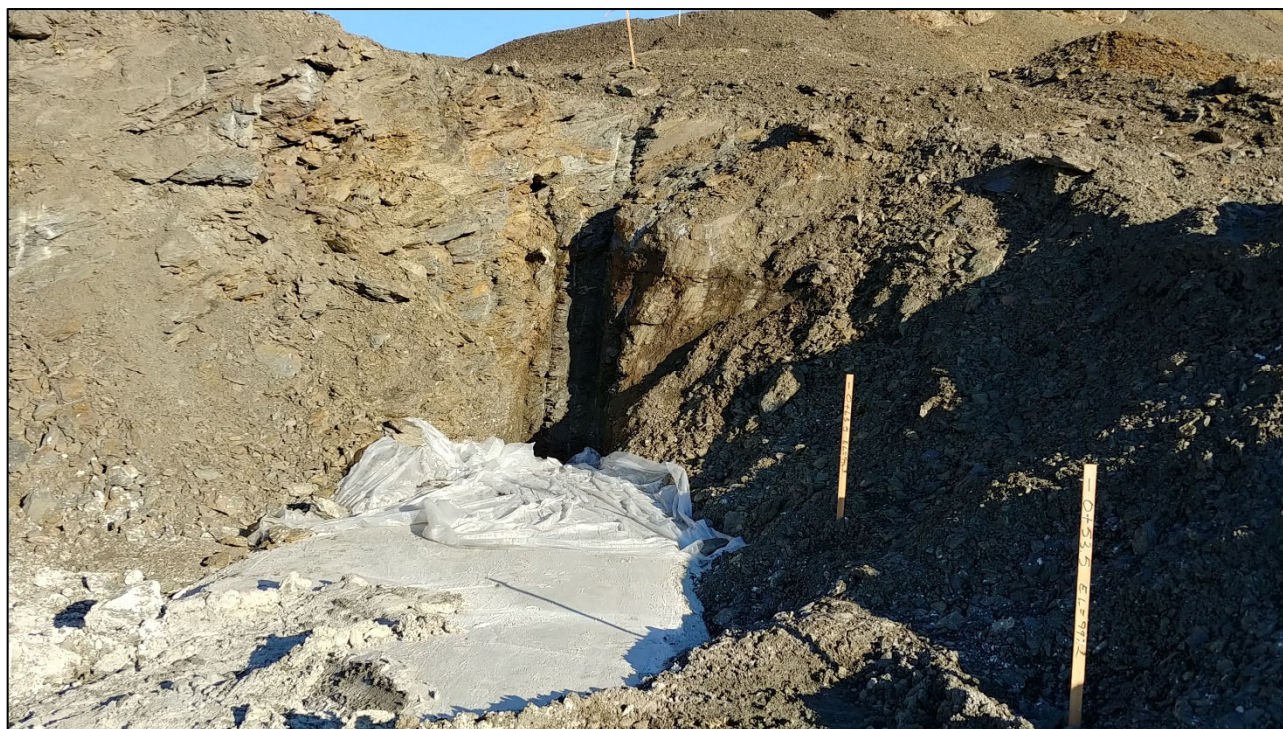
Photograph 12: West abutment excavation and cutoff wall excavation/construction

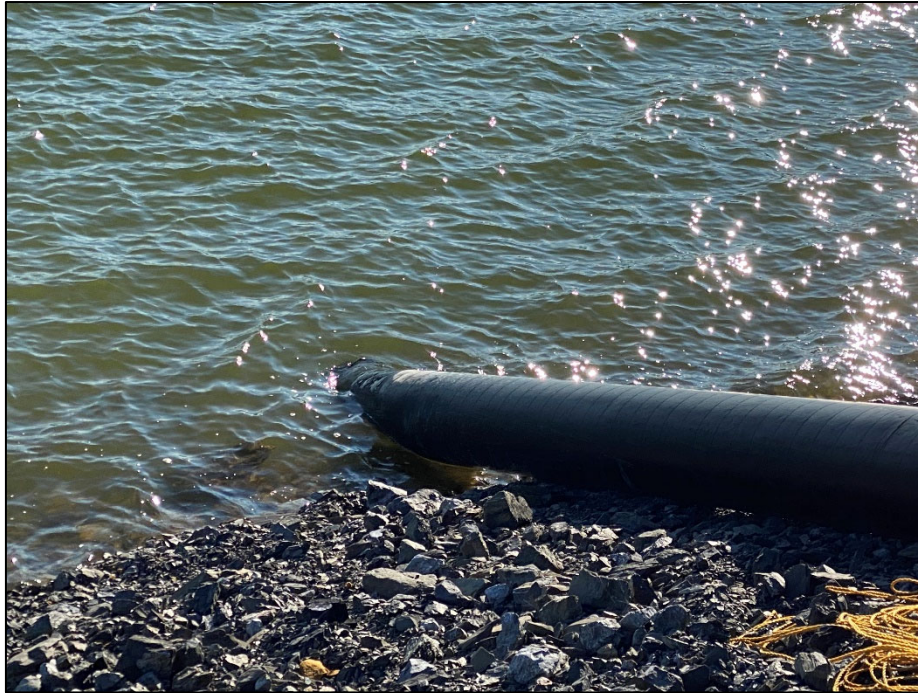
The seepage sump pump (Photo 14) was operating intermittently during the inspection as water levels within the sump triggered the level control switch. The discharge location of the seepage pump outfall was inspected, and no erosion of the upstream slope was noted. Similarly, no erosion was noted at the discharge location of the overburden stockpile pumpback discharge (Photo 13).

Photograph 13: Seepage return discharge pipe

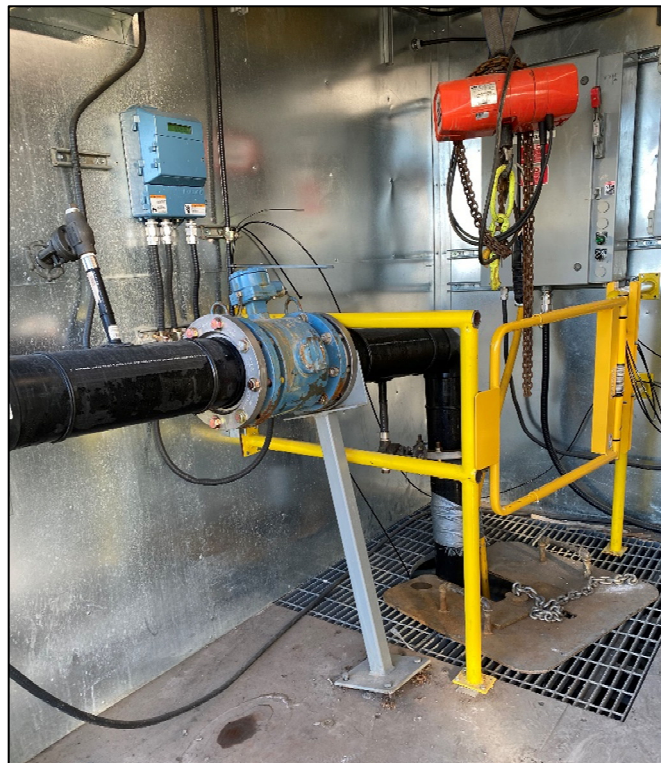
Photograph 14: Seepage collection sump pumphouse

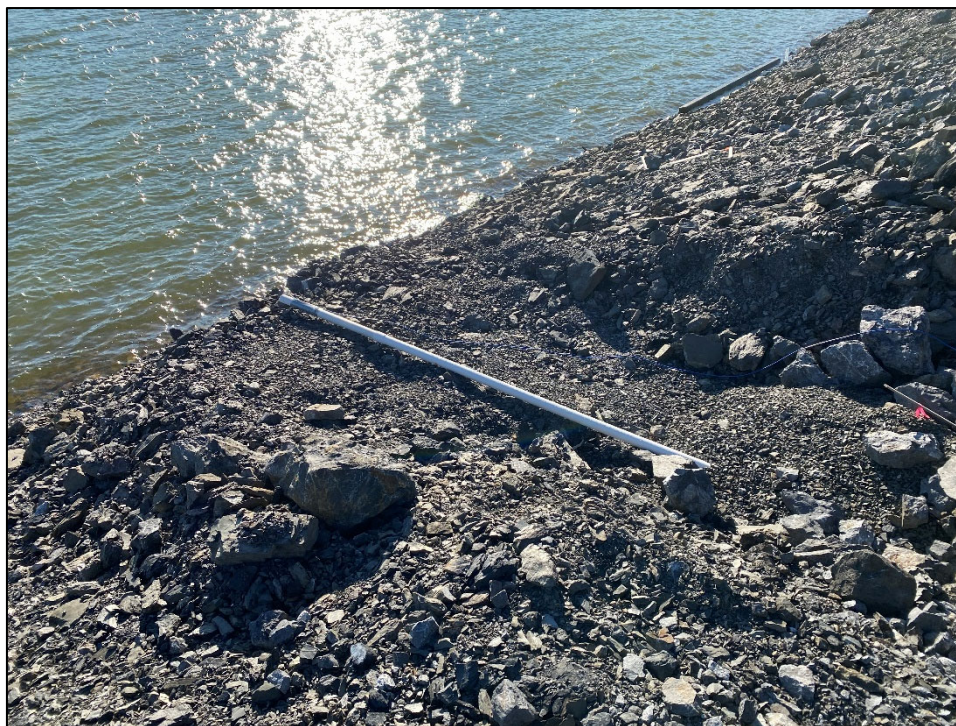
Photograph 15: Piezometer cable extension at upstream slope

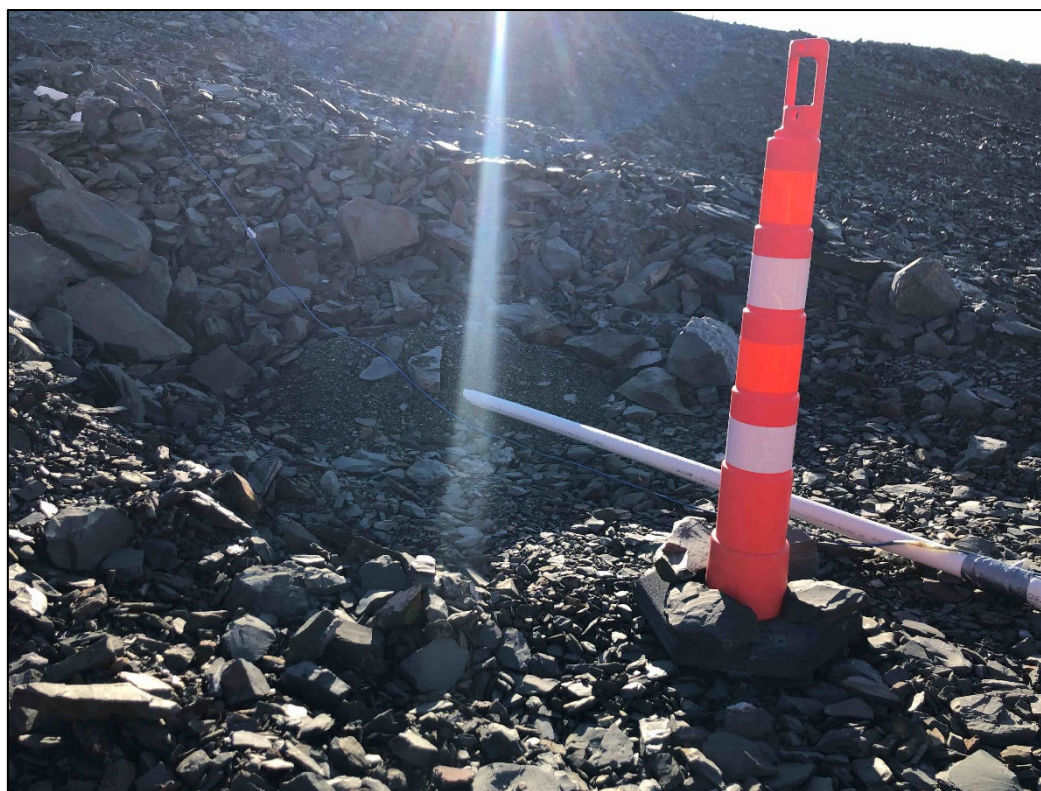
Photograph 16: Piezometer cable extension at downstream slope

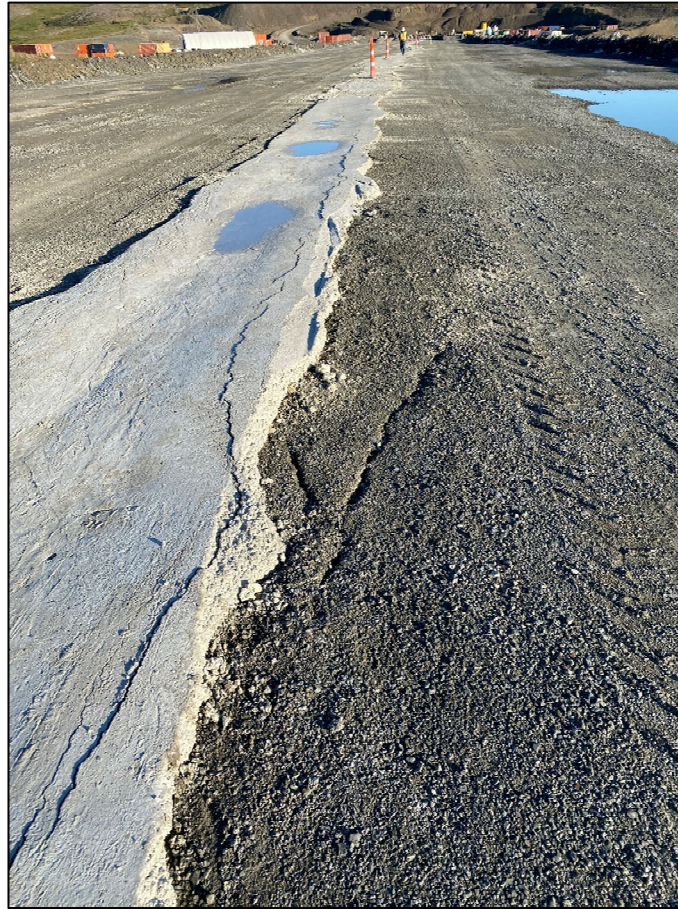
Active construction of the cut-off wall was not in progress during the inspection, but it was evident that recent activities had occurred. Cracks were noted at a few areas adjacent to the cut-off wall (Photo 17) as a result of the cut-off wall excavation. Based on our field observations of the cracks and on-going construction activities, we determined these features were construction related and not a result of a structural issue. There were cracks noted within the cut-off wall, perpendicular to the wall alignment, at several of the joints between primary and secondary wall panels (Photo 18). Based on discussions with Golder field personnel these are addressed during construction by excavating/removing the upper portion of the wall joint down to a depth where the crack is no longer visible and then backfilling with the plastic concrete. At the location where utilities and access road cross the embankment, the installation of the insulation layer was in progress during the inspection (Photo 19).

Photograph 17: Cut-off wall construction

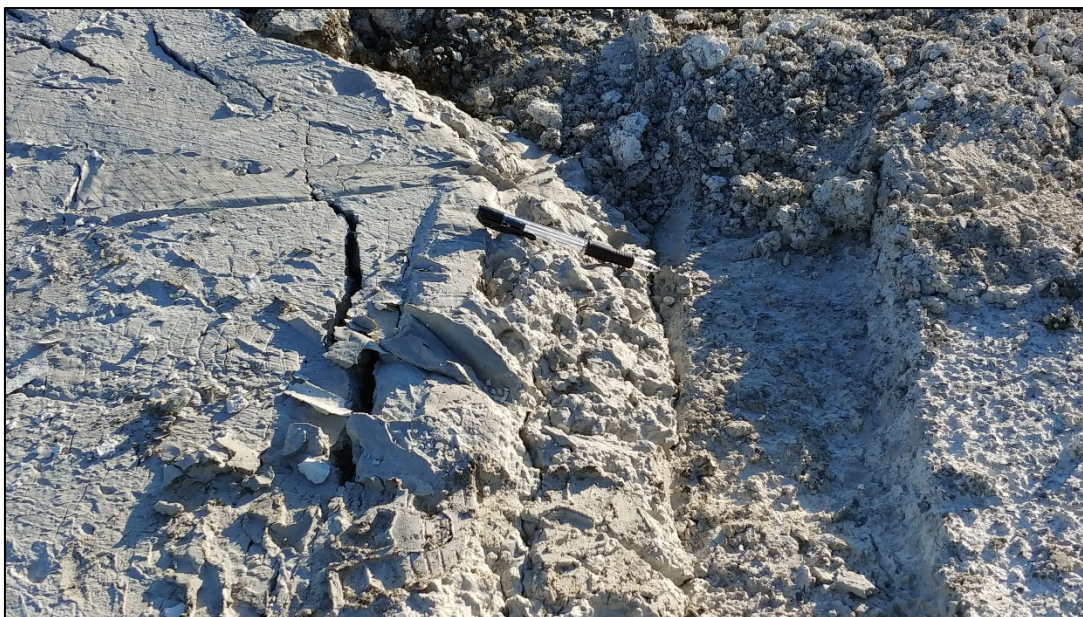
Photograph 18: Panel joint at cut-off wall (under construction)

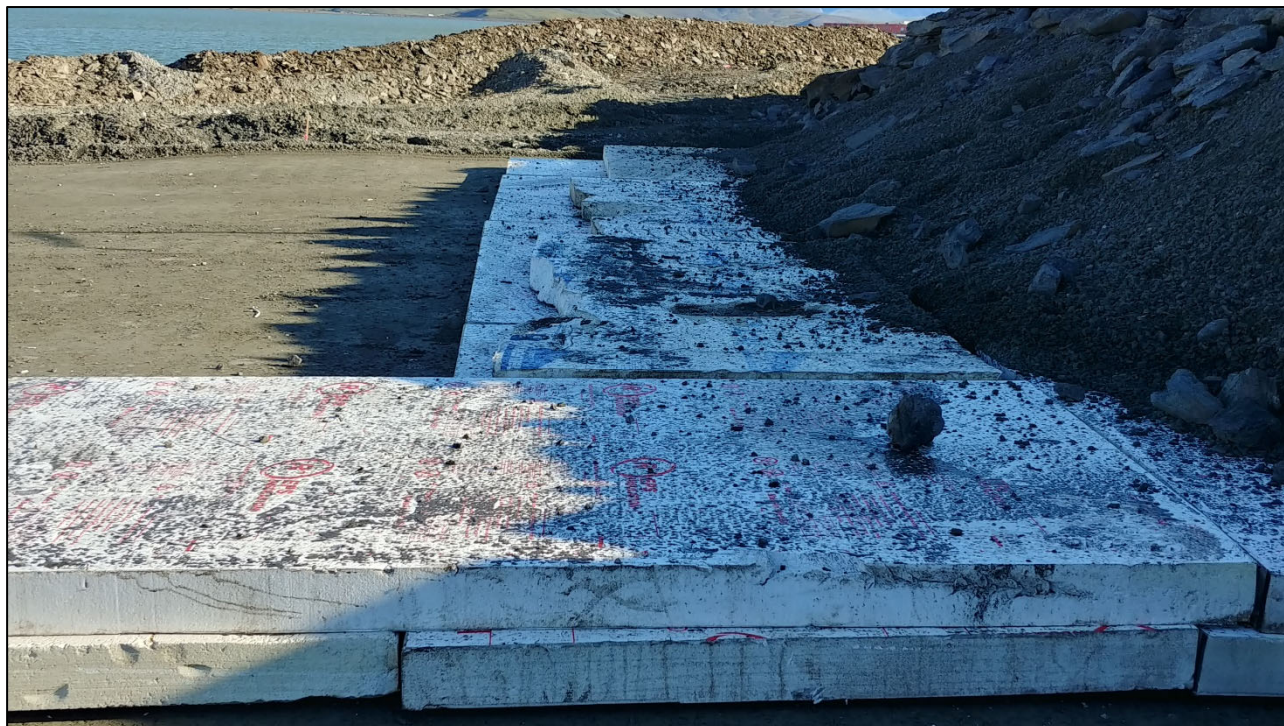
Photograph 19: Insulation installation at utility and road crossing near Sta. 42+50
