**RE:**     **2020 Periodic Safety Inspection**  
          **Tailings Main Dam (NID ID#AK00201)**  
          **Red Dog Mine**

**2020 Periodic Safety Inspection  
Tailings Main Dam (NID ID#AK00201)  
Red Dog Mine  
Northwest Arctic Borough, Alaska**

NewFields Project No. 475.0433.000  
November 2020, Revised March 2021

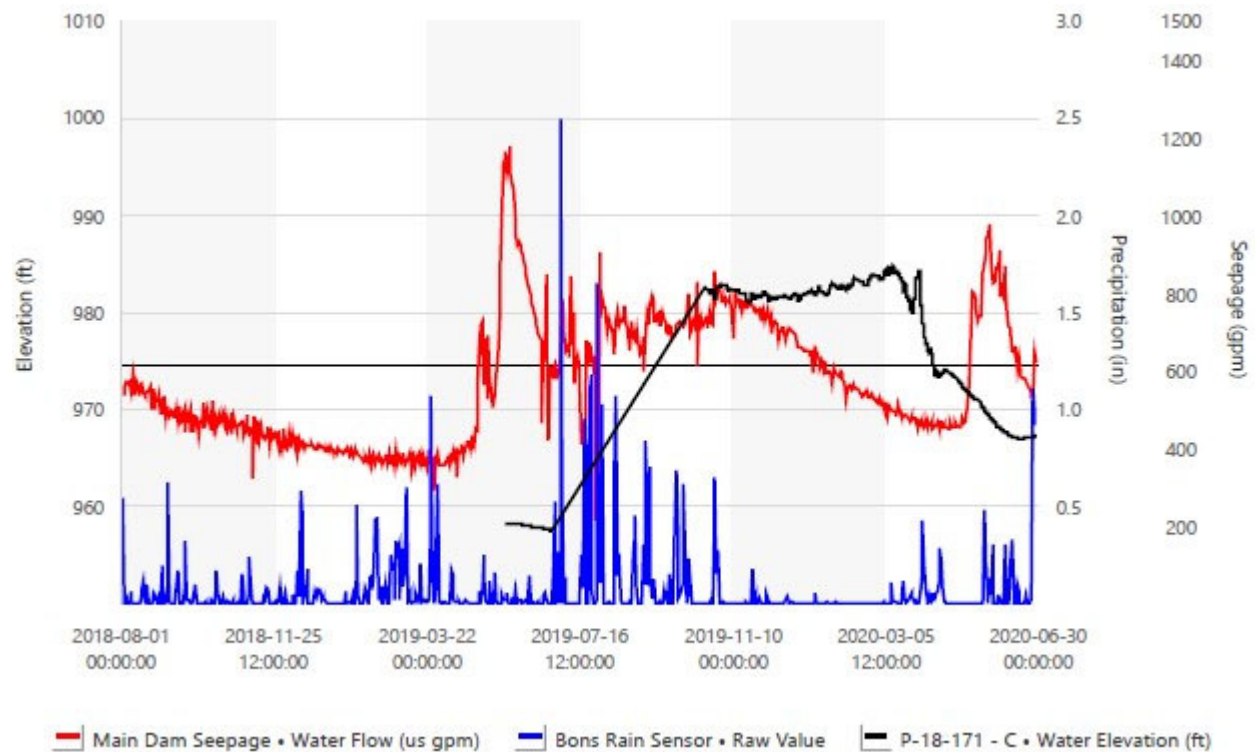
**Figure 4 – P-18-171-C Water Elevation**

Piezometer P-18-171-C indicates a decrease in pressure head between approximately late March and May 2020 (Figure 4). While P-18-172 indicates a sharp increase in pressure head in February 2020 (Figure 5) followed by a steady increase in pressure head which precedes the increase in the main dam seepage flow rate. Data for both piezometers, in addition to the other piezometers installed along the southern portion of the Wing Wall, is presented in Figure 6. The source and cause of the change in pressure head and subsequent leveling at these two piezometers are not explained by changes in precipitation, barometric conditions, or seasonal changes, based on the information reviewed. The most recent instrumentation assessment (TAK 2020b) found no abnormalities in the Wing Wall South embankment or piezometer data although the February 2020 (TAK 2020a) assessment did note the changes in P-18-172 as summarized in Table 4. Further evaluation of weekly reporting (TAK 2020c) and images provided by TAK and gathered

- Taken from TAK Periodic Instrumentation Assessment June 2020
- Sharp decrease noted between late March 2020 and May 2020

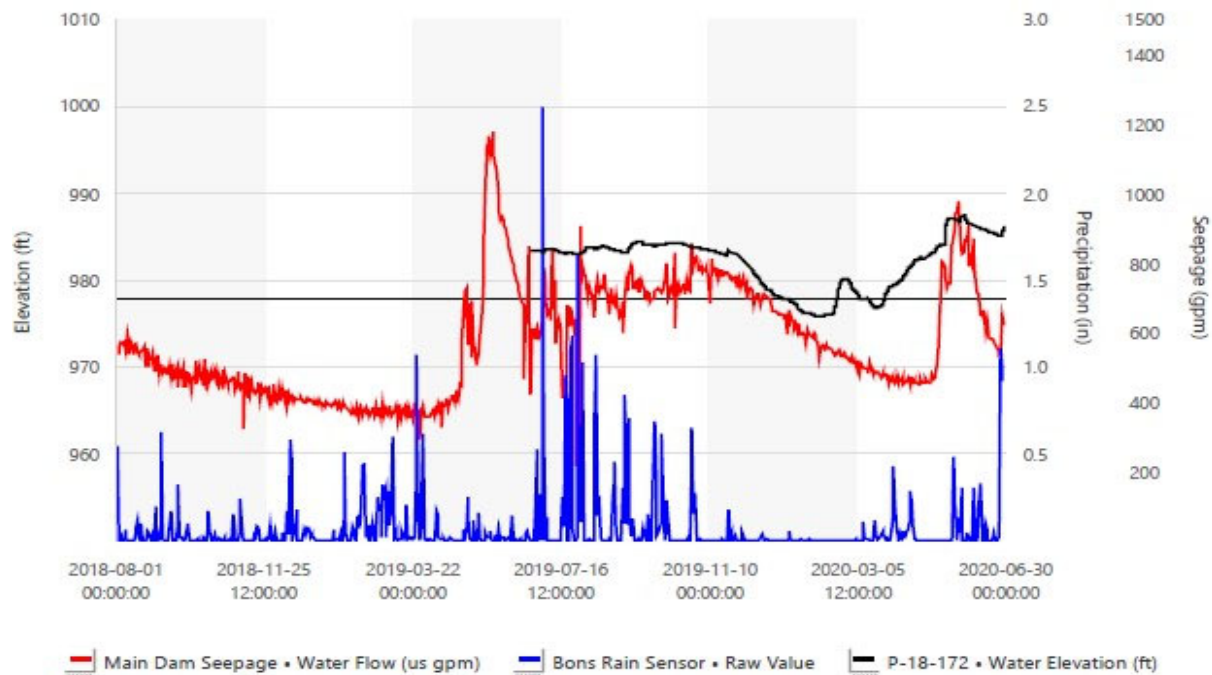
**Figure 5 – P-18-172 Water Elevation**

- Taken from TAK Periodic Instrumentation Assessment June 2020
- Sharp increase noted in February 2020 followed by steady rise prior to increase in Main Dam Seepage

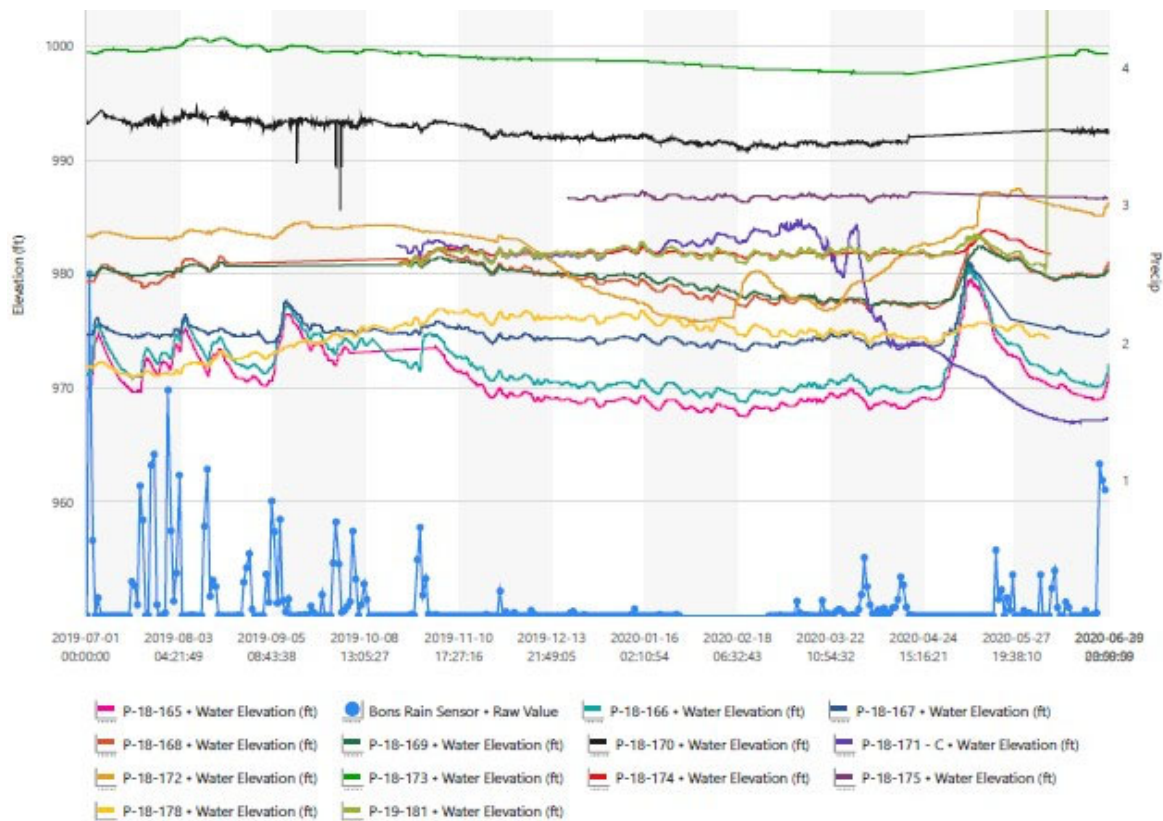
**Figure 6 – Wing Wall South Piezometer Data (June 2020)**

- Taken from TAK Periodic Instrumentation Assessment June 2020
- P-18-171-C data shows decrease in water level beginning in late March 2020
- P-18-172 data shows two sharp increases in water level, with subsequent leveling after each

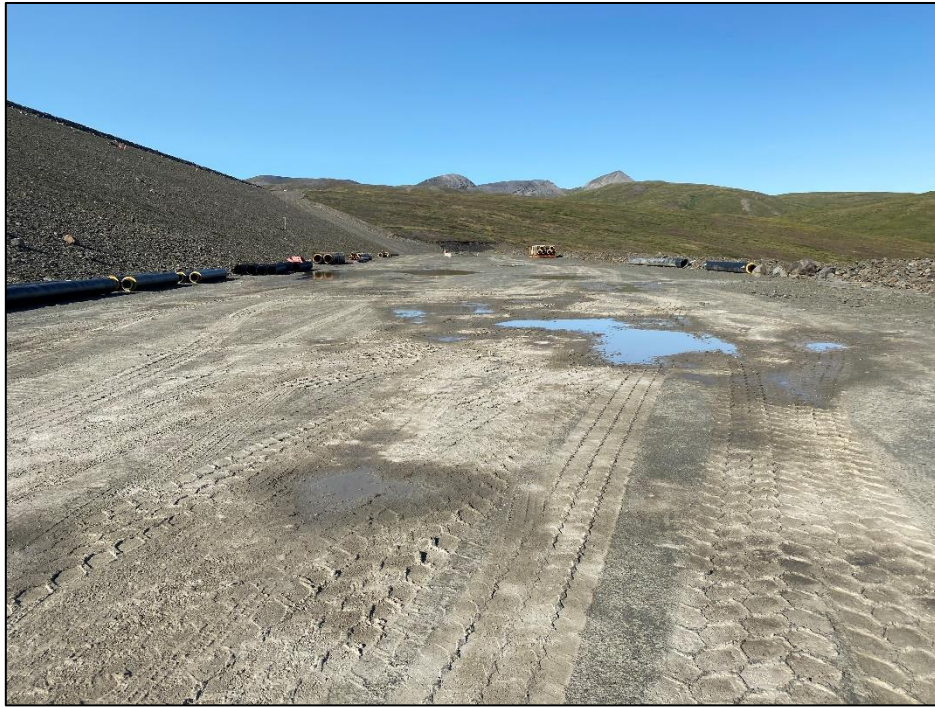
**Photograph 01:** Ponded water on Stage XI Buttress (looking southwest)

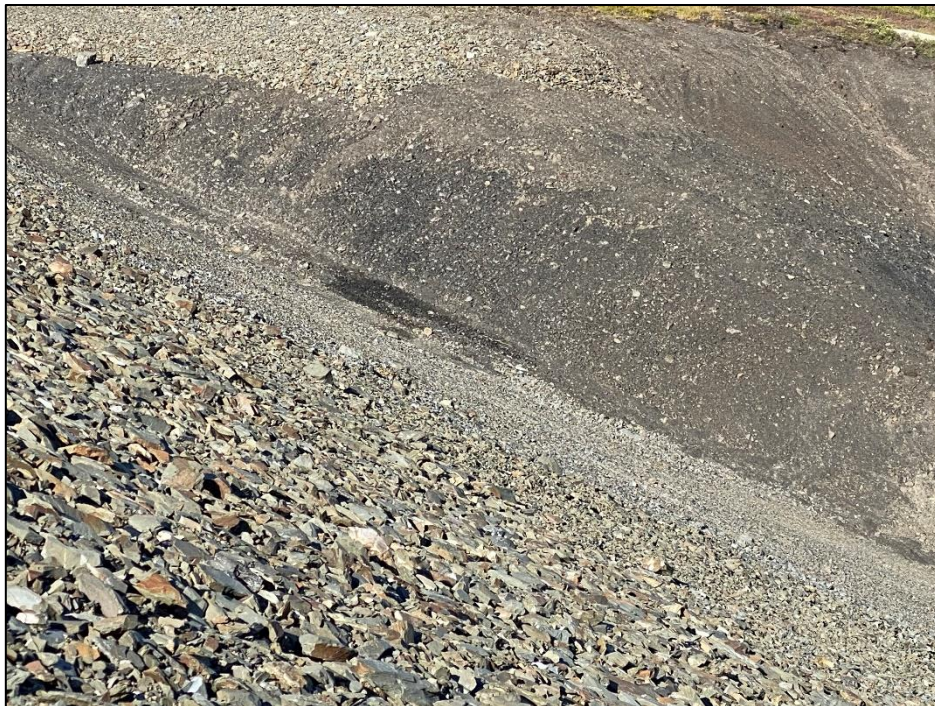
There were two areas of seepage noted along the west abutment (Photos 02, 03 and 04). These were located on the natural hillside and not on the embankment. Seep #1 was located below the Stage XI Buttress elevation while Seep #2 was located near the Stage X TMD crest elevation. No discoloration or turbidity was noted in the flows and the flow rates were estimated at less than one gallon per minute. Based on discussions with TAK personnel these seeps have been noted and are likely the result of the ground thawing in the area. These seeps do not appear to pose a stability risk to the embankment although continued monitoring of these seeps is recommended. No other signs of seepage were observed along the embankment.

**Photograph 02:** Seep #1 at west abutment, below Stage XI Buttress elevation (looking southwest)

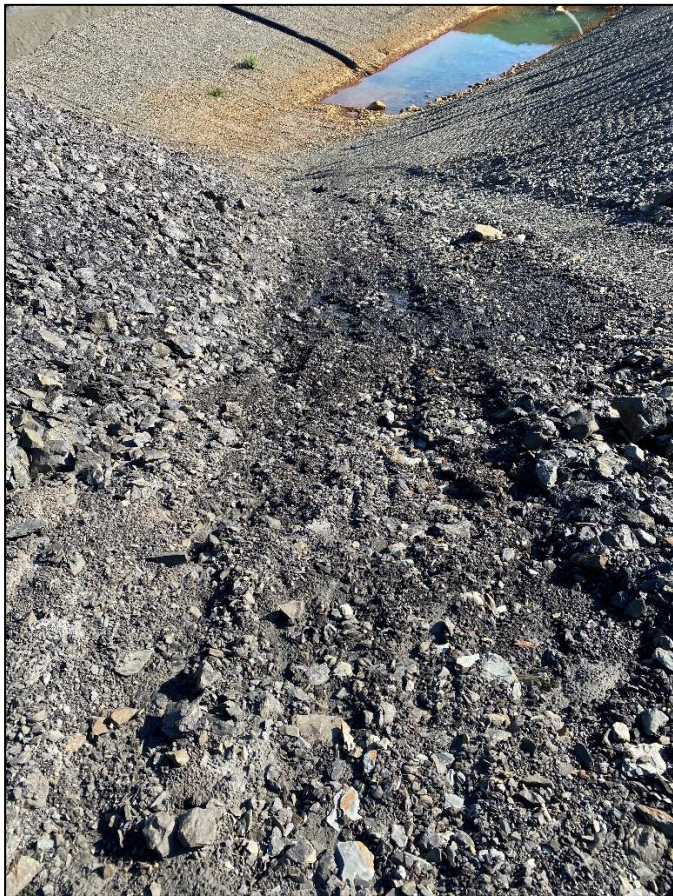
**Photograph 03:** Close-up view of seep #1 at west abutment, below Stage XI Buttress elevation

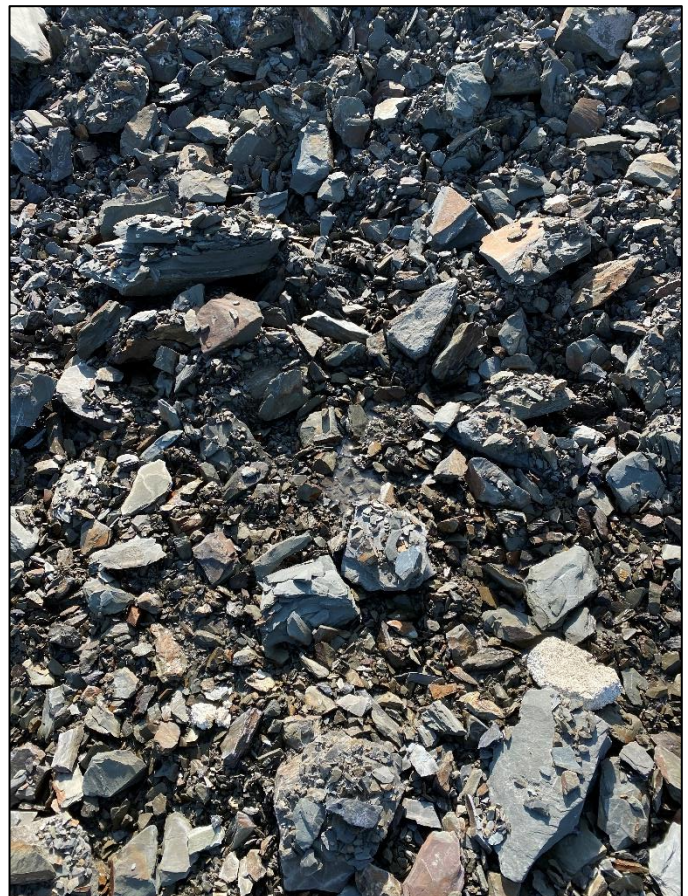
**Photograph 04:** Close-up view of seep #2 at west abutment, below Stage XI Buttress elevation

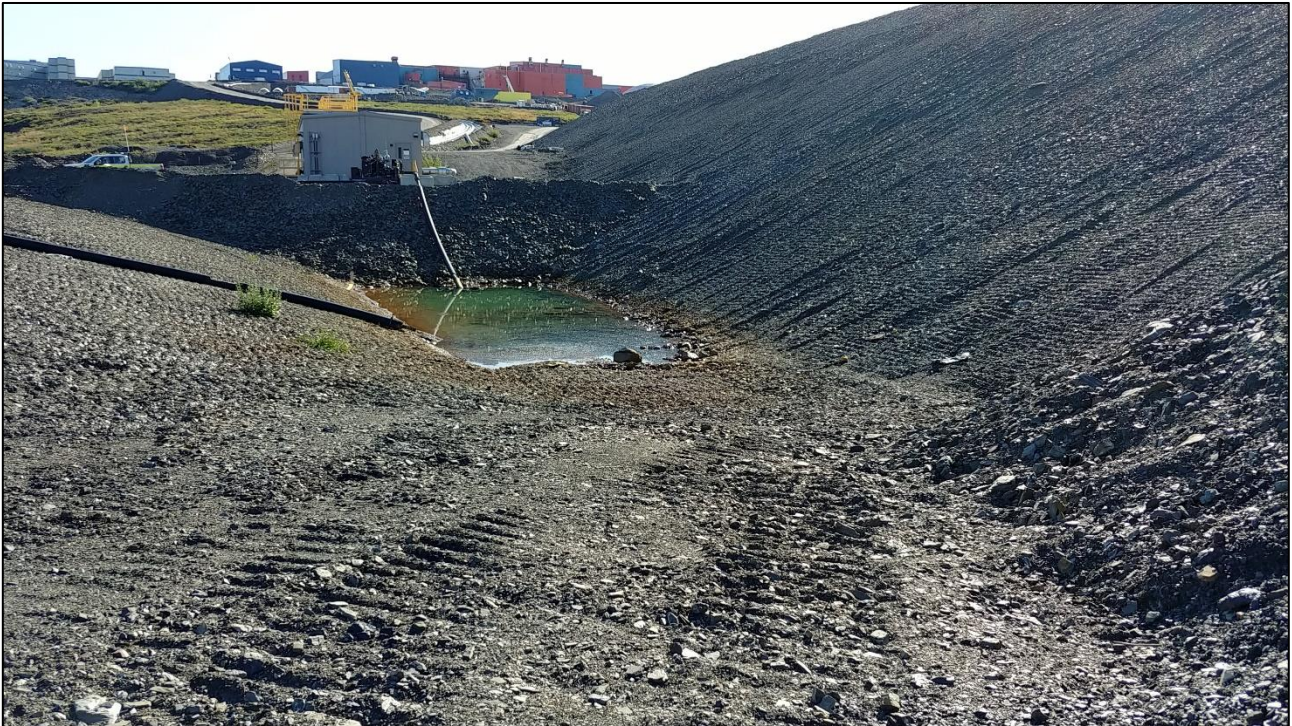
The seepage collection pond contained minimal water at the time of the inspection (Photo 05) and active discharge into or reclaim from the pond was not occurring. The geomembrane-lined spillway and riprap outfall (refer to Photo 13) were inspected with no items of concern being noted.

**Photograph 05:** Seepage Collection Pond (minimal volume of water)

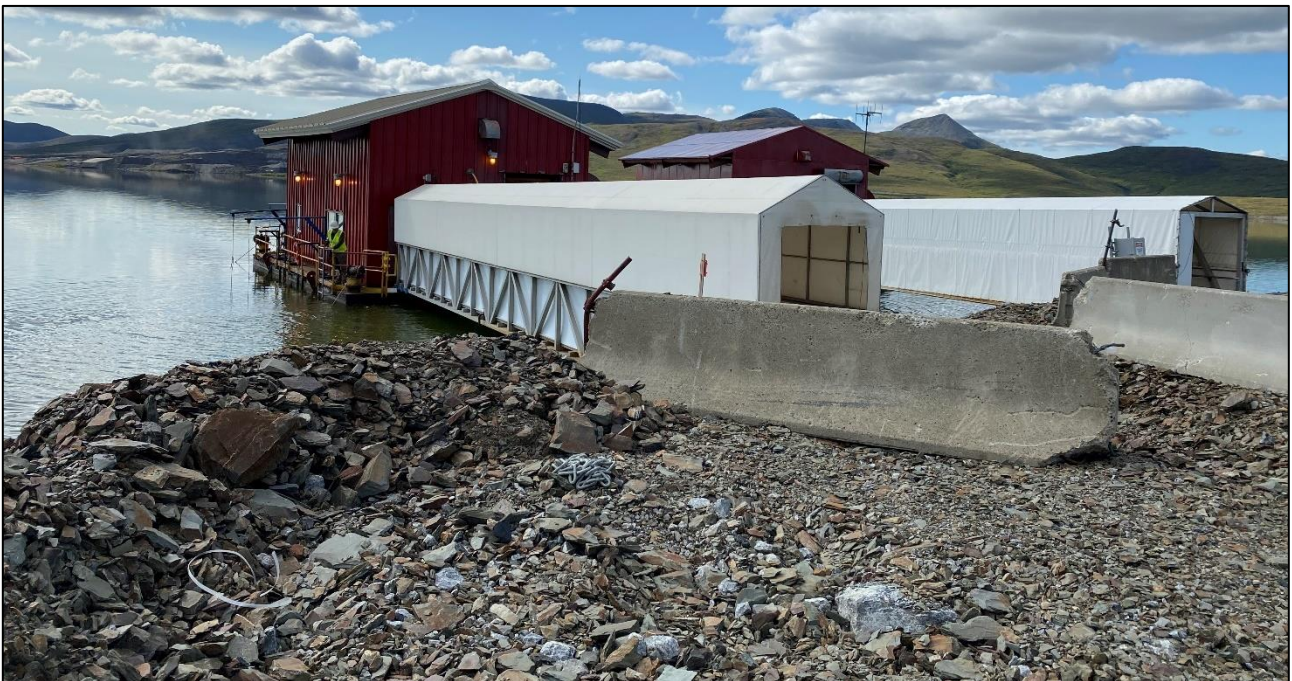
Two reclaim barges are located south of the wing wall along the western edge of the impoundment. Active reclaim was occurring at the time of the inspection with both barges in operation. Both barges were visually inspected along with the associated HDPE pipes back toward the mine complex (Photos 08 and 09) and no items of concern were noted.

**Photograph 08:** Reclaim barges

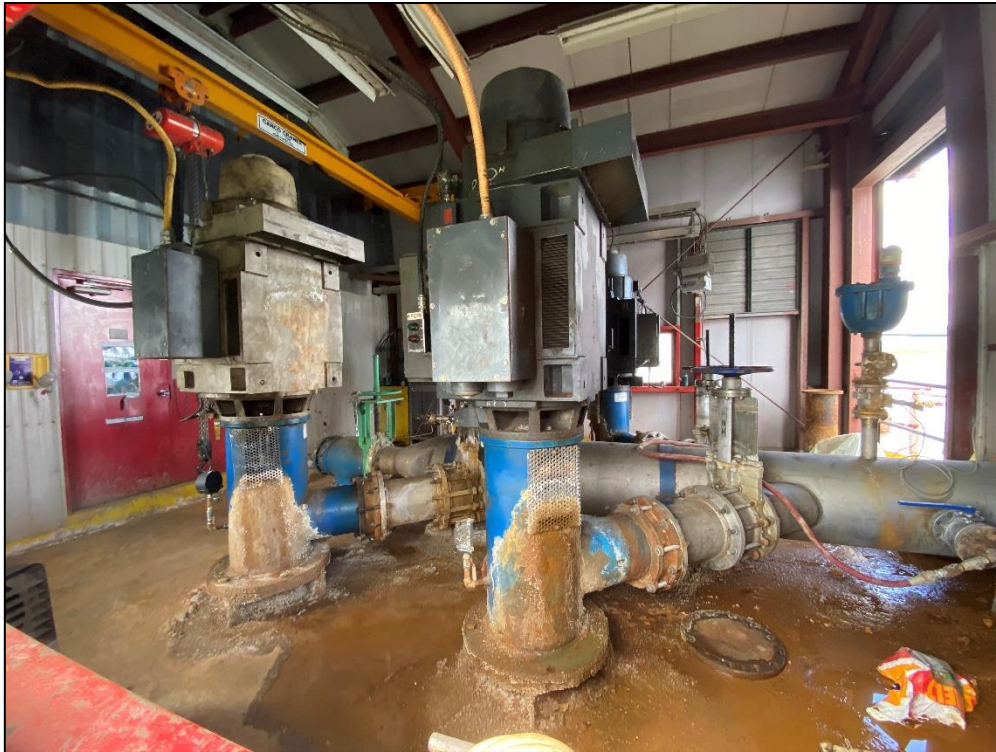
**Photograph 09:** Reclaim pumps inside reclaim barge

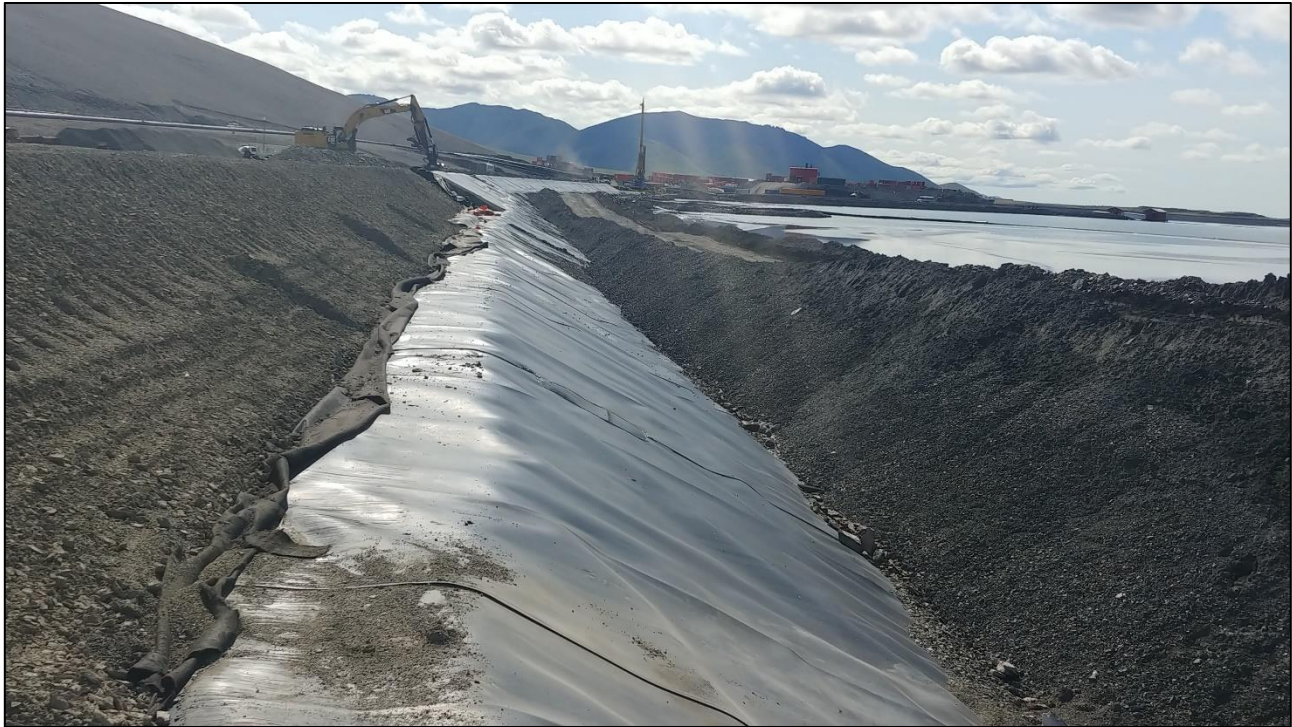
Construction activities were in progress at both north and south ends of the wing wall and consisted of fill placement (~Sta. 32+00), geomembrane installation (~Sta. 36+00 to 38+00) (Photos 19 and 20) and secant wall construction (~Sta. 58+75) (Photo 21). Cracks in the embankment which were previously noted in the 2019 Annual Inspection (Golder 2019b) were not evident due to the construction activities which had occurred or were still in progress at the time of the inspection. The field inspection did not identify any items of concern.

**Photograph 19:** Stage Xla wing wall under construction (near Sta. 40+00 looking south)

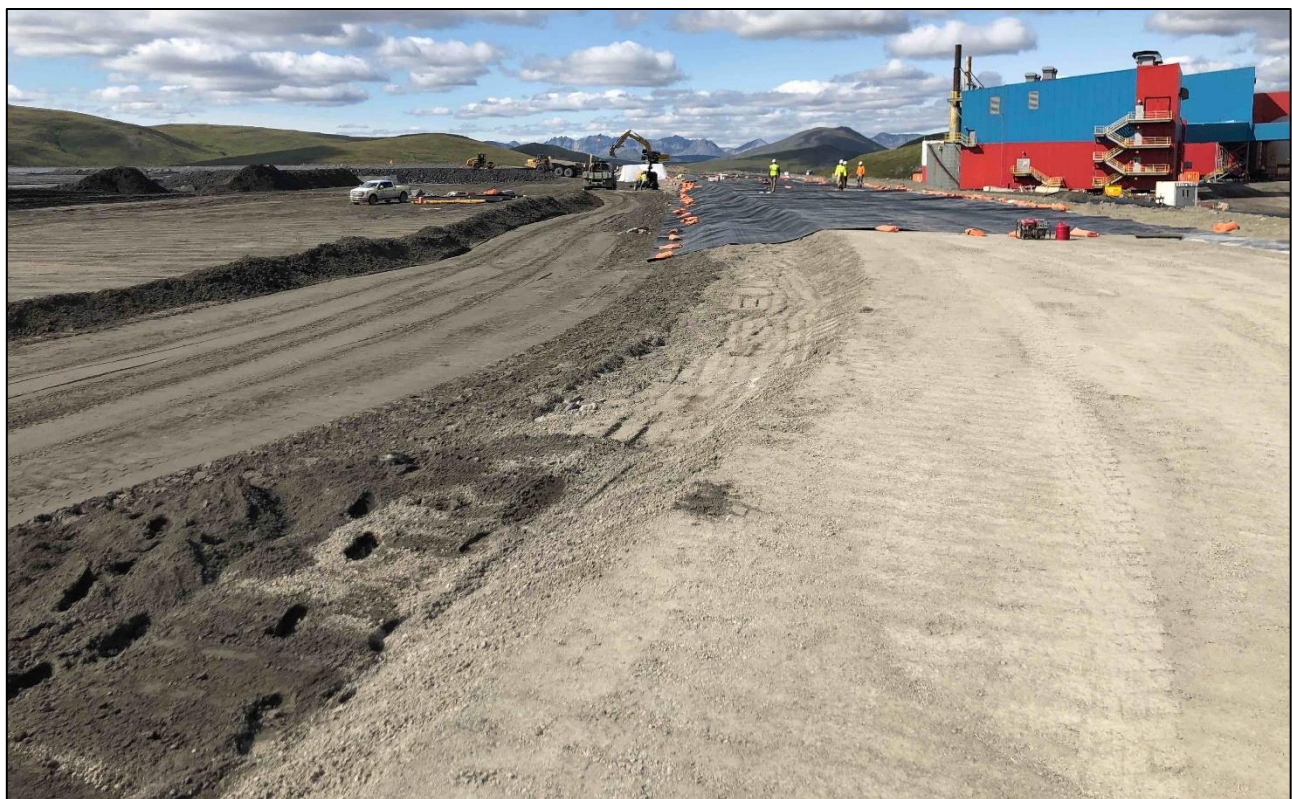
**Photograph 20:** Stage Xla wing wall under construction (near Sta. 40+00 looking northwest)
