Teck Metals Ltd.

Annual Summary of Tailings Facility Performance Report

Sullivan TSF 2020

March 30, 2021

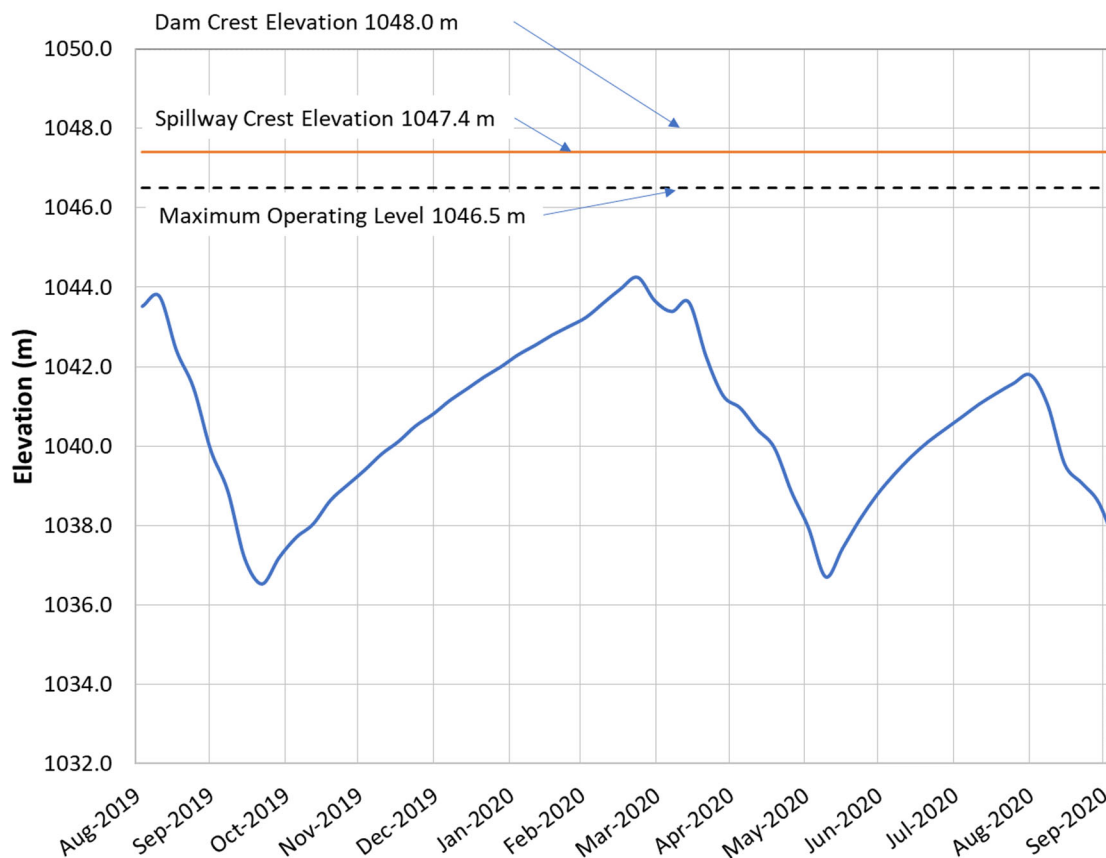
Figure 3.2 ARD Pond Level 2019 – 2020

Based on the pond water levels, the maximum level observed during the reporting period was El. 1044.3 m, which occurred on March 23, 2020. This is 2.2 m lower than the maximum operating level

(MOL) and is 3.1 m below the spillway crest elevation. There was no water discharged from the ARD Pond spillway to the Iron Pond during the water balance time period.

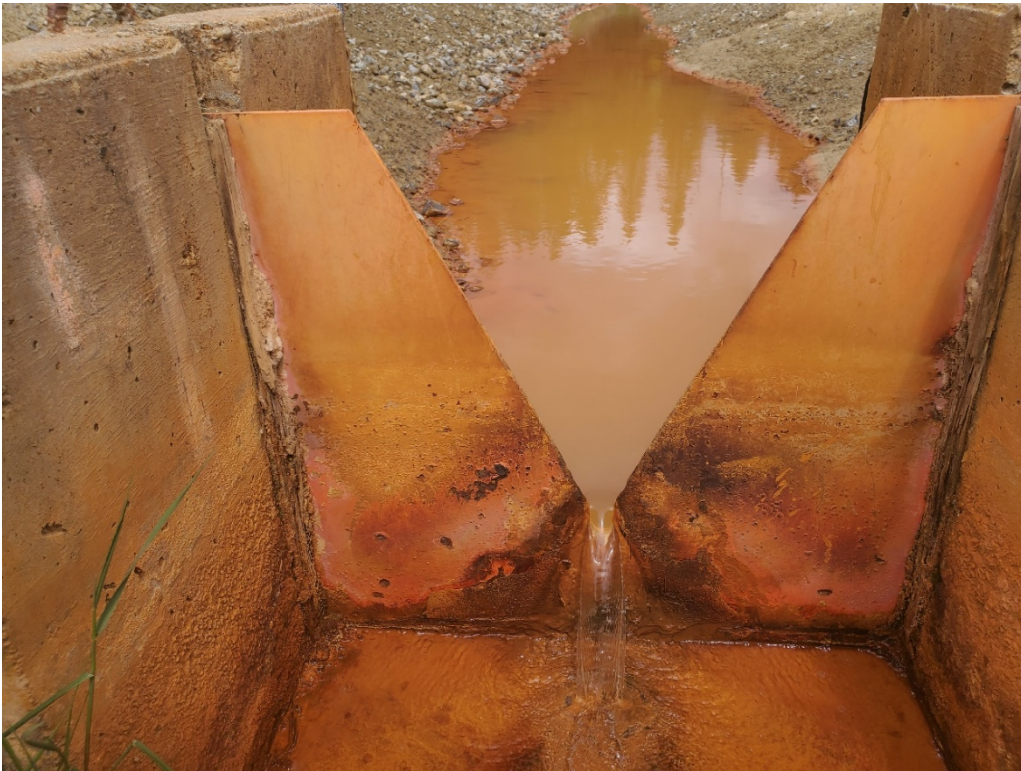
Photo II.11 Weir #4 worn notch
