Teck Highland Valley Copper Partnership

2020 Annual Facility Performance Report

Trojan Tailings Storage Facility

March 2021

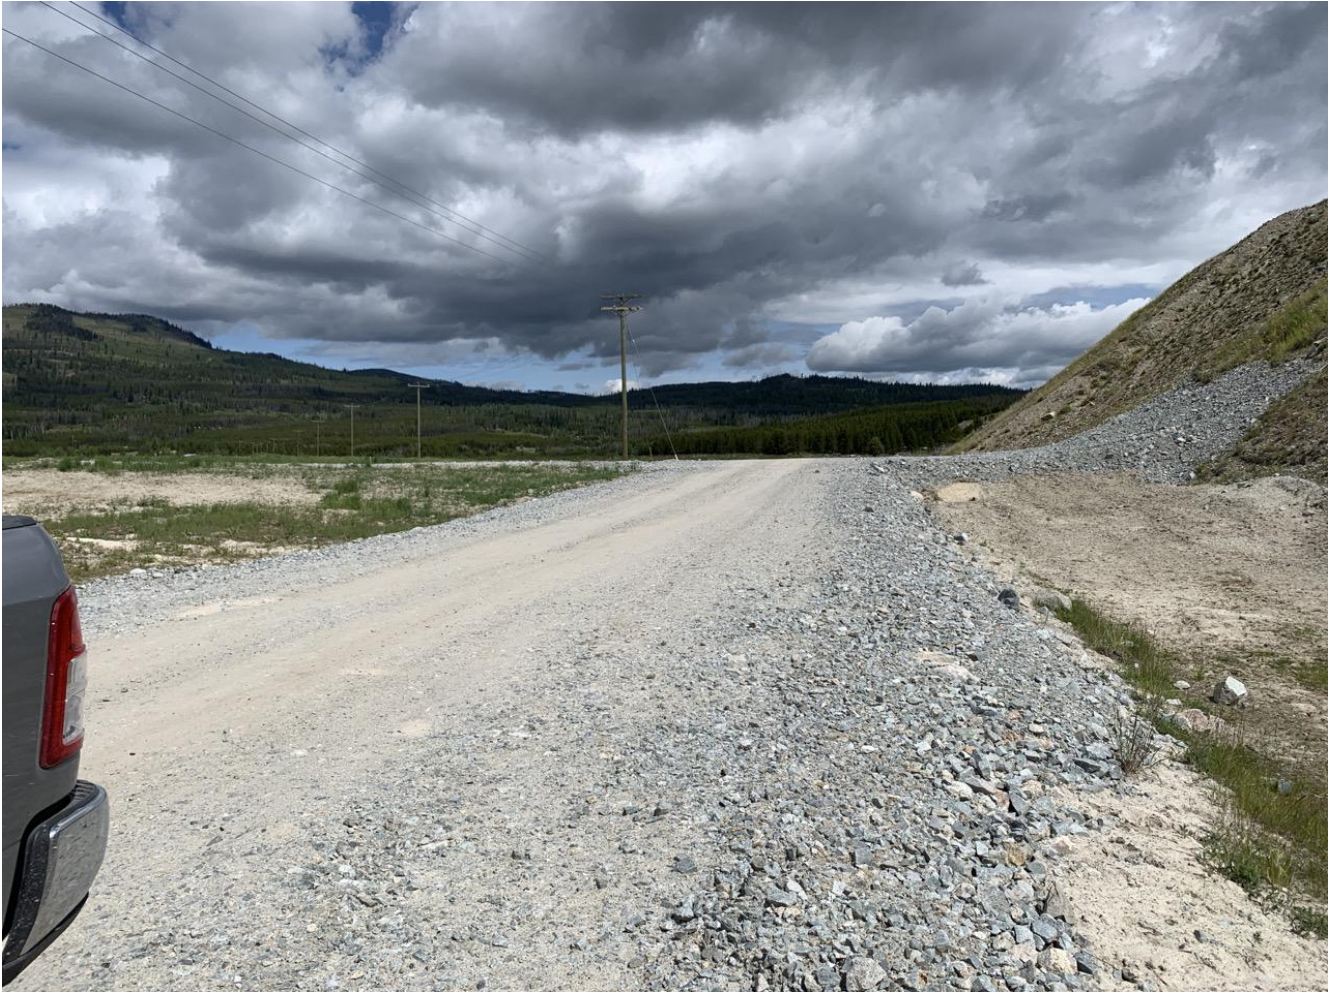
Photo I-A-2 Trojan Dam left abutment access road. Portion of road surface raised to provide minimum freeboard at design minimum flood beach width. Related recommendation was closed in 2019 AFPR (TRJ-2020-02)

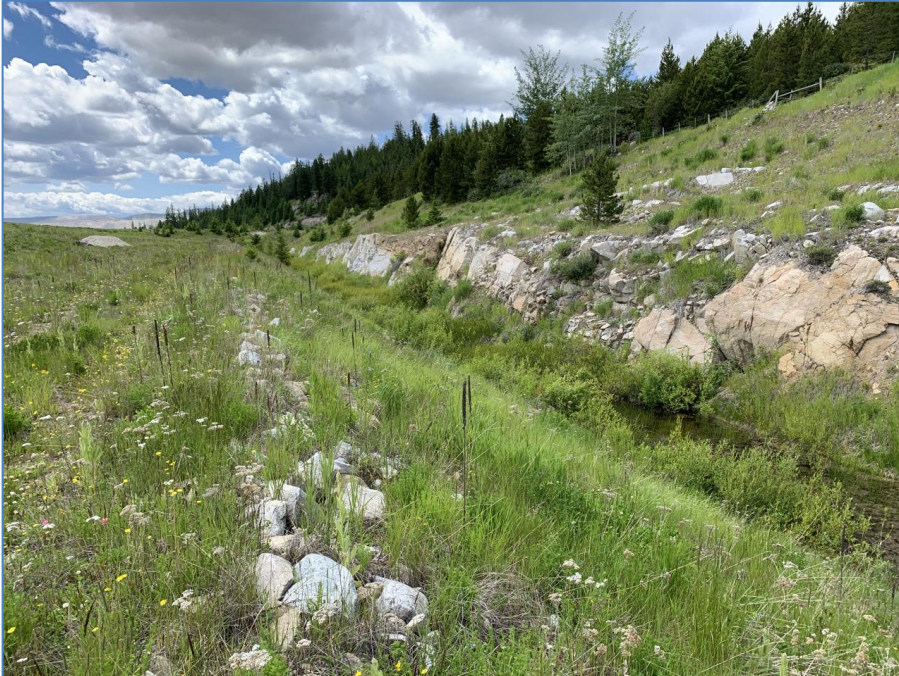
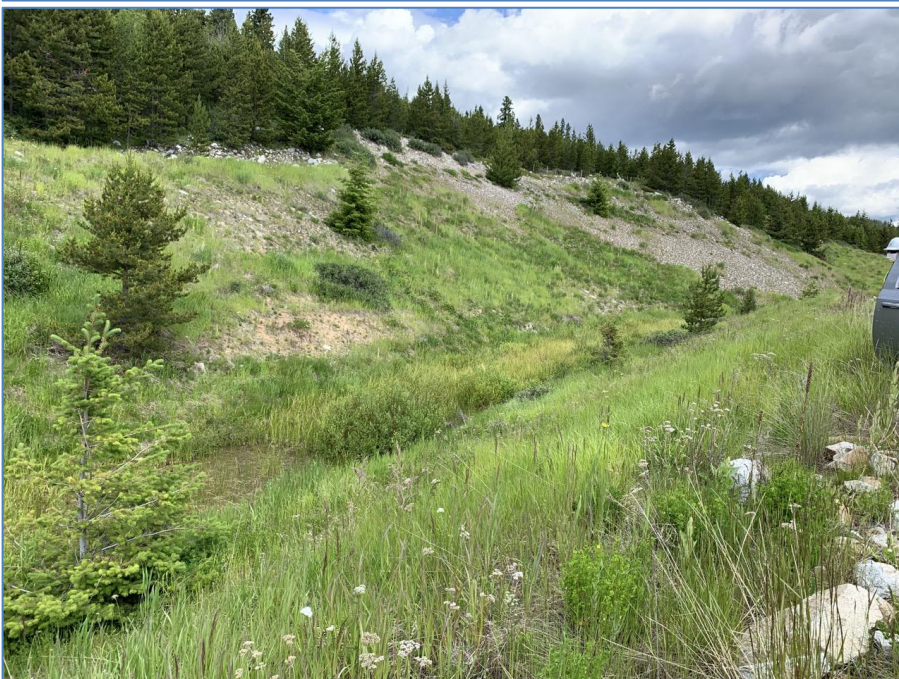
Photo I-A-9 Overview of first length of spillway channel, looking toward southwest (top photo) and looking toward northeast (bottom photo). No sign of recent flow or weathering/disruption of riprap was observed. No evidence of sloughing of cut slopes was observed. Channel is heavily vegetated. In December 2020, THVCP received permit approvals to clear vegetation. The work is scheduled for spring 2021 (TRJ-2020-08)

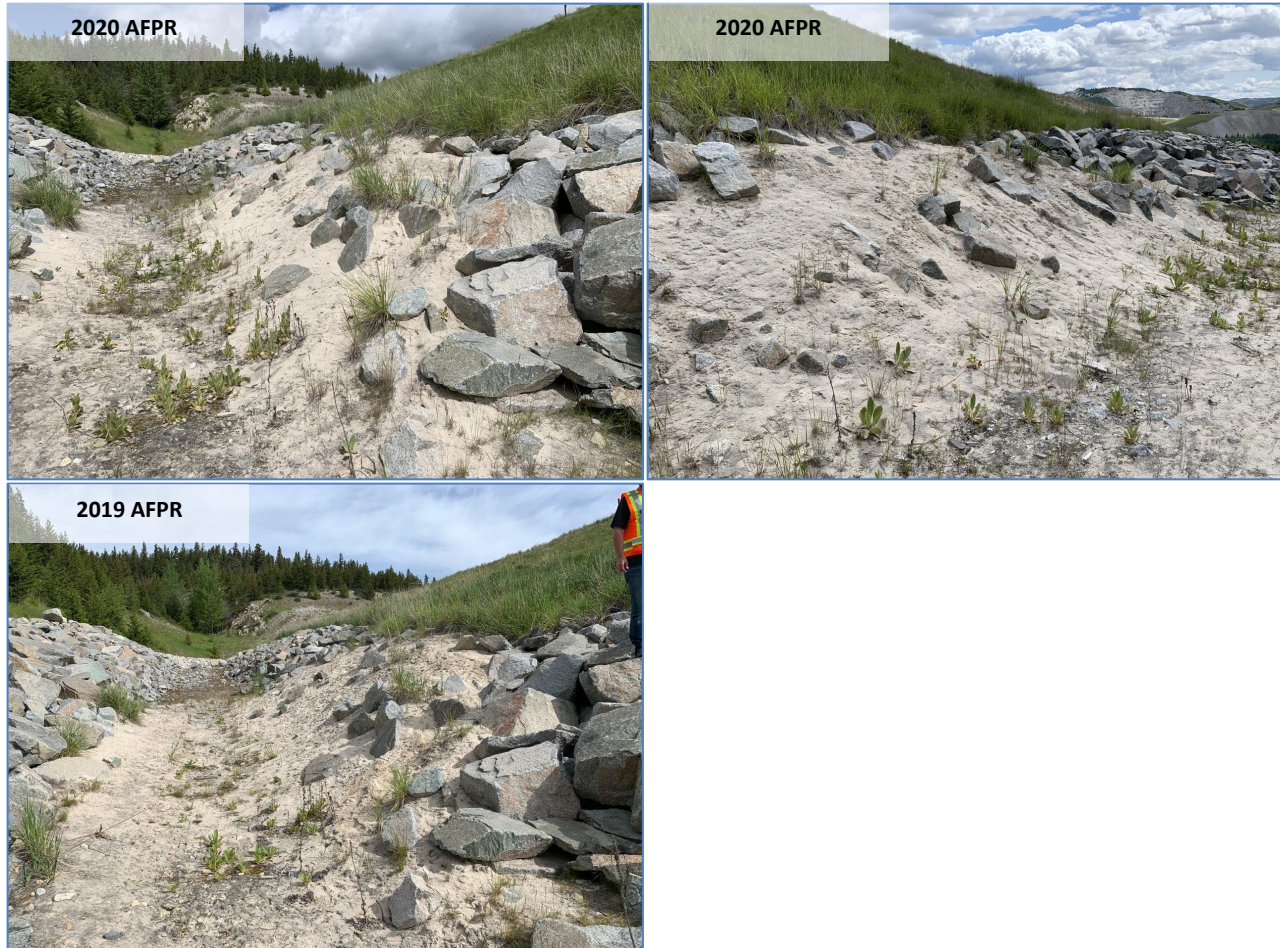
Photo I-A-12 Sand on the base and on right bank of spillway. Sand appears to have been placed/deposited on top of riprap, suggesting this is not related to piping/seepage. No active seepage faces, or erosion were observed. This is not a dam safety concern. Compared to 2019 AFPR (bottom photo) (TRJ-2020-11)

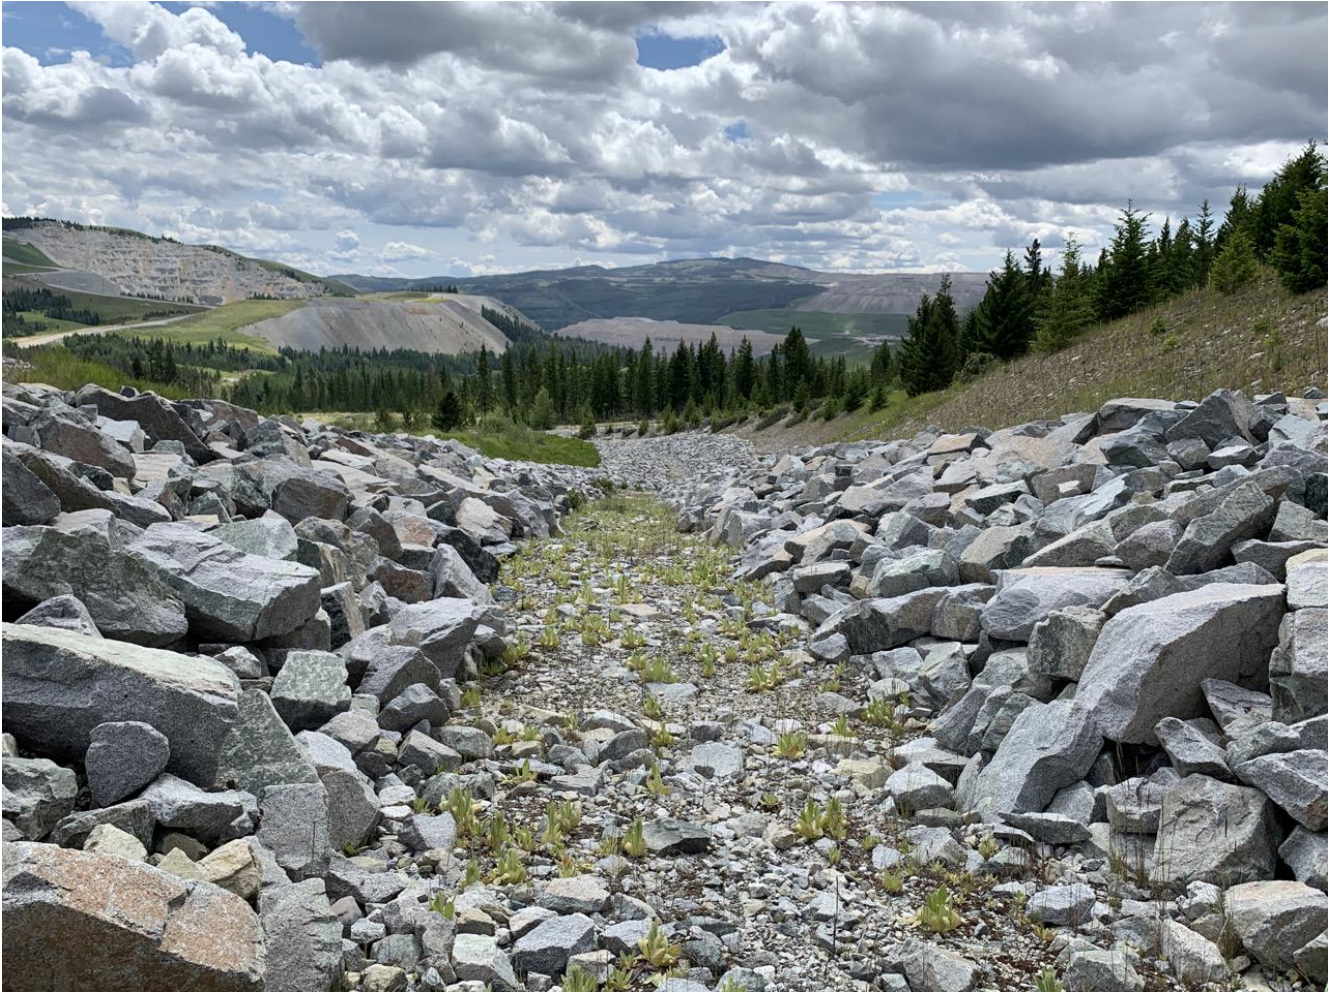
Photo I-A-13 Spillway channel downstream of the sand area observed in Photo I-A-12. No sand was observed downstream. No sign of recent flow or weathering/disruption of riprap was observed (TRJ-2020-12)

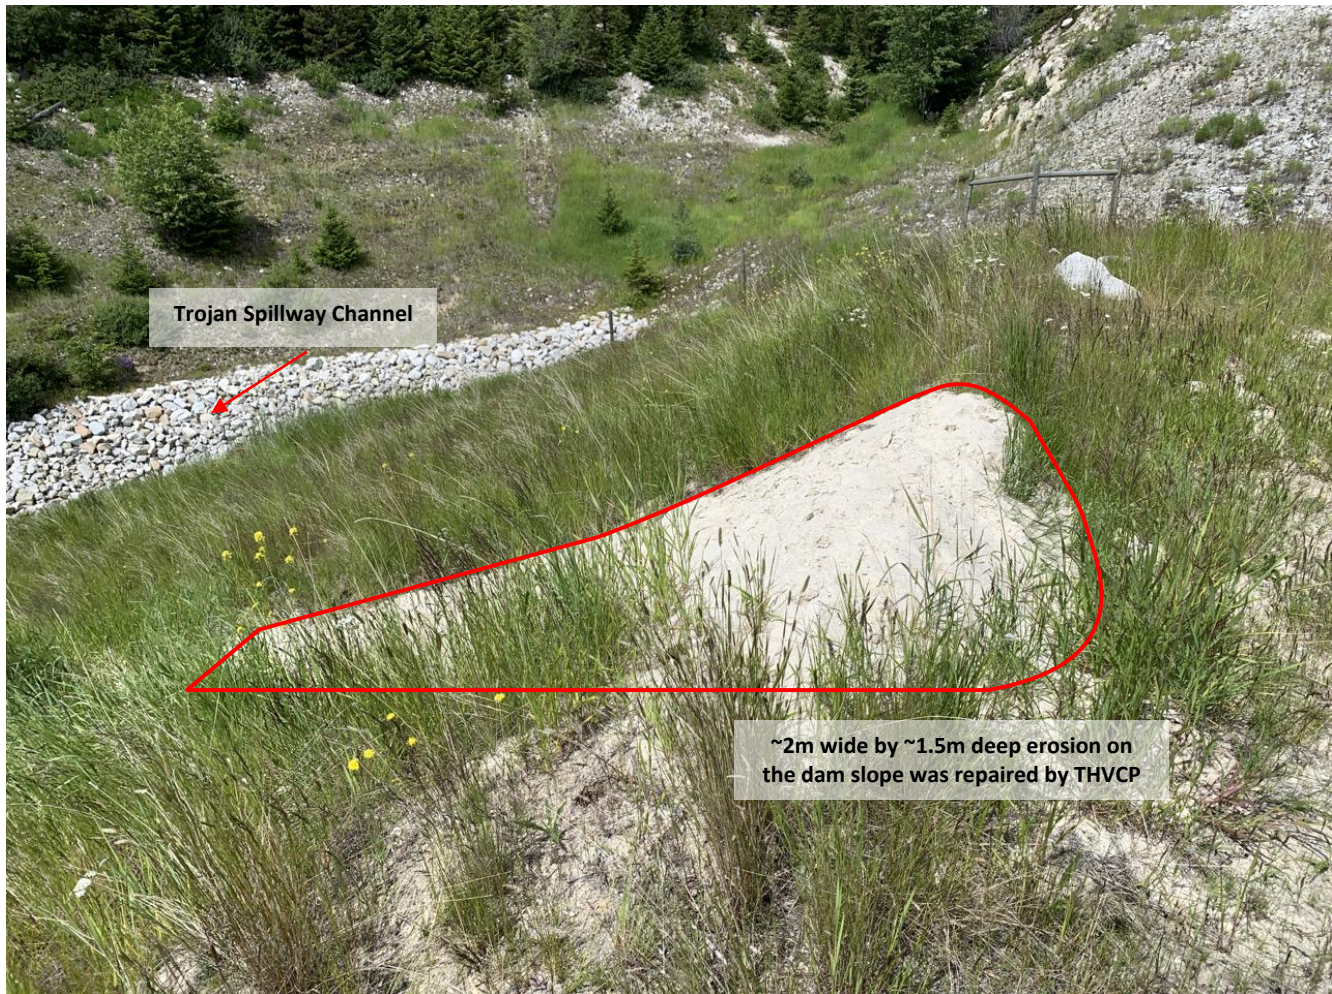
Photo I-A-14 Surface erosion / scour evidence observed upslope on dam slope in spillway channel during 2019 AFPR site visit was repaired by THVCP in 2019. Scour is not developing again (TRJ-2020-13)

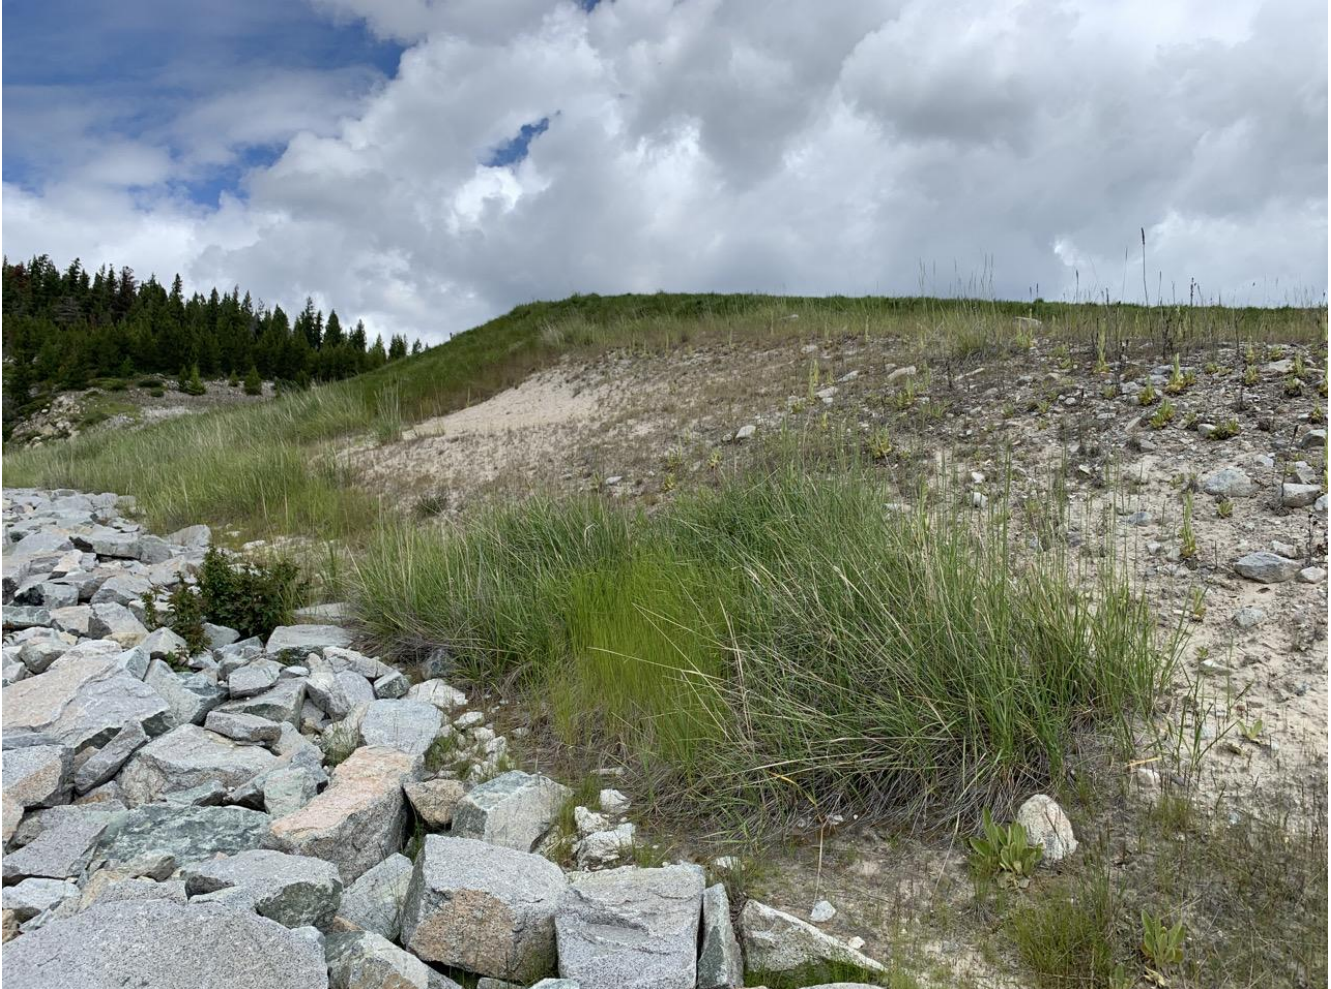
Photo I-A-15 Area of downstream slope without vegetation cover with sand exposed. Does not appear to be an active erosion area (TRJ-2020-14)

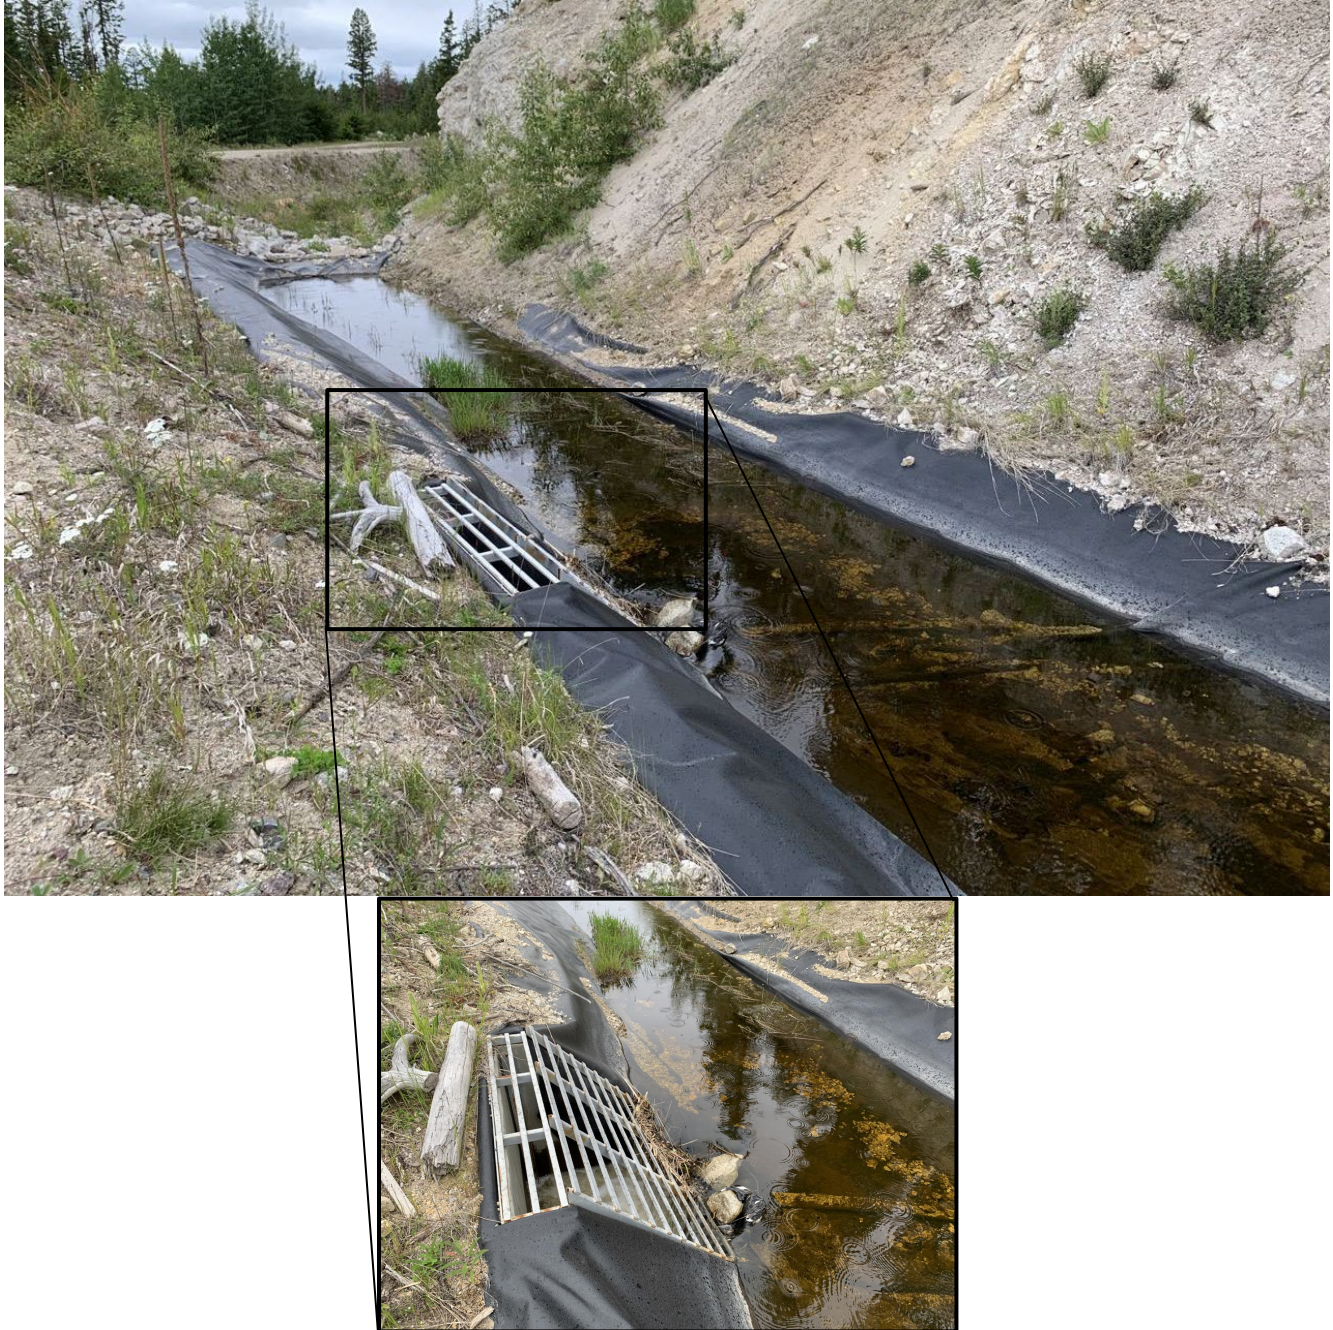
Photo I-A-18 Water flowing at the pipe intake southwest of Trojan TSF. Outlet valve here is open. Gate has minor debris accumulation. No flow bypassing diversion (i.e. flowing further downstream of channel. Trojan Diversion Valve 1 further upstream at Photo I-A-20 is closed (TRJ-2020-17)

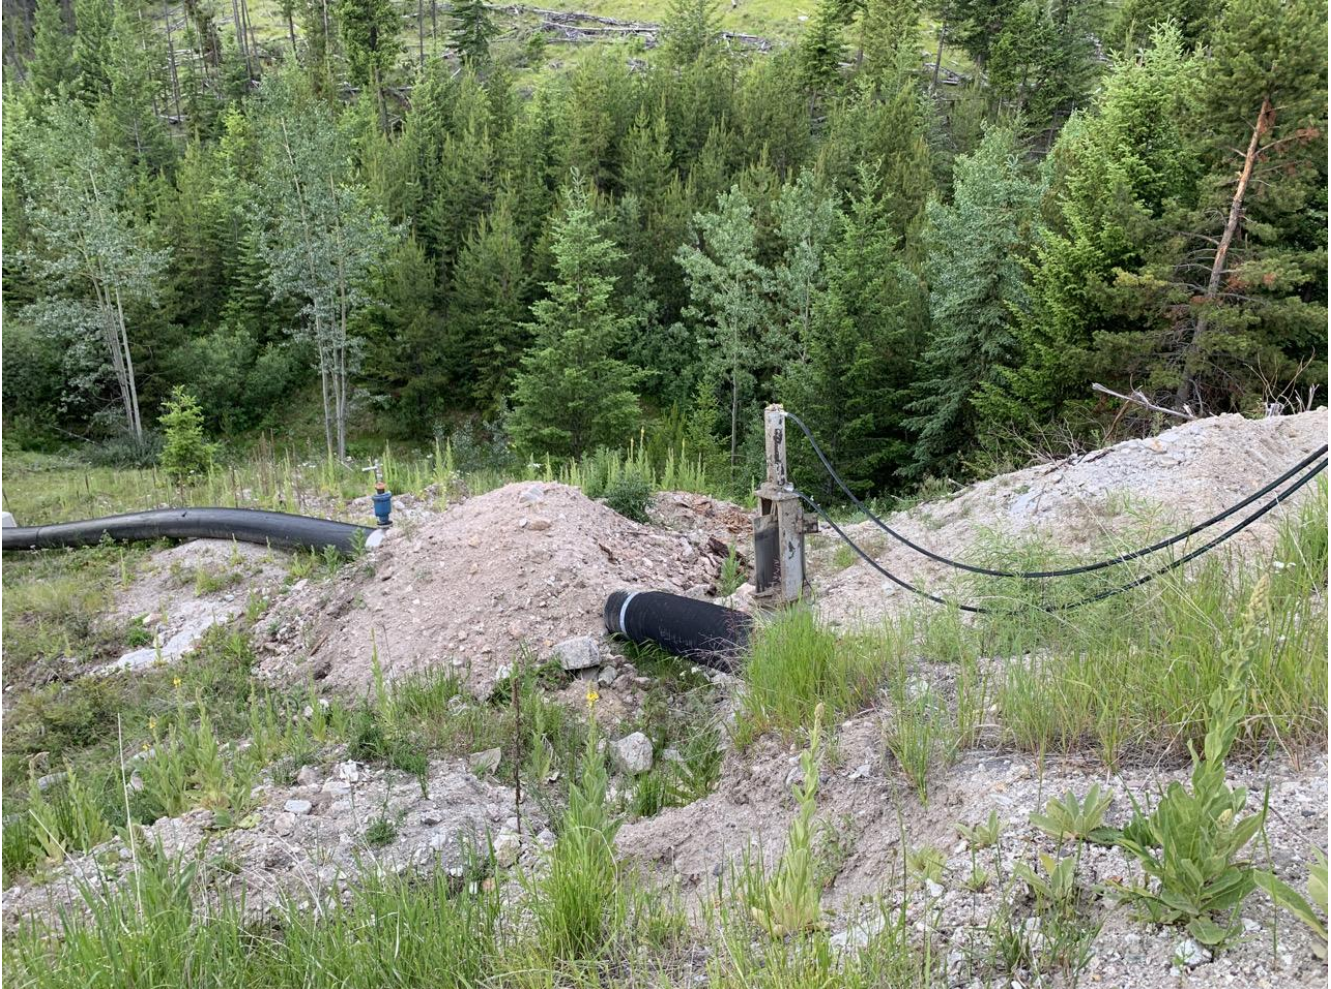
Photo I-A-19 Diversion pipe that was observed disconnected during 2019 AFPR site visit is repaired. Water discharging / valve open (TRJ-2020-17)

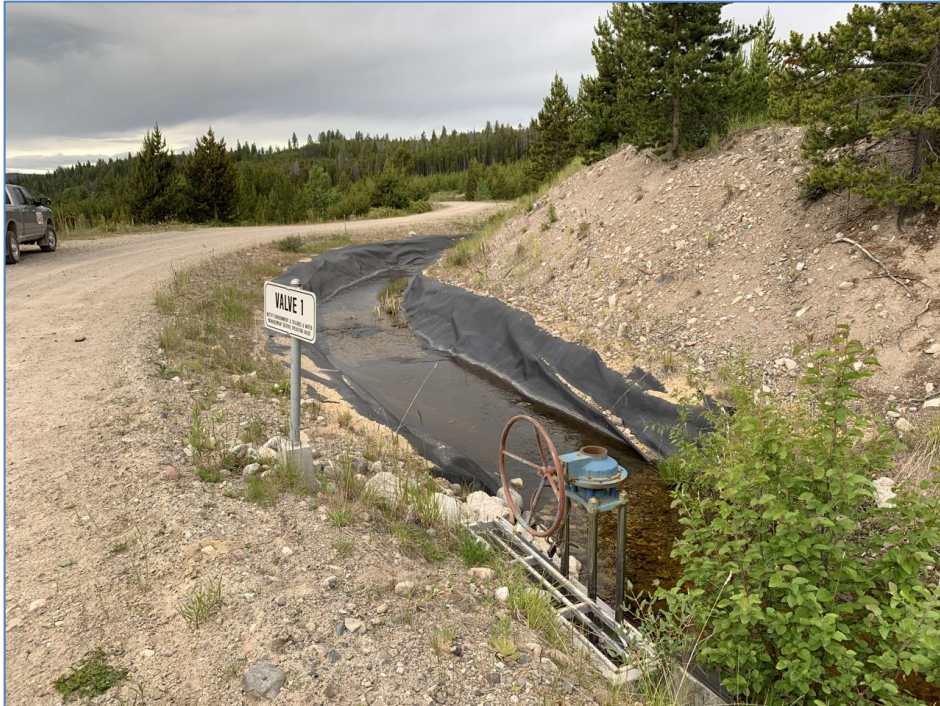
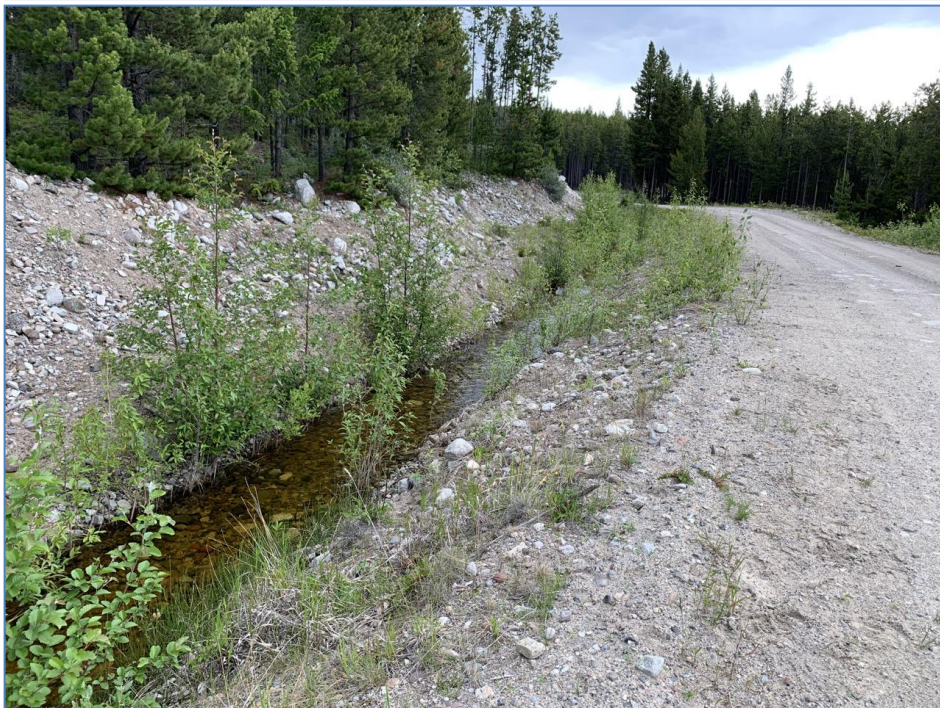
Photo I-A-20 Trojan Diversion Valve 1 is closed (no flow into impoundment) and locked. Valve is located at the transition of unlined to lined channel. Increased vegetation at the unlined channel (bottom photo), should be cleared for routine maintenance but is not a risk to Trojan flood routing) (TRJ-2020-18)

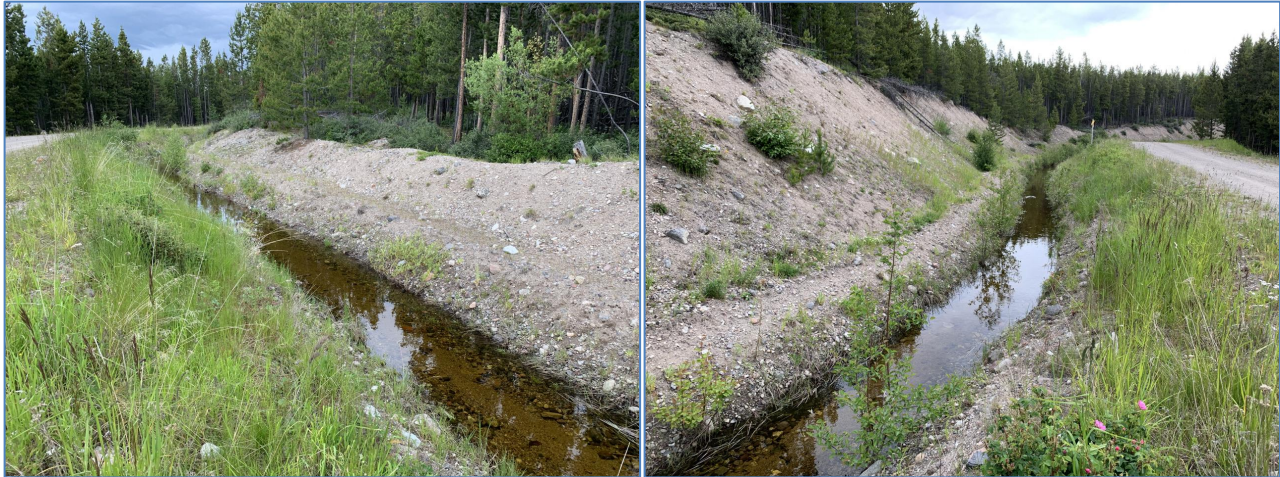
Photo I-A-21 Clear water flowing in the unlined section of channel upstream of Trojan Diversion Valve 1. Slopes with shallow grade, unlined. Vegetation growth observed. Clearing vegetation here has lower priority to spillways as diversion is assumed to fail during Inflow Design Flood (TRJ-2020-19)

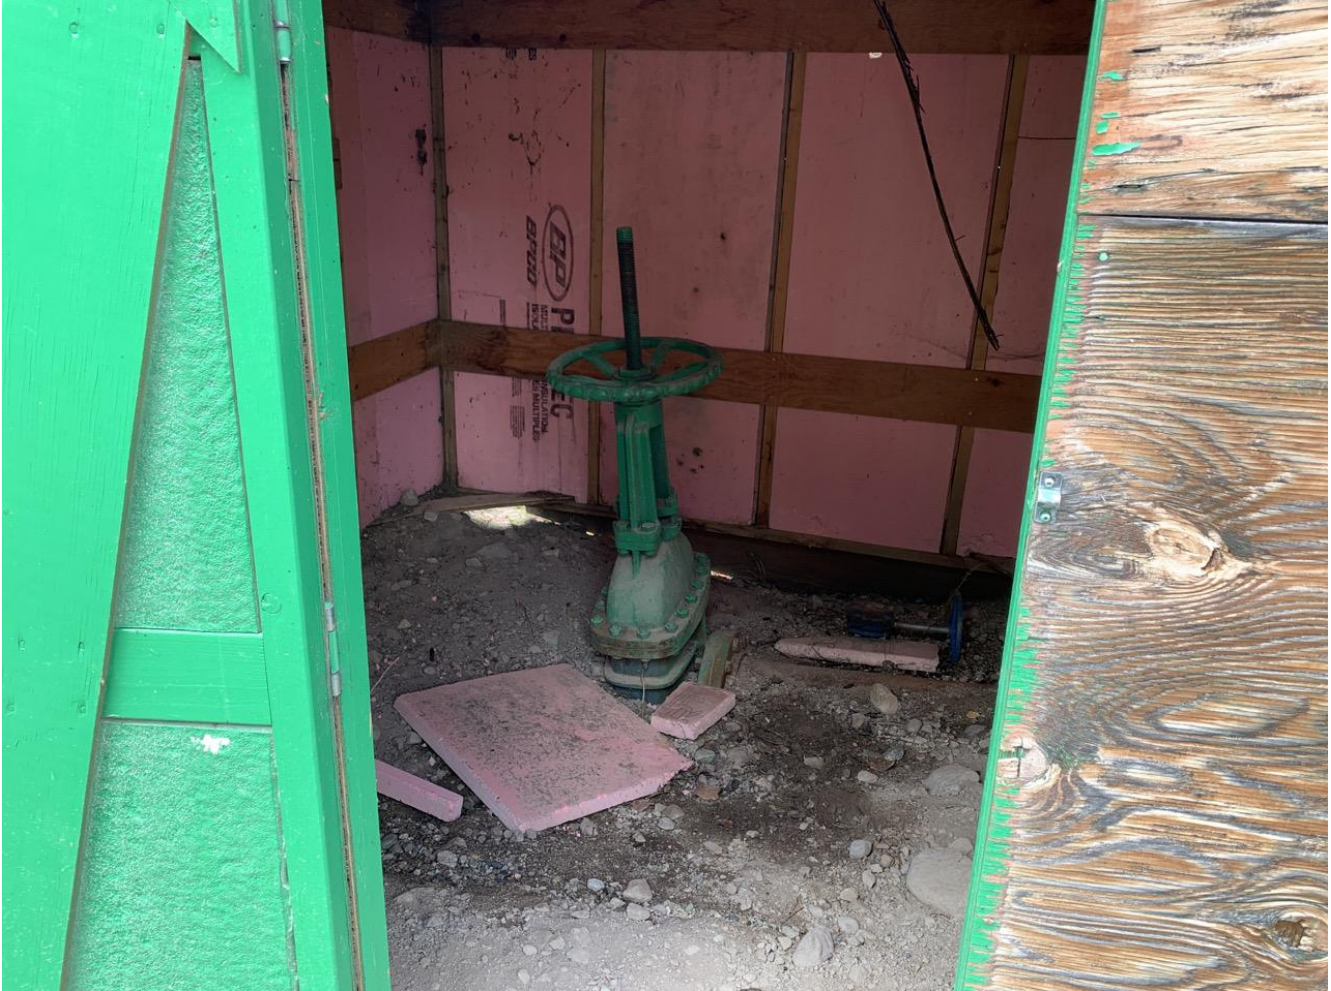
Photo I-B-4 Low Level Outlet valve in enclosure downstream of toe. The valve cannot be hand turned (TRJ-2020-23)

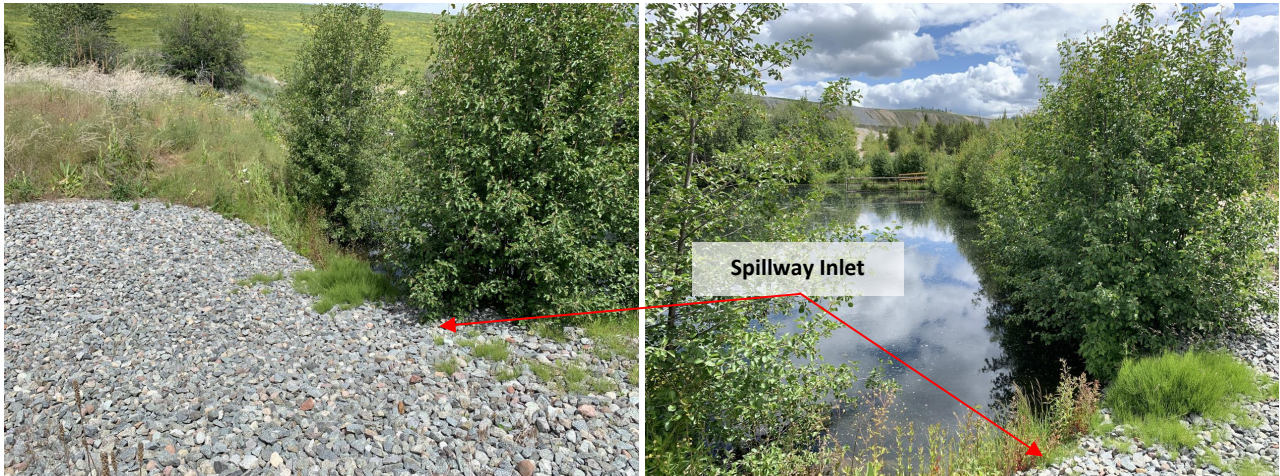
Photo I-B-5 Overview of pond and spillway inlet – Spillway inlet is clear of debris. Vegetation on upstream slope and near inlet was cleared after inspection as part of routine maintenance (TRJ-2020-24)

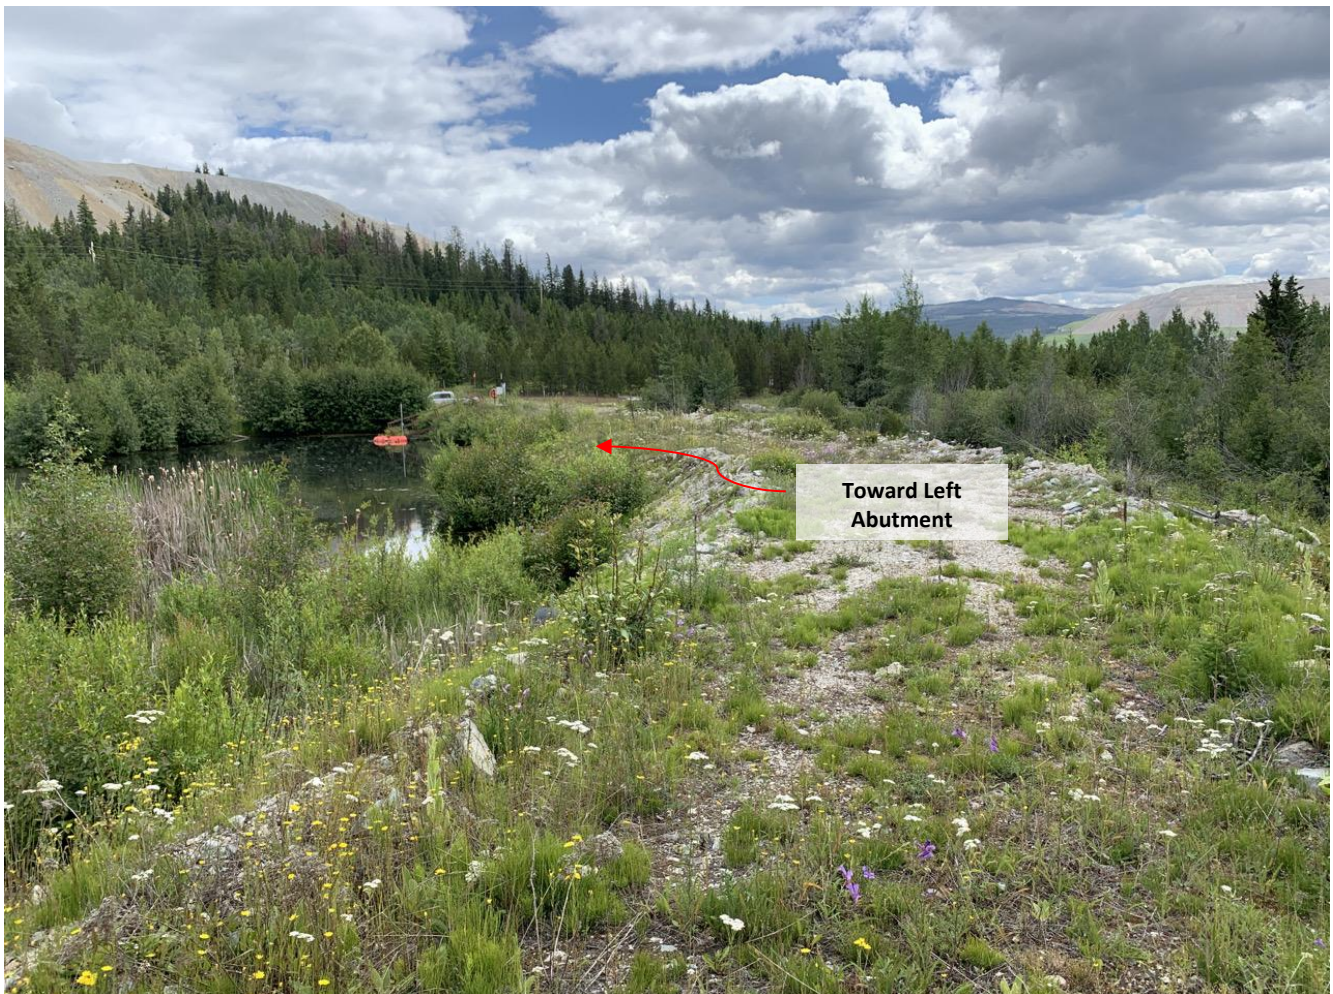
Photo I-C-1 Overview of crest from right abutment. Crest is uneven and appears to be sloped up to the west. THVCP should conduct a survey to confirm the low point (TRJ-2020-25)

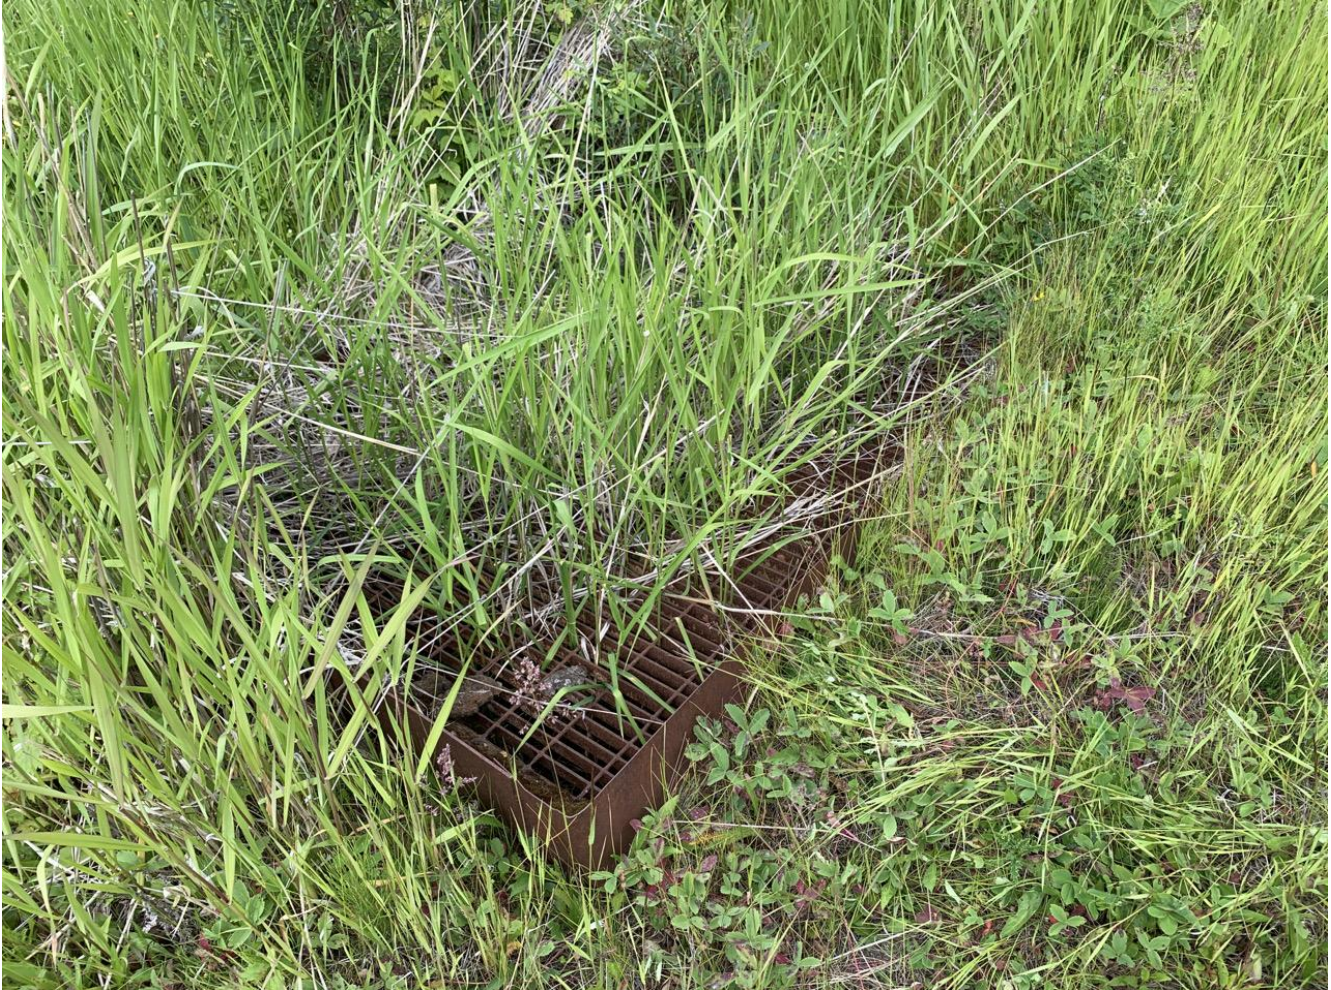
Photo I-C-6 Outlet which appeared to connect the upper basin to the lower basin at Lower Trojan Dam Pond. The inside was dry at the time of inspection and there were no sounds of flow. During inspection, flow from upper basin was reporting to lower basin via overland flow (TRJ-2020-28)

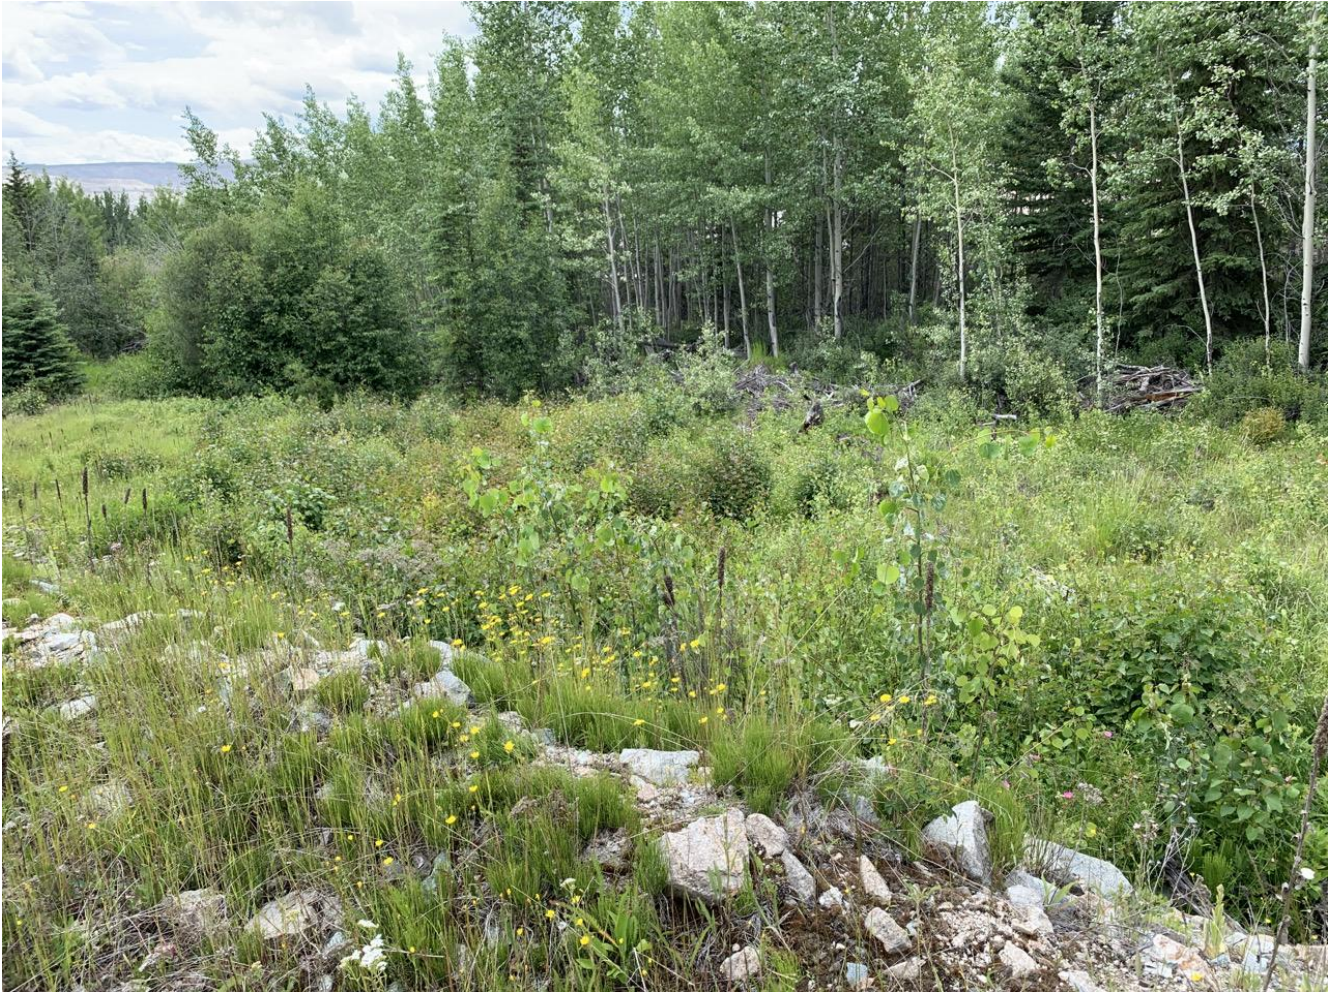
Photo I-C-8 Spillway channel looking toward south. Channel is heavily vegetated. THVCP received permit approval in December 2020 to complete clearing. Work is scheduled for spring 2021 (TRJ-2020-25)

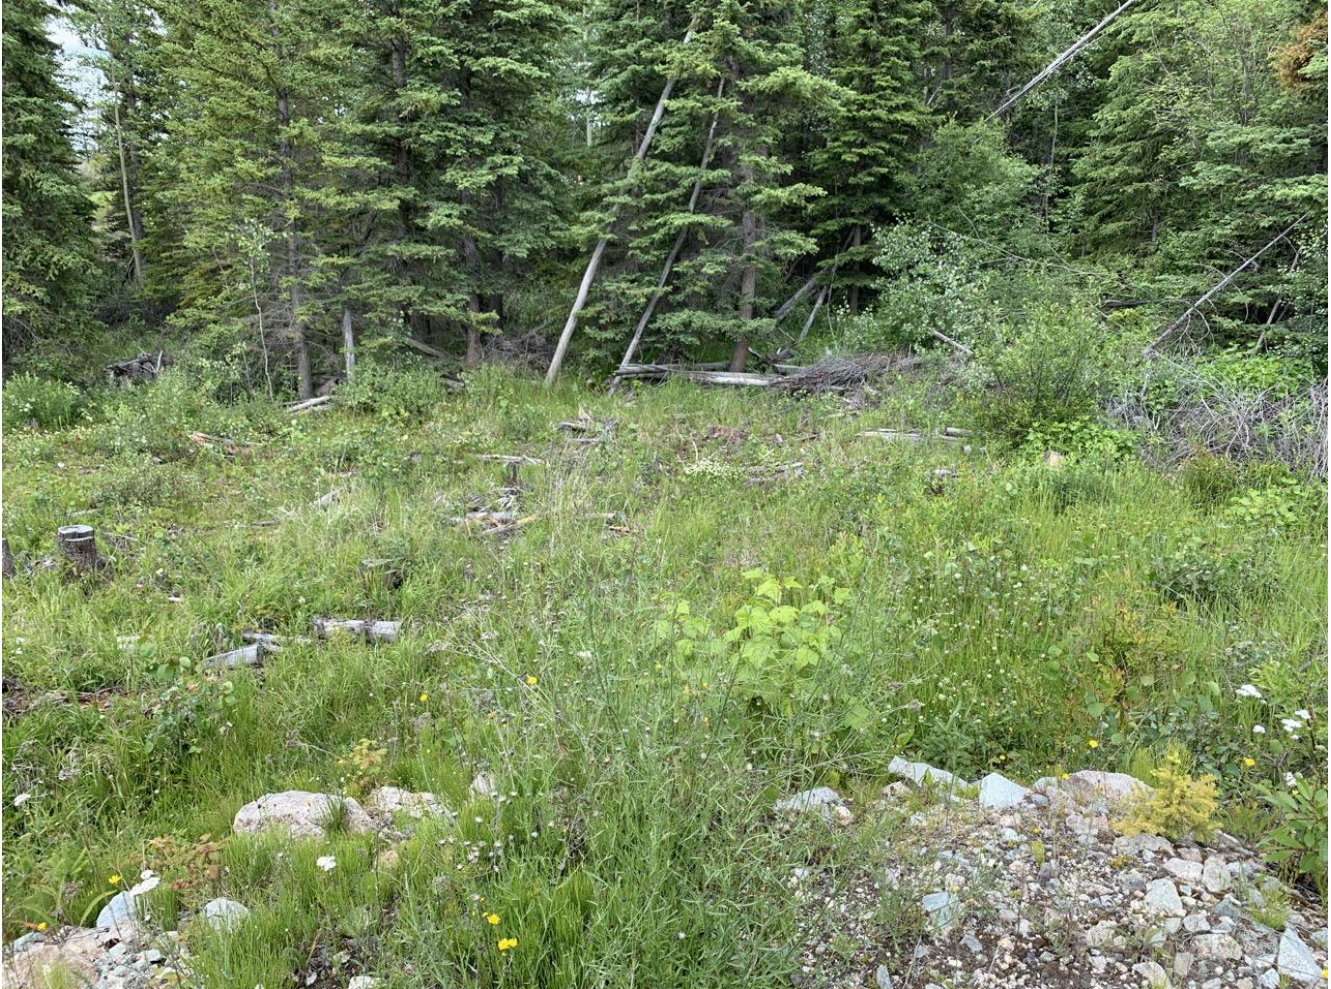
Photo I-C-9 Spillway channel is heavily vegetated. THVCP received permit approval in December 2020 to complete clearing. Work is scheduled for spring 2021 (TRJ-2020-25)

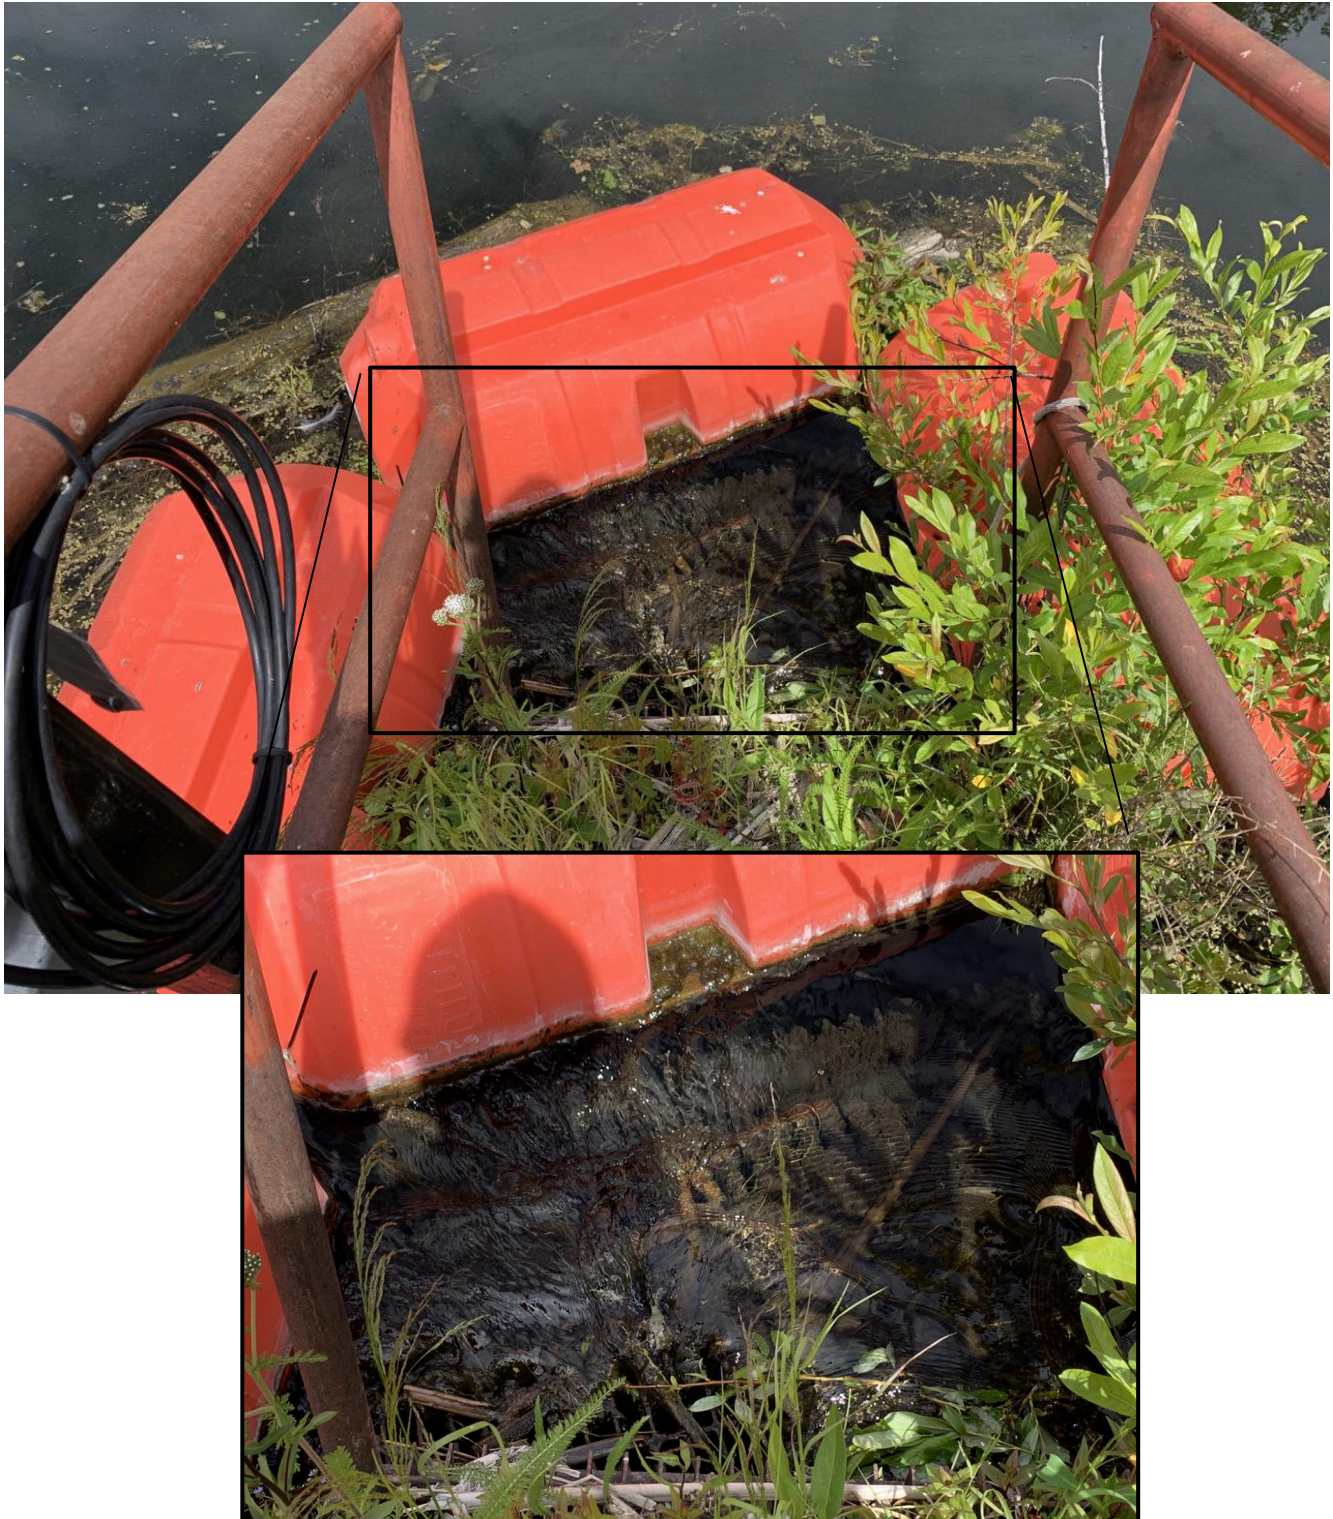
Photo I-C-10 Low-Level Outlet (LLO) inlet. Accumulated debris on trash rack was cleared by THVCP as part of routine maintenance after site visit (TRJ-2020-29)
