# 2020 Annual Inspection for Turnbull Tailings Storage Facility

*Teck Coal Limited, Fording River Operations*

Reference No. 20136981-2020-221-R-Rev0-2000

8 March 2021

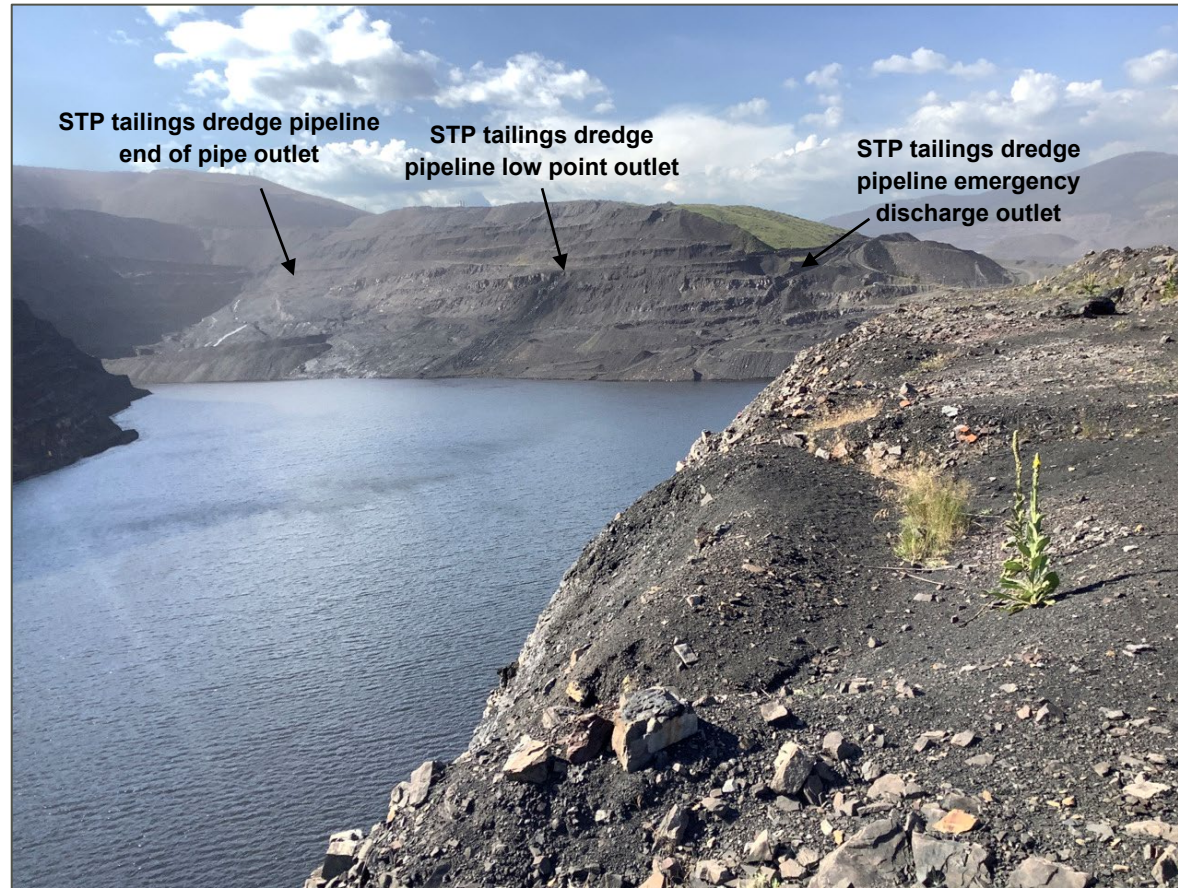
## PHOTOGRAPH A-1

Turnbull TSF overview from north endwall, looking southwest.

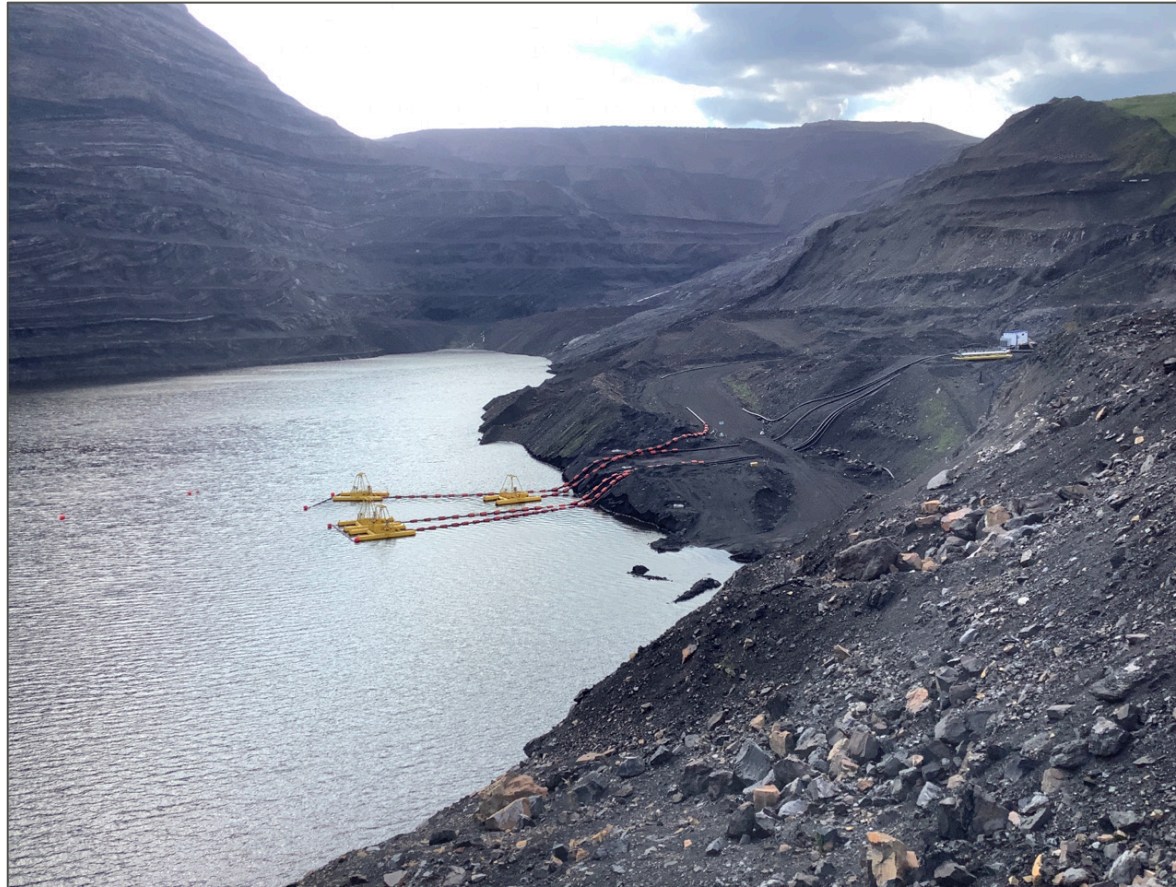
## PHOTOGRAPH A-2

Turnbull TSF Pond, reclaim water intakes and pipelines, looking southeast.

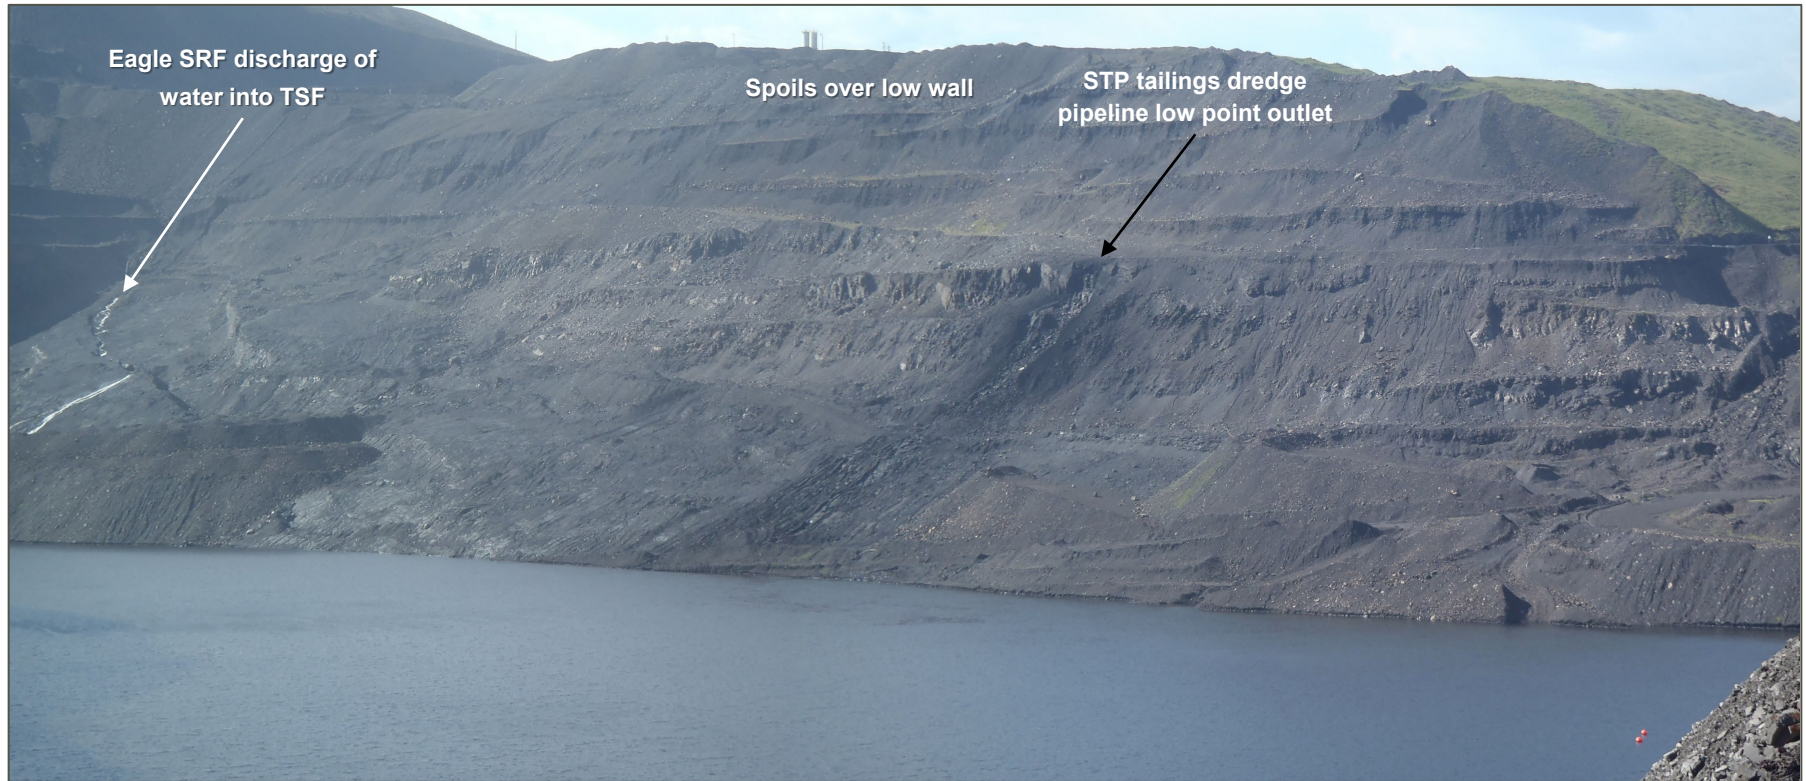
## PHOTOGRAPH A-3

Turnbull TSF Eagle Saturated Rockfill (SRF) pipeline discharge into Turnbull TSF, looking south.

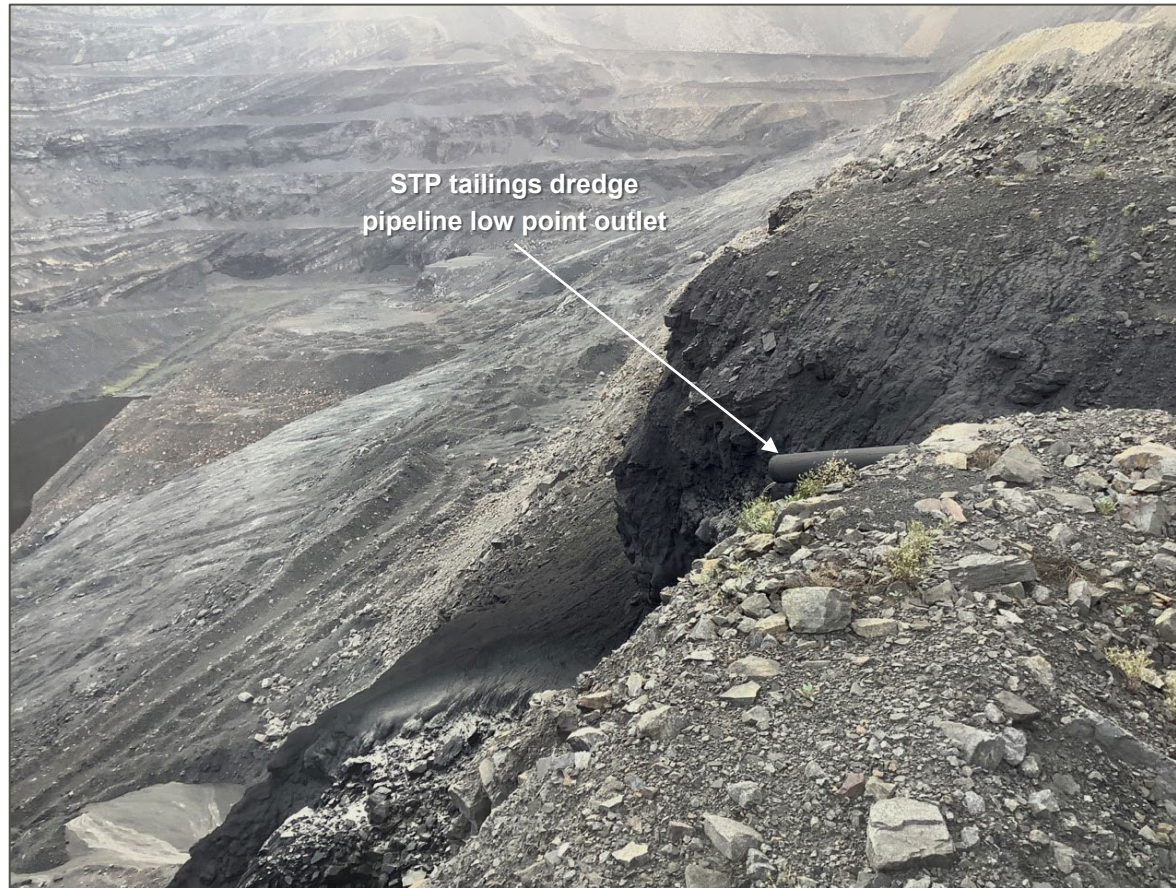
## PHOTOGRAPH A-4

Tailings dredge pipeline low point outlet, looking southeast (STP dredge was not running at time of site visit).

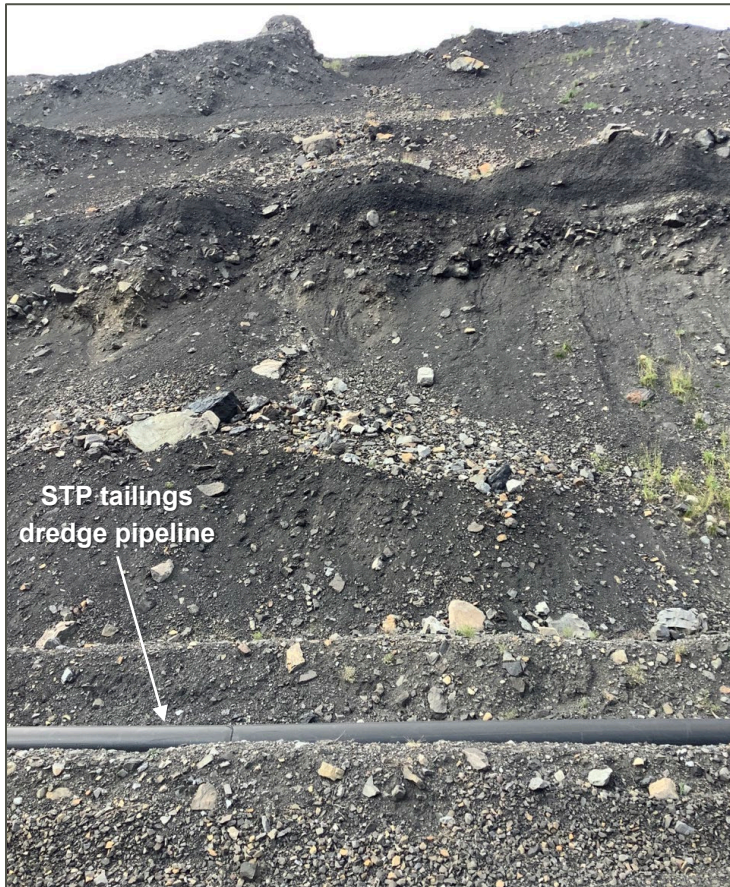
## PHOTOGRAPH A-5

Debris was observed to be collecting between tailings dredging pipeline berm and the spoils over the low wall (Photograph A-5). This debris should be cleaned out, which FRO reported it was planning to complete as part of maintenance activities.

Debris is collecting behind berm for pipeline;  
this debris should be cleaned out.

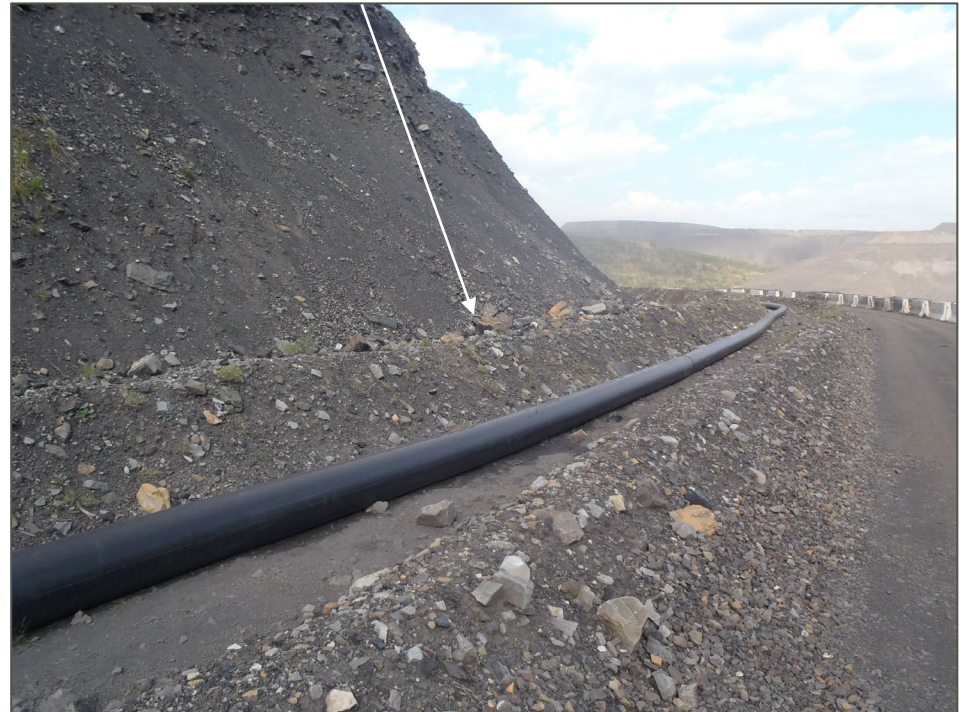
Turnbull TSF waste rock benching slope above tailings pipeline on low wall, looking southwest.

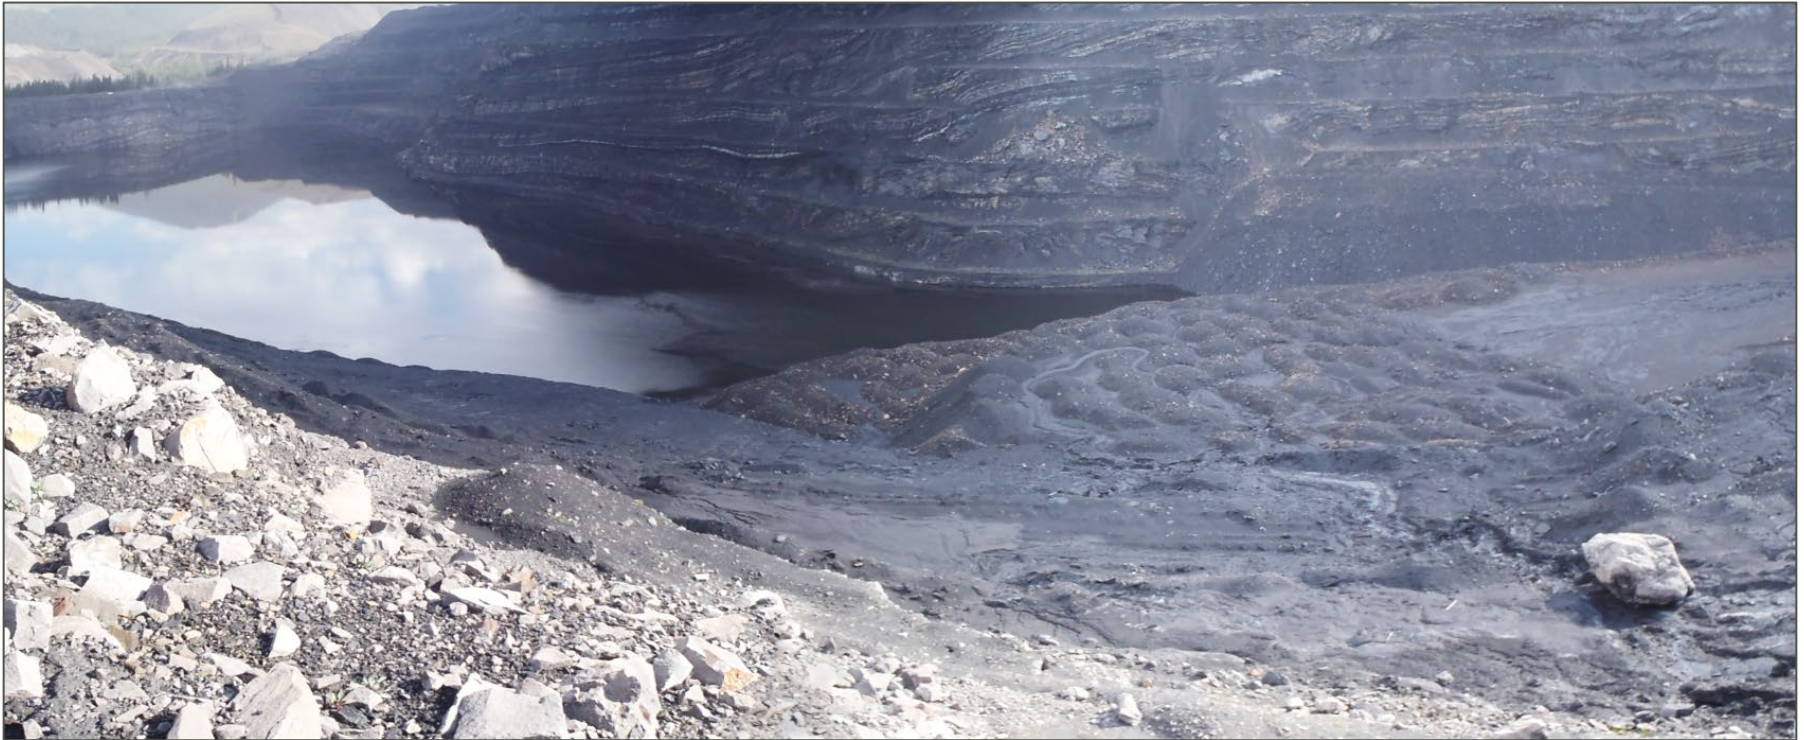
## PHOTOGRAPH A-6

Tailings flow from the pipeline low point outlet discharges over in-pit spoils into the pit pond, looking east.

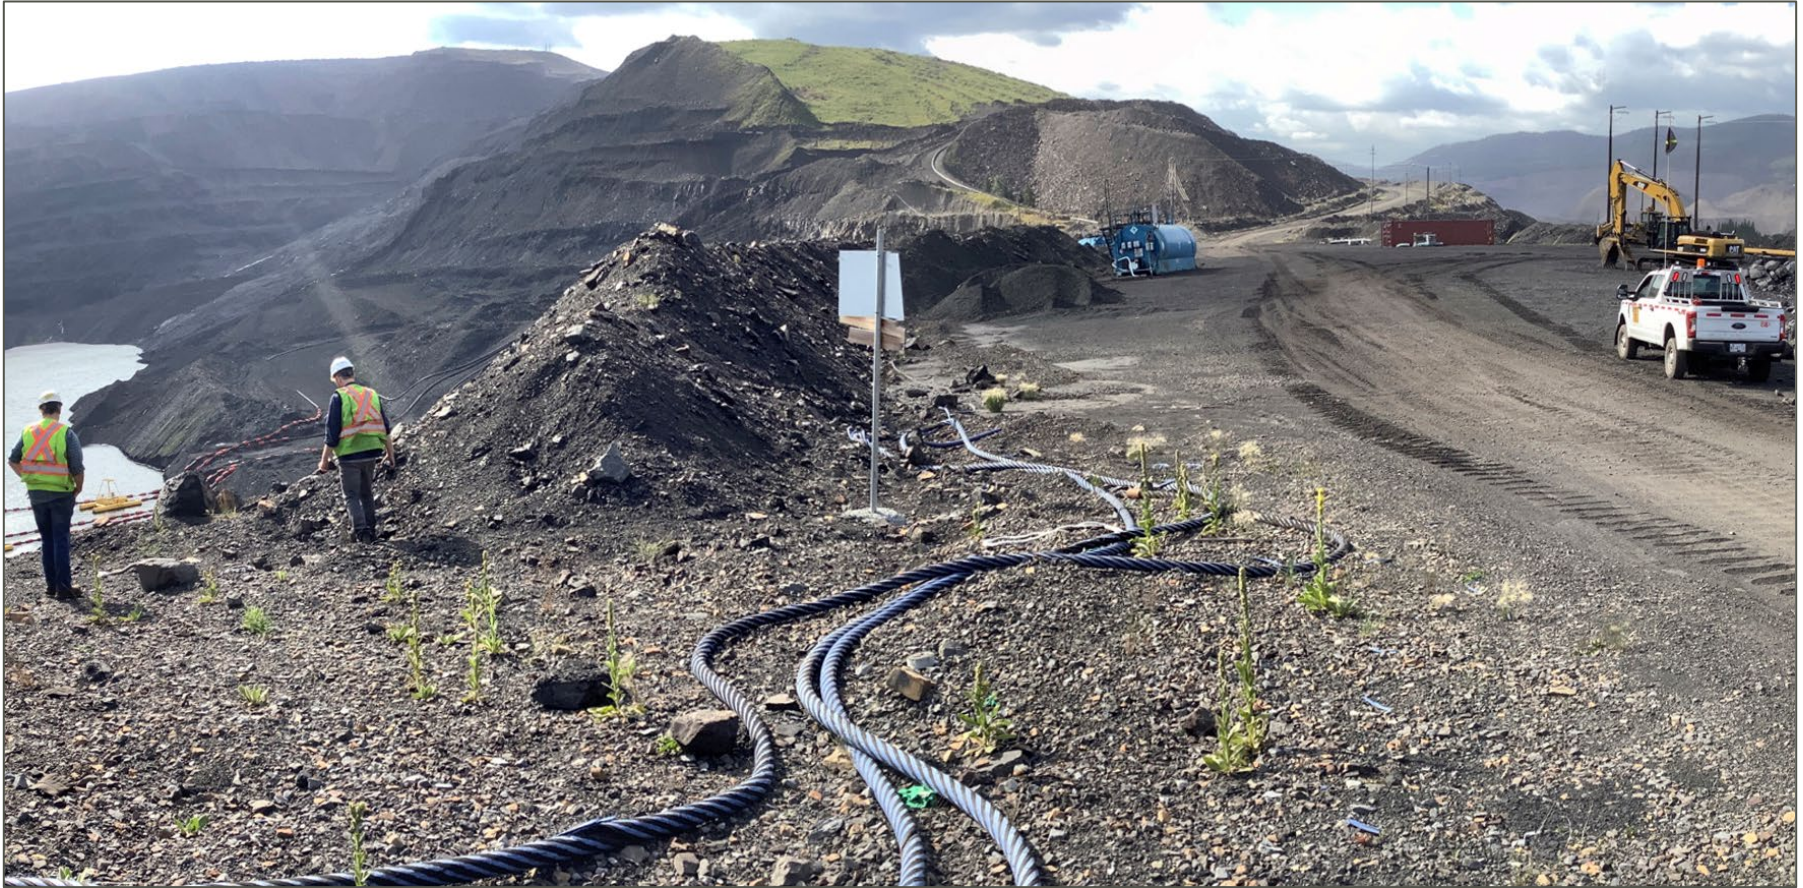
## PHOTOGRAPH A-7

Considering the potential for a highwall failure to generate a wave in the TSF pond, the backfill spoil (also a haul road at the low point of the pit area) over the footwall is considered a dam (Photograph A-7 in Appendix A). The backfill spoil and downstream toe area were inspected during the 2020 site inspection. The haul road area includes pumping infrastructure and a laydown area (Photographs A-7 and A-8). The downstream toe of the haul road is located adjacent to the Fording River (Photographs A-9 and A-10).

Turnbull TSF backfill spoil and haul road at pit low point area, looking south.

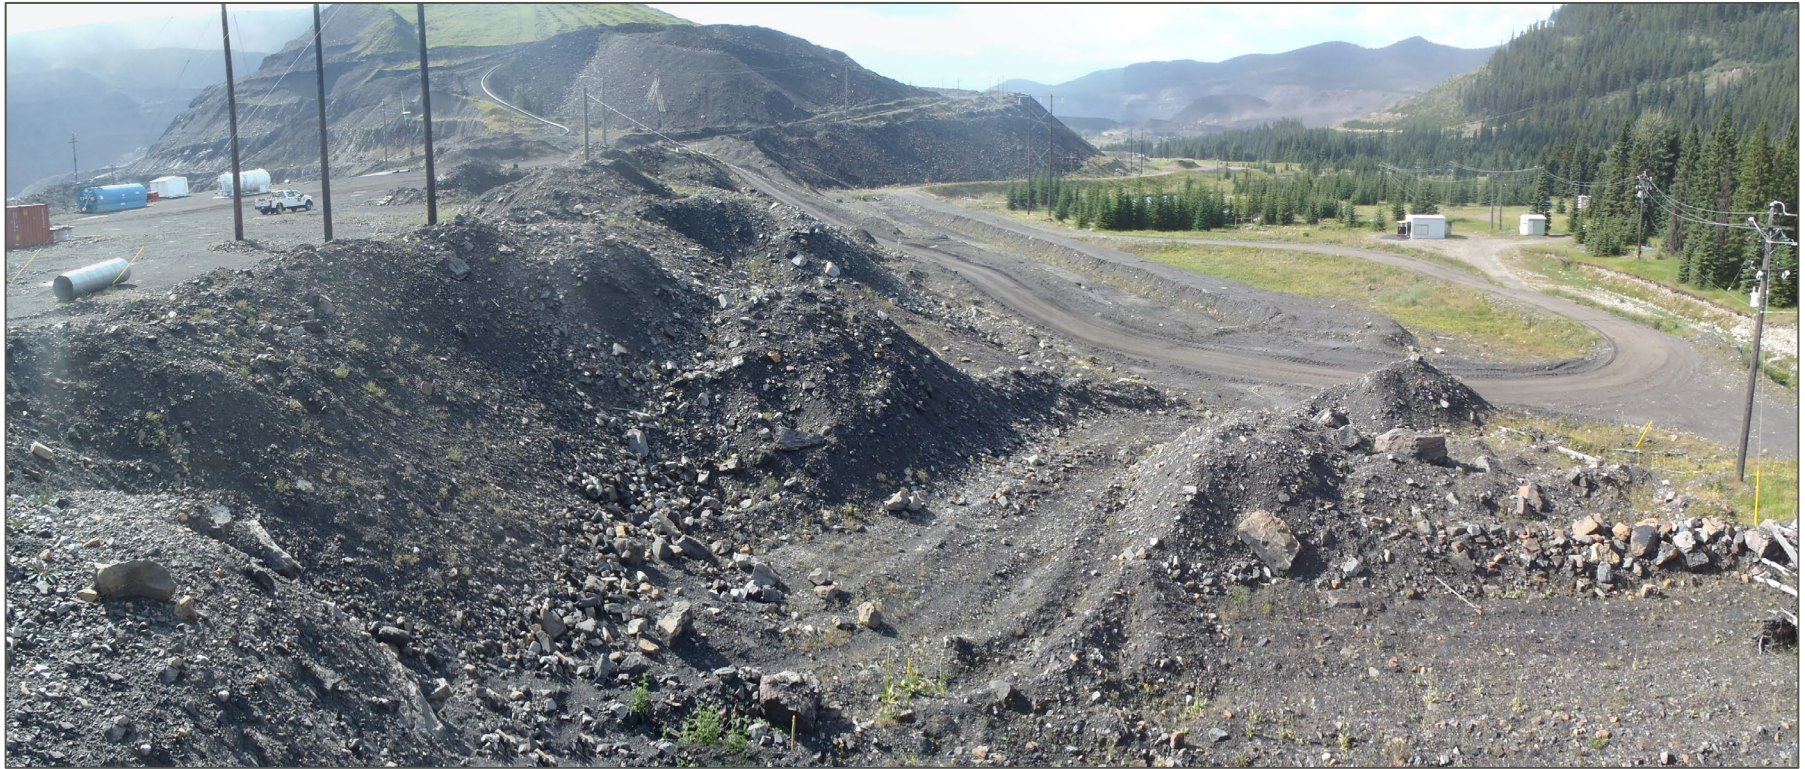
**PHOTOGRAPH A-8**

Turnbull TSF view of downstream slope to the low point area waste rock fill and haul road, looking south.

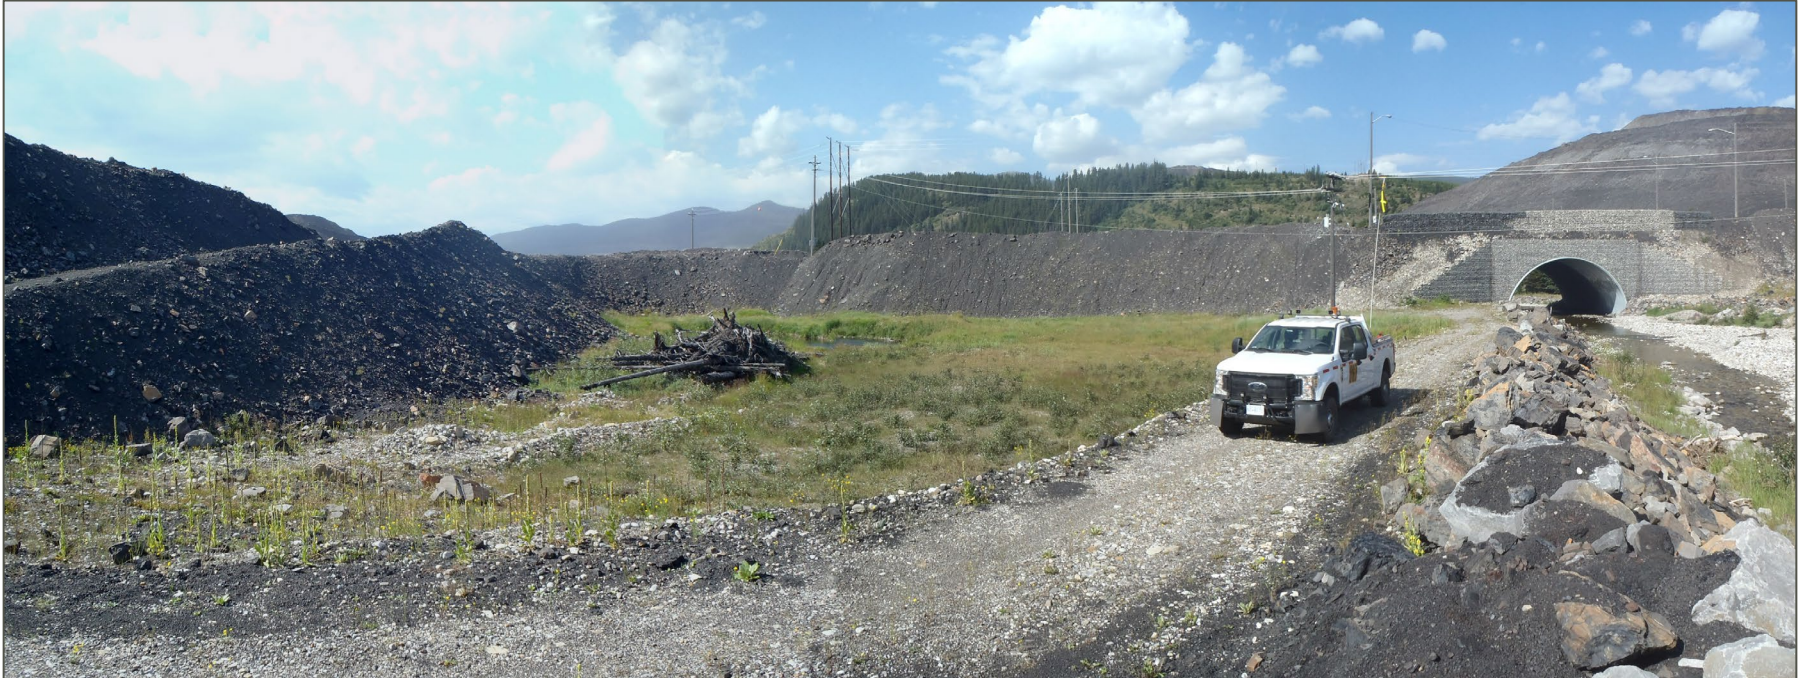
**PHOTOGRAPH A-9**

Turnbull TSF view of downstream slope toe to the low point area waste rock fill and haul road fill, looking southwest.

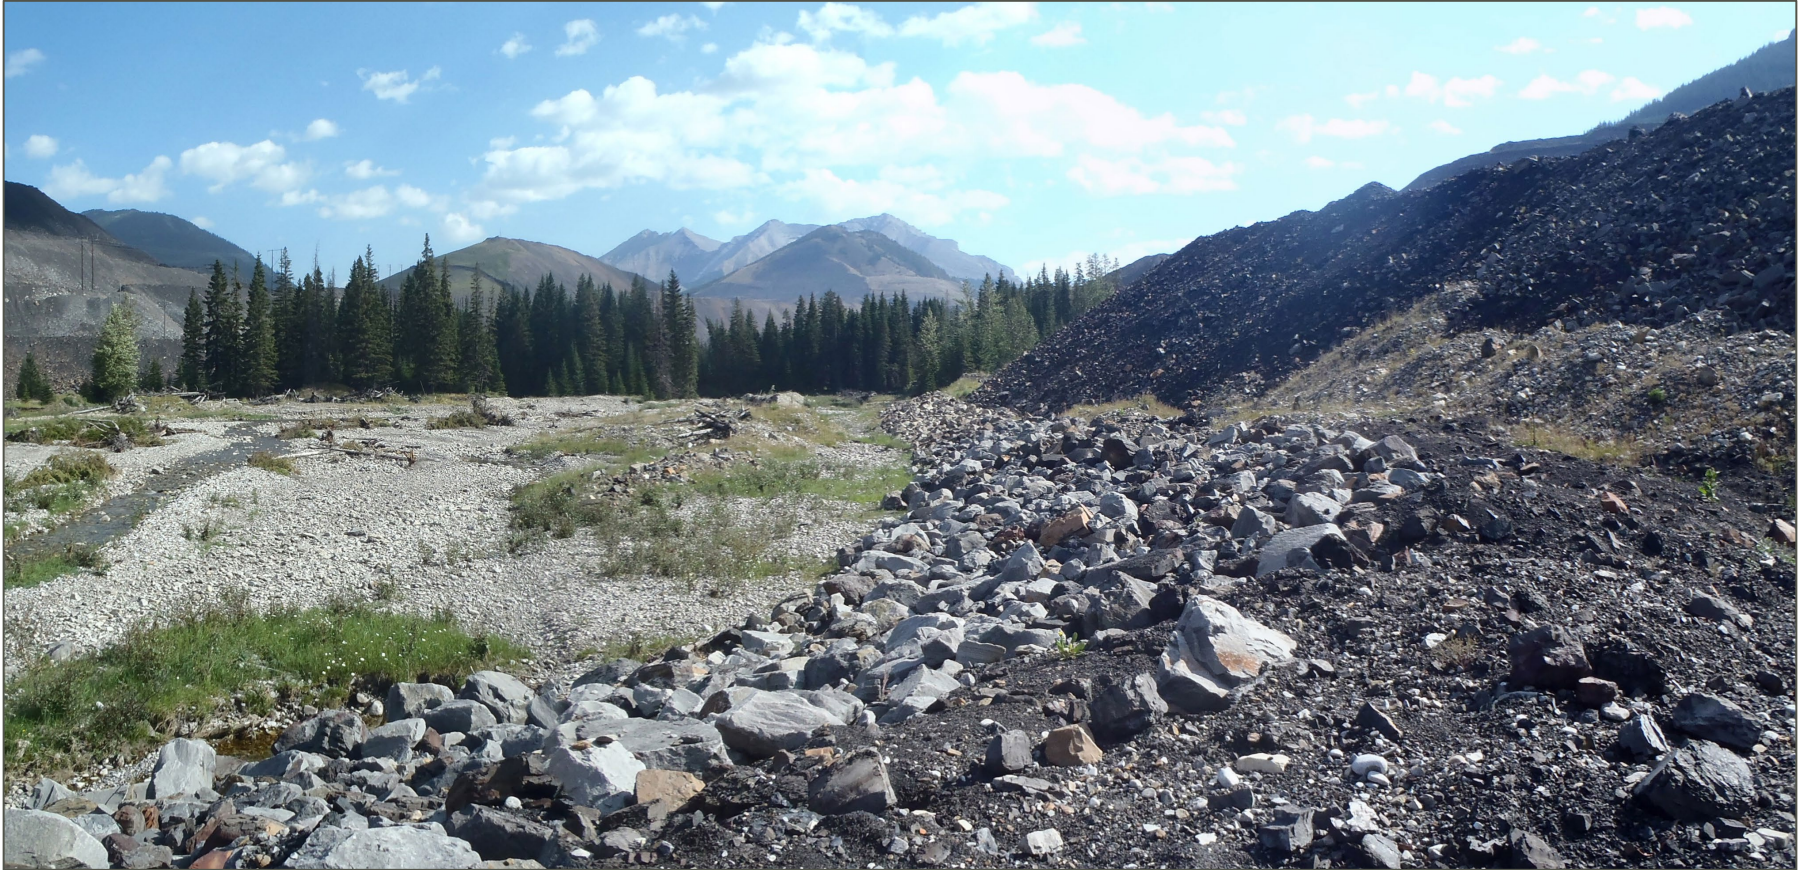
**PHOTOGRAPH A-10**

Turnbull TSF view of downstream slope toe to the low point area waste rock fill and haul road, with riprap placed along Fording River, looking northeast.
