# **2021 Annual Facility Performance Report**

Beaverdell Tailings Storage Facilities Beaverdell, BC Project # VE52701

Wood File #: Project # VE52701 30 March 2022

# Re: 2021 Annual Performance Report, Beaverdell Mine Tailings Storage Facilities, Beaverdell, BC

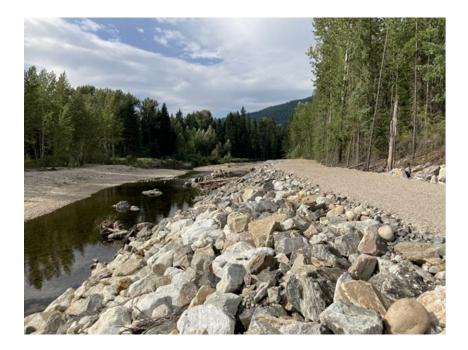
In summary, there have been no significant changes in the TSFs with the exception of the riprap armoring of toe of Cells 4 and 5 where they are adjacent to the West Kettle River. The riprap installed in 2019 and 2020 was in good condition. A reserve stockpile of riprap was present at the southeast corner of the South TSF. At the time of the site reconnaissance the water level in the West Kettle River was lower than the bottom of the upper staff gauge.

Photo 1: South TSF - Cell 5 Dam Toe Erosion Protection Riprap, Looking South. Aug 19, 2021

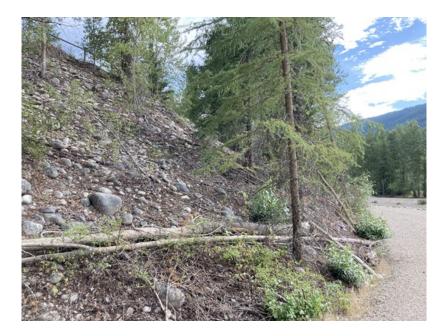
Photo 2: South TSF –Cell 5 Southeast Corner Downstream Dam Slope, Looking Northeast. Aug 19, 2021

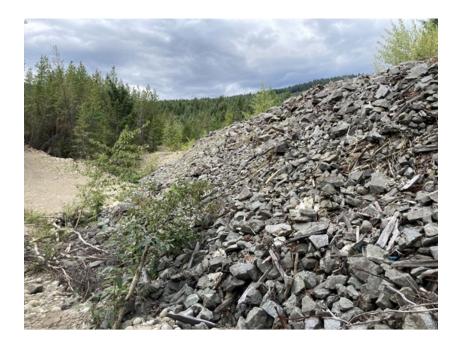
Photo 3: South TSF –Cell 5 Southwest Corner Downstream Slope with Rockfill, Looking West. Aug 19, 2021

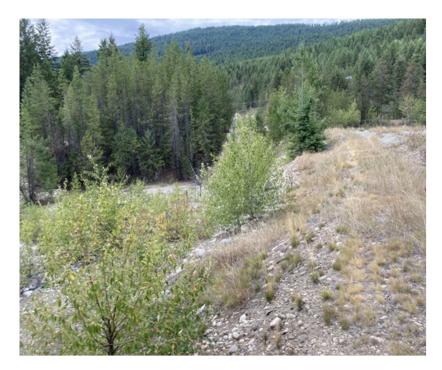
Photo 4: South TSF –Cell 1 Crest and Downstream Slope, Looking Southwest. August 19, 2021

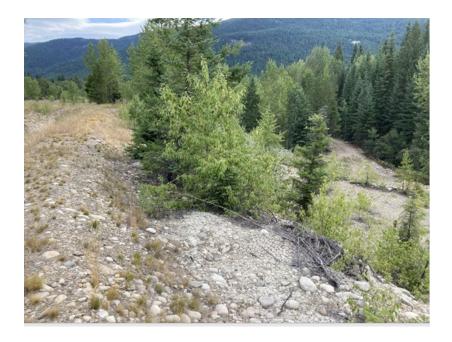
Photo 5: South TSF – Cell 1 Crest and Downstream Dam Slope, Looking East. August 19, 2021

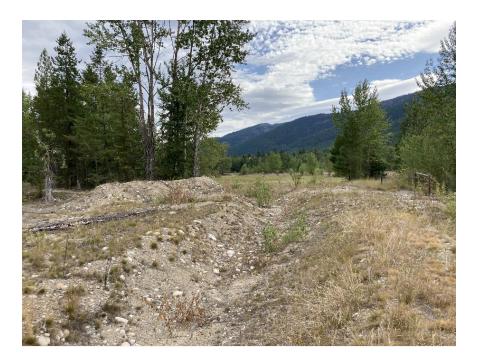
Photo 6: South TSF –Cell 1 Upstream Ditch to Cell 5, Looking Northeast. August 19, 2021

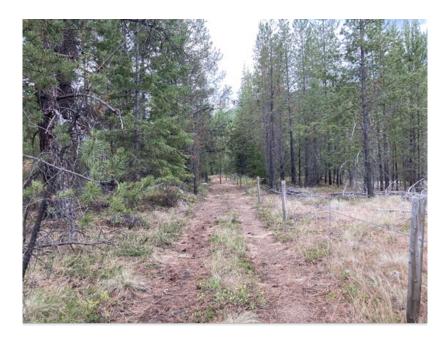
Photo 8: South TSF – Access Road at West Side of Cell 2, Looking South. August 19, 2021

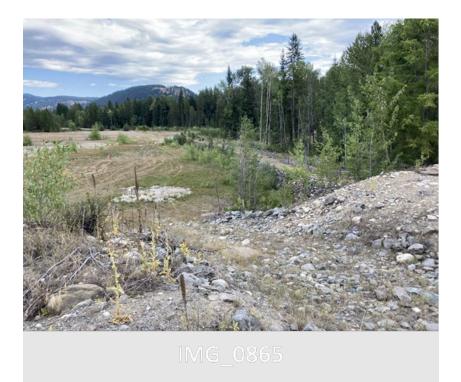
Photo 9: South TSF – Spillway from Cell 4 to Cell 3, Looking North at Cell 3. Aug 19, 2021

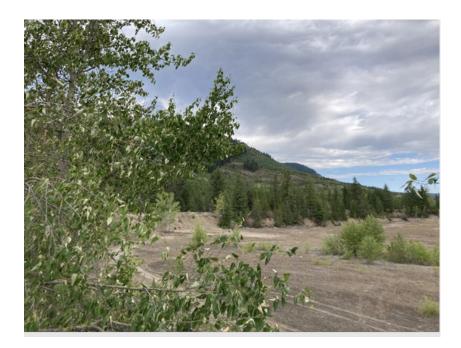
Photo 10: South TSF –Cell 3 Tailings, Looking from Cell 4. August 19, 2021

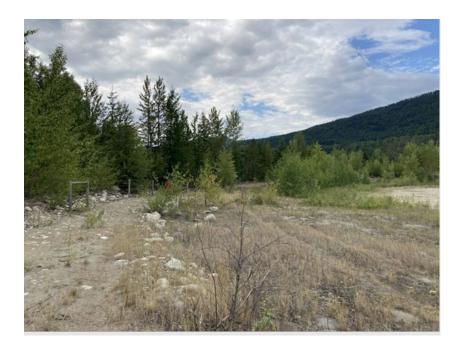
Photo 11: South TSF –Cell 4 Dam Crest and Tailings, Looking South. August 19, 2021

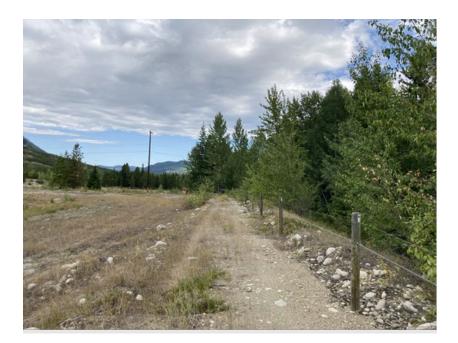
Photo 12: South TSF –Cell 4 Dam Crest and Tailings, Looking North. August 19, 2021

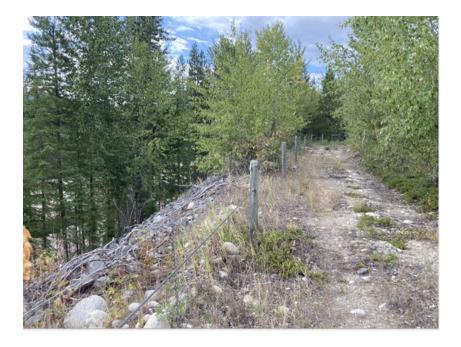
Photo 13: South TSF -Cell 5 Crest, Looking South. August 19, 2021

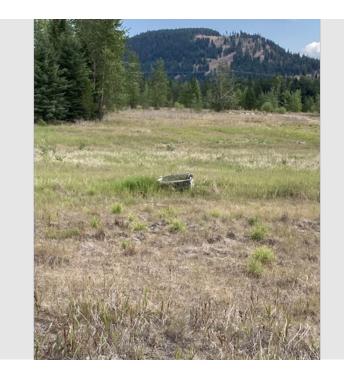
Photo 14: South TSF – Decant Tower in Cell 5, Looking West. August 19, 2021

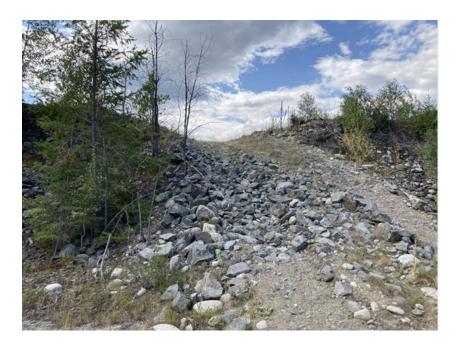
Photo 15: South TSF –View of Spillway Between Cell 3 and Cell 4, Looking South from Cell 3. August 19, 2021

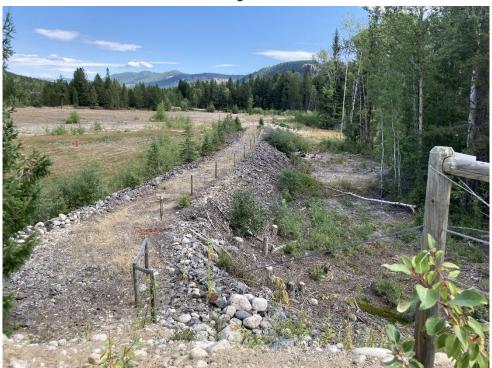
Photo 16: South TSF –Cell 3 Dam Crest, Downstream Slope and Toe Area, Looking South from Cell 4. August 19, 2021

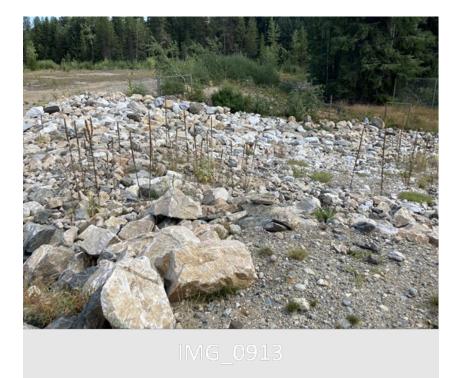
Photo 17: South TSF –Cell 3 Spillway, Looking South. August 19, 2021

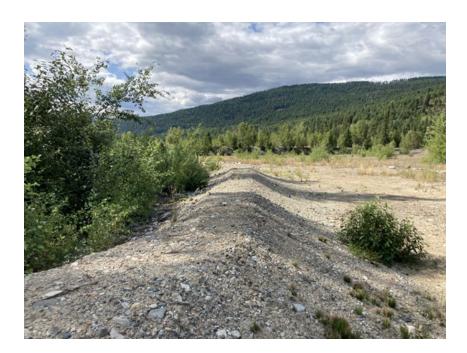
Photo 18: South TSF –Cell 3 Berm to the South of Spillway, Looking Southwest. August 19, 2021

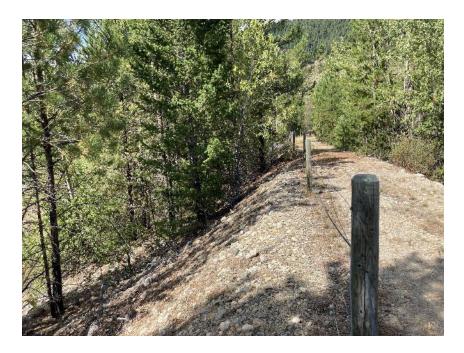
Photo 19: North TSF –Cell 6 South Dam Crest and Downstream Slope, Looking West. August 19, 2021

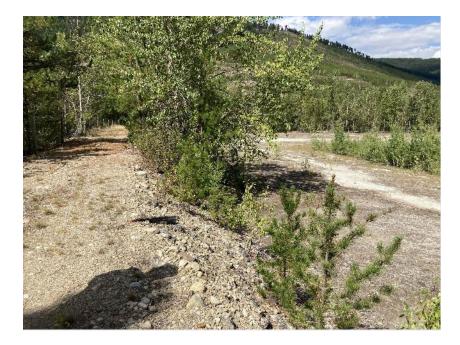
Photo 20: North TSF –Cell 6 Crest and Upstream Tailings, Looking West. August 19, 2021

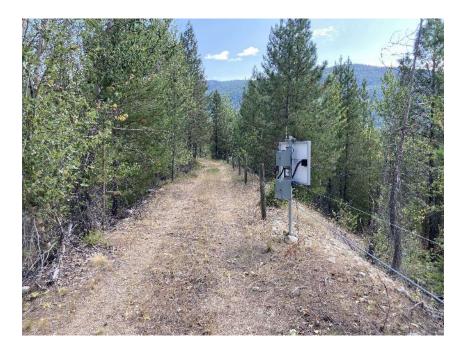
Photo 21: North TSF -Cell 7 South Dam Crest with Signal Repeater, Looking East. August 19, 2021

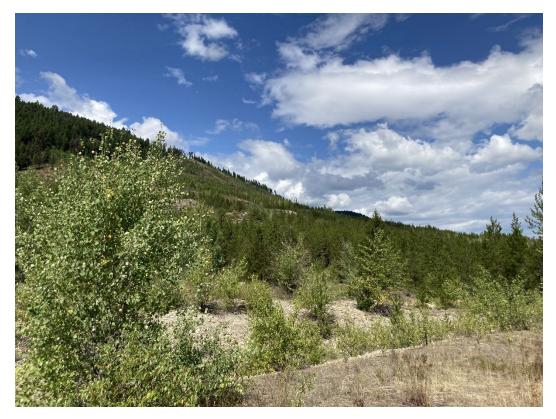
Photo 22: North TSF – Cell 7 Southwest Corner Diversion and Spillway, Looking West. August 19, 2021

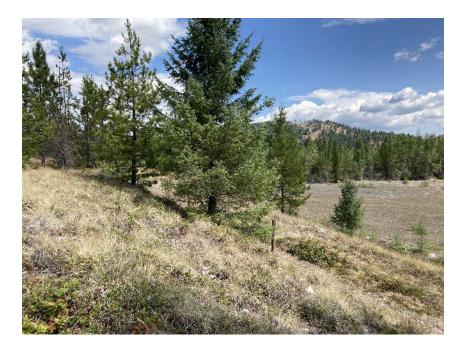
Photo 23: North TSF – Cell 7 Tailings and West Backslope, Looking North. August 19, 2021

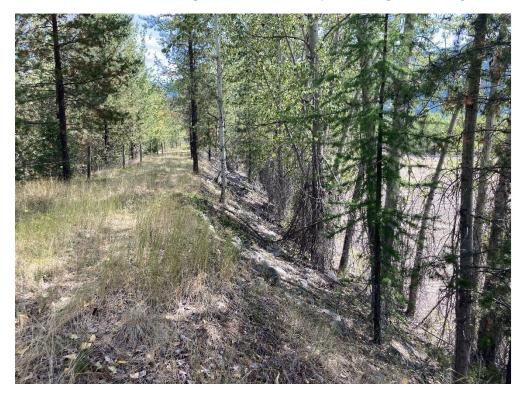
Photo 24: North TSF –Cell 7 North Dam Crest and Upstream Slope, Looking East. August 19, 2021

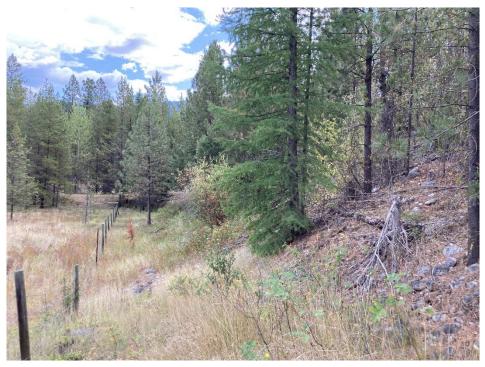
Photo 25: North TSF –Cell 7 North Dam Downstream Slope and Toe, Looking North. August 19, 2021

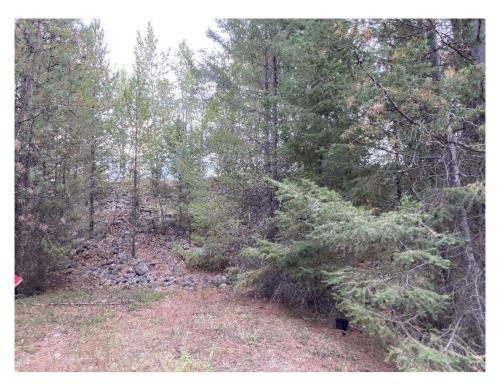
Photo 26: North TSF –Cell 6 Downstream Slope and Toe, Looking East. August 19, 2021

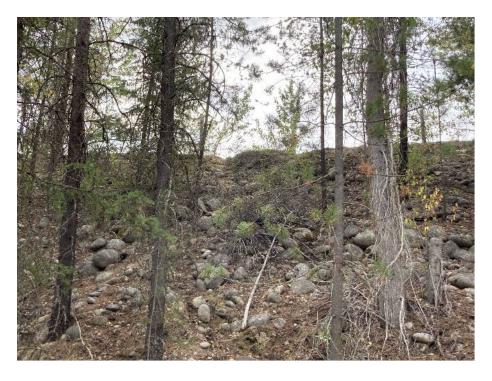
Photo 27: North TSF -Cell 6 Downstream Slope. Looking West. August 19, 2021

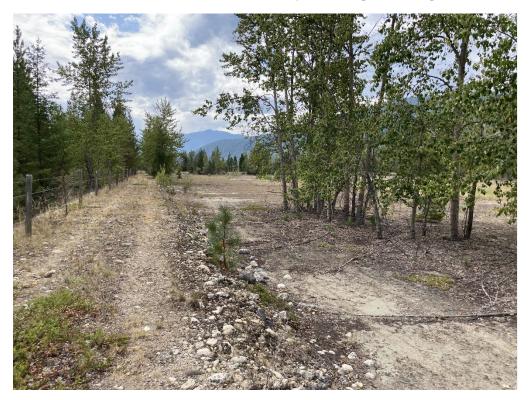
Photo 28: North TSF –Cell 6 Crest and Tailings, Looking South. August 19, 2021

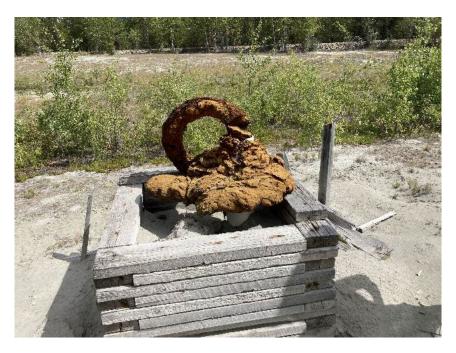
Photo 29: North TSF -Cell 6 Plugged Decant Tower. August 19, 2021

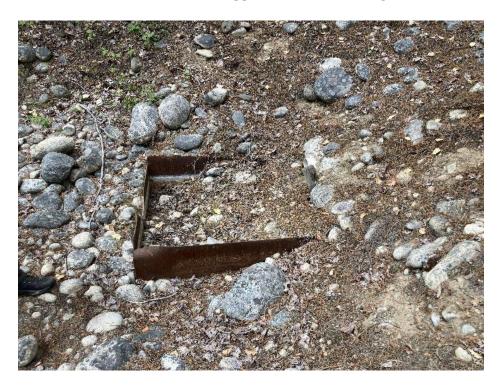
- Sinkholes or subsidence of the tailings surface was noted, though the entire tailings surface was not observed.
- The outlet pipes for the Cell 6 and 7 decants were dry.

Photo 30: North TSF -Cell 6 Decant Outlet. August 19, 2021

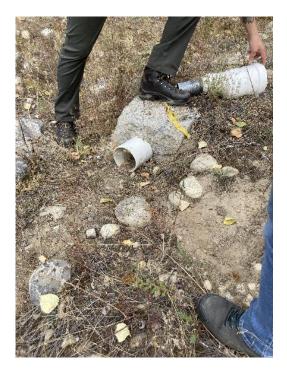
Photo 31: North TSF – Cell 7 Decant Outlet. August 19, 2021

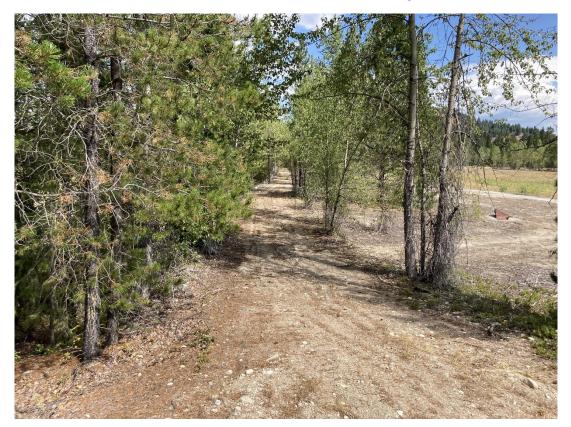
Photo 32: North TSF – Divider Dyke Between Cell 6 and Cell 7, Looking North. August 19, 2021

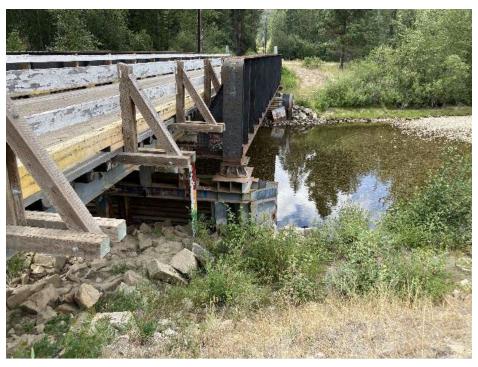
Photo 33: Staff Gauge Installed on Bridge Crossing at West Kettle River, Looking West. August 19, 2021

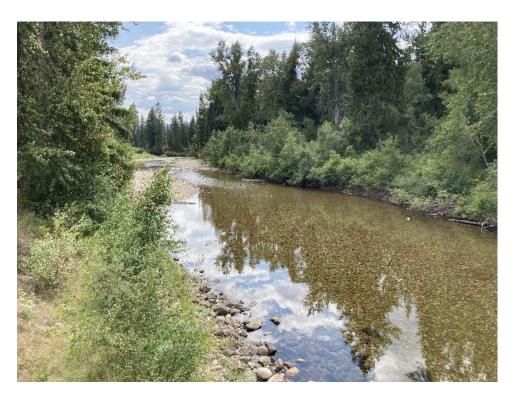
Photo 34: View of West Kettle River, Looking South from East Side of Bridge. August 19, 2021
