Teck Resources Limited

Bullmoose Mine

Bullmoose Tailings Storage Facility 2021 Annual Facility Performance Review

March 22, 2022

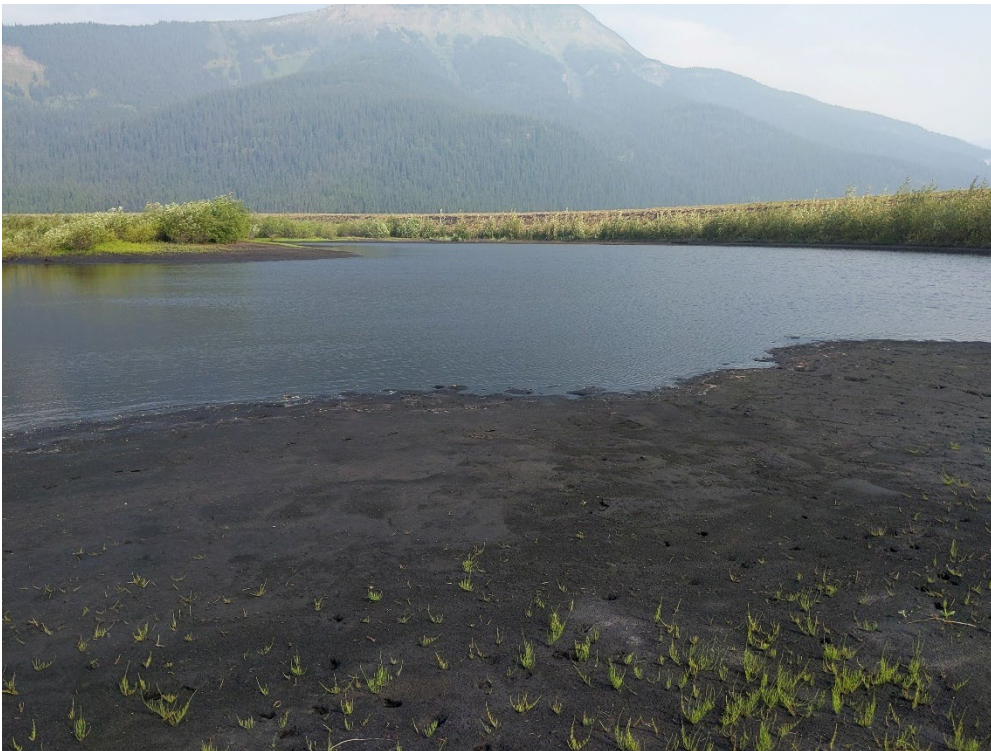
Photo II-19 Pond – High water mark indicated by edge of vegetation (BTD-2021-10)

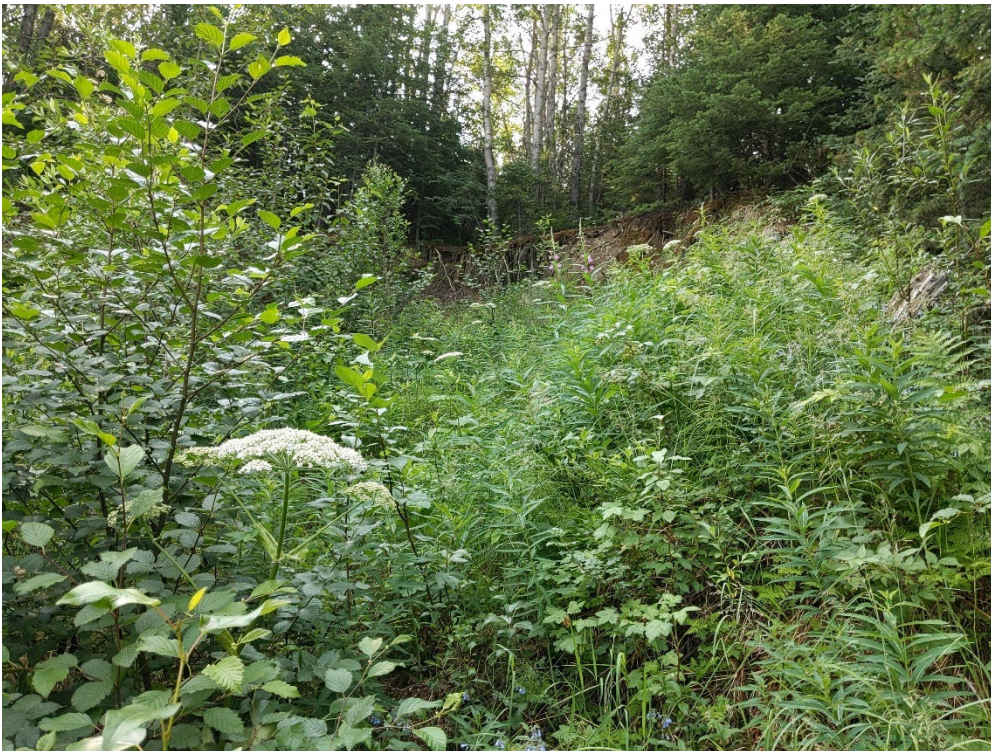
- **Historical Slope Failure on Natural Slope South of Impoundment:** A historical slope failure is present in the natural slope on the south side of the impoundment (Photo II-21). The failure is also visible in photographs from previous annual reports (Teck 2013a, KCB 2011, KCB 2014a, and KCB 2020a) indicating this has been present since at least 2010. The slide mass is overgrown with vegetation including small trees. Comparison of photographs between 2010

Photo II-21 Location of historic slide (BTD-2021-12)

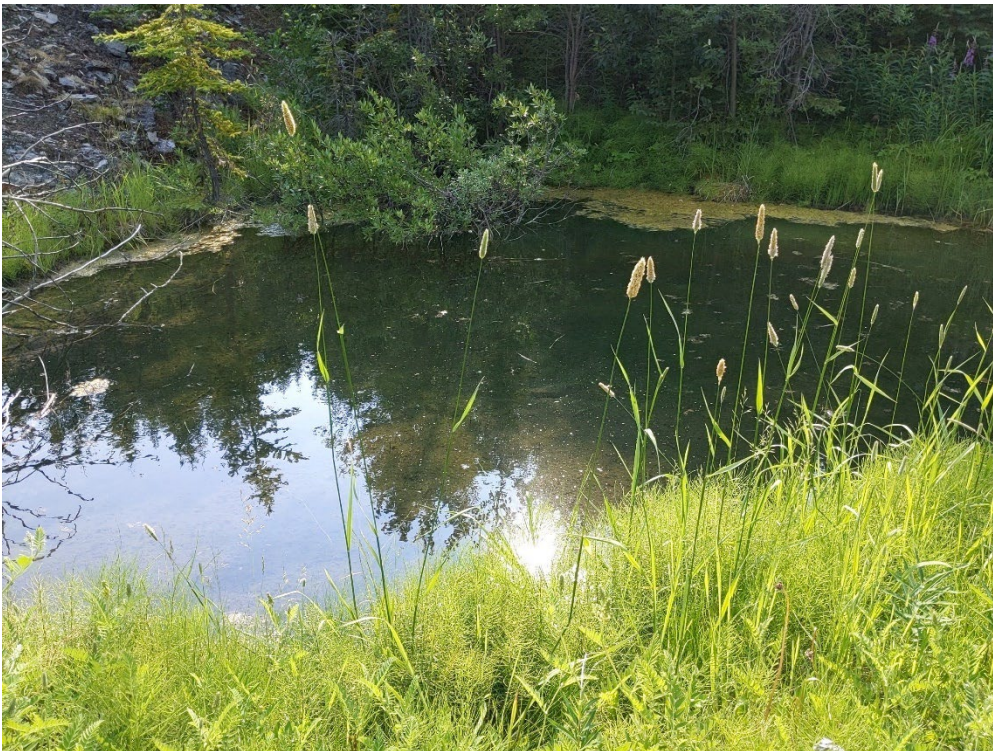
Photo II-25 BTDF Toe – Ponded water at toe (BTD-2021-14)

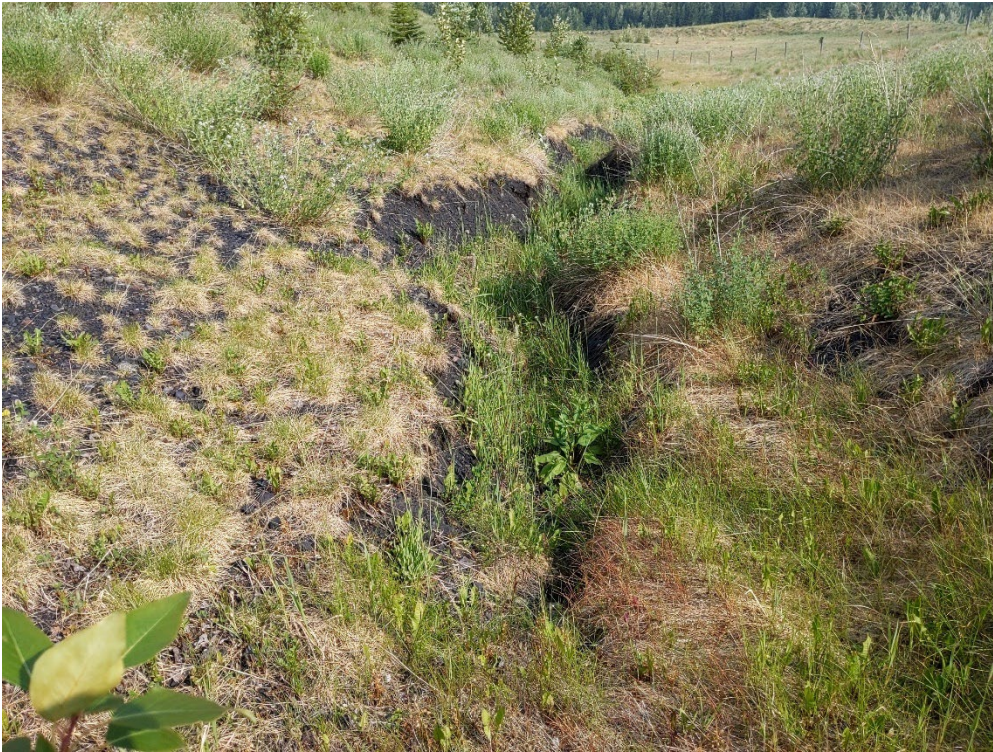
- ◆ No change to the erosion gully observed at the toe near the right abutment (Photo II-26). The gully was first observed in 2017 and has not changed significantly since that time. The likely cause was concentrated local flow during spring freshet. This feature continues to be monitored and inspected for signs of change during routine visual inspections and annual site visits.

Photo II-26 BTD Toe – Erosion gully at toe (BTD-2021-15)

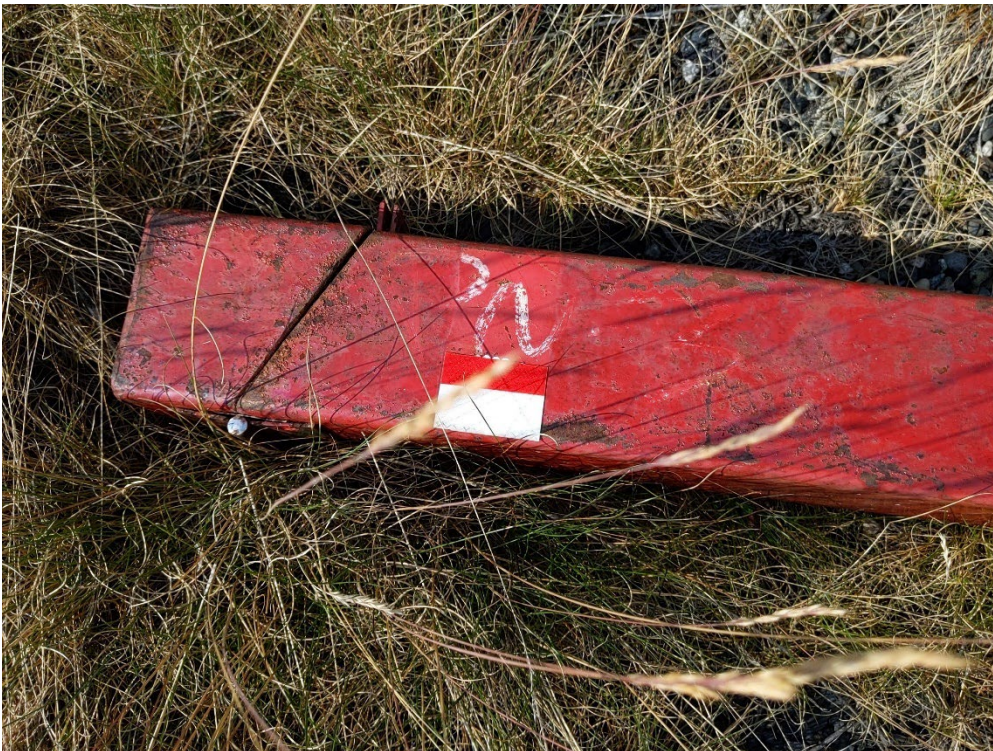
Photo II-27 Piezometer PN-3 needs repair (BTD-2021-16)

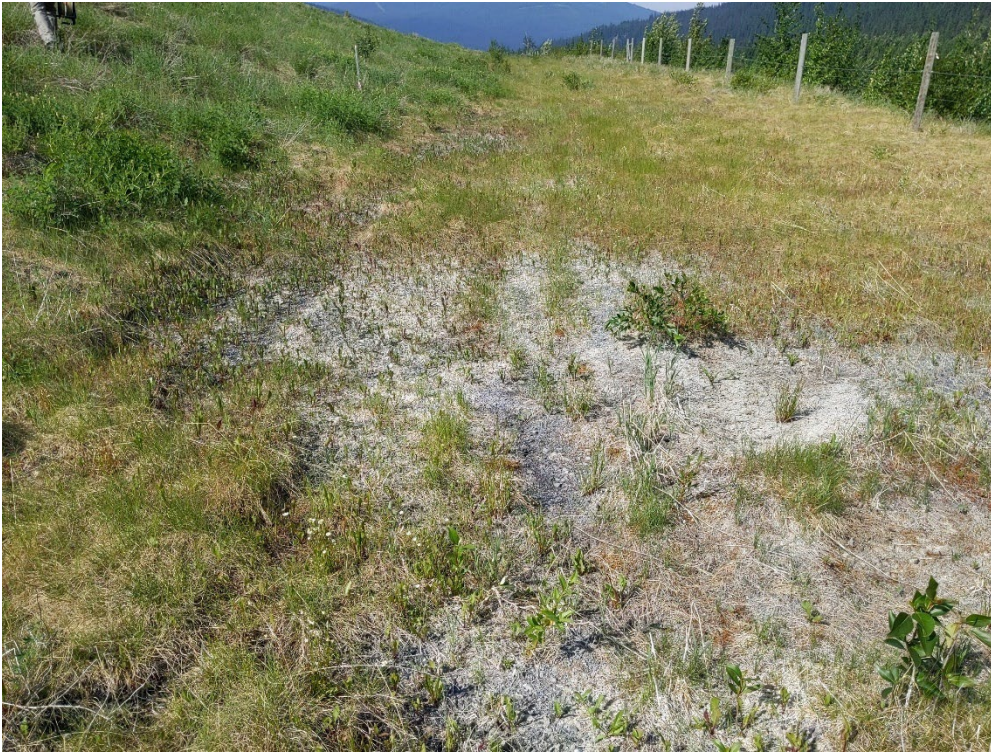
- ◆ There is a small wet area near the toe of the north arm of the BTSF (Photo II-30, II-33) which was first noted in 2019. There were no signs of seepage emerging from the downstream slope, and the wet area is believed to be due to ponding from snowmelt from the slopes.

Photo II-30 BTD Toe – Known wet area was dry at time of site visit (BTD-2021-18)

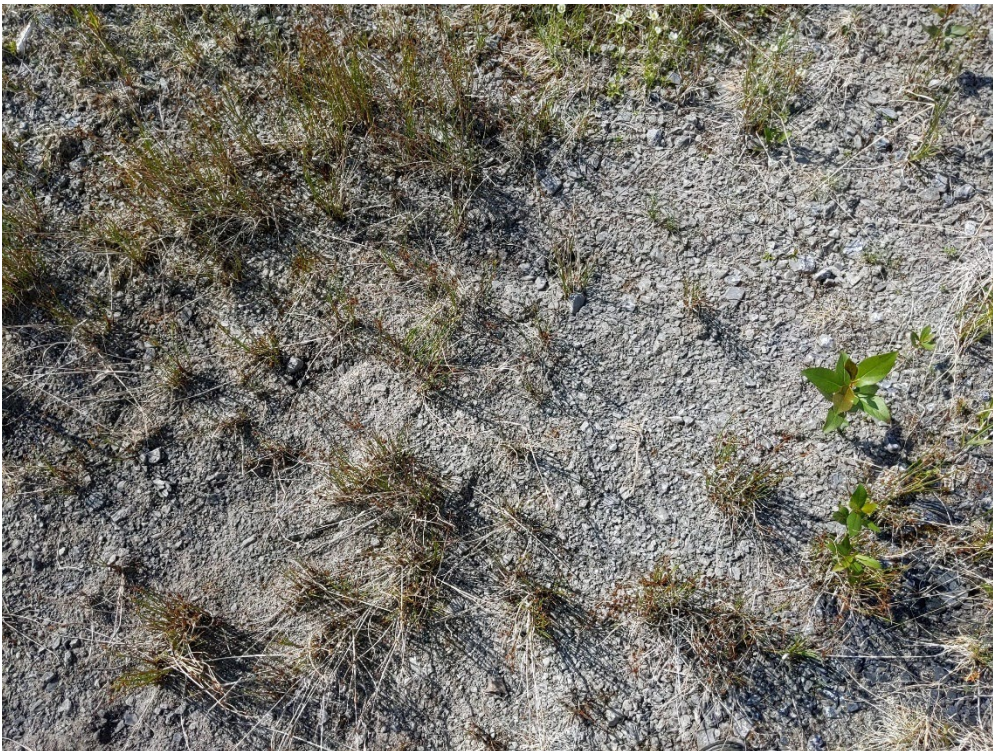
Photo II-33 BTD Toe – Known wet area was dry at time of site visit (BTD-2021-19)

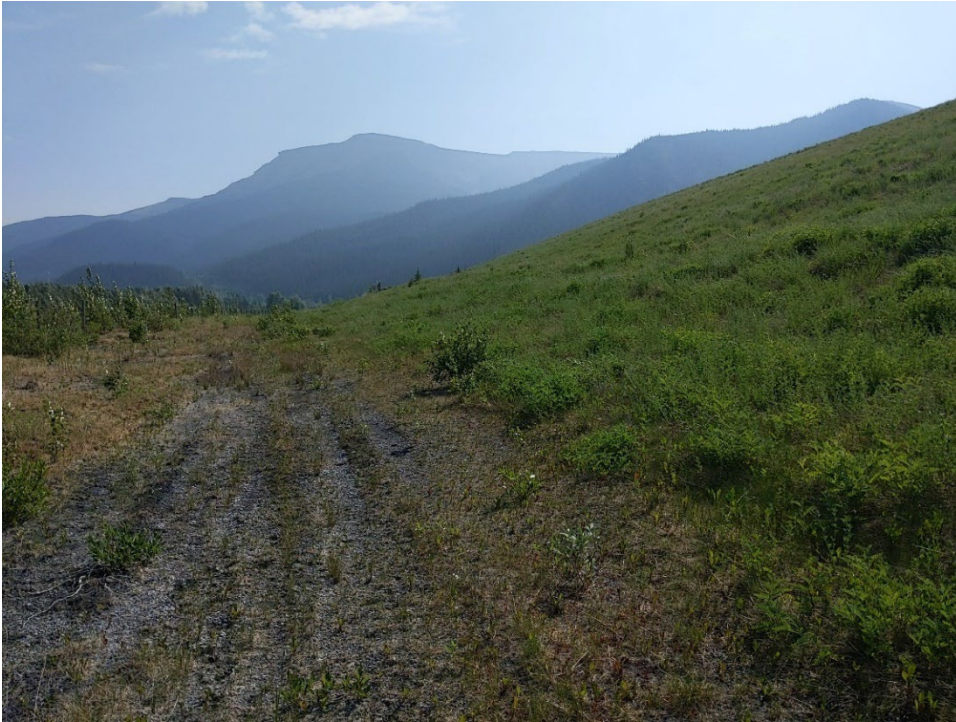
Photo II-34 **BTD Downstream slope – Looking east, known wet area was dry at time of site visit (BTD-2021-19)**
