Teck Coal Limited

Coarse Coal Refuse Dump

2021 Annual Facility Performance Report

March 30, 2022

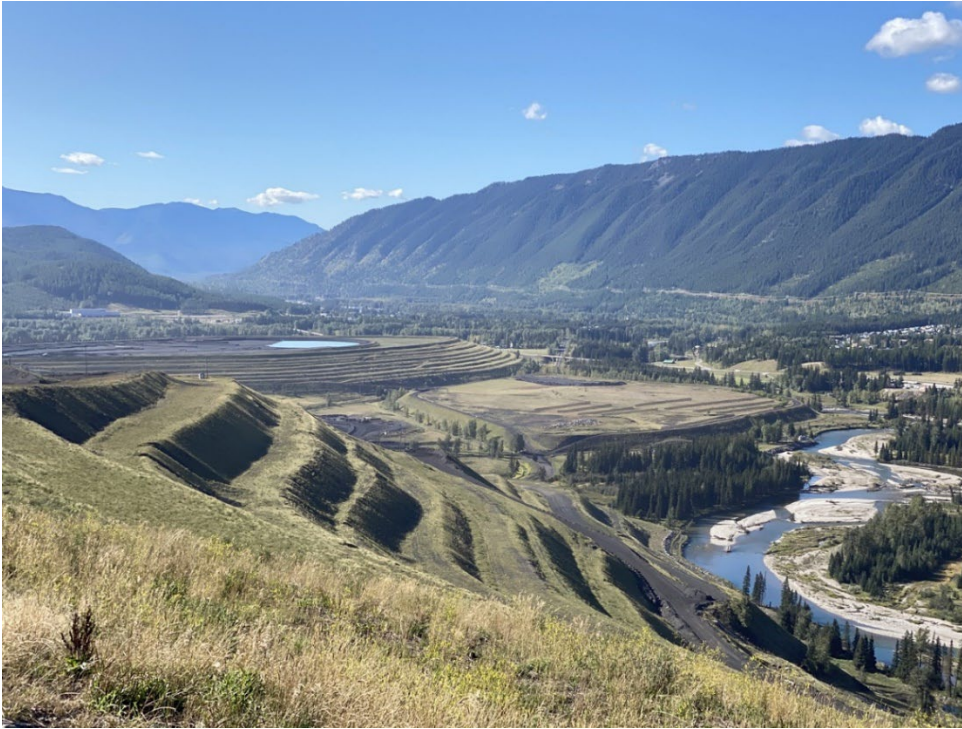
Photo I-1 CCR Dump upper benches typical condition. (Looking South – Taken 16 September 2021)

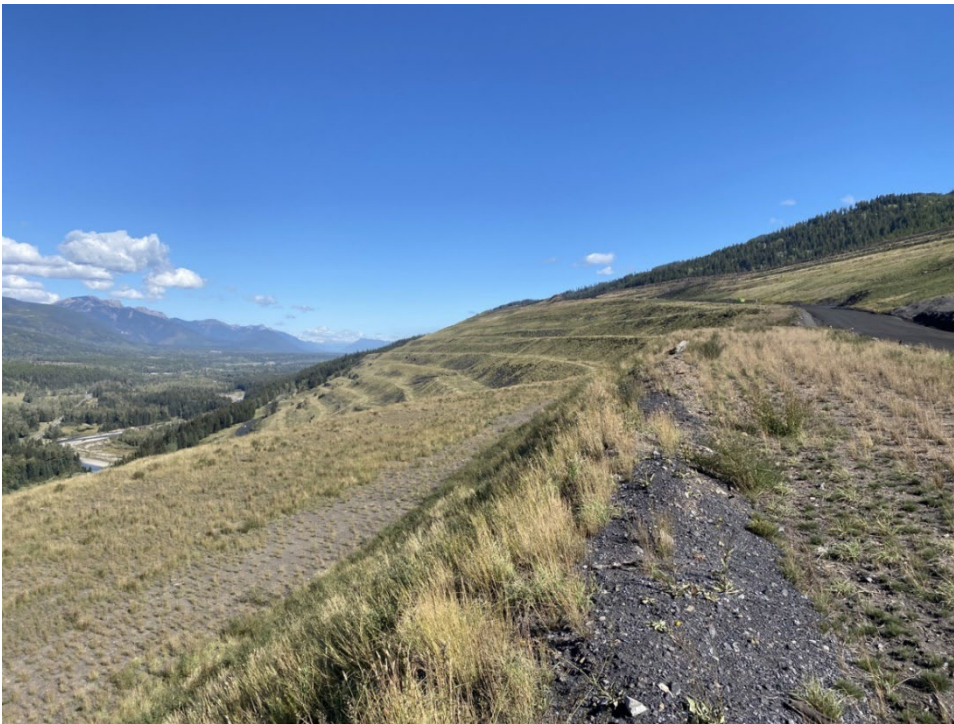
Photo I-2 CCR Dump bench typical condition. (Looking North – Taken 16 September 2021)

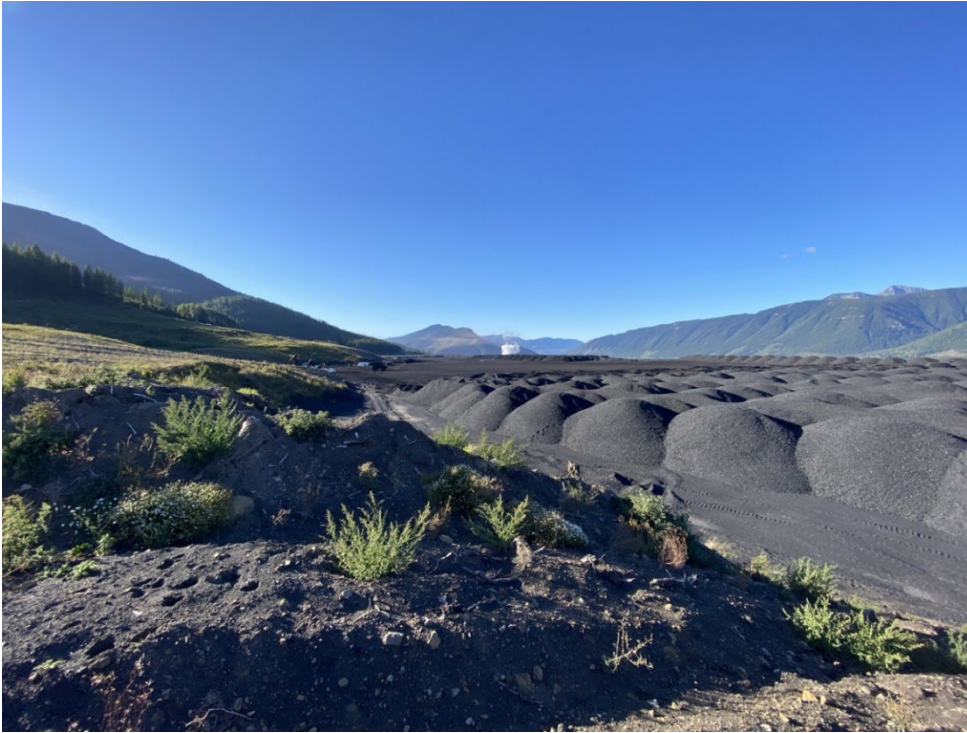
Photo I-3 CCR Dump crest and loose CCR material for geochemical trial program. (Looking South – Taken 16 September 2021)

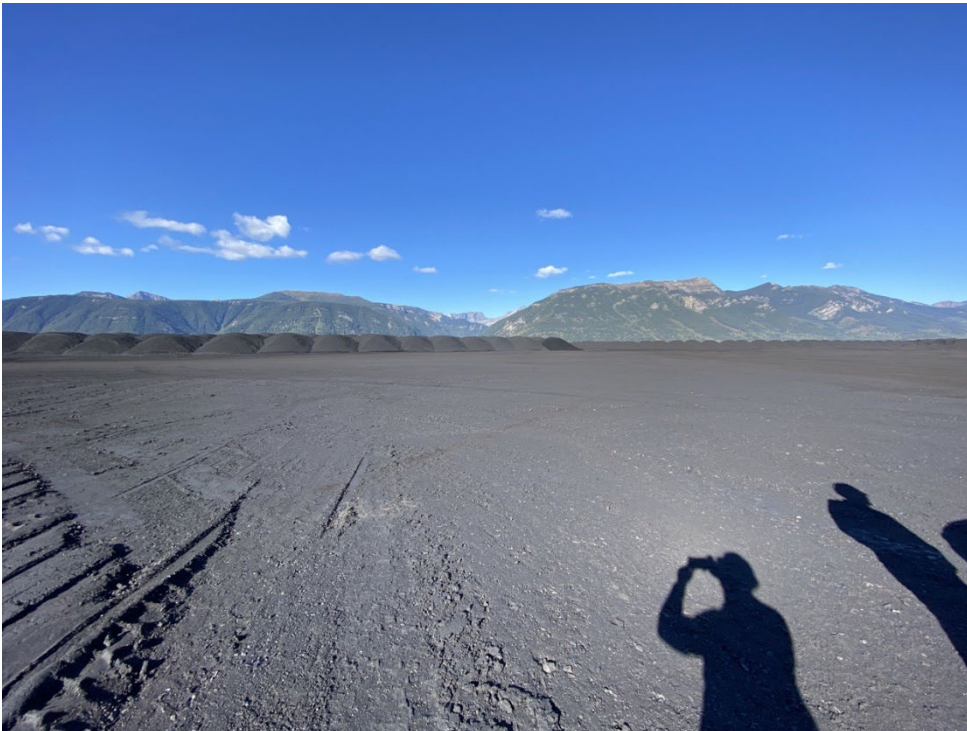
Photo I-4 CCR Dump crest typical conditions. (Looking SW – Taken 16 September 2021)

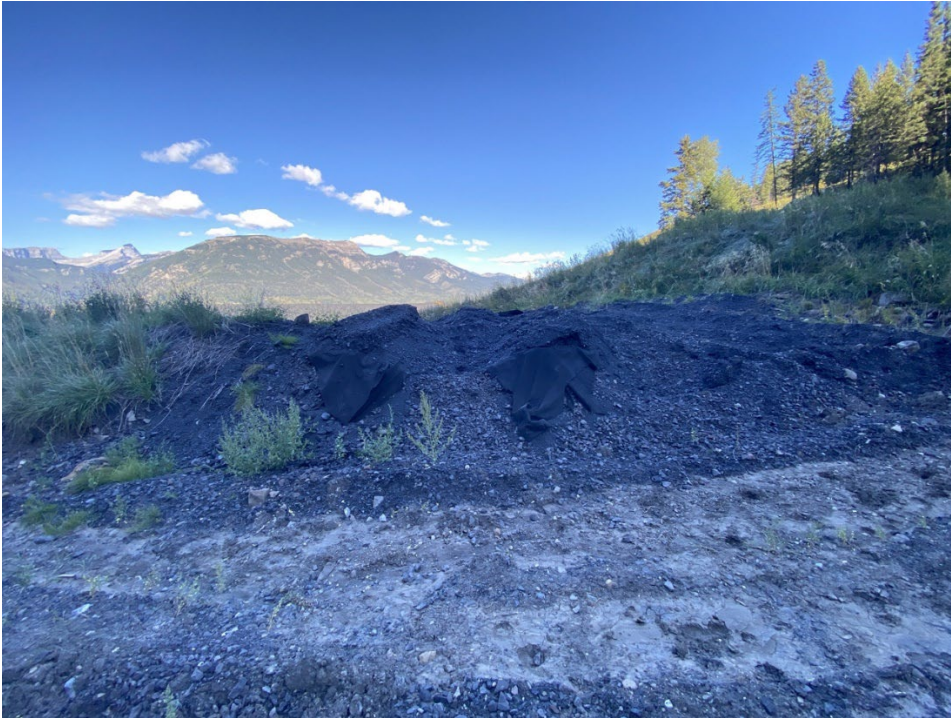
Photo I-5 CCR Dump diversion ditch and Lindsay Drain extension. (Looking west – Taken 16 September 2021)

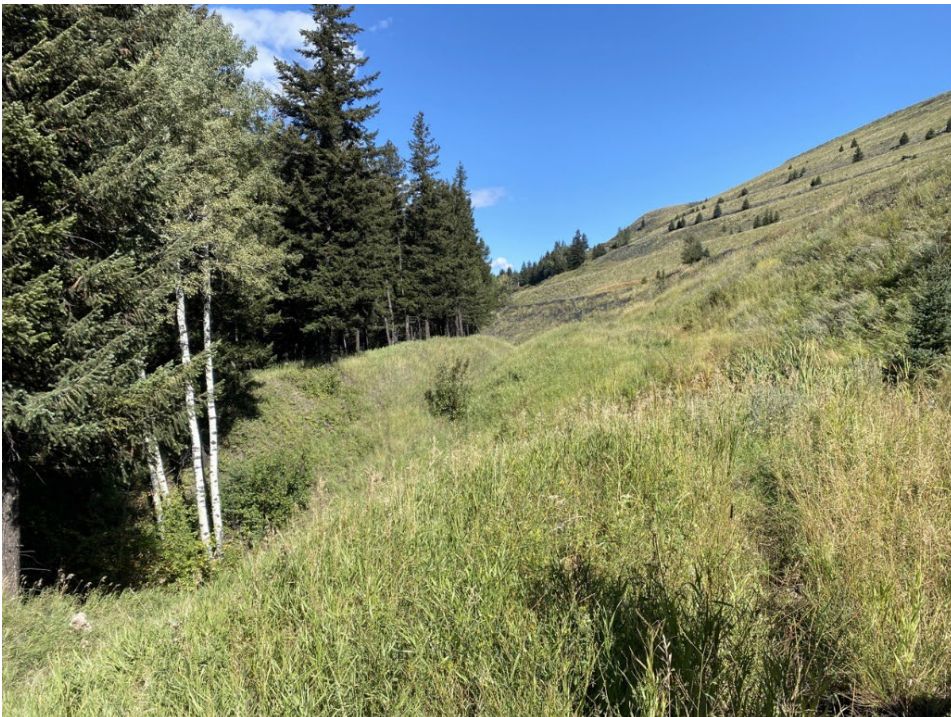
Photo I-6 CCR Dump lower bench typical conditions. (Looking North – Taken 16 September 2021)

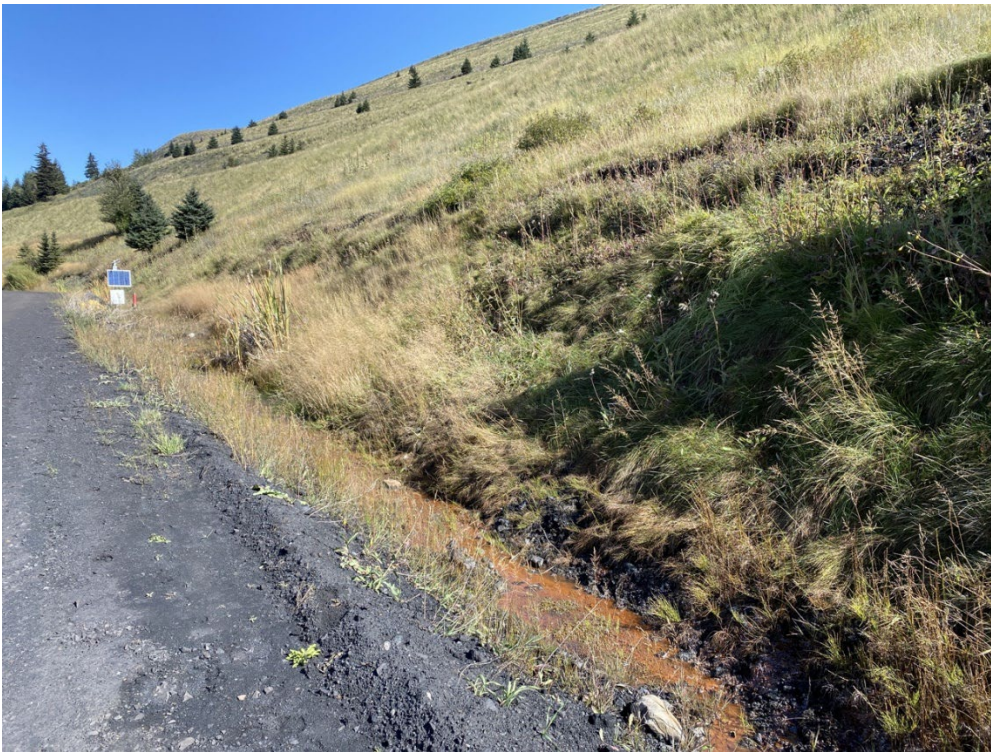
No.	Notable Observations	Change from 2020 AFPR?	Facility Safety Concern?	Photo Reference
CCR-1	Orange-stained seepage was observed at some CCR Dump interbench ditches.	No	No	I-7
CCR-2	Localized seepage areas were observed on the natural hillside above the current CCR Dump crest elevation.	No	No	I-8
CCR-3	Minor erosion was observed on some sections of the interbench slopes.	No	No	I-9, I-12
CCR-4	The Lindsay drain outlet was wet, but not flowing at the time of the inspection. The drain outlet appeared to be in good condition.	No	No	I-10, I-11
CCR-5	Surficial cracks at the crest surface of the CCR Dump were observed. This is a common occurrence as the placed MCR settles over time.	No	No	I-14

Seepage was observed at several lower interbench slopes at the north end of the CCR Dump in the locations consistent with those observed during the 2020 AFPR site visit (KCB 2021). Some ditch drains on CCR benches were observed to contain seepage with an orange colouration. The observed seepage is consistent with historic observations and is not a facility safety concern.

Photo I-7 CCR Dump seepage at bench ditches. (Looking NE – Taken 16 September 2021)

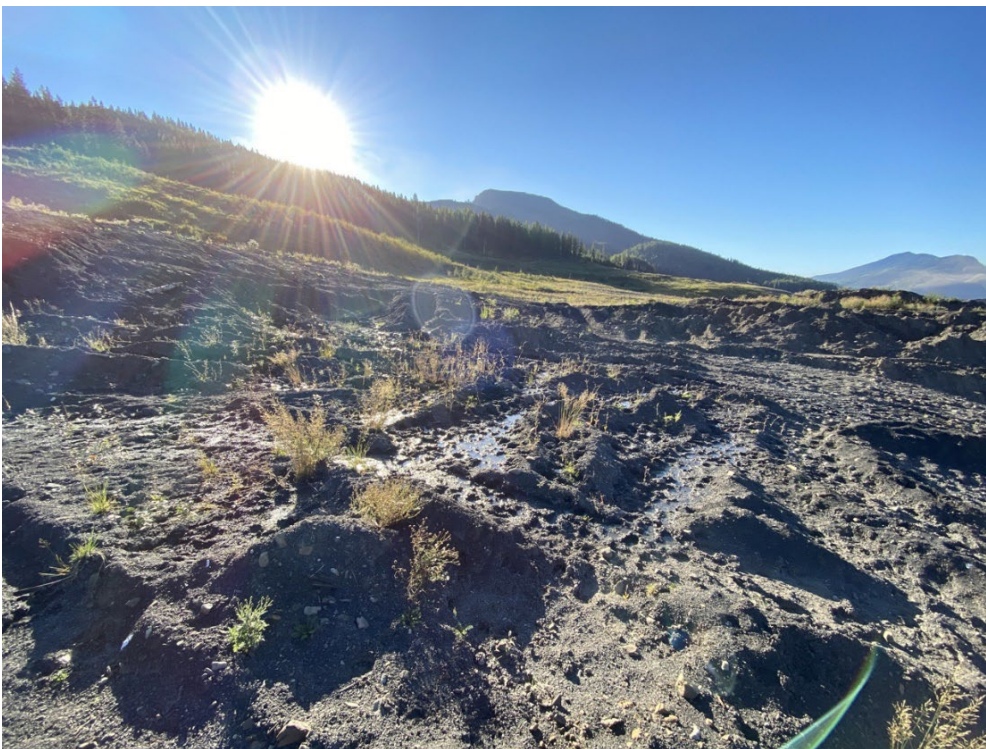
Photo I-8 CCR Dump natural hillside wet spot. (Looking South – Taken 16 September 2021)

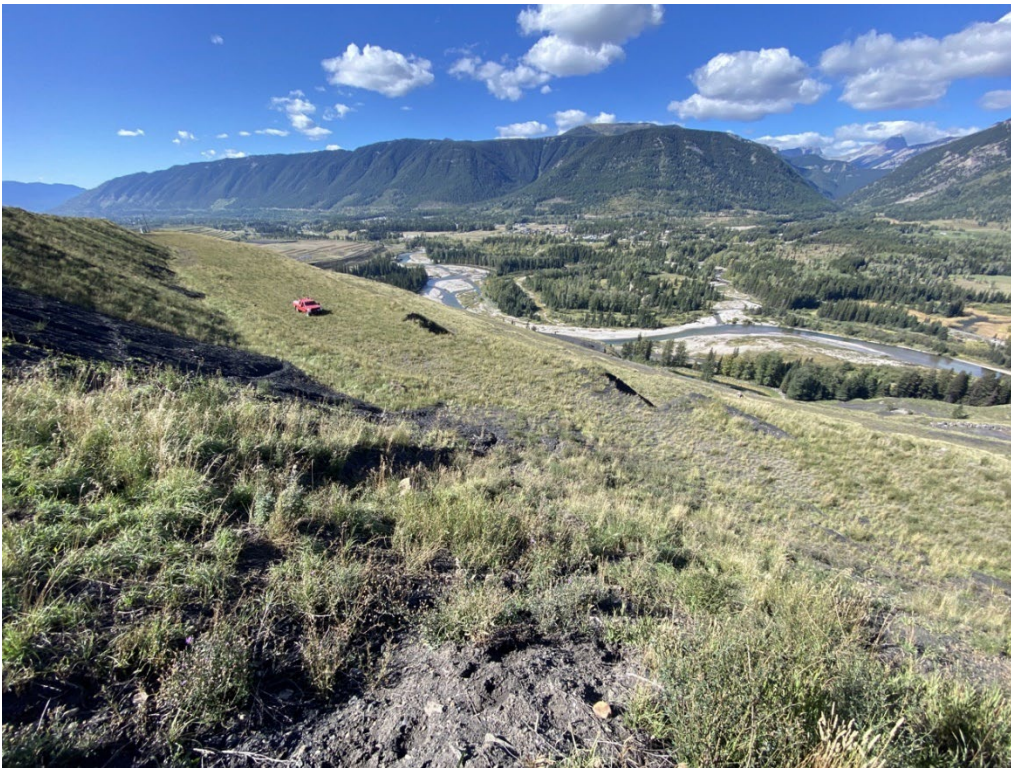
Vegetation is sparse in some localized areas of the CCR and minor gully erosion was observed at several locations. However, the magnitude of the observed erosion areas is not a concern to slope stability. EVO has been hydroseeding to effectively control most of the erosion on the downstream face of the structures. Therefore, large scale failure via surface erosion is considered non-credible as this is effectively managed with the current controls.

Photo I-9 CCR Dump bench erosion. (Looking West – Taken 16 September 2021)

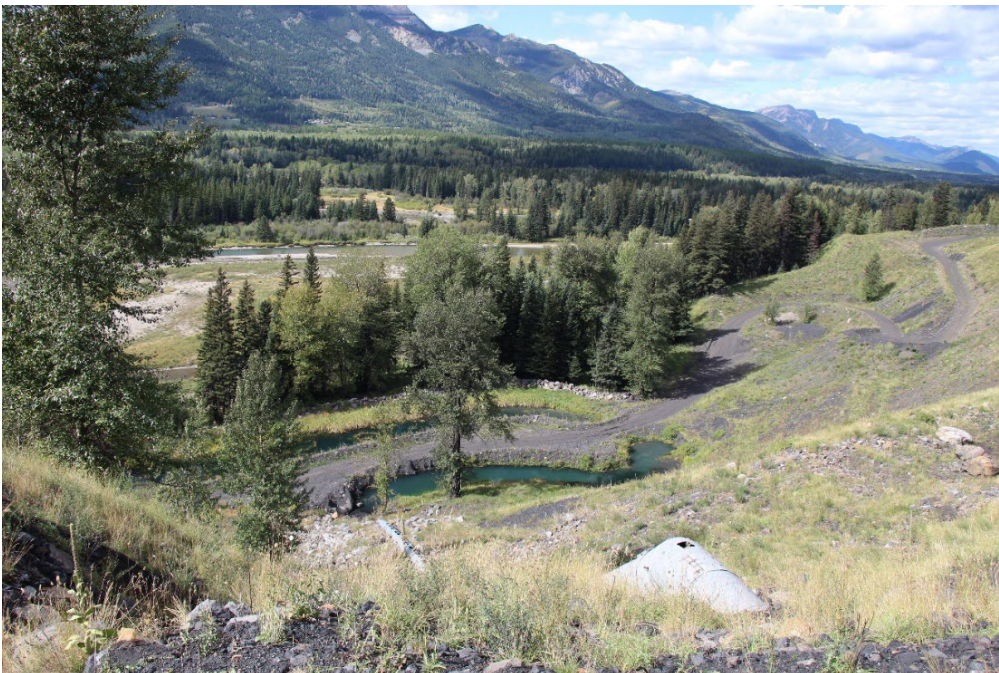
Photo I-10 CCR Dump Lindsay Drain culvert outlet. (Looking West – Taken 16 September 2021)

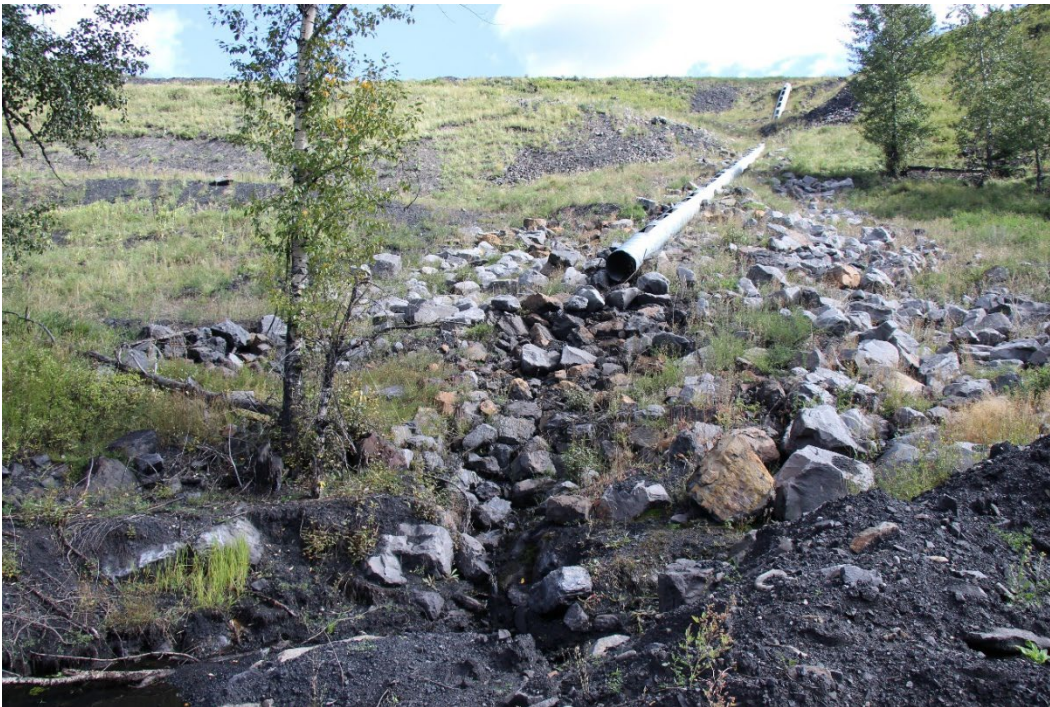
Photo I-11 CCR Dump Lindsay Drain outlet. (Looking east – Taken 16 September 2021)

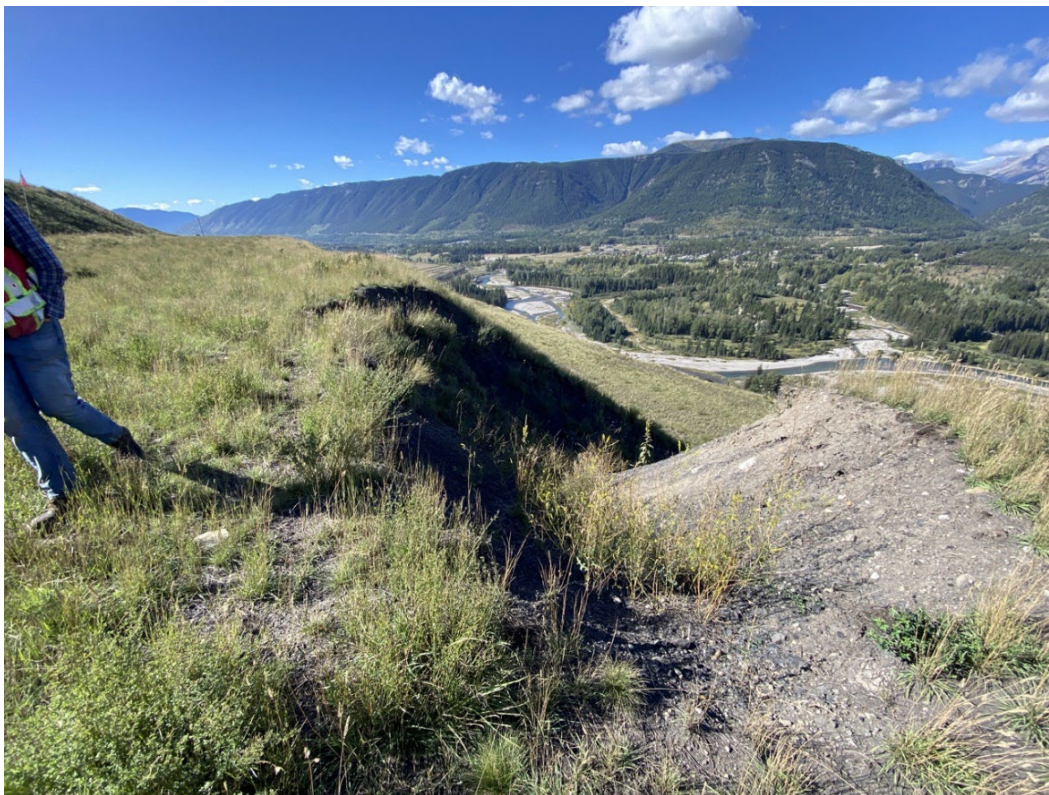
Photo I-12 CCR Dump Bench Erosion. (Looking SW – Taken 16 September 2021)

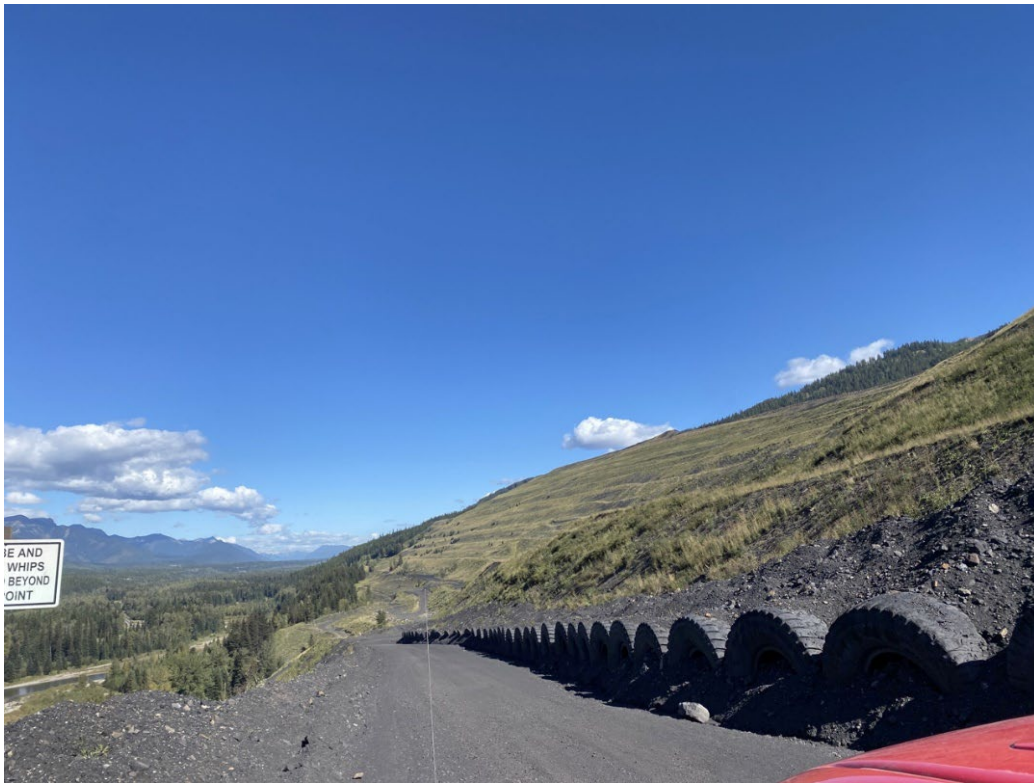
Photo I-13 CCR Dump benches typical condition. (Looking North – Taken 16 September 2021)

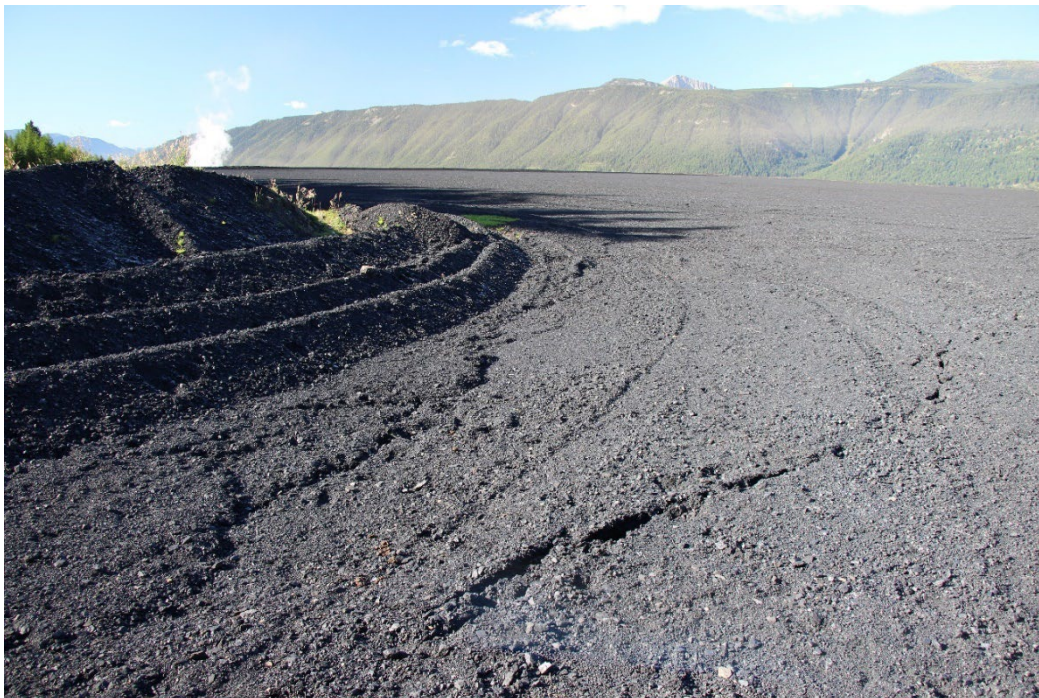
Photo I-14 Surficial cracks at the CCR dump. (Looking SW – Taken 16 September 2021)

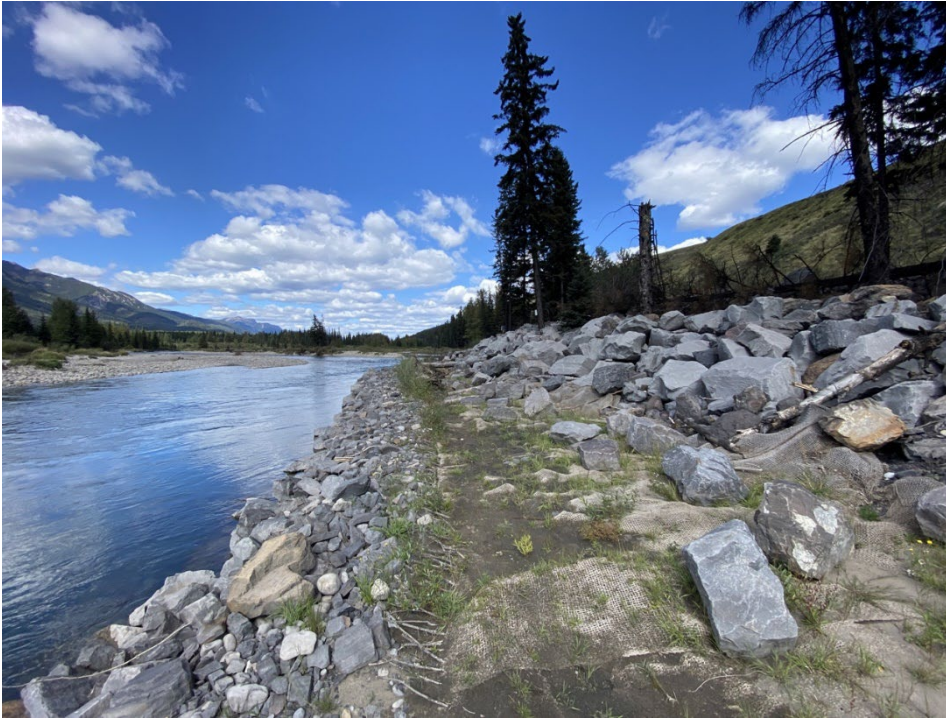
Erosion protection at the toe of the CCR Dump appears to be in good condition although vegetation is yet to be established across the full width of the erosion protection area. The riprap does not extend across the full length of the exposed CCR Dump toe, but does appear to protect previously vulnerable areas.

Photo I-15 CCR Dump toe riprap adjacent to the Elk River (Looking North – Taken 16 September 2021)

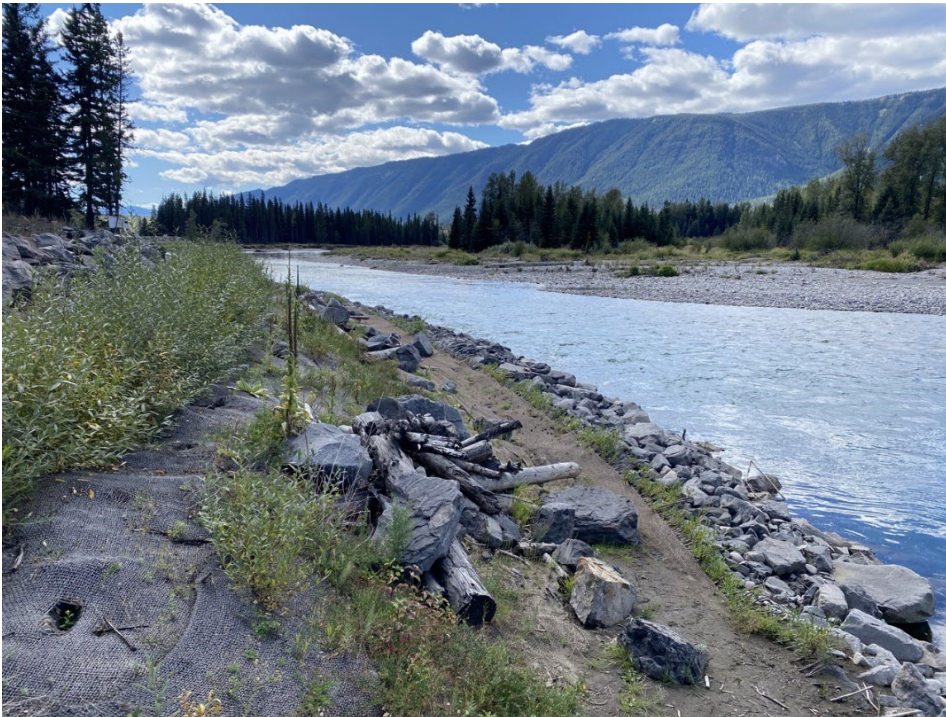
Photo I-16 CCR Dump toe riprap adjacent to the Elk River (Looking South – Taken 16 September 2021)

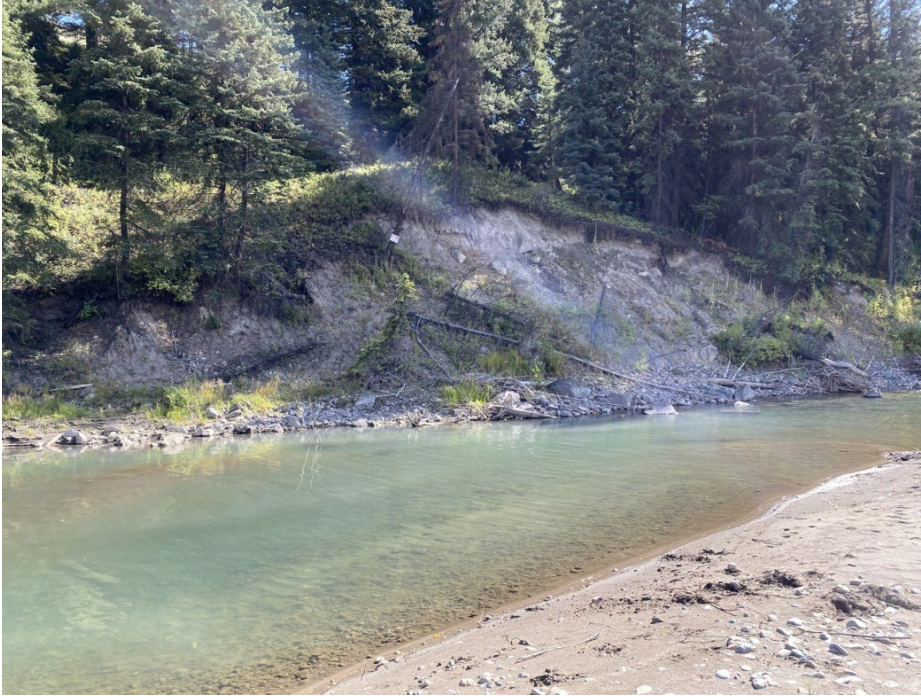
Photo I-17 CCR Dump toe foundation conditions adjacent to the Elk River. River erosion has exposed bedrock at the base of the slope (not visible in photo). (Looking East – Taken 16 September 2021)

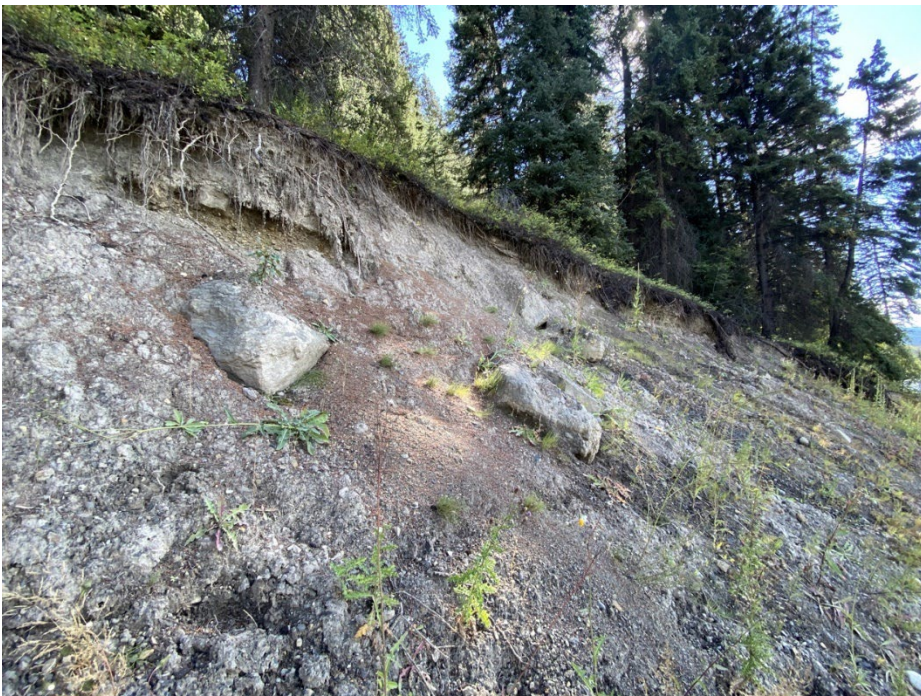
Photo I-18 CCR Dump toe foundation conditions adjacent to the Elk River. (Looking SE – Taken 16 September 2021)
