Teck Coal Limited - Elkview Operations

West Fork Tailings Facility and Lagoons A, B, C, and D

2021 Annual Facility Performance Report

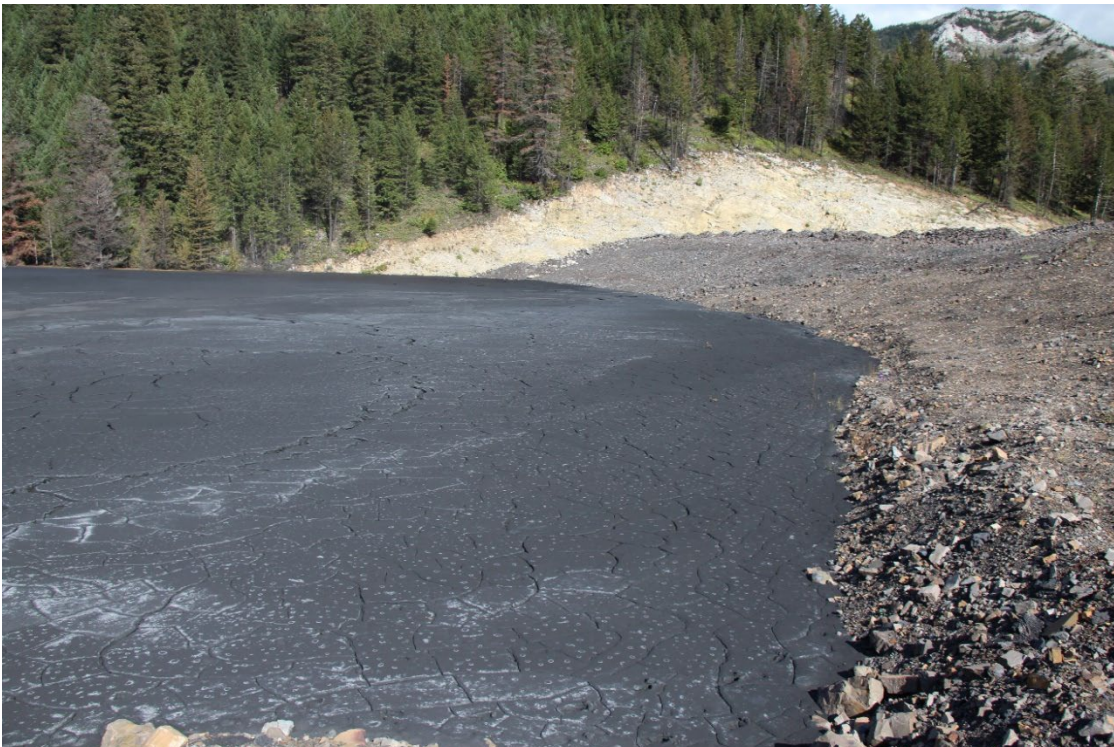
Photo IW-5 WFTF typical crest conditions and downstream slope at the east abutment. (Looking West – Taken 15 September 2021)

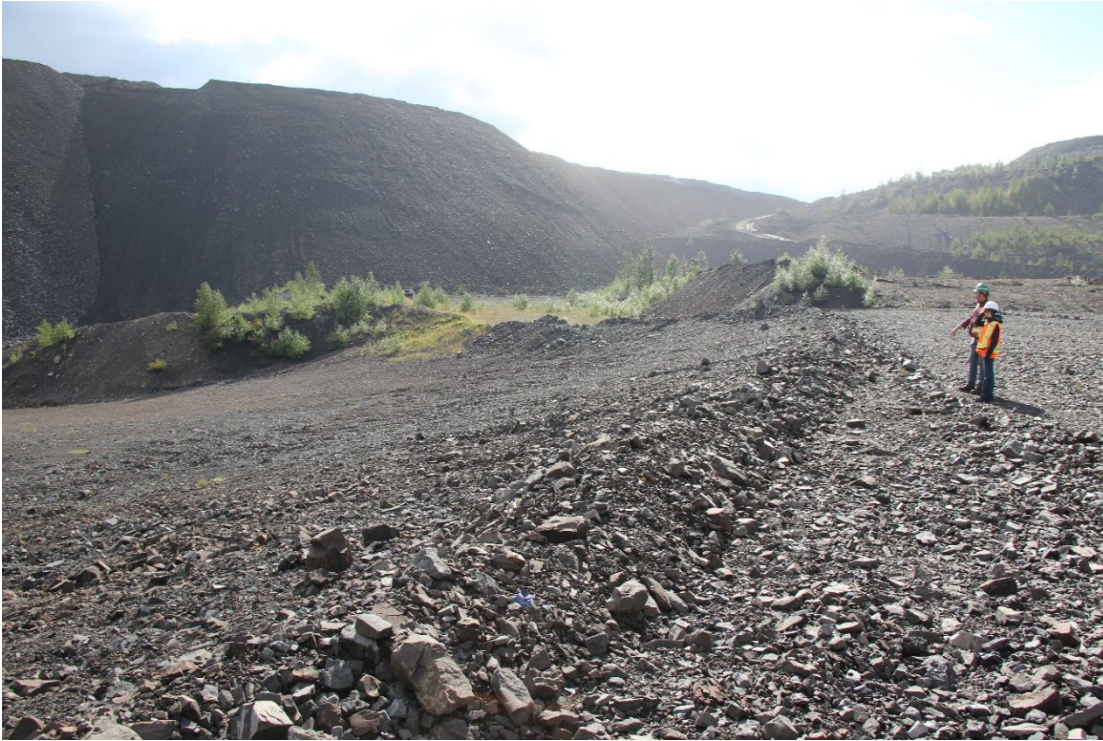
Photo IW-6 WFTF downstream of embankment. (Looking South – Taken 15 September 2021)

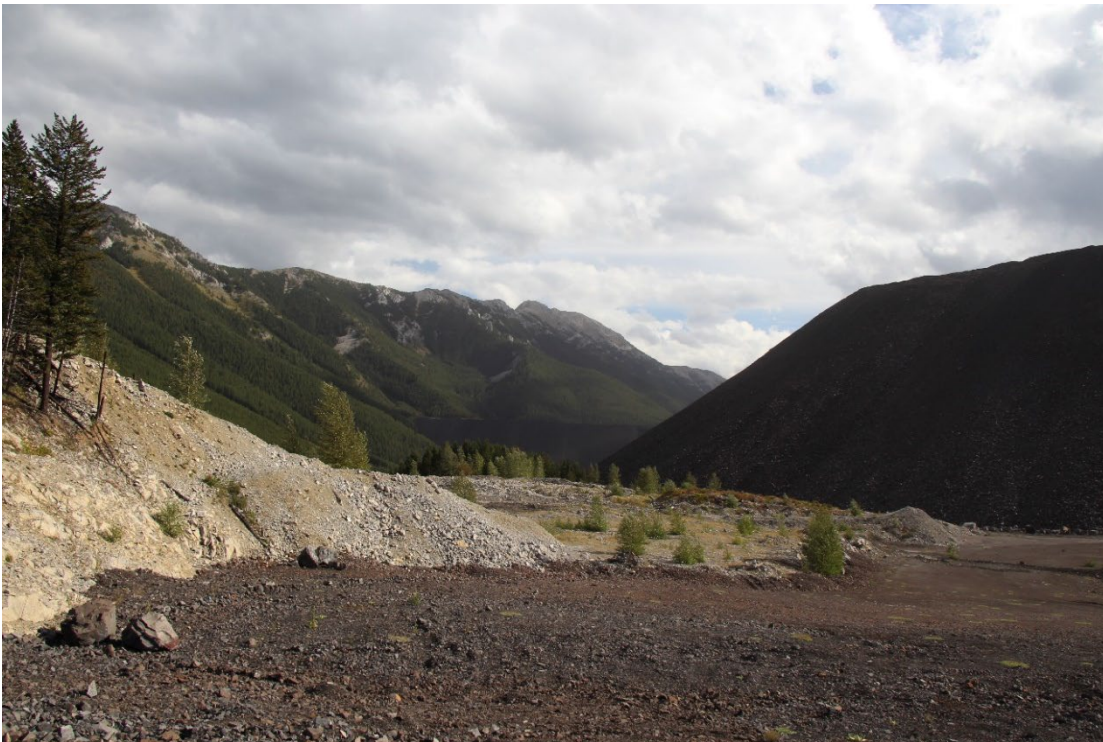
Photo IW-7 WFTF Adit Filter Berm construction in progress - typical conditions. (Looking North – Taken 15 September 2021)

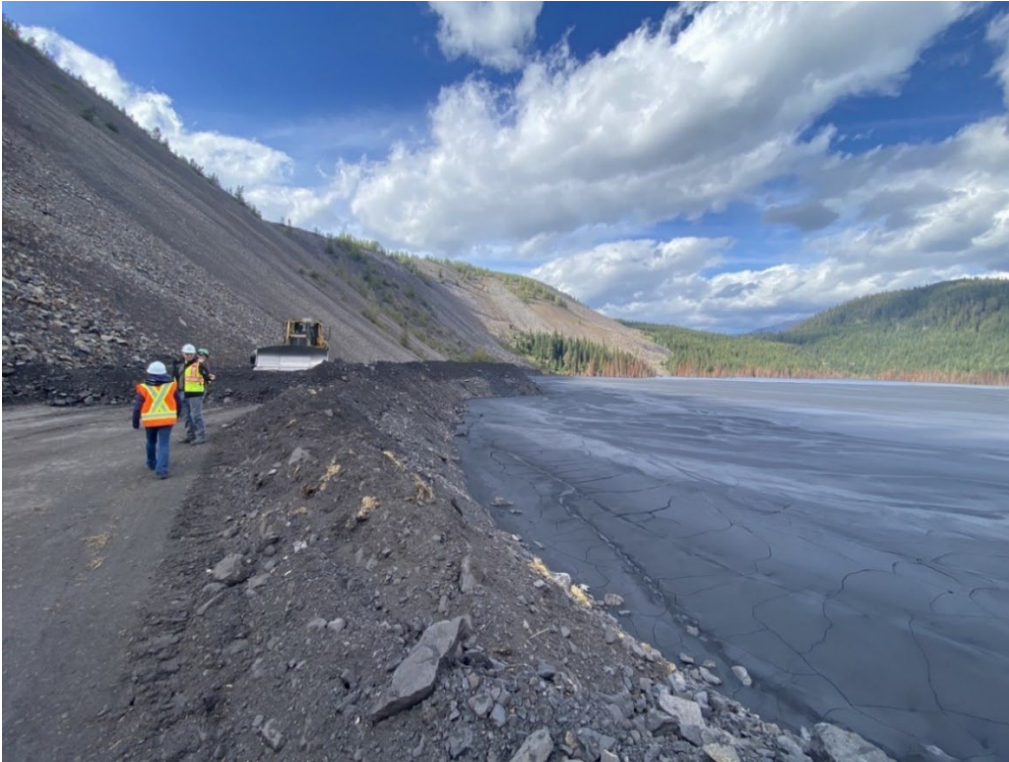
Photo IW-8 WFTF Adit Dump erosion above Adit Filter Berm. (looking west – Taken 15 September 2021)

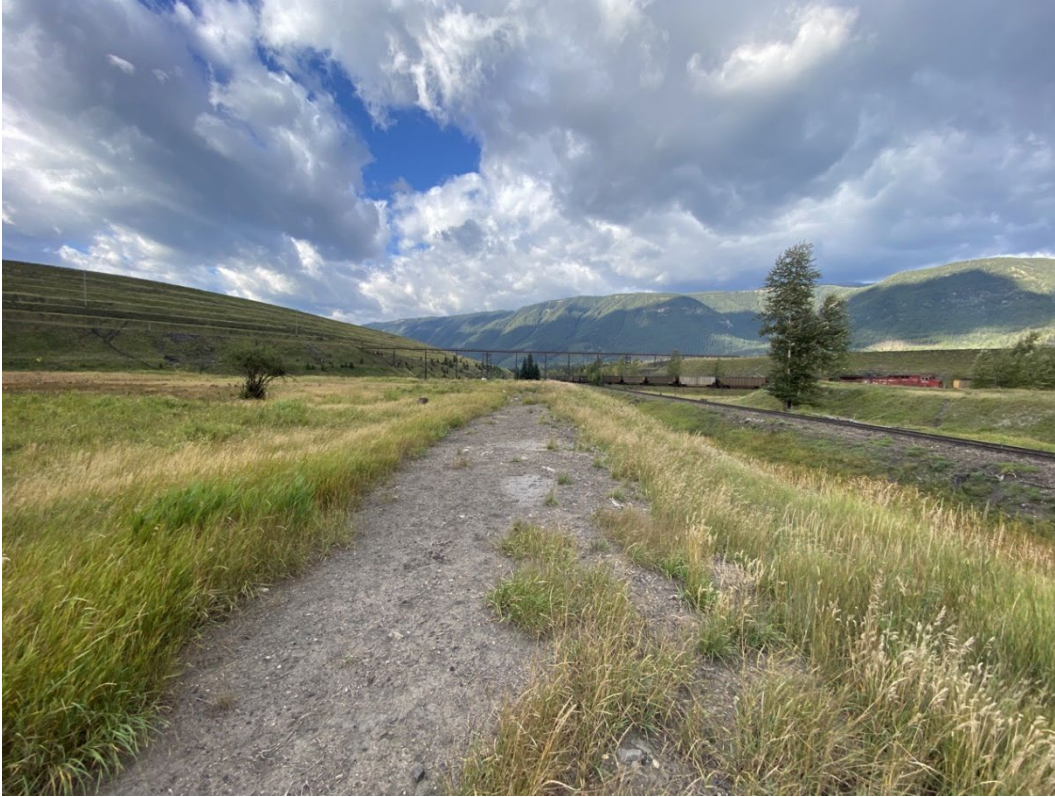
Photo IA-6 Lagoon A typical conditions. (Looking East from Lagoon C crest – Taken 15 September 2021)

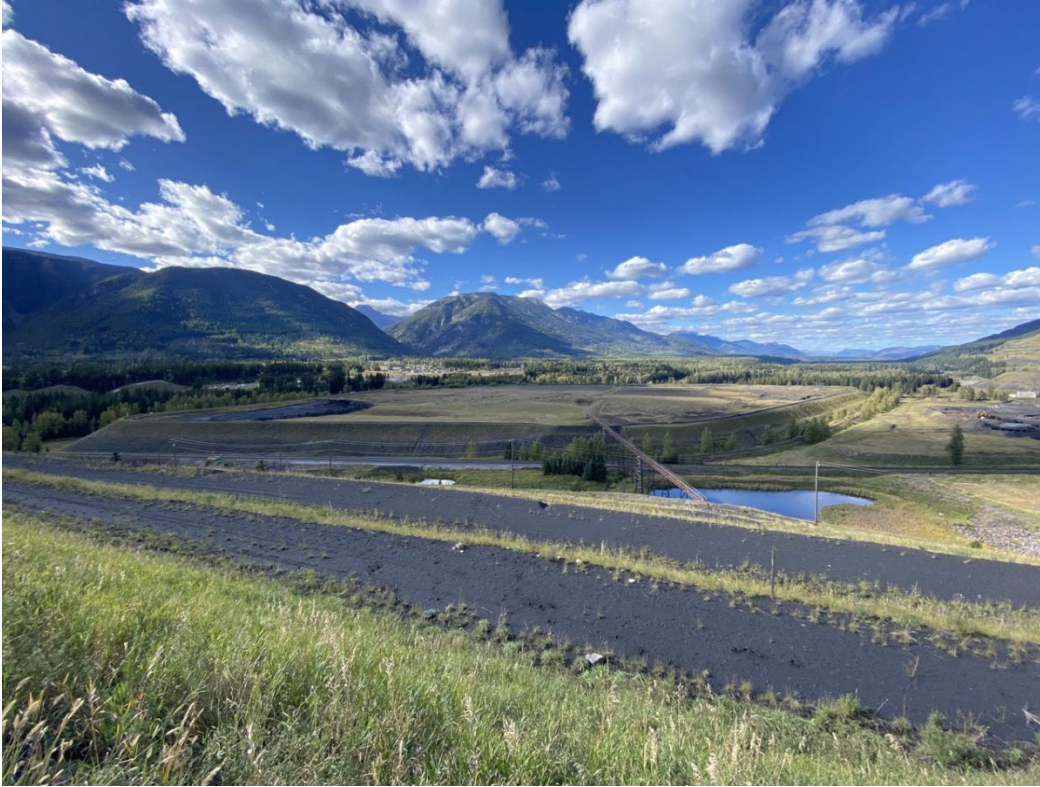
Photo IC-2 Lagoon C crest typical condition. (Looking North – Taken 15 September 2021)

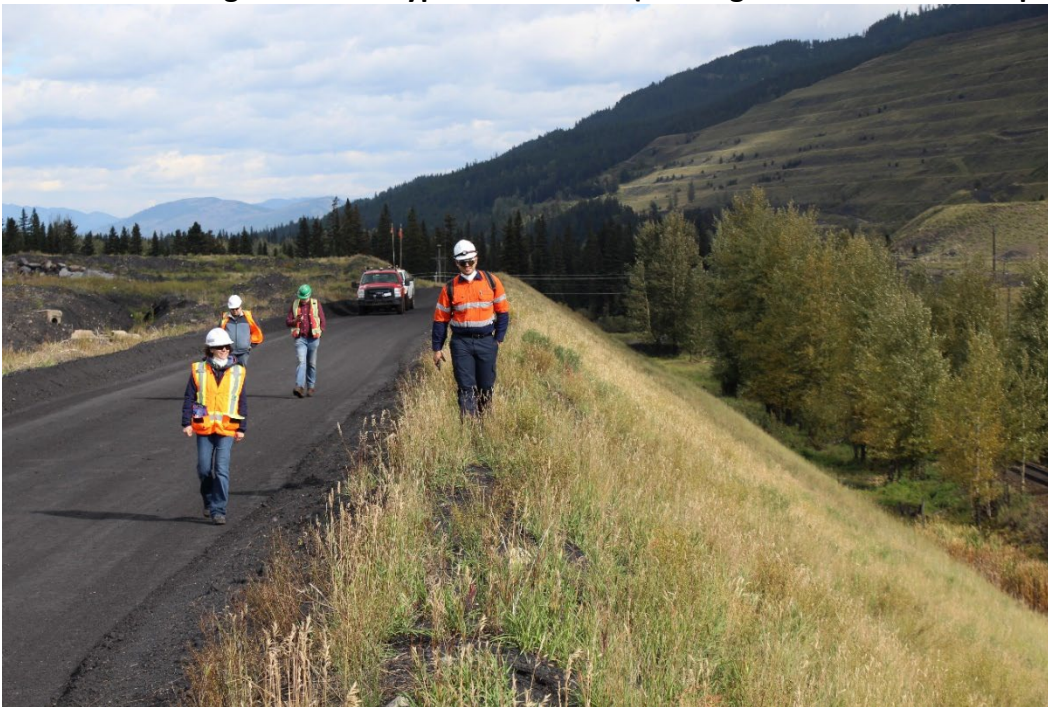
Photo IC-3 Lagoon C typical crest typical condition with piezometer OW-C-88-1. (Looking SW – Taken 15 September 2021)

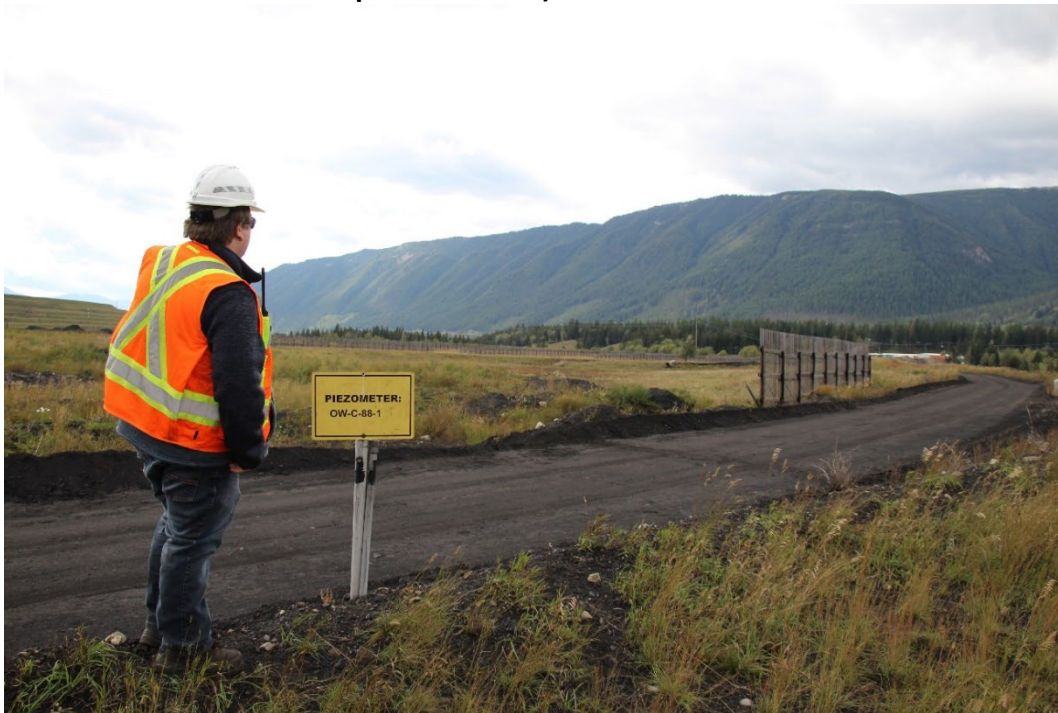
Photo IC-4 Lagoon C crest and downstream slope typical conditions. (Looking NW – Taken 15 September 2021)

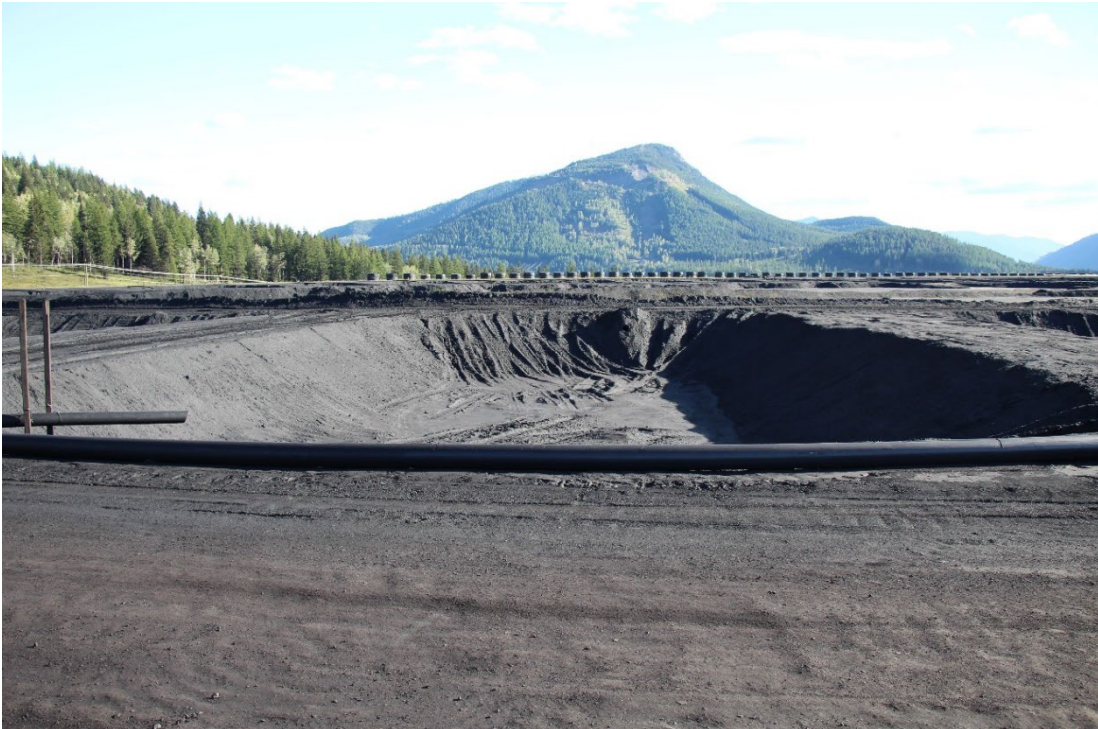
Photo ID-3 Lagoon D crest typical condition. (Looking West – Taken 16 September 2021)

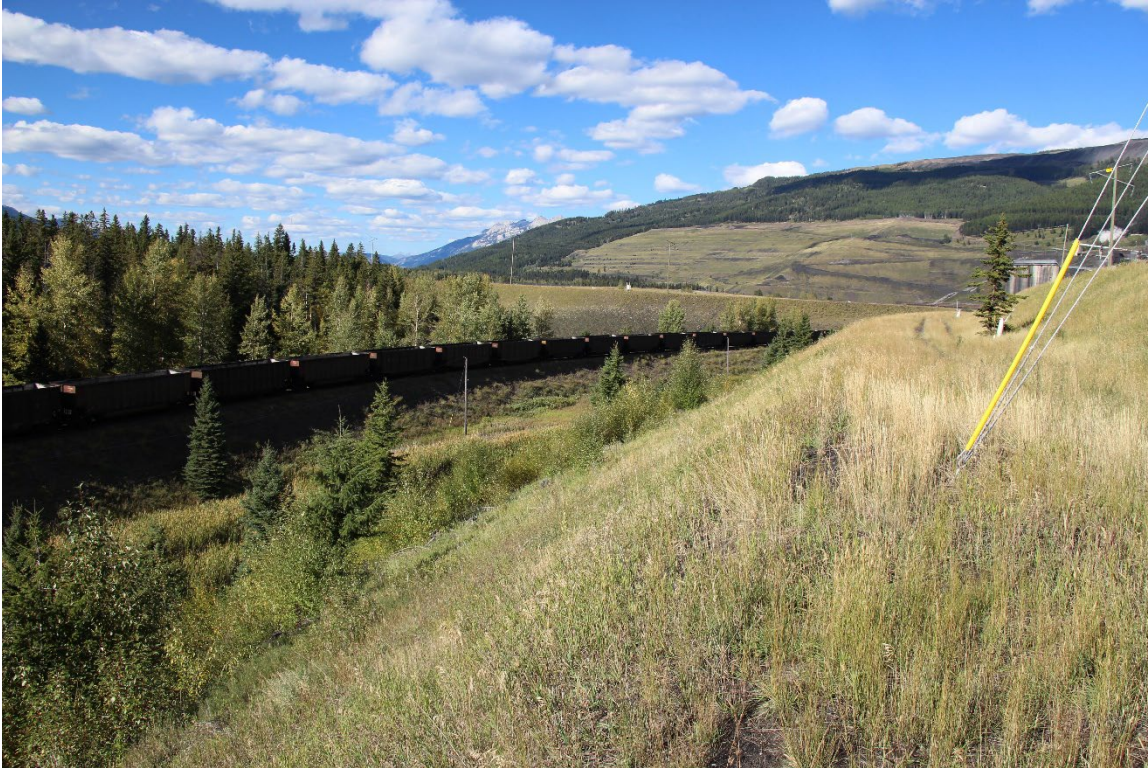
Photo ID-6 Lagoon D bench typical conditions. (Looking NE – Taken 16 September 2021)

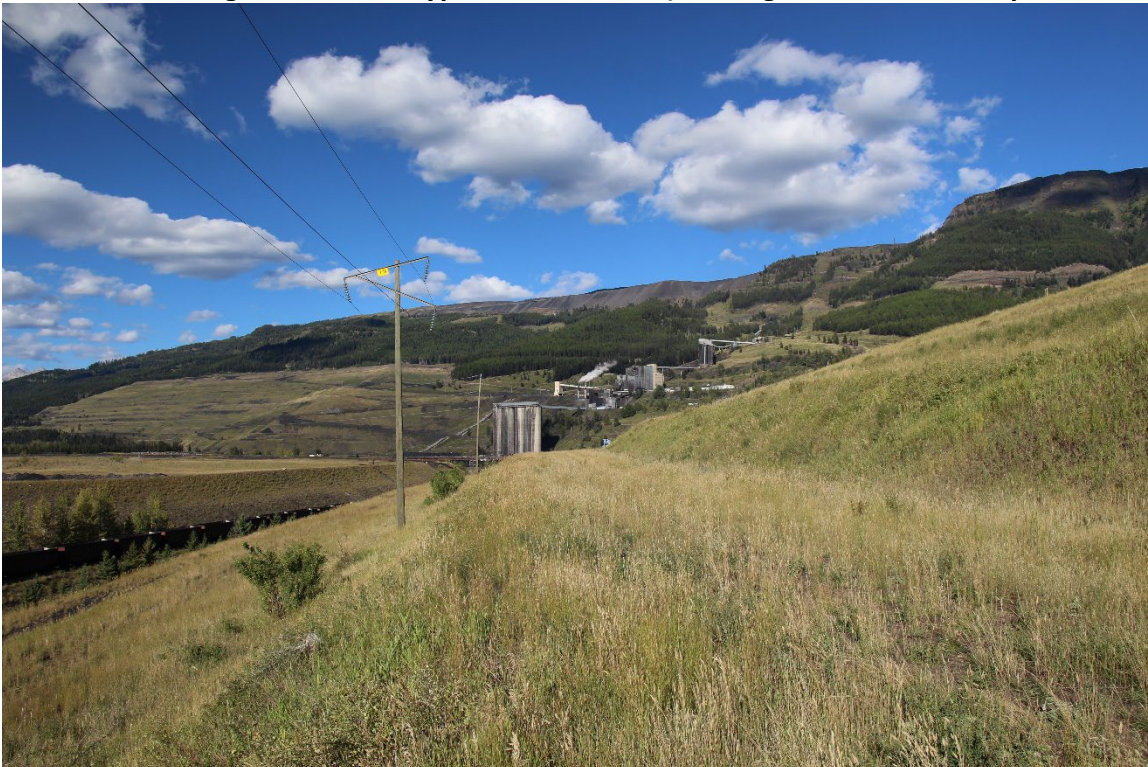
Photo ID-7 Lagoon D bench typical conditions. (Looking East – Taken 16 September 2021)

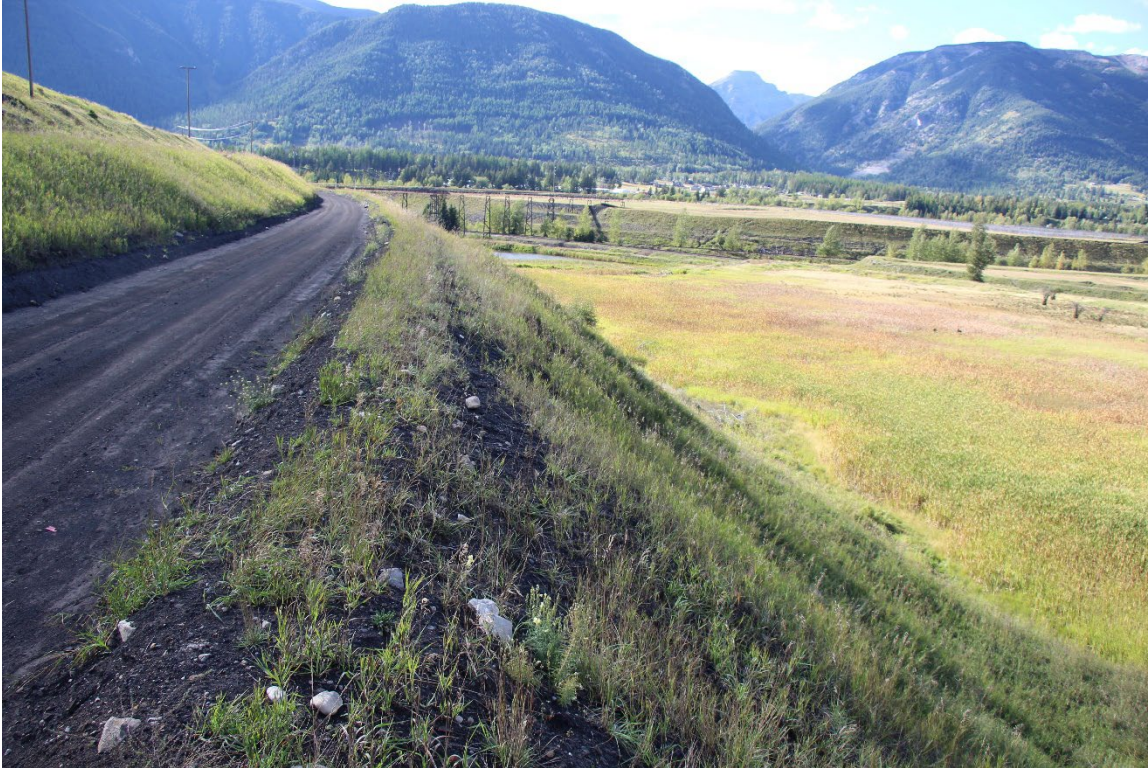
Photo ID-10 Lagoon D bench minor erosion. (Looking West – Taken 16 September 2021)
