# 2021 Annual Facility Performance Report for the Coal Reject Spoils

*Teck Coal Limited, Fording River Operations*

Reference No.: 21456080-2021-254-R-Rev0-600

30 March 2022

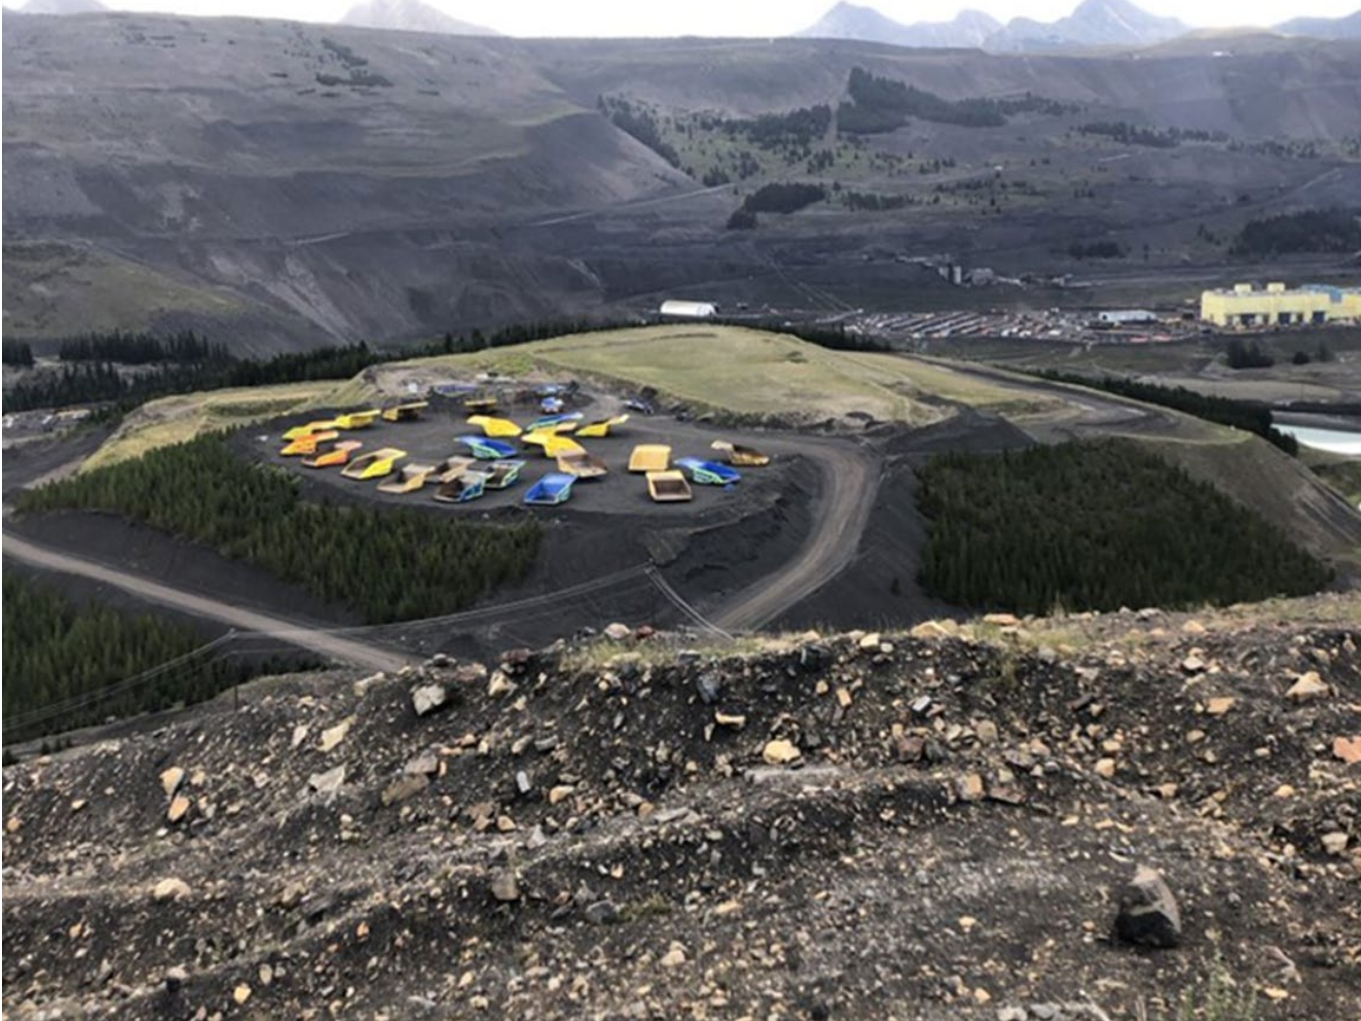
## PHOTOGRAPH A-1

A-Spoil - Overview of crest including new shovel yard constructed in 2020/2021, looking east

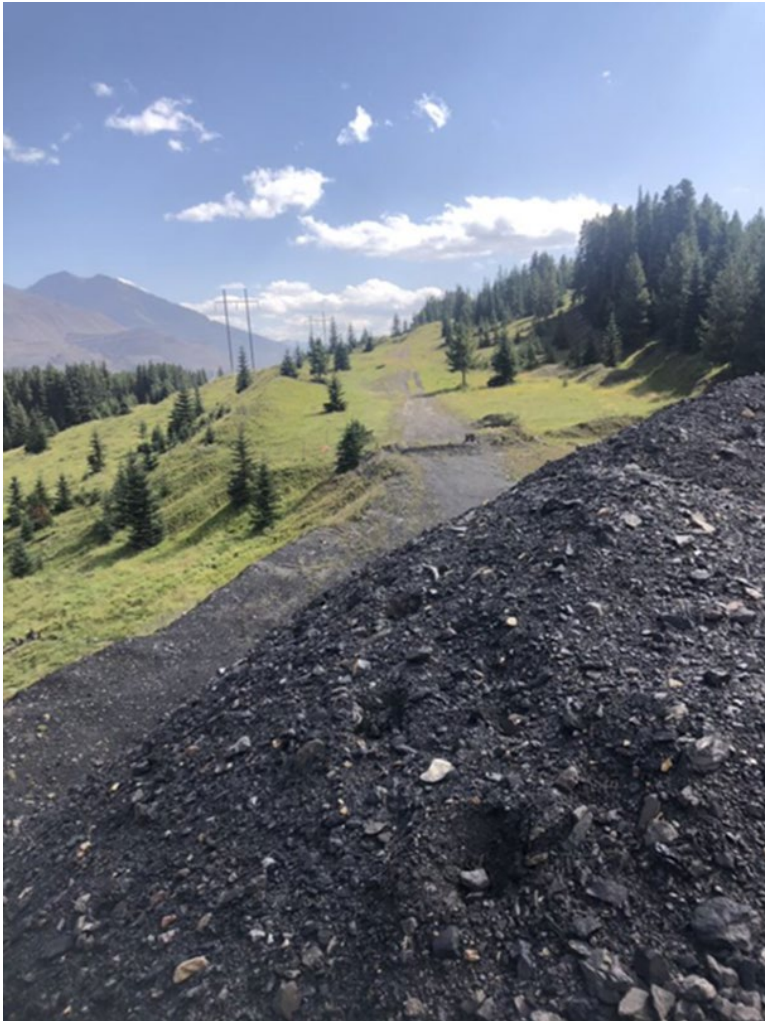
### PHOTOGRAPH A-2

A-Spoil - North side, revegetated, looking northeast

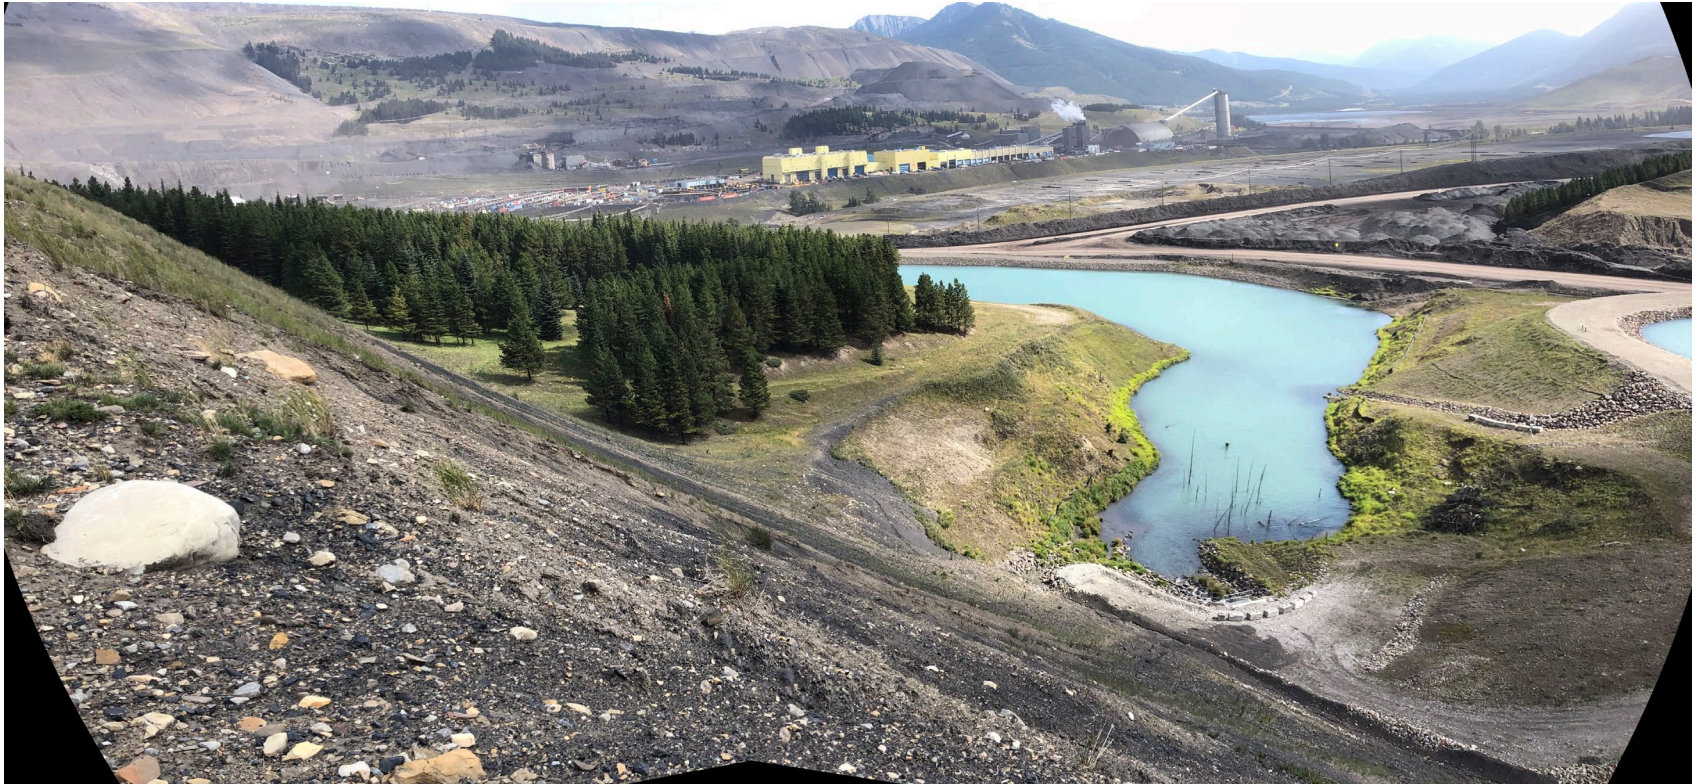
## PHOTOGRAPH A-3

A-Spoil - South side on angle of repose slope above Liverpool Settling ponds, looking south

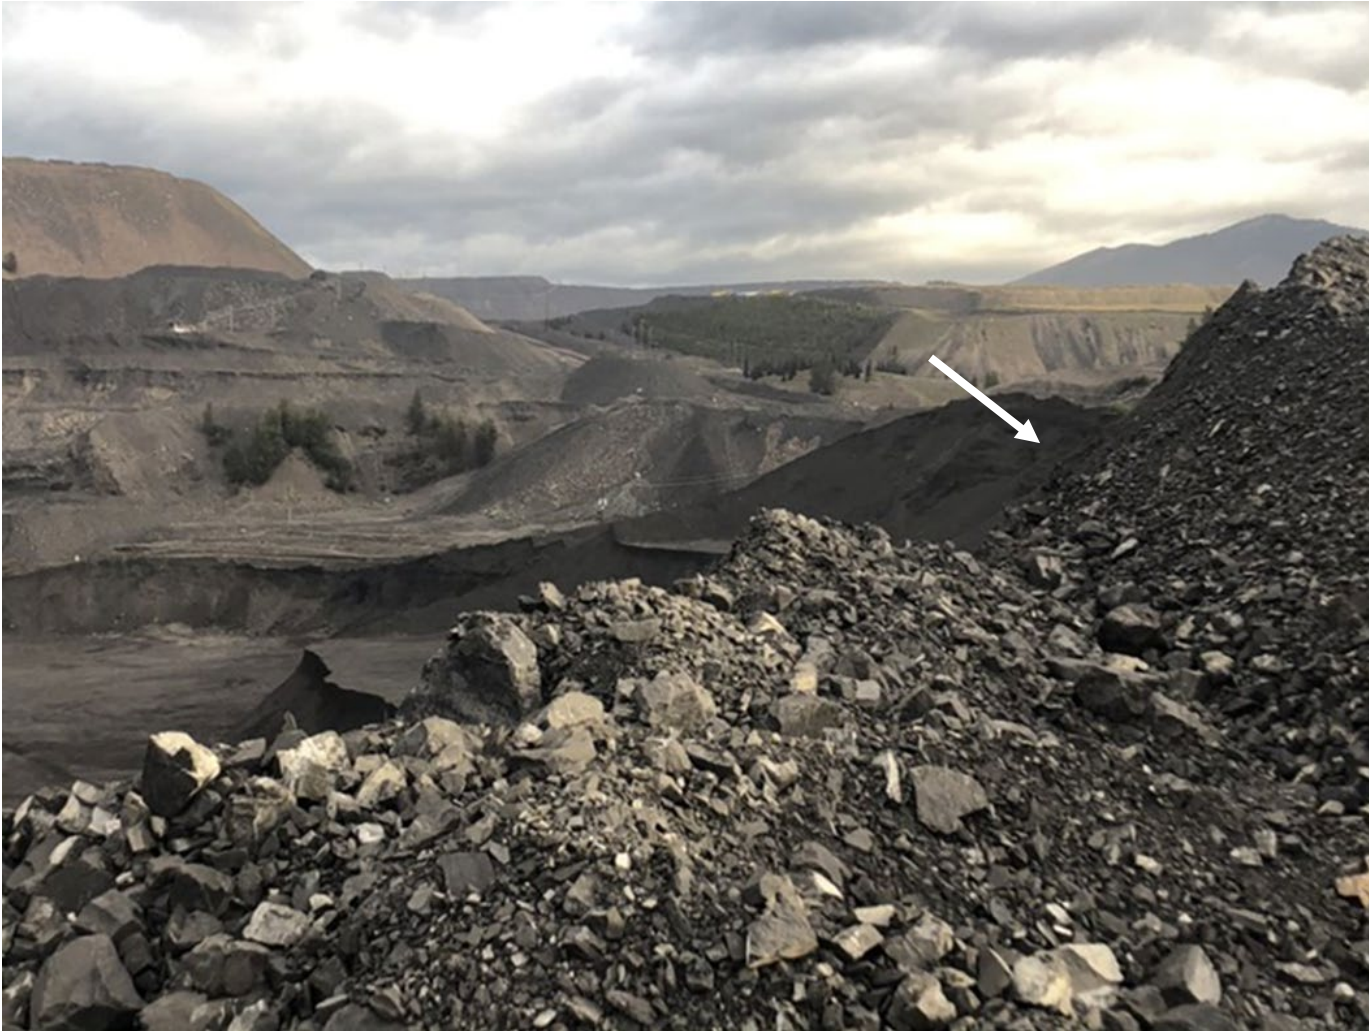
### PHOTOGRAPH A-4

Box Yard spoil – Excavated Spoil (white arrow), looking northeast

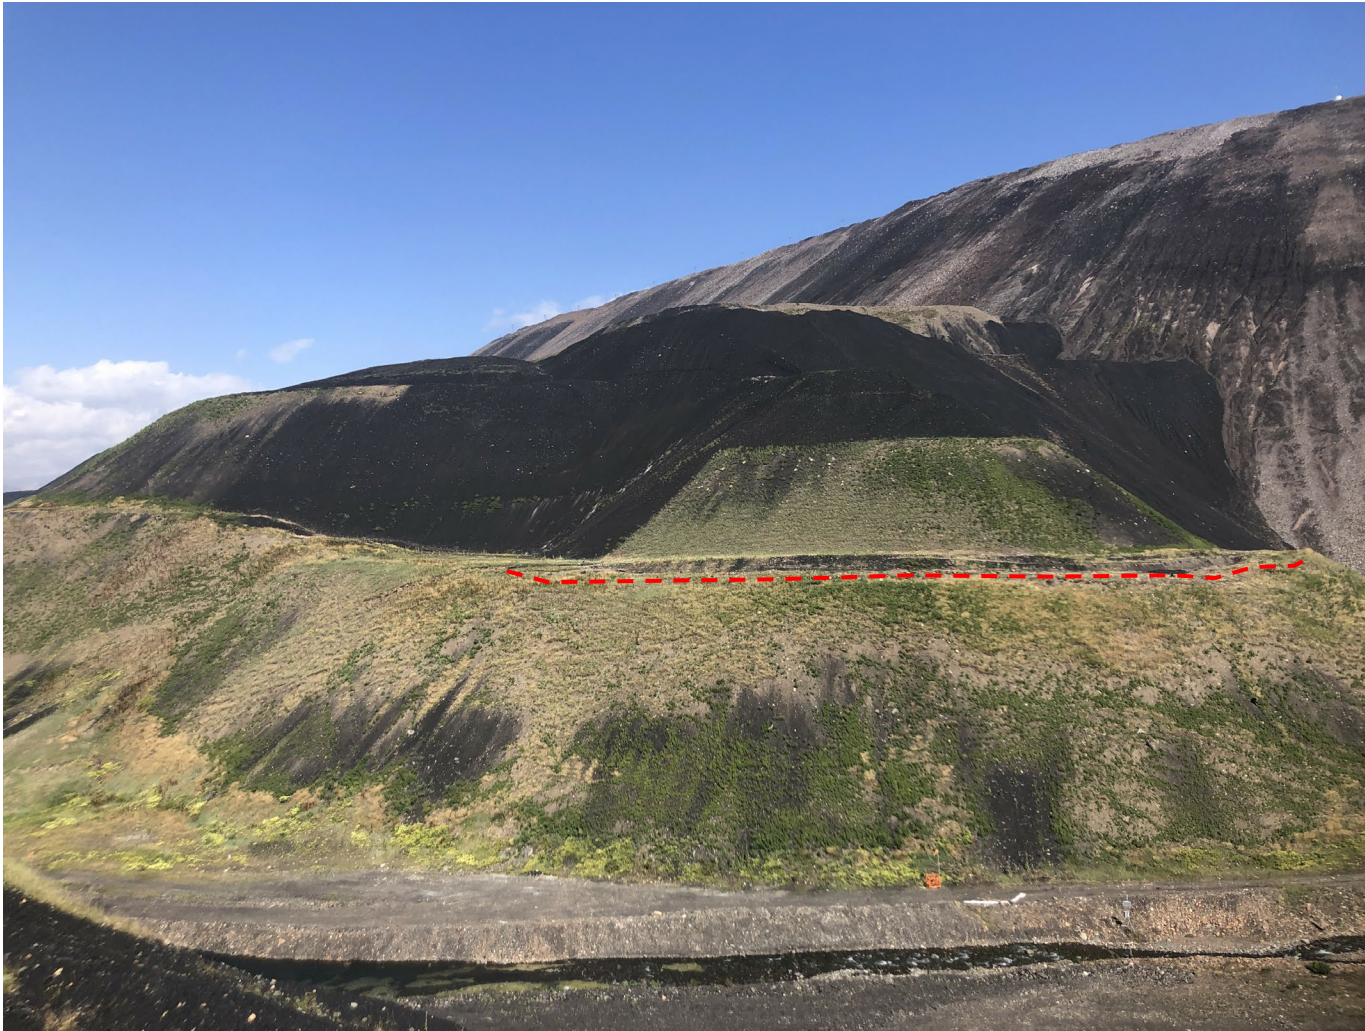
## PHOTOGRAPH A-5

Kilmarnock /Toe Berm spoil - overview, crest settlement noted in red, looking north

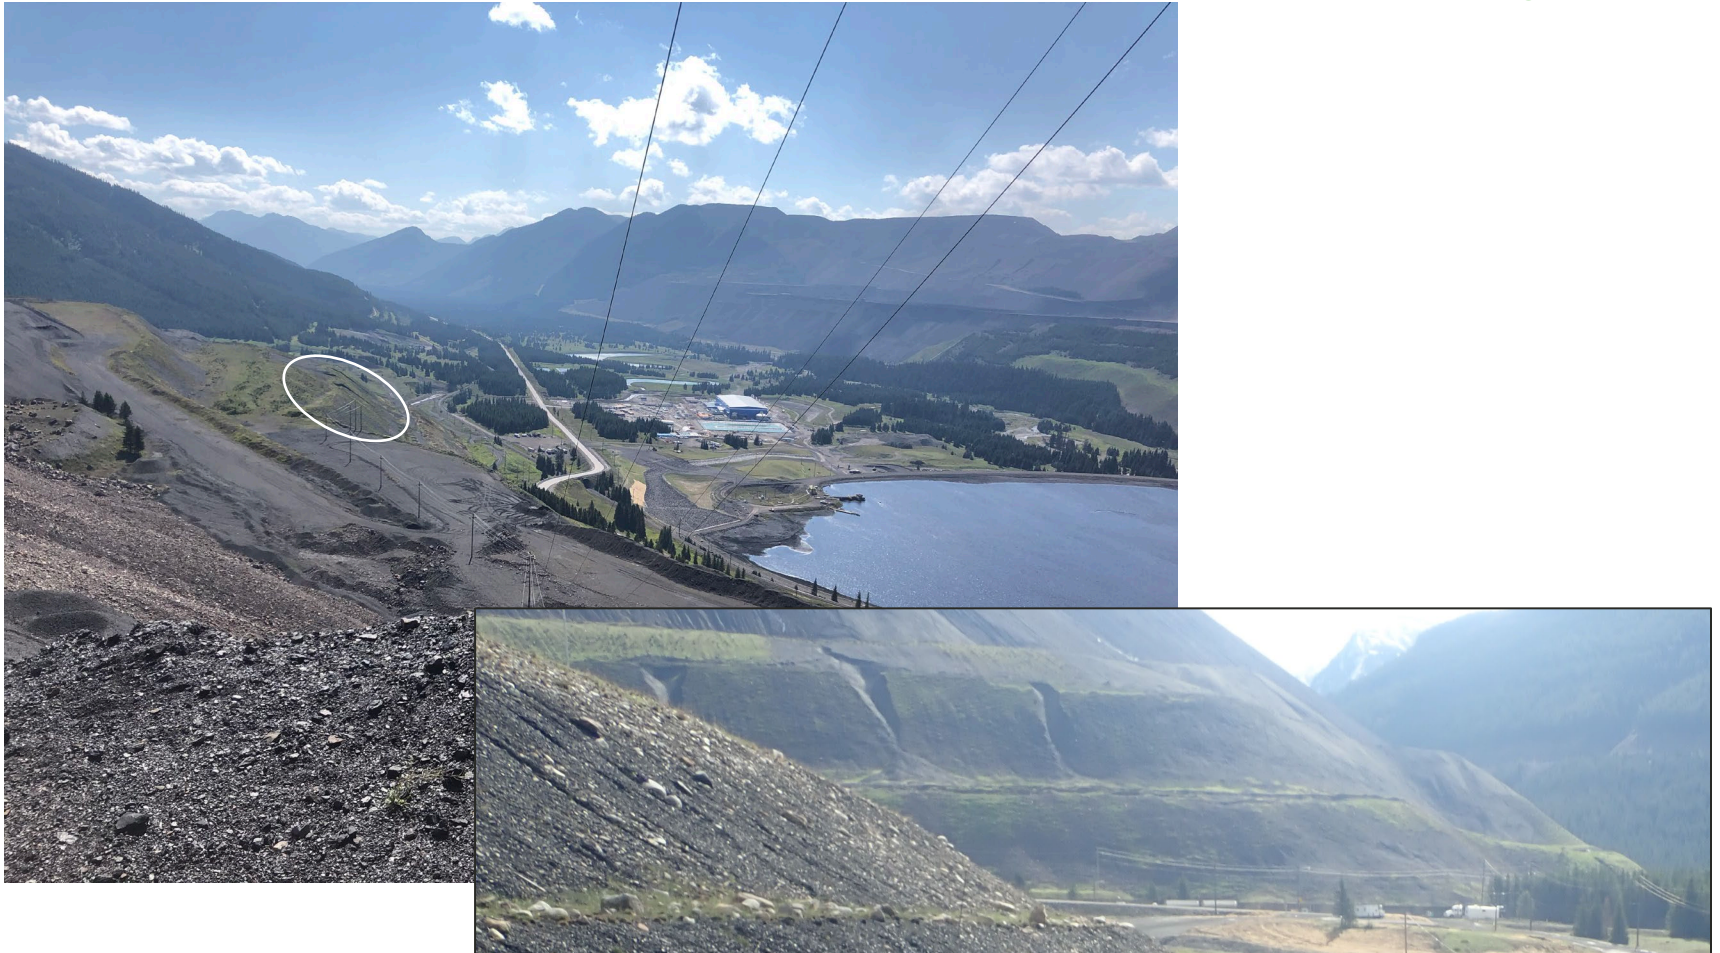
## PHOTOGRAPH A-6

Kilmarnock /Toe Berm spoil - erosion gullies from the 2013 flood, looking south from Blake spoil (top left) and looking east from the South Tailings Pond (bottom right)

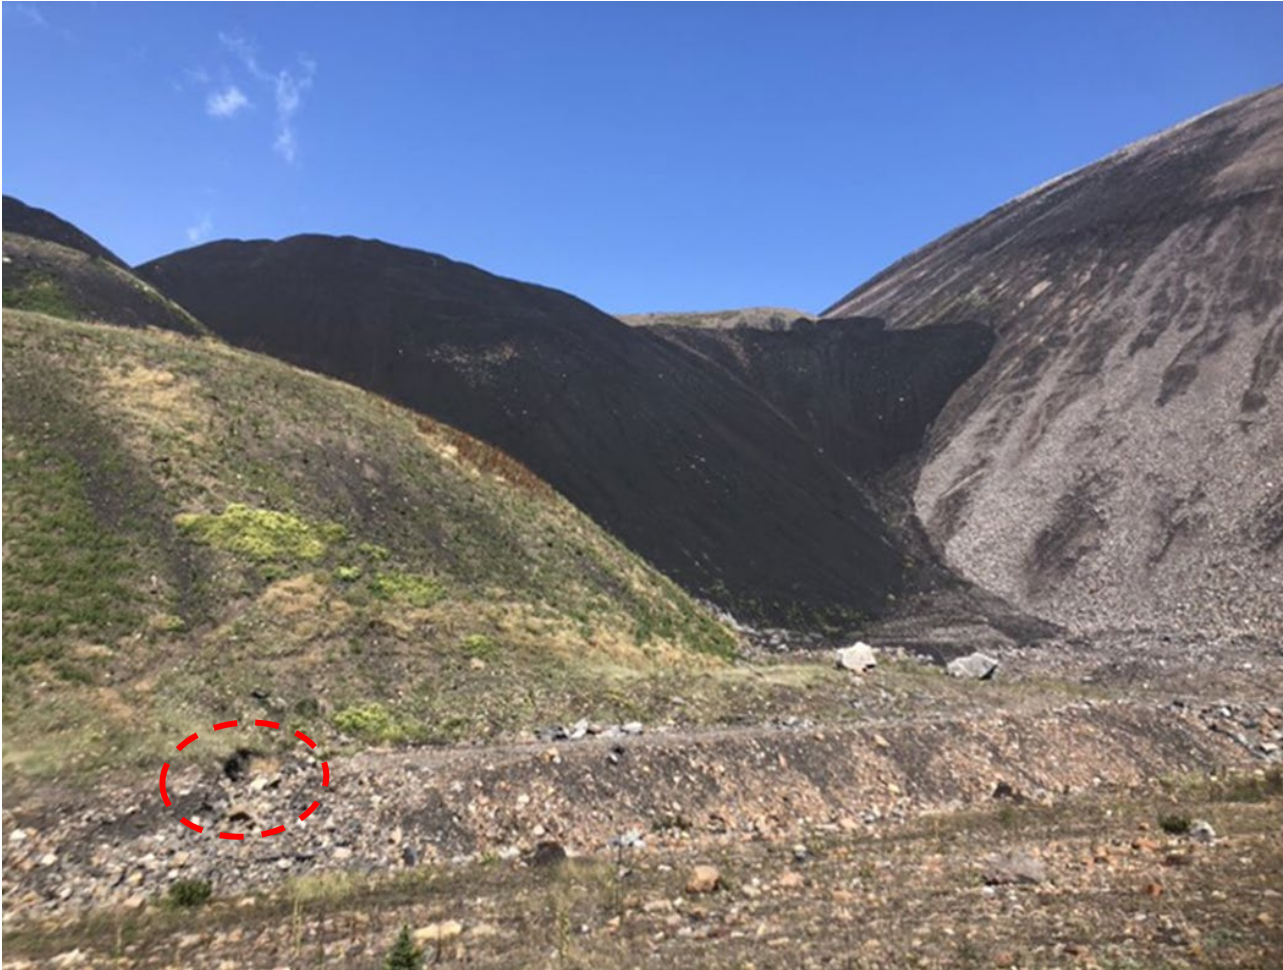
### PHOTOGRAPH A-7

- Erosion was observed at the toe of the Kilmarnock / Toe Berm spoil due to water flowing out of the Old South spoil and along the road. Additional erosion of the toe could lead to spoil instability, which could impact the Kilmarnock Creek.

Kilmarnock / Toe Berm spoil - new erosion feature (shown in red) due to water seepage from Old South spoil, looking north

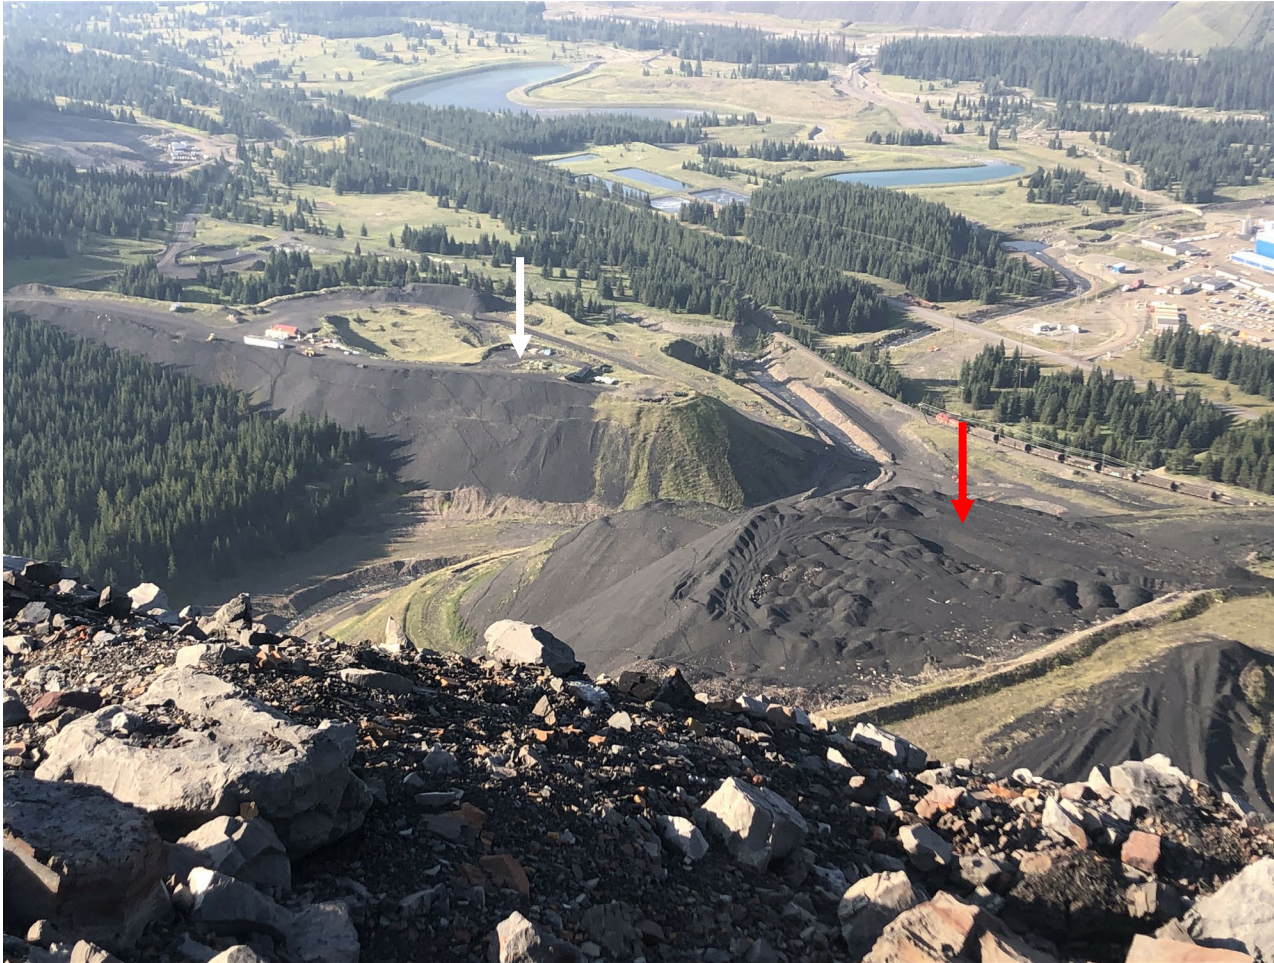
### PHOTOGRAPH A-8

Kilmarnock / Toe Berm spoil (red arrow) and Impact Berm spoil (white arrow) - looking southwest from Old South spoil

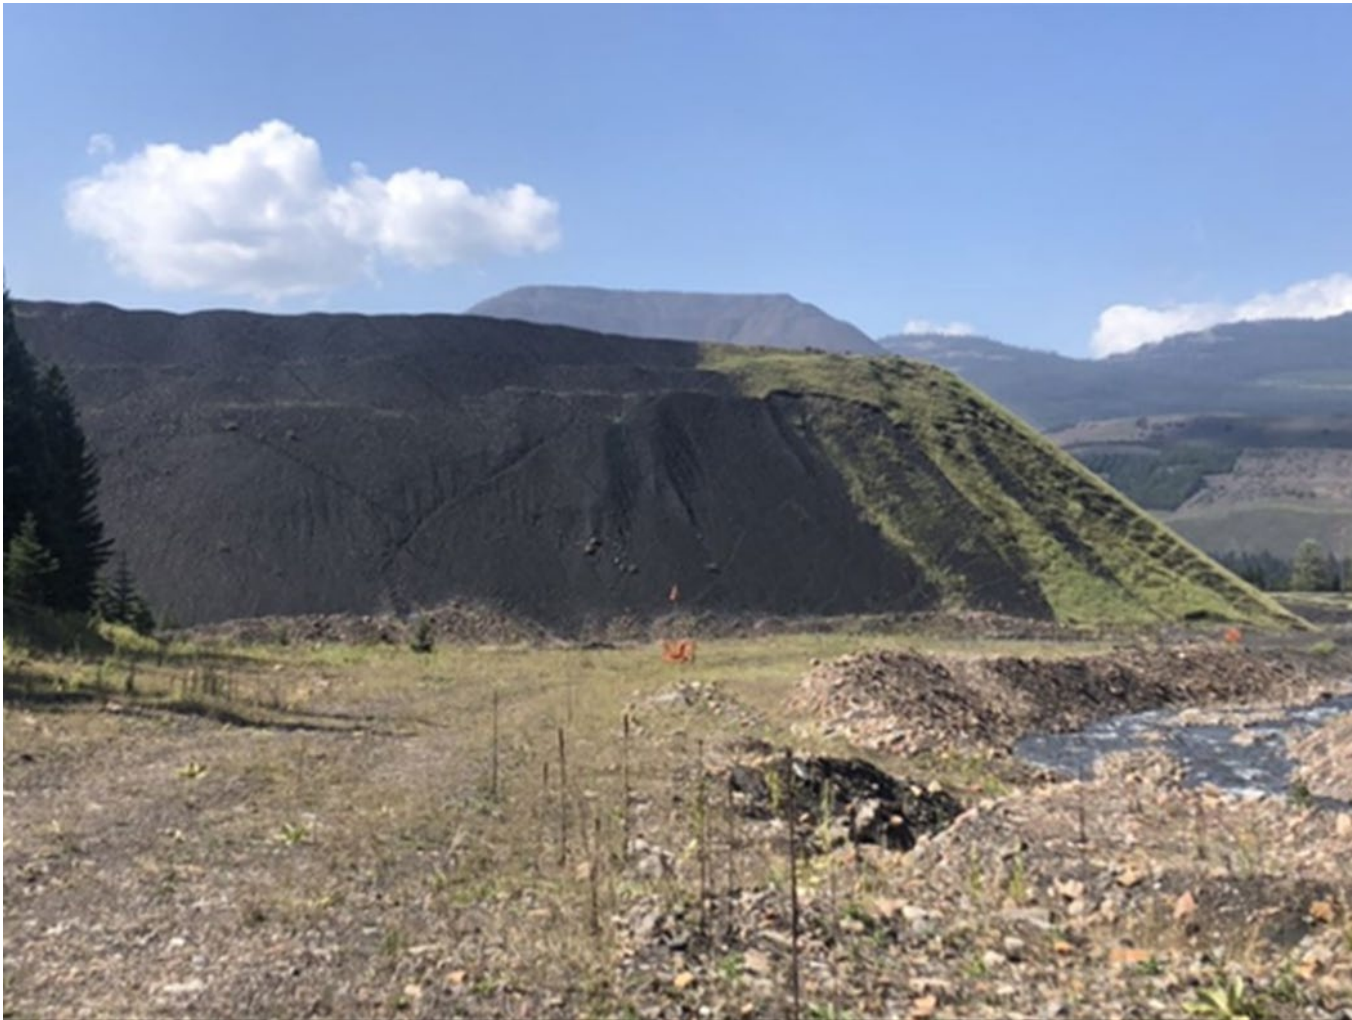
### PHOTOGRAPH A-9

Impact Berm spoil - eastern slope and toe, looking southwest from Kilmarnock Creek

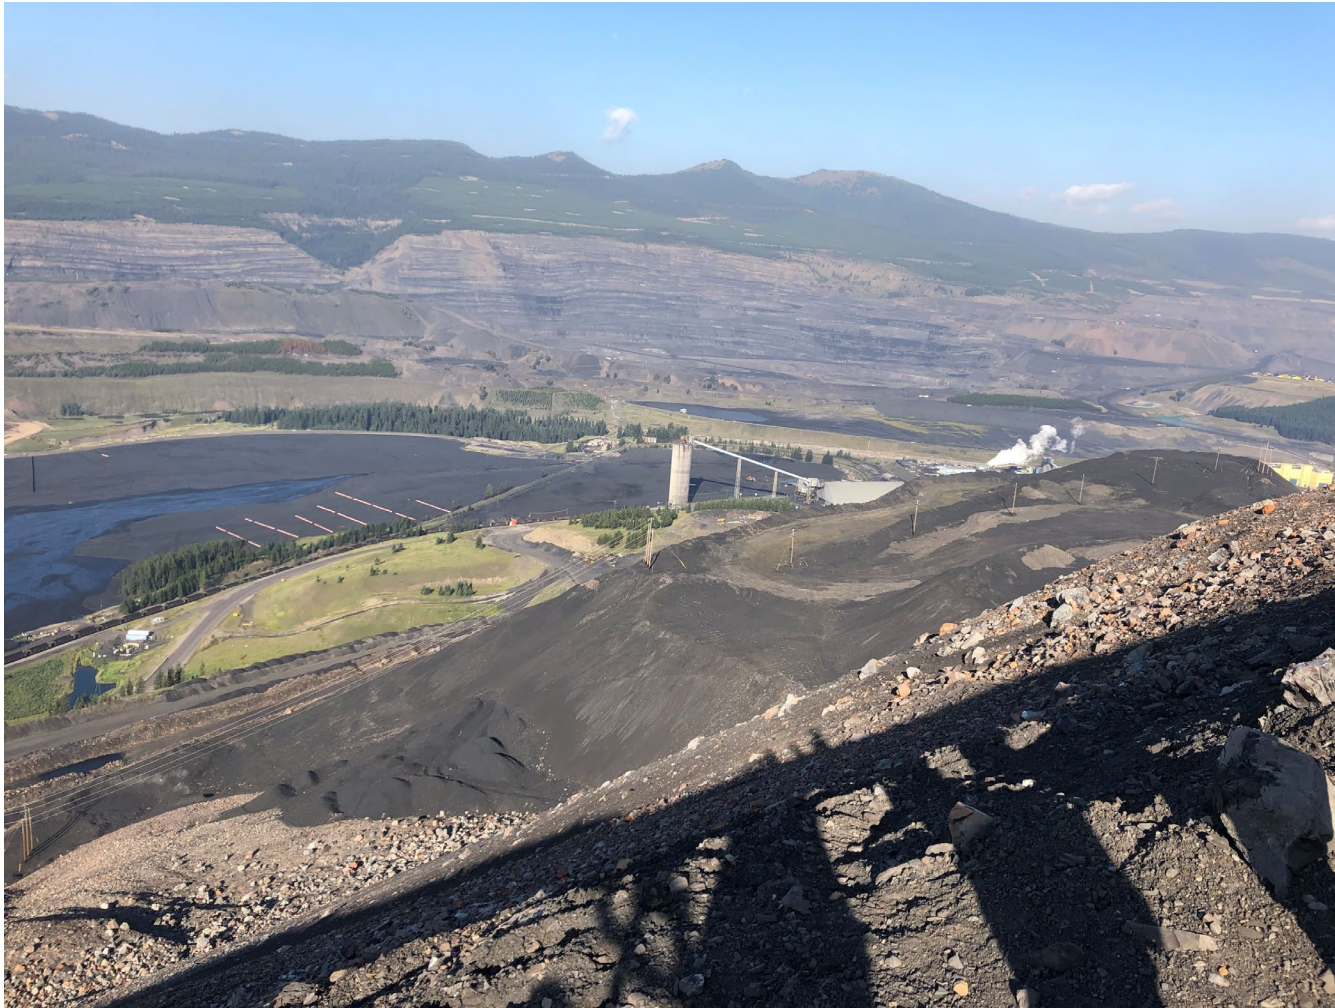
## PHOTOGRAPH A-10

Blake spoil - Overview from Old South spoil, looking northwest

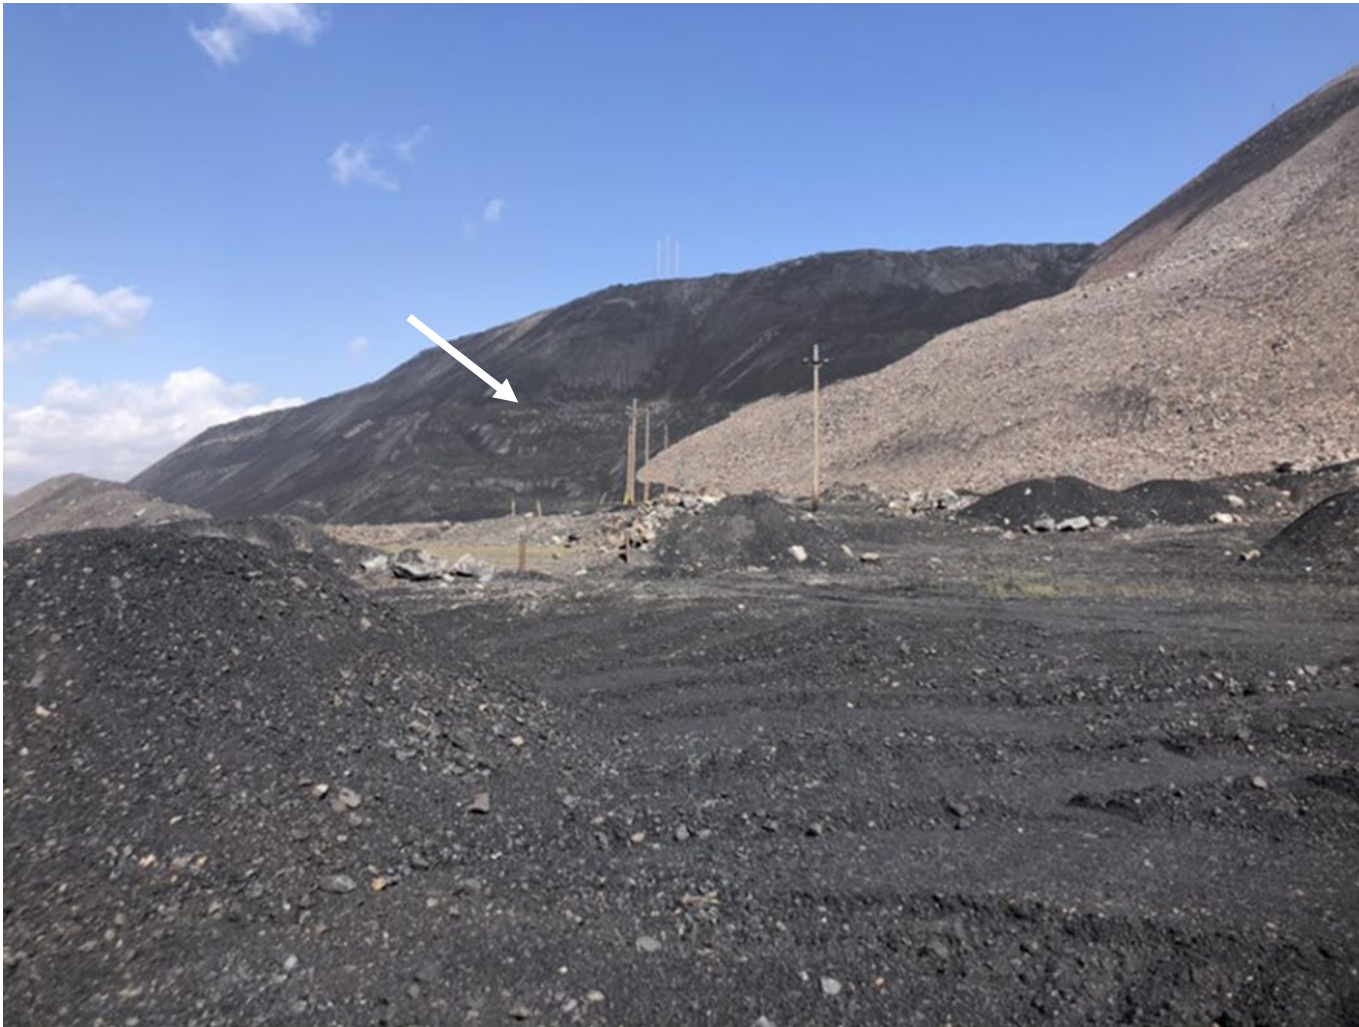
### PHOTOGRAPH A-11

Blake spoil (white arrow) - North end of Kilmarnock / Toe Berm spoil looking northeast

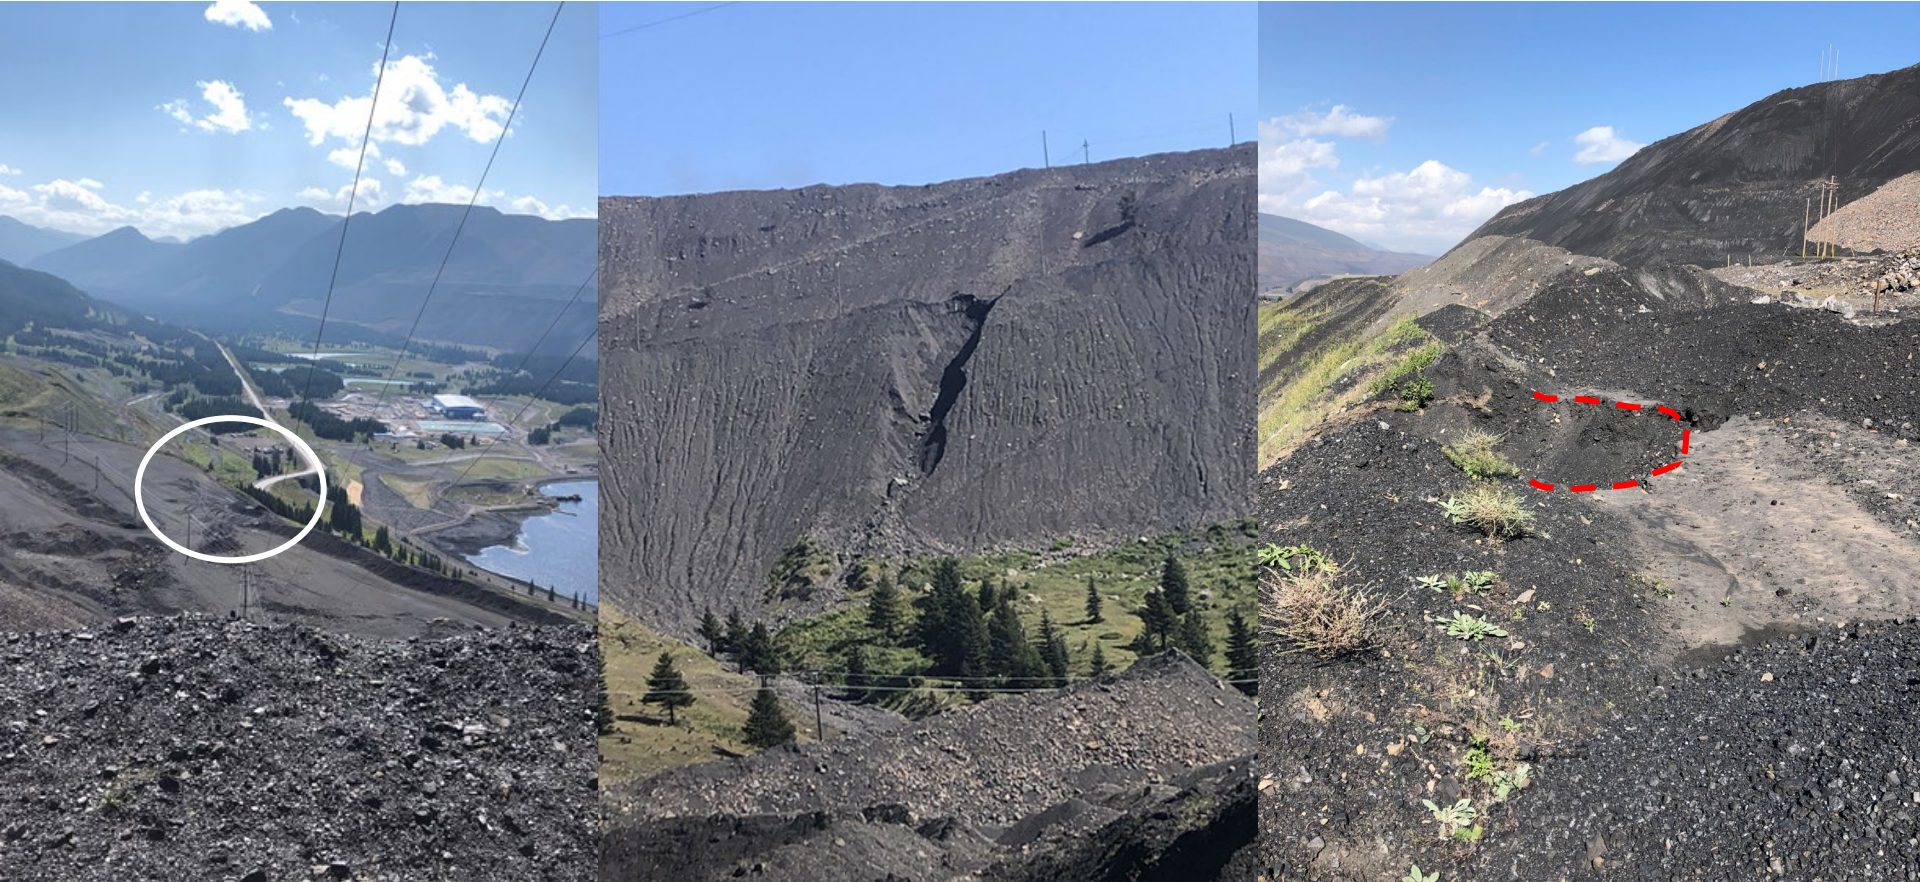
## PHOTOGRAPH A-12

- A new erosion gully at the south end of the Blake spoil along the western crest of the 1,780 m platform was observed. Additional erosion of this gully could lead to local bench instability and further mobilization of material downslope.

Blake spoil - Erosion channel and loss of berm on western lift due to surface water. Run out of coal rejects onto 1,730 lift of Kilmarnock / Toe Berm spoil

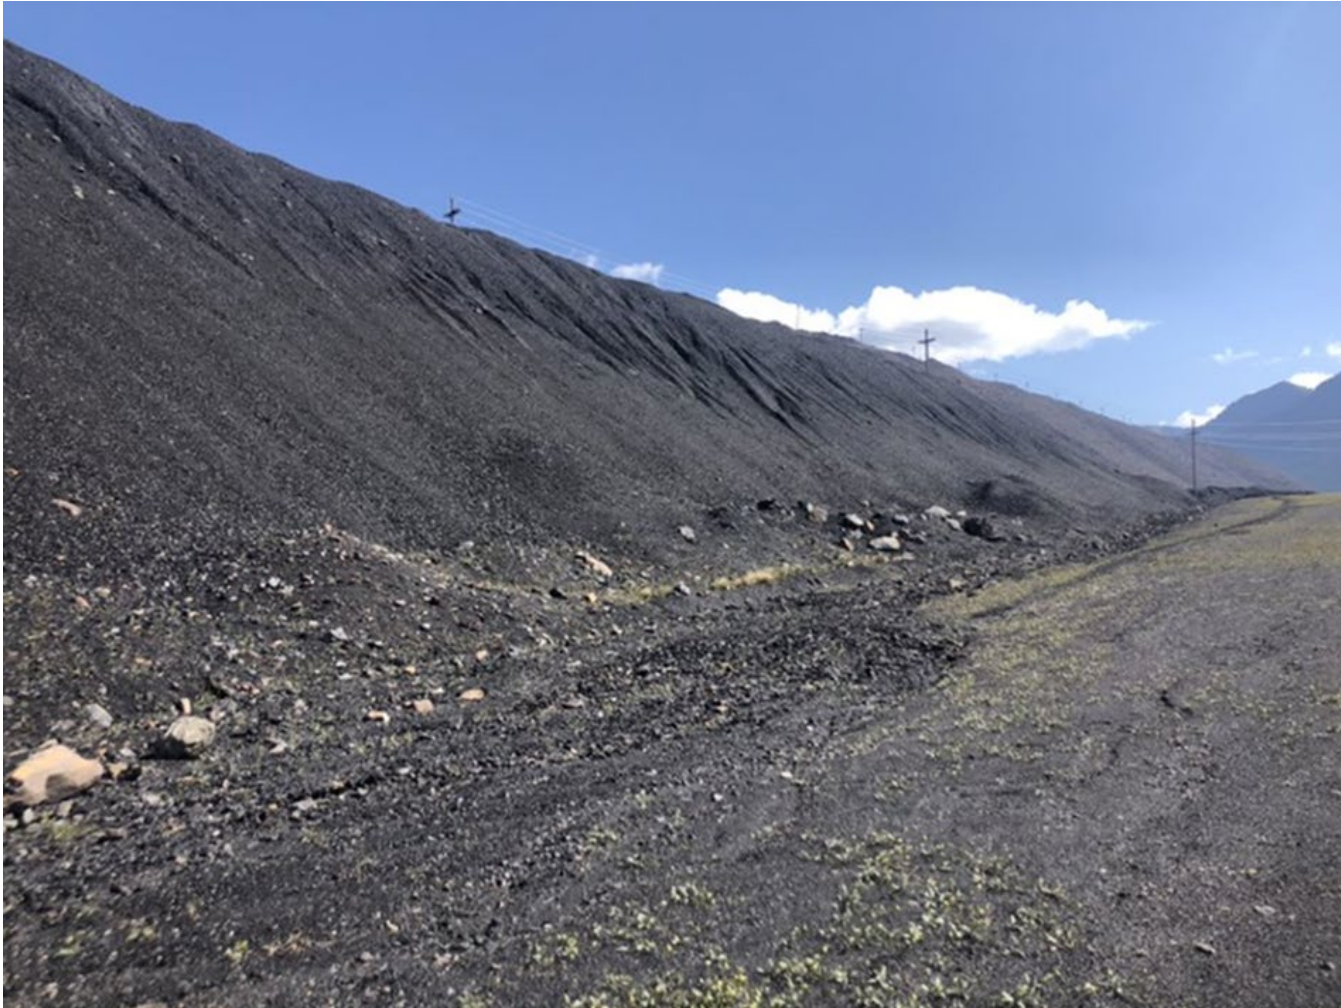
### PHOTOGRAPH A-13

Blake spoil - Upper lift with minor erosion rilling, looking south

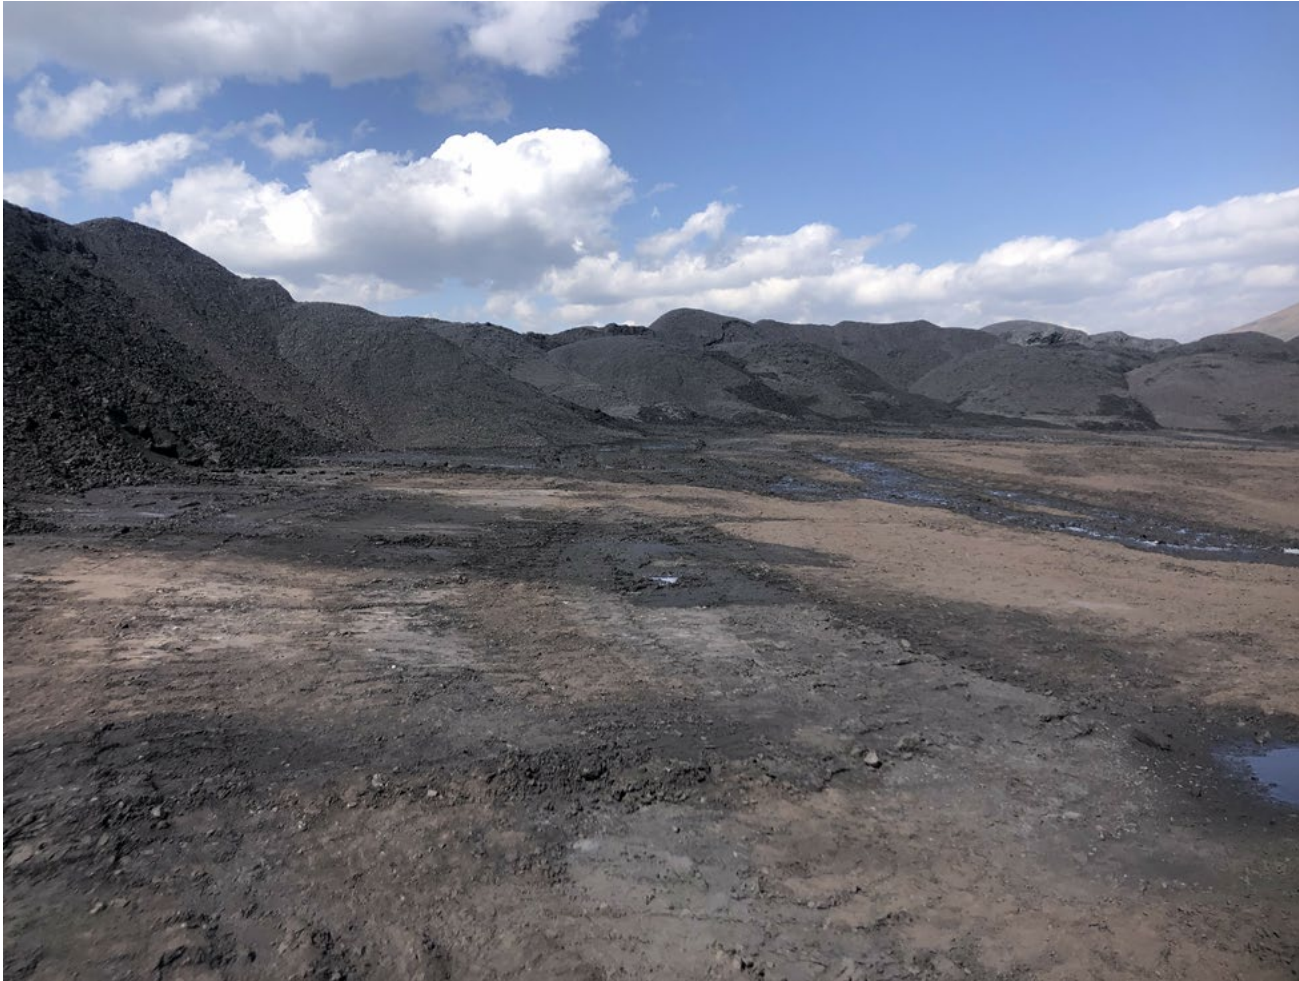
### PHOTOGRAPH A-14

The Blake spoil has been dormant since 2014. However, freshly tipped CR was observed during the 2021 annual inspection (Section 5.0).

Blake spoil - Freshly dumped combined coarse and fine rejects, looking northwest

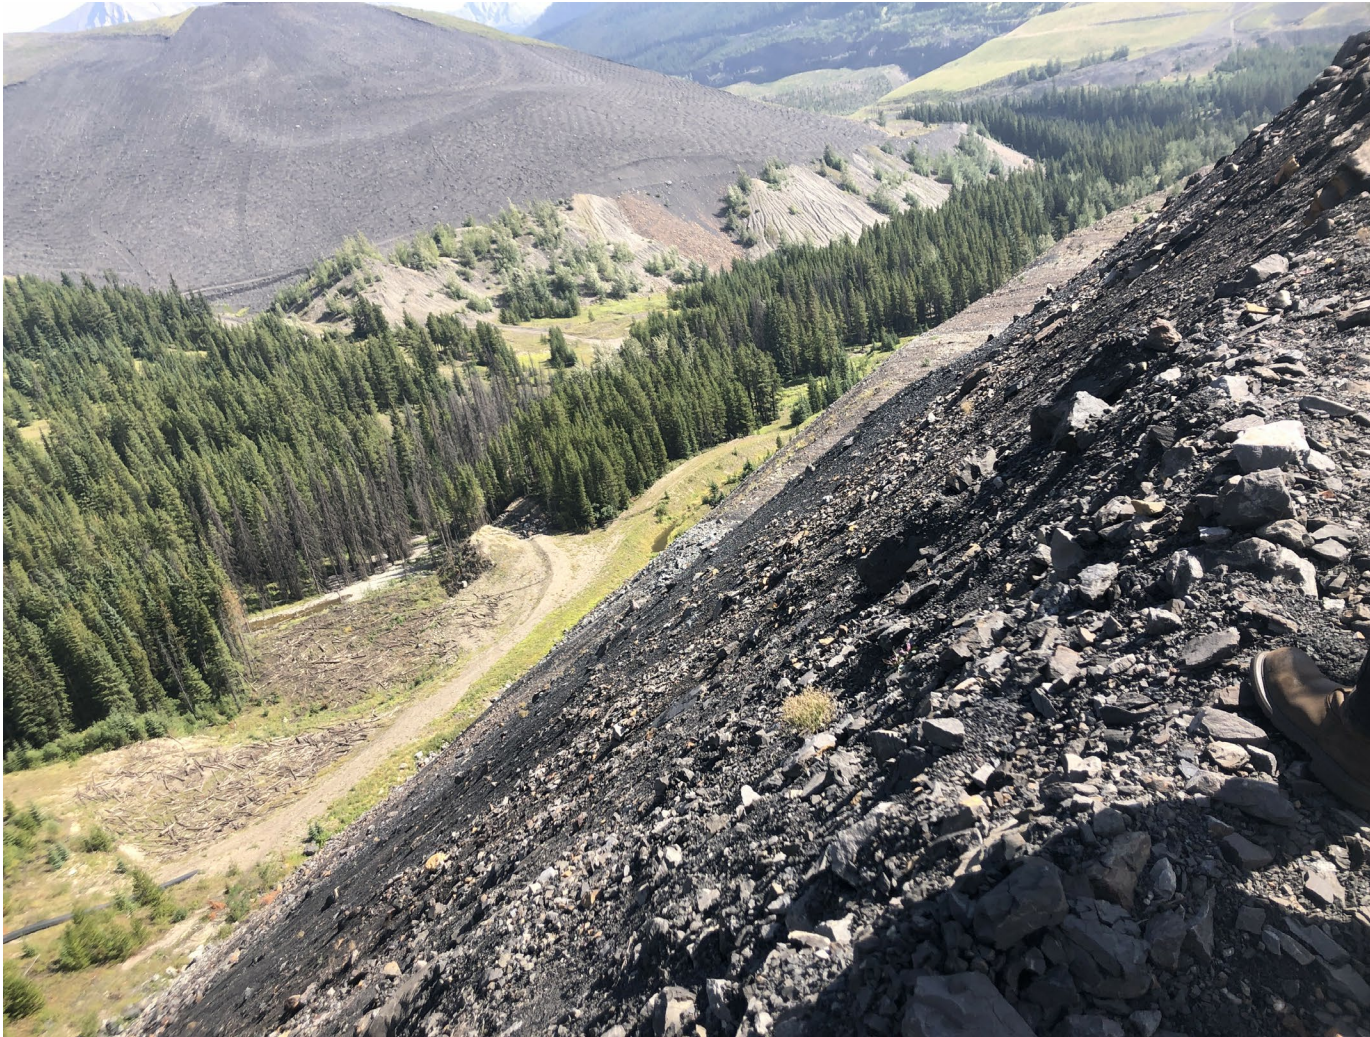
## PHOTOGRAPH A-15

Turnbull West spoil - looking west towards Fording River at toe

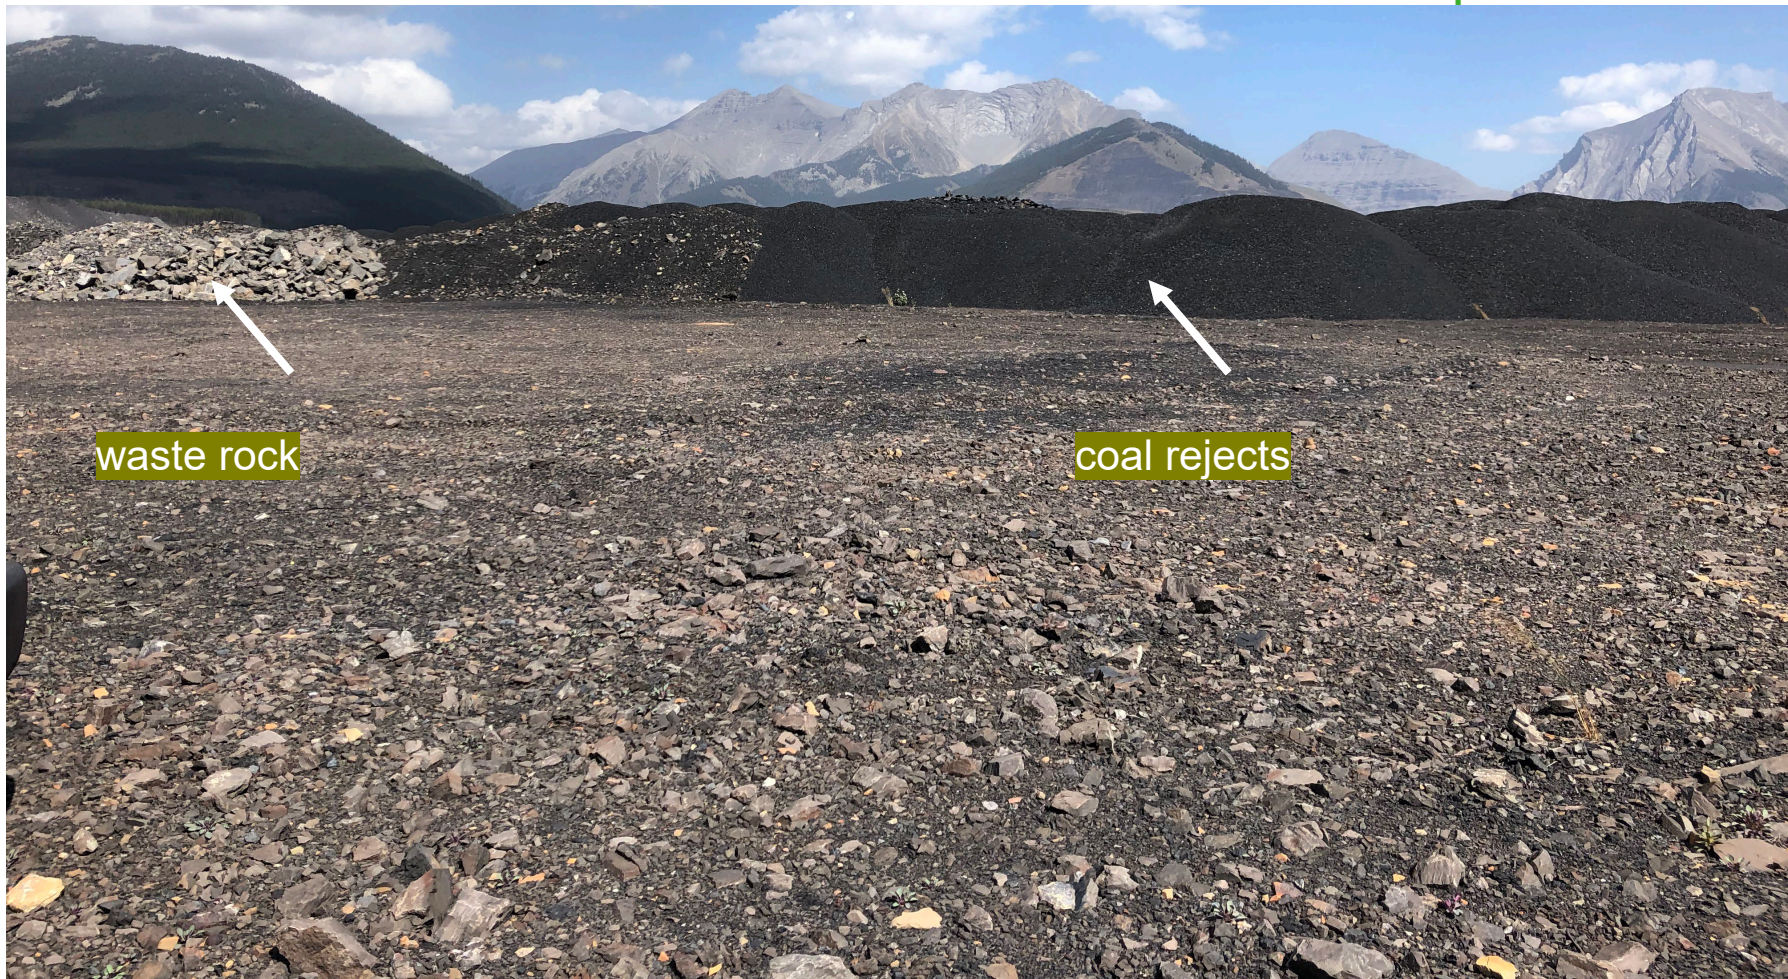
**PHOTOGRAPH A-16**

Turnbull West spoil - platform, looking northeast
