# 2021 Annual Facility Performance Report for the Coal Reject Spoils

*Teck Coal Limited, Fording River Operations*

Reference No.: 21456080-2021-254-R-Rev0-600

30 March 2022

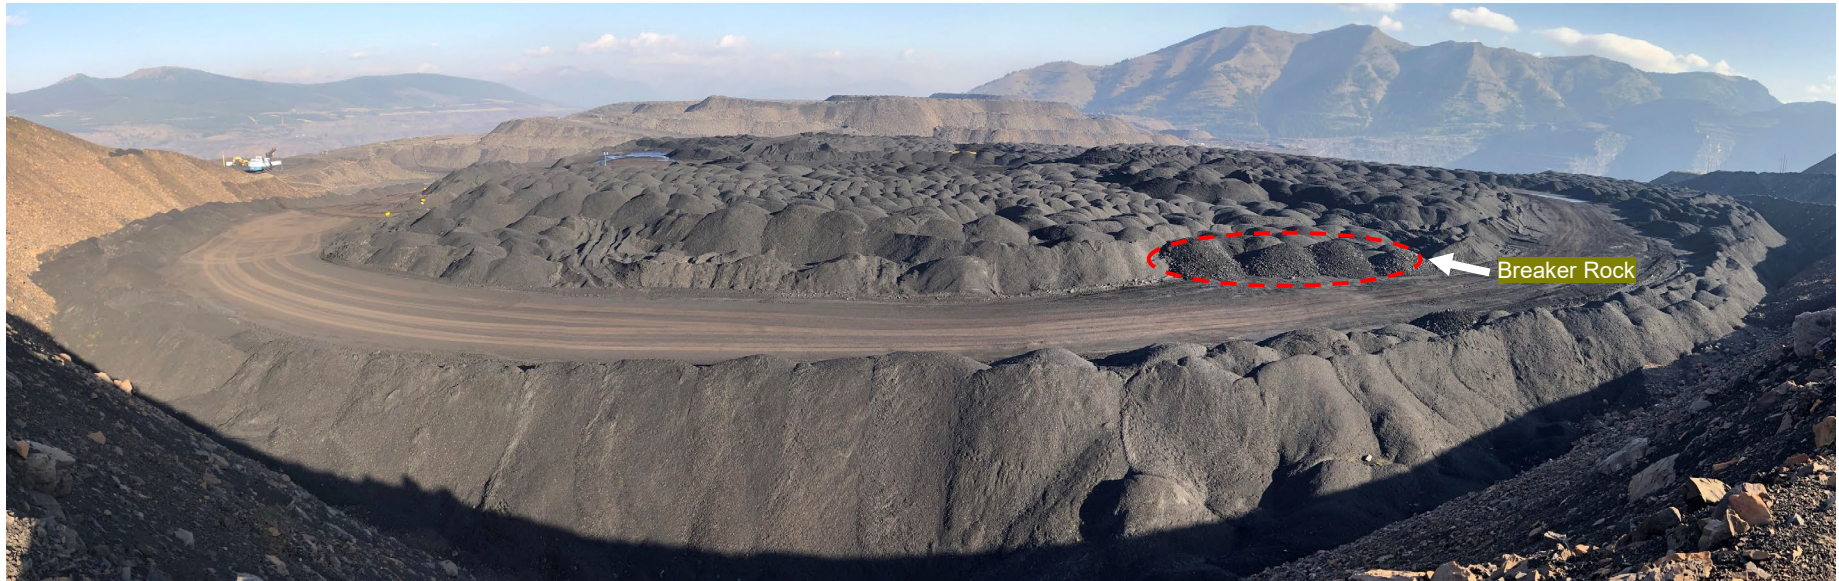
## PHOTOGRAPH A-17

Eagle 4 South Backfill spoil - Overview, looking north

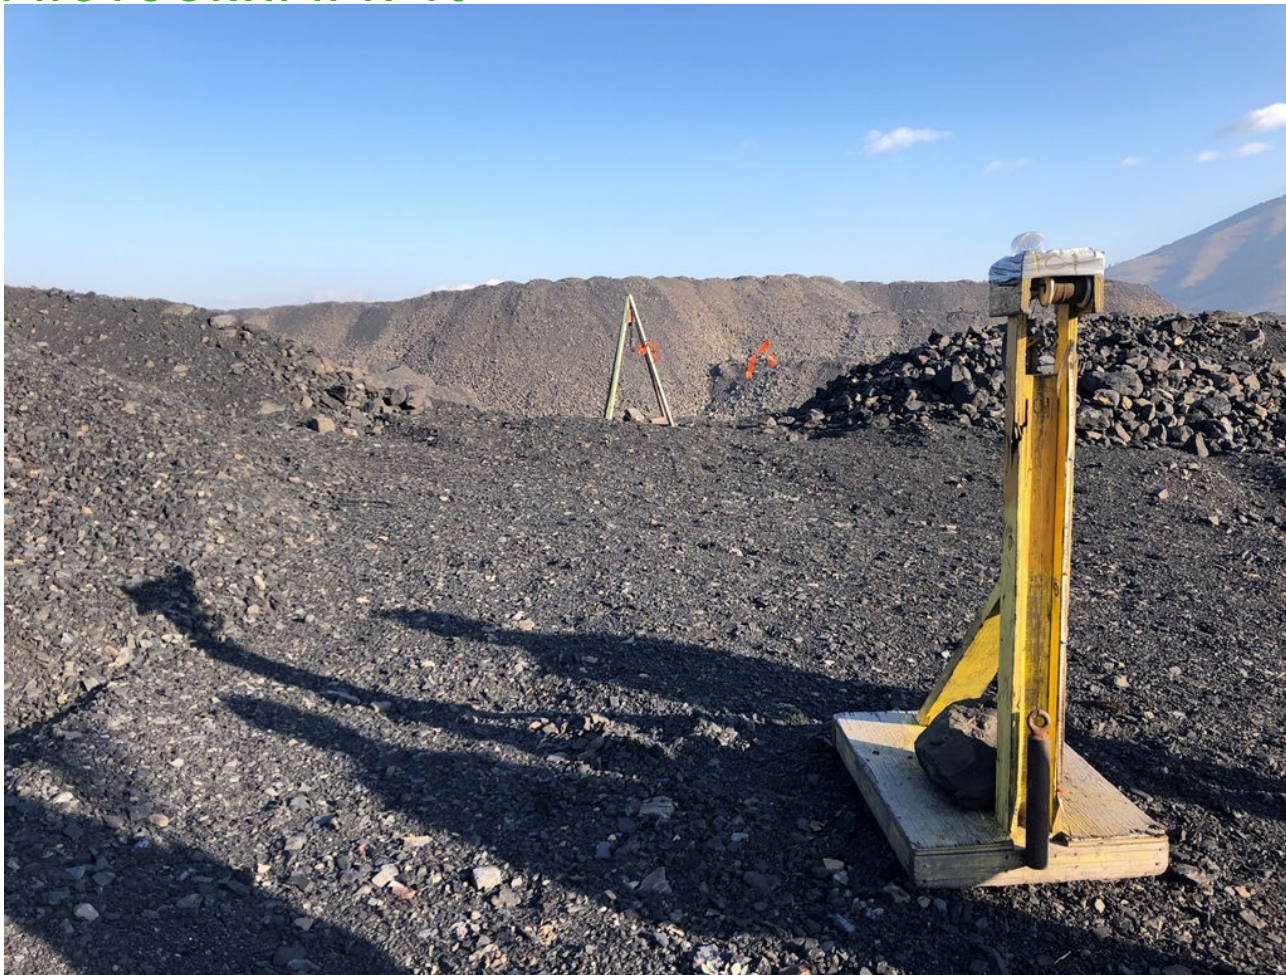
### PHOTOGRAPH A-18

Edge of Eagle 4 South Backfill spoil - west side of active platform with extensometer, looking southeast
