2021 Annual Facility Performance Report for South Tailings Pond and North Tailings Pond

Teck Coal Limited, Fording River Operations

Golder Associates Ltd.

25 March 2022

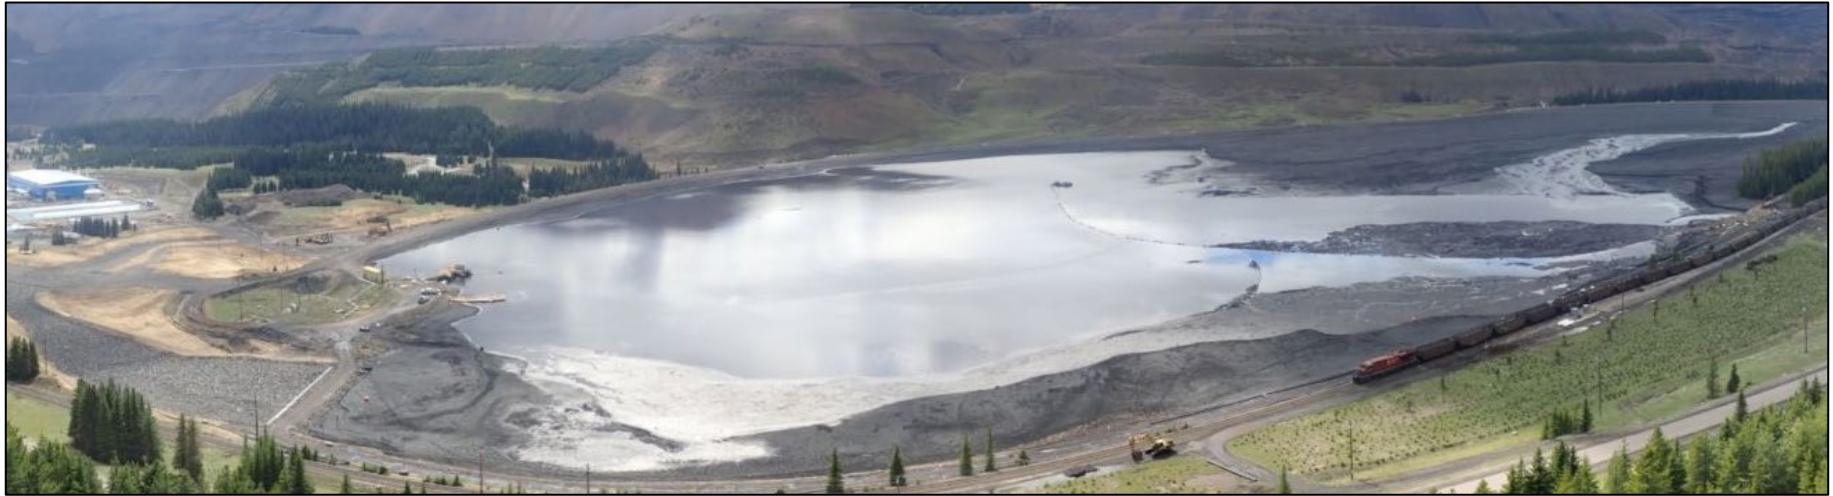
South Tailings Pond (STP) overview, looking southwest.

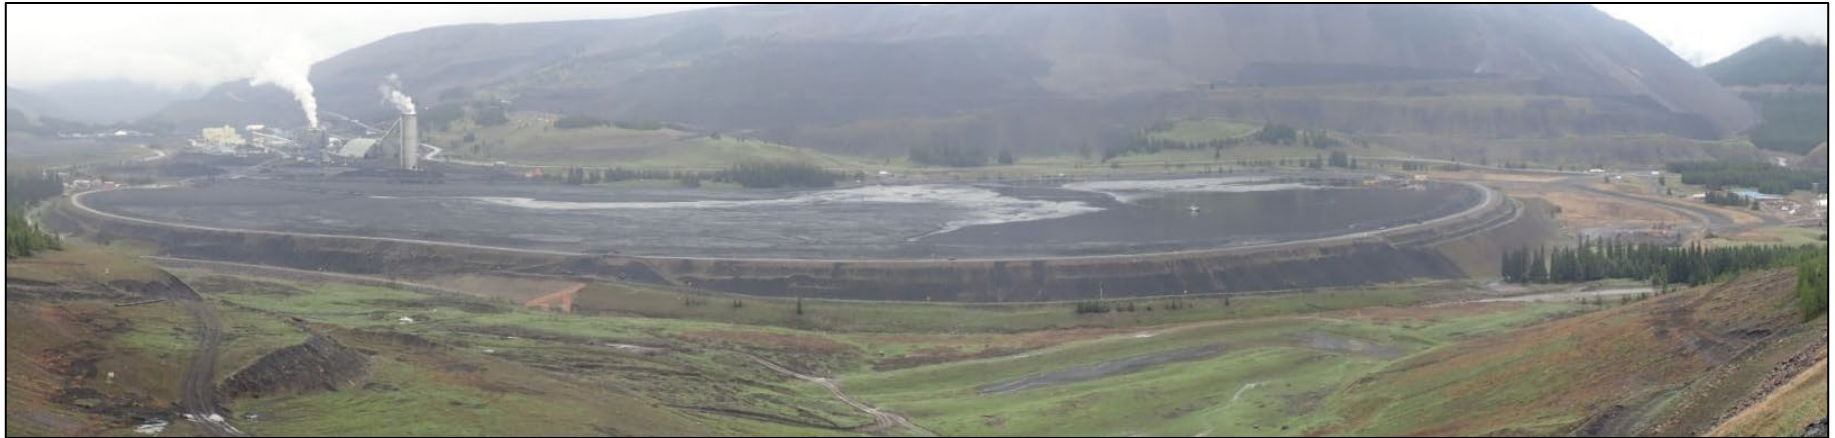
STP overview, looking northeast.

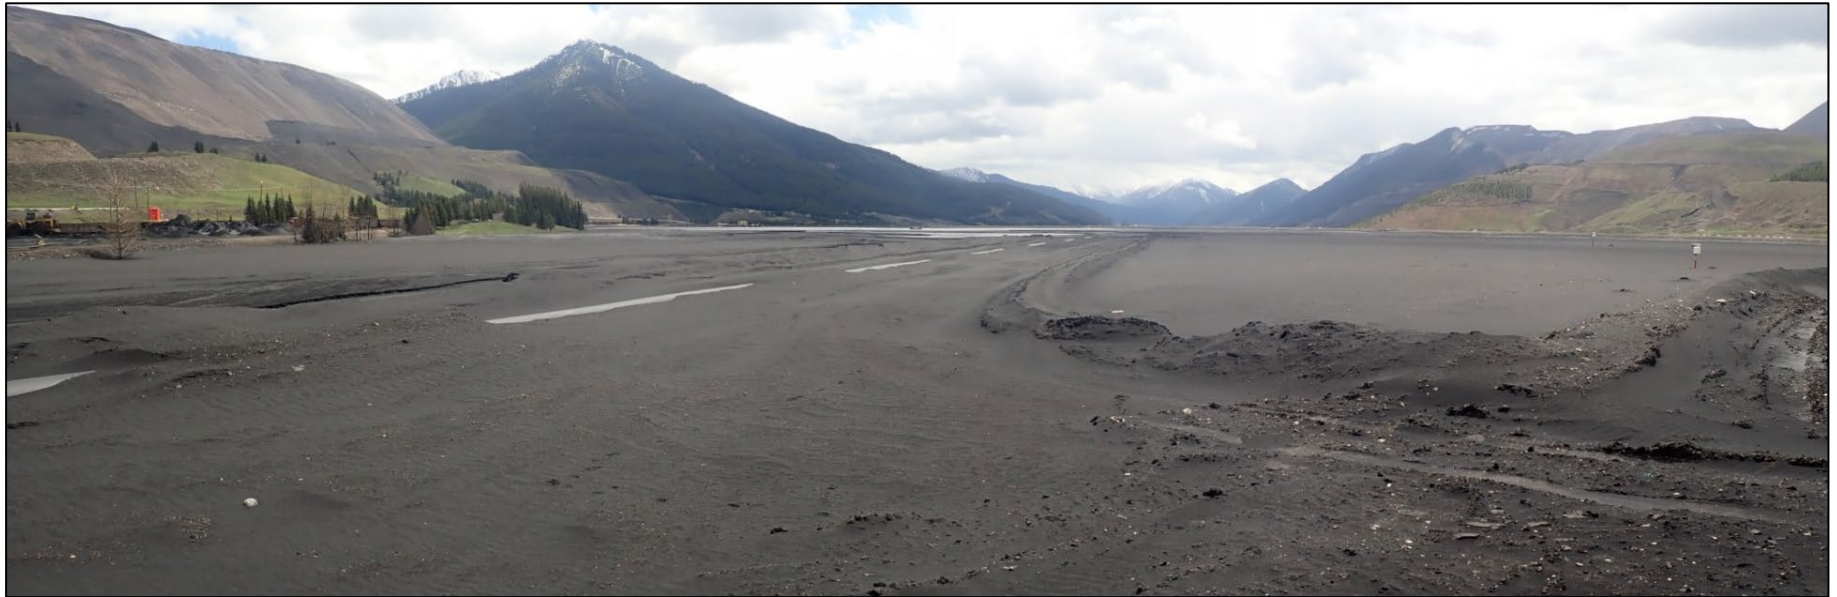
STP north single point discharge pipeline extension to main pond, and north end beach area, looking southeast.

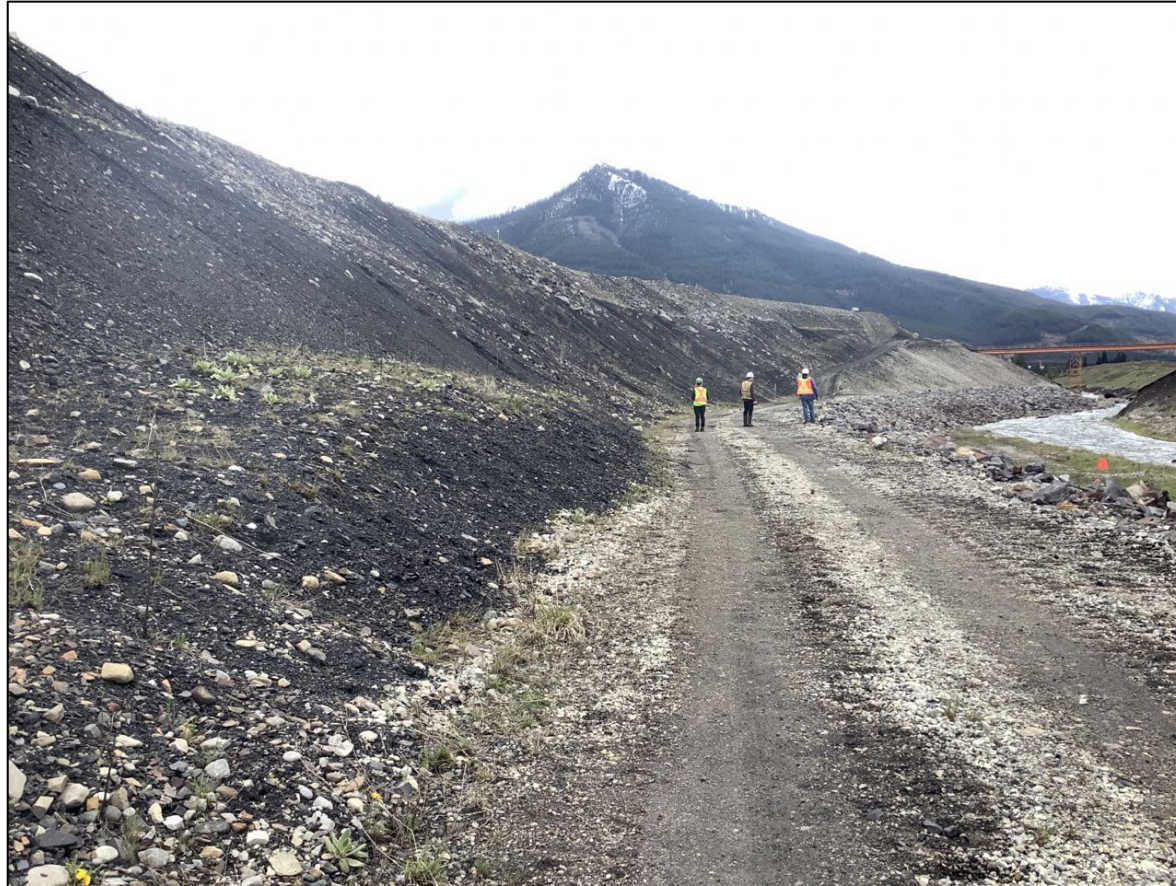
STP West Dam downstream slope and riprap along Fording River, looking southeast from approximately Sta. 0+400.

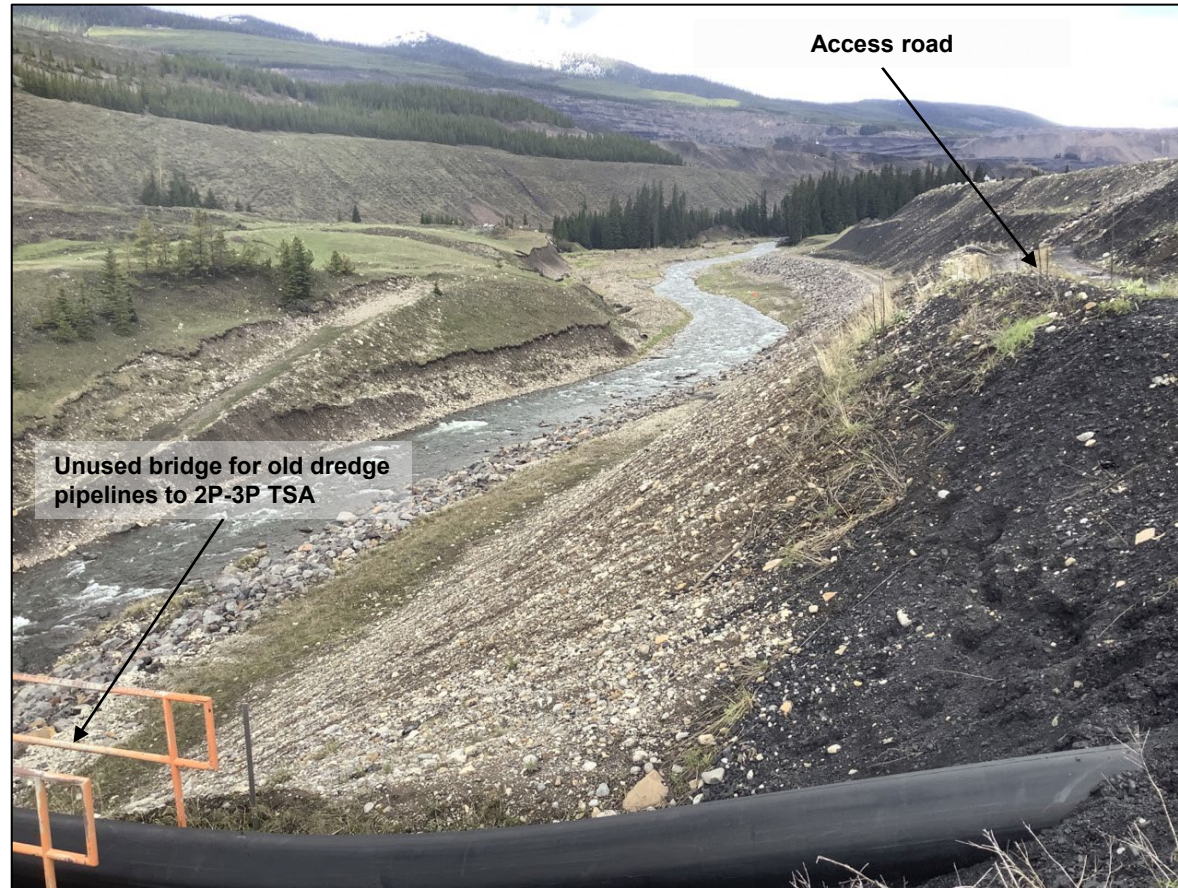
STP West Dam, downstream slope, Fording River diversion channel cut and access road below dam, looking northwest from approximately Sta. 0+650.

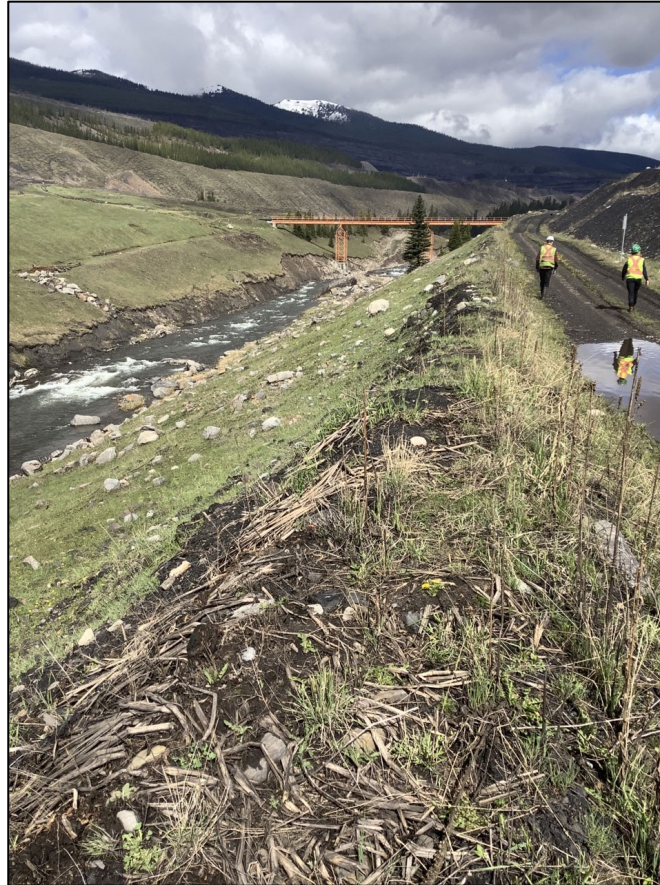
STP West Dam access road along downstream slope, Fording River, and pipeline bridge, looking northwest from approximately Sta. 0+900.

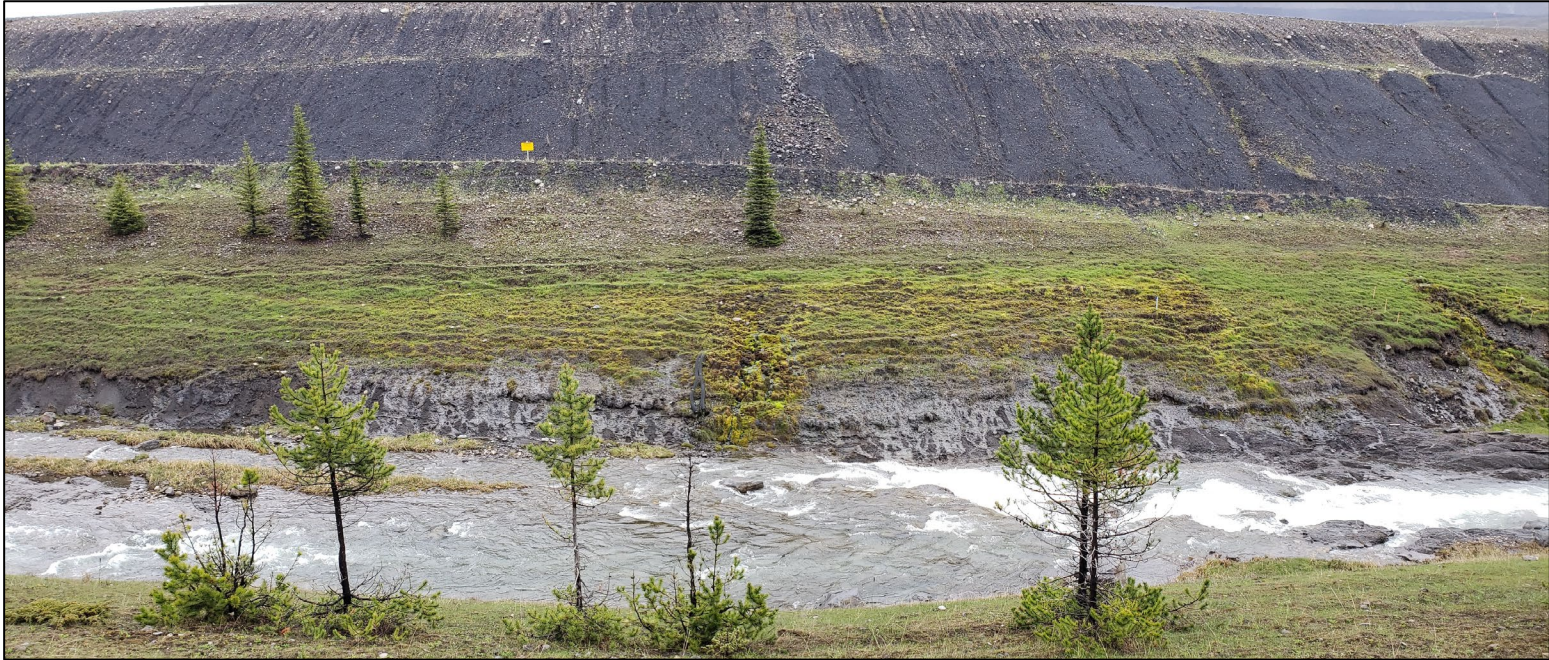
STP West Dam downstream slope and Fording River diversion channel cut, looking northeast from approximately Sta. 1+000.

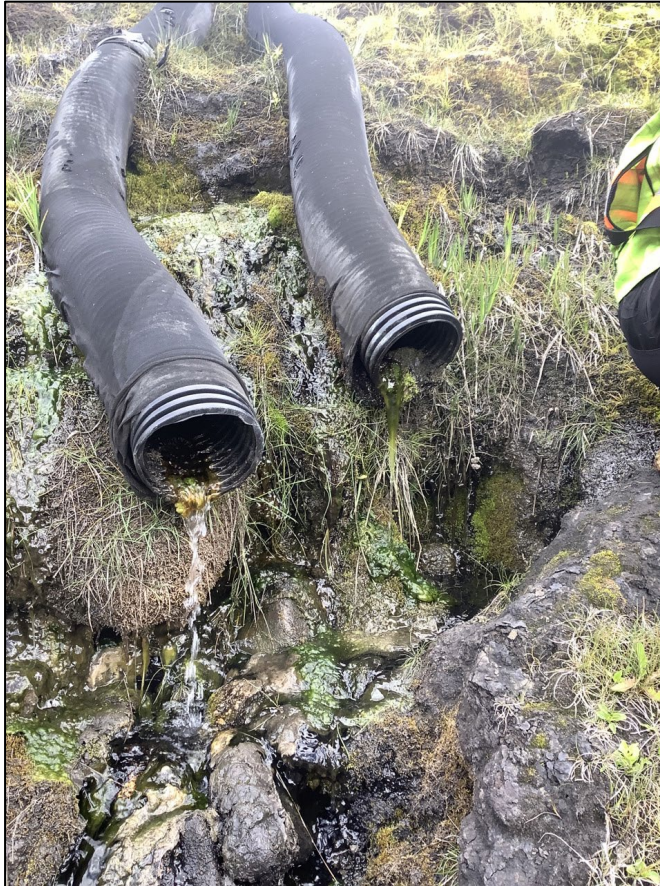
Pipe	Seepage Rate (L/s)
North (left)	0.07
Bypassing pipes (estimated)	0.30

STP West Dam till slope below dam toe and West Seepage collection Pipes, looking northeast from approximately Sta. 1+000.

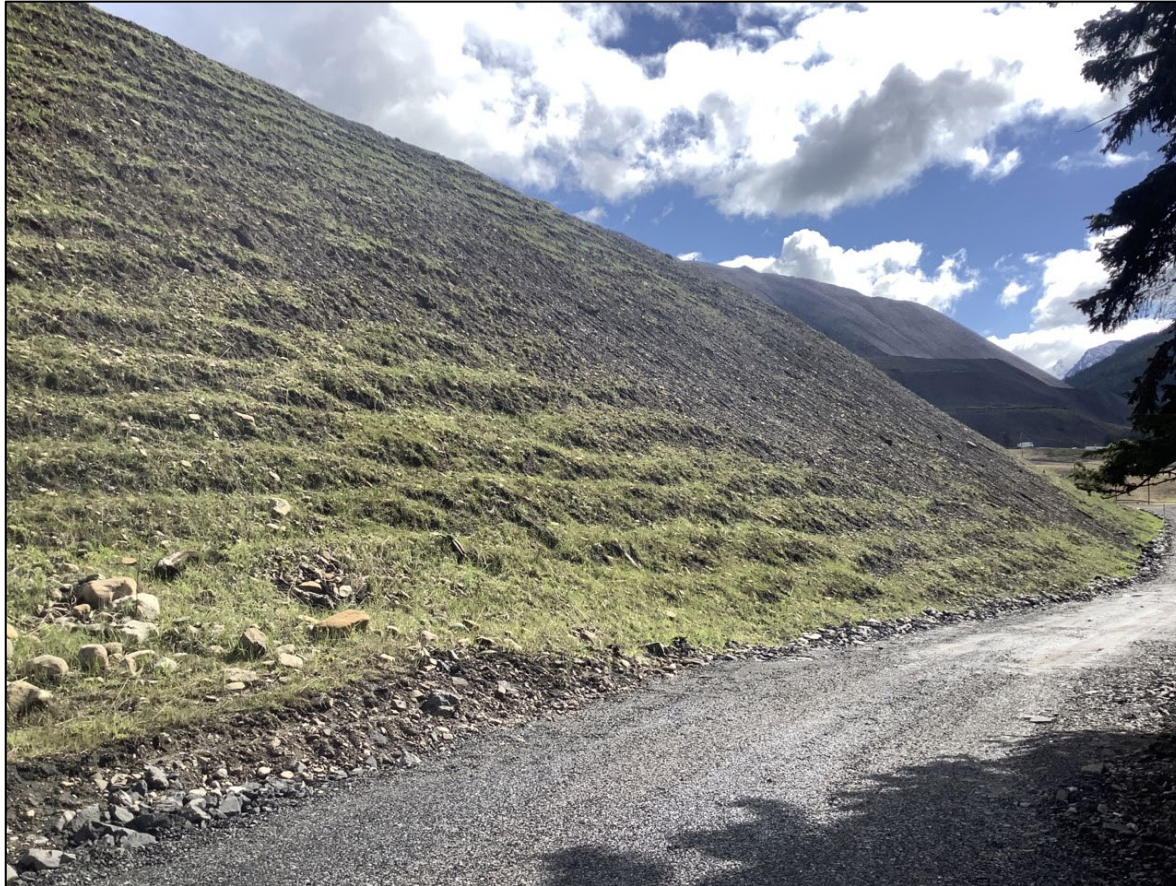
STP West Dam downstream slope, looking southeast from approximately Sta. 1+200.

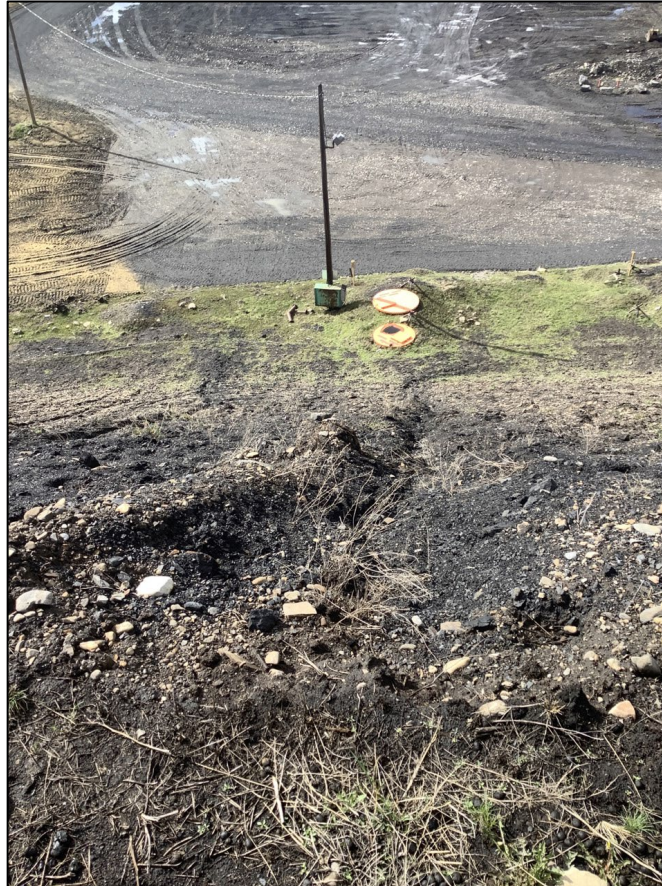
STP Main Dam downstream slope showing erosion above seepage return wells, looking southeast from approximately Sta. 1+450.

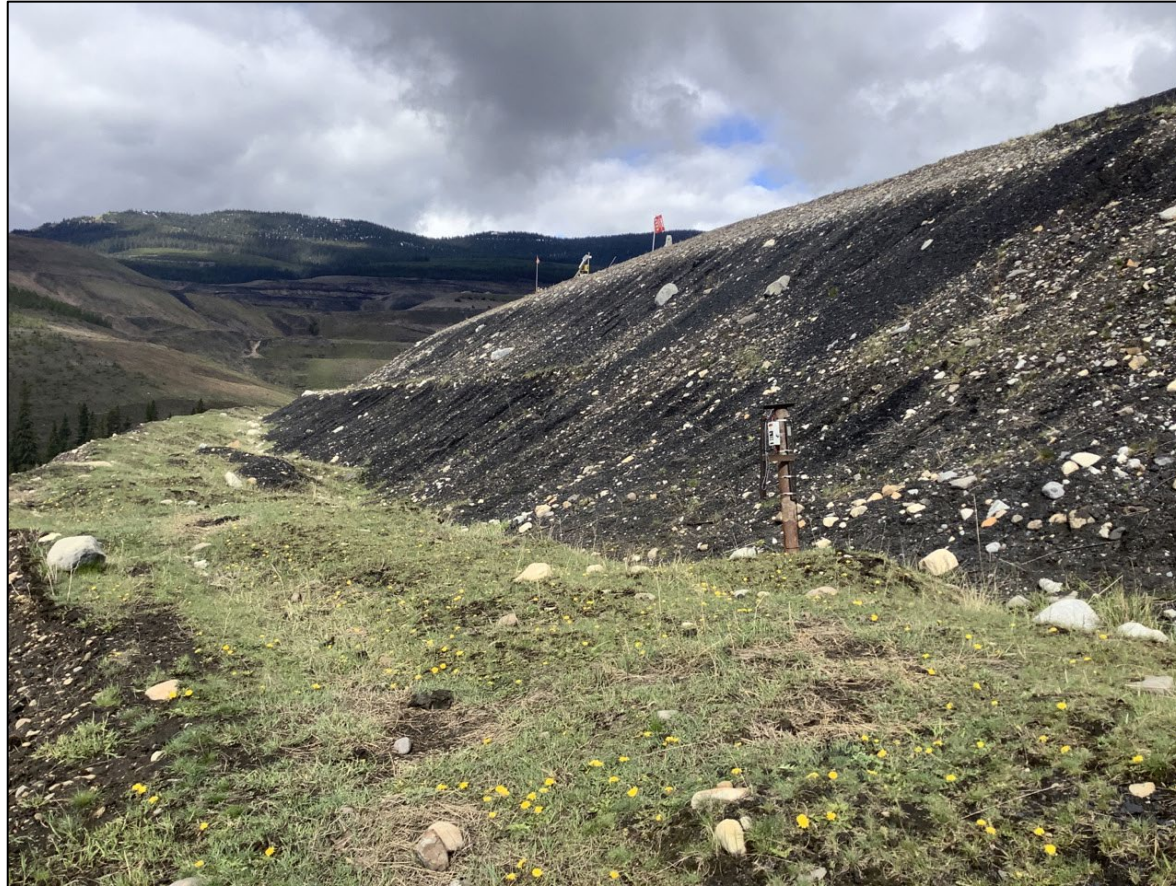
STP Main Dam downstream slope and till bench above coarse rejects section of slope, looking west from approximately Sta. 1+450.

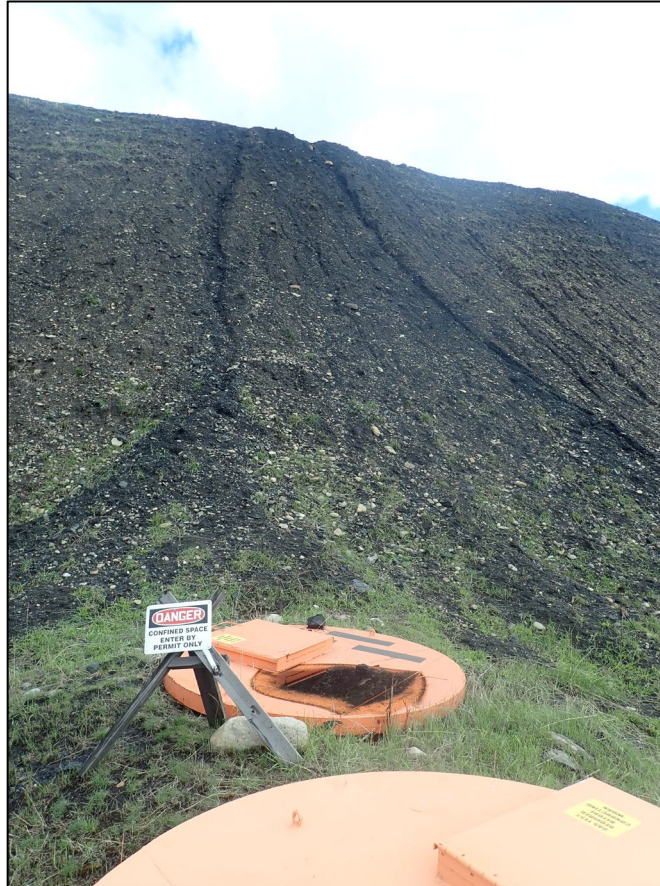
STP Main Dam downstream slope, erosion above well, looking northwest from approximately Sta. 1+400.

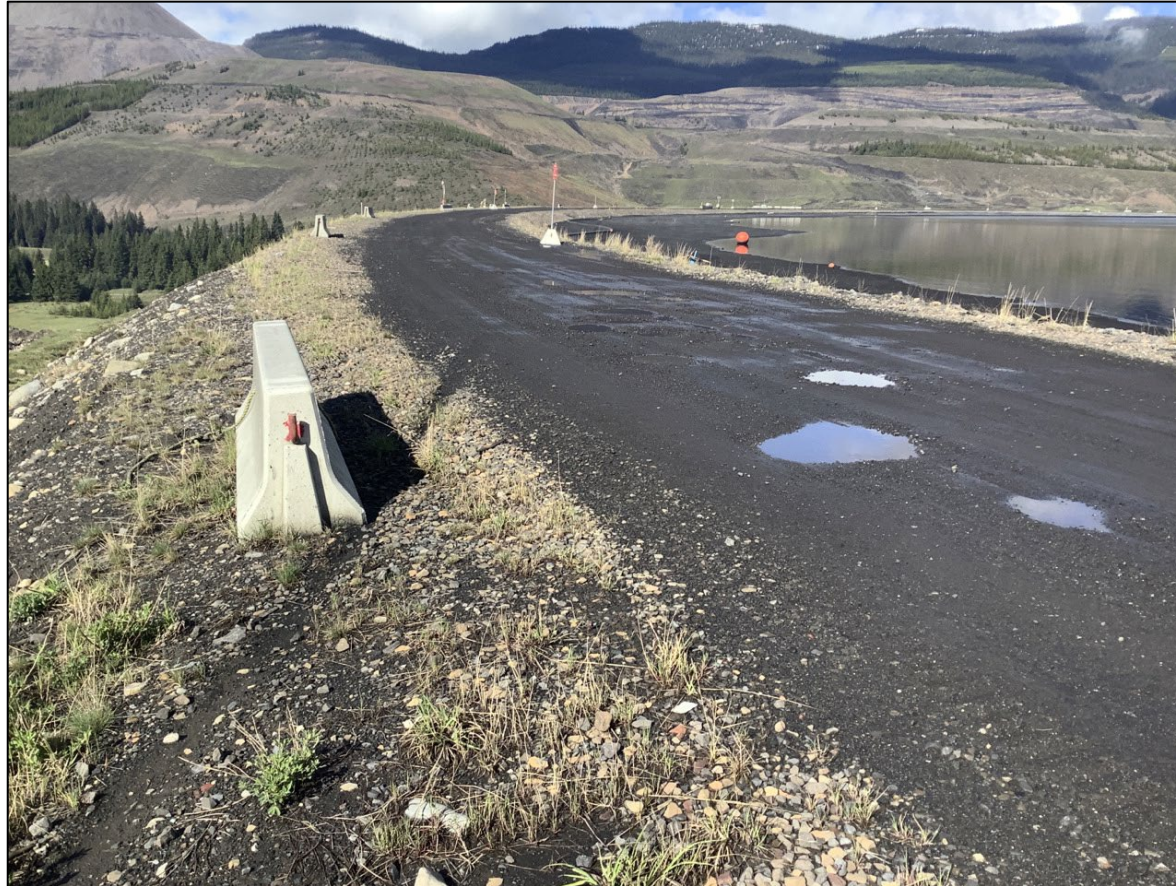
STP Main Dam crest, downstream slope, and tailings beach, looking southwest from approximately Sta. 1+650.

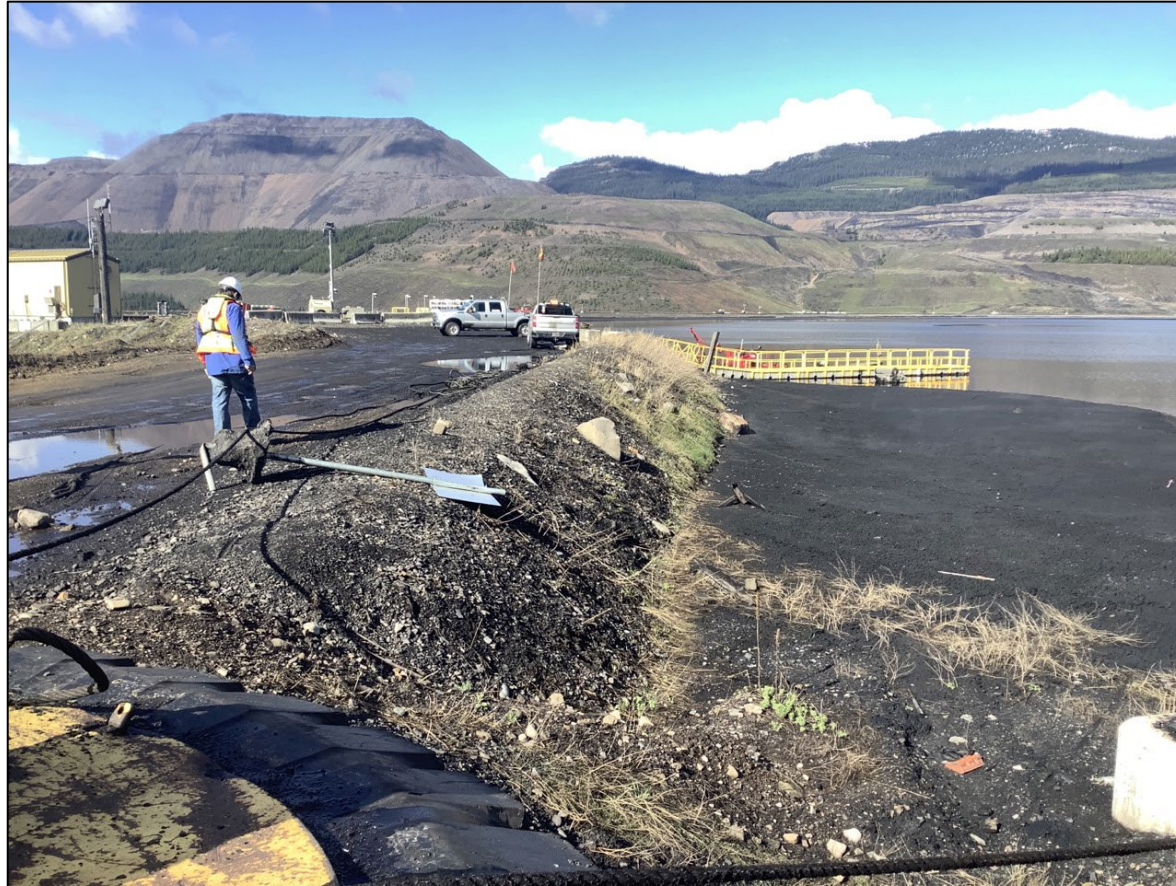
STP Main Dam crest and upstream slope at south abutment, looking southwest from approximately Sta. 1+800.

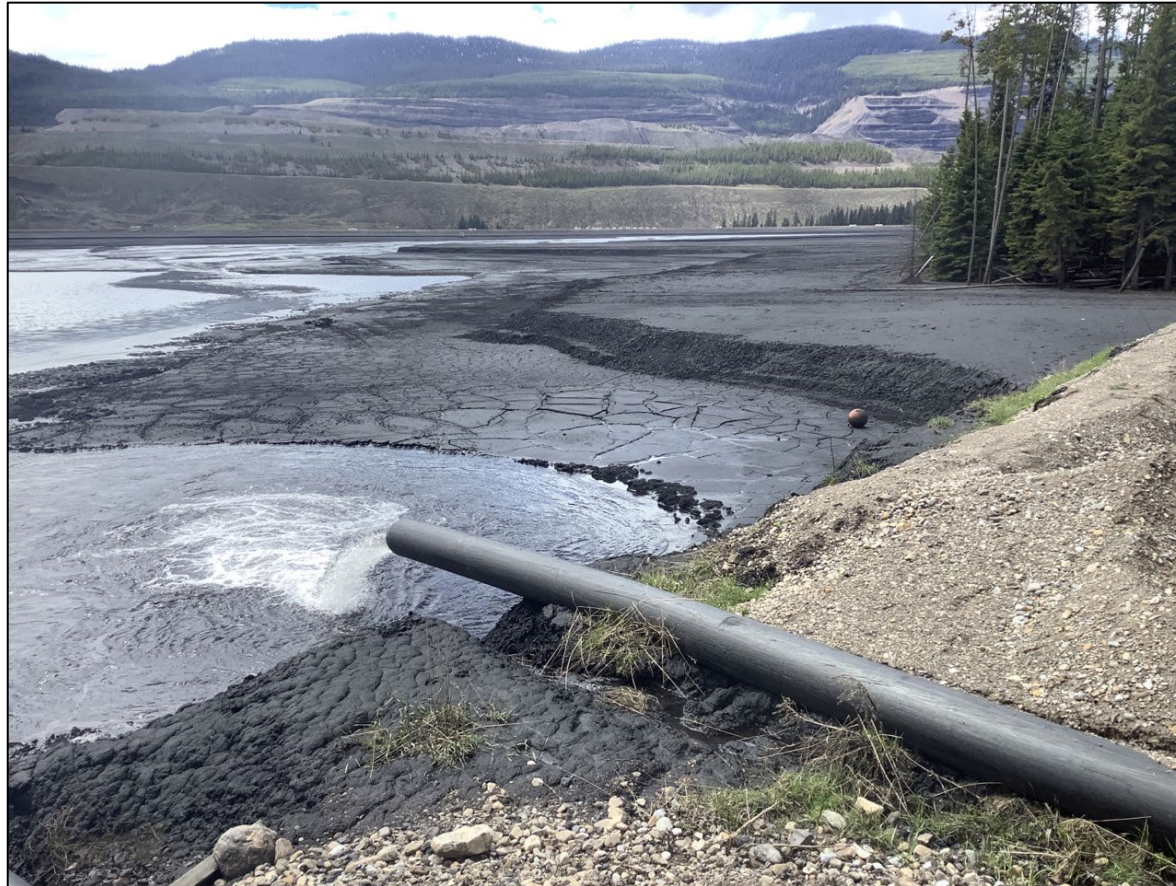
STP water reclaim line from Turnbull TSF, looking southwest.

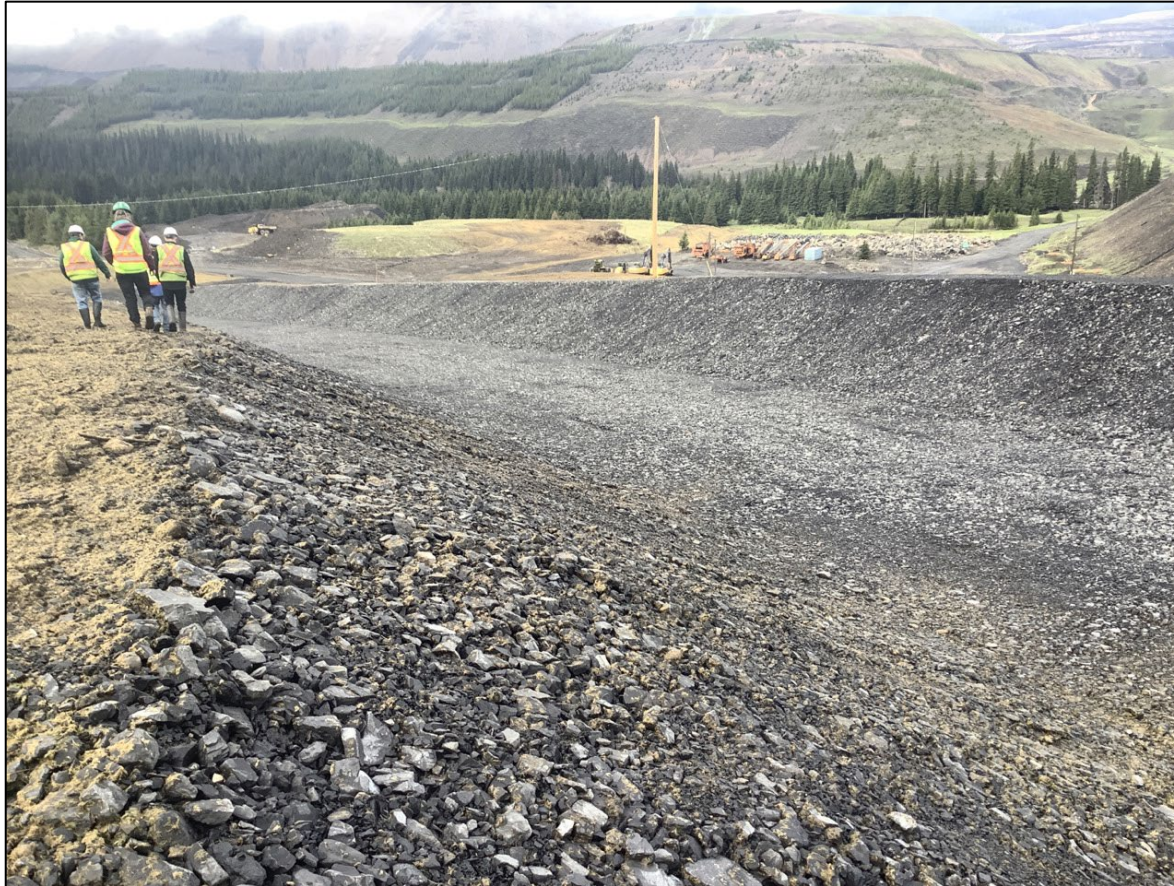
Lower section of spillway channel, looking southwest.

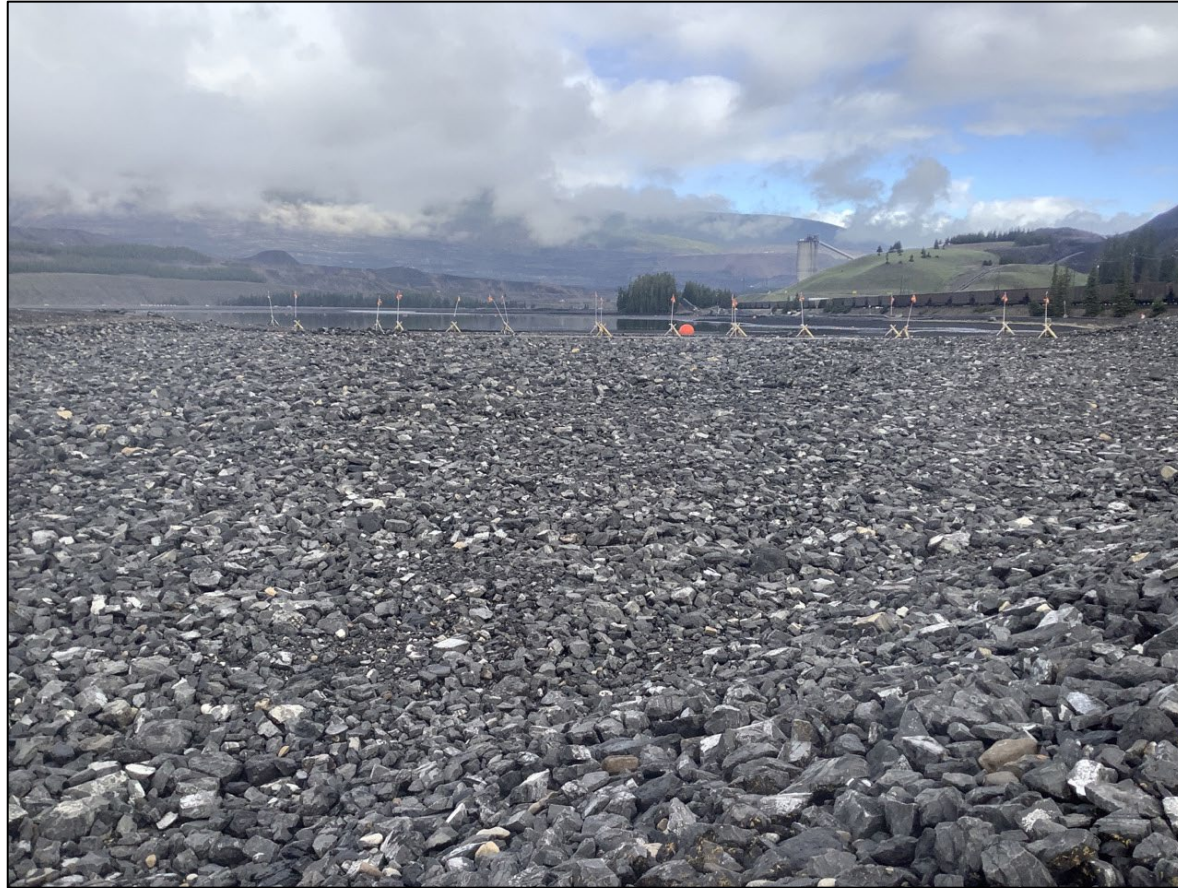
Spillway channel at invert, looking northwest.

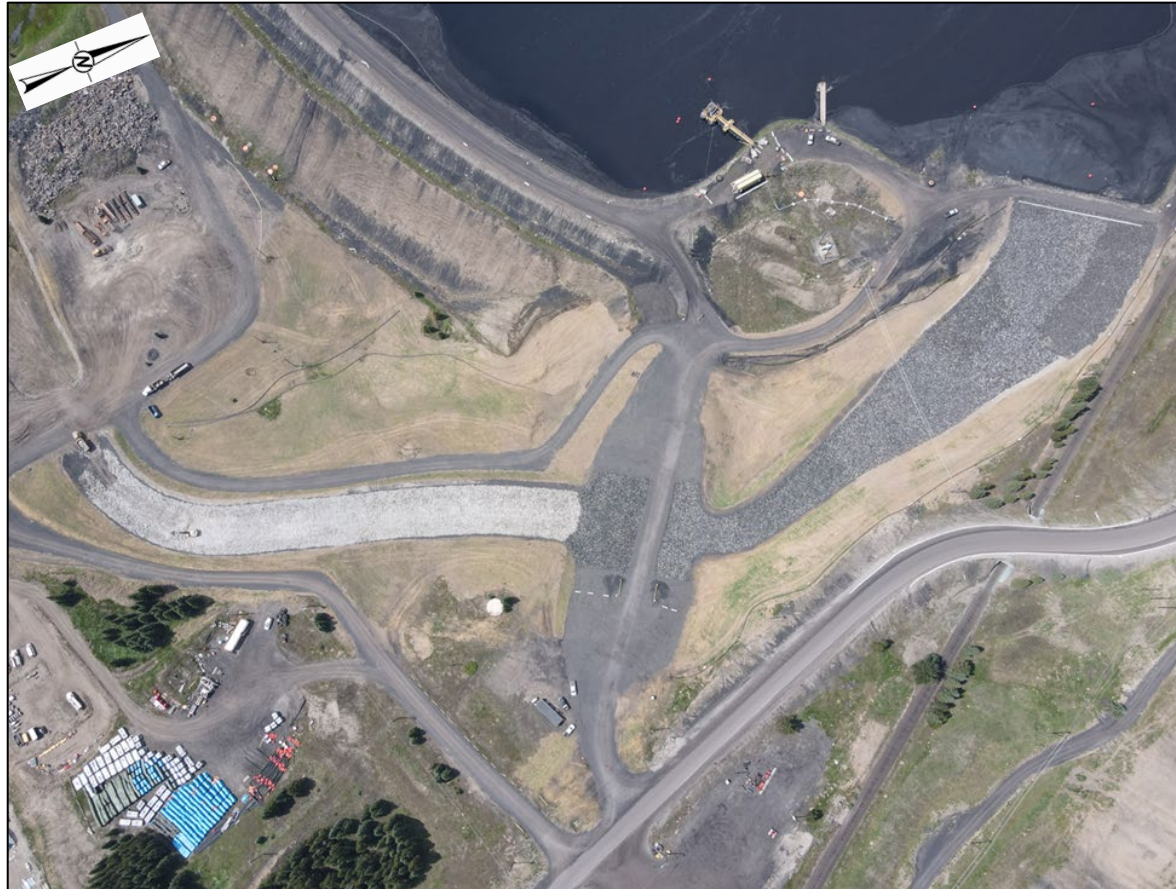
Overview of completed spillway construction, drone photo provided by FRO.

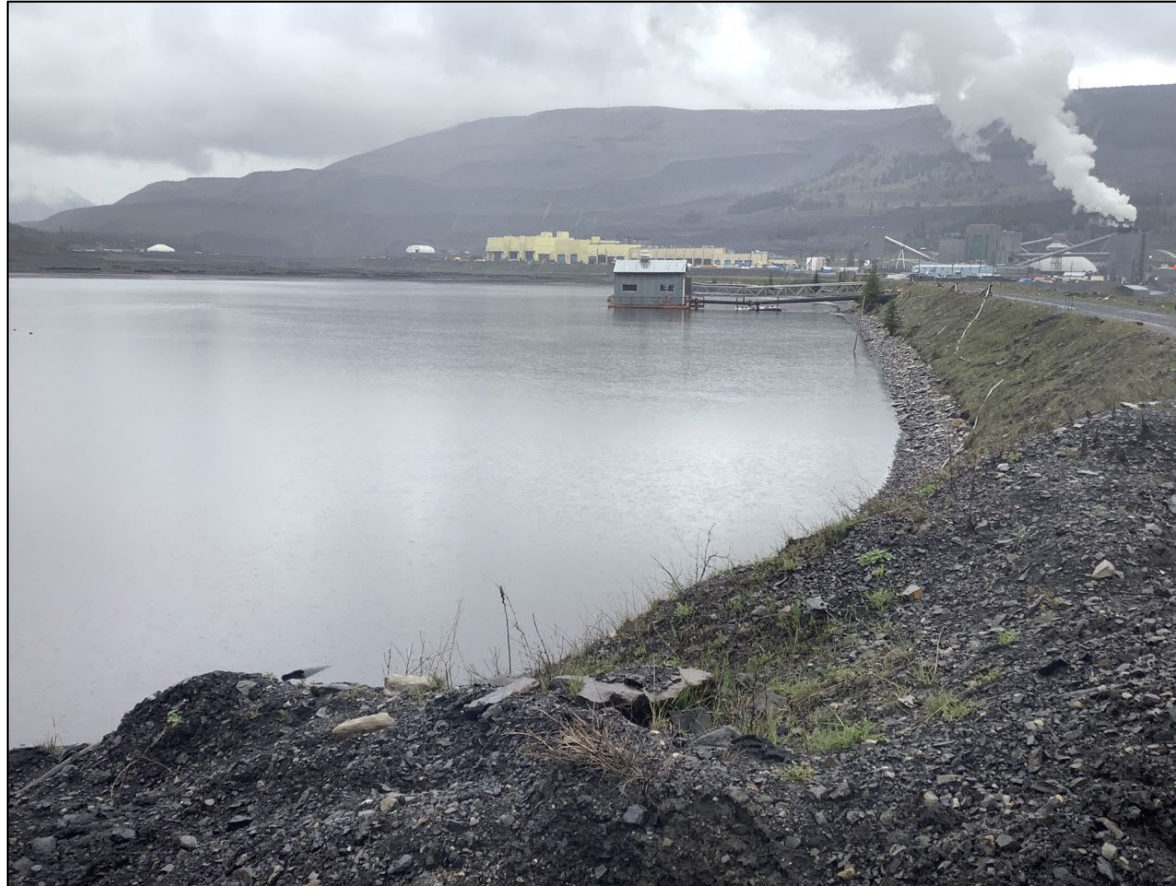
North Tailings Pond (NTP) overview of pond and upstream slope at south end, looking north from approximately Sta. 1+400.

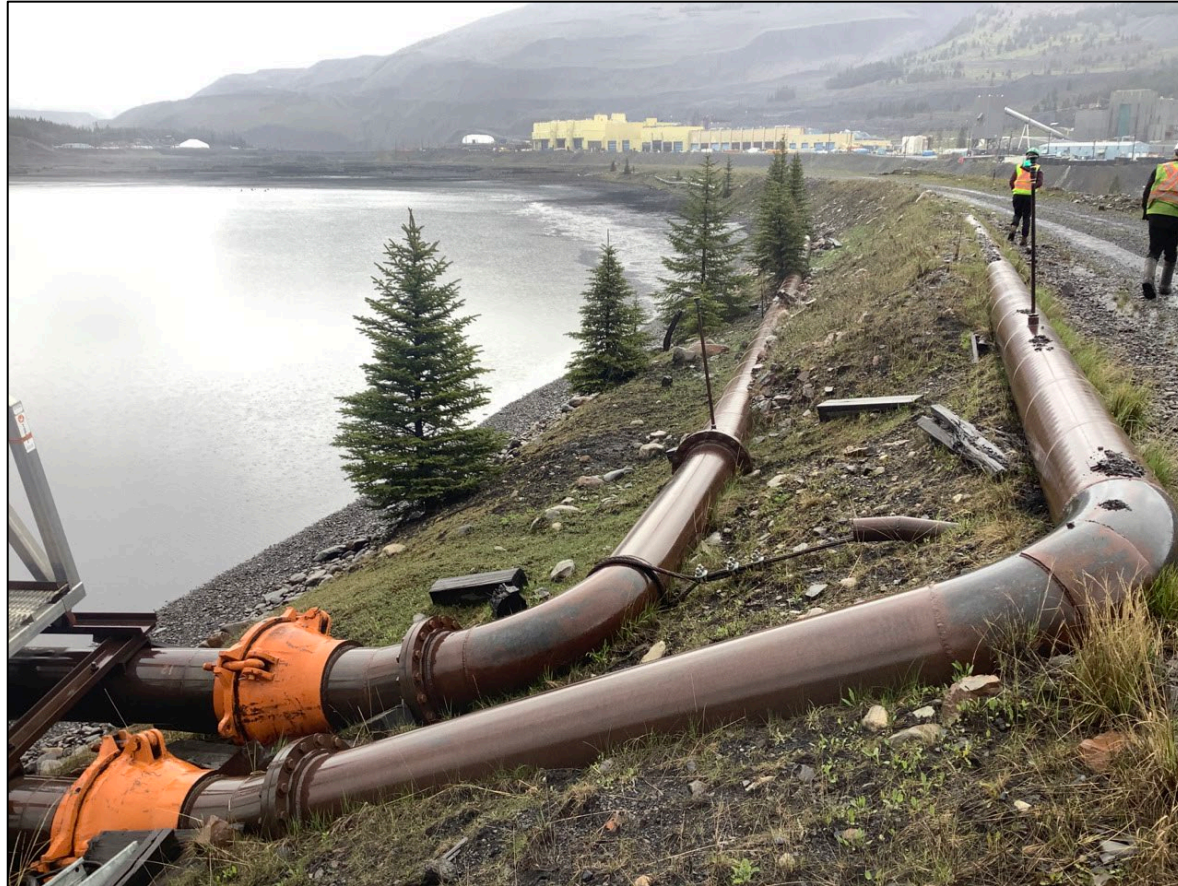
NTP Dam crest and upstream slope, looking northeast from approximately Sta. 1+275.

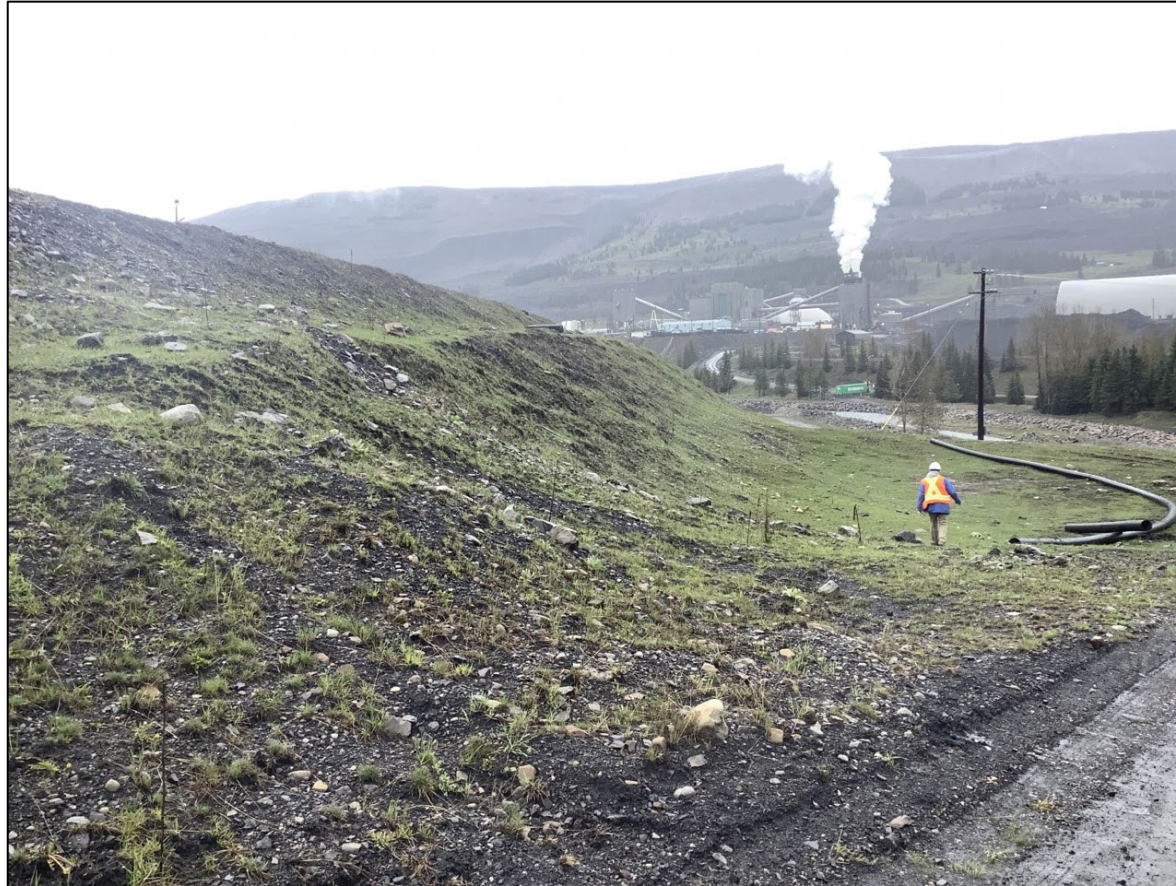
NTP Dam downstream slope, looking northeast from approximately Sta. 1+400.

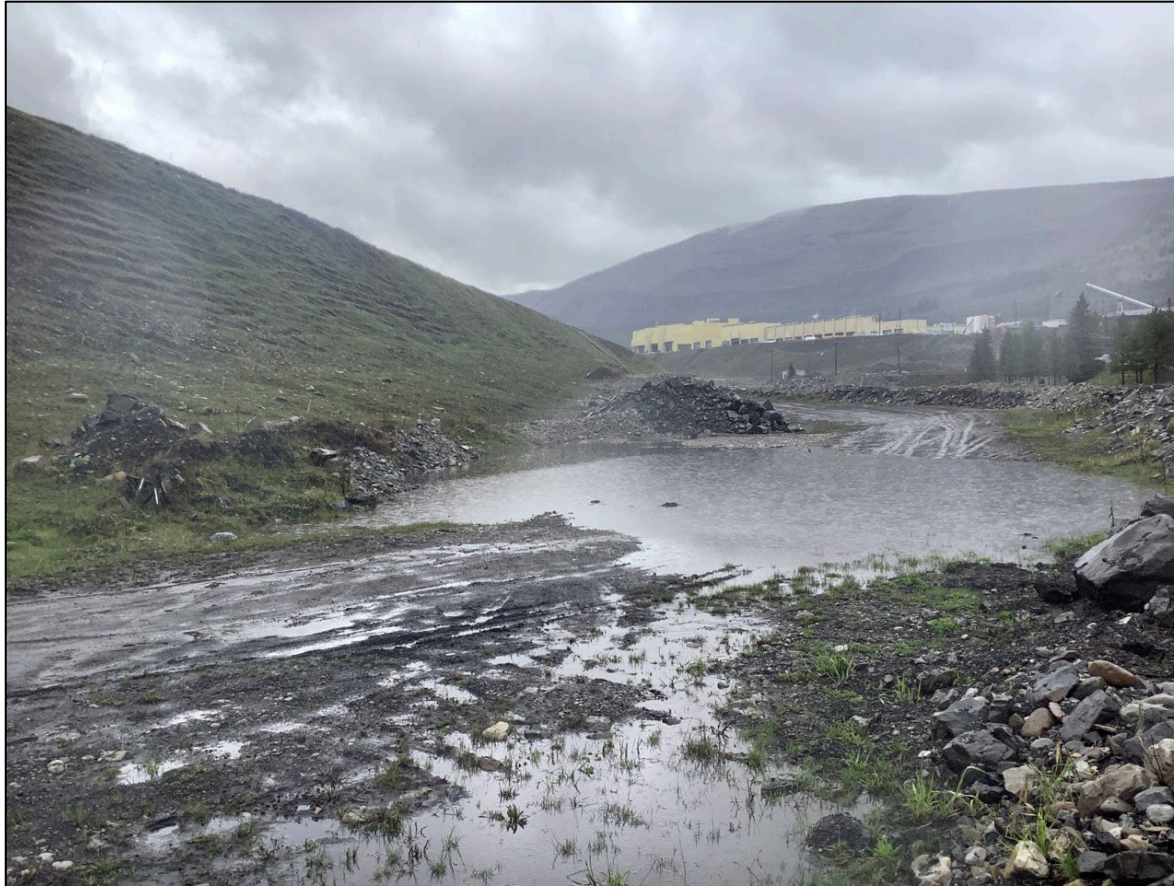
NTP Dam toe and area of ponding after rain events near at Sta. 1+250, looking northeast.

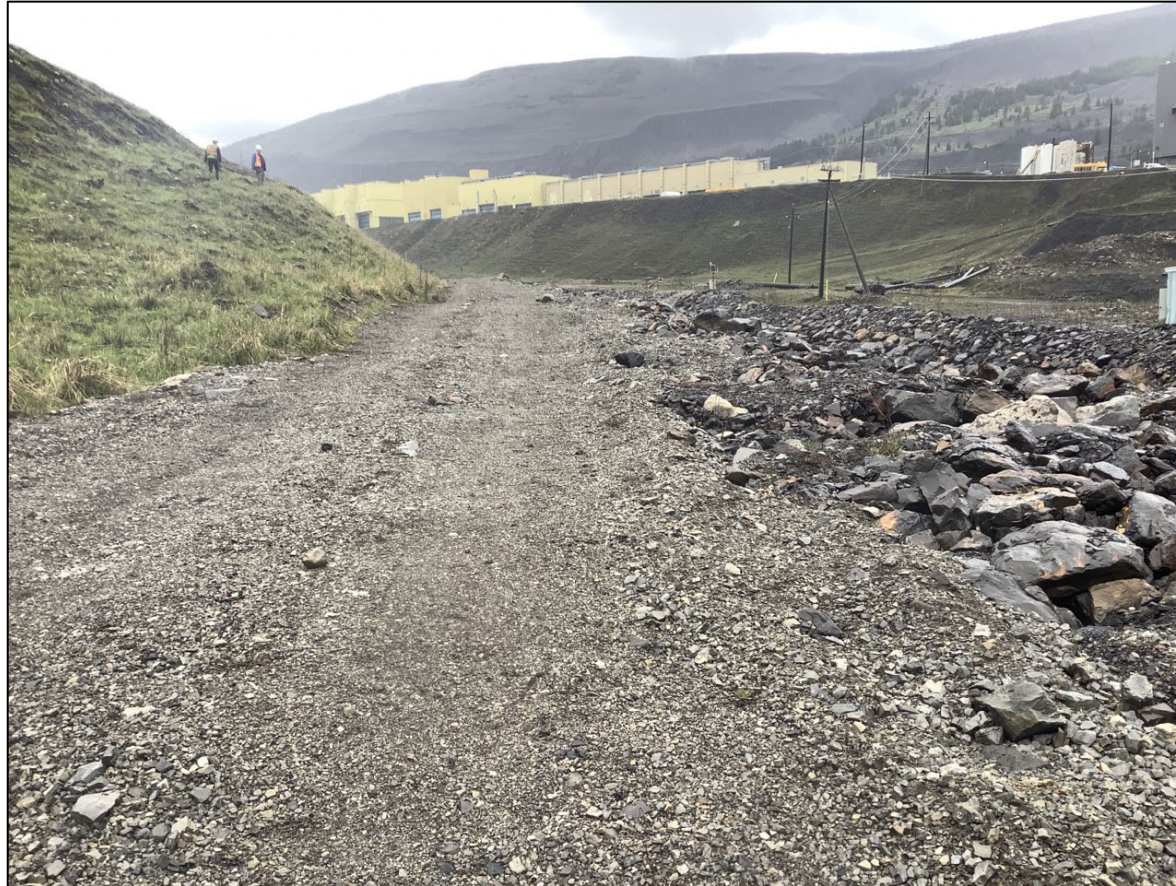
NTP Dam downstream slope and riprap along Fording River, looking northeast from approximately Sta. 0+900.
