2021 Annual Facility Performance Report for South Tailings Pond and North Tailings Pond

Teck Coal Limited, Fording River Operations

Golder Associates Ltd.

25 March 2022

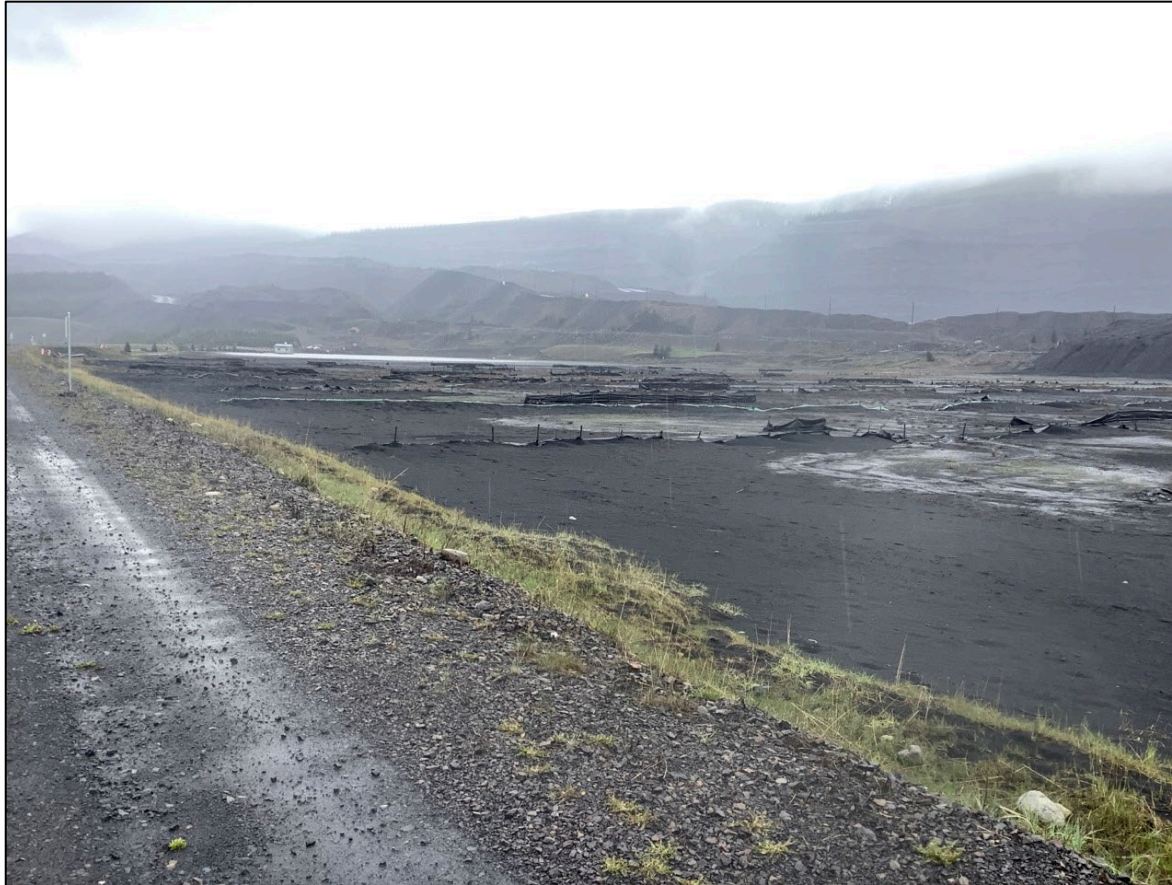
NTP Dam crest, upstream slope, and tailings surface, looking southeast from approximately Sta. 0+600.

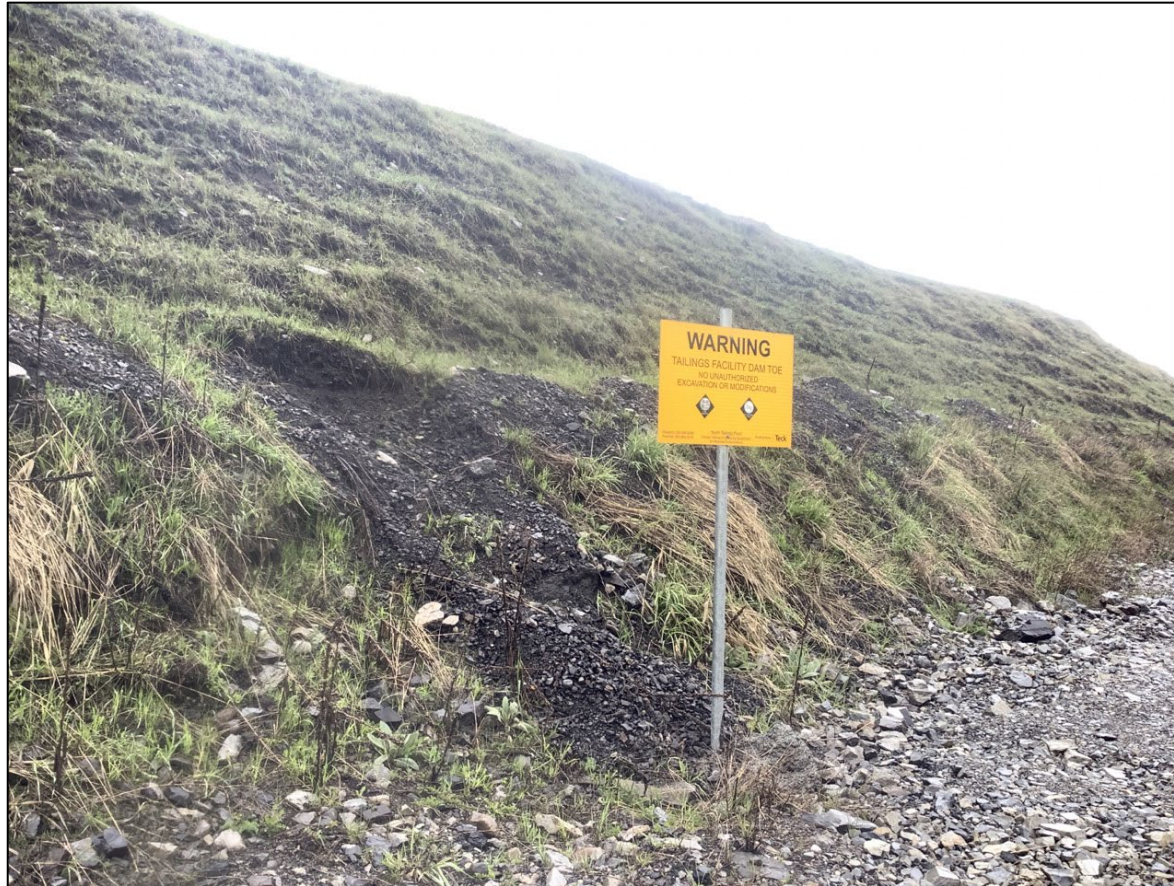
NTP downstream slope, looking northwest from approximately Sta. 0+550.

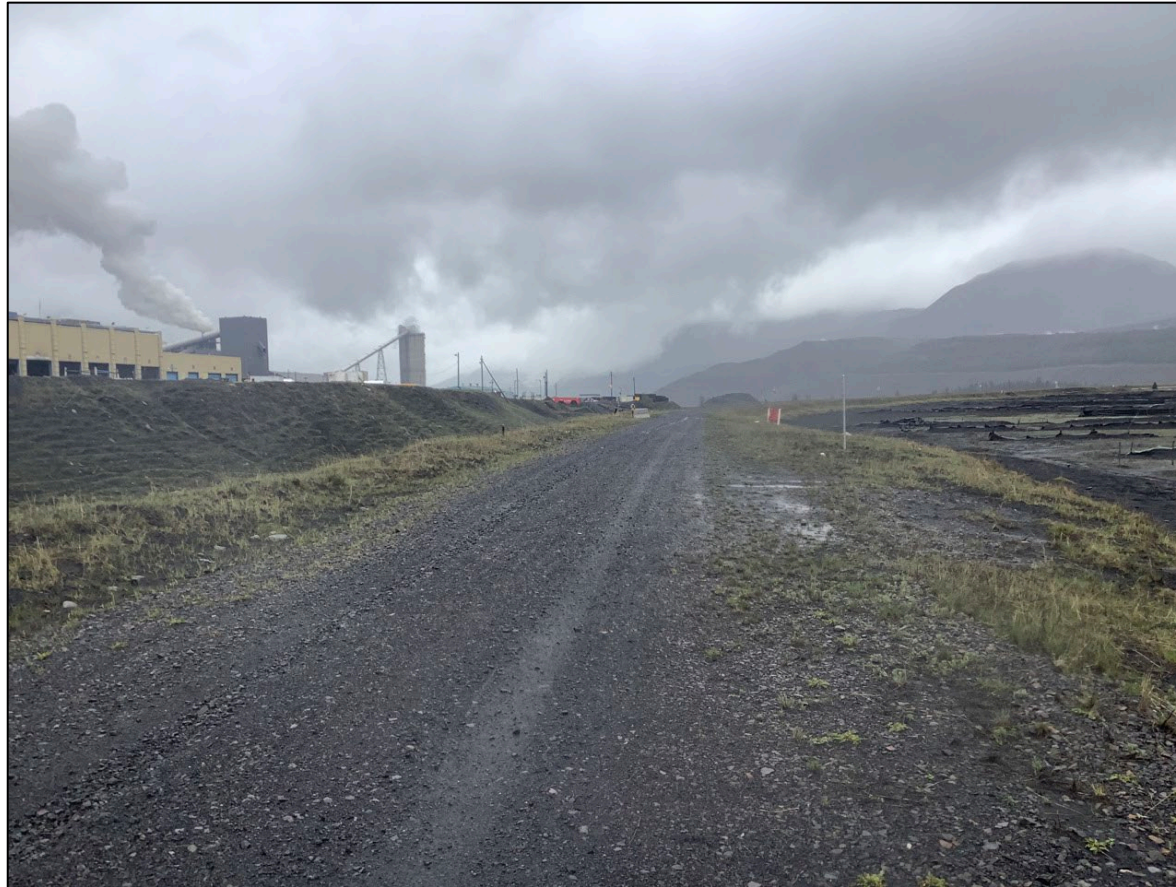
NTP Dam crest and upstream slope, looking southeast from approximately Sta. 0+500.

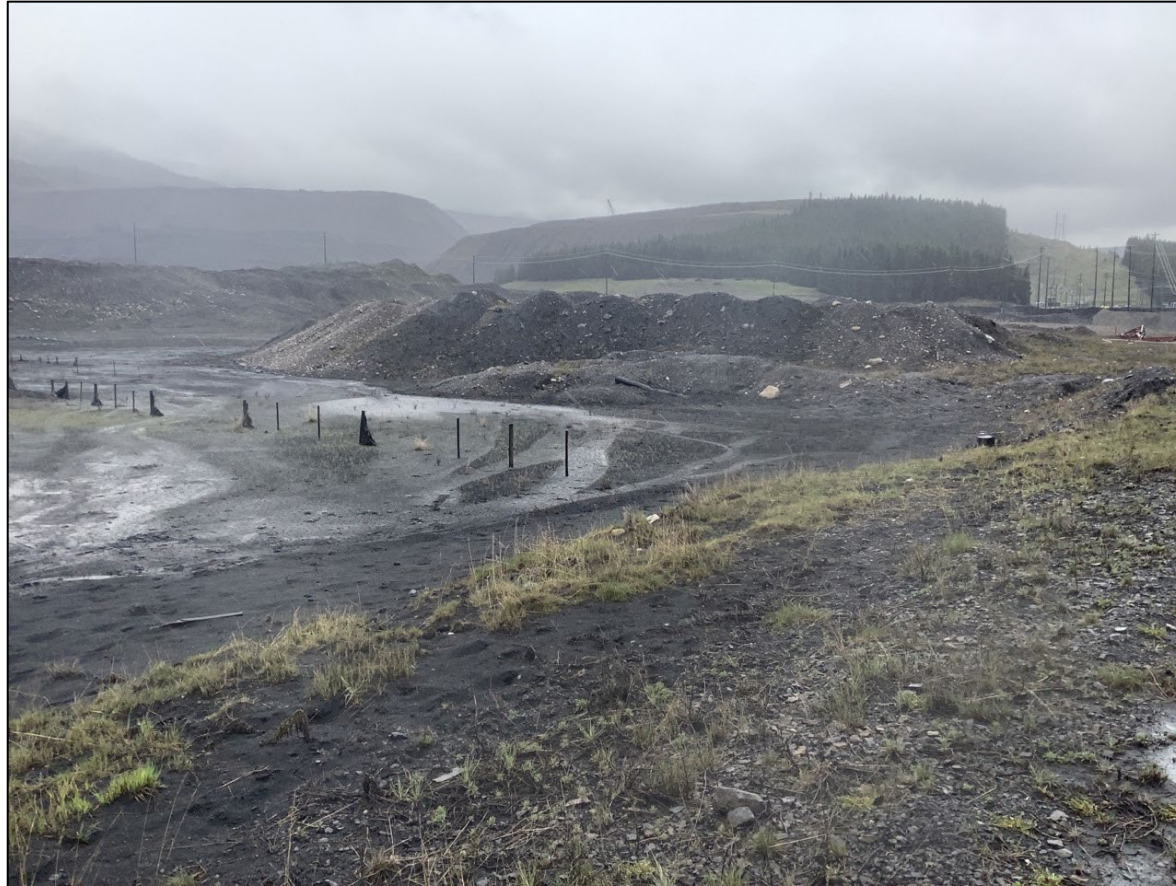
NTP upstream slope and tailings surface, looking northwest from approximately Sta. 0+350.

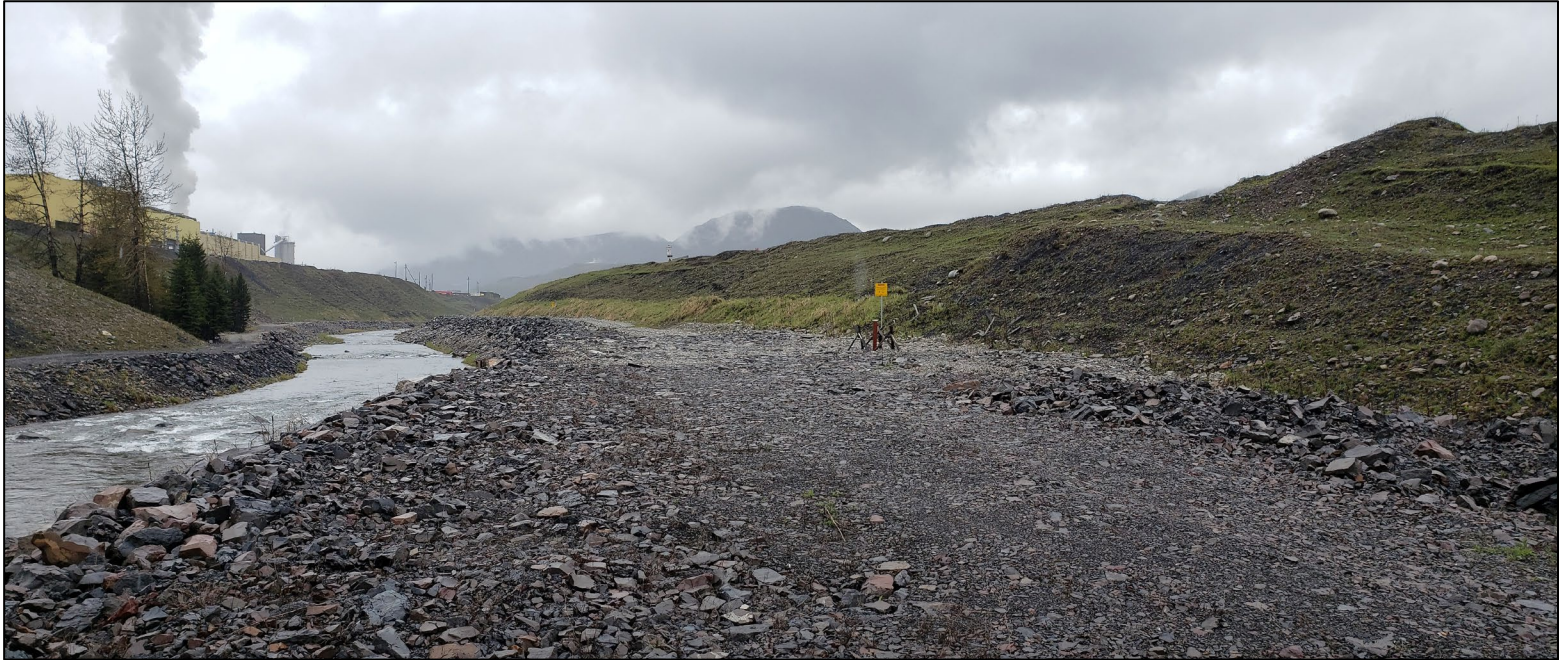
NTP downstream slope, downstream riprap, and Fording River, looking south from approximately Sta. 0+250.

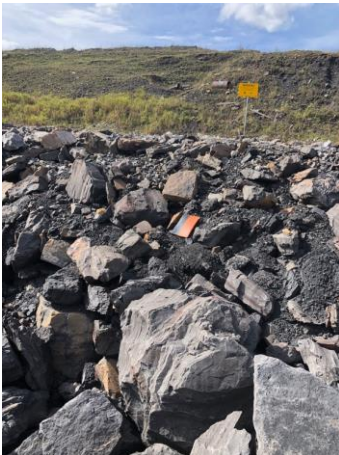
Photo 3: Riprap degradation due to weathering on several pieces of riprap along NTP (Sta. 0+225)

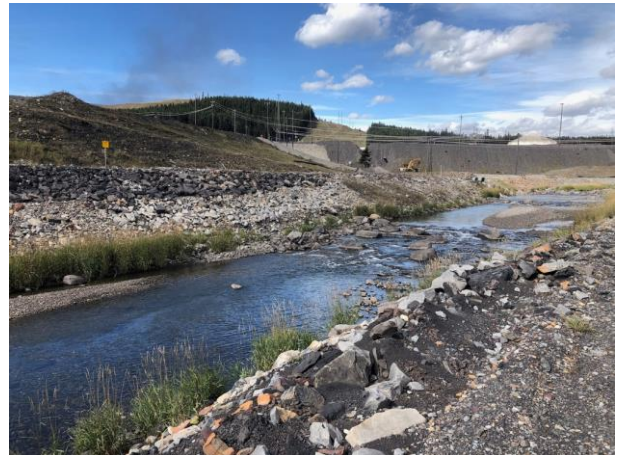
Photo 4: Looking upstream at NTP riprap (from approx. Sta. 0+250)

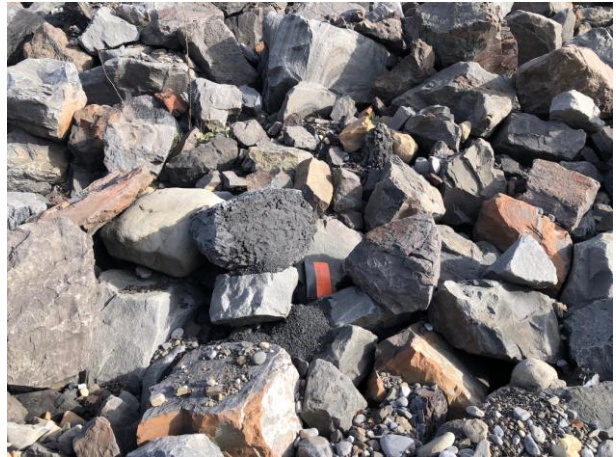
Photo 10: Riprap degradation due to weathering on several pieces of riprap

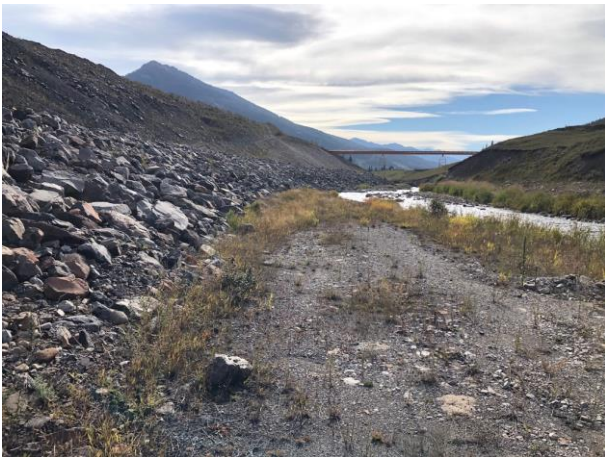
Photo 11: Looking downstream at STP riprap (from approx. Sta. 0+475)

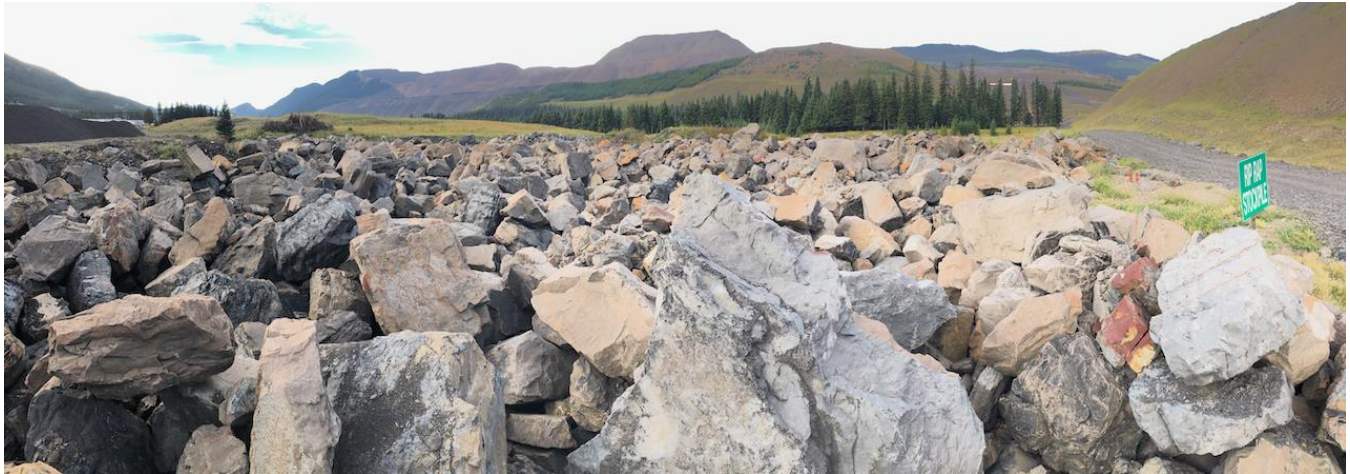
Photo 13: Emergency riprap stockpile south of STP
