2021 Annual Facility Performance Report for Turnbull Tailings Storage Facility

Teck Coal Limited, Fording River Operations

Golder Associates Ltd.

Reference No. 21456080-2021-190-R-Rev0-200

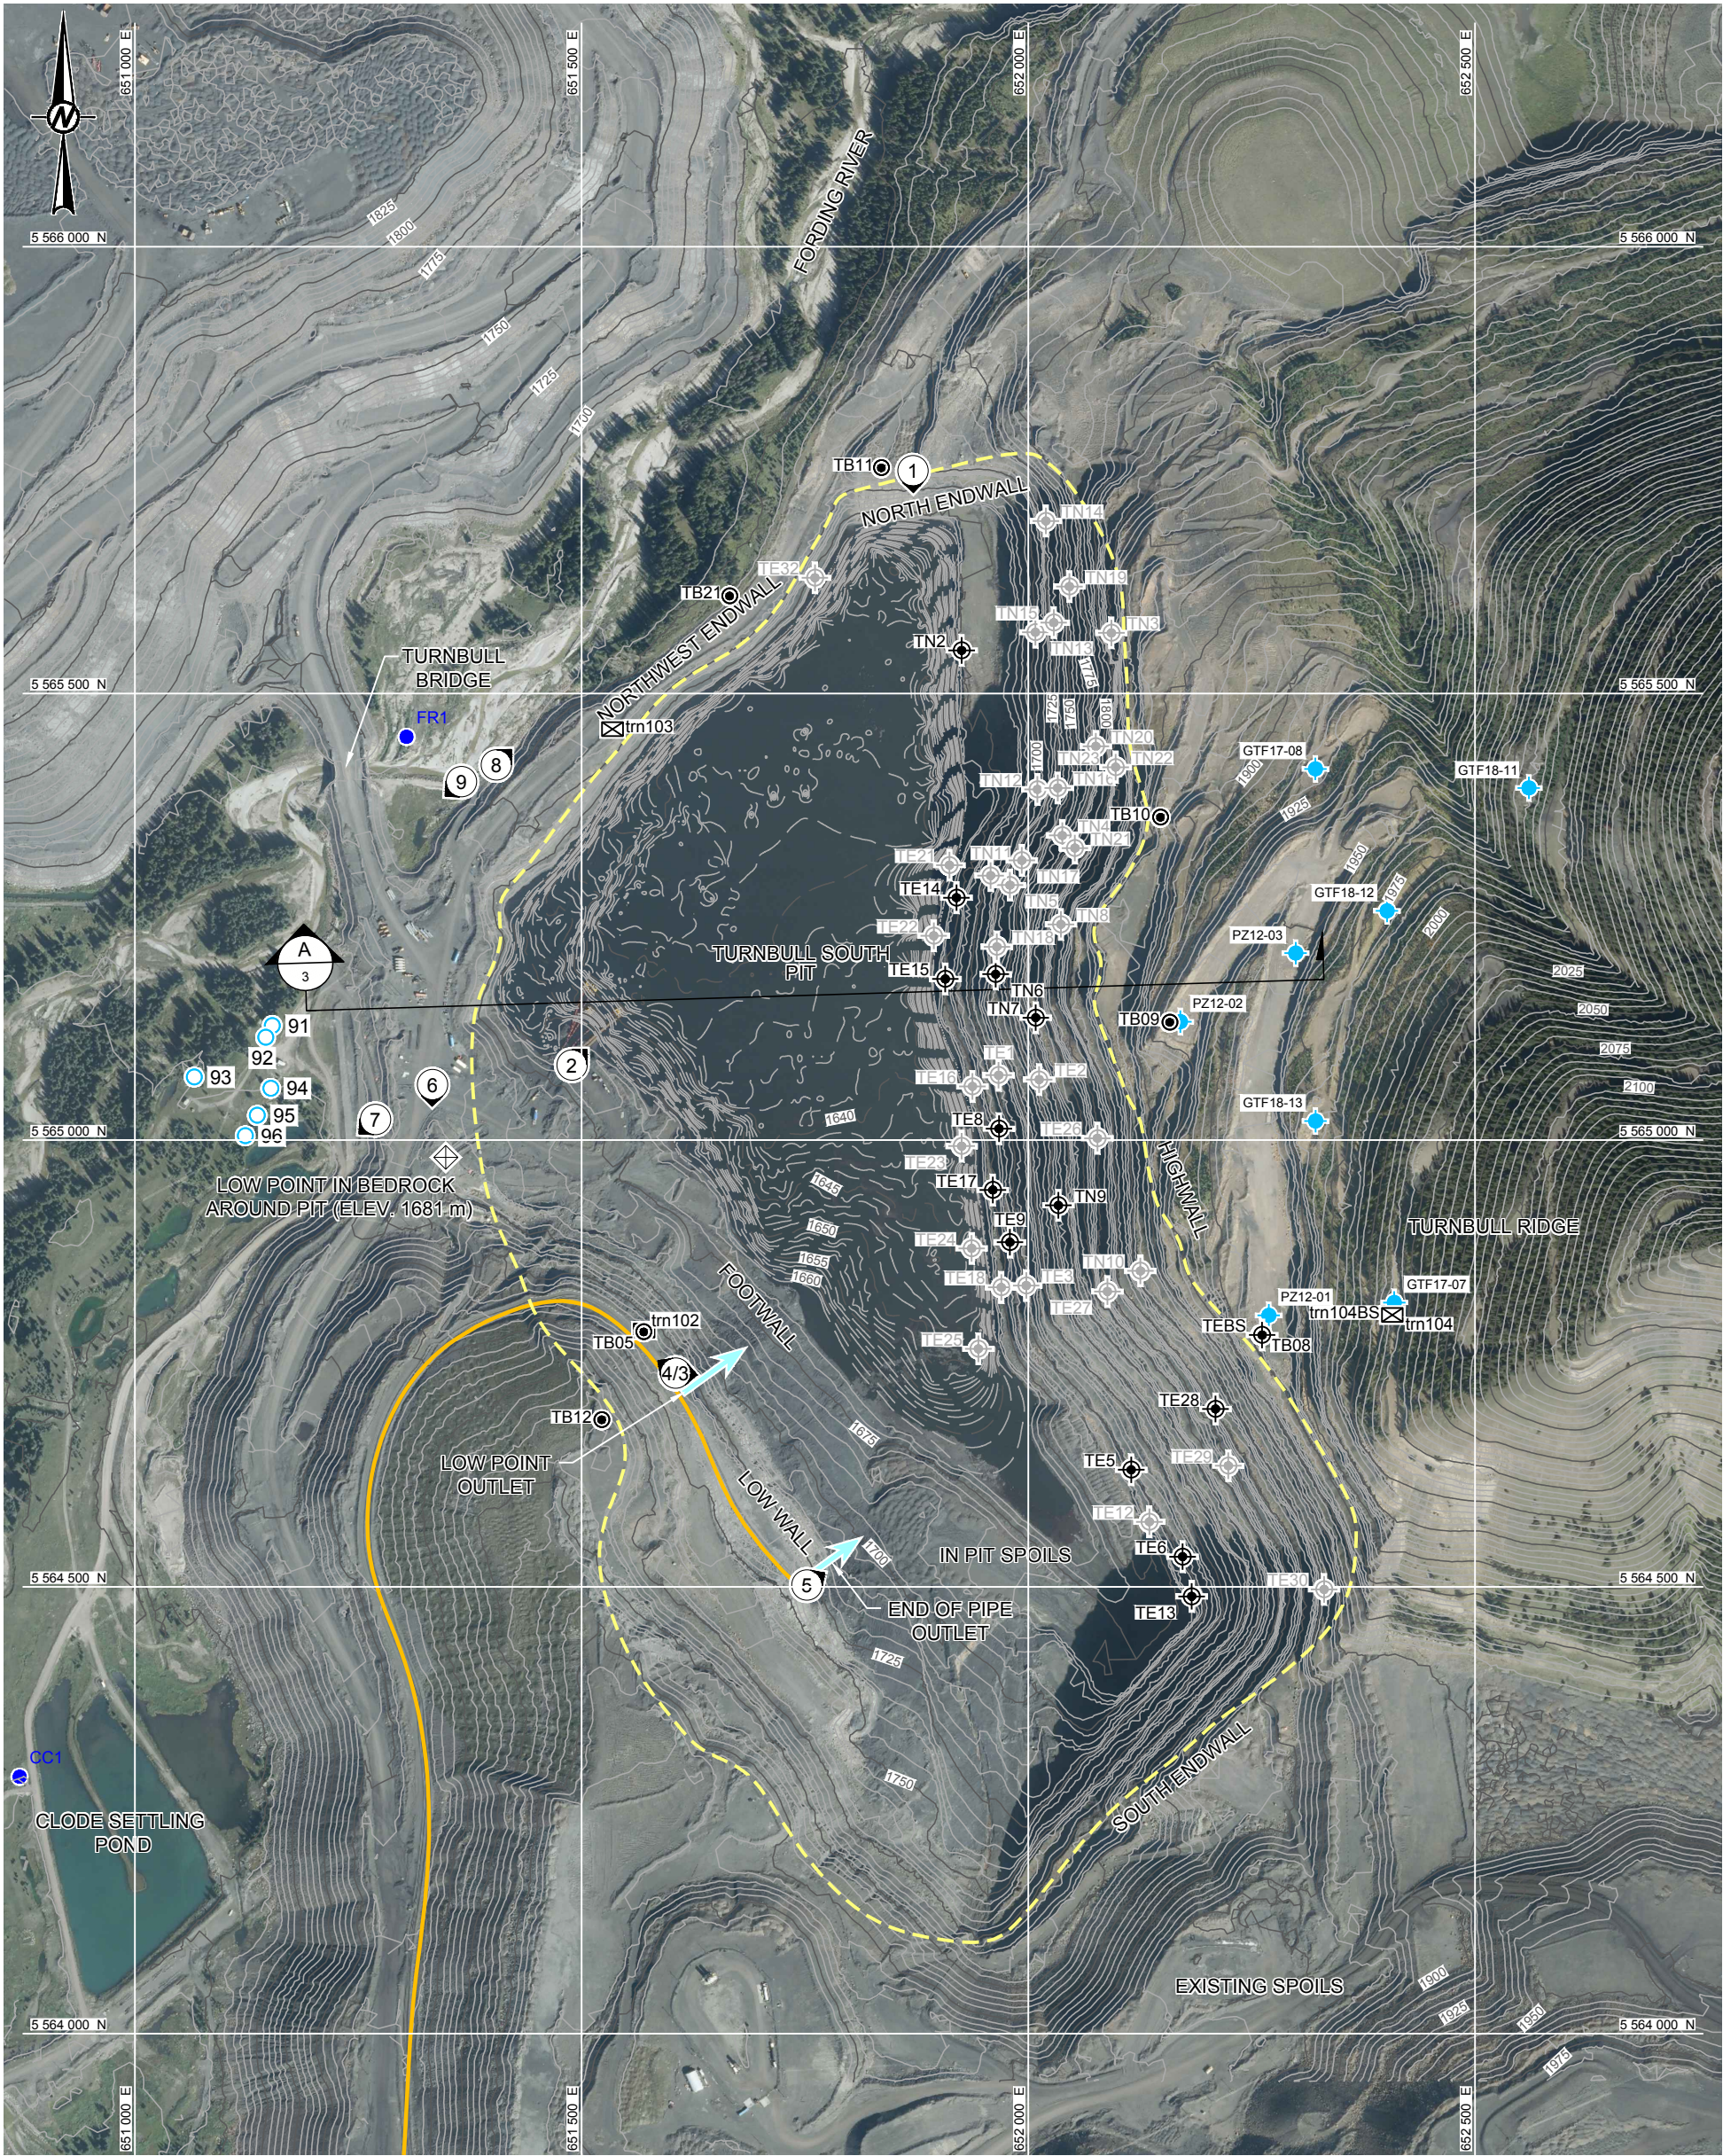
PROJECT NO.	PHASE/TASK/DOC.	REV.	FIGURE
21456080	200/207/2021-190	0	2

There are 33 prisms that did not have location data collected over the past year and they are shown in grey in Figure 2. Prisms along the lower portions of the highwall will become inactive as the TSF pond elevation rises. Although prism coverage has improved since 2019 with the new prisms, it is recommended that additional prisms be installed along the crest of the highwall, to monitor potential overall slope instability (Golder 2022). The areas of recommended additional coverage are marked in Figure 4 in (Golder 2022).

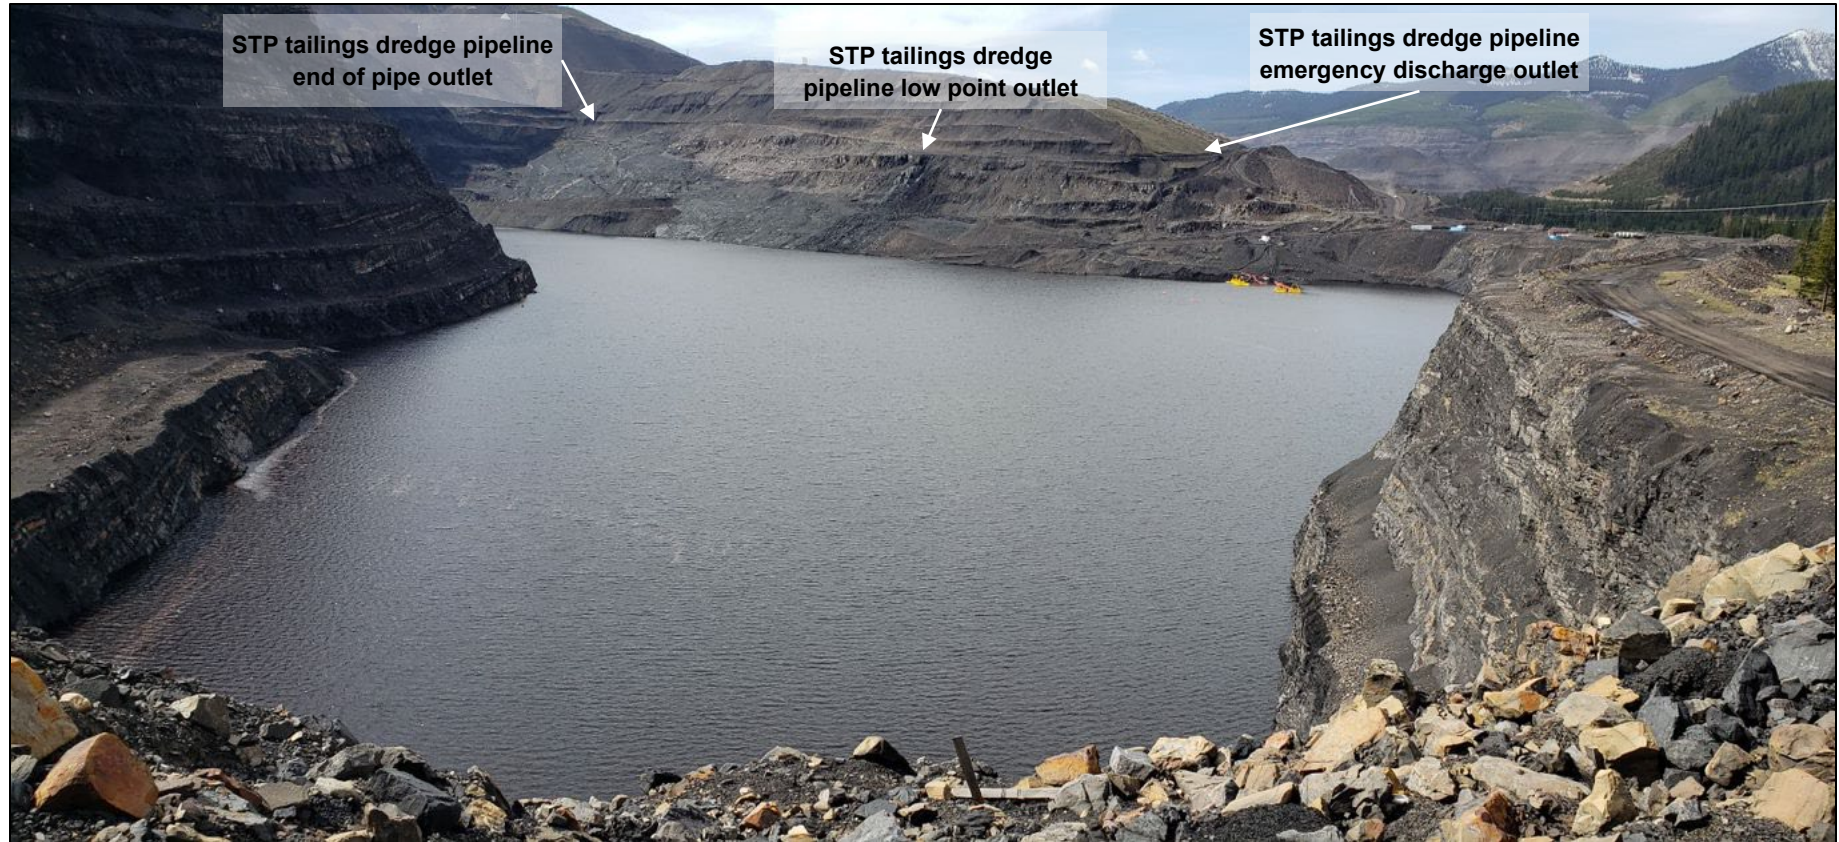
PHOTOGRAPH A-1

Turnbull TSF overview from north endwall, looking south.

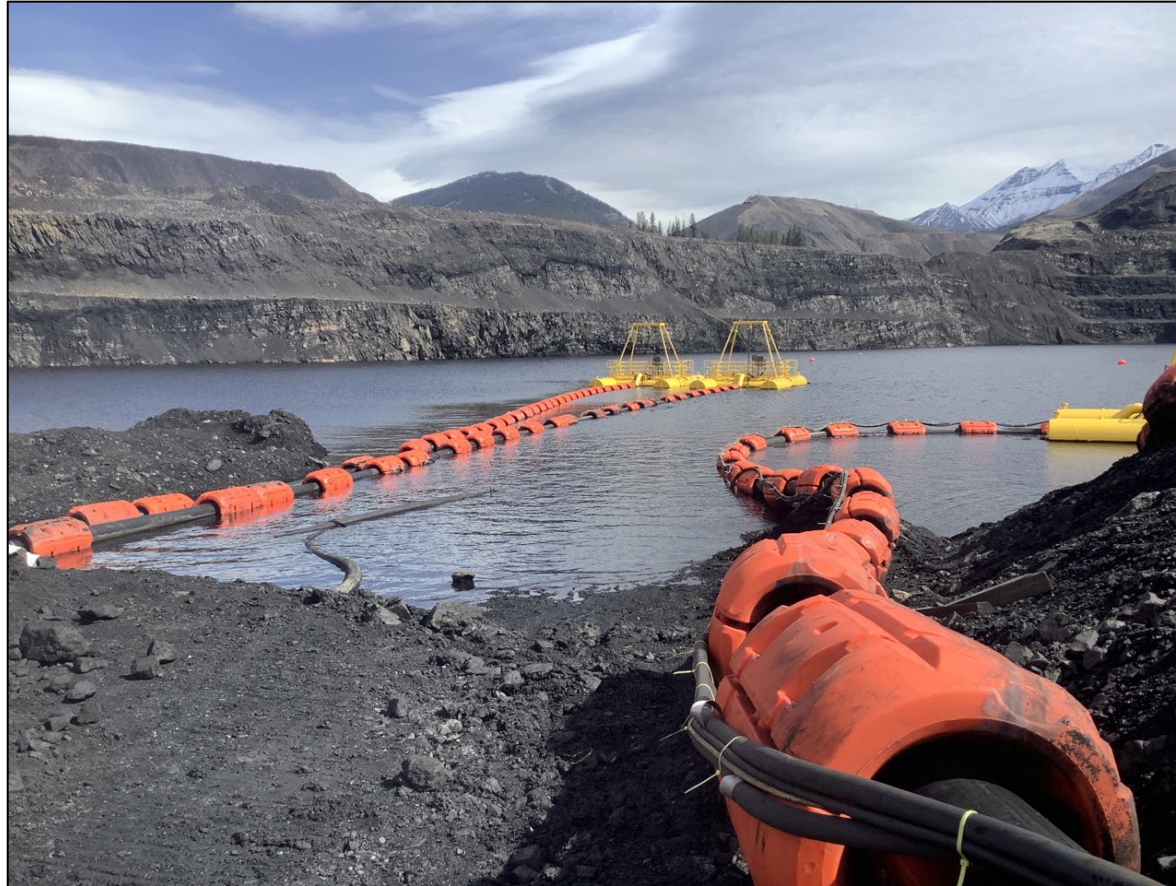
PHOTOGRAPH A-2

Turnbull TFS Pond, reclaim water intakes and pipelines, looking northeast.

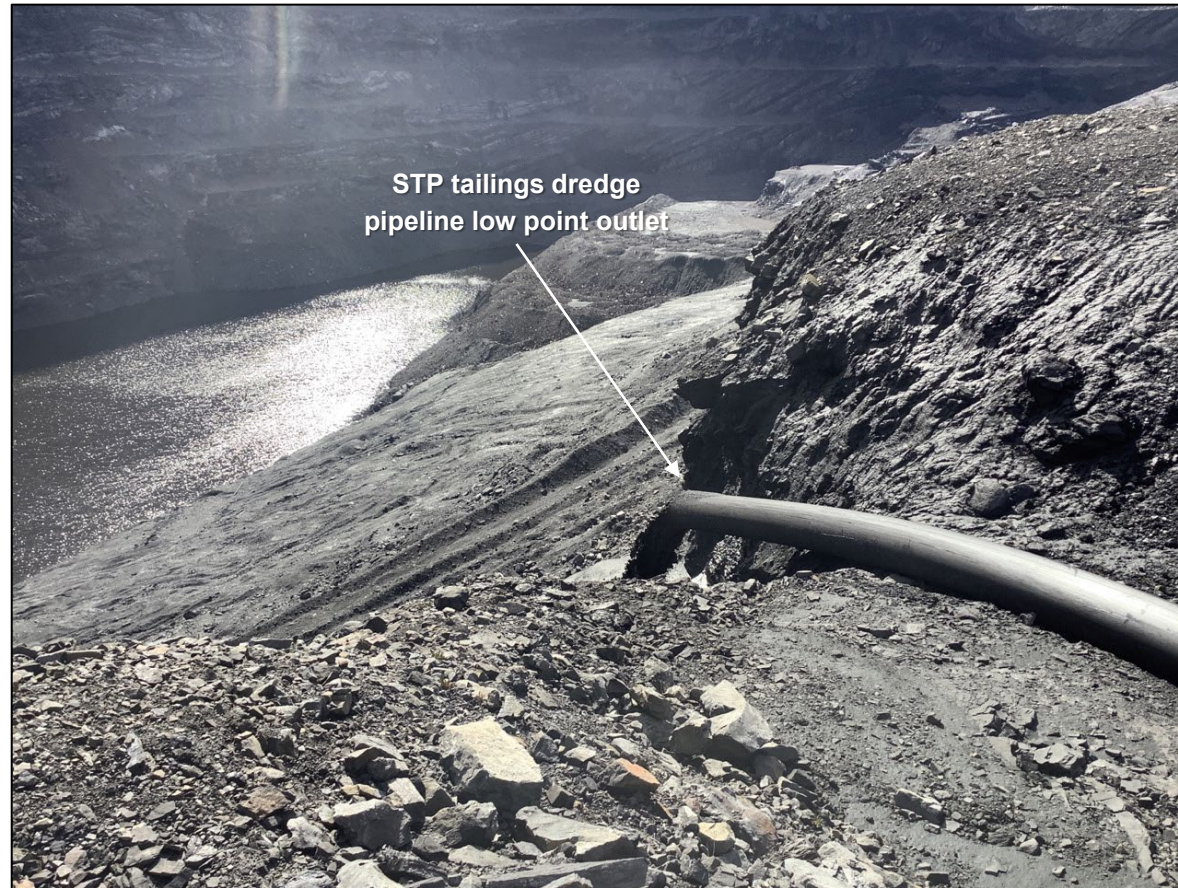
PHOTOGRAPH A-3

Discharge of Tailings from South Tailings Pond at the Tailings dredge pipeline low point outlet, looking east.

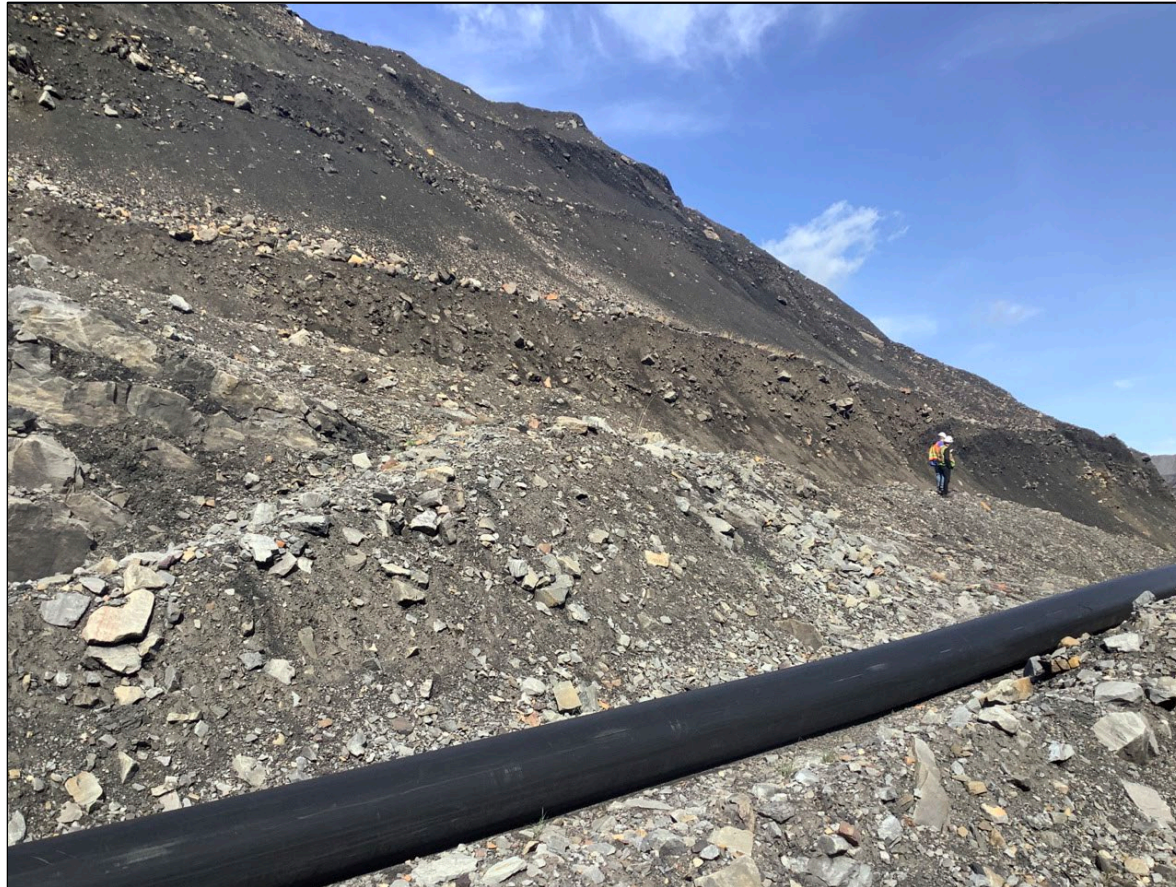
PHOTOGRAPH A-4

This failure mode is managed by routine inspections of the pipeline by the dredging contractor during active dredging. During the 2021 site inspection by the EoR, debris was observed to be collecting between the tailings dredging pipeline berm and the spoils over the low wall in an area within the TSF. No leakage from this pipeline was observed during the reporting period. The debris is to be cleaned out such that the berm could catch ravelling rocks from the waste rock slope above the pipeline (recommended action 2020-01 in Table 11).

Turnbull TSF waste rock benched slope above tailings pipeline on low wall, looking northwest.

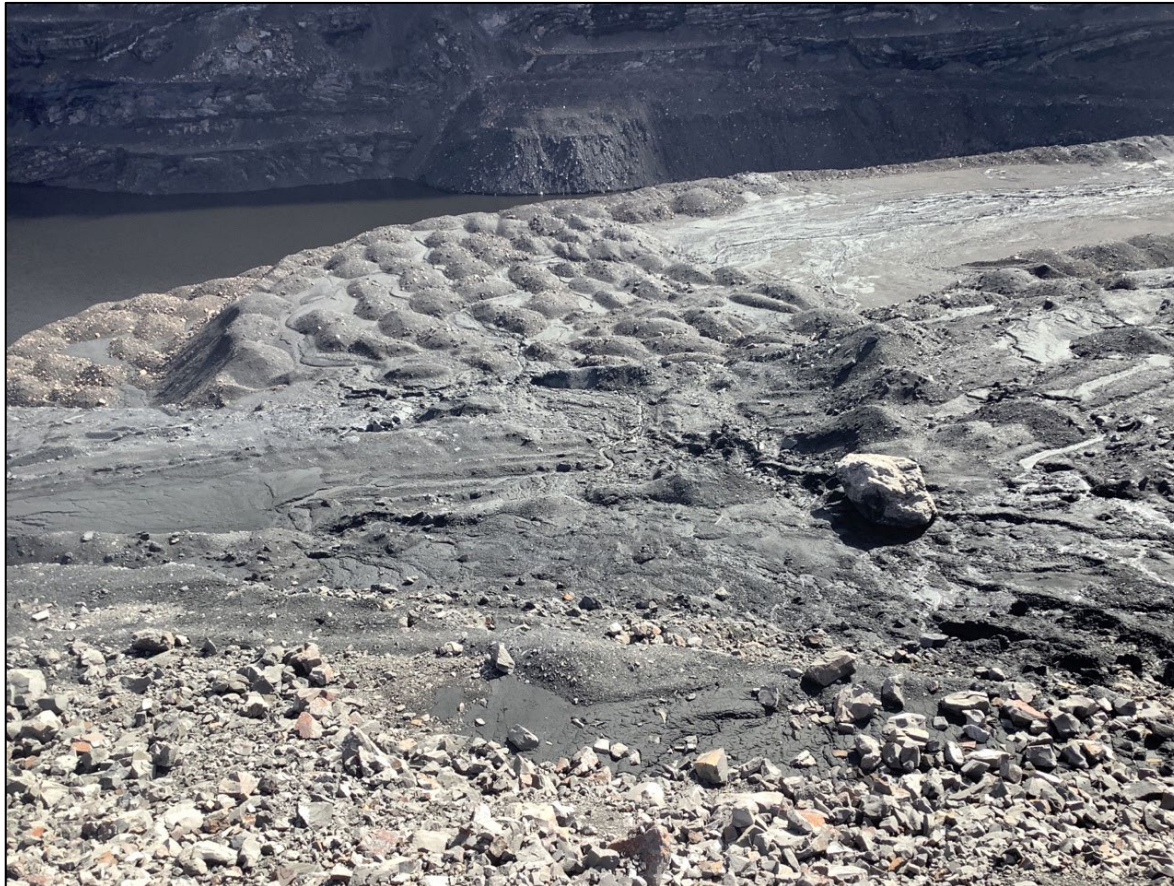
PHOTOGRAPH A-5

In pit spoils below the tailings pipeline low point outlet discharge, looking east.

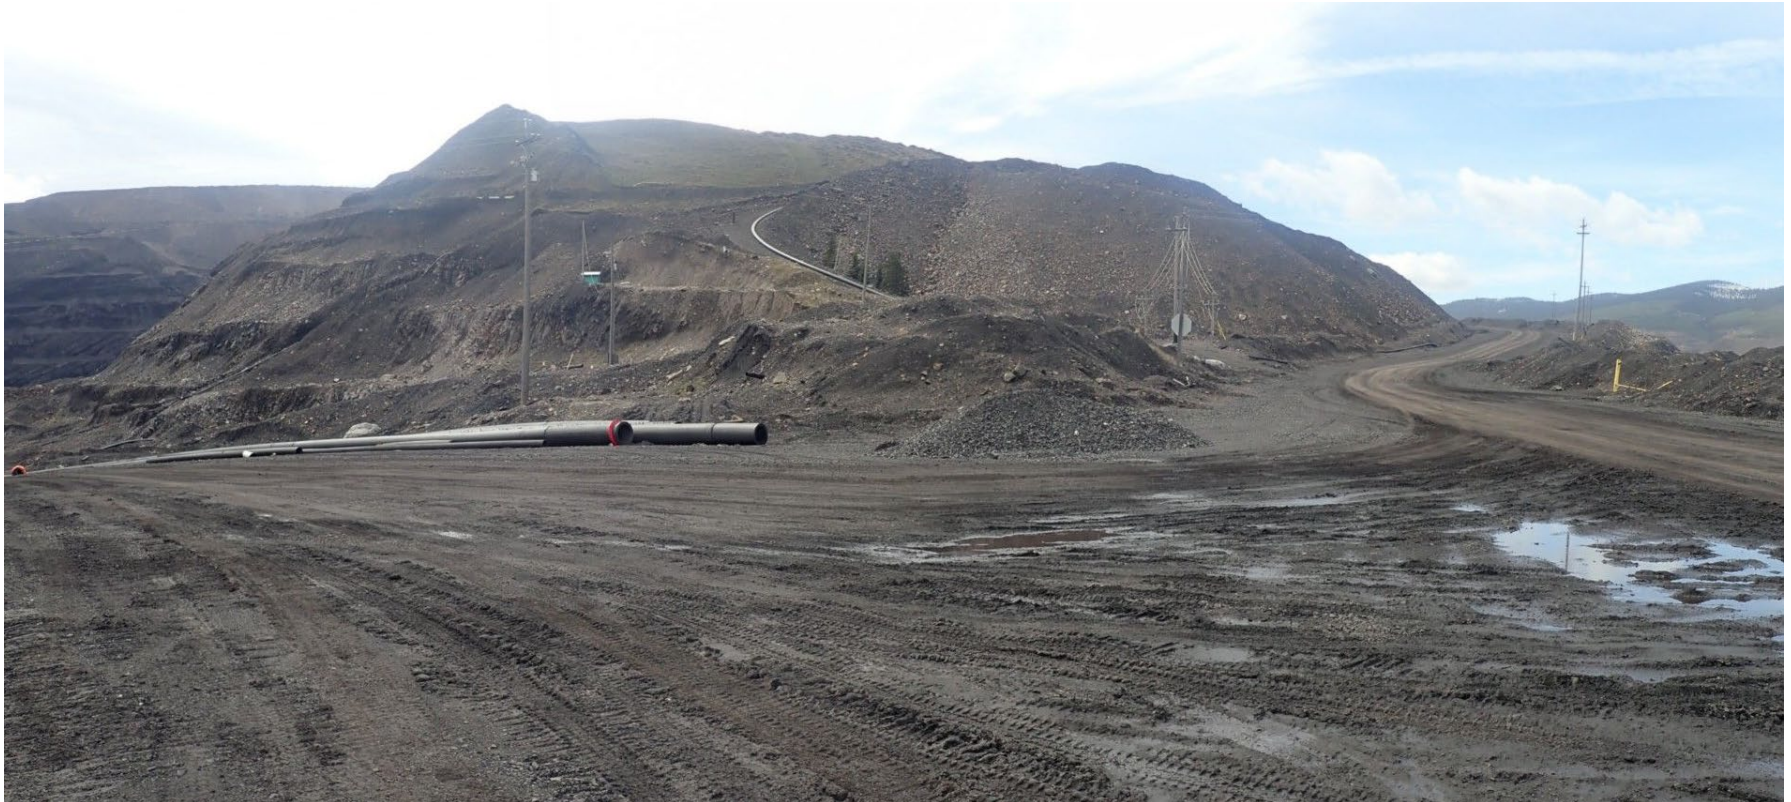
PHOTOGRAPH A-6

Backfill waste rock fill and haul road which is the topographic low point (saddle area) of Turnbull TSF, looking south.

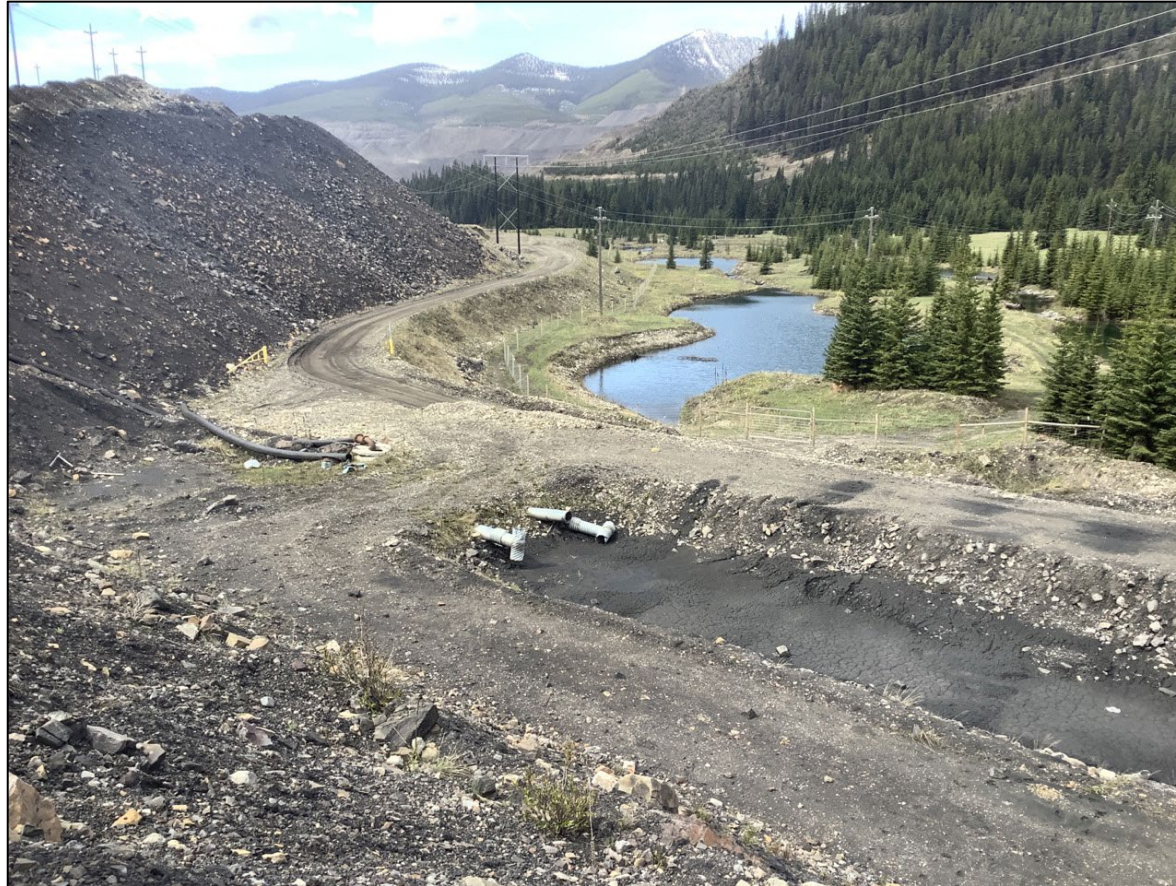
PHOTOGRAPH A-7

Turnbull TSF view of the downstream slope of low point area waste rock fill and haul road, looking southwest.

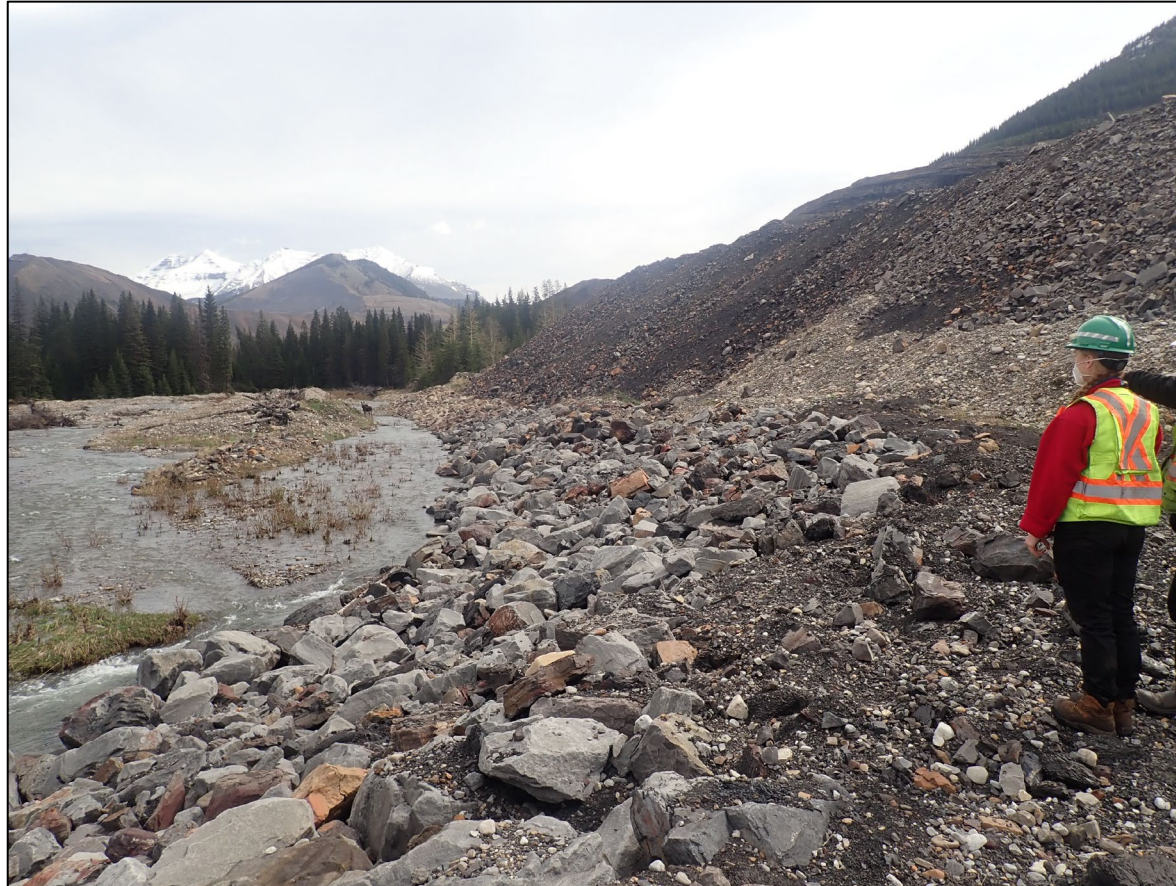
PHOTOGRAPH A-8

Turnbull TSF view of downstream slope toe of low point area waste rock fill and Fording River, looking Northeast.

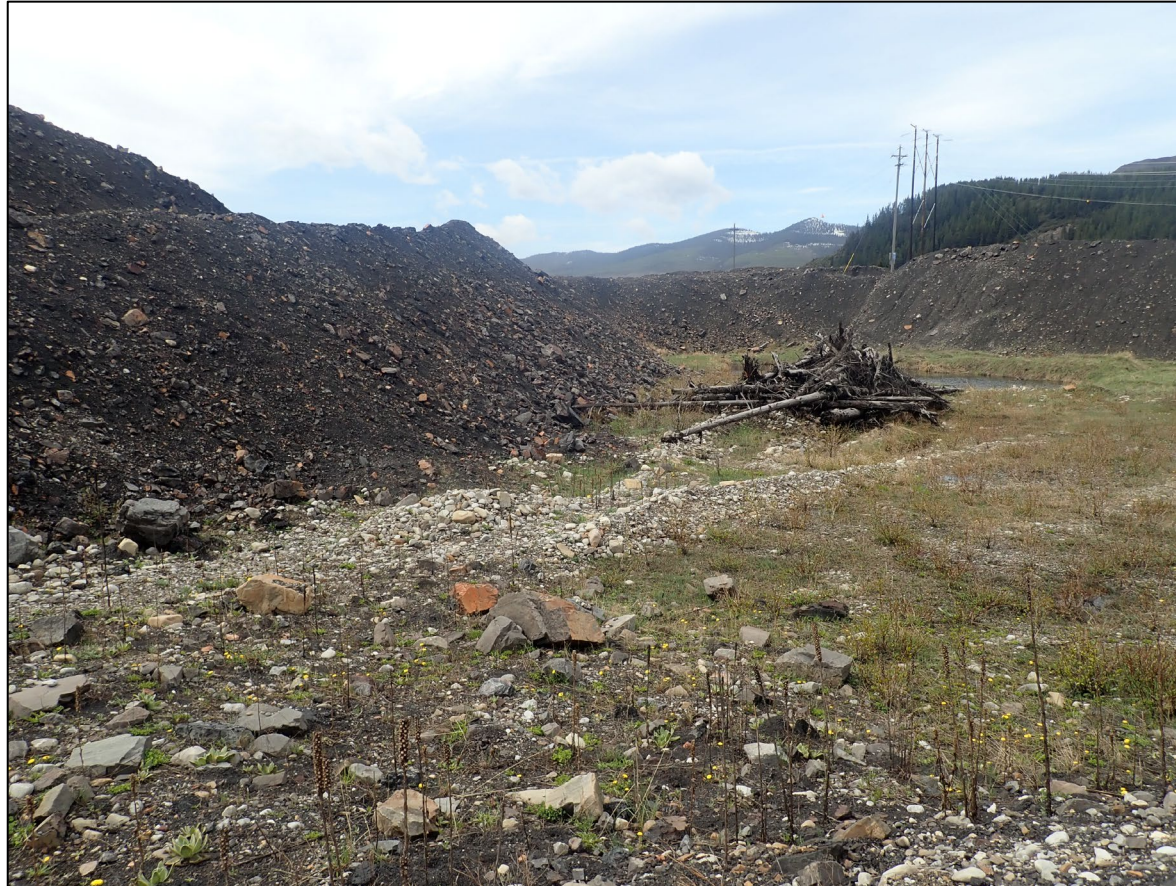
PHOTOGRAPH A-9

Turnbull TSF view of downstream slope toe of low point area waste rock fill, looking southwest.
