# 2021 Annual Facility Performance Report for 2 Pit and 3 Pit Tailings Storage Area

*Teck Coal Limited, Fording River Operations*

Reference No. 21456080-2021-191-R-Rev0-200

23 March 2022

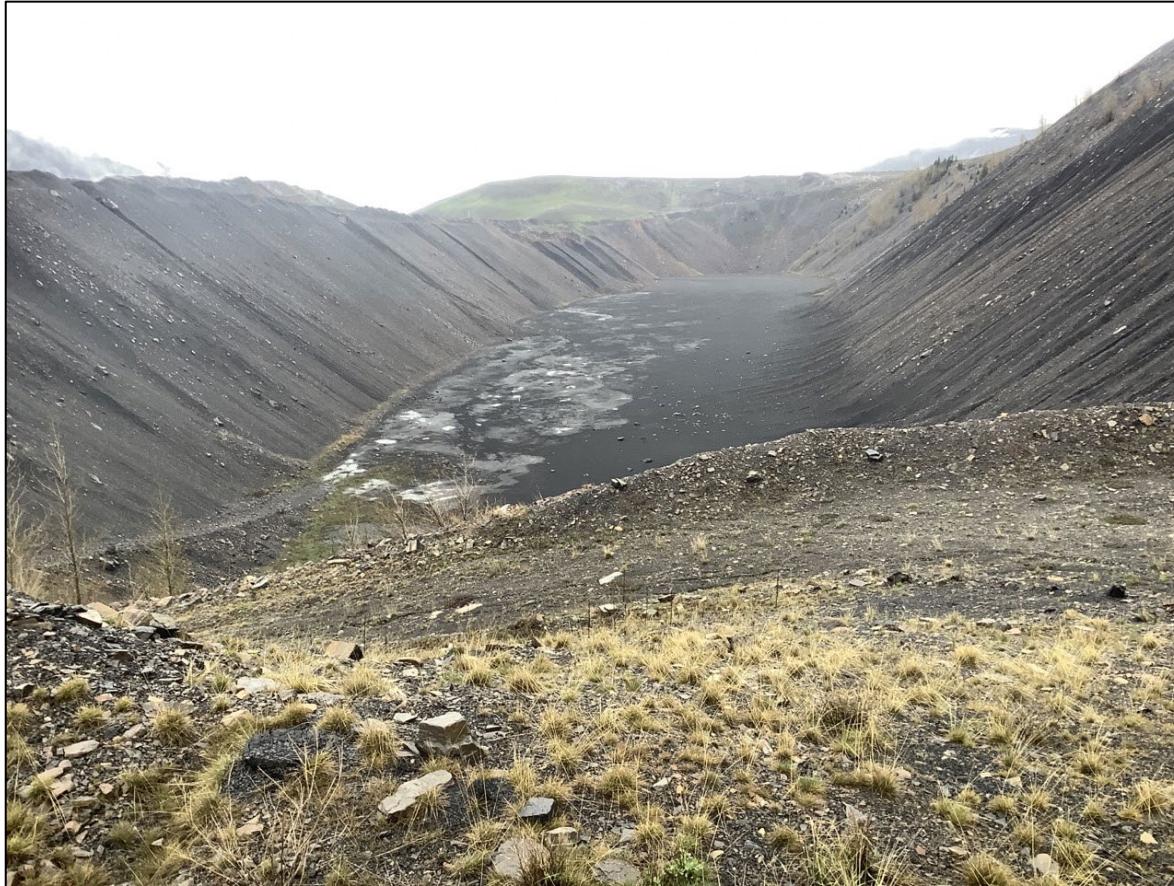
## PHOTOGRAPH A-1

2 Pit Overview, Looking Southeast

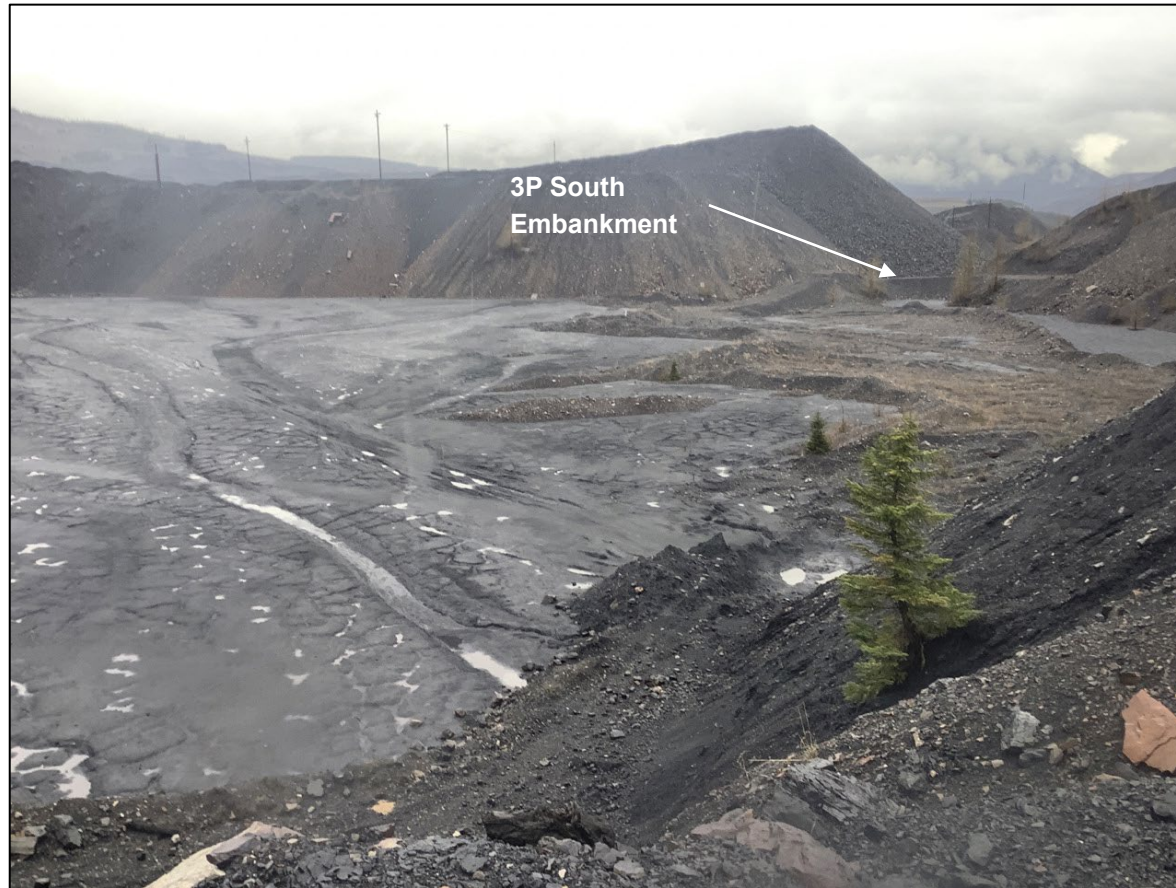
### PHOTOGRAPH A-2

3 Pit South Overview, Looking North

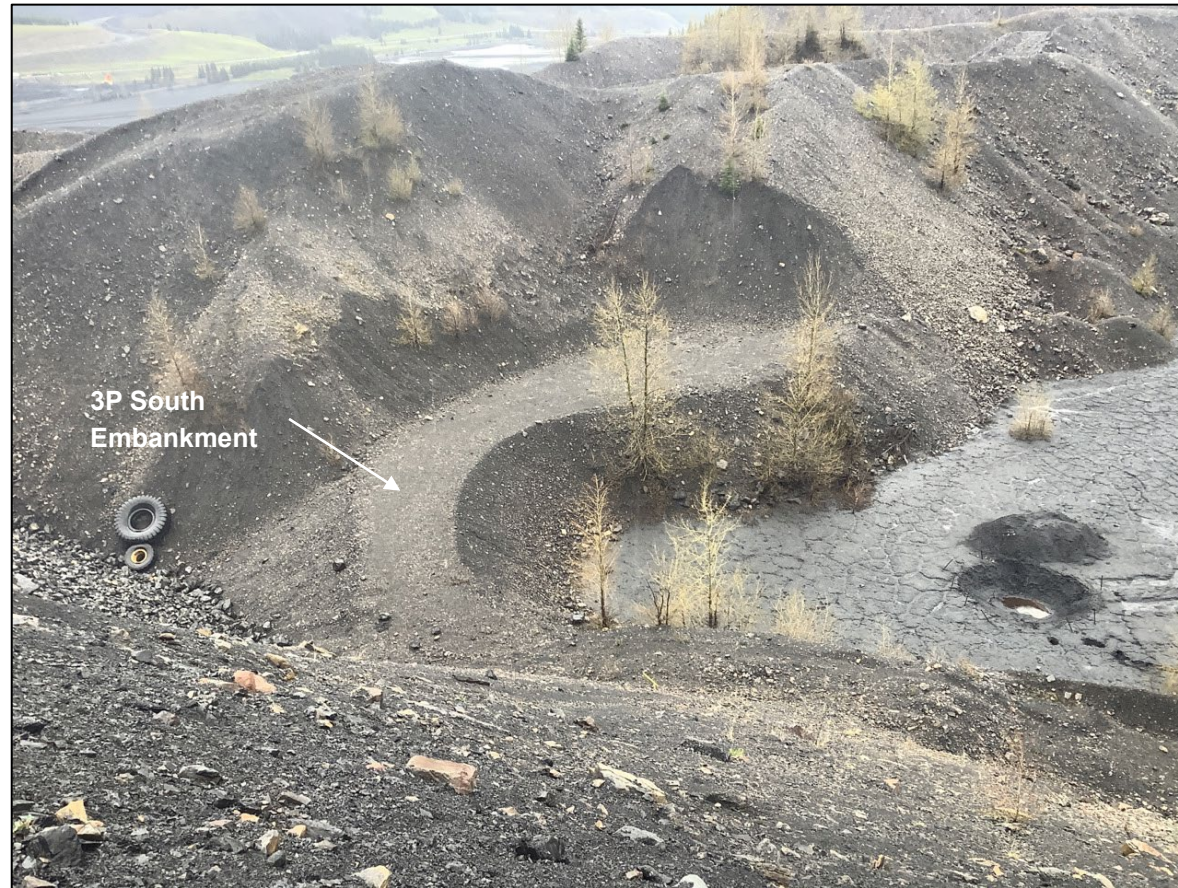
### PHOTOGRAPH A-3

During the 25 May 2021 inspection, dry tailings were noted (Photo A-3 in Appendix A) in the 3PS observation pit, which was dug in 2016. Ponding water was noted at the base of the pit from rain and surface runoff during the inspection. The 3PS water elevation was noted as having no water or being dry on the FRO monthly inspection sheets throughout the reporting period.

3 Pit South Desiccated Tailings Surface and Moist Conditions (from Rain) Observed in Test Pit Upstream of 3 Pit South Embankment, 3 Pit South Embankment Crest, Upstream, and Downstream Slope, Looking Southeast

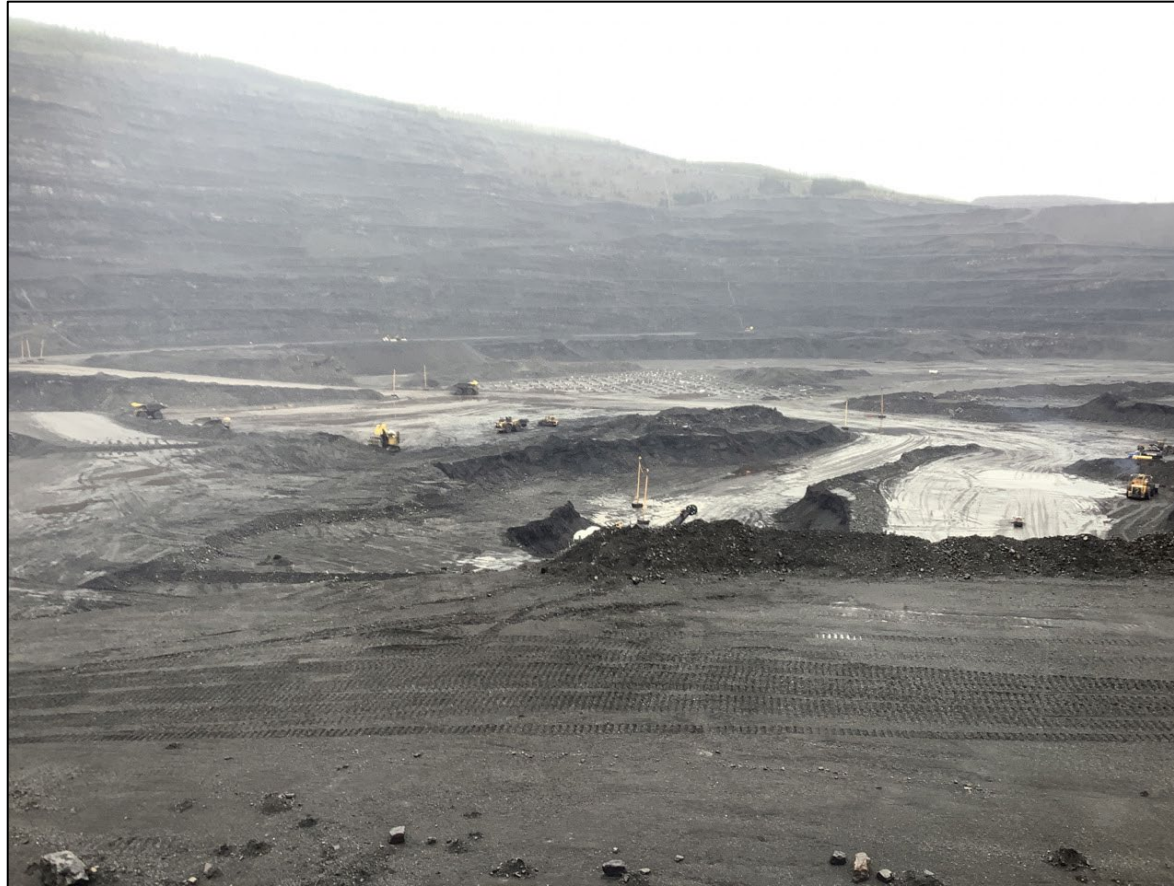
### PHOTOGRAPH A-4

3 Pit North and Swift Pit Mining Overview Including Mining out of Tailings and Tailings Mixed with Waste Rock, Looking Northwest

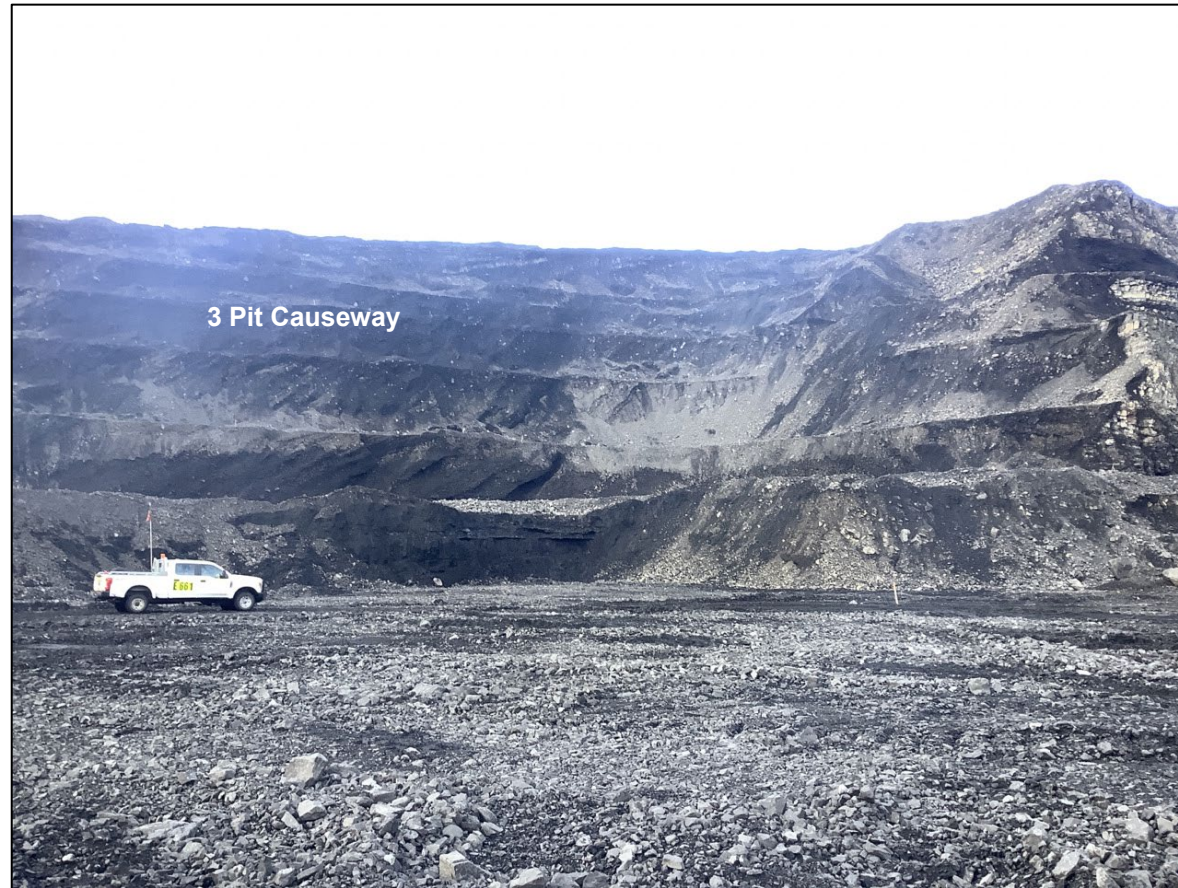
### PHOTOGRAPH A-5

Working Surface of the Tailings Excavation in 3 Pit North. Tailing and Tailings Mixed with Waste Rock are Being Mined Out Below the 3 Pit Causeway, Looking Southeast

Regular inspections of the 3 Pit Causeway and review of piezometric conditions relative to triggers established in the analyses carried out by FRO (FRO 2021), should continue to support Swift Pit mining operations in this area and be documented for the 2P-3P TSA.
