2021 Annual Facility Performance Report

Coarse Coal Refuse Facilities

Teck Coal Limited

Golder Associates Ltd.

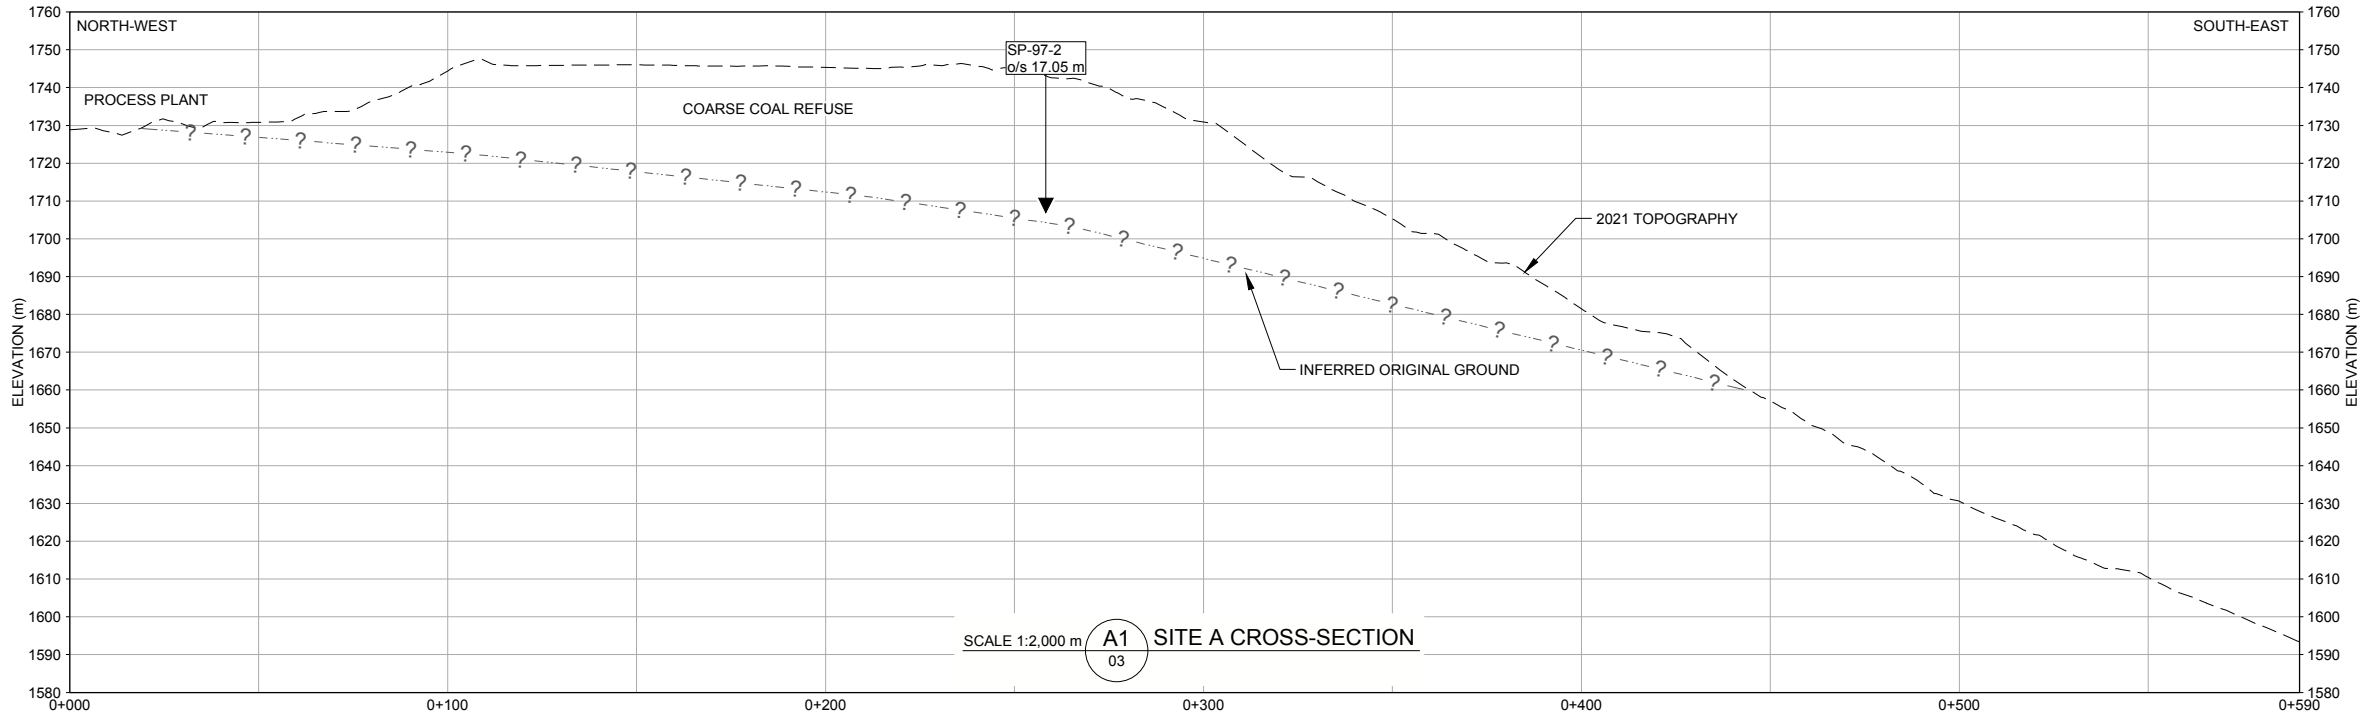
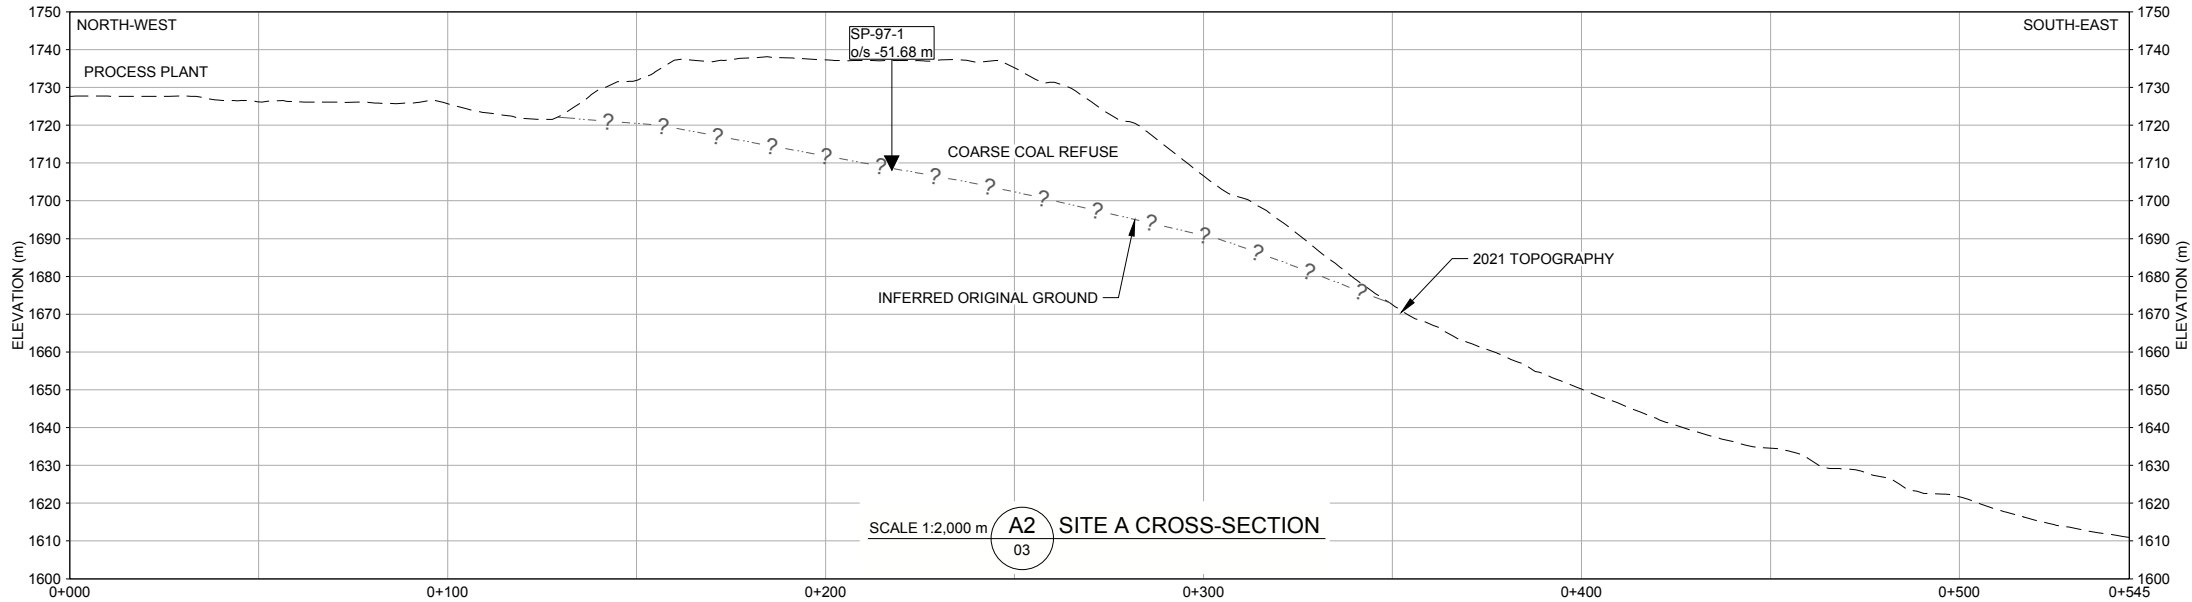
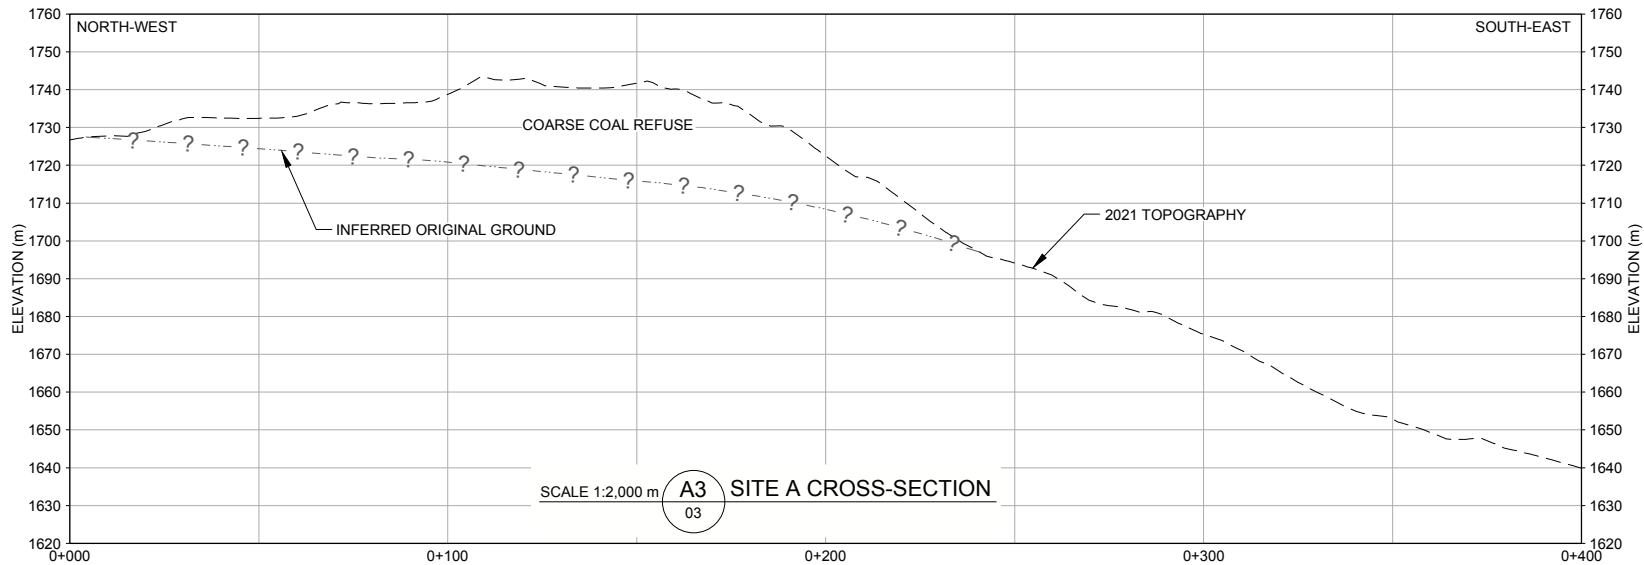
PROJECT			
GREENHILLS COARSE COAL REFUSE FACILITIES			
2021 ANNUAL FACILITY PERFORMANCE REPORT			
TITLE			
SITE A CCR FACILITY CROSS-SECTIONS A1, A2 AND A3			
PROJECT NO.	PHASE/TASK/DOC	REV.	FIGURE
21452085	3000/3330/206	0	4

Two vibrating wire piezometers (VWPs), SP-97-1 and SP-97-2, were installed in the Site A Facility, as shown in Figure 3, to monitor the phreatic surface within the facility. Historical data, recorded in these VWPs between 1993 and 2015, do not indicate any evidence of the CCR material being saturated. VWP data after April 2015, and throughout the 2020/2021 reporting period, were not available to assess the pore pressure conditions within the facility. Instruments should be measured.

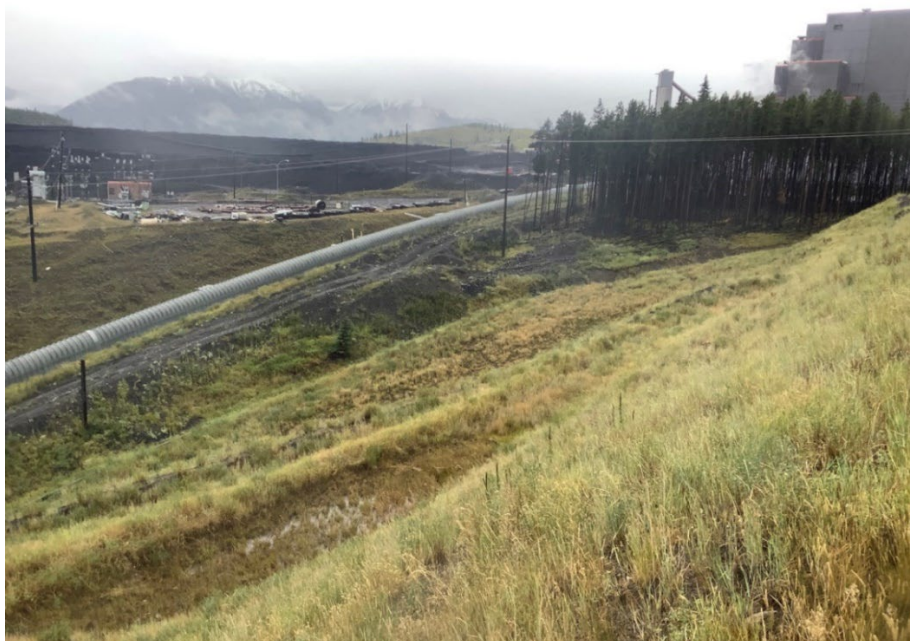
- Minor localized depressions with ponded surface water were observed on the intermediate benches at the east and west sides of the Site A Facility (Photographs 4, 9, and 10).
- No sign of instability was observed on the slopes of the Site A Facility during the 2021 site visit (Photographs 3 to 10).
- Visual observations of the ancient/relict landslide near the southeast toe of the Site A Facility did not indicate any signs of recent movement at the time of the 2021 site visit (Photograph 7).

Photograph 4: Site A CCR Facility – Southwest Slope; Minor Surface Water on Intermediate Bench; Looking Northwest, 17 August 2021

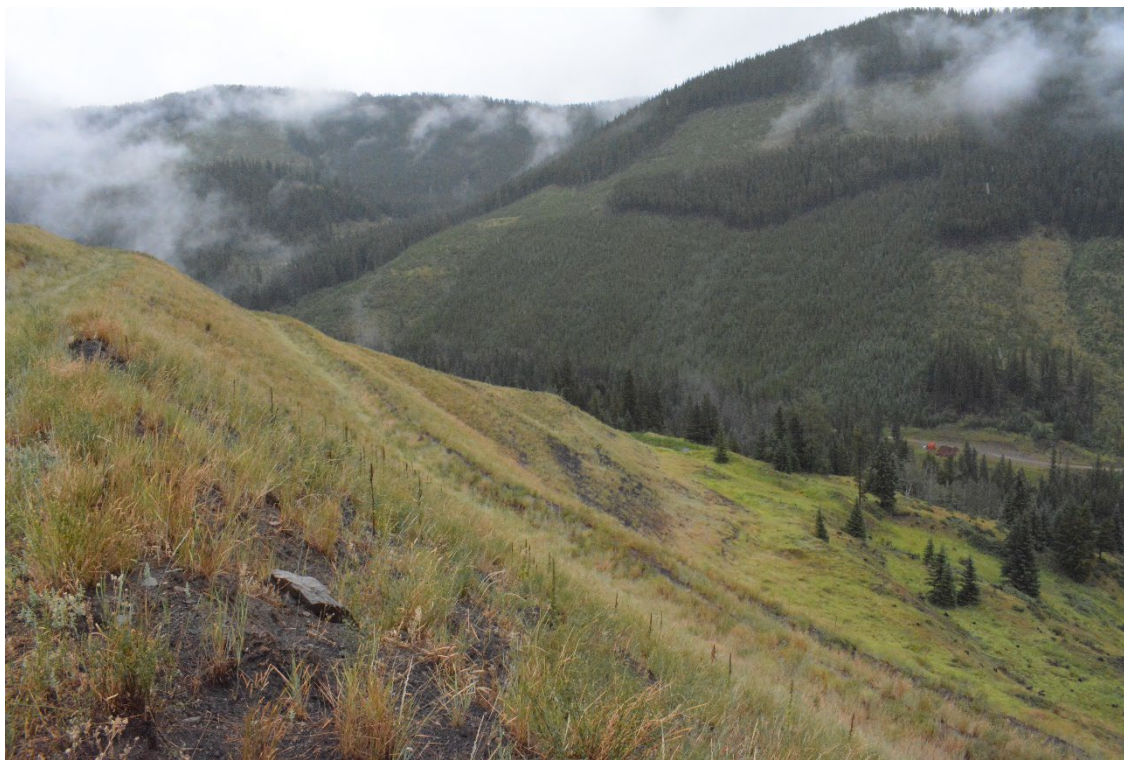
Photograph 7: Site A CCR Facility – Ancient Landslide at Southeast Toe; Looking East, 17 August 2021

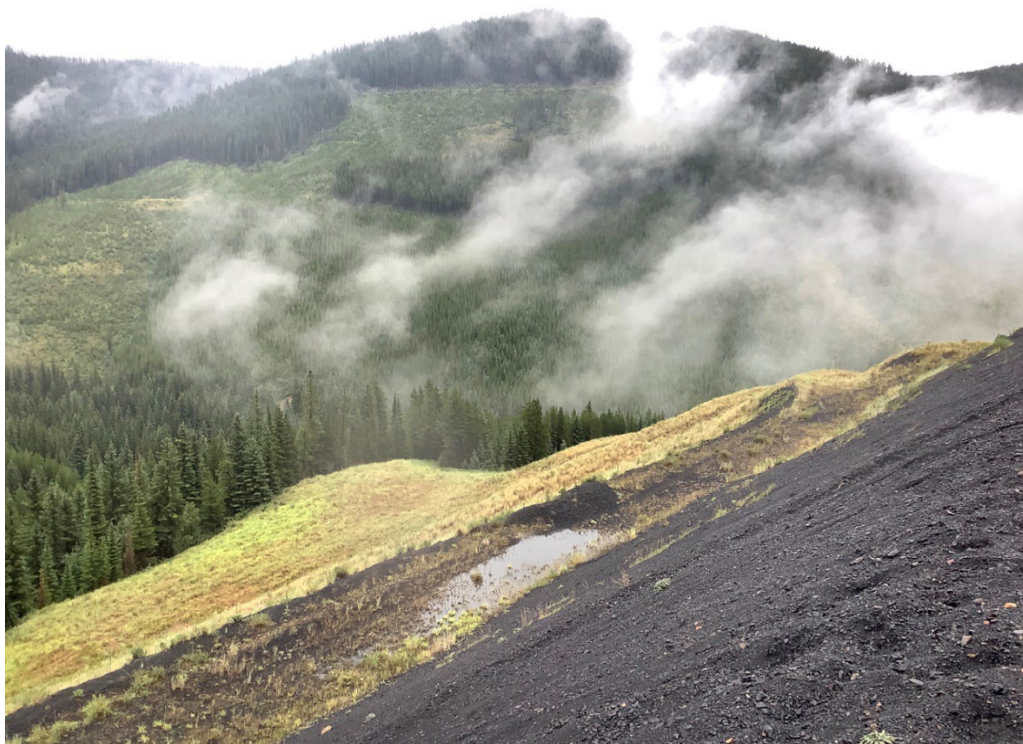
General observations during GHO routine inspections and at the time of the 2021 site visit, in relation to external erosion, included minor erosion rills on unvegetated areas of the east slope of the facility (Photographs 9 and 10). No erosion of the toe of the Site A Facility was noted at the time of the 2021 site visit or routine inspections by GHO.

Photograph 9: Site A CCR Facility – East Slope with Minor Surface Water on Intermediate Bench; Looking East, 17 August 2021

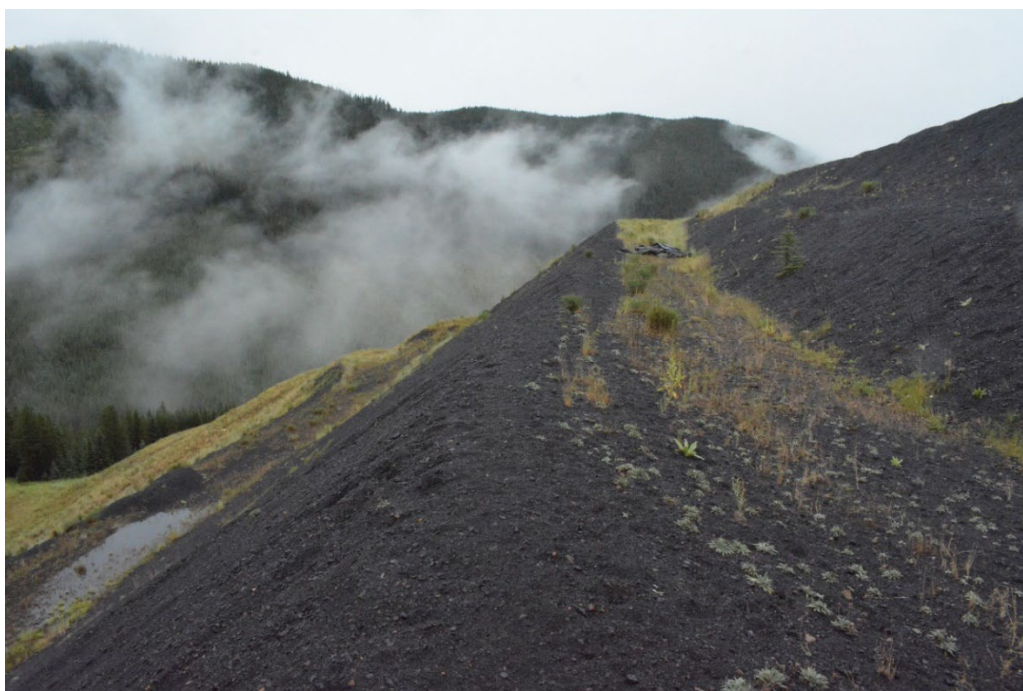
Photograph 10: Site A CCR Facility – East Slope and Intermediate Benches; Looking Southeast, 17 August 2021

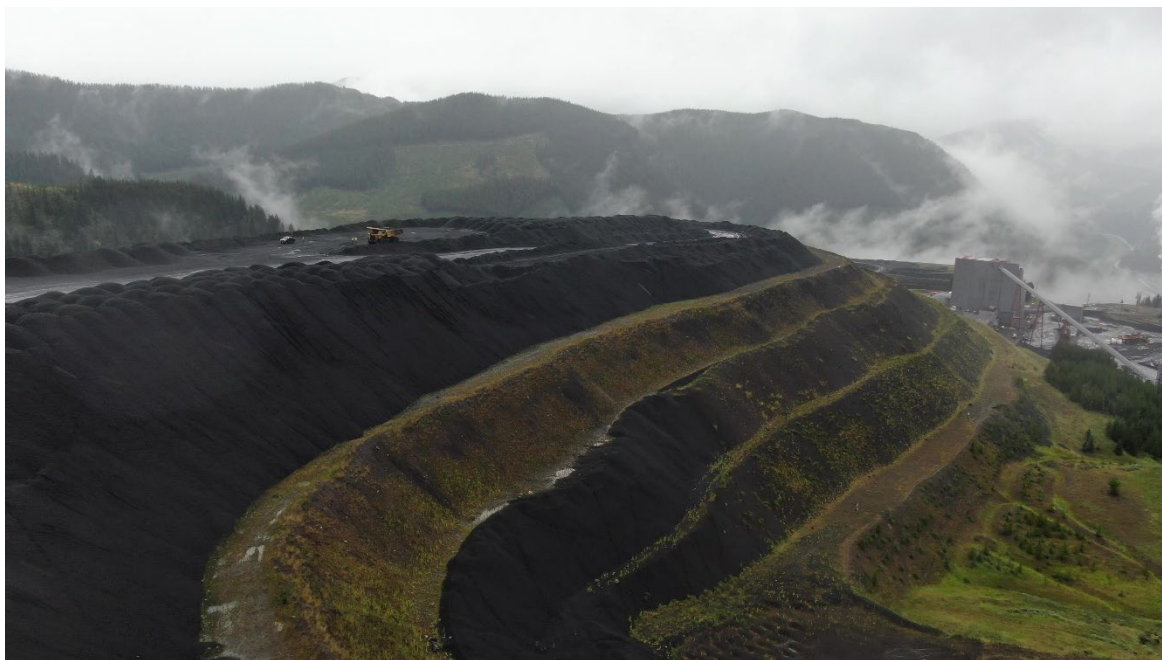
- Regrading was completed by GHO outside of the reporting period and no longer presents a safety concern.
- Minor ponded surface water was noted on the intermediate benches at the west side of the facility during the 2021 site visit (Photograph 13).

Photograph 13: Site B CCR Facility – Overview of West Side; Looking South, 17 August 2021

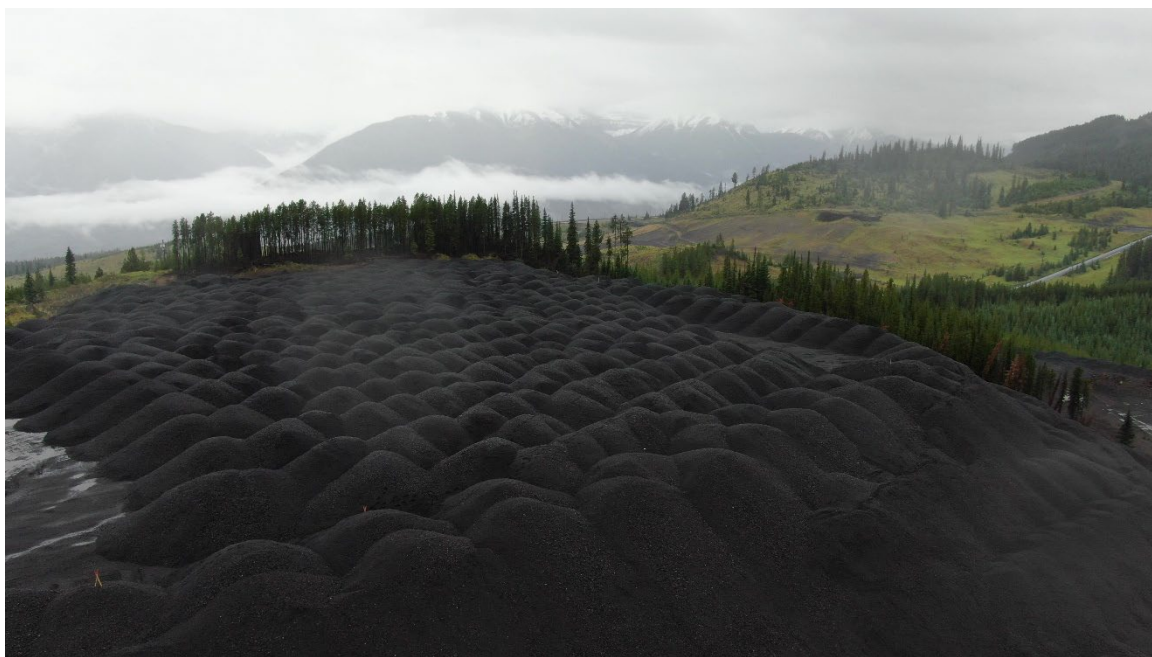
- A portion of the northeast slope of the Site B Facility, above the haul road, had been overbuilt with CCR placed beyond the design profile up to a maximum height of approximately 35 m without an intermediate bench and mid-bench cracks were noted (Photographs 20, 21, 22, and 23). In addition, dumping of CCR beyond the design limits was observed on the Site B Facility platform during the 2021 site visit (Photograph 14).

Photograph 14: Site B CCR Facility – North and East End of Platform; Looking Northwest, 17 August 2021

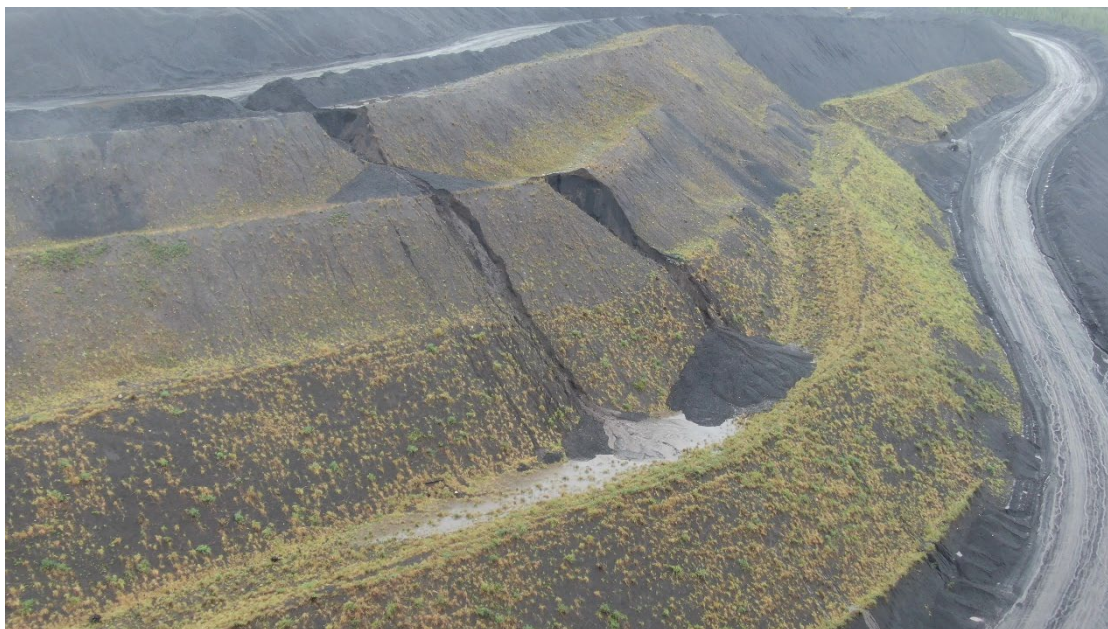
General observations at the time of the 2021 site visit, in relation to external erosion of the slope of the Site B Facility, included erosion, as a result of heavy rains (Photographs 17, 18, and 19) adjacent to the haul road. The affected area was remediated on 26 August 2021 (Photograph 19b). No erosion of the toe of the Site B Facility was noted at the time of the 2021 site visit or routine inspections by GHO.

Photograph 17: Site B CCR Facility – Erosion of Slope and Intermediate Benches at East Side of Facility; Looking East, 17 August 2021

Maintenance activities completed during the reporting period included the repair of an erosion feature, caused by heavy rain, at a portion of the east slope of the Site B Facility, which was identified during the 2021 site visit (Section 4.4.2). Additional maintenance, such as regrading of access roads, was routine and typical for normal operations.

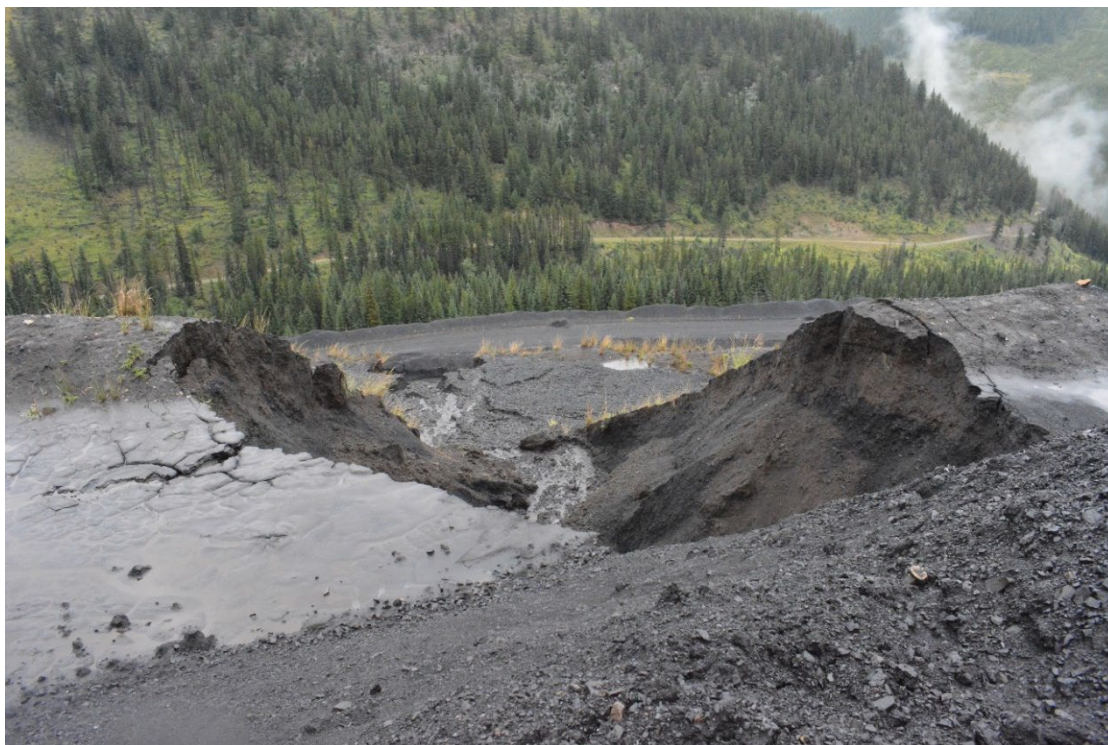
Photograph 18: Site B CCR Facility – Close-Up View of Erosion at East Slope; Looking East, 17 August 2021

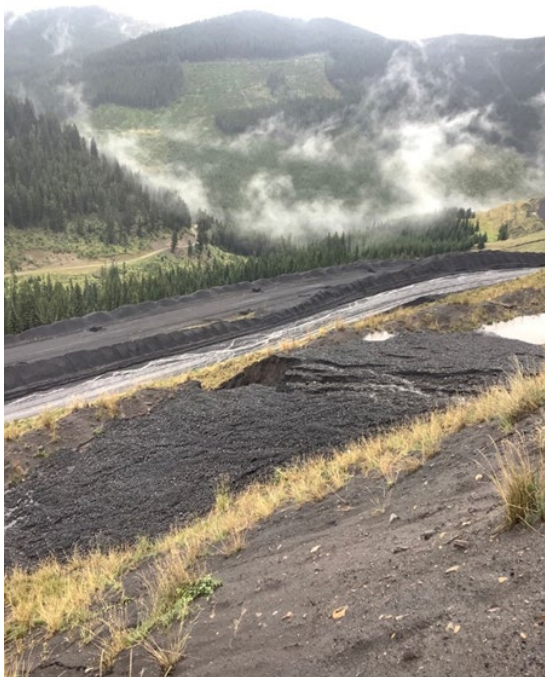
Photograph 19a: Site B CCR Facility – Erosion of Intermediate Bench at East Side of Facility; Looking Southeast, 17 August 2021

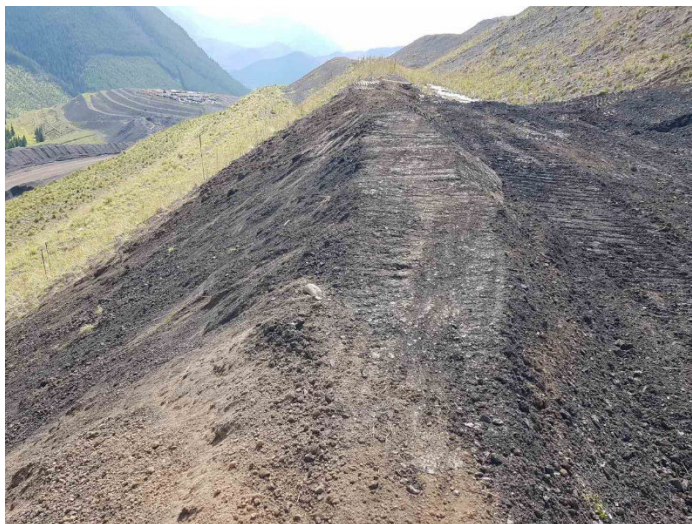
Photograph 19b: Site B CCR Facility – Repair of Erosion on Intermediate Bench at East Side of Facility; Looking South, 19 October 2021

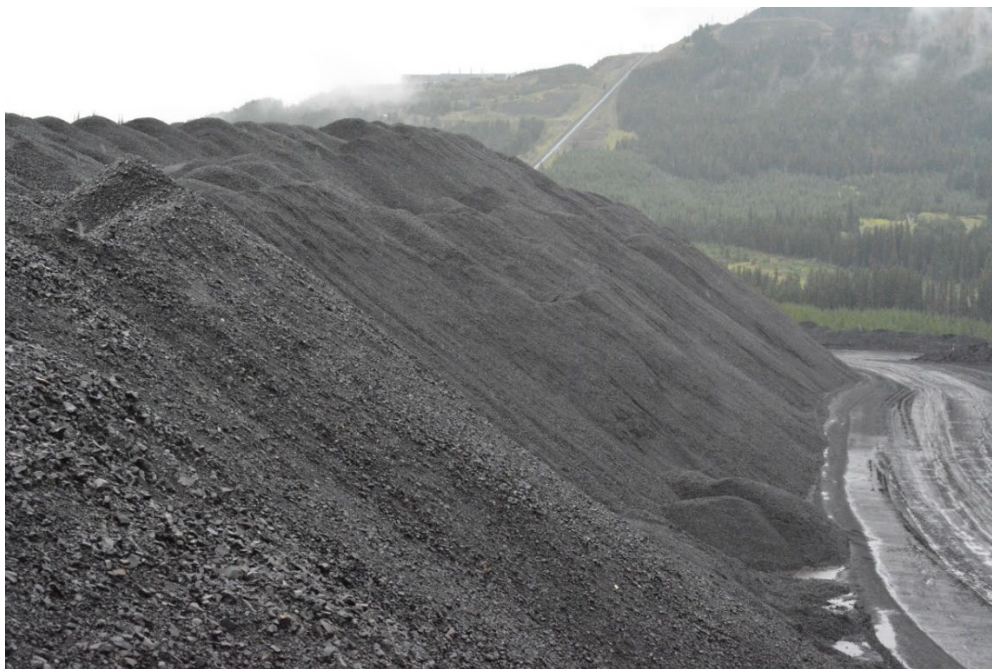
- A stability assessment was completed (Golder 2021b) with regard to potential short-term impacts to haul road traffic. The calculated static FoS of this portion was less than 1.3 and the overbuilt portion of the northeast slope of the Site B Facility had the potential to impact traffic safety on the haul road. It was recommended that this should be regraded to achieve a minimum factor of safety of 1.3.

Photograph 20: Site B CCR Facility – Overbuilt Portion of Slope at Northeast Side of Facility; Looking East, 17 August 2021

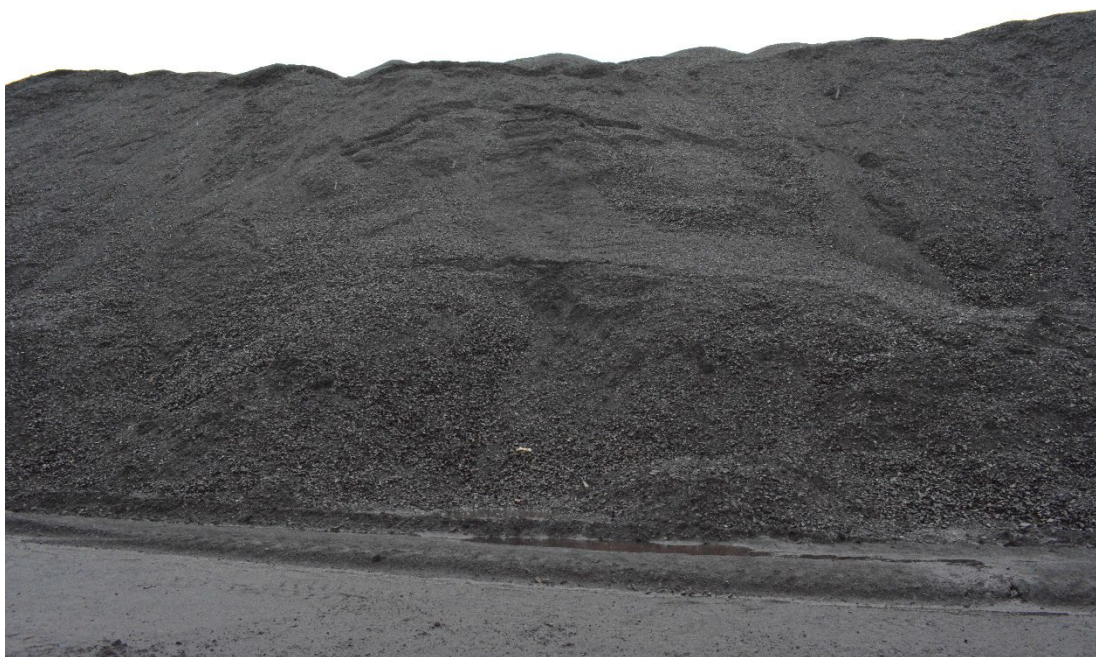
Photograph 21: Site B CCR Facility – Surficial Cracking at Overbuilt Portion of Slope at Northeast Side of Facility; Looking East, 17 August 2021

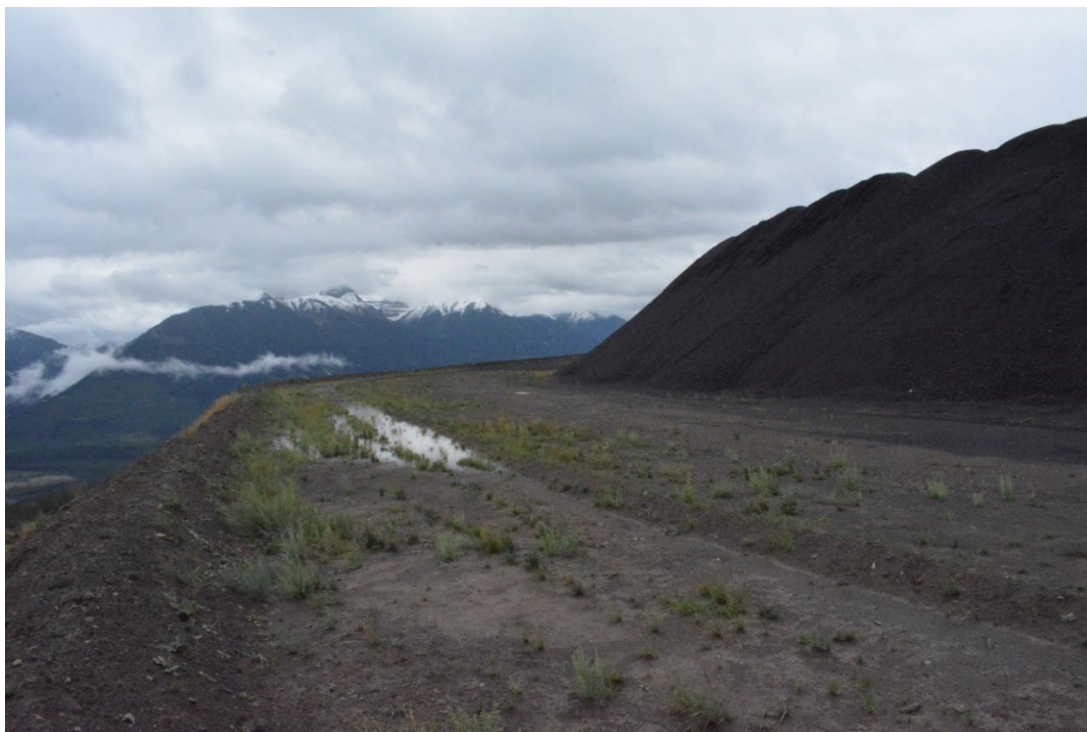
General observations during GHO monthly inspections and at the time of the 2021 site visit include minor ponded surface water observed in localized depressions on the intermediate benches at the south side for the facility.

Photograph 31: Site E CCR Facility – Intermediate Bench with Minor Ponded Surface Water; Looking West, 17 August 2021
