# **Teck Highland Valley Copper Partnership**

## **2021 Annual Facility Performance Report**

### ***Highland Tailings Storage Facility***

March 2022

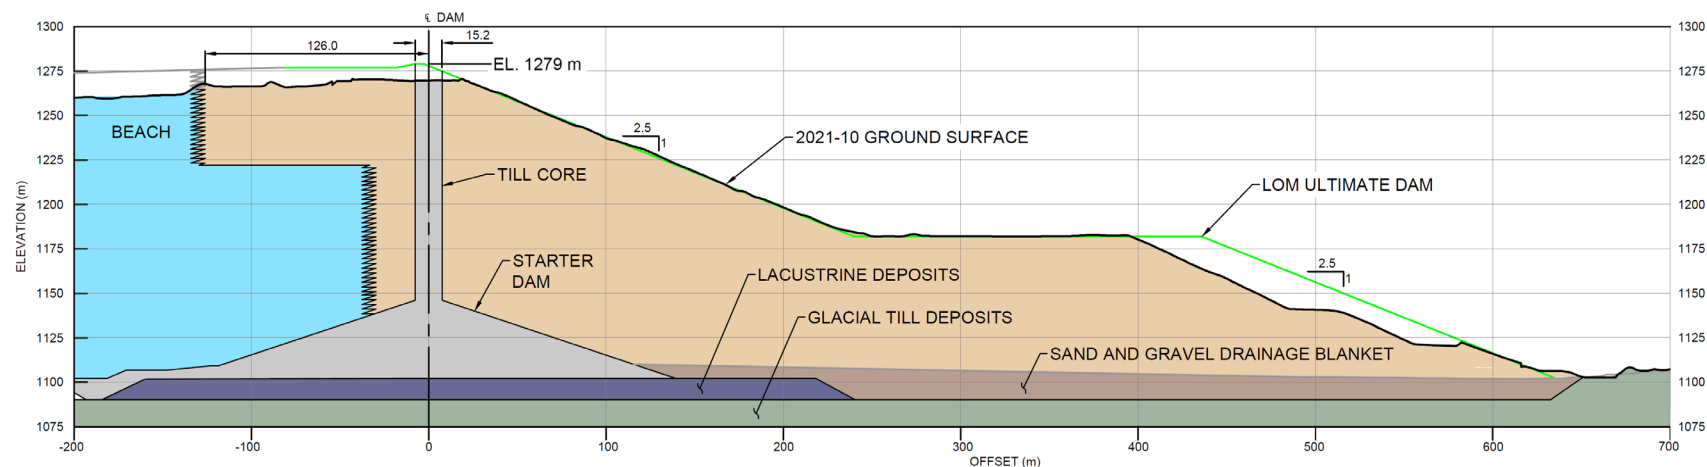
**Figure 2.1 End of 2021 Configuration and Ultimate Design Section at L-L Dam VBB (Sta. 1+850)**

Figure 2.1 shows a typical design section of the L-L Dam, through the VBB at Sta. 1+850 (Section 9 on Figure 3, at the end of the report) along the crest. The dam includes a glacial till core for seepage control, which extends from the existing crest, through the Starter Dam, and is keyed into the foundation. The Starter Dam crest has been raised using the centreline method with the core supported by compacted cycloned sand on the upstream and downstream sides. Figure 2.3 shows the crest rise over the life of the structure. The majority of the cycloned sand fill in the dam has been placed and densified hydraulically, rather than by conventional construction equipment.

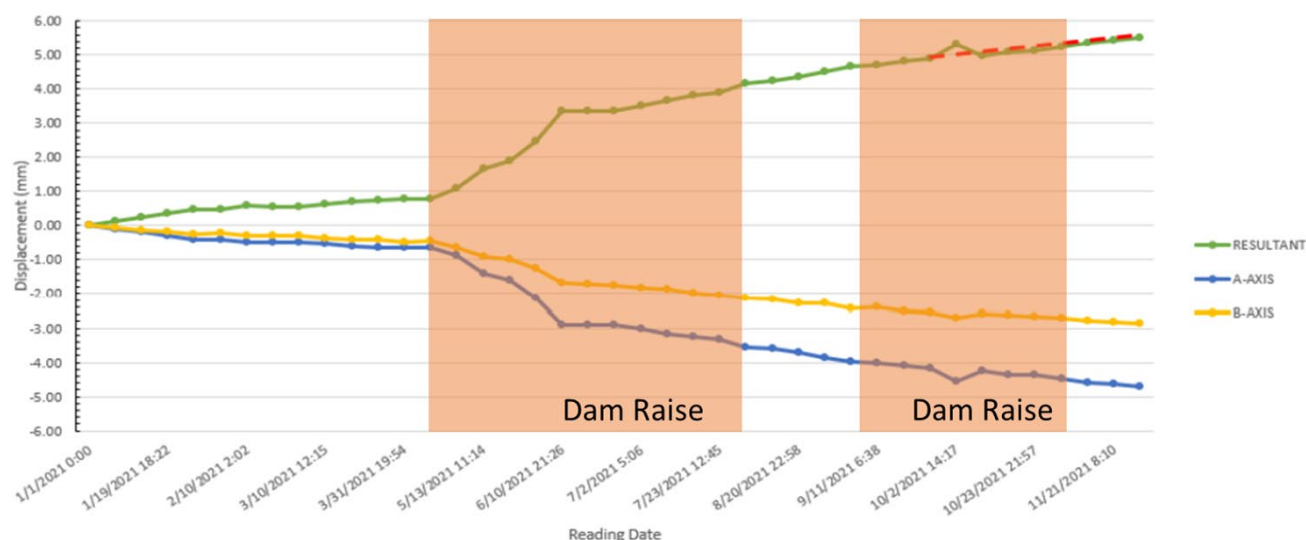
**Figure 5.13 199-05 Measured Deformation Along Mudstone Layer (~El. 1153 m)**

Further north, at I10-03 and I19-02, where mudstone layers are deeper and not do not influence dam design, no shear deformations were measured in the foundation.

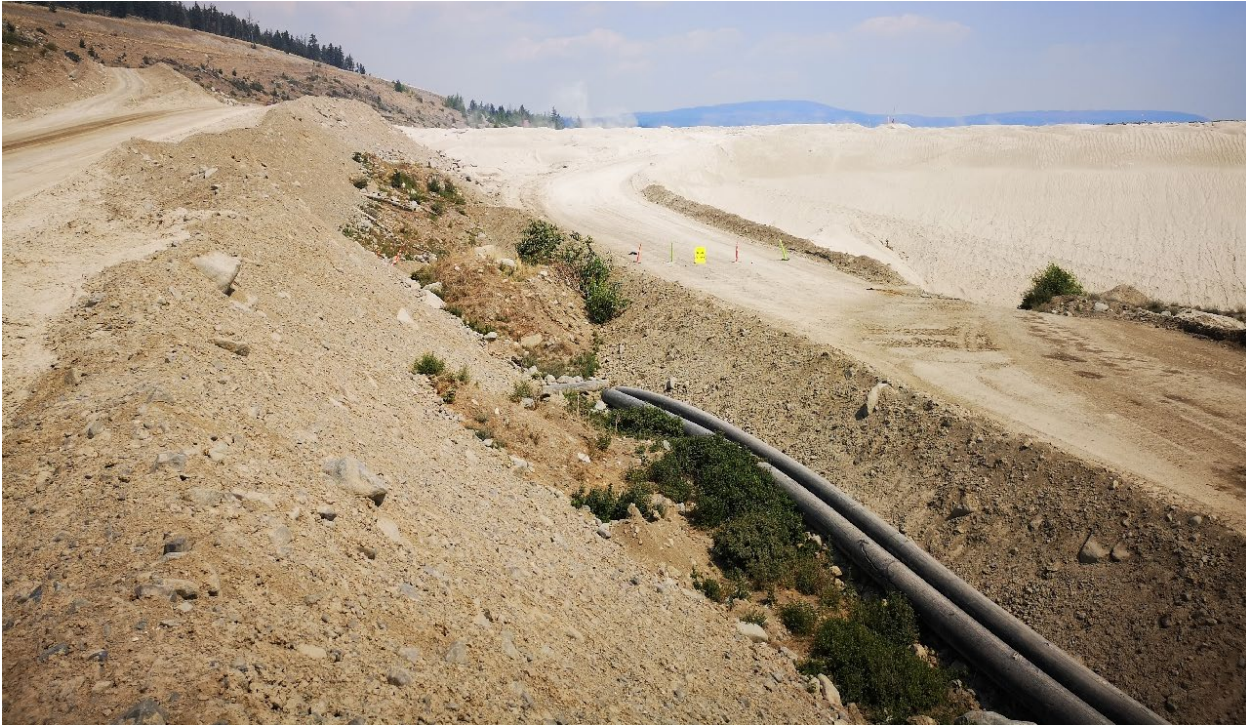
**Photo I-A-4 Overview of the downstream slope at the North Abutment and mine access roads. No areas of excessive erosion or scour were observed over or near the dam surface. (LL-2021-03)**

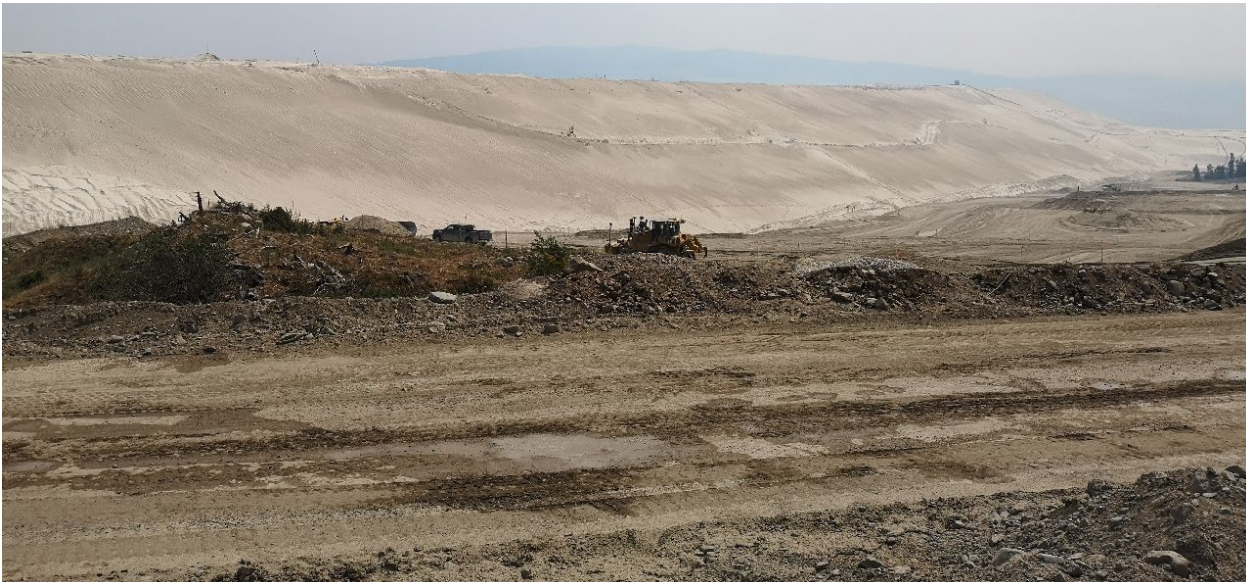
**Photo I-A-5 Overview of downstream slope of North Dam U-GLU and Bedrock segments, looking south. North Dam buttress foundation preparation areas visible along toe (LL-2021-03)**

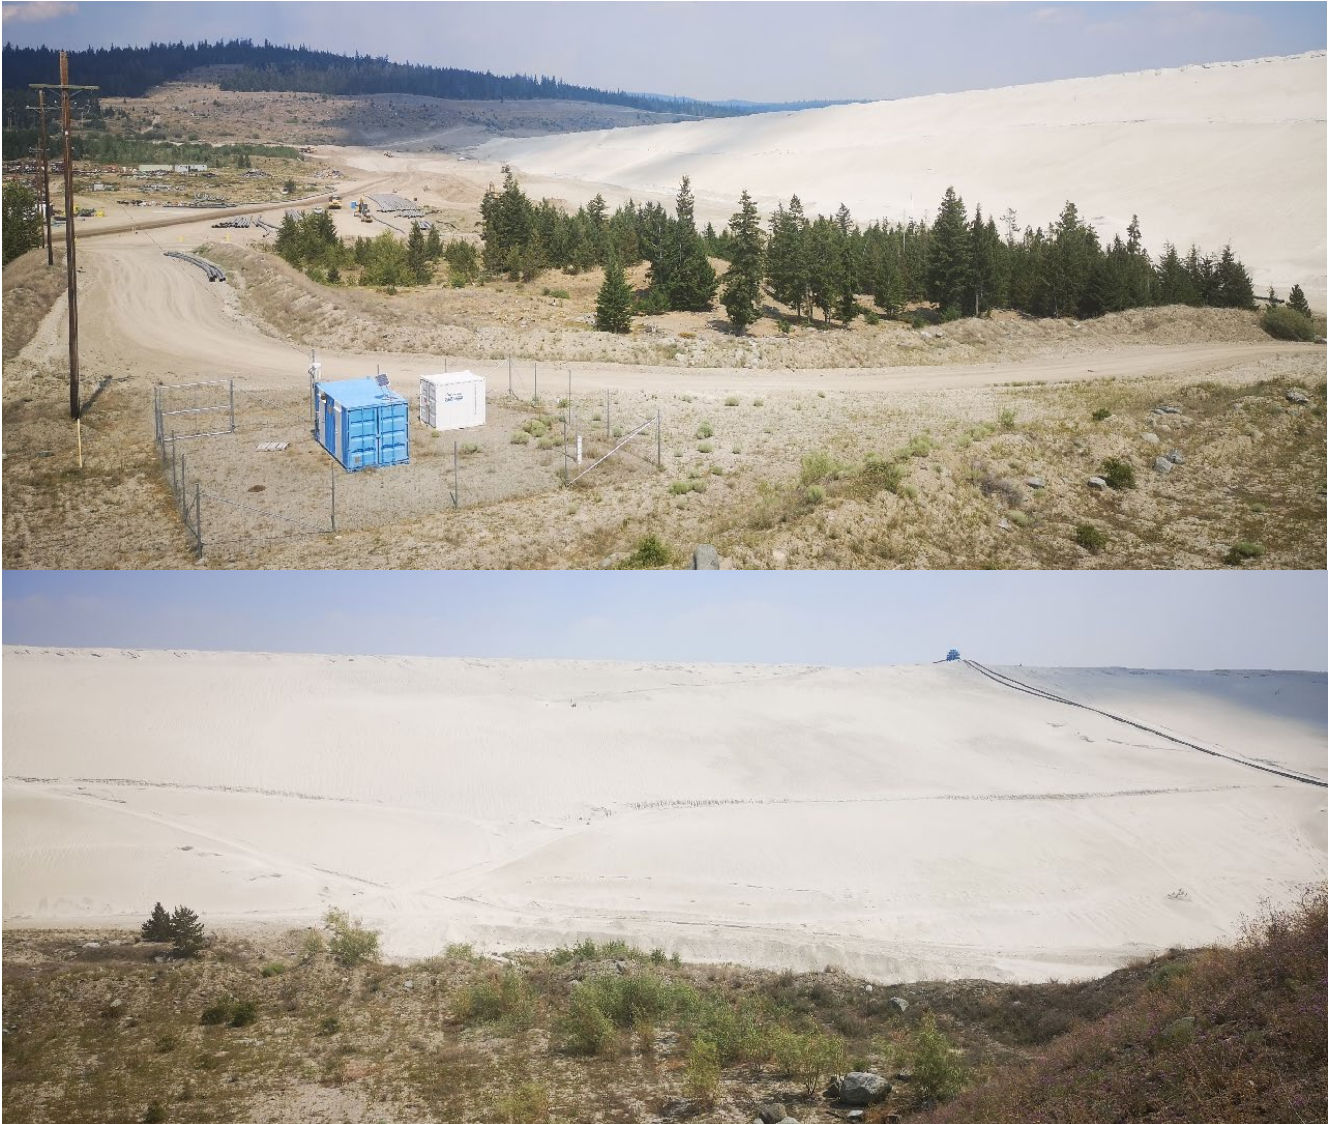
**Photo I-A-6 Overview of downstream slope of North Dam Bedrock and U-GLU segments (north of the NBB), looking north. North Dam buttress foundation preparation areas visible along toe. (LL-2021-04)**
