Pine Point Mine Tailings Impoundment Area

2021 Annual Facility Performance Review

November 2, 2021

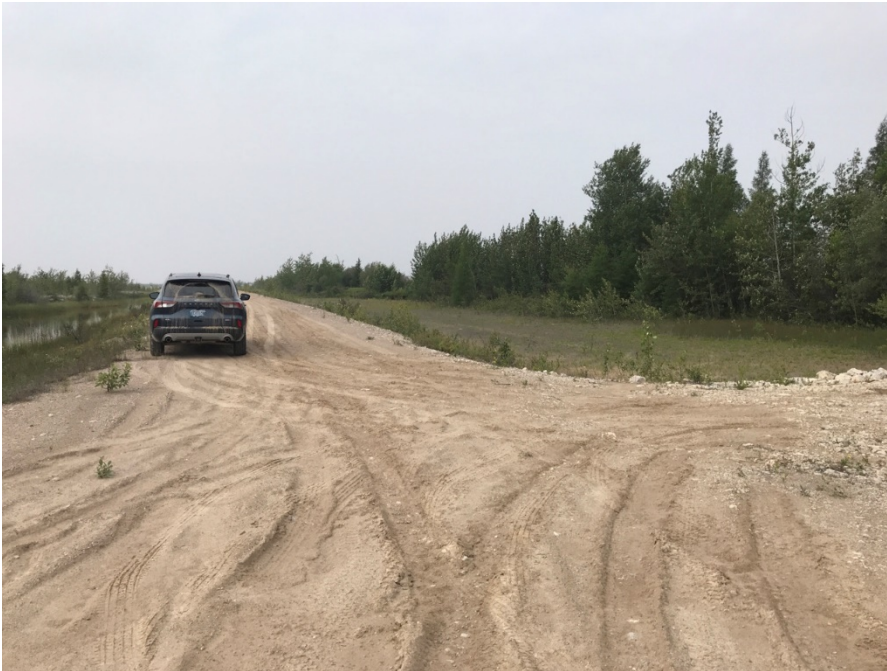
- Ponding was observed downstream of the toe in some areas (Photo II-10).
- Minor rutting of the crest was observed near the east end of the dyke (Photo II-1).

Photo II-1 South Dyke – looking southwest, minor rutting

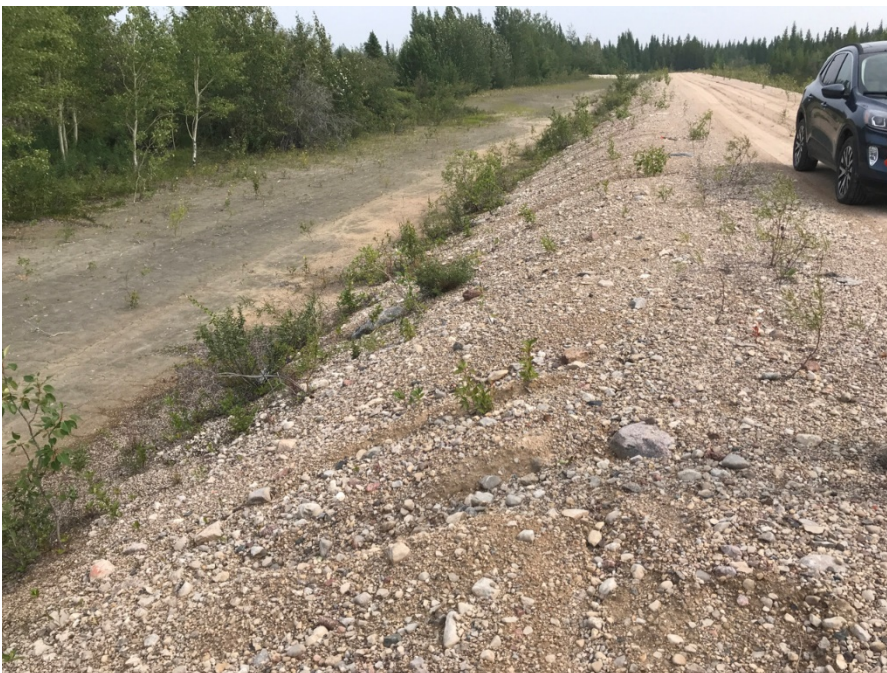
- Minor rills were observed on both upstream and downstream slopes in some areas (Photos II-2 to II-6). These are relatively small and do not require repairs unless their condition worsens.

Photo II-2 South Dyke – looking northeast, minor rills on upstream slope, exposed tailings

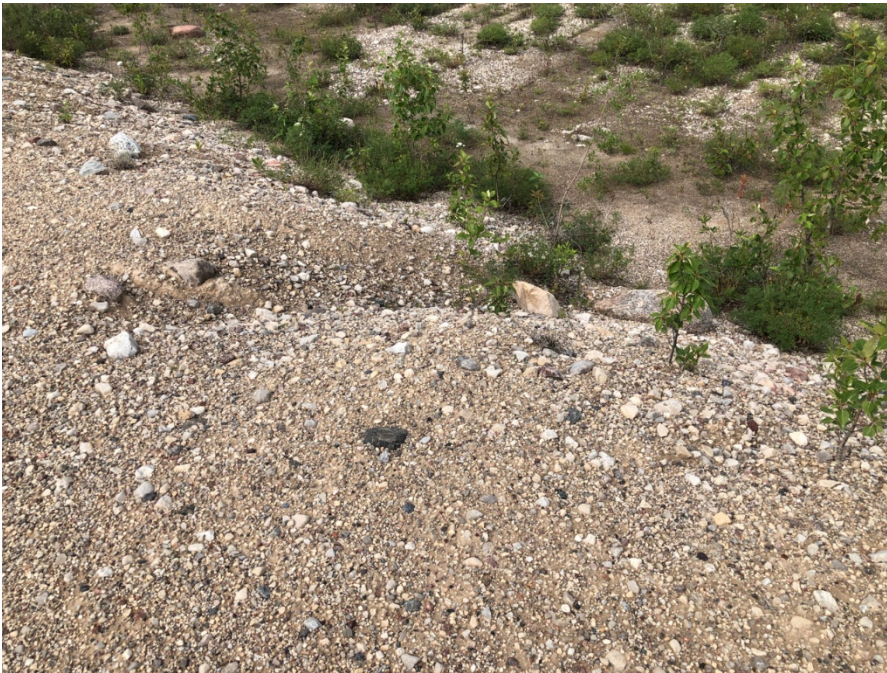
Photo II-3 South Dyke – looking northwest, minor rills on upstream slope

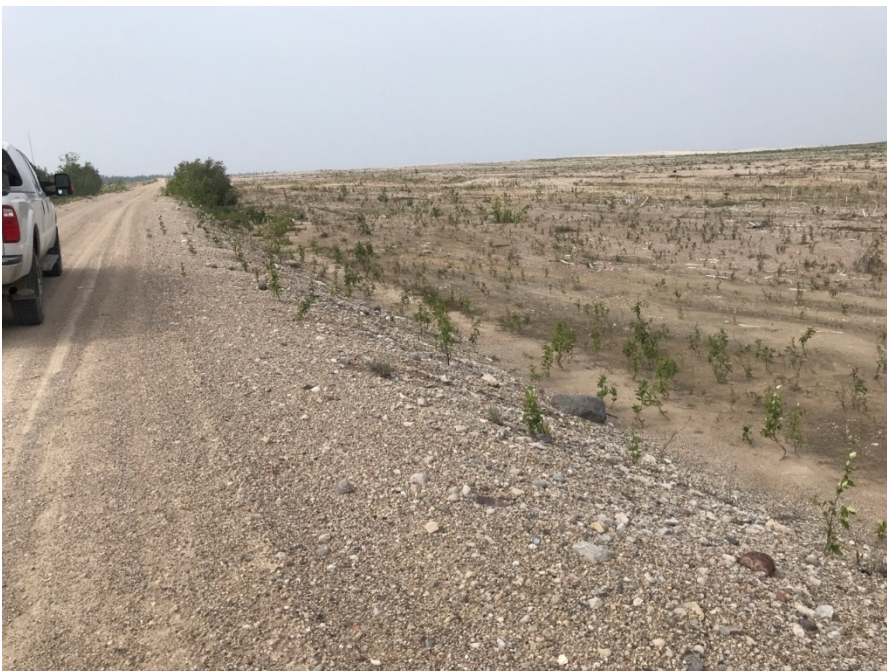
Photo II-4 South Dyke – looking southwest, minor rills on upstream slope

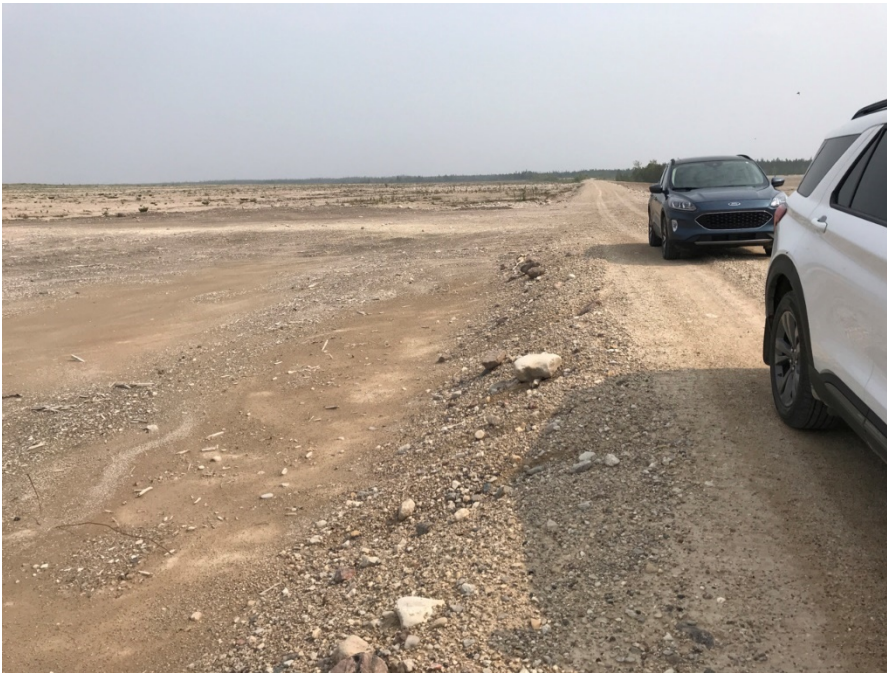
Photo II-5 South Dyke – looking northeast, minor rills on upstream slope

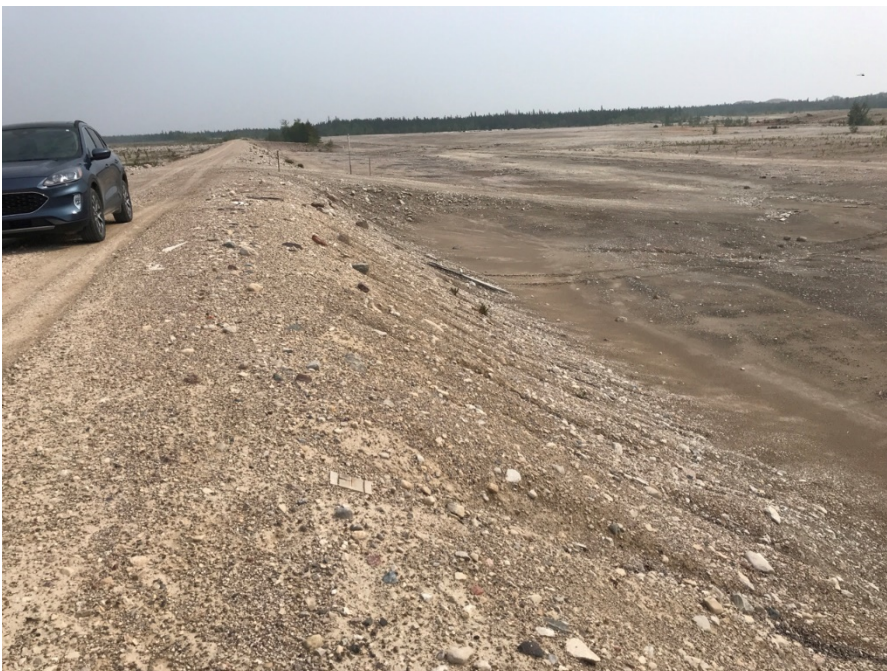
Photo II-6 South Dyke – looking northeast, minor rills on downstream slope

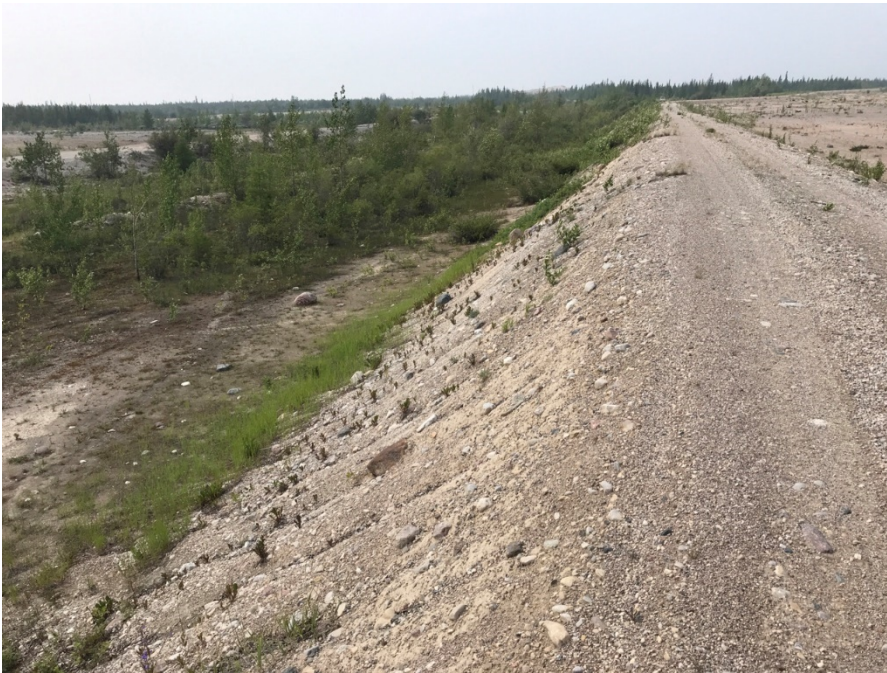
Photo II-7 South Dyke – looking southwest (note steep downstream slope)

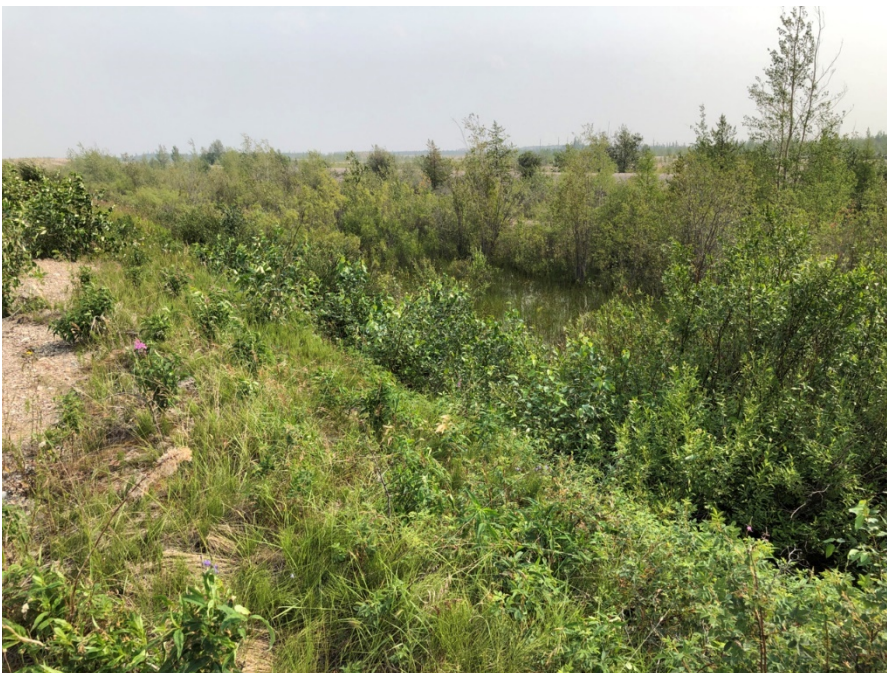
Photo II-8 South Dyke – looking northeast, standing water at downstream toe

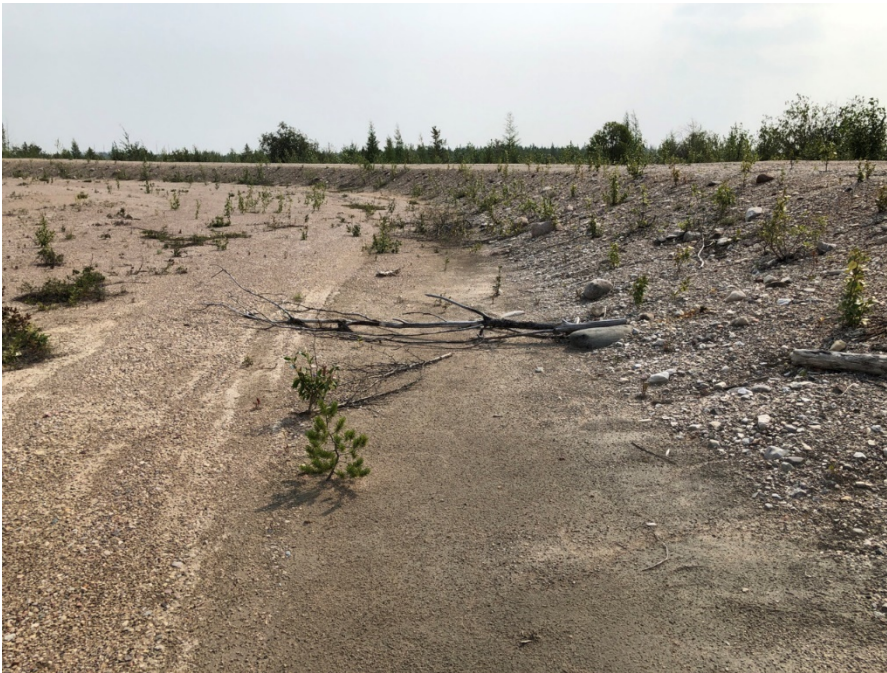
- The South Dyke crest, and upstream and downstream slopes were in good condition (Photos II-1 to II-11).
- The upstream tailings surface is dry. The tailings surface near the dyke has a granular cover, but exposed tailings were observed at the east side (Photo II-2), and also in a few locations further west where Maskwa reports flow has previously been observed during freshet, which has apparently eroded parts of the cover (Photo II-9).

Photo II-9 South Dyke – looking northeast, exposed tailings at upstream toe

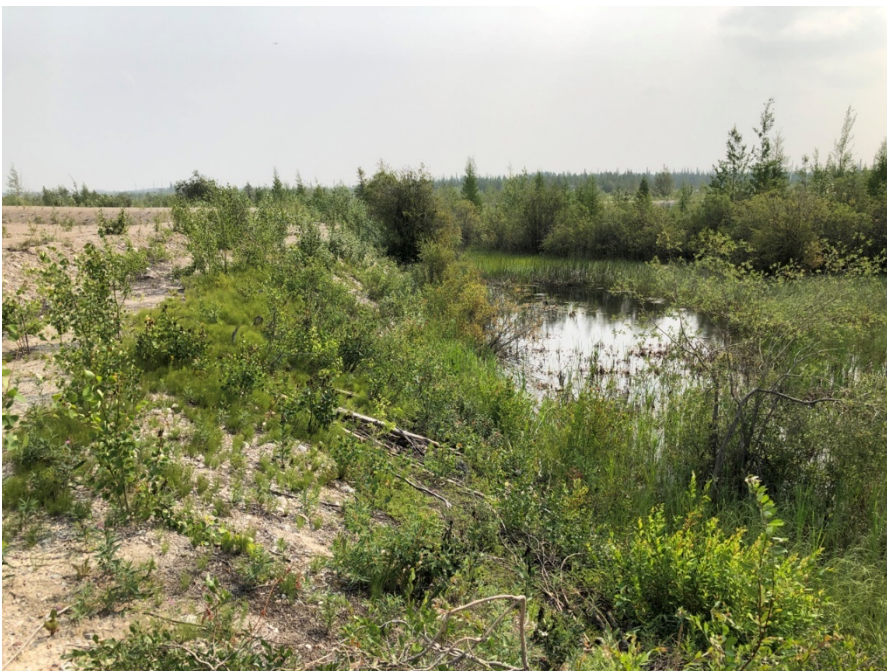
Photo II-10 South Dyke – looking southeast, standing water at downstream toe

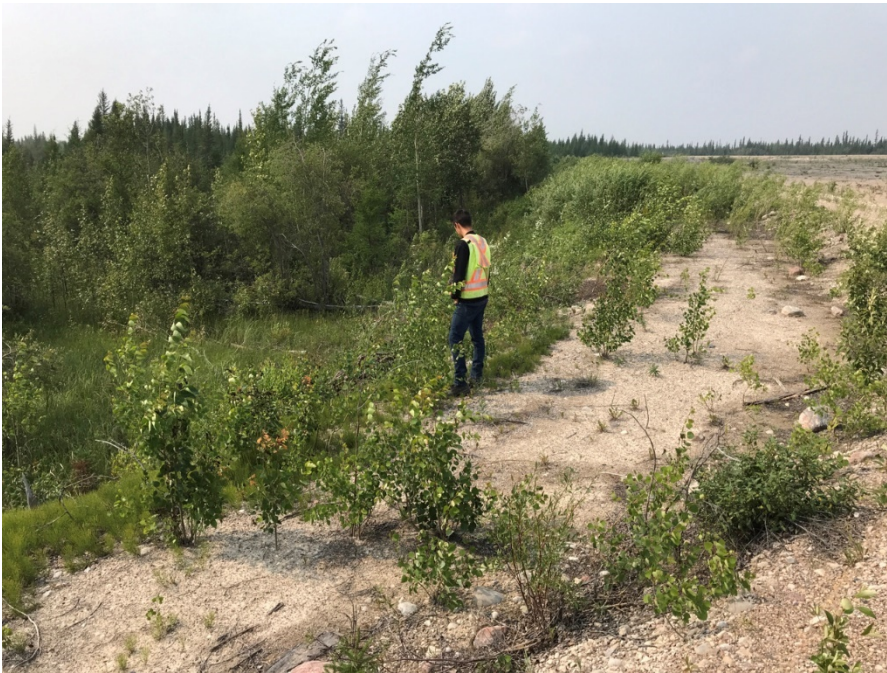
Photo II-11 South Dyke – looking west, vegetation on downstream slope

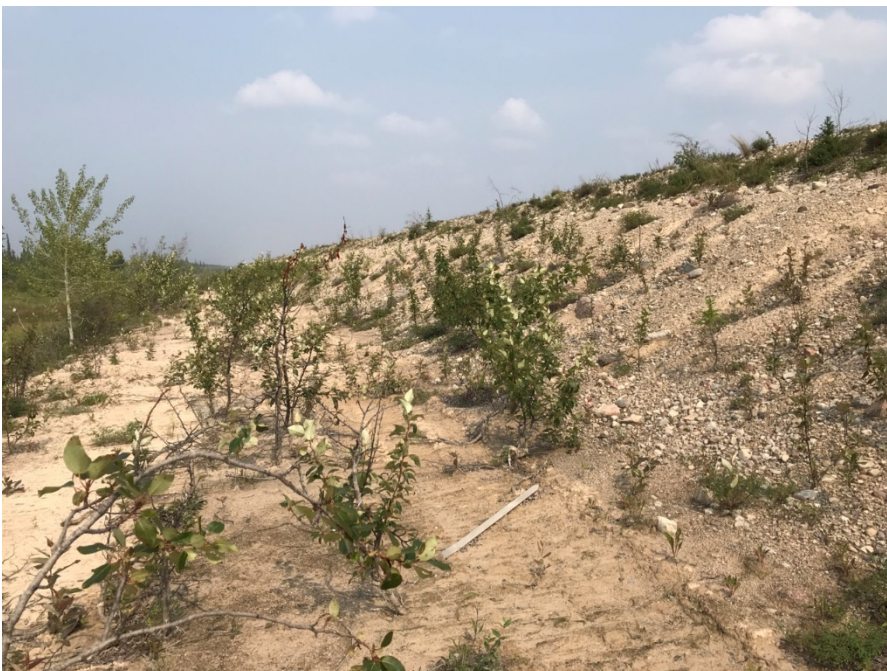
Photo II-12 West Dyke – looking north, minor vegetation on downstream slope

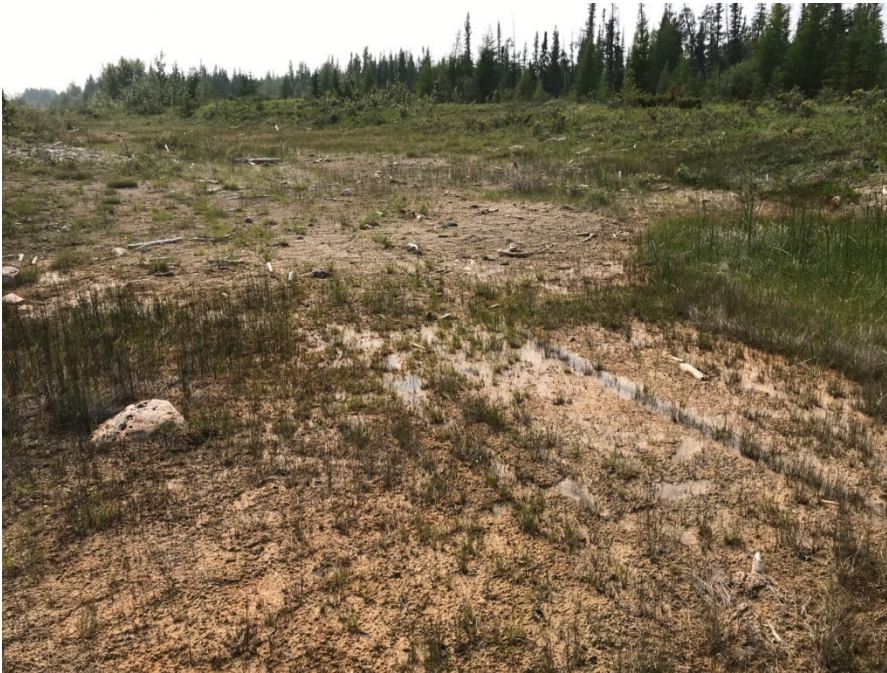
Photo II-13 West Dyke – looking south, red staining at former seepage point

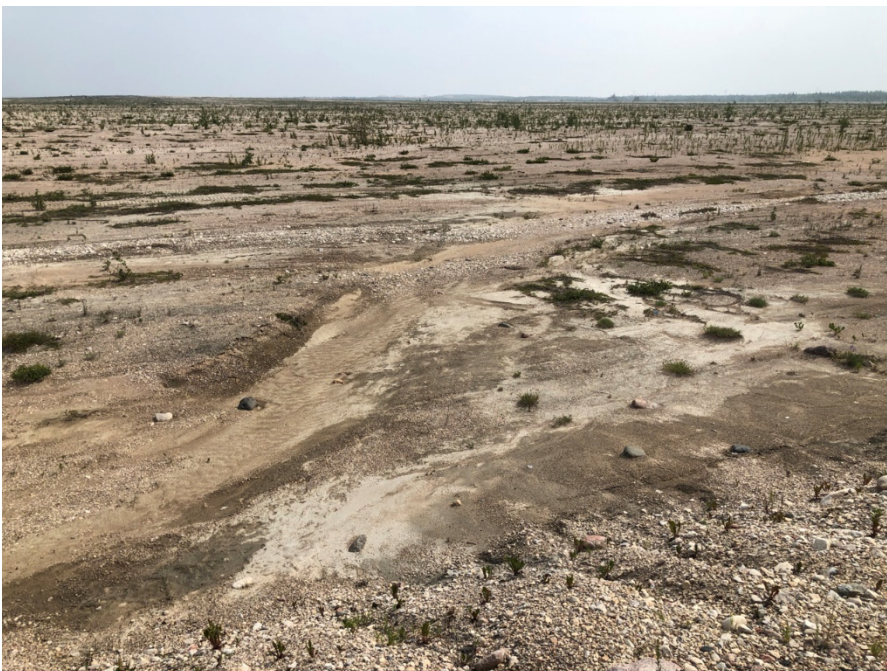
Photo II-14 West Dyke – looking east, erosion of tailings cover

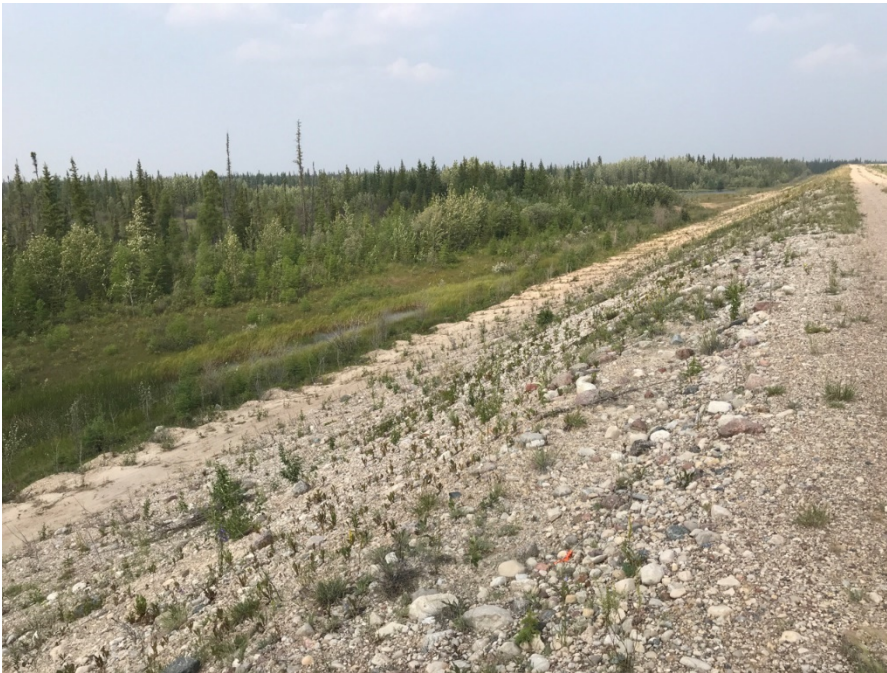
Photo II-15 West Dyke – looking north, water ponding at downstream toe

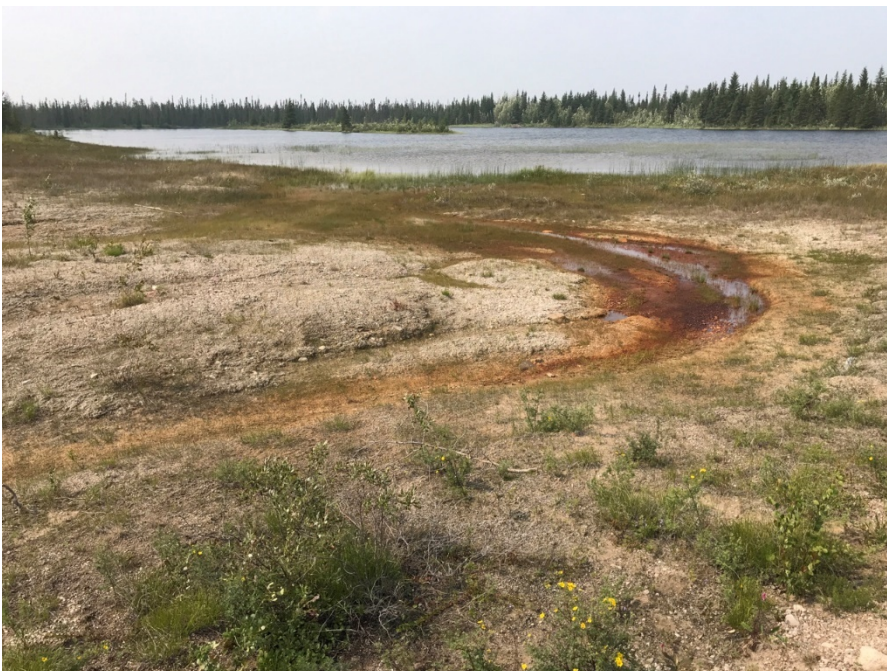
- Ponding was observed downstream of the toe in some areas, including two larger ponds at the north end. Minor seepage with red staining was observed at the dam toe flowing into these larger ponds (Photo II-16). The seepage water was clear.
- Minor rills were observed on the downstream slope at a few locations. One larger rill was observed at the northwest corner on the downstream slope (see Location 1 in Figure 4.1; Photo II-17), up to 1 m wide and 0.4 m deep, which Maskwa indicated was not present during the spring 2021 inspection. This rill is not an immediate concern, but should continue to be monitored, and could be repaired on an opportunistic basis if equipment is already on site for another purpose.
- There is minor vegetation on the upstream and downstream slopes, but it is not approaching the removal criteria.

Photo II-16 West Dyke – looking west, seepage and pond downstream of dyke

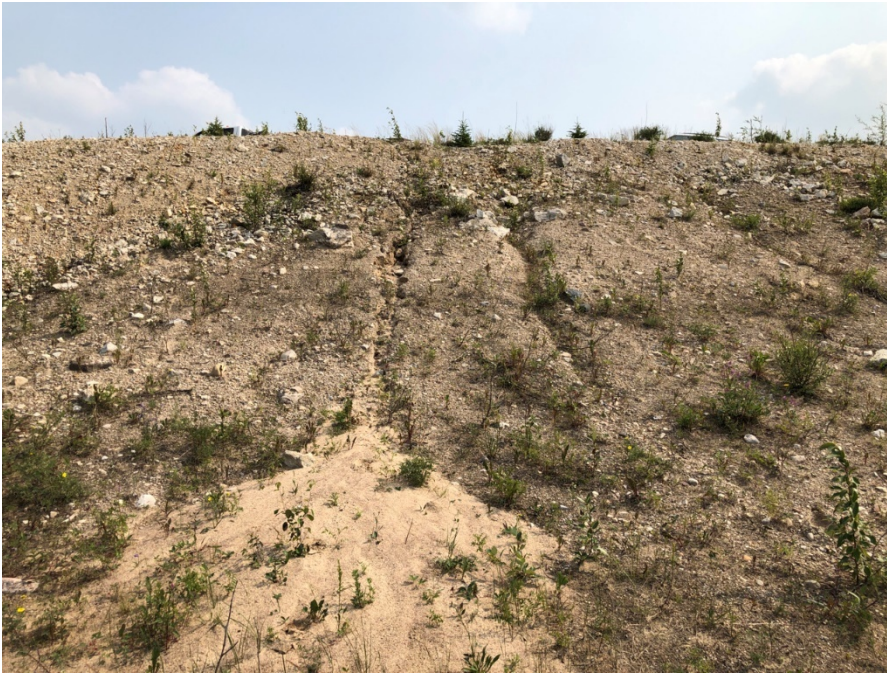
Photo II-17 West Dyke – northwest corner, looking southeast, new erosion rill with sediment fan on downstream slope

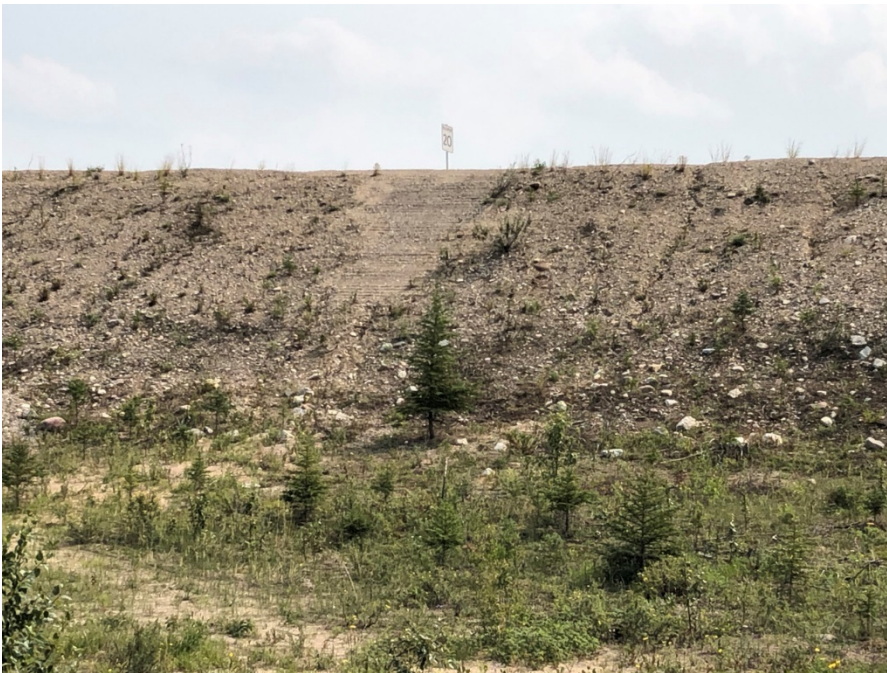
Photo II-18 North Dyke – looking south, minor slope repair on downstream slope

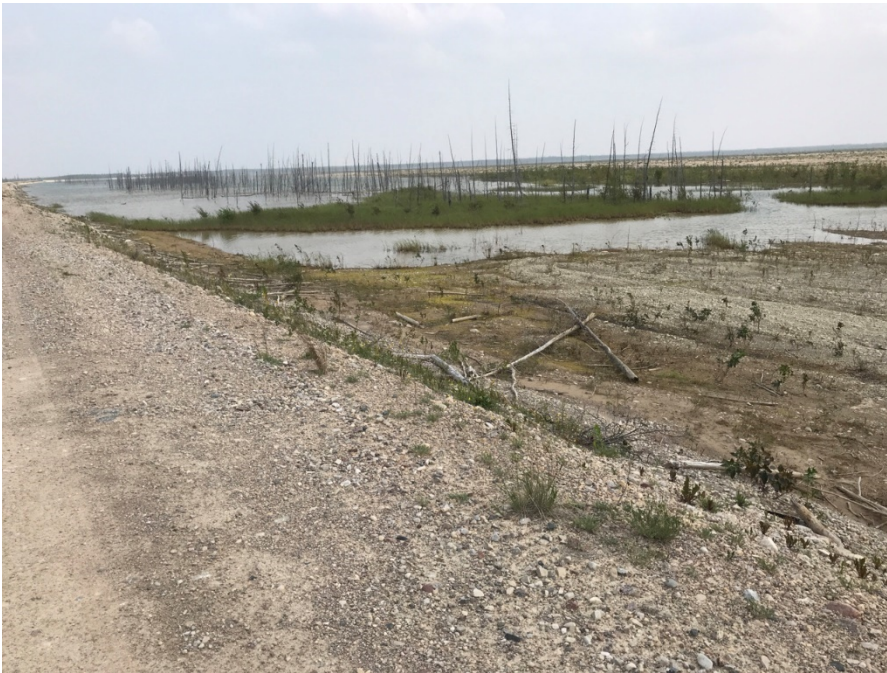
- The Main Pond was in contact with the upstream slope of the North Dyke across most of its length, apart from a ~300 m zone near the northwest corner (see west edge of pond in Photo II-19). About 700 m of this length is protected by riprap with a typical diameter of around 15 cm to 20 cm and appeared to be in good condition (see Location 2 in Figure 4.1; Photo II-23). Areas without riprap have experienced minor erosion at the toe of the upstream slope (see Location 3 in Figure 4.1), leading to slumping and 30 cm to 50 cm head scarps partway up the slope (Photos II-20 to II-21, and II-25 to II-28). In some locations this has exposed a well-graded fill zone (probably glacial till) which may be the upstream low permeability zone in the dyke. This erosion is not currently a major issue, but it may be prudent to repair it before the condition deteriorates. KCB understands that Teck is already planning to repair these areas in 2021.

Photo II-19 North Dyke – looking northeast, edge of pond

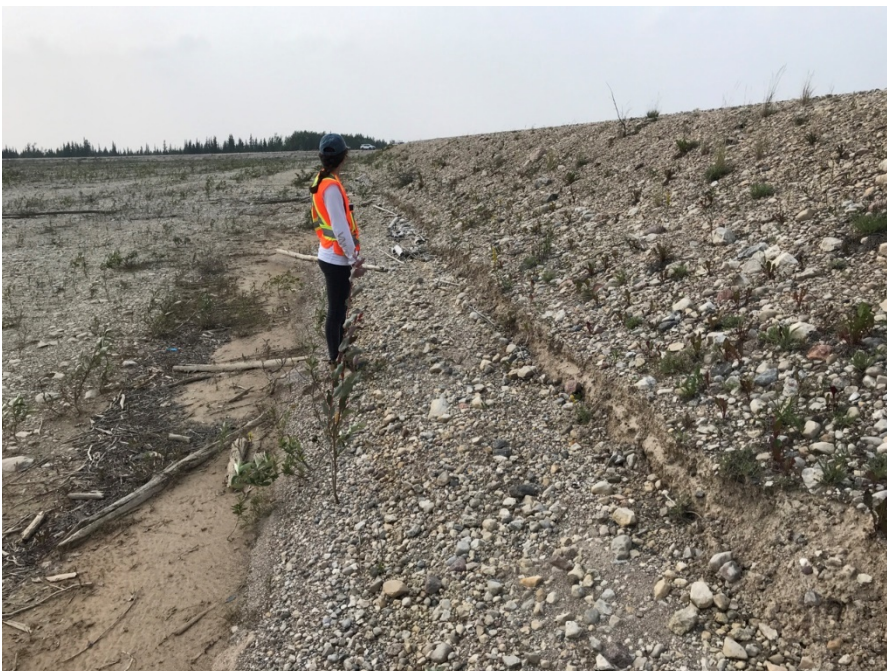
Photo II-20 North Dyke – looking west, slumping and erosion along toe of upstream slope

The absence of riprap in parts of the North Dyke upstream slope has resulted in erosion damage. Adequately sized riprap should be placed in locations that do not have riprap protection.

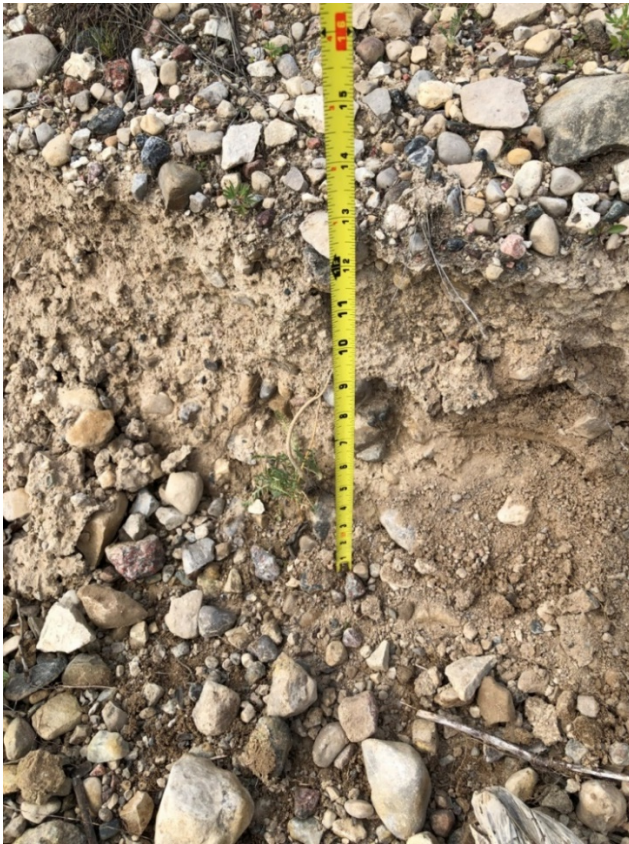
Photo II-21 North Dyke – head scarp of slump along upstream toe

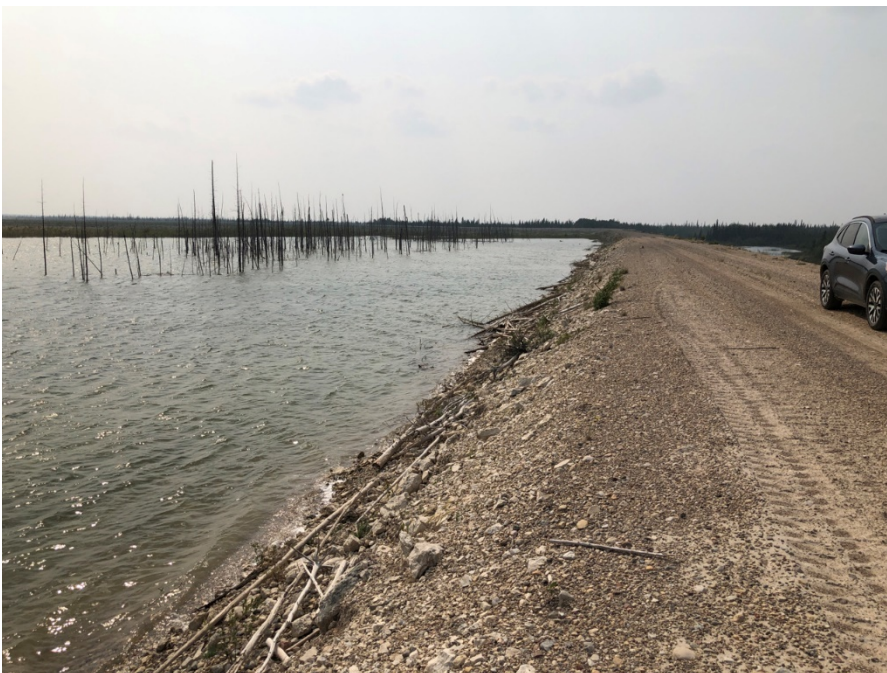
Photo II-22 North Dyke – looking east, minor erosion on upstream slope

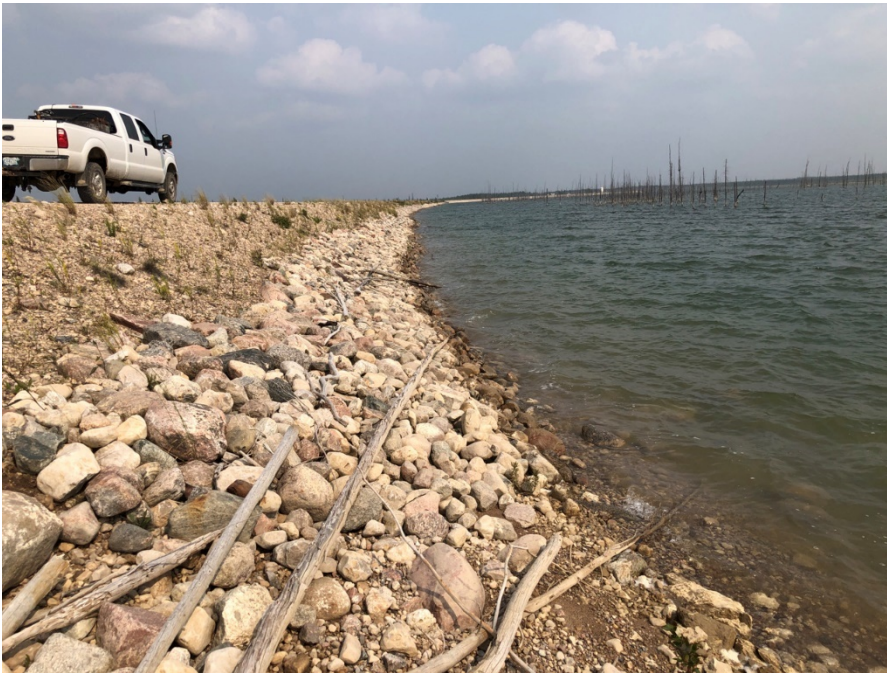
Photo II-23 North Dyke – looking east, riprap placed on upstream slope

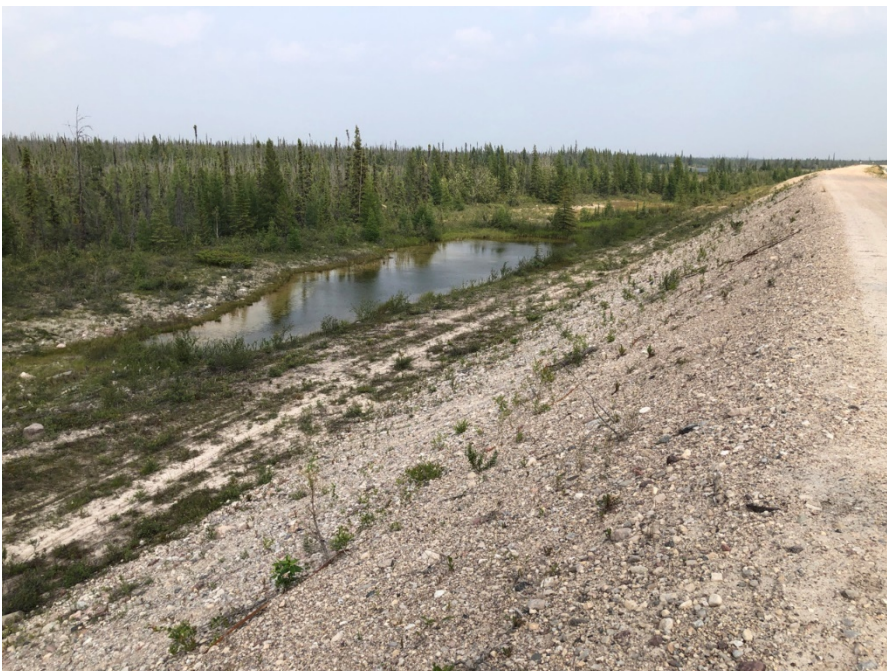
Photo II-24 North Dyke – looking northeast, pond near downstream toe

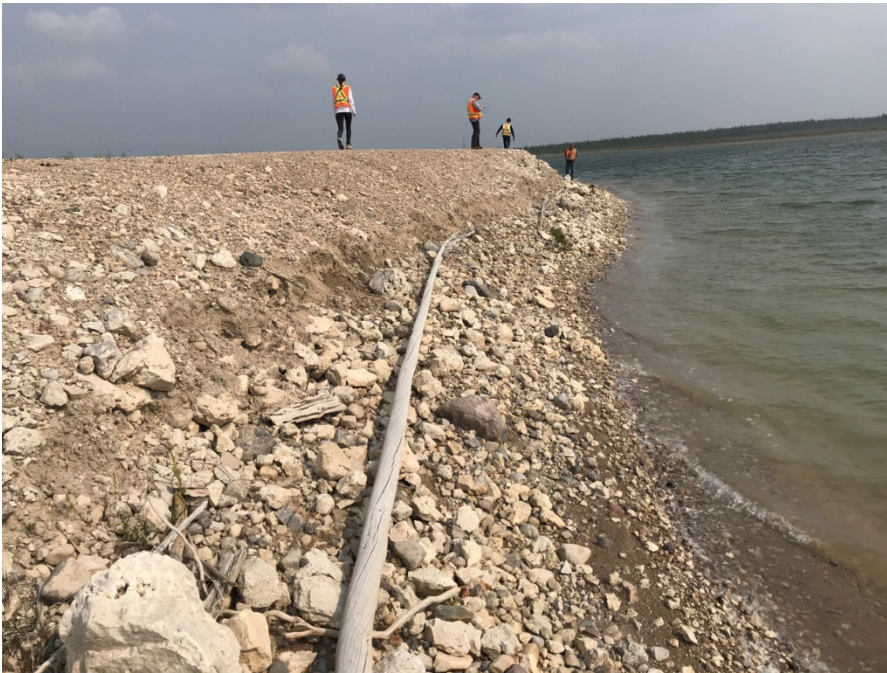
Photo II-25 North Dyke – looking east, slumping and erosion on upstream slope

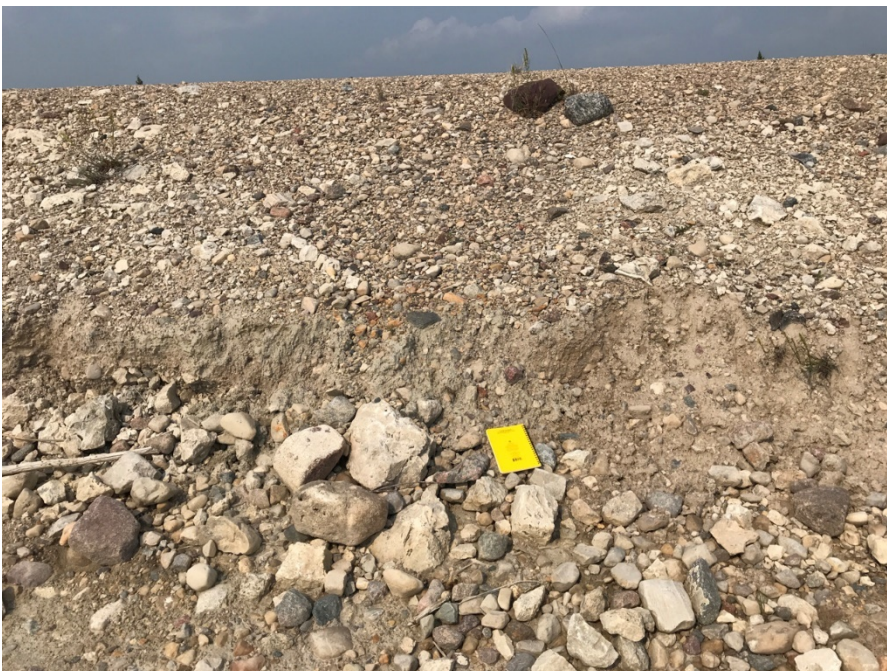
Photo II-26 North Dyke – looking north, slumping and erosion on upstream slope

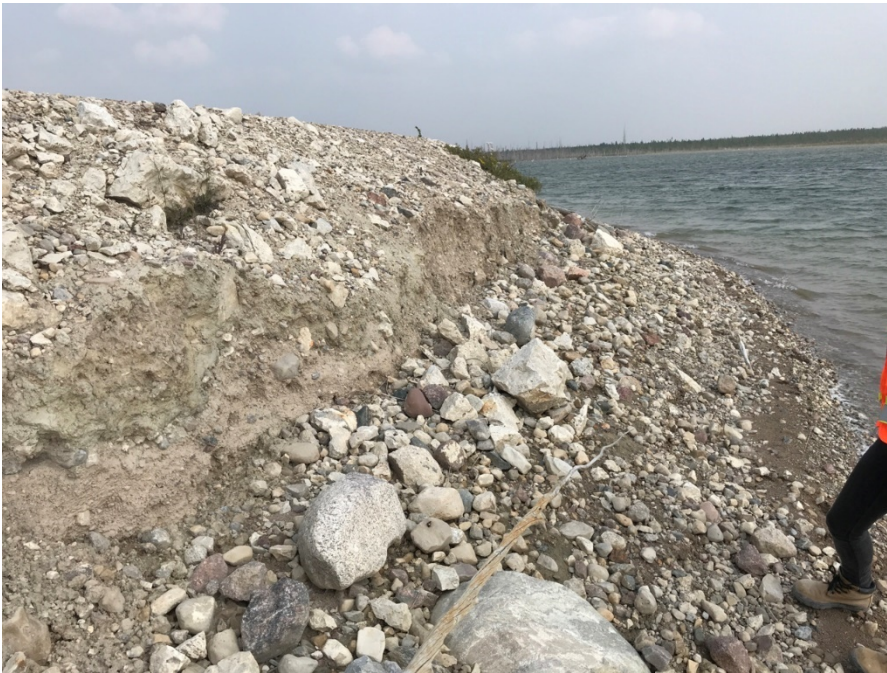
Photo II-27 North Dyke – looking east, slumping and erosion on upstream slope

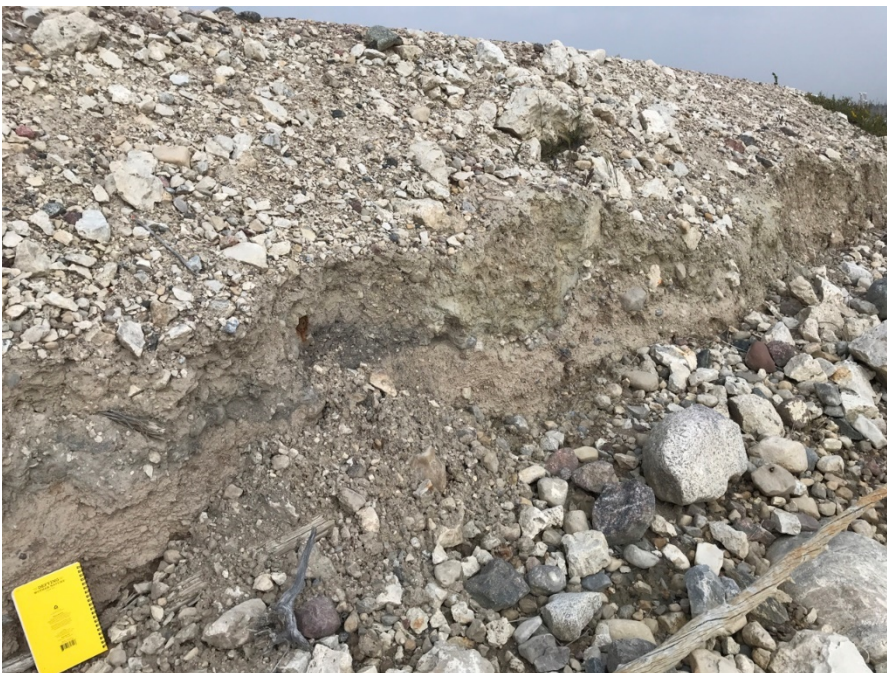
Photo II-28 North Dyke – looking north, slumping and erosion on upstream slope

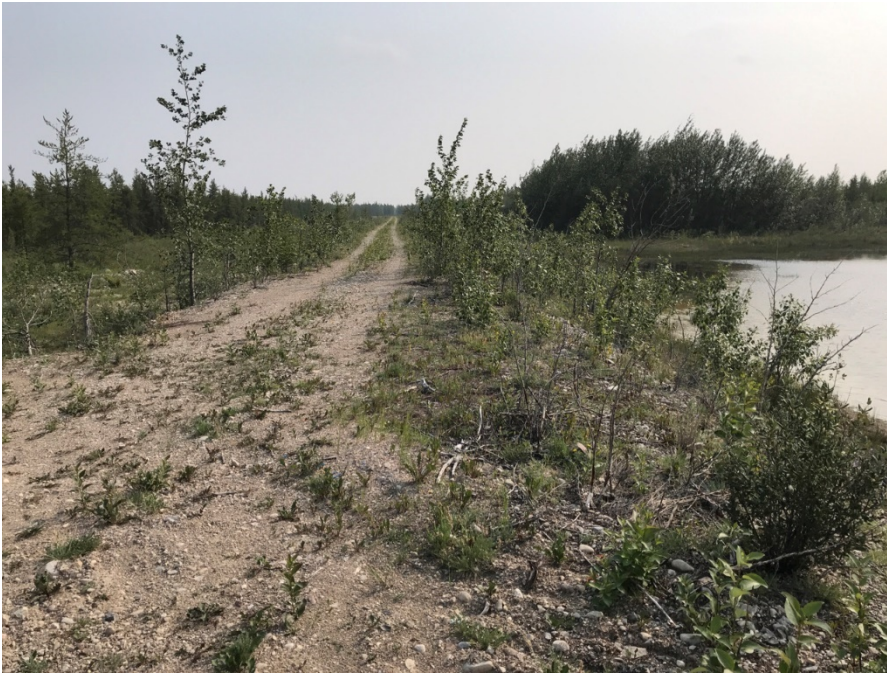
- The East Dyke crest, and upstream and downstream slopes were in good condition (Photos II-29 to II-31).
- Ponding was observed both upstream and downstream of the dyke in some areas (Photos II-29, II-31).
- Minor rills were observed on the downstream slope at some locations (Photo II-30).
- Vegetation on the downstream and upstream slopes of the East Dyke is larger than was observed on the other dykes (Photo II-29), with trunk diameters around 20 mm but not approaching the removal criteria of 100 mm for the East Dyke.

Photo II-29 **East Dyke – looking south, ponding near upstream slope, vegetation present on both sides of dyke**

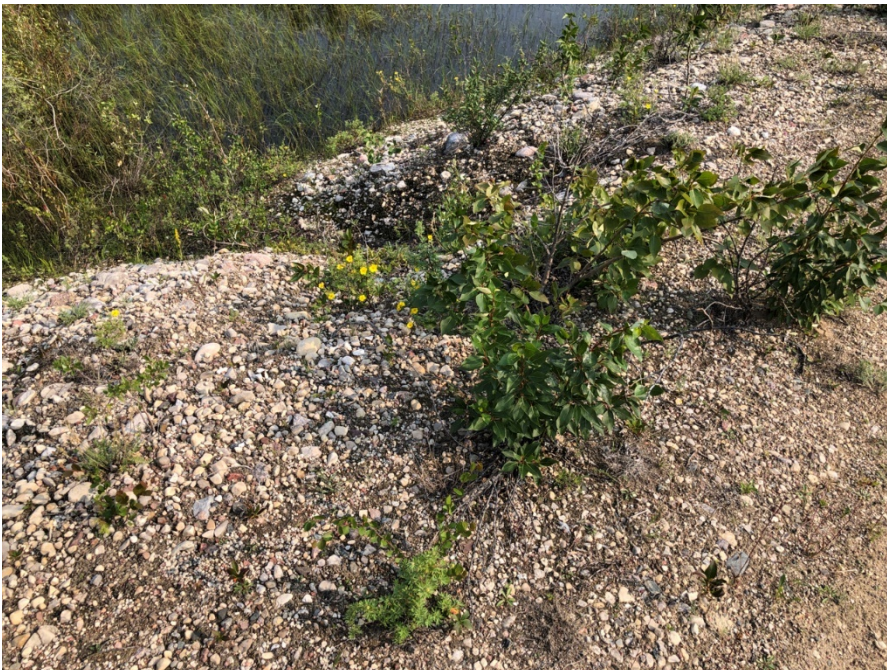
Photo II-30 **East Dyke – looking southeast, rill observed on downstream slope**

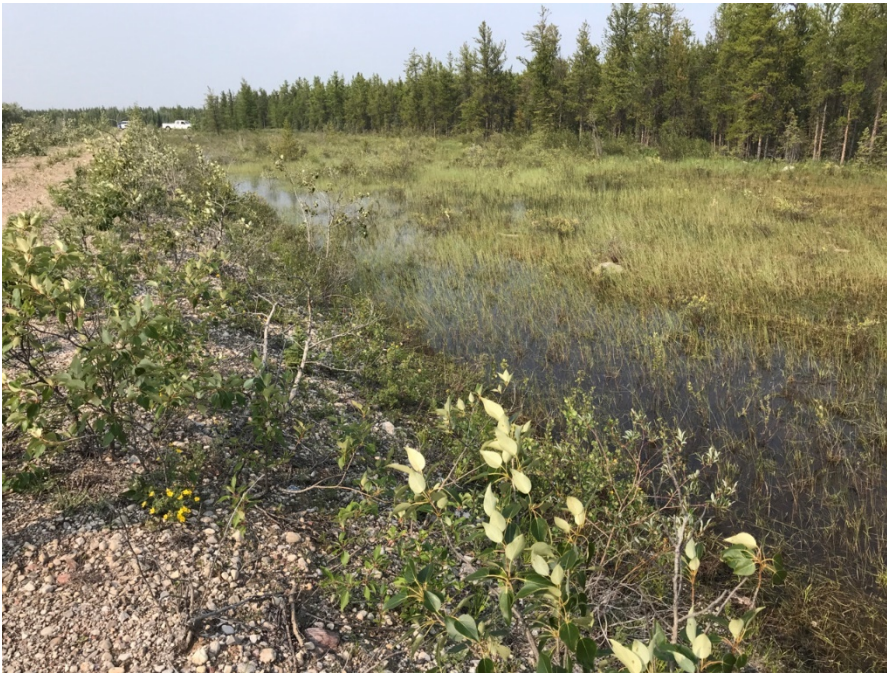
Photo II-31 East Dyke – looking north, vegetation on downstream slope and ponding at toe

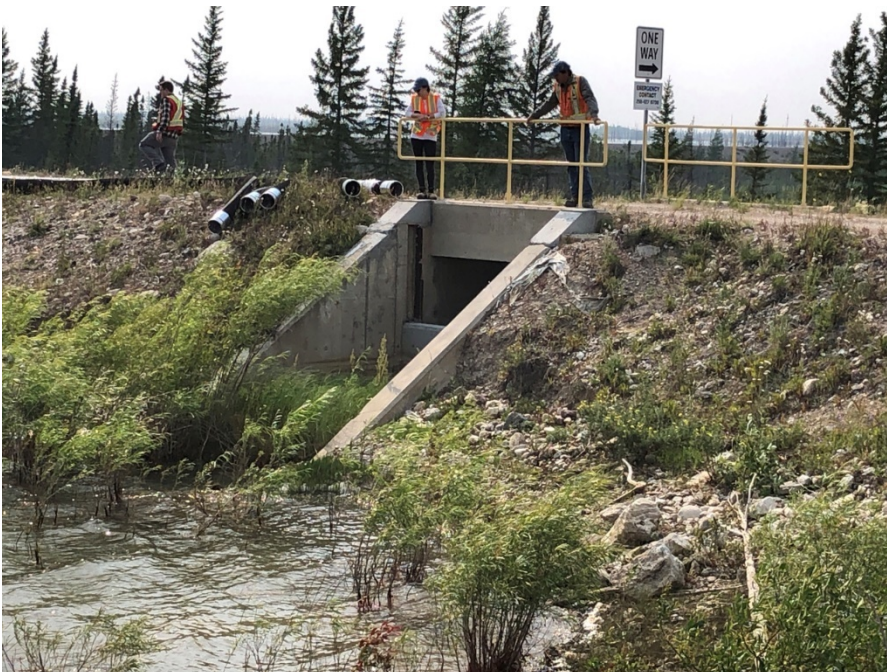
- The concrete Main Pond Spillway structure appeared to be in good condition (Photo II-32).
- Minor vegetation is growing along the base of the channel, but not enough to significantly affect the flow capacity.
- The erosion and slumping of the North Dyke upstream slope noted above is also occurring locally on either side of the spillway concrete wing walls, leaving 50 cm head scarps on either side (Photo II-32). Maskwa also observed minor erosion on the slope below the spillway inlet during the August 27 inspection after the pond had been drawn down further (Maskwa 2021d).
- Maskwa observed woody debris floating in the pond at the inlet of the Main Pond Spillway during the May 26 inspection (Maskwa 2021b). This was removed shortly after (Maskwa

Photo II-32 Main Pond Spillway – looking southwest, erosion and slumping of upstream slope on either side of spillway wing walls

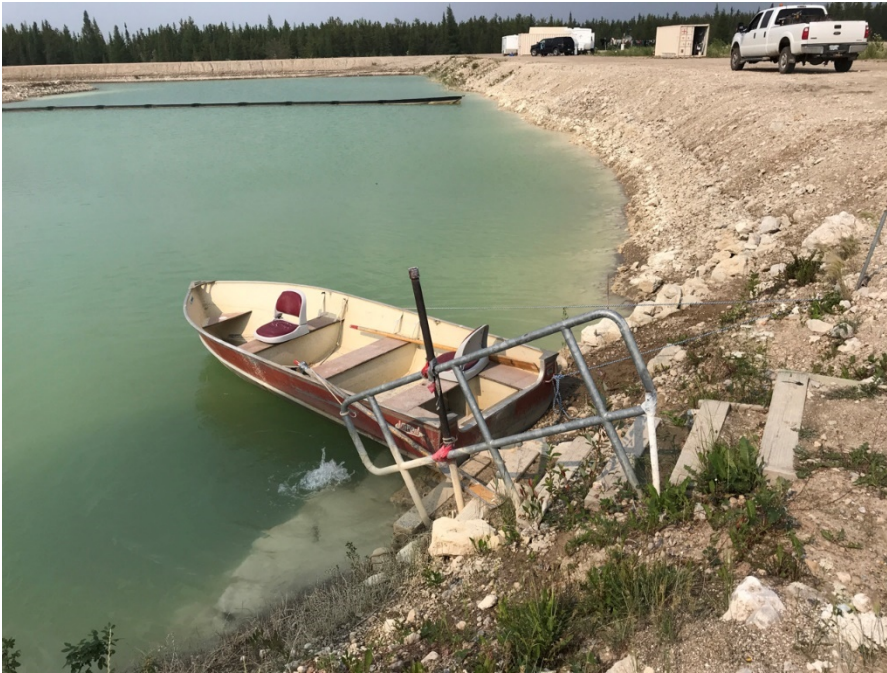
- The Polishing Pond Dykes were in good condition (Photos II-33 and II-34).
- Water treatment was in progress at the time of the inspection. Both ends of the culvert between the Main Pond and the Polishing pond were submerged, the culvert valve was open, and flow was observed bubbling up above the outlet in the Polishing Pond. Lime solution was being added to the water at the culvert inlet, and air was being injected into the middle of the culvert to promote mixing. The main pond level was observed at the staff gauge (see location in Figure 4.2) at 201.41 m in the morning, and had dropped to 201.40 m in the afternoon. This water level is 1.4 m above the culvert inlet, and is below the revised, temporary NOWL of 201.9 m for the 2021 freshet period (Golder 2021a).

Photo II-33 Polishing Pond – looking northeast, water observed bubbling above culvert outlet(p87)

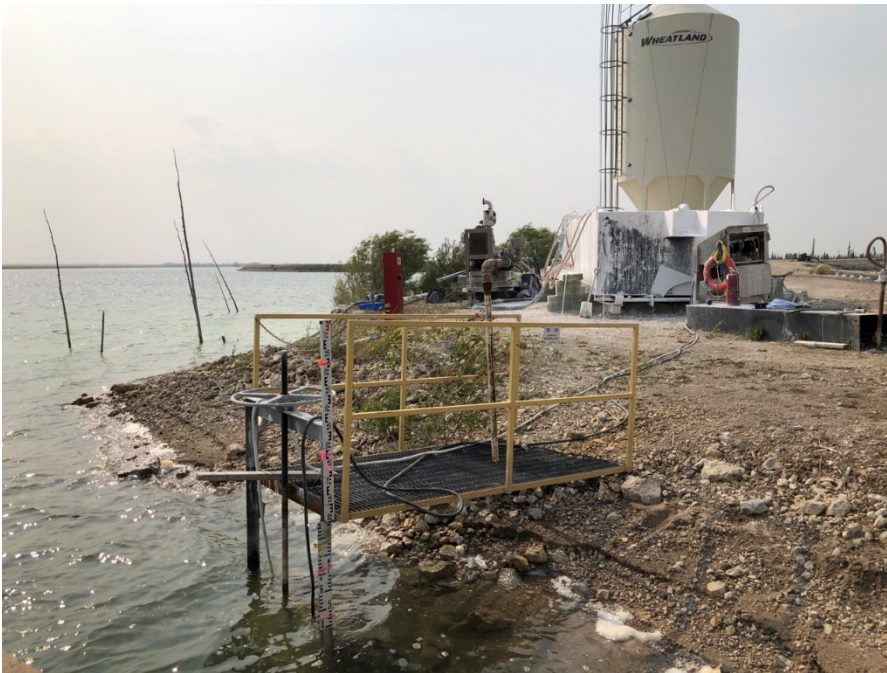
Photo II-34 Polishing Pond – looking southwest, staff gauge flagged for multiple levels

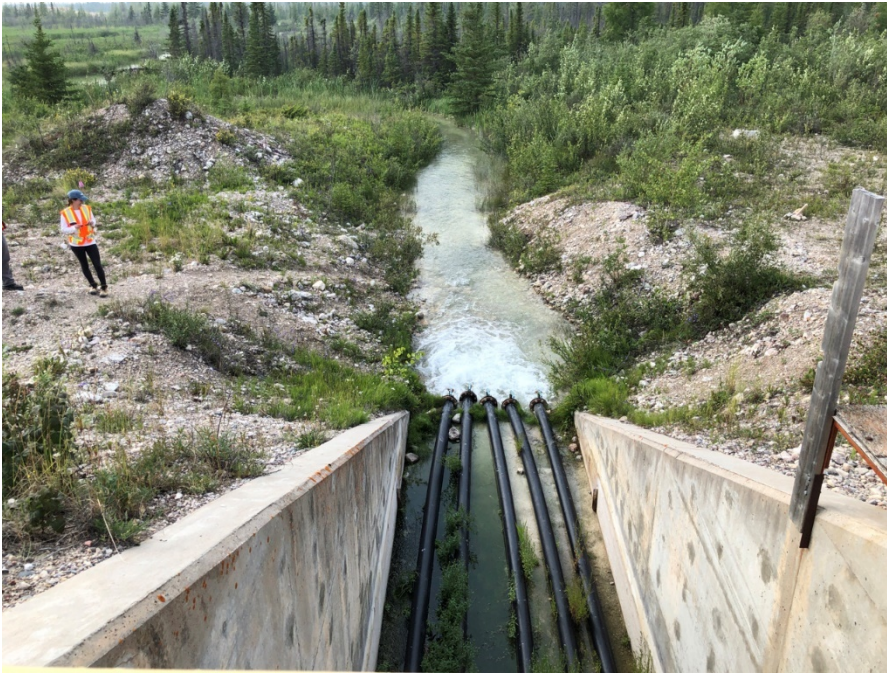
- The concrete Polishing Pond Spillway structure appeared to be in good condition (Photos II-35 and II-36).
- Five siphon pipes run from the Polishing Pond over the spillway to the downstream end of the spillway, and the valves were open and all five were flowing at the time of the inspection (Photo II-35). The water treatment operator estimated the flow rate at 20,000 m³/day.
- There were no signs of erosion at the discharge point.

Photo II-35 Polishing Pond Spillway – looking northwest, pond outlet pipes (est. 20,000m³/day outflow)
