Pine Point Mine Tailings Impoundment Area

2021 Annual Facility Performance Review

November 2, 2021

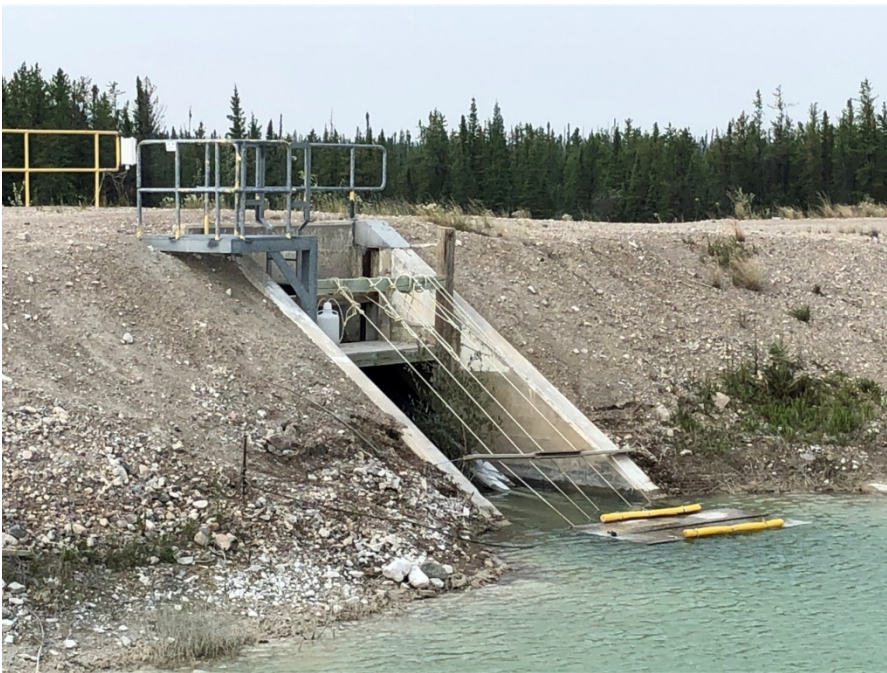
Photo II-36 Polishing Pond Spillway Inlet – looking northwest

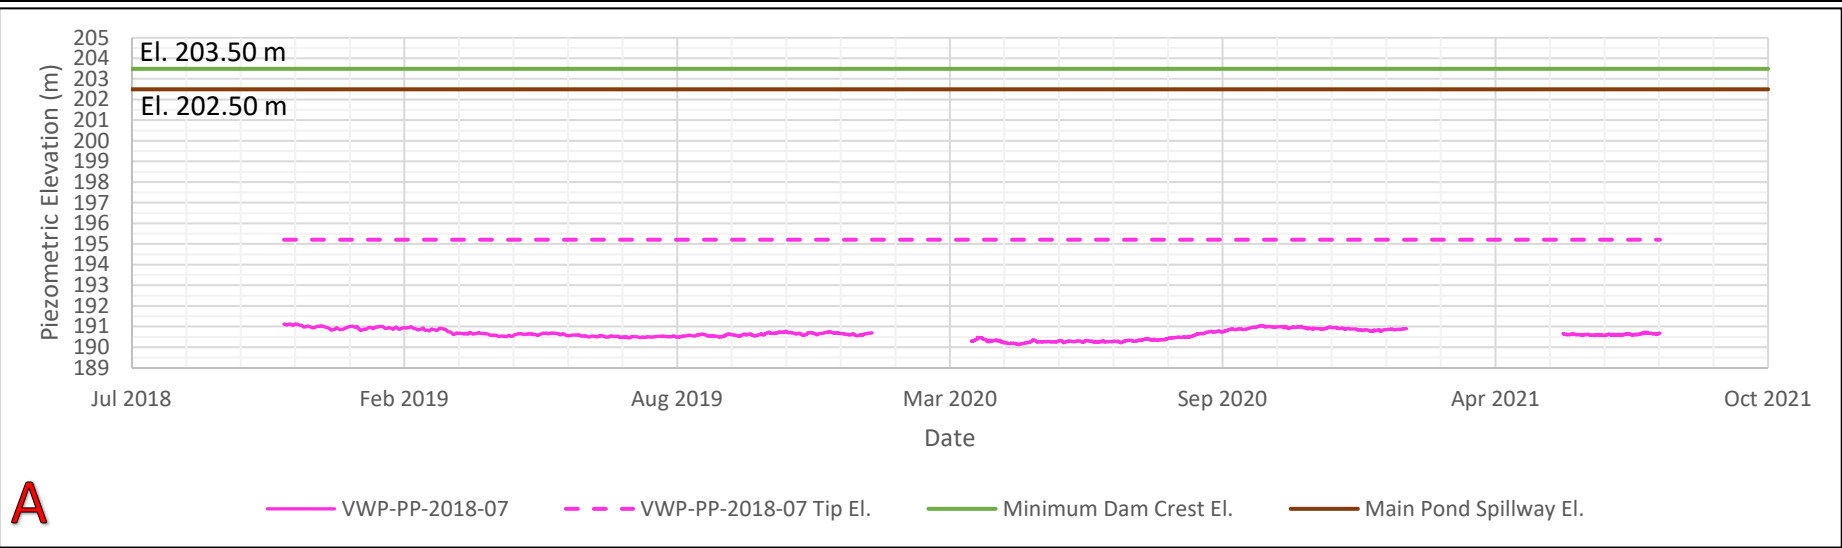
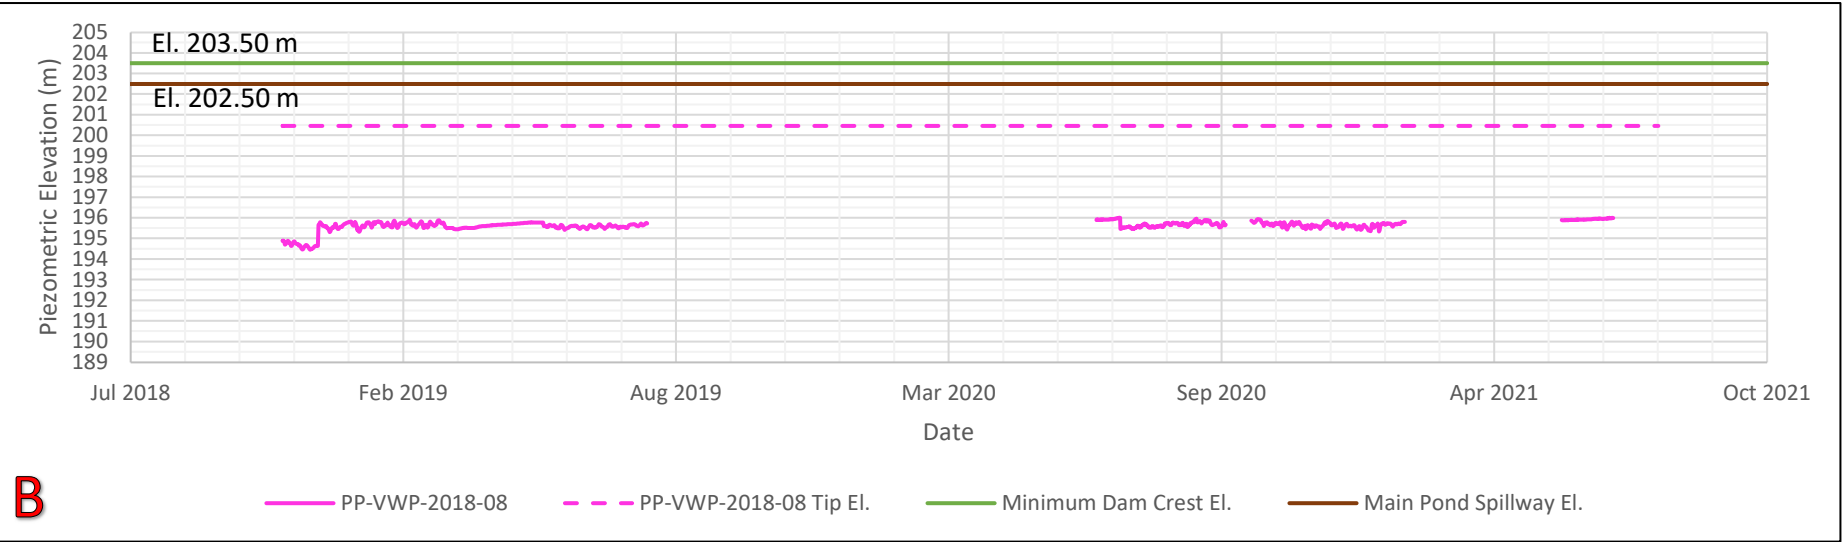
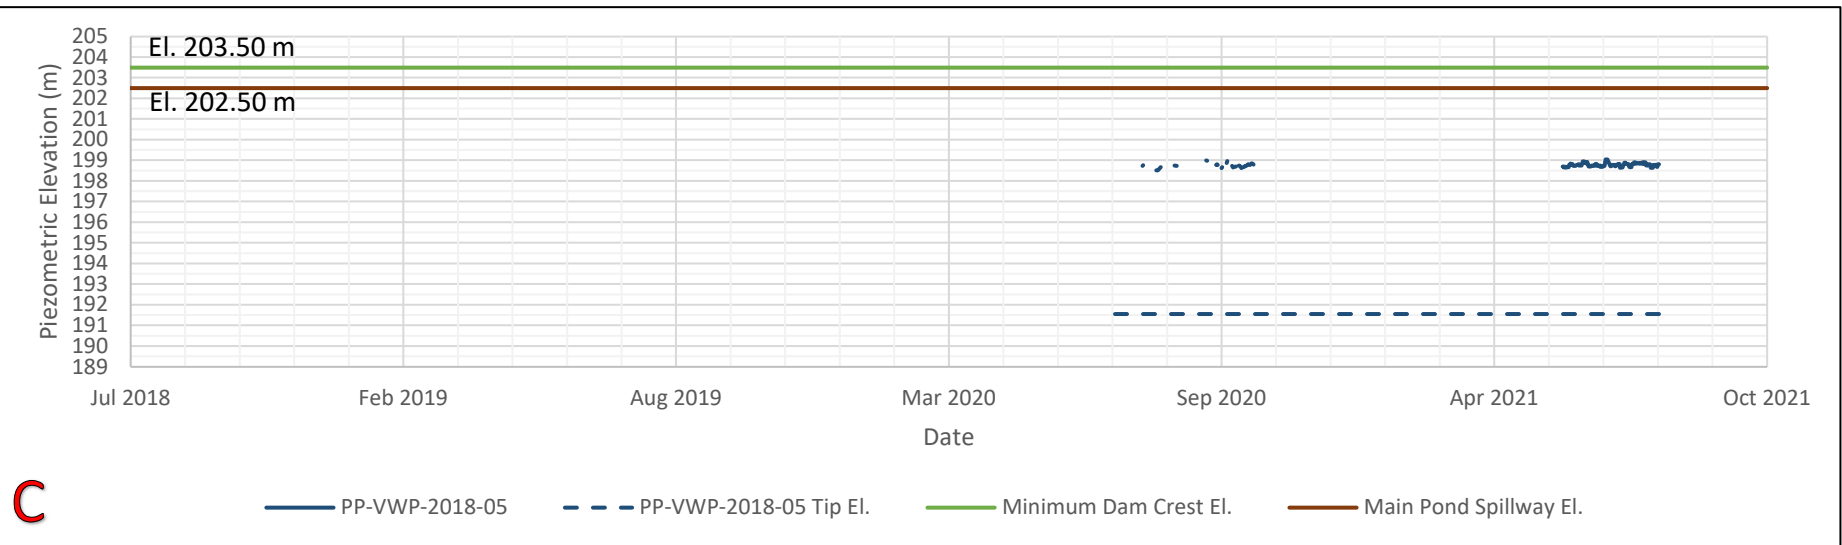
PROJECT	PINE POINT MINE TAILINGS IMPOUNDMENT AREA 2021 ANNUAL FACILITY PERFORMANCE REVIEW	
TITLE	NORTH DYKE PIEZOMETERS SHEET 1 OF 2	
PROJECT No.	M10397A01	FIG No. IV-1

- A** -Instrument PP-VWP-2018-07: Pressure head readings are negative. Piezometric levels cannot be determined from negative pressure readings.
- B** -Instrument PP-VWP-2018-08: Pressure head readings are negative. Piezometric levels cannot be determined from negative pressure readings.
- C** -Instrument PP-VWP-2018-05: Trigger action response plans (TARPS) are scheduled to be developed for this instrument. As such any malfunctioning instrument should be repaired or replaced (Golder, 2020)

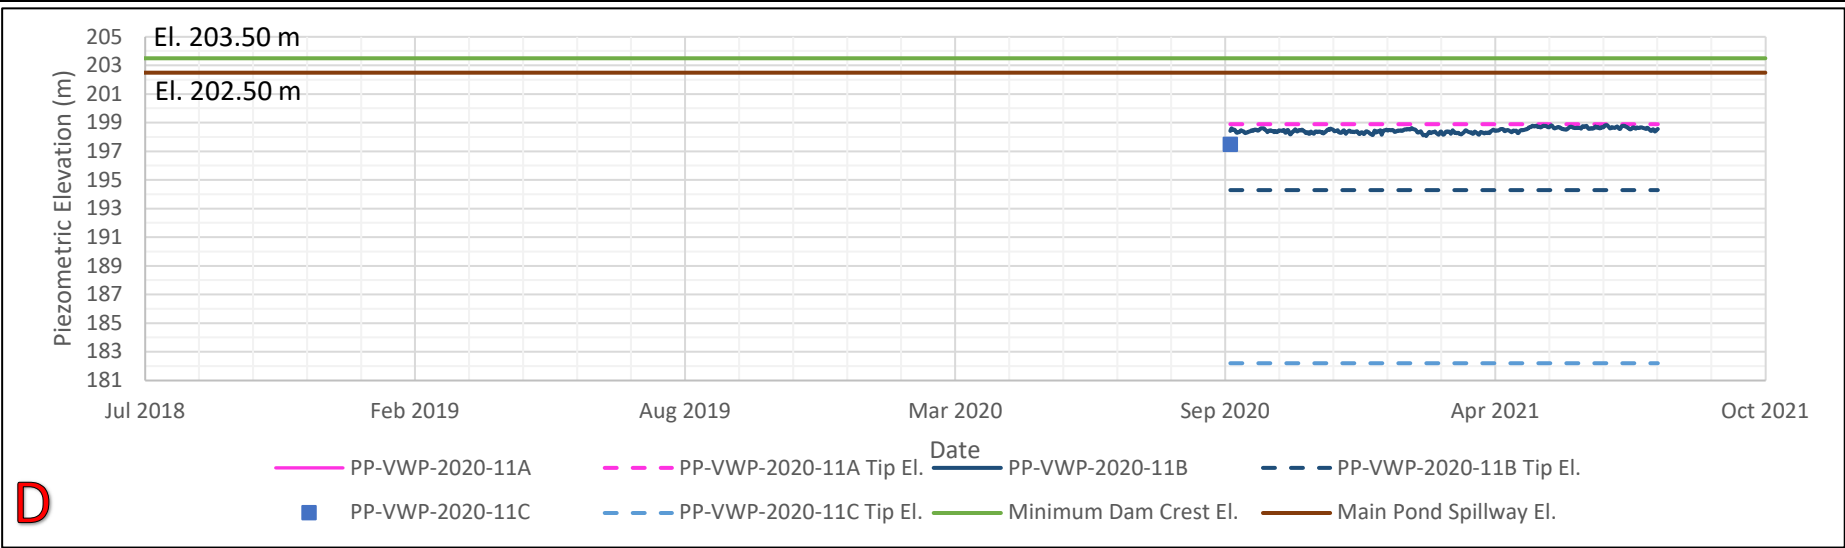
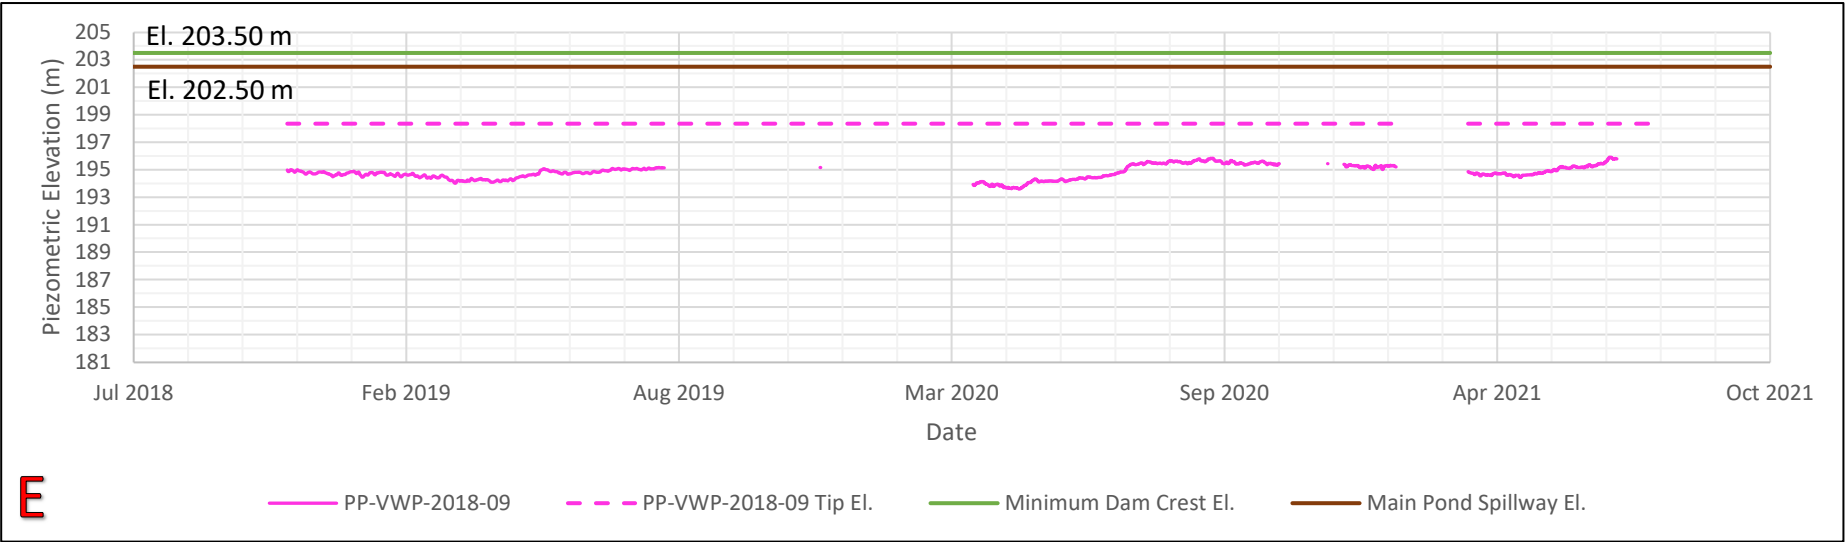
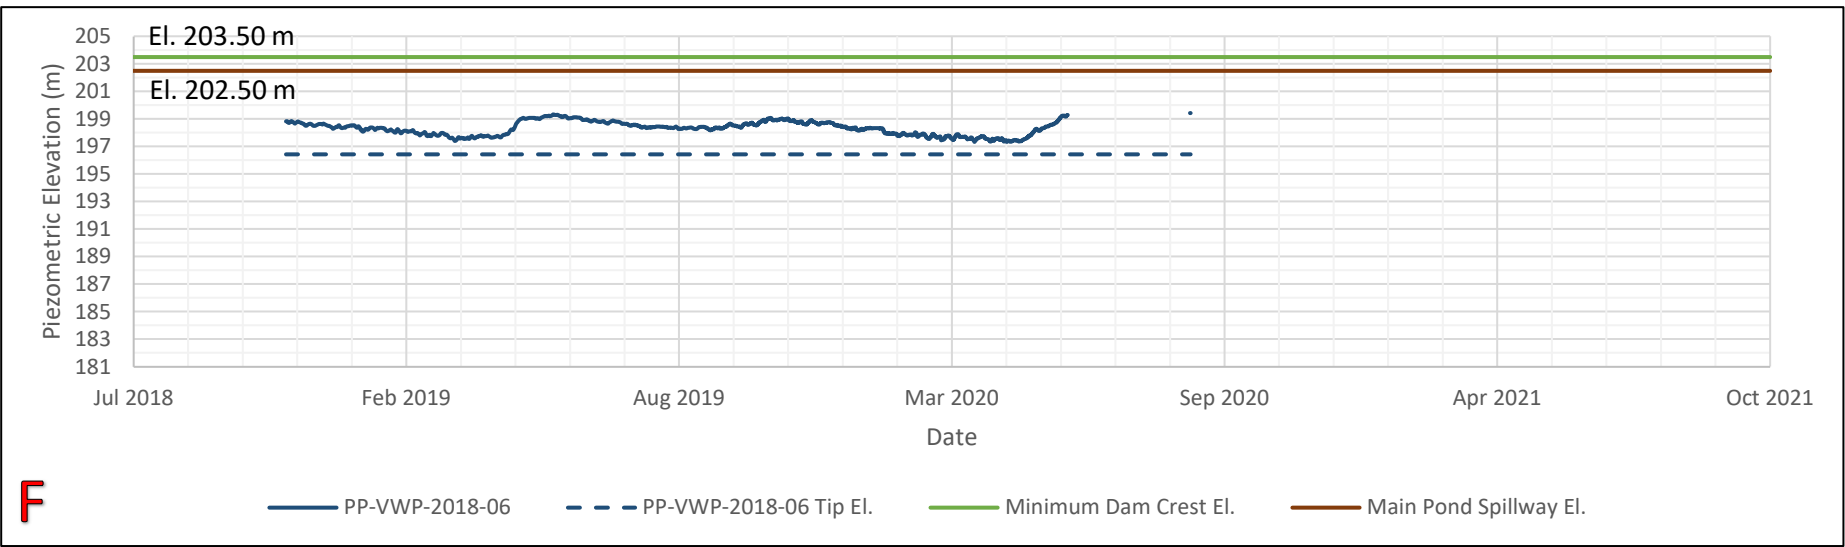
PROJECT	PINE POINT MINE TAILINGS IMPOUNDMENT AREA 2021 ANNUAL FACILITY PERFORMANCE REVIEW	
TITLE	NORTH DYKE PIEZOMETERS SHEET 2 OF 2	
PROJECT No.	M10397A01	FIG No. IV-2

- D** -Instrument PP-VWP-2020-11A: Pressure head readings equivalent to a piezometric surface on the order of 400 m elevation (omitted).
-Instrument PP-VWP-2020-11C: Single reading available for instrument.
- E** -Instrument PP-VWP-2018-09: Pressure head readings are negative. Piezometric levels cannot be determined from negative pressure readings.
- F** -Instrument PP-VWP-2018-06: Pressure readings stopped recording 2020-09-30.

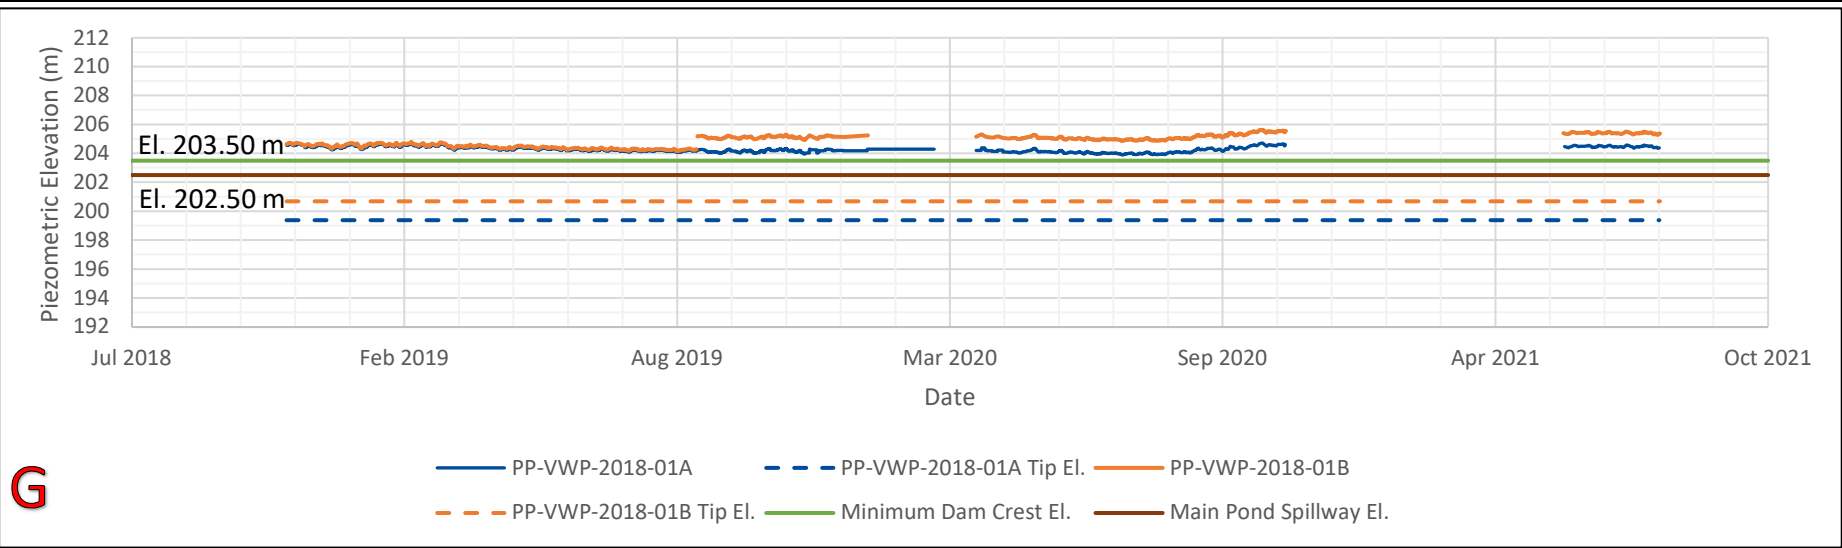
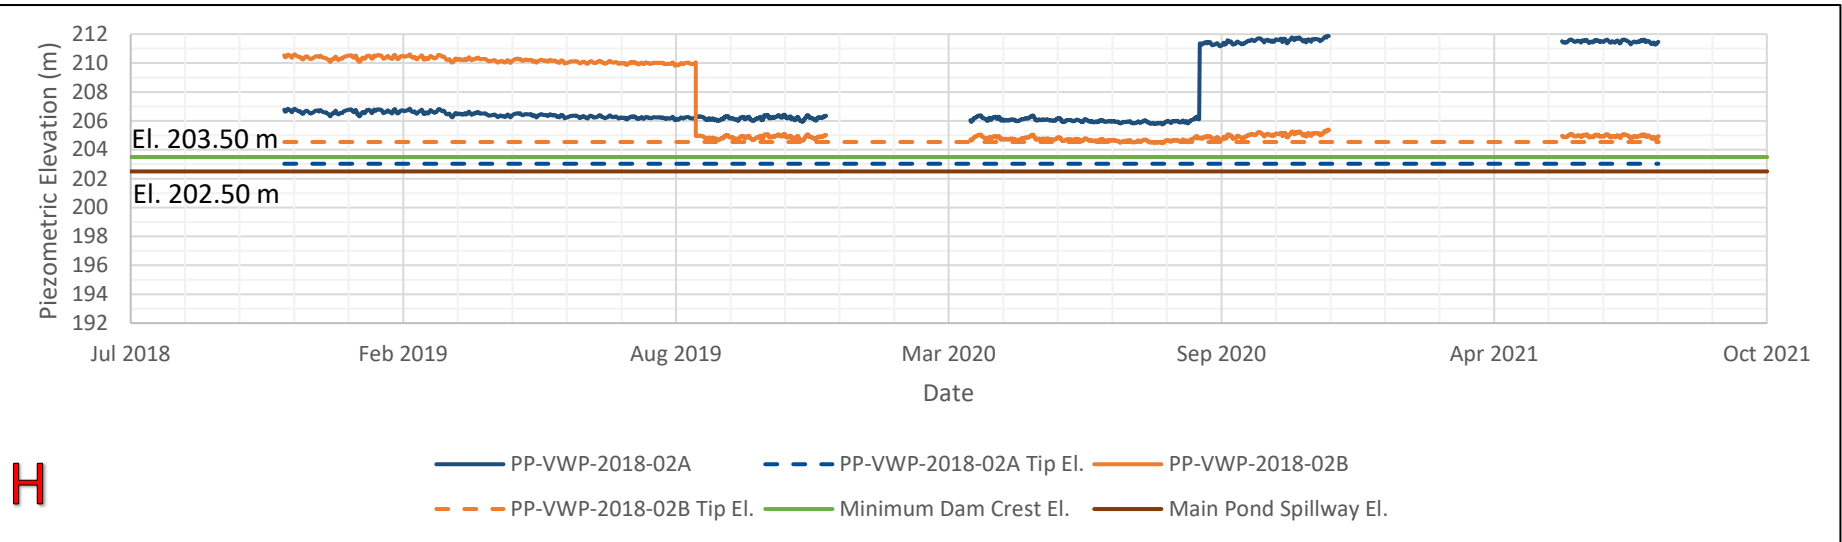
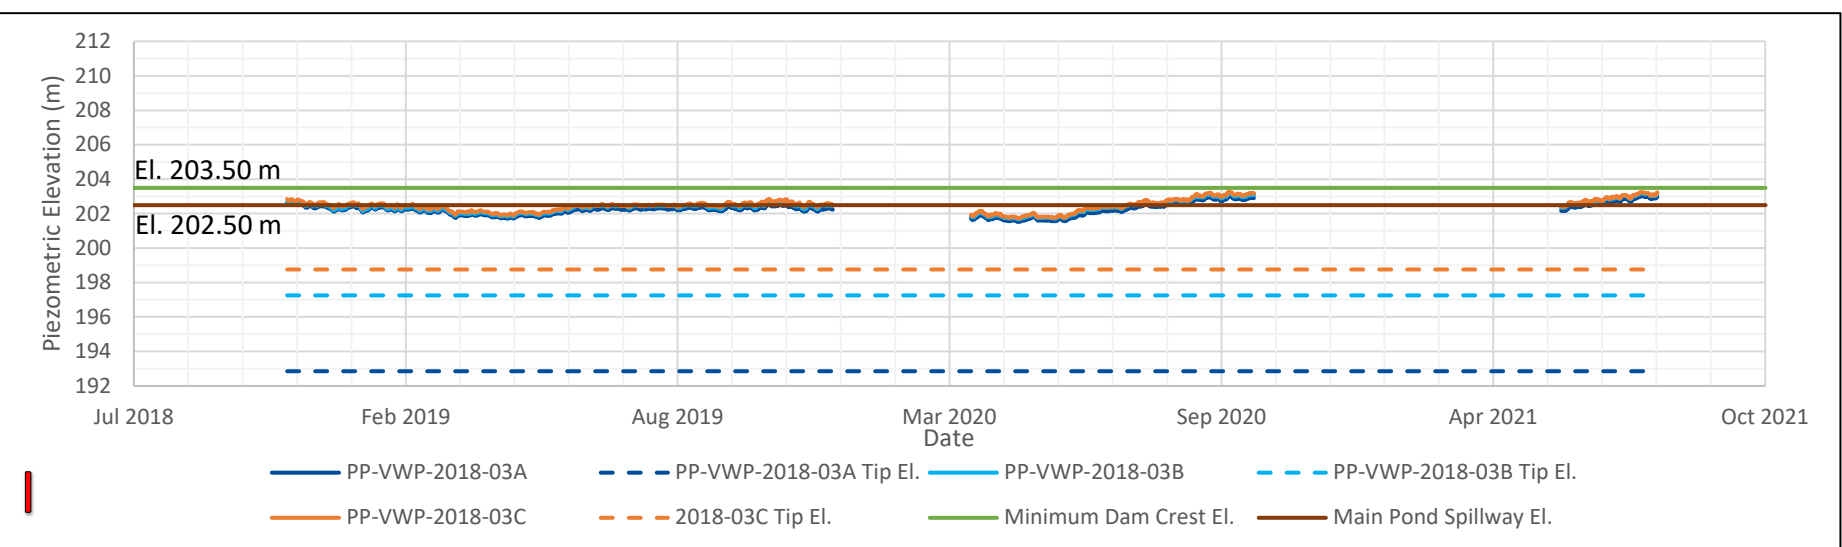
PROJECT No. M10397A01 FIG No. IV-3

- G** -Instrument PP-VWP-2018-01B: Considered not functioning as of 2020 DSI (Golder, 2020). Significant and instantaneous increase in pressure recorded is anomalous and unexplained.
- H** -Instrument PP-VWP-2018-02A and 02B: Considered not functioning as of 2020 DSI (Golder, 2020). Significant and instantaneous increase/decrease in pressure recorded is anomalous and unexplained.

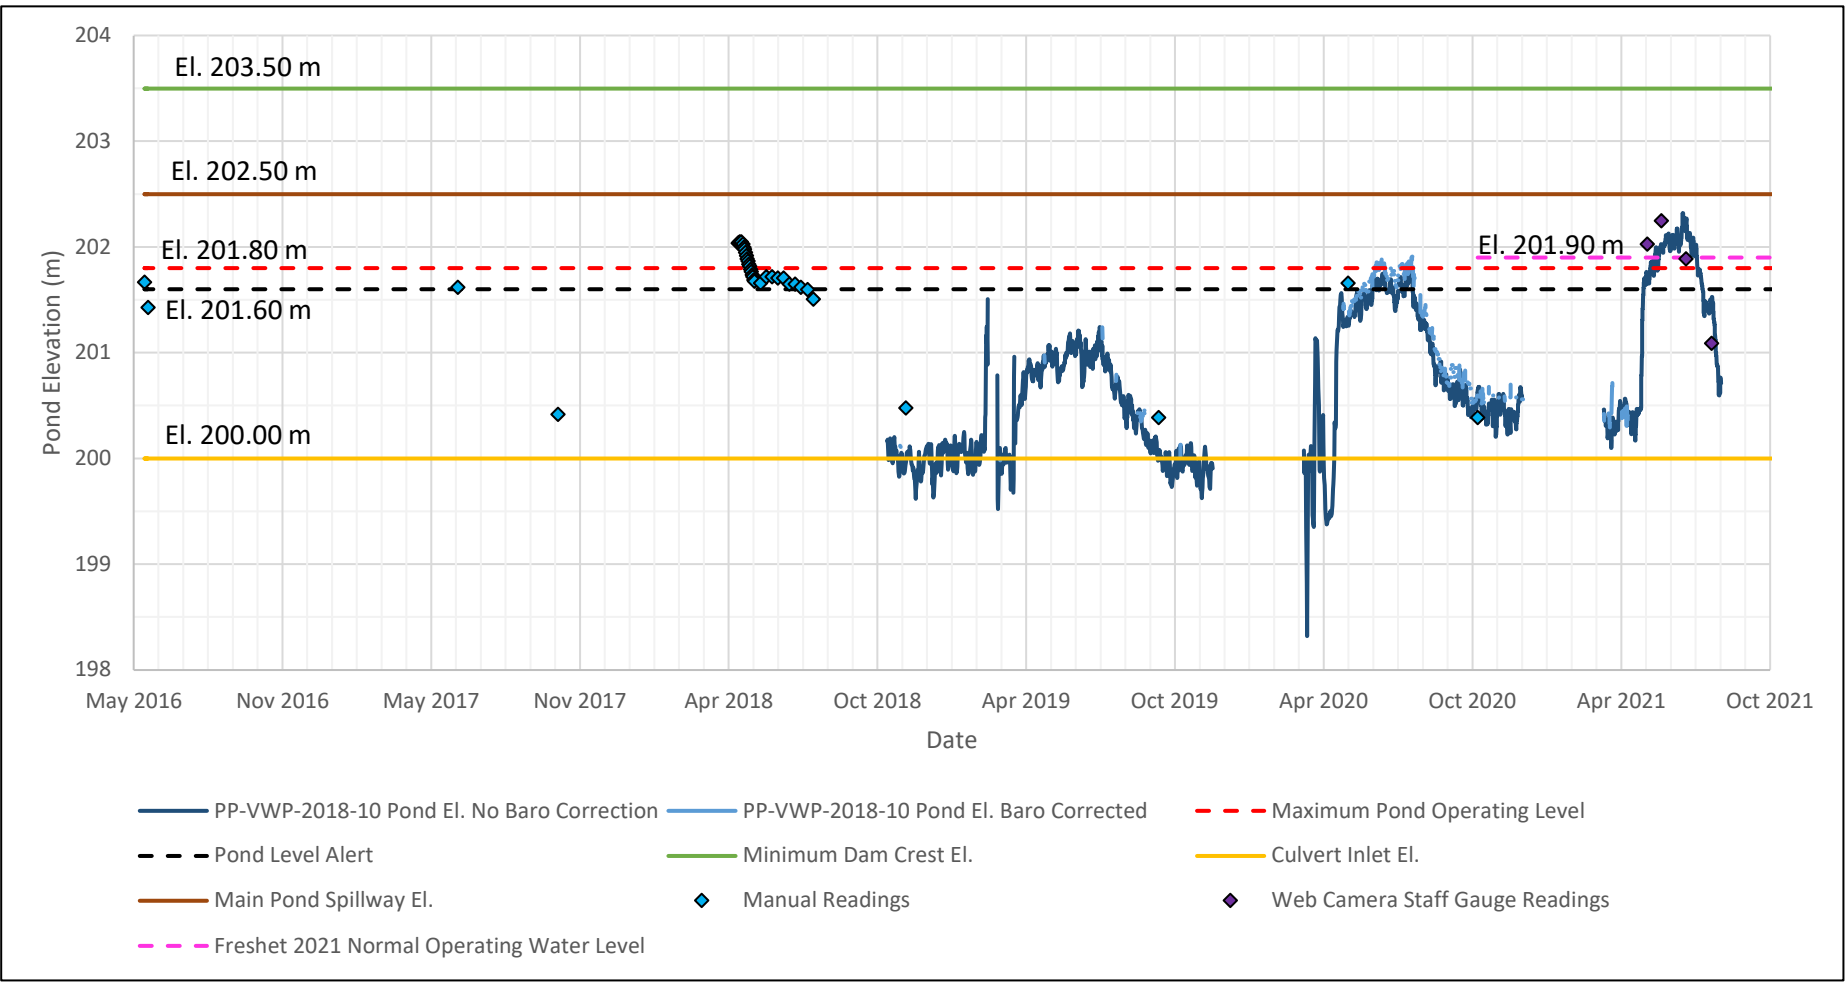
IV-4

-PP-VWP-2018-10 pond level readings differ from manual readings (Golder 2021b)
