Teck Coal Ltd.

Quintette Coal Operations

Shikano North Tailings Dam

2021 Annual Summary of Tailings Facility Performance

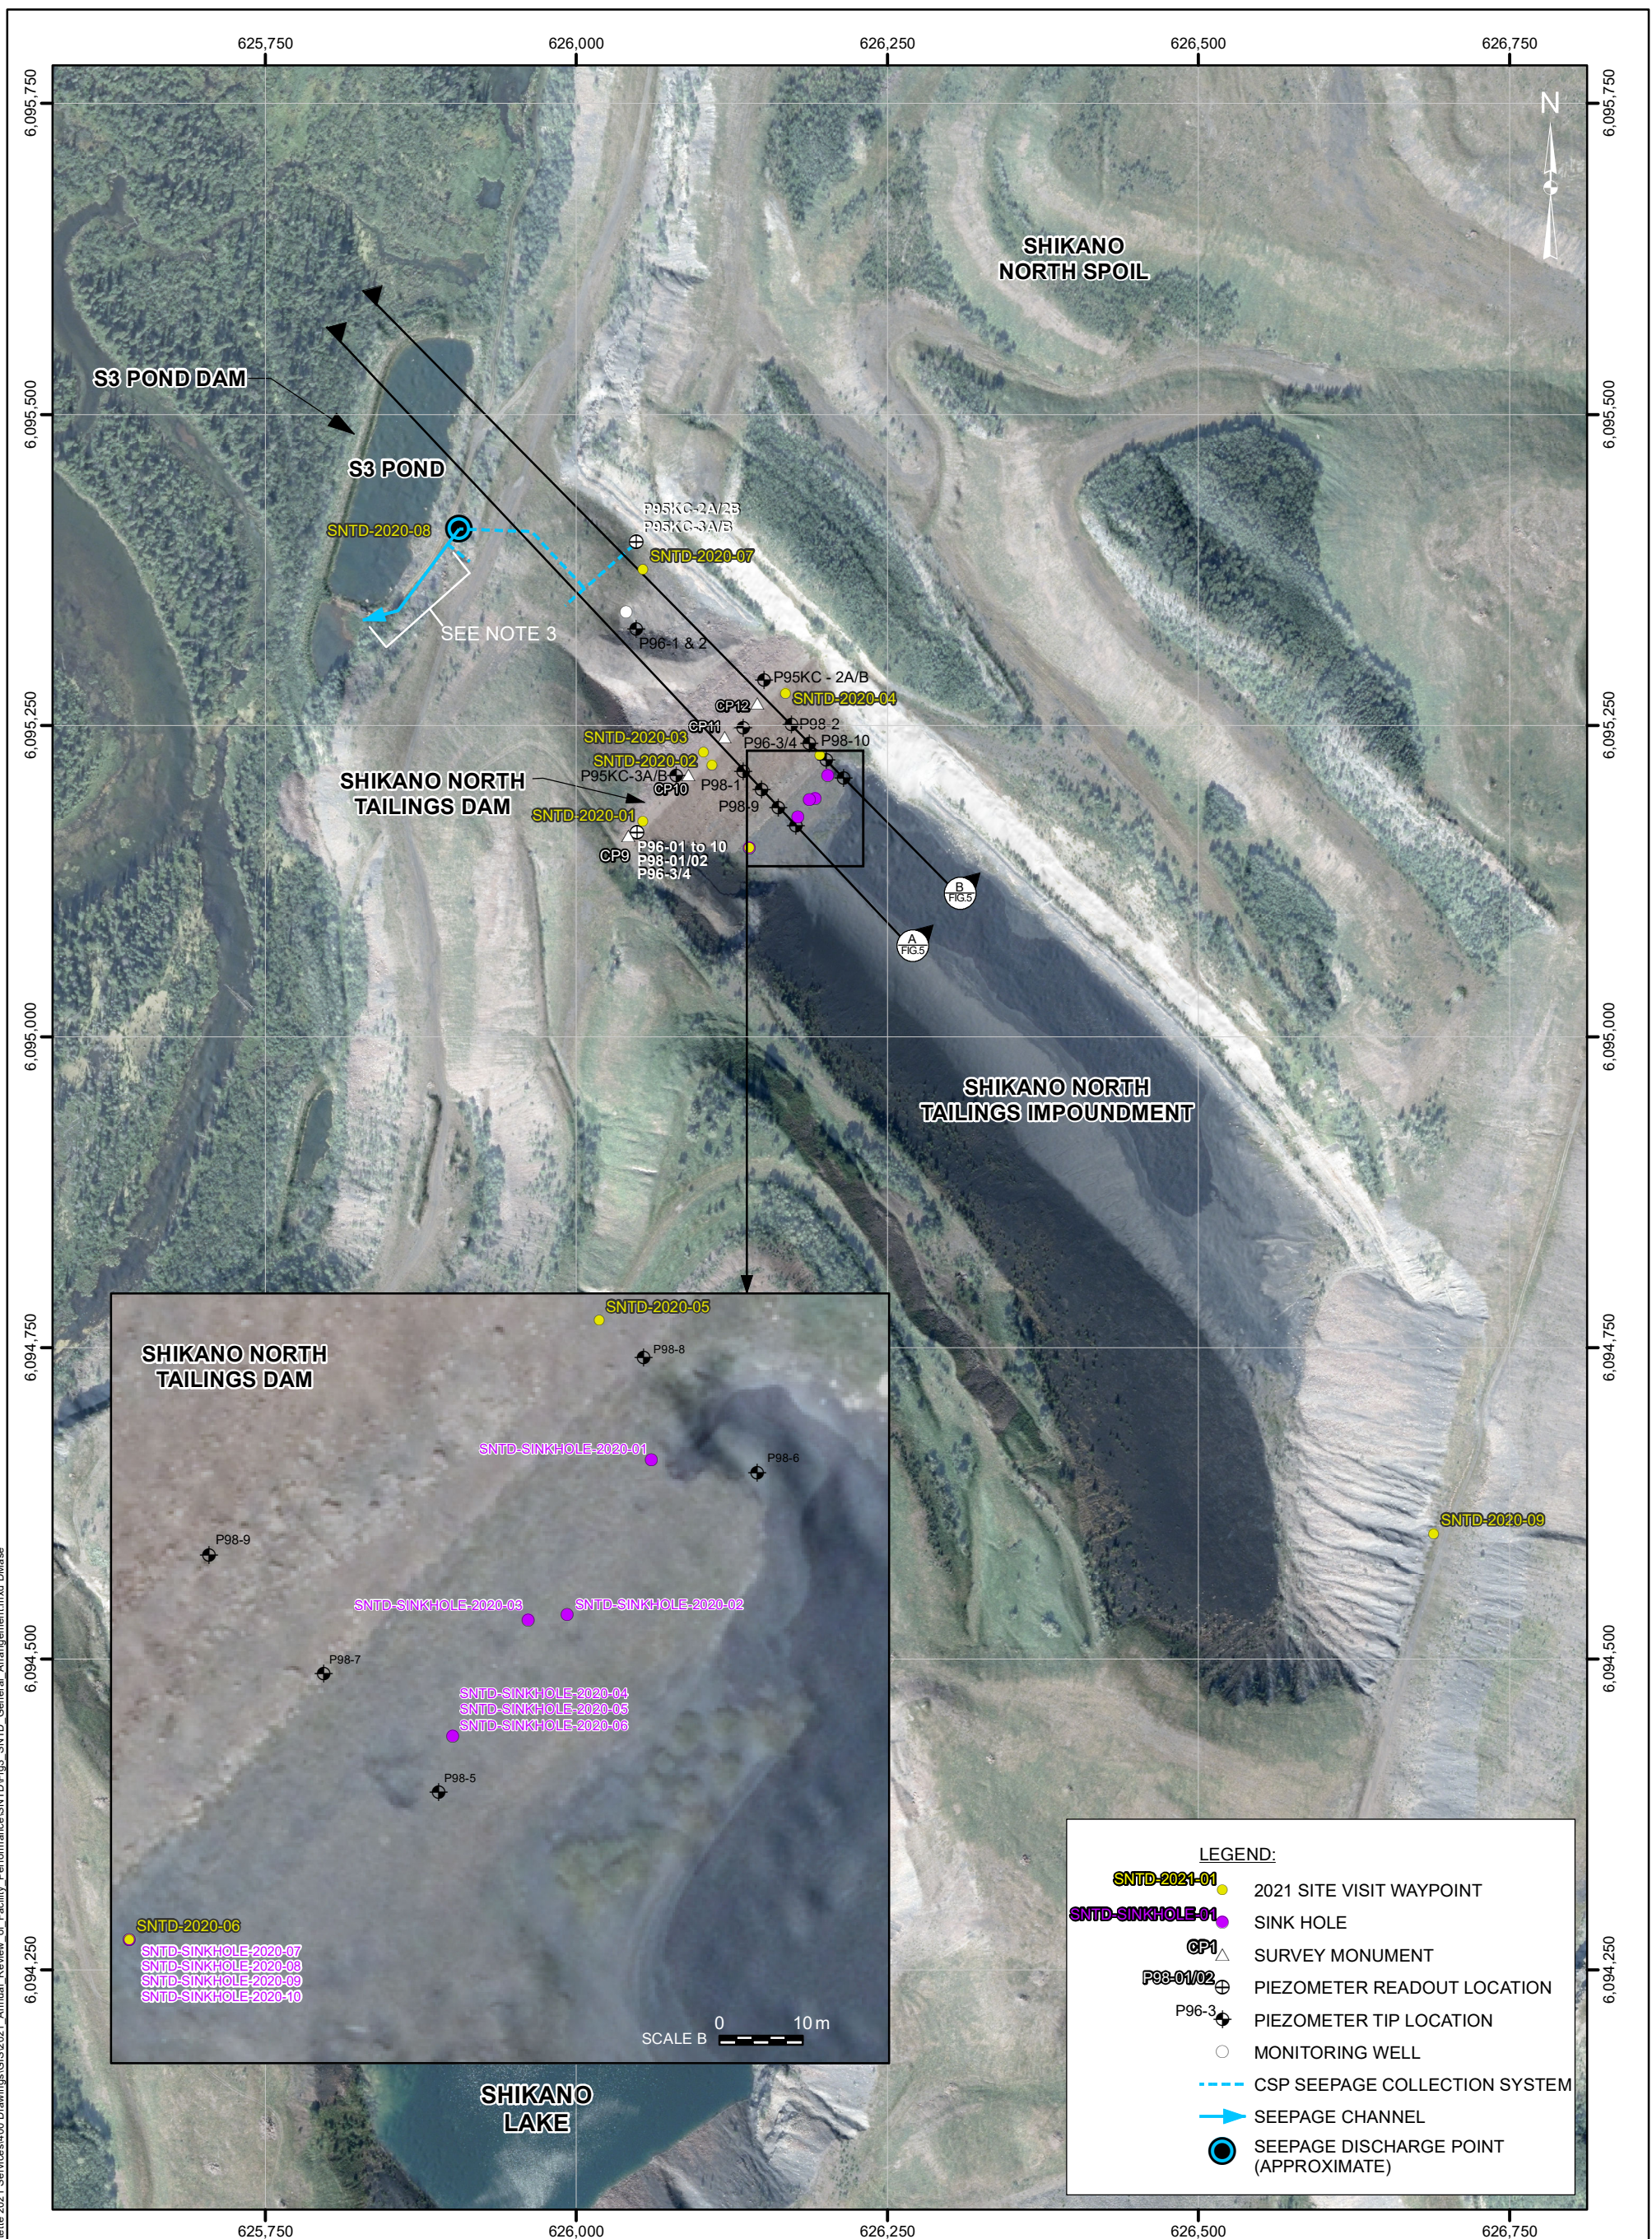
3

There are a number of sinkholes on the tailings beach; the location of the sinkholes are shown on Figure 3. The sinkholes were first observed during a site visit in 2010 (KCB 2011), but may have been present or started to develop prior to this date. The cause of these features is most likely the migration of tailings into the upstream coarse rockfill shell (2 m minus waste rock) (Figure 5), which is upstream of the filter zones. The sinkholes are considered a local condition and not a risk to the SNTD integrity.

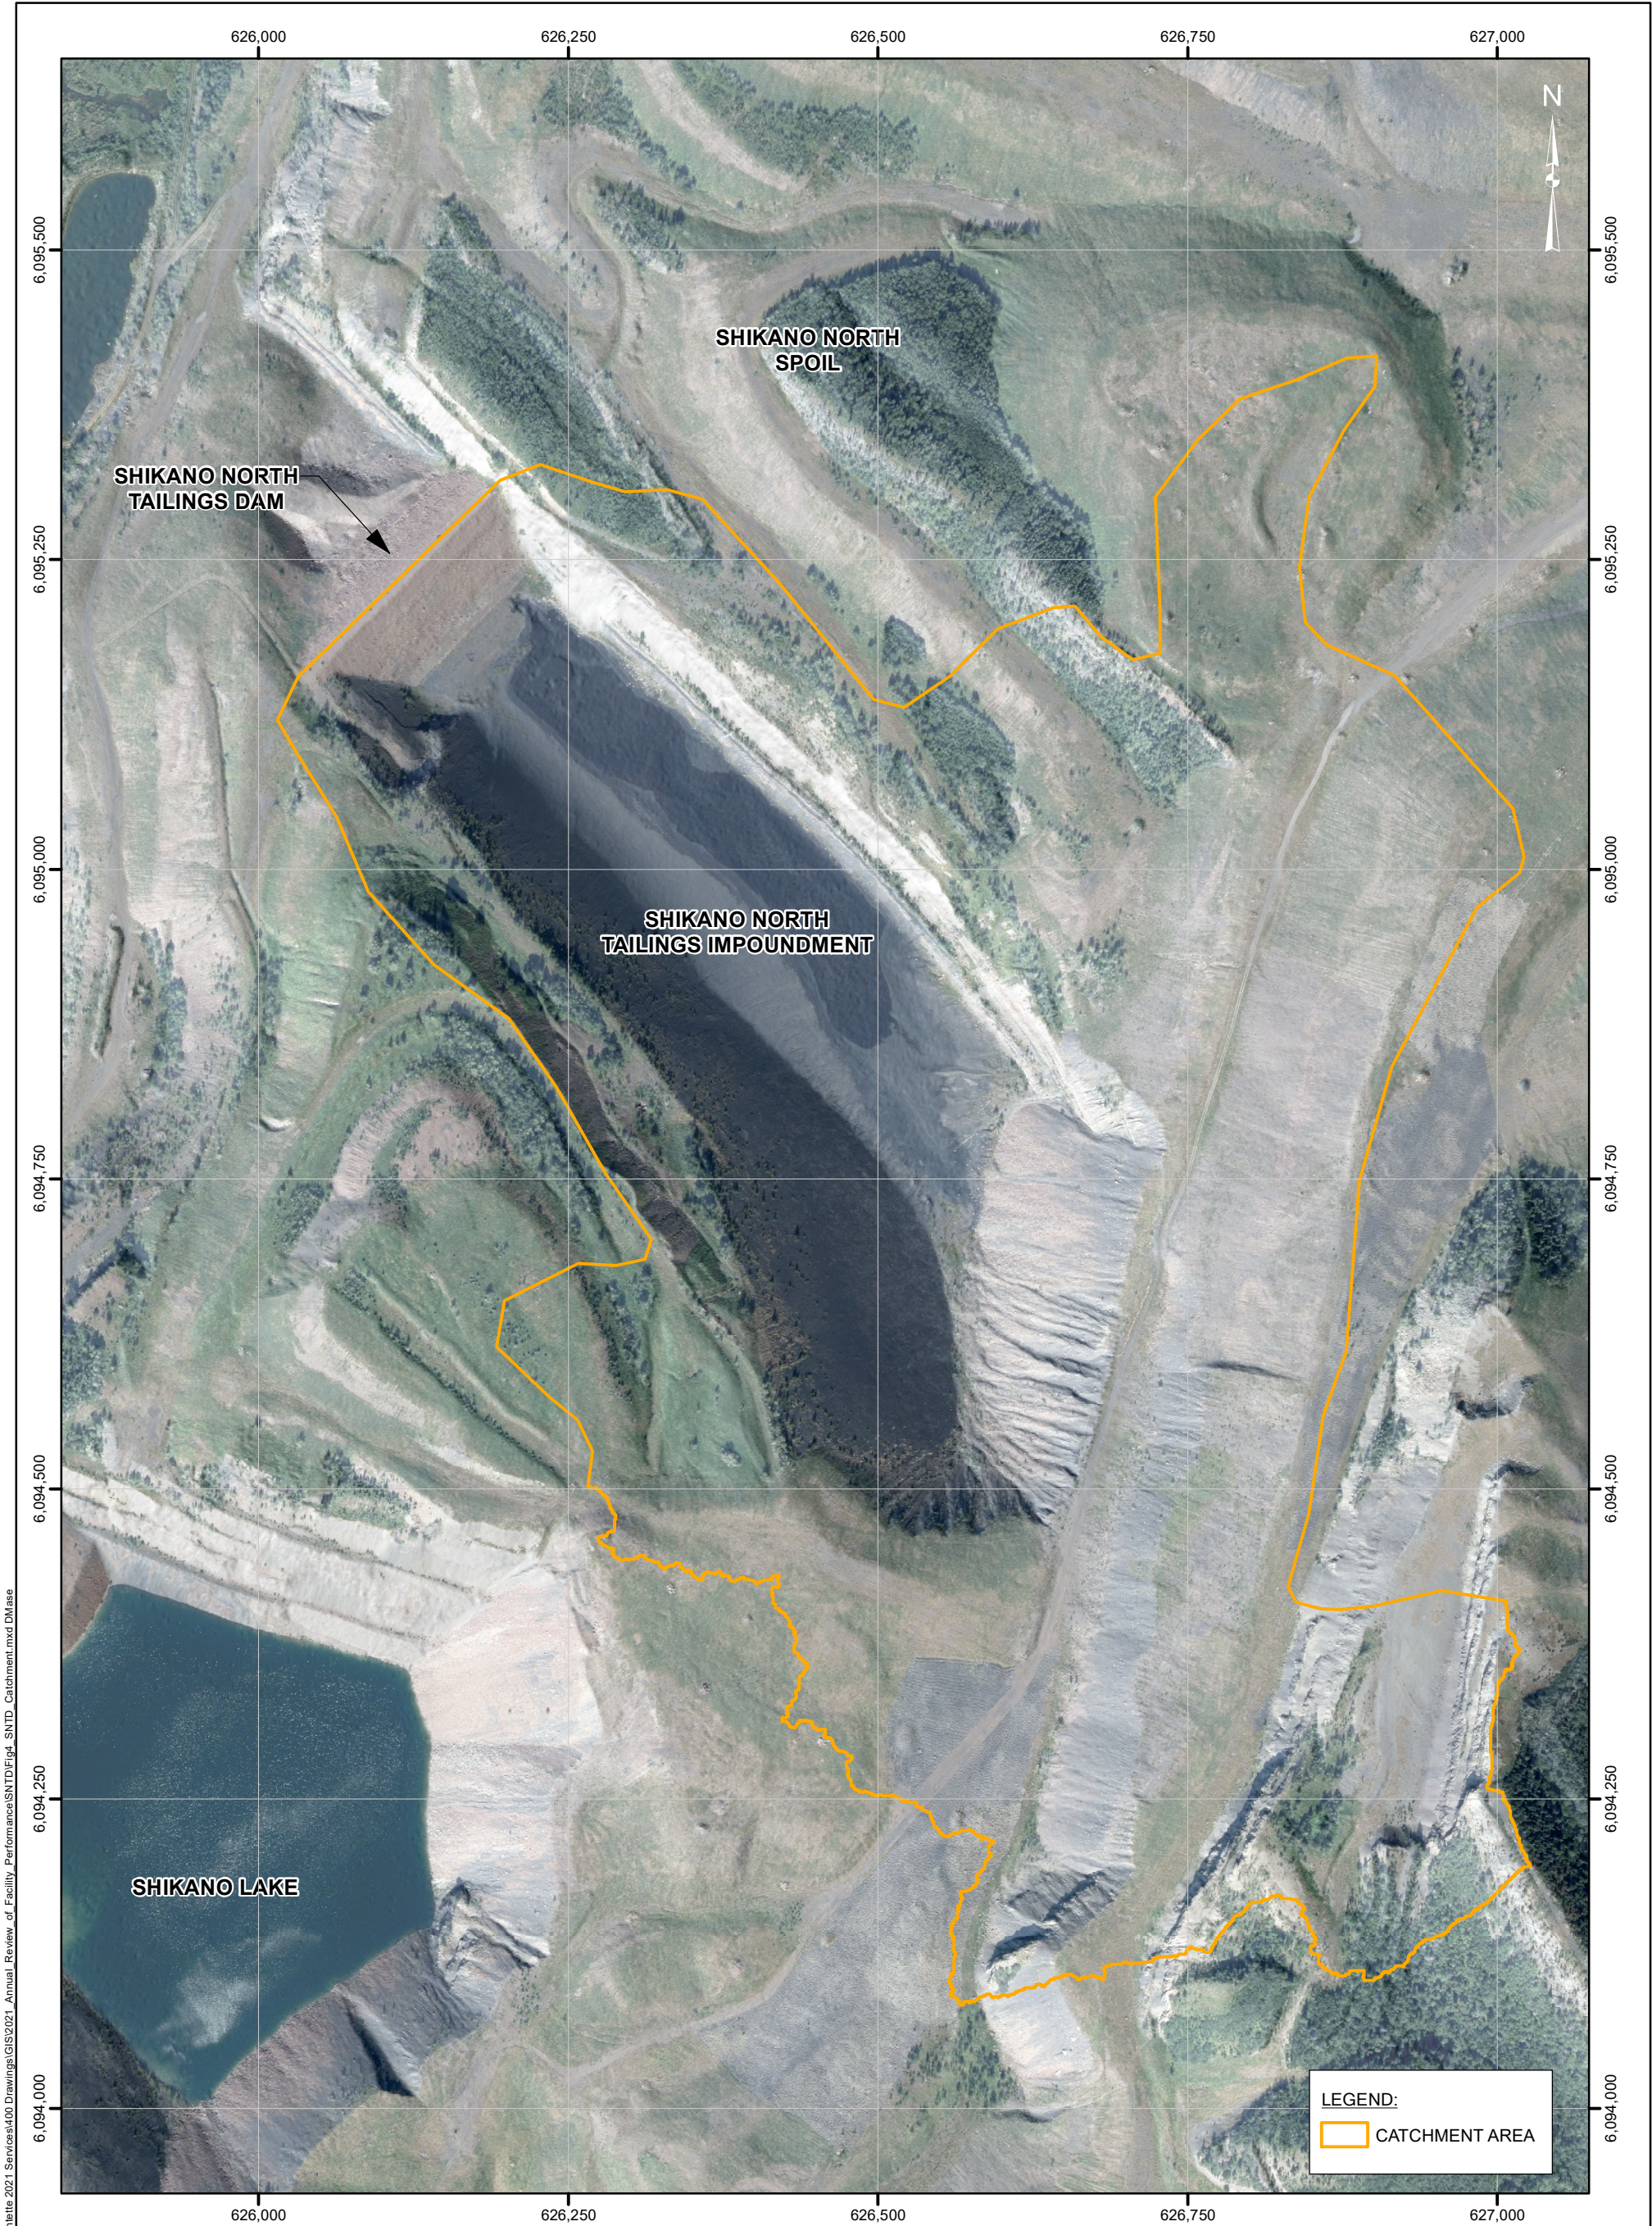
4

Under normal and flood conditions, the primary inflows into the impoundment are runoff from the catchment and impoundment, and direct precipitation on the pond. The total catchment area reporting to the SNTSF is 76 ha, of which the pond and impoundment are 24 ha and the upstream catchment is 52 ha. The catchment area is shown on Figure 4.

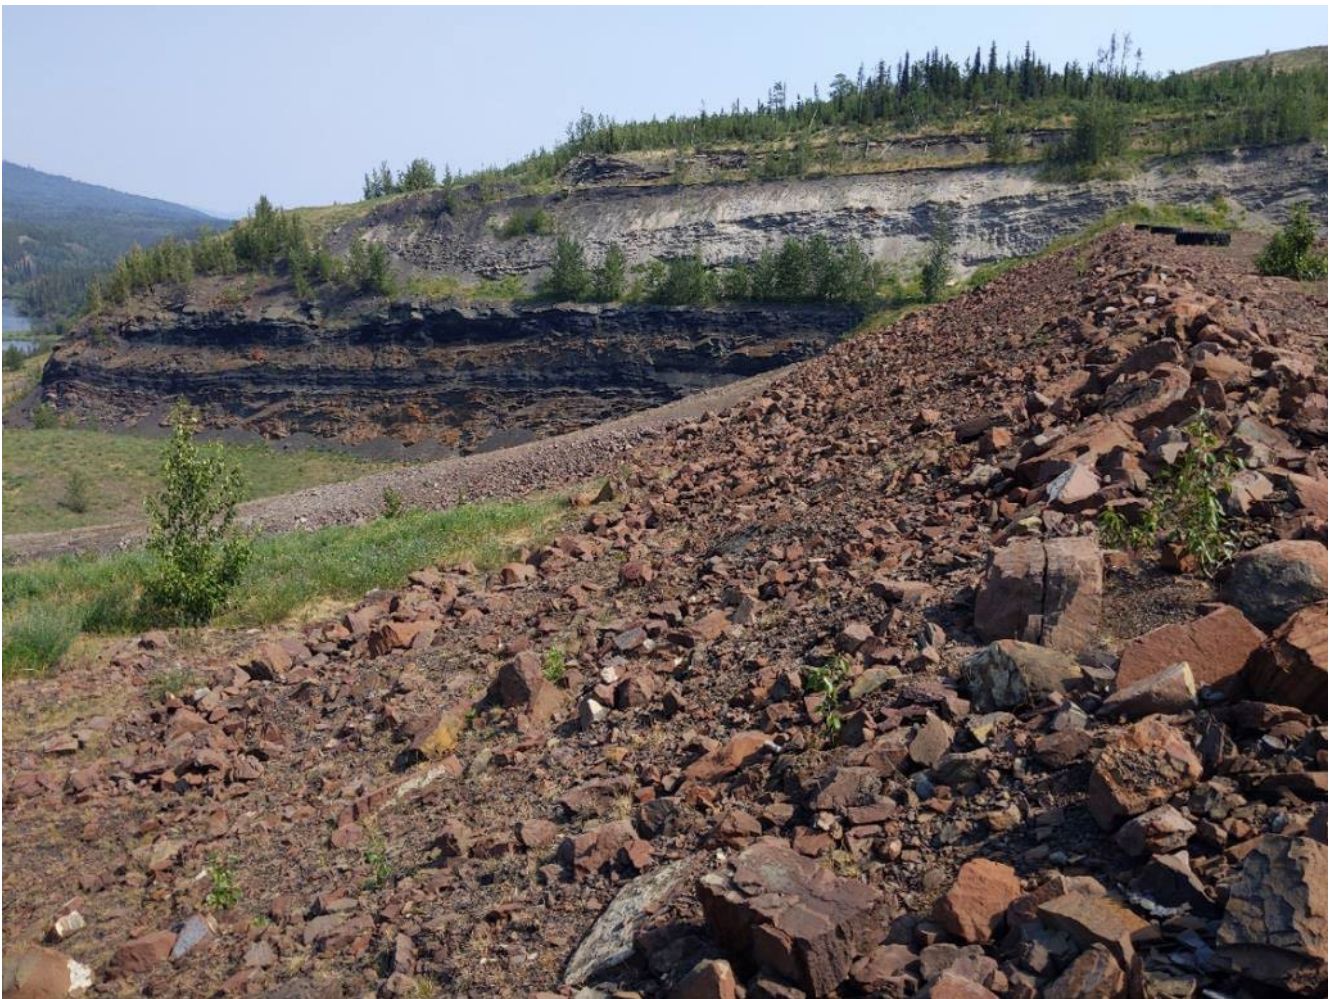
- **Crest:** Good condition. No signs of cracking, settlement, sinkholes, erosion, excessive vegetation, or animal activity.
- **Downstream Slope and Abutments:** Good condition. No signs of cracking, sloughing, slumping, erosion, seepage, excessive vegetation, or animal activity.

Photo I-1 Downstream slope – looking northeast from the left abutment (SNTD-2021-01)

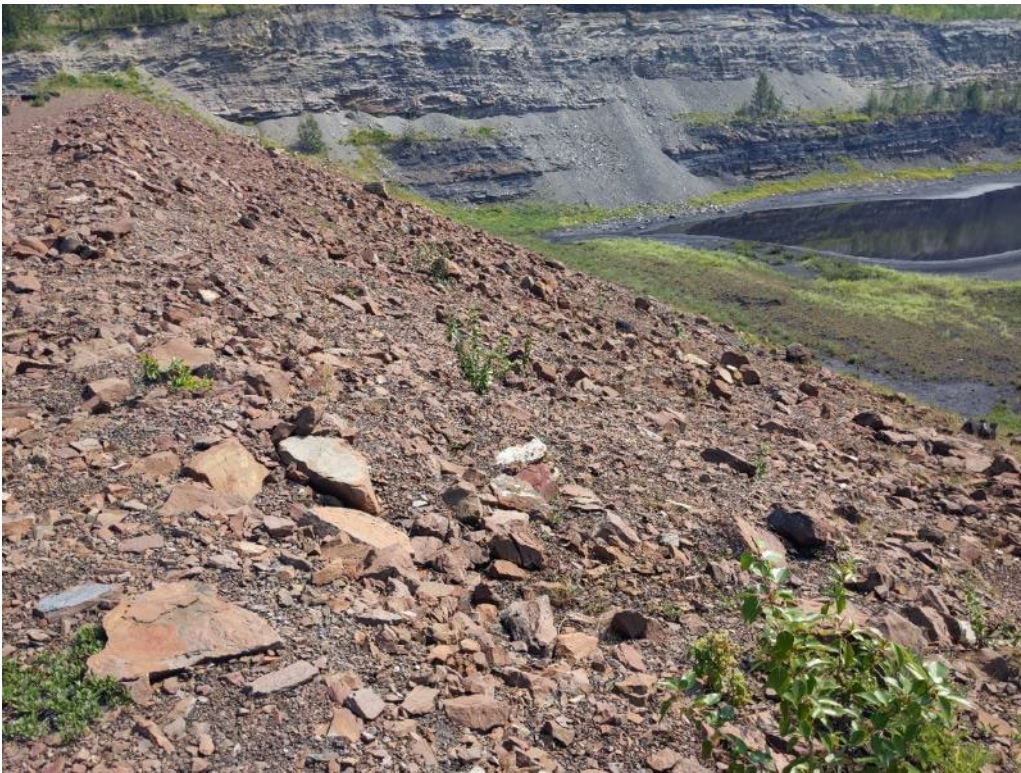
- **Upstream Slope and Abutments:** Good condition. No signs of cracking, sloughing, slumping, erosion, excessive vegetation, or animal activity.
- **Tailings Impoundment:** The impoundment area was sparsely vegetated near the pond and embankment. Away from the pond, the tailings surface is well drained and can be walked on. The ponded area appears to be smaller than that of the 2020 inspection (likely due to the drier year), and the pond level was well below the freeboard monitoring stake.

Photo I-2 Upstream slope – looking northeast from the left abutment (SNTD-2021-01)

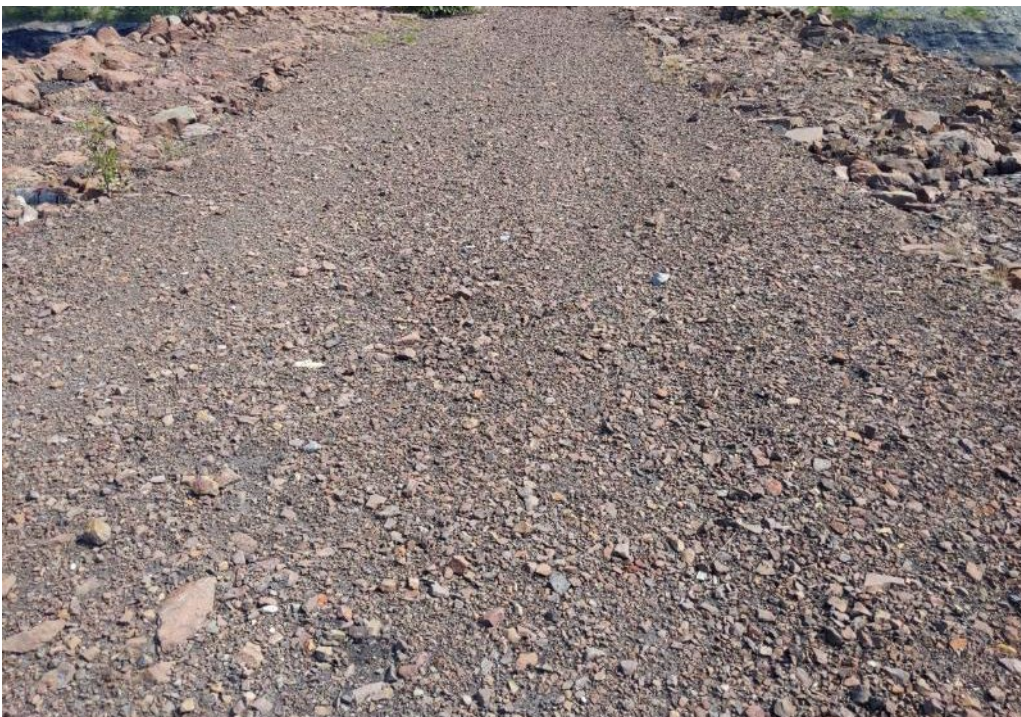
Photo I-3 Embankment crest – looking northeast from the left abutment (SNTD-2021-01)

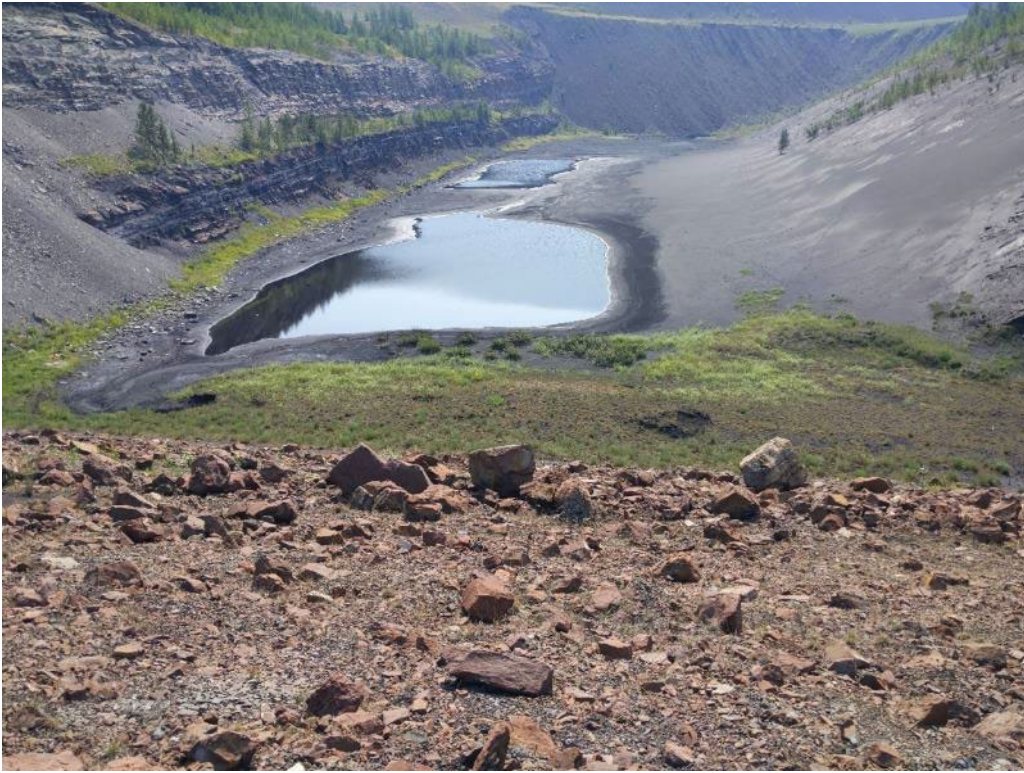
Photo I-4 Impoundment – looking southeast (SNTD-2021-02)

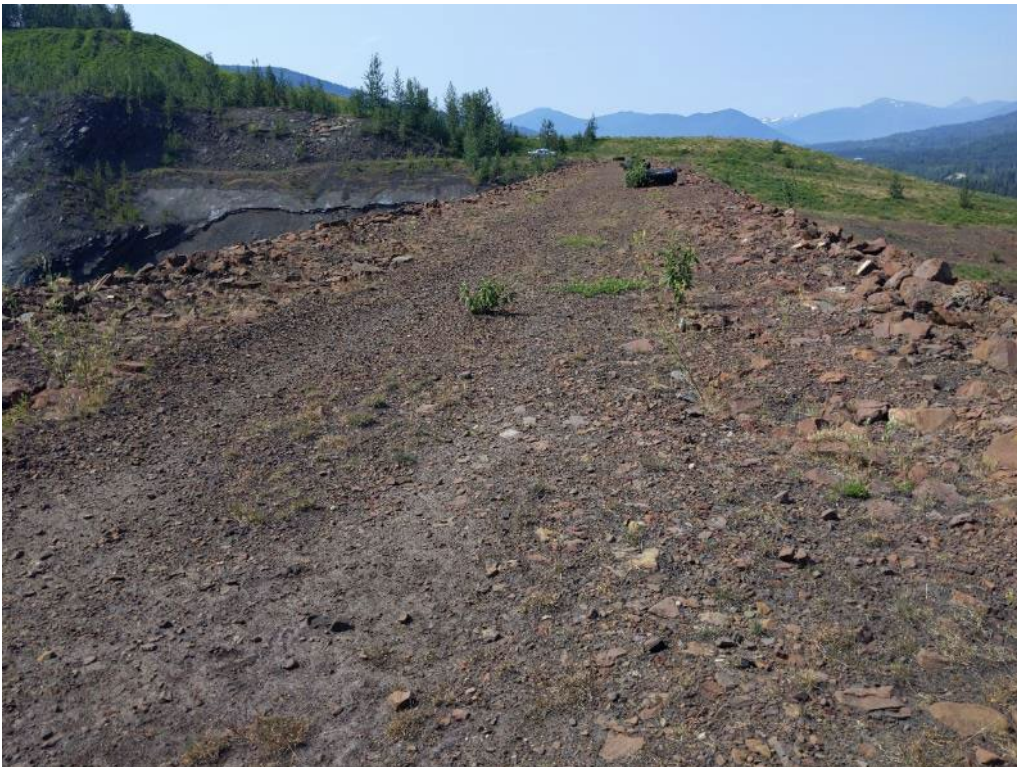
Photo I-5 Embankment crest – looking southwest from the right abutment (SNTD-2021-03)

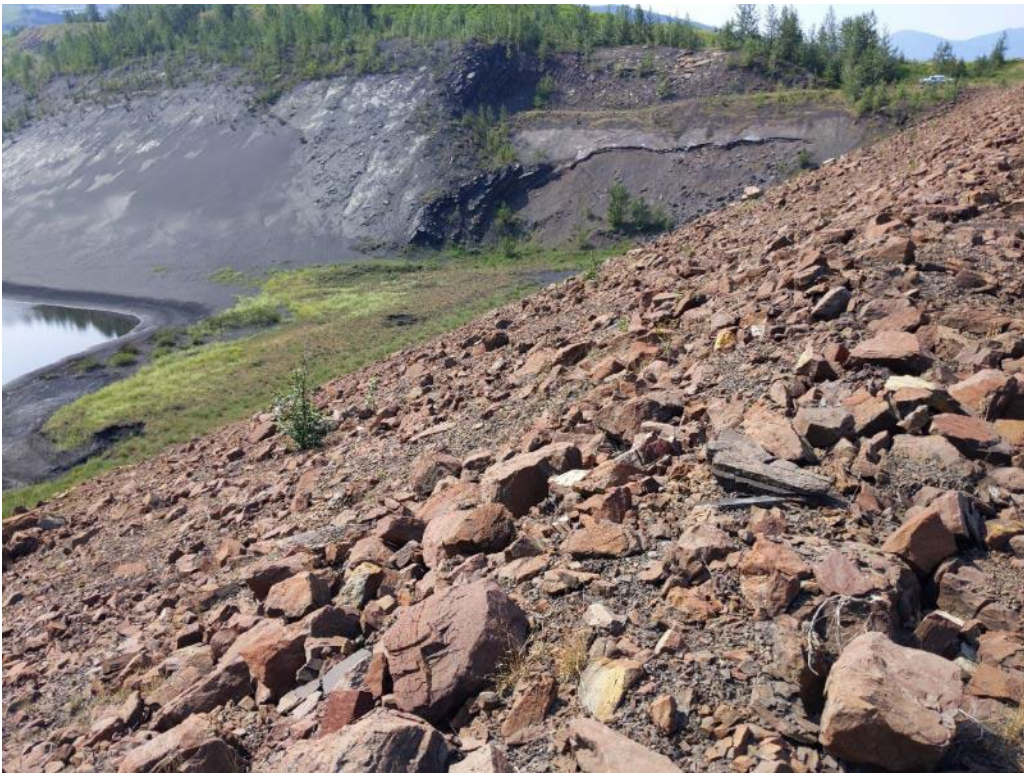
Photo I-6 Upstream slope – looking southwest from the right abutment (SNTD-2021-03)

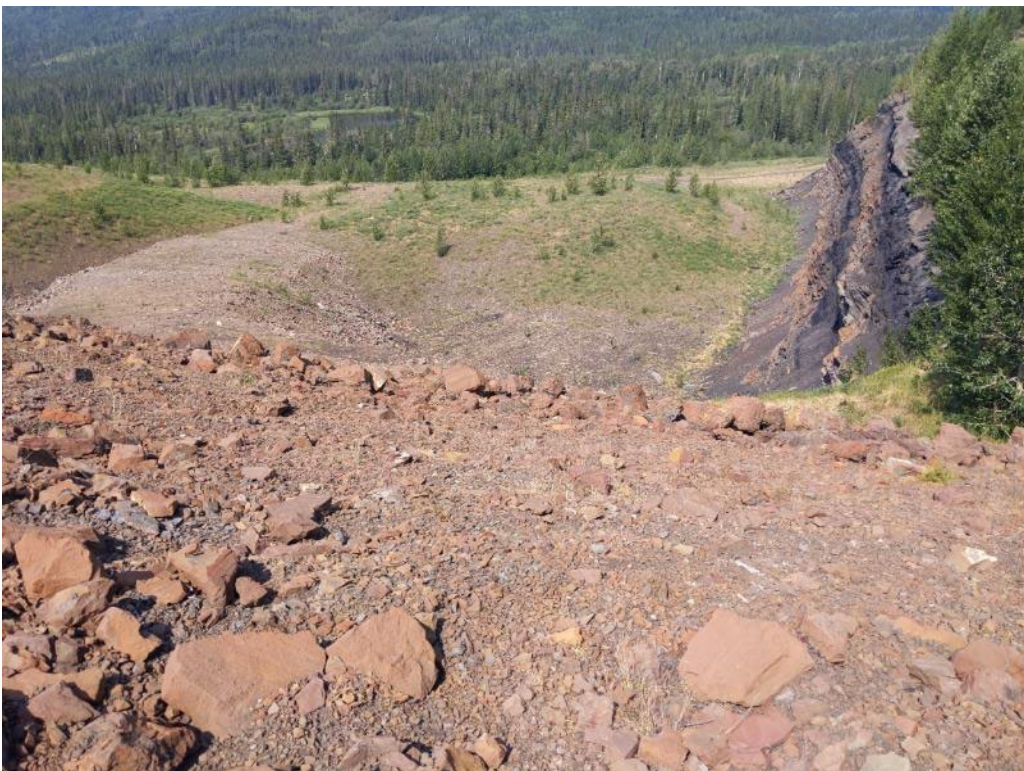
Photo I-7 Downstream slope – looking southwest from the right abutment (SNTD-2021-03)

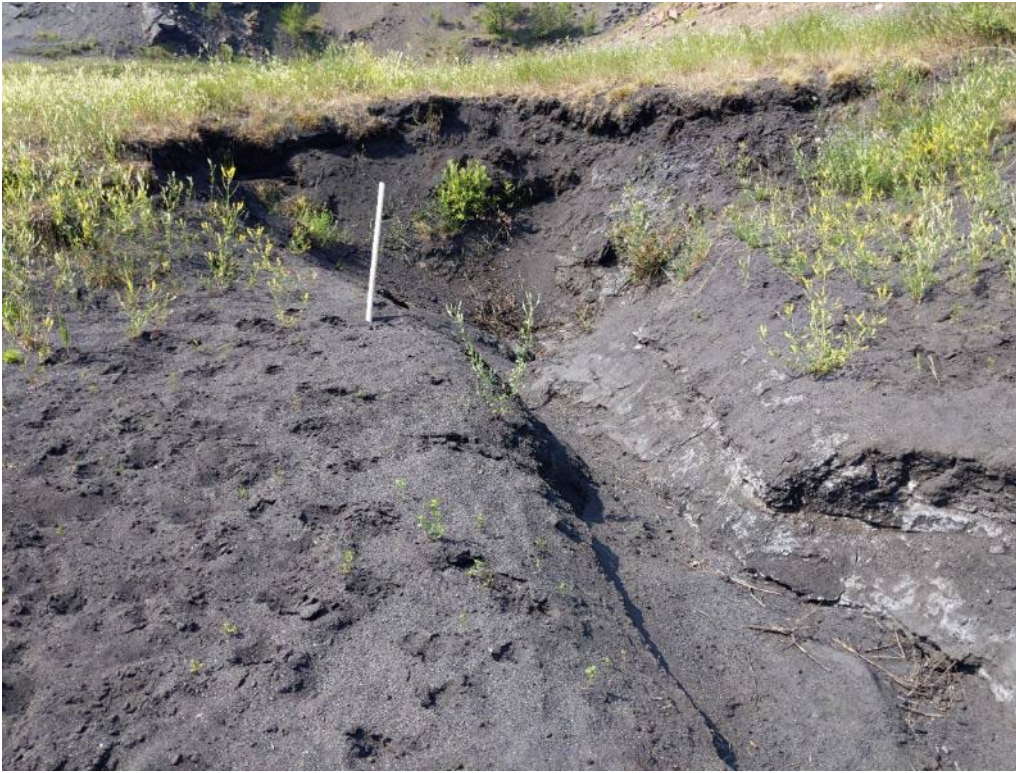
The sinkholes are monitored for changes during visual inspections. No obvious changes were noted in the sinkholes between the 2020 and 2021 inspections.

- ◆ Sinkholes have formed on the tailings beach but are localized features, caused by tailings migrating into the upstream coarse rockfill shell (2 m minus waste rock). These features do not represent a dam safety concern.

Photo I-8 Sinkhole on the tailings beach (SNTD-2021-05)

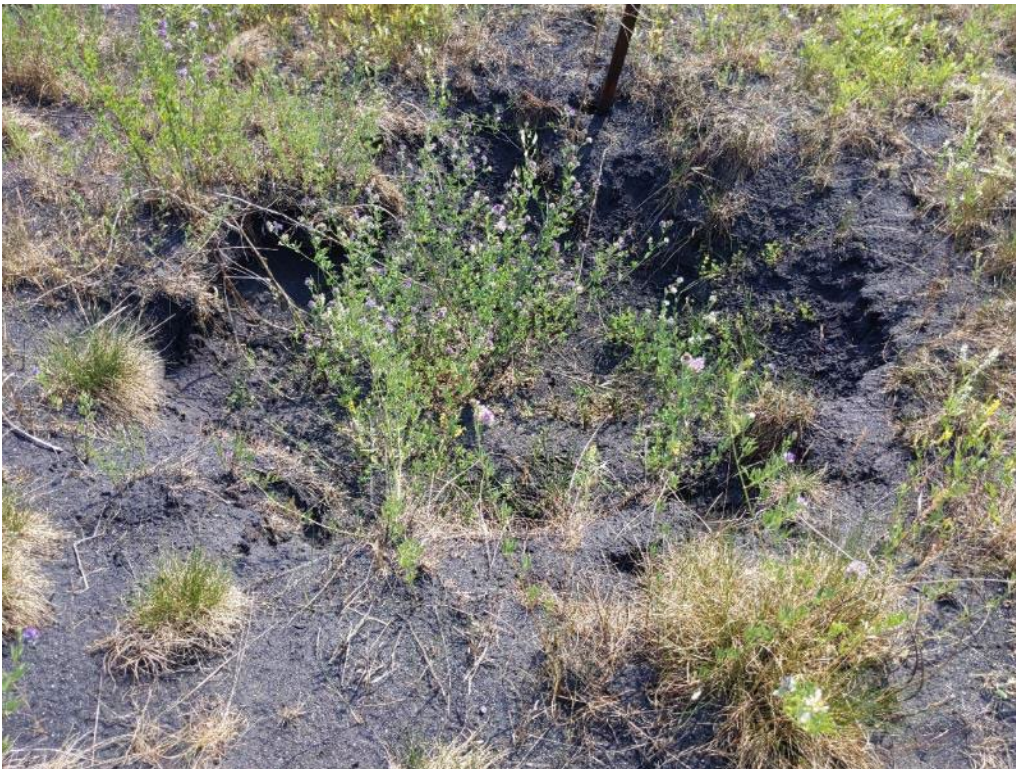
Photo I-9 Sinkhole on the tailings beach (SNTD-2021-06)

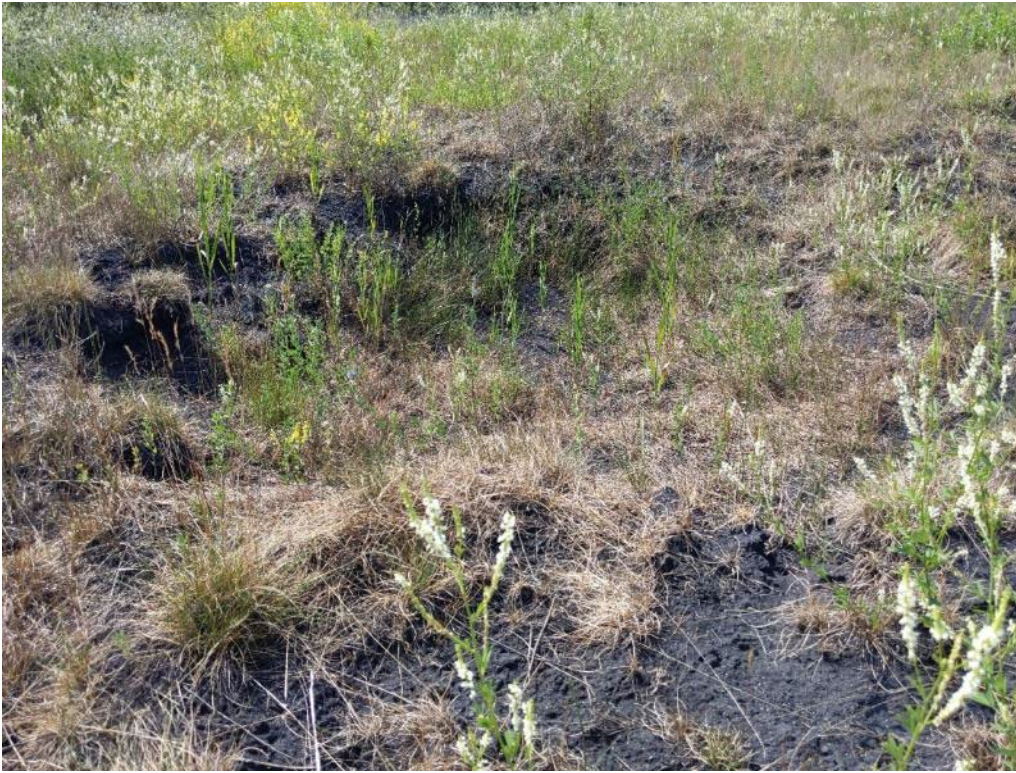
Photo I-10 Sinkhole on the tailings beach (SNTD-2021-07)

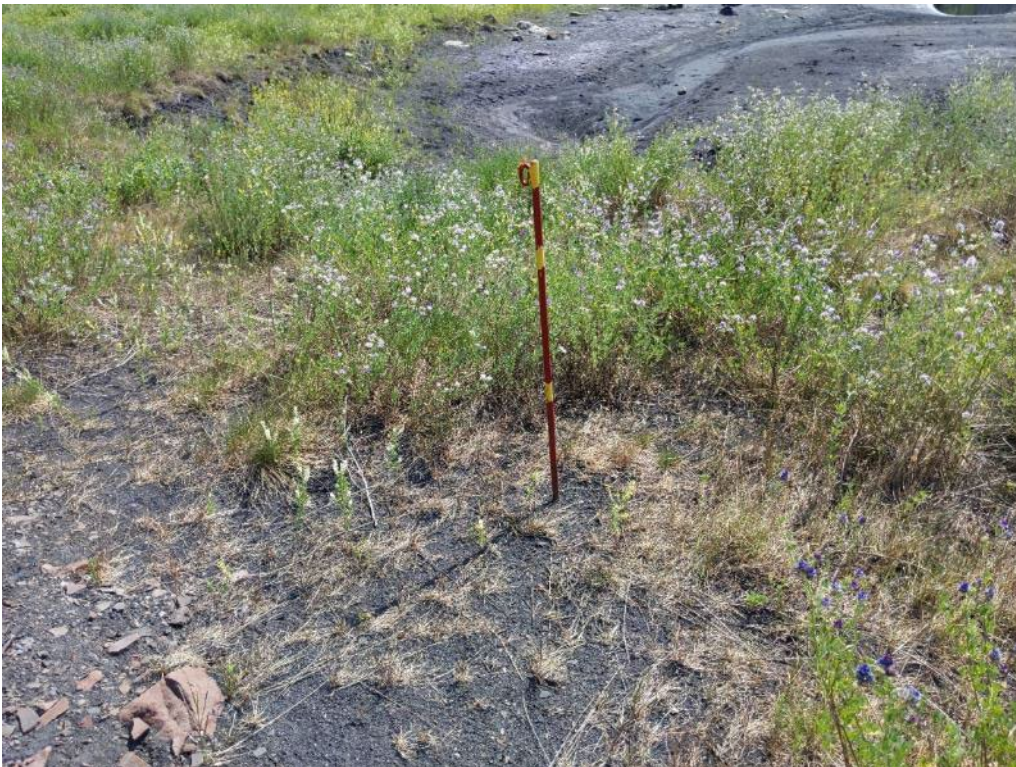
Pond level in the SNTD is visually monitored as an indication of potential change in the impoundment water balance (i.e. is water accumulating). A pond level stake is installed where tailings beach meets the upstream rockfill zone. This is not associated with a dam failure mode given the significant freeboard capacity available (Section 3.4). The pond was well below the pond level stake during inspections that occurred during the review period.

Photo I-11 Freeboard monitoring stake (SNTD-2021-09)

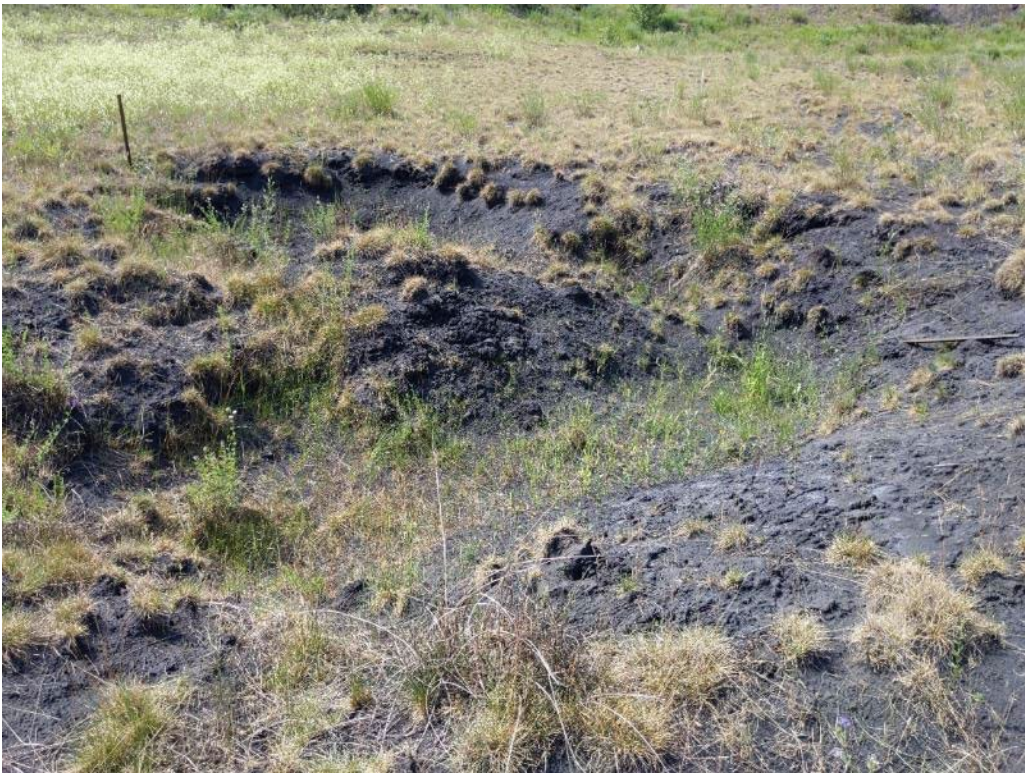
Photo I-12 Sinkhole on the tailings beach (SNTD-2021-10)

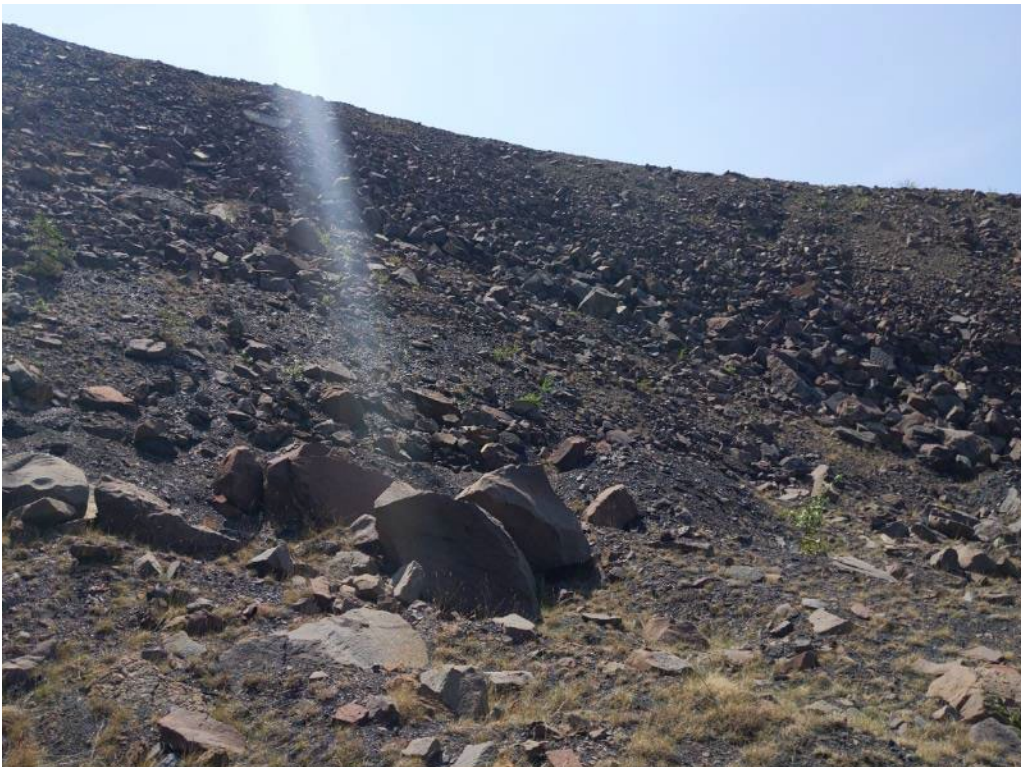
Photo I-13 Downstream slope – looking south from the right abutment (SNTD-2021-11)

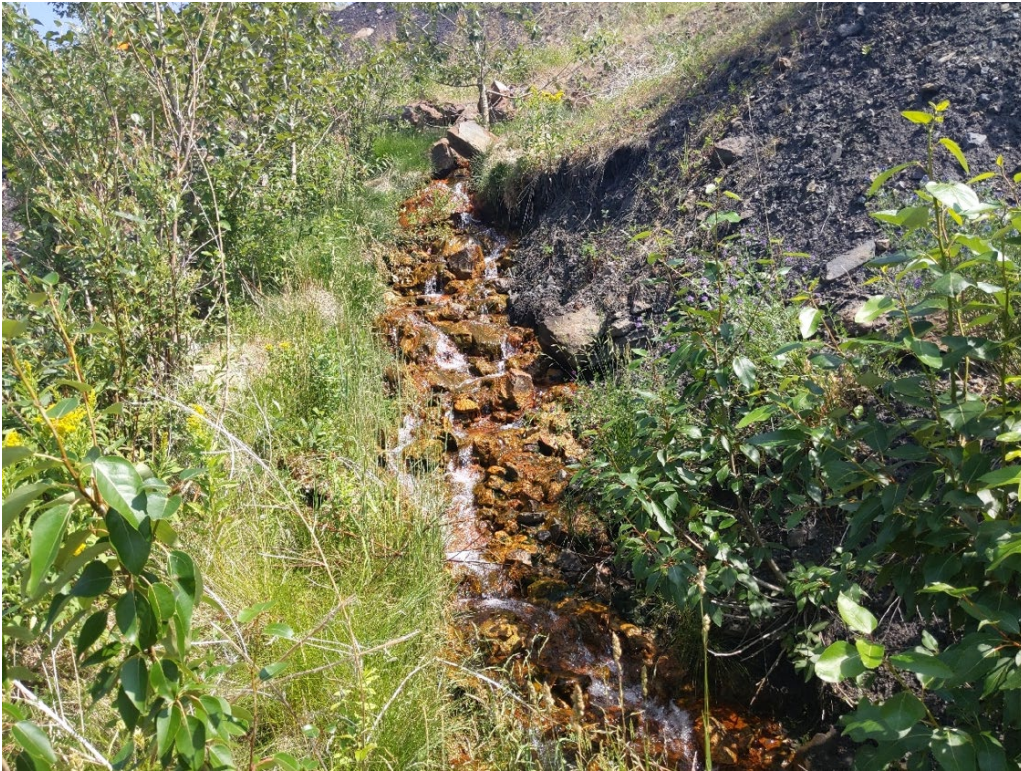
- **Seepage Collection Pipe:** Flow from the seepage collection pipe was observed and estimated to be approximately 5 L/s, which is similar to the flow rate observed in previous years.

Photo I-14 Seepage collection pipe outflow channel (no waypoint)
