# 2021 Annual Facility Performance Report

Sä Dena Hes Mine, Yukon Territory

Teck Resources Limited

SRK Consulting (Canada) Inc. ■ 1CT008.075 ■ December 2021

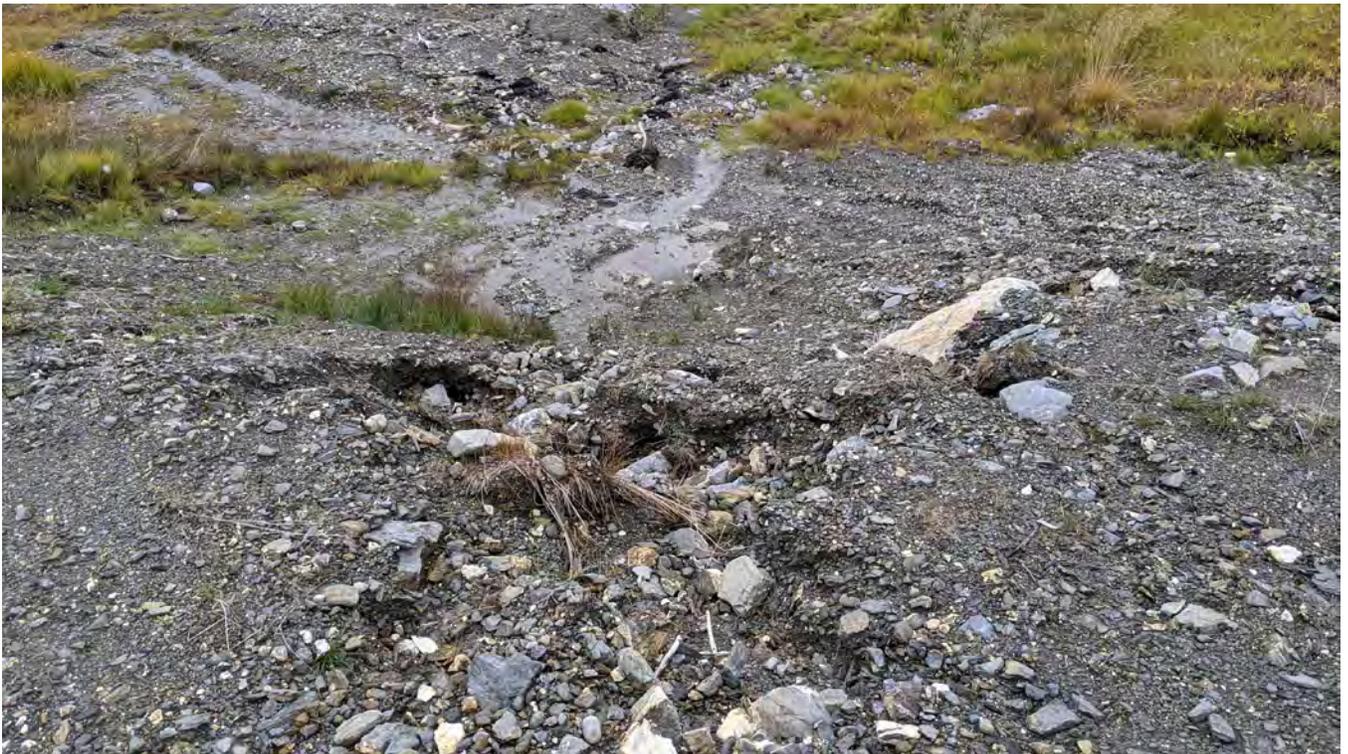
Photo DC-02: Area of the North Diversion berm repair area completed in 2020 looking west from the berm crest. Additional surface erosion over the berm has occurred. Seepage emerging at the toe of the repair area is clear with no sign of sediment transport..

- Repairs were completed to the slough in the North Diversion Channel Berm observed in the 2020 inspection (Photo DC-02). The slough was backfilled with riprap wrapped in geotextile and covered with soil.
- Additional surface erosion was observed at the repair location, but the repair is functioning as intended. Seepage from the hillside that contributed to the sloughing continues to emerge from the base of the repair area and was clear with no signs of sediment transport.
- An additional erosion gulley is present adjacent to the outlet of the channel to the SRS pond (Photo DC-03).
- No actions are required to address the erosion as it is not a risk to the SRS. Once the SRS is removed and the vegetation on the TMA cover is further established, the diversion channel will no longer be required, and may be decommissioned.

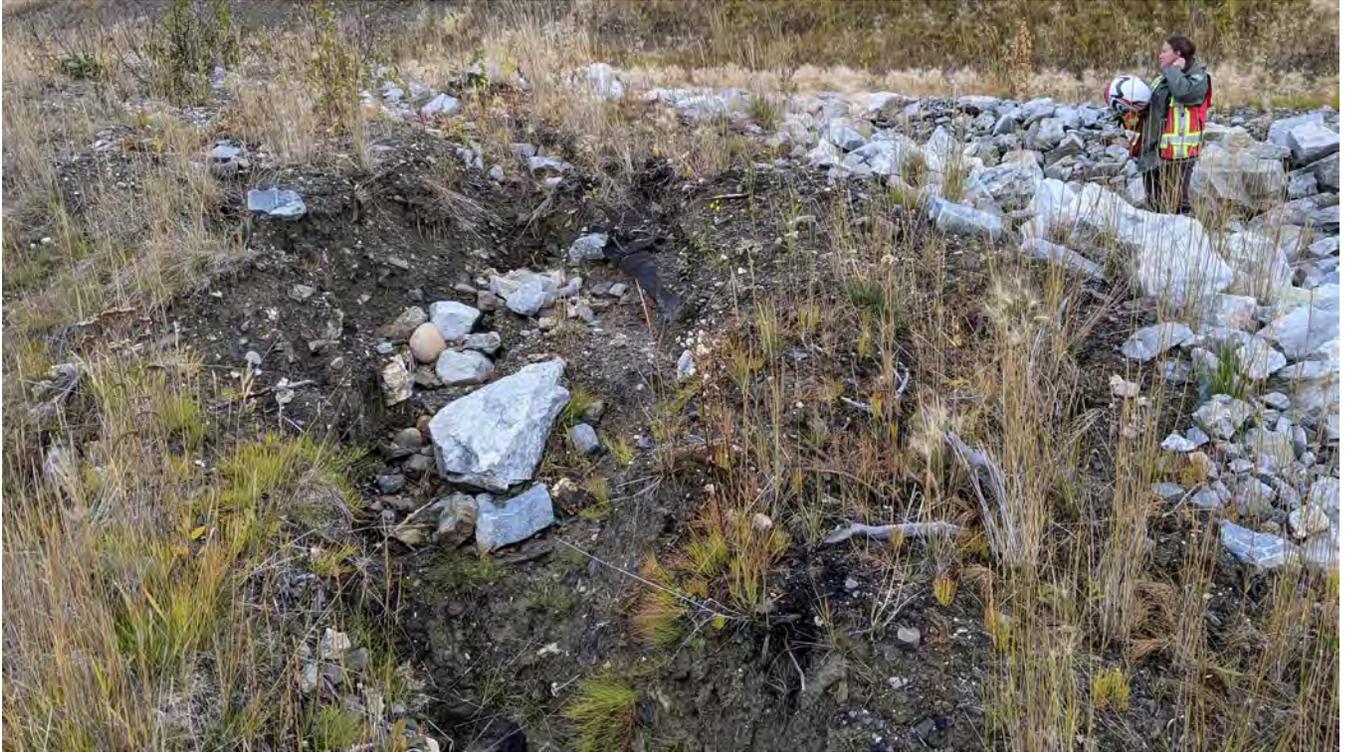
Photo DC-03: Erosion gully at the downstream end of the North Diversion Channel Berm looking northeast.

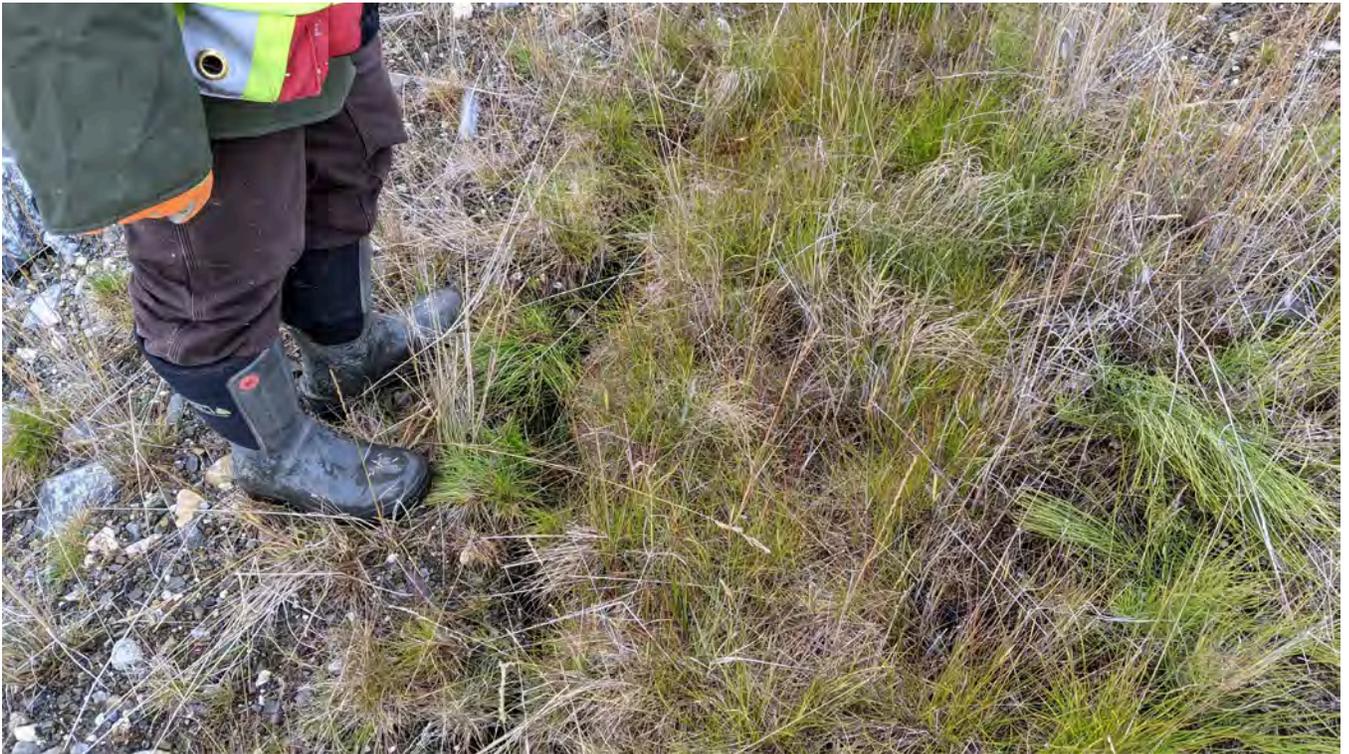
- The South Drainage Channel is in good condition with no signs of major subsidence or movement of the riprap erosion protection.
- Minor cracking was observed parallel to the channel that was typically offset from the crest by 1 to 2 meters (Photo DC-06). The cracking is suspected to have resulted from frost heave and does not impact channel performance.

Photo DC-06: Cracking observed parallel to the South Drainage Channel crest (typically offset by 1 m) over a significant portion of the channel.

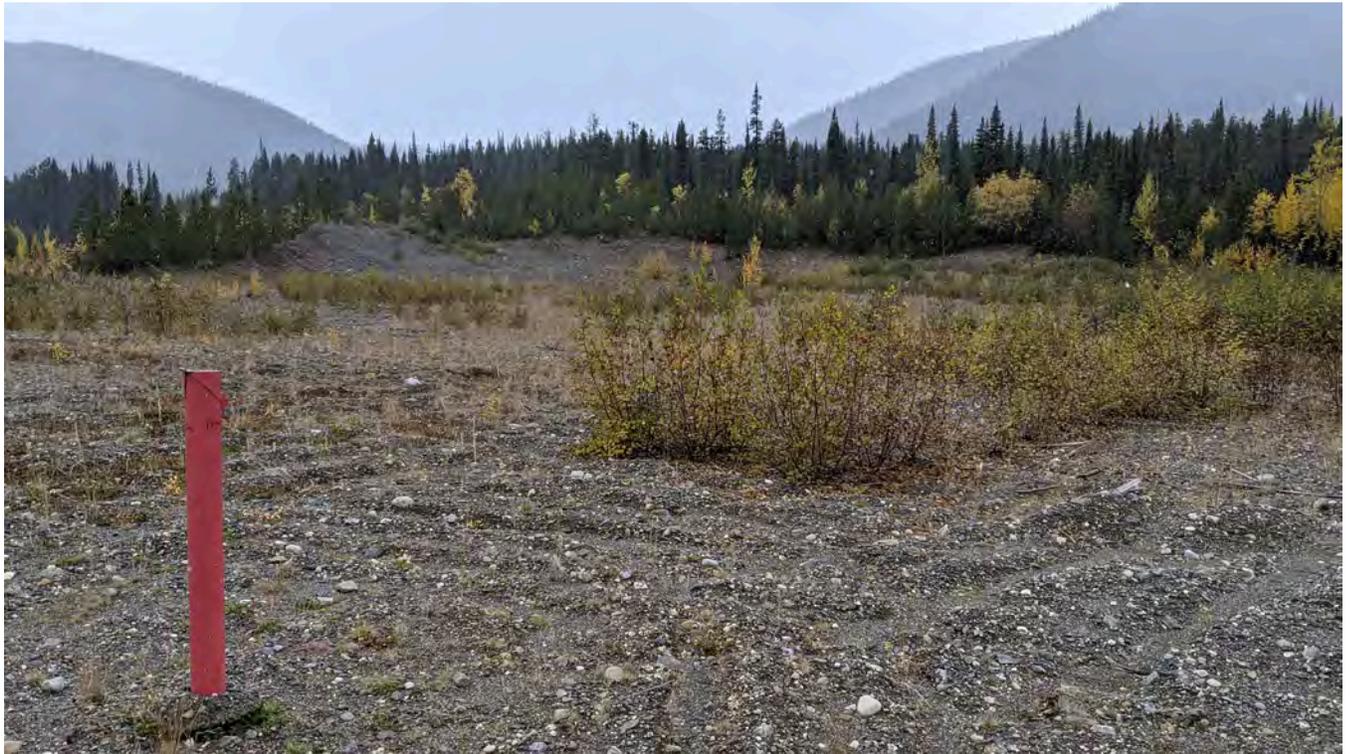
Photo L-01: Landfill area looking east. Frost heave has lifted the monitoring well casing in the photo foreground up approximately 15 cm..

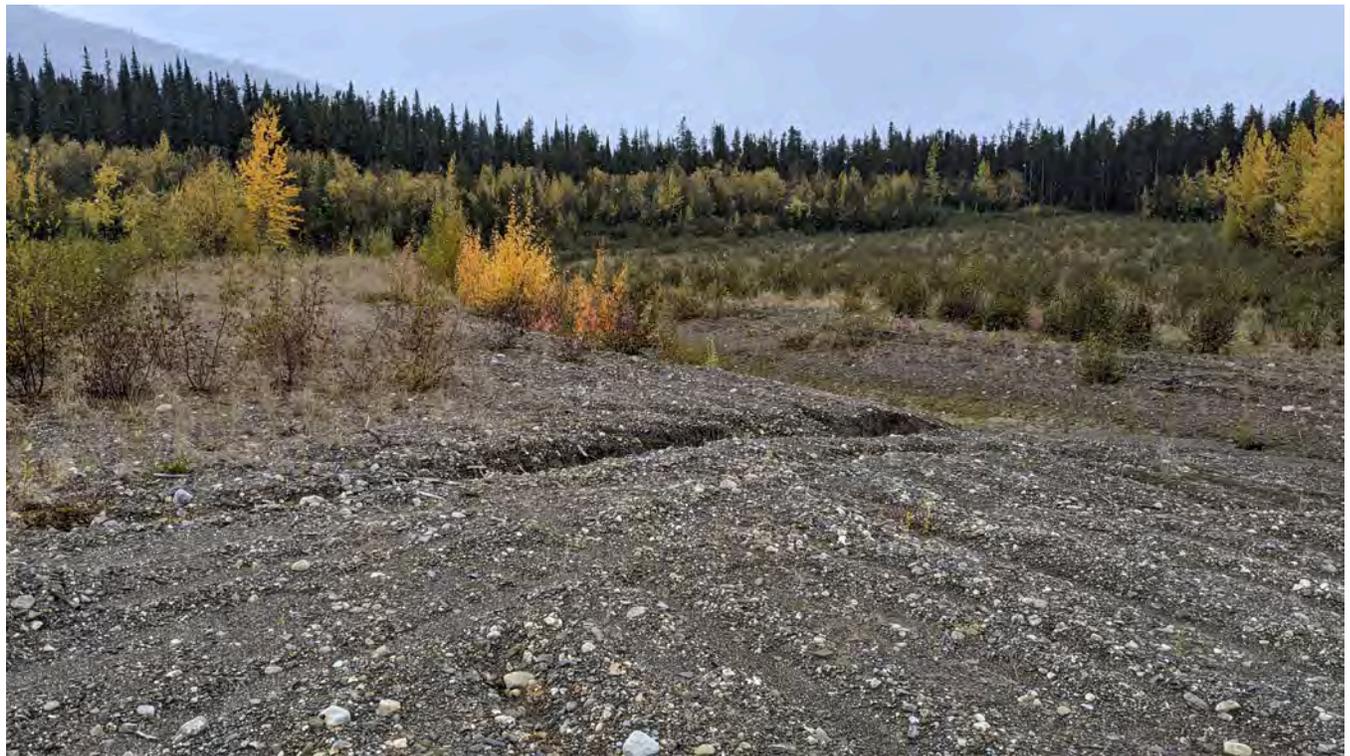
Photo L-02: Erosion gully in the landfill area.

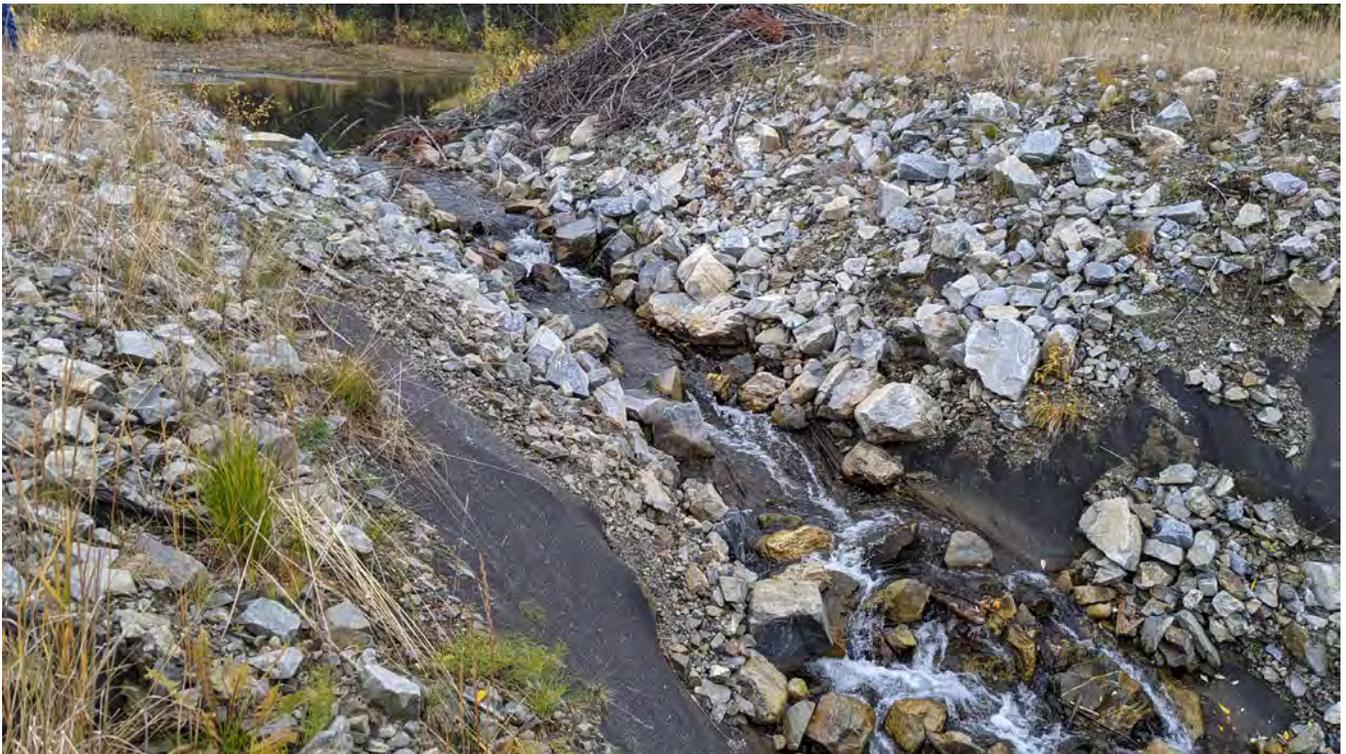
Photo NC-02: On-going channel erosion at the downstream end of the upper decommissioned access road crossing of North Creek to the landfill area.

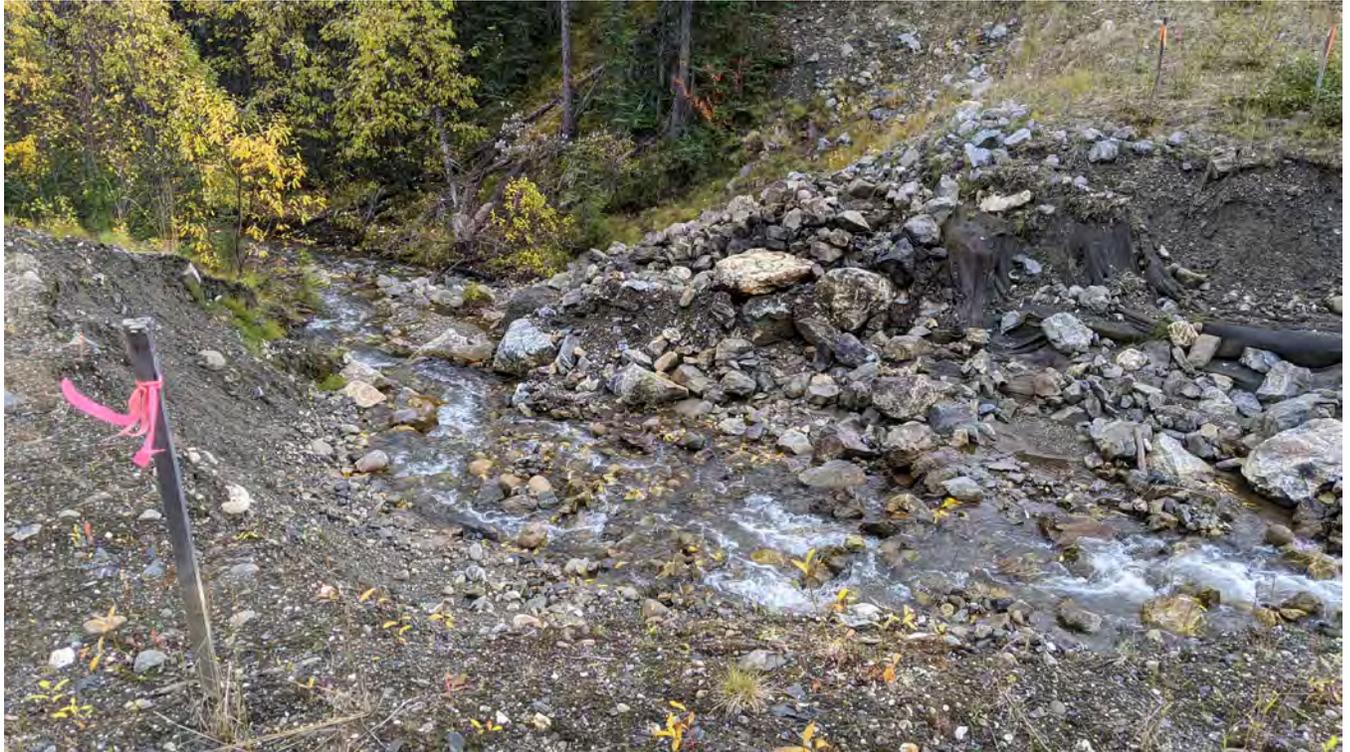
Photo NC-03: On-going channel and bank erosion at the downstream end of the lower decommissioned access road crossing of North Creek to the landfill area.

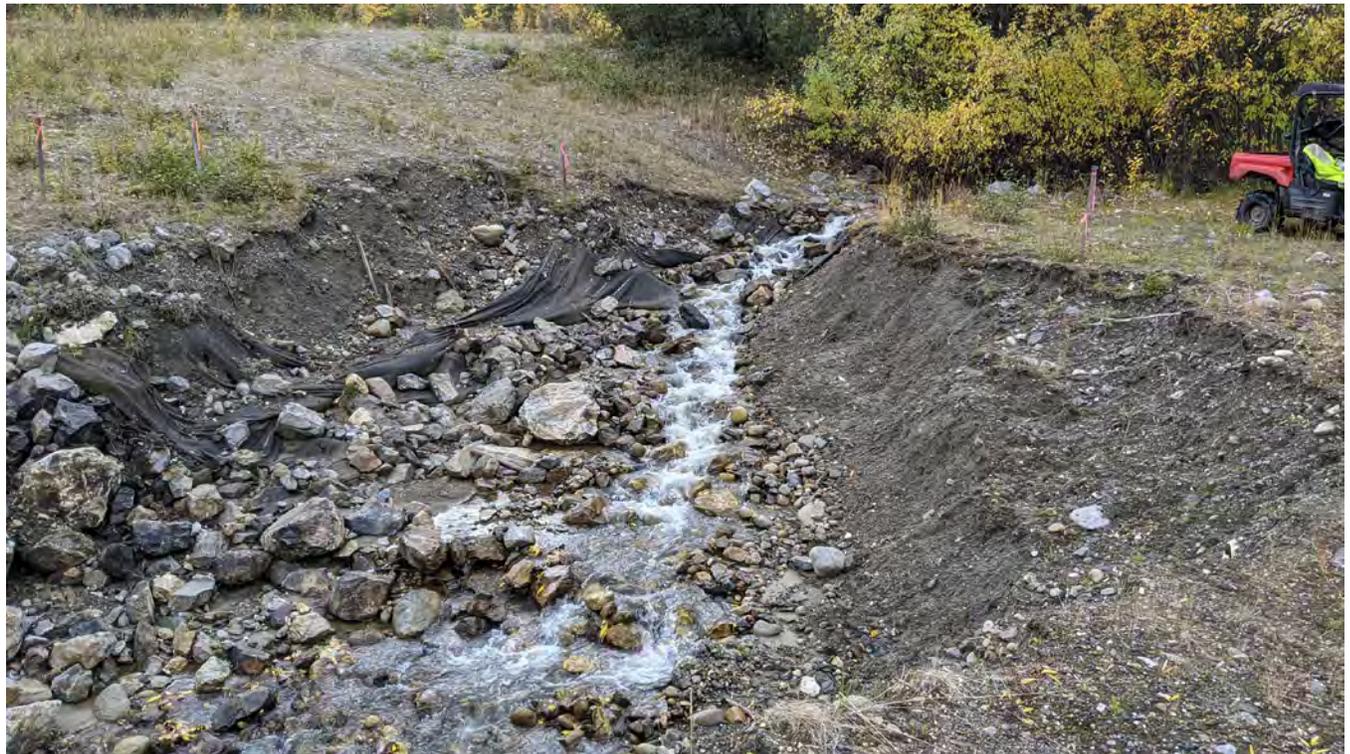
Photo NC-04: On-going channel and bank erosion at the downstream end of the lower decommissioned access road crossing of North Creek to the landfill area.

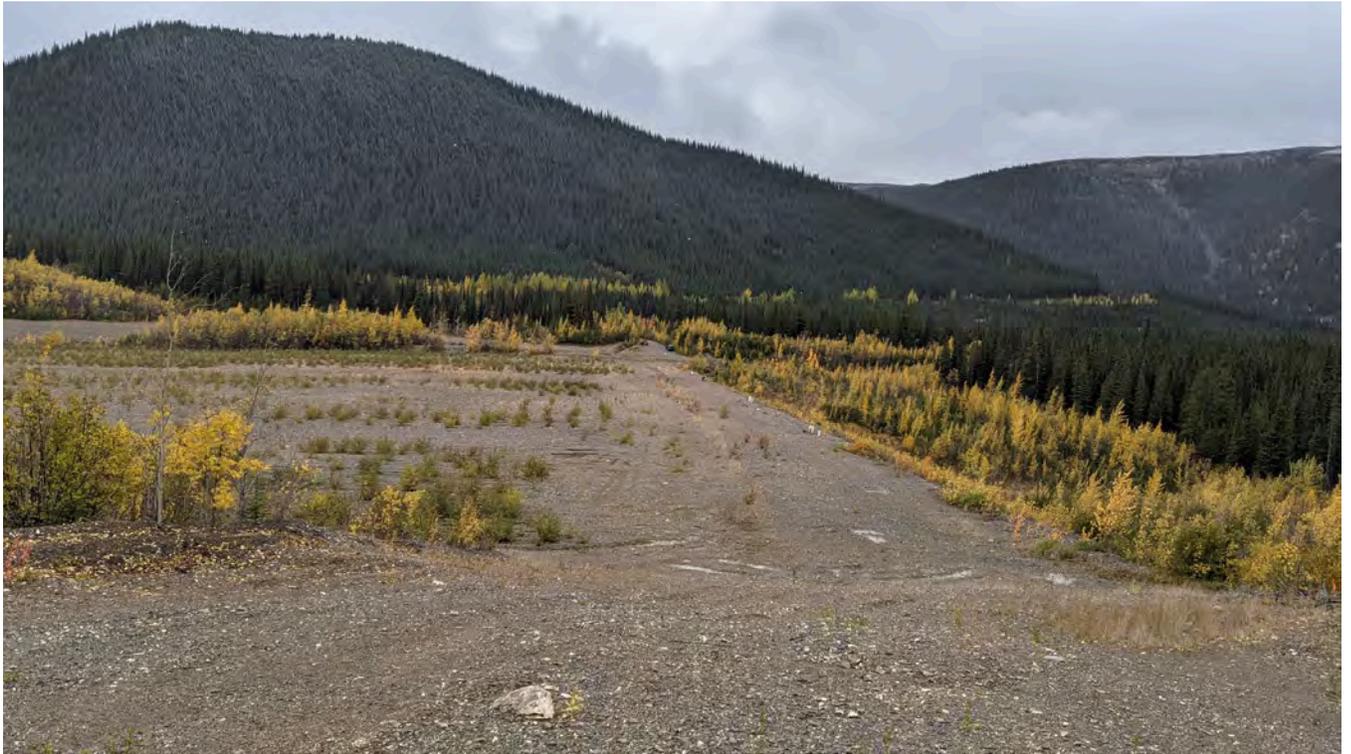
- The crest of the North Dam is shown in Photos ND-01 and ND-02 (Appendix A). The dam is in good condition and shows no signs of deformation or abnormal settling.

Photo ND-01: North Dam looking west.

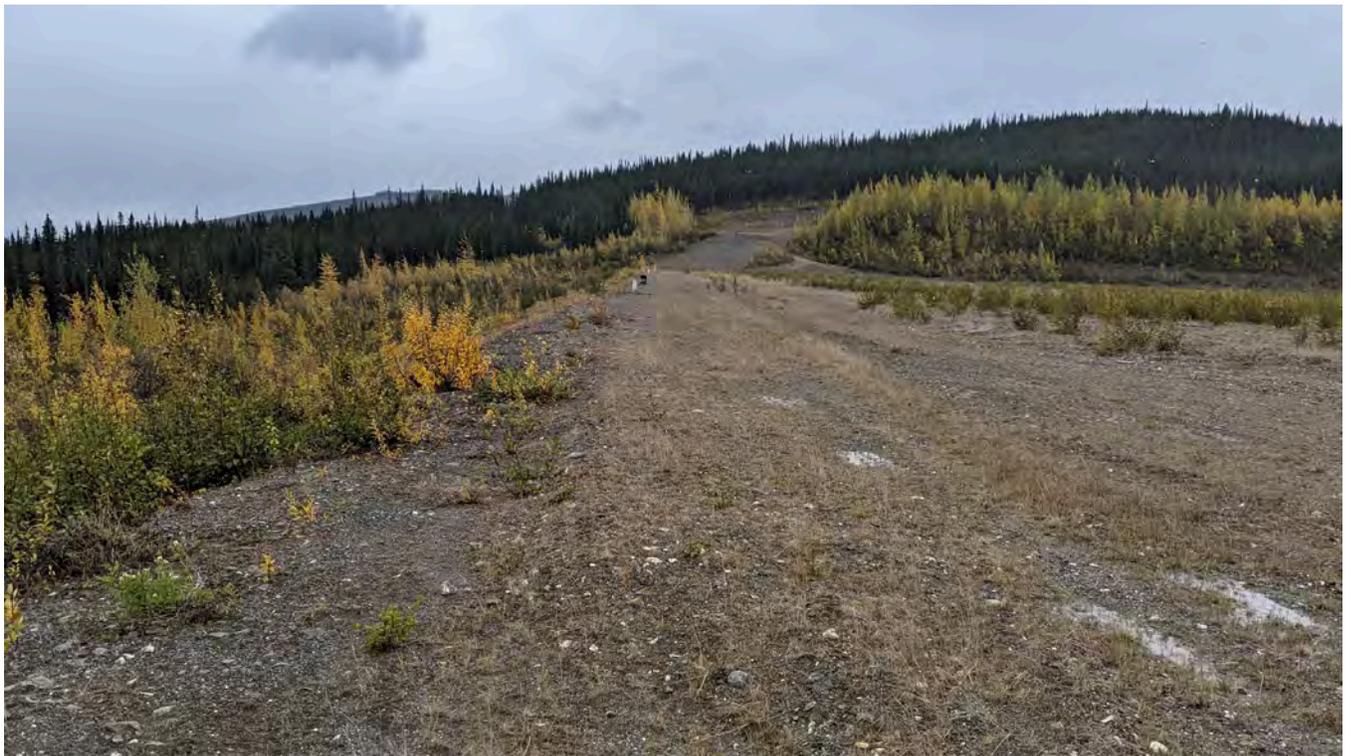
Photo ND-02: North Dam looking east from the west abutment.

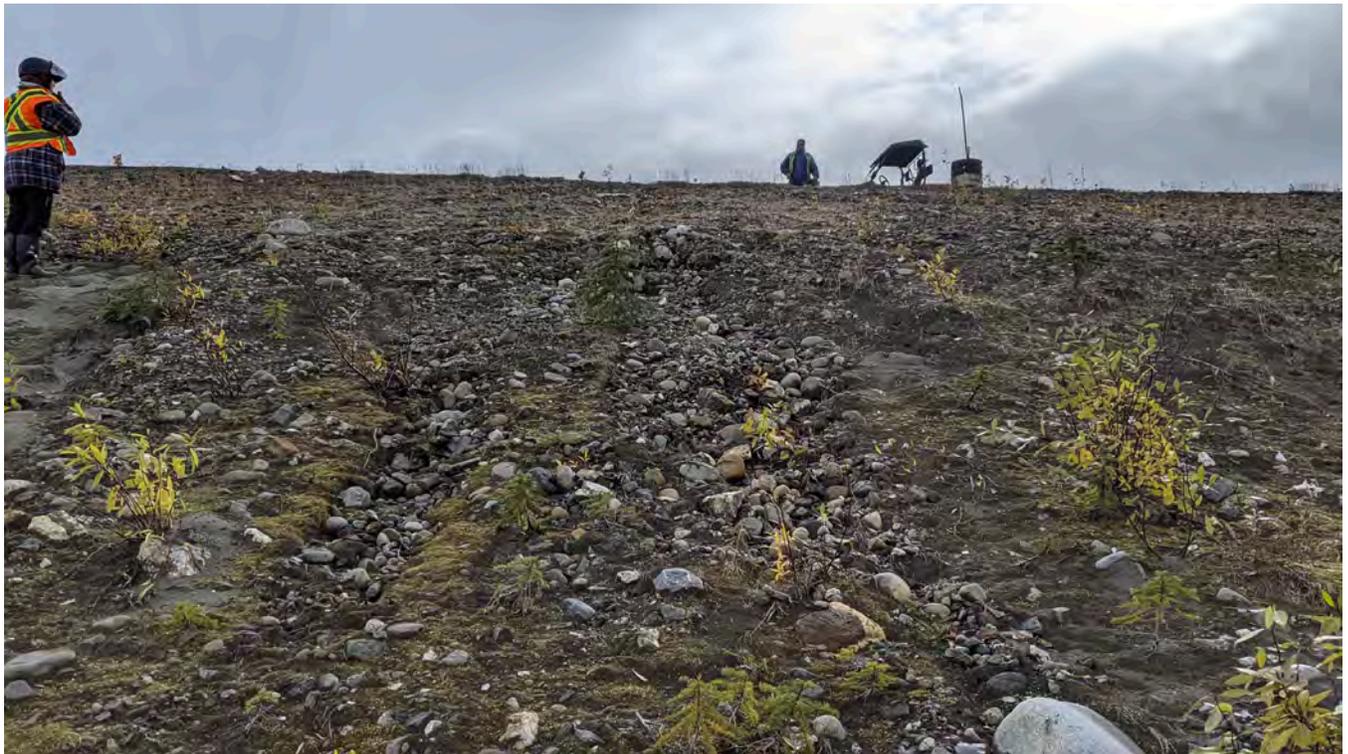
The North Dam is in good condition and shows no signs of deformation or abnormal settling. Sheet and rill erosion of the wind-blown tailings and fine-grained was observed on the downstream slope of the dam that is believed to be caused by a rain event that occurred soon after the spring thaw when the surficial soils may have been saturated and loosened from the thawing process. No remedial action is required as the downstream embankment consists of sand and gravel material that are expected to self-armour as the fine-grained material erodes.

Photo ND-04: Sheet and rill erosion of wind-blown tailings and fine-grained soil on the downstream slope of the North Dam.

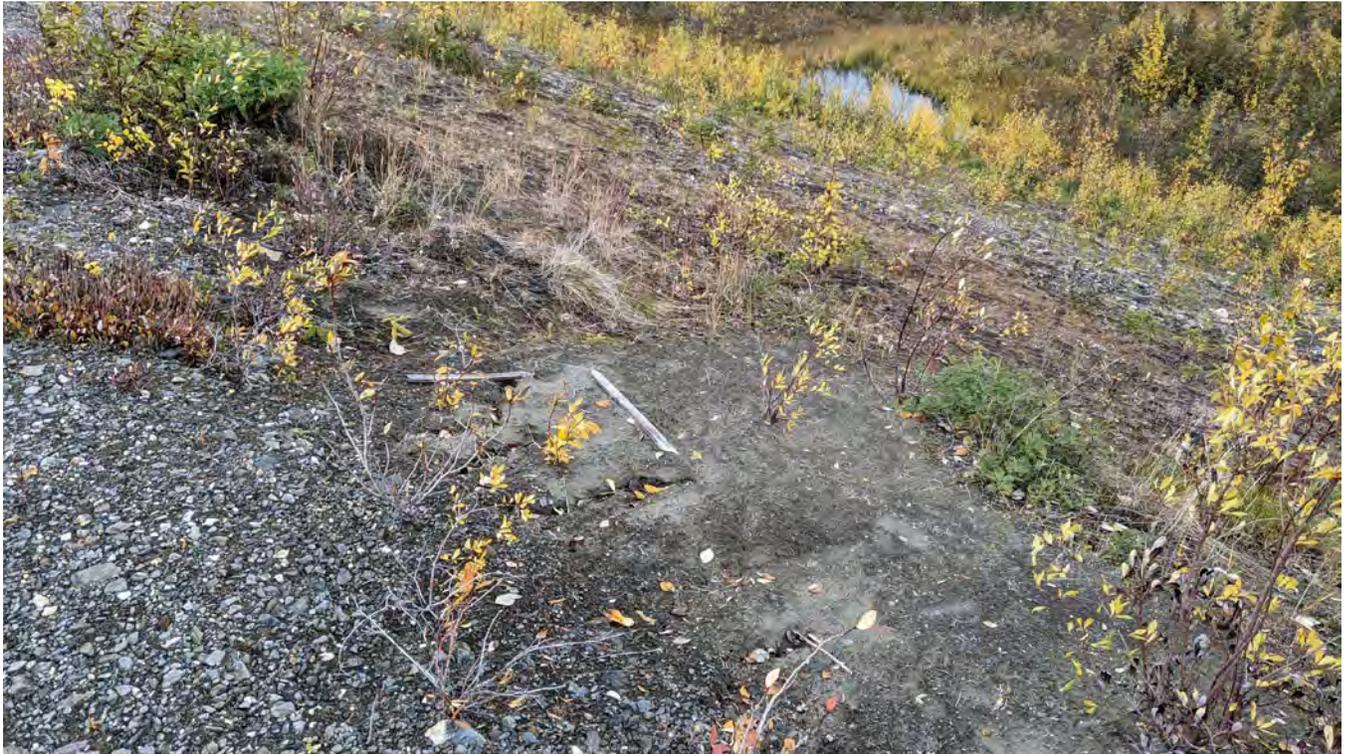
Photo ND-07: Wind-blown tailings on the downstream face of the dam immediately below the crest.

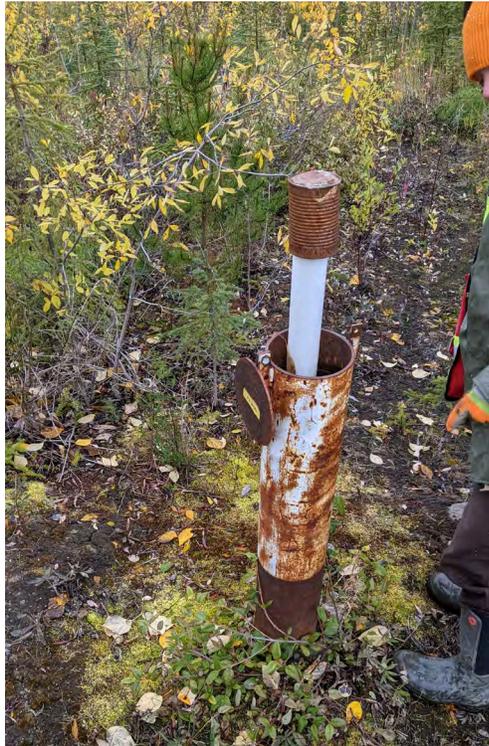
Photo ND-09: Piezometer NDW-4A downstream of the dam toe. The PVC pipe extends above the protective casing. A soup can is used as an end cap and would found displaced during the inspection.

Structure	ID No.	Deficiency or Non-Conformance	Applicable Regulation or OMS Reference	Recommended Actions	Priority (Table E2)	Recommended Deadline / Status
North Dam	2021-1	The soup can used as a cap on NDW-4A was displaced at time of the inspection.	OMS Section 5.2.1	Install a proper 2-inch PVC pipe plug and trim the PVC pipe such that it fits in steel protective casing. Water pooled within the casing should be removed (either siphoned or by drilling a small hole within the steel casing).	4	Complete during the next routine inspection in the Spring 2022.
North Dam	2021-2	A long-term goal for the TMA is to reduce all potential failure modes to non-credible.	-	Undertake a credible failure modes assessment for the TMA.	4	Before end of 2022
North Dam	2021-3	Water levels in Piezometer 2A triggered alerts and event-driven inspections during the last two freshets that are attributable to higher snowpacks and rainfall. The event-driven inspection resulted in no dam safety concerns.	OMS Section 6.2.2	Undertake a review of the trigger action alert levels and consider additional levels for seasonal freshet conditions.  Establish snowpack monitoring stations to investigate the impact between snowmelt and the North Dam foundation pressures.	4	Before end of 2022.

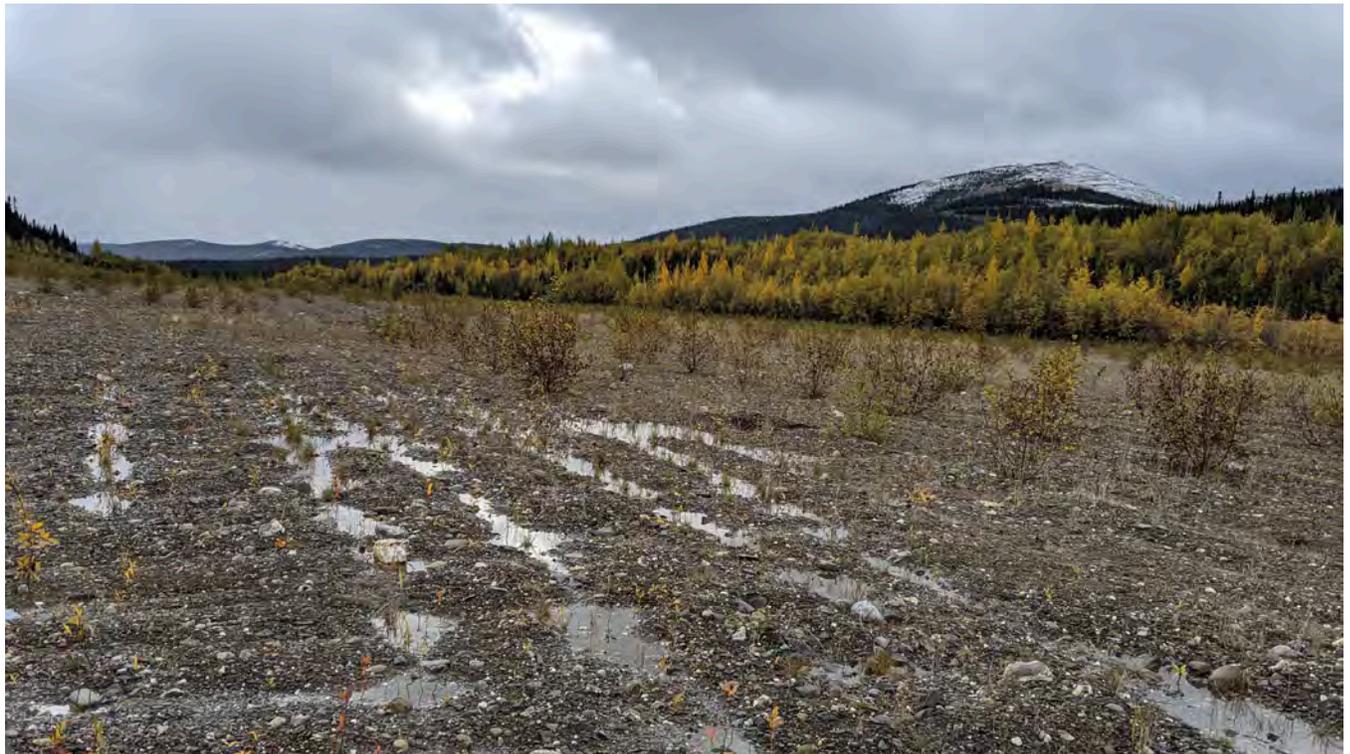
Photo TC-02: Small areas of standing water present throughout the tailings cover.

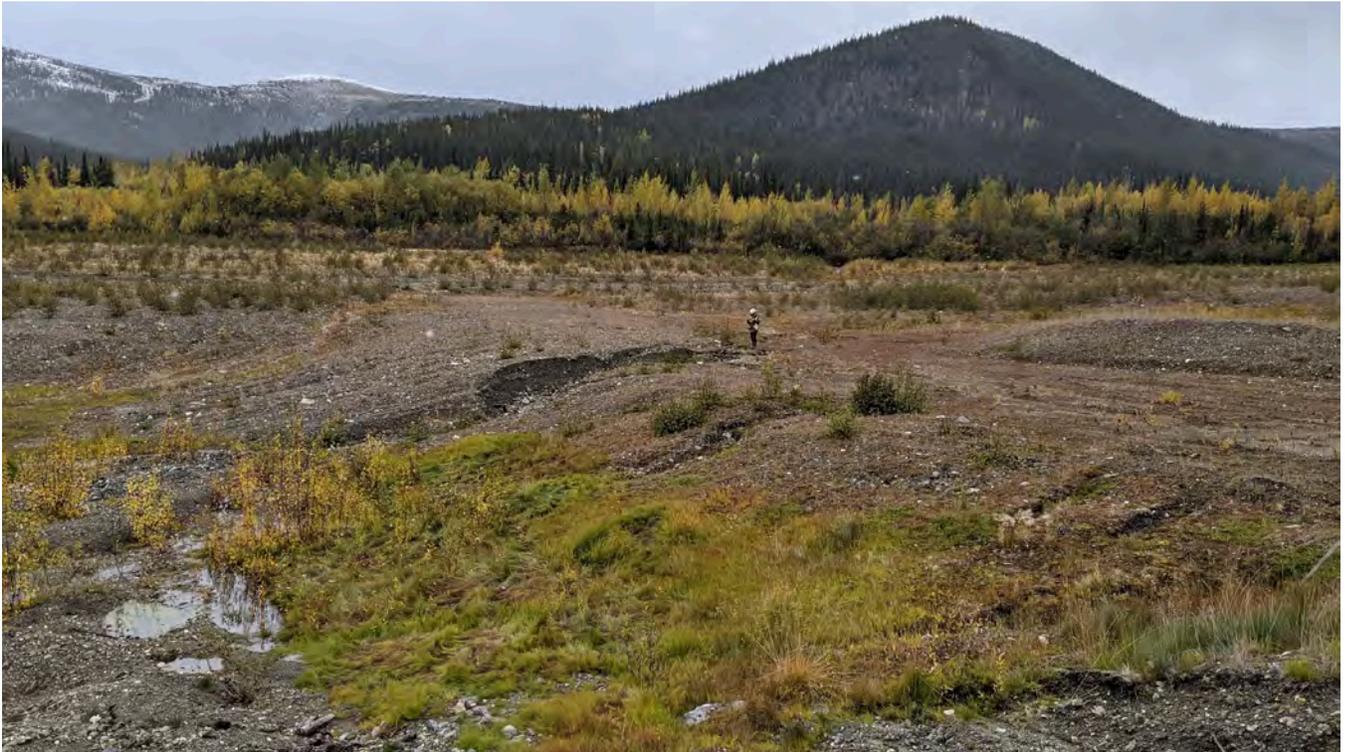
Photo TC-03: Erosion gully at the south end of the till cover and north of the SRS pond. No exposed tailings were observed.

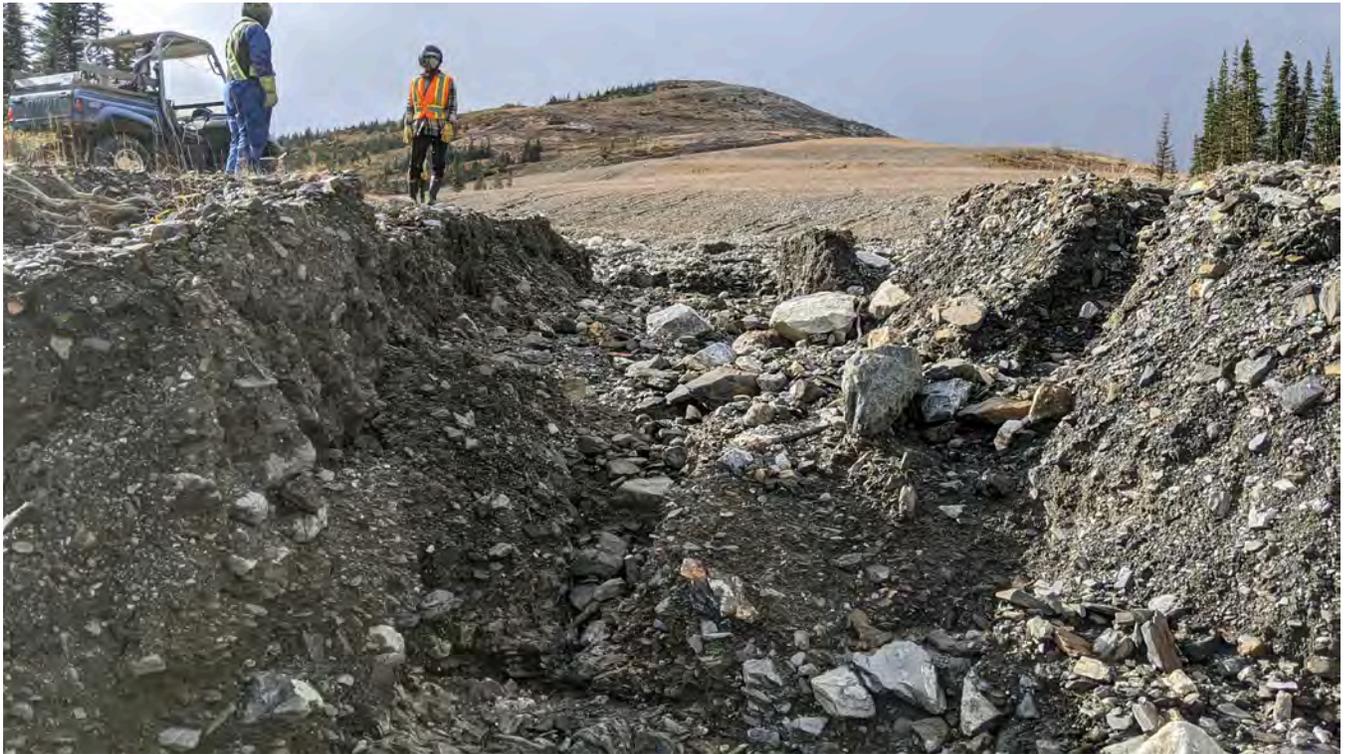
Photo WR-02: Erosion gully at base of Jewelbox Waste Dump looking upslope.

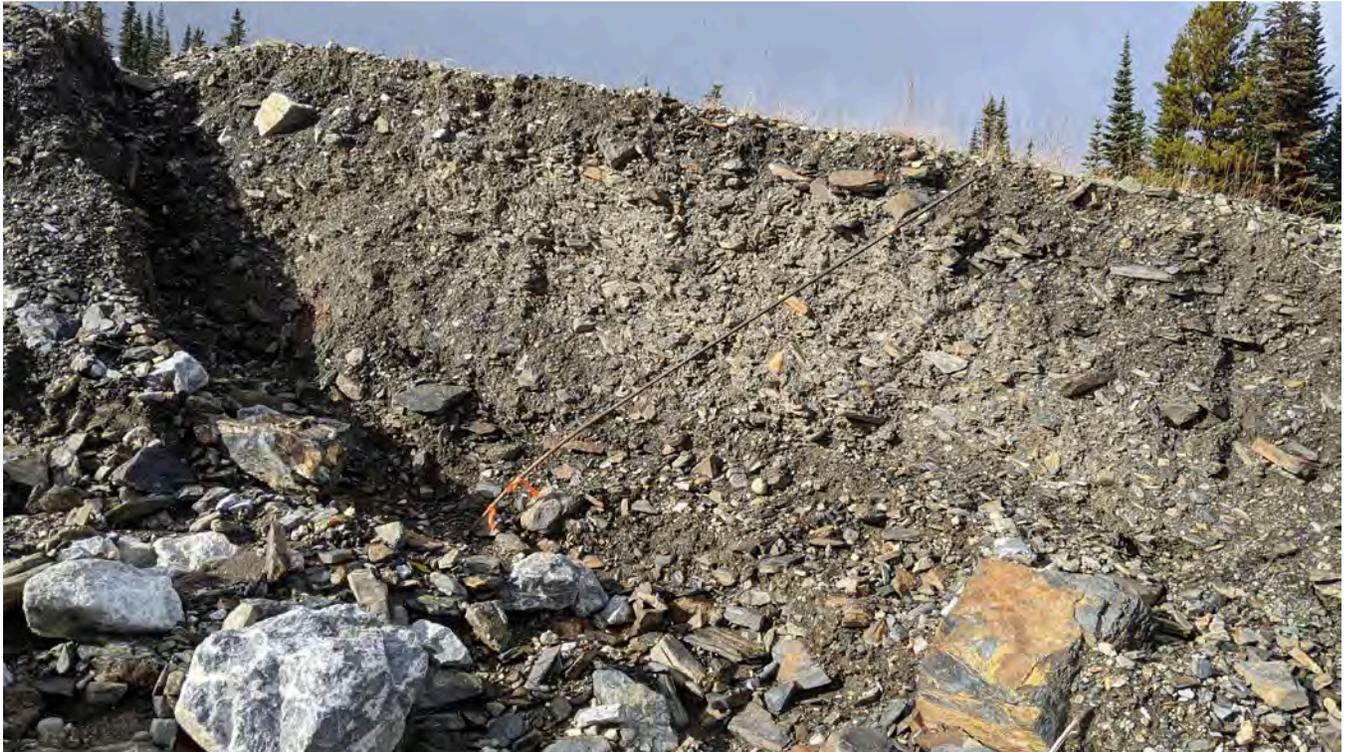
Photo WR-03: Side-wall of the erosion gully at the base of Jewelbox Waste Dump. The gully is approximately 2 m deep with vertical sidewalls.

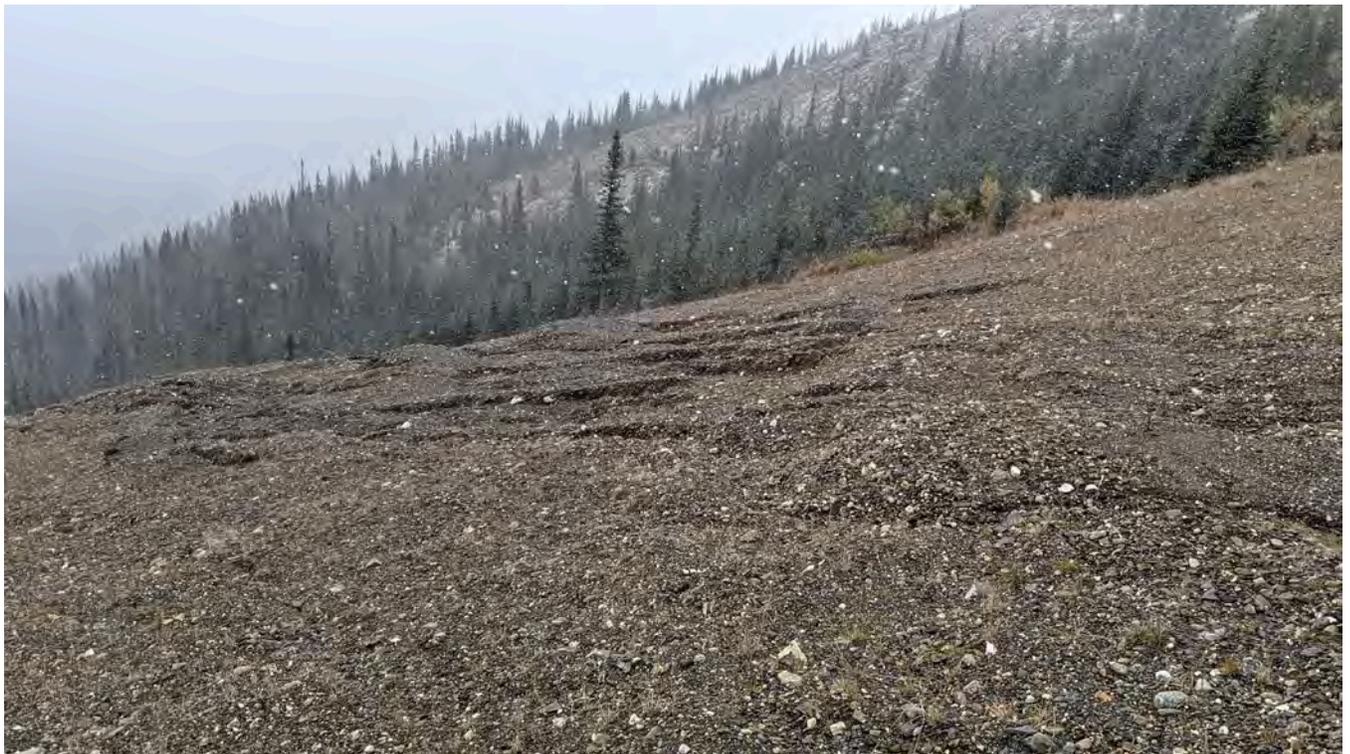
Photo WR-06: Surficial sloughing/deformation downslope of the 1408 Portal.

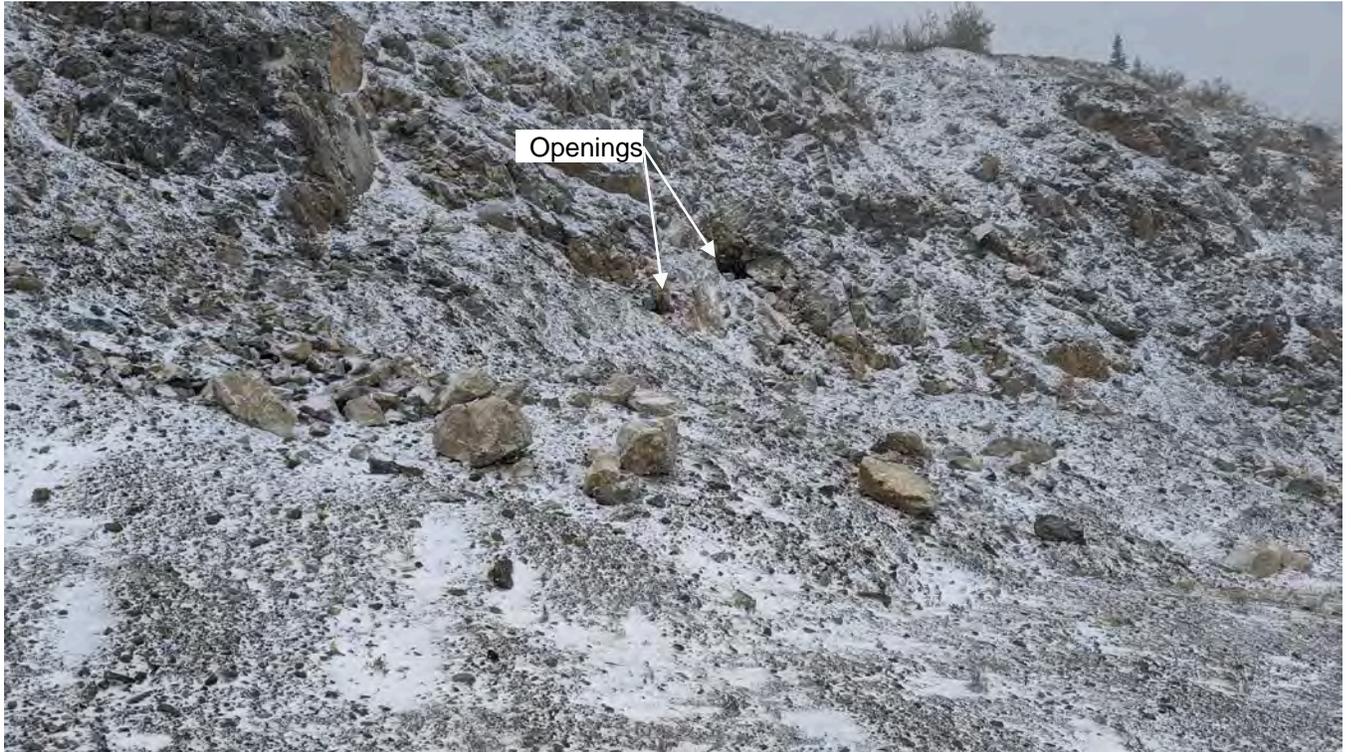
Photo WR-07: Openings in the Jewelbox Pit wall above Main Zone Waste Rock Dump.

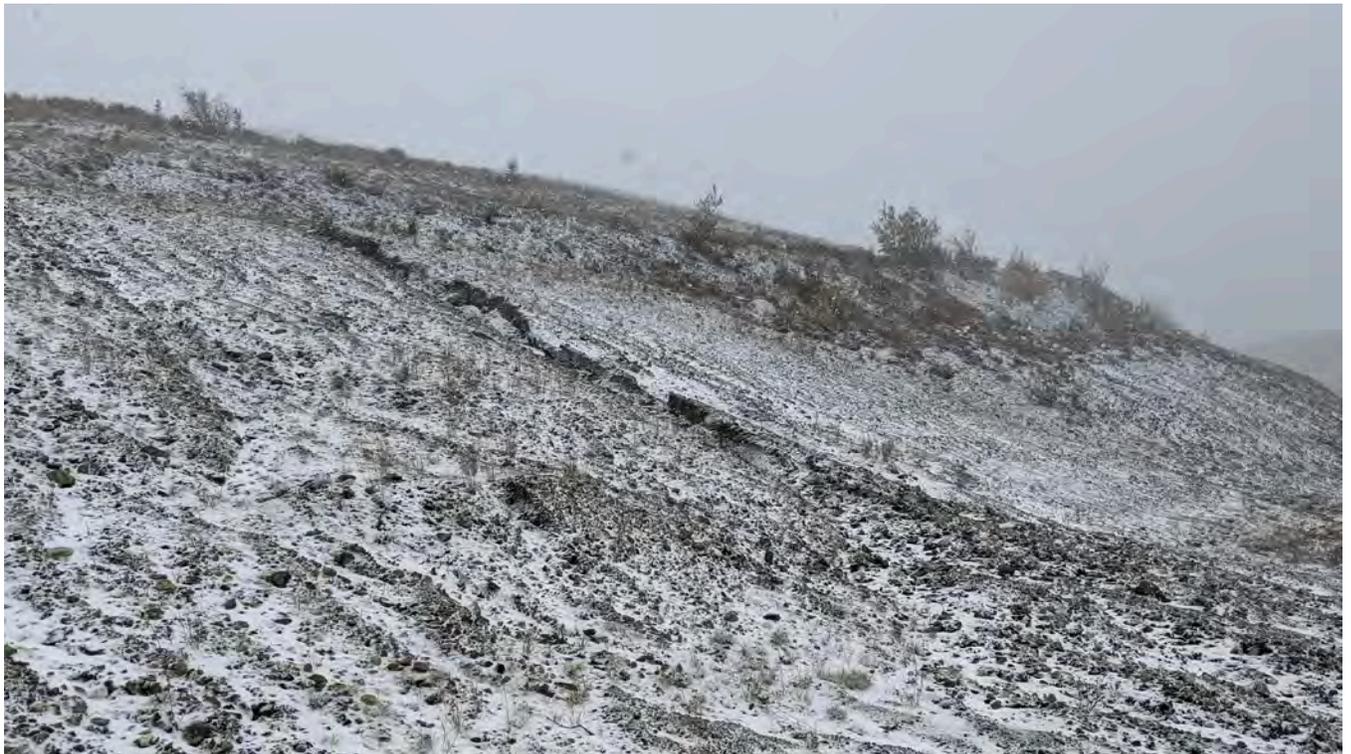
Photo WR-08: Erosion gully near the base of the Jewelbox Pit Waste Rock Dump.

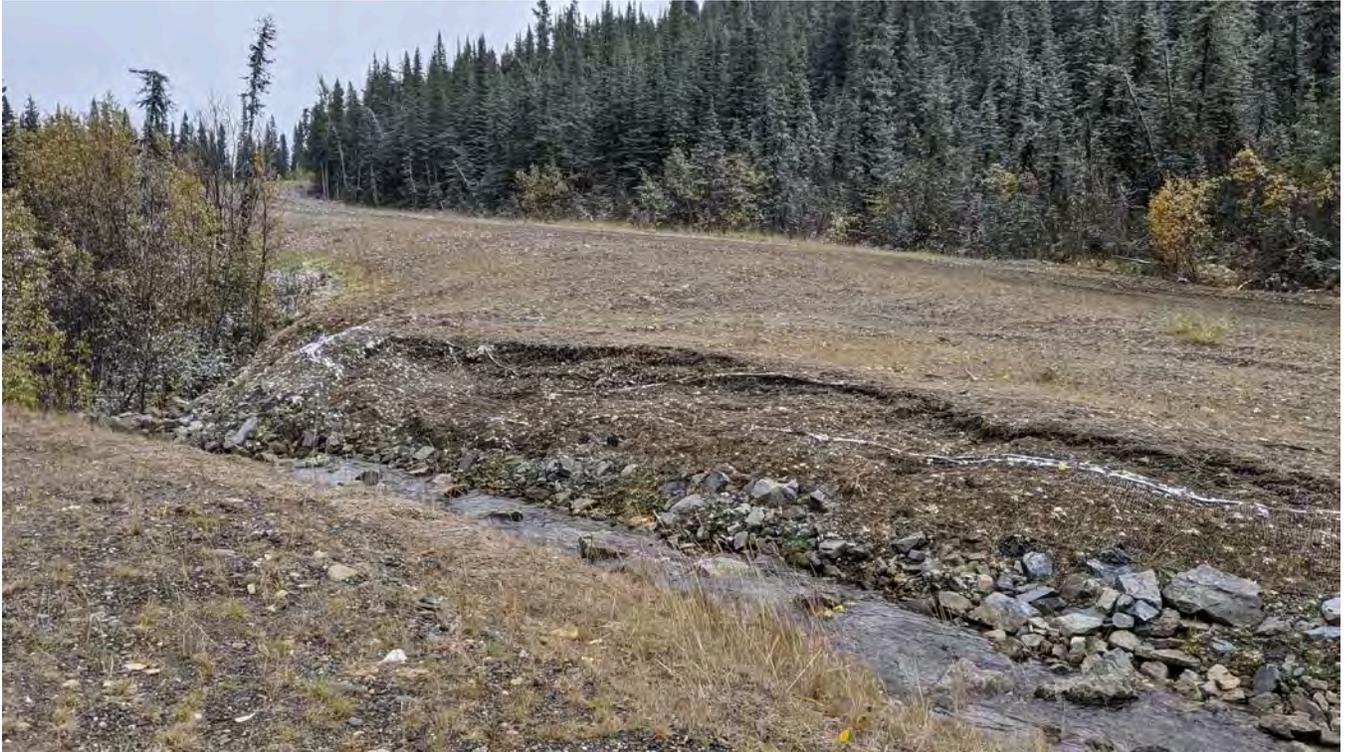
Photo WR-13: Subsidence of the south slope of North Creek across the decommissioned access road to the Burnick Zone.
