# 2021 Annual Facility Performance Report

Sä Dena Hes Mine, Yukon Territory

Teck Resources Limited

SRK Consulting (Canada) Inc. ■ 1CT008.075 ■ December 2021

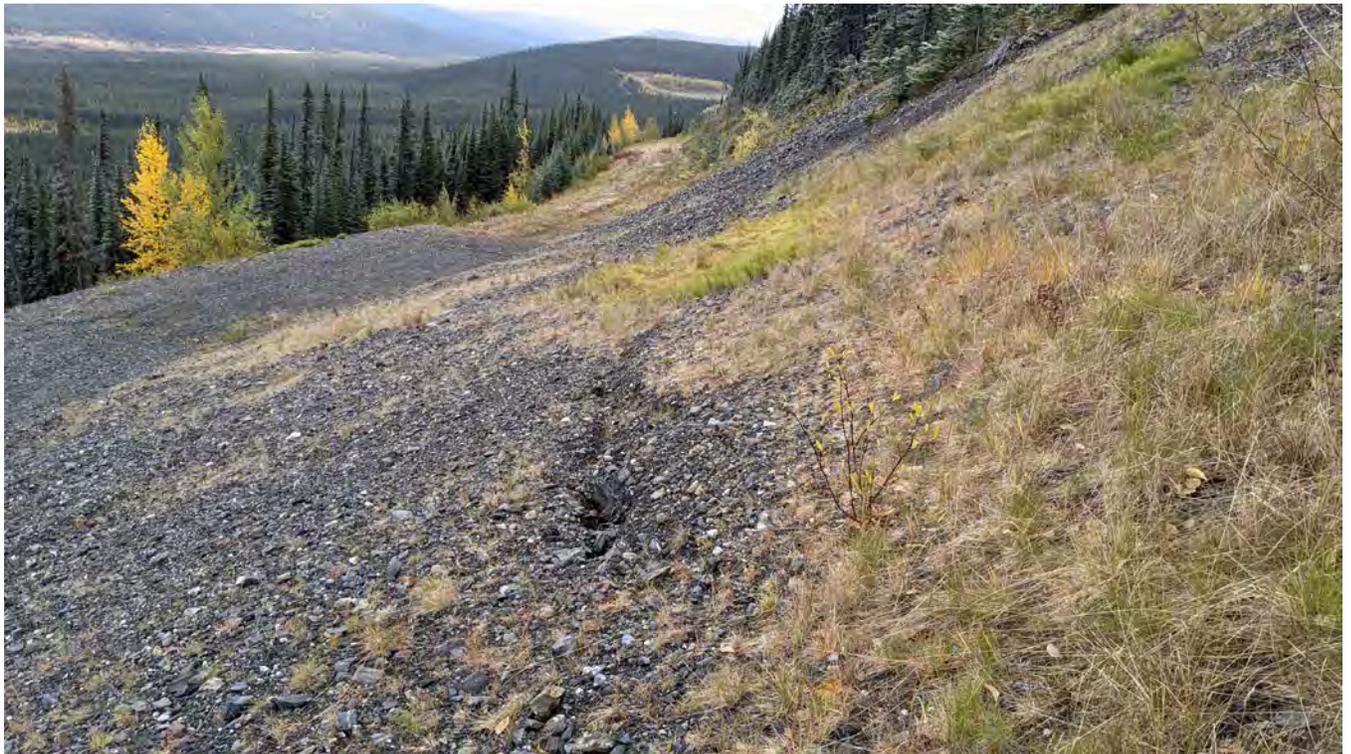
Photo WR-16: Regraded Burnick Waste Dump and 1200 Portal Area looking south. Minor settlement cracking is visible in the foreground. The scarp is approximately 5 cm in height..
