Teck Metals Ltd.

Sullivan TSF 2021

Annual Summary of Tailings Facility Performance Report

March 25, 2022

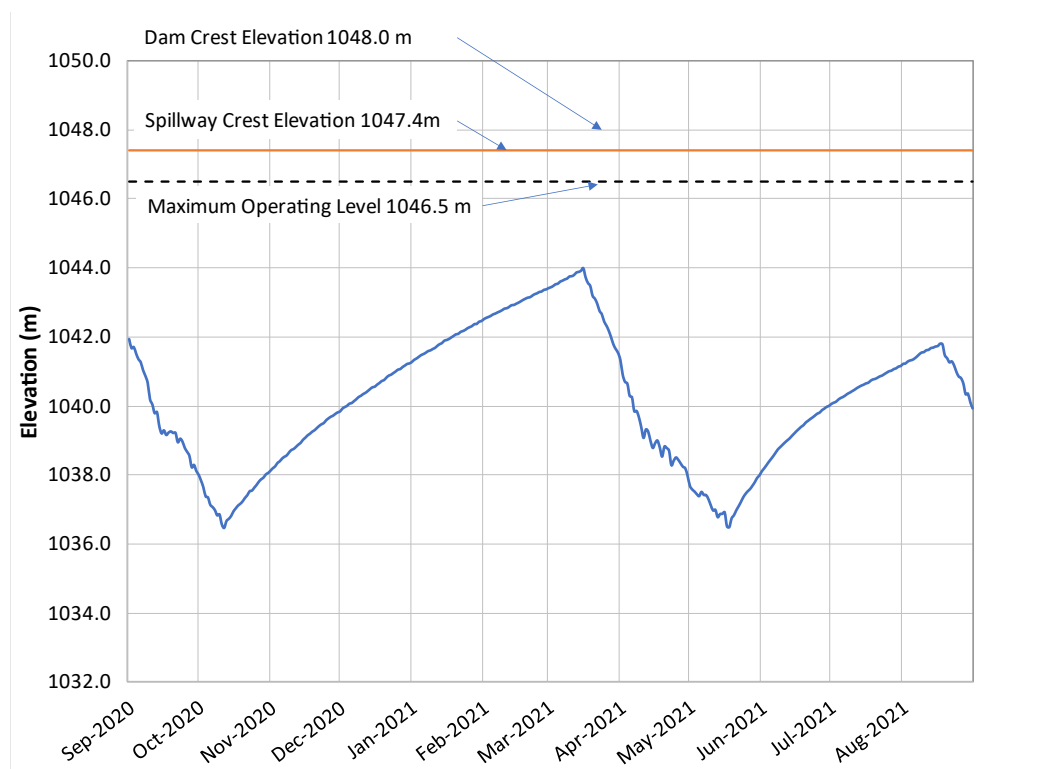
Figure 3.2 ARD Pond Level 2020 – 2021

Based on the pond water levels, the maximum level observed during the reporting period was El. 1044.0 m, which occurred on March 16, 2021. This is 2.5 m lower than the maximum operating level (MOL) and is 3.4 m below the spillway crest elevation. There was no water discharged from the ARD Pond spillway to the Iron Pond during the water balance time period. The spillway has never discharged since the ARD pond was constructed.

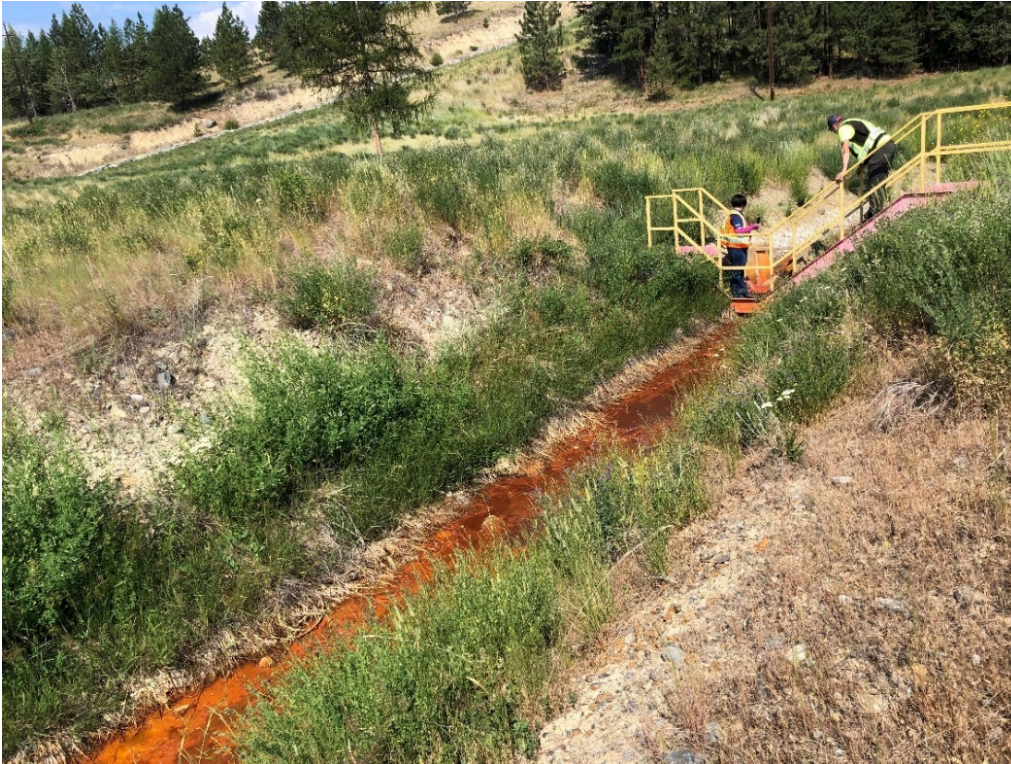
Photo II.15 Weir #4

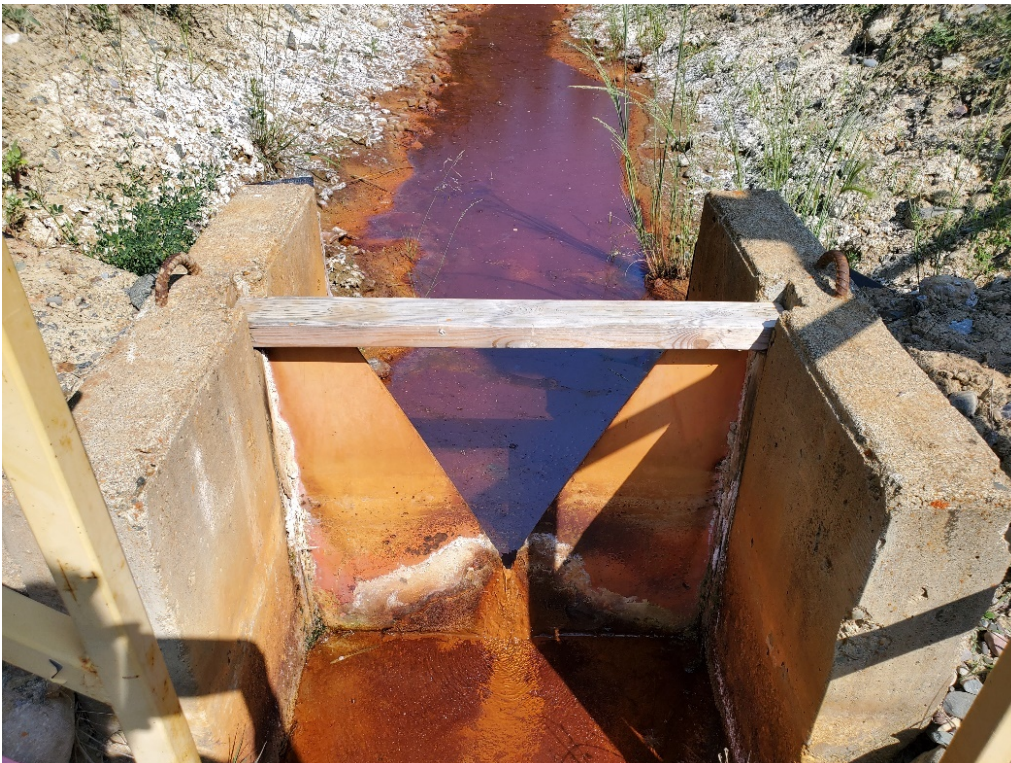
Photo II.16 Weir #4 worn notch
