Teck Highland Valley Copper Partnership

2022 Annual Facility Performance Report

7-Day Pond Tailings Storage Facility

March 2023

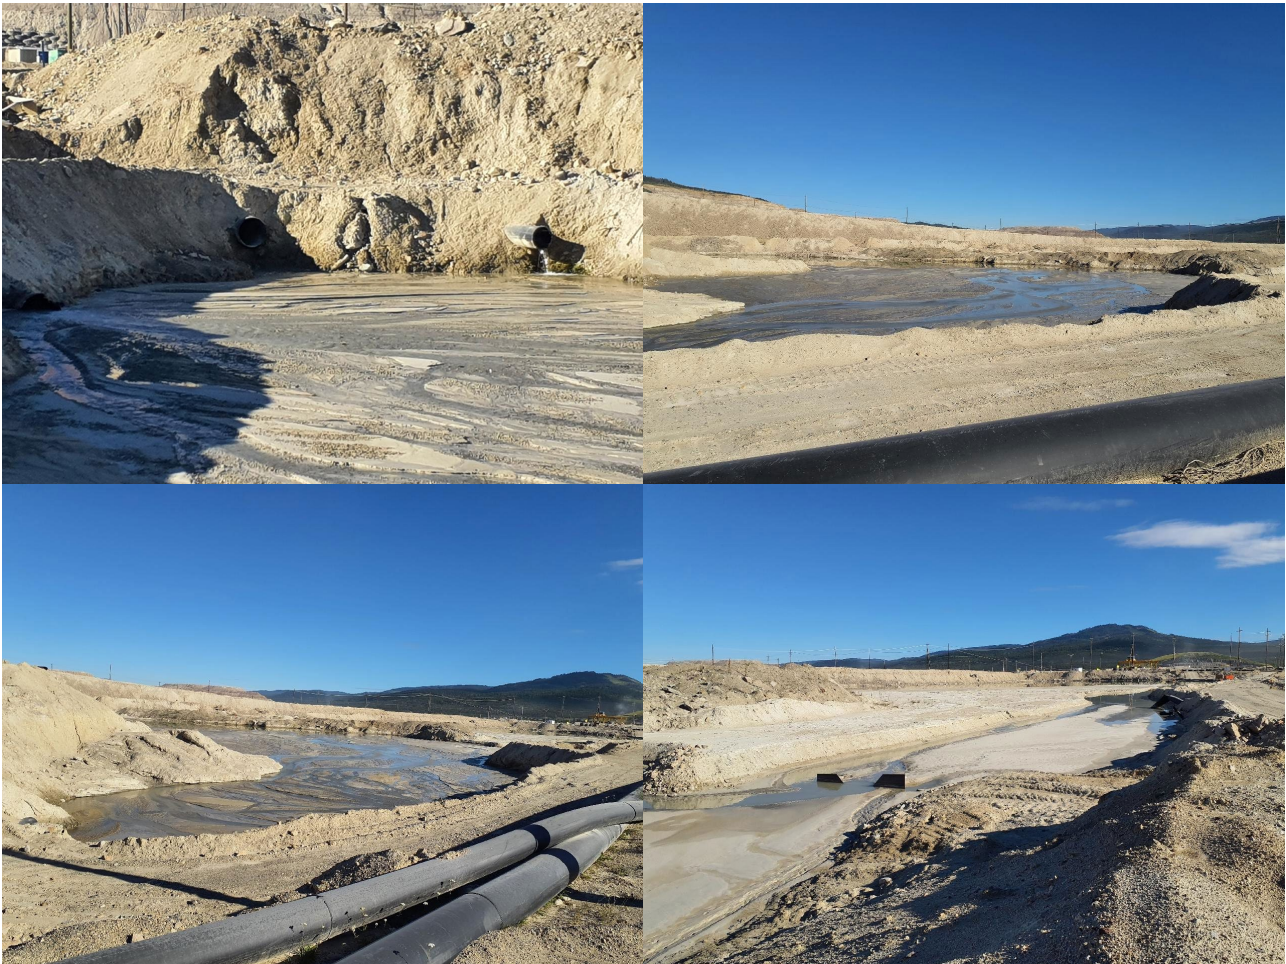
- **Crest:** The haul road which forms the crest of the dam around 7-Day Pond TSF was in good physical condition. No indicators of significant concern were observed (e.g., cracking, slumping) (Photo I-1 and Photo I-2).
- **Upstream and Downstream Slopes:** Upstream and downstream slopes were in good physical condition. They were not vegetated and no indicators of significant concern were observed (e.g. animal activity, cracking, slumping, surface erosion features).
- **Tailings Beach and Pond:** Impoundment had a visible beach as well as ponded water near the outlet. The v-notch weir near the inlet was buried by tailings, and the east flank trench was filled with tailings and water (Photo I-1).
- **Outflow Pump:** Fixed pumping system operational.
- **Seepage:** None observed.

Photo I-1 7-Day Pond TSF. Two inflow pipes observed: one pipe discharging clear water at the time of the site visit (SDP-2022-01, SDP-2022-02 and SDP-2022-03)

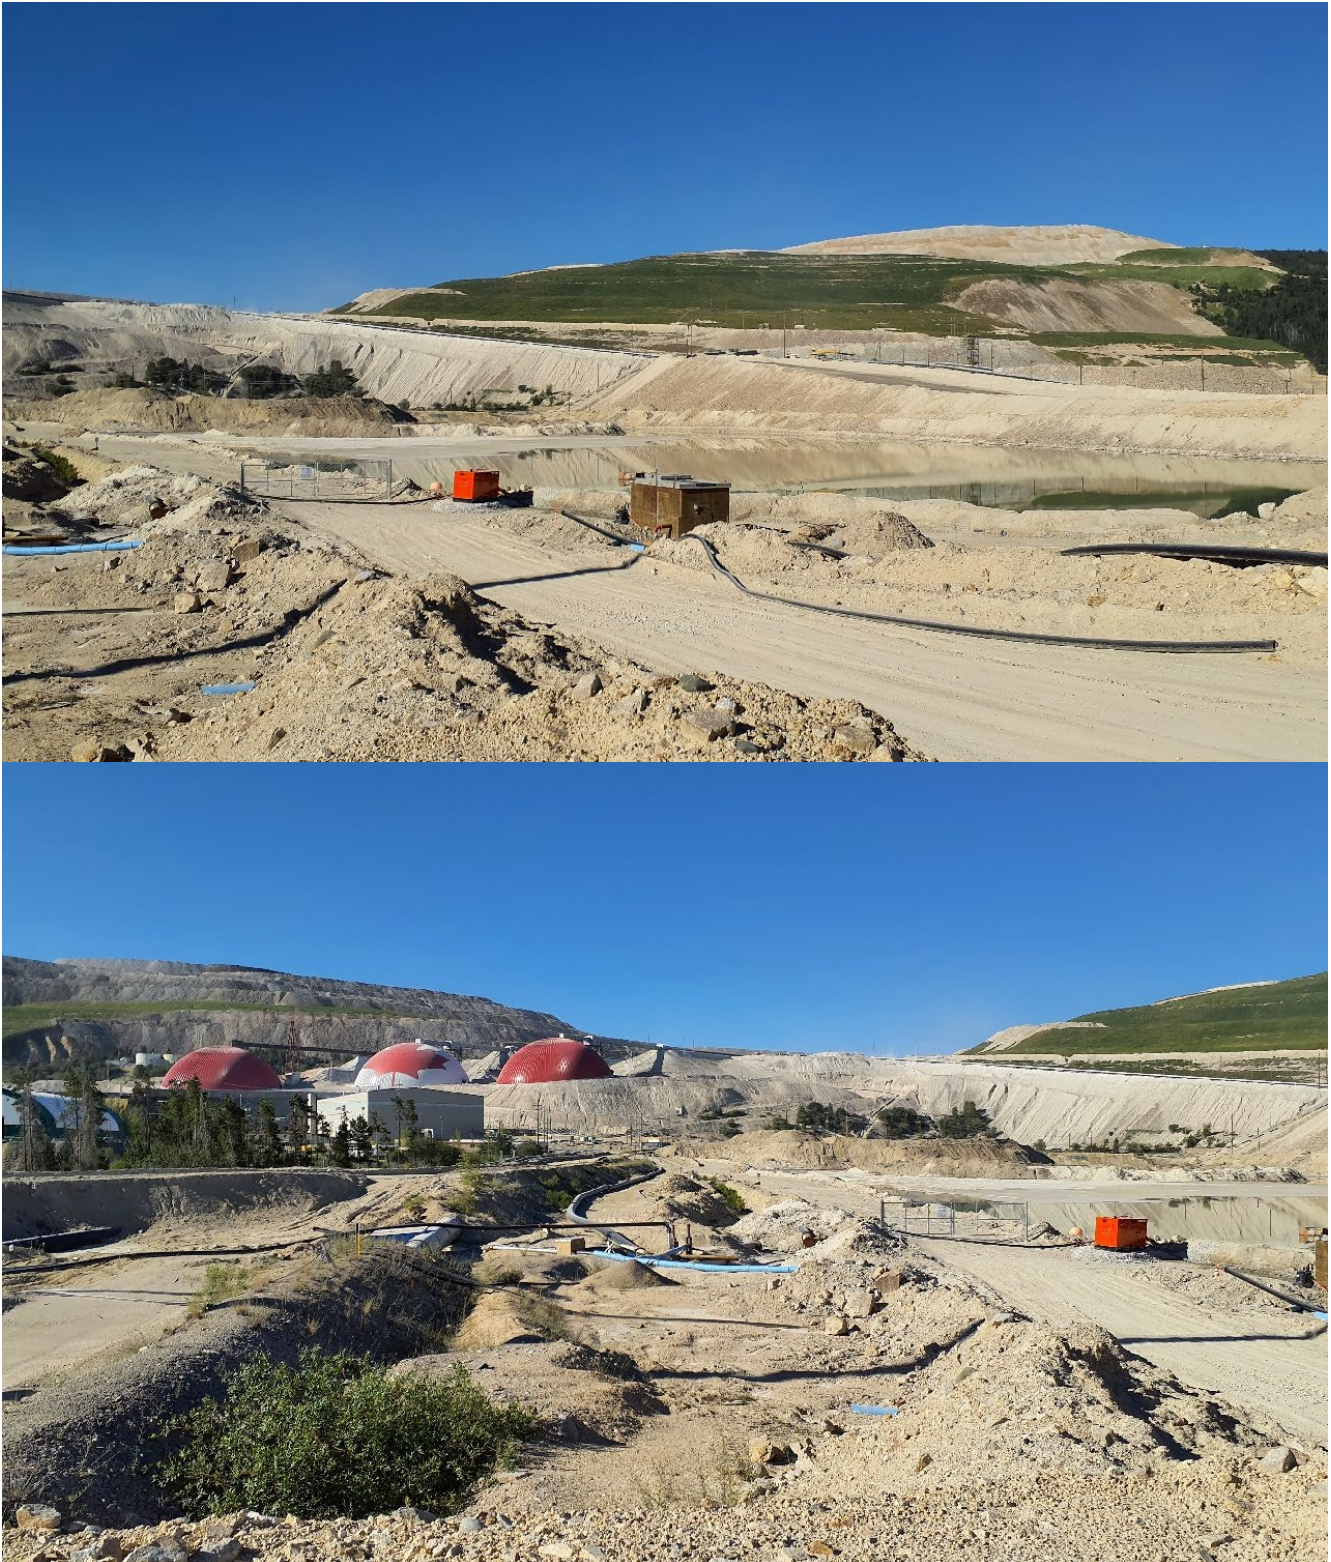
Photo I-2 7-Day Pond TSF crest (SDP-2022-04)

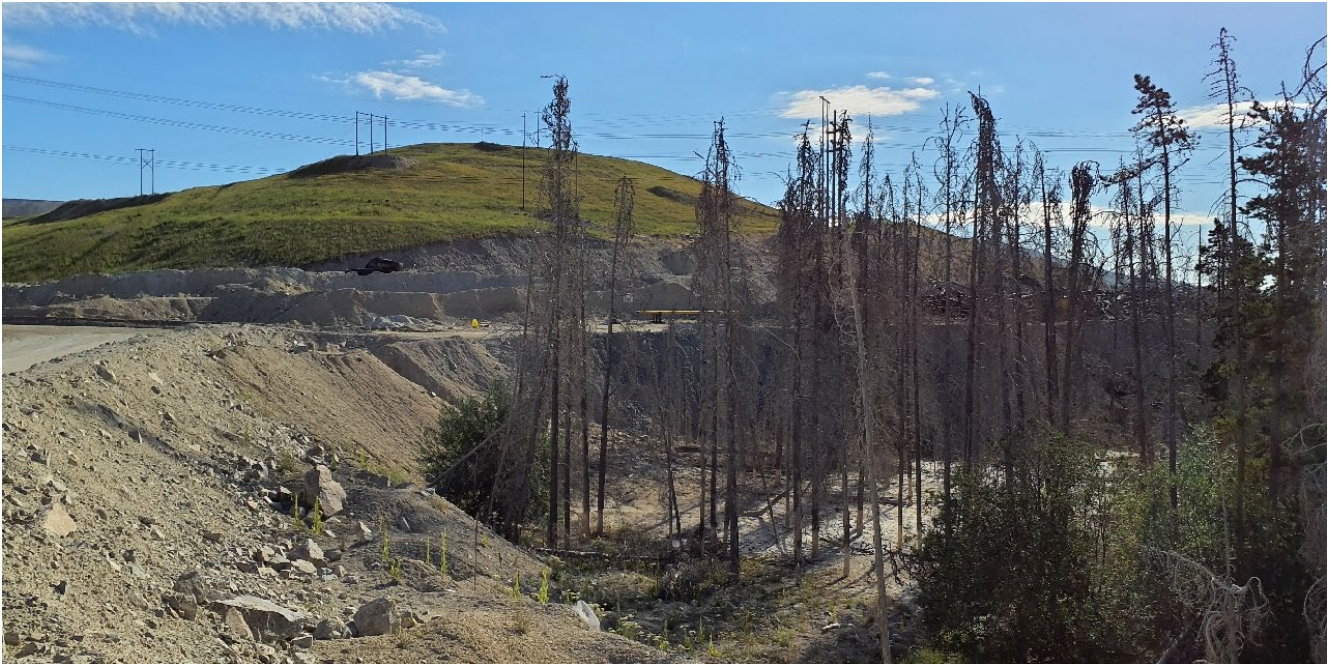
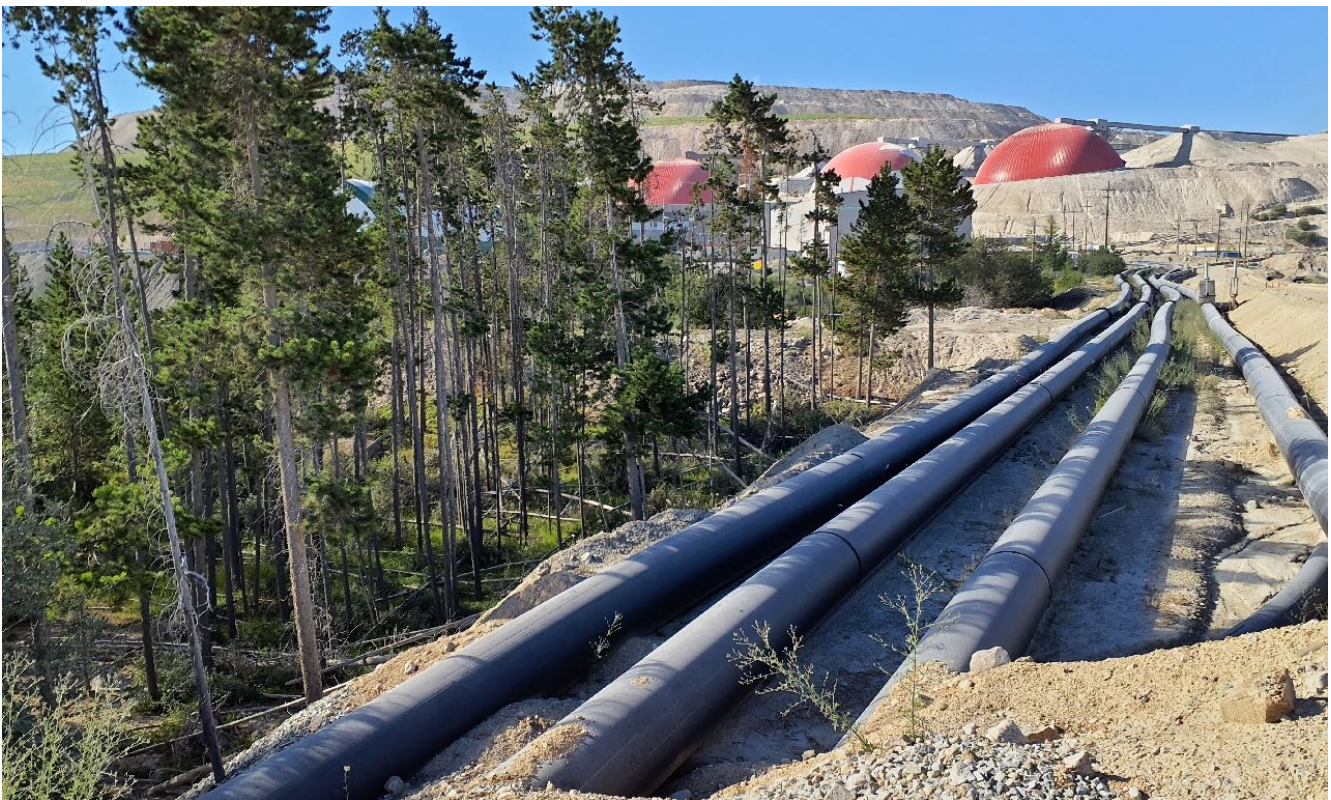
Photo I-3 Treed area downstream (D/S) of East Berm

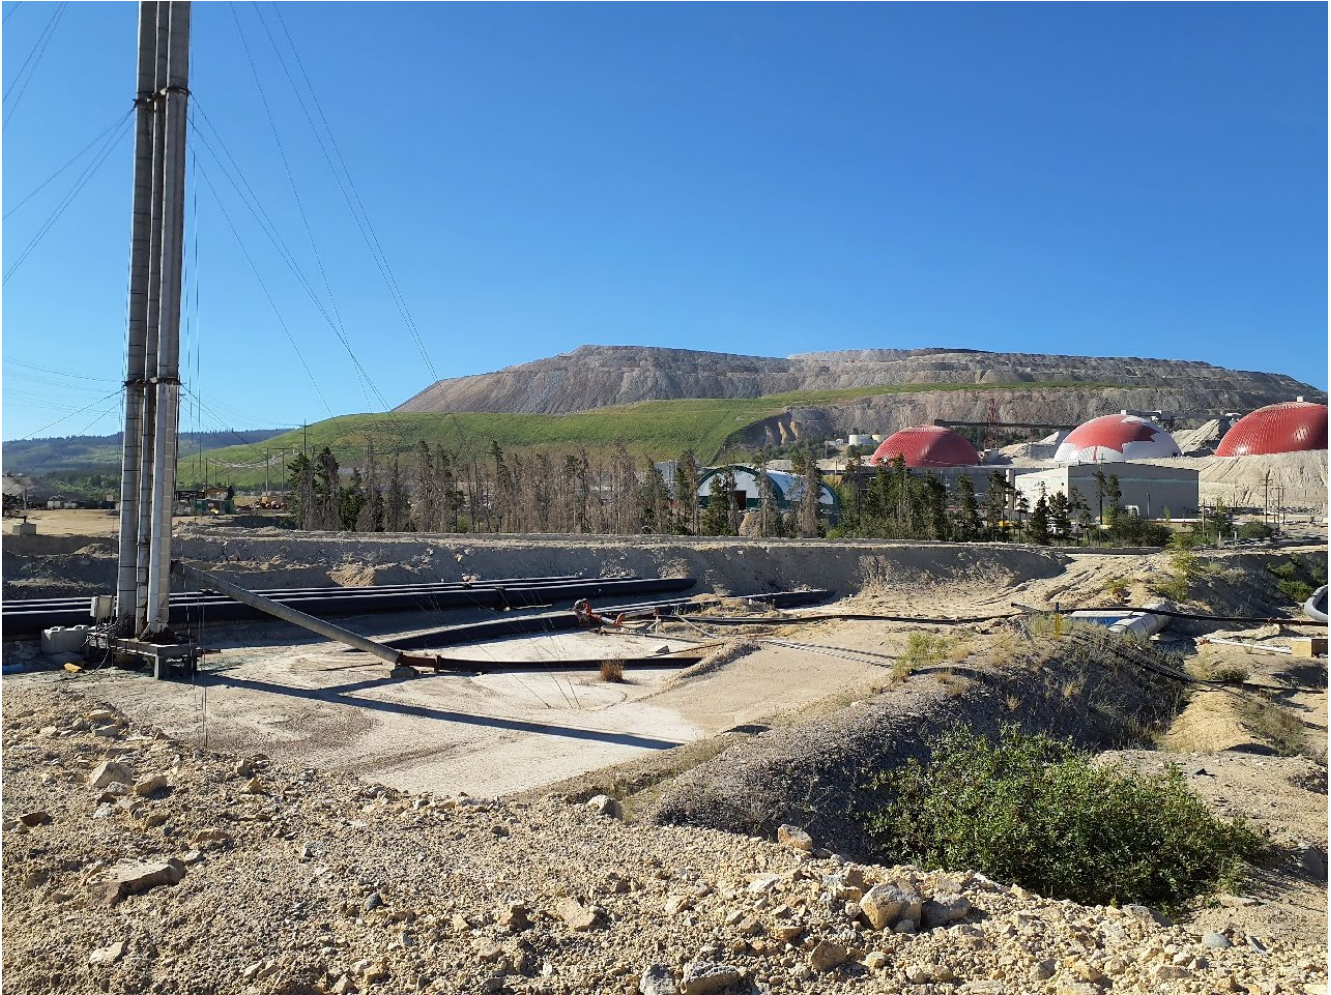
Photo I-4 **7-Day Pond TSF impoundment. Structure within TSF impoundment is part of permanent dewatering-pump system. Pumping system was active at the time of the site visit (SDP-2022-04)**

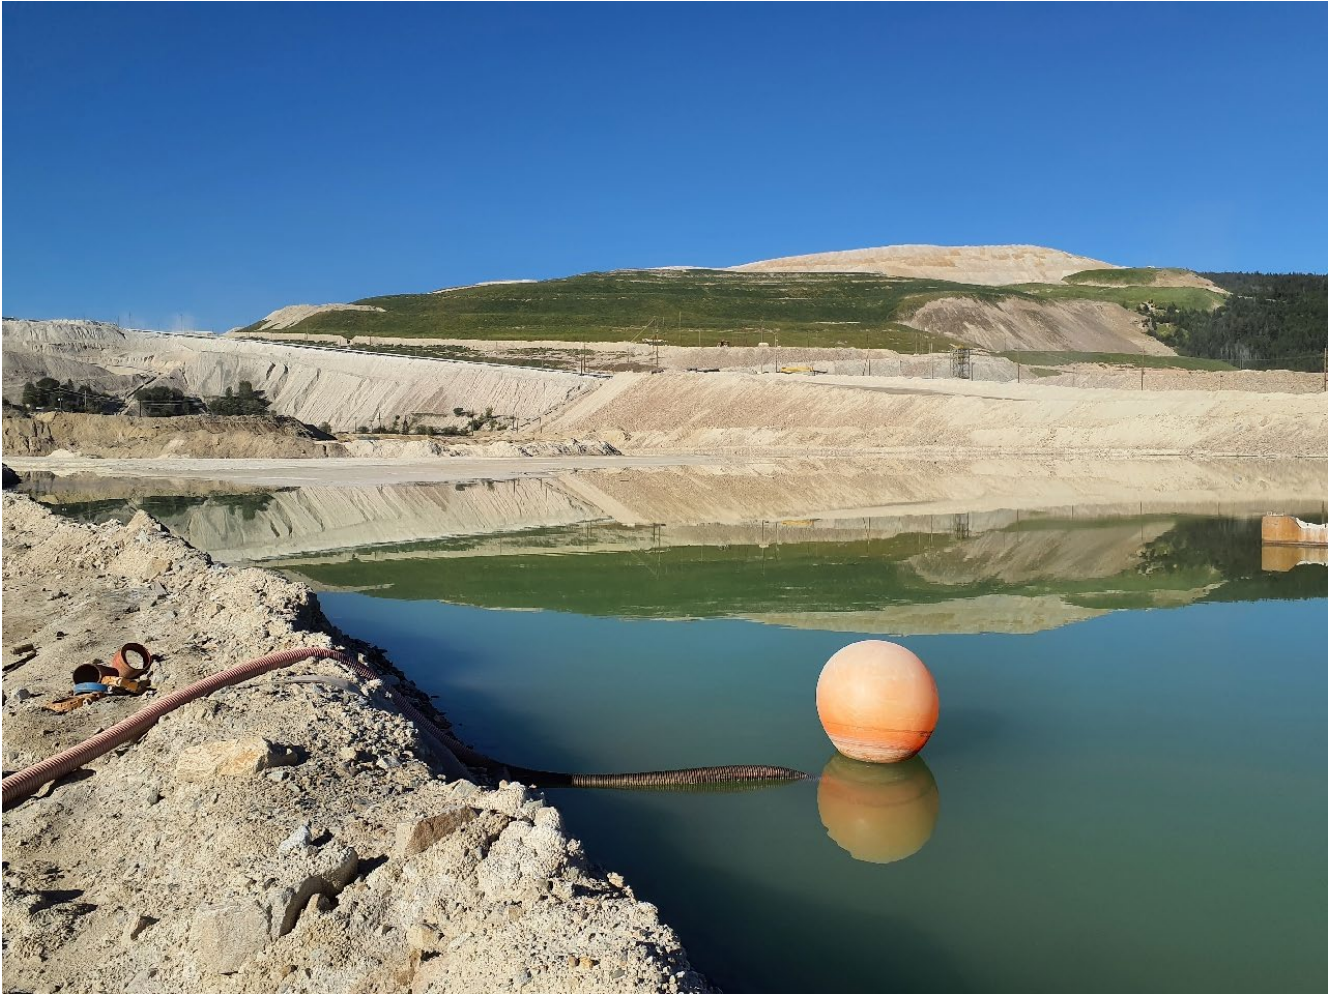
Photo I-5 7 Day Pond TSF impoundment view from north abutment. Poned water observed at the time of the site visit (SDP-2022-05)
