Teck Highland Valley Copper Partnership

2023 Annual Facility Performance Report

Bethlehem No.1 Tailings Storage Facility

March 2024

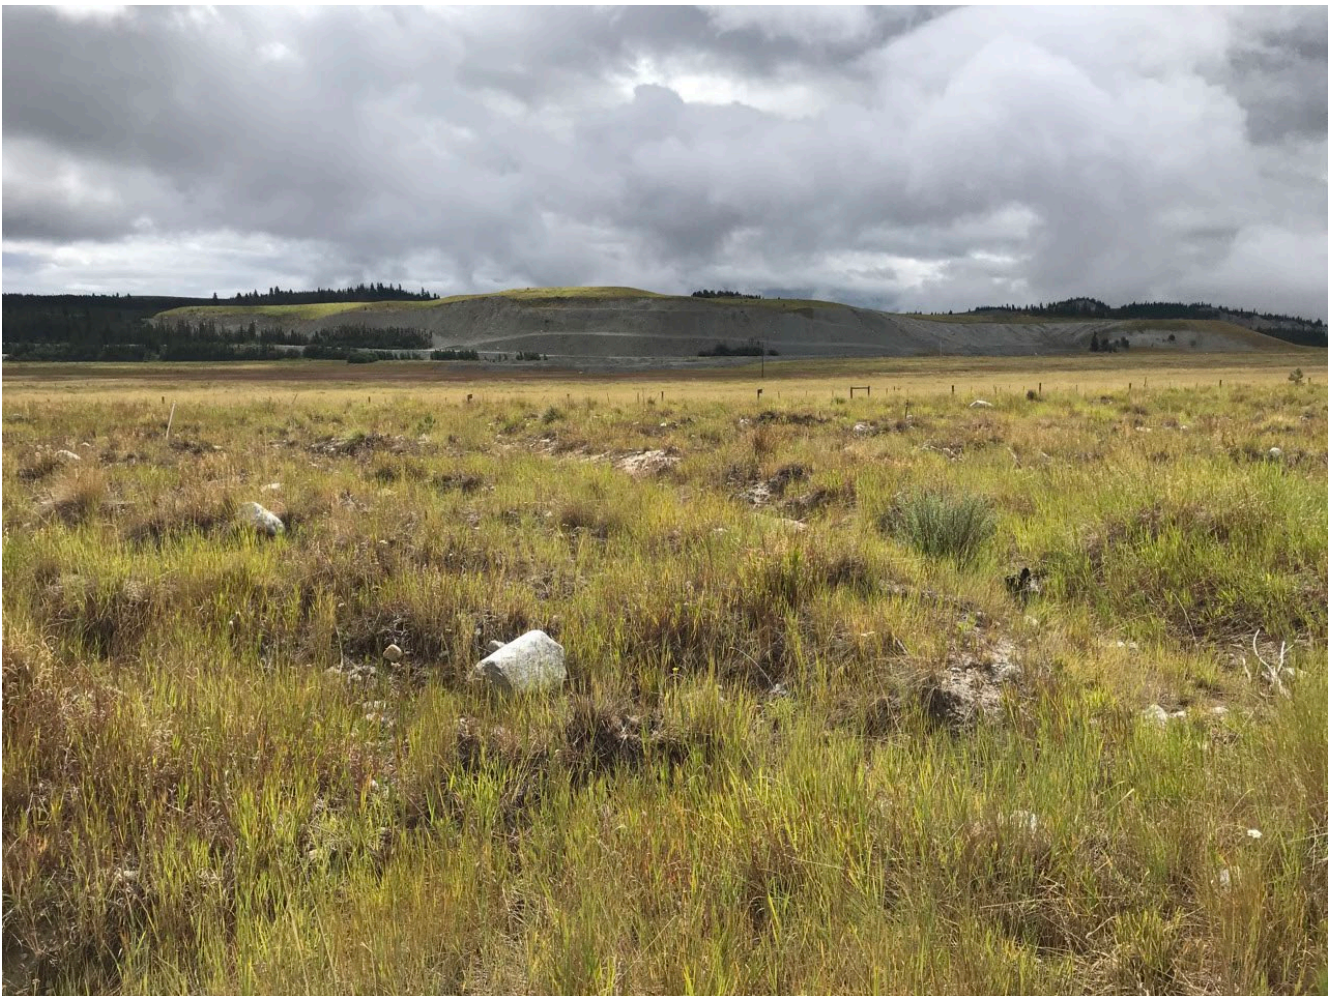
Photo I-A-1 Overview of reclaimed cycloned tailings beach and impoundment area upstream of Dam No. 1 (BTH-2023-01)

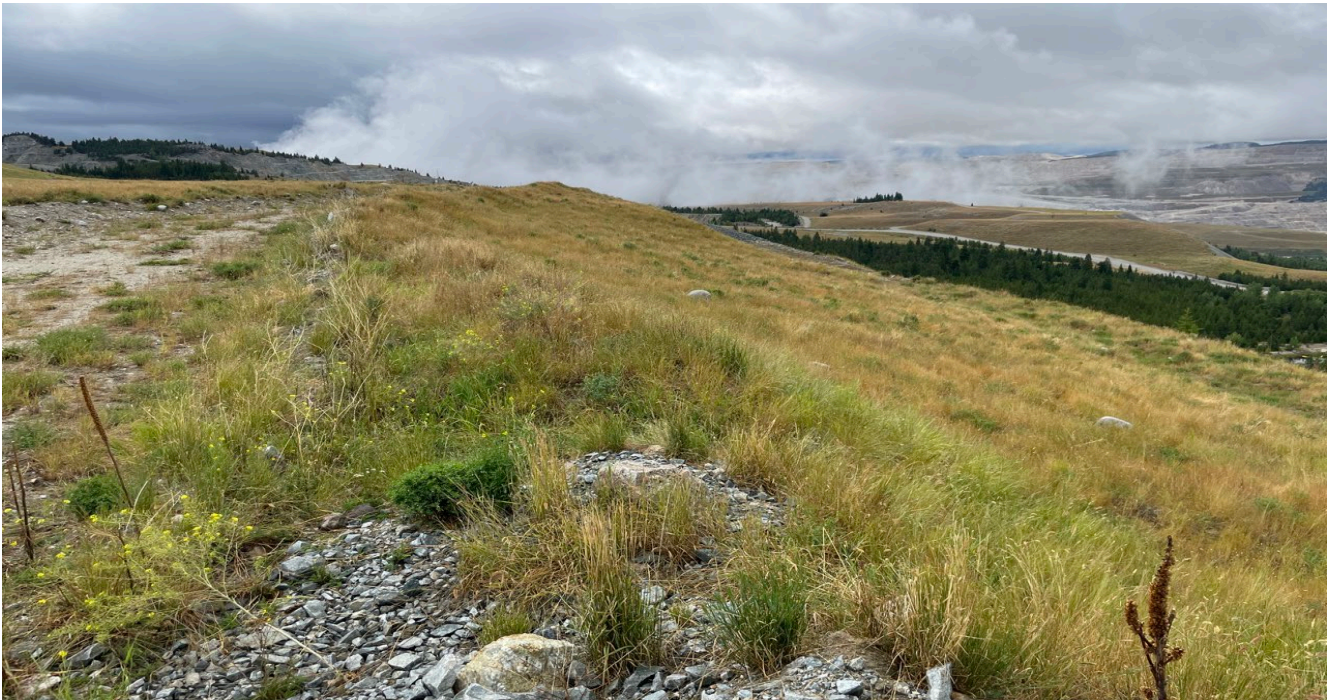
Photo I-A-6 Upper portion of downstream slope with reclamation cover. (BTH-2023-02)

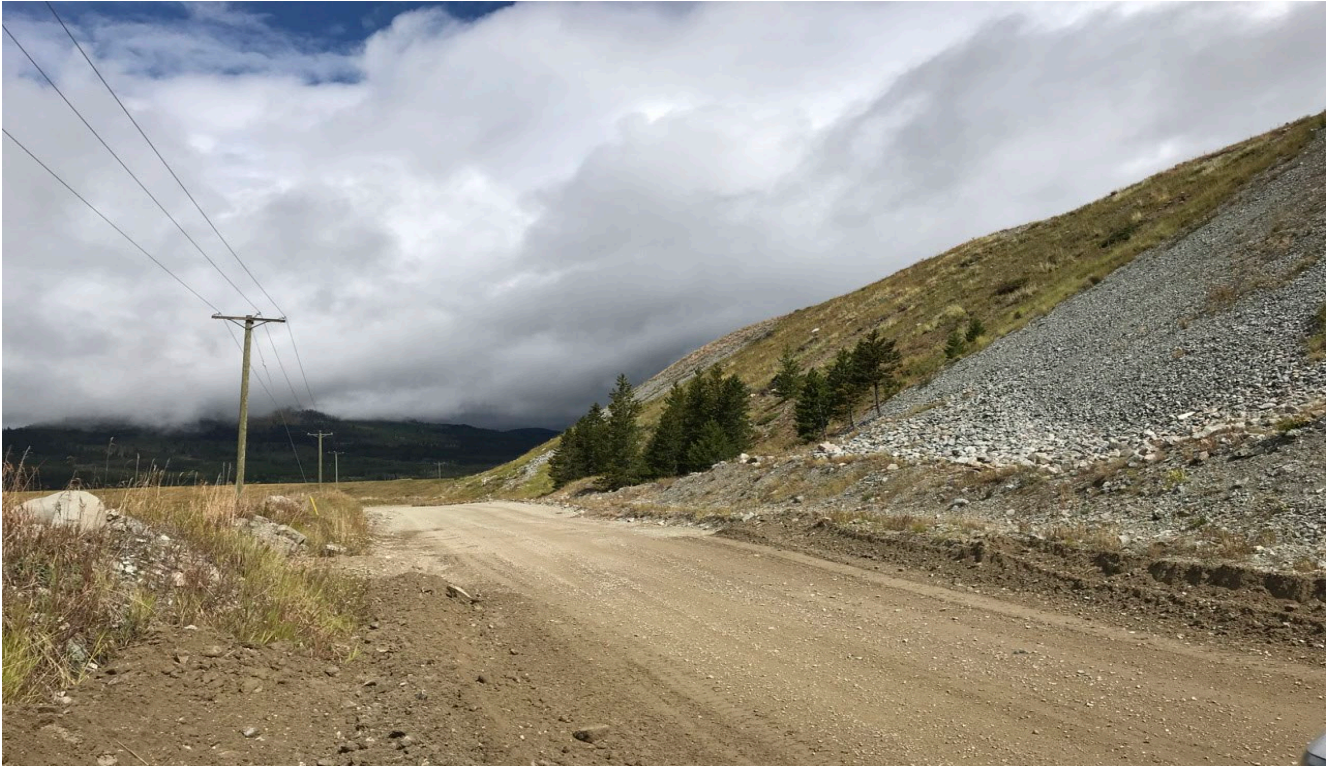
Photo I-A-7 Overview of downstream slope from mine road. Vegetation cover is well established. Previous erosion areas, covered by rockfill, are holding up well (BTH-2023-03)

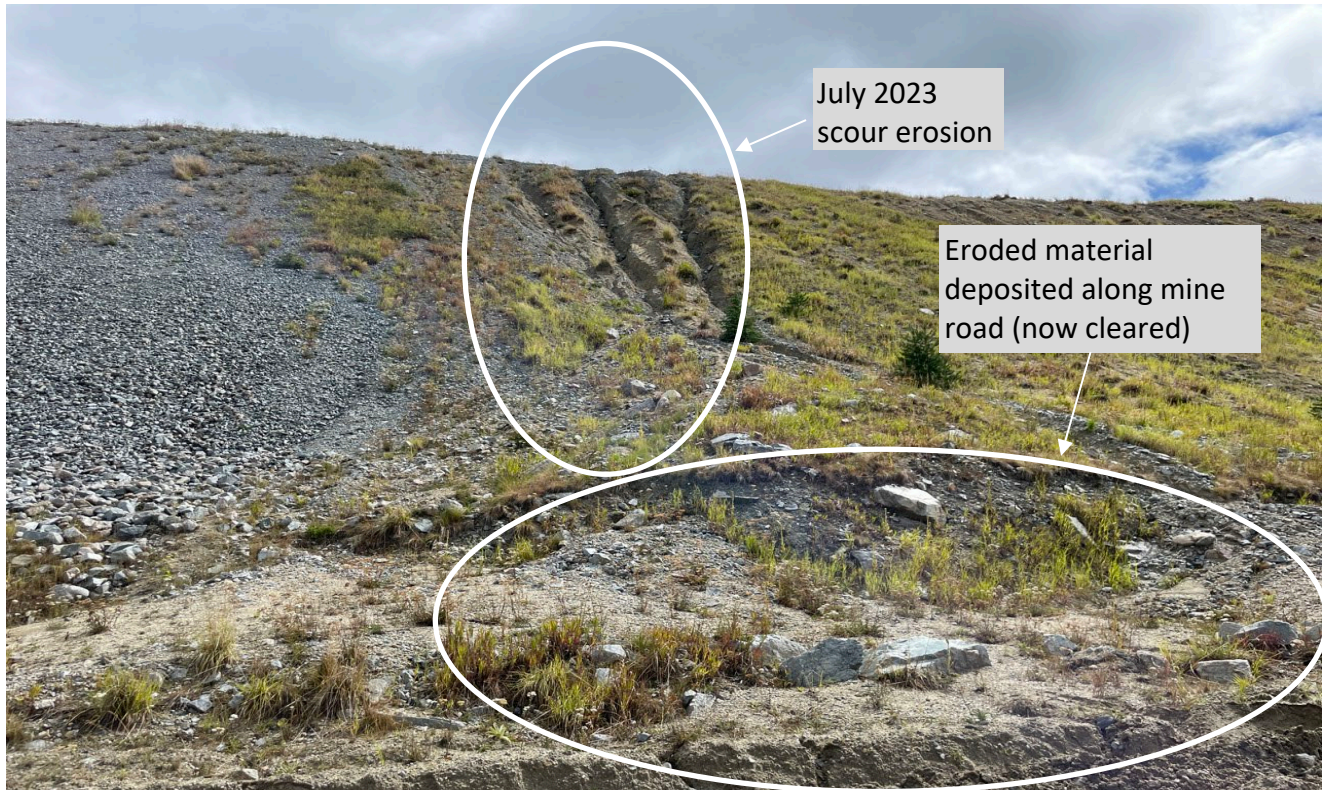
One new recommendation was identified (Table 2) to regrade the crest to prevent ongoing surface flow over the downstream slope. This does not represent an imminent dam safety concern at the facility but should be done to prevent ongoing erosion.

Photo I-A-8 Erosion scour that formed during July 2023 thunderstorm when runoff from crest flowed over downstream slope. Regrading of the crest to prevent ongoing erosion has been recommended. (BTH-2023-04)

ID No.	Performance Area	Recommended Action	Priority ⁽¹⁾	Deadline (Status)
Dam No. 1				
BD1-2023-01	Maintenance	Regrade the area of the crest where runoff flowed over the downstream slope and establish a berm to prevent continued erosion where the scour originated.	3	Q3 2024

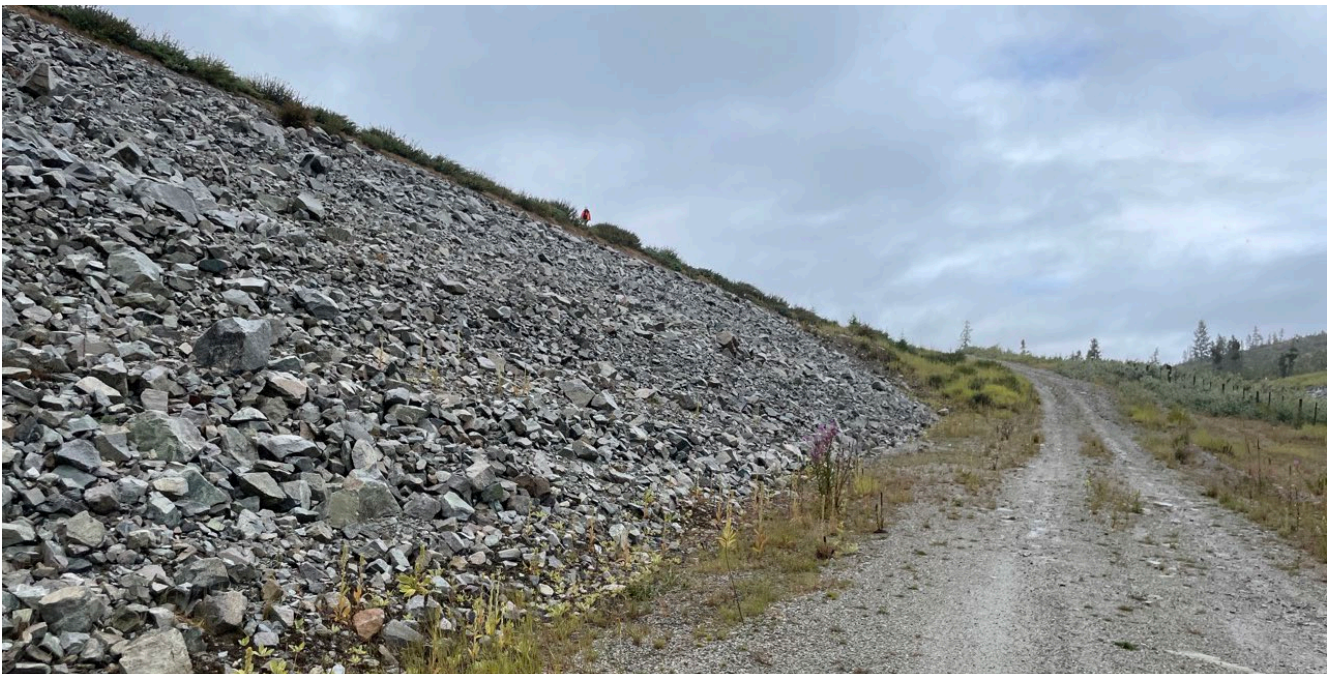
Photo I-B-3 Left abutment and downstream slope, looking north, with no observation of erosion scours or damage. (BTH-2023-07)

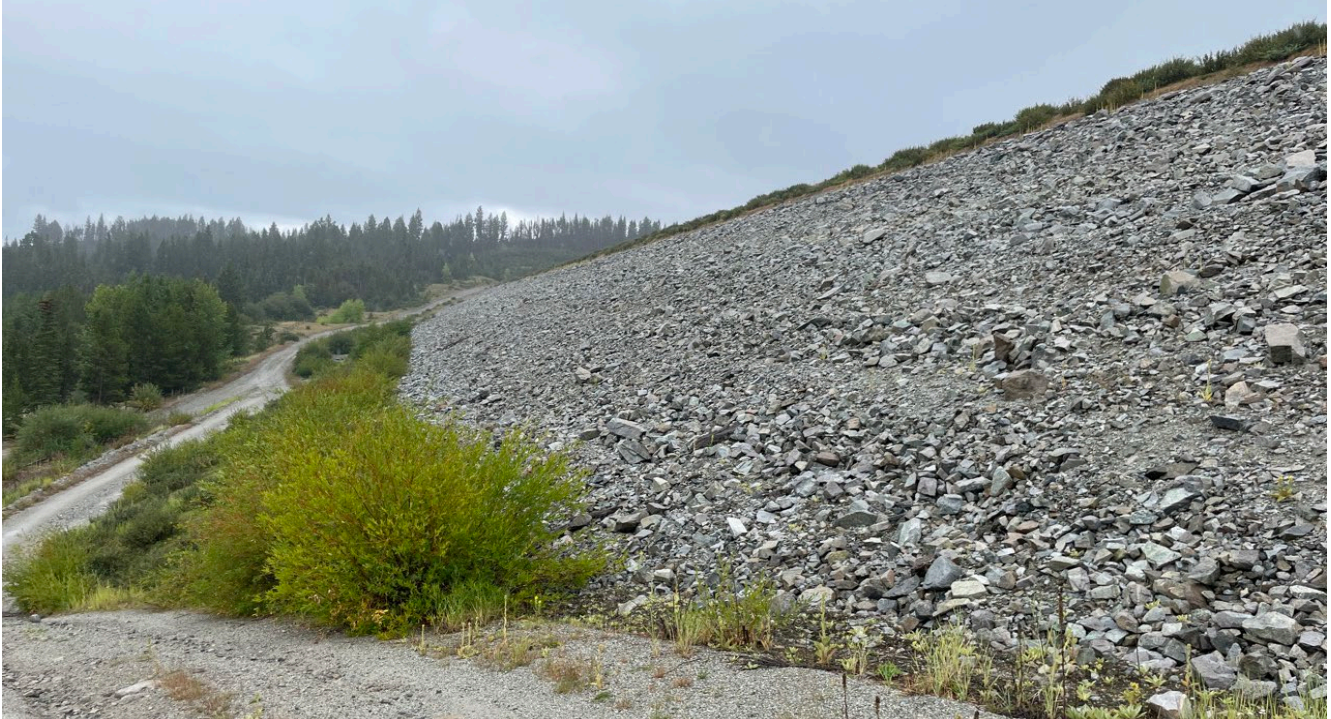
Photo I-B-4 Left abutment and downstream slope, looking south, with no observation of erosion scours or damage. (BTH-2023-07)

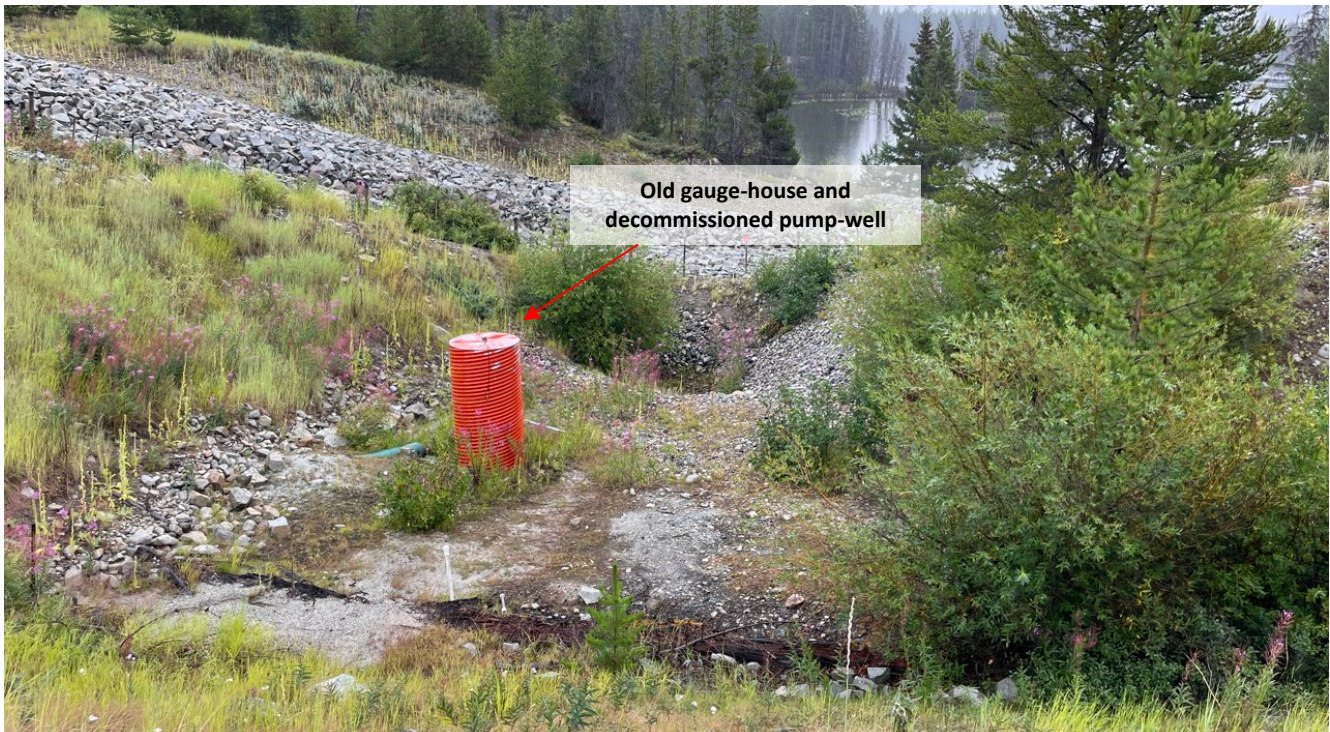
Photo I-B-6 Decommissioned pumping well and discharge point of underdrain. (BTH-2023-09)

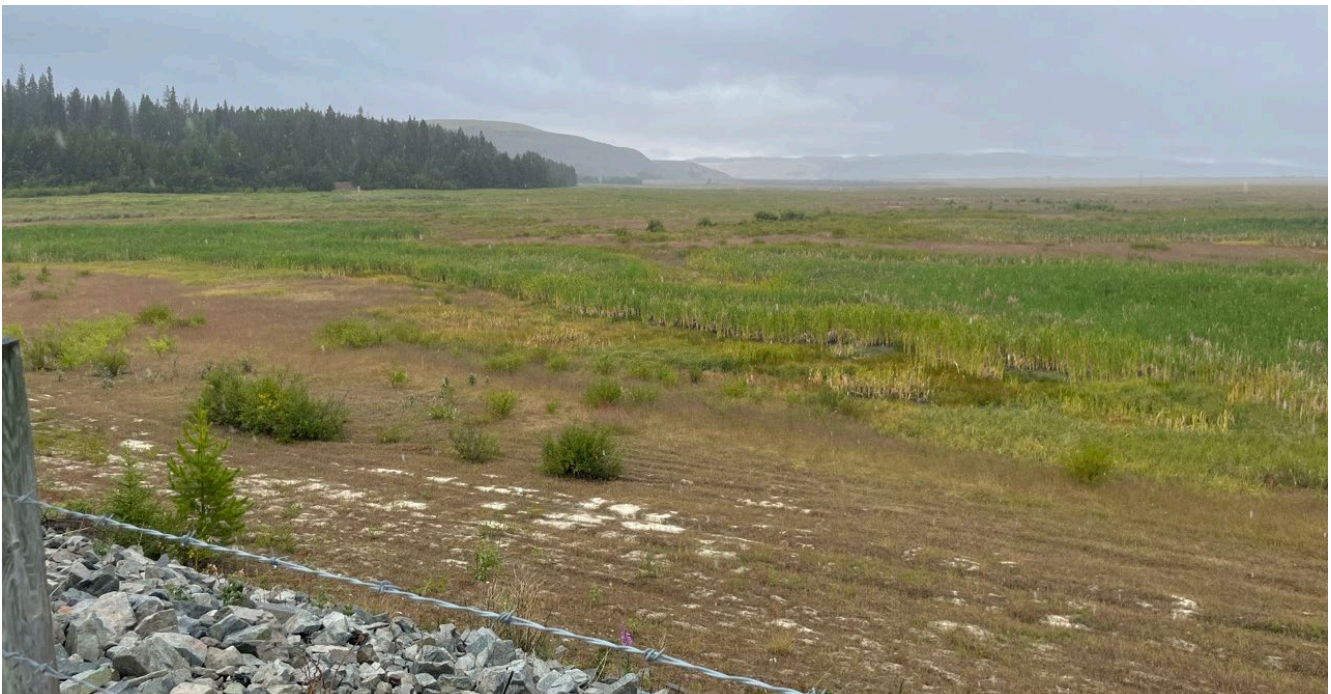
Photo I-B-9 Overview of upstream beach, looking towards dam. No sign of erosion or depression was observed. (BTH-2023-08)

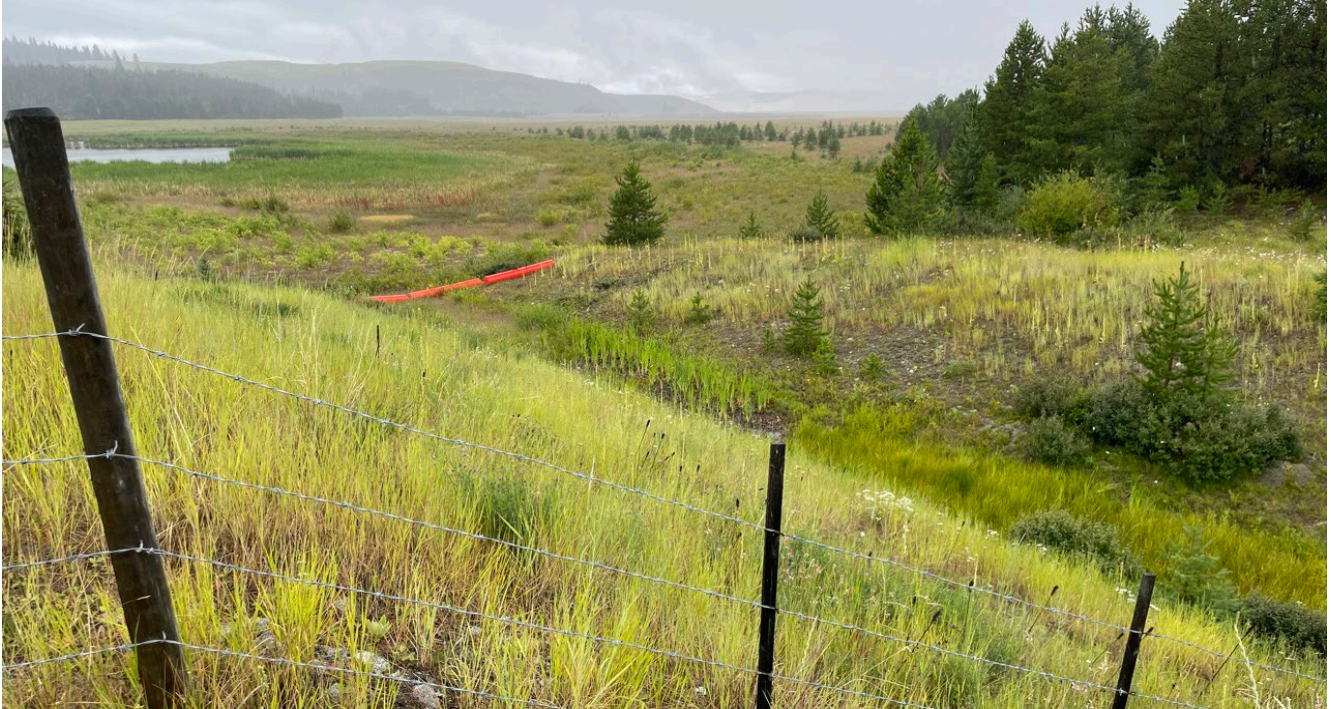
Photo I-B-11 Spillway inlet and approach channel. Channel is vegetated with grass and bushes. Clearing of vegetation is managed as part of routine maintenance. (BTH-2023-10)

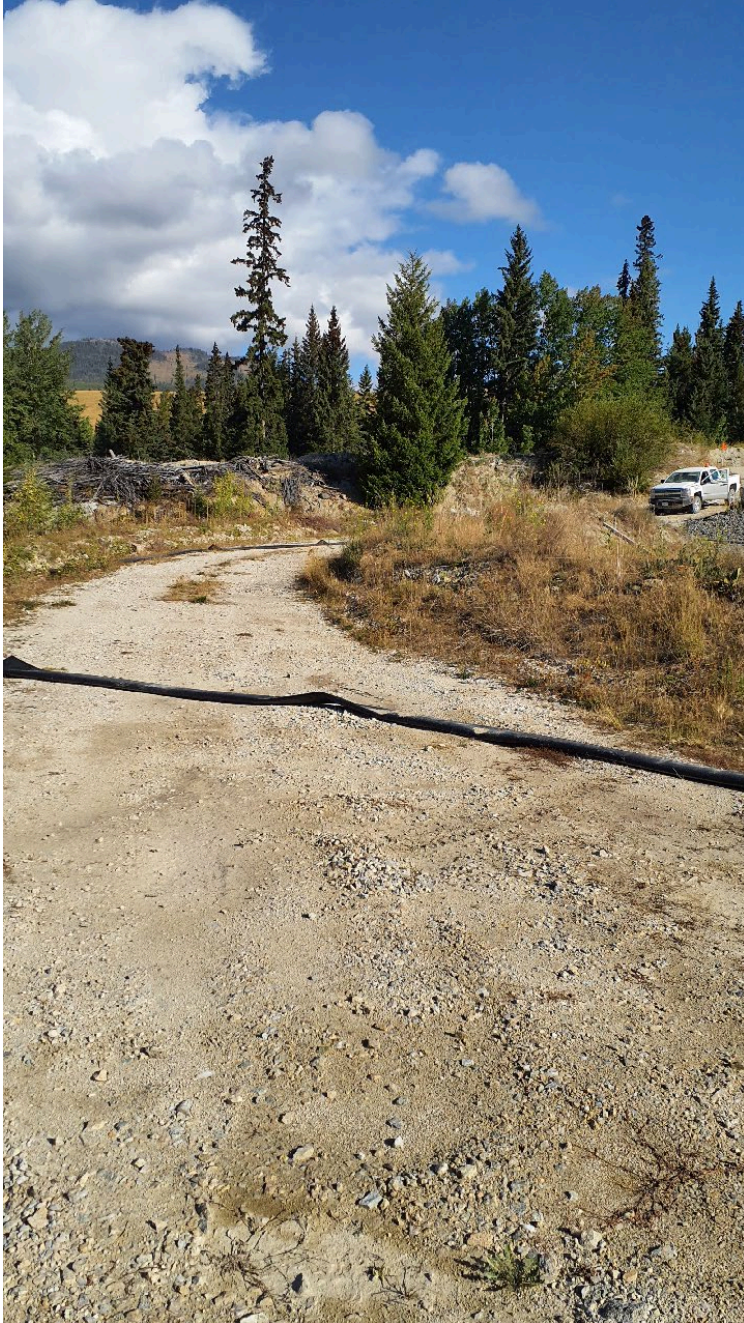
**Photo I-C-2 R3 Seepage Pond dam crest, no cracking or no sign of distress was observed.
(BTH-2023-13)**

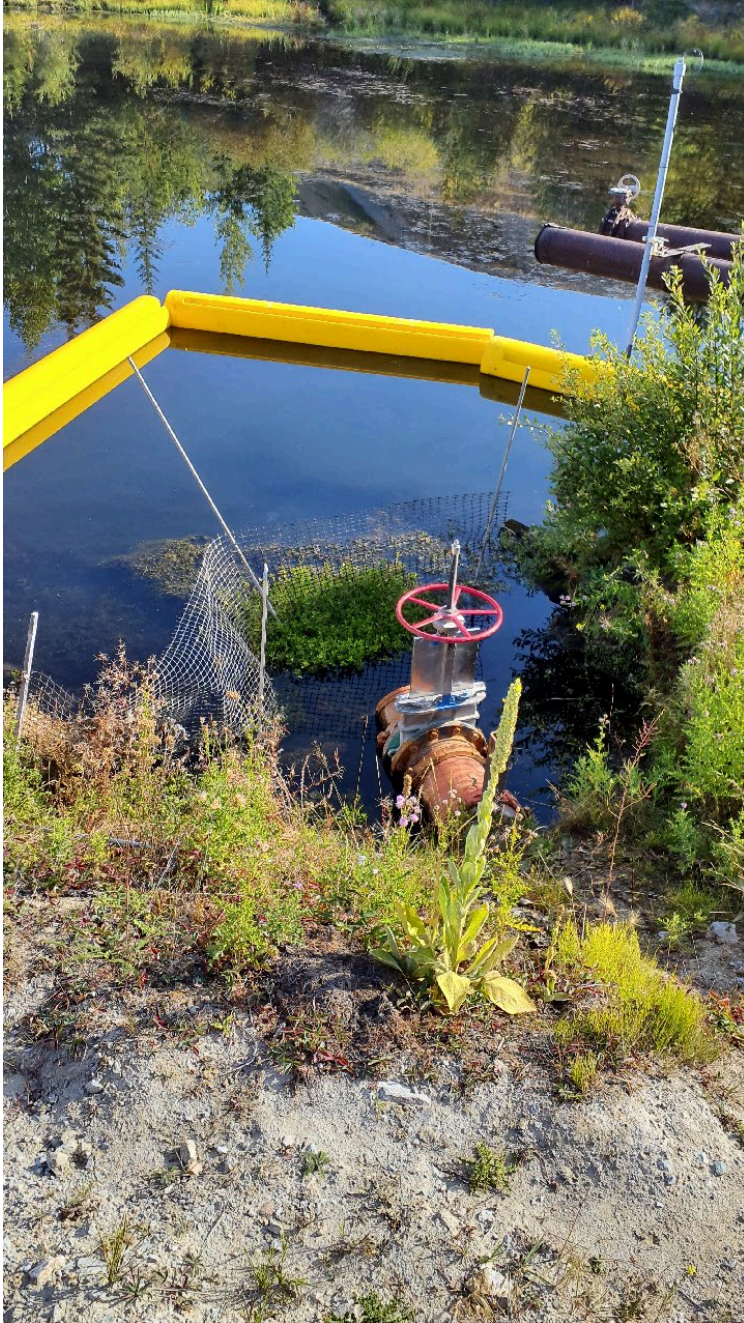
Photo I-C-3 View of outlet pipe, debris mesh and new debris boom. Clear water was flowing at the time of the site visit. (BTH-2023-14)

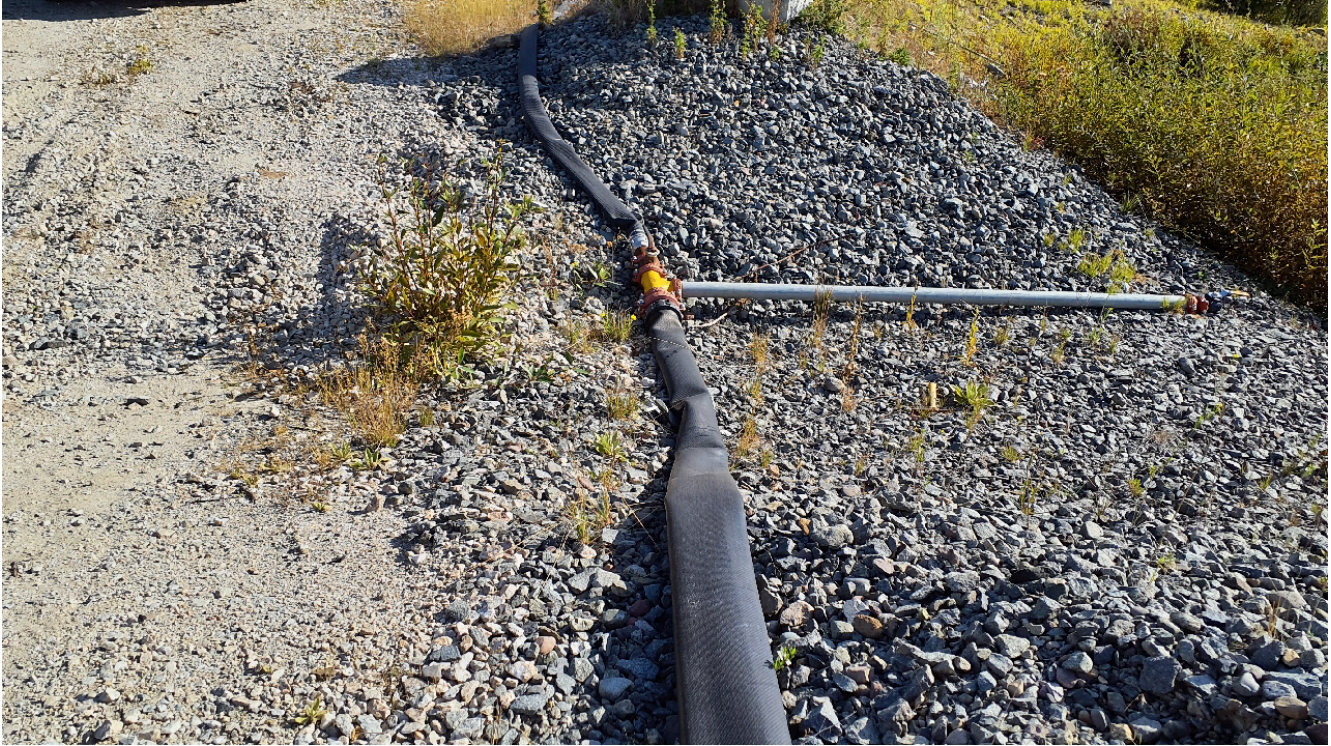
Photo I-C-4 View of spillway inlet. Pipeline is related to temporary diesel pump stationed on crest. (BTH-2023-15)

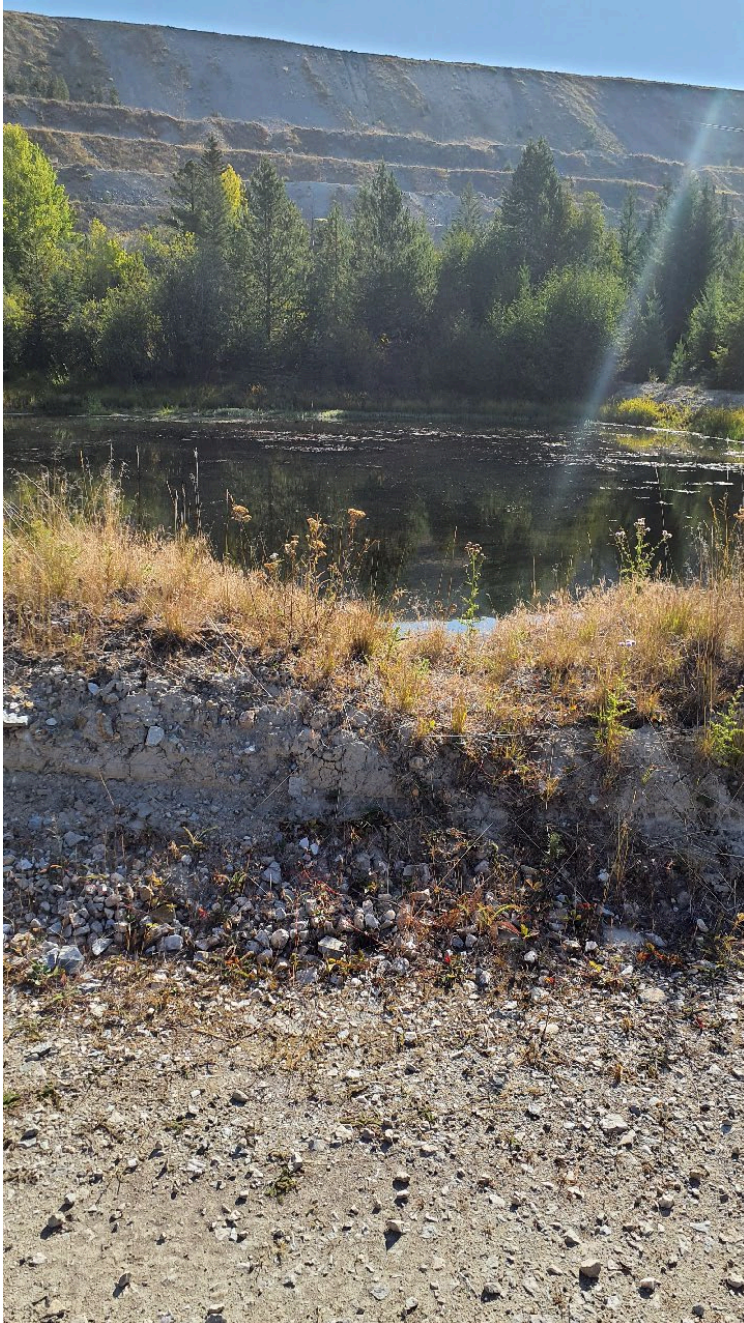
Photo I-C-7 Low point of the berm along upstream side of dam crest. KCB recommended the dam survey be checked to confirm this feature is captured and has been accounted for in the freeboard calculation. (BTH-2023-17)
