Teck Highland Valley Copper Partnership

2023 Annual Facility Performance Report

Highland Tailings Storage Facility

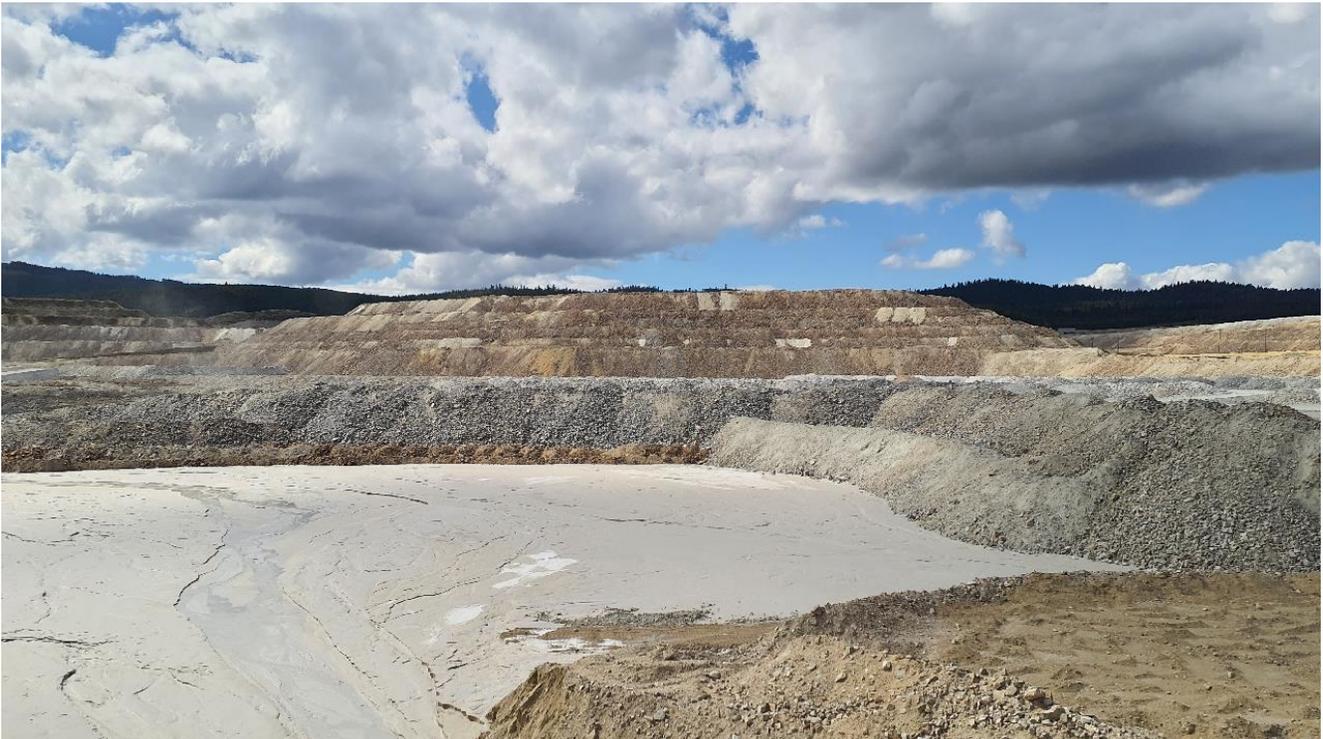
Photo I-B-6 North end of 24 Mile TSF, 24 Mile Waste Dump that has been placed over tailings (foreground) and I-9 Dump (background) downstream of H-H Dam. (HH-2023-04)

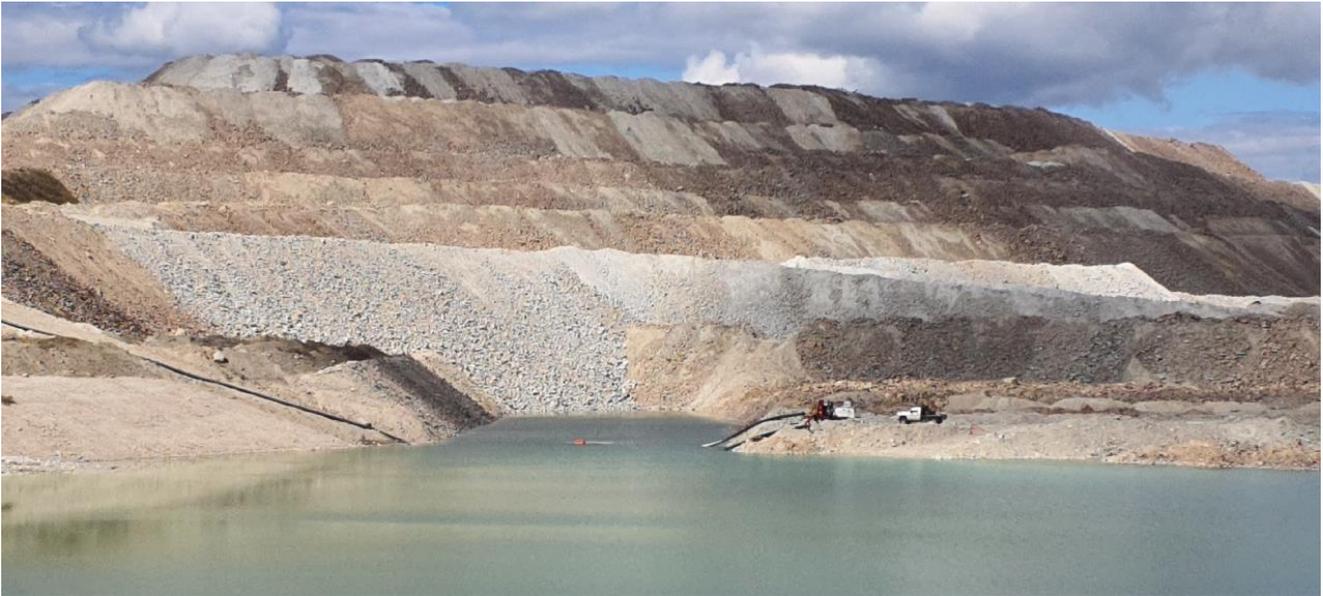
Photo I-B-7 24 Mile TSF diesel pump reclaim barge system. This was temporary and replaced by electric pumps after site visit. (HH-2023-05)
