2023 Annual Facility Performance Review Summary Report

Tailings Management Facility, Quebrada Blanca 2

WSP Reference N° 8013-TSC-099-RE-1400-C-00133_3

September, 2024

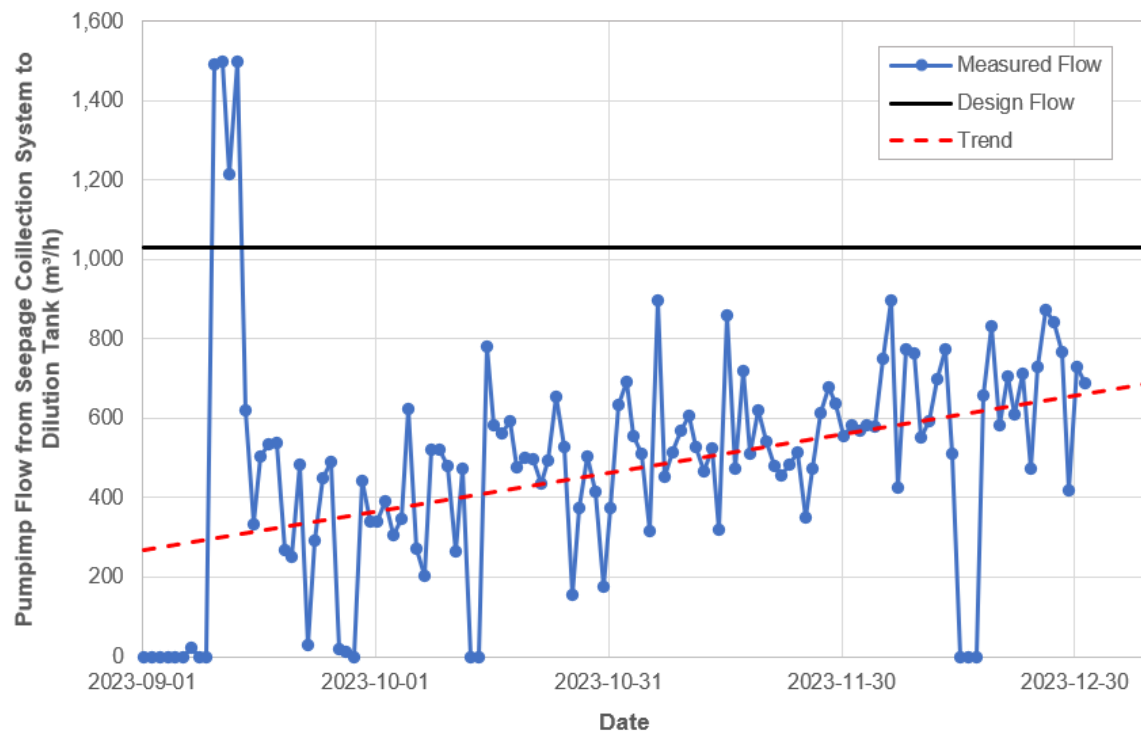
Figure 5: Daily Pumping Flow from the Seepage Collection System to the Dilution Tank in the Cyclone Station for 2023.

Figure 5 shows that the average pumping flows are lower than the design flow, but there is an increasing trend exists in pumping flow. The main contributor to the flow from the dam reporting to the Seepage Collection Ponds is the sand transport water. The average sand placement rate has been constant (the flow depends on the sand placement rate and not the placement area), which could mean that the increase in flow could be from seepage water.

It is recommended to monitor the pumping rate and evaluate if the pumping rate continue to increase. If the flow continues to increase and may exceed the design flow, a solution should be planned in advance so as not to interrupt the pumping and the continued supply of seepage water to the cyclone sand process and to maintain with the minimum freeboard criteria in the Seepage Collection Ponds.

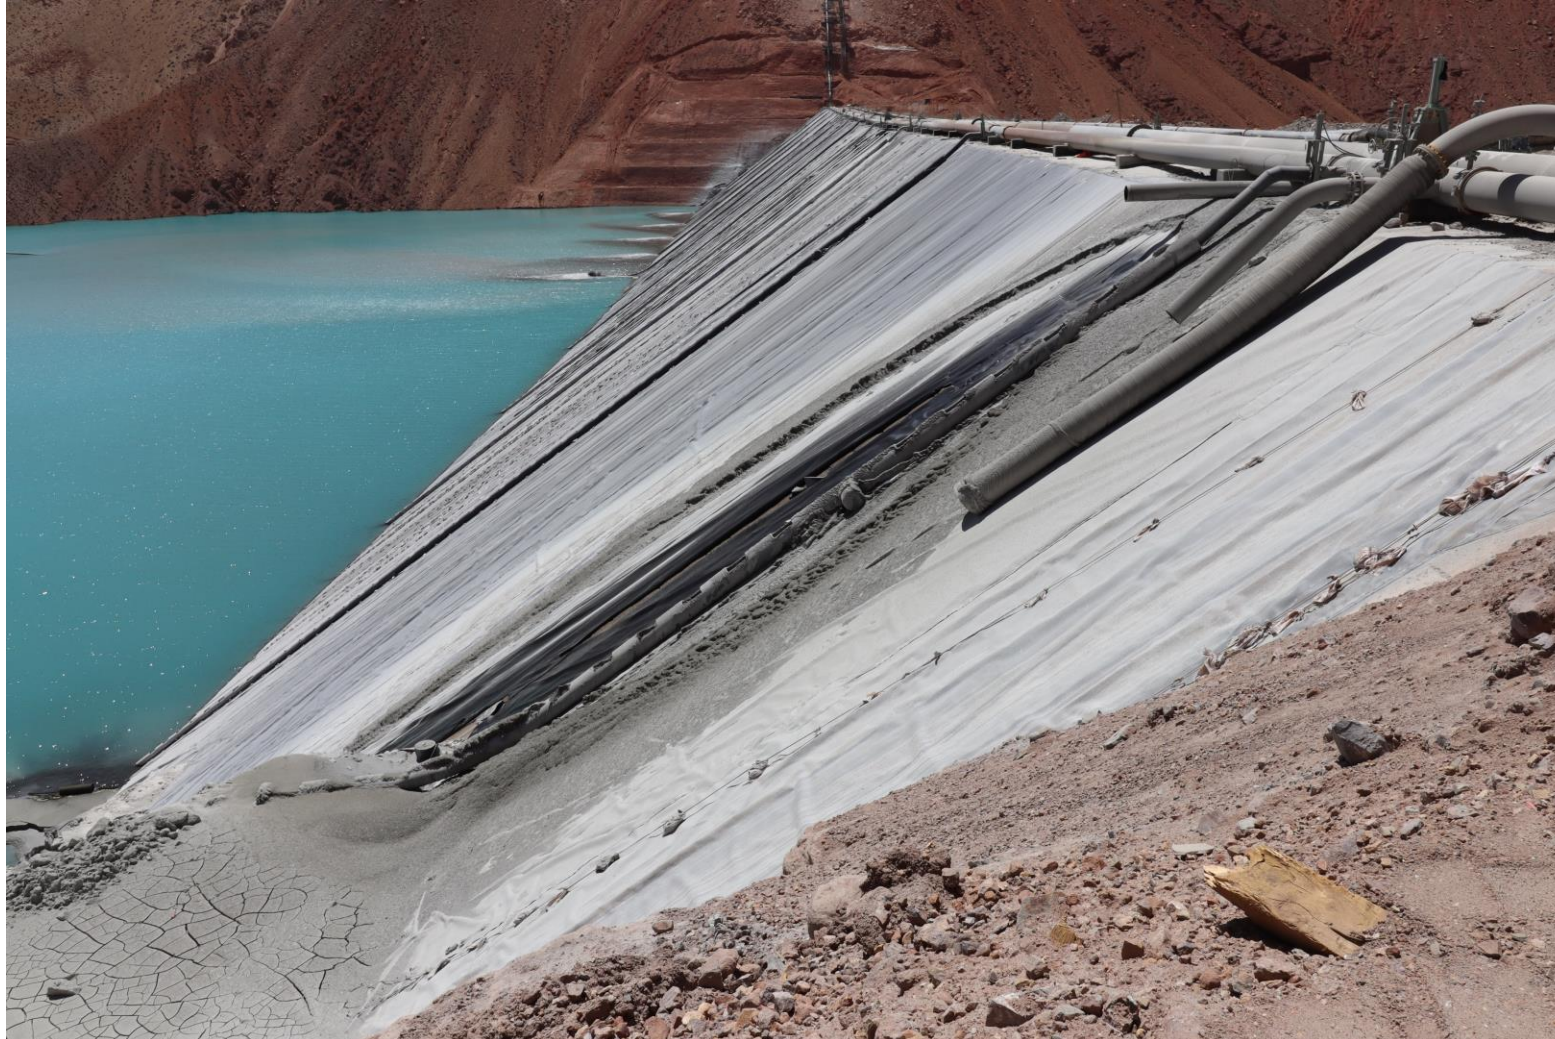
Plate 9: Starter Dam (1452)

- Stater dam performing as expected.
- No evidence of instability on the upstream slope, crest, downstream slope, or buttress.
- Damage to liner (east and west ends of dam) to be repaired (Plate 9).
- Sand lines: construction nearing completion.
- CMTQB advancing repairs to VWPs, inclinometers, and SAA.
- Seismograph installed on crest.
- Downcomers on upstream slope functioning well.

Upstream face. Damage to liner. Sand reject outlet from “el chimbombo”

2023-AFPR-05	Assessment of water levels and water quality downstream of seepage cutoff.	3	Q2 2024. Work is in-progress.
2023-AFPR-06	Repair to starter dam liner below rejected sand outlet of on-crest manifold ("el chimbombo"). Repair will reduce seepage losses from reclaim pond and will protect concrete curb (critical element that protects filter zone in starter dam).	3	Q2 2024. Work is in-progress.
2023-AFPR-07	Repair to starter dam liner below east abutment drainage outlet. Repair will reduce seepage losses from reclaim pond and will protect the liner from wind damage (due to wind entering through opening).	3	Q2 2024.
2023-AFPR-08	Extension to rejected sand outlet of on-crest manifold ("el chimbombo"). Outlet to be extended onto west abutment (upstream of plinth) using similar setup to upstream downcomers (i.e., multiple outlet ports). Extension will reduce likelihood of repeated damage to starter dam liner	3	Q2 2024.

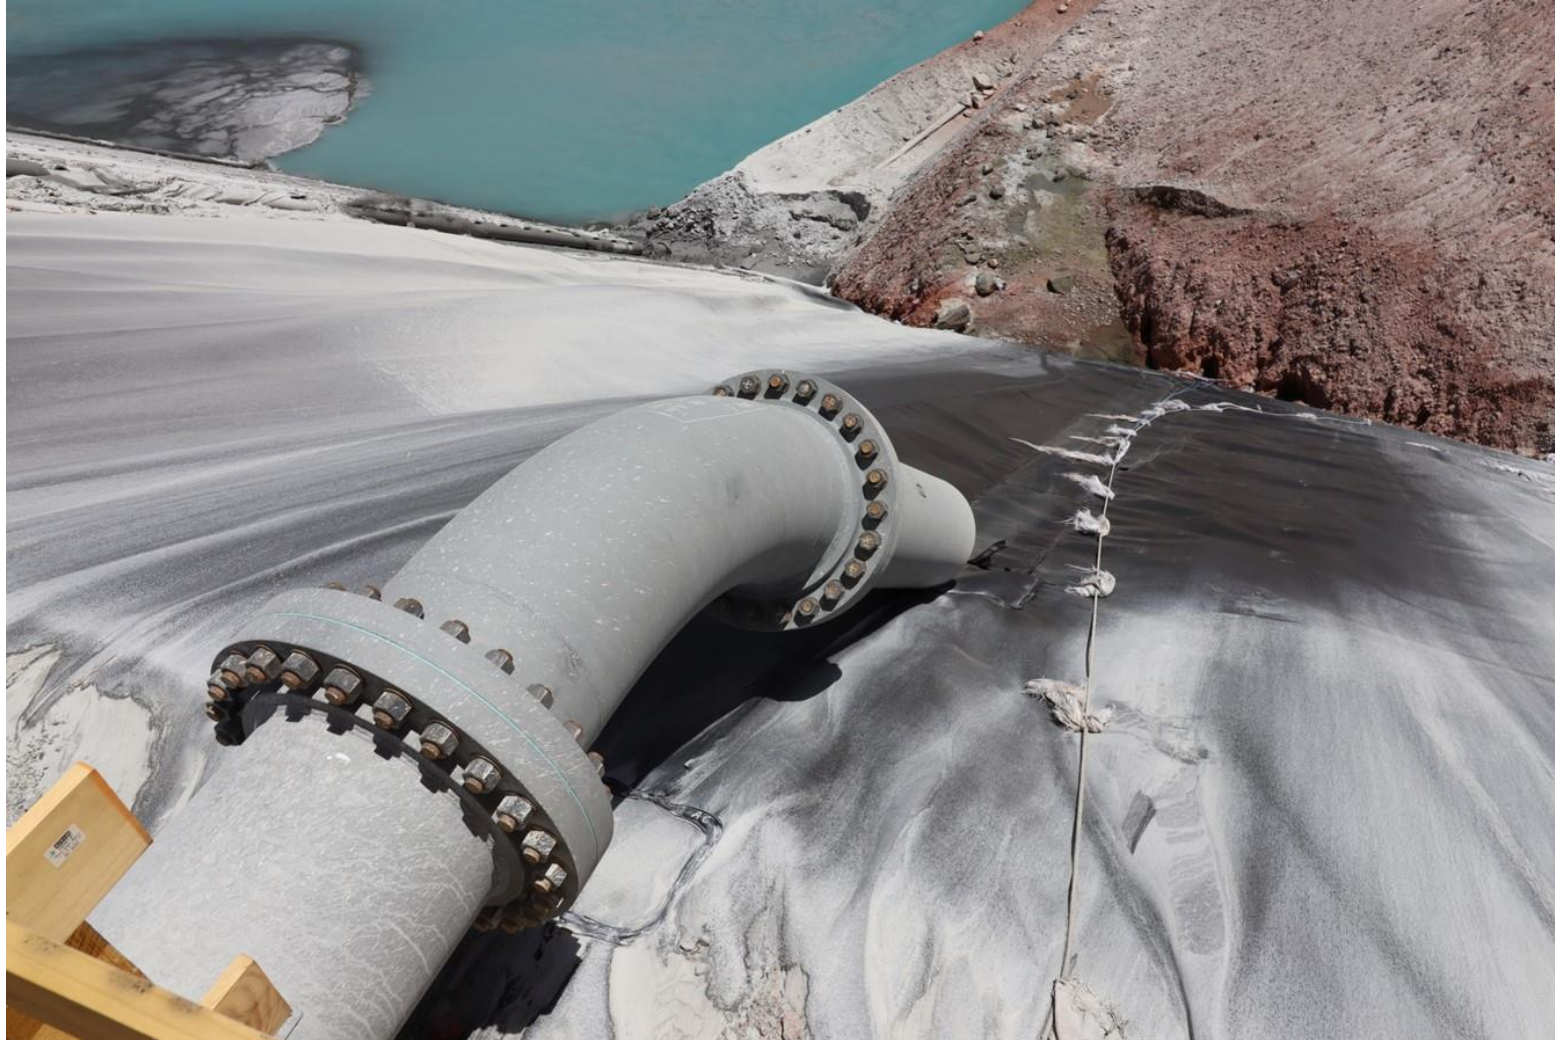
Plate 10: Starter Dam (1452)

Upstream face. Damage to liner. East abutment discharge

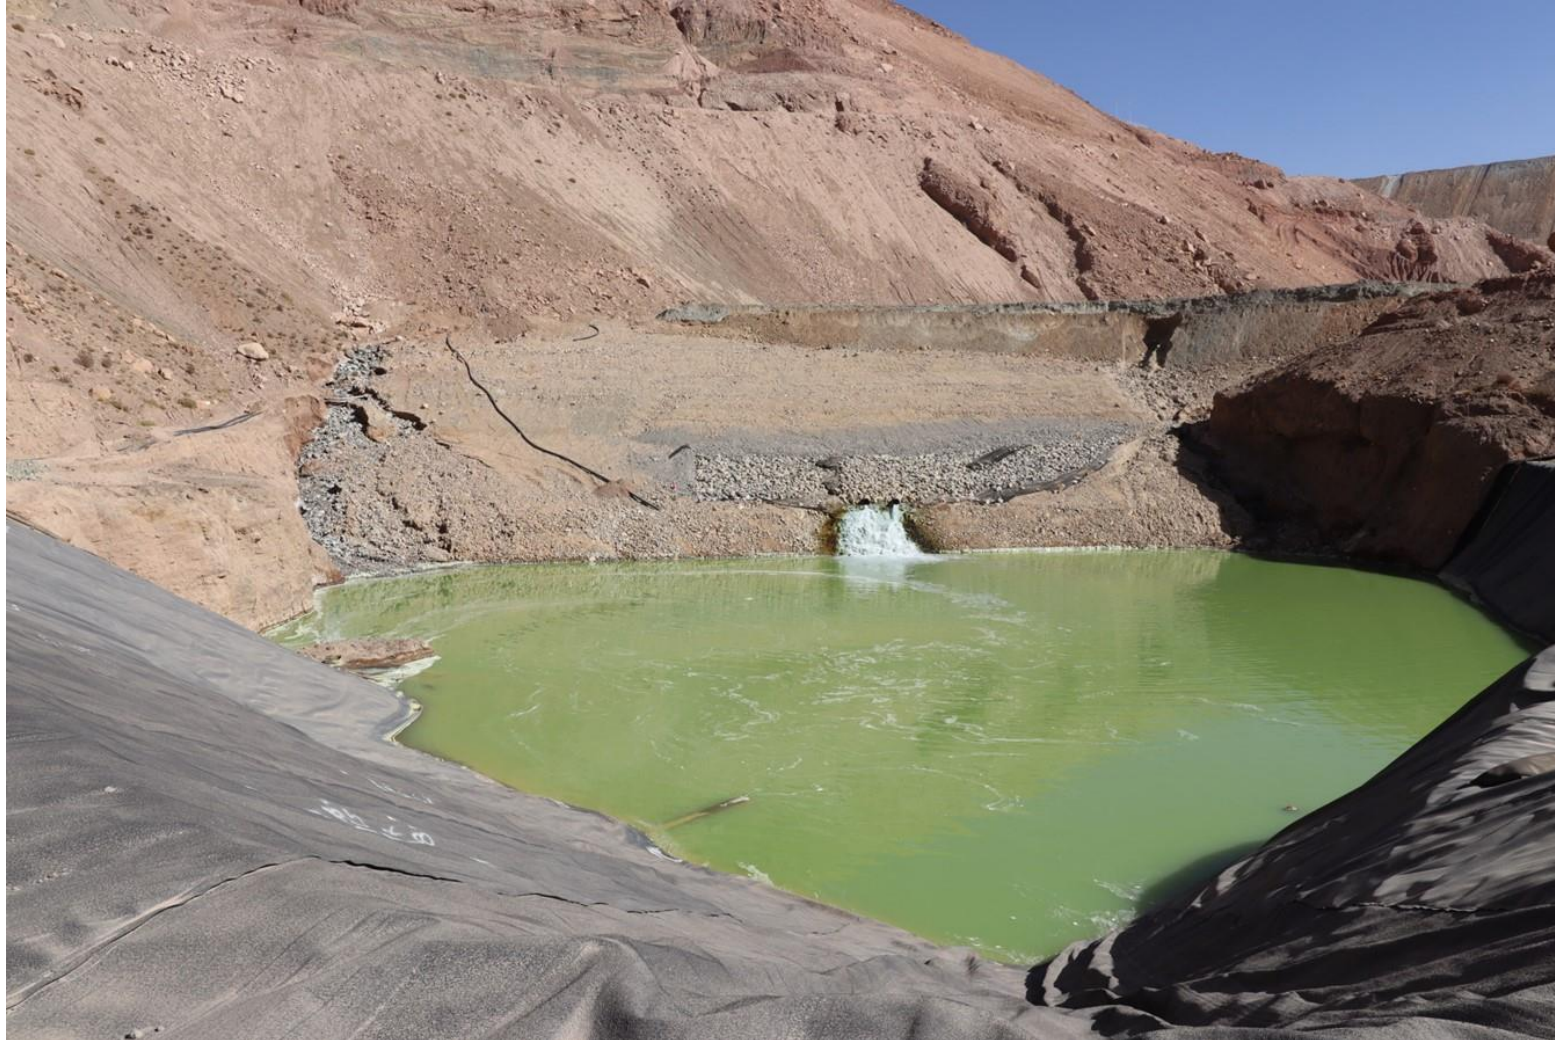
Plate 14: Drainage System (1453)

- The system is performing as expected, no evidence of sink holes, blockage, or turbidity in the seepage water.
- Year 2 sump:
 - Recent erosion damage on east and north slopes due to routing of sand transport water from paddocks to sump. CMTQB to improve water management to avoid water flowing on slopes. Monitoring and repair programs described in WSP (2023) will also need to be applied to this erosion damage (Plate 14).

Year 2 sump. Erosion damage on east and north slopes

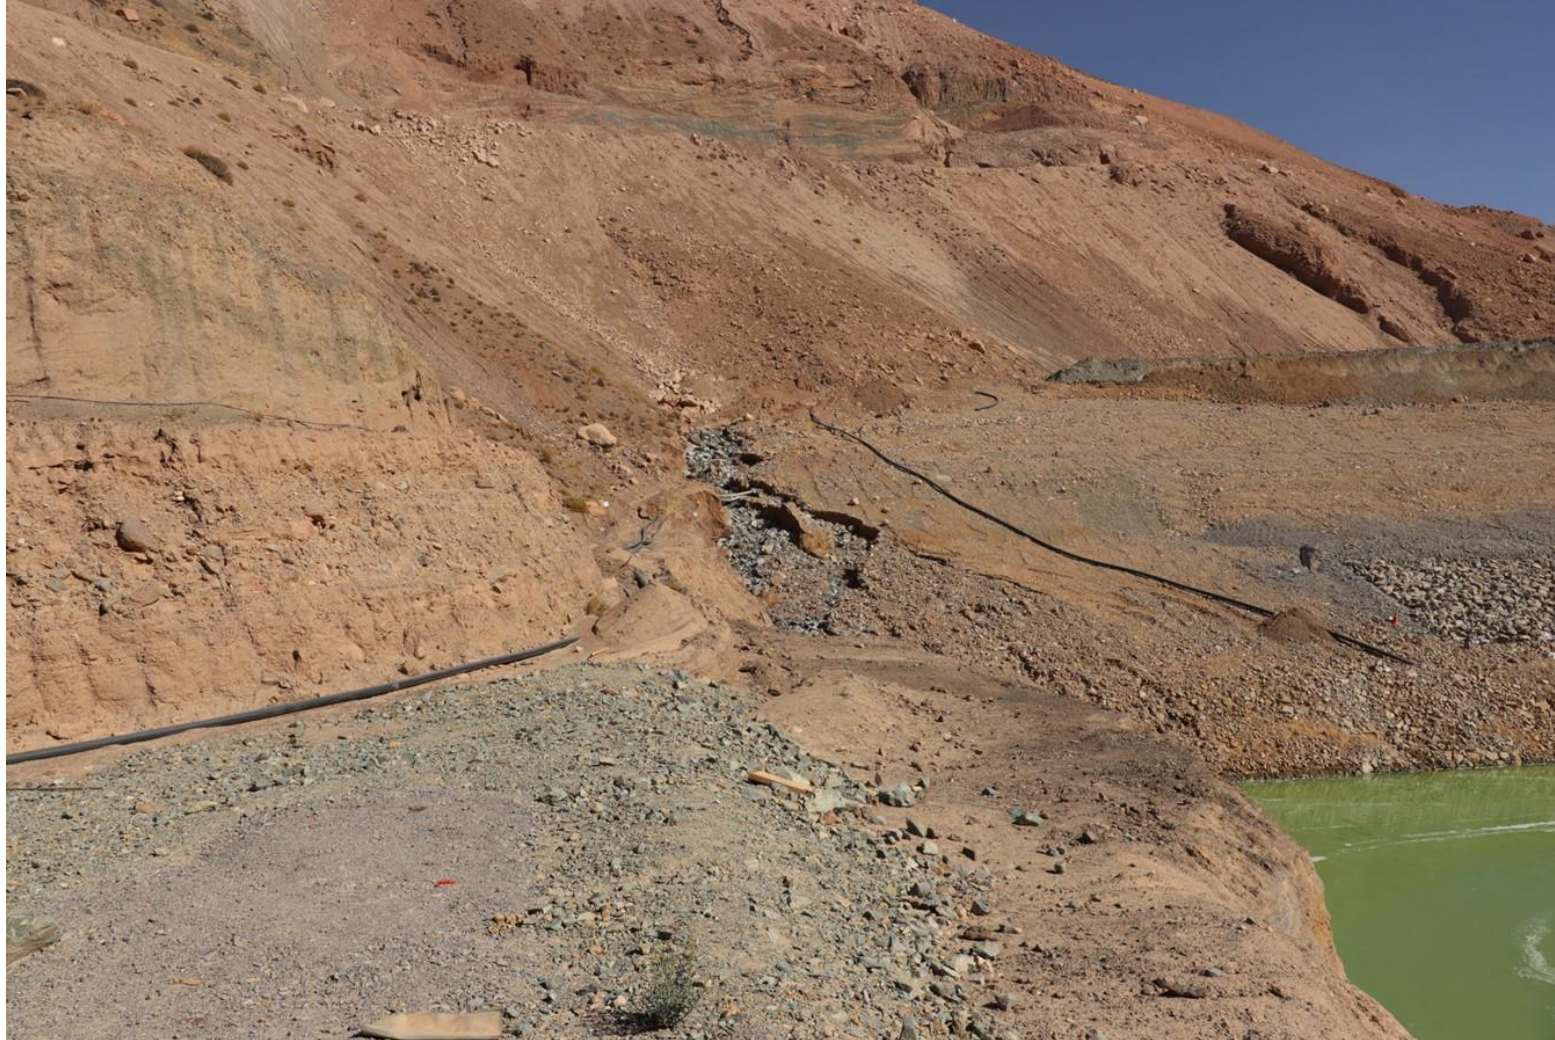
Plate 15: Drainage System (1453)

- No observable degradation of erosion damage noted in the 2022 AFPR (slopes above sump on west side). WSP (2023) prepared a technical memorandum regarding monitoring and repair programs. CMTQB to implement programs and include in the OMS manual and notify EoR of same (Plate 15).

Year 2 sump. Erosion damage noted during 2022 AFPR

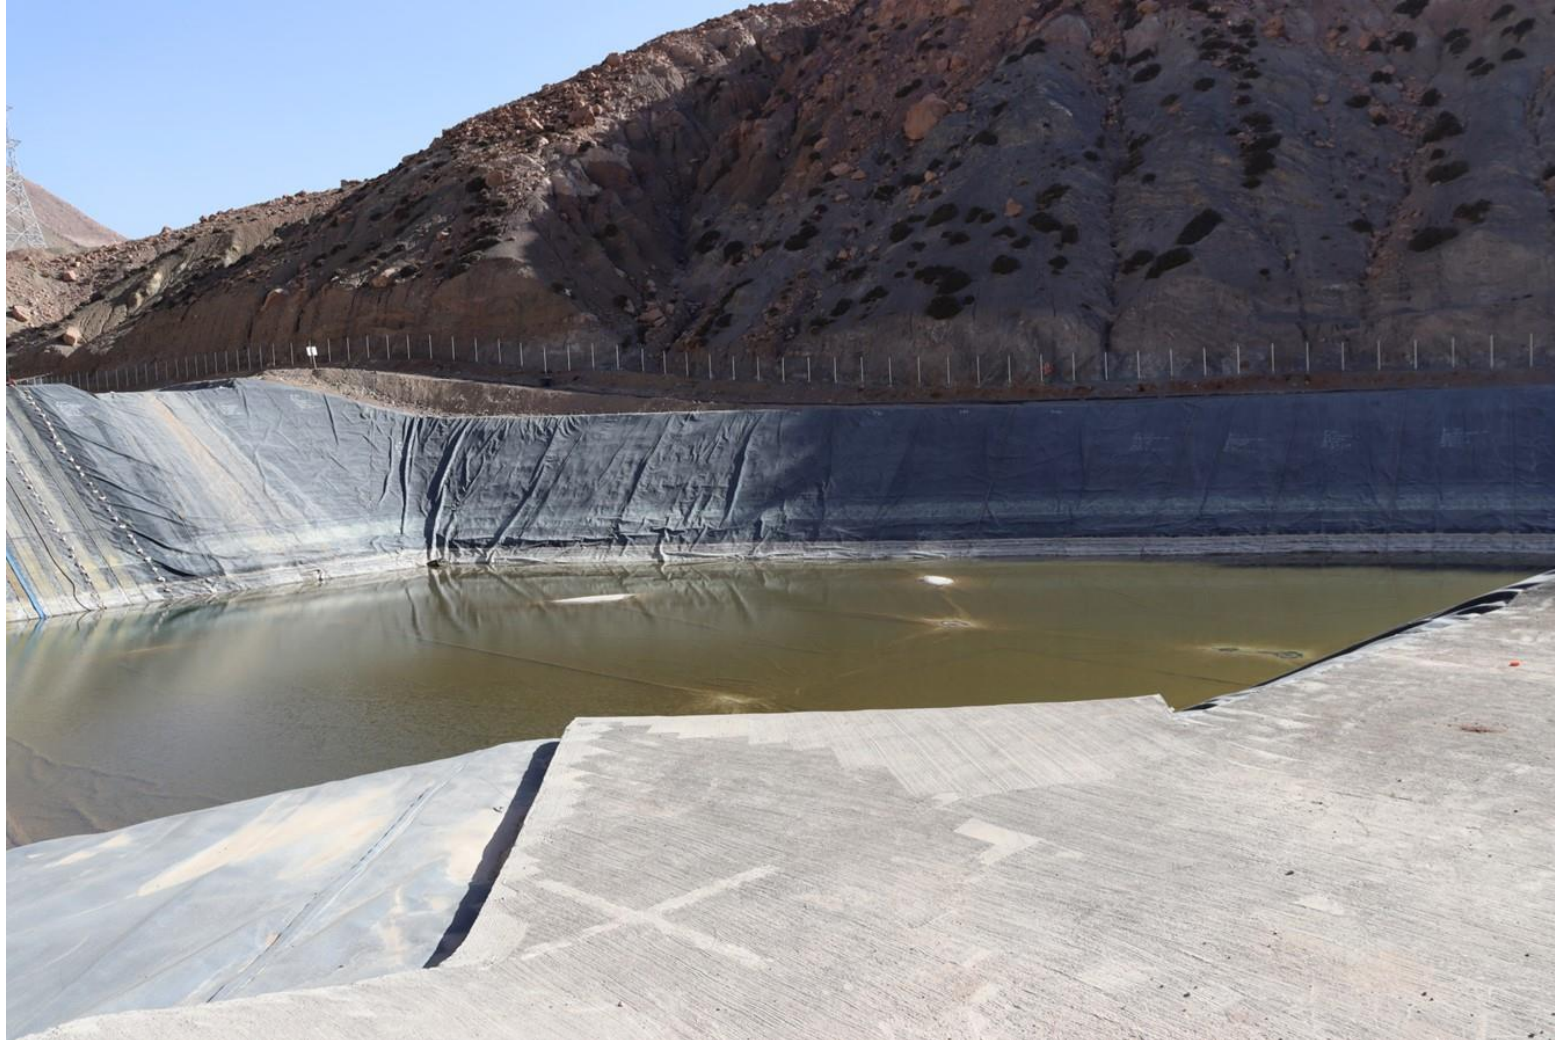
Plate 22: Seepage Collection System (1461)

- Localized floating of upper liner in Seepage Collection Pond 2 likely due to concentrations of air in leak detection system (Plate 22).
- Repair of upper liner in Seepage Collection Pond 2 required (Plate 23).
- WSP suggests that life rings in Seepage Collection Pond 2 be relocated to the inside of the cable trays. These are currently installed on the perimeter fencing—their use would require navigating around/under cable trays to retrieve and then to re-access the pond crest for use (Plate 24).
- Repeated suggestion: CMTQB to install Jersey barriers to protect pumps/critical infrastructure from potential vehicle damage. Note that some Jersey barriers have been installed following the 2022 AFPR suggestion. Corrosion was observed in the impellers of the pumps and in some portions of pipes in the seepage station.

Seepage Collection Pond 1 - Localized floatings of upper liner

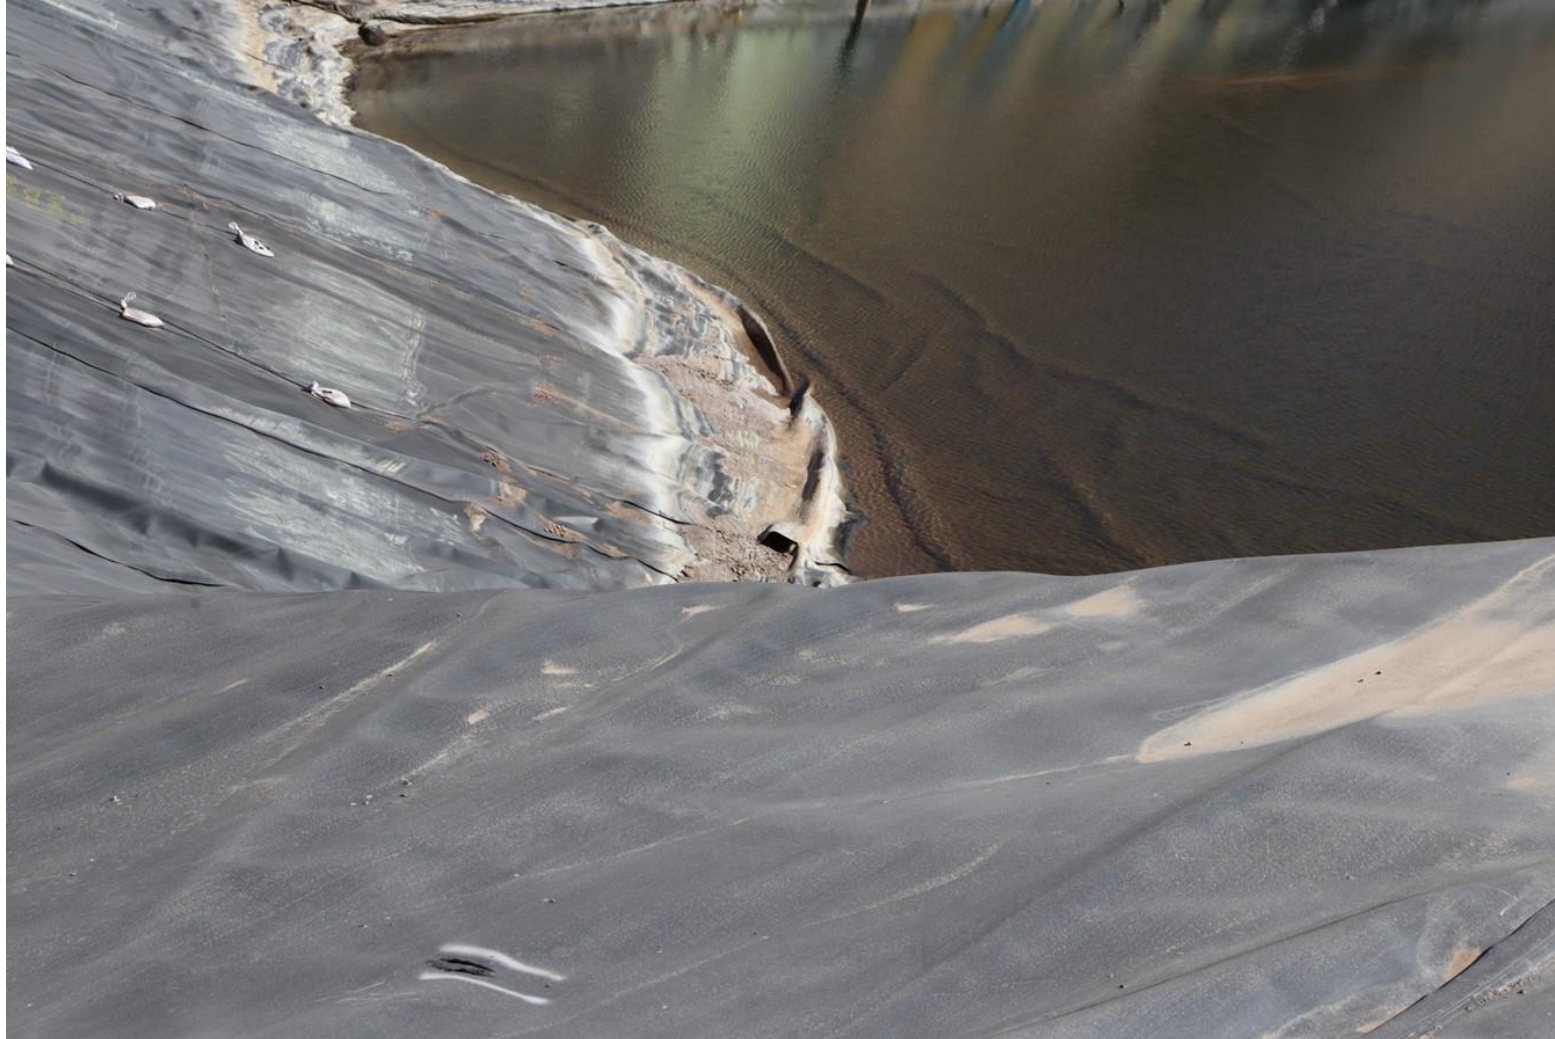
Plate 23: Seepage Collection System (1461)

Seepage Collection Pond 1 – Damaged liner

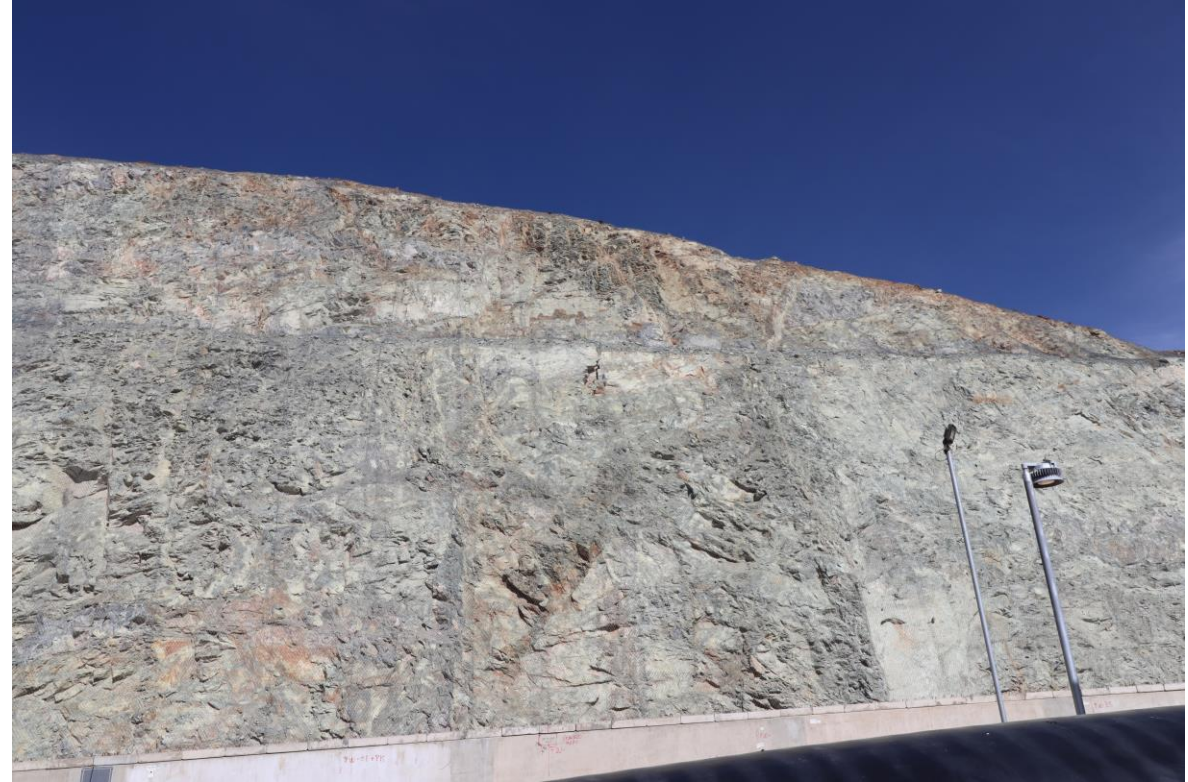
Plate 31: Dilution Water Terminal Station (1644)

- The slope has performed well in 2023, with no evidence of change since the 2022 AFPR site visit.
- Drape mesh installed following 2022 AFPR.
 - Two hanging/loose blocks remain as-observed during the 2022 AFPR; bolting continues to be suggested to protect launder from rockfall hazard. WSP has issued a document outlining the drape mesh and bolting requirements (Plate 31).

Drape mesh installed following 2022 AFPR

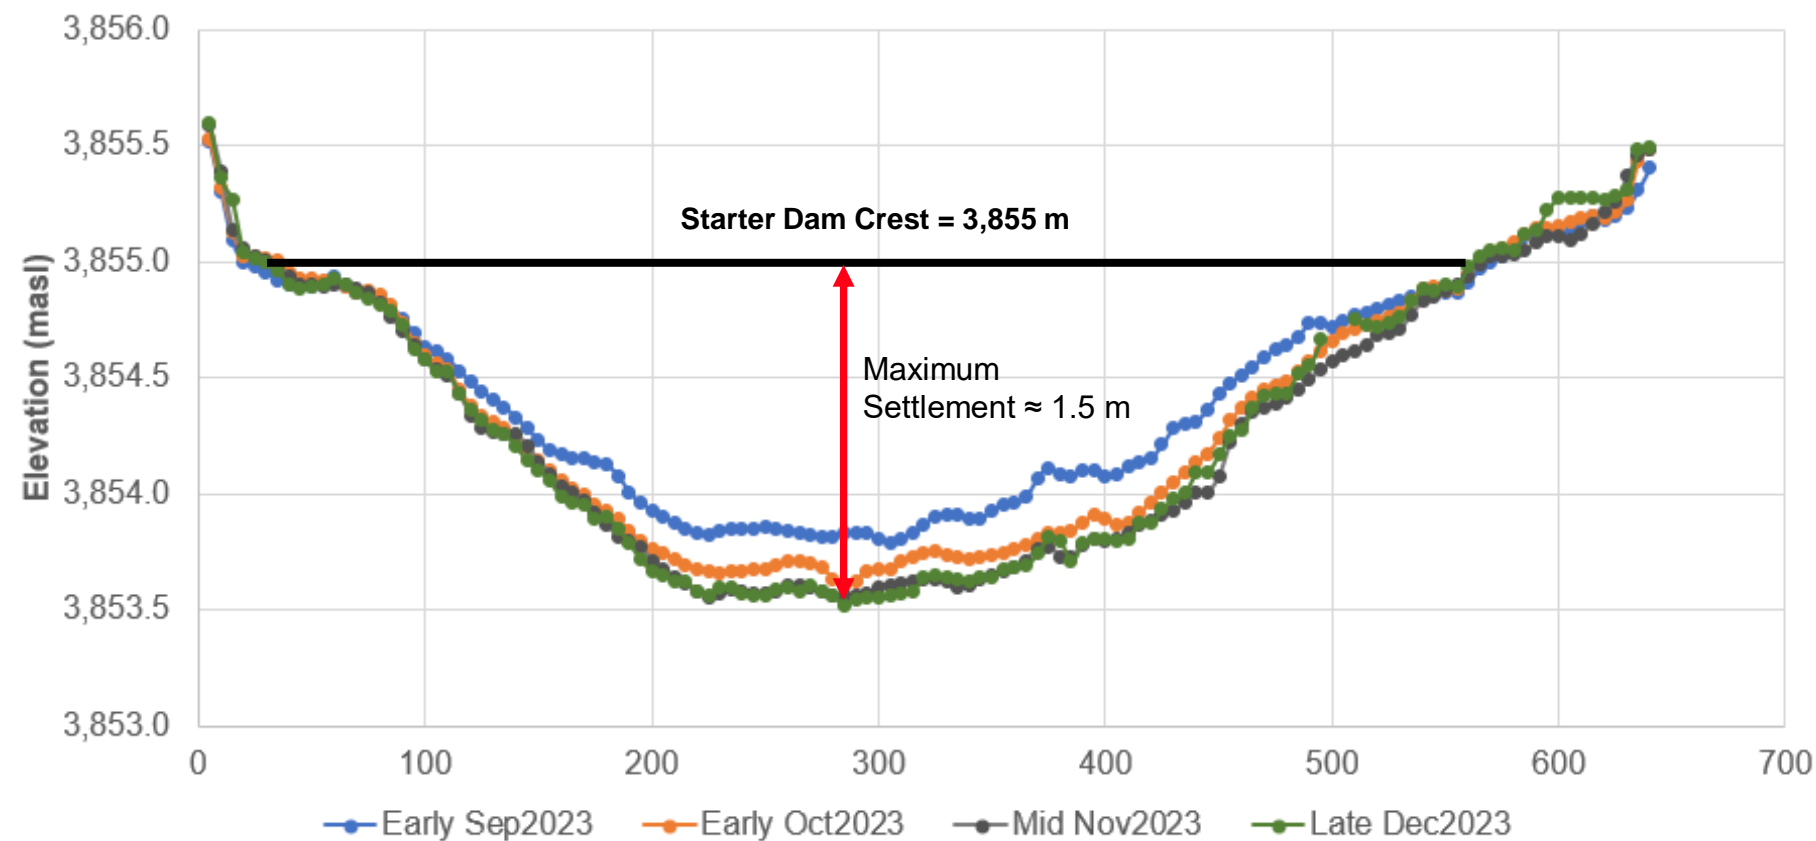
**Crest Settlement Profile as of 23
December 2023**

- Maximum settlement: ~1.5 m (as of 23Dec2023).
 - 1.3% of the height of the starter dam.
- Settlement due to wetting of rockfill and dam foundation.
 - Piezometric responses to pond raising (upstream of dam, dam centreline, dam drain) started in early Jul2023.
