TECK RESOURCES LIMITED BEAVERDELL MINE

Beaverdell Tailings Storage Facilities 2017 Annual Dam Safety Inspection

Reference Number: 1778313-052-R-Rev0-1000

This report presents the 2017 annual dam safety inspection (DSI) for the embankments of the tailings storage facilities (TSF) at the closed Beaverdell Mine. The facilities consist of the South TSF and North TSF.

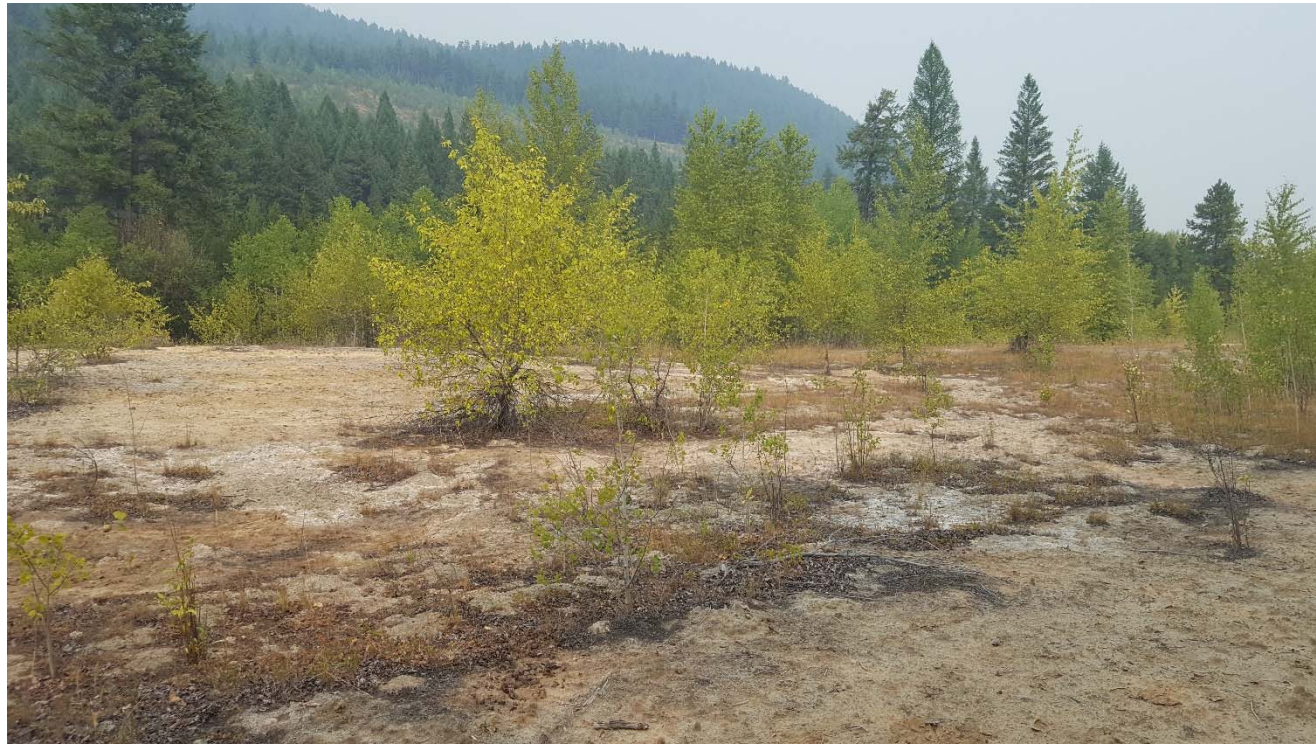
Photograph 1: South Tailings Storage Facility (TSF), Cell 1, overview of tailings surface, looking northwest. 8 August 2017.

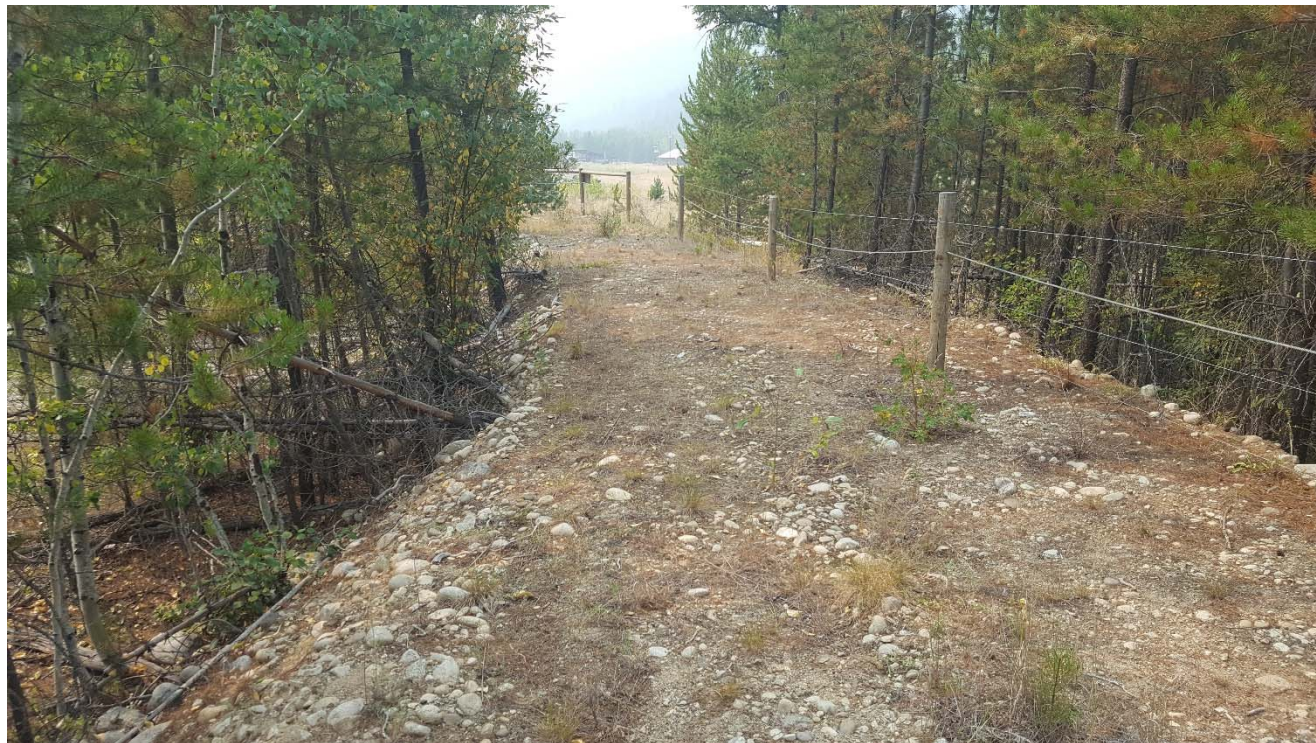
Photograph 3: South TSF, Cell 1, crest of west embankment (access road), looking southwest. 8 August 2017.

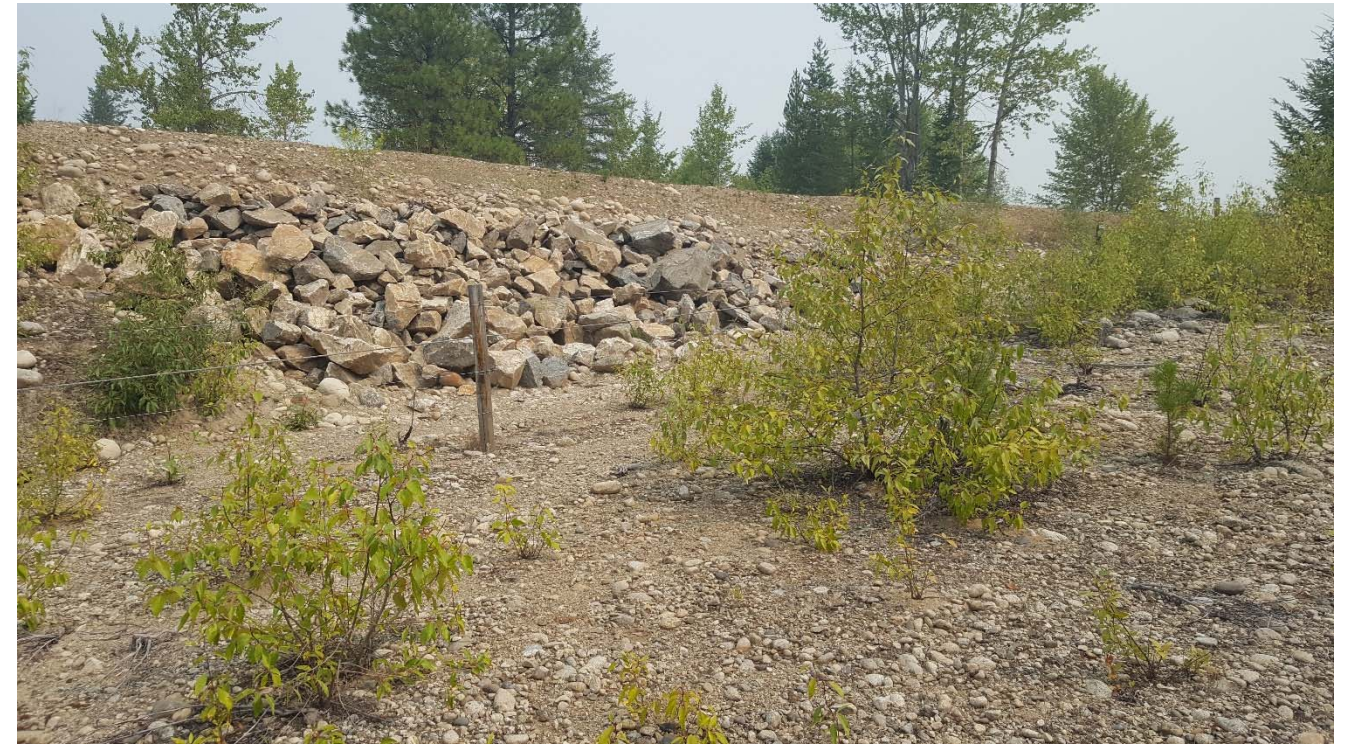
Photograph 6: South TSF, Cell 1, embankment at southeast corner of cell, looking north. 8 August 2017.

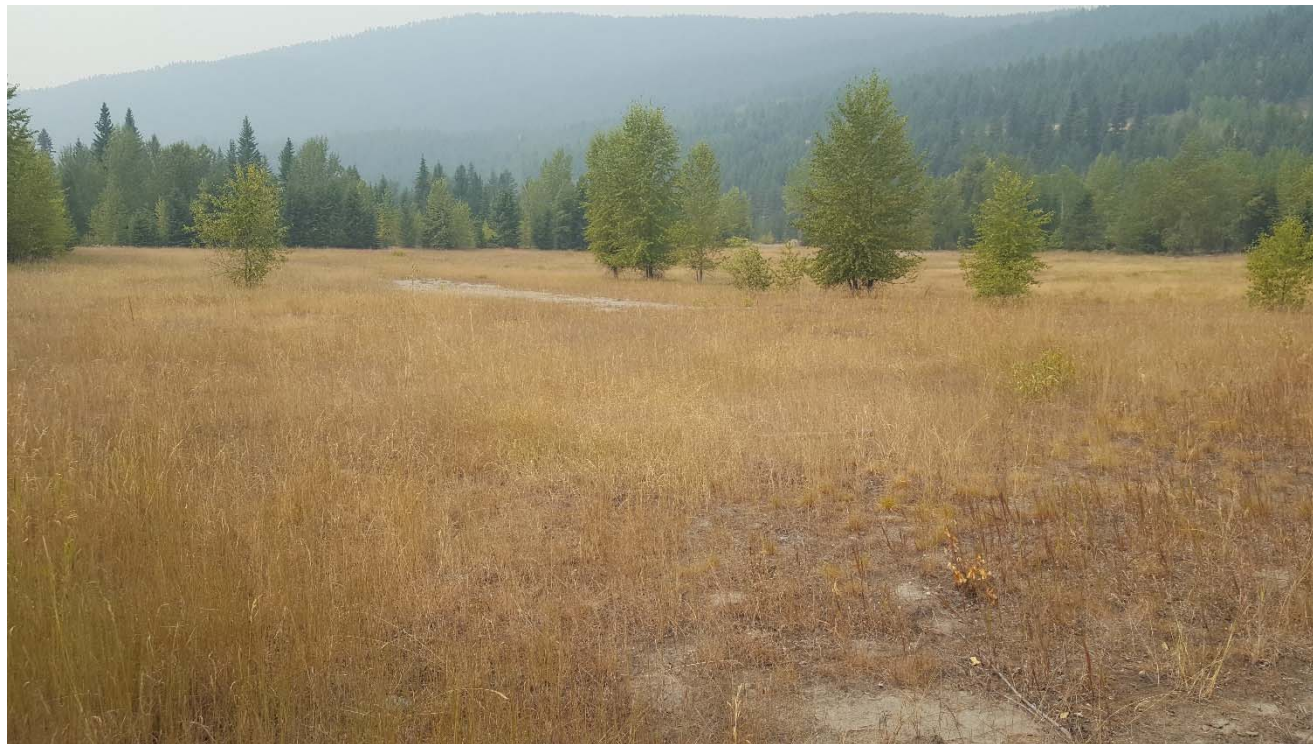
Photograph 11: South TSF, Cell 5, overview of tailings surface, looking southwest. 8 August 2017.

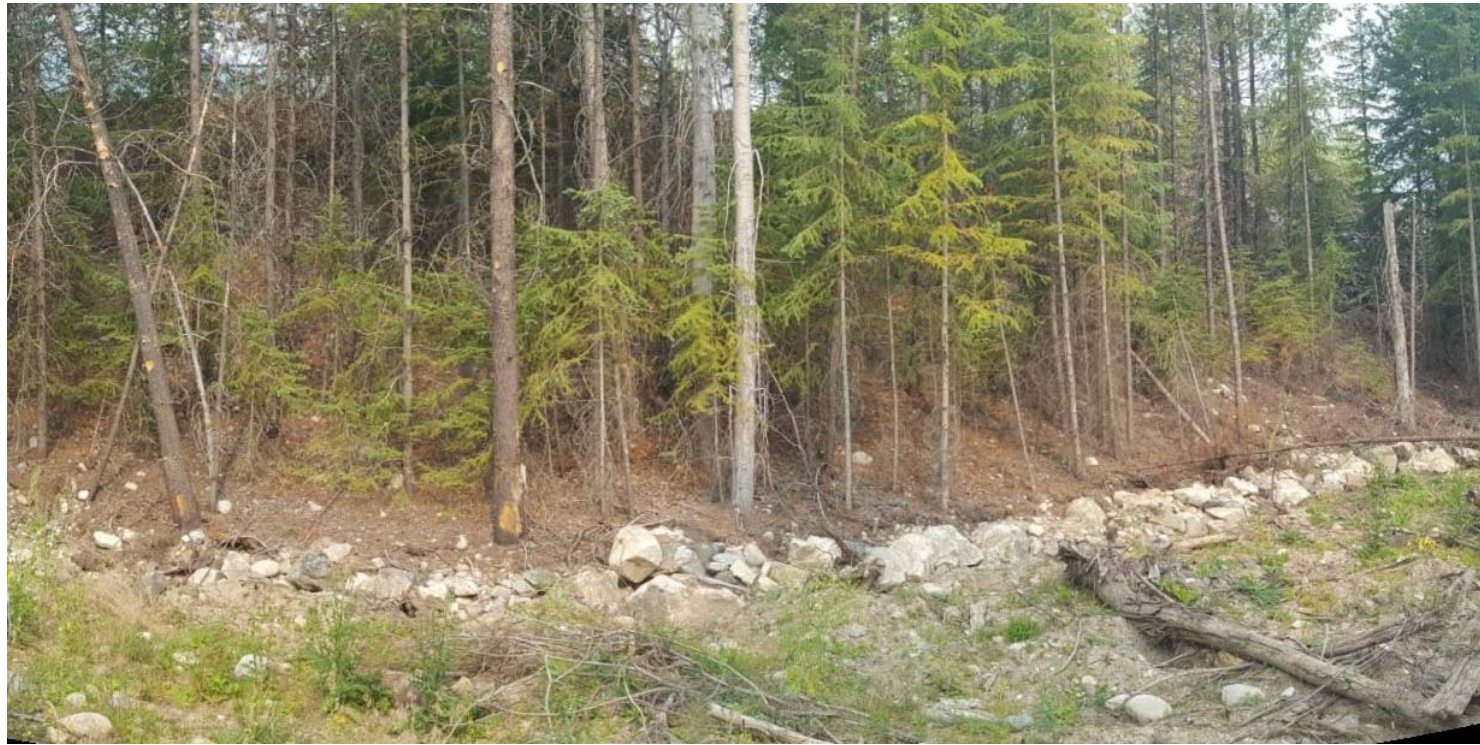
Photograph 12: South TSF, Cell 5, buried riprap at toe of downstream slope, looking northwest. 8 August 2017.

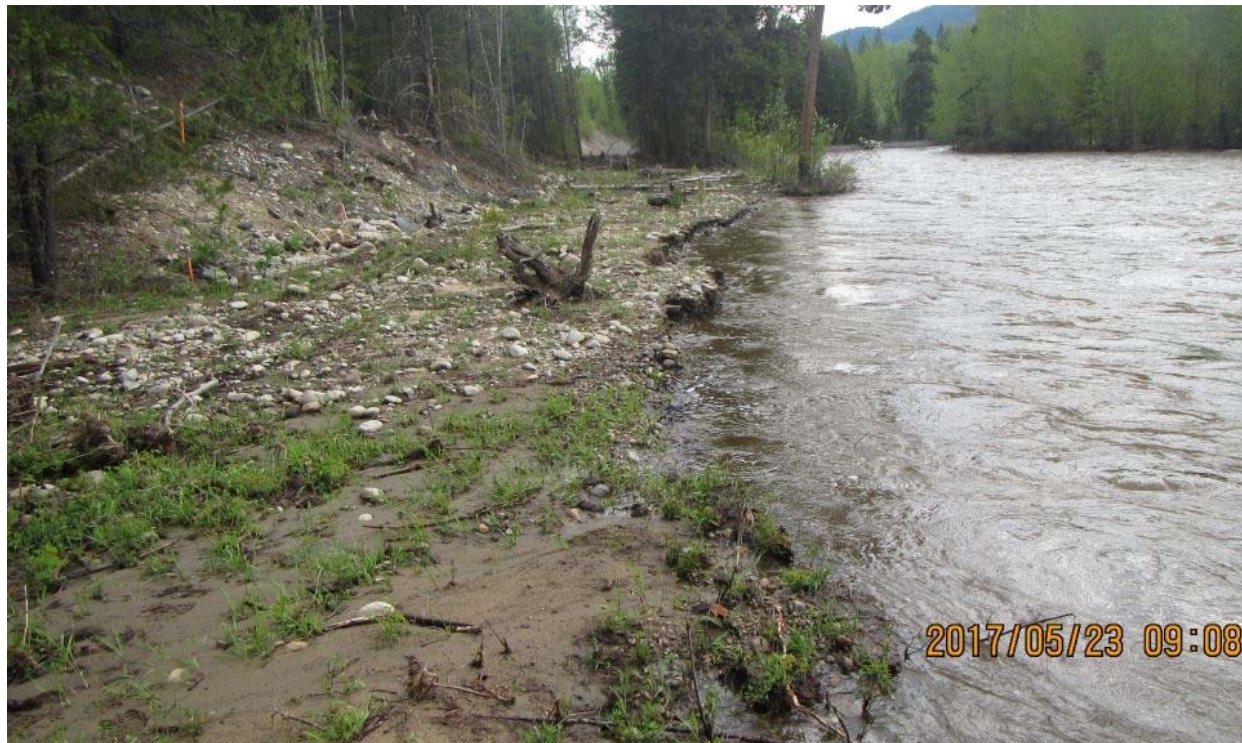
Photograph 13: South TSF, Cell 5, buried riprap at toe of TSF downstream slope during May 2017 high water event, looking northeast. 23 May 2017. Photograph provided by Teck.

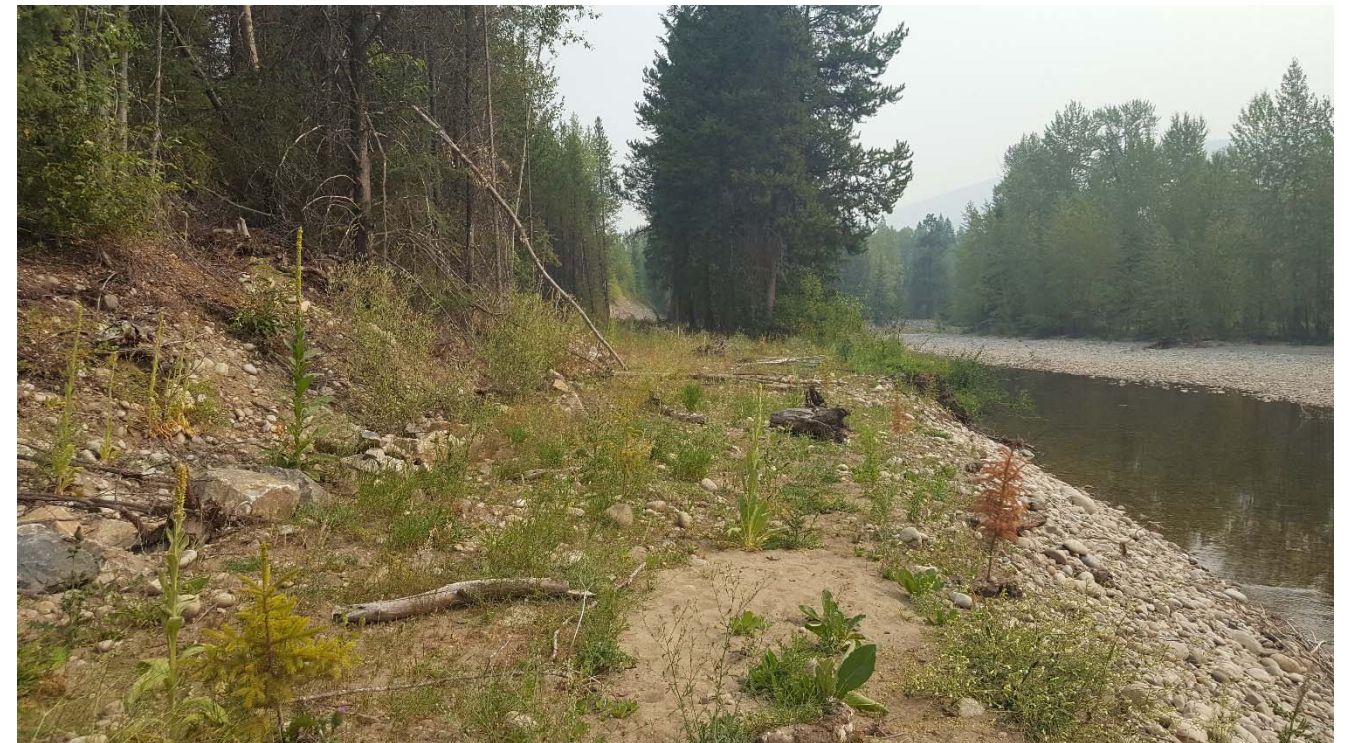
Photograph 14: South TSF, Cell 5, buried riprap at toe of TSF downstream slope, looking northeast. Same location as Photograph 13, low river flow. 8 August 2017.

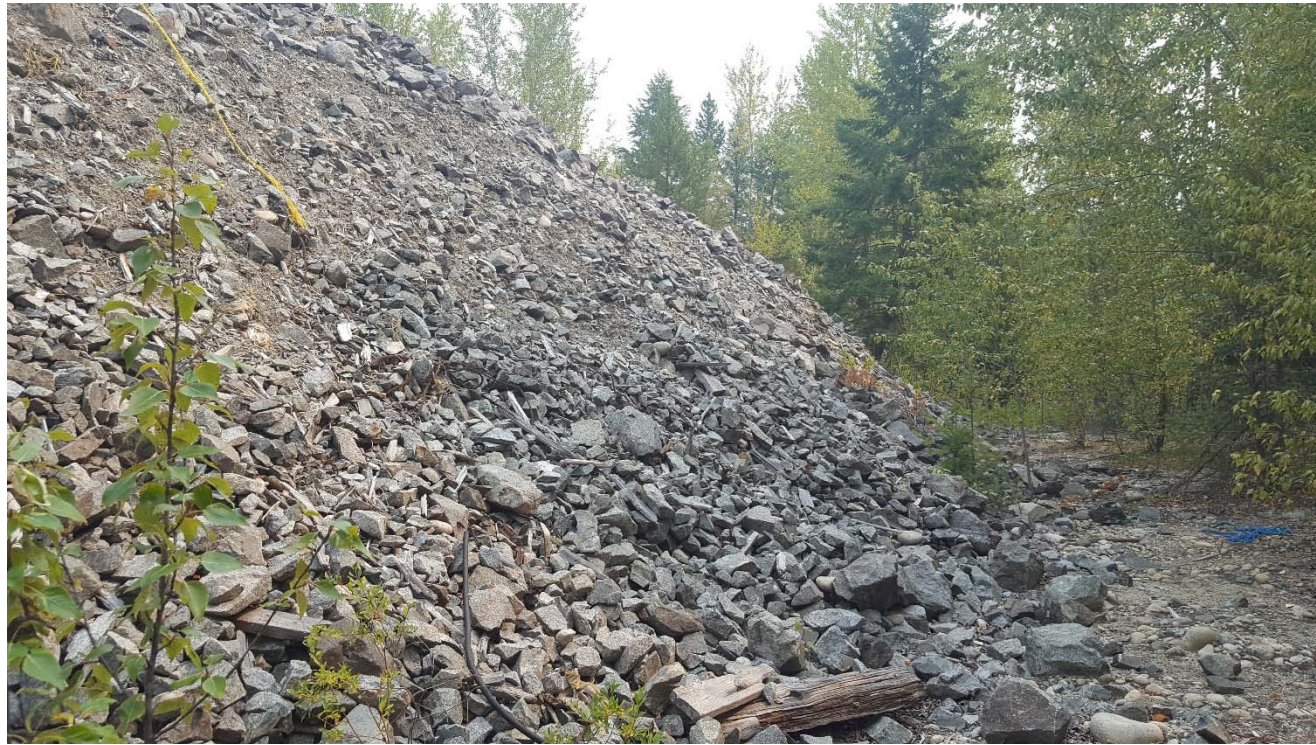
Photograph 15: South TSF, Cell 5, downstream slope consisting of waste rock, looking northeast. 8 August 2017.

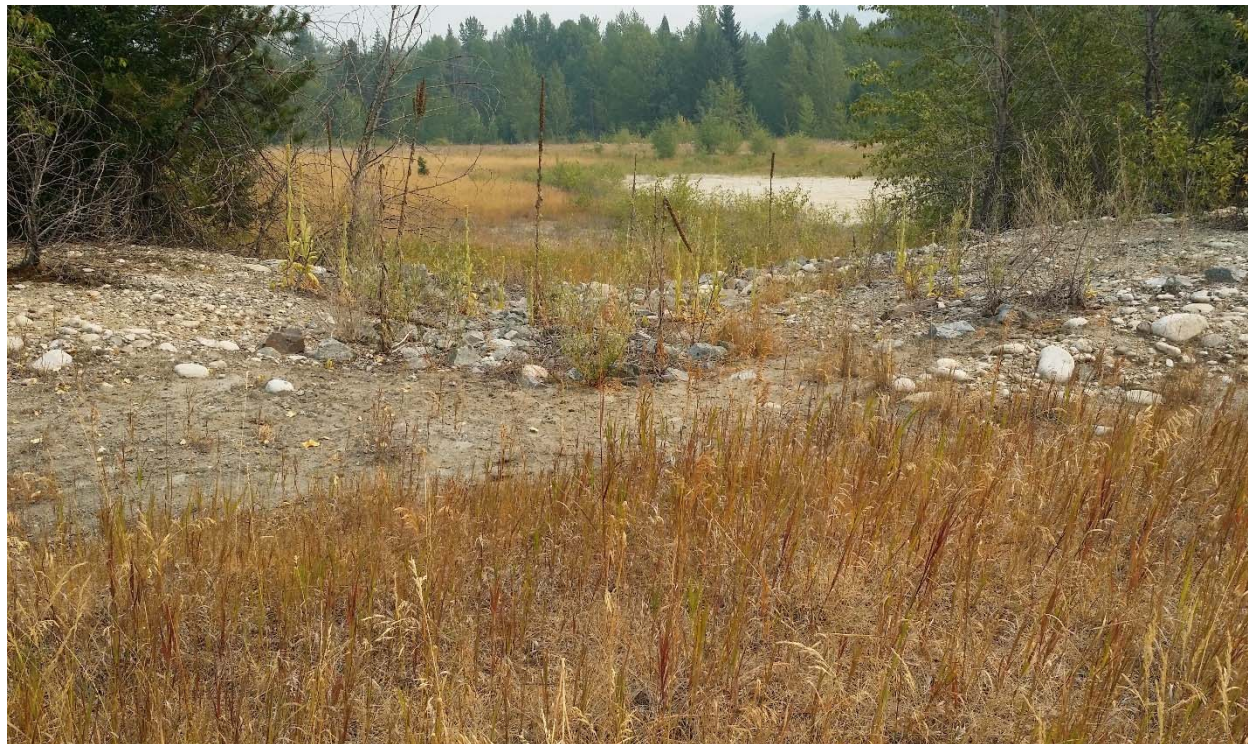
Photograph 16: South TSF, internal spillway between Cell 5 and Cell 4, looking northeast. 8 August 2017.

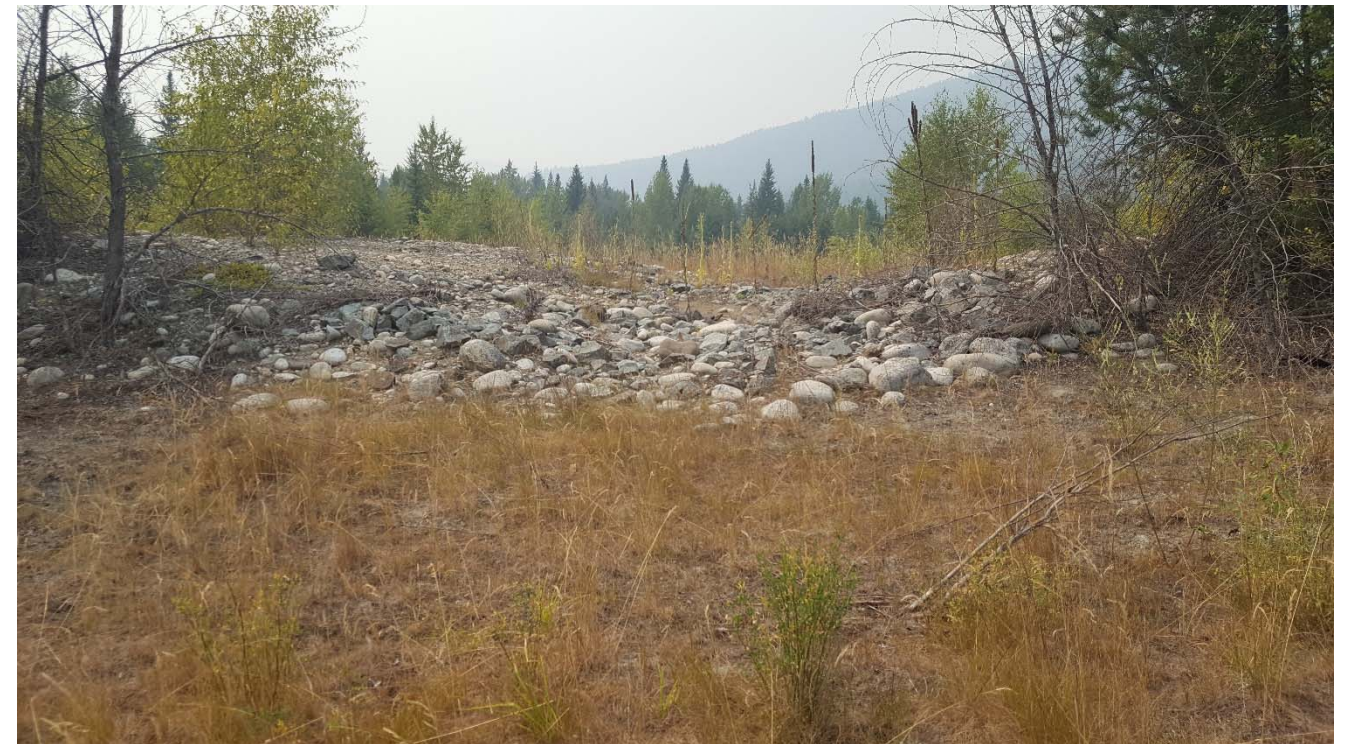
Photograph 17: South TSF, internal spillway between Cell 5 and Cell 4, looking southwest. 8 August 2017.

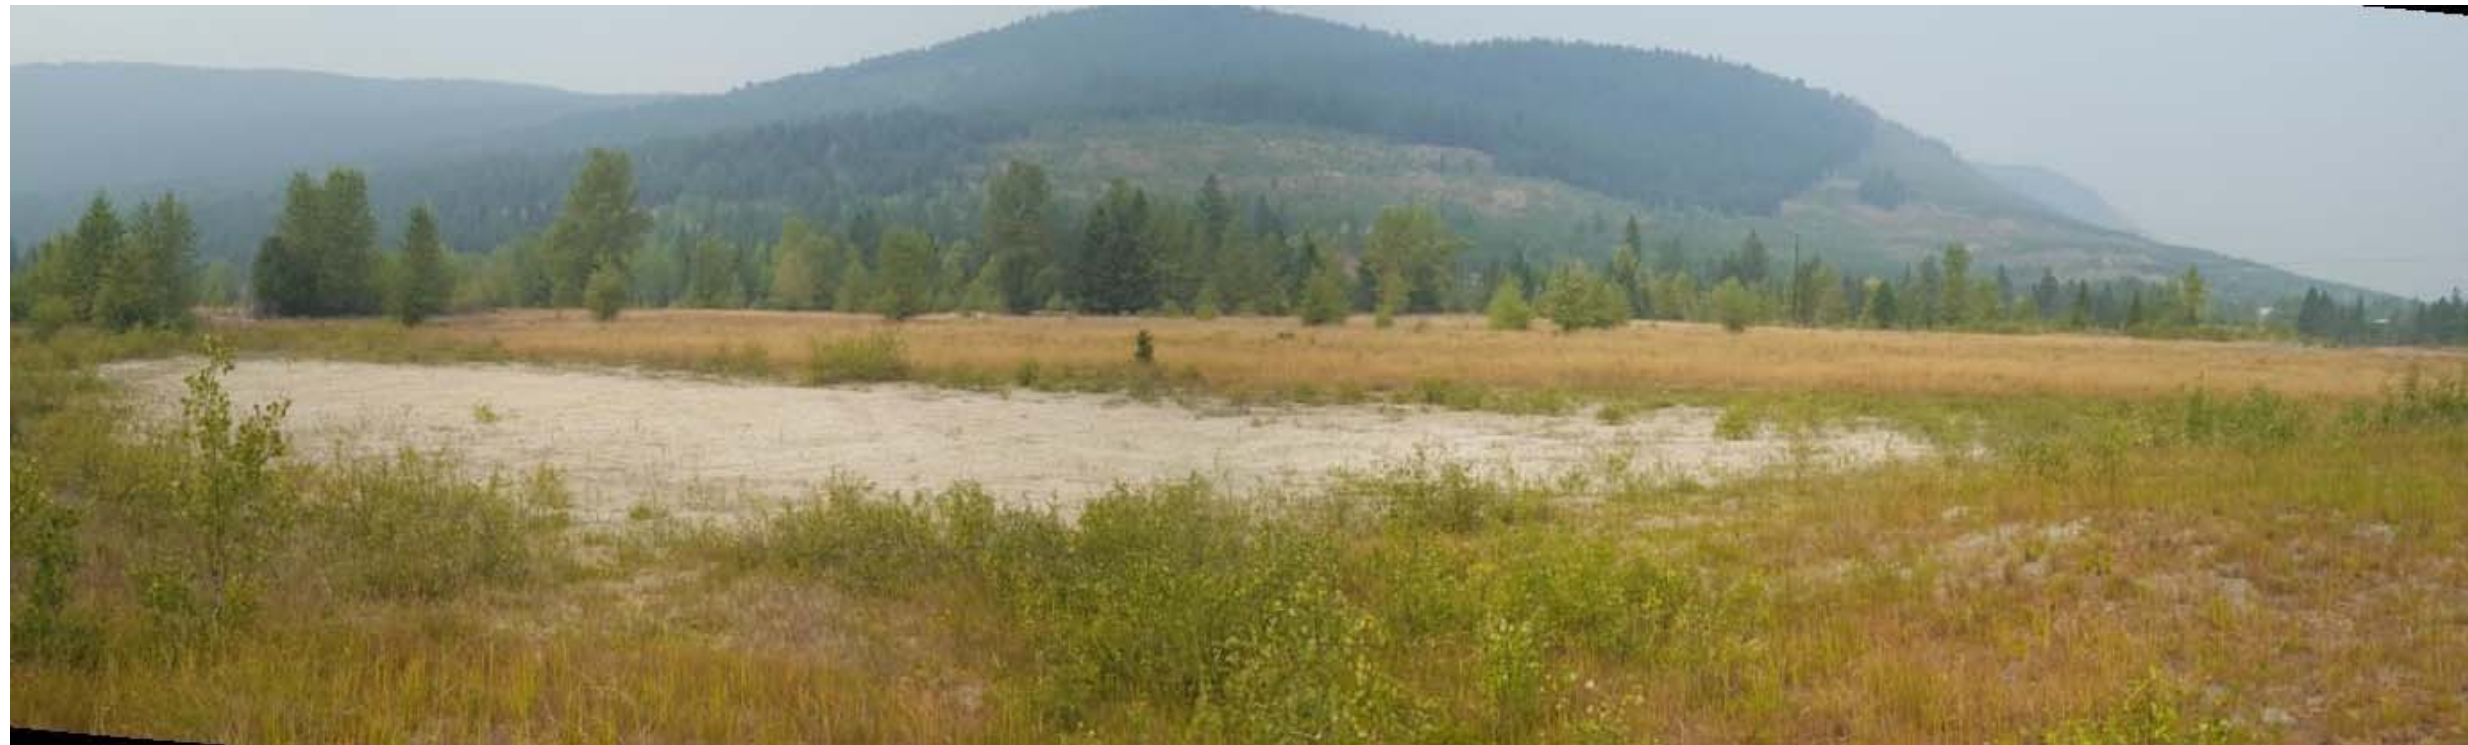
Photograph 18: South TSF, Cell 4, overview of tailings surface and dry ponding area, looking west. 8 August 2017.

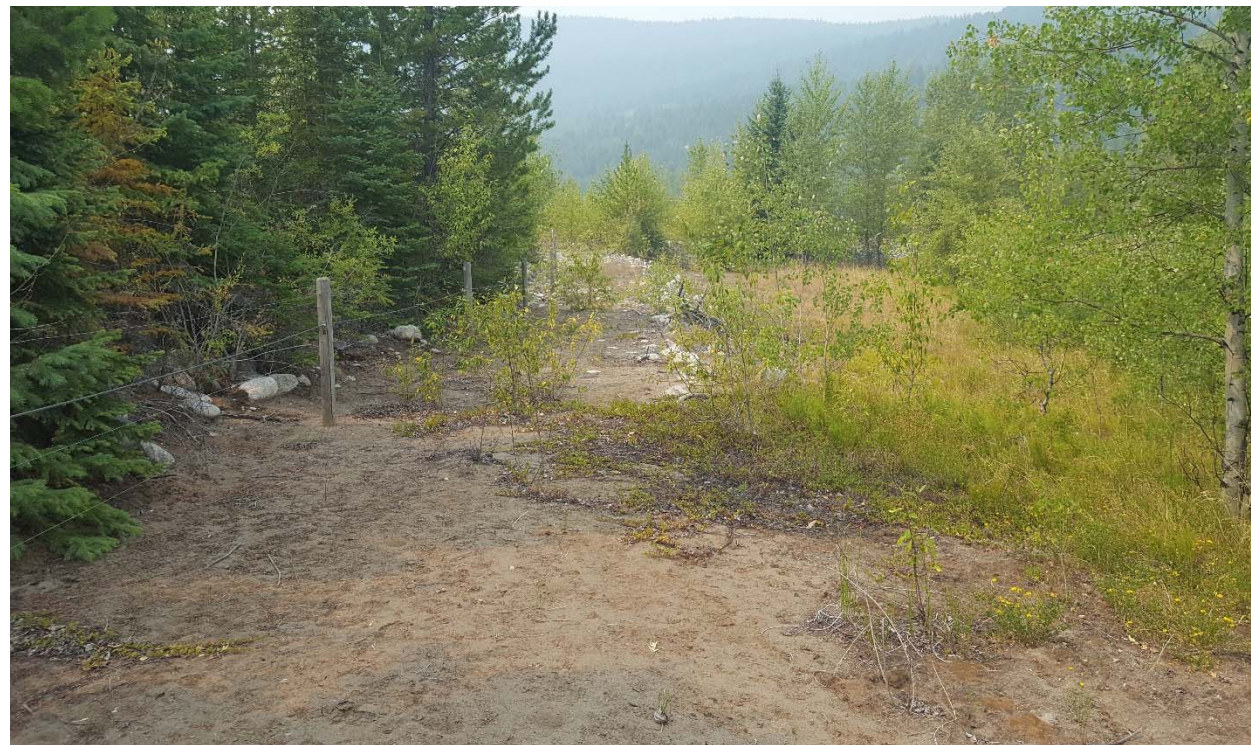
Photograph 19: South TSF, Cell 4, crest of dam, looking south. 8 August 2017.

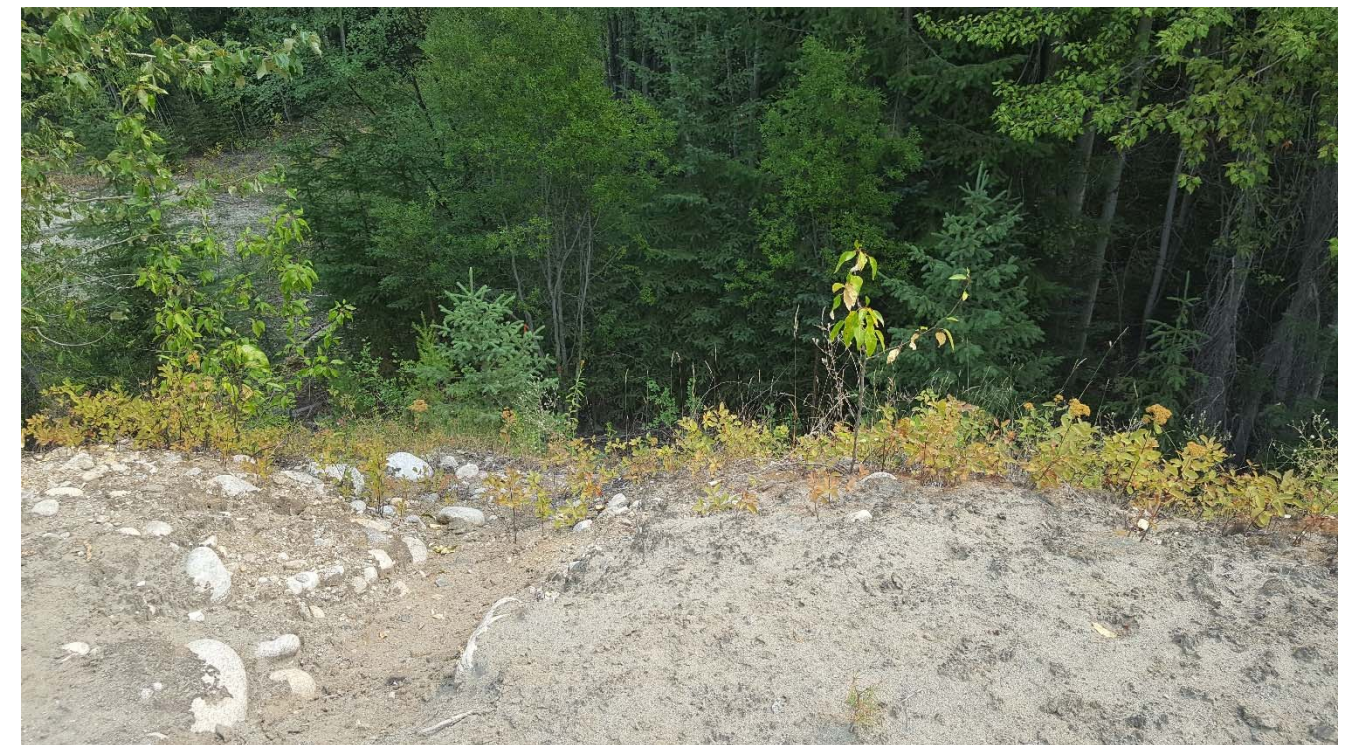
Photograph 20: South TSF, Cell 4, tailings on crest of dam, looking east. 8 August 2017.

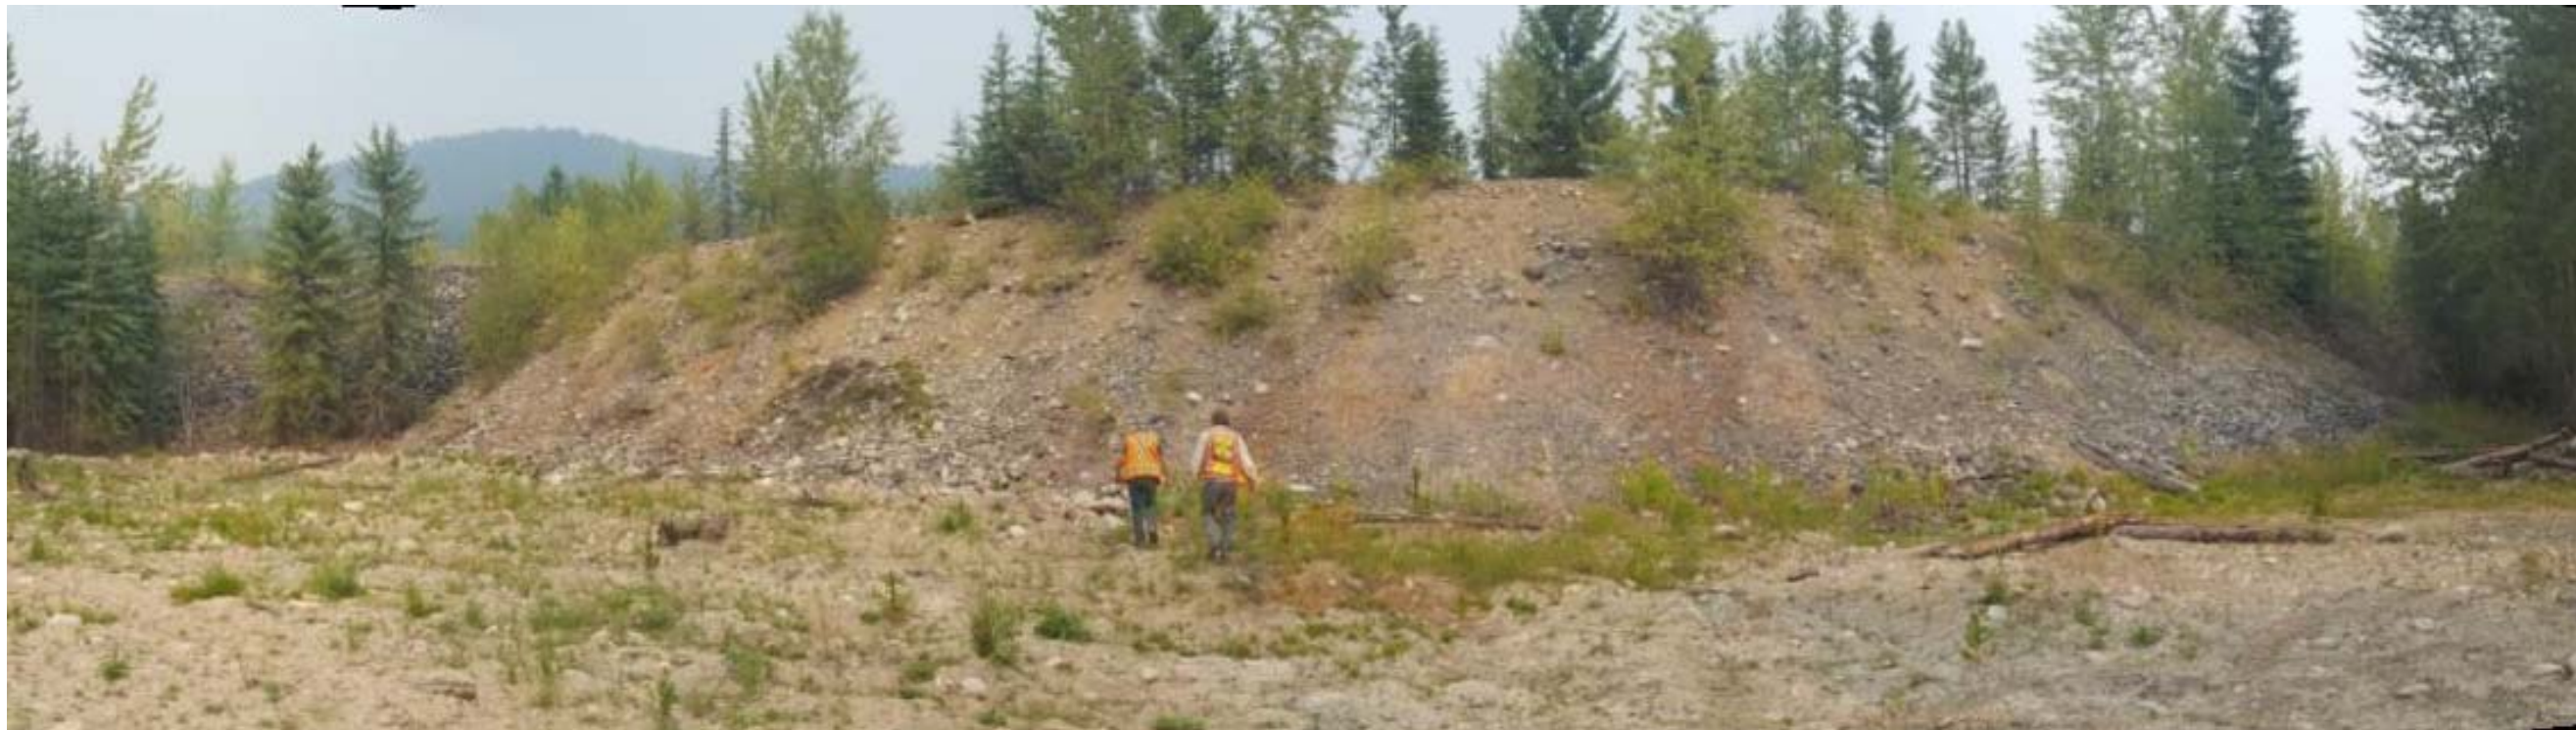
Photograph 21: South TSF, Cell 4, downstream slope and northern extent of buried riprap, looking northwest. 8 August 2017.

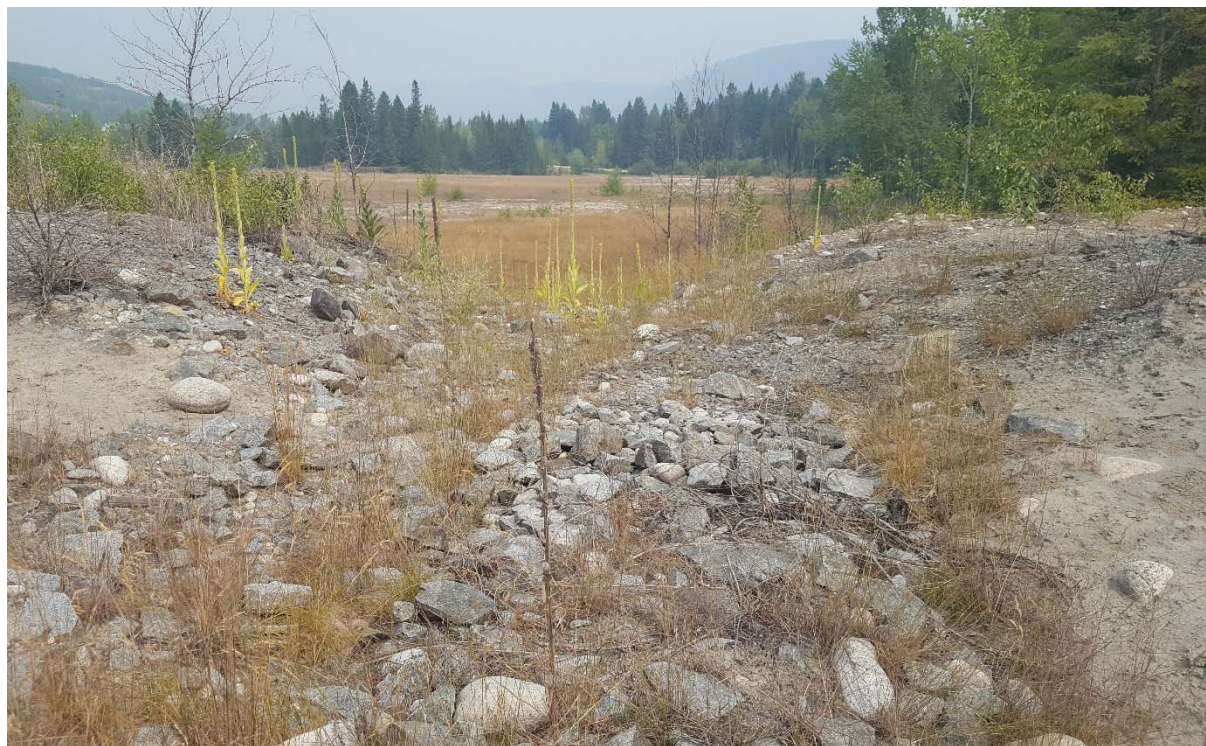
Photograph 22: South TSF, spillway between Cell 4 and Cell 3, looking north. 8 August 2017.

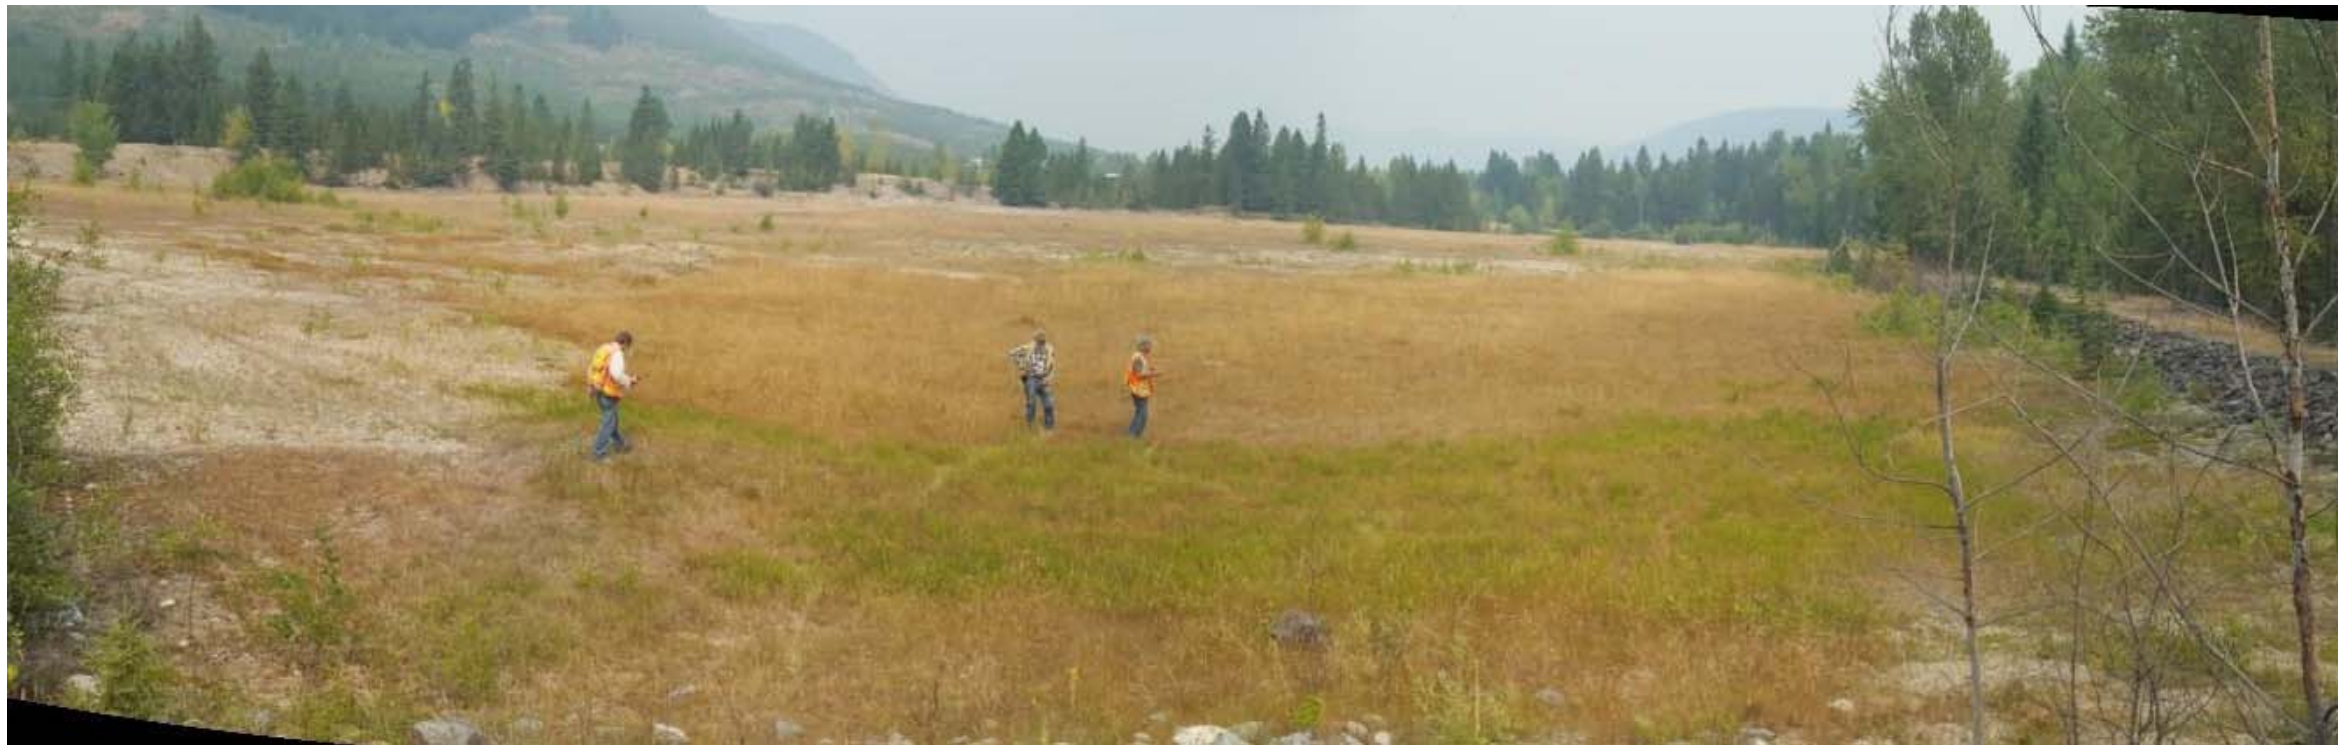
Photograph 24: South TSF, Cell 3, overview of tailings surface, looking north. 8 August 2017.

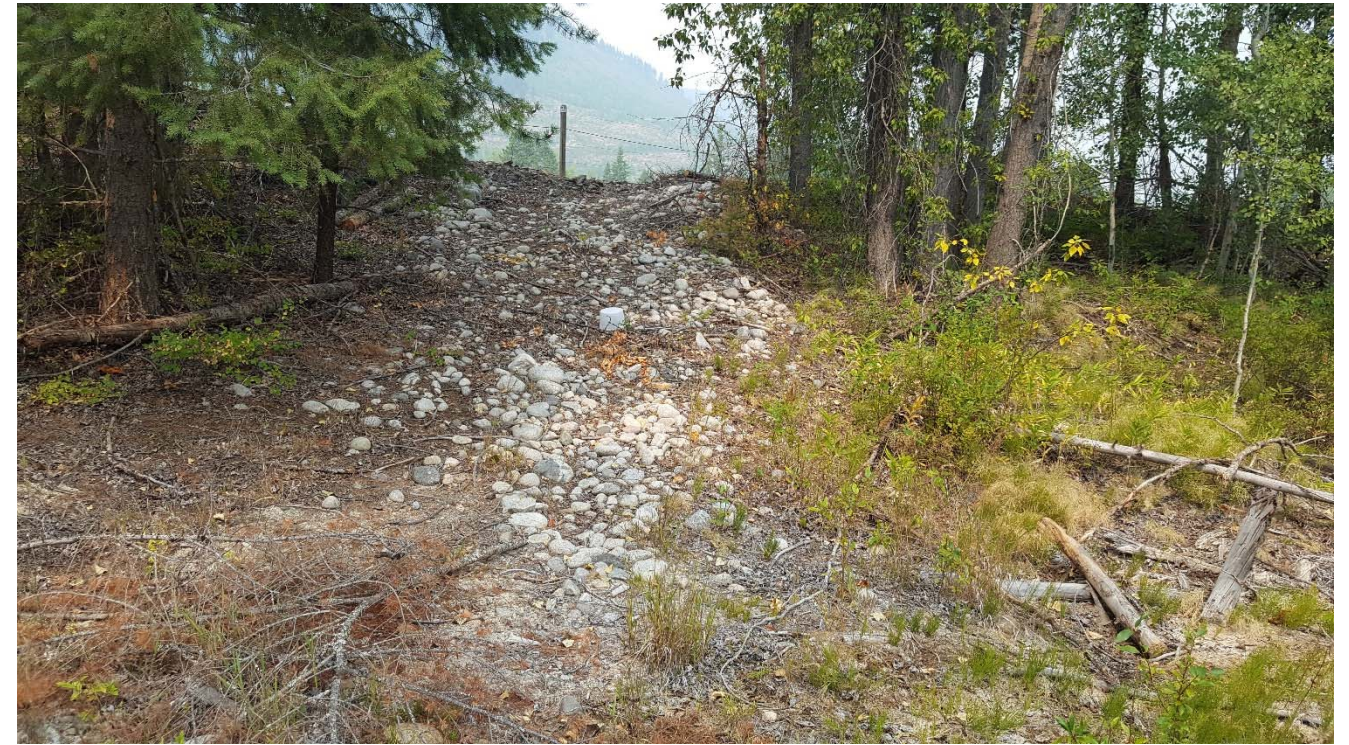
Photograph 28: South TSF, Cell 3, spillway from Cell 3, looking west from downstream toe area. 8 August 2017.

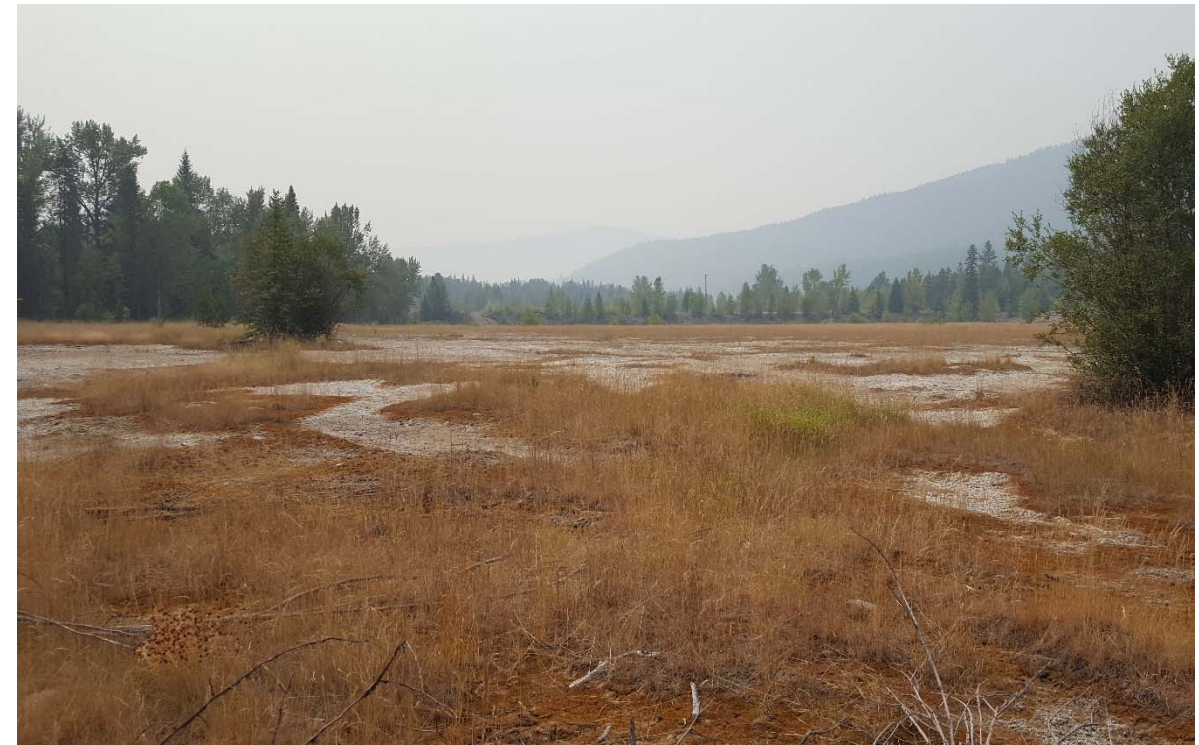
Photograph 30: South TSF, Cell 3, overview of tailings surface, looking south. 8 August 2017.

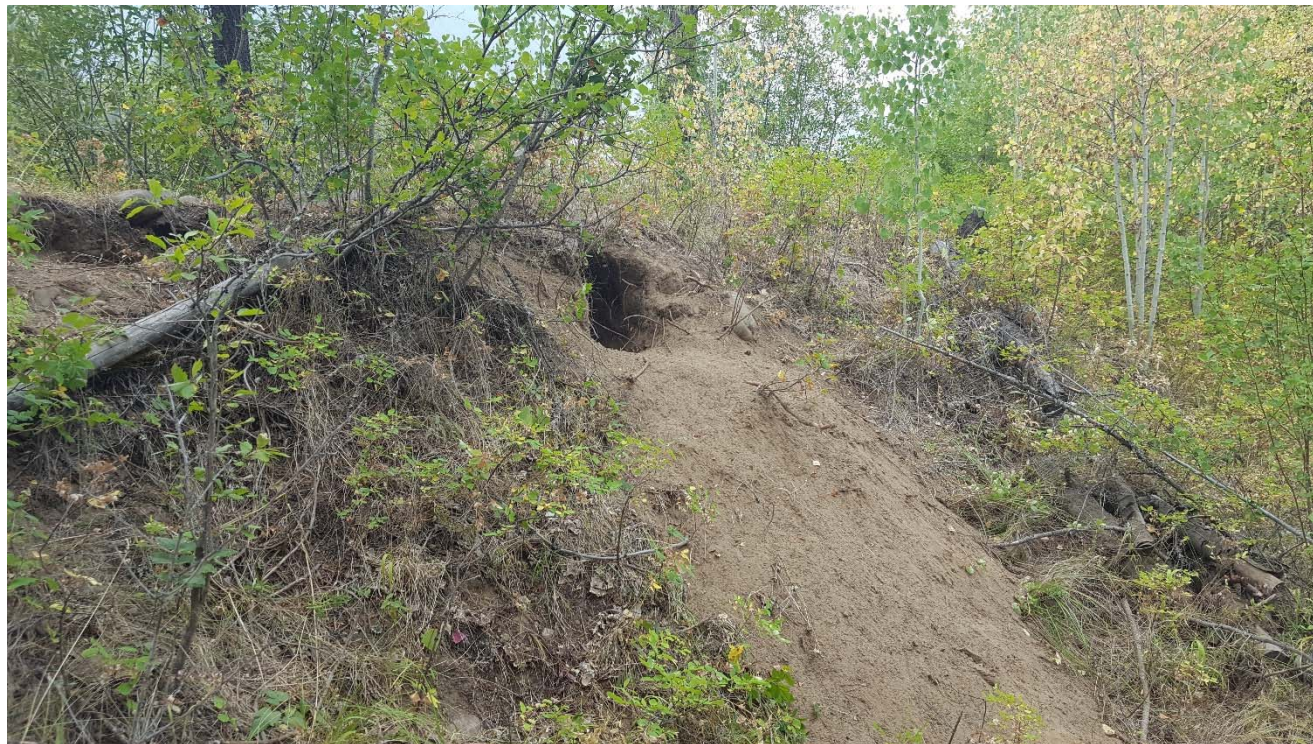
Photograph 33: South TSF, Cell 3, animal burrow in dam on northeast side of cell, looking west. 8 August 2017.
