TECK RESOURCES LIMITED BEAVERDELL MINE

Beaverdell Tailings Storage Facilities 2017 Annual Dam Safety Inspection

Reference Number: 1778313-052-R-Rev0-1000

This report presents the 2017 annual dam safety inspection (DSI) for the embankments of the tailings storage facilities (TSF) at the closed Beaverdell Mine. The facilities consist of the South TSF and North TSF.

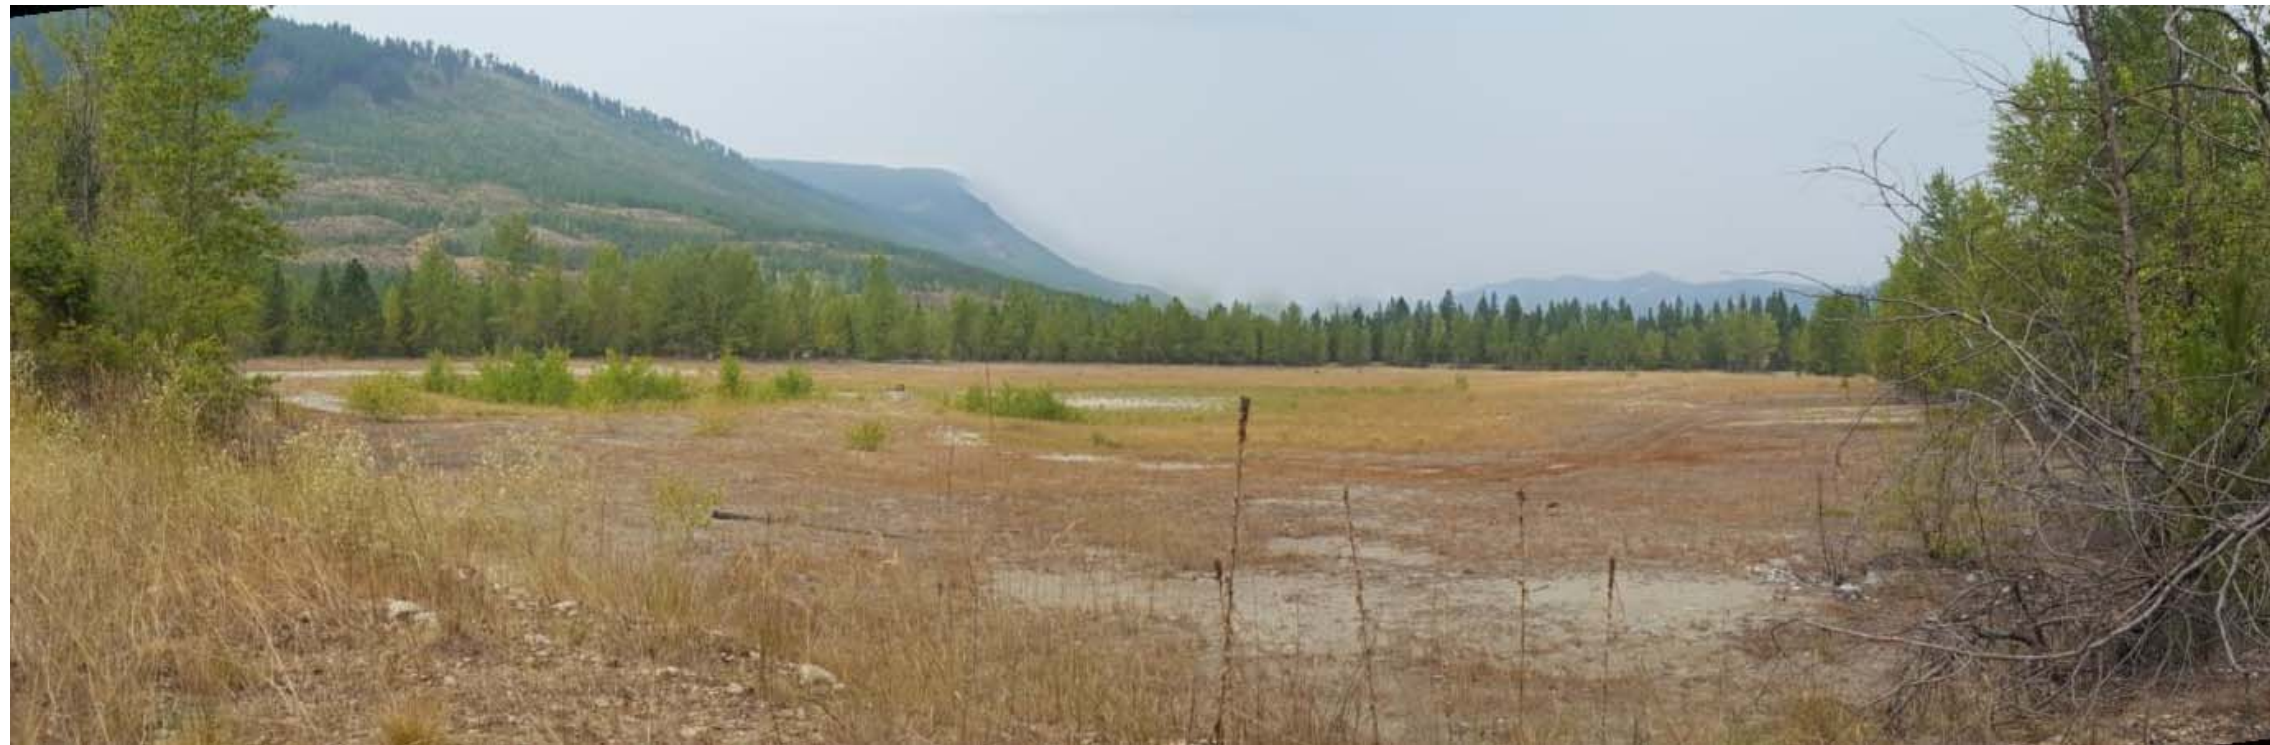
Photograph 34: North TSF, Cell 6, overview of tailings surface, looking northwest. 8 August 2017.

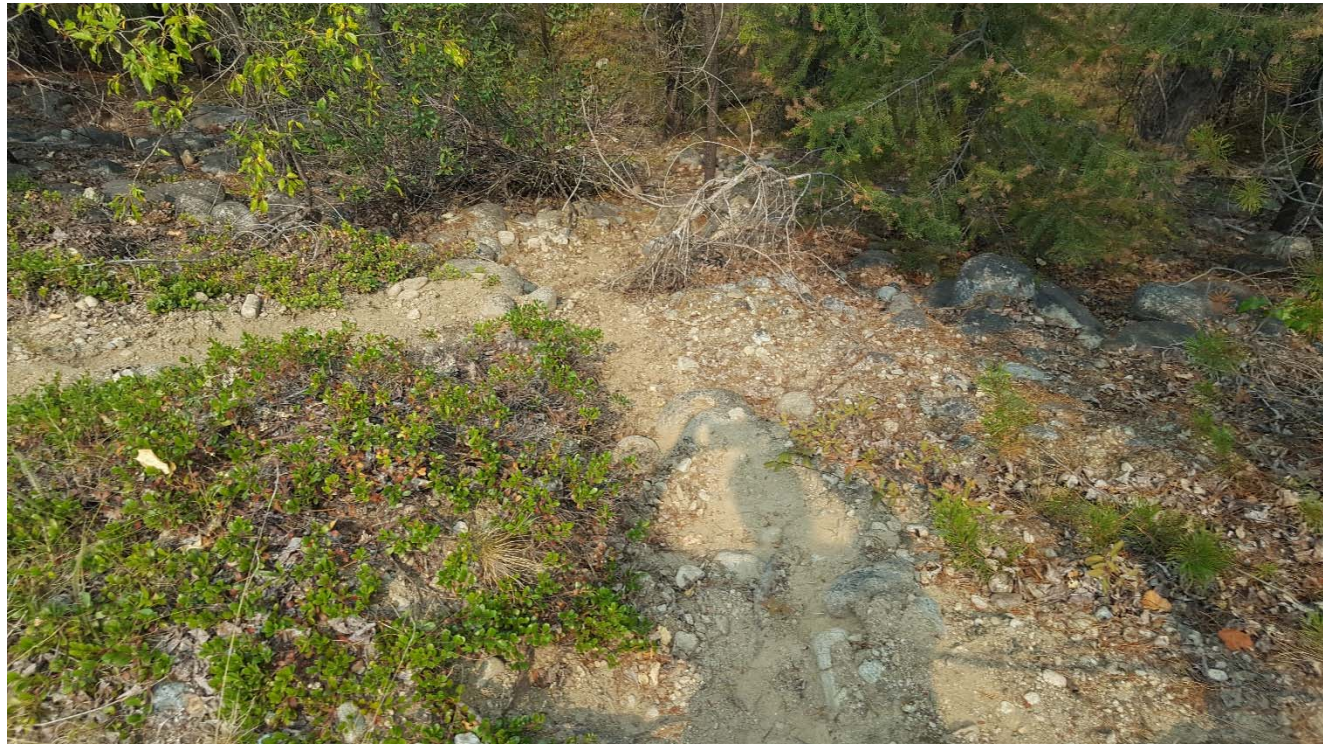
Photograph 37: North TSF, Cell 6, minor erosion on downstream dam slope, looking north. 8 August 2017.

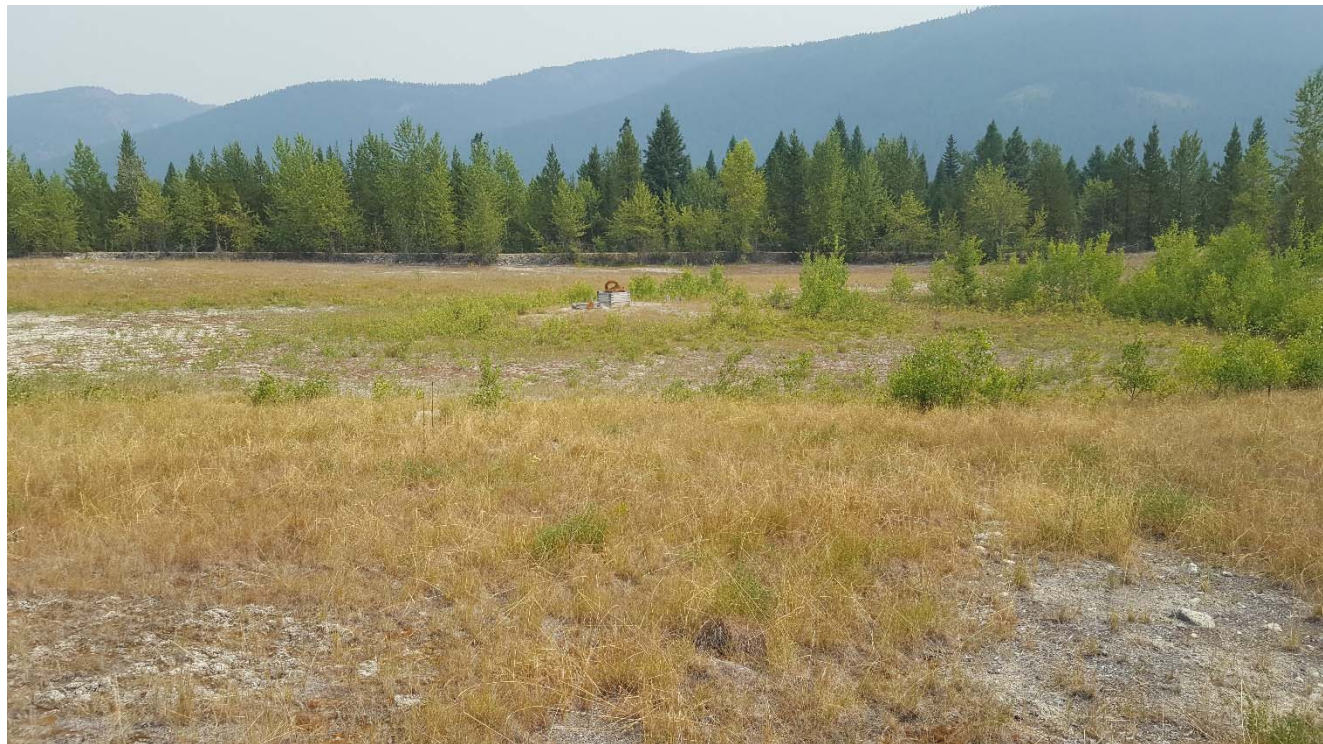
Photograph 39: North TSF, Cell 6, plugged decant tower, looking east. 8 August 2017.

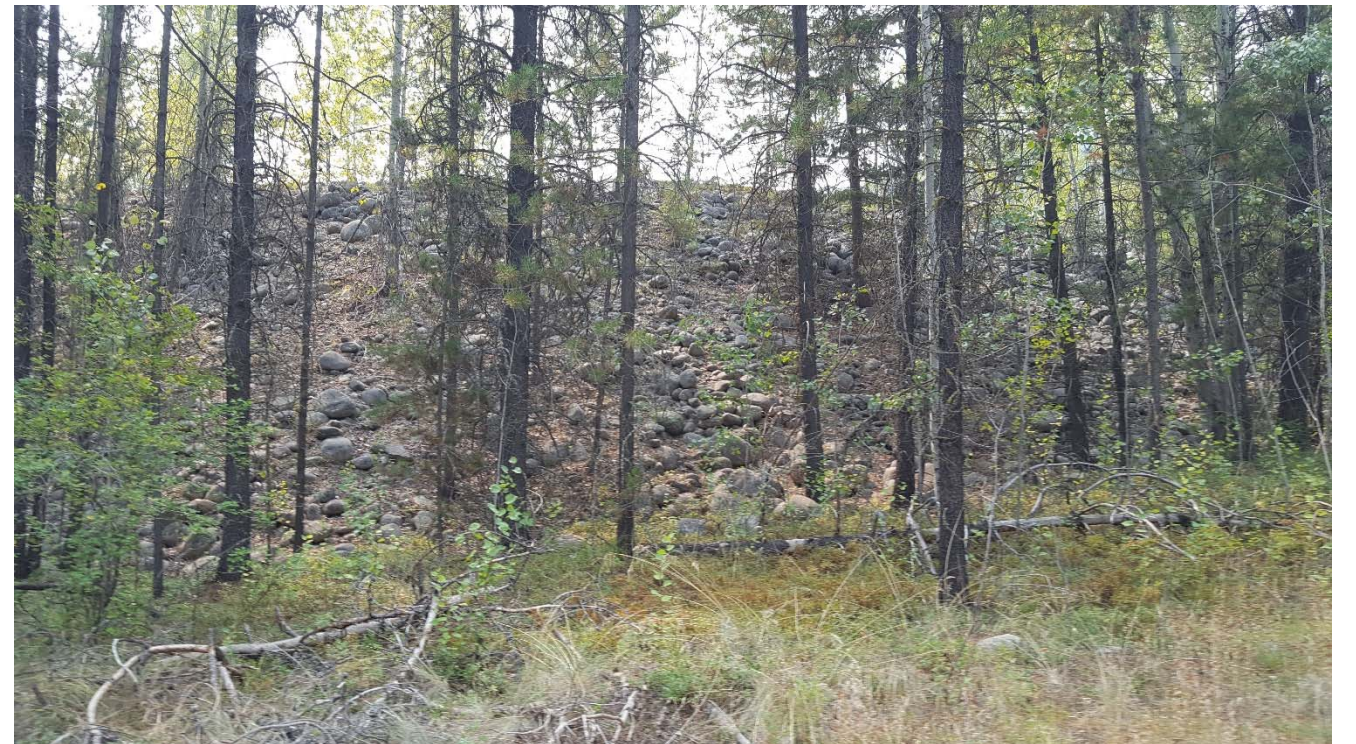
Photograph 40: North TSF, Cell 6, downstream slope and toe, looking south. 8 August 2017.

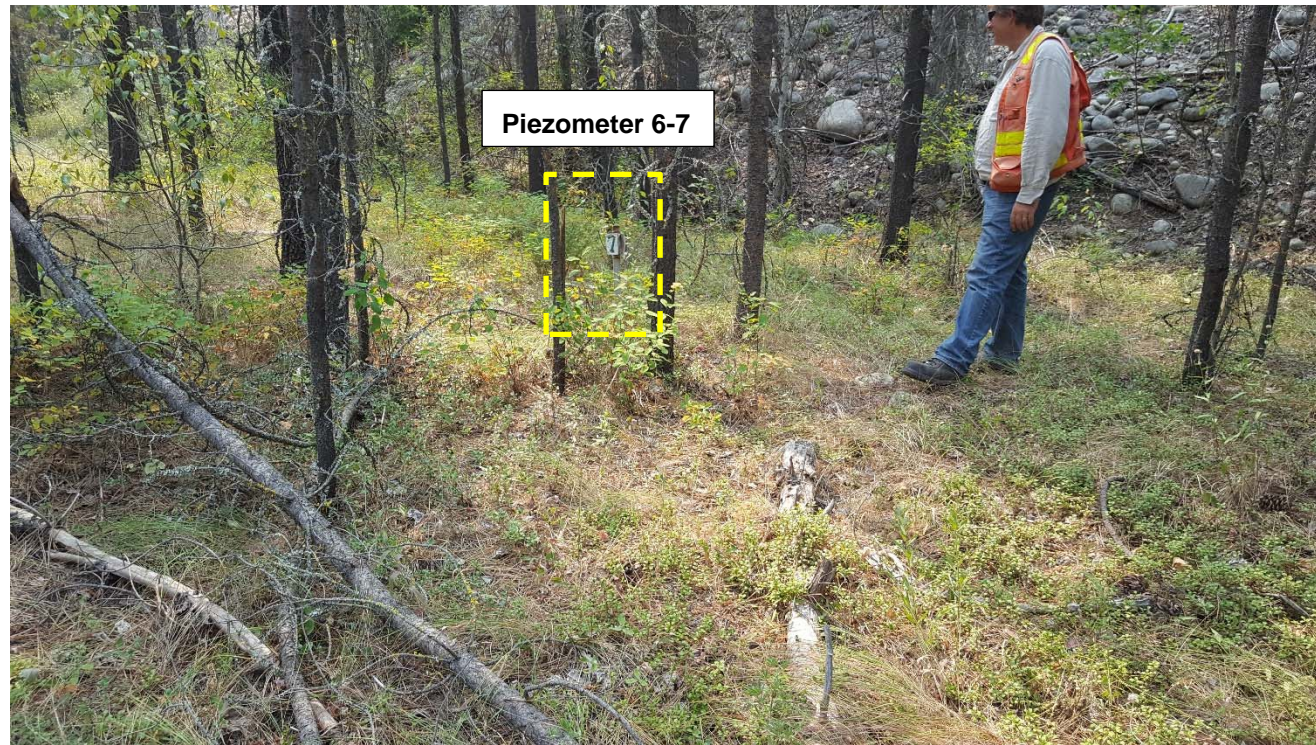
Photograph 41: North TSF, Cell 6, piezometer 6-7 (not functional) at toe of dam, looking southwest. 8 August 2017.

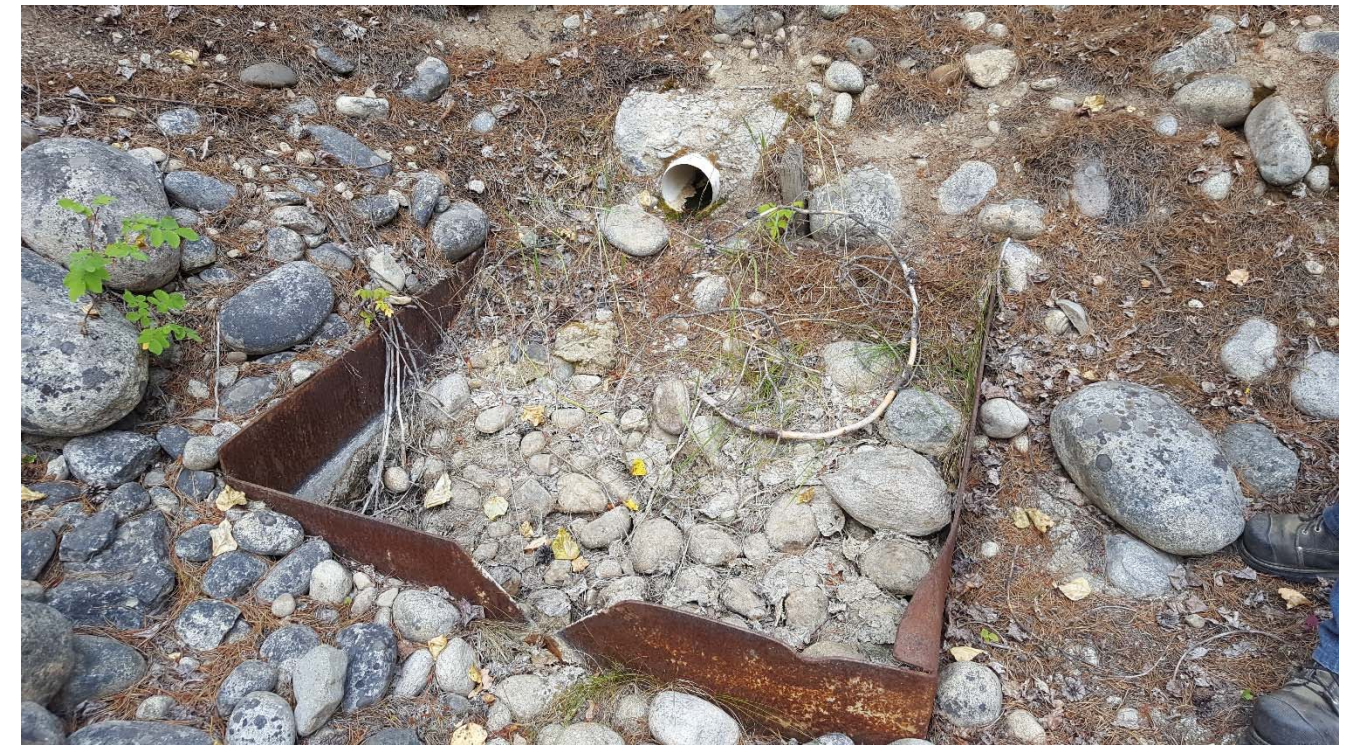
Photograph 42: North TSF, Cell 6, decant outlet at toe of dam, looking northwest. 8 August 2017.

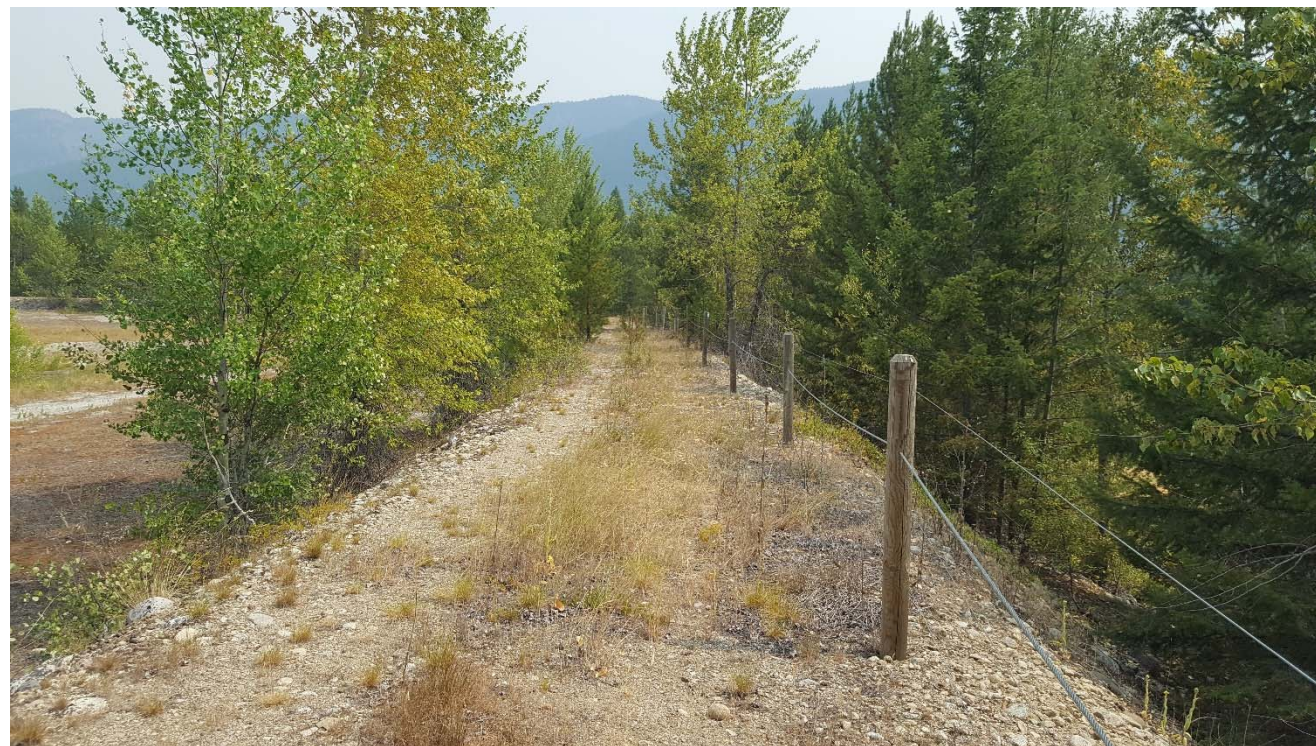
Photograph 43: North TSF, Cell 6, crest of dam on south side of cell, looking east. 8 August 2017.

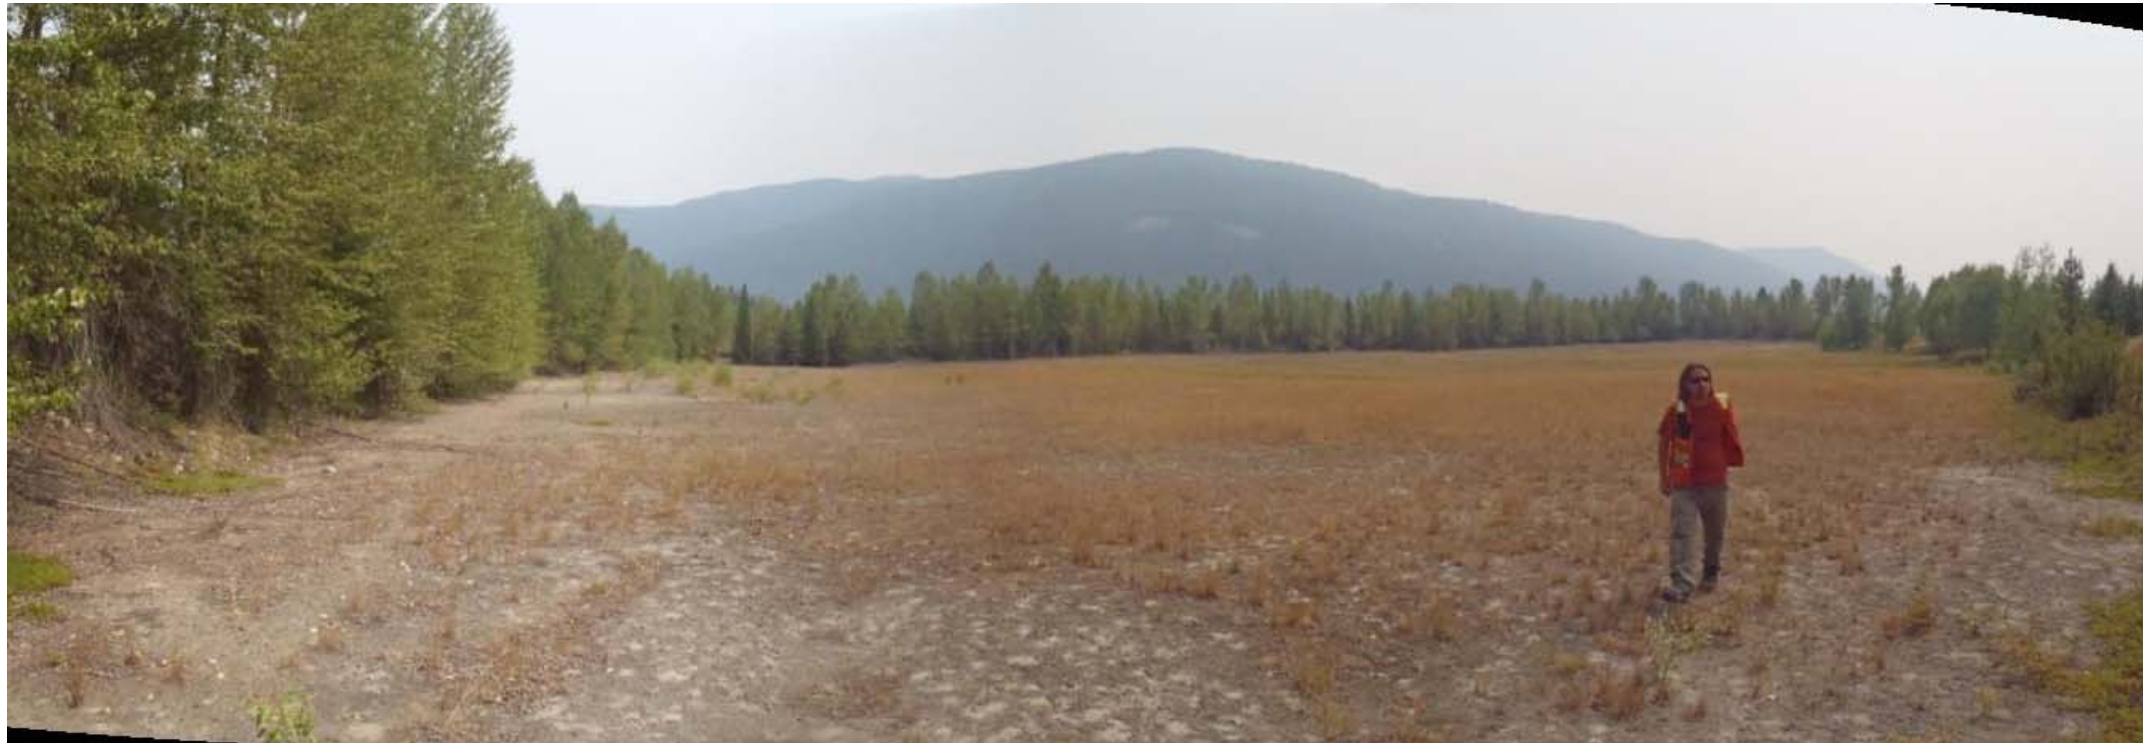
Photograph 44: North TSF, Cell 7, overview of tailings surface, looking southeast. 8 August 2017.

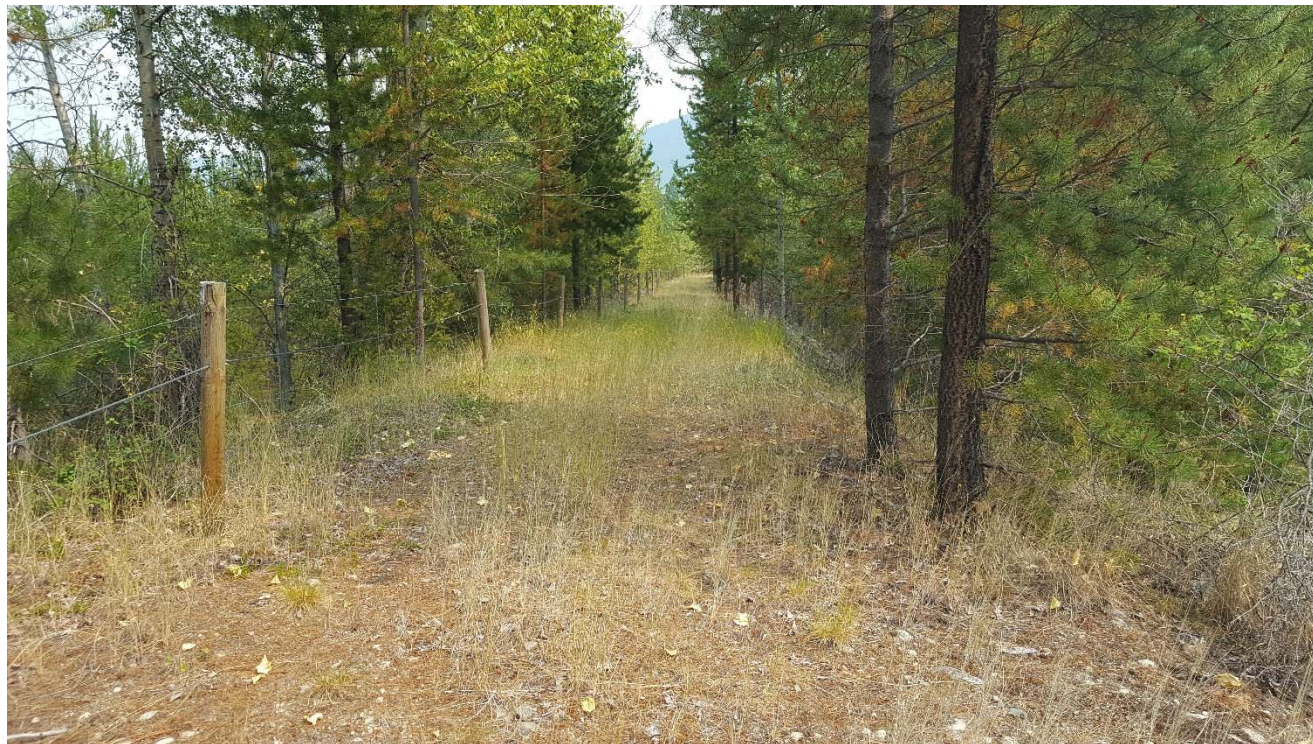
Photograph 45: North TSF, Cell 7, crest of dam on north side of cell, looking east. 8 August 2017.

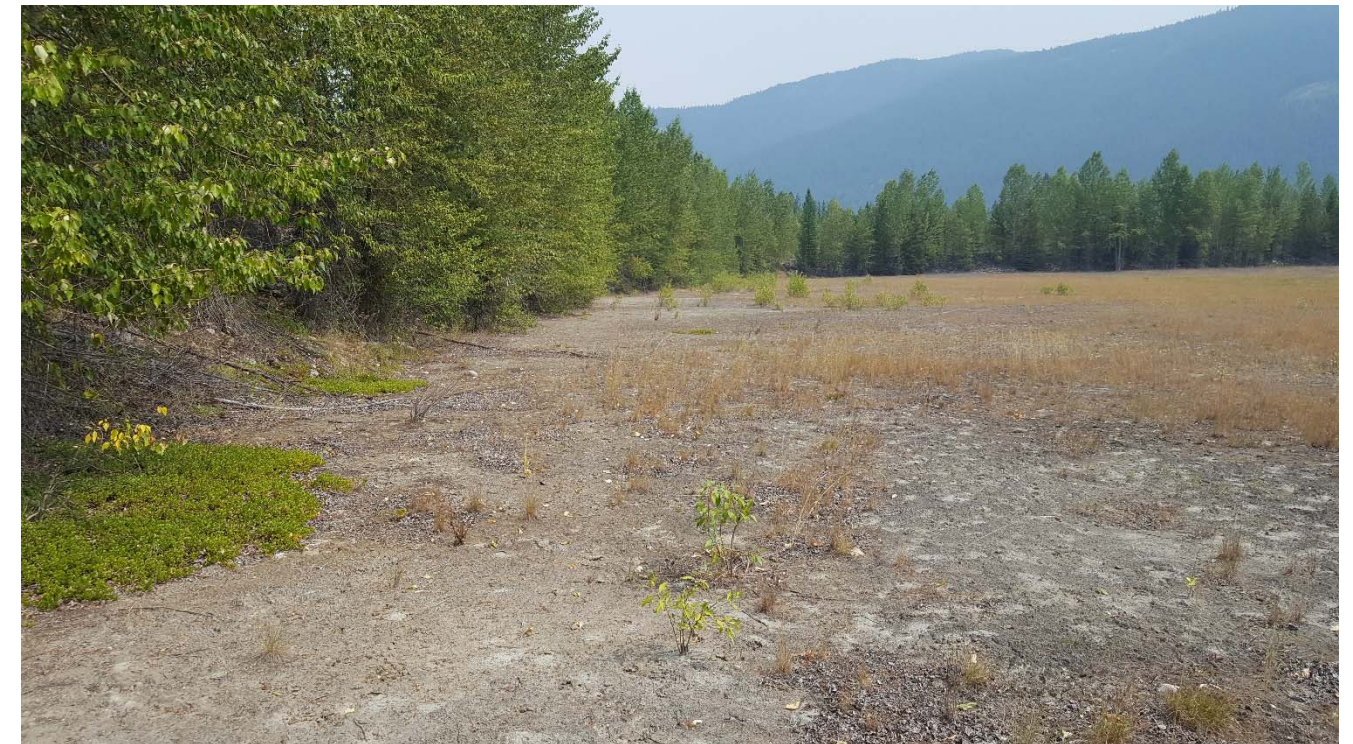
Photograph 46: North TSF, Cell 7, upstream slope on dam on north side of cell, looking east. 8 August 2017.

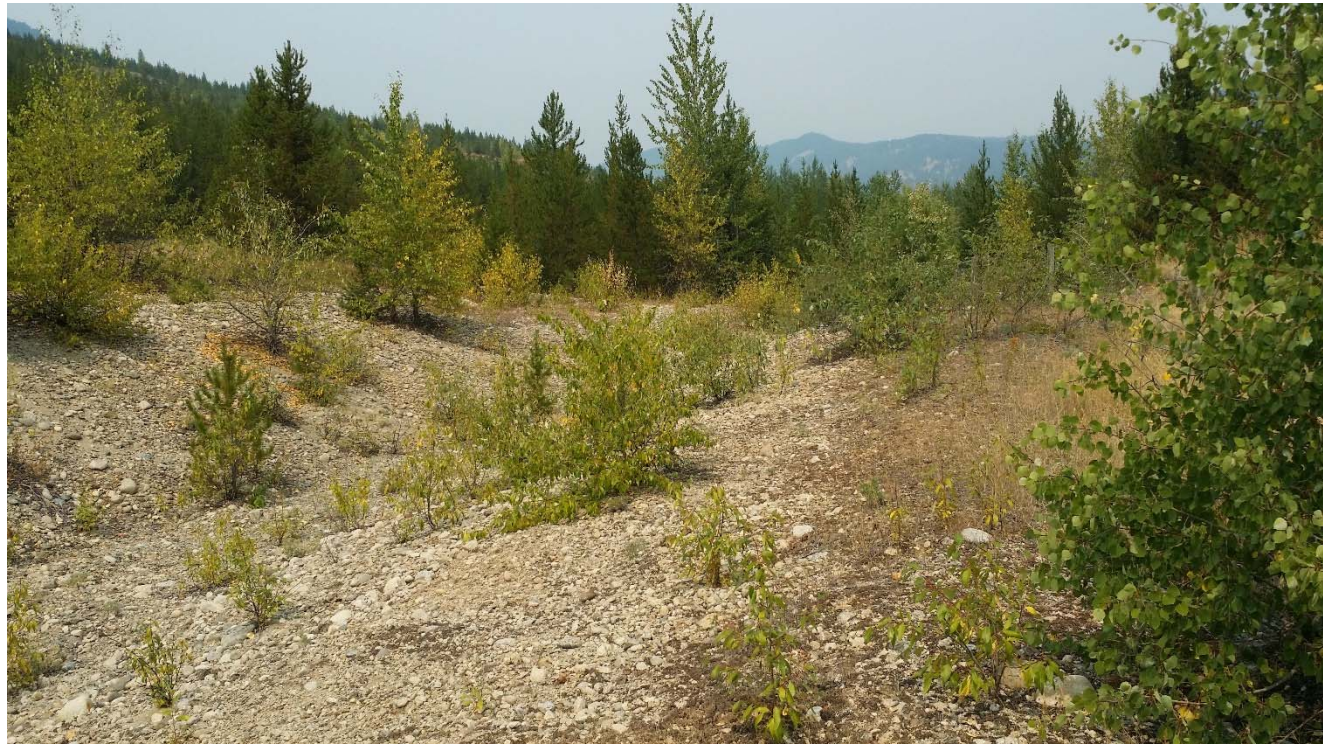
Photograph 47: North TSF, Cell 7, spillway at southwest corner, looking north. 8 August 2017.

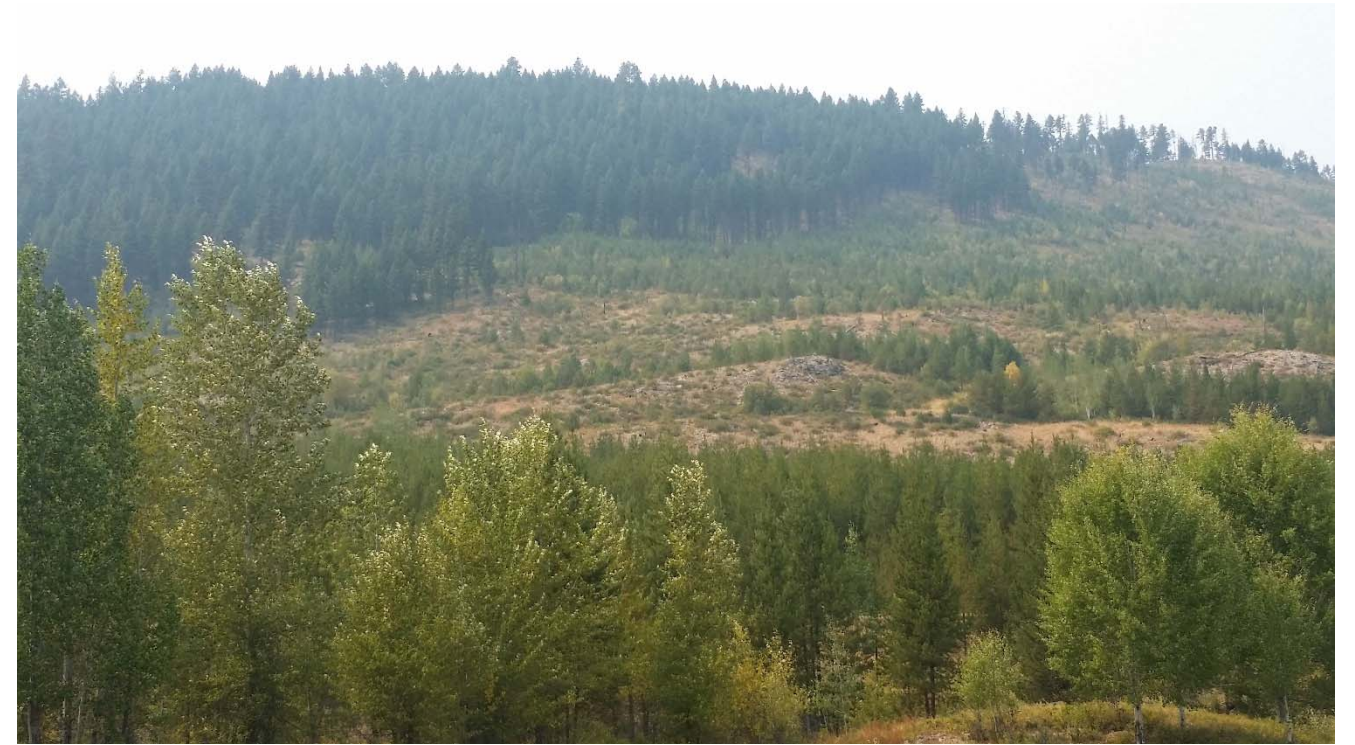
Photograph 48: North TSF, Cranberry Ridge above Cell 7, looking west. 8 August 2017.

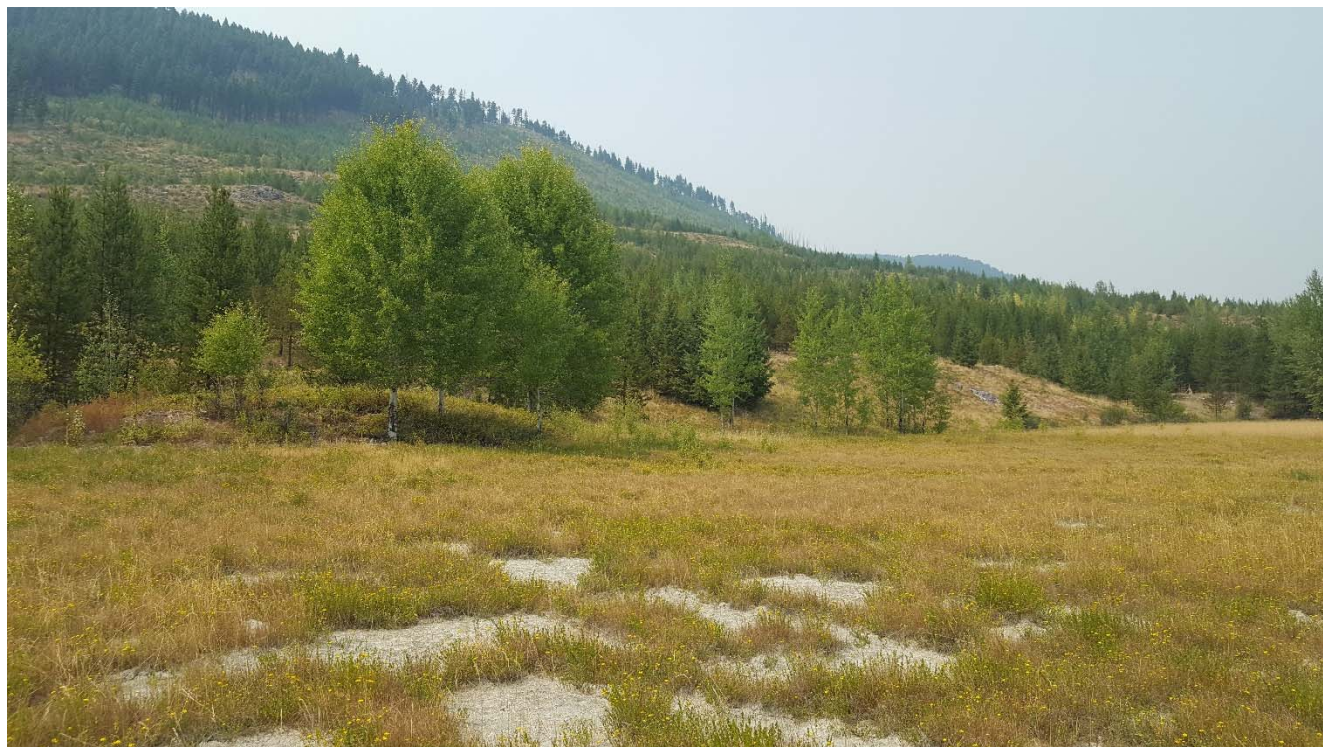
Photograph 49: North TSF, Cell 7, tailings and original ground in southwest corner of Cell 7, looking northwest. 8 August 2017.

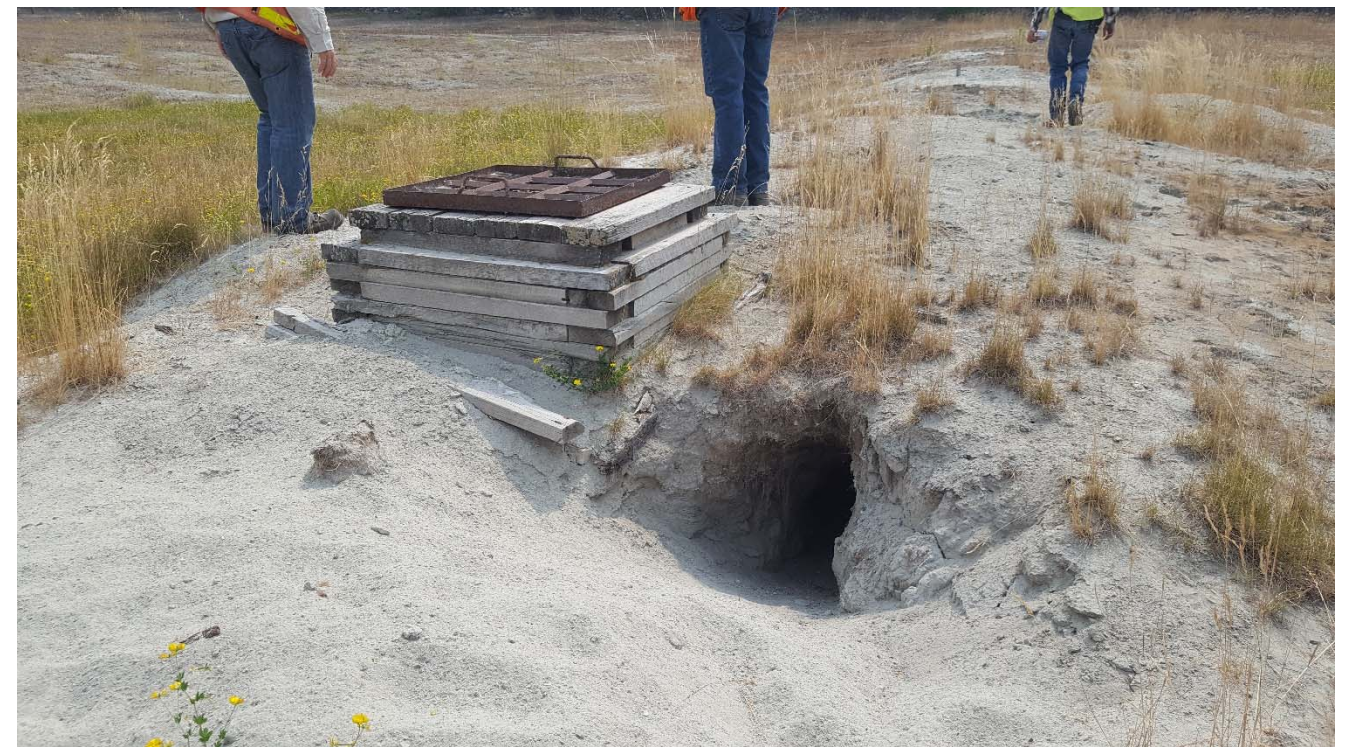
Photograph 50: North TSF, Cell 7, decant tower structure and animal den, looking south. 8 August 2017.

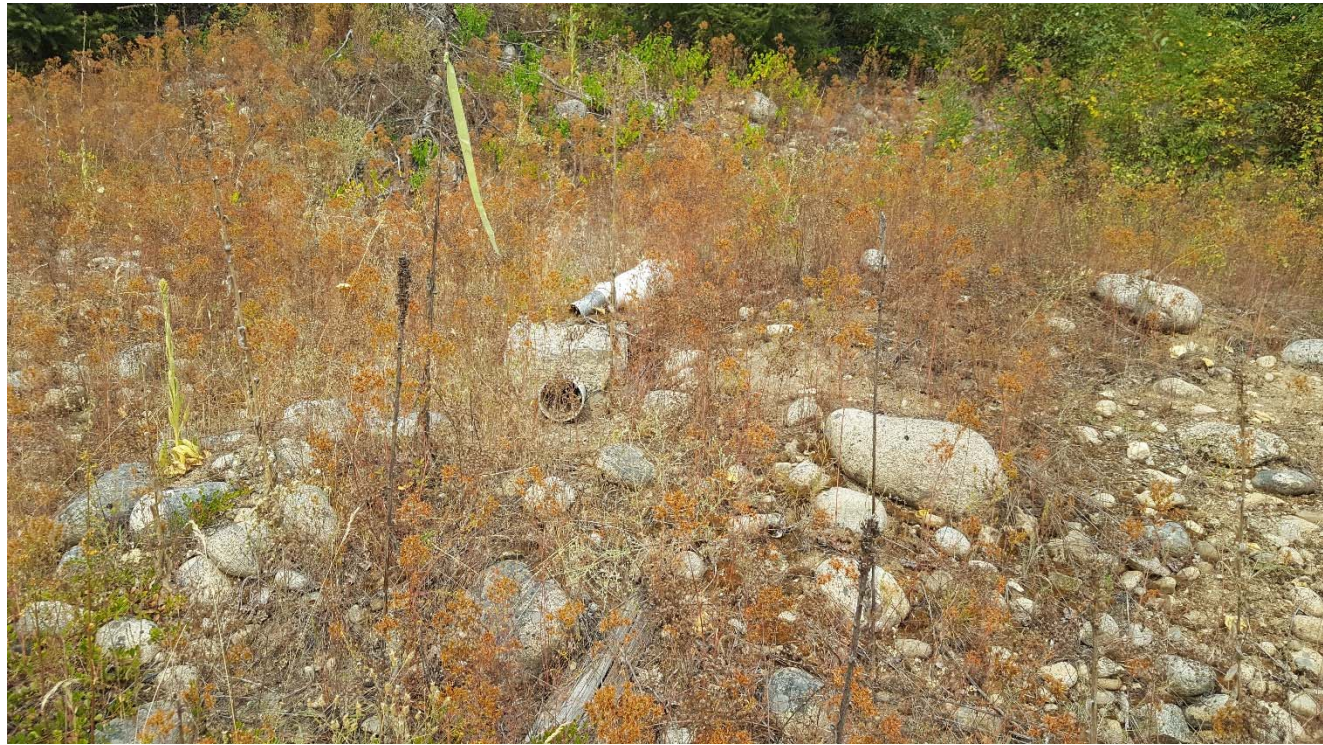
Photograph 51: North TSF, Cell 7, decant outlet at toe of dam, looking north. 8 August 2017.

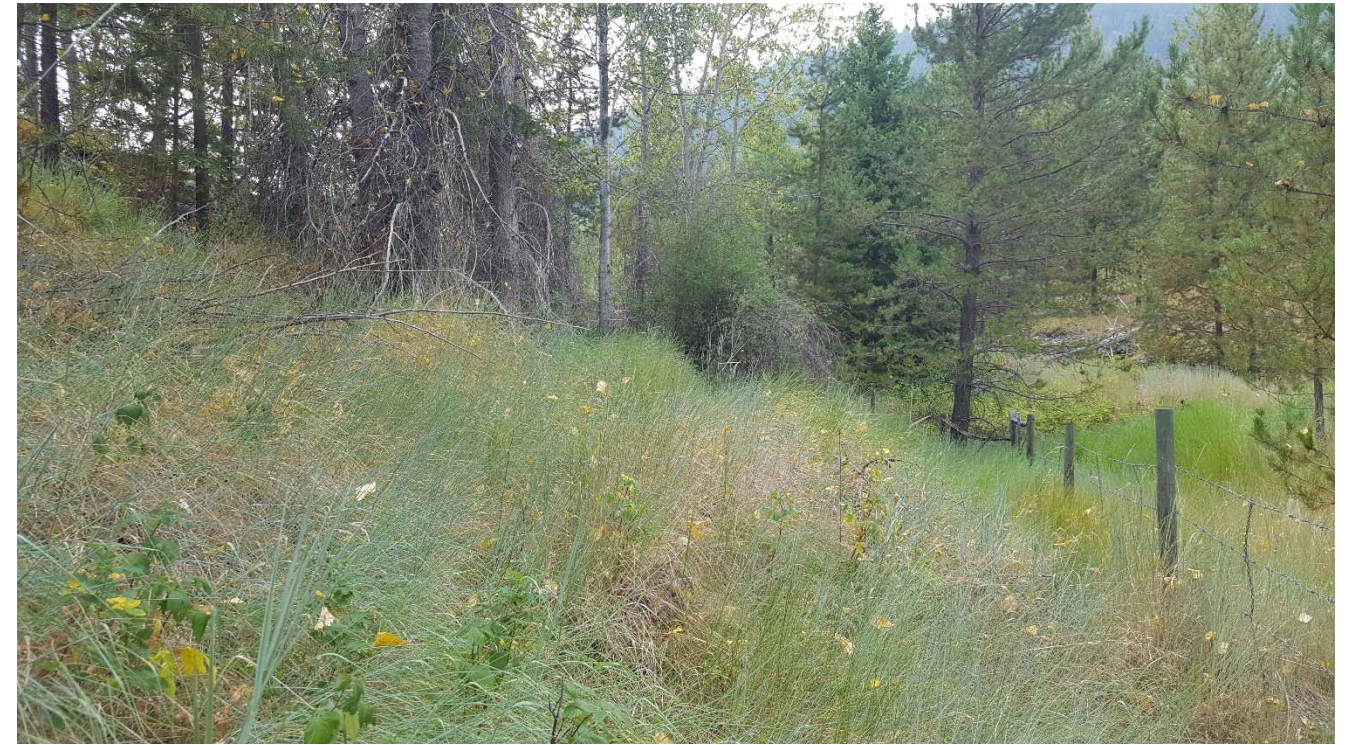
Photograph 52: North TSF, Cell 7, downstream slope and toe, looking west. 8 August 2017.

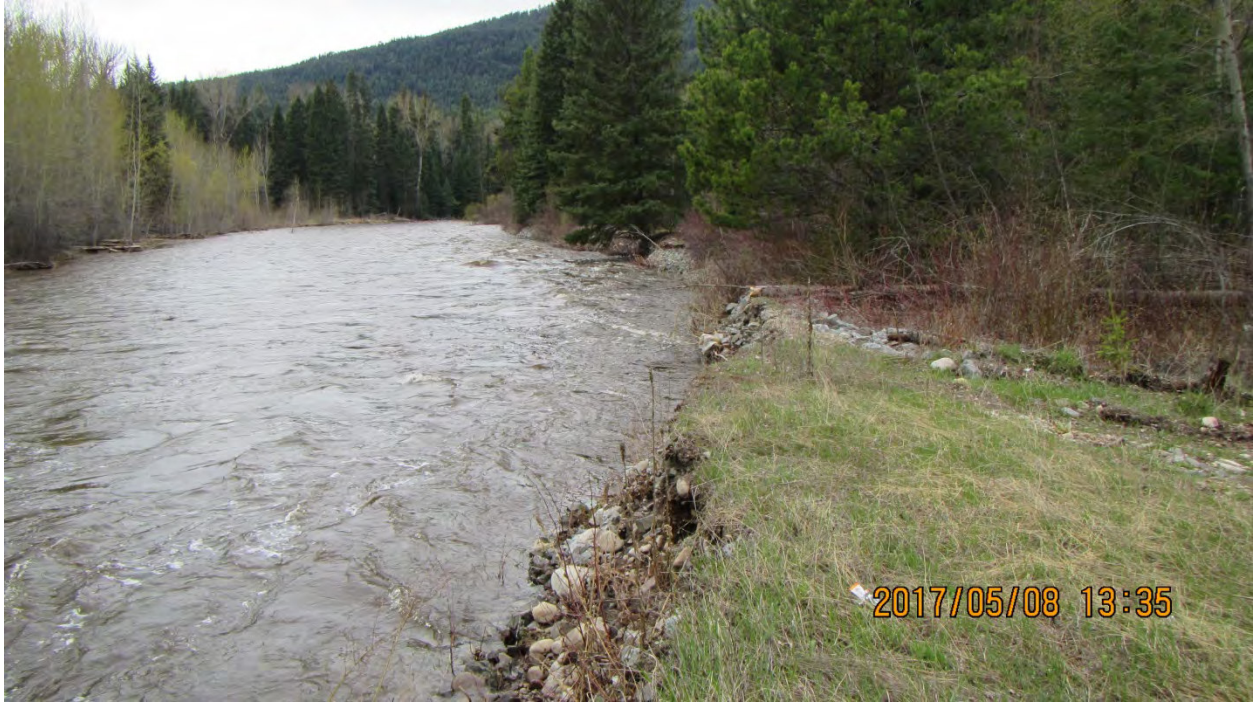
Photo 1
Deterioration in berm between WKR and Cell 4/5

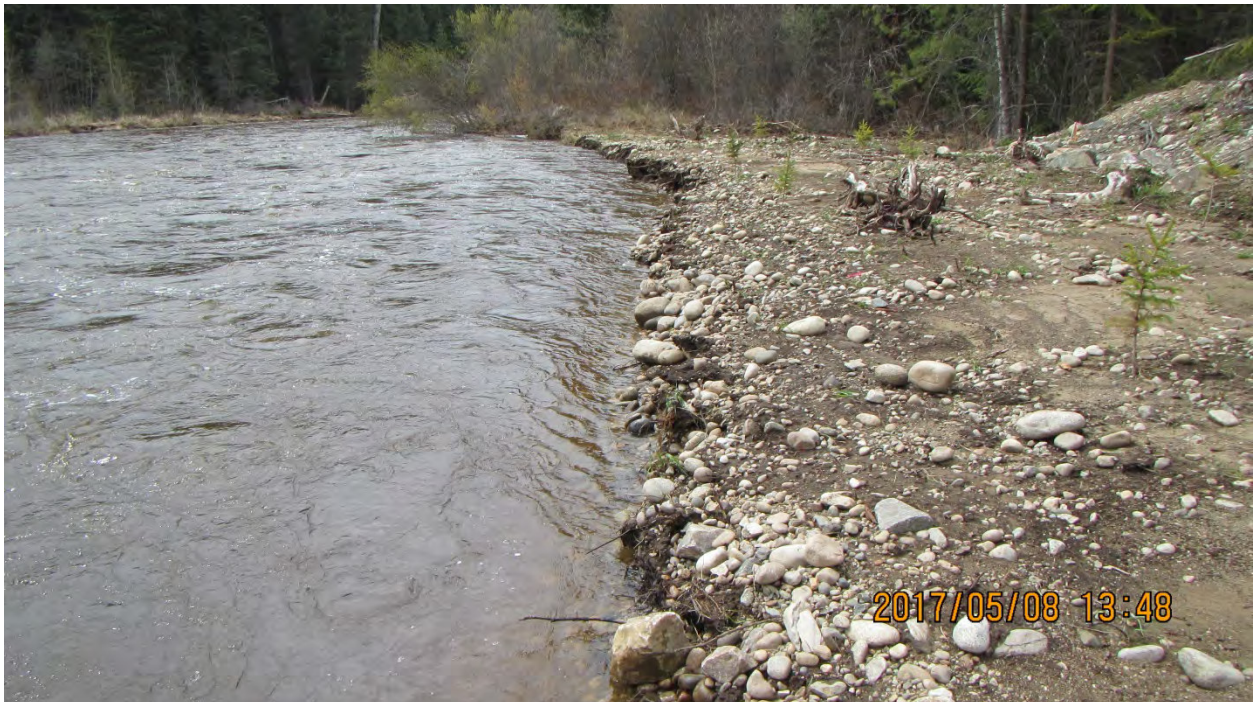
Photo 2
Deterioration in river back, by south corner of Cell 5

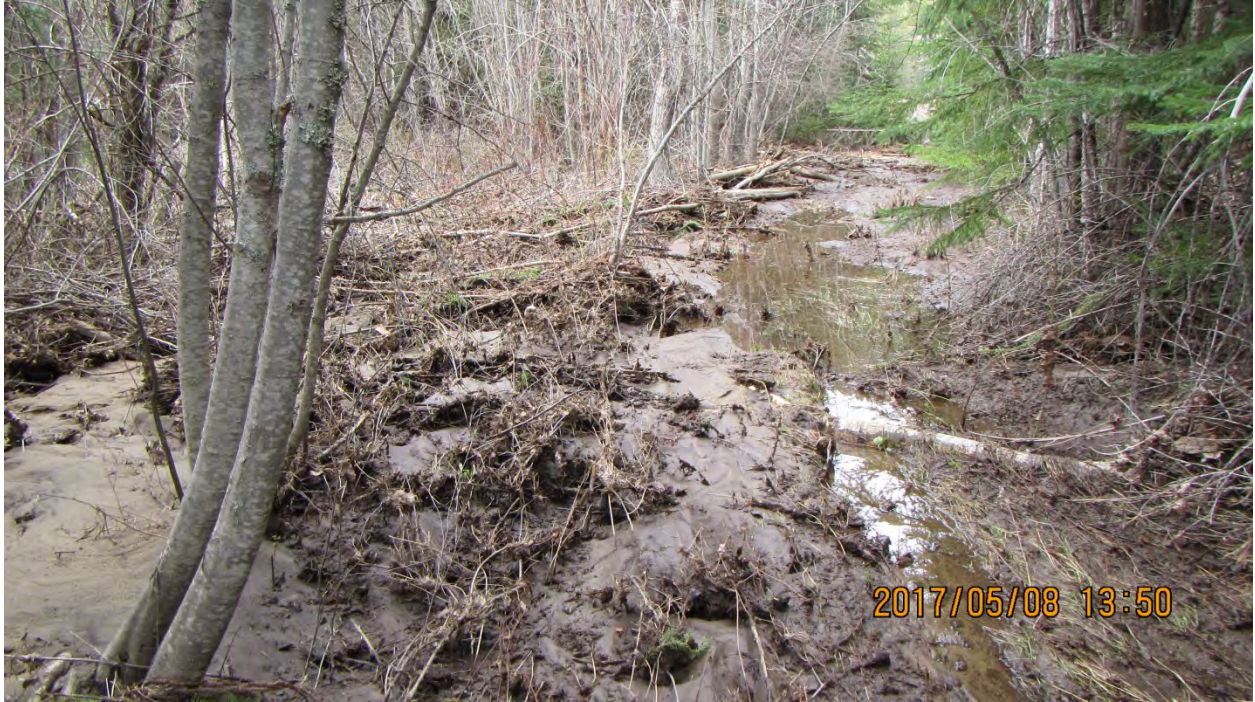
Photo 3
Standing water to the south of Cell 5

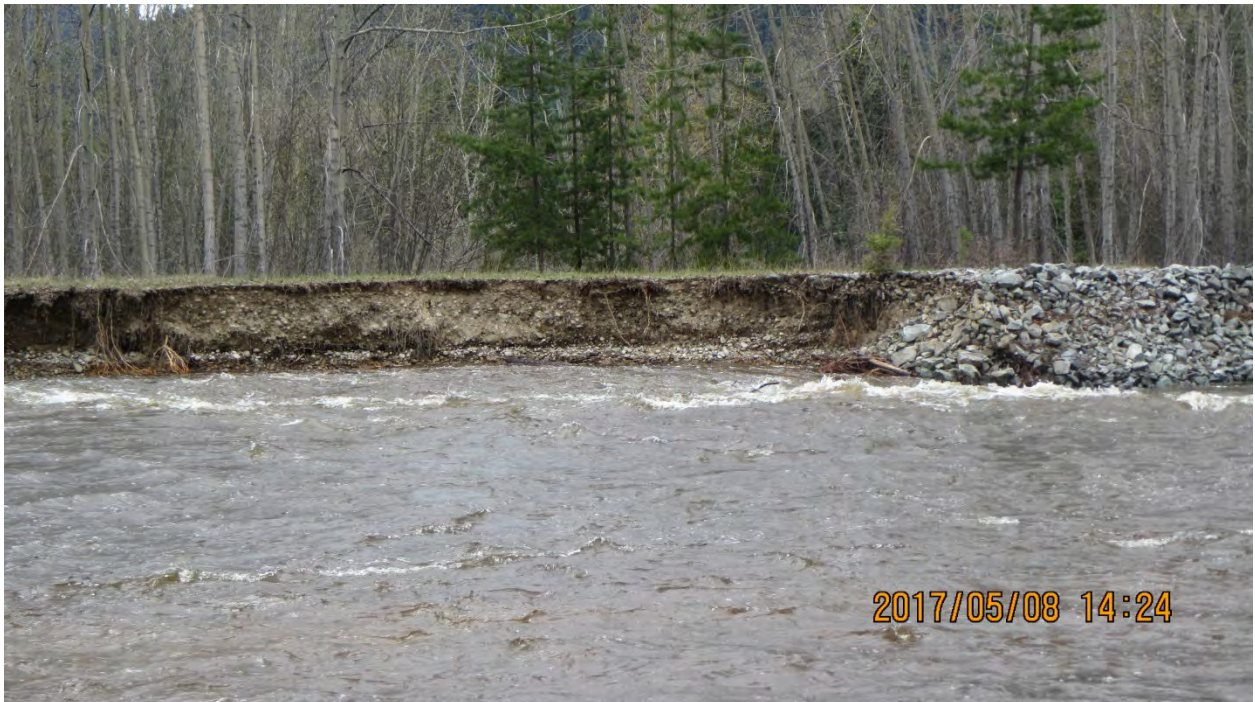
Photo 6
Missing armor and berm section south side of WKR
(red hatched section on figure BEA 2017-001)

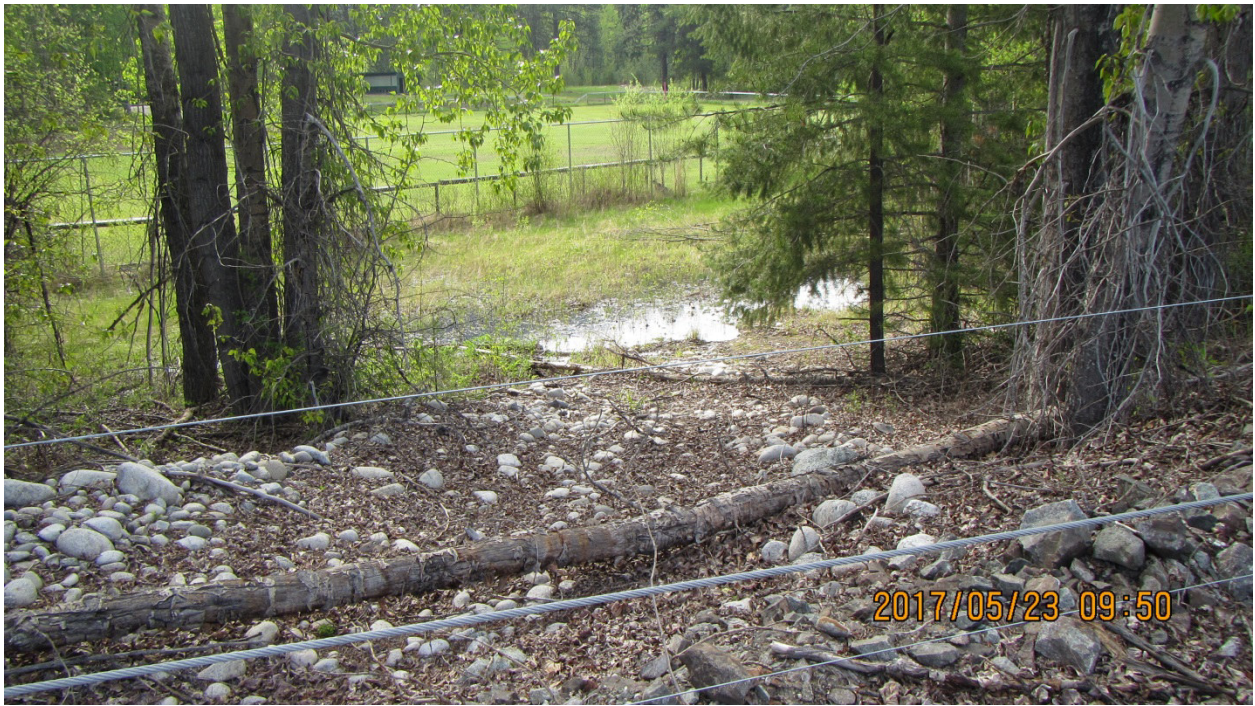
Spillway Debris Cell 3

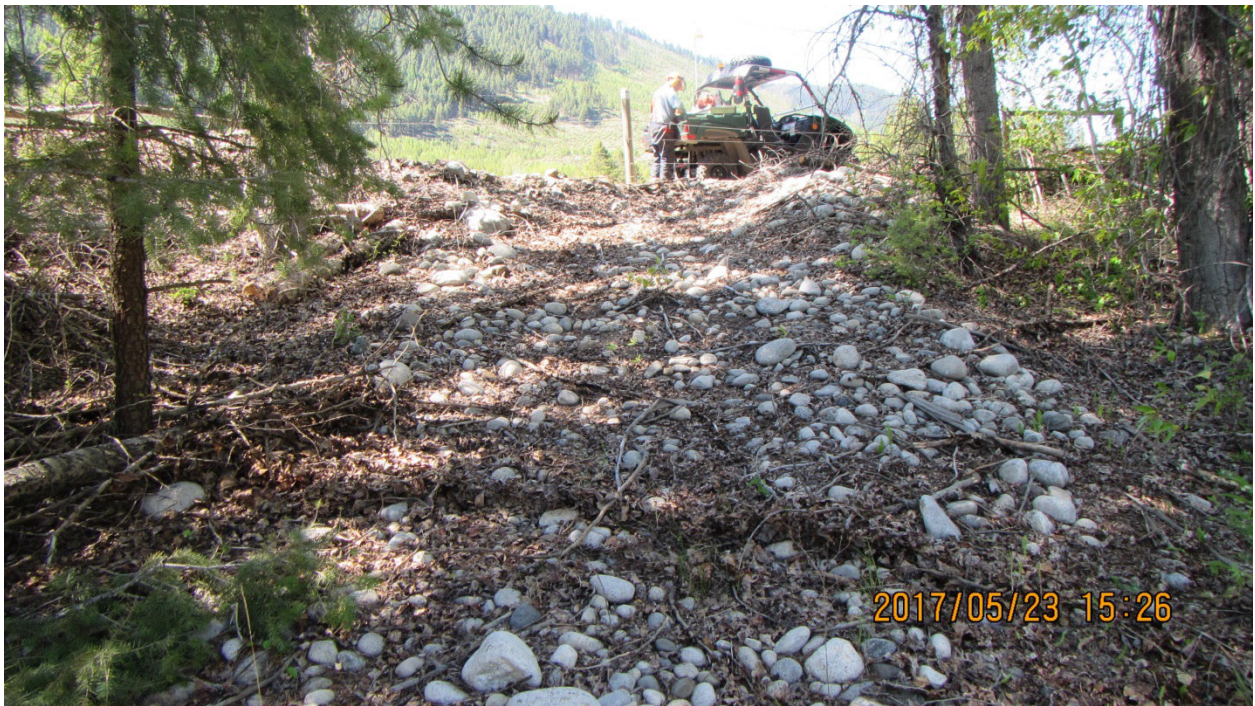
Spillway Debris Removed Cell 3
