TECK RESOURCES LIMITED BEAVERDELL MINE

Beaverdell Tailings Storage Facilities 2017 Annual Dam Safety Inspection

Reference Number: 1778313-052-R-Rev0-1000

This report presents the 2017 annual dam safety inspection (DSI) for the embankments of the tailings storage facilities (TSF) at the closed Beaverdell Mine. The facilities consist of the South TSF and North TSF.

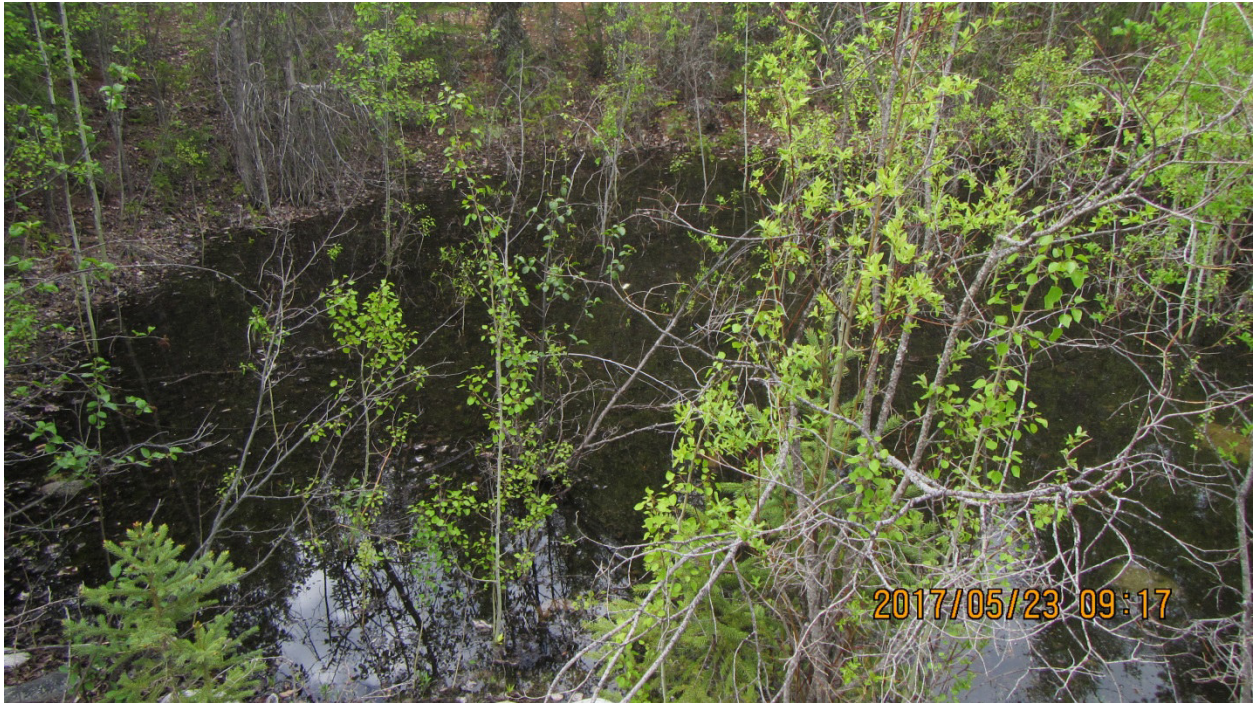
Ponded Water to the South of Cell 5

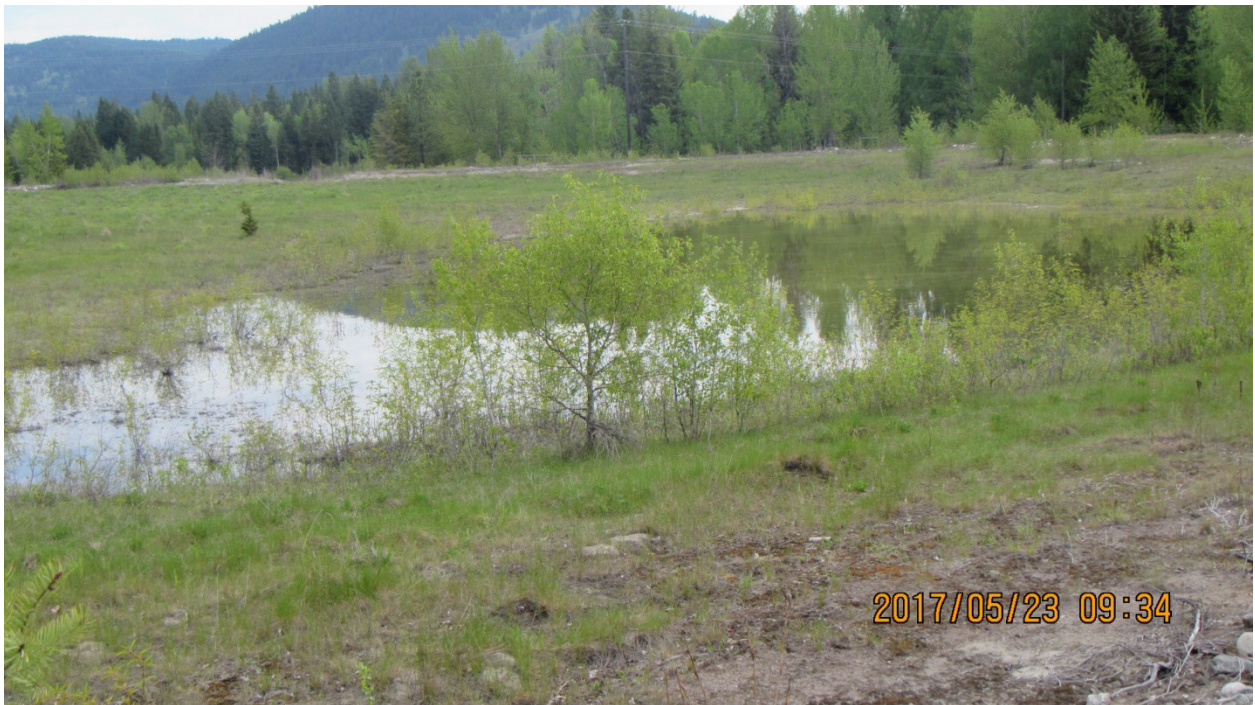
Ponded water in Cell 4

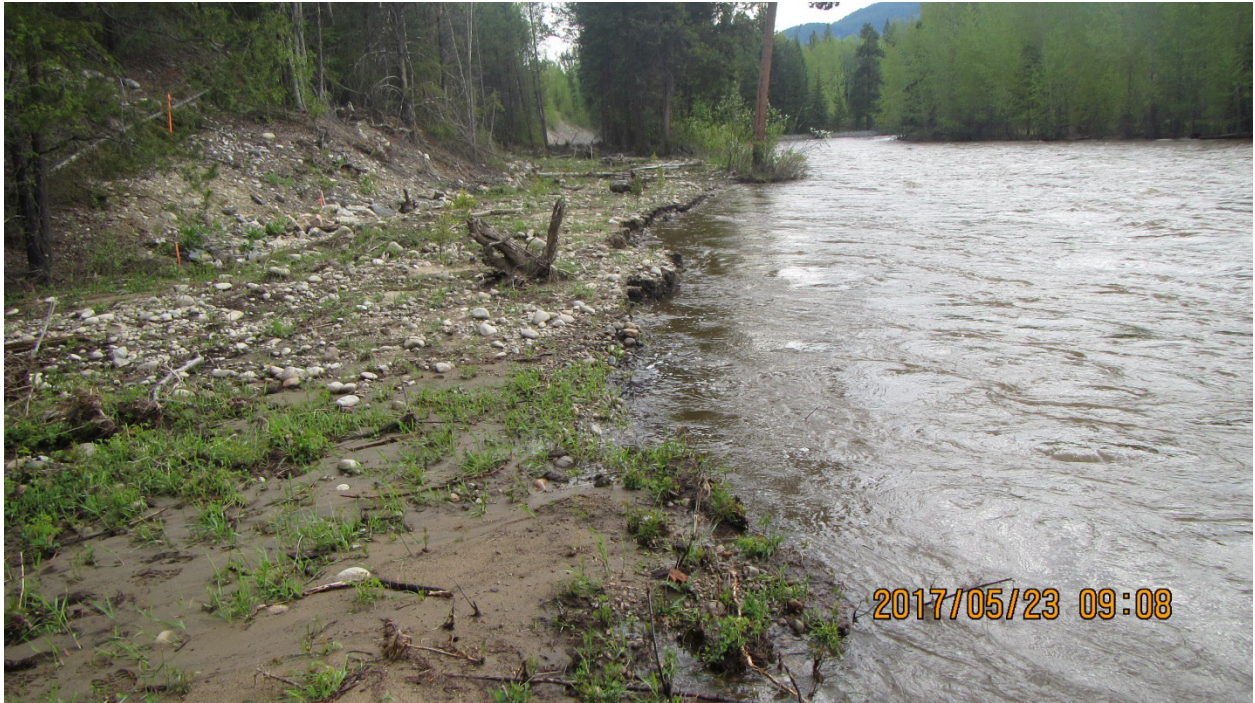
Eroded River bank SE corner of cell 5

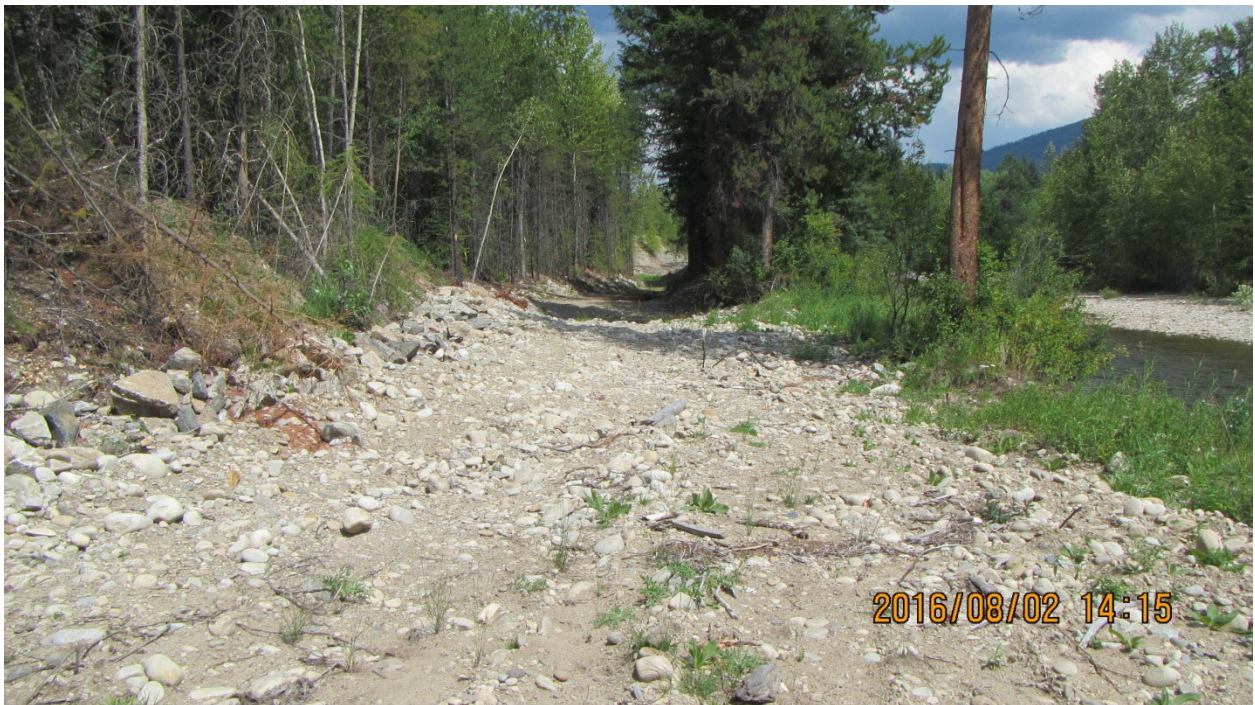
River Bank August 2016

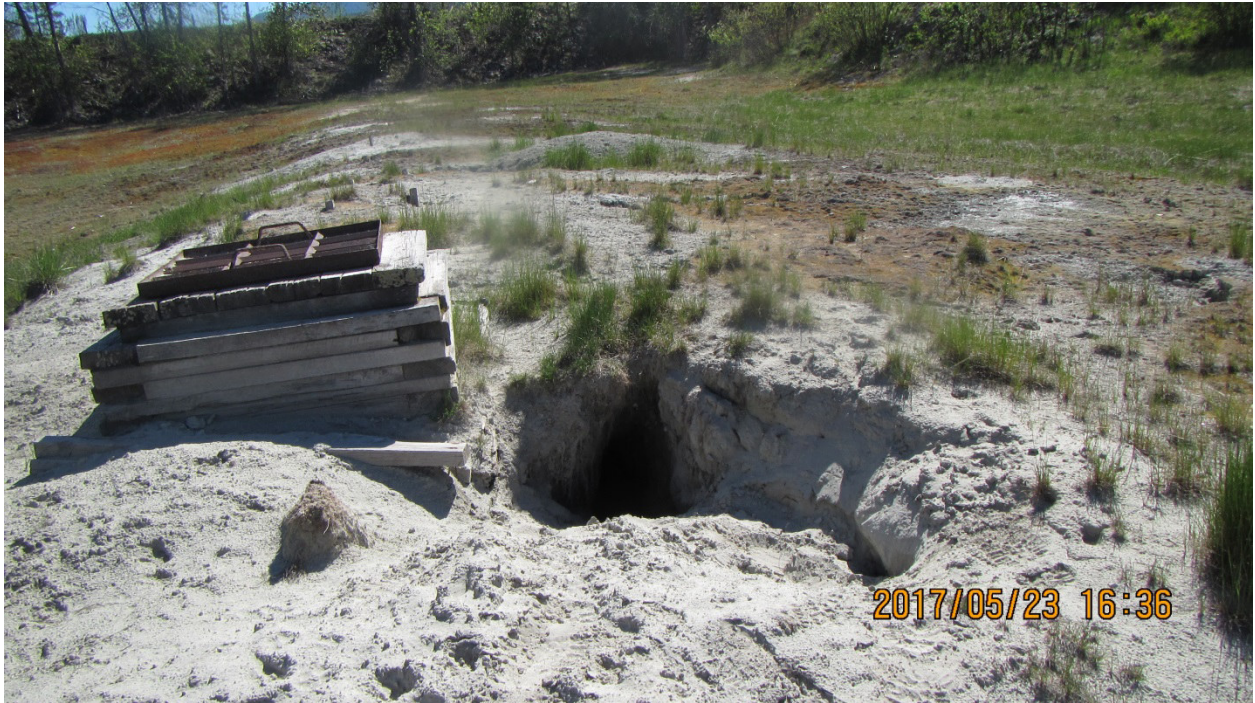
Burrow in Floor of Cell 7

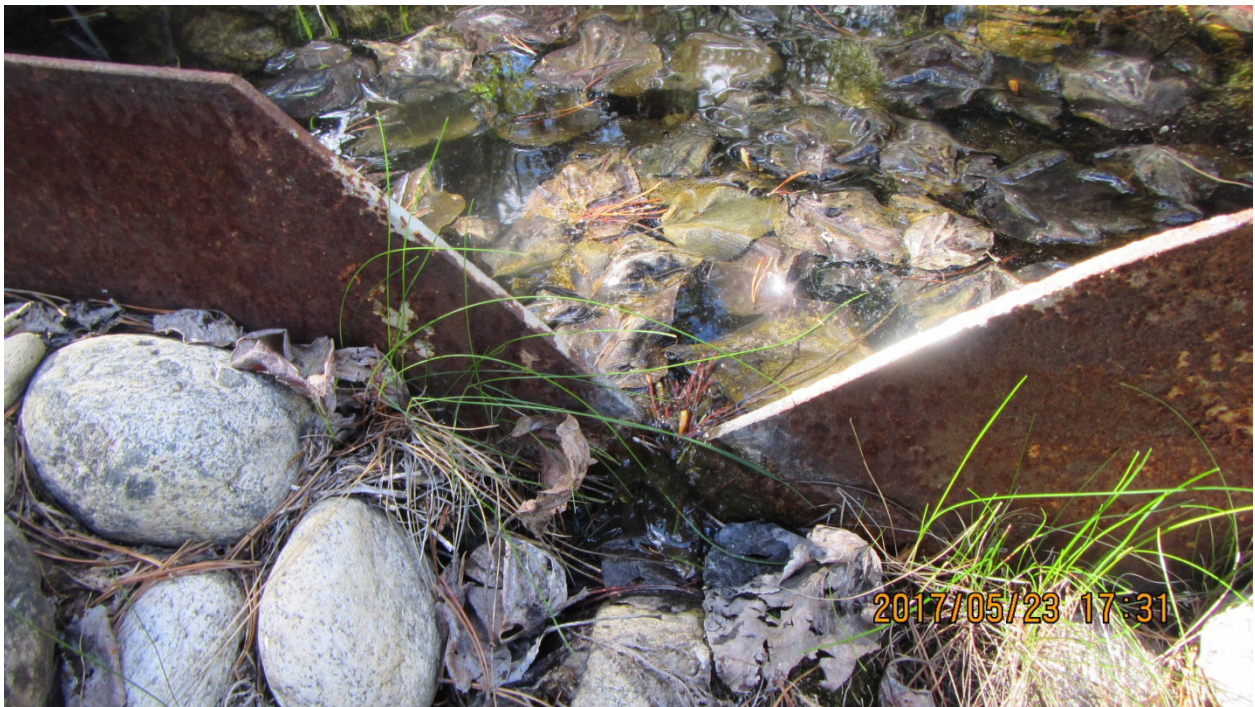
Weir at Decant Outlet Cell 6

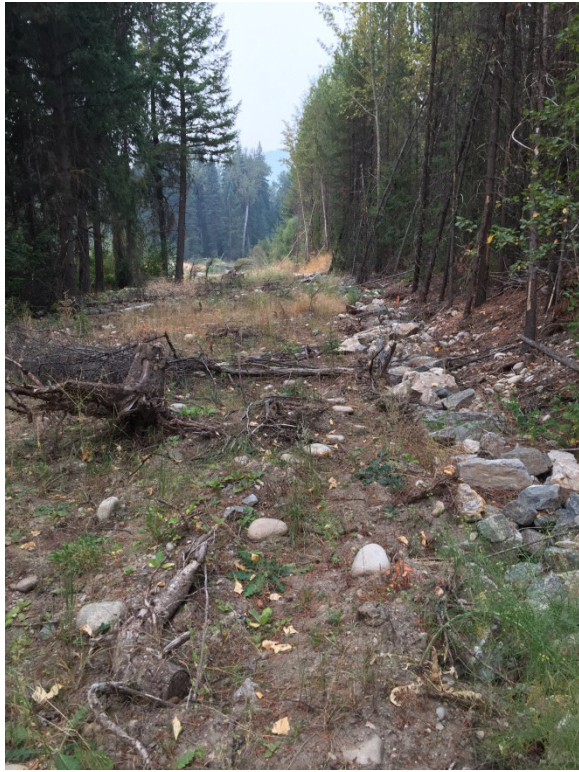
Riprap Cell 5

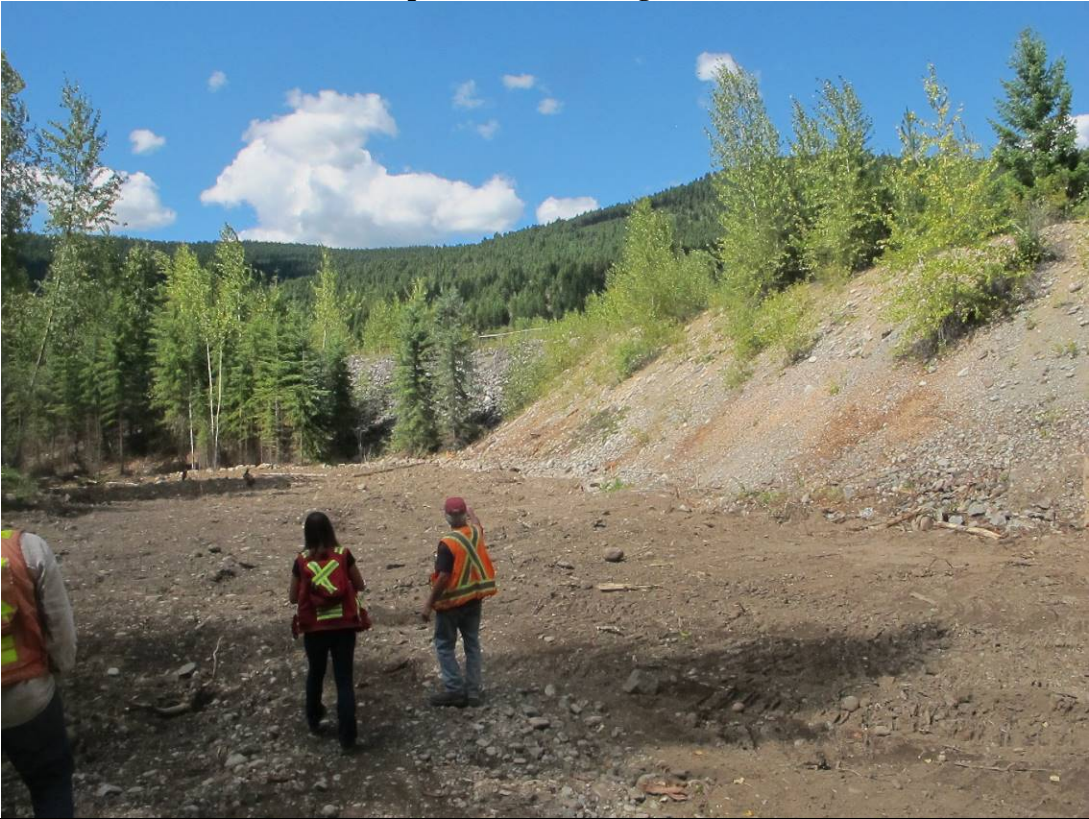
Photo 3: Current spillway of Pond 3
